**Repair and Rehabilitation of Reinforced Concrete
Harbour Structures**

Andrew George Rowan

February 2007

A thesis submitted to the University of Cape Town in partial fulfilment of
the requirements for the degree of Master of Science in Engineering.

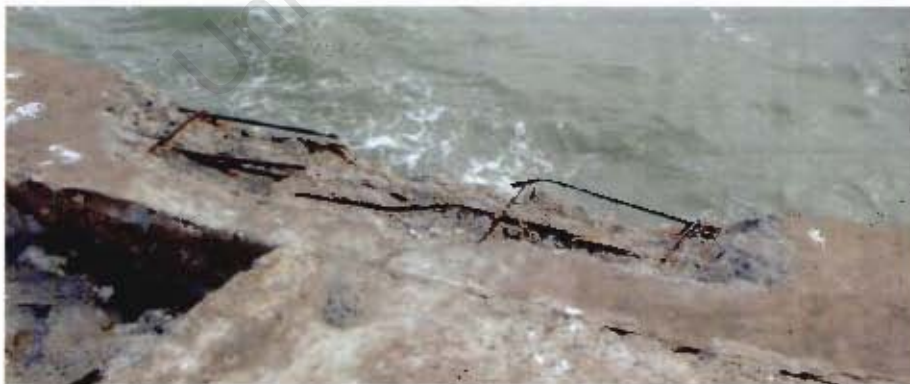
The majority of the work that was performed here comprised patch repairs to the long edge beams of each breakwater, and an example of this is shown in Figure 5-2.

Figure 5-2: Spalling to Western Breakwater (Typical across site)

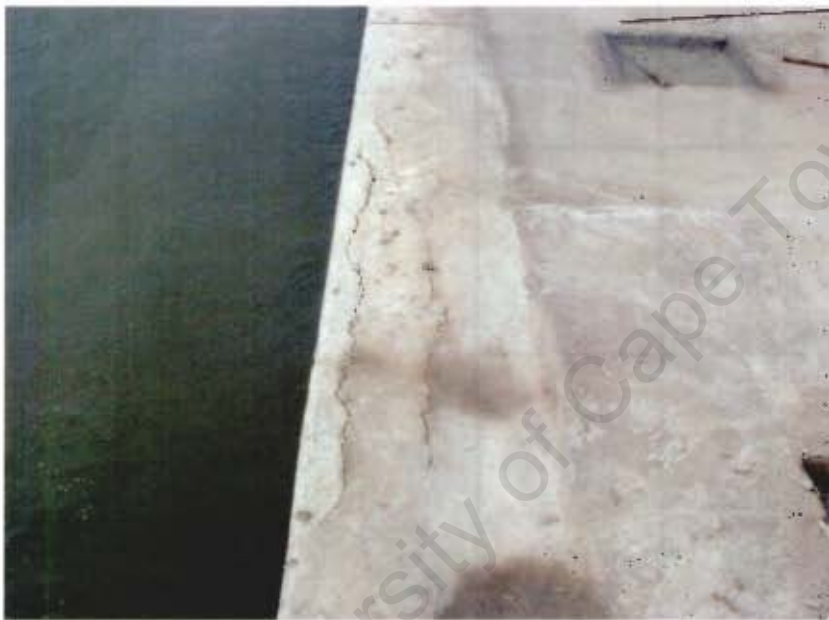
A visual inspection of the Laaiplek Harbour site was performed by the author towards the completion of the repair works, and it was possible even at this late stage to identify many locations of damage due to chloride induced corrosion. The most predominant manner in which damage could be identified was through the cracking and spalling of the cover concrete along the long pile cap beams. Figure 5-3 shows such cracking, and further inspection showed that a large piece of the concrete had fully delaminated.

Figure 5-3: Cracking to Edge Beam

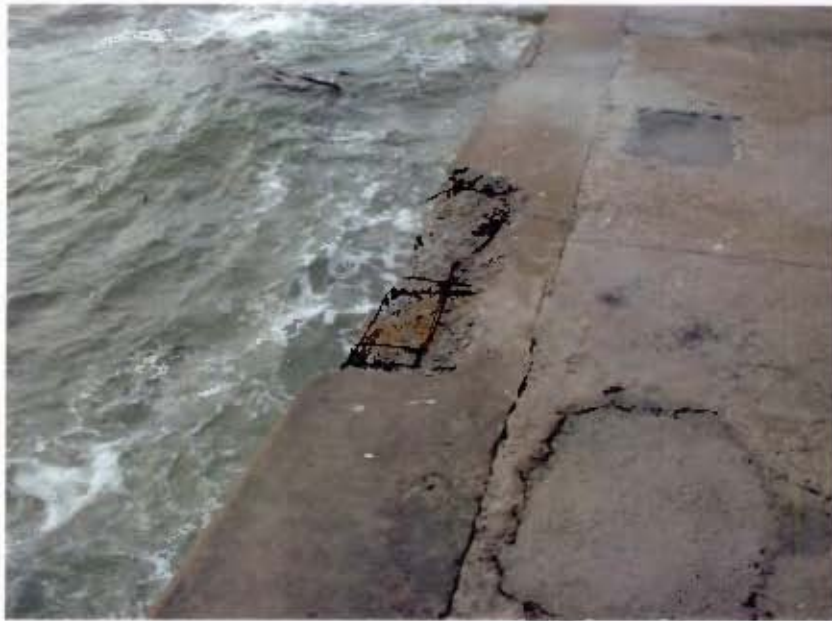
Upon removal of the concrete at such locations, as shown in Figure 5-4, the reinforcing steel was found to be at an advanced stage of corrosion. The two smaller photographs (Figure 5-5), show steel that was found at similar locations and the loss of cross-sectional area can be seen. This was estimated at 50% loss, which suggested an advanced level of corrosion present.

Figure 5-4: Spalling to Edge Beam

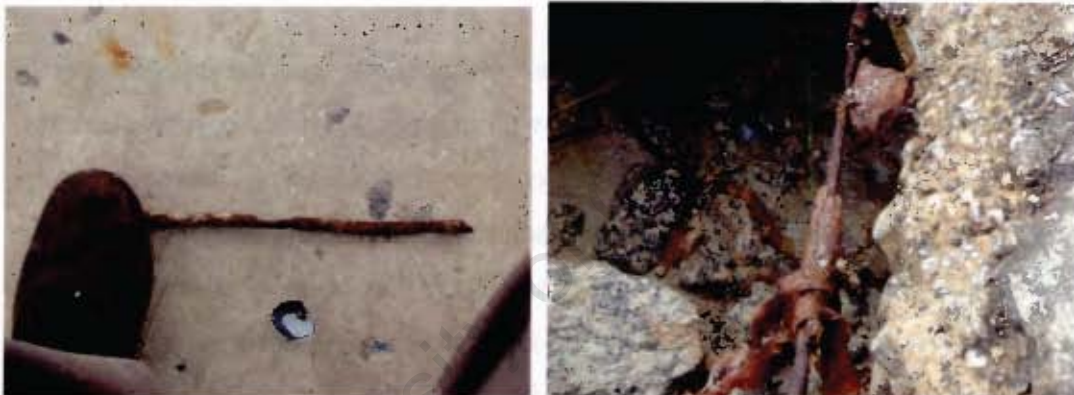
Figure 5-5: Severe loss of section due to corrosion

The survey showed the pernicious nature of chloride attack, with seemingly 'untouched' reinforced concrete being located adjacent to severely damaged concrete.

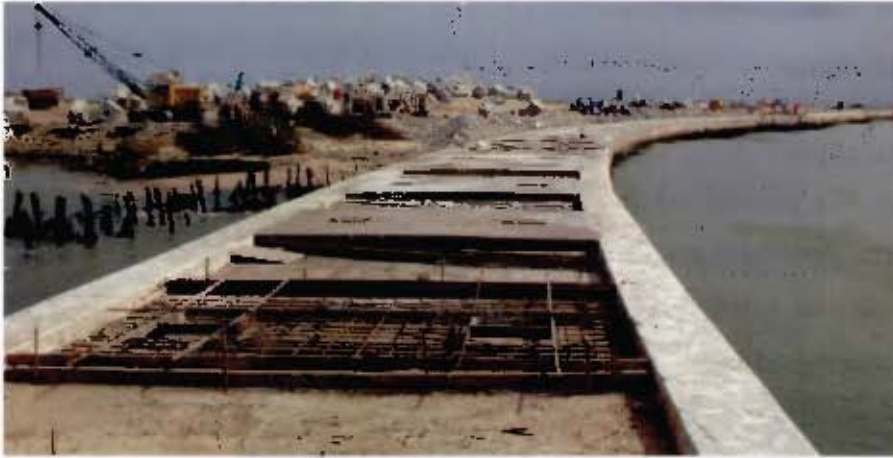
Figure 5-7 below shows the slabs on the western breakwater that were replaced. It was decided that the damage to these elements was too great for rehabilitation, and that the demolition and the reconstruction of the surface slabs was a more suitable option.

Figure 5-7: Reinstating of new slabs on Western Breakwater (Note existing capping beams)

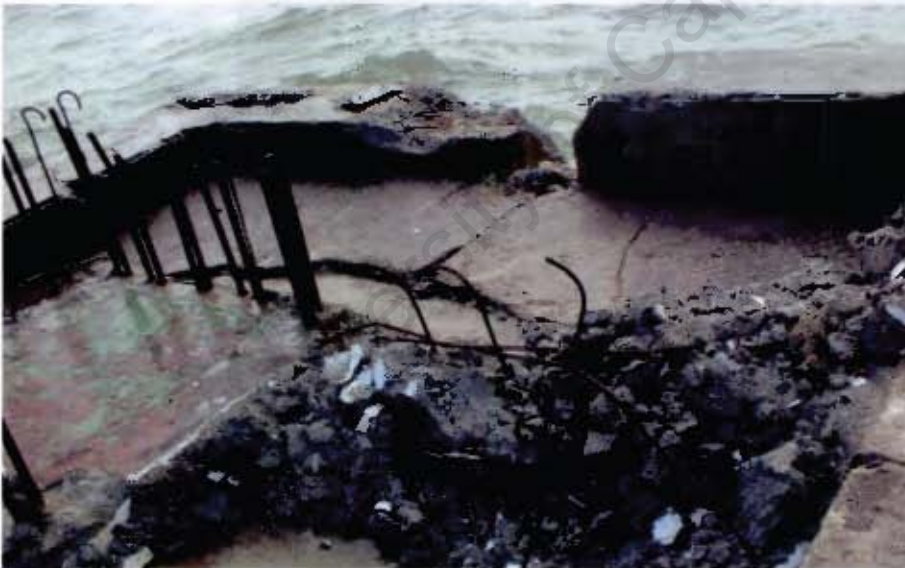
There were numerous instances of patch repairs along the edges of the eastern breakwater too, but the main work at this location concerned the breakwater head. This had settled due the corrosion damage and the settled structure was linked to the breakwater using a new reinforced concrete edge beam.

Figure 5-8: Settled Slab at Lighthouse end of Eastern Breakwater

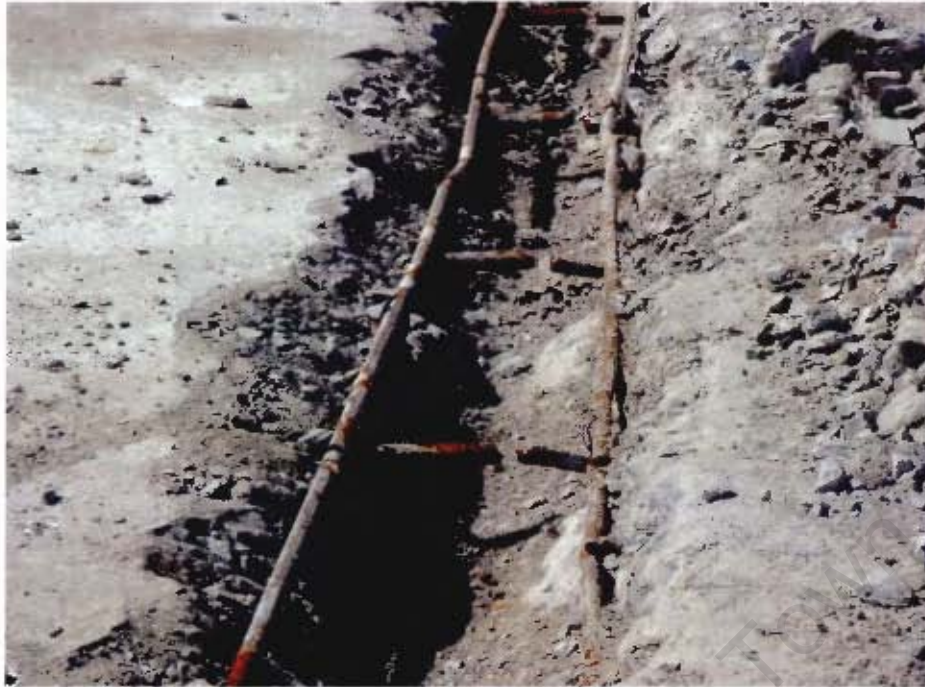
Figure 5-11: General Corrosion damage

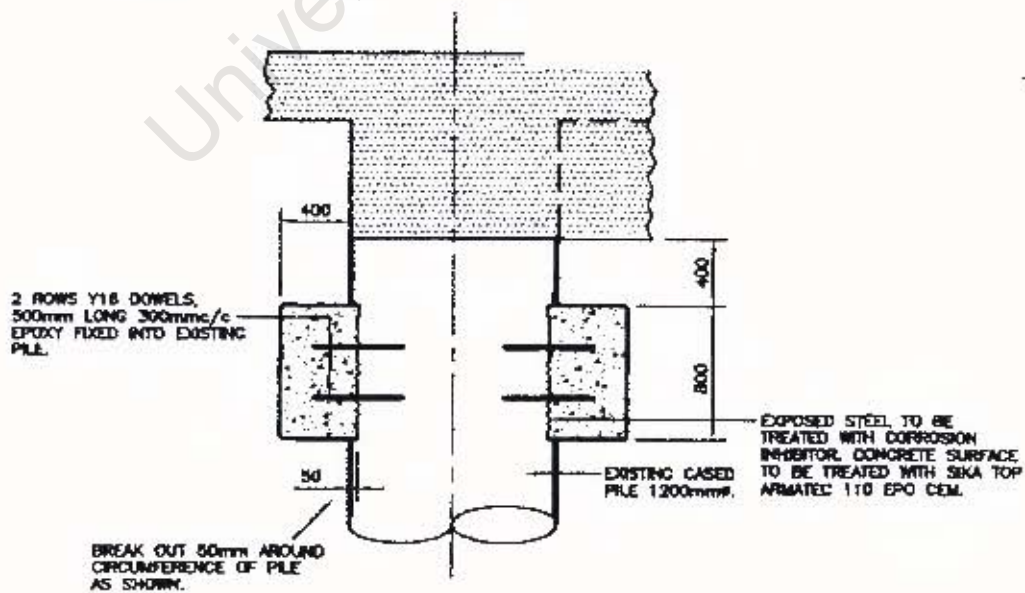
Figure 5-12: Jetty 1 Hout Bay

The above Figure 5-12 shows the rehabilitation of Jetty 1 at Hout Bay Harbour, by placing a new supporting ring beam underneath the structure. The use of surface treatments as is shown in the diagram is noteworthy.

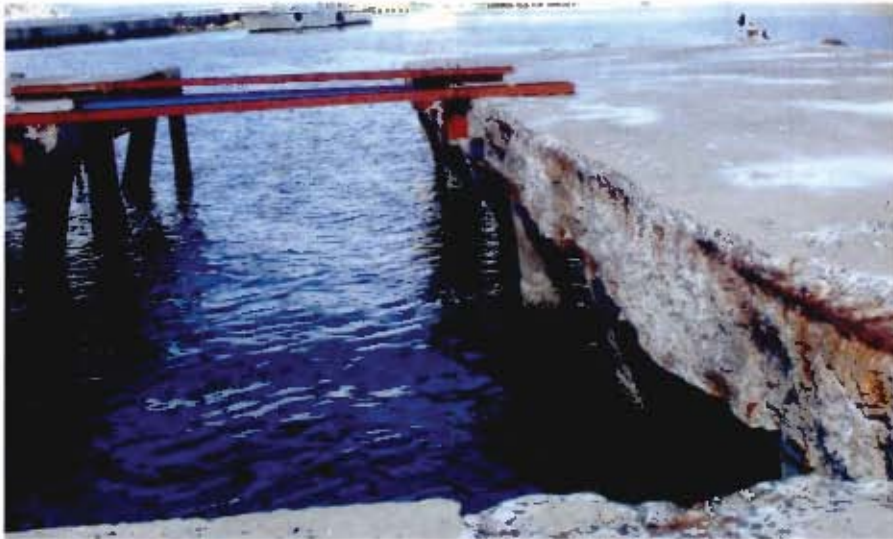
The turning bay structure on the North Mole was of particular interest because it was a structure that had reached the point of ultimate structural failure. Figure 5-14 shows the structure at a stage of partial collapse, where the central spanning slab had failed in an assumed shear mechanism. The exposed steel revealed minimal reinforcement and the minimal visible steel (assumed to be designed to minimum code requirements) was found to be in an active state of corrosion, despite showing good cover depths (>50mm).

Figure 5-14: Collapsed bay of Turning Mole, showing damaged steel reinforcement

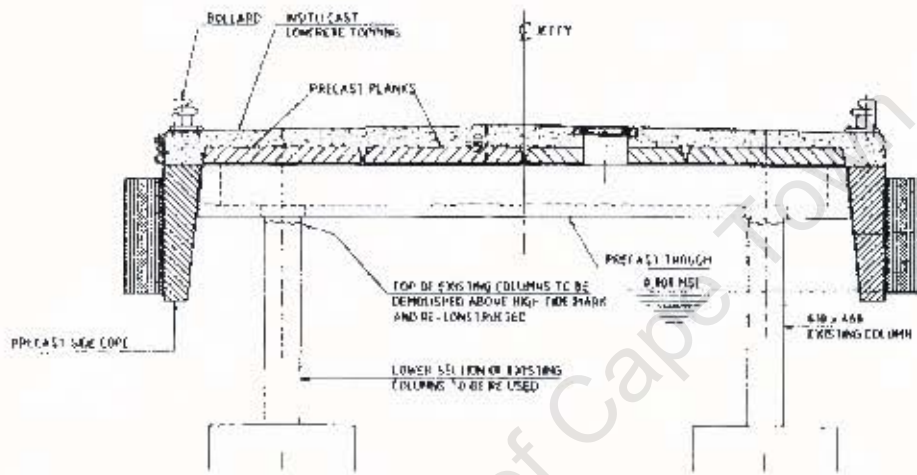
One of the main focus points of the rehabilitation contract at St Helena bay was the identification of major corrosion damage at Jetty 1. Investigation of the underneath of the jetty showed severe cracking to the longitudinal and transverse beams supporting the main deck, and the decision was made to demolish the deck along with the support beams, but to retain the columns. The new design used both precast elements and in situ cast members.

Figure 5-26: Concrete Repairs at St Helena Bay, Jetty 1

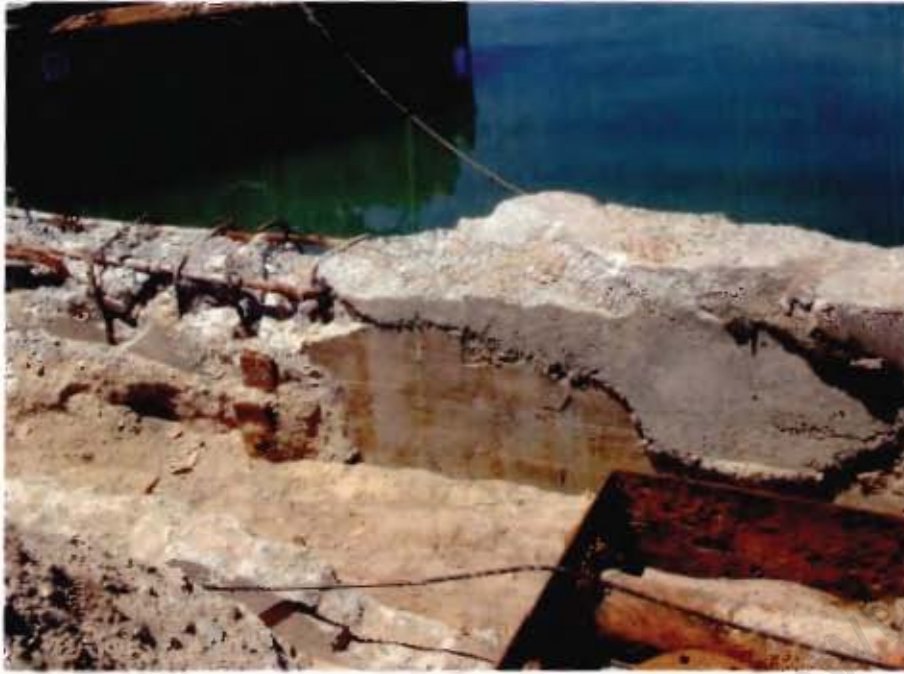
Figure 5-17: Previously performed patch repairs

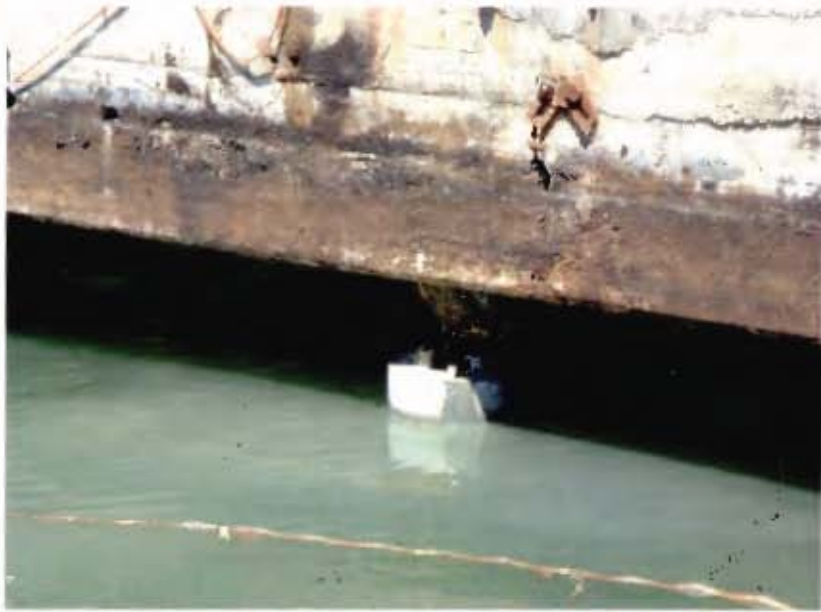
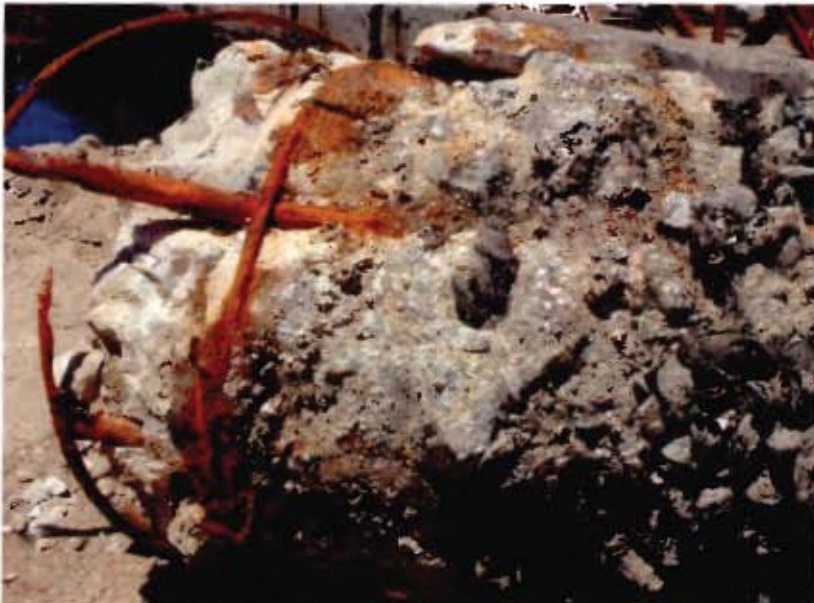
Figure 5-20: Severe damage to Trawler Quay beams and columns

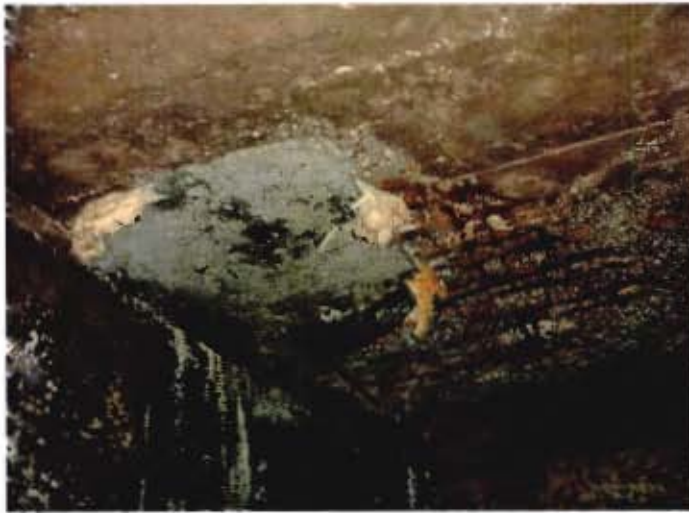
Figure 5-28: Failure of previously performed repairs at Jetty 1, St Helena Bay

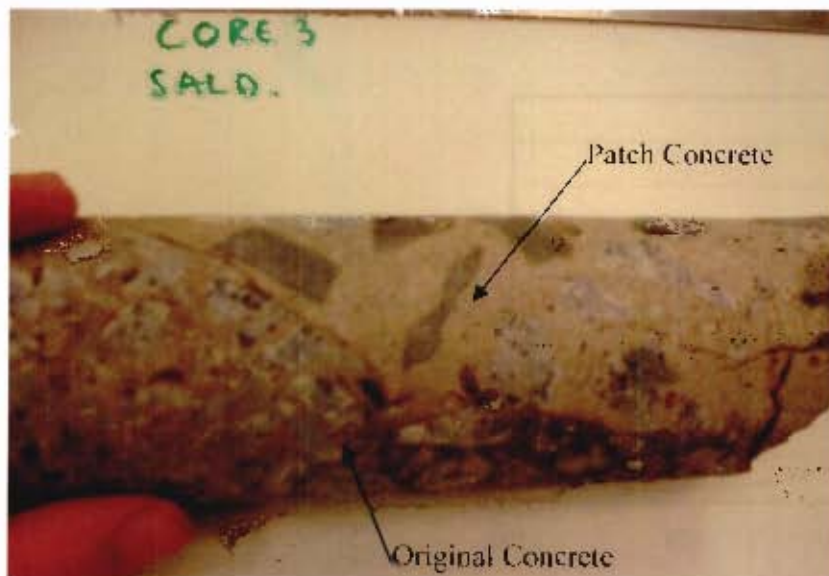
Figure 6-8: Core through Trawler Quay showing original concrete (below left) and patch repair (above right).
