Department of Civil Engineering

**A comparative study on the structural behaviour of concrete arch
dams subjected to swelling due to aggregate silica reactions**

Civil Infrastructure Management and Maintenance

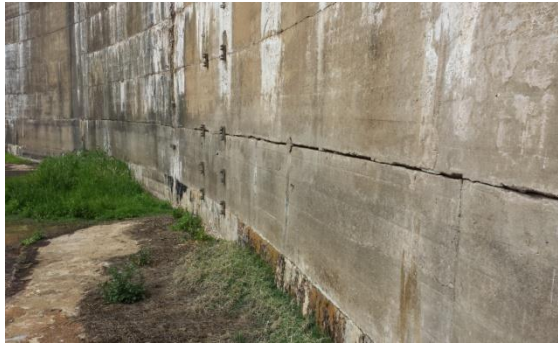
Figure 2-14: Typical separation of a horizontal construction lift joint at Poortjieskloof Dam in South Africa

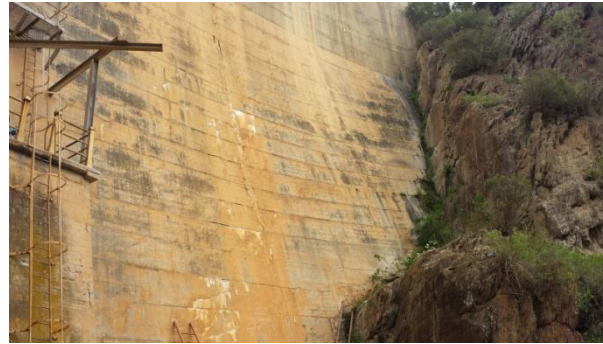
Figure 2-15: Typical peripheral cracks at Poortjieskloof Dam in South Africa

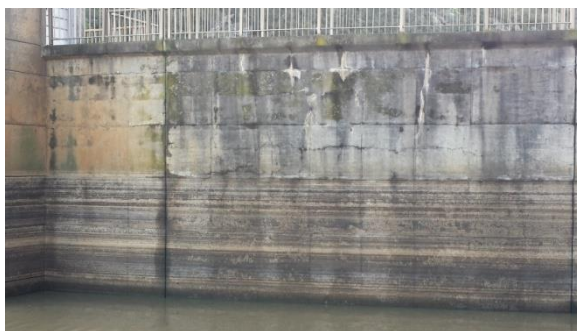
The upstream face of the right flank mostly displayed horizontally orientated cracks (see Figure 4-2 and Figure 4-3).

Figure 4-2: Hartebeeskuil Dam: The upstream concrete face of the right flank displaying horizontal cracks

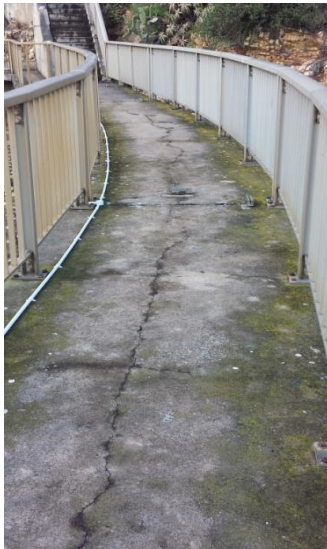
orientations (see Figure 4-4 and Figure 4-5). The smaller cracks are possibly only shrinkage cracks due to the small crack widths and random orientation. A core sample of the significant tangential crack was drilled in 1999 and it revealed that the crack was only approximately 0.4 m deep.

Figure 4-4: Hartbeeskuil Dam: A major tangential crack on the right flank crest

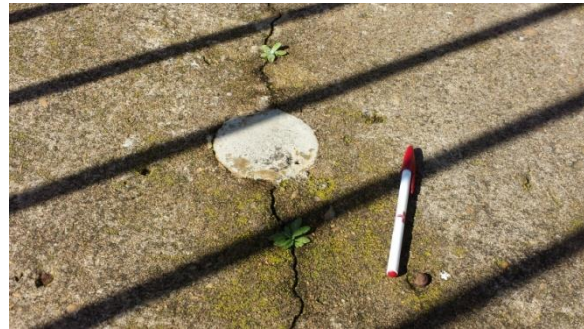
Figure 4-5: Hartbeeskuil Dam: An indication of the crack width and previous core drill hole that determined the depth of the crack

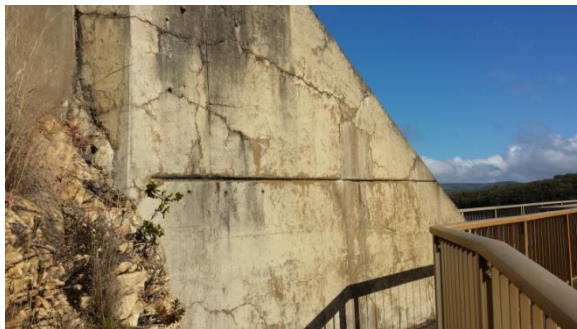
There are steps on the far-right flank that provide access to a survey beacon on the right abutment. These steps showed signs of possible AAR-related cracking. This was especially evident from the crack width, crack orientation and staining around the cracks (see Figure 4-6 and Figure 4-7).

Figure 4-6: Hartbeeskuil Dam: AAR cracking pattern on the far-right abutment steps

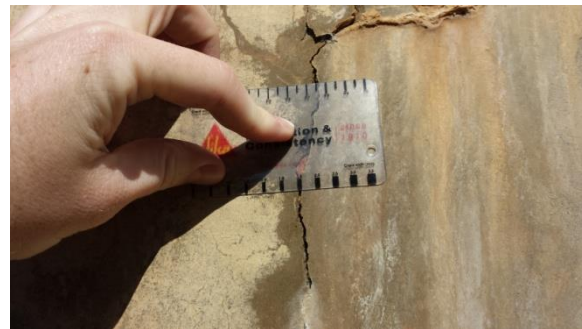
Figure 4-7: Hartbeeskuil Dam: Crack width and typical ASR crack staining

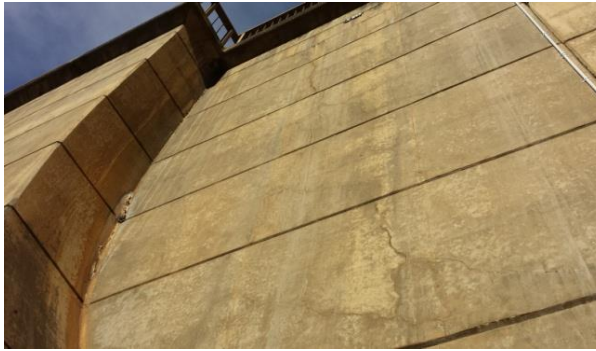
The right flank downstream face displayed peripheral cracks that are orientated approximately parallel to the abutments (see Figure 4-8 to Figure 4-11). These peripheral cracks give evidence of a principal stress distribution that is not ideal for an arch dam which is similar to that typically caused by AAR-related swelling.

Figure 4-8: Hartebeeskuil Dam: Typical parallel peripheral cracks in the vicinity of the right flank "pulvino"

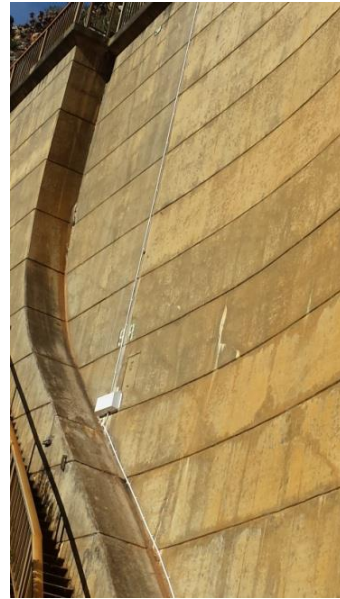
Figure 4-9: Hartebeeskuil Dam: Parallel cracks evident on the right flank downstream face

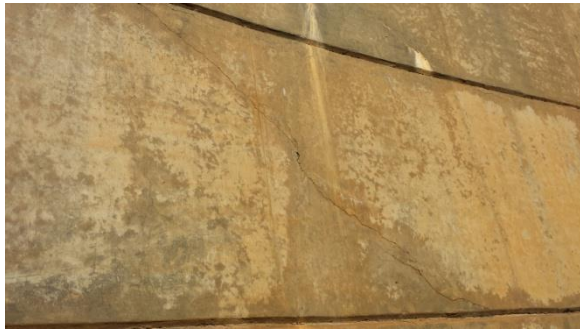
Figure 4-10: Hartebeeskuil Dam: Close-up view of one of the peripheral cracks on the right flank downstream face

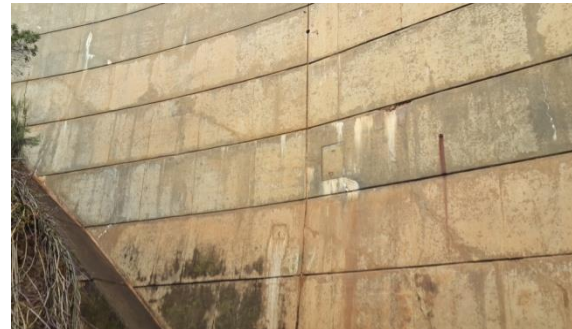
Figure 4-11: Hartebeeskuil Dam: Parallel cracks in the vicinity of the "pulvino"

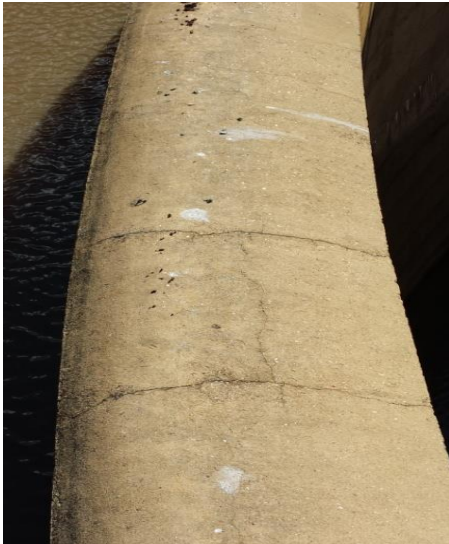
The upstream face of the spillway could not be inspected due to restricted access and the fairly high water level. The crest of the spillway displayed one significant tangential crack.

Figure 4-12: Hartebeeskuil Dam: Tangential crack between two radial cracks on the spillway crest

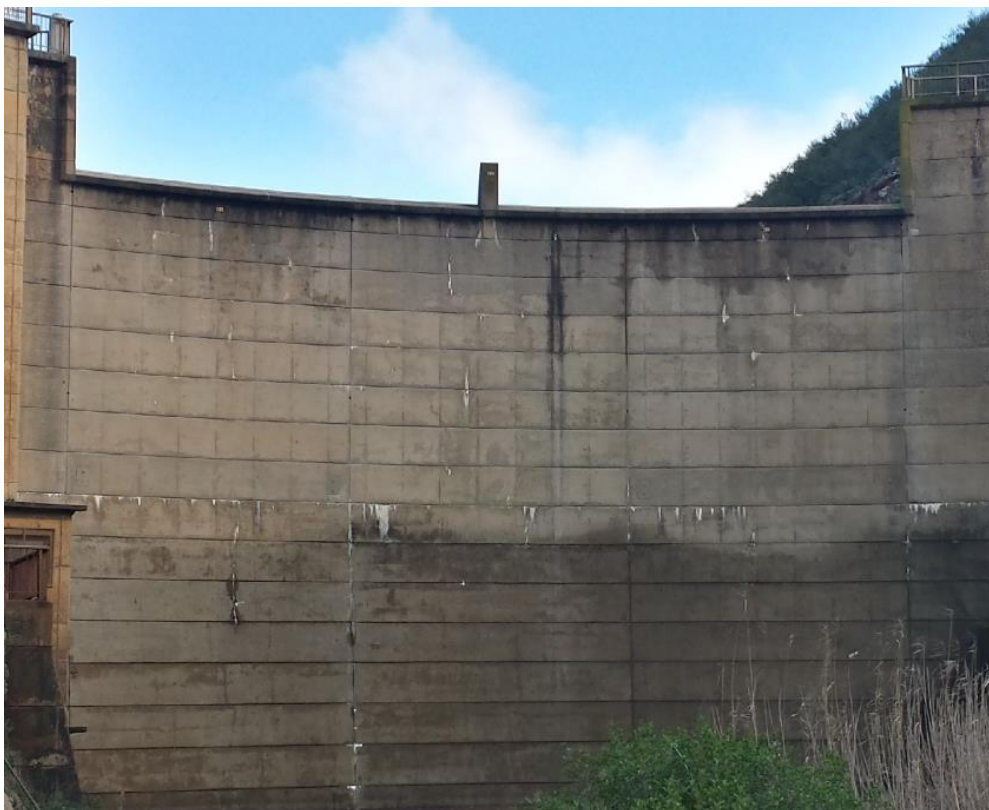
The spillway downstream face was generally in a good condition. No prominent cracking patterns were visible. One horizontal lift joint (the lift joint where the vertical profile of the concrete above and the slightly sloped concrete below, meet) displayed evidence of calcite staining which is indicative of an open joint (see Figure 4-14).

Figure 4-14: Hartebeeskuil Dam: Calcite staining visible on the downstream face of the spillway section

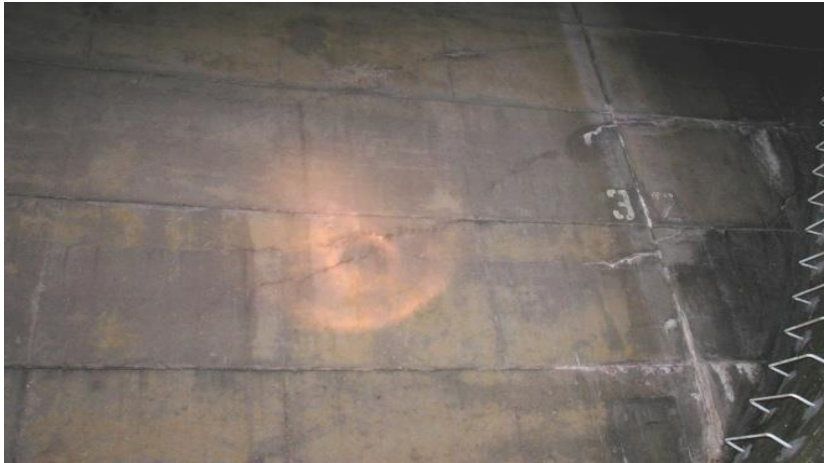
The left flank upstream face and non-overspill crest (NOC) could not be accessed. The left flank downstream face displayed more of the same cracks as were evident on the right flank downstream face though slightly less prominent (see Figure 4-15 to Figure 4-17).

Figure 4-17: Hartebeeskuil Dam: Typical peripheral cracks on the left flank

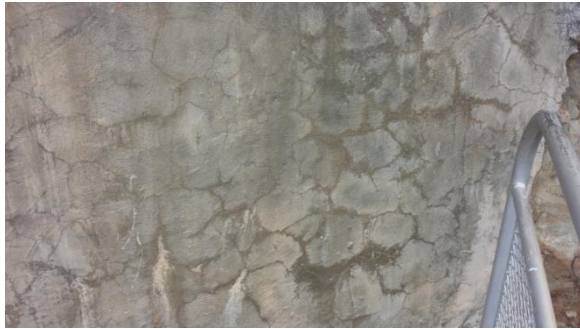
The left flank NOC was in a good condition (see Figure 5-5). The concrete structure to the left of the NOC (which include the steps from the parking area) displayed AAR cracking patterns as shown in Figure 5-4 and Figure 5-6.

Figure 5-4: Poortjieskloof Dam: Map cracking on concrete step structure left of the NOC

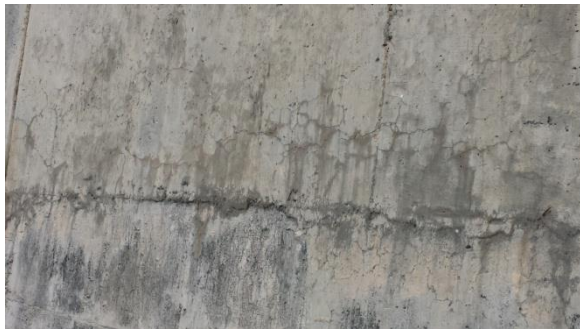
Figure 5-6: Poortjieskloof Dam: Some more map cracking on the concrete step structure

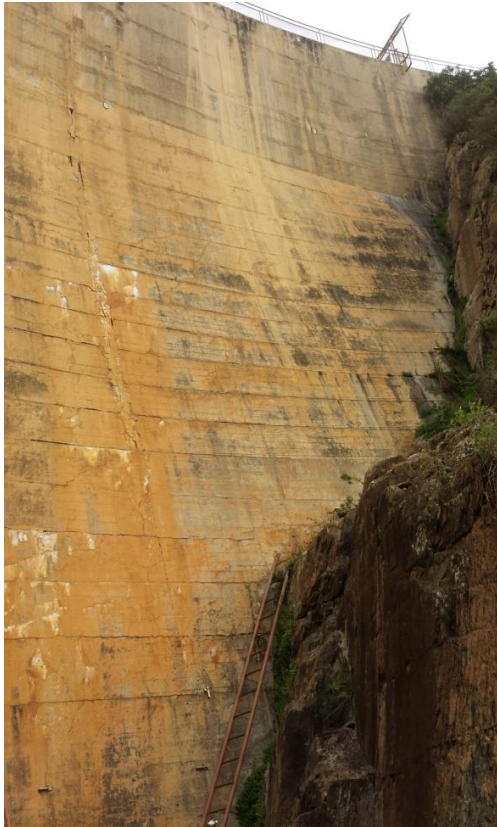
Figure 5-7: Poortjieskloof Dam: Clear parallel peripheral cracking patterns visible on the left flank downstream face

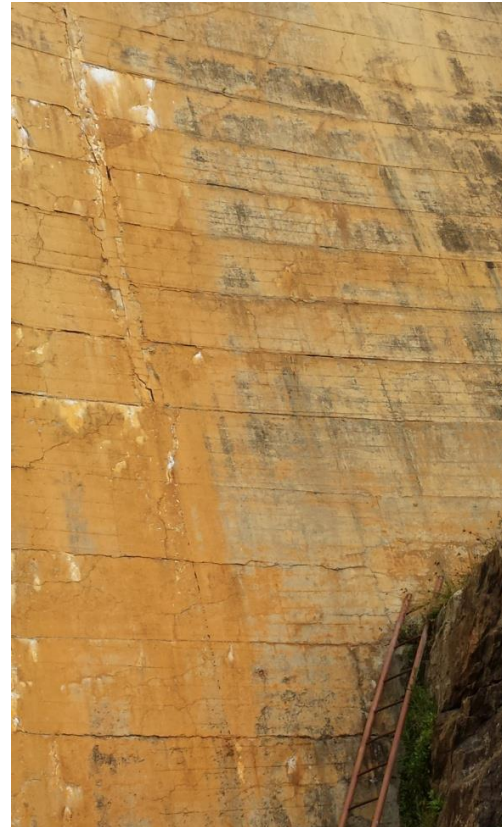
Figure 5-8: Poortjieskloof Dam: Close-up view of the cracking patterns on left flank downstream face

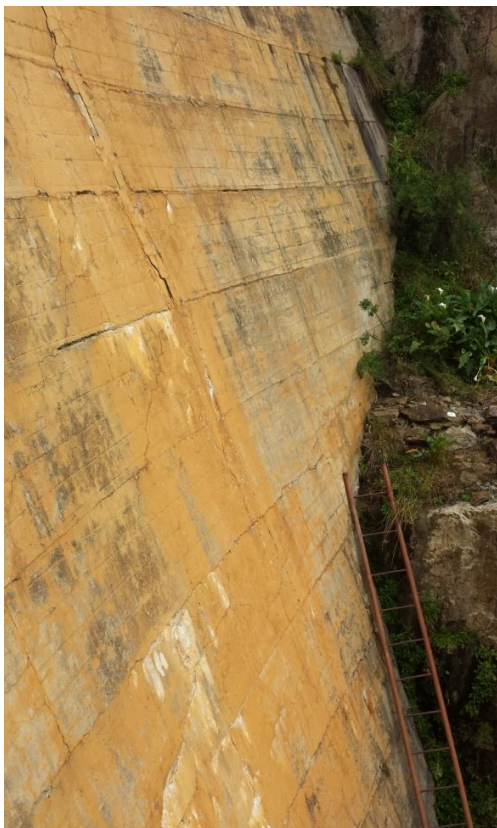
Figure 5-9: Poortjieskloof Dam: Some seepage through horizontal lift joints bordering the left abutment

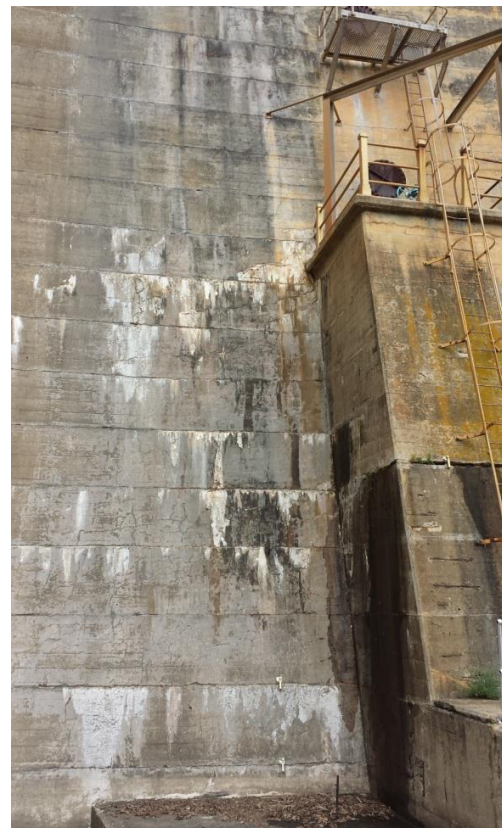
The area around the outlet structure displayed excessive map pattern cracking. This area also displayed evidence of seepage and staining around the cracks. The stiffness of the outlet structure clearly has an influence on the immediate surrounding arch structure as more severe cracking was present in the vicinity of this structure (see Figure 5-10 and Figure 5-13).

Figure 5-10: Poortjieskloof Dam: Excessive map cracking patterns surrounding the outlet structure; also, note the staining

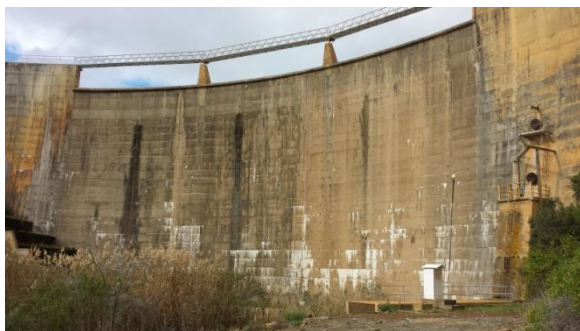
The downstream face of the spillway displayed excessive seepage through the horizontal construction lift joints, which is characterised by calcite staining and moist areas (see Figure 5-12). The first major lift joint above the apron showed clear separation on the downstream side (see Figure 5-14). The separation and excessive leakage of the horizontal construction lift joints are typical AAR expansion phenomena.

Figure 5-12: Poortjieskloof Dam: General view of spillway downstream face

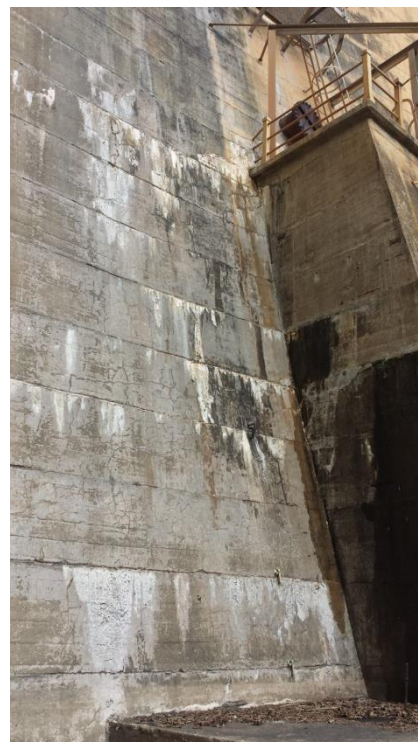
Figure 5-13: Poortjieskloof Dam: Increased cracking in the area surrounding the outlet structure

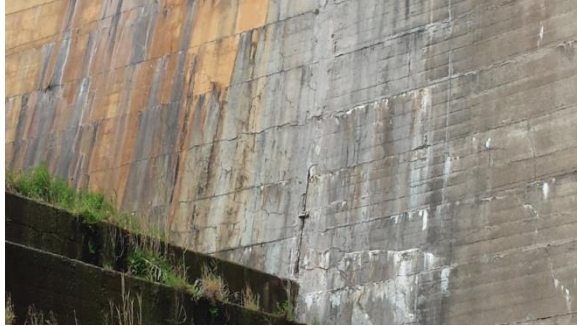
Figure 5-15: Poortjieskloof Dam: Unfavourable cracking patterns on the right flank

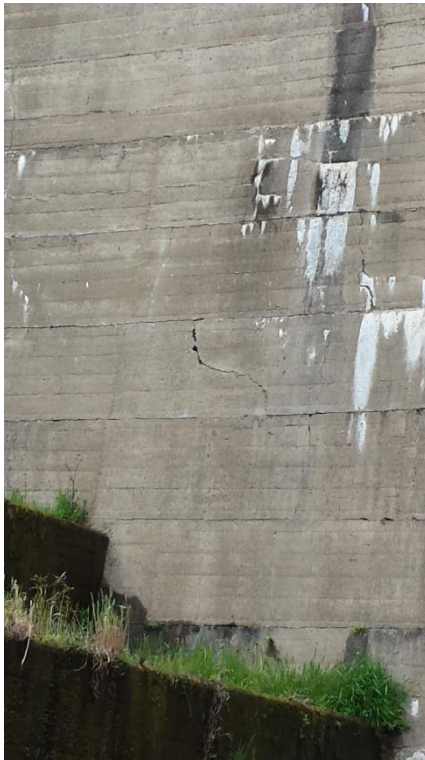
Figure 5-17: Poortjieskloof Dam: A prominent crack parallel to the abutment

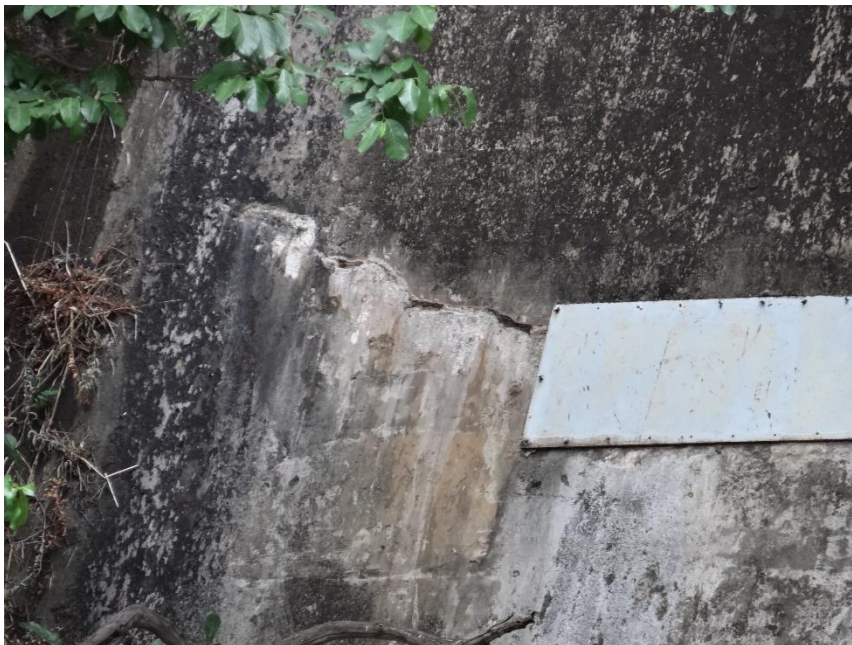
Figure 6-4: The prominent crack near the base of the right flank abutment area

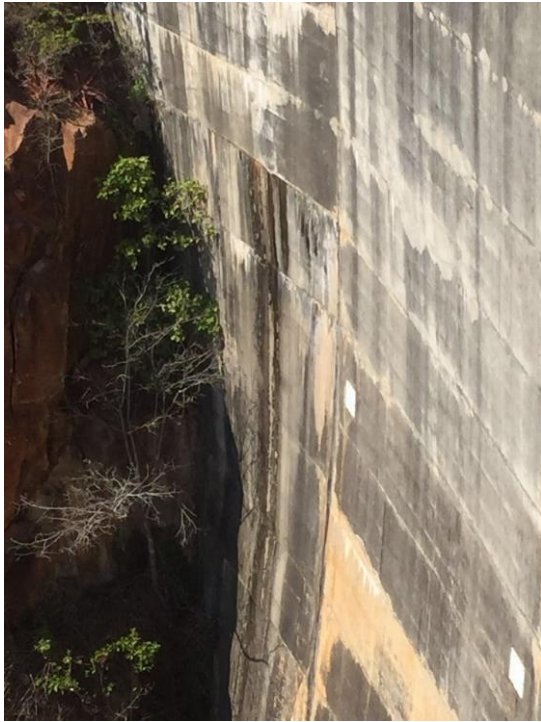
Figure 6-5: View of the horizontal lift joint that displays active seepage
