CIV5017Z: MINOR DISSERTATION FOR THE DEGREE OF MASTER OF
ENGINEERING

An Analysis of the Impact of Chloride-Induced Corrosion on Reinforced Concrete Structures in the Port of Cape Town

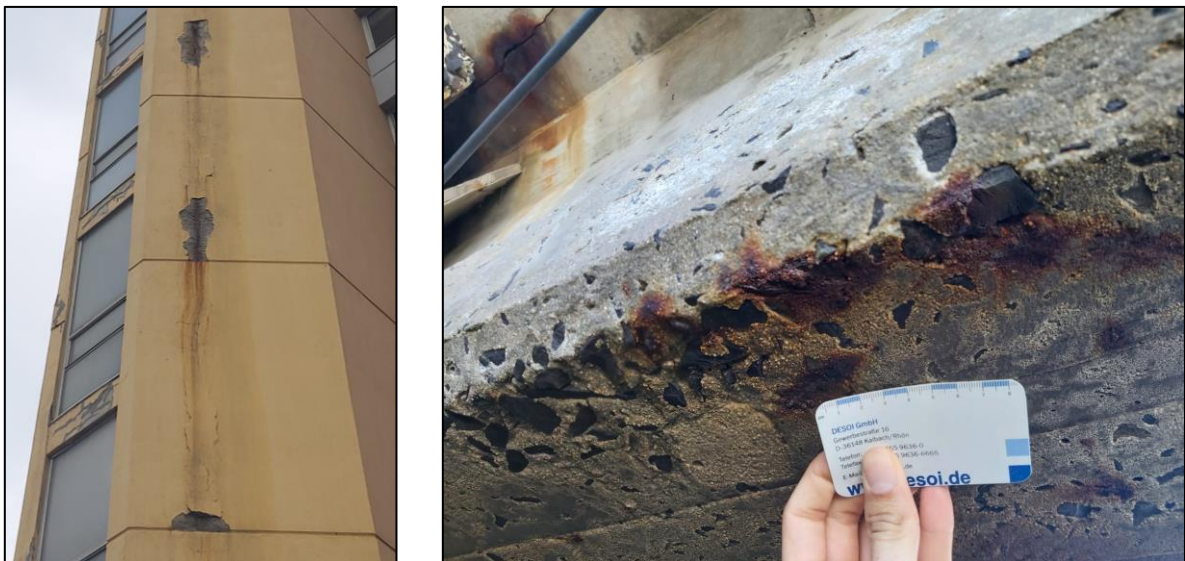
Figure 10 Effects of corrosion at TNPA House building (left) and Eastern Mole Approach Bridge (right)

Figure 10 below illustrates two examples, one relating to rust staining and spalling at the TNPA House building with a damage rating of 5 (left) and the other relating to localised rust staining at the Eastern Mole Approach Bridge with a damage rating of 2 (right).

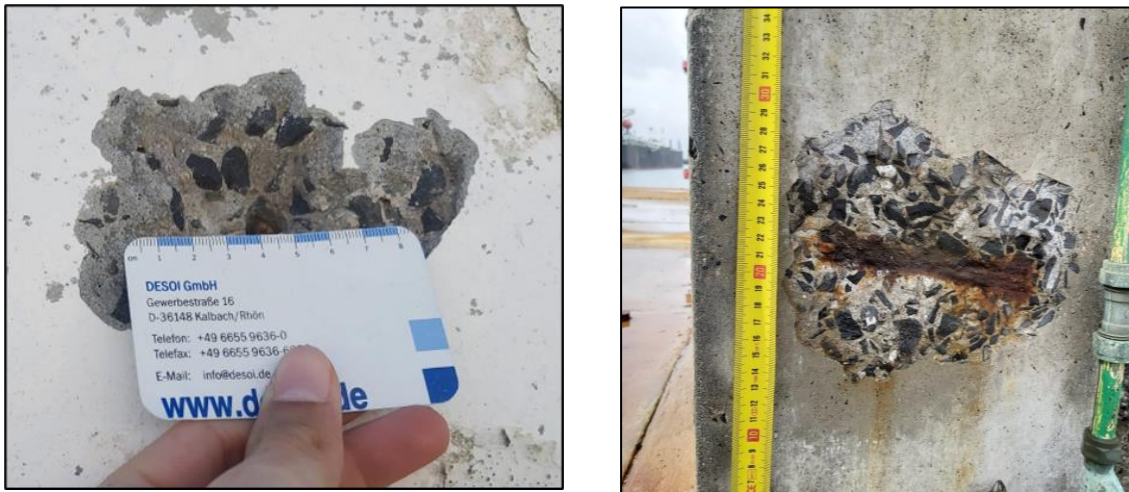
Figure 11 Pop-outs at the Quay 700 Prefabricated Substation (Left) and the Eastern Mole Pumproom (right)

(left) and at the Eastern Mole Pumproom building (right), both with a damage rating of 5 (greater than 50 mm diameter).

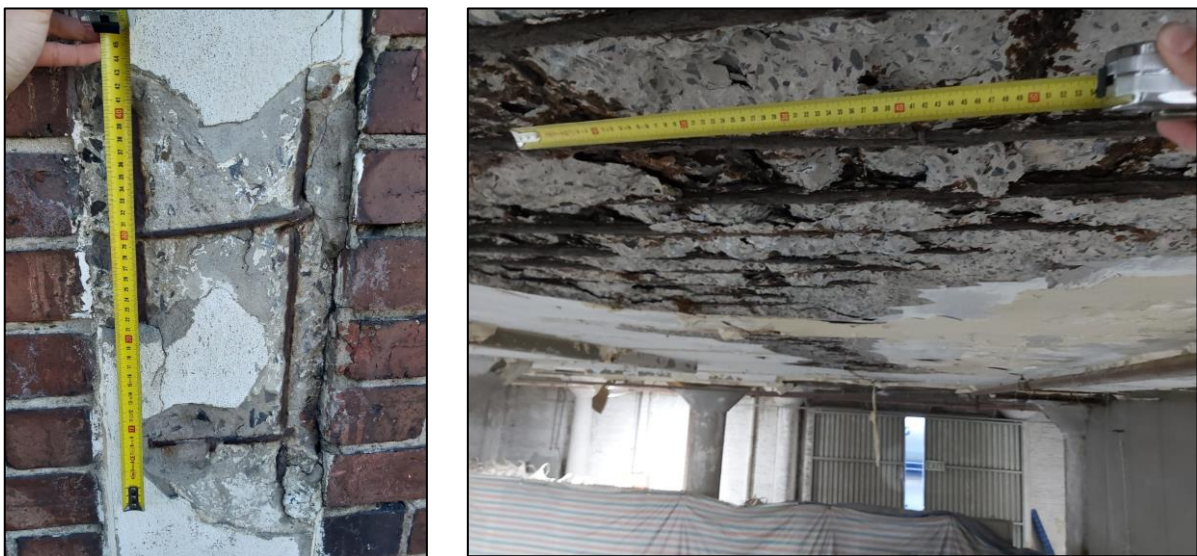
Figure 12 Spalling at the Unitie building exterior wall (left) and the B-Berth Shed (right)

Spalling is a surface defect characterized by more widespread loss of cover and exposure of reinforcement, typically caused by expansion of the reinforcement because of reinforcement corrosion. Figure 12 below illustrates very severe spalling on the Unitie building exterior wall (left) and the B-Berth shed floor slab soffit (right), both with a damage rating of 5 as spalling affected areas are greater than 150 mm.

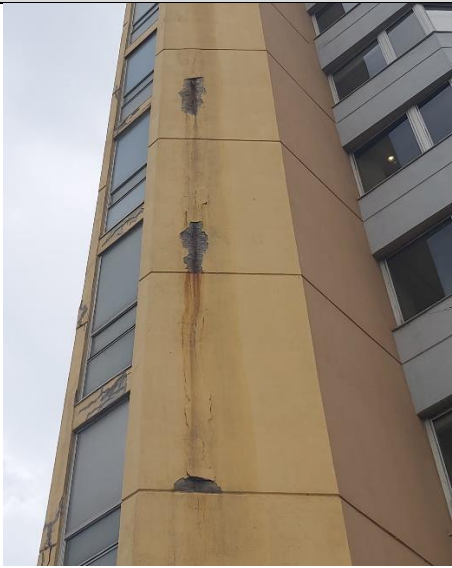
Rust staining, pop-outs and spalling evident. Some pop outs found on the ground during the inspection.	Effects of corrosion	5
				Pop Outs	5
				Spalling	5
Exterior stairway column - East			No visual signs of rust staining, pop outs or spalling.	Effects of corrosion	1
				Pop Outs	1
				Spalling	1

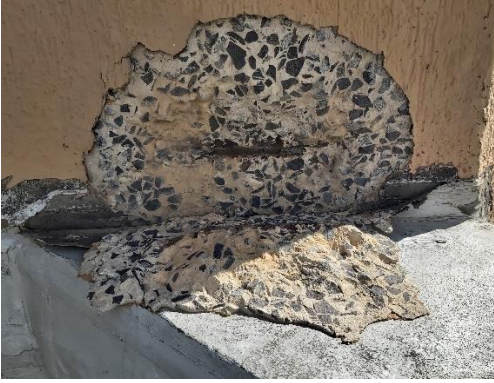
Pop outs and spalling evident.	Effects of corrosion	1
			Pop Outs	5
			Spalling	5
Roof beam soffit

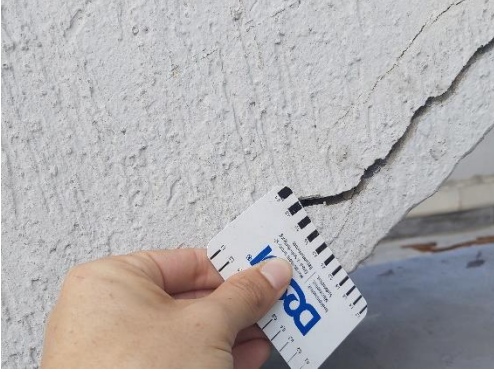
Large cracks found on soffit of roof beam along reinforcement (4.5 mm).	Effects of corrosion	4
			Pop Outs	1
			Spalling	1

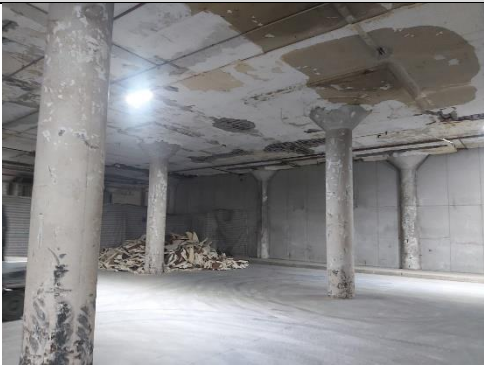
Generally in a good condition. No visual evidence of spalling and rust staining.	Effects of corrosion	1
				Pop Outs	1
				Spalling	1
Slab soffit

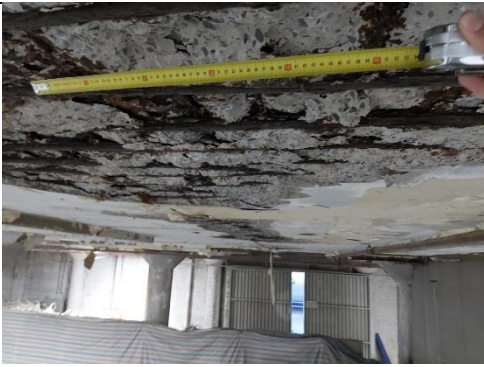
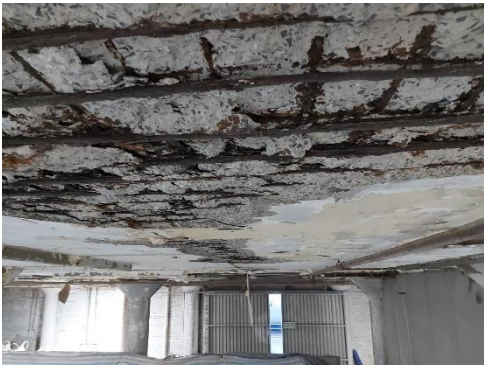
In a poor condition. Widespread spalling and severe reinforcement corrosion.	Effects of corrosion	5
				Pop Outs	5
				Spalling	5

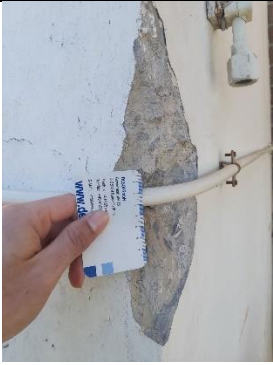
Localised areas of very severe spalling in excess of 150 mm.	Effects of corrosion	1
				Pop Outs	5
				Spalling	5

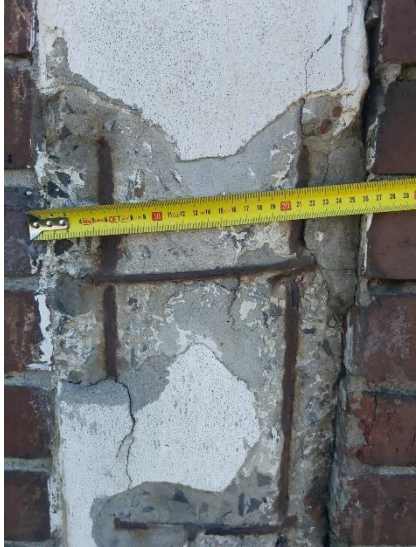
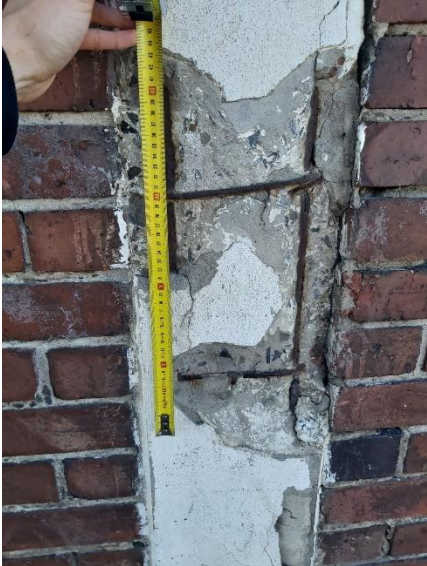
Very severe spalling and corrosion of rebar reducing structural capacity of column.	Effects of corrosion	5

Pop Outs	5
	Spalling		5

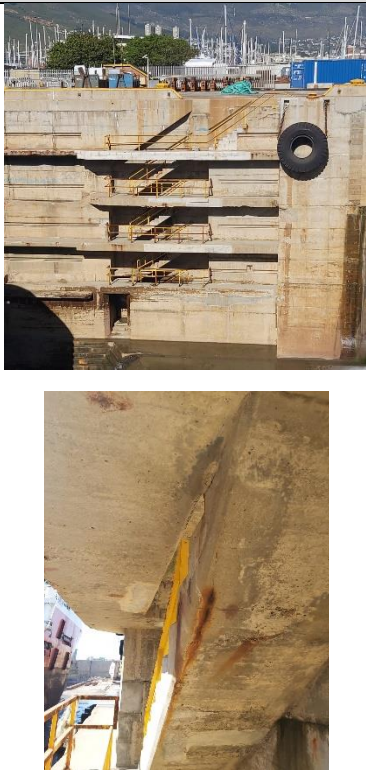
Some areas have been patch repaired however, evidence exists of very severe spalling and heavy rust staining.	Effects of corrosion	4
				Pop Outs	5
				Spalling	5
Altar soffit 2

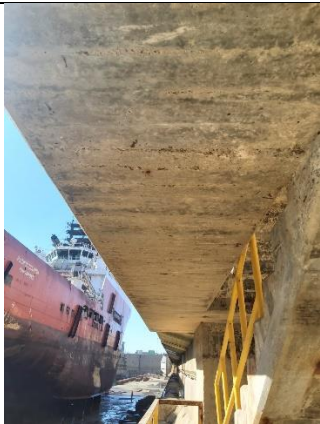
Some areas have been patch repaired. Heavy rust staining is evident and some minor spalling and pop outs up to 10 mm.	Effects of corrosion	4
				Pop Outs	3
				Spalling	2

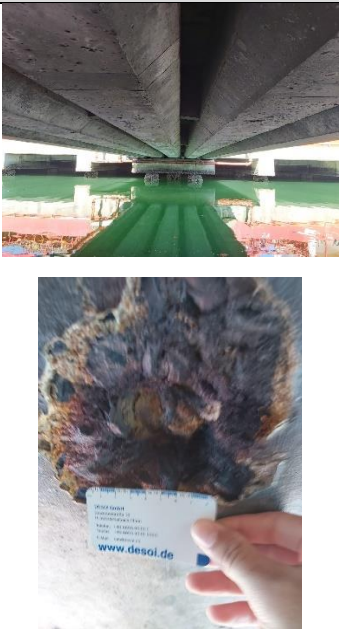
Generally in a good condition with some localised spalling and light rust staining.	Effects of corrosion	2
				Pop Outs	5
				Spalling	4
Handrail foundation

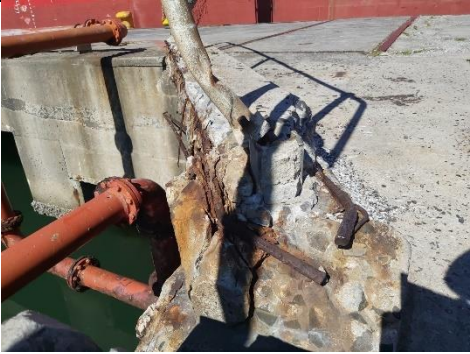
Very severe spalling and corroded rebar. Large area of rebar diameter corroded reducing structural capacity.	Effects of corrosion	5
				Pop Outs	5
				Spalling	5

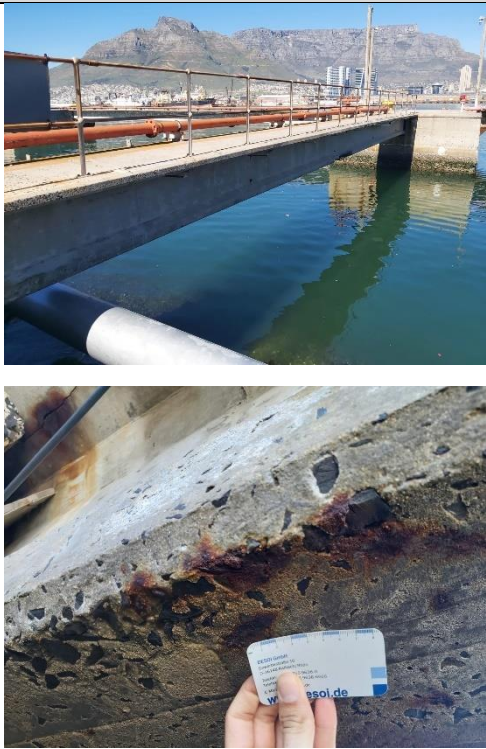
Localised spalling and rust staining.	Effects of corrosion	2
				Pop Outs	5
				Spalling	5

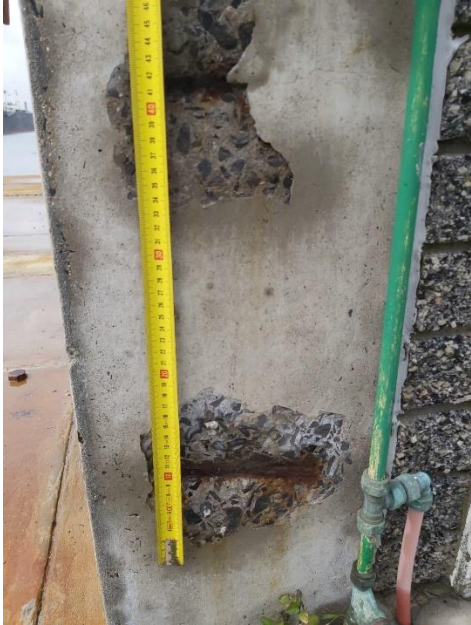
Spalling, pop-outs, and rust staining evident. Areas larger than 150 mm.	Effects of corrosion	5
				Pop Outs	5
				Spalling	5
Column - South

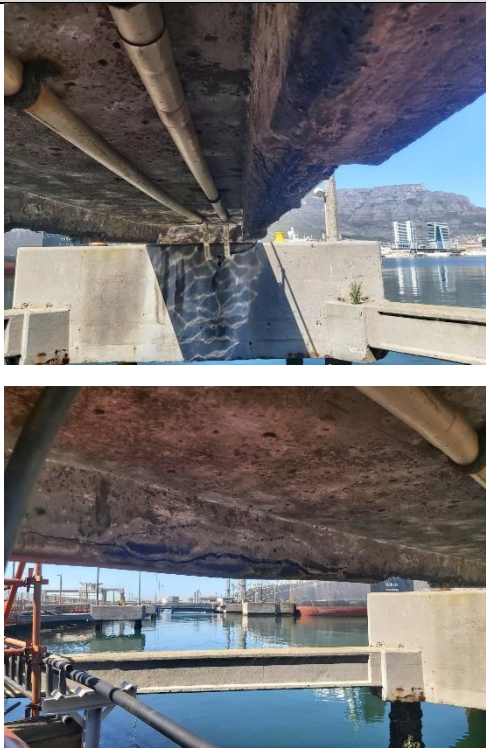
<p>Very severe spalling and pop outs larger than 150 mm. Rebar exposed indicating severe corrosion and heavy rust staining.</p>	Effects of corrosion	5
				Pop Outs	5
				Spalling	5

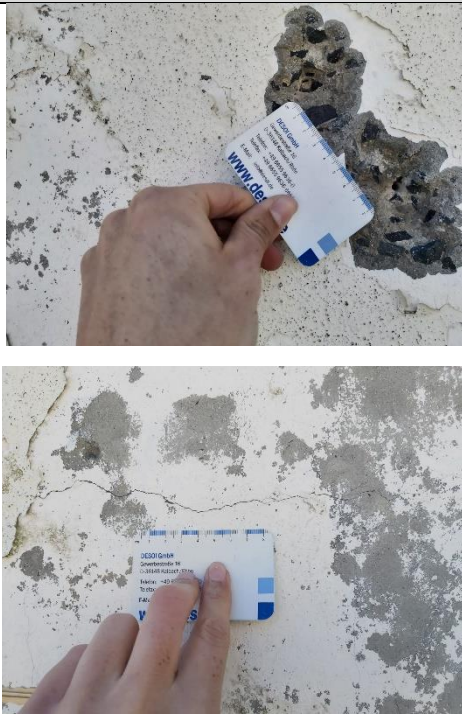
Spalling up to 150 mm with some light rust staining evident. Generally in a fair condition.	Effects of corrosion	2
				Pop Outs	5
				Spalling	4
Exterior wall - North

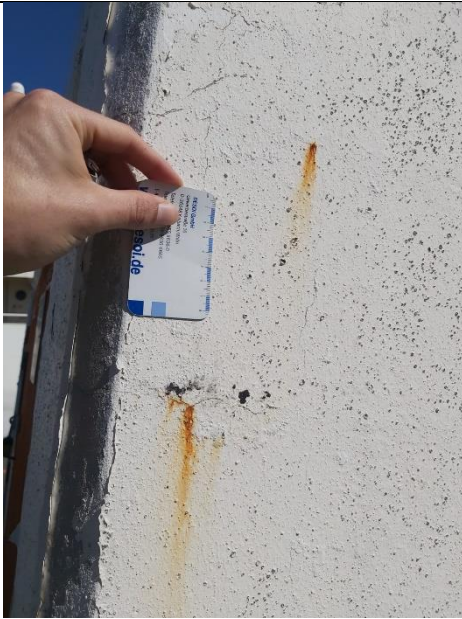
Minor spalling with some light rust stains.	Effects of corrosion	2
				Pop Outs	1
				Spalling	2

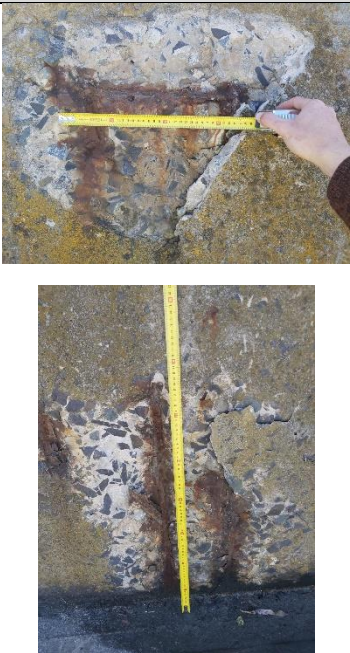
Very severe spalling and rebar corrosion with spalling in excess of 150 mm in multiple areas.	Effects of corrosion	5
				Pop Outs	5
				Spalling	5
Seawall exterior			Generally in a good condition with slight spalling and rust staining.	Effects of corrosion	2
				Pop Outs	2
				Spalling	2

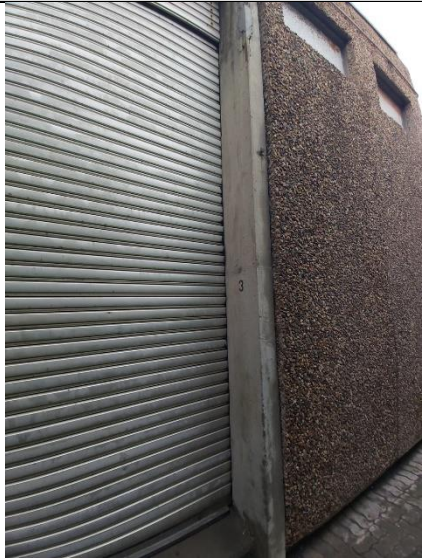
Some moderate spalling and severe pop outs evident.	Effects of corrosion	1
				Pop Outs	4
				Spalling	3
Column South

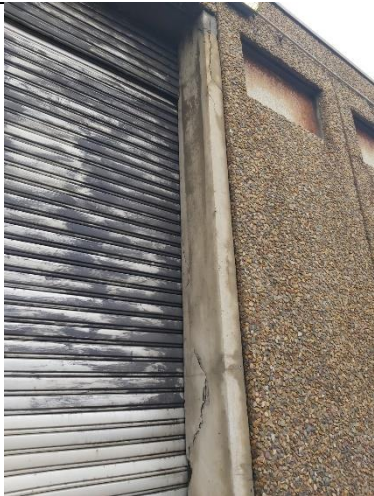
Very severe spalling evident with minor rust staining.	Effects of corrosion	2
				Pop Outs	5
				Spalling	5

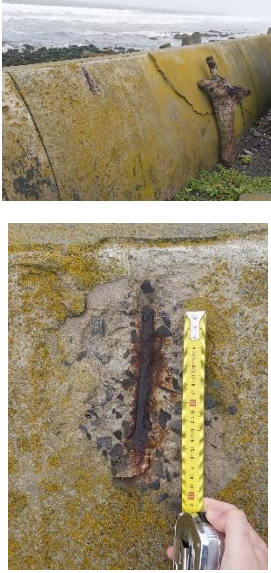
Very severe spalling in excess of 150 mm.	Effects of corrosion	5
				Pop Outs	5
				Spalling	5
Seawall exterior

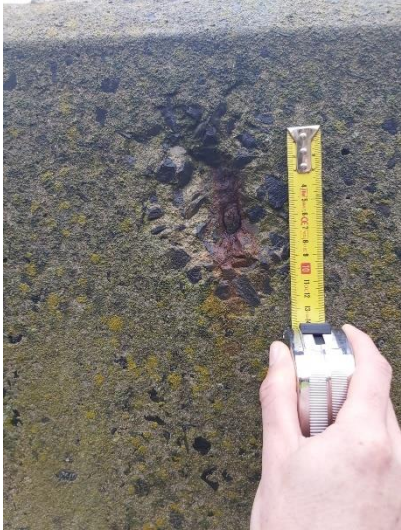
Spalling up to 150 mm with heavy rust staining.	Effects of corrosion	5
				Pop Outs	5
				Spalling	4
