**DEPARTMENT OF CIVIL ENGINEERING**

**INVESTIGATING THE OPERATIONAL BEHAVIOUR OF A  
DOUBLE CURVATURE ARCH DAM**

**Zac James Prins**

The case study used for this thesis is Kouga Dam located in the Eastern Cape Province of South Africa. It is a double curvature, concrete arch dam which supplies water for domestic, irrigation, and industrial use to the Gamtoos River Valley and Nelson Mandela Metropolitan. During construction the stability of the right flank was questioned and subsequently remedial measures were taken in order to increase the shear resistance of this flank. Previous dam safety evaluations also noted the possibility of Alkali Silica Reaction (ASR) occurring within the structure which resulted in concrete swelling and loss of strength. Due to these factors and the large hazard potential rating associated with this dam, an intensive surveillance system has been used to monitor the dam's behaviour during operation.

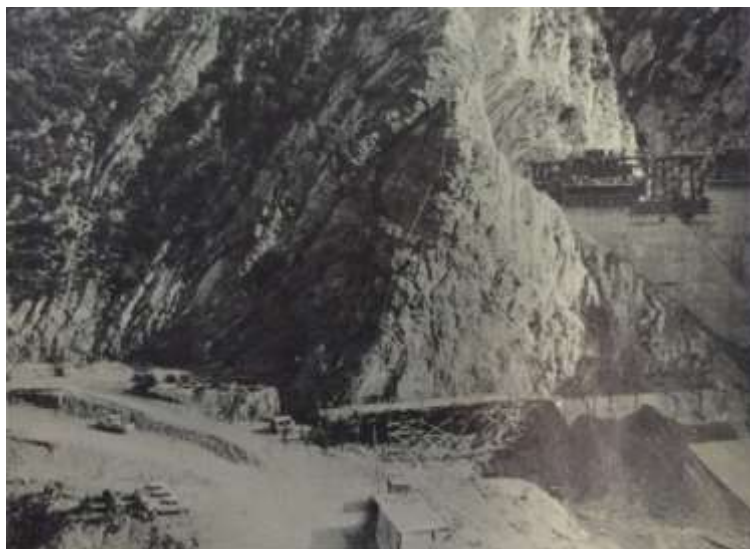
The right flank of the arch abuts into a spur on the mountain (See Figure 16). Upstream of the spur is a gully and on the downstream is a deep embayment. The embayment results in less support against the arch thrust. During excavation of the right flank foundation phyllite seams were encountered which rapidly deteriorated. This raised further concerns regarding the integrity of the foundations.

Figure 16: Right flank prior to completion and stress pad remedial measures (Hobbs et. al., 1967: 654)

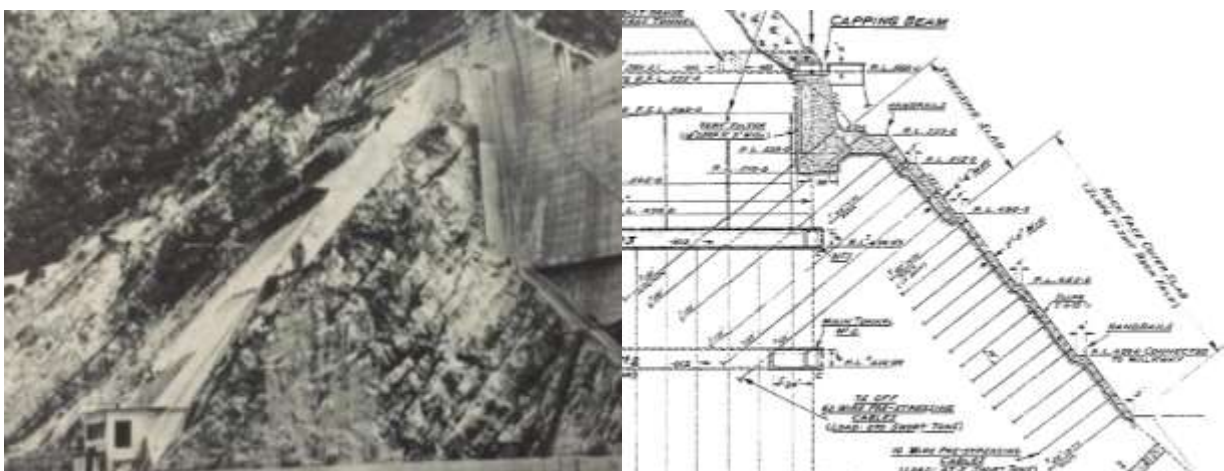
The stressing slab is anchored into the right abutment with 62 high tensile steel cables. These cables are anchored to a depth of 40m and post-tensioned to 245 tonnes. The anchoring confines the layers of strata together into a monolith and as a result deepens the load carrying rock mass. This further reduces the tendency of buckling failure of the strata under the arch thrust load.

**Figure 17: Capping beam and stressing slab on right flank (Hobbs et. al., 1967: 664,650)**

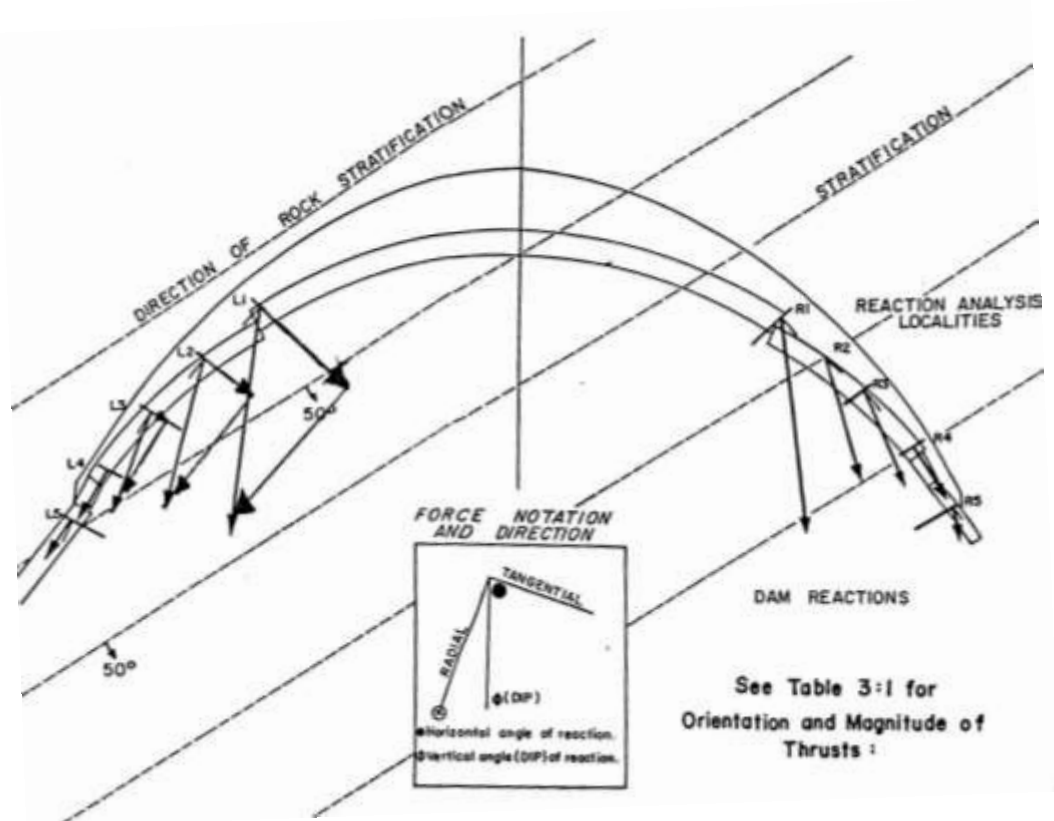
Figure 18 shows the stratification of the foundation and arch thrusts of the structure. Forbes Dick (1989: 13) notes that the most probable potential failure mode in the direction of thrusting on the right flank is shear across the bedding planes in combination with tensile foliation of the phyllite layers. The bedding layers act as cantilever slabs that are stacked on each other, with the fixed end within the abutment and the free end closest to the dam. Movements within the foundation on the right flank may be initiated by deteriorating phyllite layers and produce near perpendicular forces relative to the bedding planes, acting in a downstream direction. This would result in excessive bending moments on the bedding layers, cause the layers to buckle under the load, and initiate a shear failure downstream.

Figure 18: Arch and cantilever reactions on the rock foundation in relation to the stratification dip and strike directions (Forbes Dick, 1989: 14)

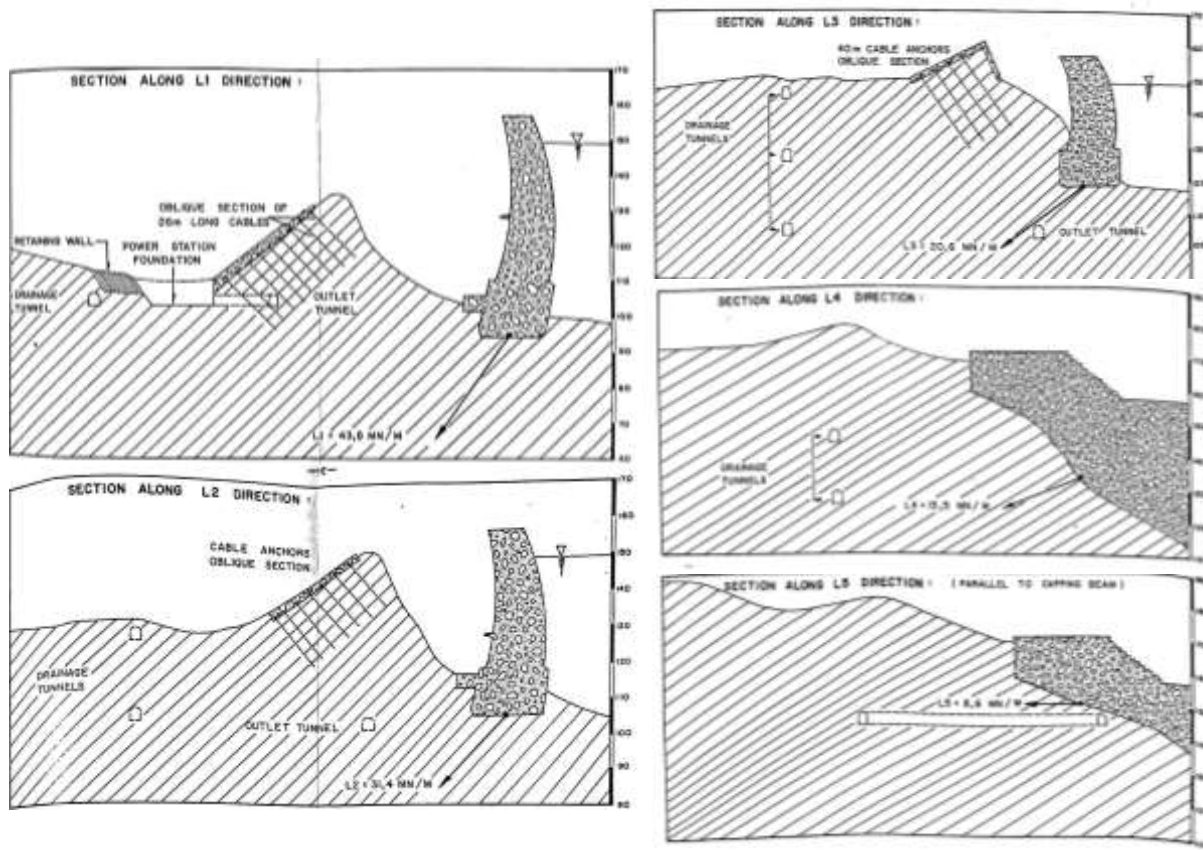
The forces which could initiate shear failure occur adjacent to the spillway due to its large resultant and downstream components. The thrust has a similar dip to the bedding planes and is directed towards the right abutment well below the power station. The thrusts closer to the abutment are less favourable in terms of the orientation as the resultant forces are near horizontal. The resultant and downward components are significantly lower compared to that closer to the spillway. The upper arch thrusts on the capping beam and assists in redirecting the forces along the strata below the stress pad.

Figure 19: Resultant forces on the right foundation (Forbes Dick, 1989: 16)

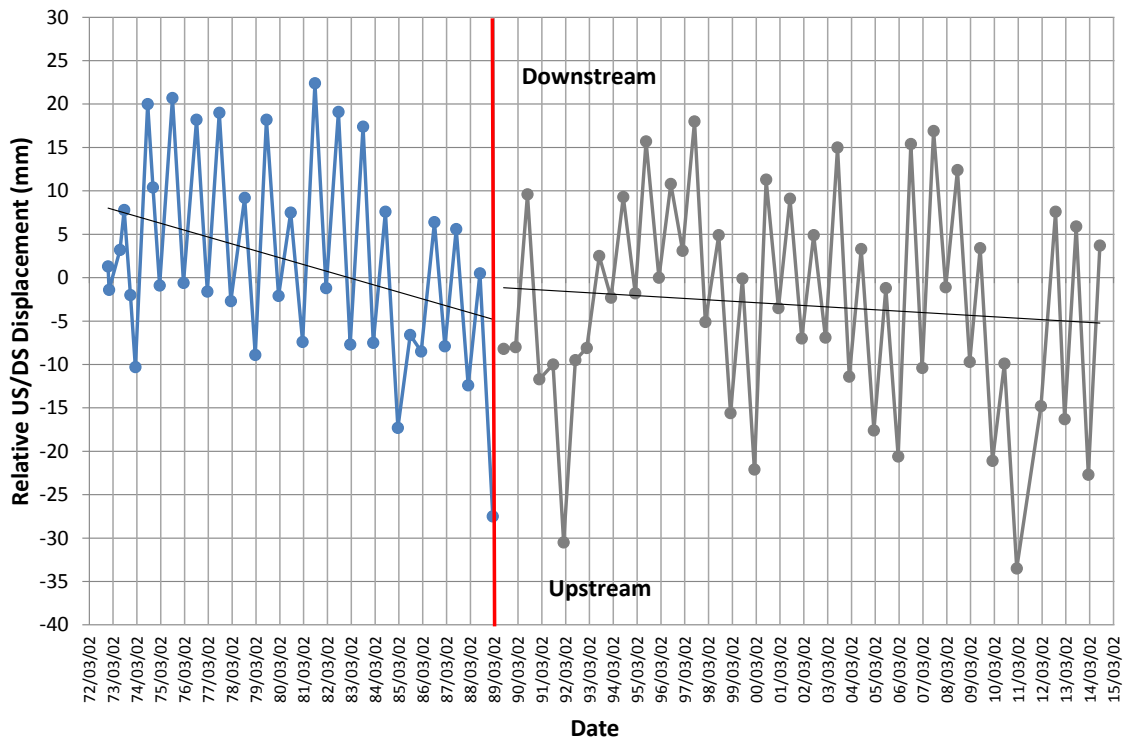
As expected the upstream and downstream displacements are dependent on the water level. The severe droughts can be identified in the displacement graphs as the low extremities and this indicates upstream displacement (negative direction). The displacement for both quarter and centre points follow a similar signature. However since 1985 the right flank exhibits 10mm larger seasonal displacement fluctuations compared to the left flank. The upstream and downstream displacements for the centre of the dam are shown in Figure 35. In the figure the red line indicates the drought that occurred in 1989.

**Figure 35: Relative upstream/downstream displacement (116)**

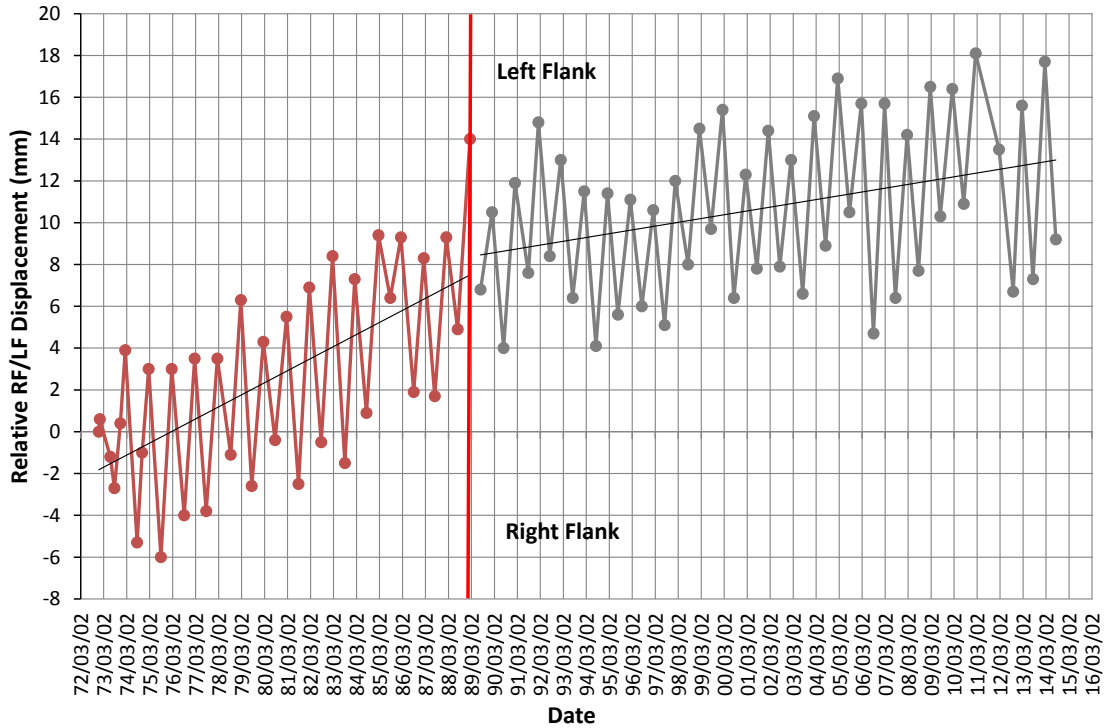
The right flank and left flank displacement of the centre of the dam wall fluctuates around 0mm, whereas the right and left quarter points diverge towards its opposite flank. The tangential displacement of the right flank quarter point is shown in Figure 36.

Figure 36: Relative right flank/left flank displacement of right flank quarter point (111)

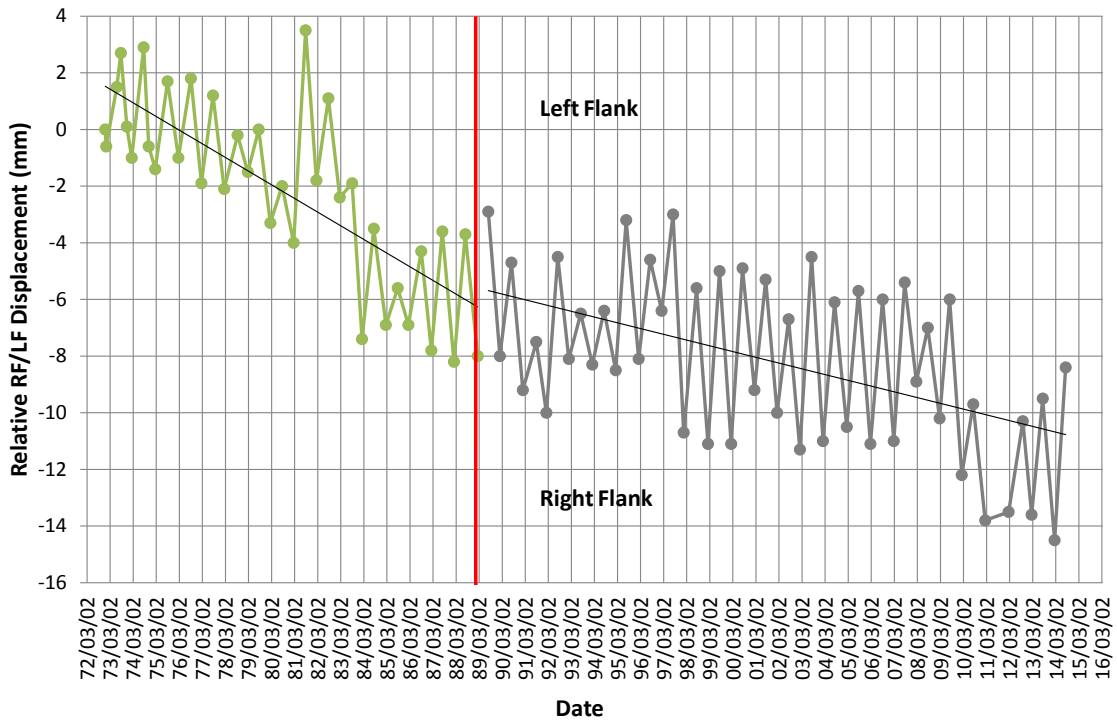
The tangential displacement of the left flank quarter point is shown in Figure 37.

Figure 37: Relative right flank/left flank displacement of left flank quarter point (122)

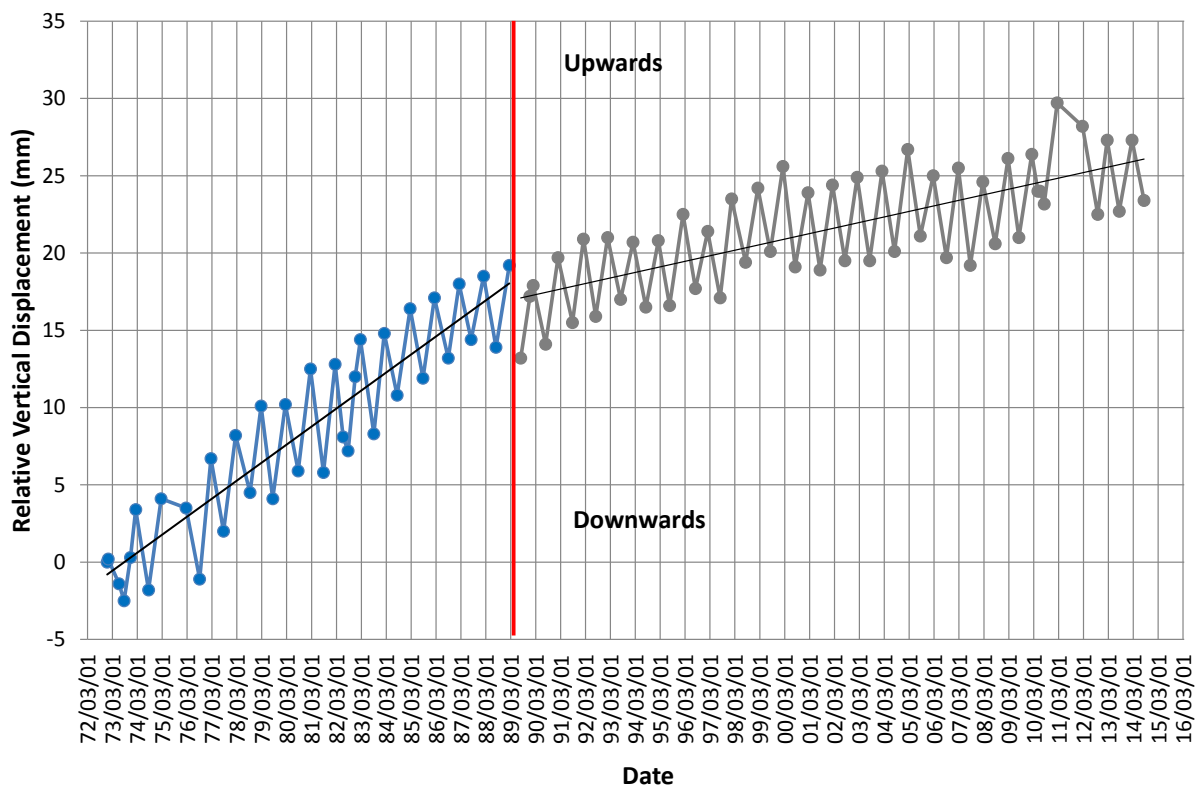
The displacement for both quarter and centre points follow a similar signature. The centre of the dam wall exhibits the greatest relative vertical displacement and has a larger strain rate compared to the flanks. The vertical displacements for the centre of the dam are shown in Figure 38.

**Figure 38: Relative vertical displacement at centre (117)**

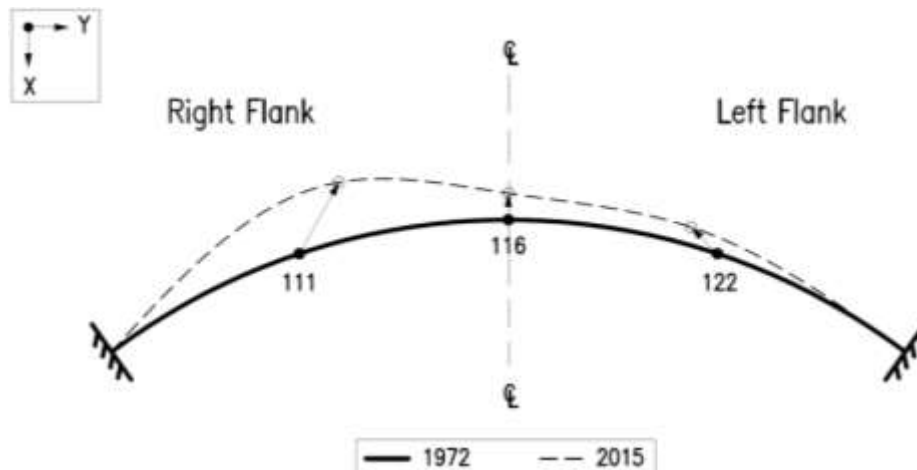
Curtis (2000) notes that the response of ASR-affected arch dams are vertical and upstream displacements over. Kouga is swelling to a lesser extent in the constrained direction towards the flanks and considerably more along the unrestrained boundaries in the upward and upstream directions. The average permanent displacements (in the x-y plane) exhibited by the dam are shown in the schematic below (Figure 39).

**Figure 39: Schematic of permanent x-y displacement of dam wall**

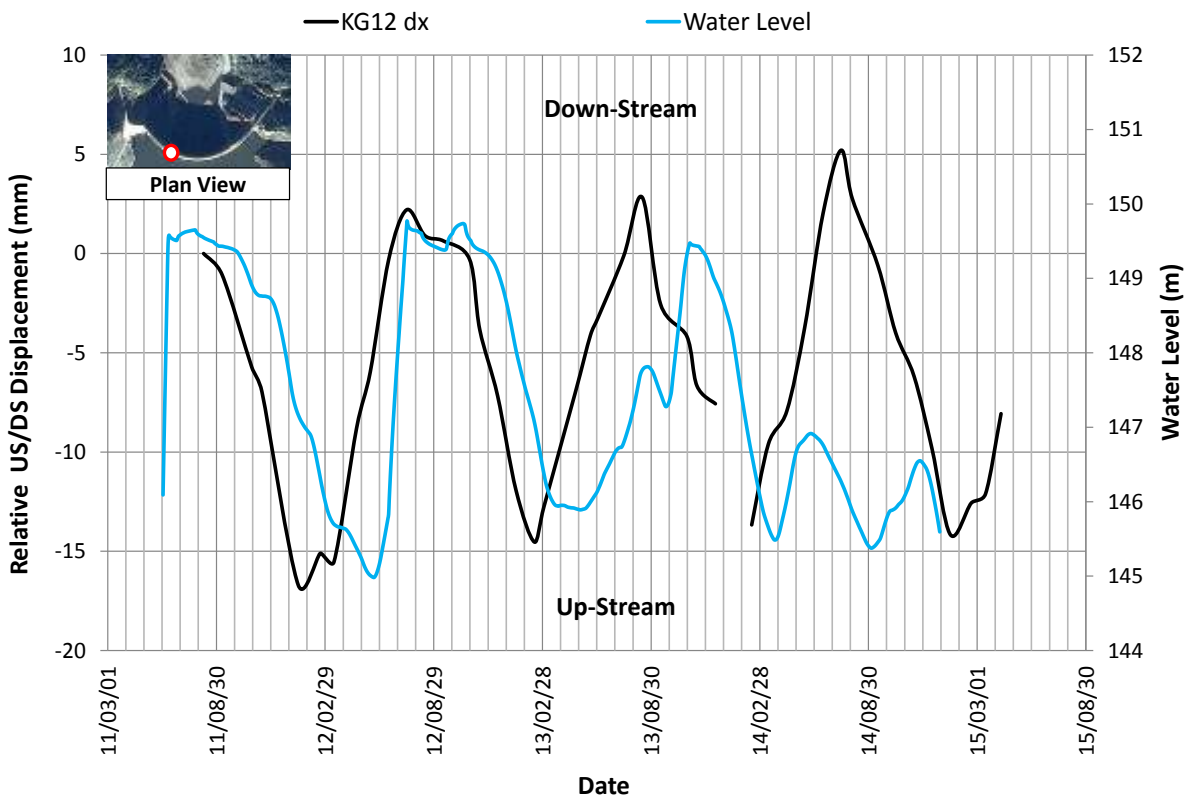
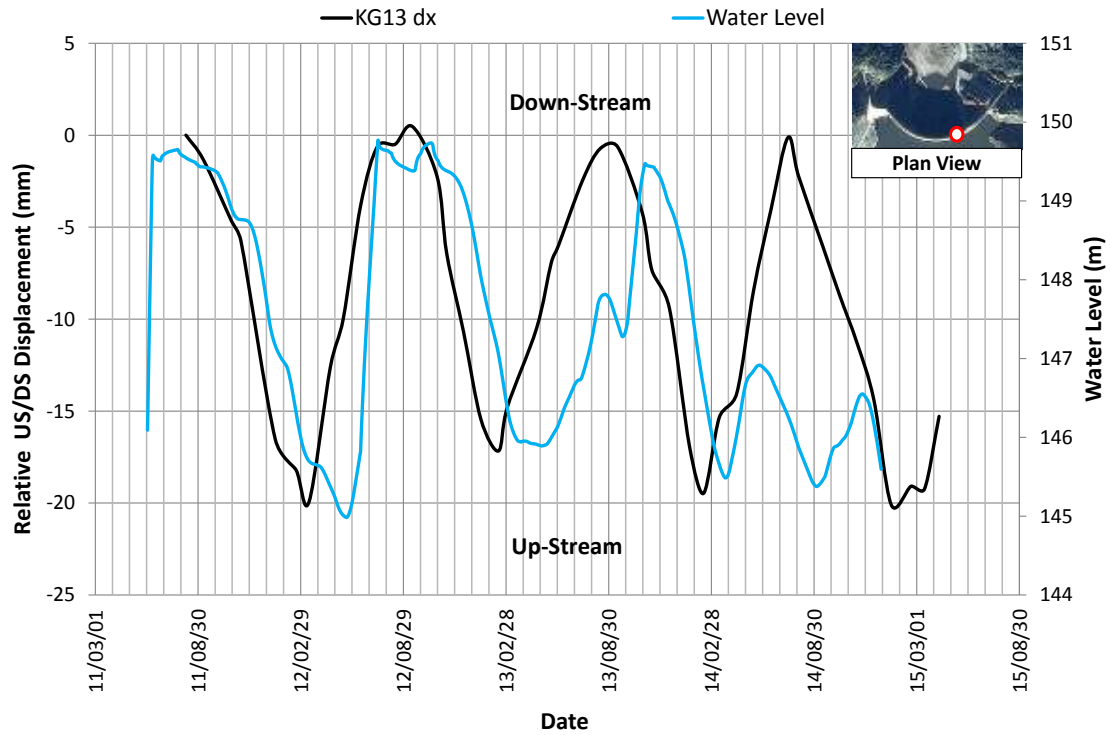
Both the displacements and water levels follow cyclic patterns. Intuition would suggest that the larger the hydraulic loading the greater the downstream deflection. However it is clear from Figure 42 and 43 that the structure's response is not initiated by changes in the reservoir level.

Figure 42: Displacement and WL data for left flank

**Figure 43: Displacement and WL data for right flank**

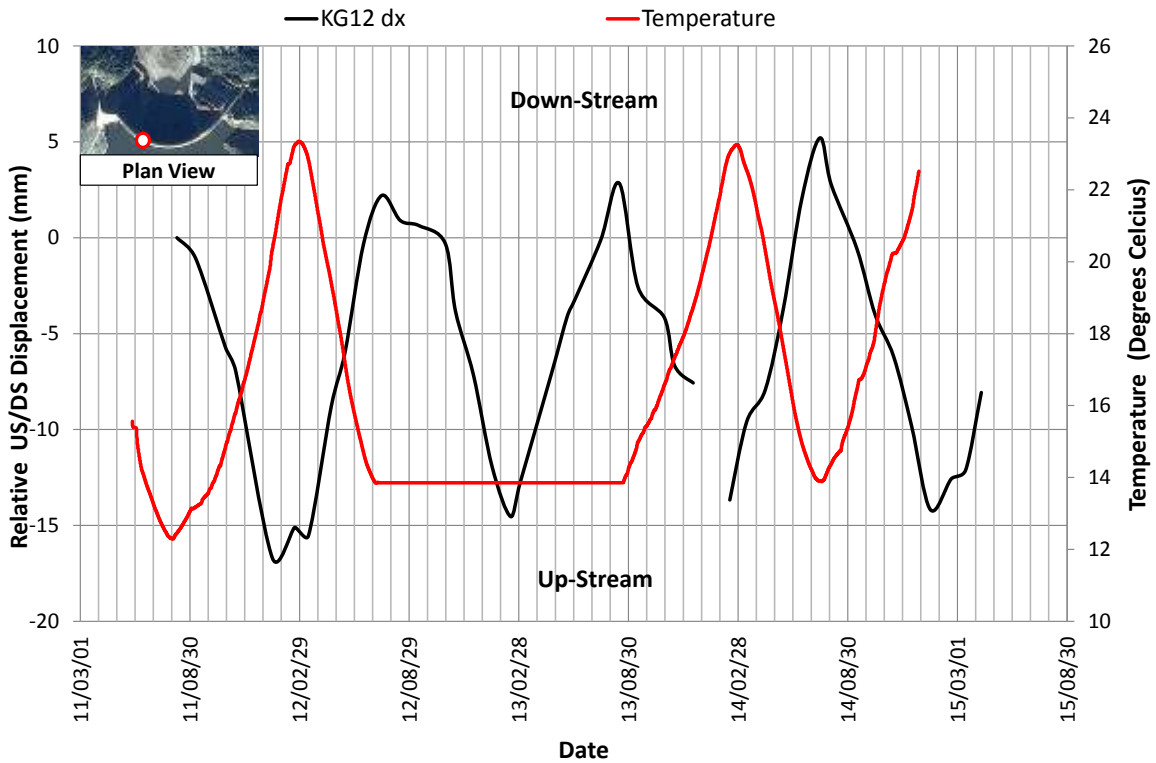
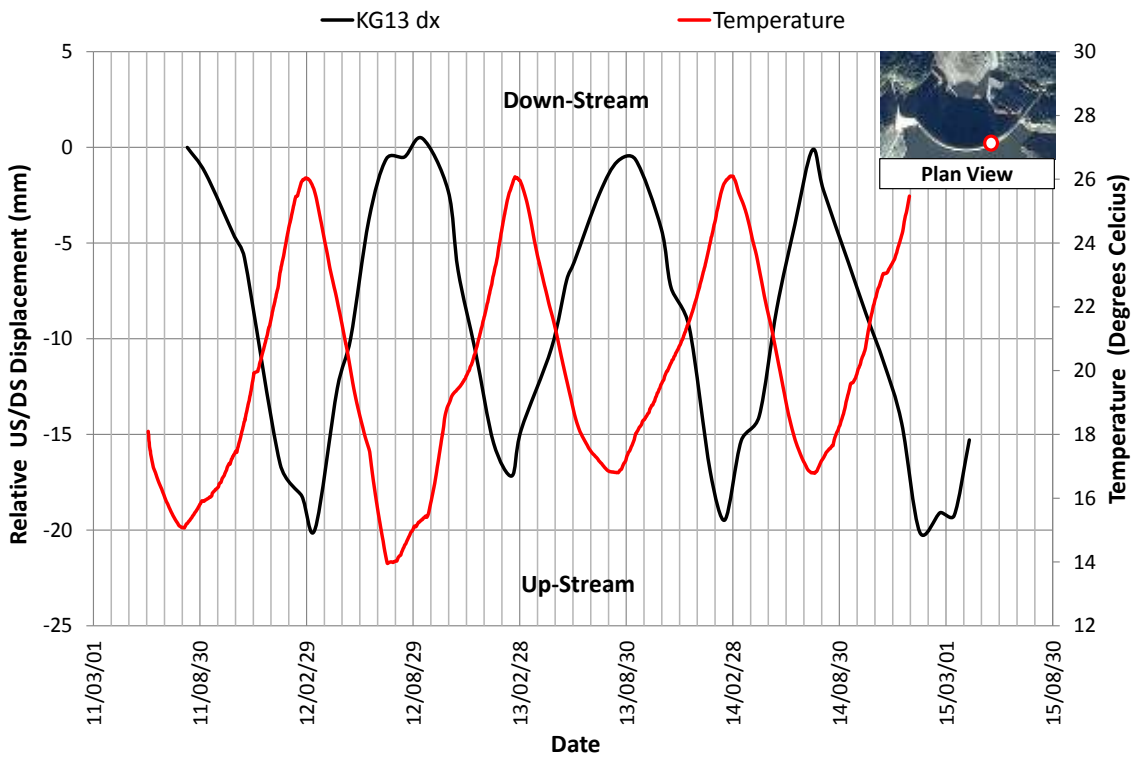
The displacements of the structure are approximately 180 degrees out of sync with the temperature at any given point in time. See Figures 45 and 46 below.

Figure 45: Displacement and Temperature data for left flank

Figure 46: Displacement and Temperature data for right flank

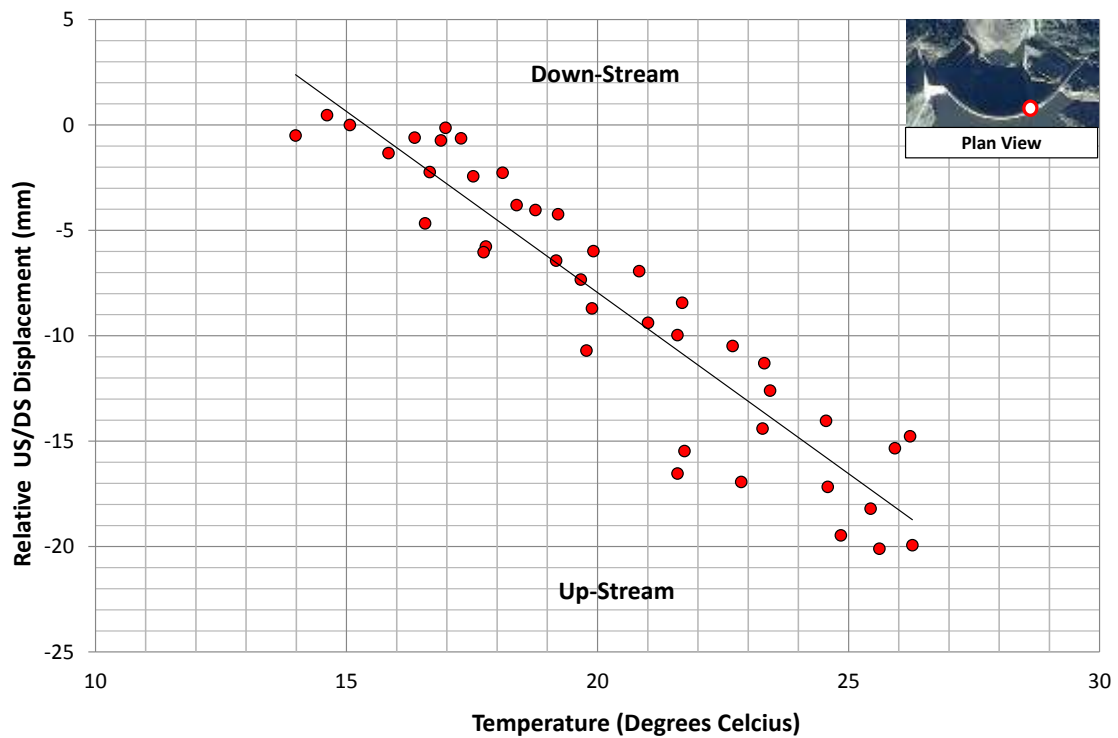
Figure 47 shows the relationship between displacement and temperature. The relationship is linear with an increase in temperature resulting in an upstream displacement and vice versa.

Figure 47: Displacement VS Temperature

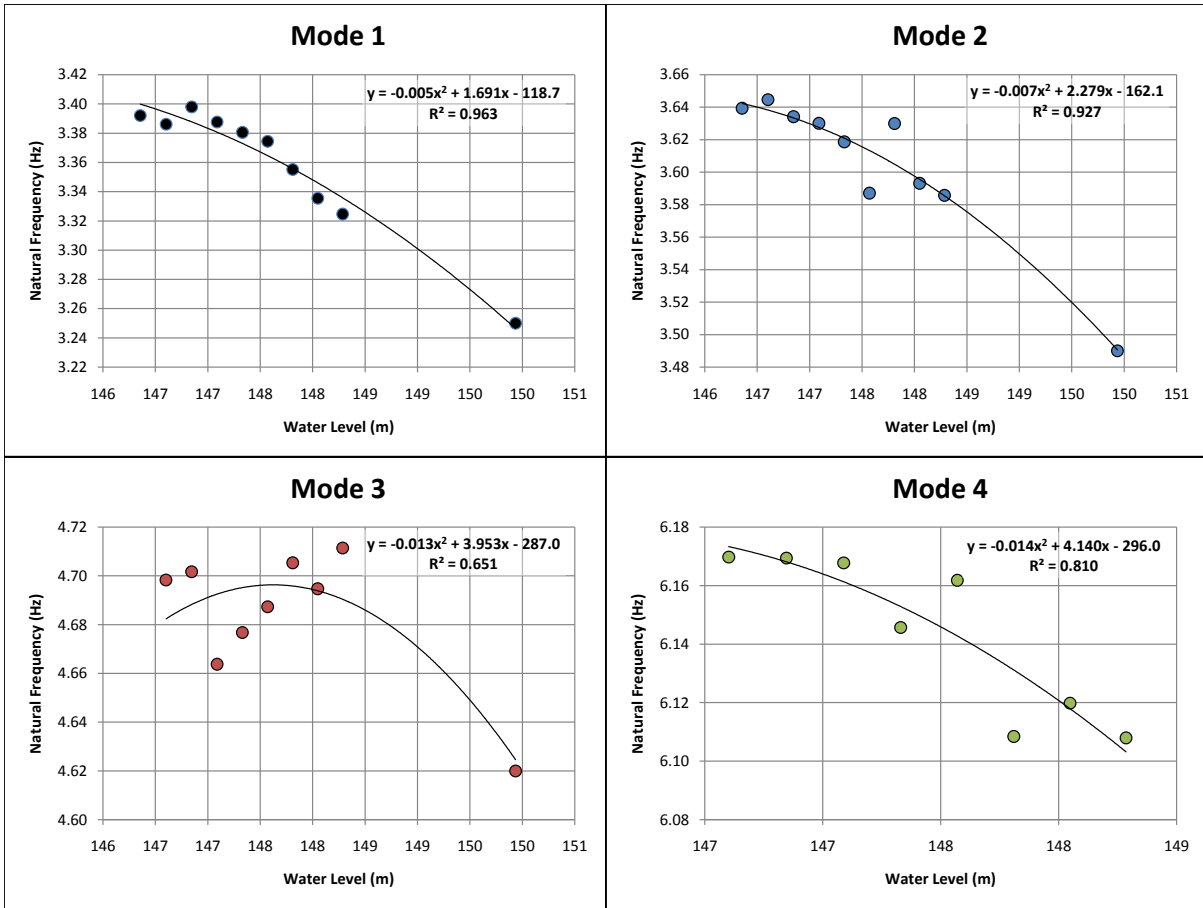
Clear changes occur in the recorded natural frequency as a result of changes in water level. The natural frequencies ( $\omega_n$ ) for the first four modes of vibration ( $\phi_i$ ), at varying water levels are shown in Figure 49.

**Figure 49: Natural frequencies of the first four modes of vibration at varying water levels**

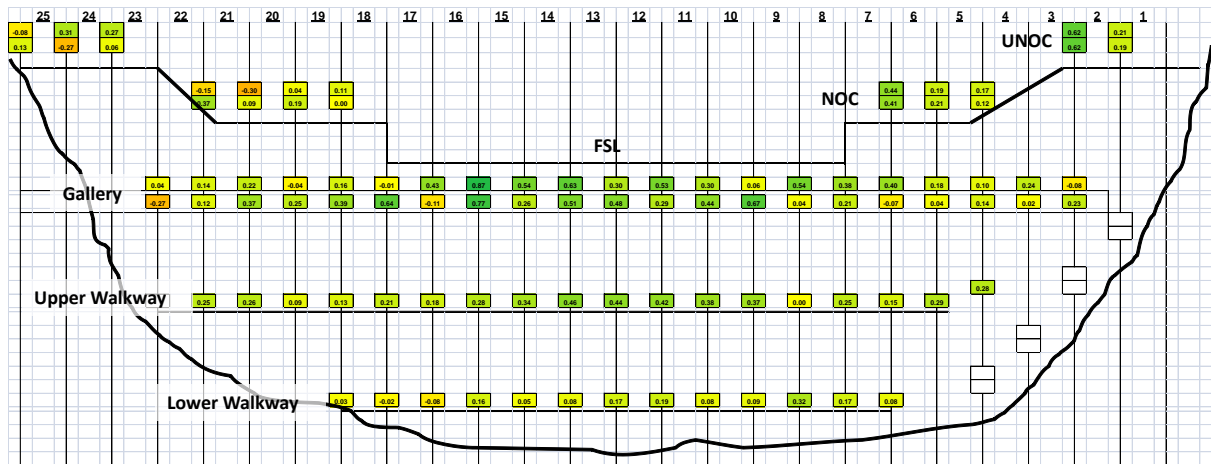
Figures 51 and 52 show the crack width gauge results for the displacement across the joints (tangential). A positive value indicates an opening (green) of the joint while a negative value indicates a closure (red/orange) of the joint. The yellow values indicate little change in joint movement.

Figure 51: Period A - Falling water level
