CIV 5017Z: DISSERTATION FOR THE DEGREE OF MASTER OF ENGINEERING

# **Review of Current Asset Maintenance in South African Ports and Recommendations for Smart Port Maintenance**

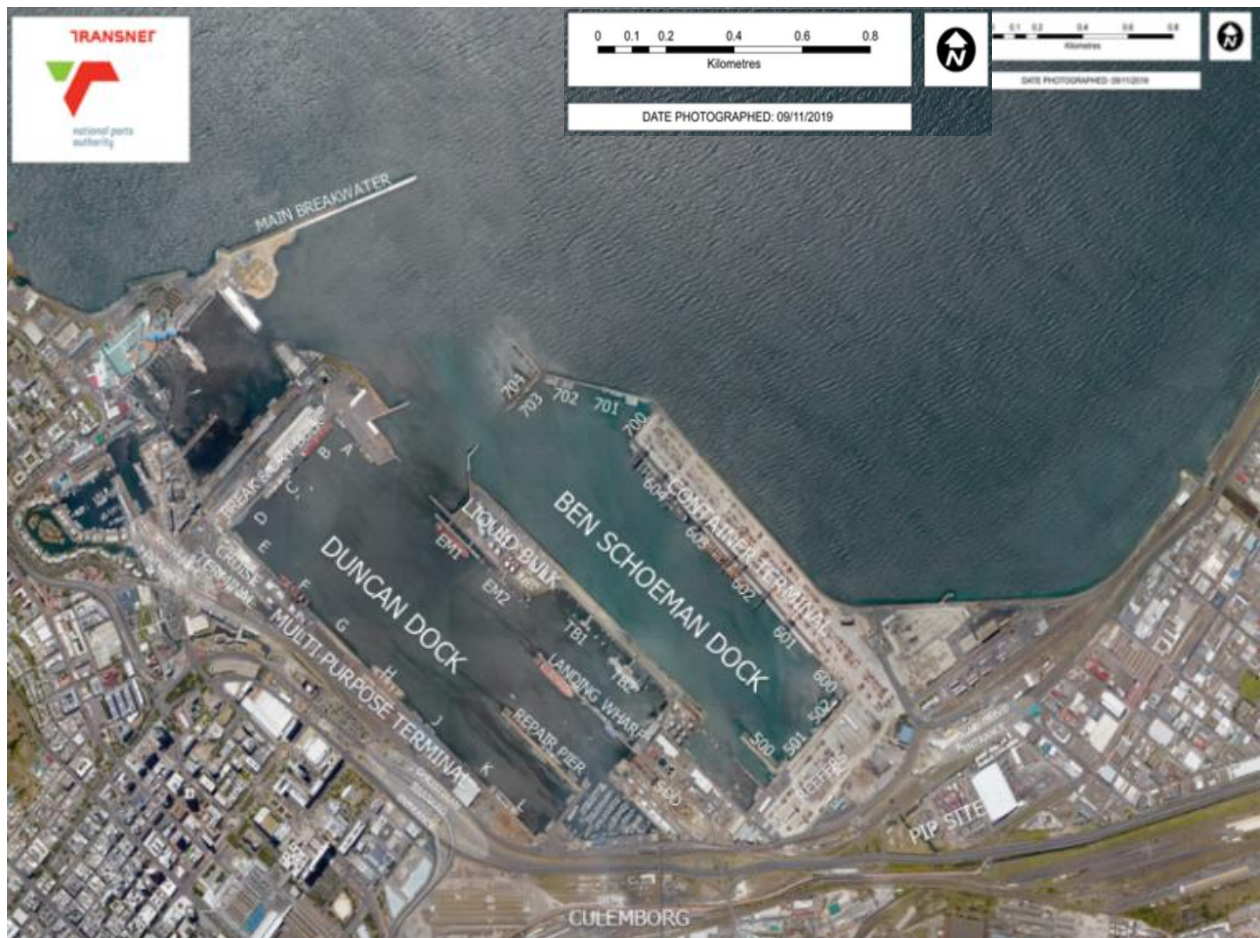
**Figure 1.1: Aerial view of the Port of Cape Town (Picture supplied by TNPA)**

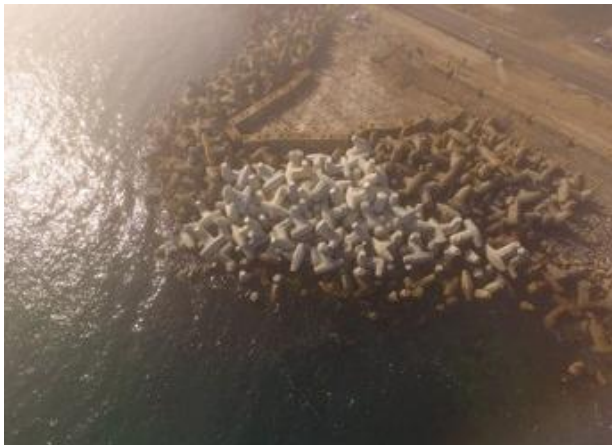
**Figure 2.1: Table Bay breakwater at the Port of Cape Town (Picture supplied by TNPA)**

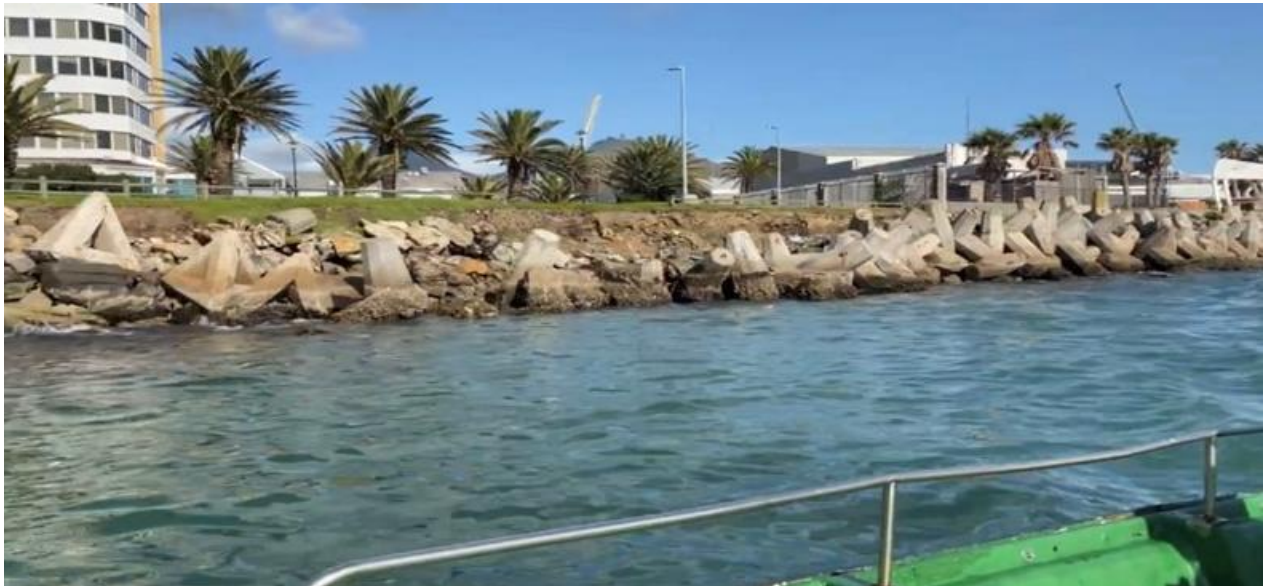
**Figure 2.5: Port of Cape Town's A-Berth seawall (Picture supplied by TNPA)**

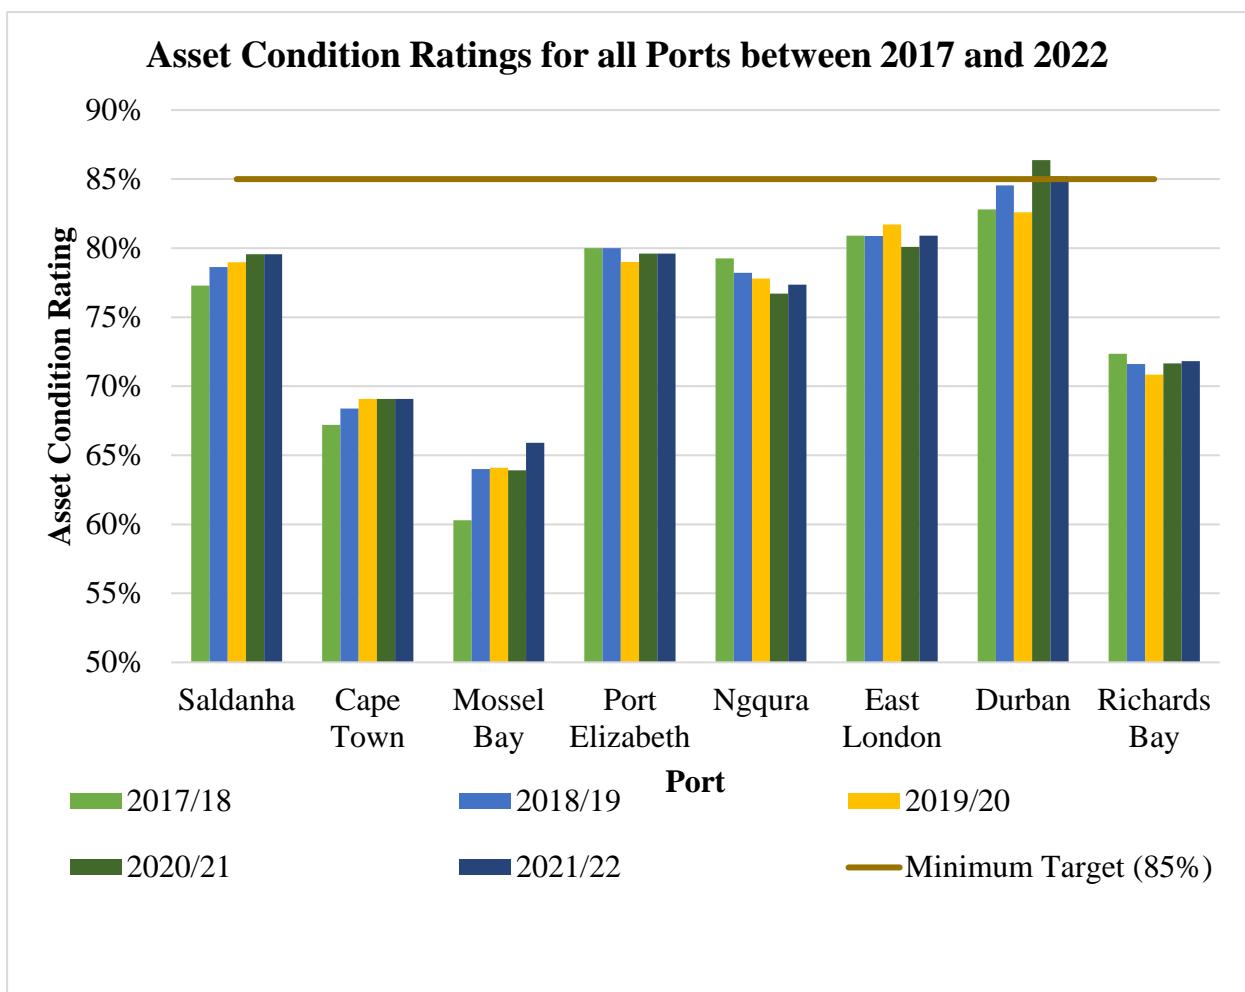
**Figure 2.6: Ports’ Asset Condition Assessment Ratings between 2017 and 2022 (Data supplied by TNPA)**

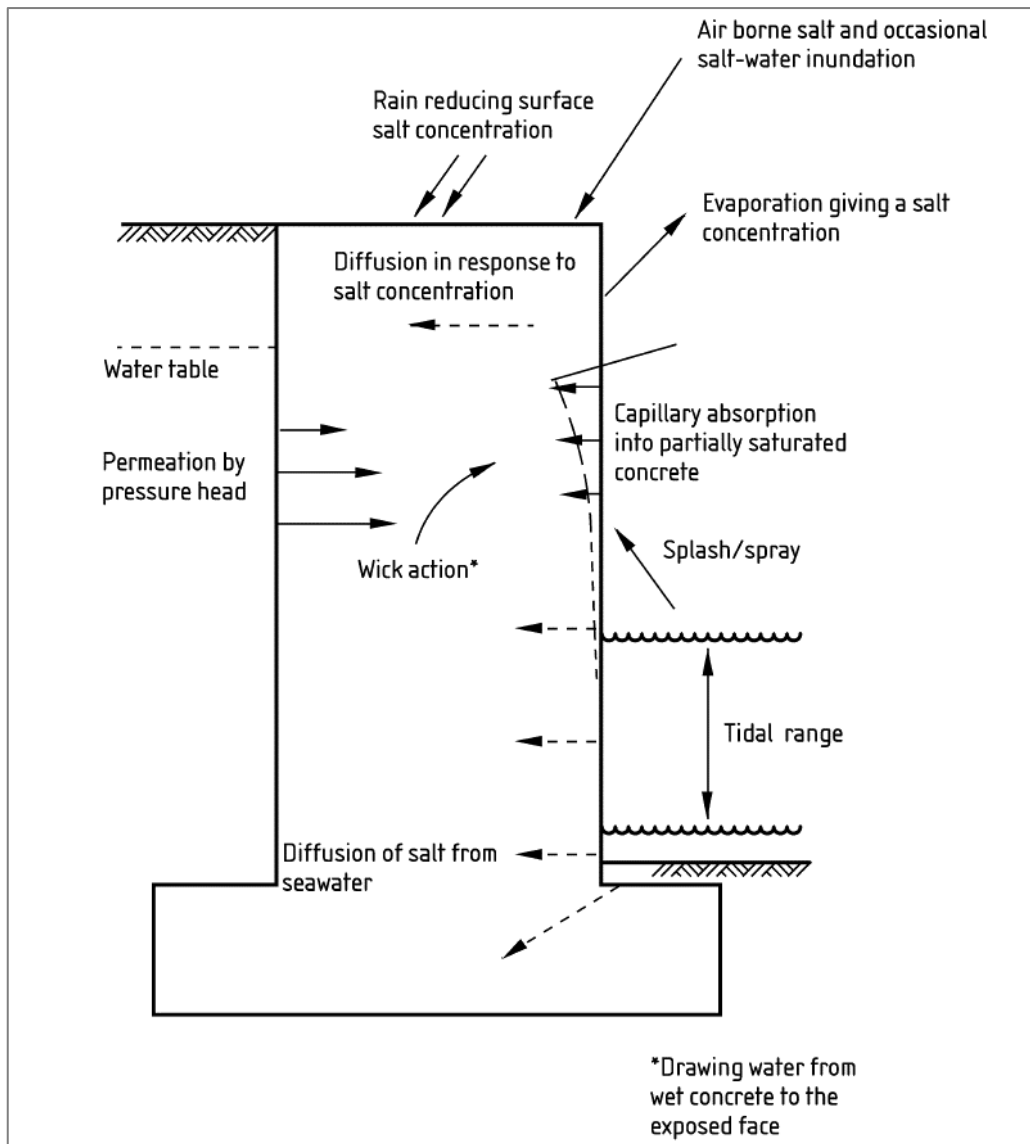
**Figure 2.7: Exposure condition zones for concrete in marine environments (British Standards Institution, 2000)**

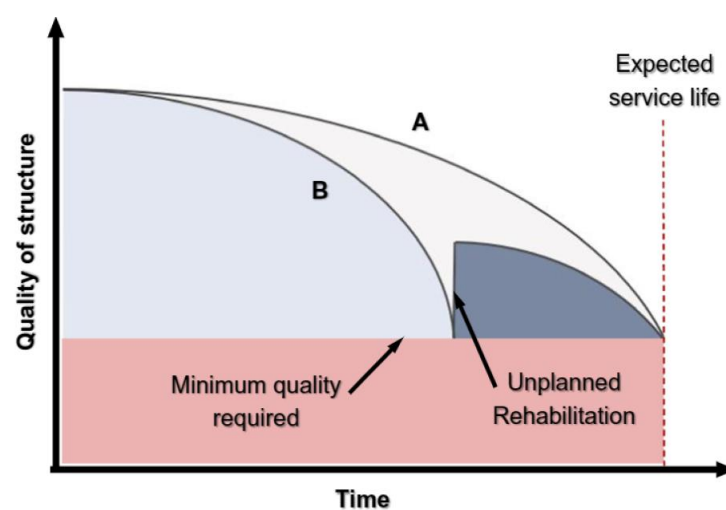
**Figure 2.8: Schematic illustration of a structure's deterioration over its service life (Alexander & Beushausen, 2019)**

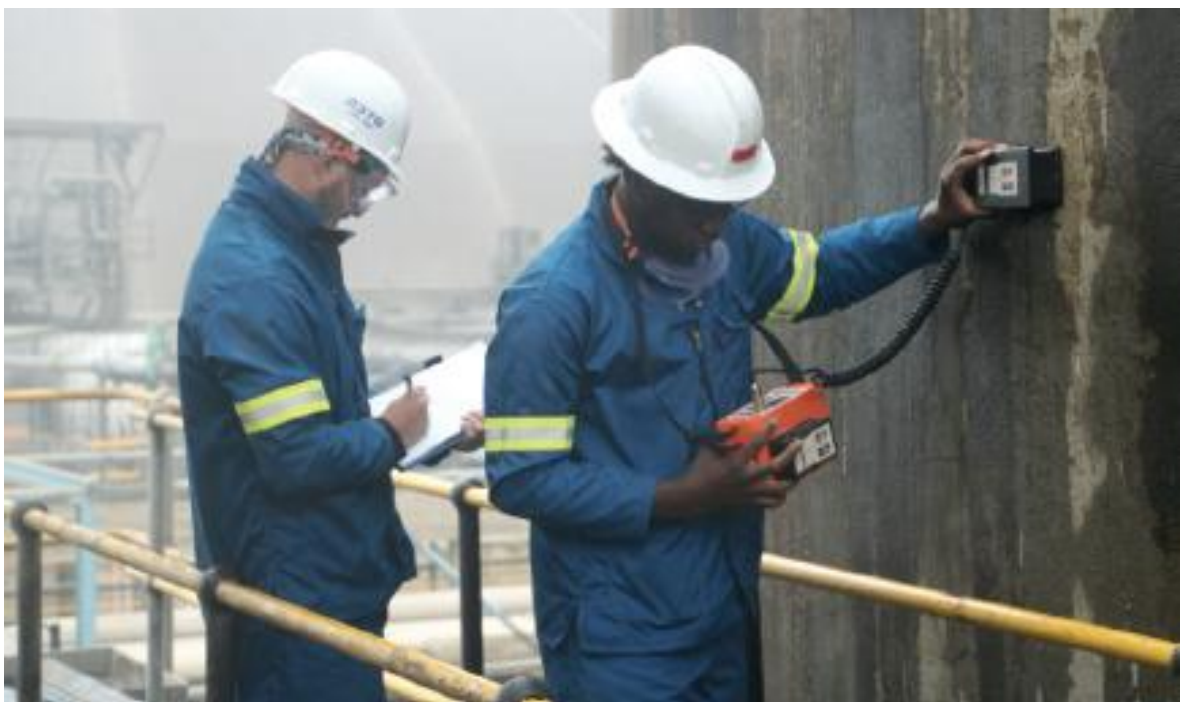
**Figure 2.9: Cover depth assessment on site (Beushausen & Louw, 2021)**

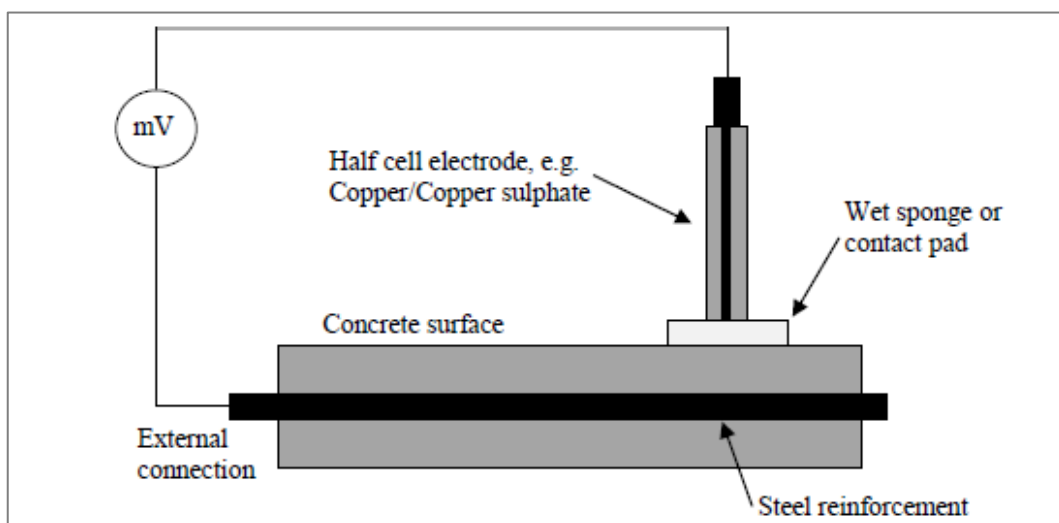
**Figure 2.10: Schematic of the half-cell potential measurement (Alexander, et al., 2012)**

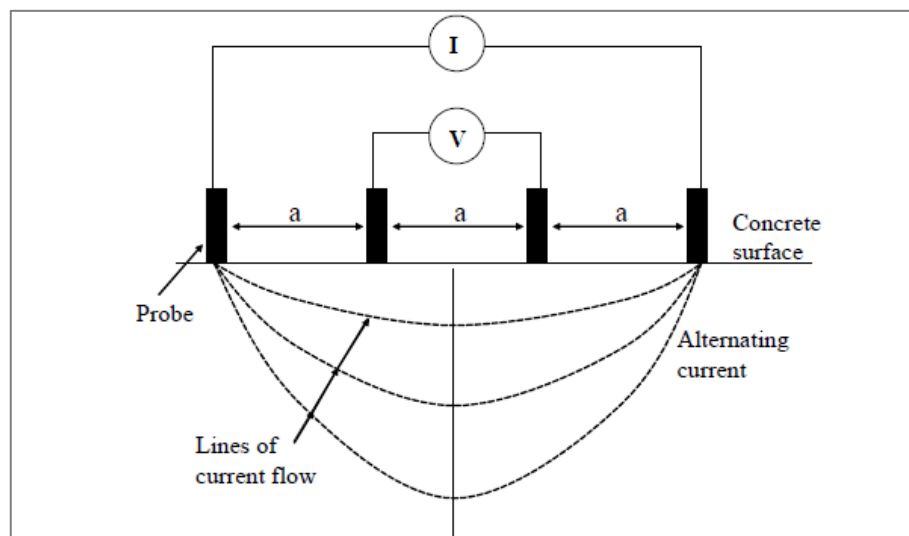
**Figure 2.11: Schematic of the 4-point Wenner probe (Alexander, et al., 2012)**

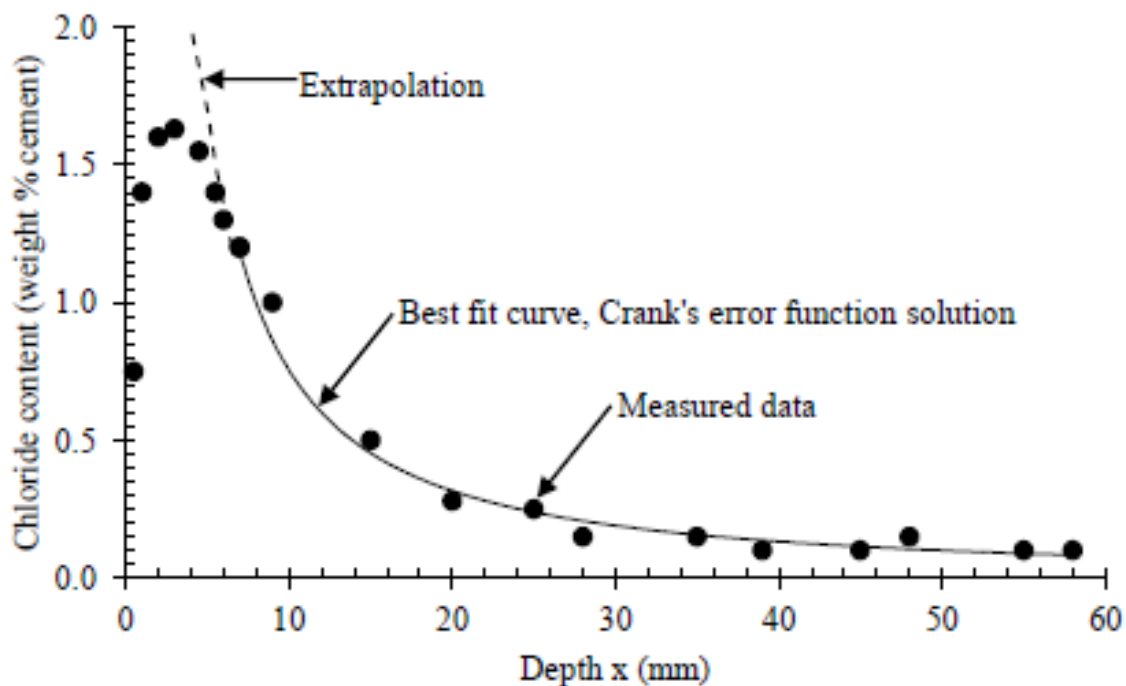
Figure 2.12: Typical chloride profile curve ignoring the convection zone (Alexander, et al., 2012)

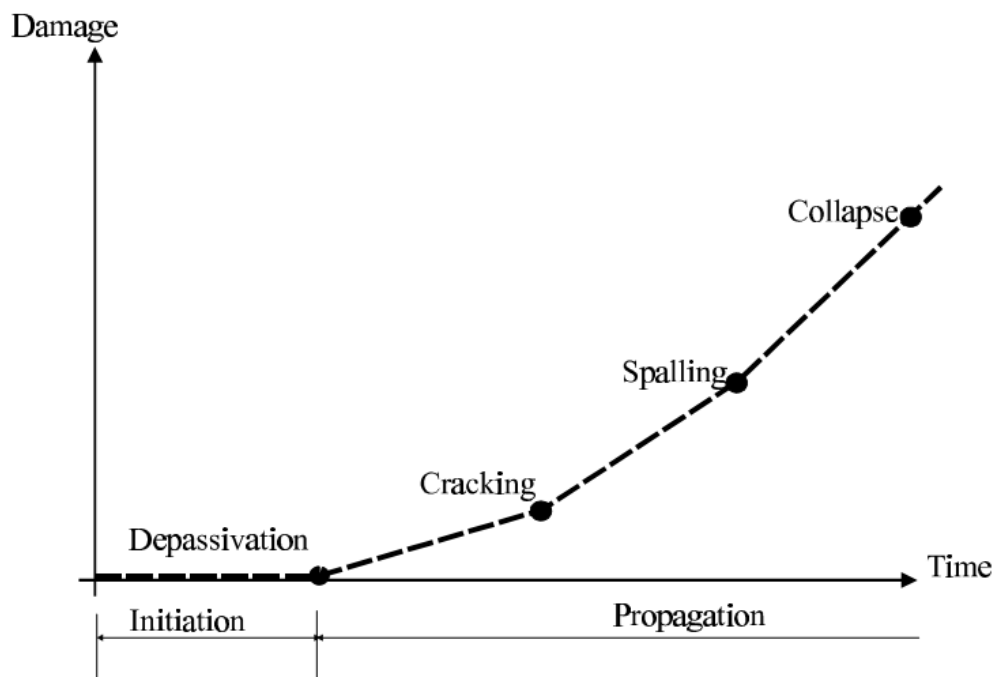
**Figure 2.13: DuraCrete service life model's durability limit states for reinforcement corrosion (Siemes, 1999)**

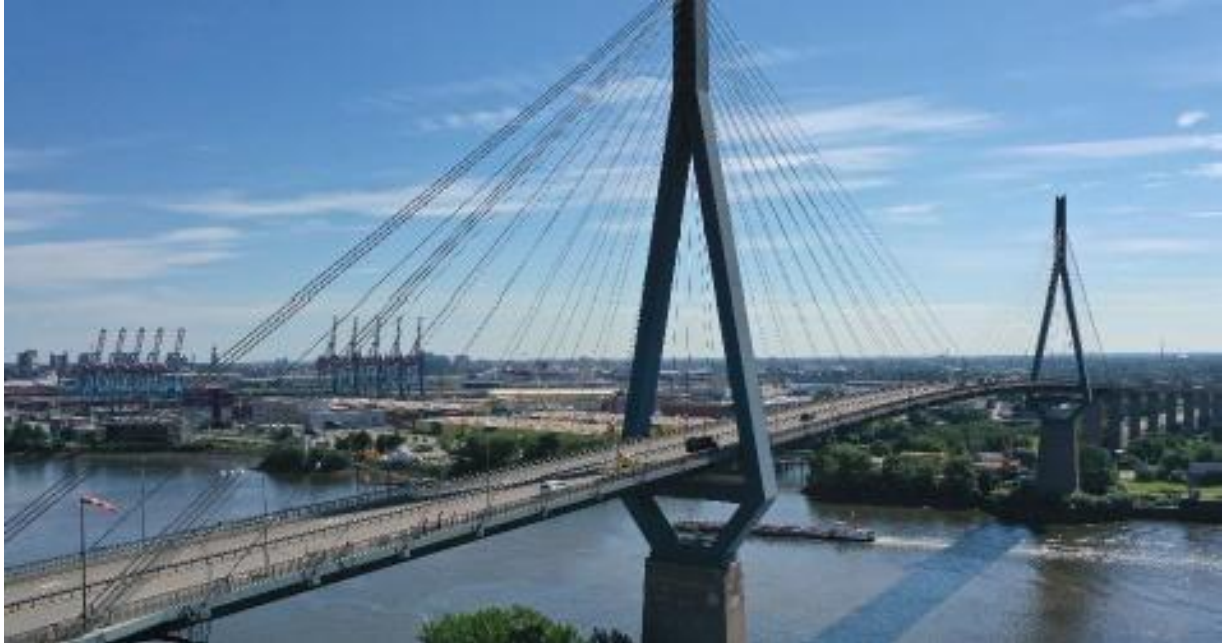
**Figure 2.15: The Köhlbrand Bridge in Hamburg, Germany (Wenner, et al., 2021)**

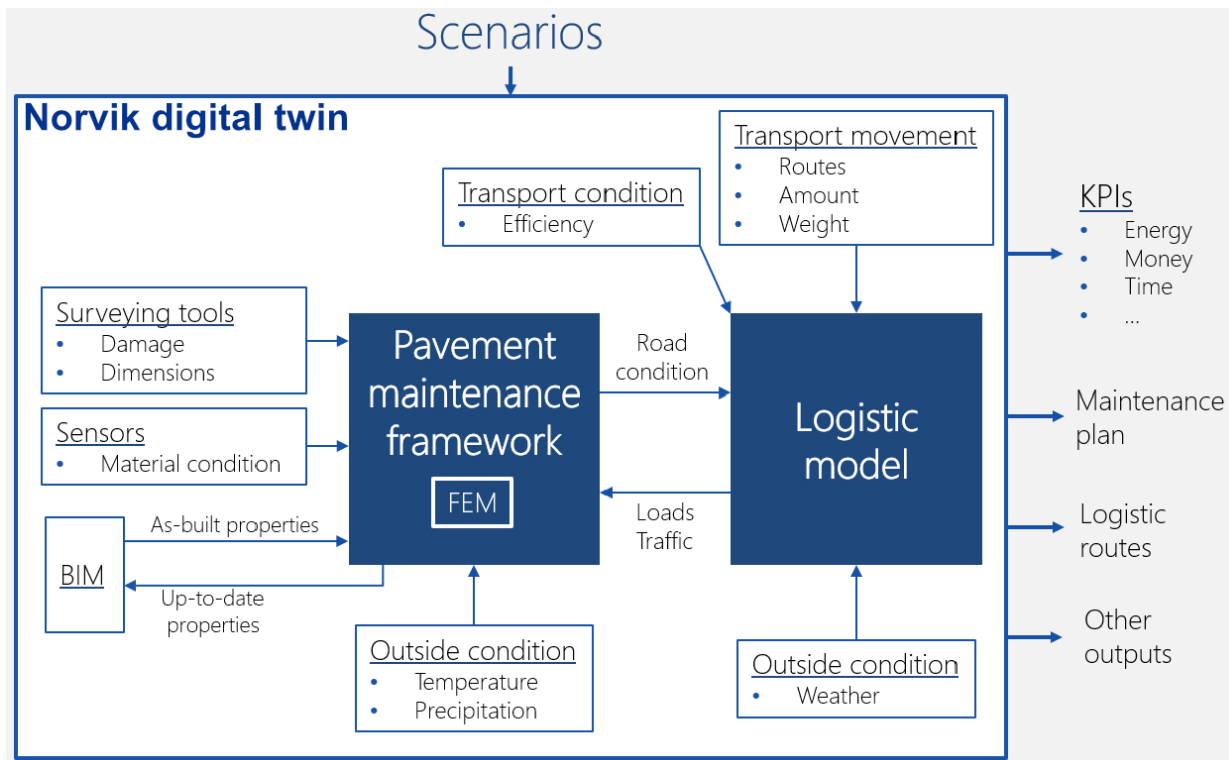
**Figure 2.18: Input parameters for Norvik Port's DT model (Millan, 2023)**

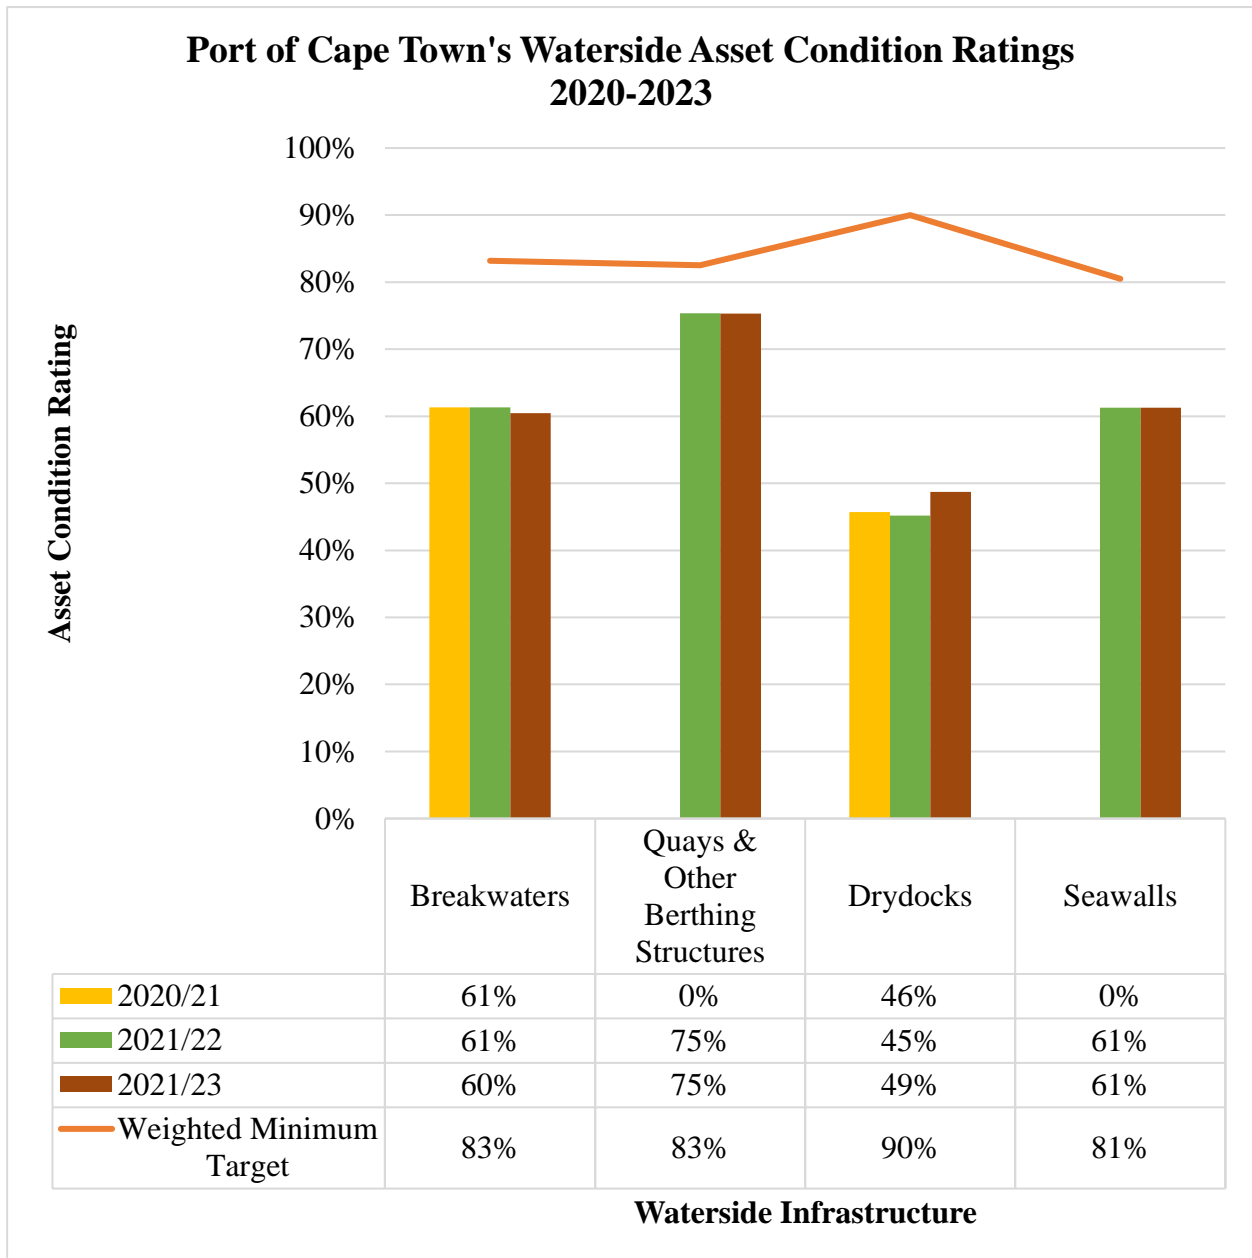
**Figure 4.1: Summary of Port of Cape Town’s waterside asset condition ratings between 2020 and 2023 (Data supplied by TNPA)**

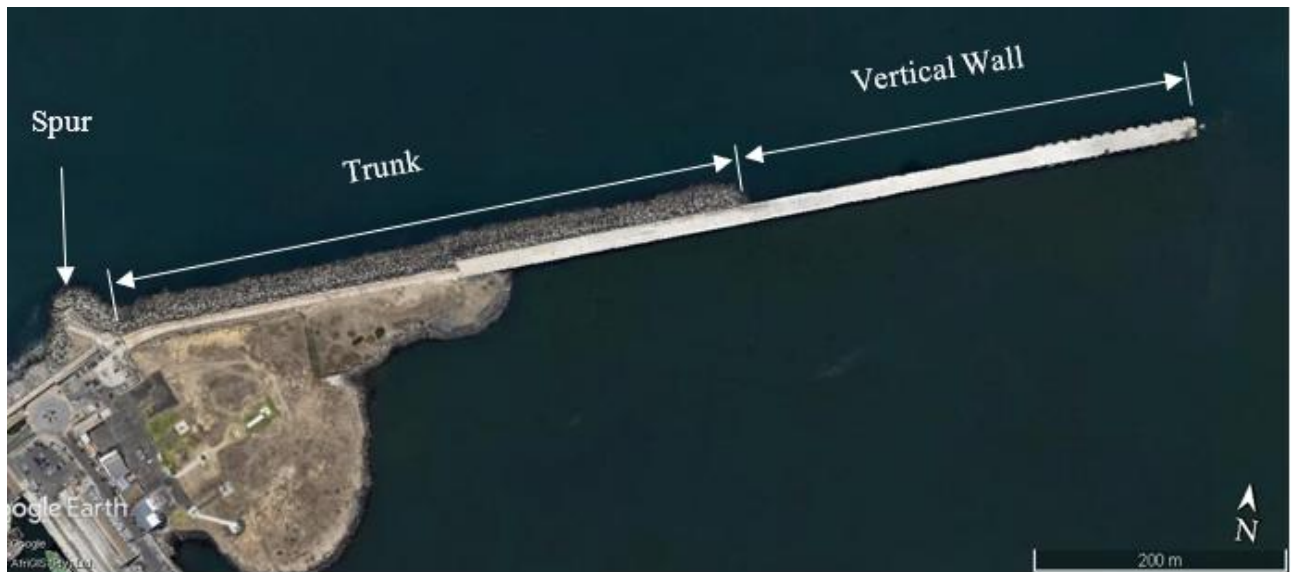
**Figure 4.2: Port of Cape Town's Main Breakwater (Picture supplied by TNPA)**

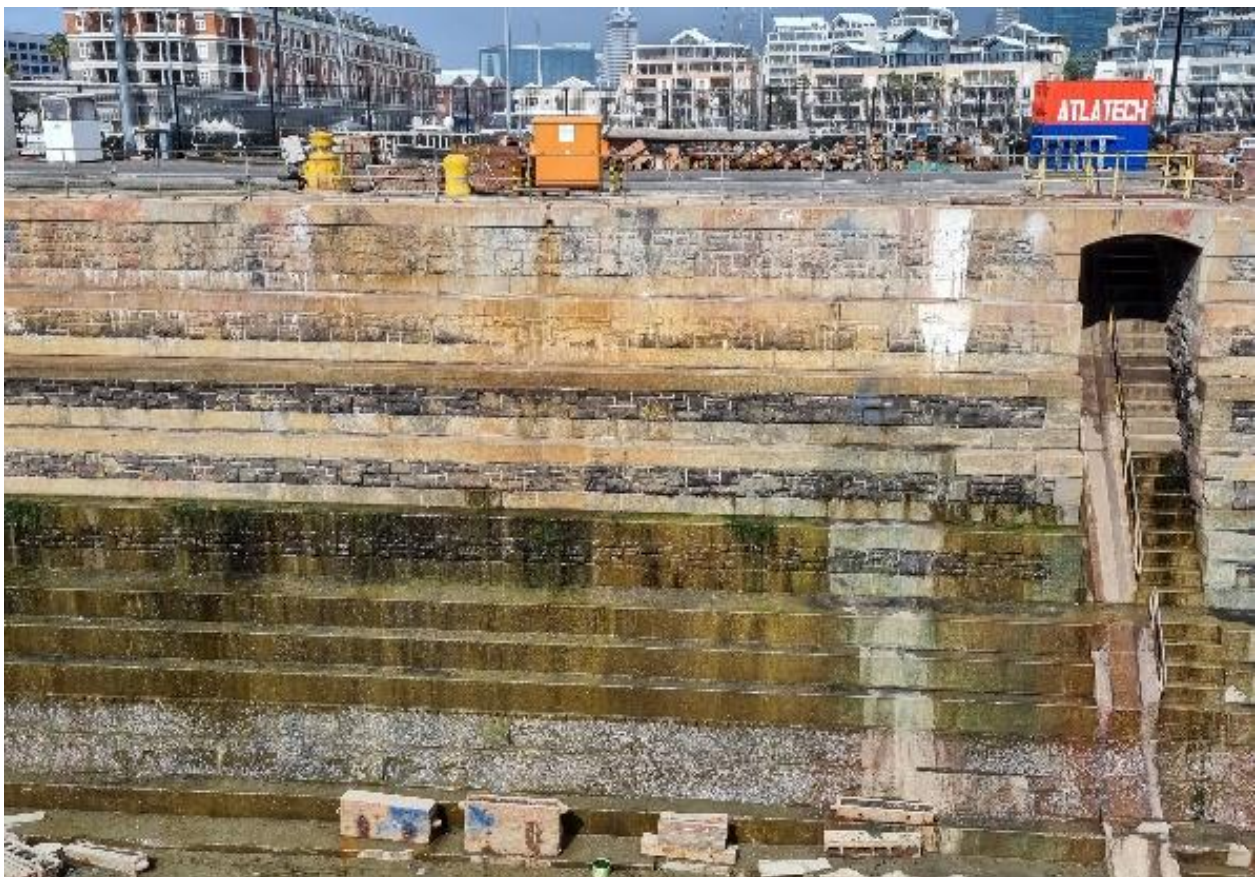
**Figure 4.3: Robinson Dry Dock at the Port of Cape Town (Picture supplied by TNPA)**

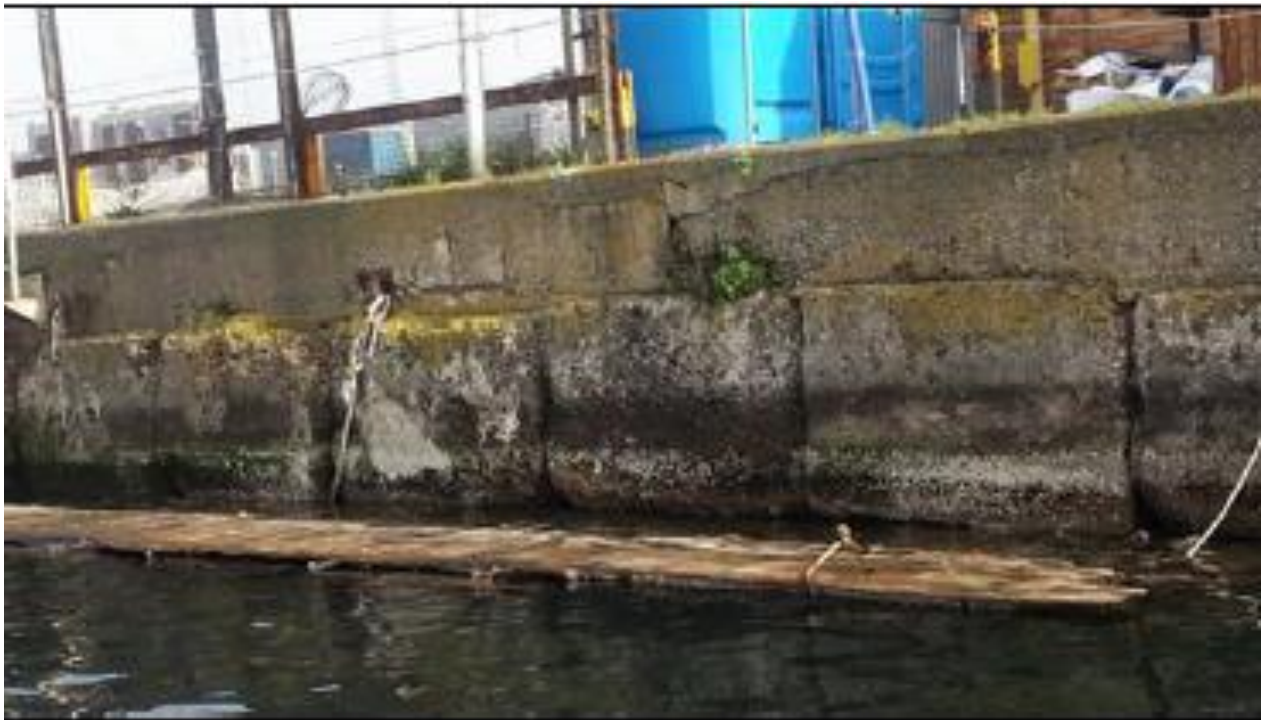
**Figure 4.4: Port of Cape Town’s quay wall section at M-Berth (Picture supplied by TNPA)**

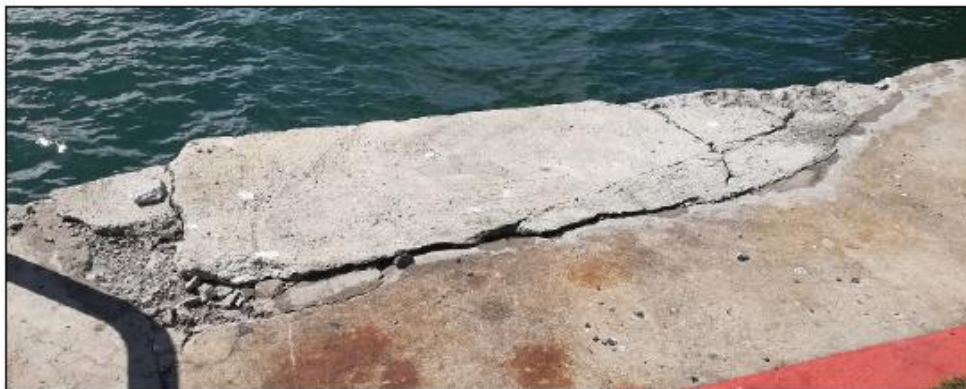
Figure 49: A piece of loose concrete along the cope edge

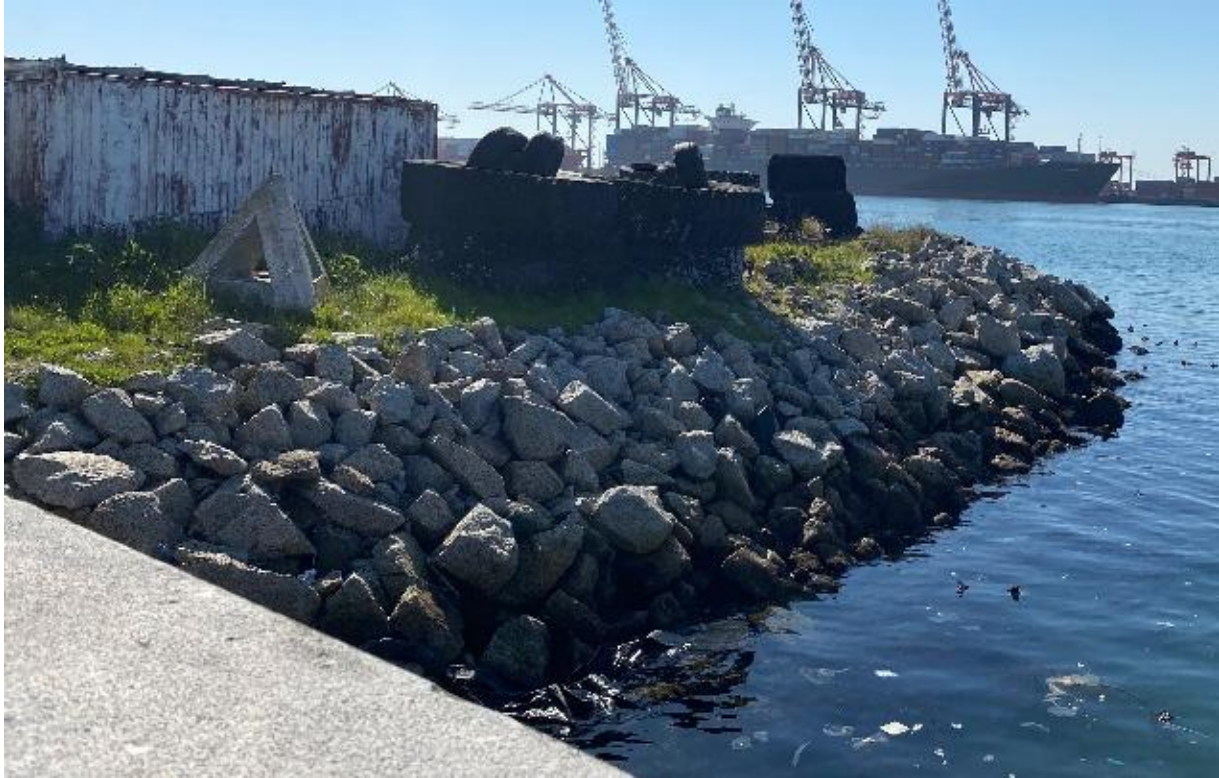
**Figure 4.6: Seawall at the Port of Cape Town (Picture supplied by TNPA)**

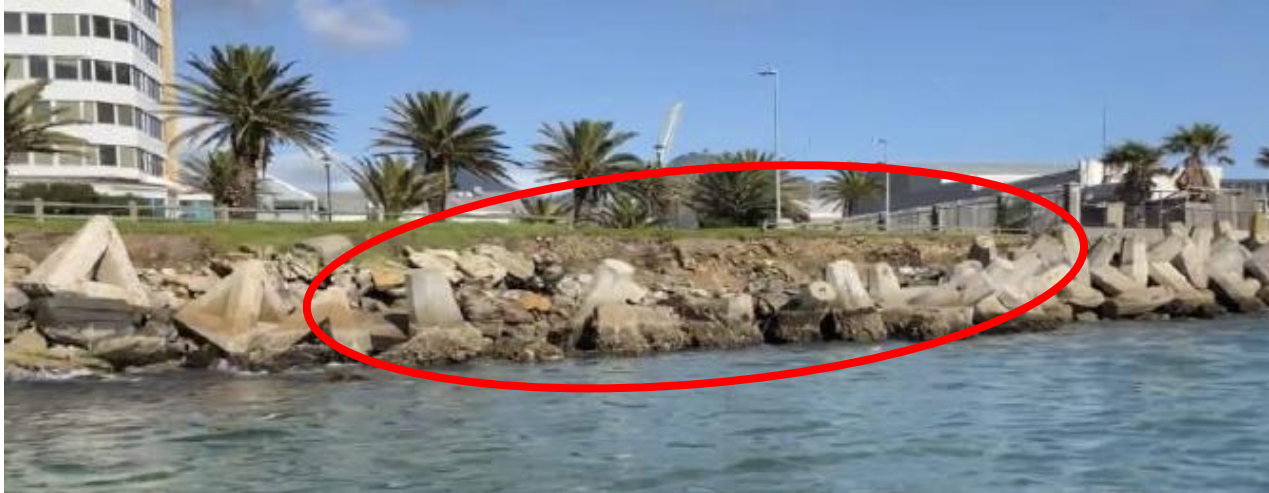
**Figure 4.7: Excessive erosion on a seawall section at the Port of Cape Town (Picture supplied by TNPA)**

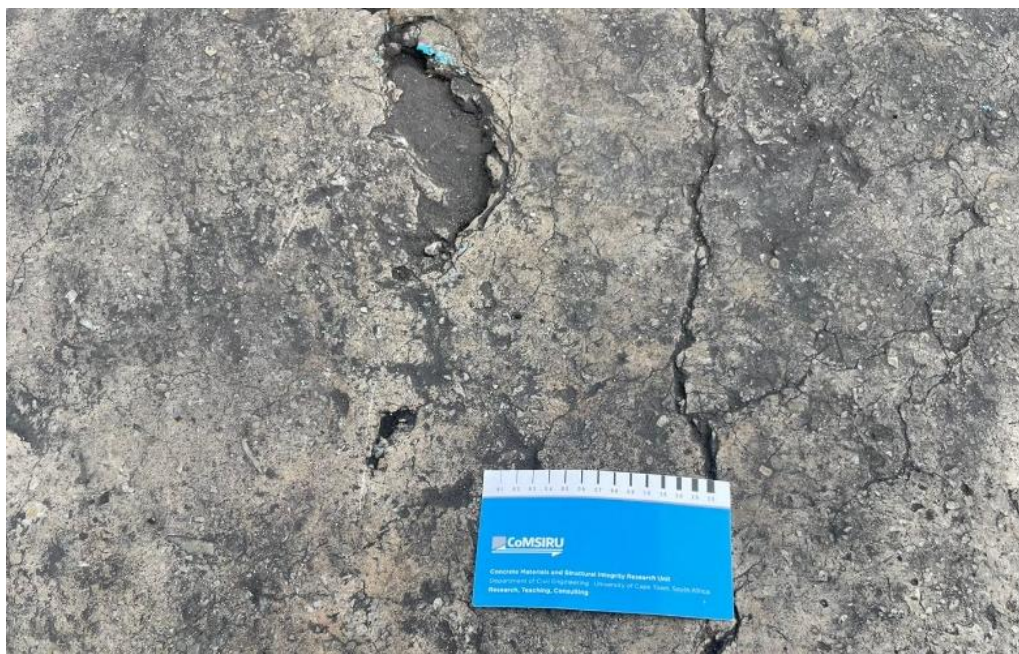
**Figure 4.8: Example of a crack ruler for the eyeball method**
