An Investigation of the Regional Expression of the Vernacular Architecture and Cultural Landscape in the Sandveld

Dissertation presented for the degree of Master of Philosophy

Department of Archaeology, University of Cape Town

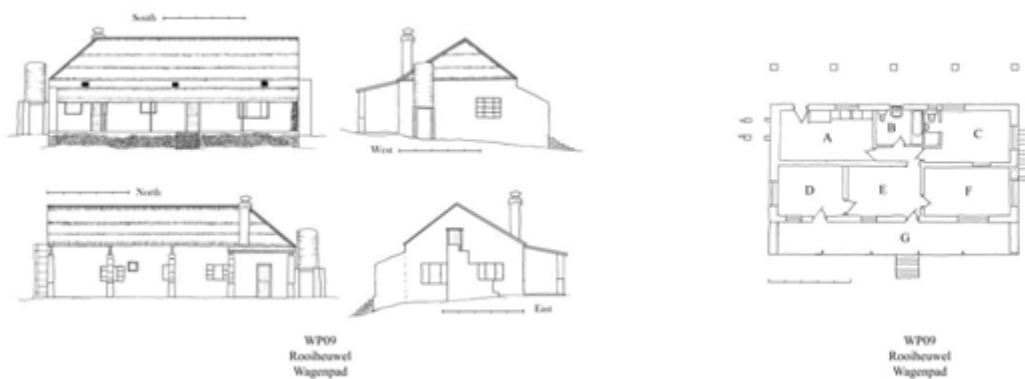
WP09 is the main farm house on the Rooiheuvel werf and situated on portion 5 of Wagenpad. As it stands in the present, the werf of Rooiheuvel consists of only two structures, however in the past at least two more structures were present.

WP09 is used as a dwelling and weekend residence and is in a good state. The house is rectangular and takes the form of two parallel rows of rooms lying in an East-West orientation. The house is 14.3m long and has a steep on the southern side.

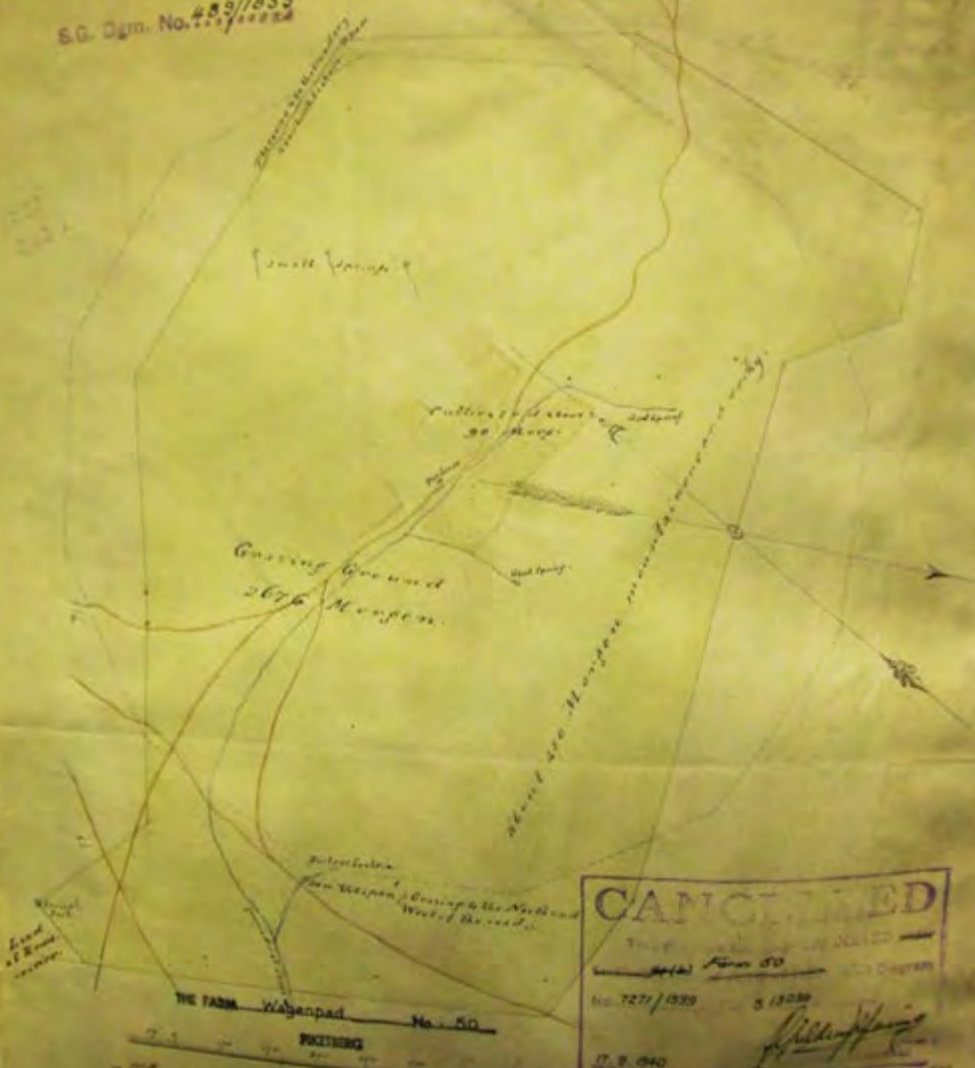
Figure 1: 1839 Survey Diagram, Wagenpad

The earliest map specifically showing infrastructure on the farm is that of the 1839 quitrent survey diagram (Appendix 2: Wagenpad: Figure 1). The diagram shows several fields of cultivated crops, as well as the roads and rivers on the farm. A single house, labelled as *DW Huis*, is indicated on the southern side of the road. Several springs are labelled on the survey diagram as well as their resultant water courses. The main river draining to the east is noted as being a *perennial stream*.

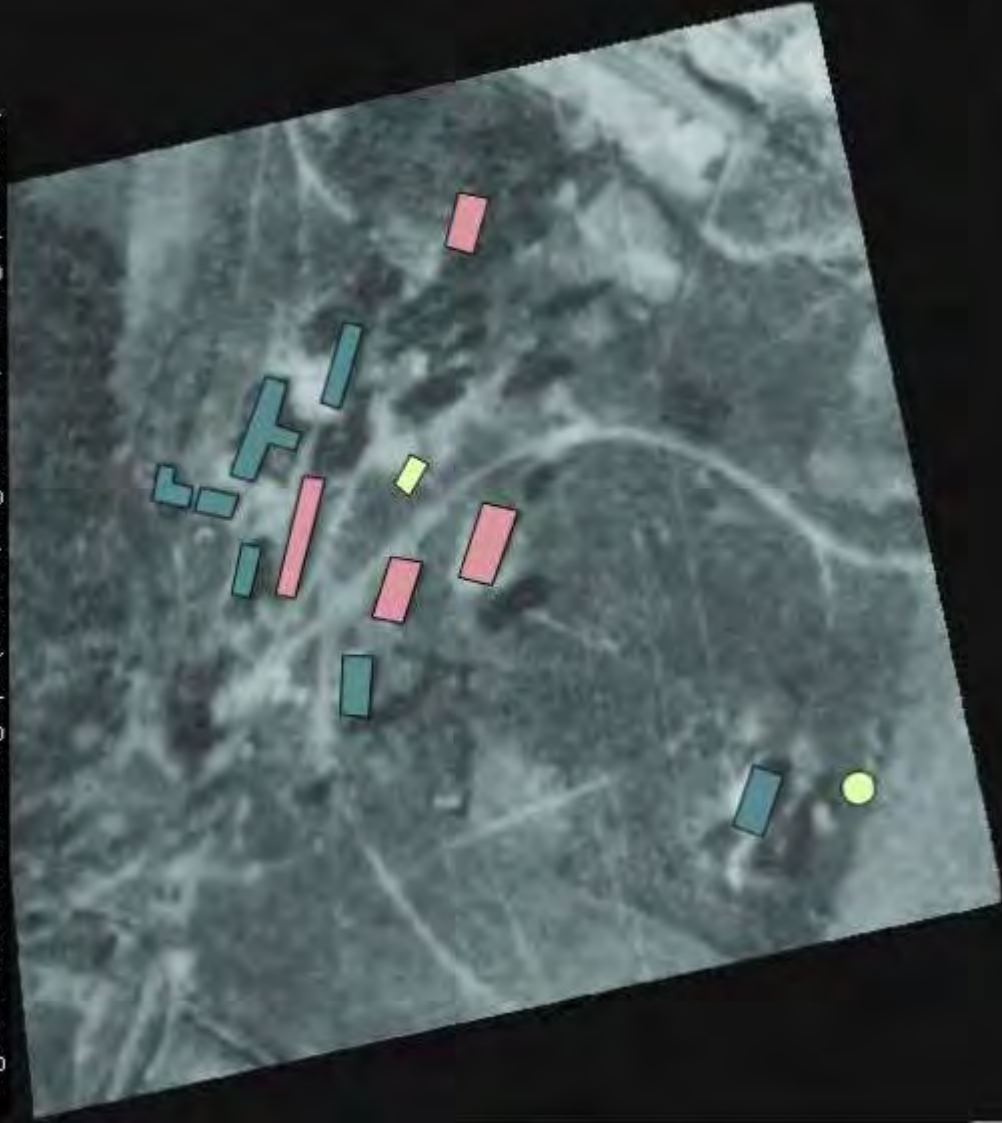
Figure 4: 1942 Aerial Photograph (Job 168, Flight Path 9, Photograph 37919)

Wagenpad is next described in one of the earliest aerial photos of the region taken in 1942 (Job 168, Flight path 9, photo number: 37919)(Appendix 2: Wagenpad: Figure 4). This image was taken soon after the creation of the previously described survey diagram, and represents the first objectively accurate description of the farm in graphic form. The image itself was sourced from the Surveyor General's mapping office, but unfortunately is not of as high a resolution as it could have been. The original negatives have been lost, and the diagram included in this project is a high quality scan of the contact sheet. Nevertheless, I have tried to identify the relevant buildings. By creating a geo-referenced overlay of modern images from Google Earth and other aerial photos from the late twentieth century, it is clear that several buildings are no longer present on the werf (represented in pink), while others have survived (represented in green).

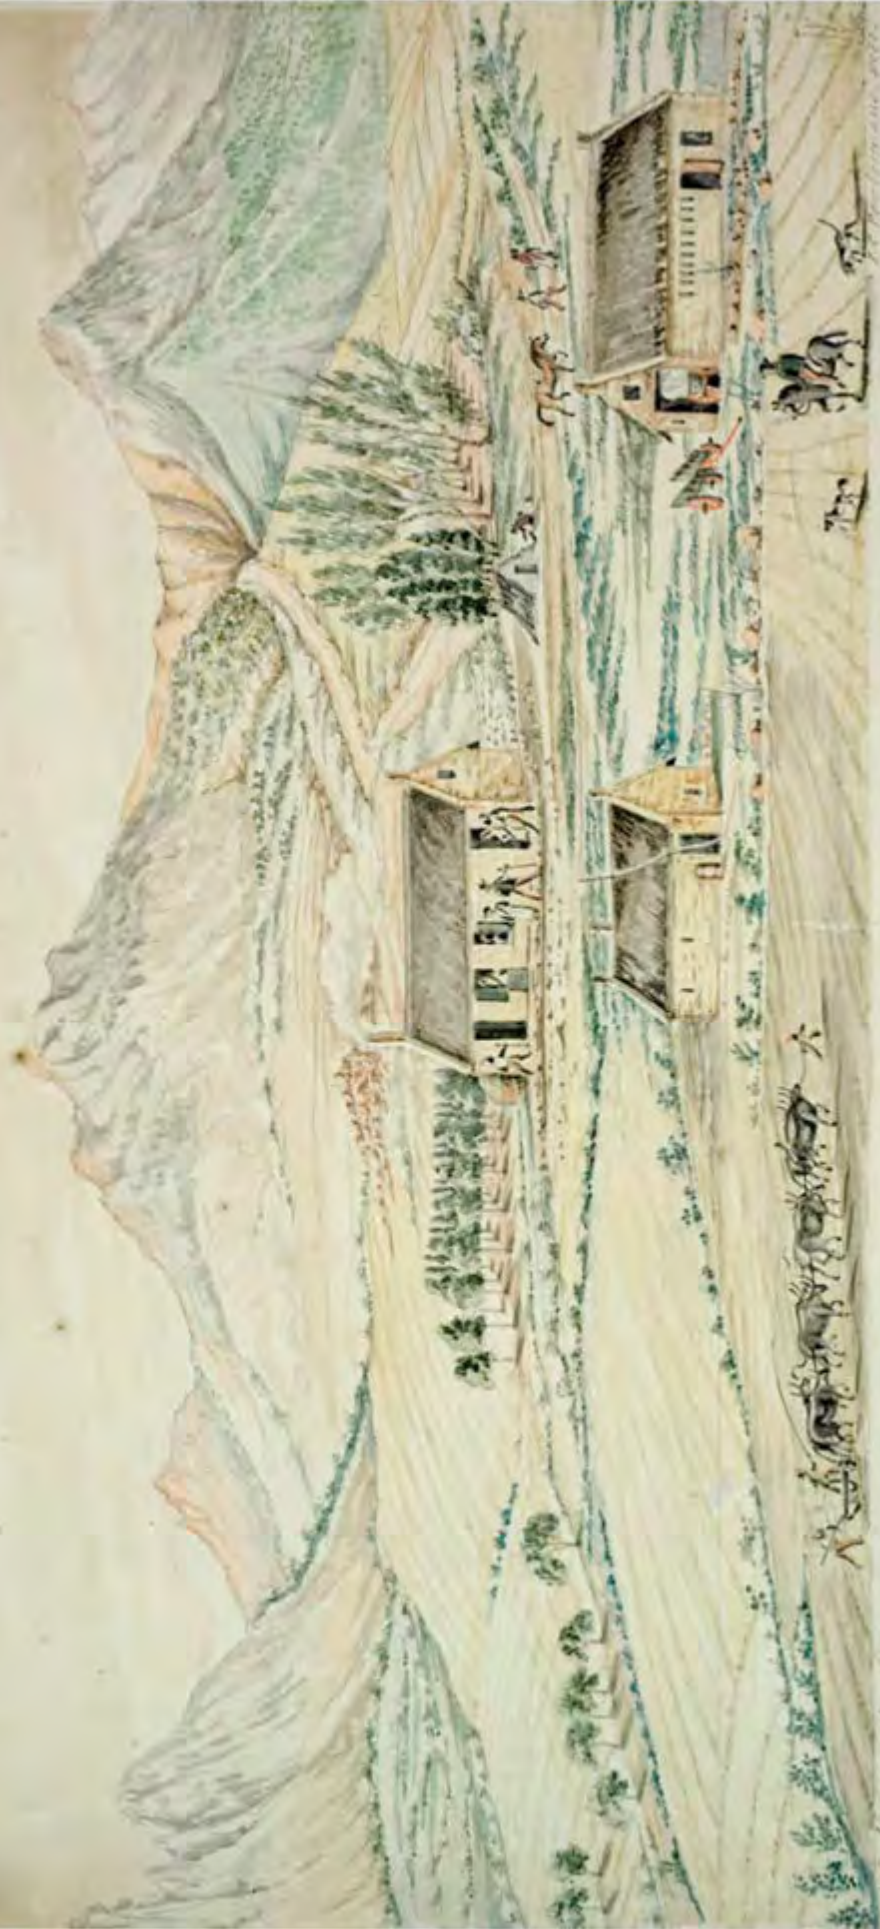
Figure 2: Painting of Ezelshoek by J Poortermans 1849

The Poortermans painting (*Ezelshoek corn estate of Mr. [P] van Zyl, Piquet mountains, Pass to Banghoek, Leading by a long Valley to Cape Town*)(Appendix 2: Voetpad: Figure: 2) shows a building with two doors on the eastern end of the building, as well as a chimney. The doors depicted show what James Walton called a *bo-onder-deur*, Walton which directly translated is an "above below door", otherwise known as a stable door. Poortermans depicts several figures leaning out of the doors. The piercings on the depicted house show that there are two doors on the eastern end of the house's northern wall, and a window and a door at the western end of the building. These piercings are in keeping with what remains of the ruins. There is a piercing on the western most extent of the northern wall, but the exact nature of this is impossible to ascertain.

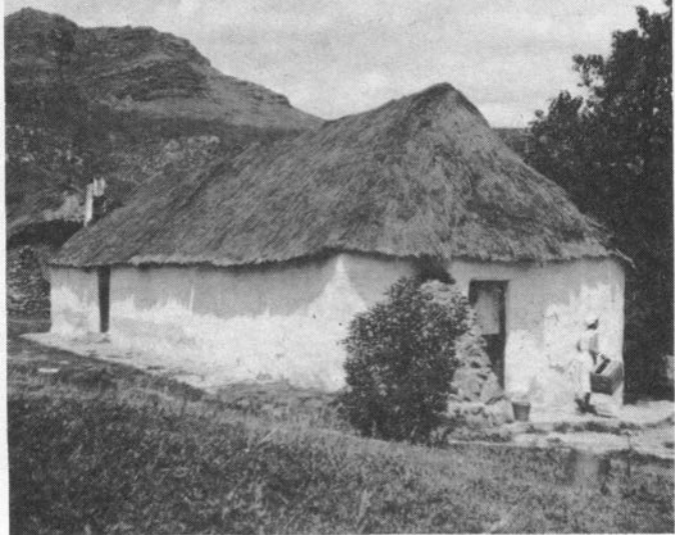
Fig 14: Eselshoek. A dwelling with gable entrance and a kitchen entrance at the opposite end. Built after Poortermans made his painting but typical of many Piquetberg houses which he illustrated.
