MSc. Dissertation

**The Fatigue Performance Assessment of Corrosion Damaged RC
Beams, Patch Repaired and Externally Strengthened Using CFRP**

Thesis submitted to the faculty of Engineering and the Built Environment,
University of Cape Town, South Africa, in partial fulfilment of the requirements
for the degree of Masters of Science in Engineering

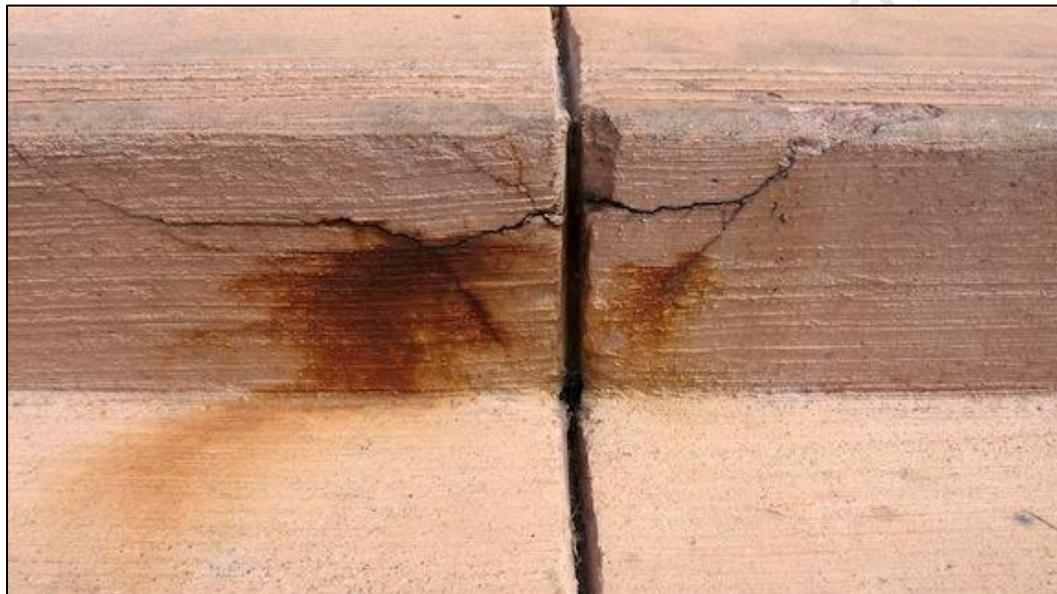
Figure 2: Longitudinal corrosion cracking (www.nachi.org)

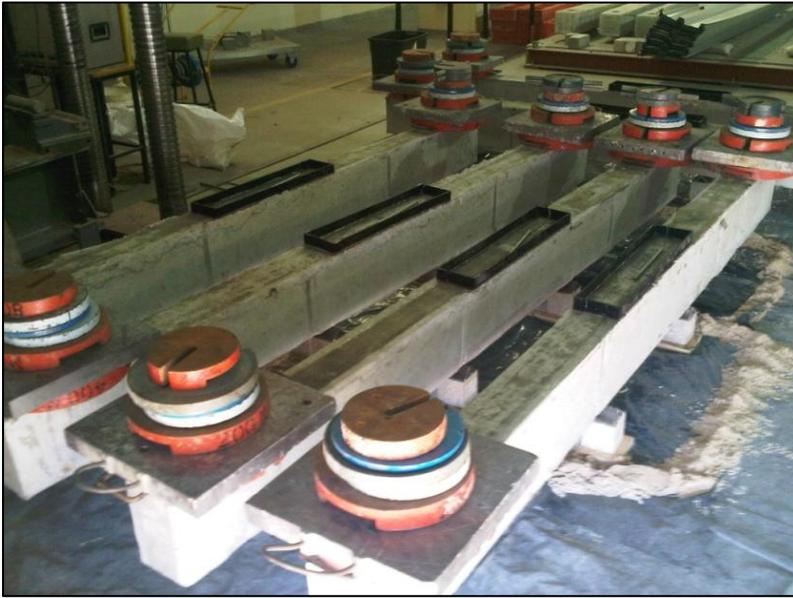
Figure 29: Accelerated corrosion under sustained load

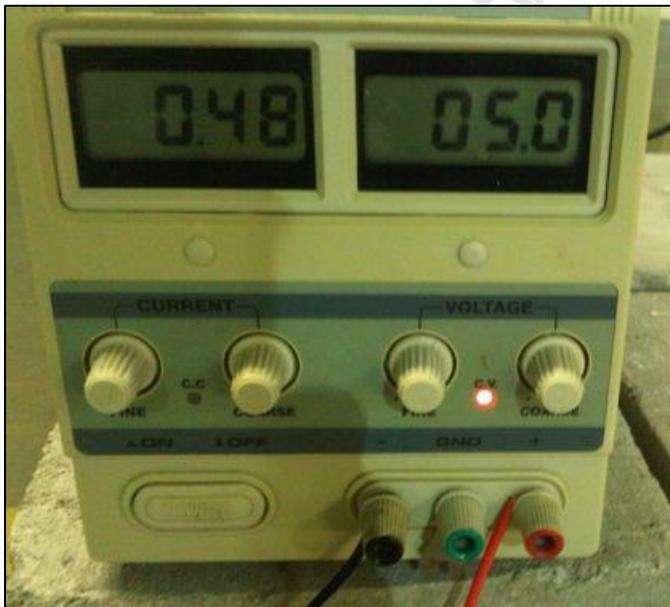
To monitor the rate and degree of corrosion more effectively, all corroded beam specimens were supplied with the same current of 480 mA/cm^2 which was divided equally between the two bars in a series arrangement (See Figure 28). The duration of accelerated corrosion depended on the desired degree of corrosion for each specimen and was calculated using Farady's Law.

Figure 30: Constant current of 480 mA/cm^2 supplied.

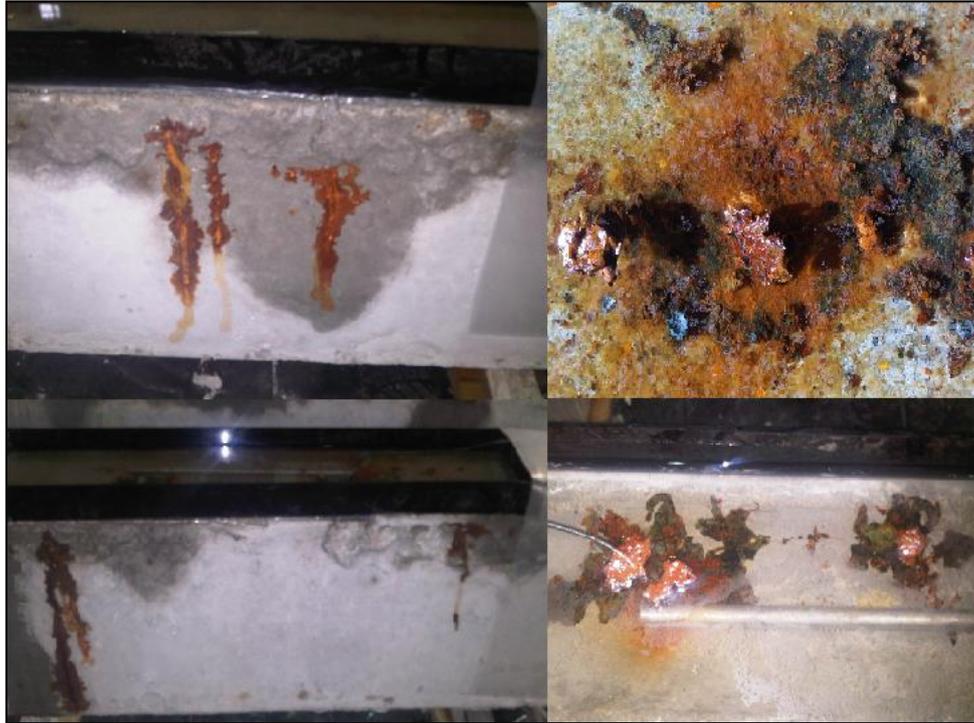
Figure 31: Internal corrosion of the RC beams

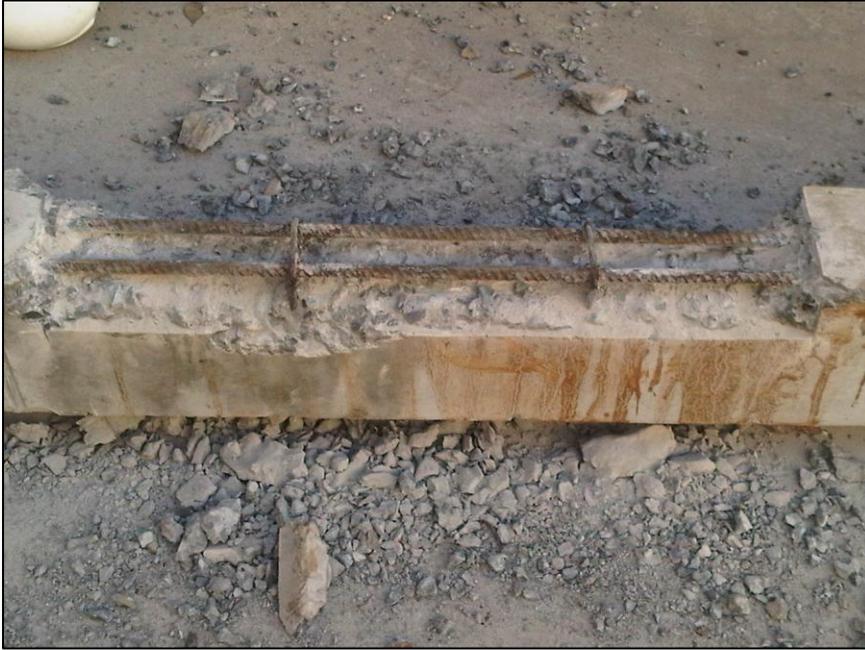
The corrosion damaged RC beams were prepared by removing all the damaged concrete that had been affected. The damaged concrete was removed by cutting out the affected area using a grinder and jack hammer, the affected area removed totaled to a depth of approximately 25mm below the internal tensile steel reinforcement. The damaged reinforcement was then cleaned with a wire brush thus removing all excess corrosion products, then any loose existing concrete particles were removed by sand blasting the cut away surface, finally the concrete and steel surfaces were cleaned of all contaminates. The exposed beam was then wetted overnight to ensure full saturation for preparation of the patch repair application.

Figure 32: Damaged Concrete removed and internal steel treated

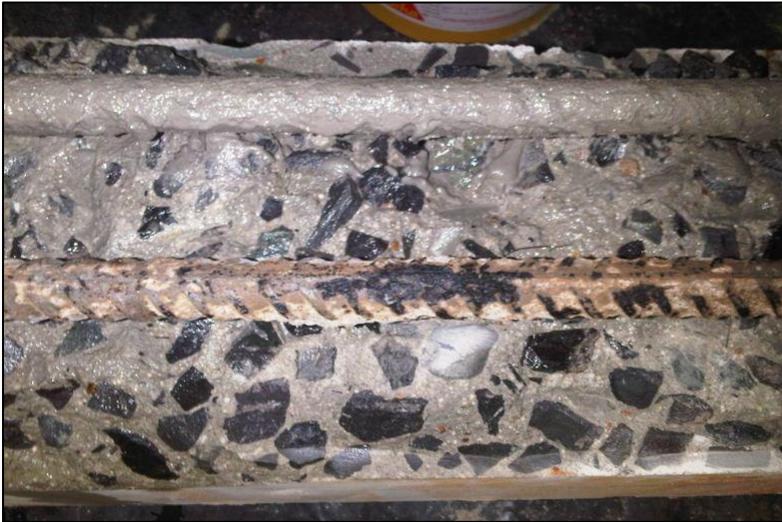
The repair technique of patch repairing was implemented for all six test specimens. After the damaged concrete was removed and the surface and internal reinforcement was adequately coated with *Sikatop Armatec 110 EpoCem* adhesive bonding agent, *SikaCrete 214* repair mortar was mixed with 3l of water and poured in the formwork, no vibrating was necessary. Once the repair mortar was at the same level as the existing concrete the beams were covered with a polythene sheet overnight and demoulded after 24 hours. The repaired section was covered with wet hessian to ensure that the section cures properly for the remaining 3 days. *SikaCrete 214* is a rapid hardening repair mortar which boasts compressive strengths of 55MPa after just 24 hours.

Figure 33: Internal steel pitting and treatment technique

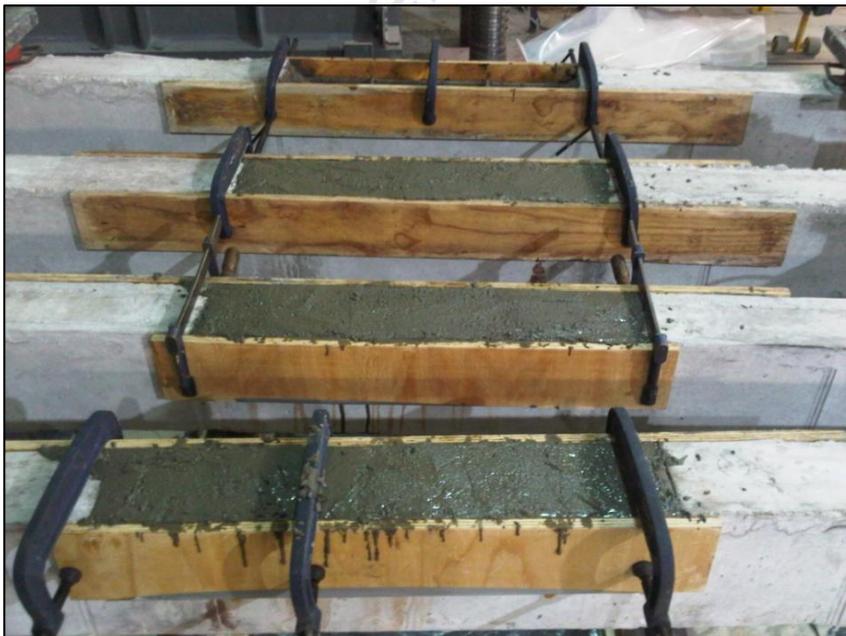
Figure 35: Patch repair casting and moulds under sustained loading

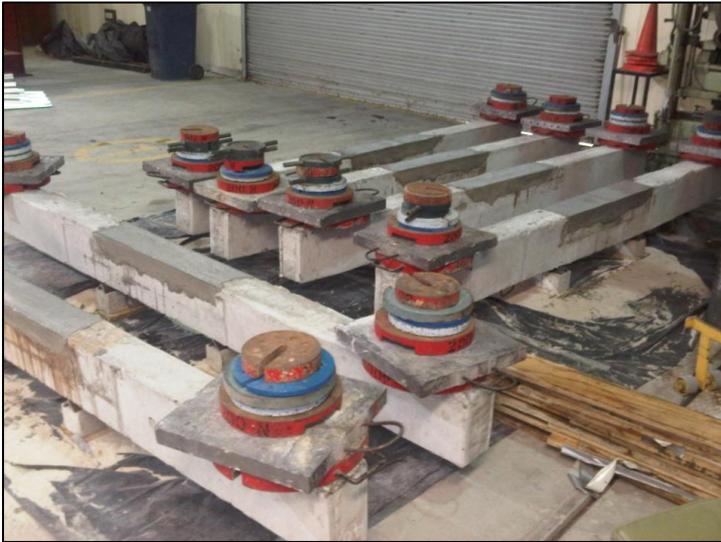
Figure 36: Cured Patch repair under sustained loading

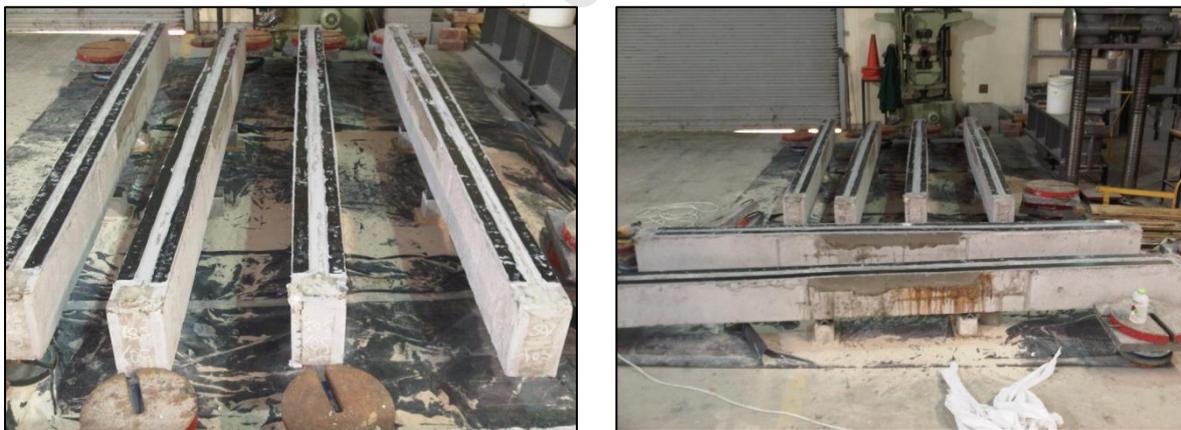
Two CFRP laminates were bonded parallel to each other along the entire length of the tensile face for each RC beam (Figure 37). A Light weight, uni-directional 200mm CFRP wrap was bonded around the entire beam at the location of the supports to provide adequate anchorage during the testing phase (Figure 38). The test beams were finally coated with white paint in an effort to easily identify early stage cracking.

Figure 37: CFRP laminate application along the tensile face

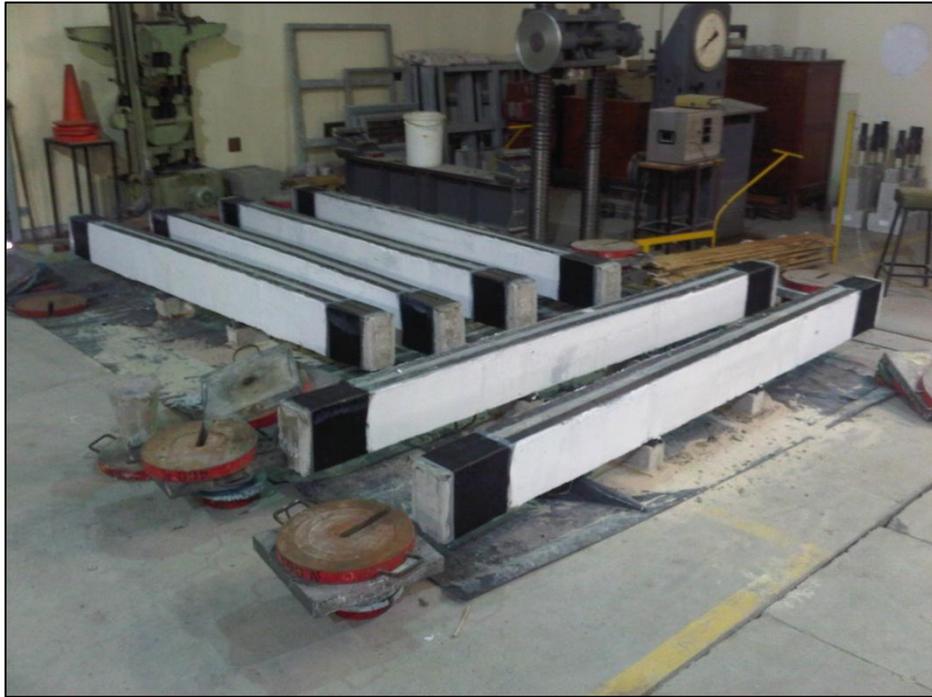
Figure 38: CFRP Wrap applied at support ends for anchorage

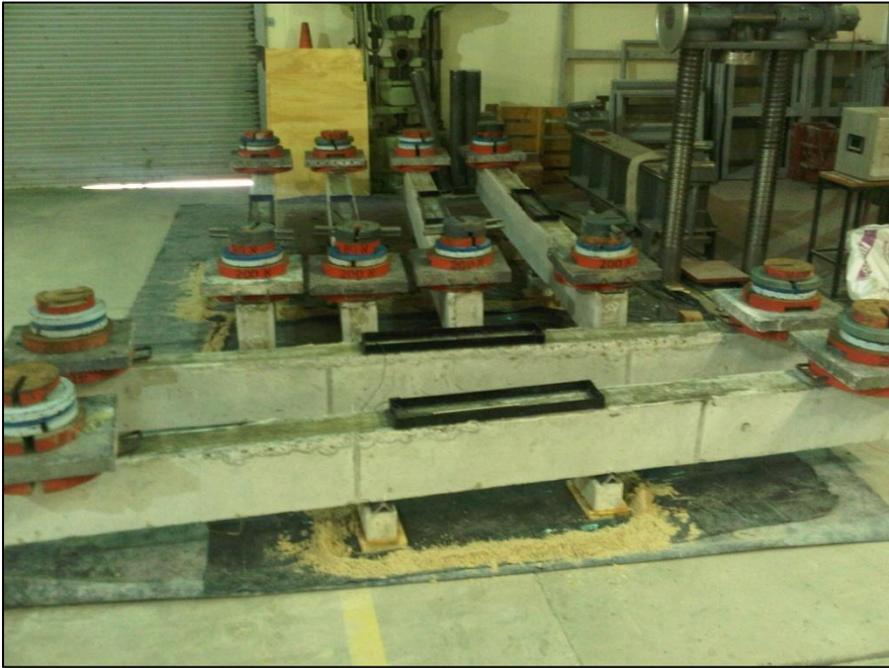
Figure 40: Static load set up and accelerated corrosion phase

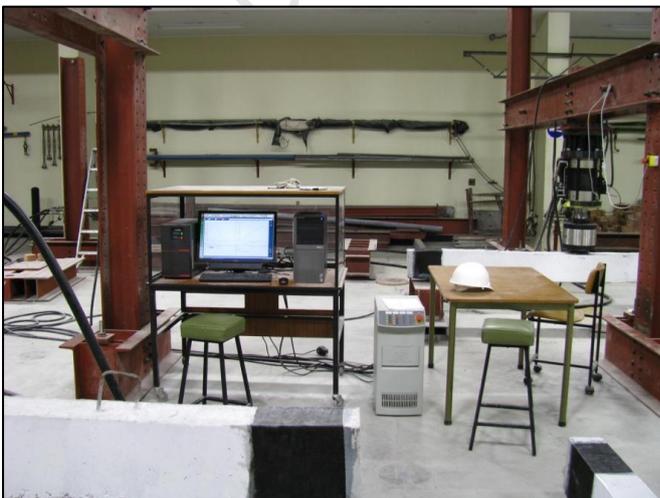
The program Wave Matrix was used to form the applied load waves for the cyclic and static test sequences. The Instron is connected to the 250kN actuator which applied the desired cyclic and static loads, throughout the loading sequence; Wave Matrix collects load and displacement data according to the position of the actuator whilst performing the desired load. The data captured was used to graphically represent the deterioration of each test specimen over a period of time. The graph displays the number of cycles versus midspan displacement throughout the entire test sequence.

Figure 41: Data acquisition and Instron set up

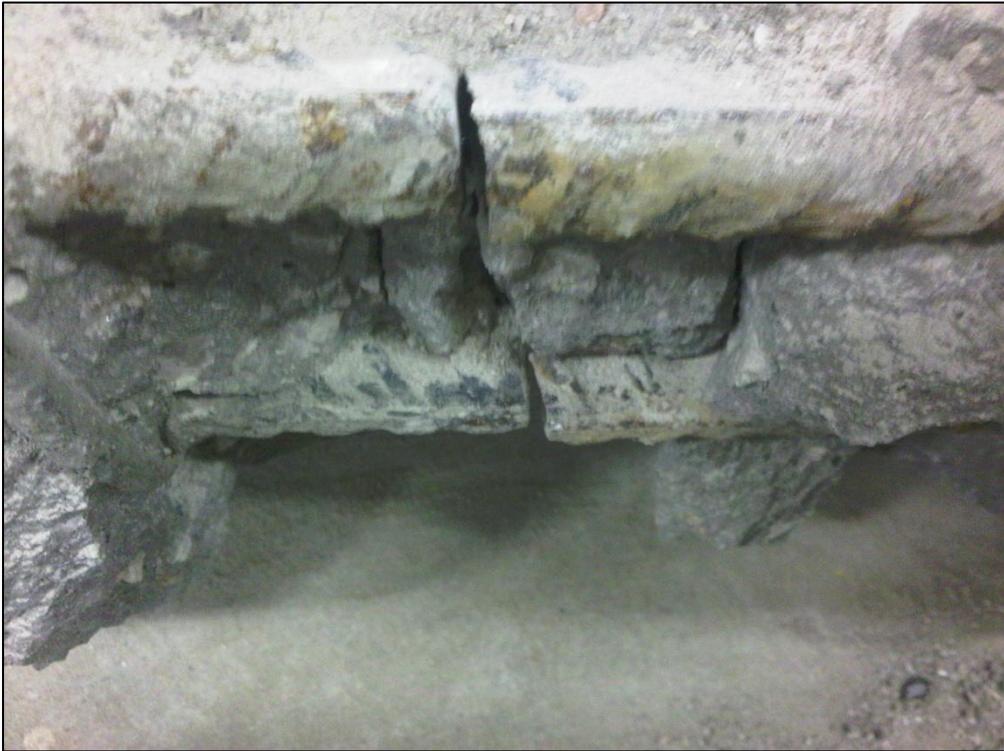
Figure 43: Internal steel fracture

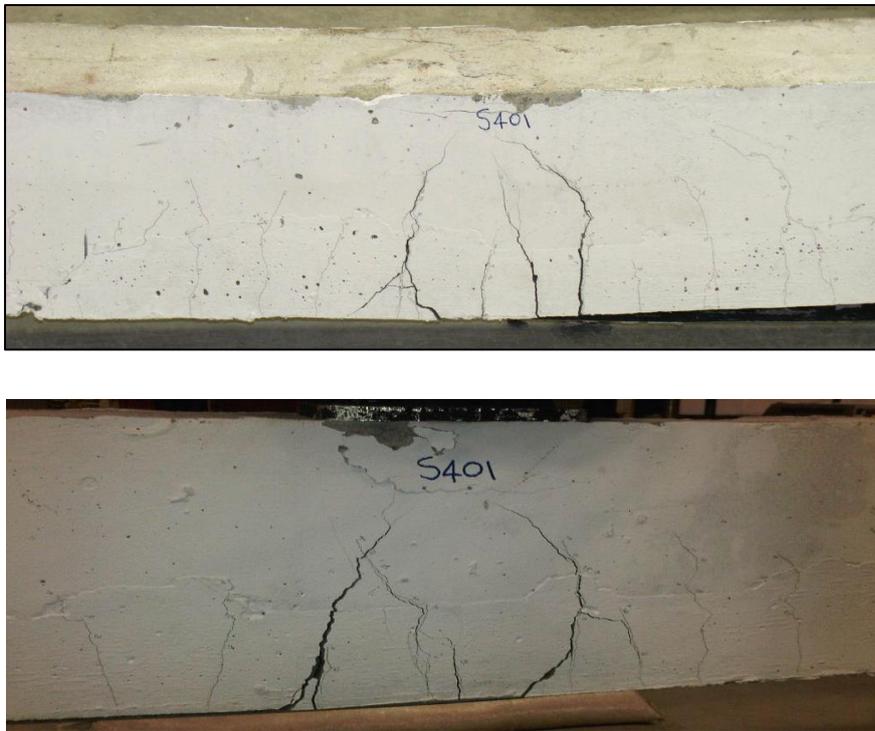
Figure 46: S-40 Bending Failure

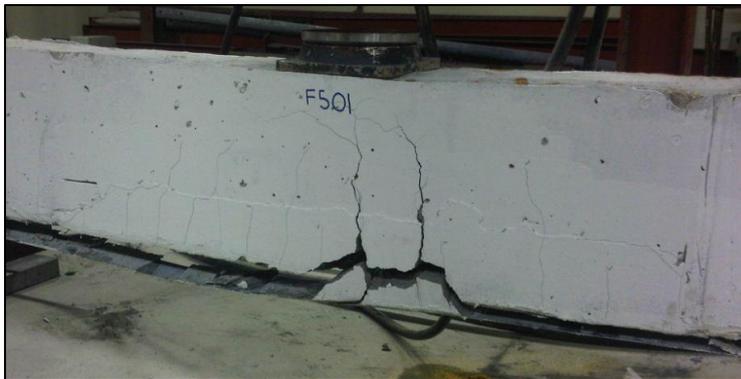
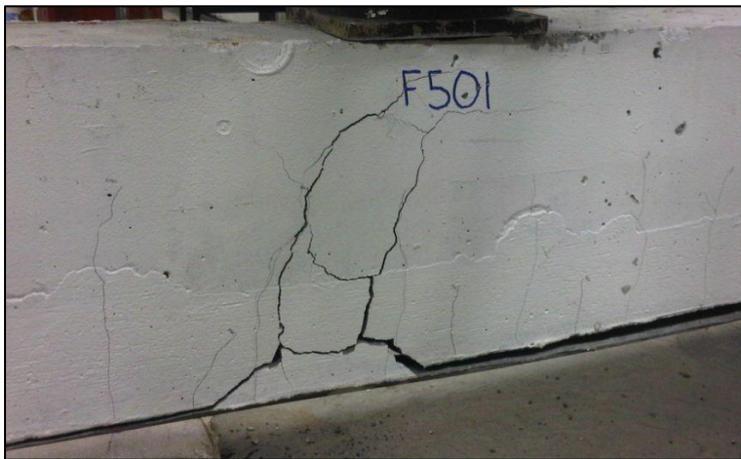
applied until eventual CFRP debonding occurs and the beam ultimately fails after 3,010,817 cycles due to the ultimate bending capacity being exceeded.

Figure 50: F-50-1 CFRP debonding at failure

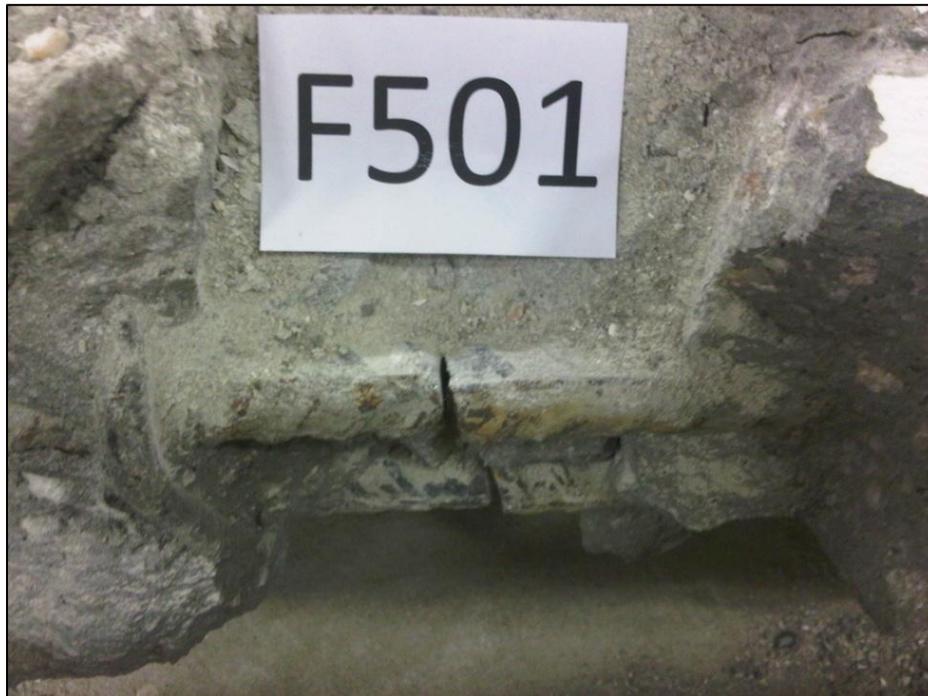
Figure 52: Internal Steel fractured after approximately 2,400,000 cycles

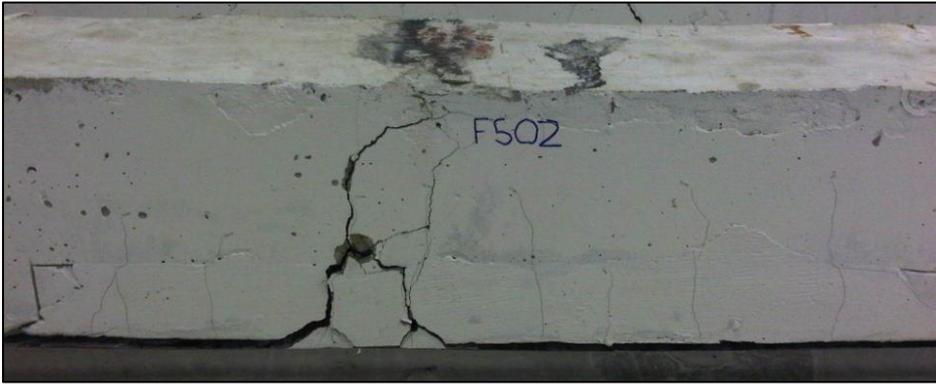
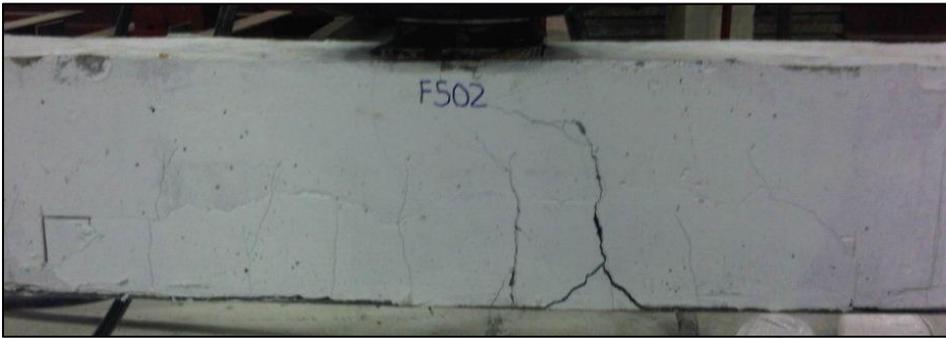
Figure 54: F-50-2 Cracking and debonding at failure

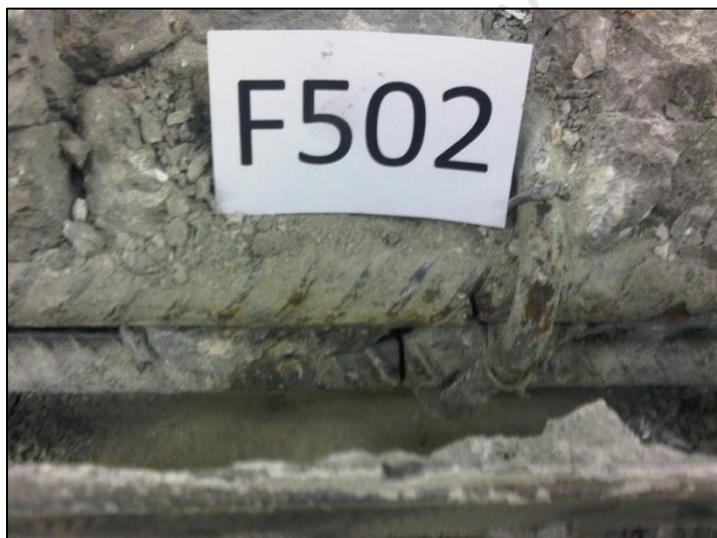
Figure 56: Internal steel fractured

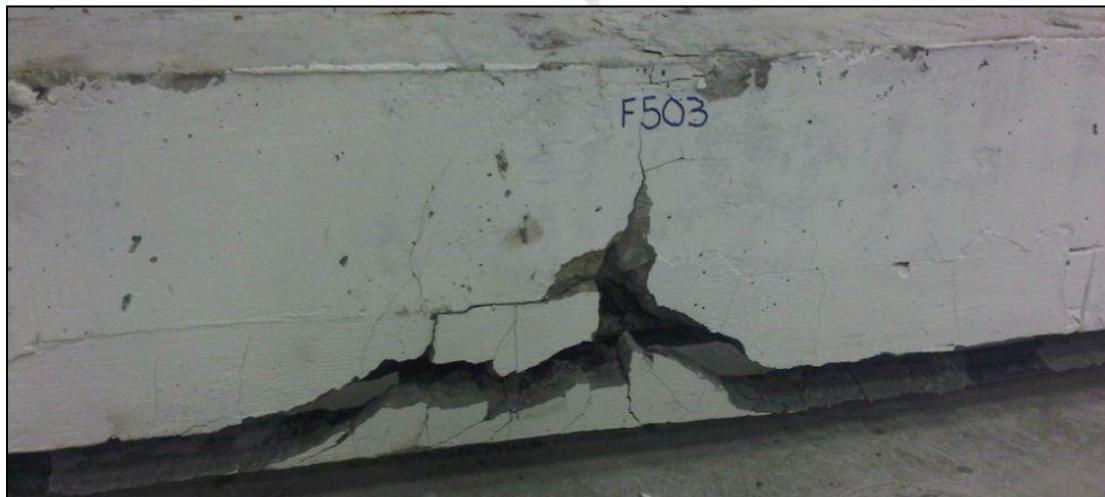
Figure 58: F-50-3 Cracking, debonding and spalling

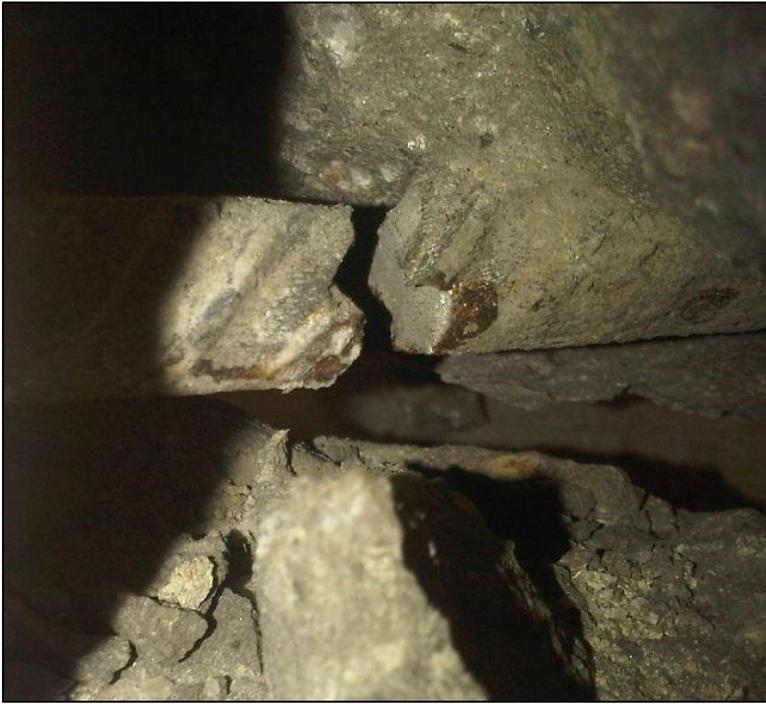
Figure 59: F-50-3 internal steel fracture

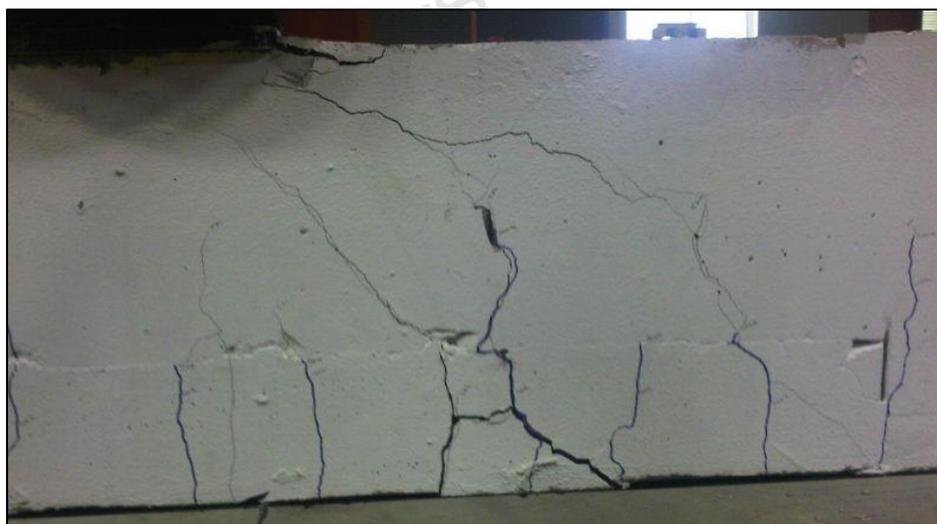
Figure 63: F-40-2 Shear failure

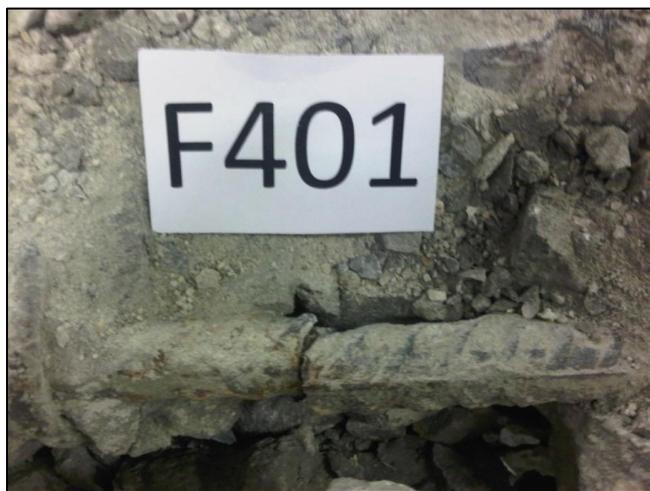
Figure 65: Internal steel fracturing (1)

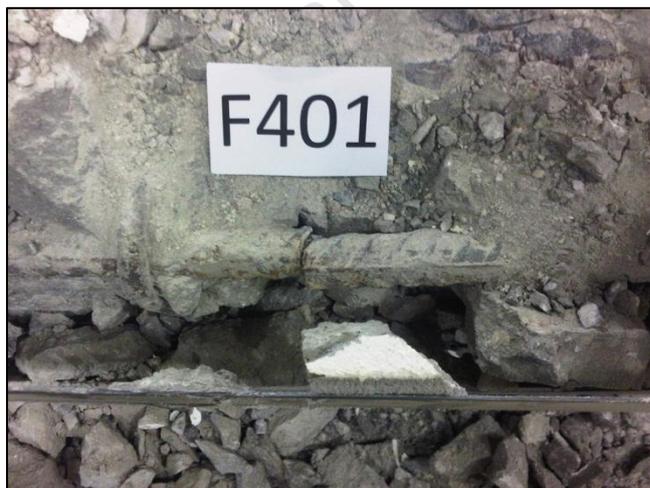
Figure 66: Internal steel fracturing (2)
