# **THE TRIBOLOGICAL BEHAVIOUR OF ALUMINIUM MATRIX COMPOSITES**

**A thesis submitted to the Faculty of Engineering, University of Cape Town in fulfilment  
of the degree of Doctor of Philosophy**

**Department of Materials Engineering  
University of Cape Town  
February 1993**

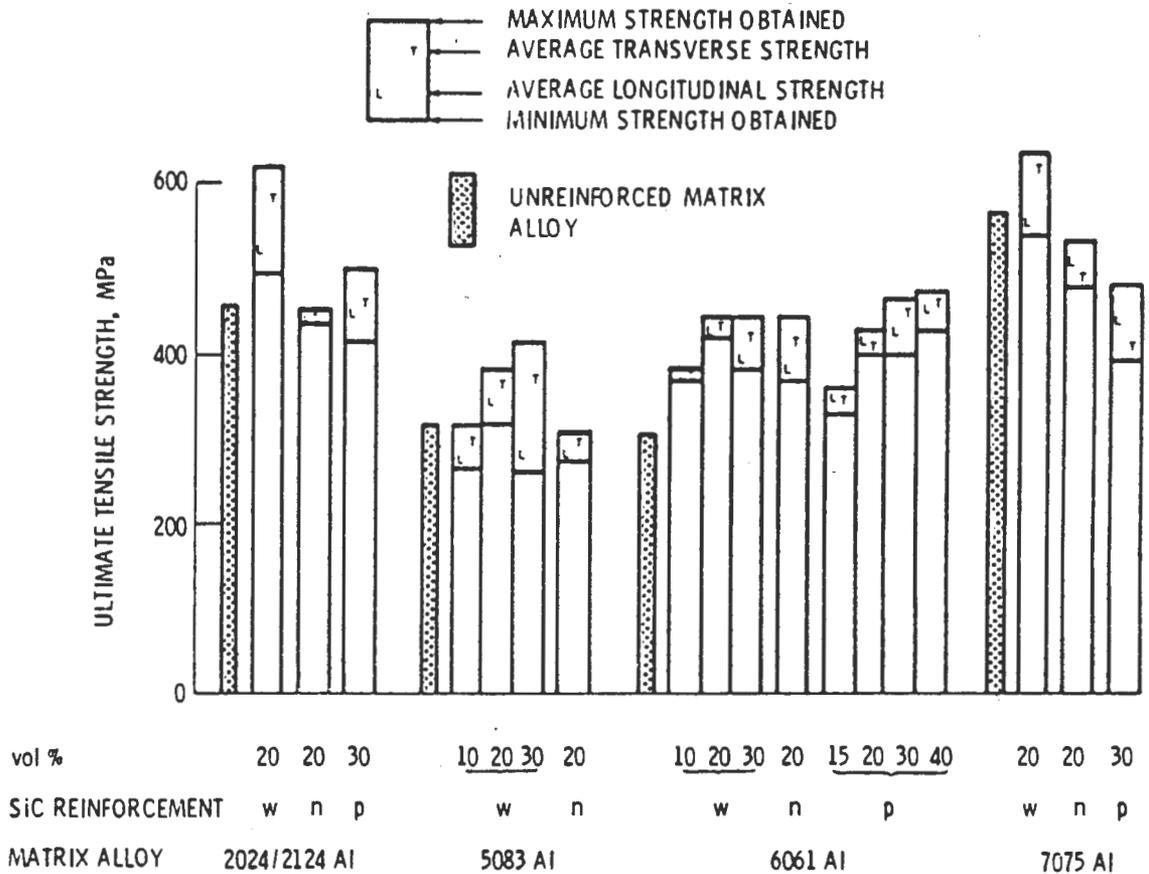
Fig.1: Effect of SiC reinforcement type and content on the ultimate tensile strengths of various discontinuous SiC/Al composites. After McDanel's [16].

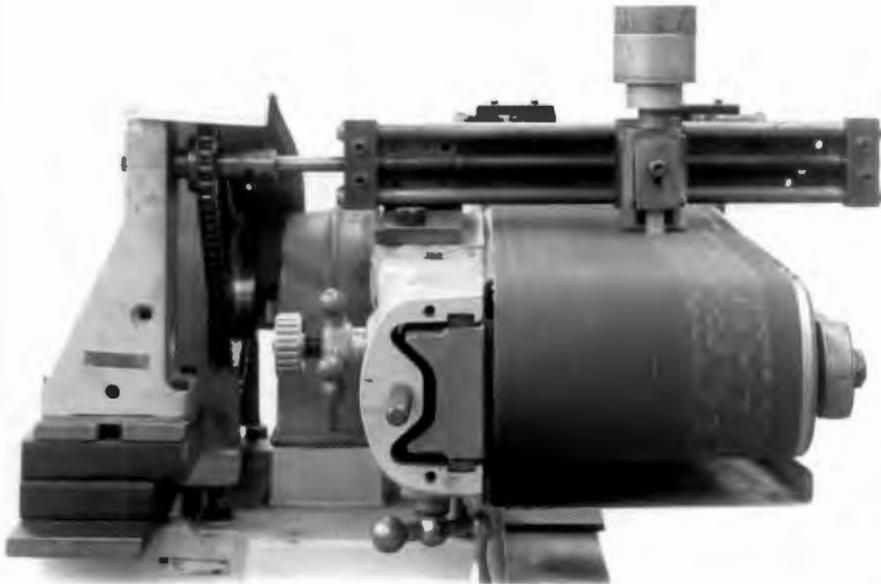
Fig.2: The abrasion test rig used for each abrasive wear experiment. The apparatus consists of a modified Rockwell belt sanding machine, where the wear specimen is made to traverse normal to the direction of the belt movement so that it always abrades against unworn particles. The specimen is clamped in a holder which is able to move freely in a vertical direction. Weights are placed above the specimen, providing a constant normal load.

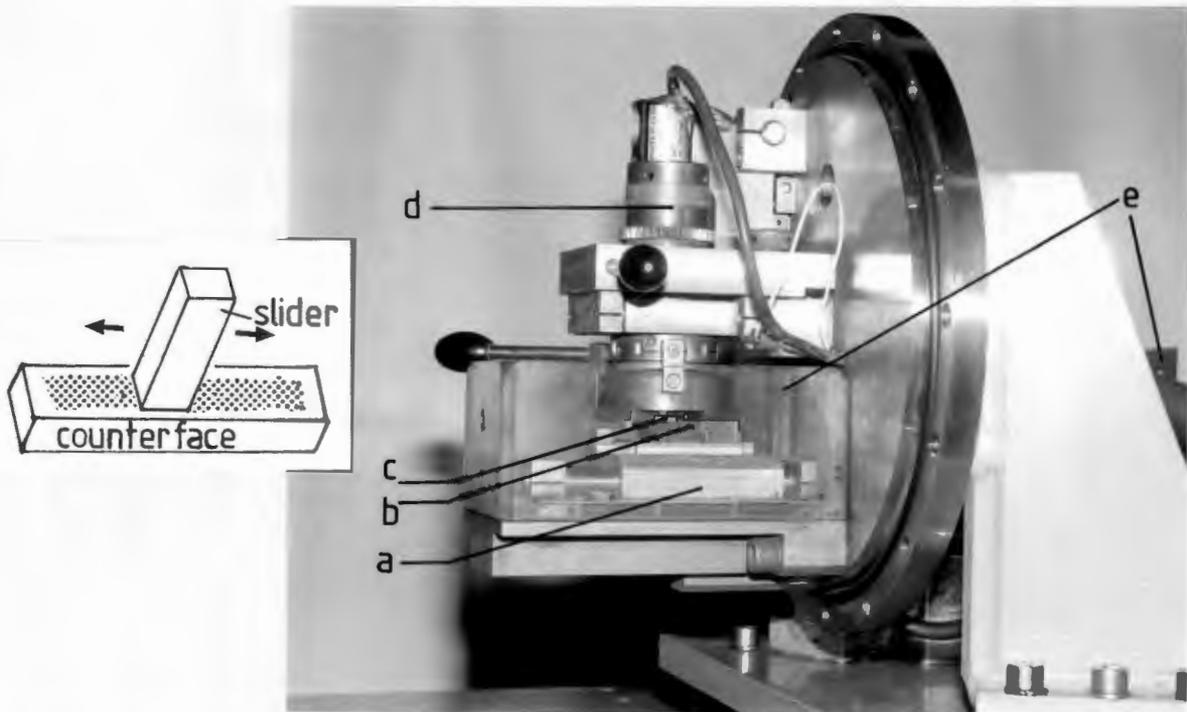
Fig.3: The reciprocating sliding wear test rig. The sliding specimen (c) is loaded against a stainless steel counterface (b) which is attached to a reciprocating base arrangement (a). The load on the wear specimen is adjusted using the spring/load-cell arrangement at (d). Water is fed into the system at (e); the outer environmental/drainage chamber has been removed to facilitate observation. The schematic shows the specimen/counterface contact geometry.

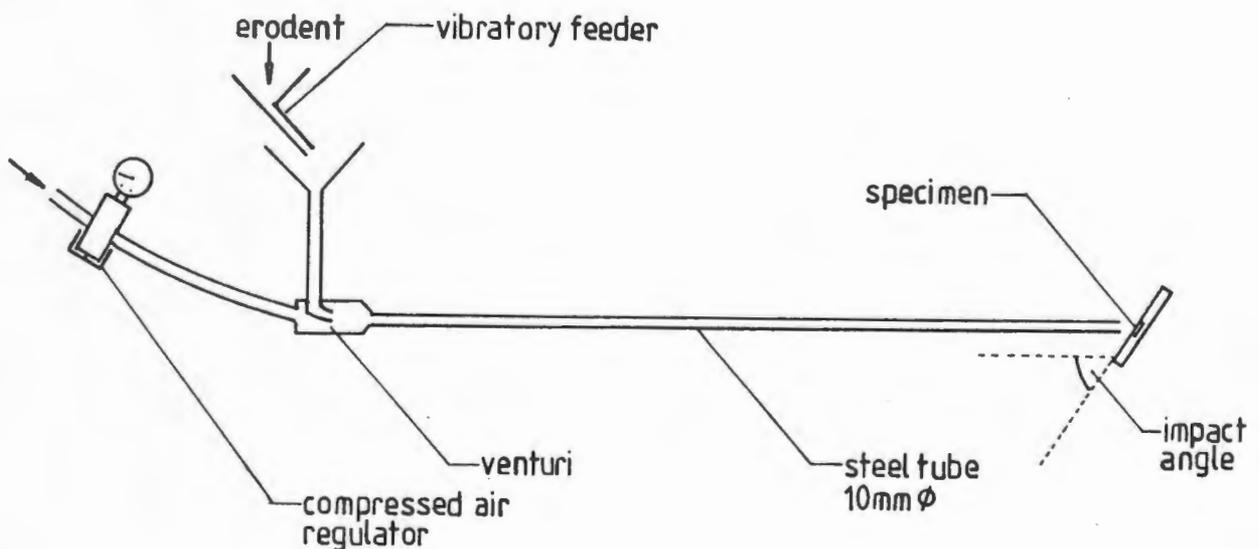
Fig.4: Schematic showing the air-blast type erosion rig used for solid particle erosion testing of each material.

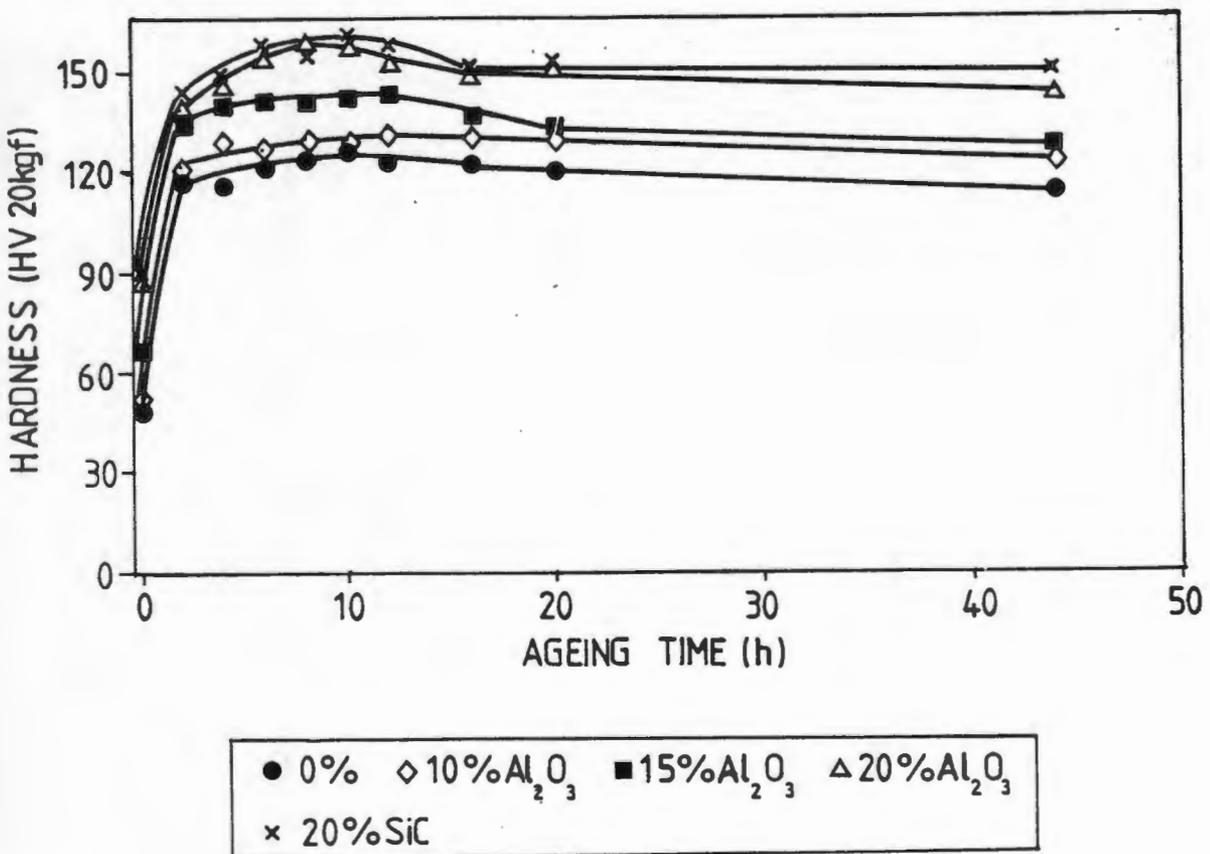
Fig.6: Age hardening characteristics of the reinforced and unreinforced 6061 matrix alloys. The heat treatment was carried out at an ageing temperature of 175°C being solution treated at 520°C, followed by quenching into water.

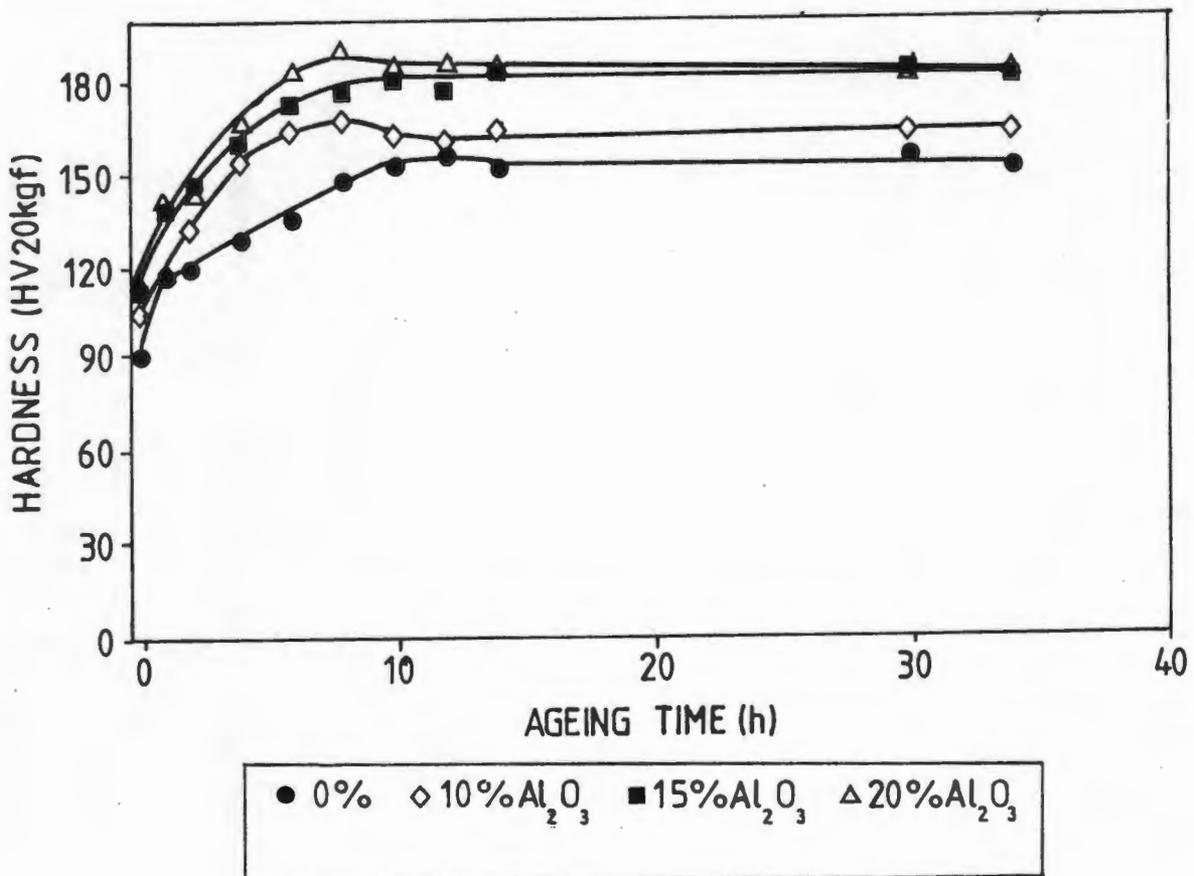
Fig.7: Age hardening characteristics of the reinforced and unreinforced 2014 matrix alloys. The heat treatment was carried out at an ageing temperature of 175°C after being solution treated at 495°C, followed by quenching into water.

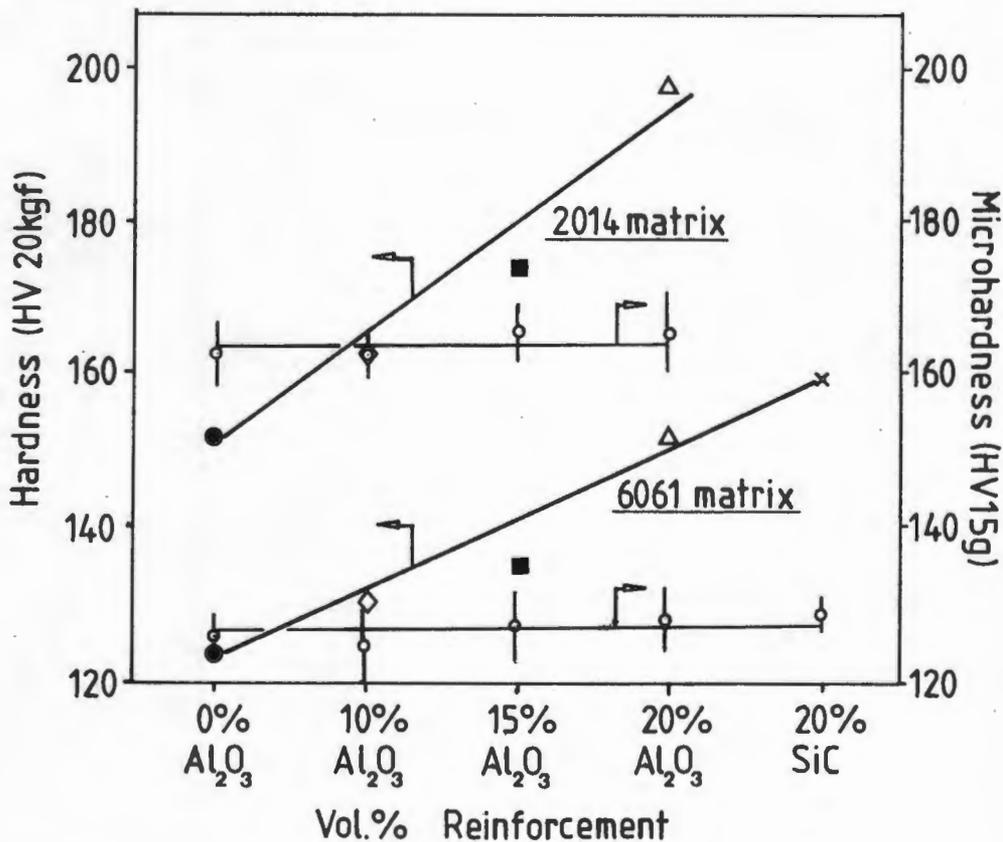
Fig.8: The plot shows bulk hardness values ( $HV_{20kg}$ ) and matrix microhardness measurements ( $HV_{15g}$ ) of composite and matrix alloy specimens which were solution treated and aged to their respective peak hardness values. The error bars associated with the microhardness readings, show the calculated standard deviations obtained from a minimum of twenty indents per sample.

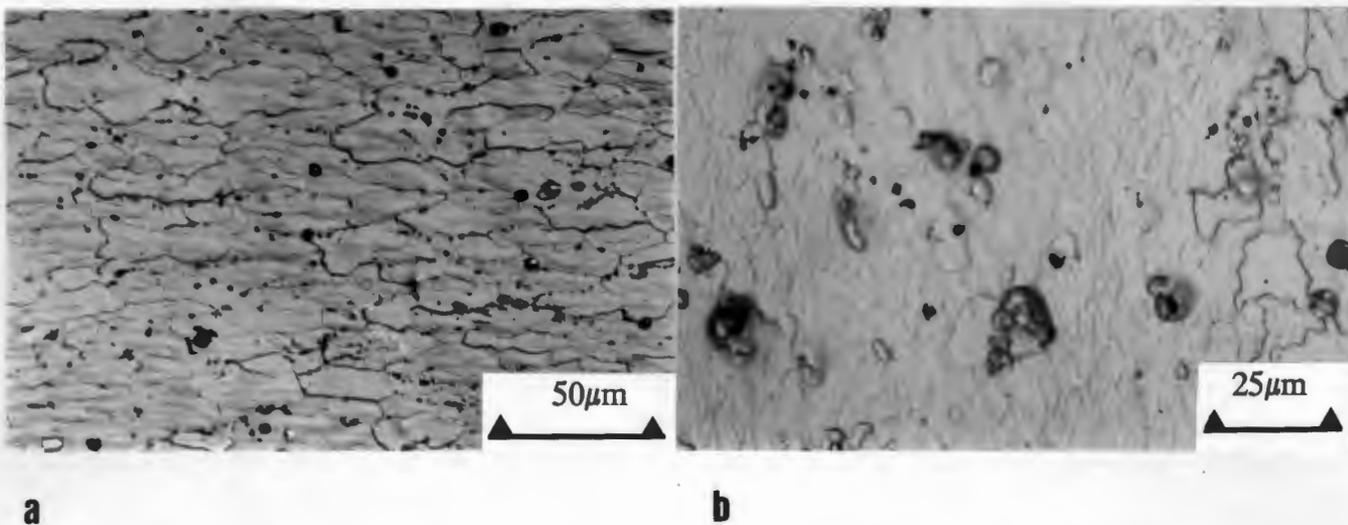
Figs.9a and 9b: Optical micrographs showing the microstructures of the 6061 and 2014 monolithic alloys respectively.

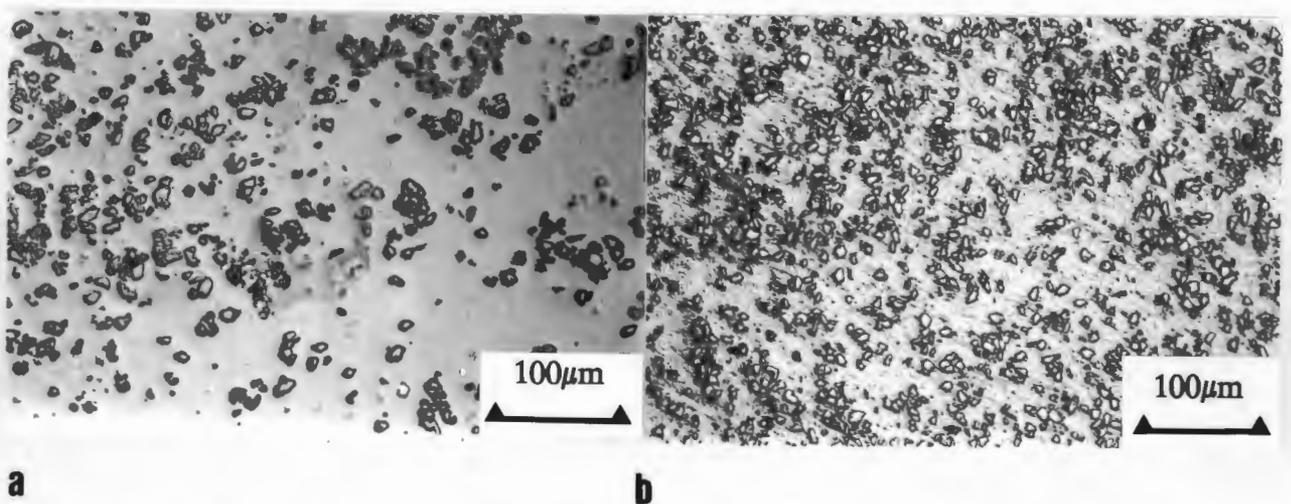
Figs.10a and 10b: Optical micrographs of the reinforced 6061 matrix alloy containing 10 and 15 vol.%  $\text{Al}_2\text{O}_3$  respectively.

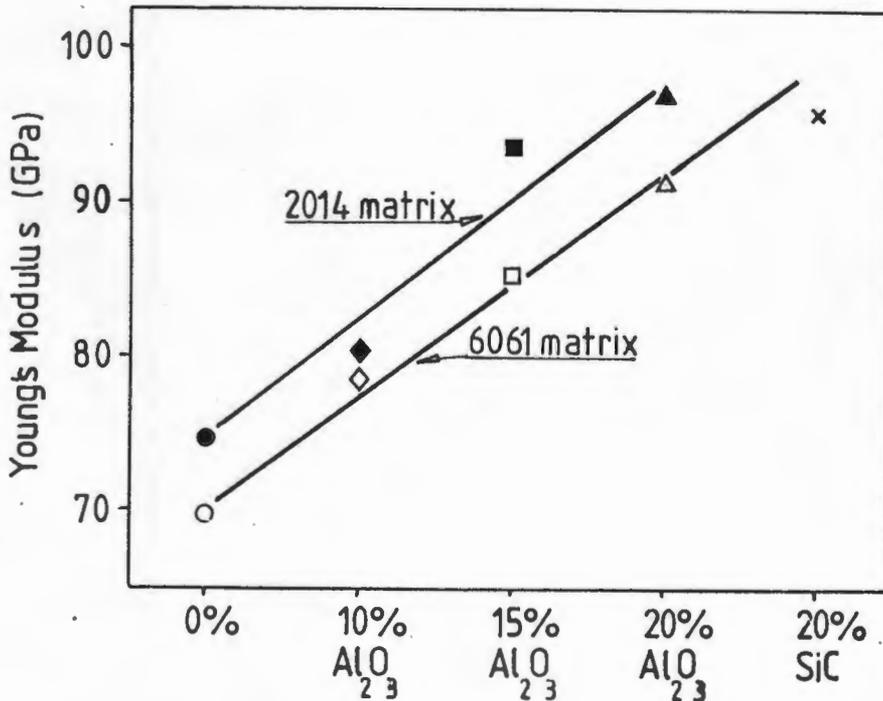
Fig.11: Plot of Young's modulus values of the composites and their respective monolithic alloys.

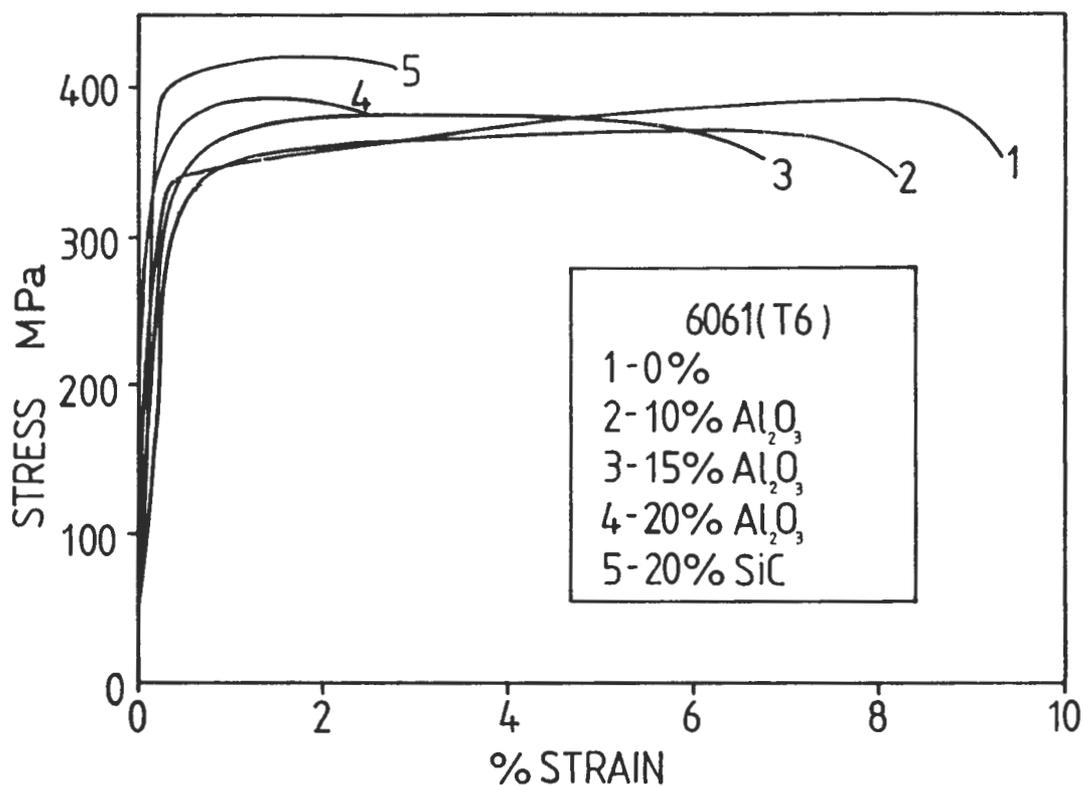
Fig.12: Tensile stress-strain curves of the reinforced and unreinforced 6061 aluminium matrix alloys.

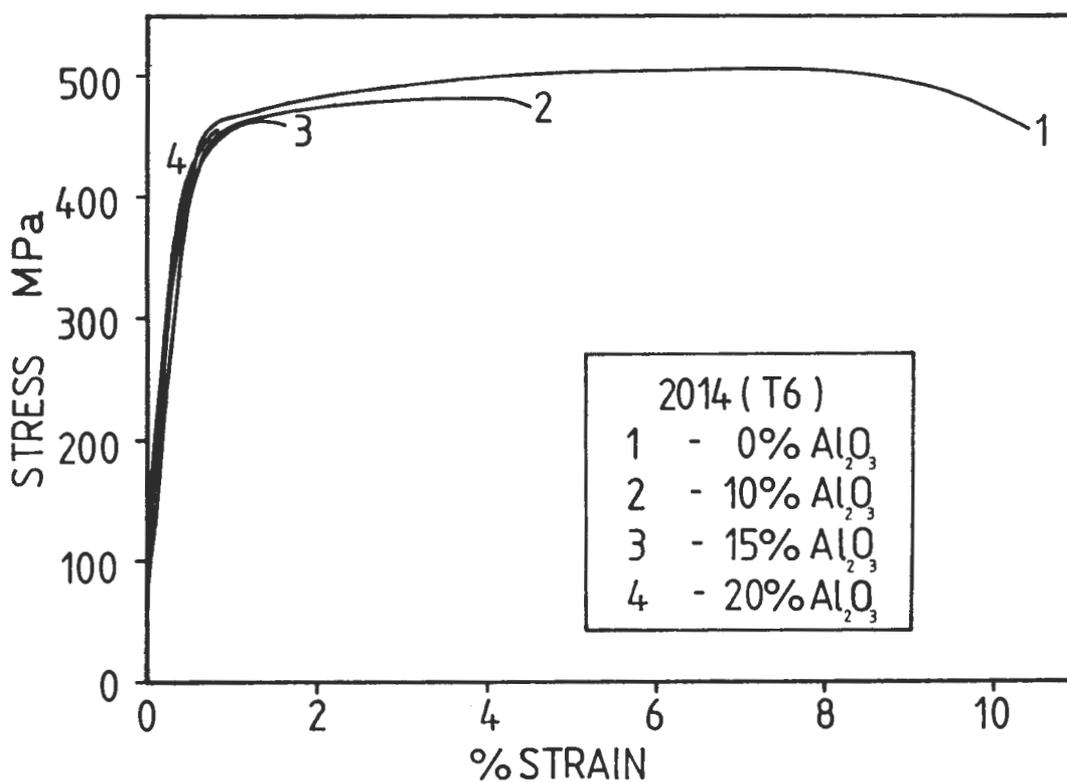
Fig.13: Tensile stress-strain curves of the reinforced and unreinforced 2014 aluminium matrix alloys.

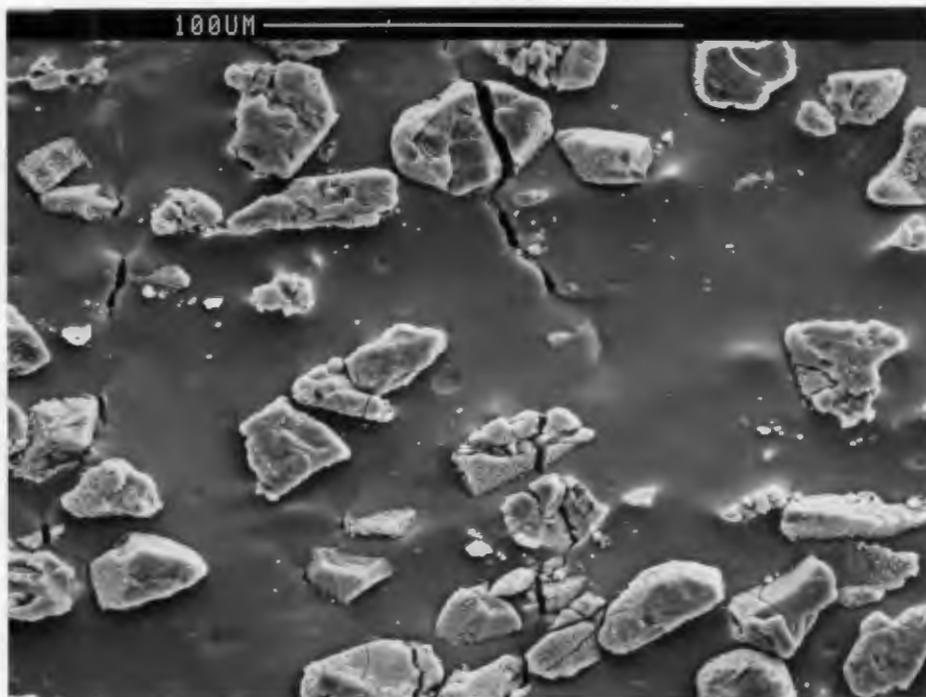
Fig.14: Electron micrograph of the 20 vol.%  $\text{Al}_2\text{O}_3$  reinforced 2014 alloy gauge length after tensile failure. The area shown is approximately 1 mm below the specimen fracture surface. Arrows indicate tensile axis.

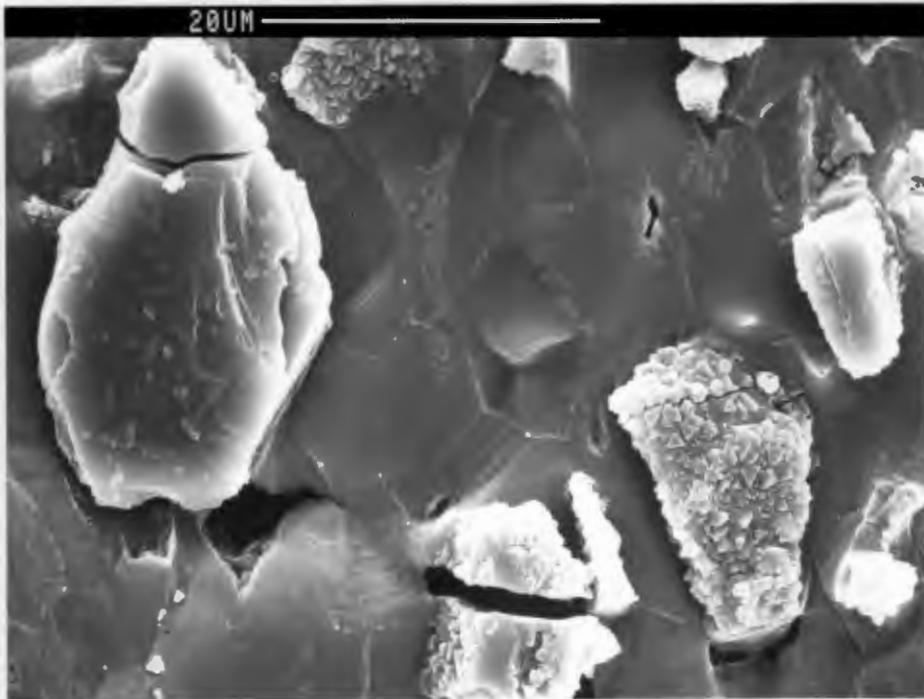
Fig.15: Electron micrograph of the 15 vol.%  $\text{Al}_2\text{O}_3$  reinforced 6061 alloy gauge length after tensile failure. The area shown is approximately 0.5 mm below the specimen fracture surface where particulate cracking and cavity formation associated with localised tearing of the matrix alloy is evident. Note the presence of  $\text{MgAl}_2\text{O}_4$  spinel crystals on particulate surfaces - it is possible that these act as additional stress raisers and crack initiators on alumina particulates. Arrows indicate tensile axis.

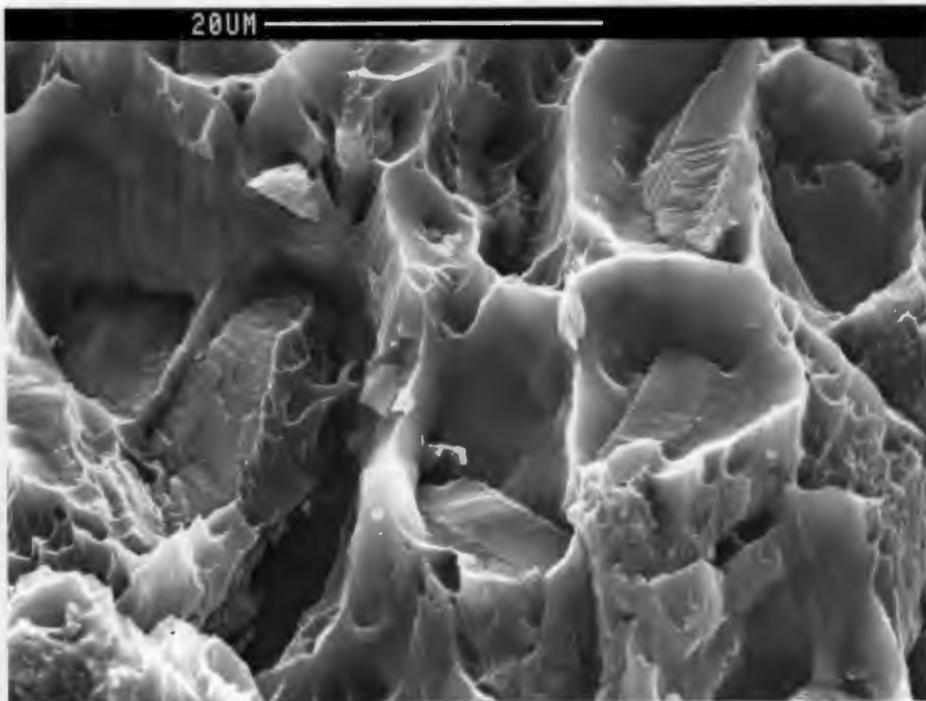
Fig.16: Electron micrograph showing the tensile overload fracture surface of the 6061 alloy reinforced with 15 vol.%  $\text{Al}_2\text{O}_3$  particulates. Particulates have fractured in the plane normal to the tensile direction, forming regions of intense shear and cavities of torn matrix alloy. Isolated patches of small dimples are also visible on the fracture surface.

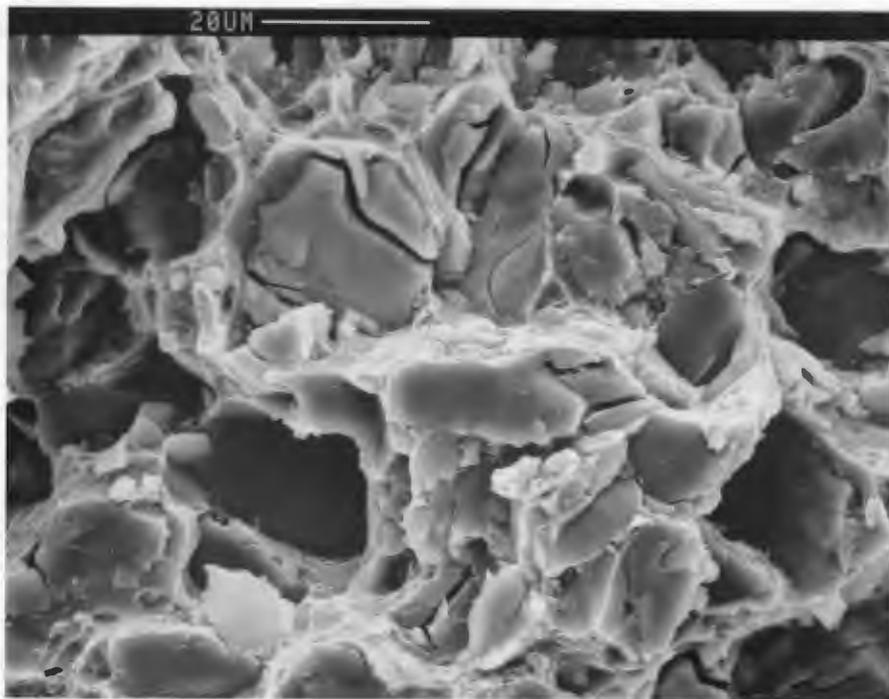
Fig.17: Electron micrograph showing tensile overload fracture surface of the 2014 matrix alloy reinforced with 20 vol.%  $\text{Al}_2\text{O}_3$  particulates.

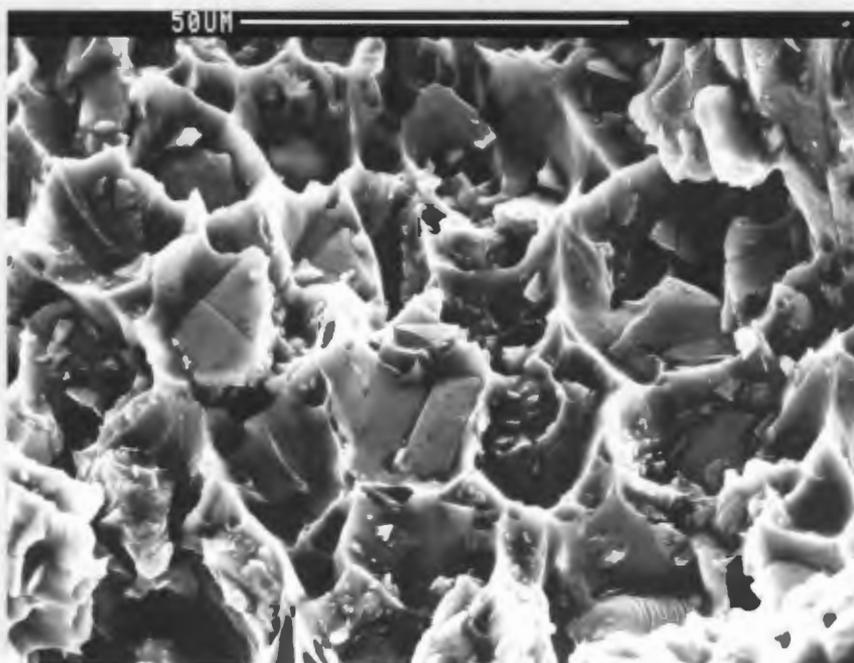
Fig.18: Electron micrograph showing the tensile overload fracture surface of the 6061 alloy reinforced with 20 vol.% SiC.

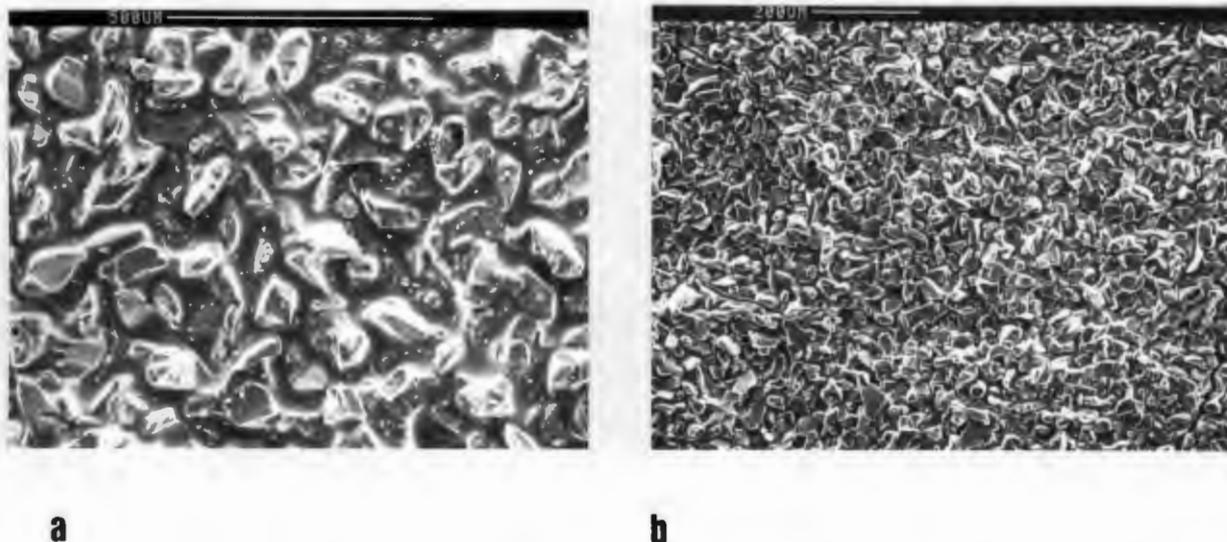
Fig.19a and 19b: Surface morphologies of the coarse grade (220 grit) and fine grade (600 grit) bonded alumina abrasive belts respectively.

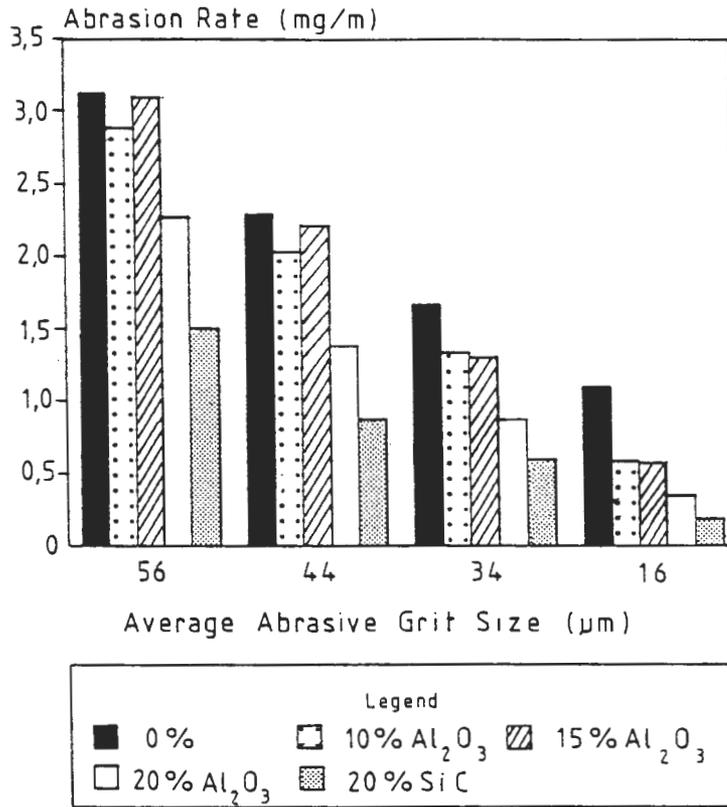
Fig.20: Abrasive wear rates of the 6061 matrix alloy and respective composites, determined as a function of abrasive grit size (alumina).

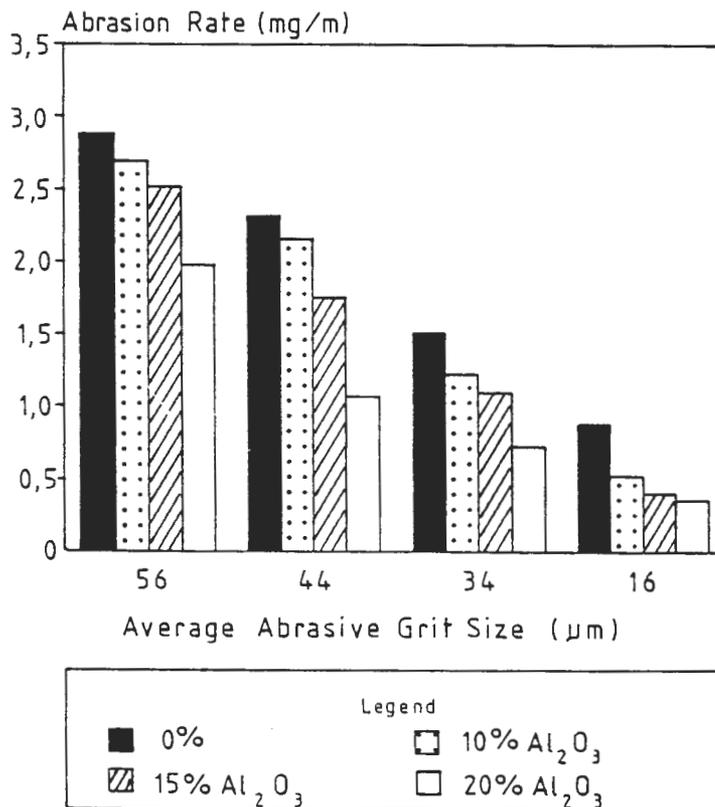
Fig.21: Abrasive wear rates of the 2014 matrix alloy and respective composites, determined as a function of abrasive grit size (alumina).

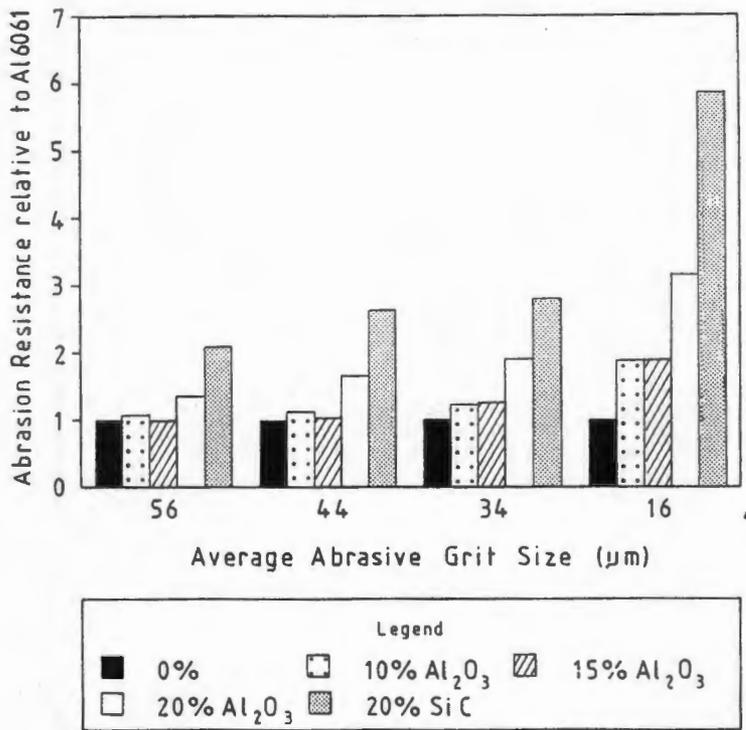
Fig.22: Abrasive wear resistances of the reinforced 6061 alloys, determined relative to the unreinforced matrix alloy and as a function of abrasive grit size (alumina).

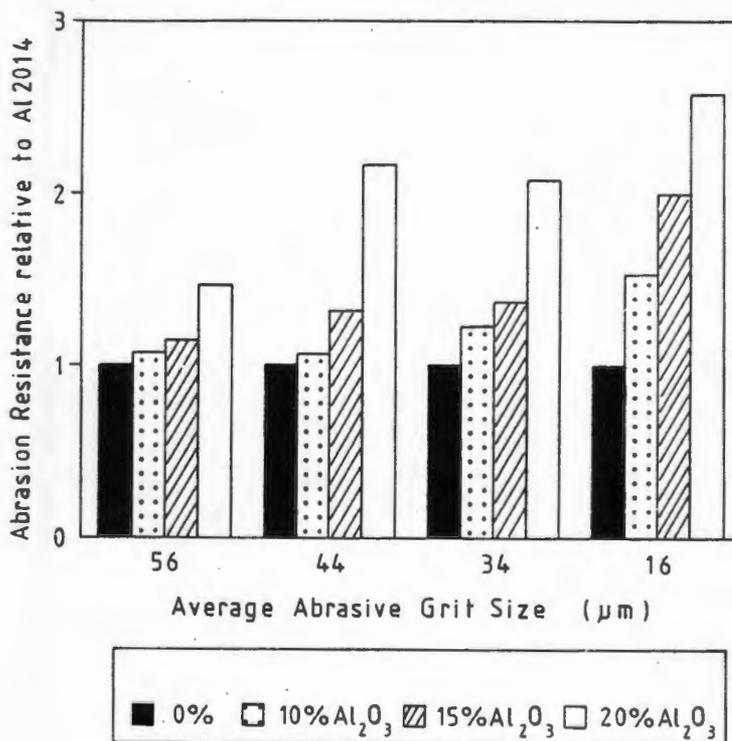
Fig.23: Abrasive wear resistances of the reinforced 2014 alloys, determined relative to the unreinforced matrix alloy and as a function of abrasive grit size.

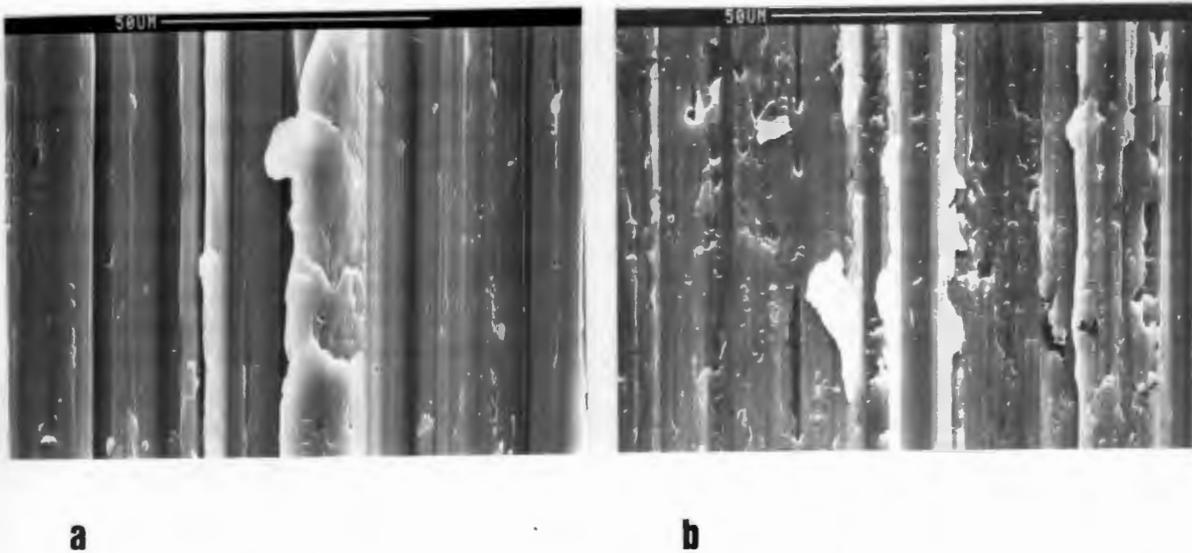
Figs.24a and 24b: Electron micrographs of the 6061 matrix alloy after abrasion by the coarse grade (220 grit - 56  $\mu\text{m}$ ) and fine grade (600 grit - 16  $\mu\text{m}$ ), abrasive papers respectively.

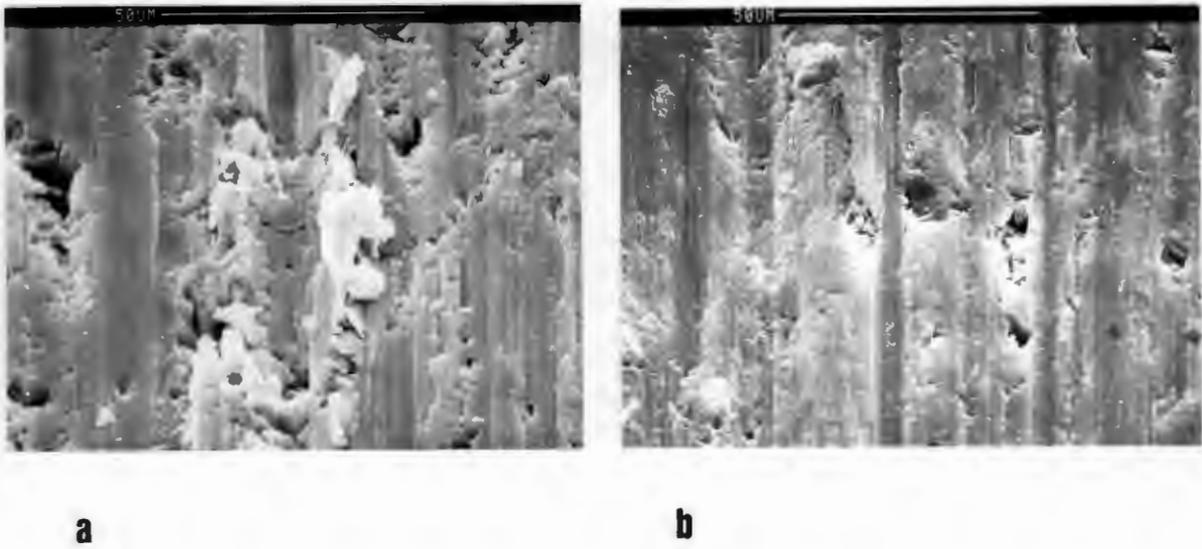
**Figs.25a and 25b:** Electron micrographs of the 20 vol.% SiC reinforced 6061 alloy after abrasion by the coarse grade (220 grit - 56  $\mu\text{m}$ ) and fine grade (600 grit - 16  $\mu\text{m}$ ), alumina abrasive papers respectively. Note the larger groove depths associated with abrasion against the coarse abrasive. The reinforcing particulates are approximately 10 $\mu\text{m}$  apart which is similar to the width of the wear grooves.

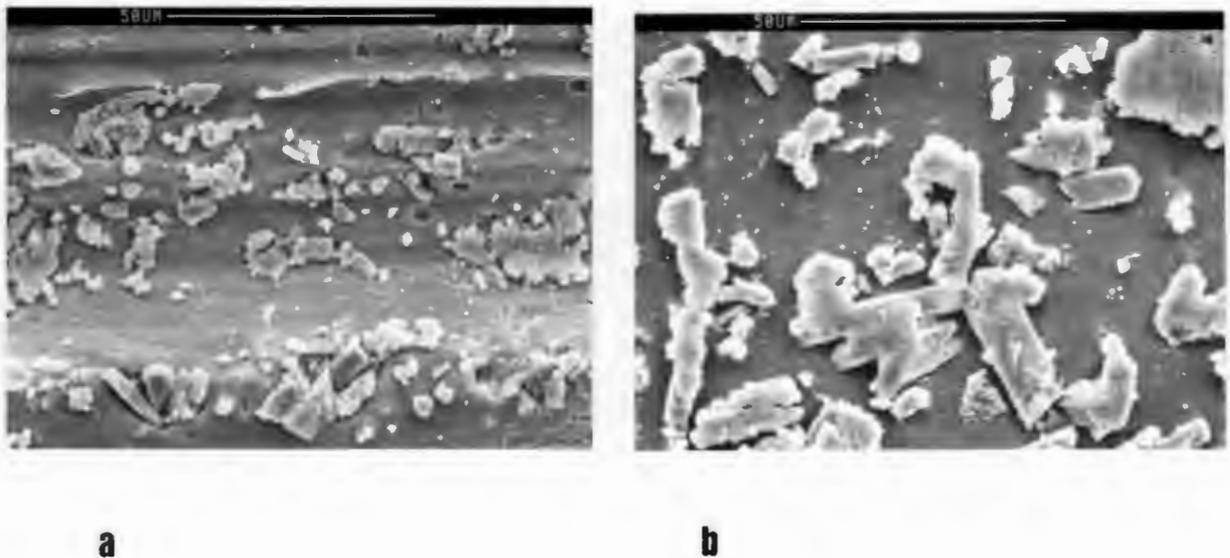
**Fig.26a and 26b:** Subsurface damage in the 15 vol.%  $\text{Al}_2\text{O}_3$  reinforced 2014 alloy after abrasion by the coarsest (56  $\mu\text{m}$ ) and finest (16  $\mu\text{m}$ ) abrasive grits respectively. The worn surfaces were electropolished for 1-2 seconds to reveal particulate damage. Note the extensive fragmentation in the case of the abrasion with the coarse grit.

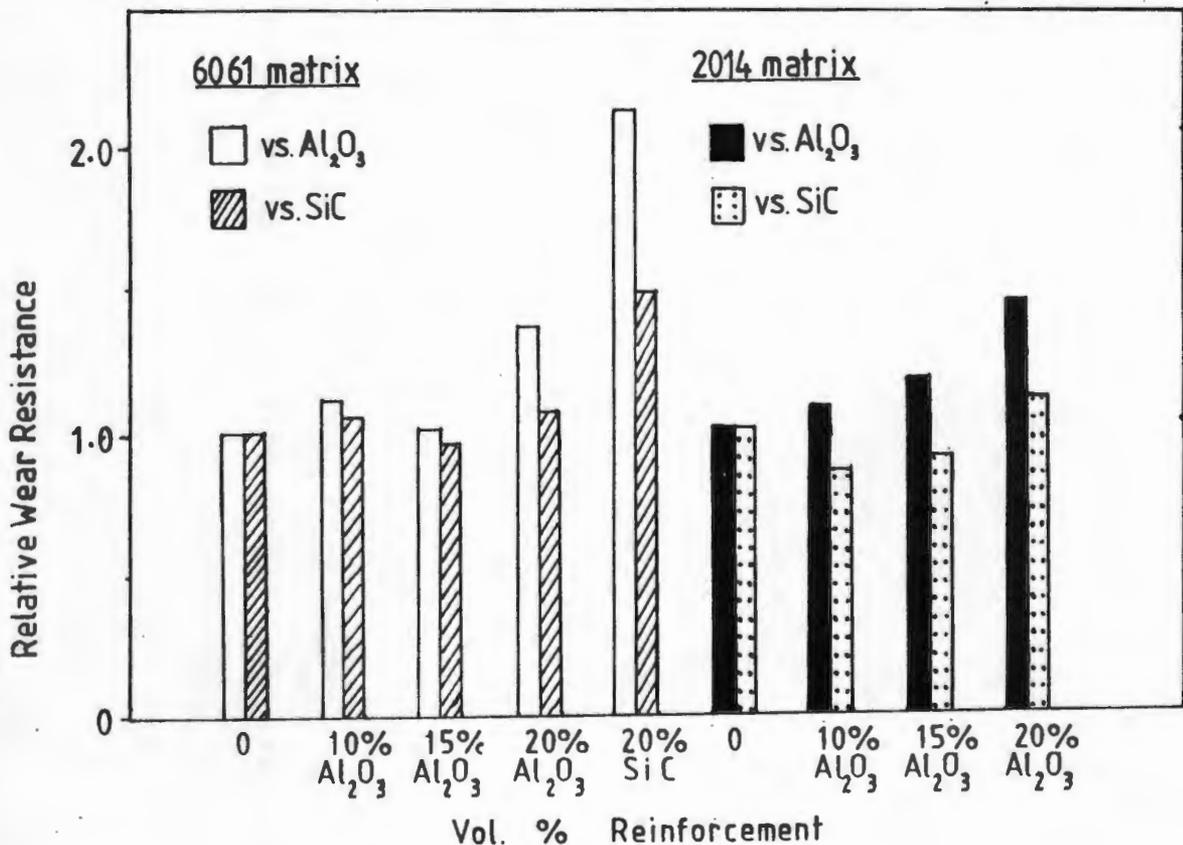
Fig.27: Bar chart showing the wear resistances of each of the reinforced alloys calculated relative to their respective matrix alloys. The relative wear resistances shown, are for abrasion against alumina and silicon carbide abrasive belts (220 grit - 56 $\mu$ m grit size).

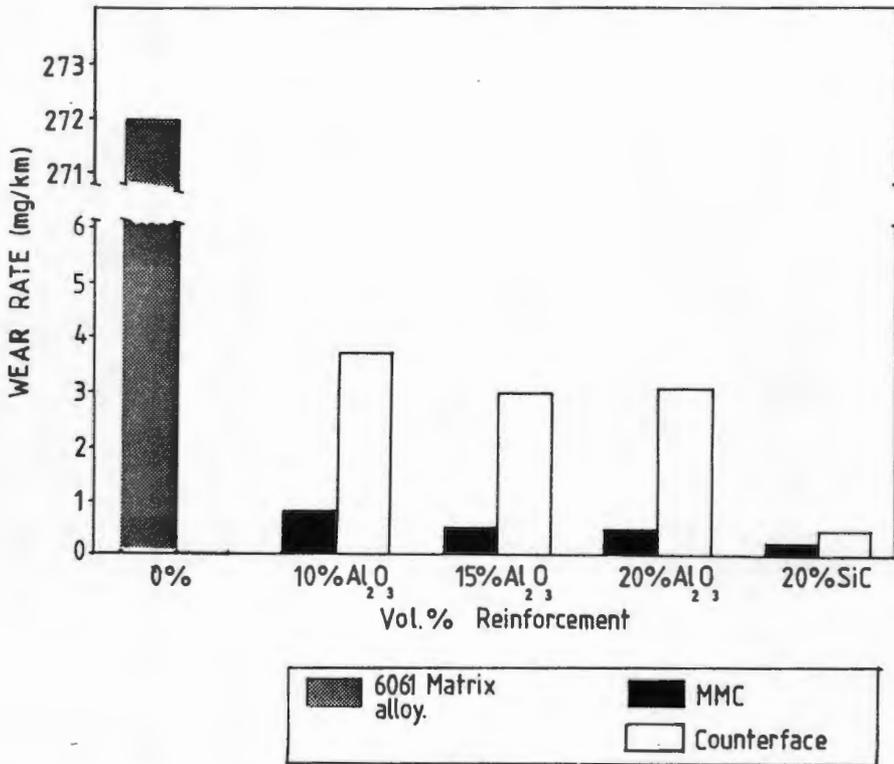
Fig.28: Reciprocating sliding steady-state wear rates for each of the 6061 composites, the unreinforced 6061 matrix alloy and respective stainless steel counterfaces.

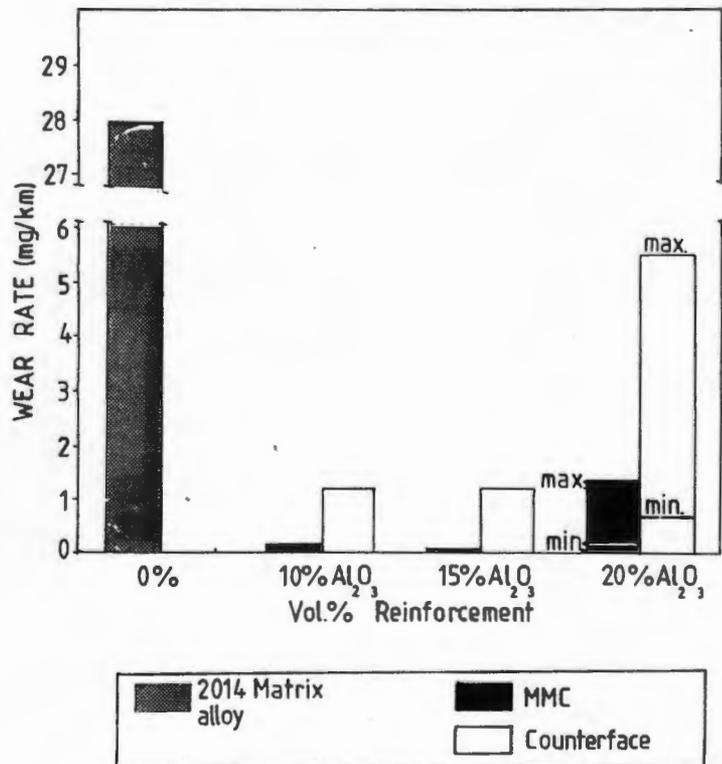
Fig.29: Reciprocating sliding steady-state wear rates for each of the 2014 composites, the unreinforced 2014 matrix alloy and respective stainless steel counterfaces. The wear behaviour of the 20 vol.% Al<sub>2</sub>O<sub>3</sub> composite was noticeably erratic, showing, in most tests, an initial low wear rate followed by a period of greater slider and counterface material loss.

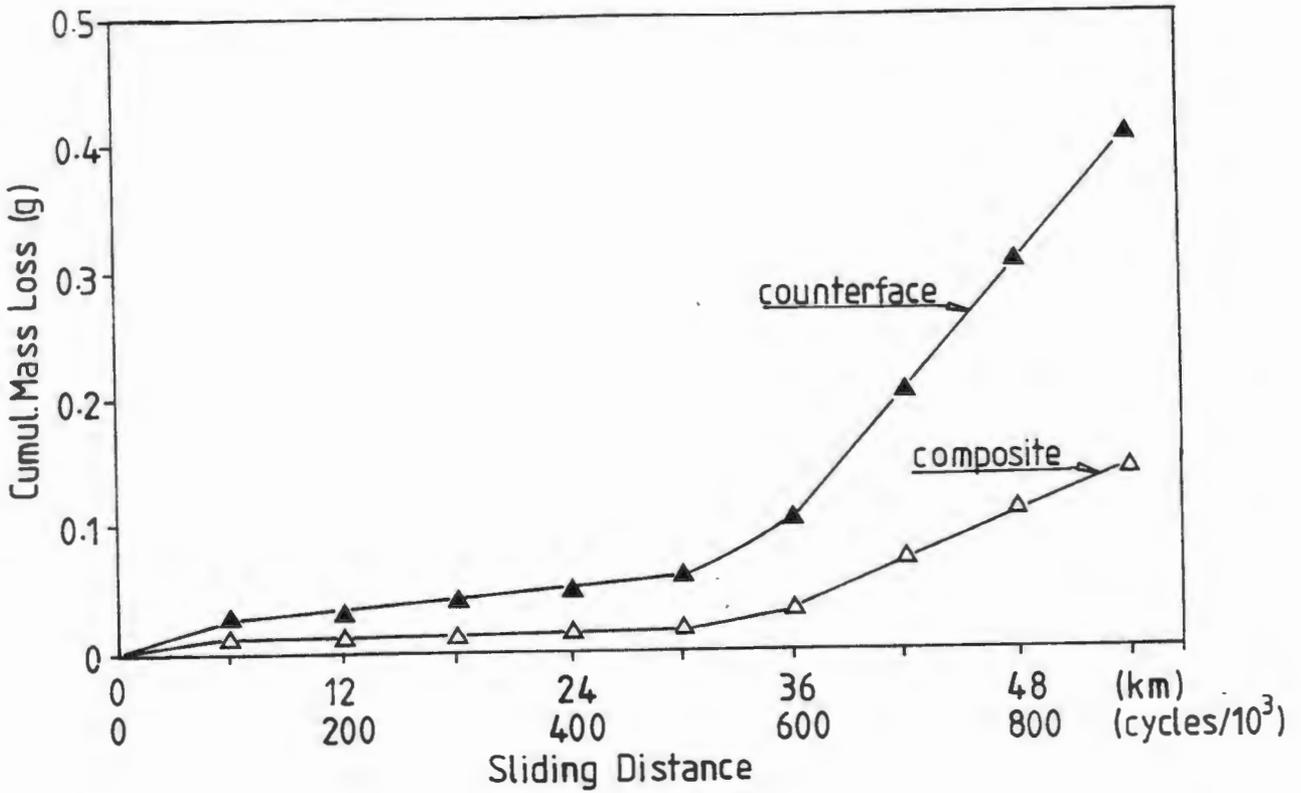
Fig.30: Cumulative mass losses of the 2014 alloy reinforced with 20 vol.% Al<sub>2</sub>O<sub>3</sub> and counterface from a typical reciprocating sliding wear test. The onset of a high wear regime is a characteristic feature of the wear test.
