# **THE TRIBOLOGICAL BEHAVIOUR OF ALUMINIUM MATRIX COMPOSITES**

**A thesis submitted to the Faculty of Engineering, University of Cape Town in fulfilment  
of the degree of Doctor of Philosophy**

**Department of Materials Engineering  
University of Cape Town  
February 1993**

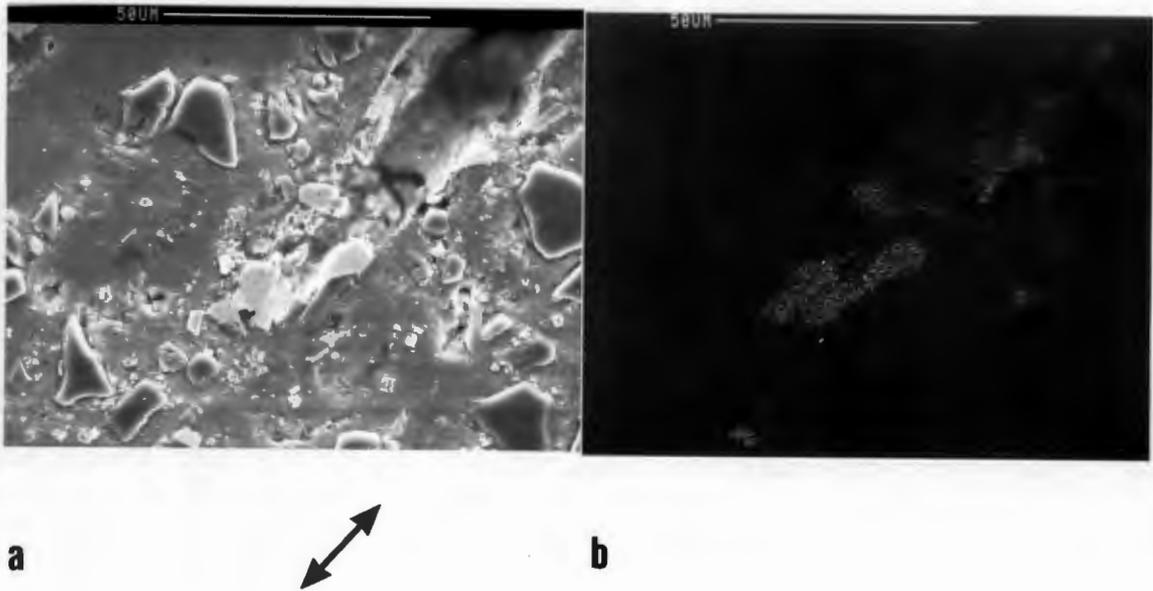
Fig.32a and 32b: Taper section ( $5^\circ$ ) of the 20 vol.% SiC reinforced 6061 alloy surface after being worn to steady state during reciprocating sliding, against a stainless steel counterface. Stainless steel debris, transferred during the sliding process, is visible as lighter inclusions in the subsurface region of a wear groove. Arrow indicates sliding direction and taper direction. The top of the micrograph is the wear surface region. Fig.32b shows an Fe-Xray map of the same region shown in fig.32a, displaying the distribution of steel debris in the subsurface wear zone.

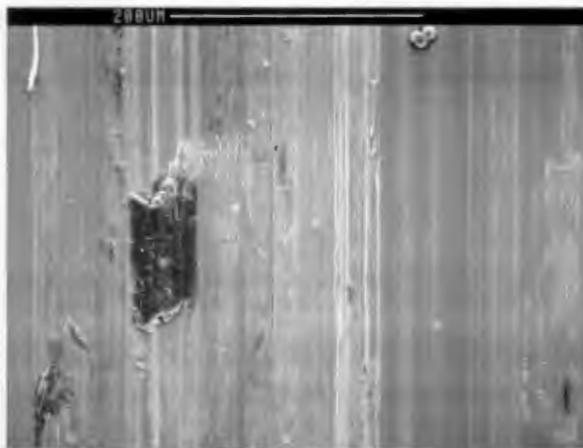
Fig.34: Counterface surface after being worn by the 20 vol.%  $\text{Al}_2\text{O}_3$  reinforced 2014 alloy, showing debris transfer to the stainless steel surface. Arrow indicates sliding direction.

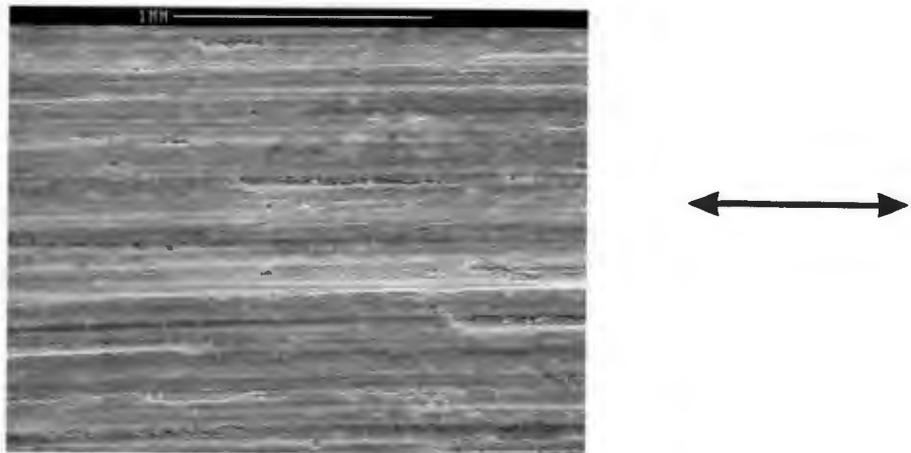
Fig.35: Low magnification scanning electron micrograph of the surface of the 20 vol.% Al<sub>2</sub>O<sub>3</sub> reinforced 6061 alloy, having been worn to steady state conditions. The surface morphology is typical of that found for all of the alumina reinforced alloys.

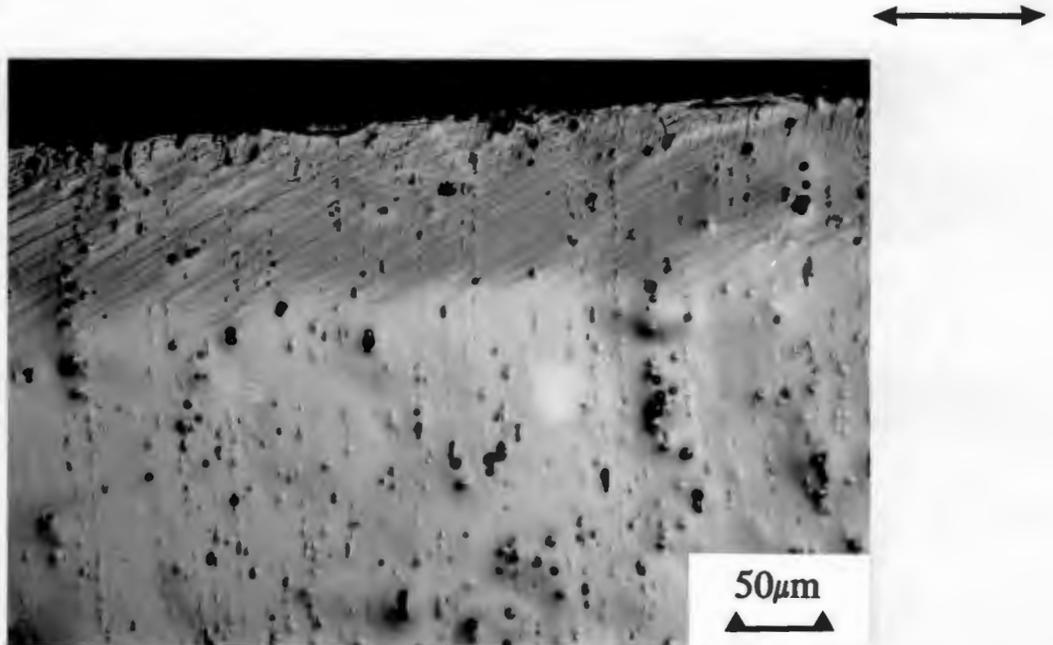
**Fig.41:** Optical micrograph of the subsurface deformation (perpendicular section) present in the unreinforced 6061 alloy, after being worn to steady state in reciprocating sliding conditions. The region shown is an anomalously large single grain in the subsurface wear region - all the slip lines are oriented in the same direction. Arrow indicates sliding direction.

**Fig.42:** Optical micrograph of the subsurface deformation (perpendicular section) present in the unreinforced 2014 alloy, after being worn to steady state in reciprocating sliding conditions. Arrow indicates sliding direction. Note that this alloy has a larger subsurface strain gradient compared to the 6061 alloy shown in fig.41.

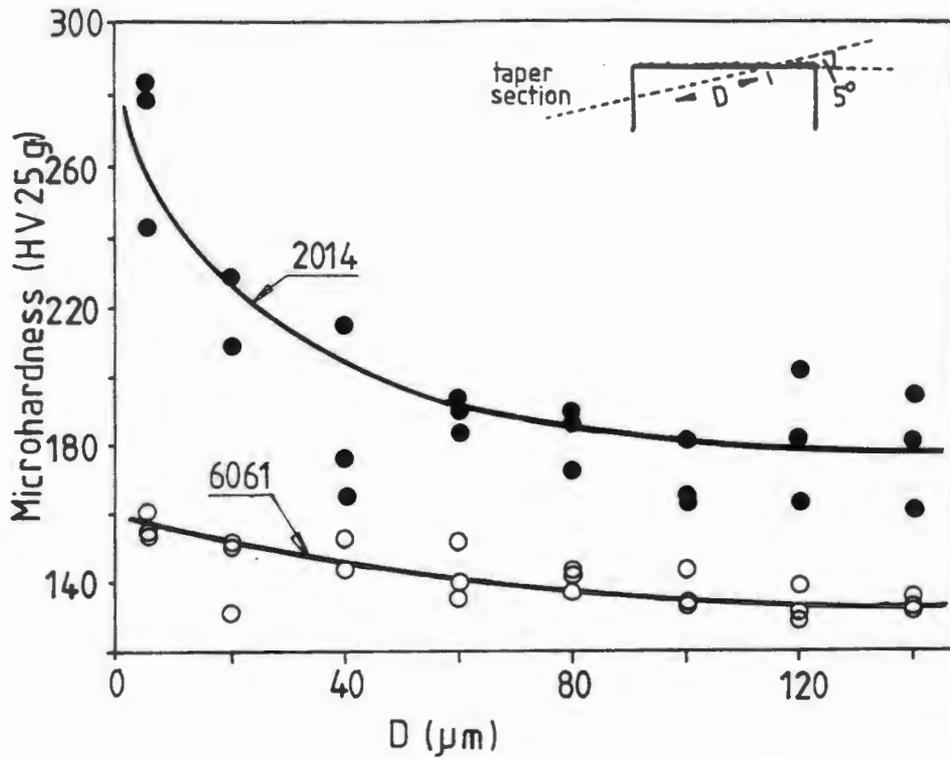
Fig.43: Plot of subsurface microhardness variations beneath the steady-state worn surfaces of the monolithic 6061 and 2014 alloys.

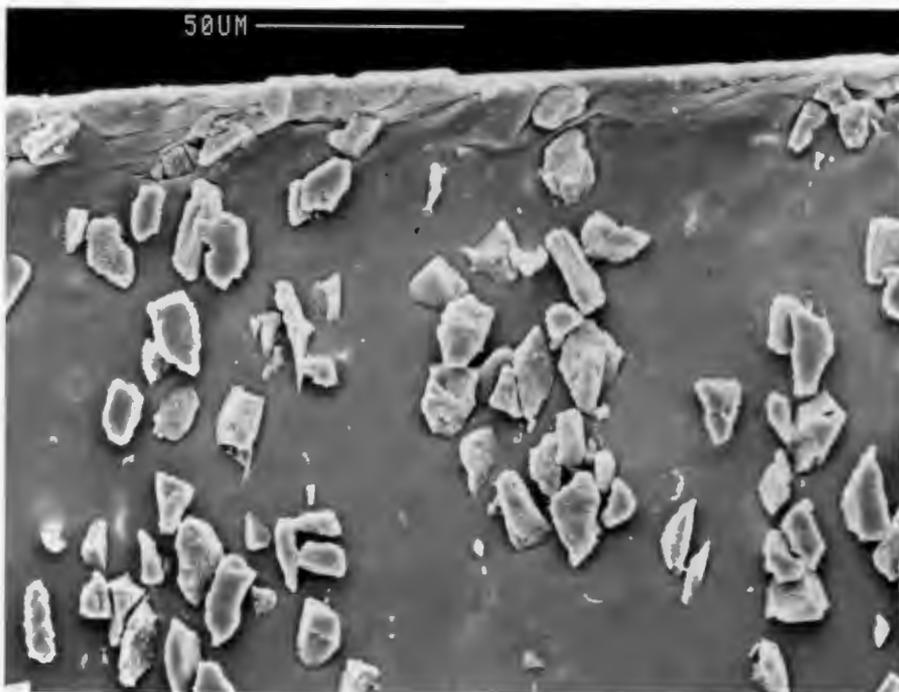
Fig.44: Scanning electron micrograph of the subsurface region (perpendicular section) of the steady state worn 15 vol.%  $\text{Al}_2\text{O}_3$  reinforced 6061 alloy. Shear failure of the matrix alloy accompanied by some particulate fracture, has occurred in the heavily sheared region immediately below the worn surface.

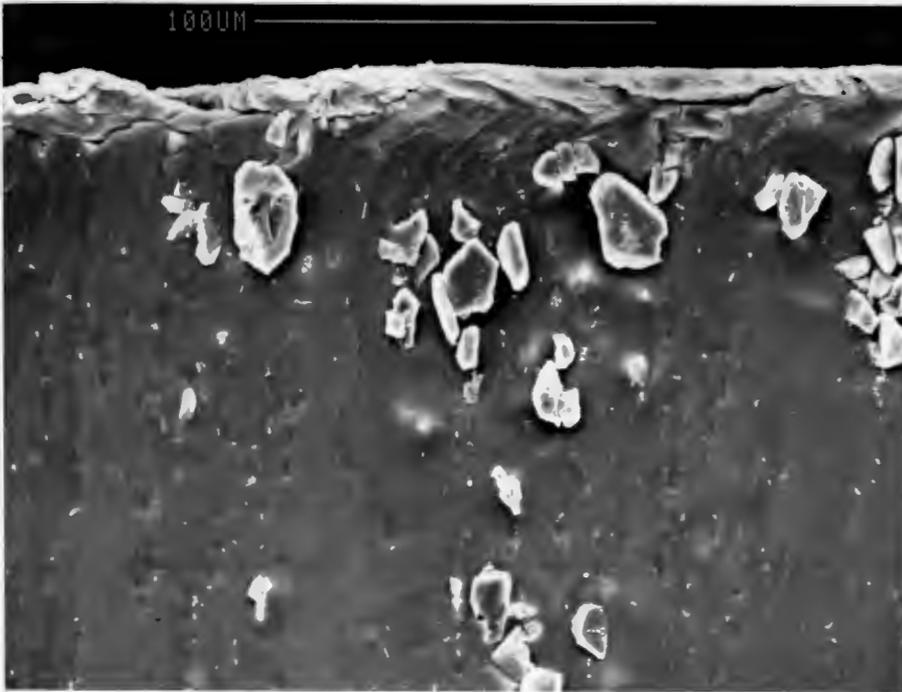
Fig.45: Scanning electron micrograph of the subsurface region (perpendicular section) of the steady state worn 10 vol.%  $\text{Al}_2\text{O}_3$  reinforced 2014 alloy. Extensive shear failure of the matrix alloy has occurred in the surface wear zone.

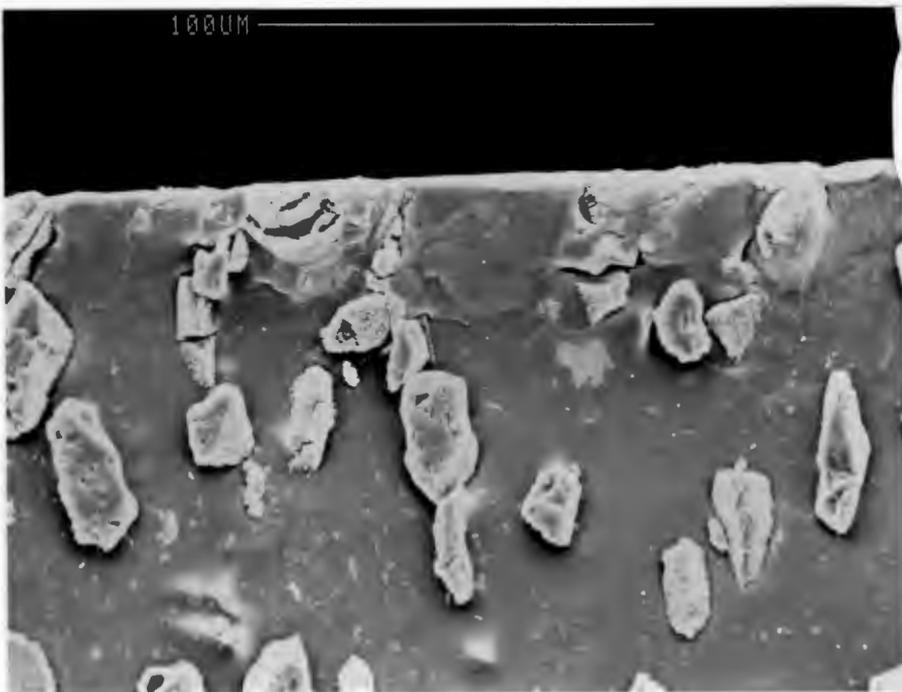
Fig.46a: Electron micrograph of the subsurface region (perpendicular section) of the steady state worn (high wear regime) 20 vol.%  $\text{Al}_2\text{O}_3$  reinforced 2014 alloy. There is evidence for subsurface cracking of particulates approximately  $40\mu\text{m}$  below the worn surface. Arrow indicates sliding direction.

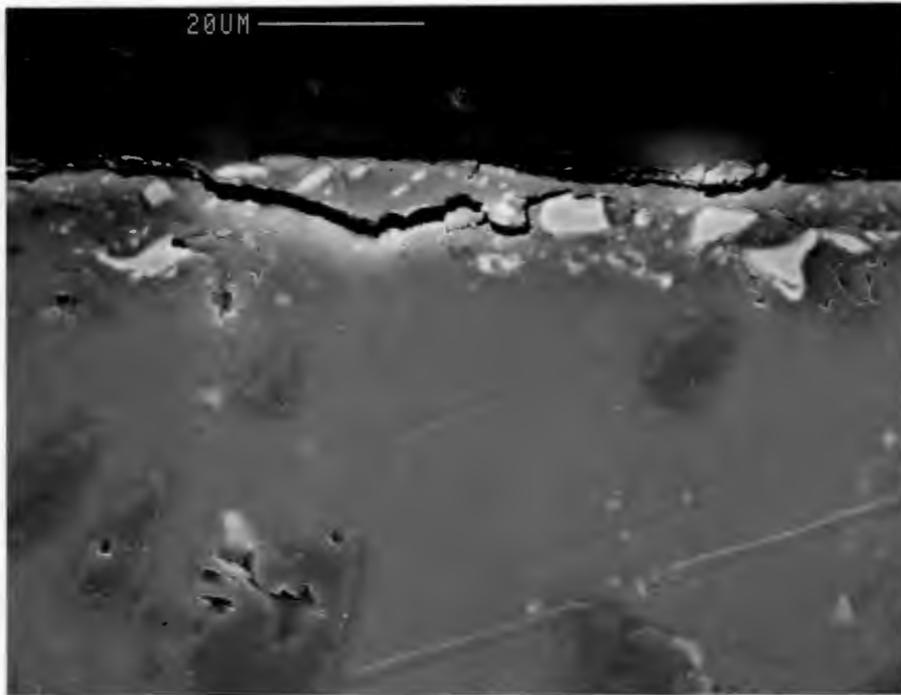
Fig.46b: Electron micrograph showing delamination of surface transfer layer in the 20 vol.%  $\text{Al}_2\text{O}_3$  reinforced 2014 alloy. The subsurface section was obtained from a composite sample that had been worn into the steady-state high wear rate regime.

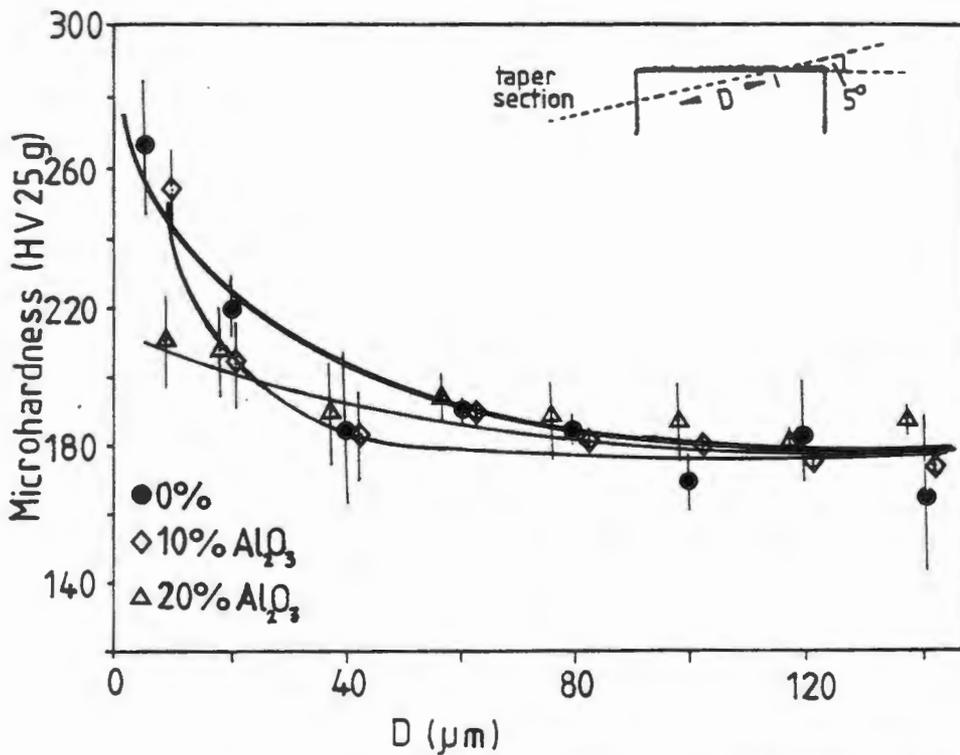
Fig.47: Plot of subsurface microhardness variations beneath the steady state worn surfaces of the monolithic 2014 alloy and the two 10 vol.% and 20 vol.% alumina reinforced 2014 alloy composites.

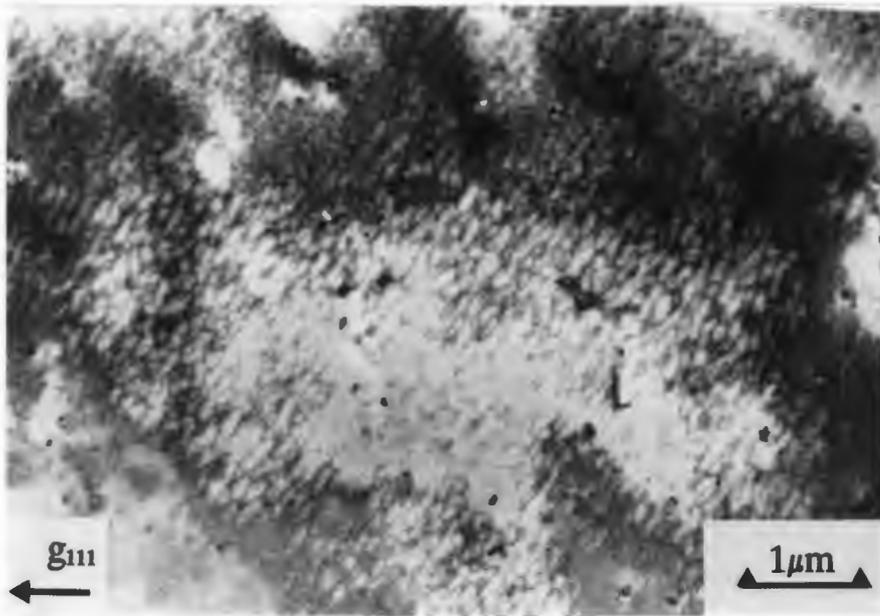
Fig.48a: Transmission electron micrograph showing cell-like dislocation substructure in the unreinforced 6061 alloy, which has been worn to steady state under reciprocating sliding conditions. The region shown is approximately  $60\mu\text{m}$  below the worn surface of the slider.

Fig.48b: Higher magnification micrograph of the cell structure shown in fig.48a. Note the extremely high dislocation density in the cell walls, where it is difficult to resolve individual dislocations.

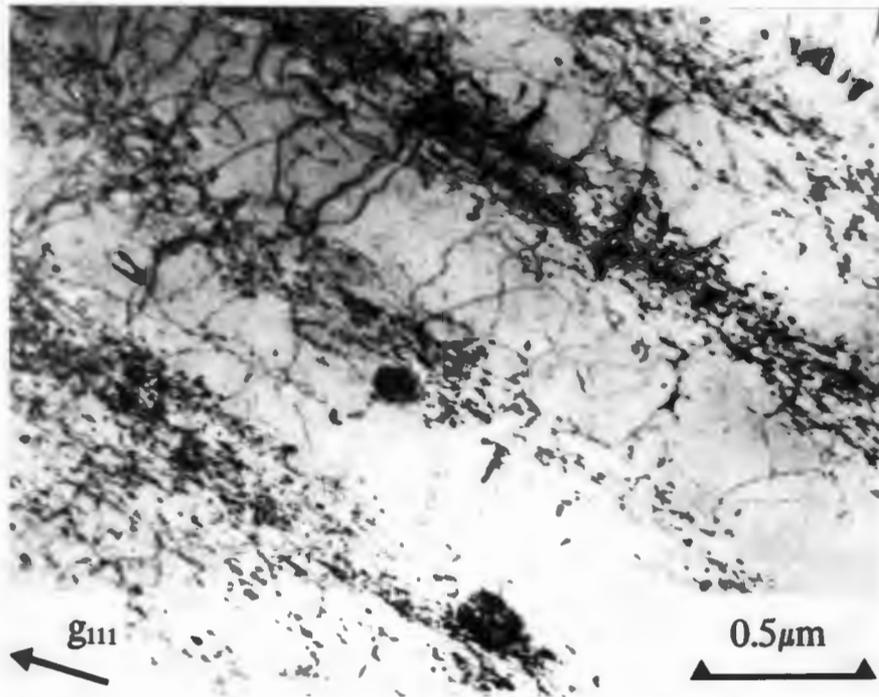
Fig.49a: Transmission electron micrograph of the dislocation substructure found in the 10 vol.%  $\text{Al}_2\text{O}_3$  reinforced 6061 alloy, which has been worn to steady state ( $> 10^5$  reciprocating cycles). The region displayed is approximately  $60\mu\text{m}$  below the worn surface and shows a characteristic persistent slip band (PSB) "ladder" structure [109].

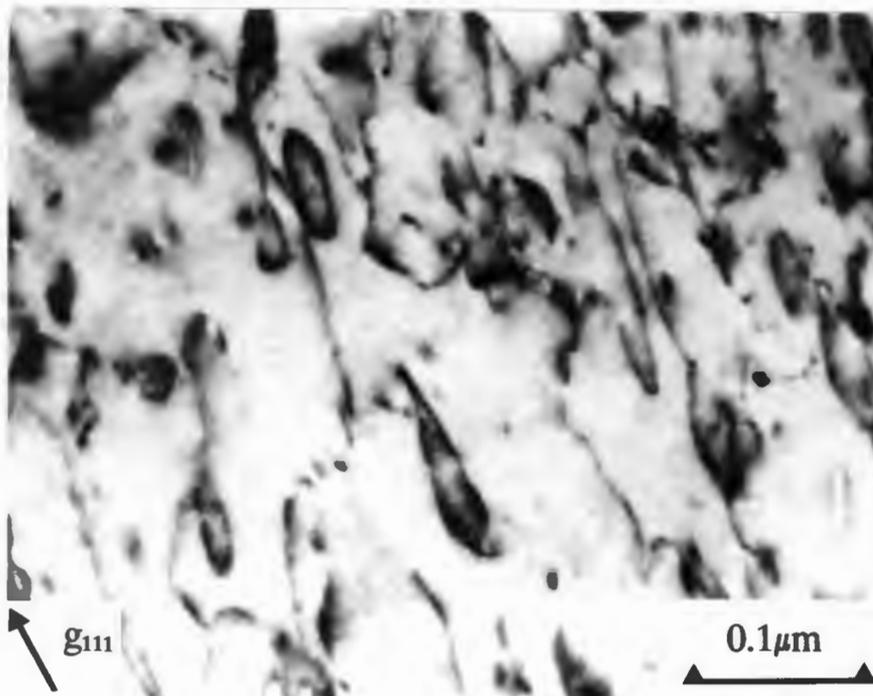
Fig.49b: Persistent slip band structure showing a high concentration of dislocation loops and jogs.

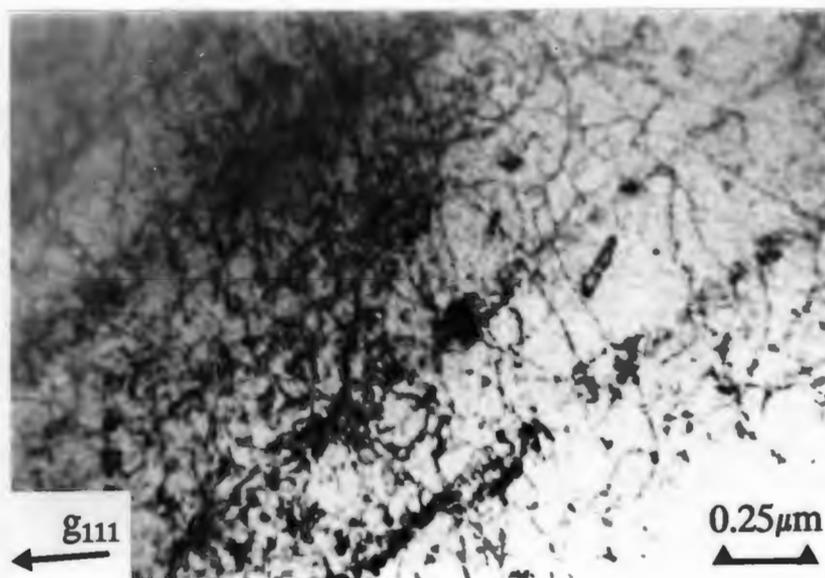
Fig.50: Transmission electron micrograph of the dislocation substructure found in the 20 vol.%  $\text{Al}_2\text{O}_3$  reinforced 6061 alloy, which has been worn to steady state ( $> 10^5$  reciprocating cycles). The region displayed is approximately  $20 \mu\text{m}$  below the worn surface and also shows a PSB "ladder" structure, which is not as well defined as that exhibited in the 10 vol.%  $\text{Al}_2\text{O}_3$  reinforced alloy.

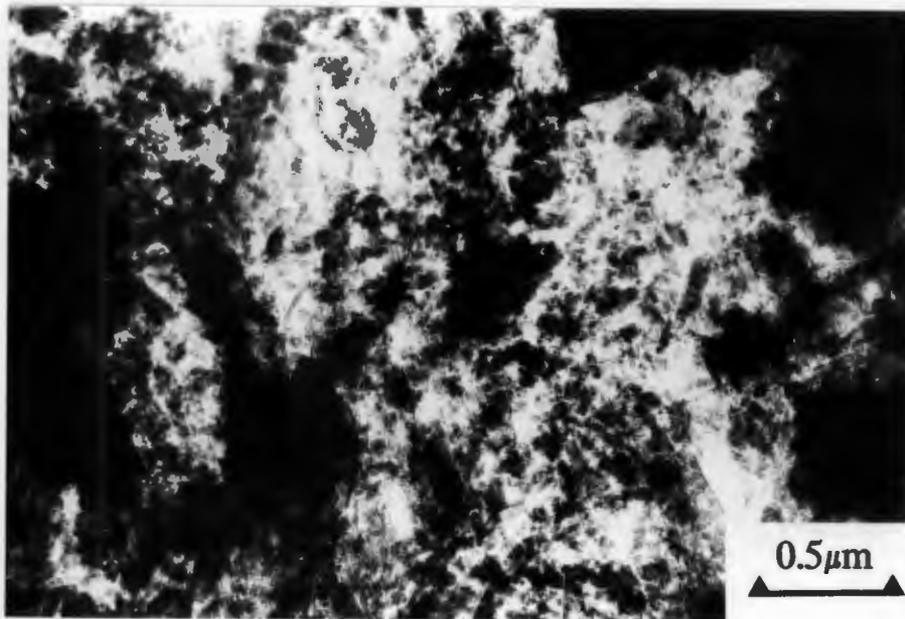
Fig.51: Transmission electron micrograph of the surface transfer layer formed during steady-state reciprocating wear of the 20 vol.%  $\text{Al}_2\text{O}_3$  reinforced 6061 alloy. The microstructure is extremely fine grained in nature, with particle sizes ranging between 20-100nm.

Fig.52: Transmission electron micrograph showing a heavily deformed cell/crystallite type microstructure, from a region of matrix alloy immediately below the fine grained transfer layer shown in fig.51.

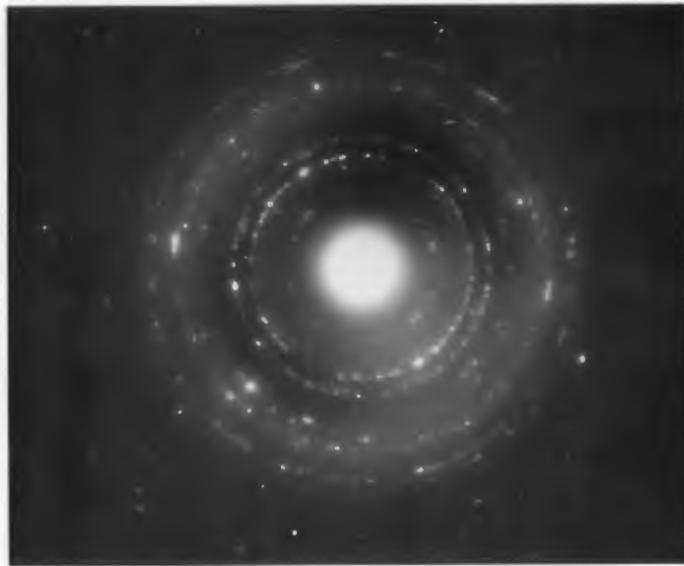
Fig.53: Typical selected area diffraction pattern taken from the steady state wear transfer layer of the 20 vol.% alumina reinforced 6061 alloy.

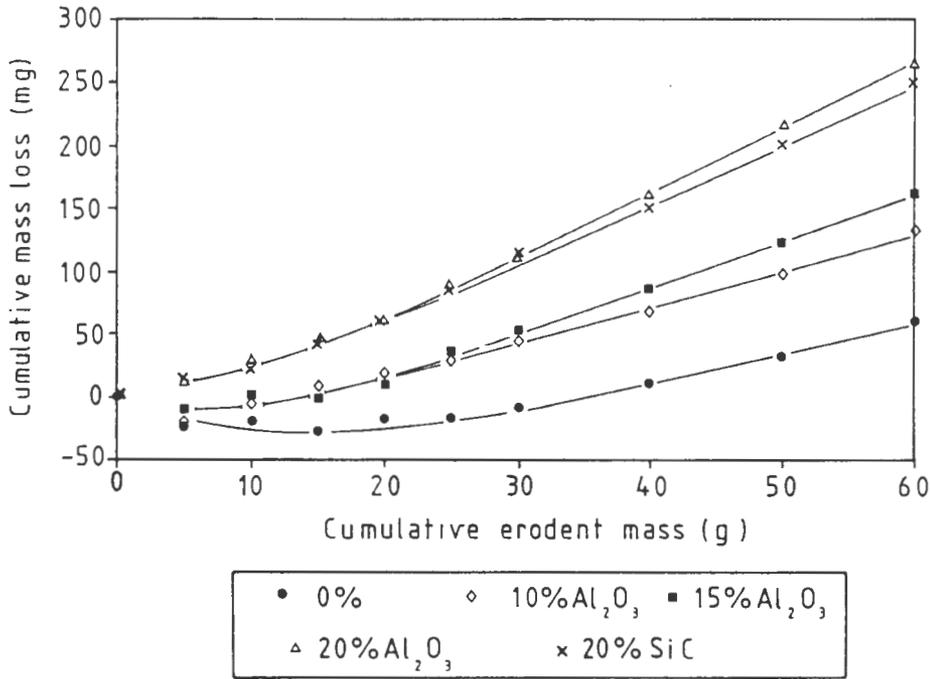
Fig.55: Cumulative mass losses of the 6061 matrix alloy and composites, for erosion by 120 grit SiC particles at a 90° impact angle and an average velocity of 60 ms<sup>-1</sup>.

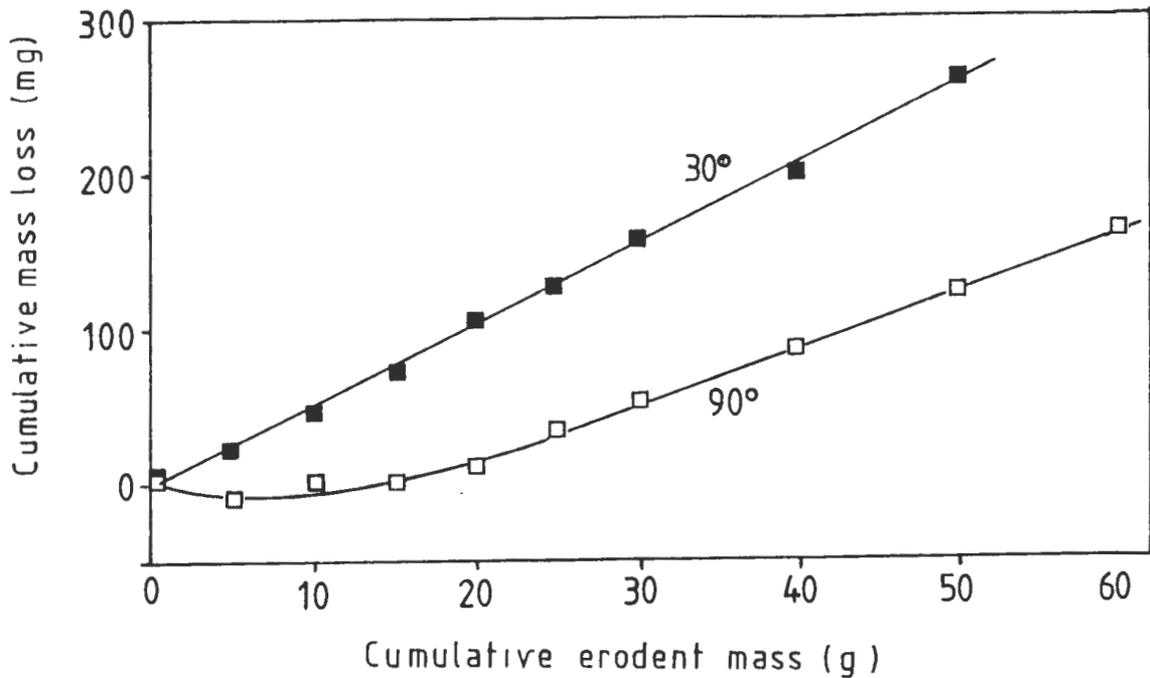
Fig.5.7: Plot showing the erosion behaviour of the 15 vol.%  $\text{Al}_2\text{O}_3$  reinforced 6061 alloy at erosion impact angles of  $90^\circ$  and  $30^\circ$ .

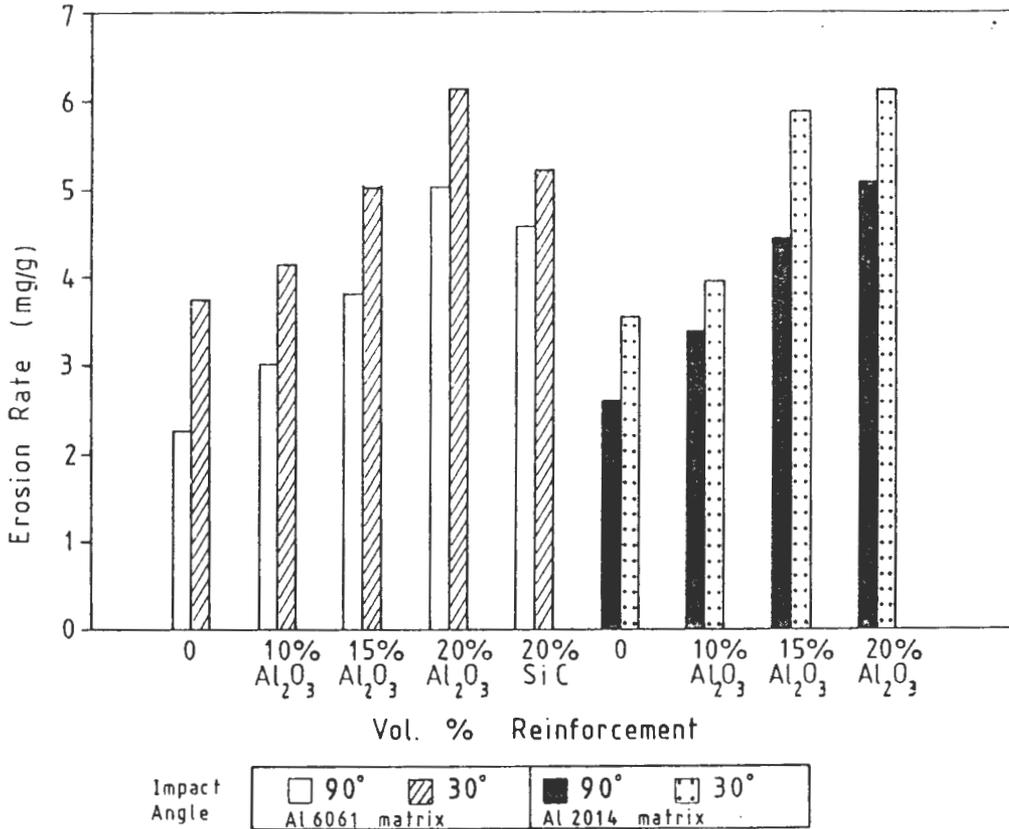
Fig.58: Steady-state solid particle erosion rates for the two matrix alloy composite systems at erodent impact angles of 90° and 30°.

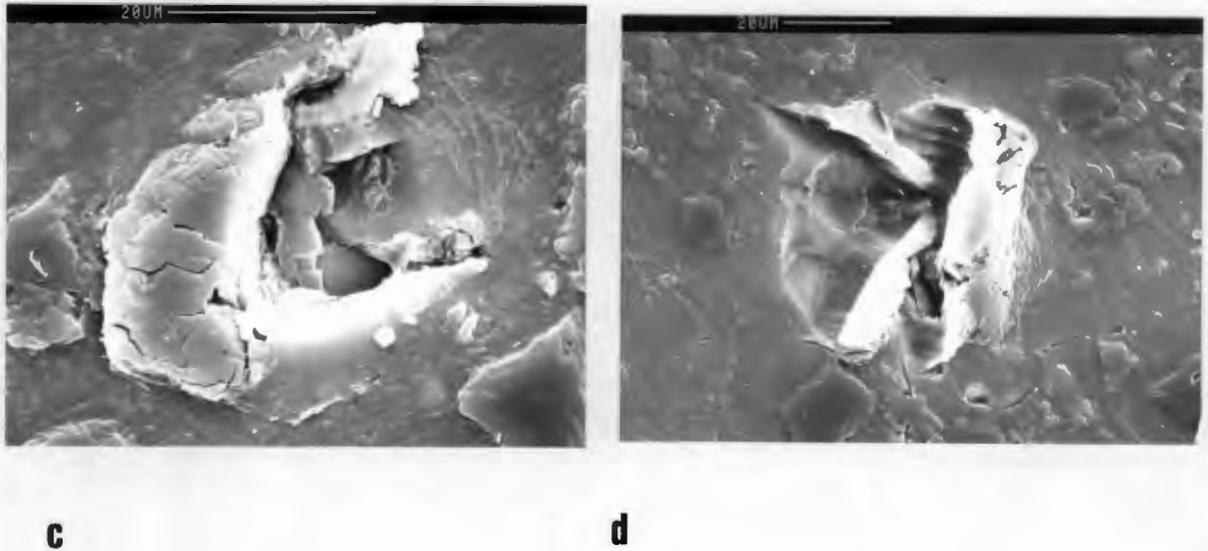
Fig.60c and 60d: Scanning electron micrographs of single impact sites in the 2014 alloy reinforced with 20 vol.% alumina, at 90° and 30° impact angles respectively. Note the lack of ductility and extensive fracture associated with each impact site.

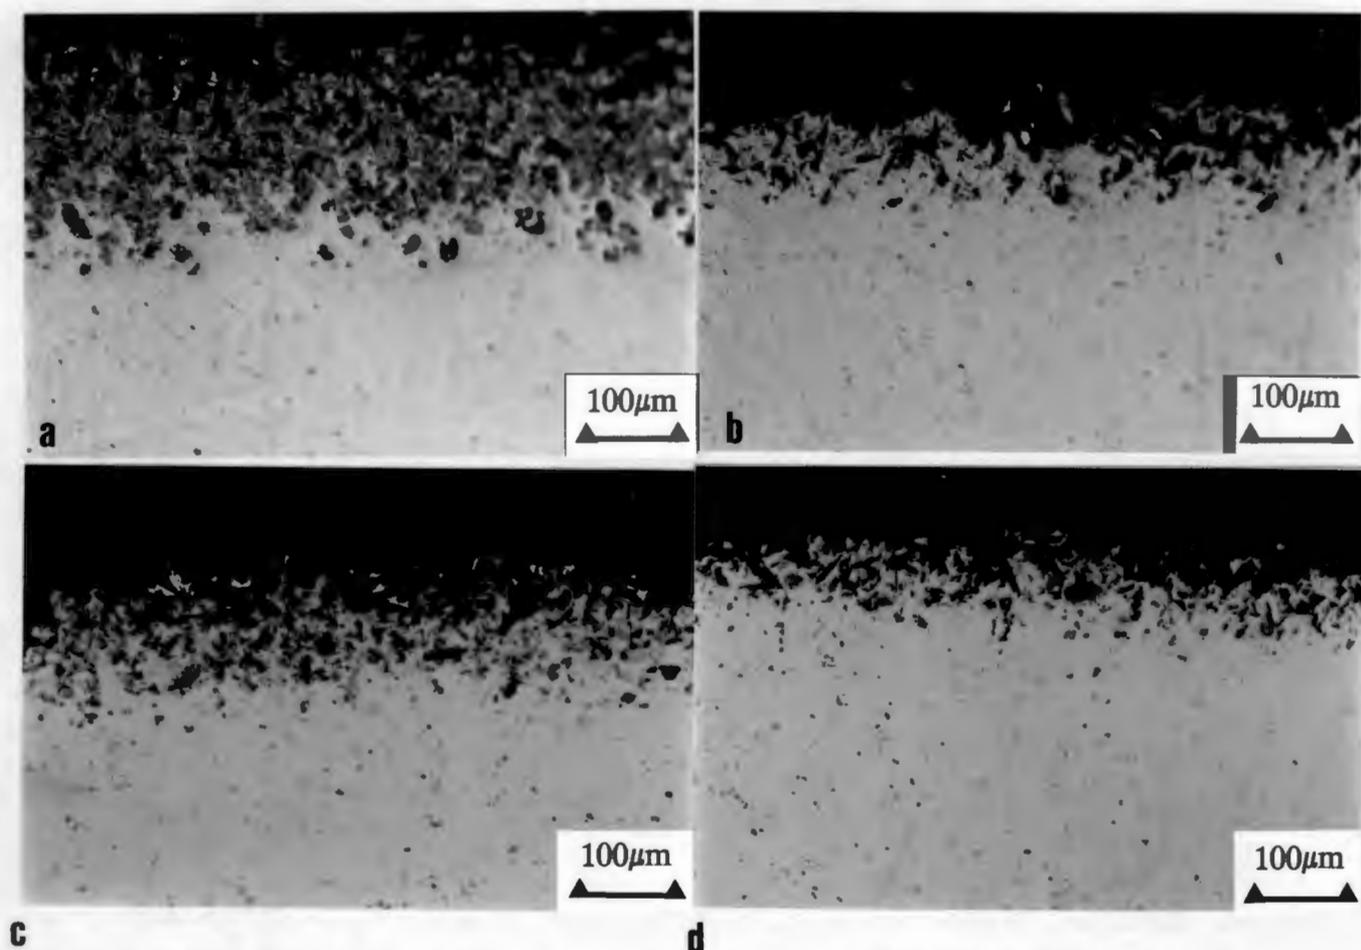
Fig.61a to 61d: Optical micrographs (5° taper section) showing the subsurface deformation obtained in the unreinforced 6061 and 2014 alloys, after having been eroded to steady state under 90° and 30° impacting conditions. Figs.61a and 61b show erosion at 90° and 30° impact angles in the 6061 alloy respectively. Figs.61c and 61d show erosion at 90° and 30° impact angles in the 2014 alloy respectively. Note the greater subsurface deformation associated with erosion under 90° impact conditions.

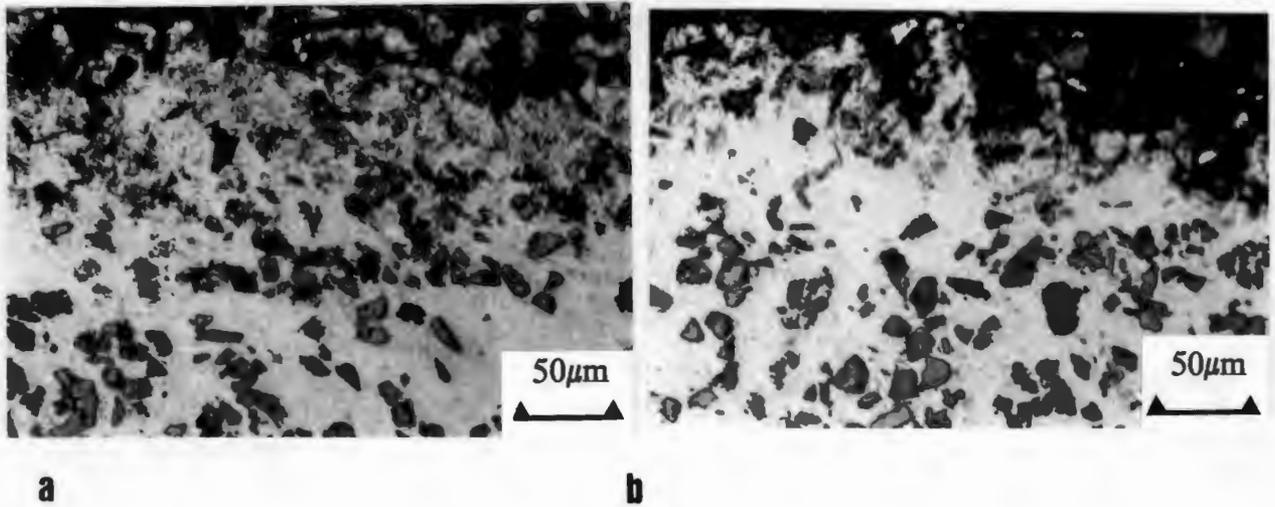
Fig.62a and 62b: Optical micrographs (5° taper section) showing the subsurface deformation and particulate fracture obtained in the 20 vol.% SiC reinforced 6061 alloy, after having been eroded to steady state under 90° and 30° impacting conditions respectively.

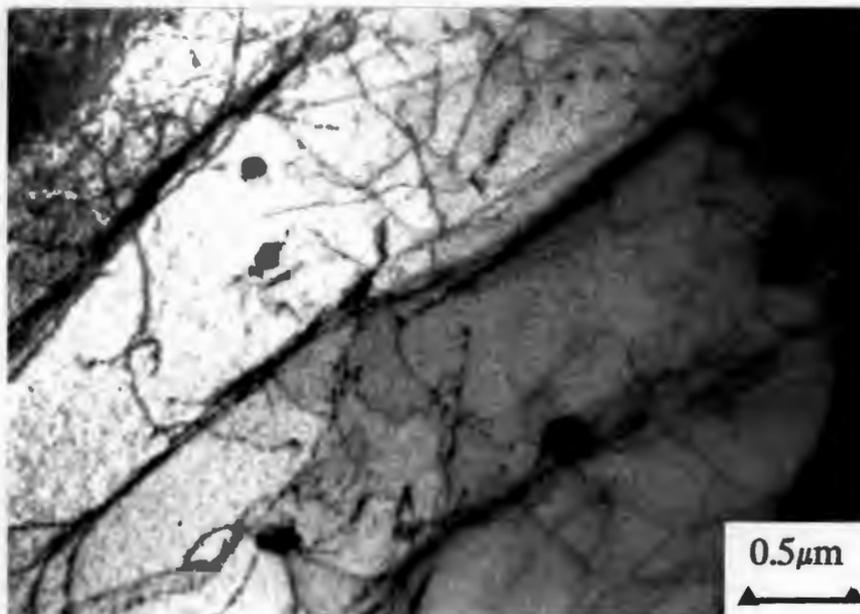
Fig.63: Transmission electron micrograph showing the dislocation structure in the matrix of the 20 vol.% Al<sub>2</sub>O<sub>3</sub> reinforced 6061 alloy, after being eroded by solid particles to steady state conditions. The microstructure is from a region of material some 50 μm below the eroded surface and shows a subgrain structure comprised of loose tangles of dislocations surrounding relatively dislocation free regions.

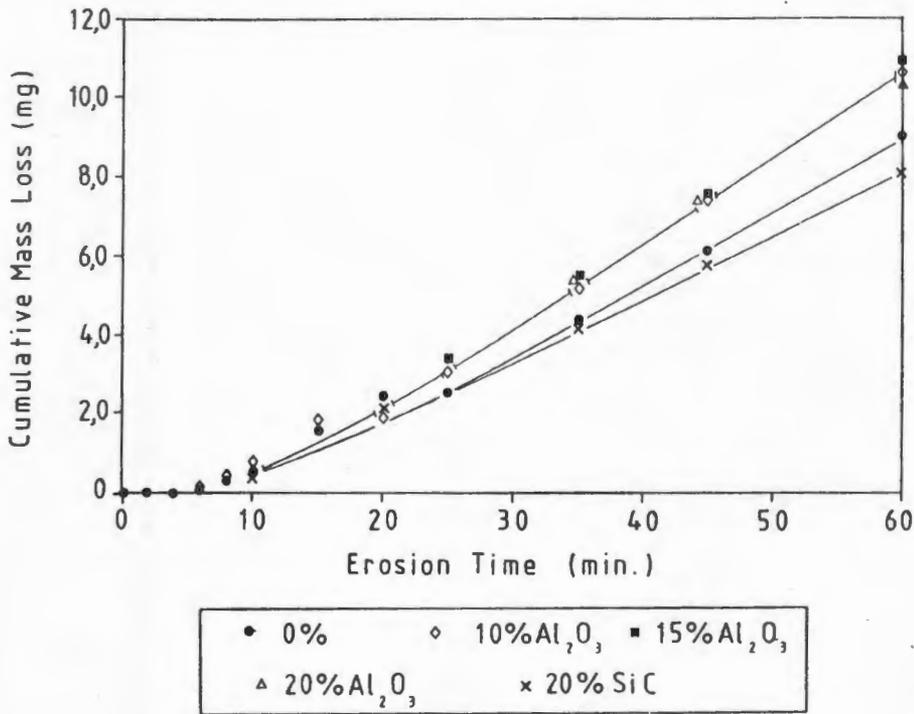
Fig.64: Cumulative mass losses of the unreinforced and reinforced 6061 matrix alloys shown as a function of exposure time to vibratory cavitation erosion.

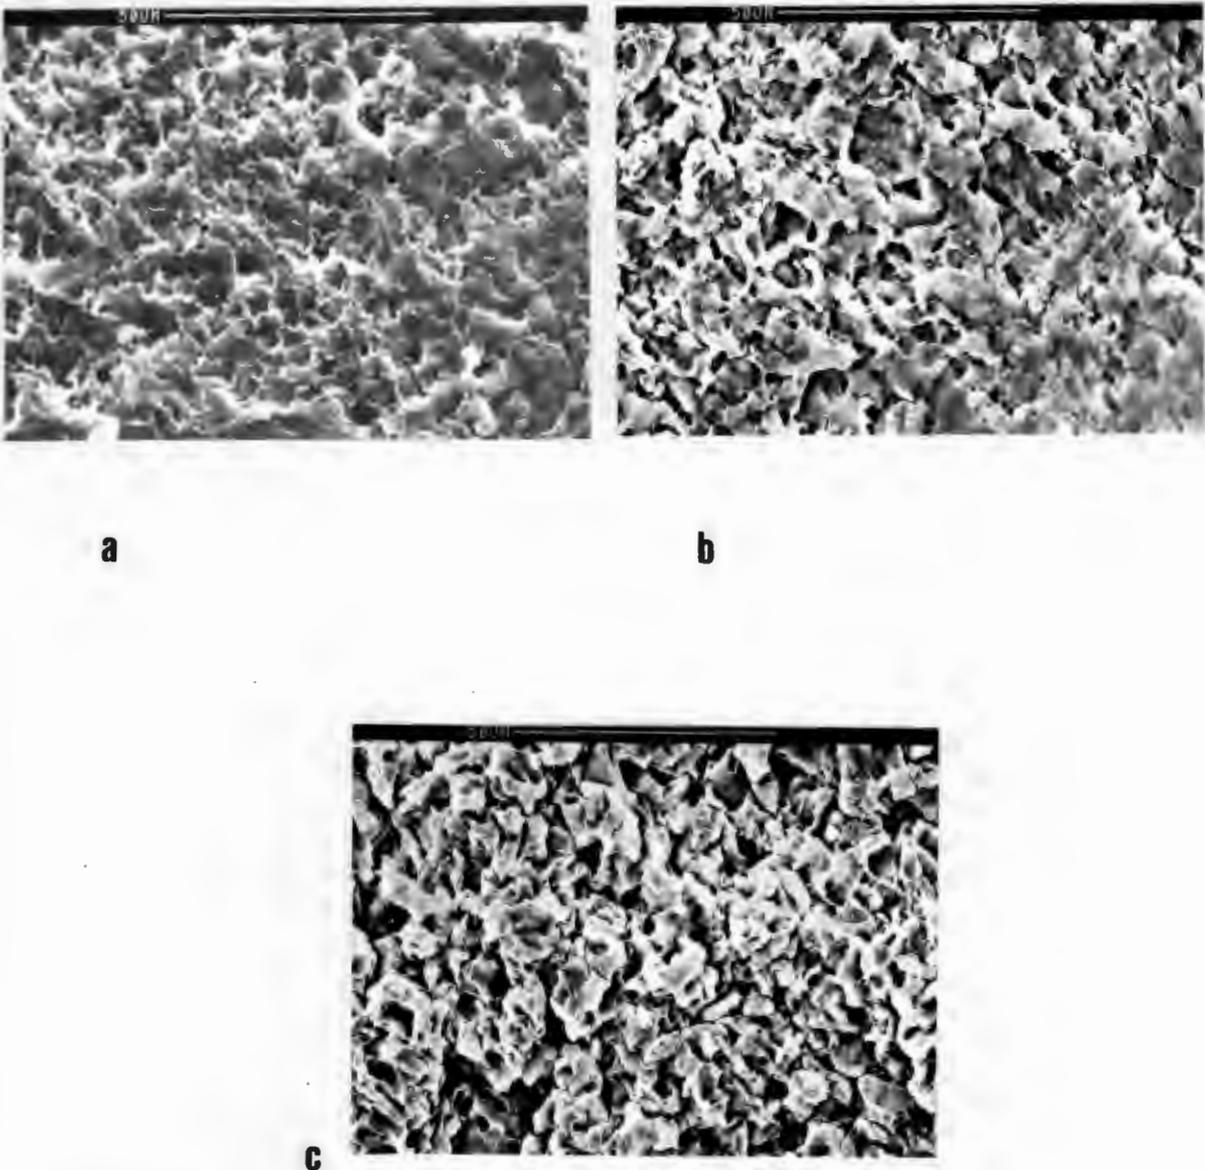
Figs.67a to 67c: Scanning electron micrographs of the cavitation eroded surface of the unreinforced 2014 alloy, after erosion periods of approximately two, five and sixty minutes respectively.

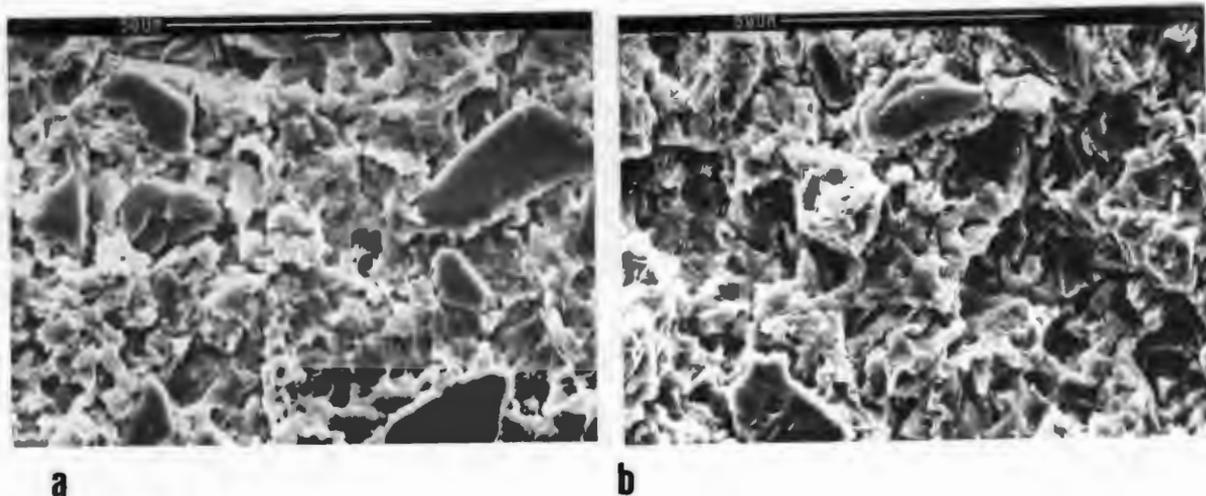
Figs.68a and 68b: Scanning electron micrographs of the 20 vol.% alumina reinforced 2014 alloy surface, after exposure to cavitating conditions of approximately five and ten minutes respectively. The matrix alloy has undergone extensive ductile deformation accompanied by intense shear at particulate interfaces.
