ELECTRO-MAGNETIC TESTING OF WINDING ROPES.

A Thesis

Presented to the Faculty of Engineering of the University of Cape Town

A. SEHRLINK.

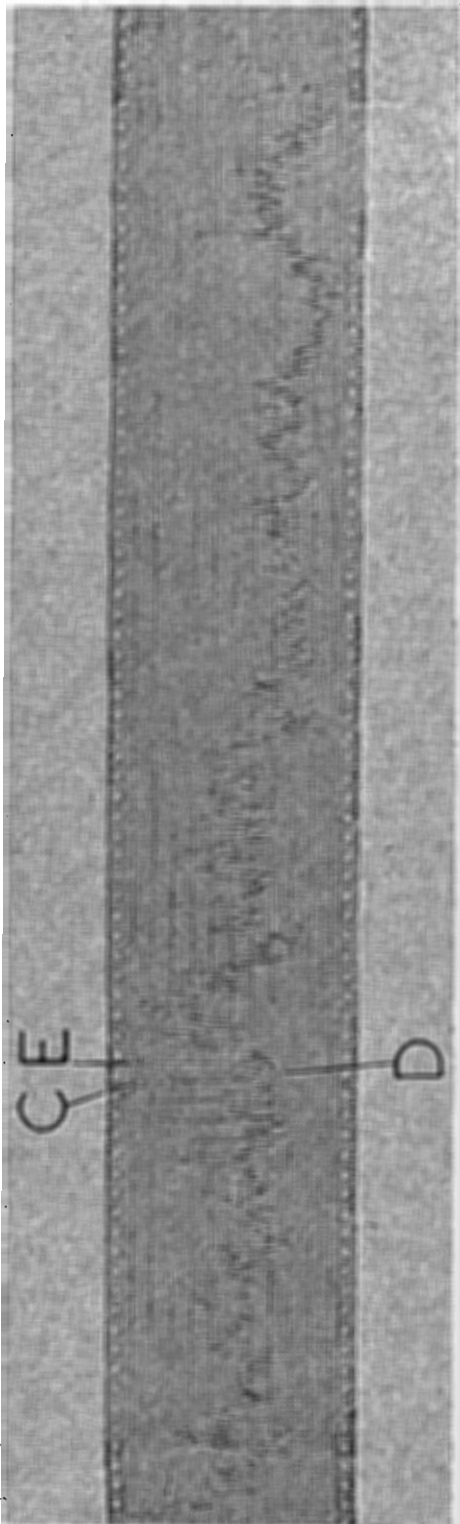
Fig. 1—Chart of St Helena test, July 1950

The first Union Corporation experiments with an electromagnetic method were conducted in 1946. A magnetizing coil of twenty turns of welding cable was used carrying a current of 100 amperes at 50 c.p.s. together with a searchcoil of several thousand turns; the distance between the coils could be varied. The rope was passed through the centres of both coils. On testing a rope just before it was taken off it was found that all visible corrosion and broken wires caused voltage variations in the searchcoil. A peak-reading valve voltmeter and an oscilloscope were used to measure these voltage variations. The results from this test were sufficiently encouraging to lead to the decision that further research work should be done. The author was appointed to do this, some equipment was ordered, a drawing board in the engineer's office at Marievale mine was made available as a laboratory and work started in April 1950. In July a test was made on a non-spin rope at St Helena gold mine, the variations along the rope were recorded on a sound-level recorder. A record of this test is shown in Fig. 1.

Fig. 1 shows a record obtained with this apparatus at St Helena in July 1950 of a 1½ inch diameter non-spin rope. It was known that excessive corrosion occurred at a number of points in this rope, corresponding to points such as C and E on the chart. It was found at tests in the Government Mechanical Laboratory that the breaking load of the rope at C was 61.3 tons, at E 68.3 tons and at a point D between these two 115.5 tons, which was near to the initial breaking strength of 120.0 tons.

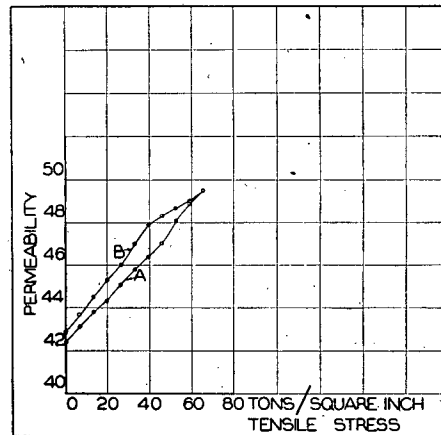
Fig. 3—Variation of permeability by stress variation
A—Increasing stress. B—Decreasing stress

It was found that increase of tensile stress in the wire caused an increase of permeability. For a stress of 65 tons/sq. in.

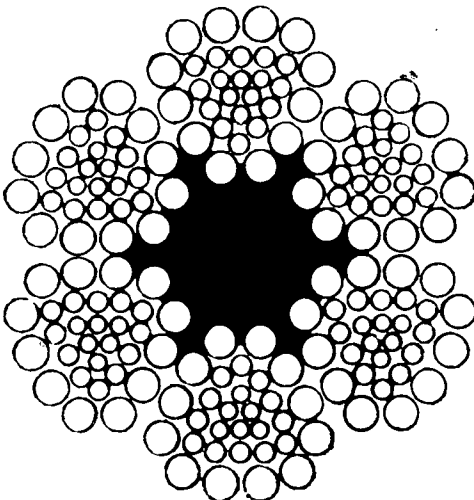
Fig. 4—Cross-section of triangular strand rope

In Fig. 4 there is no contact between the strands. This is the case for newly laid-up ropes. When the rope is put into service

the strands will touch each other due to bedding into the sisal core, and eddy currents will then be able to flow in a path around the core. The amplitude depends on the voltage induced in and on the resistance of each path, while the voltage is proportional to the frequency and to the flux linkage. When the magnetizing force is low enough to make hysteresis losses negligibly small, eddy currents determine the phase-angle between the magnetizing current and the voltage induced in a searchcoil surrounding the rope. In the absence of eddy currents this angle will be 90°. In addition to their effect on the phase angle, eddy currents will reduce also the total flux in the rope, as their direction of flow is opposite to that of the magnetizing current. As the largest flux linkage occurs in a path surrounding the core, the currents flowing from strand to strand will have considerable influence on both the amplitude and phase angle of the flux. This path will also be subject to the largest variations; when there is no contact between the strands the resistance is infinite; when the contact is good and the wires are bright the resistance will be a fraction of an ohm; when the surface of the wires is corroded the resistance may increase appreciably.

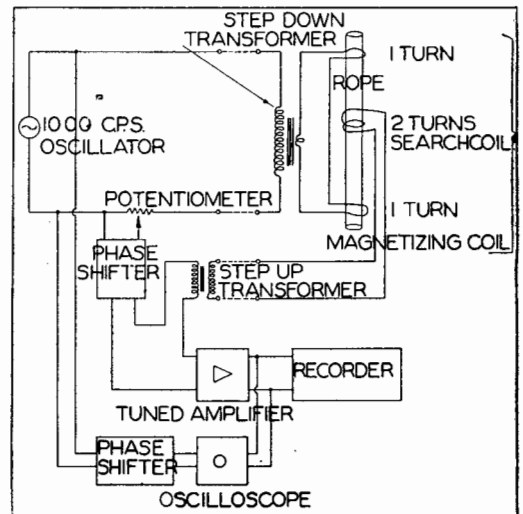
Fig. 5a—Block diagram of Model I

The equipment used for the St Helena test in July 1950 was constructed on the lines set out in Section 4.2. The split coil former was 6 inches long and 5 inches in diameter, 2 inches bore and made of hardwood. It was clamped over the rope by two copper straps, which also formed the magnetizing coil. A stepdown transformer mounted on the former connected the output of a beat-frequency oscillator, set to 1 000 c.p.s. to this coil. A co-axial searchcoil of two turns was placed half way between the two magnetizing windings where the diameter of the former was reduced to $2\frac{1}{2}$ inches. A second transformer was inserted between the searchcoil and the balancing circuit which consisted of a potentiometer followed by a phase shifter. The circuit is shown in block form in Fig. 5a.

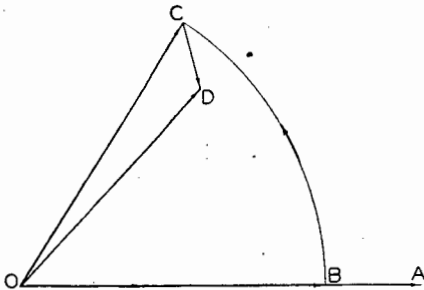
Fig. 5b—Vector diagram of Model I

A permanent record of the flux variations along the rope was obtained from a sound-level recorder connected to the output of the balancing circuit through an amplifier tuned to 1 000 c.p.s. An oscilloscope was used to determine whether these variations were caused by changes of flux amplitude or phase angle.

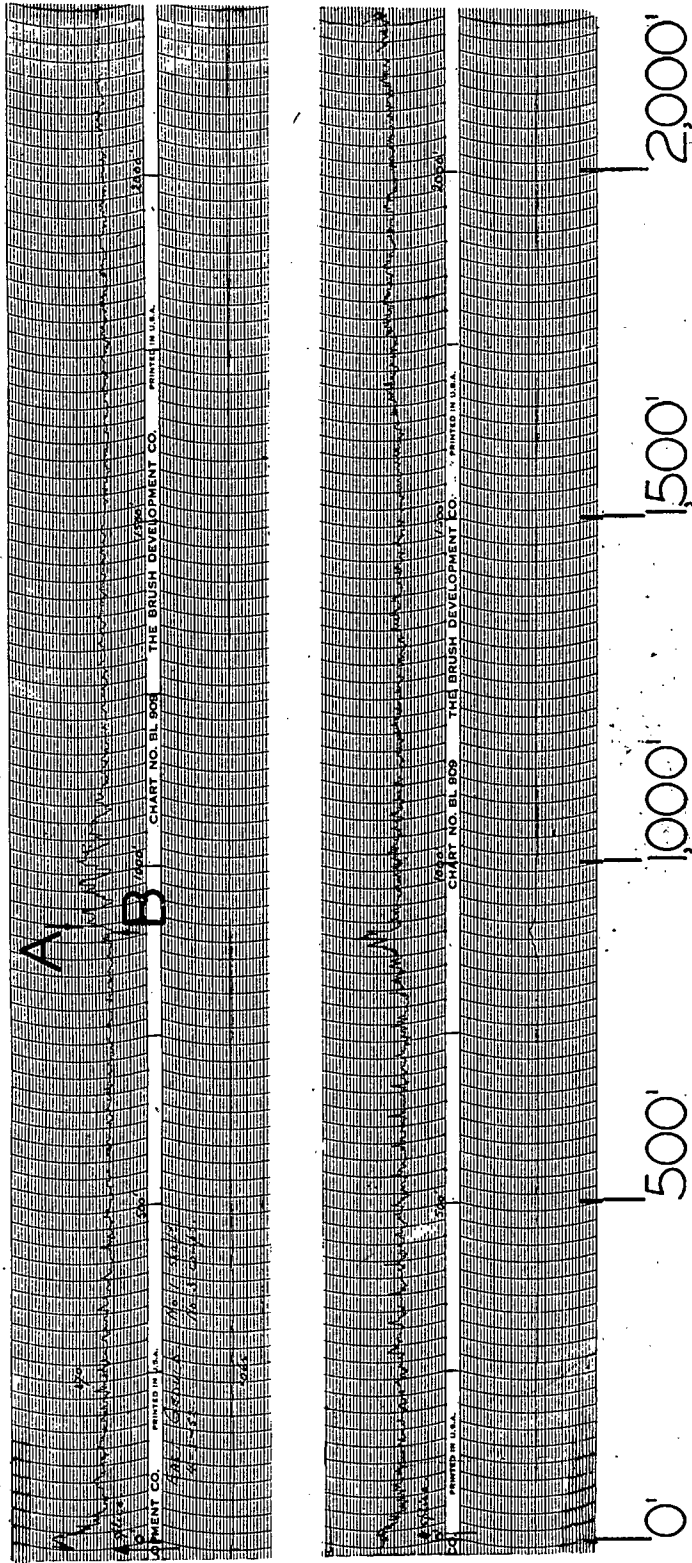
Fig. 7—Charts of East Geduld, No 1 shaft, Nos 2 and 3 compartments ropes, tested March 1952

At a point corresponding to point A on the chart the No. 3 compartment rope was opened up to find out whether the deviation was caused by corrosion as suspected. Some scale was found on the wires, but not at point B which was also opened up. The bottom trace of these charts which recorded the change of phase angle, showed very little variation. It was thought that greater variation of phase might show up if other frequencies were used. This led to the decision to redesign the equipment to enable tests to be made at a number of frequencies from 10 to 20 000 c.p.s.

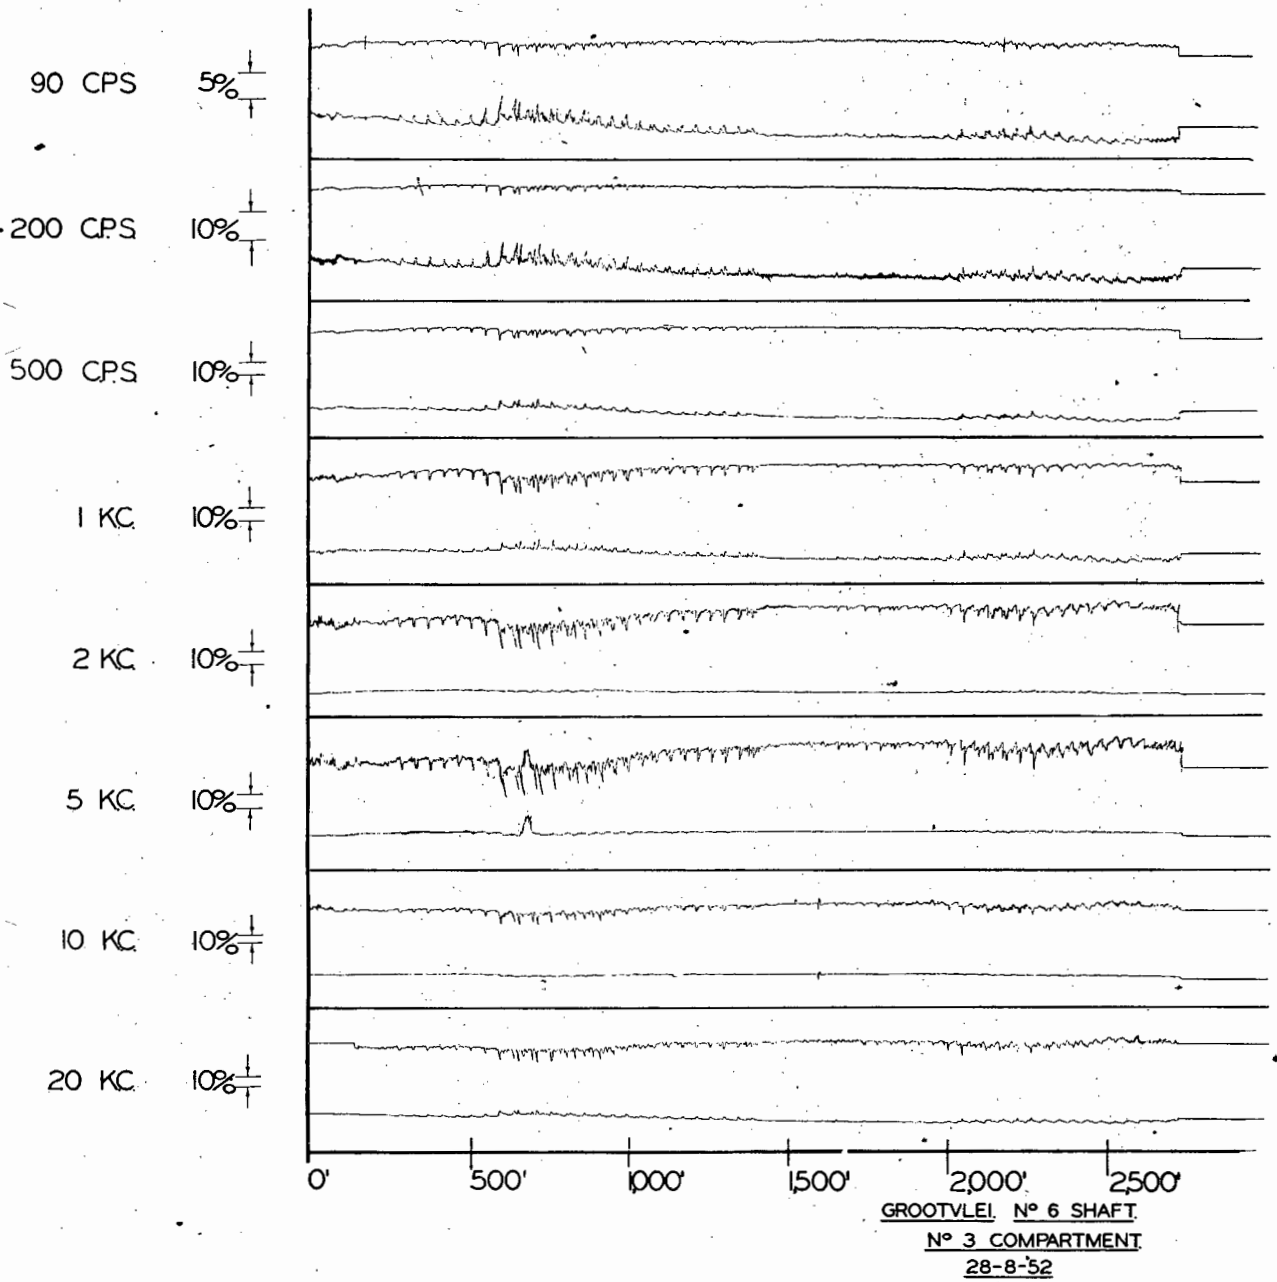
Fig. 10—Test with eight frequencies for Grootvlei No 6 shaft, No 3 compartment rope on 28th August 1952

From the tests in Section 4.3.4 and subsequent tests in the laboratory it was found that for the separation of permeability and cross-sectional area changes and changes of eddy-current path, frequencies of below 100 c.p.s. were preferable. At frequencies below 70 c.p.s. not only had the rope speed to be very slow but the equipment gave a low signal-to-noise ratio. Due to these considerations and in order to avoid interference with harmonics of the mains supply frequency 85 c.p.s. was chosen. A second survey of the main winding ropes in the Group was started in September 1952 and 46 ropes have been tested at this frequency.

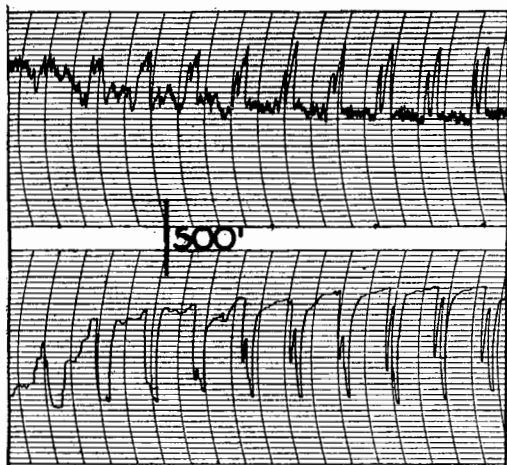
Fig. 11—Part of chart of East Geduld rope, tested 8th March 1953

The increase on the top trace is here accompanied by a decrease on the bottom trace. This corresponds to an increase of flux and a decrease in eddy currents. It is thought possible that the increase of flux was caused by the decrease in eddy currents and that the complete separation of flux changes which had been aimed at has not been achieved.

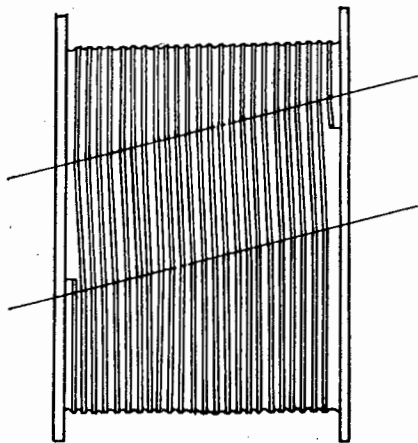
Fig. 12—Diagram of drum, showing crossover points

almost exactly to the circumference of the drum. These winder drums have parallel grooves and at each revolution of the drum the rope has to cross over to the next groove. This is shown in Fig. 12.

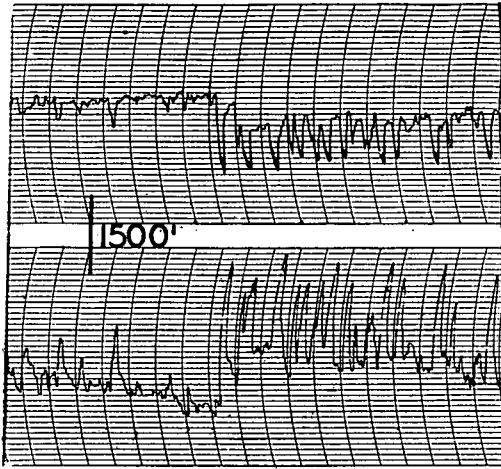
Fig. 13—Part of chart of Grootvlei rope, tested 26th February 1953

Fig. 13 shows a part of a chart of a rope tested shortly before it was taken off. Each variation shown consists of a decrease on the top trace and an increase on the bottom trace, or a decrease of flux and an increase

of eddy current. The increase of eddy current may be explained by the improved contact between wires at points of plastic wear, while the decrease of flux may be caused either by the increase in eddy current or by a decrease of steel area or permeability. As the rope has been pulled in at the drum end a number of times, the peaks are evenly distributed. Tests for breaking load on rope specimens having this type of plastic wear show little difference from initial breaking load.

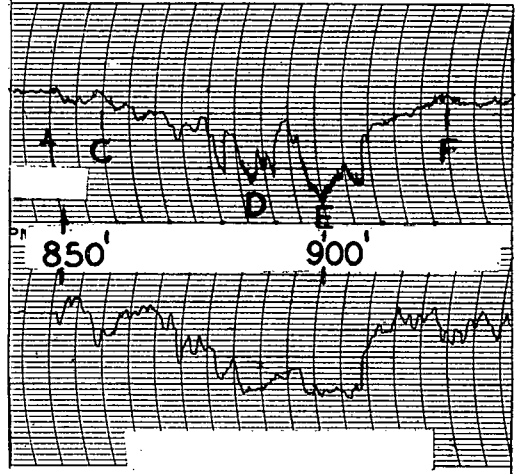
Fig. 15—Detail of chart shown in Fig. 14A

The old rope traces show considerable decrease of amplitude and also a decrease of eddy-current loss at a point about 900 feet from the splice. Visual examination of the rope did not, however, show any defect. As the rope was discarded shortly afterwards, samples were taken at points marked *C*, *D*, *E* and *F* on the chart, as shown in the detailed chart Fig. 15.

D and *E* showed 3 per cent and 4 per cent decrease, while *C* and *F* were normal samples taken for comparison purposes. On testing the breaking loads were found to be:—*C*=157.0 tons, *D*=137.7 tons, *E*=130.0 tons and *F*=154.5 tons. A load-elongation diagram for these specimens is given in Fig. 16.

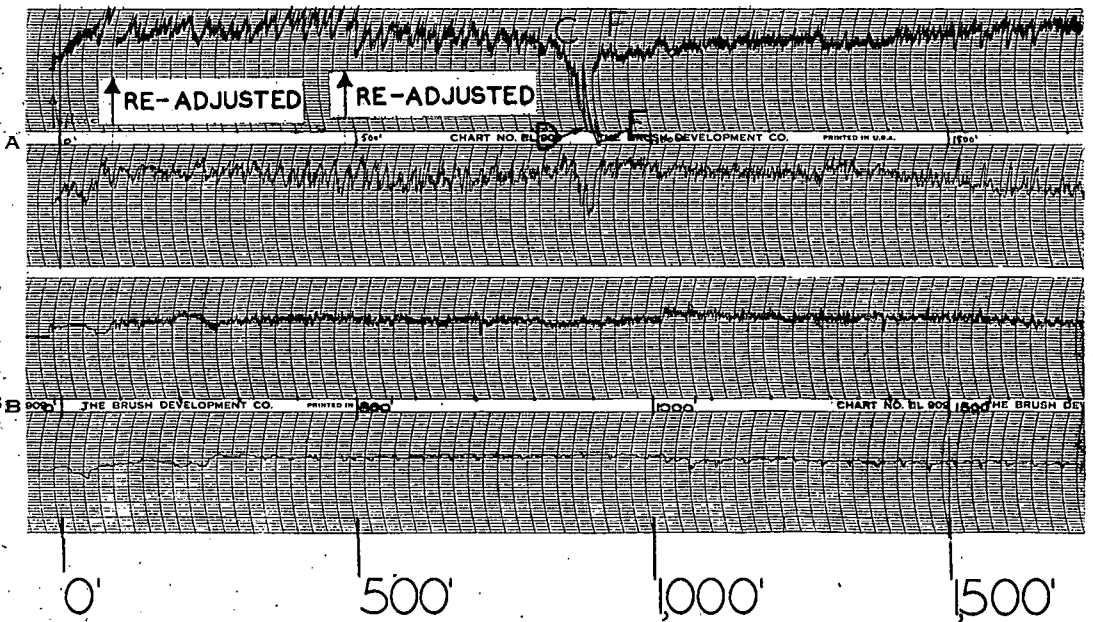
Fig. 14—Charts of East Geduld No 1 shaft, No 4 compartment

It will be noted that the charts show a decrease of both amplitude and phase angle. This combination is considered to be indicative of internal corrosion. Subsequent tests seem to confirm this.

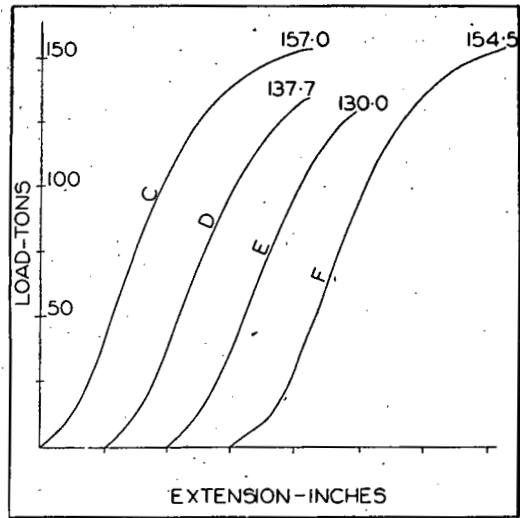
Fig. 16—Load-elongation diagrams of samples

The original breaking load of this rope was 159.3 tons. Examination of *D* and *E* after the test showed excessive corrosion inside the strand, some inner wires were entirely corroded through. Fig. 17 shows the inside and outside of a corroded strand.

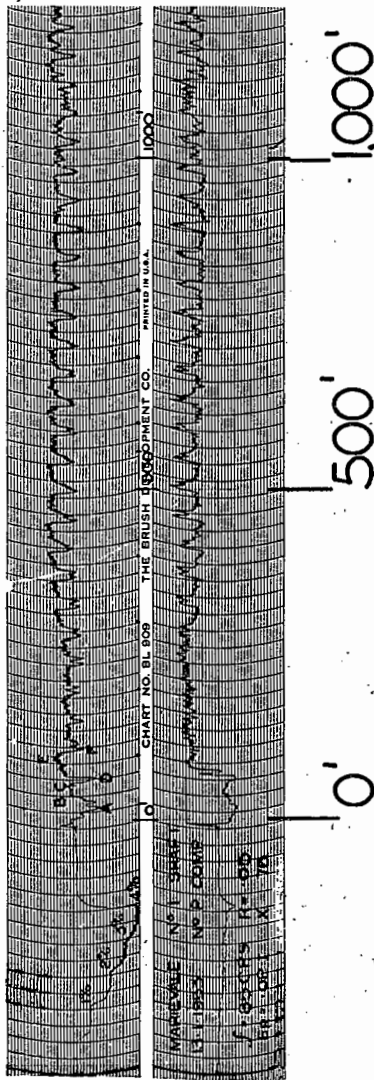
Fig. 18—Chart of Marievale No. 1 shaft, No 2 compartment rope, tested 13th January, 1953

The regular peaks on this chart, showing points of plastic wear as discussed in Section 5.2, are typical of crossover points with a cylindrically grooved drum. This rope has been taken out of commission and samples have been tested at points A—F, with the object of finding the reason for the variations near the splice. The results are given in Table II.

The rope of 1 3/4 inches diameter has an original breaking load of 150.7 tons. The

reduction in breaking load of these specimens may be due partly to corrosion and partly to corrosion fatigue. The weakest section—Specimen *D*—corresponds to a sharp decrease on each trace.

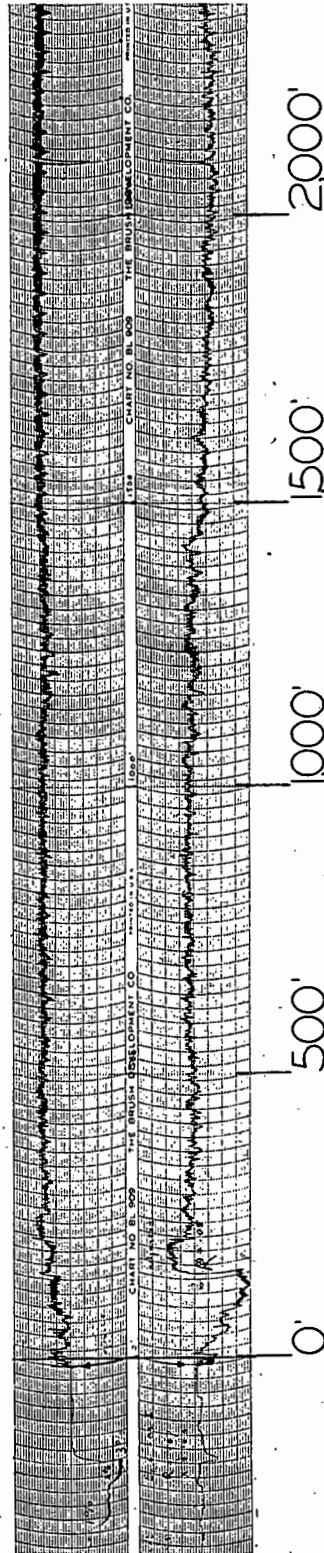
Fig. 19—Chart of Marievale No 5 shaft, No 1 compartment rope, tested 23rd September, 1952

This rope was first tested with Model I ten days after it was put on. Since then several tests have been made with both Model II and Model III. At a point some 2 000 feet from the splice a decrease in amplitude of approximately 10 per cent was found with the first two models. The chart, shown in Fig. 13, taken during the last survey with Model III shows a reduction of 3 per cent in amplitude; the increase on the lower trace is a transient originating in the equipment, which disappears if the rope moves slowly.

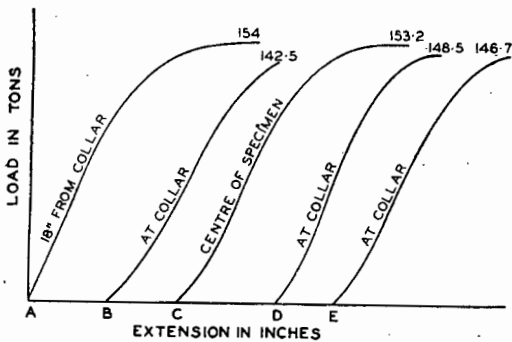
Fig. A

The result of this test revealed that the specimen had broken at the metal collar (shown by B in Fig. A) with a breaking

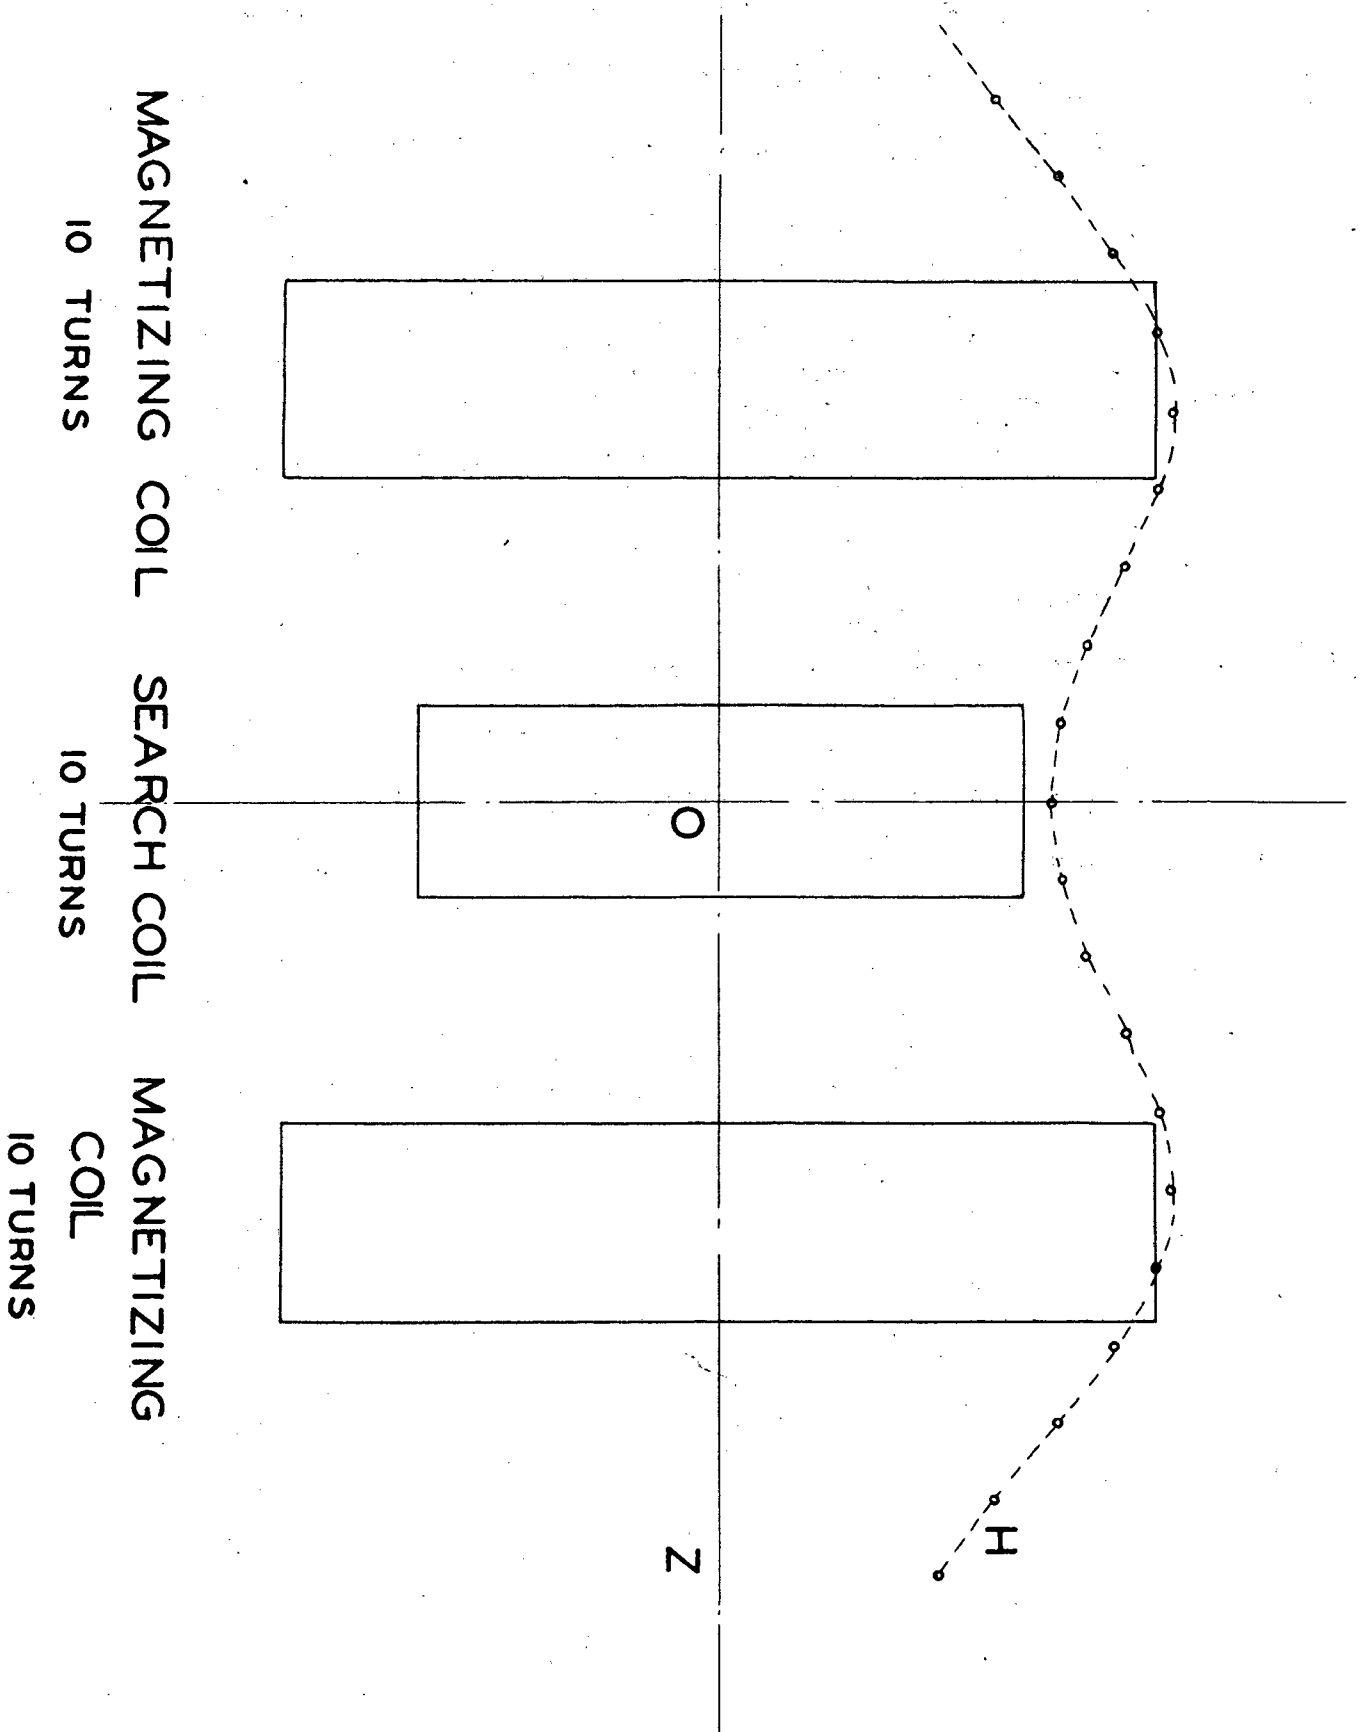
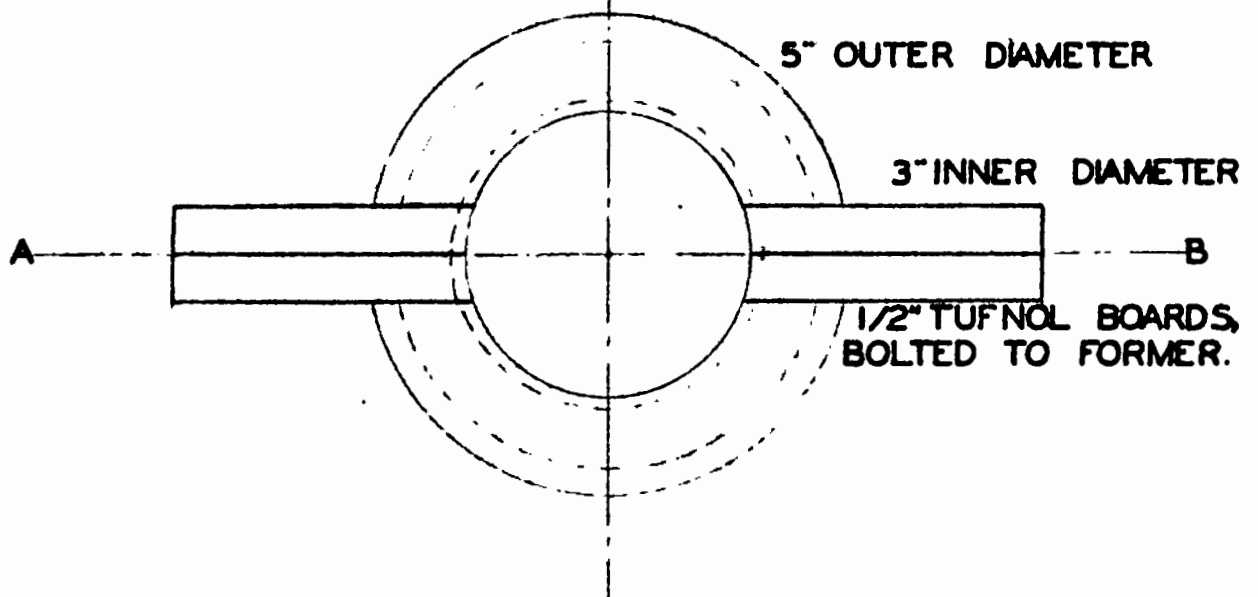
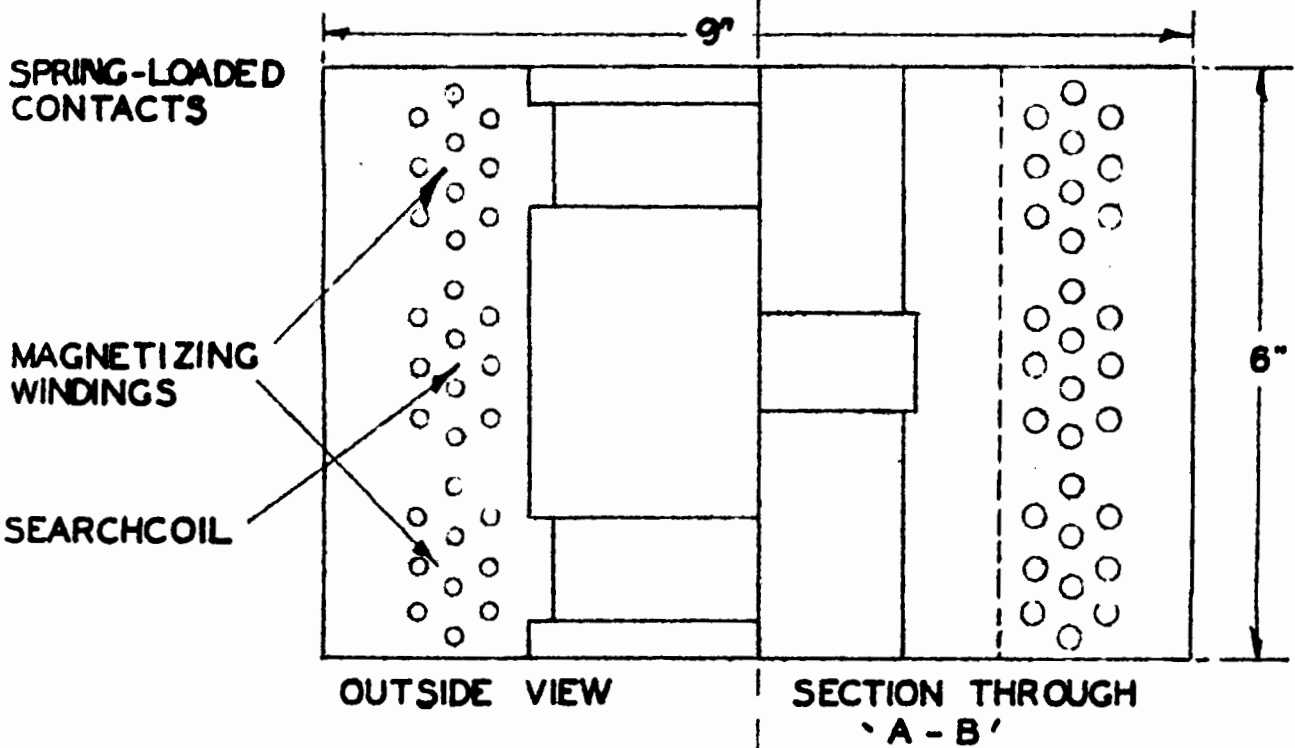
FIGURE 2A . COIL-FORMER

CYLINDRICAL BAKELIZED PAPER FORMER

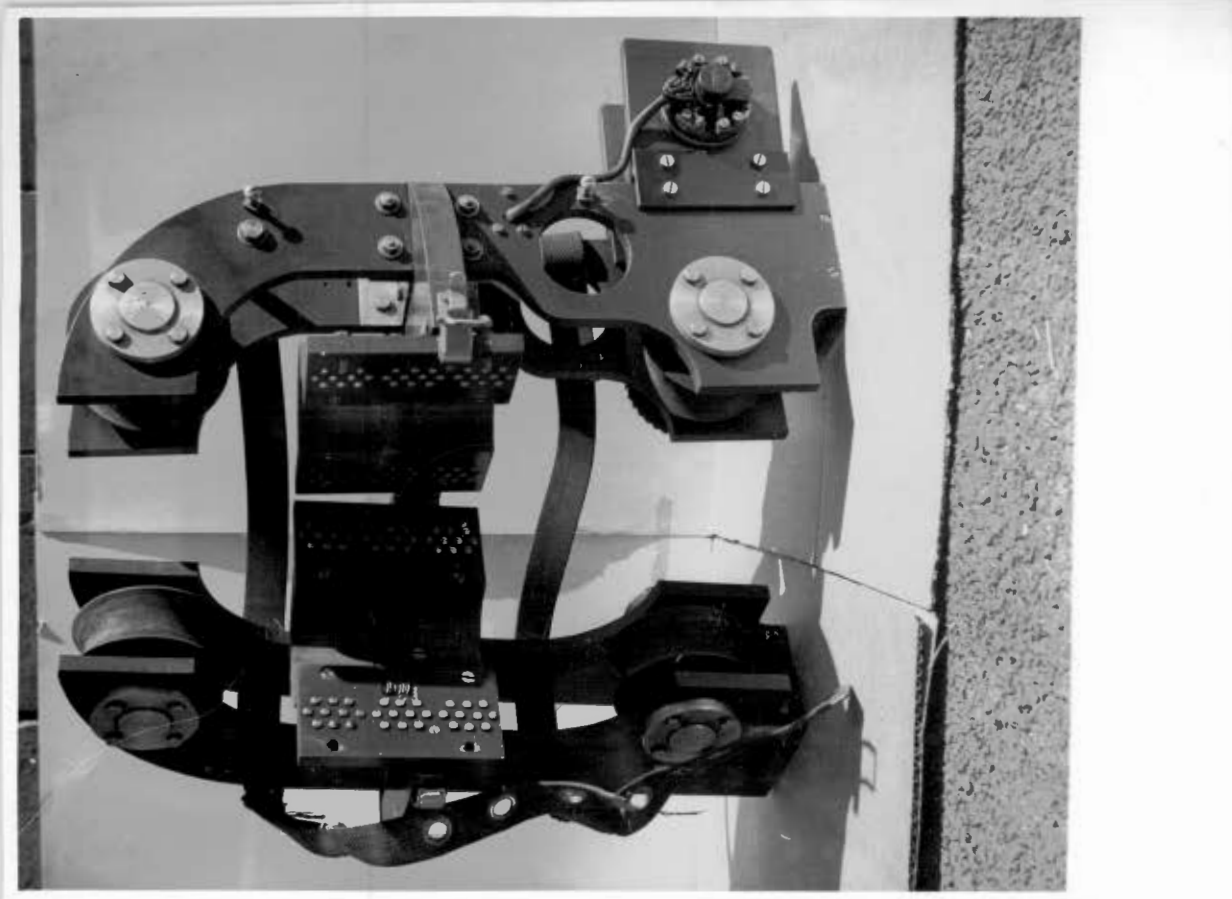
Figure 3a, Coilframe opened.

The coil former is mounted in a frame with four tufnol pulleys which ride on the rope and serve to keep the rope along the axis of the coils. One of the pulleys drives a magalip generator which is part of a synchronous link for the recorder. The frame is hinged on one side, is fitted with a simple clamp on the other side, while two rubber belts prevent the contacts from opening. The whole is illustrated in Fig. 3a and 3b.

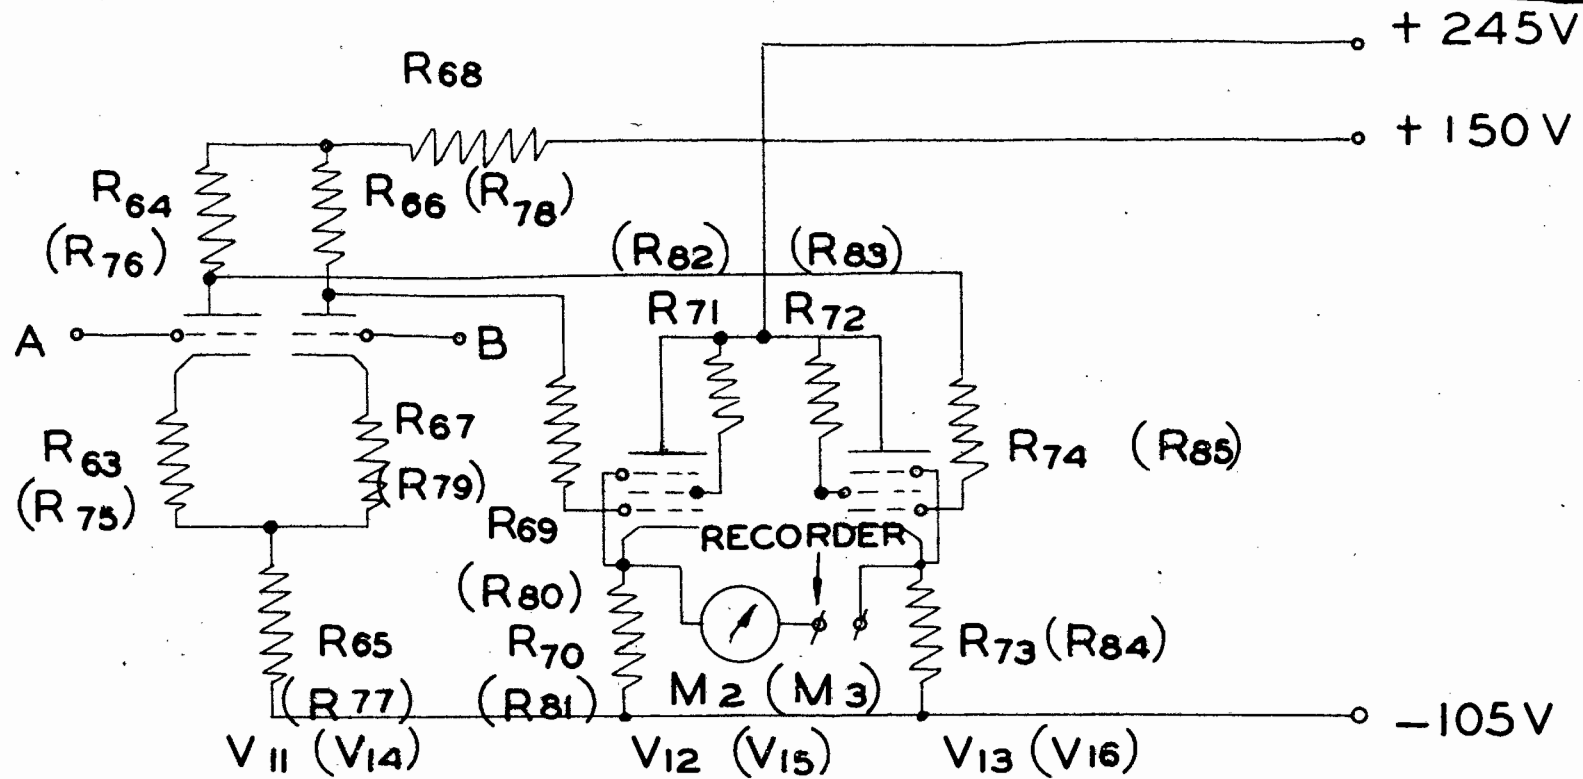
D. C. AMPLIFIERS

VALUES IN BRACKETS REFER TO R COMPONENT AMPLIFIER.

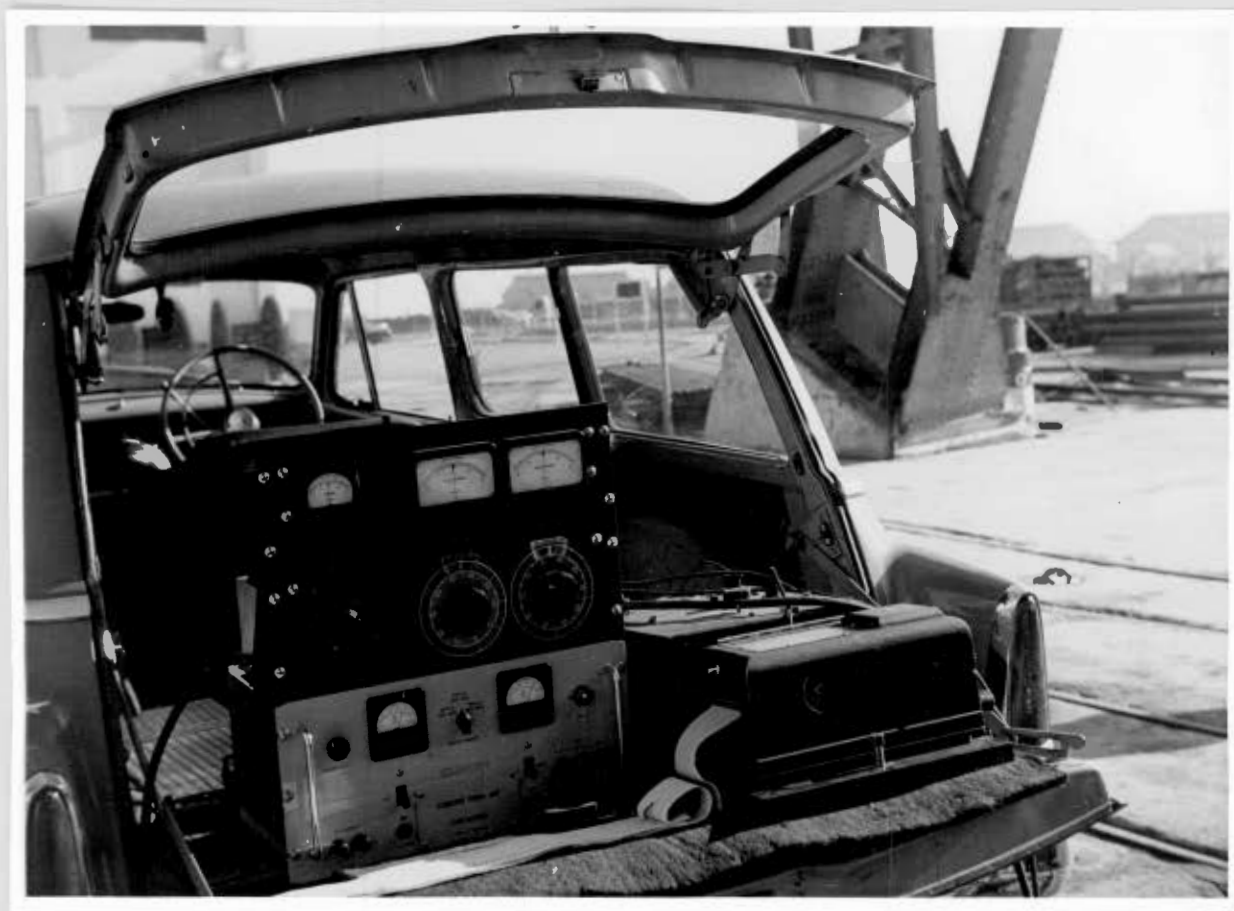
Figure 10. Apparatus in stationwagon.

As already stated the recorder is a high-speed oscillograph. It has a frequency response essentially flat from d.c. to 30 c.p.s. and falling to 120 c.p.s. It has two identical channels with centre-zero, one of which records the variations of the reactive component and the other those of the resistive component. The records are much easier to interpret when the longitudinal scale is proportional to distance along the rope. This is accomplished by means of a synchronous link, consisting of two megalips.

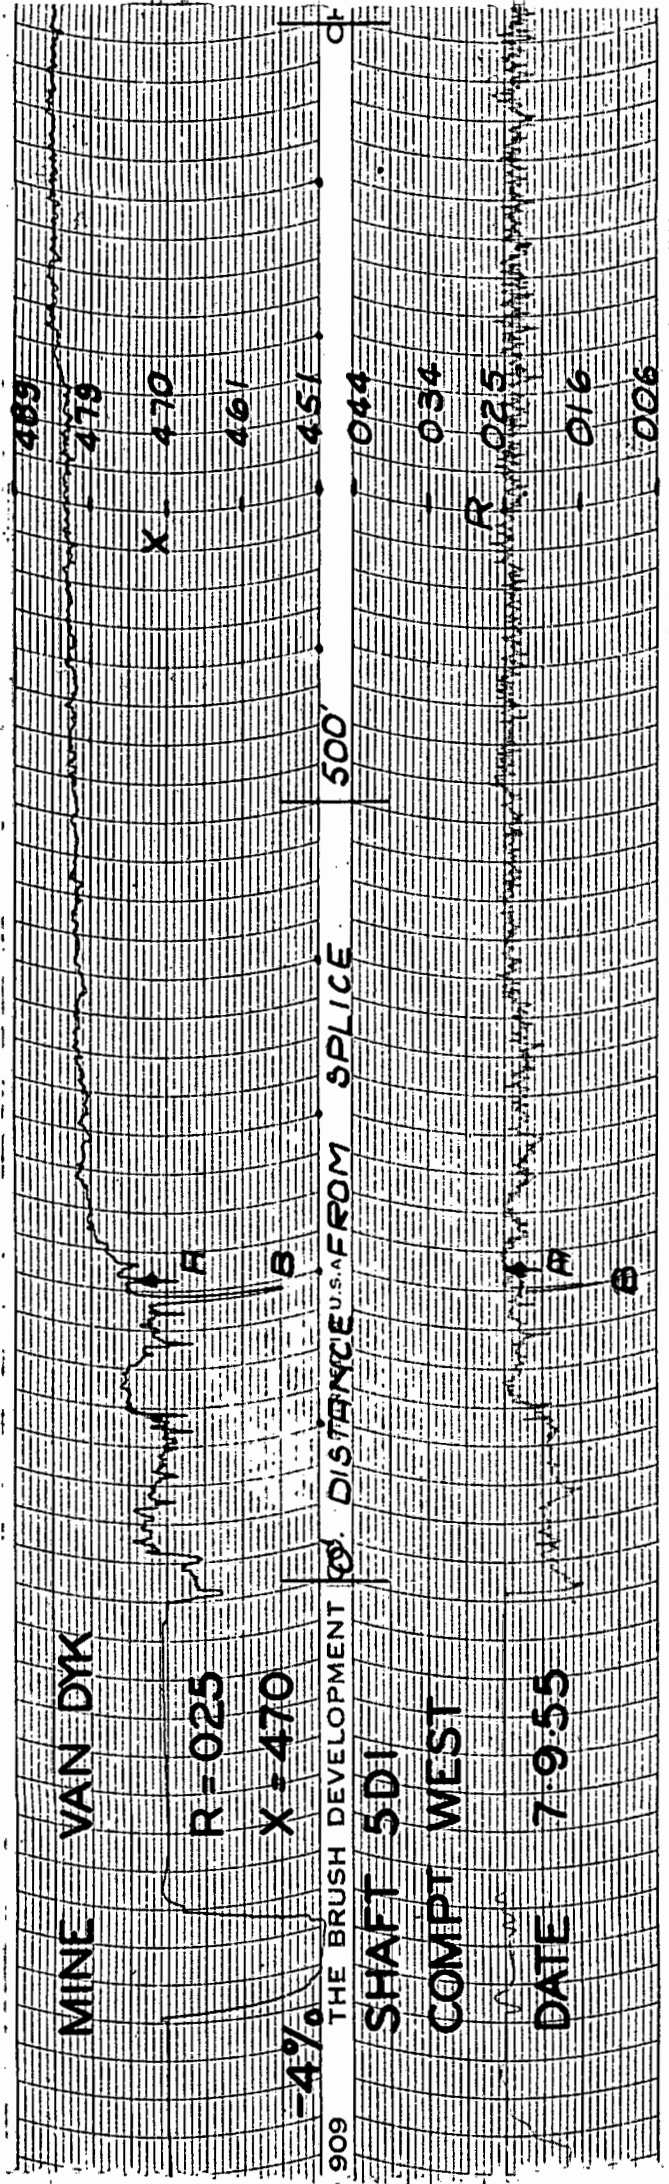
Figure 12, Example of chart.

An example of a chart is shown in Fig. 12. To the left the name of the mine, shaft and compartment number are noted, as well as the date of the test and the settings of the R and X controls. The calibration mark is marked minus four percent. The value of output voltage for any point along the rope may be calculated as follows; at point A the X reading is 475 and the R reading 025, while at B X = 456 and R = 013, the output voltage is obtained by multiplying the X reading by $.02 \times .5$ Amperes to give millivolts. The rope concerned is of 1 1/4" diameter and 79.2 tons original breaking load.
