ELECTRO-MAGNETIC TESTING OF WINDING ROPES.

A Thesis

Presented to the Faculty of Engineering of the University of Cape Town

A. SEHRLINK.

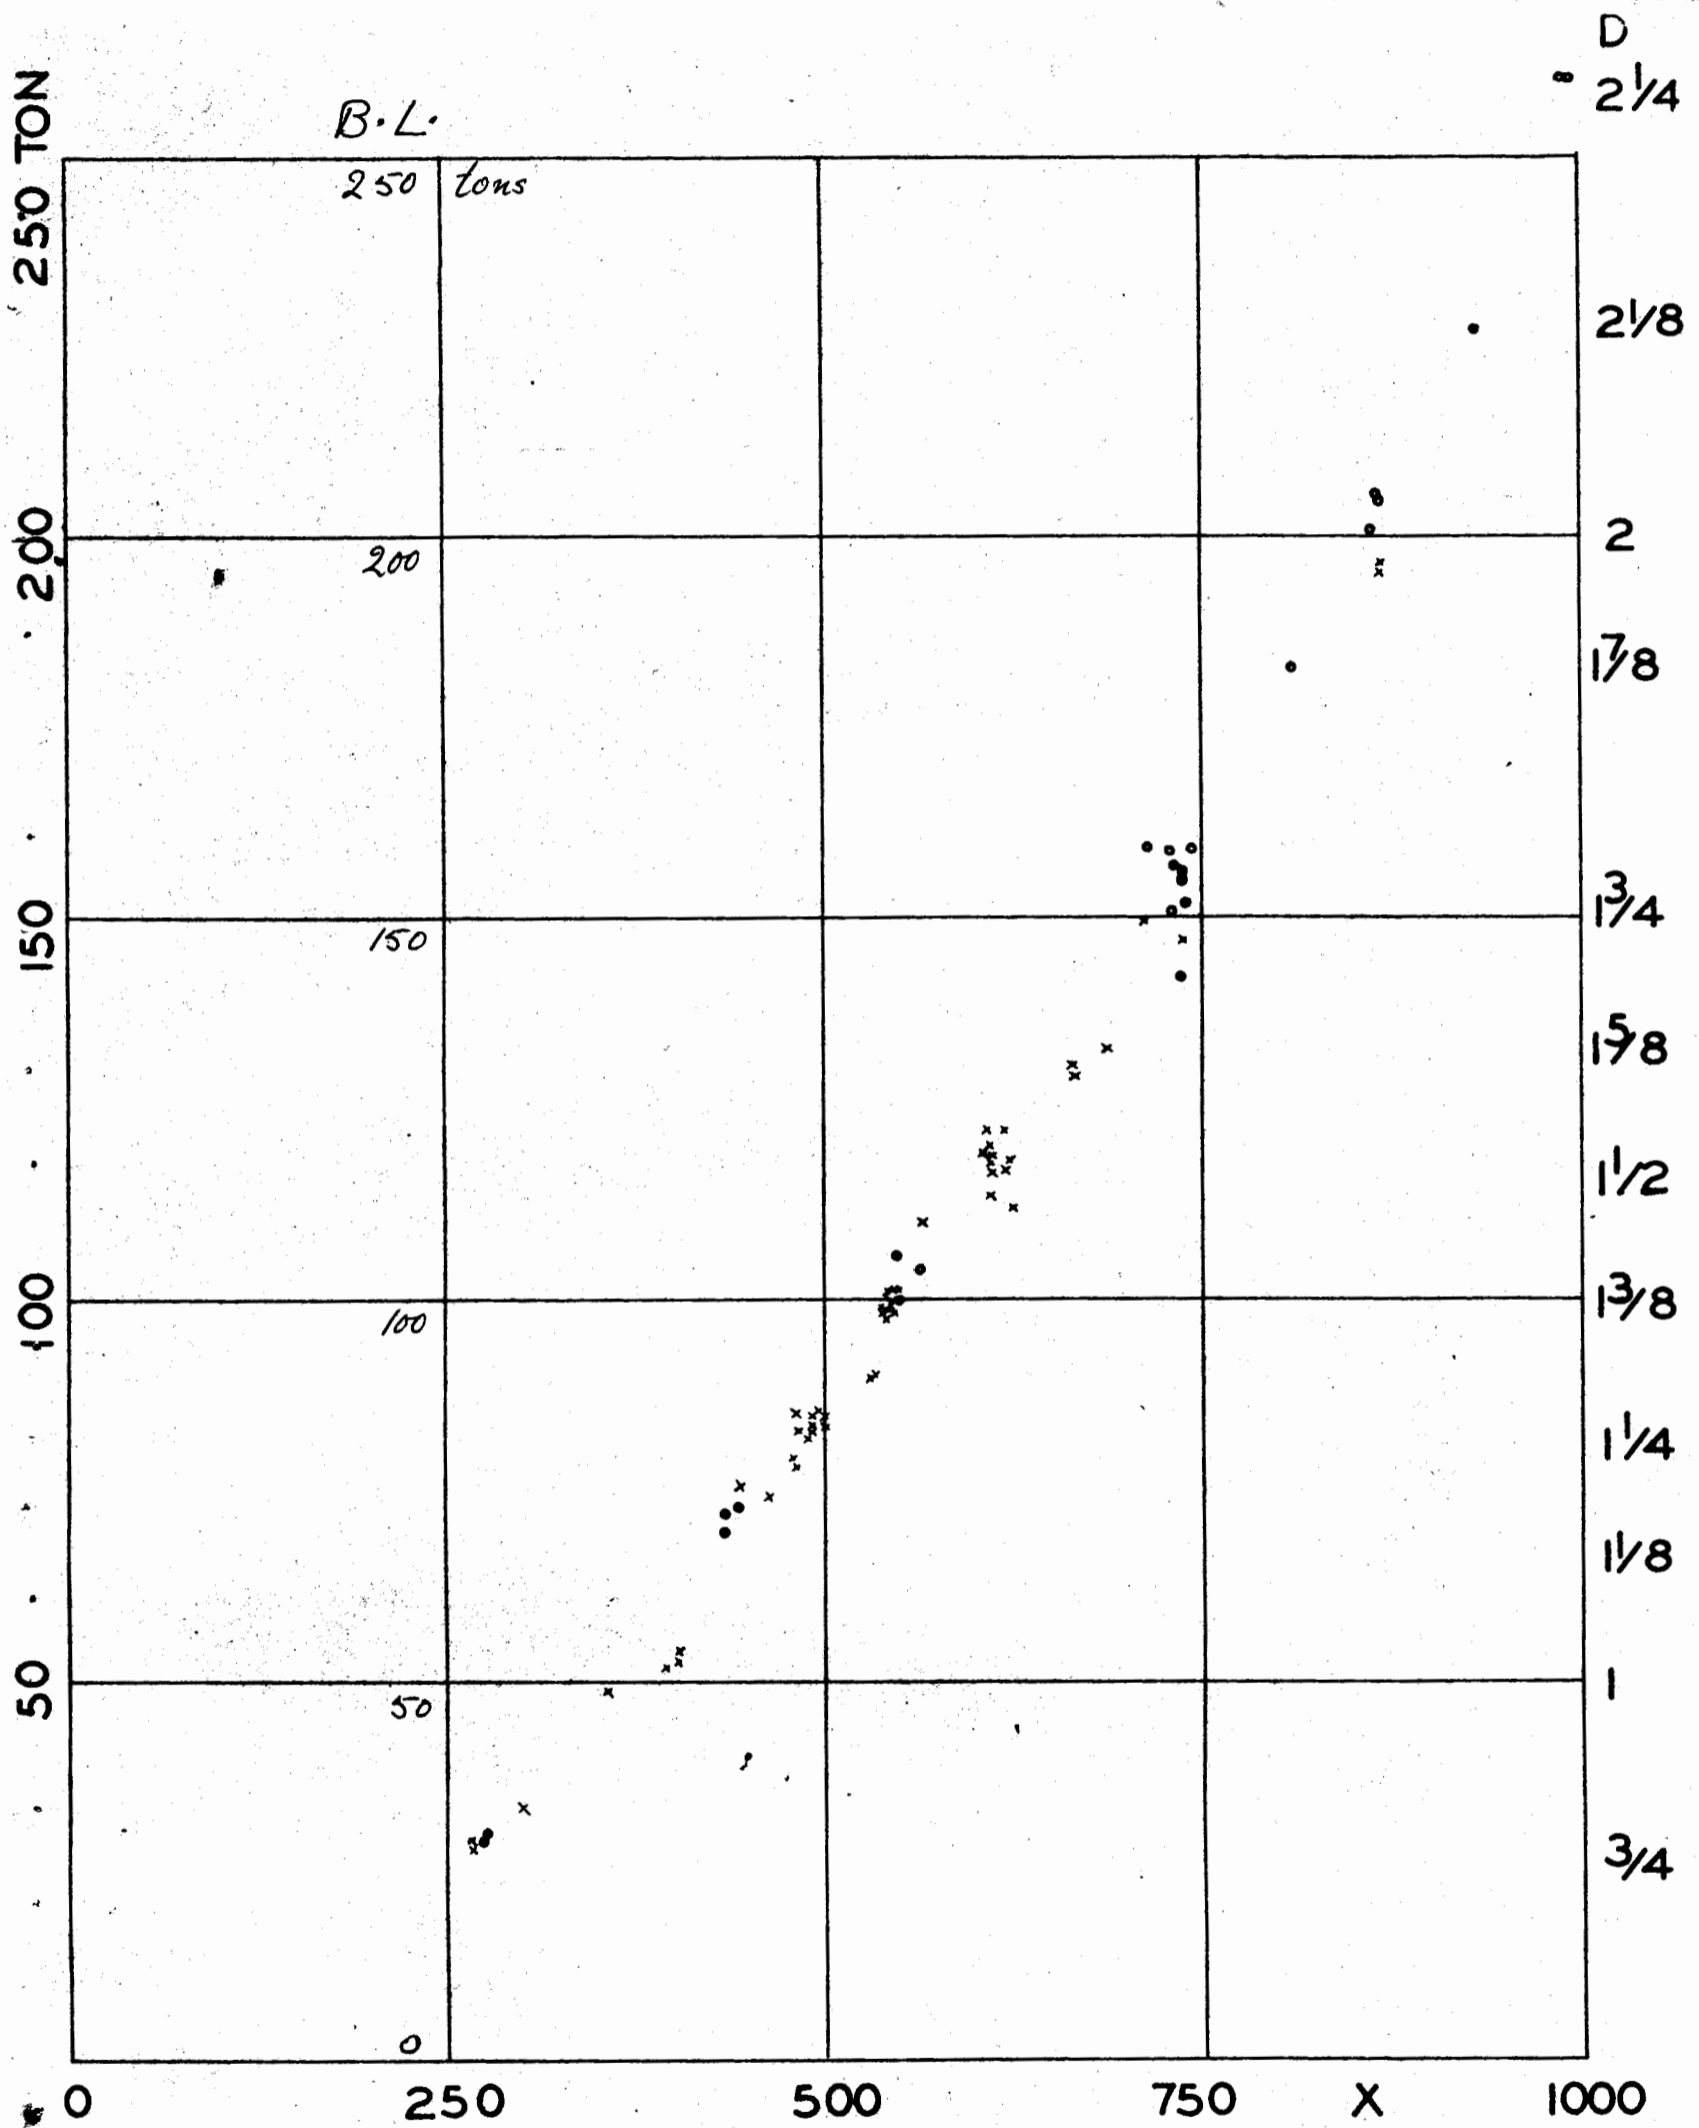
B. L. AGAINST X
FIGURE 14A

From measurements carried out at Cape Town University and published in the first paper it was found that the difference in permeability for the two classes of steel is negligible. The breaking load of the 128/140 steel for the same X reading may be expected to be higher than those of the 125/134 steel. Most ropes from which the samples were taken are made of basic, Iscor special steel (ref.9, p.241).

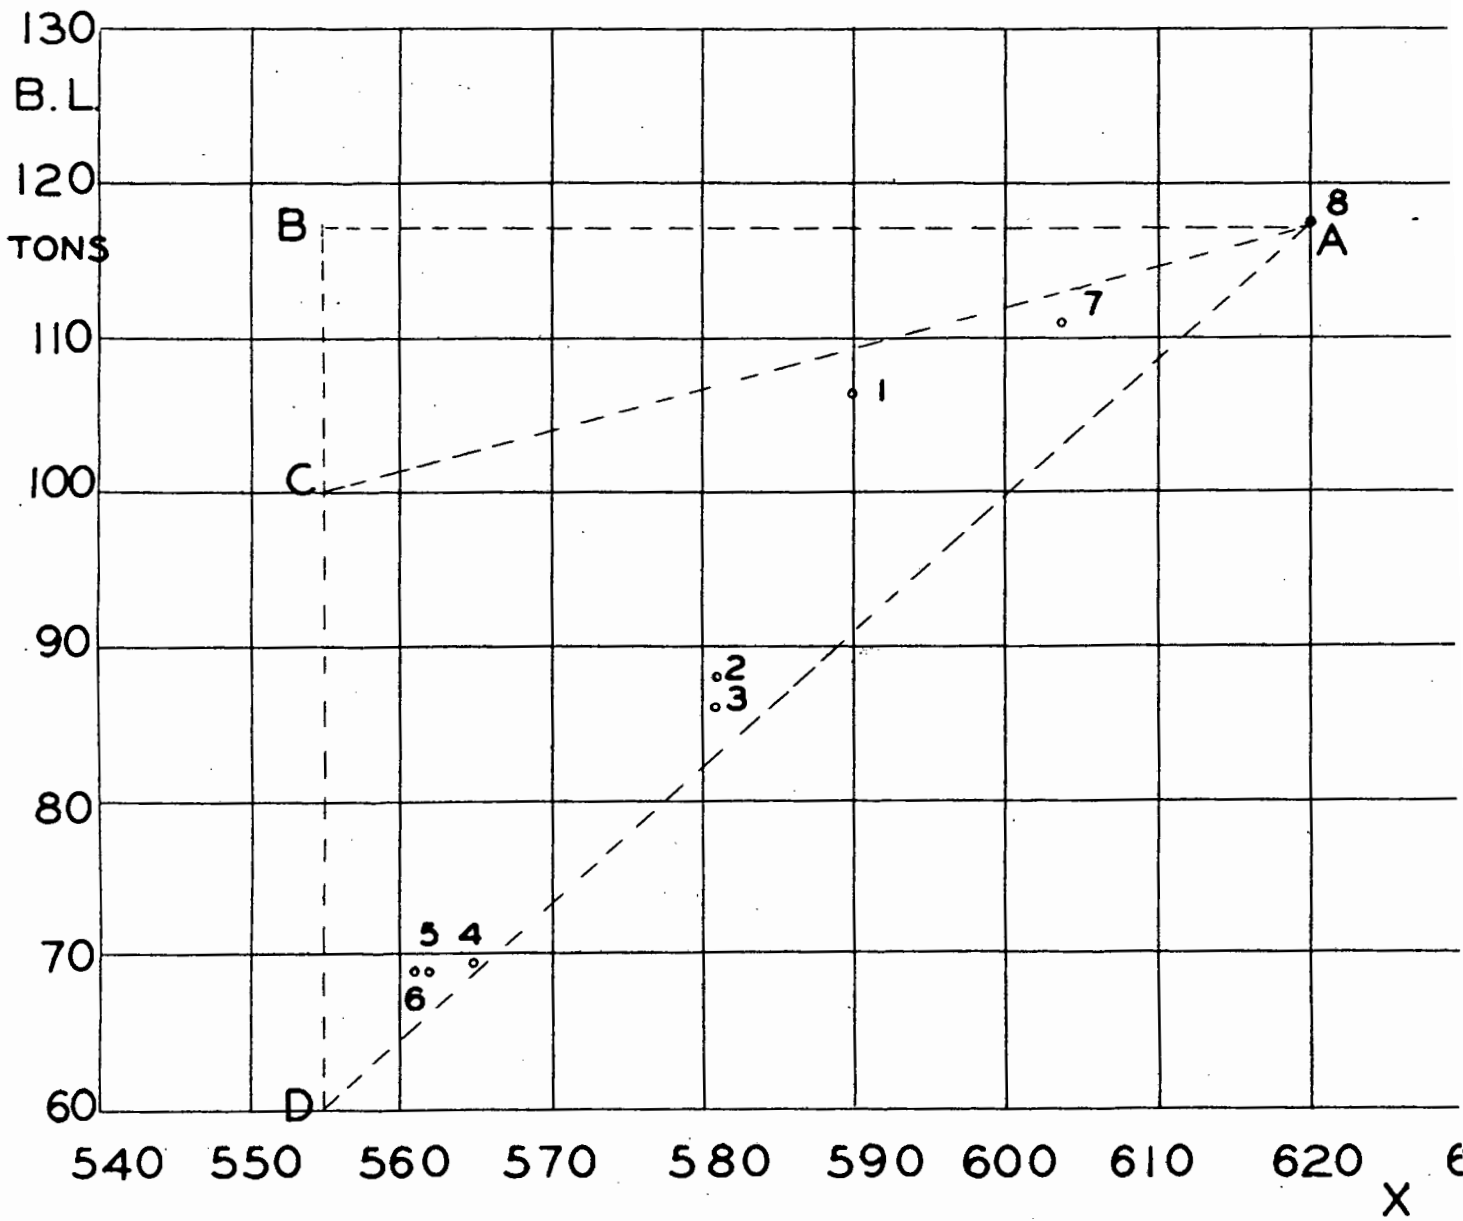
FIGURE 15

B.L. VERSUS X FOR ROPES
SHOWING CORROSIVE WEAR

In Figure 15 a line A-C has been drawn. This corresponds to a section of the line drawn through the points of Figure 13. The vertical distance between A-C and the horizontal line A-B should give the approximate reduction in B.L., but only three samples showed B.L. in agreement with this expectation. To find the explanation for the different behaviour of the other samples, specimen 5 was cast in plastic, cut, polished and photographed (Figure 16). These ropes had originally six strands of ten out wires, .126" dia, twelve inner wires, .060" dia, six core wires, .052" dia, and three filler wires .038". It may be seen from Figure 16 that most of the reduction in area has taken place in the three or four outer wires at the surface of the rope. If we assume that in each strand three outer wires have lost half their area, then the total loss will be $1/2 \times 3/10 \times 75\% = 11.25\%$, as the ten outer wires represent 75% of the

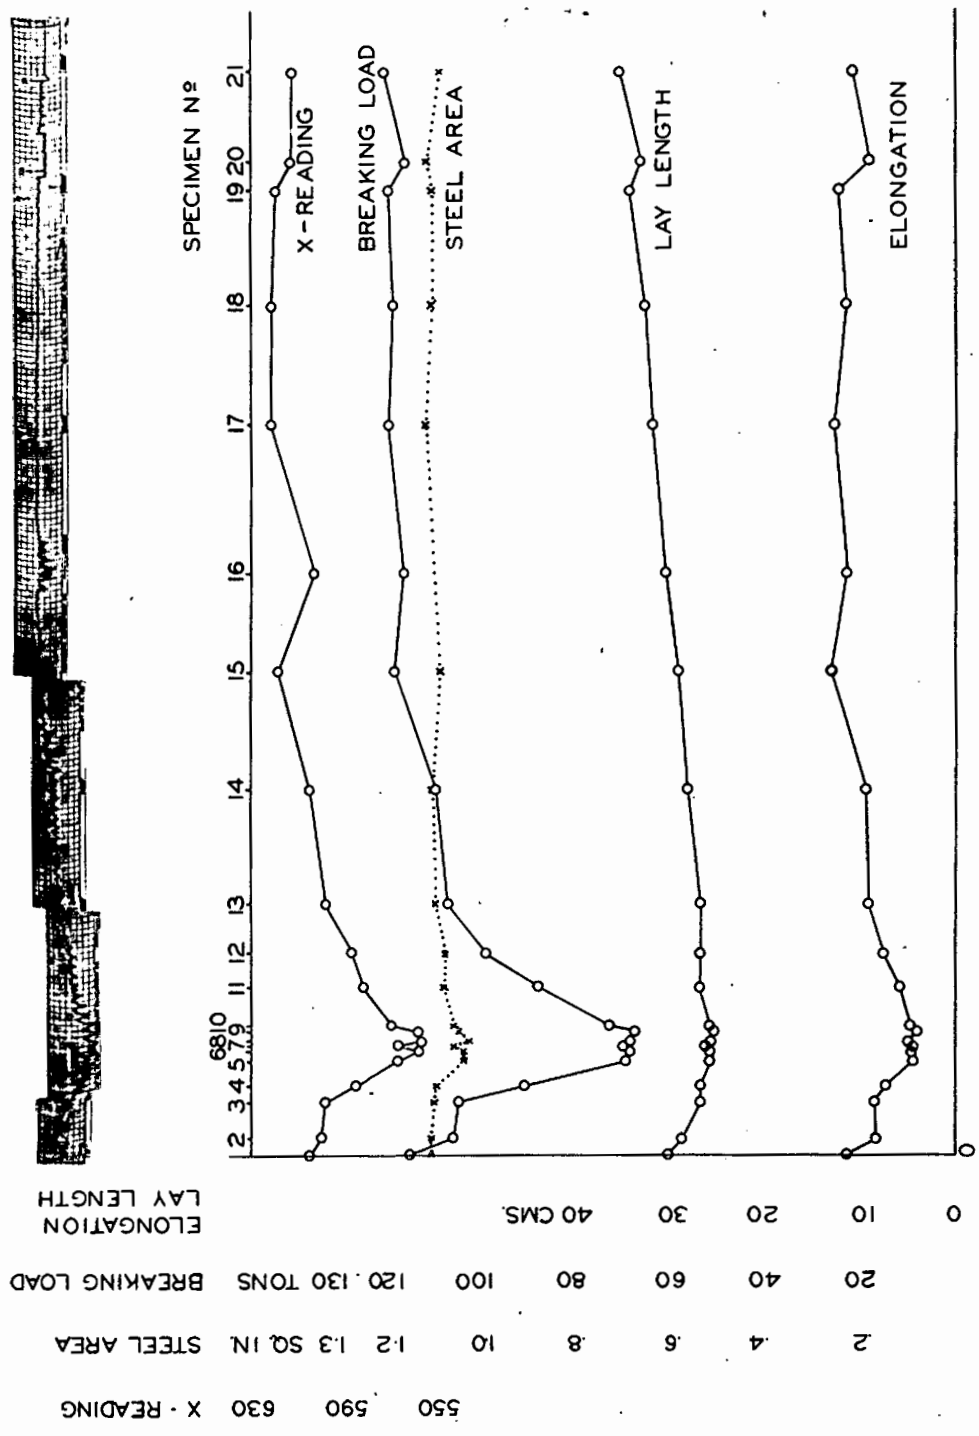
Figure 20b, X reading, steel area, breaking load, lay length and elongation against distance from splice.

The R trace is considerably lower up to 1500' compared with the previous records. After the record was made the rope was inspected visually at a point near 500' from the splice and excessive corrosive wear of the external wires was found. This coupled with the X reading of $X = 570$ and taking into account the results of section 3.22 as shown in Fig. 15, suggested a breaking load at this point of 70 tons. The original B.L. being 119.2 tons, this would represent a

These same results have been plotted against distance in Figure 20b, in Figure 20c values of B.L. are plotted against X readings, in Fig. 20d steel area against X and in Fig. 20e B.L. against steel area.

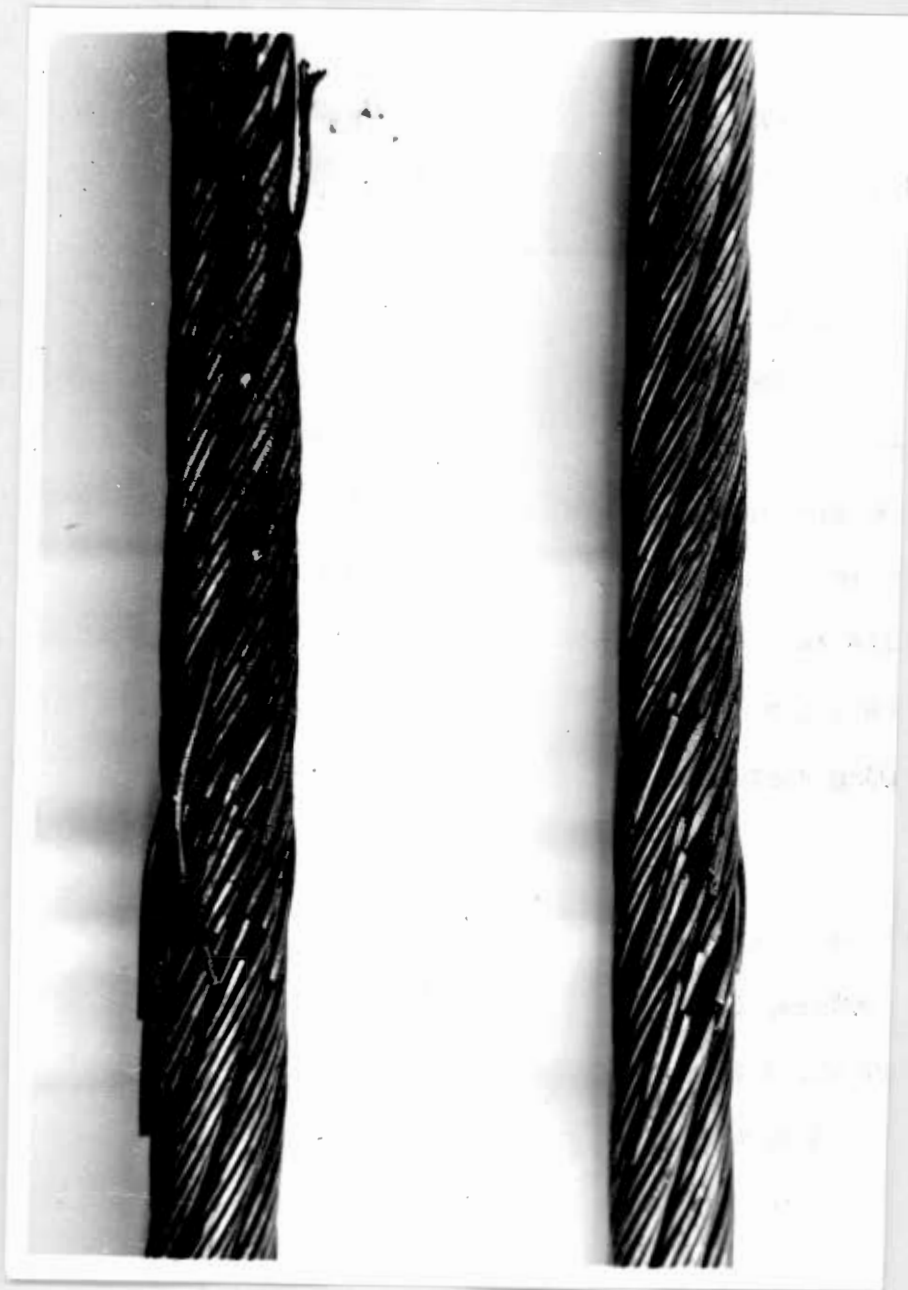
Figure 24b. Broken wires in two sections of a rope, caused by crushing. The sections are taken from the 'dead' turns of the rope.

Another use of the records is demonstrated by the chart of Fig. 24. Three months before, the ropes of this hoist had to be taken off rather suddenly after the discovery of numerous broken wires at a number of points in the "dead" turns, which are never unwound except during pulling-in at the drum end. No records of these ropes had been made. As the affected portion of the rope cannot be tested with our equipment in the normal way, an indirect method was used. It was believed that the broken wires were caused by excessive crushing, in which case signs of crushing should be found in the second layer. This proved to be the case and at points A, B, and C, in the chart, plastic deformation was recorded. These points were marked, run back on the drum and in this way the corresponding points in the bottom ^{layer} were located. Visual examination at these spots revealed, in the words of the examining engineer "a degree of cold-working of outer wires at the cross-over points, such that any appreciable delay in pulling in might have resulted in broken wires.

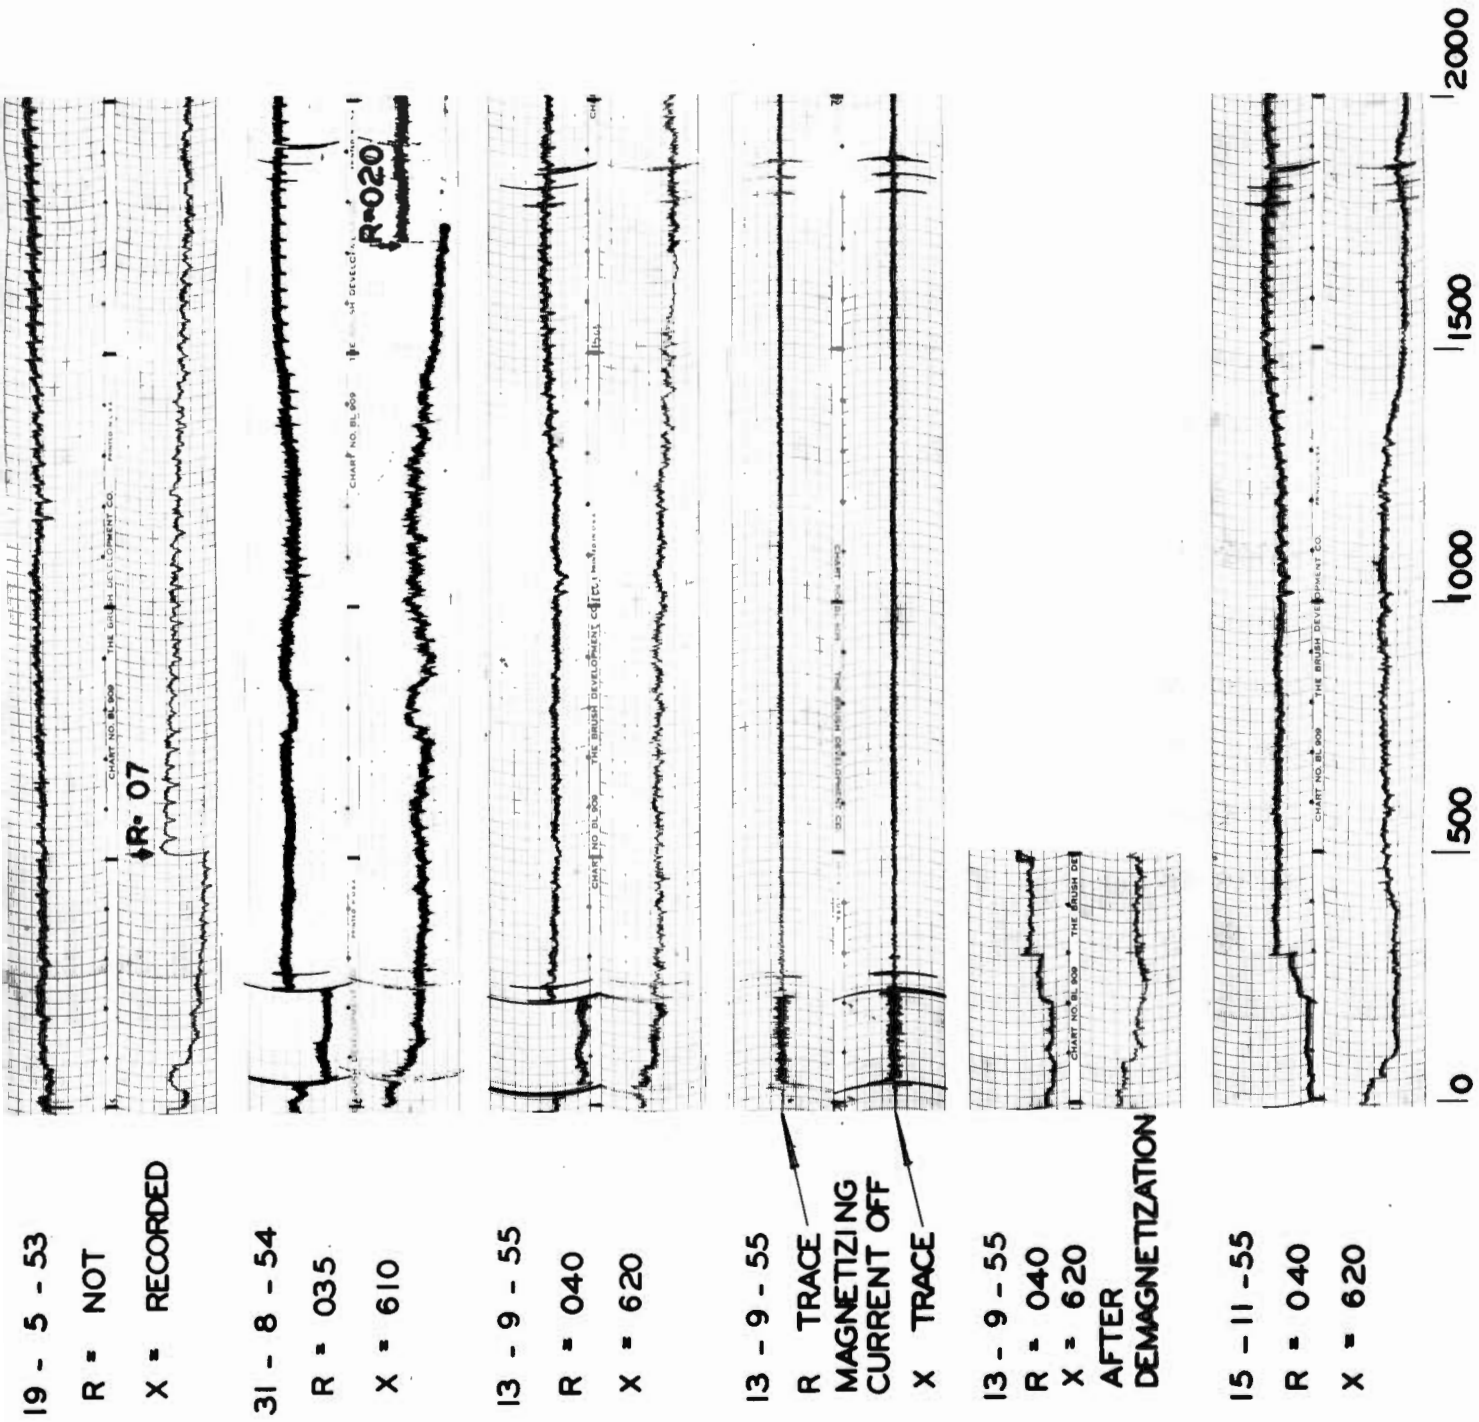
Figure 26. Chart showing permeability change due to permanent magnetization.

of less than 50 f.p.m. In a further experiment the first 300 feet of this rope were demagnetised by moving the rope slowly through a coil, one foot long, 3" diameter and having 80 turns. This coil was connected to the 50 c.p.s. mains through a step-down transformer, giving a current of 6 Amperes. A further record was made of the first 500 feet of rope, the result is shown in the fifth chart. It may be seen that the transients have disappeared, but the X trace of the part of the rope which was demagnetised is lower than before. The sixth chart shows a further test on the same rope two months later. The transients have not reappeared and the X trace is still lower over the first 300 feet. These tests show that the original depression was caused by a decrease in permeability, due to the rope being permanently magnetised. This will occur in ropes where part of it is at rest for long periods in line with the earth's magnetic field.
