**UNIVERSITY OF CAPE TOWN**

**EVALUATION OF THE RESIDUAL PRESTRESS FORCE IN AGED  
RAILWAY CONCRETE SLEEPERS CONSIDERED FOR REUSE**

*A Thesis Submitted in Partial Fulfilment of The Requirements of the Degree of  
Master in Engineering  
In  
The Faculty of Engineering and Built Environment*

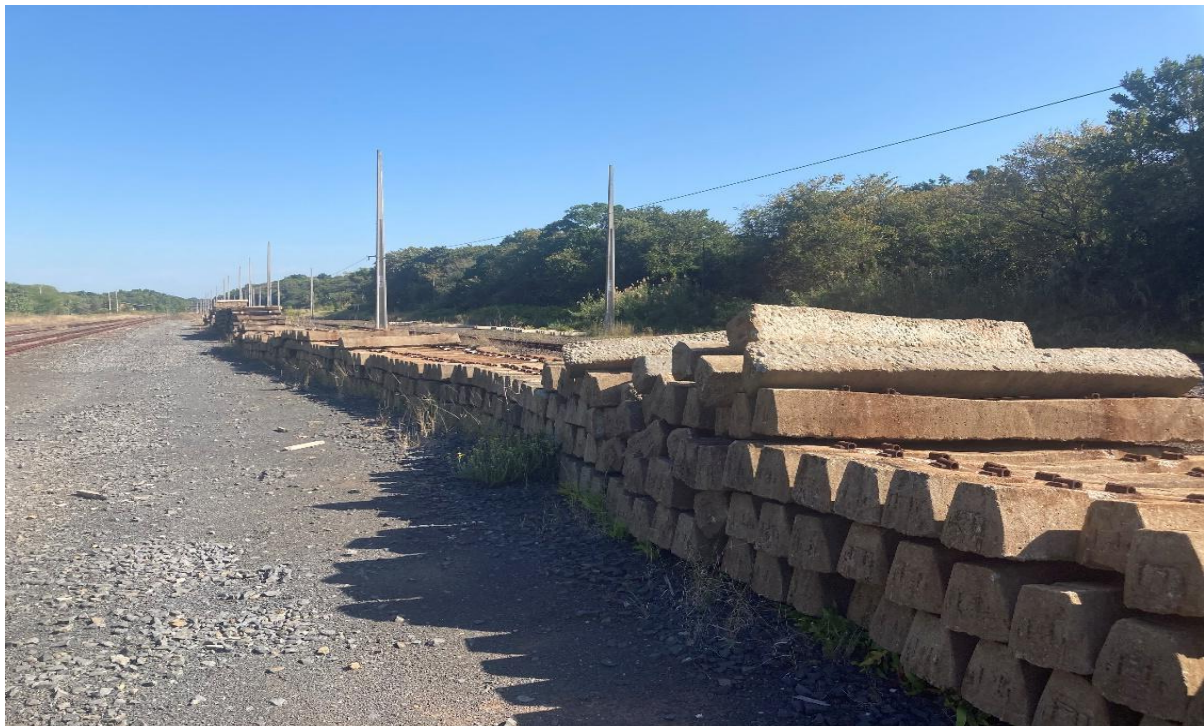
Figure 1.2: Stacked aged concrete sleepers removed from service; awaiting installation in the yard/station

In South Africa, it has become common ad-hoc practice to replace the steel and timber sleepers on branch, sidings and yard lines with aged prestressed concrete sleepers uninstalled from primary running lines. Primary lines are characterised by high frequency traffic and greater axle loading capacity, whereas branch and yard lines have moderate to low traffic frequency and lower axle loading capacity. Railway sidings carry variable axle loads but operate at slower speeds. Examples of the reuse of aged concrete sleepers in South Africa are depicted in the figures below. Figure 1.2 shows aged concrete sleepers that were selected and stored at the rail yard line, where installation was planned.

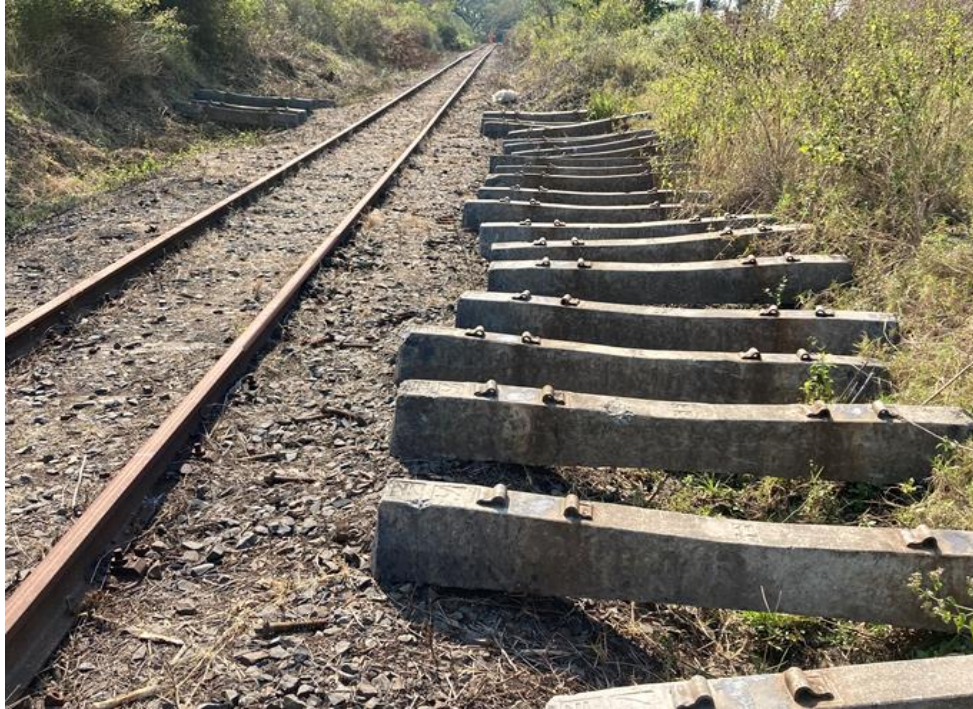
Figure 1.3: Concrete sleepers placed alongside the wooden sleeper track in preparation for replacement

The planning of concrete sleeper installation in the yard proceeds by placing the sleepers adjacent to the track, as shown in Figure 1.3.

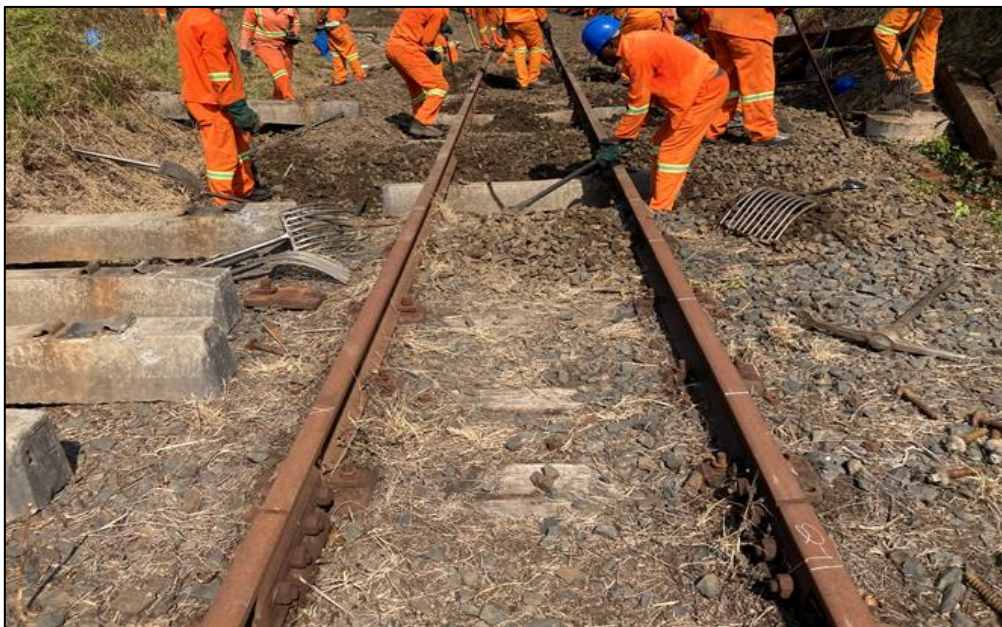
Figure 1.4: The replacement of deteriorated wooden sleepers with used concrete sleepers

An example of railway sleeper removal carried out manually is depicted in Figure 1.4.

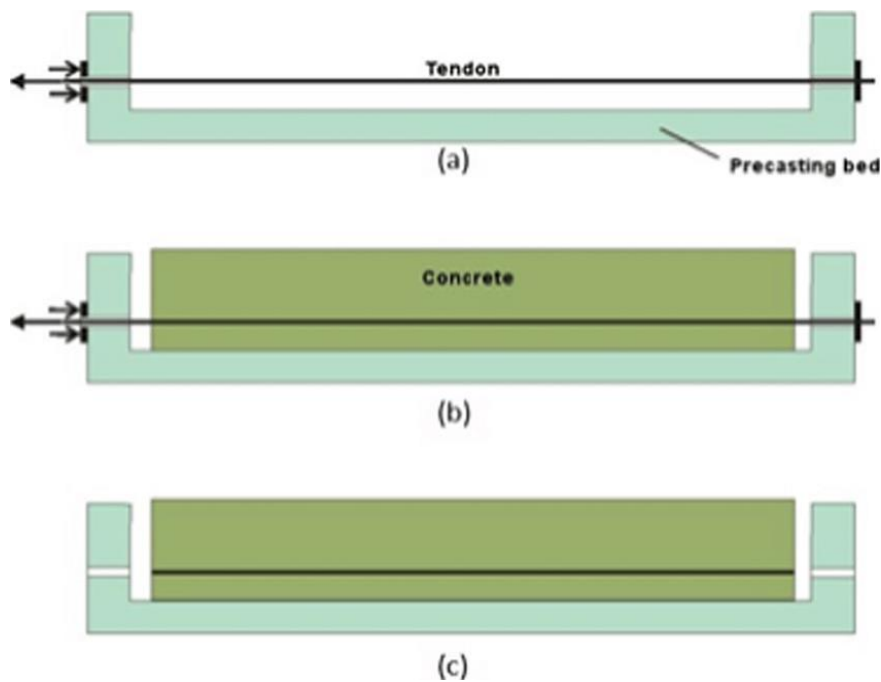
being cast around the tensioned wires. Finally, the prestress is transferred to the concrete once it has hardened in the third stage, (c) (Jhatial, 2022).

Figure 2.4: Schematic pre-tensioning diagram of concrete sleeper (Jhatial, 2022)

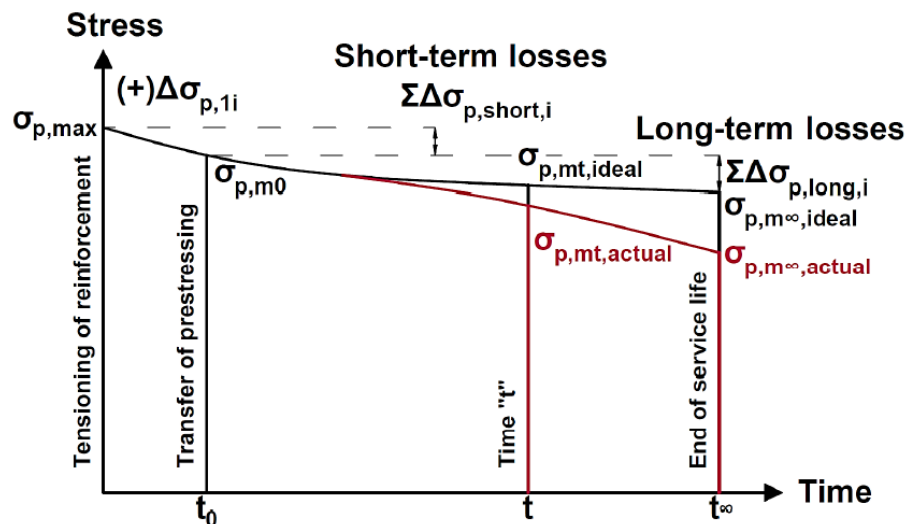
Figure 2.5: Prestressing loss in a member over time (Kraľovanec et al., 2021)

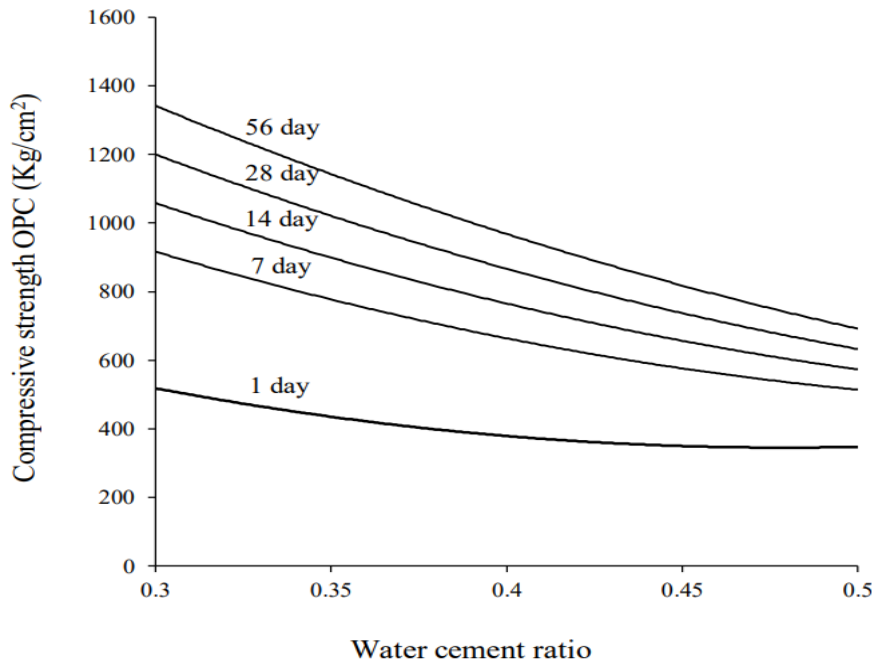
Figure 2.6: Strength of dry cast OPC concrete in relation to the water-cement ratio and curing age (Amhudo, Tavio and Putu Raka, 2018)

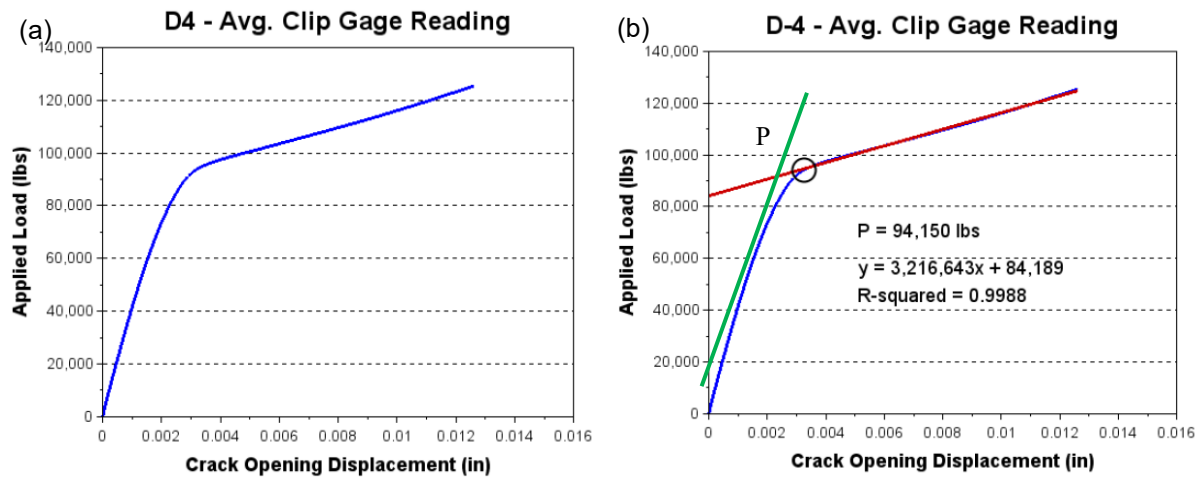
As the sleeper is pulled apart by the tensile load, the COD at the sleeper centre is measured. It is anticipated that the crack will fully open when the prestress force is exceeded by the applied load. The resulting relational plot between the applied load and the COD yields a curve with two linear segments representing two different stress resistance cases. The first part of the linear curve relates to the resistance provided by both concrete and prestressing steel at the pre-cracking state (represented by the green line, Figure 2.10-b). The second portion relates to the resistance provided by prestressing only at the post-cracking state (represented by the red line, Figure 2.105-b). The beginning of the second part of the linear curve corresponds to the load, which serves as an upper limit approximation of the prestress force in the sleeper. Figure 2.10 illustrates the example showing estimation of prestress force from the COD theory, using results of experimental work obtained from Scott (2019).

Figure 2.10: (a) Load vs crack opening displacement and (b) Prestress force estimated from the line (red) of best fit (Scott, 2019)

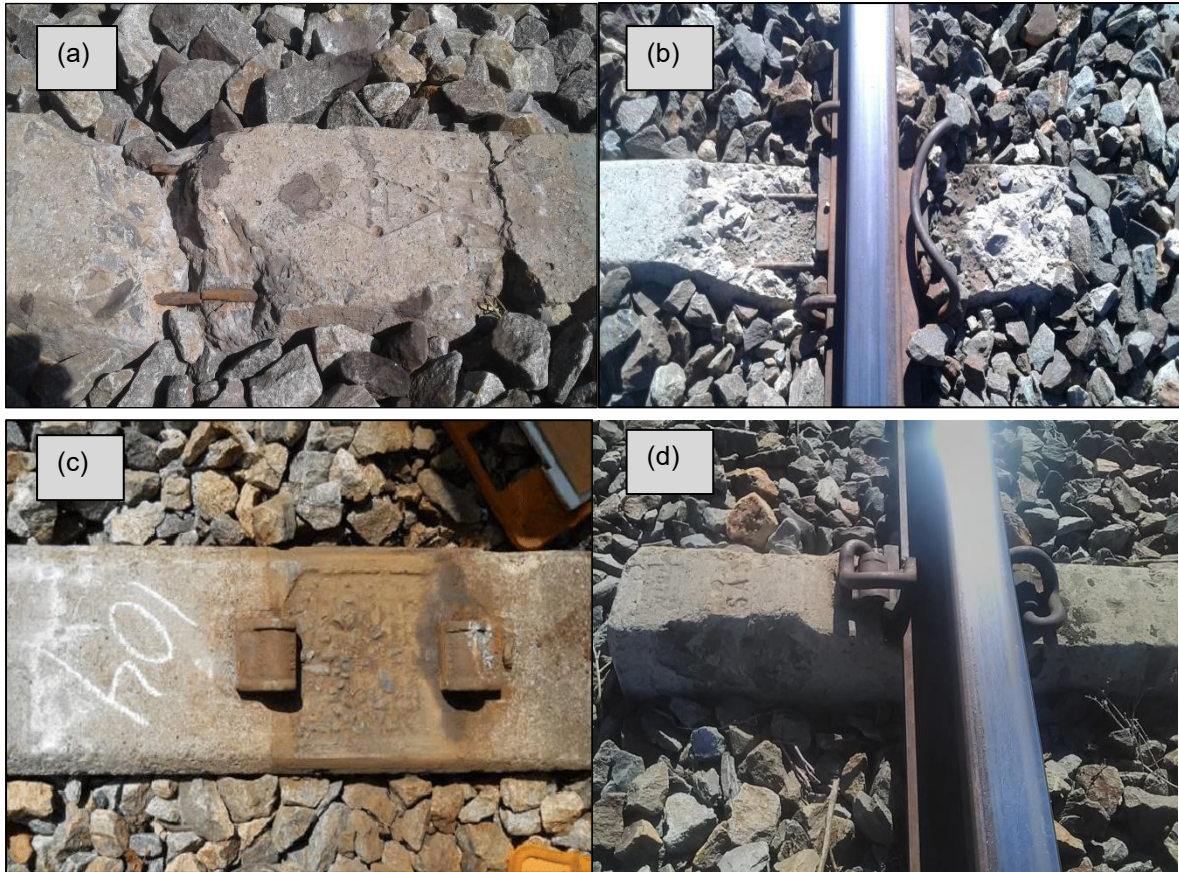
Figure 3.2: (a) A sleeper exhibiting significant cracking and compromised steel wire due to stress corrosion (b) Rupture around the rail seat position (c) Rail seat abrasion (d) Chipped concrete sleeper on the shoulder (Lutch, Harris and Ahlborn, 2009)

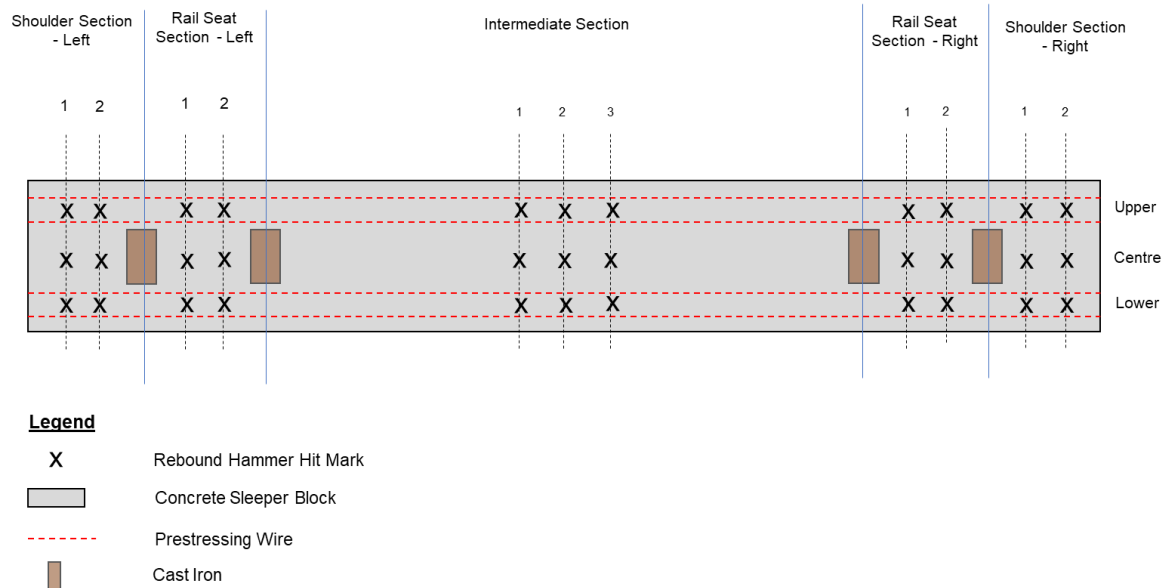
to avoid interference with the first layer of embedded prestressing wires, the locations of which were determined through destructive exposure. The overall dataset consisted of impact points grouped by test zone and combined across the three sleepers. The rebound hammer readings were taken within a confined area not exceeding 60 mm × 90 mm, with impact points evenly spaced at 30 mm intervals. Figure 3.3 illustrates the selected rebound hammer impact locations.

Figure 3.3: Schematic concrete outline indicating the locations of concrete hammer impacts

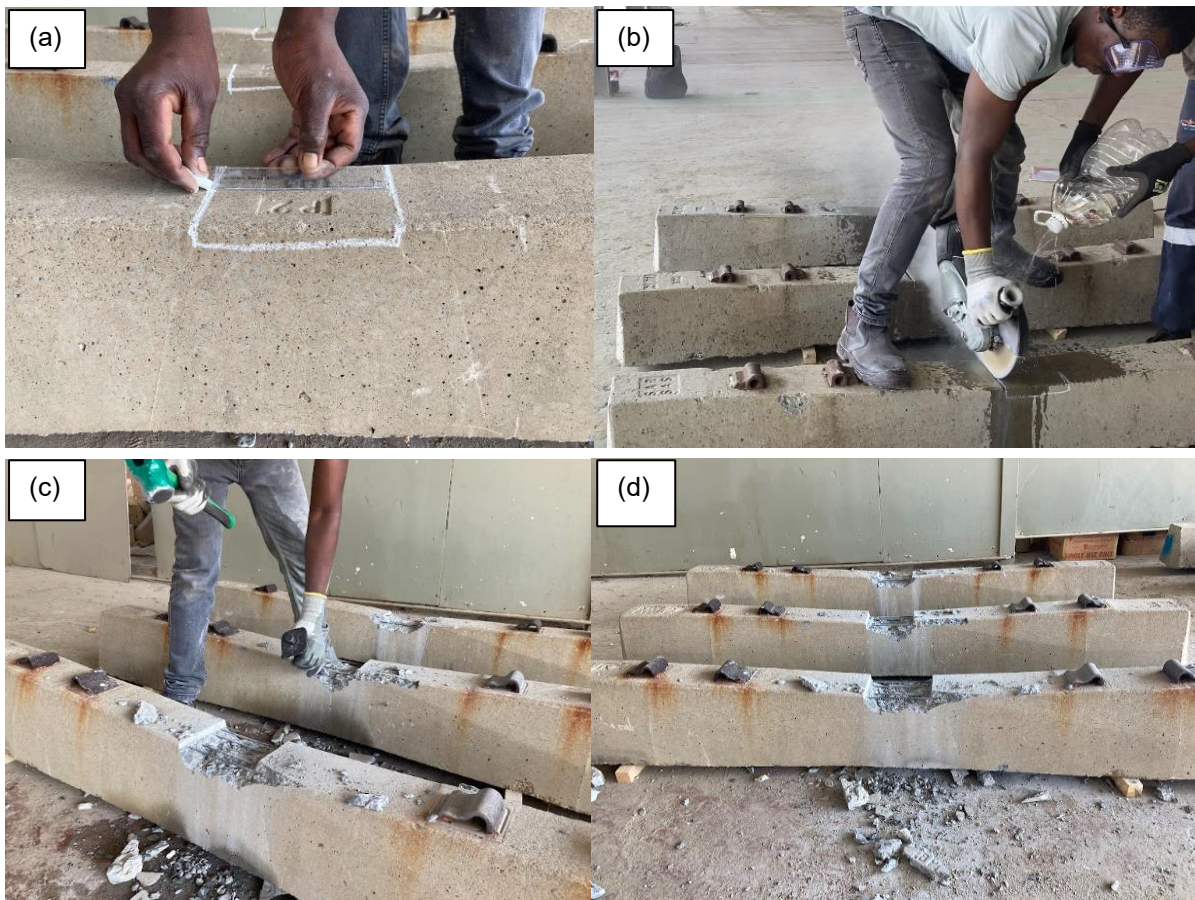
The concrete at mid-span of each sleeper was removed to a maximum length of 150 mm and a depth of less than 40 mm. This was adequate to expose and free the top row of prestressing wires of concrete bondage, which allowed axial displacement. The test zone was carefully chosen to be at mid-span to ensure enough anchorage for the tendons. Less than 10% of the sleeper's concrete was removed along its longitudinal axis to ensure that the prestress level and eccentricity were not affected by the concrete removed. Figure 3.5 presents a photographic summary of the concrete removal process.

Figure 3.5: (a) Marking of the portion of the concrete removed with a 150 mm ruler (b) Grinding of concrete at the marked transverse contours (c) Concrete removal using a 2.7 kg hammer and bull-pointed chisel (d) Exposed prestressed wires.

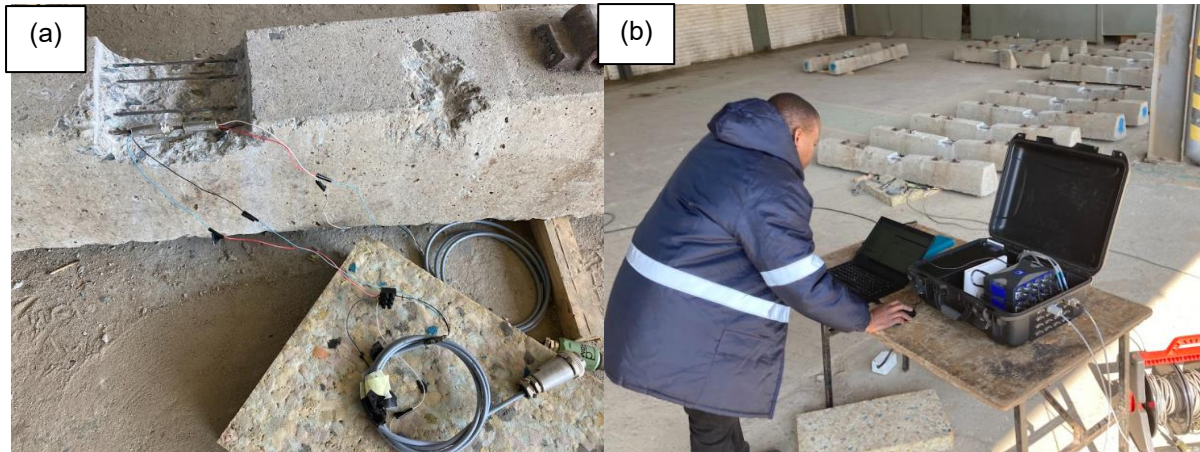
Figure 3.10 shows the setup of the data acquisition system used in the study and wire connection between the measuring equipment and specimen.

Figure 3.10: (a) Connectivity to the data acquisition system (b) Data acquisition system setup

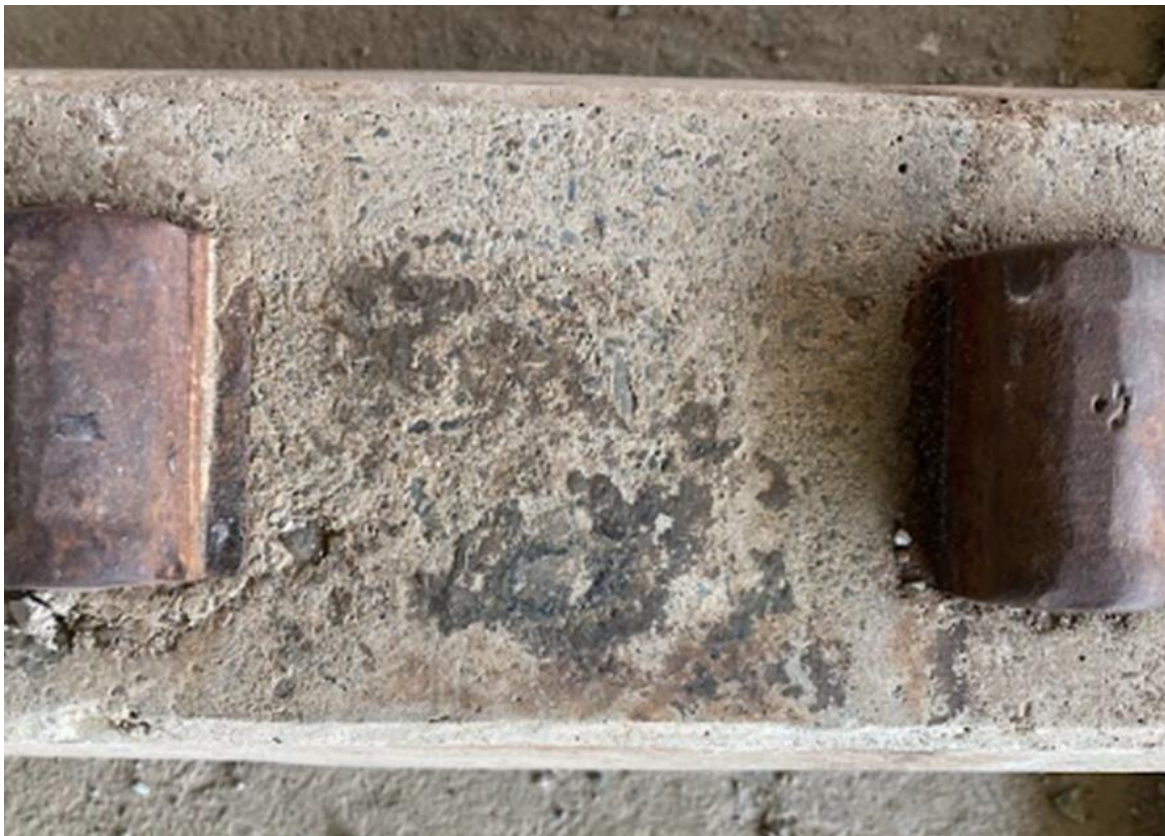
A notable and previously undocumented phenomenon observed for all sleepers was the irregular sleeper pad residual, ranging from 0.1 mm to 0.3 mm in thickness. As illustrated in Figure 4.2, this residual material defined as the remains of the sleeper pad material, appears as a uniformly or non-uniformly spread thin paste on the concrete surface at the rail seat area. The staining of the rail seat concrete surface by the sleeper pad material suggests slippage of the pad likely due to high frictional forces under externally induced and internally generated elevated temperatures. This might have occurred alongside the shifting of rails under excessive longitudinal stresses. The presence of the pad residual certainly would reduce the frictional coefficient required for adequate resistance between the pad and concrete materials.

Figure 4.2: A typical slightly abraded rail seat area exhibiting residual rail-sleeper pad material

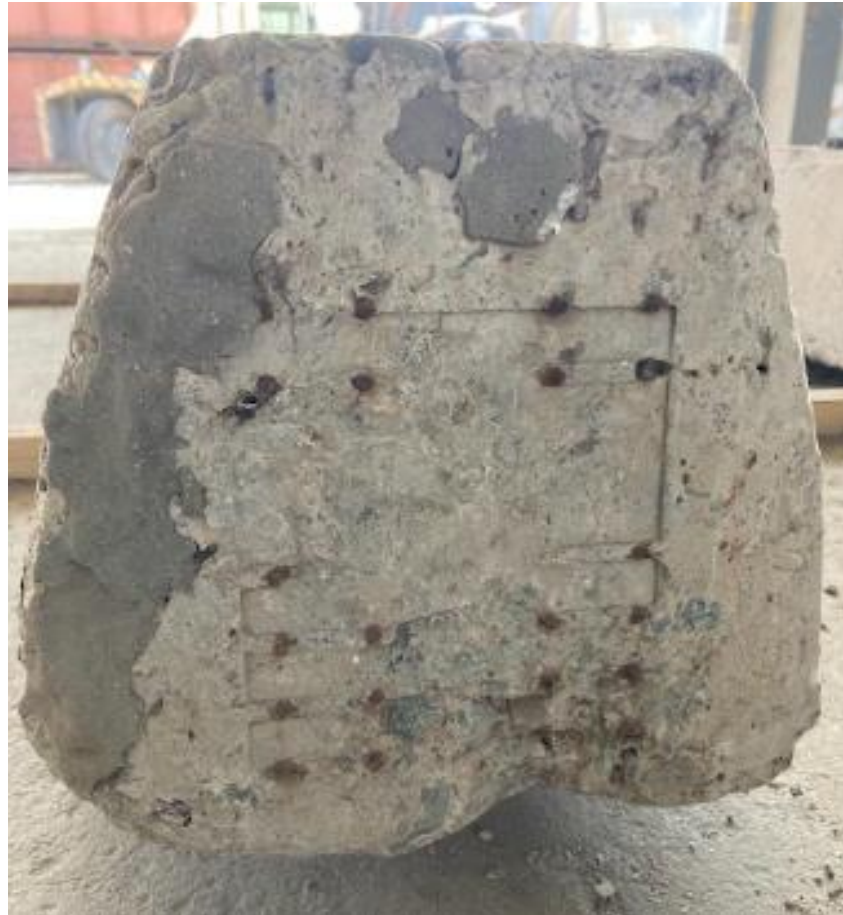
The structural integrity of sleepers depends on the state of the shoulder ends, which serve as anchors for the prestressed wires. The evaluation revealed no cracking at the sleeper ends for all sleepers, except for an interesting observation made on sleeper number 6 (Figure 4.3), which exhibited evidence of patch repair on the southern side. However, no information could be obtained for the specific sleeper or to confirm whether patch repair of sleepers was standard practice in the past.

Figure 4.3: Substandard patch repair observed on the southern side of sleeper number 6

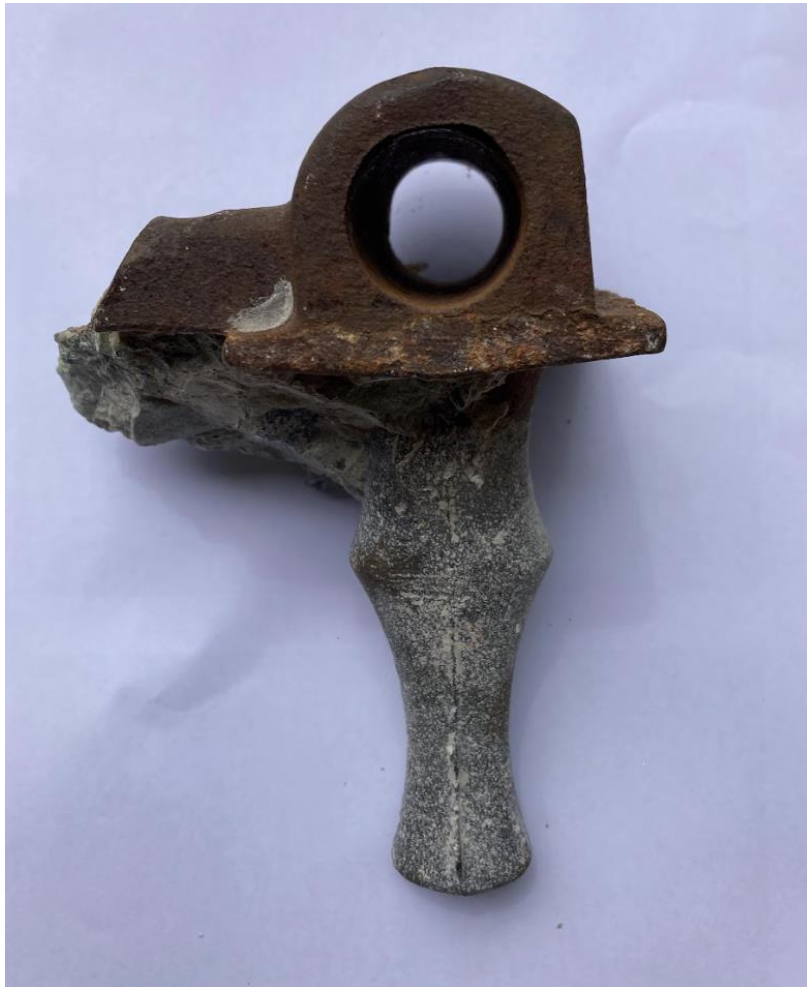
aggressiveness indicate negligible chances of such degradation mechanisms. Figure 4.6 shows the condition after the cast iron portion was removed.

Figure 4.6: Condition of the cast iron immediately following extraction from concrete

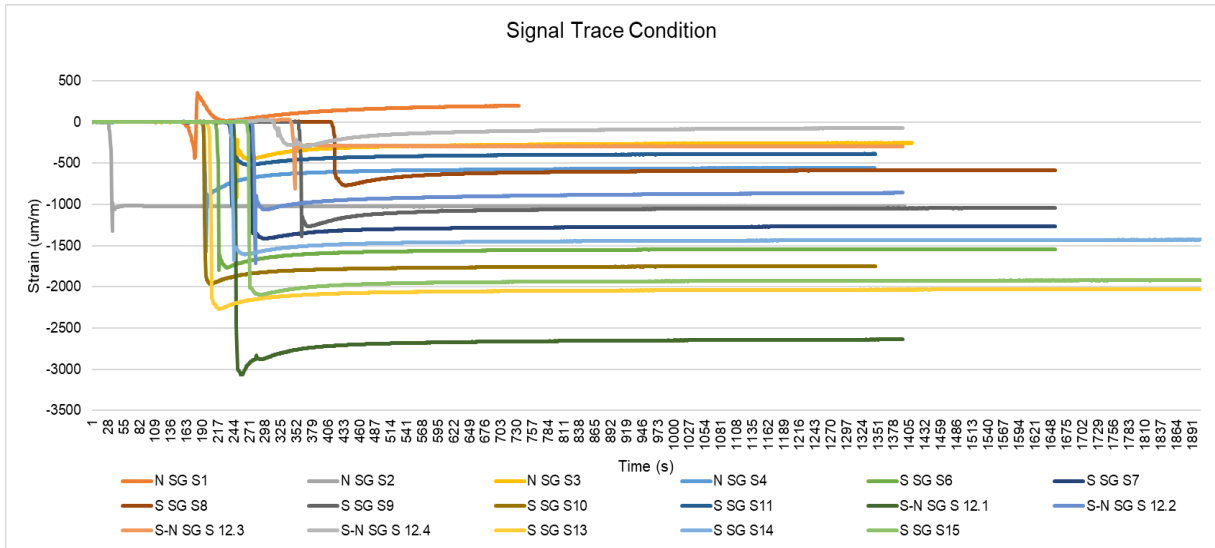
Figure 4.9: Signal tracing analysis for all sleepers

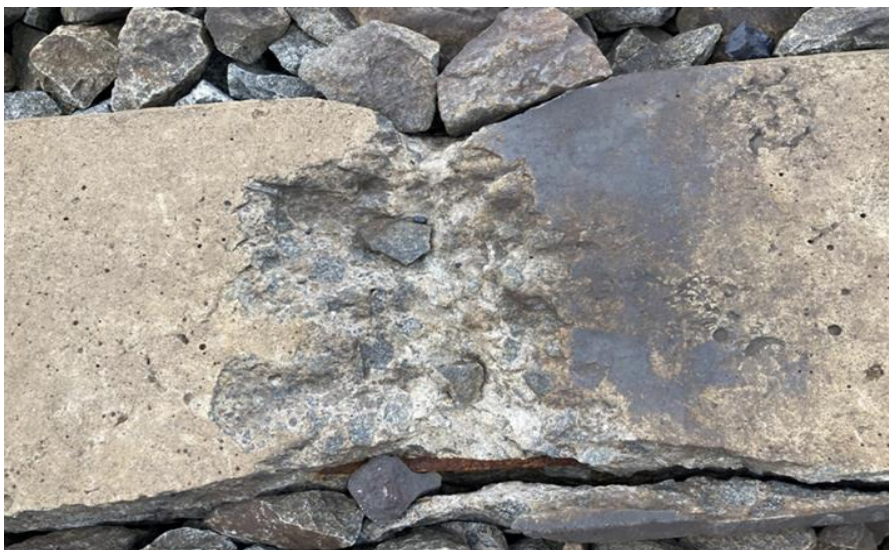
Figure 5.1: Significant concrete chipping and spalling have occurred, resulting in the exposure of corroded prestressed wires.

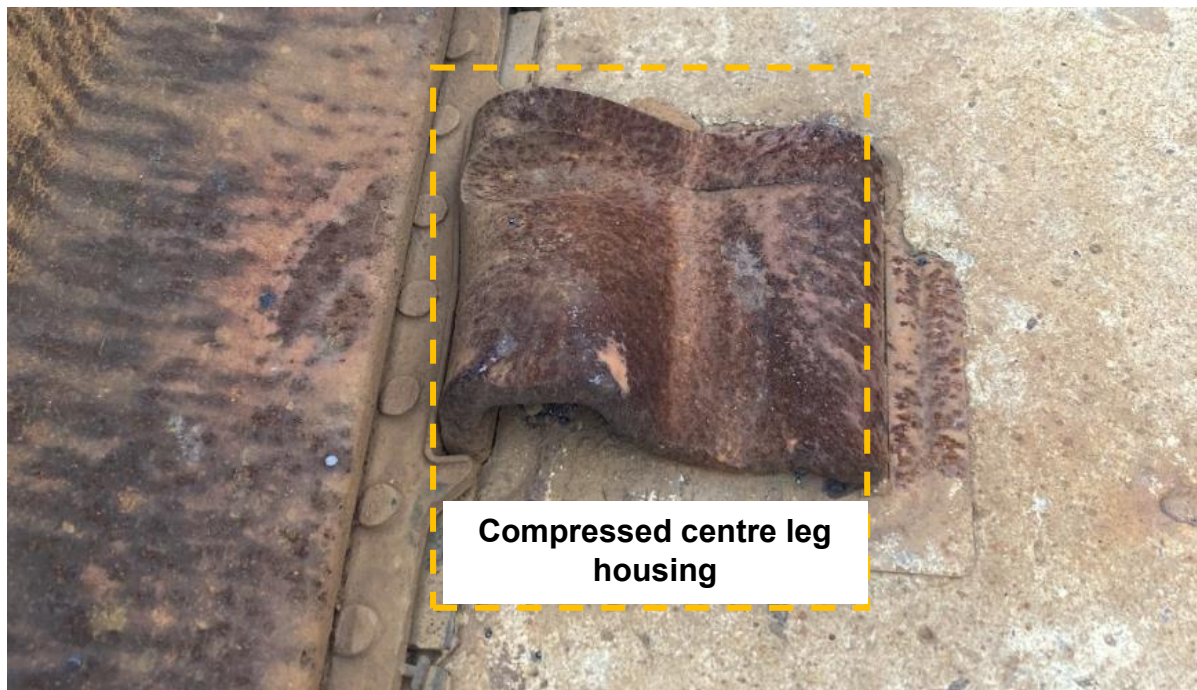
Figure 5.3: Deformed cast iron shoulder due to impact from a derailed locomotive wheel

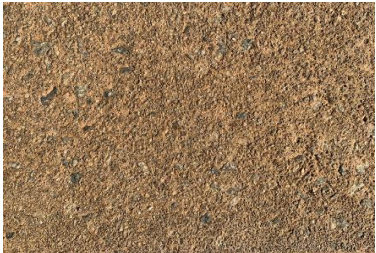
3: Poor	Surface severely worn and can no longer provide the intended service. Exposed aggregates. Irregular surface.
