DEGRADATION OF THE BETA-ALUMINA ELECTROLYTE IN A ZEBRA CELL

A thesis submitted to the Faculty of Engineering,  
University of Cape Town in fulfillment of the  
degree of Master of Science in Applied Science.

Department of Materials Engineering  
University of Cape Town

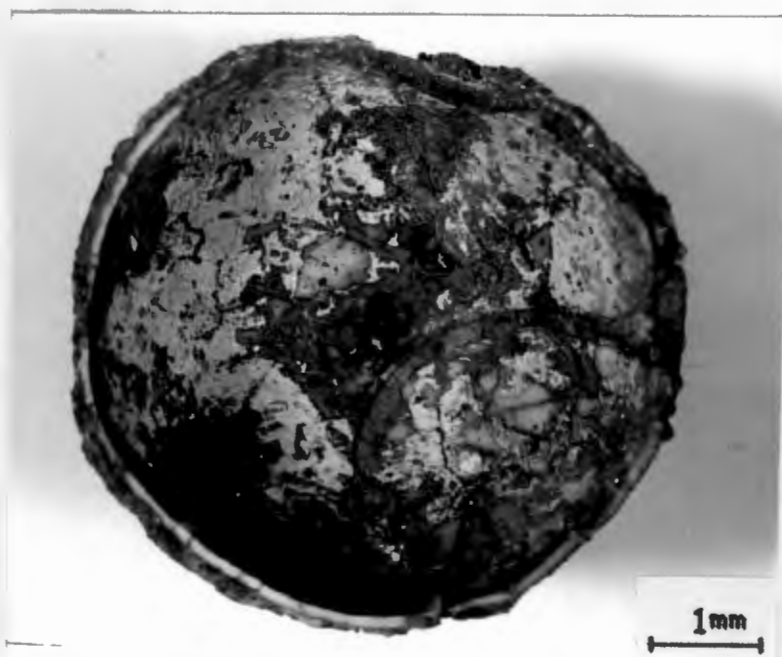
FIGURE 7.5. AN OPTICAL PHOTOGRAPH OF THE DOME OF AN ELECTROLYTE TUBE FROM A CELL WHICH FAILED AFTER ONLY TWO CYCLES.

On removal from the cell large amounts of cracking of the beta-alumina tube was found to have occurred. Unfortunately, severe mechanical damage occurred during the removal of the electrolyte from the cell. It was thus difficult to distinguish between cracking which had occurred during cell operation, and cracking caused by removal of the electrolyte from the cell. It was, however, possible to remove the dome of the tube relatively intact from the cell. The dome of the tube, prior to cleaning in ethanol, is shown in figure 7.5.

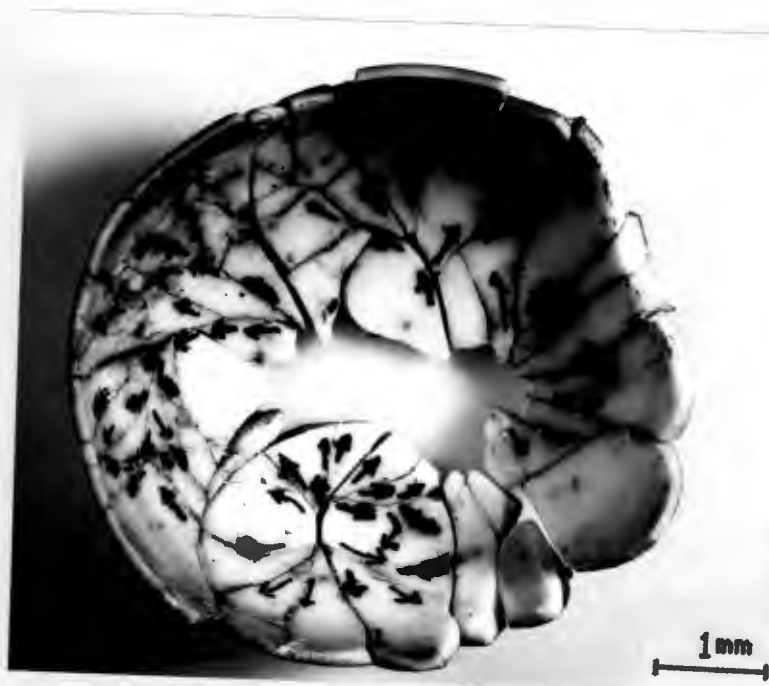
FIGURE 7.6. AN OPTICAL PHOTOGRAPH OF THE DOME OF THE ELECTROLYTE TUBE SHOWN IN FIGURE 7.6. AFTER CLEANING AND RECONSTRUCTION. THE ARROWS SHOW THE SUGGESTED DIRECTION OF CRACK PROPAGATION

The dome of the electrolyte was cleaned and then pieced together. The base of the dome was found to be too smashed to be reconstructed. The direction of cracking was determined by tracing the direction of cracking back from the bifurcations of the crack. The suggested direction of cracking is shown in figure 7.6. There was one obvious initiation point as indicated in the diagram. The surfaces of the crack in this region were examined under the SEM.

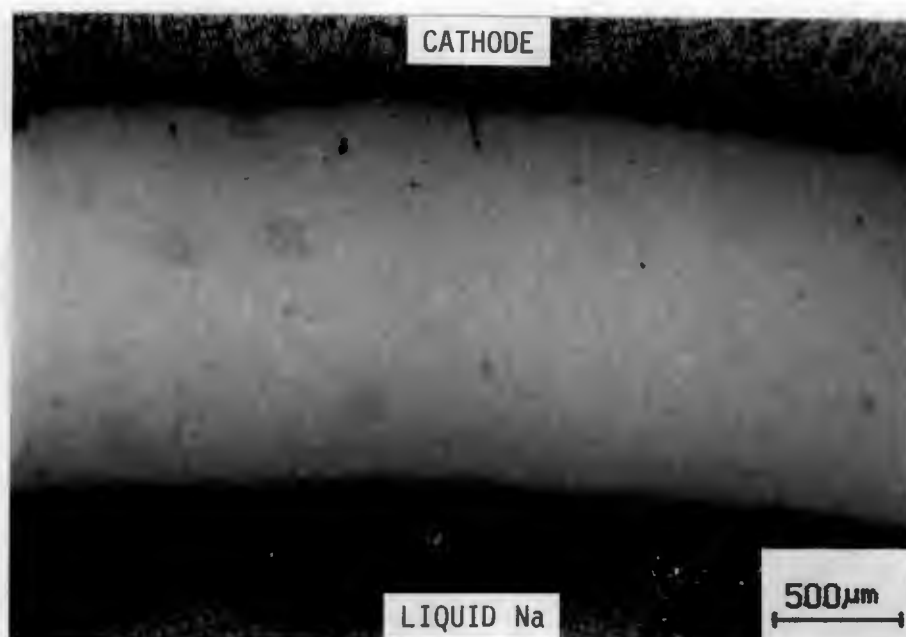
FIGURE 7.13. AN OPTICAL MICROGRAPH OF AN Ag DECORATED POLISHED CROSS-SECTION OF AN ELECTROLYTE FROM A CELL WHICH HAD EXPERIENCED CAPACITY LOSS DURING CYCLING.

A study of a silver-decorated polished cross-section of the electrolyte showed a thick black discolouration of the Na/electrolyte interface, but otherwise no signs of internal degradation of the electrolyte were found. The silver decorated cross-section is shown in figure 7.13.
