OBTAINING DESIGN INFORMATION FROM  
FULL-SCALE STRUCTURES

GEOFFREY EUSTICE BLIGHT

Publications submitted to the  
University of Cape Town in  
fulfilment of the requirements  
for the degree of Doctor of  
Science in Engineering

Field: Civil Engineering

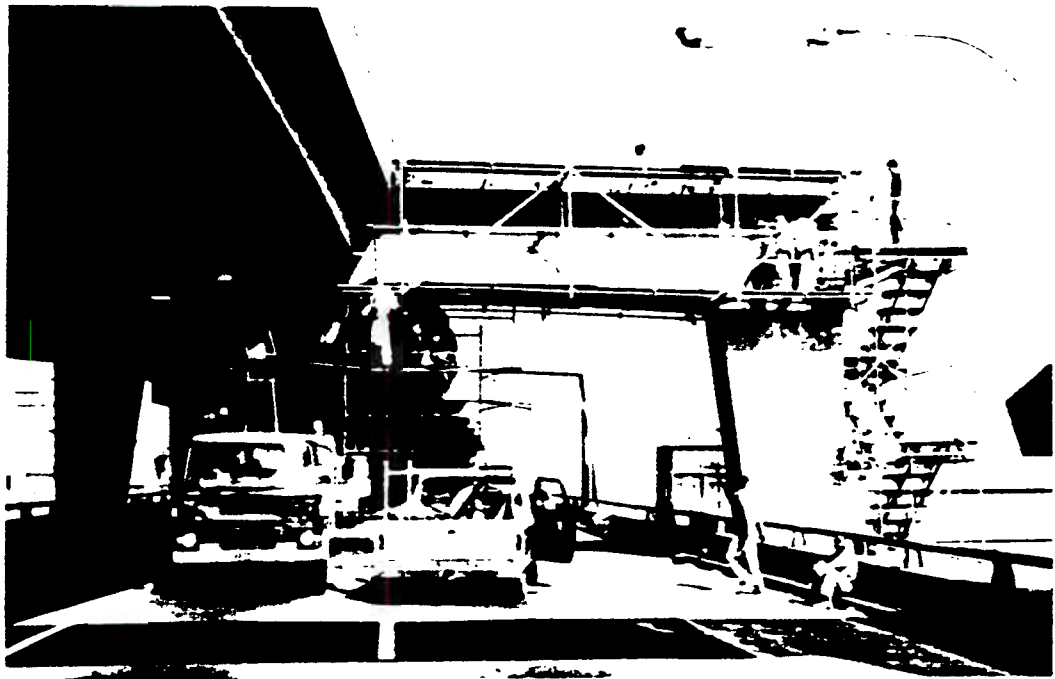
Figure 7: View of portal frame being prepared for full-scale load test
