SHELL EIA RECTIFICATION PROCESS: GAUTENG PROVINCE SITES

Report presented in partial fulfillment of the requirements for the degree of

MASTER OF PHILOSOPHY

Environmental Impact Assessment Rectification Process For Shell Fuel Storage Tanks in Gauteng, South Africa

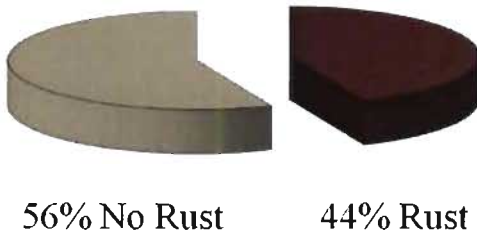
Fig 2: Percentage of Tanks with Rust

The site investigation revealed that 44% of tanks are in a dilapidated condition and very little is being done to correct the situation. (See Figures 2 and 3 below).

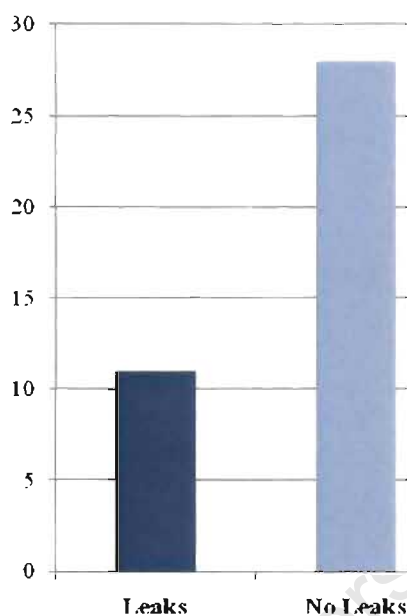
Site inspections carried out on the 39 sites visited by the UCT students revealed that 72%¹⁵ of these sites had no evidence of leakage while 28% had evidence of spills or leakage (see Figure 5). This information is based on visual inspection of the tank and associated valves, hoses etc., as well as inspection of the ground surface in the vicinity of the tank (see Figure 6).

Fig 5: Number of Sites with Product Leakages Fig 6: AST with Product Leakage

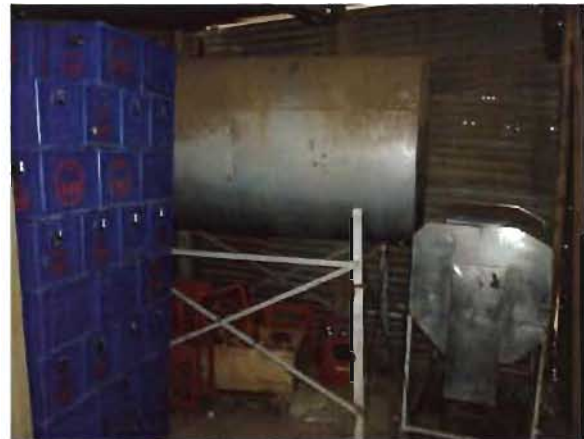
Fig 8: AST inside Alcohol Storage Structure

It is important to note the location of tanks containing paraffin on site. Paraffin has a low flashpoint meaning that paraffin is highly flammable (see Fig. 8). Vulnerability of paraffin tanks is exacerbated by spatial aspects because the tanks are situated close to buildings and houses as paraffin is sold commercially.

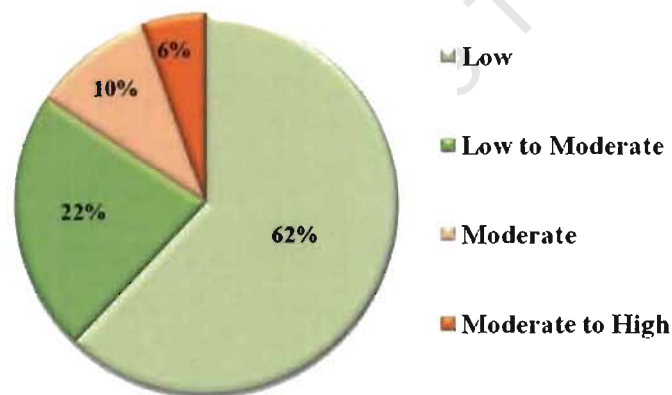
Fig 9: Overall Site Sensitivity Analysis

These environmental parameters were noted for each tank and analyzed to determine the overall site sensitivity analysis (see Fig 9 below).

Sensitivity is a measurement of the significance of the existing and potential pollution risk associated with every tank assessed. Significance was measured in relation to environmental risk using the above parameters with a standardized method provided by ERM to arrive at the ratings which ranged from Low to High. Low significance implies that the site is at no risk of pollution by the presence of the tanks. Moderate significance implies that the site is at risk but the risk can be easily managed. High significance implies that the site is threatened by the tanks. In Figure 9 above, 6% implies that only 6% of the tanks assessed were in the moderate to high category meaning that these tanks constitute a potential danger to the environment. Altogether 62% of the tanks assessed were in the low significance category which implies that they have negligible impacts on the environment.

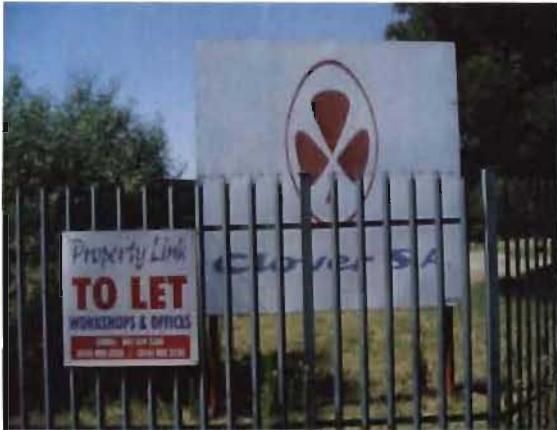
Fig 10 Clover SA (Vereeniging)

- enhance customer’s compliance with best practice in the management of fuel storage tanks;
- enable Shell to know the condition of the tanks in terms of leaks, rust and other factors that may jeopardize the environment;
- ensure that tanks are decommissioned in situations where the sites are shutting down, e.g., Clover in Vereeniging (see Fig 10) or their services are no longer required, e.g., M & H Distributors in Soweto (see Fig 11 below); and
- assist Shell in minimising environmental risks, thereby reducing their legal liabilities.

Shell should set up a framework to monitor the progress of its customers regarding the condition of the fuel storage tanks. The following benefits can be derived from the process of monitoring, to:

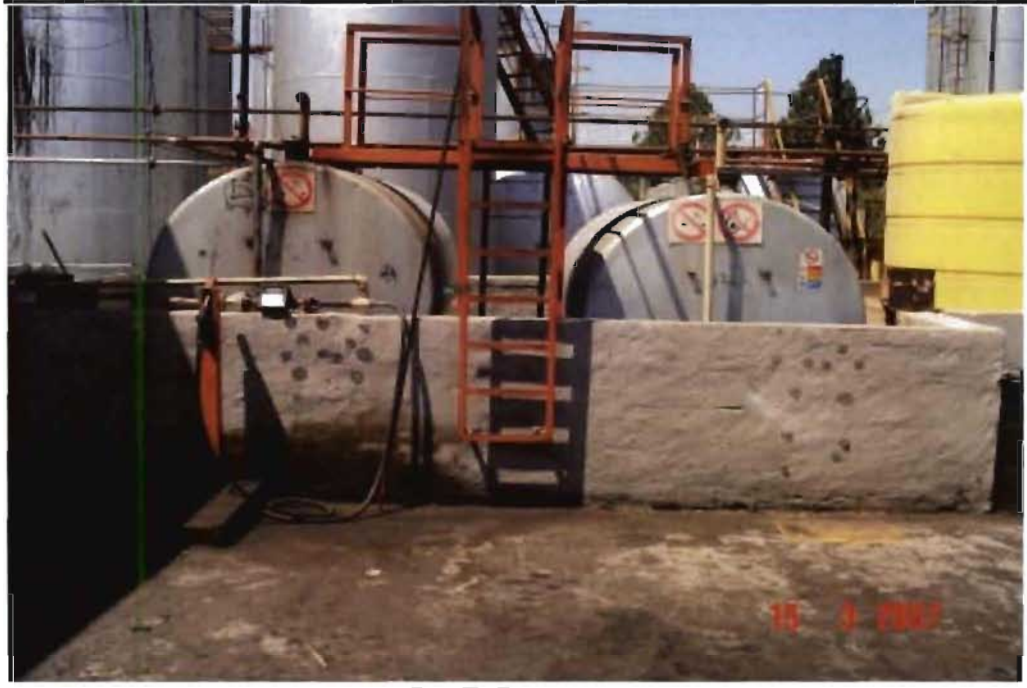
The ASTs at this site are bunded (see photo below). The integrity of the bund is reasonable and the area around the bund is also covered by concrete. The size of the bund appeared adequate to hold 110% of the tank capacity although requirements associated with a tank farm in this regard are more complex. SANS 10131 and SANS 10089 would be applicable on this site. The consultant was not in a position to sign an affidavit in this regard given the complexity of the requirements.

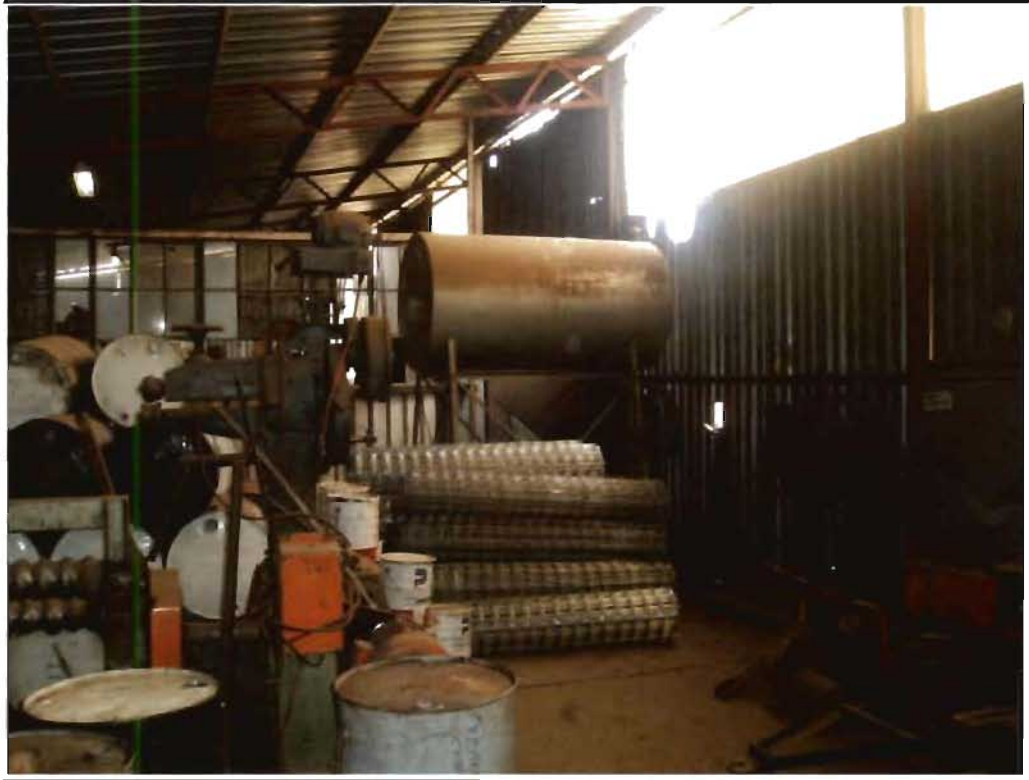
Taking the above factors into account, the potential environmental impact associated with the AST at this site is regarded as low.

Photo 3.1 View of the tanks location in a workshop (S24/G/02/967)

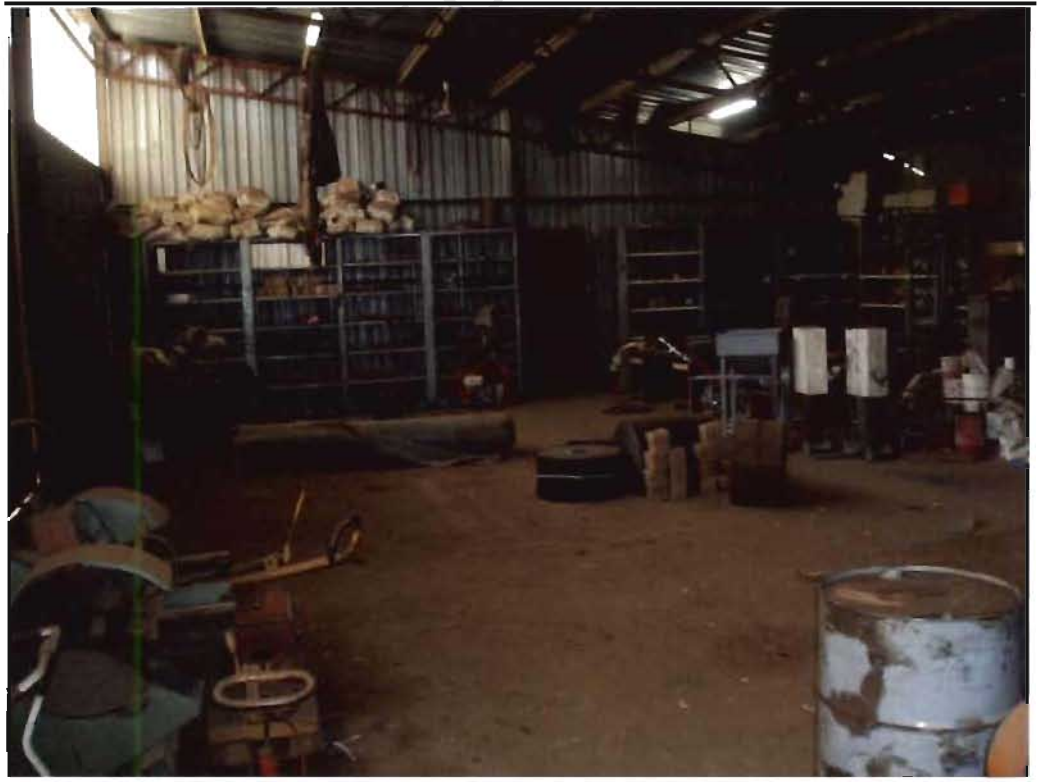
Photo 8.4 General view of the workshop

Comments: Photos not taken from required distances is as a result of obstructions from materials in the workshop.

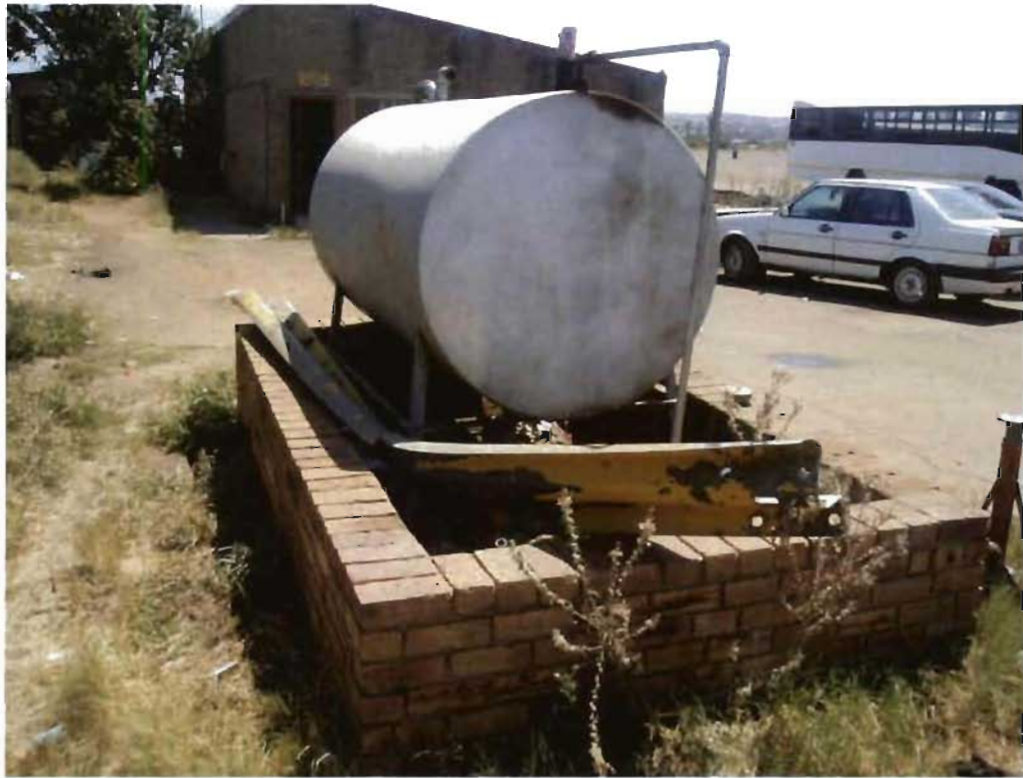
- Given that the tank is empty and unused, potential impact associated with this tank is regarded as low. Shell has been advised to decommission this tank.

Photo 5.1 *Location of tank 1 in relation to the depot offices looking north (S24/G/2/1023)*

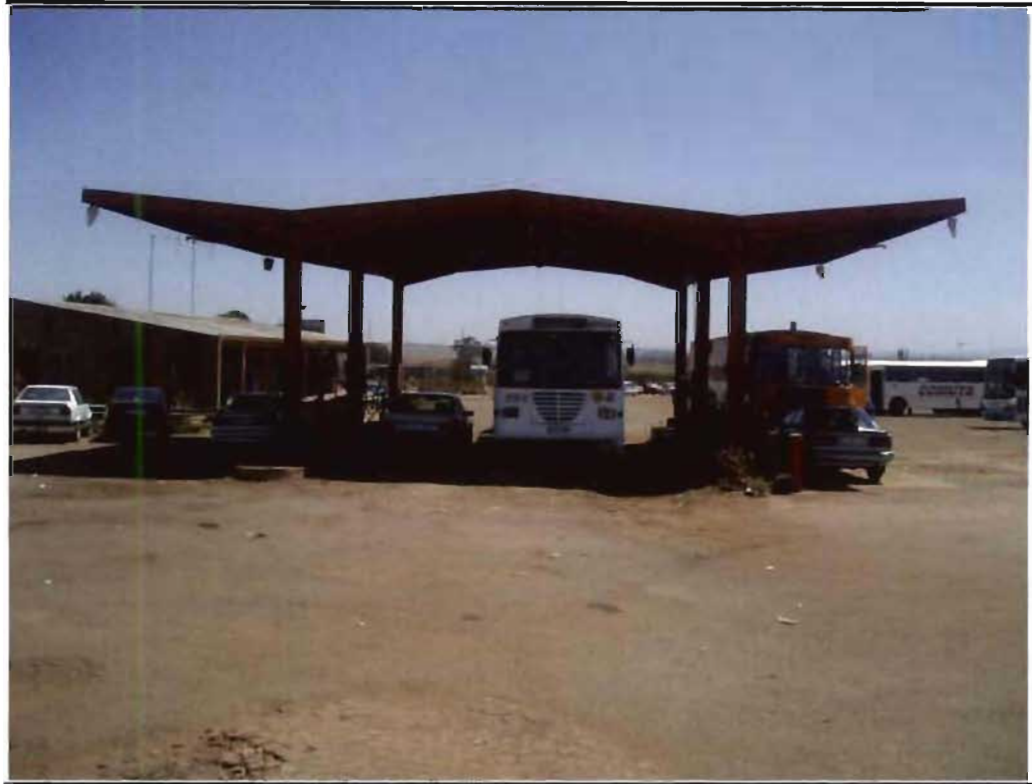
Photo 5.2.1 Location of the tank in relation to the bus servicing canopy looking north (S24/G/2/1023)

- The surface above the tank is covered by a canopy underneath which are located the dispenser pumps used to refuel the buses.
- The dispensing area is partially paved with a mix of brick and tar (see *Photo 5.2.1*). The integrity of the paving is poor and offers little protection against the percolation of potentially contaminated surface water.

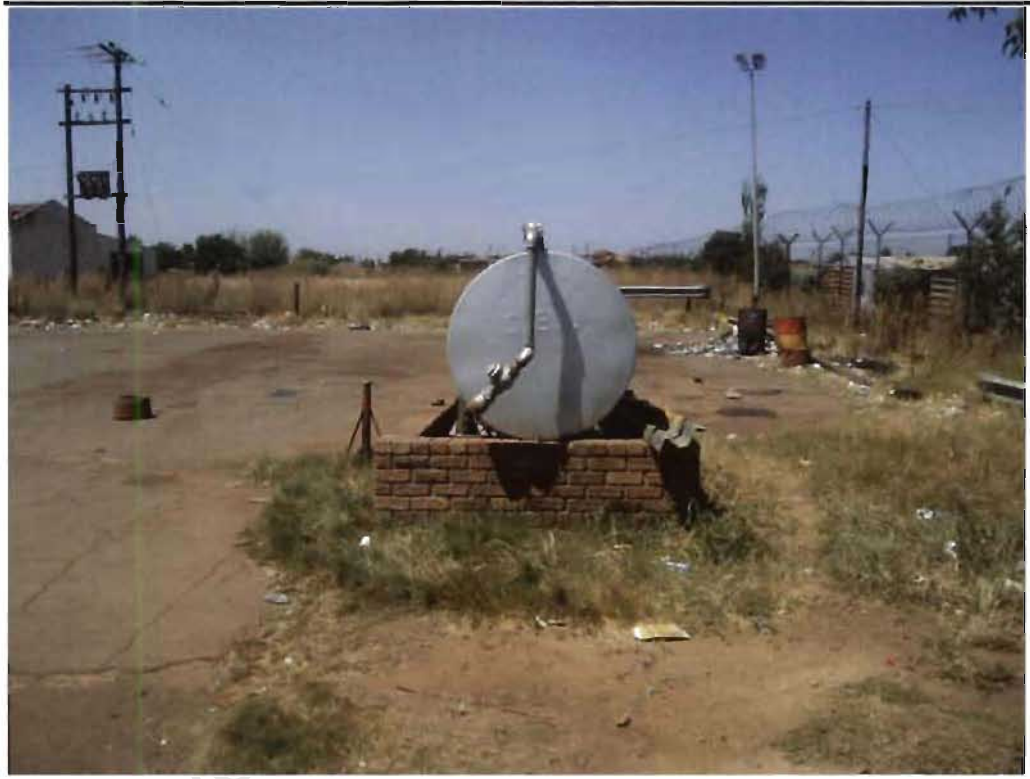
One of the ASTs on this site is bunded (see photo below). The tank is currently in use. An affidavit could not be signed in relation to this bund for the following reasons:

- The bund is constructed of bricks and is not impervious
- The size of the bund is such that it is unlikely to hold 110% of the tank's capacity
- The bund had no valve and associated oil-water separator.

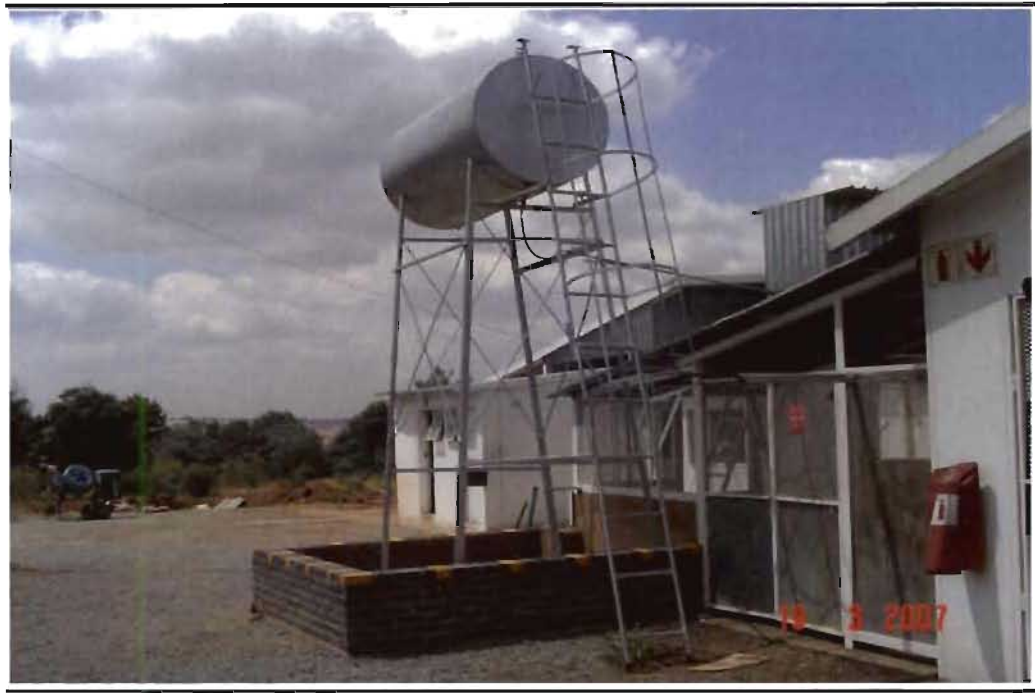
Photo 8.3 Site 1 - view of the tank from 10m looking west

Comment: tank could not be photographed from all angles and distances due to the obstructions evident in the above photos.

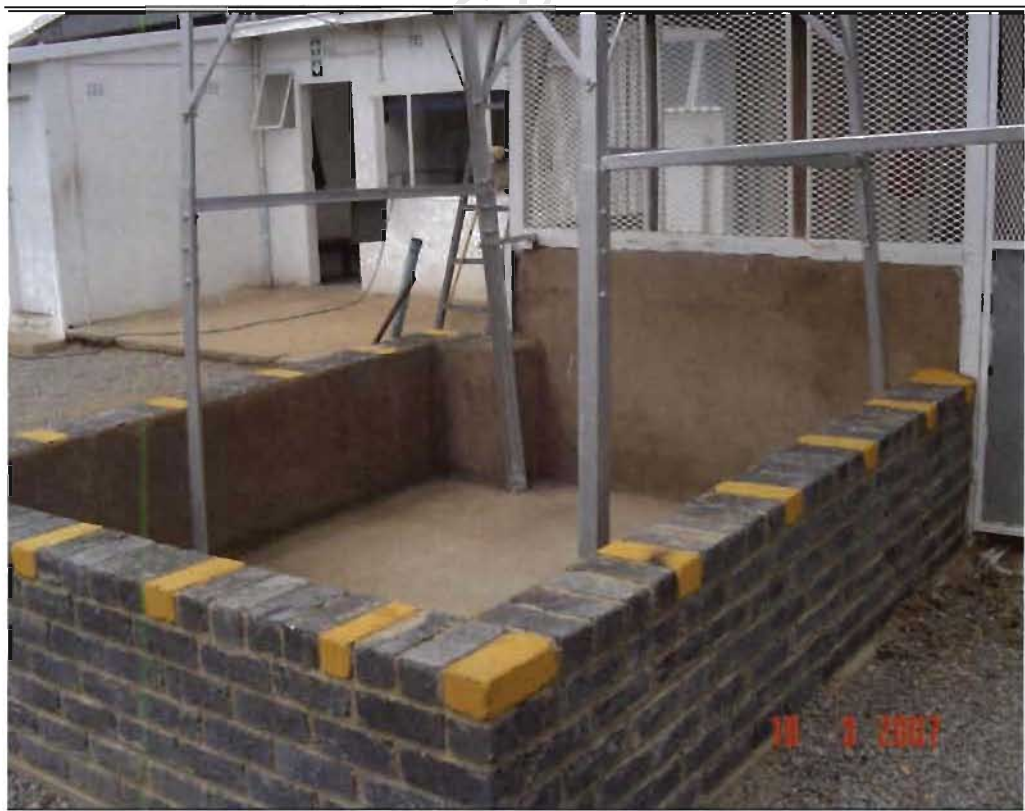
Photo 8.6 Site 1 - photo showing the depth and nature of the bunding.

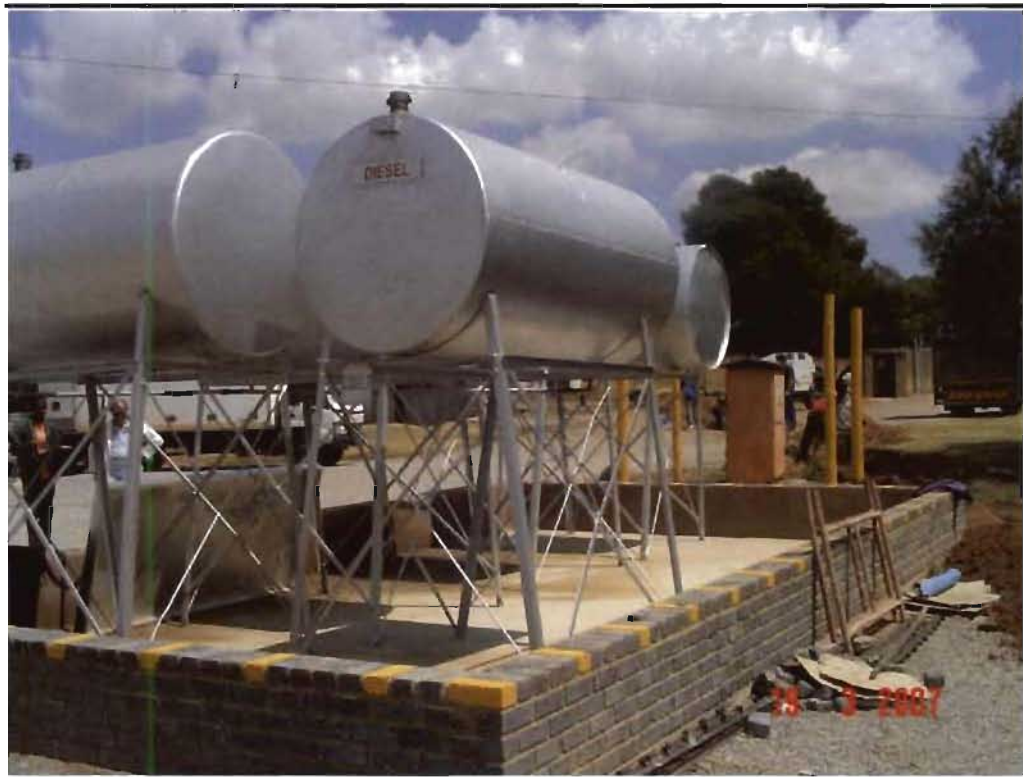
Photo 8.12 Site 2 - view of tanks showing the inside of the bunding

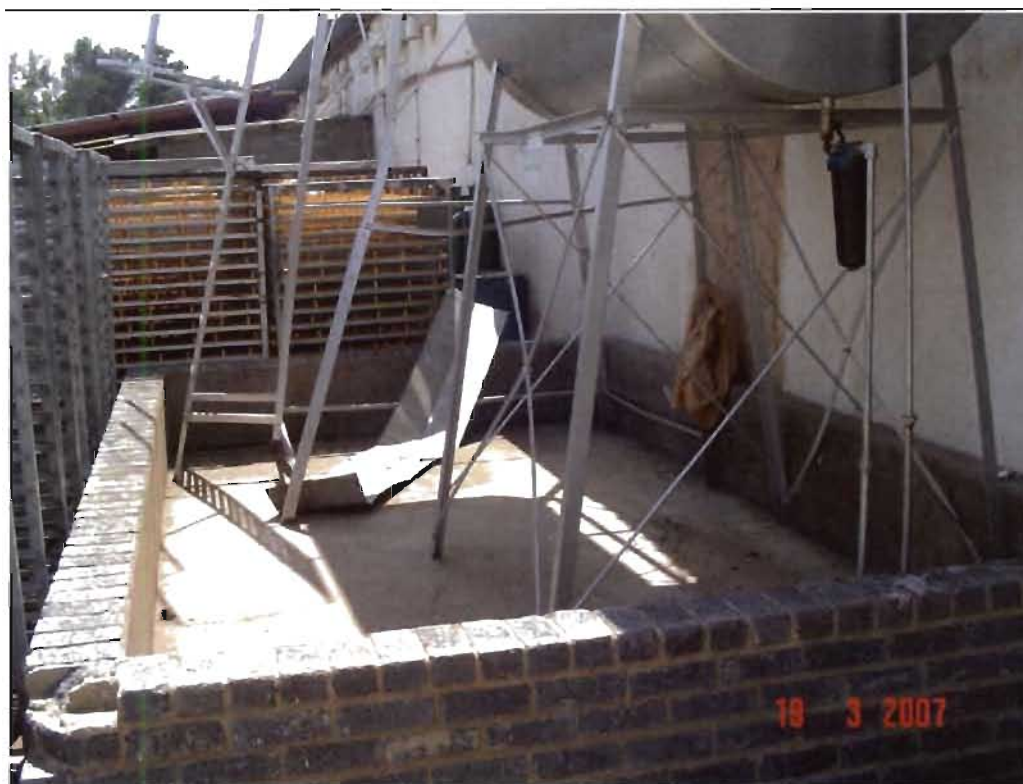
Photo 8.17 Site 3 – photo showing the condition of the tank bunding

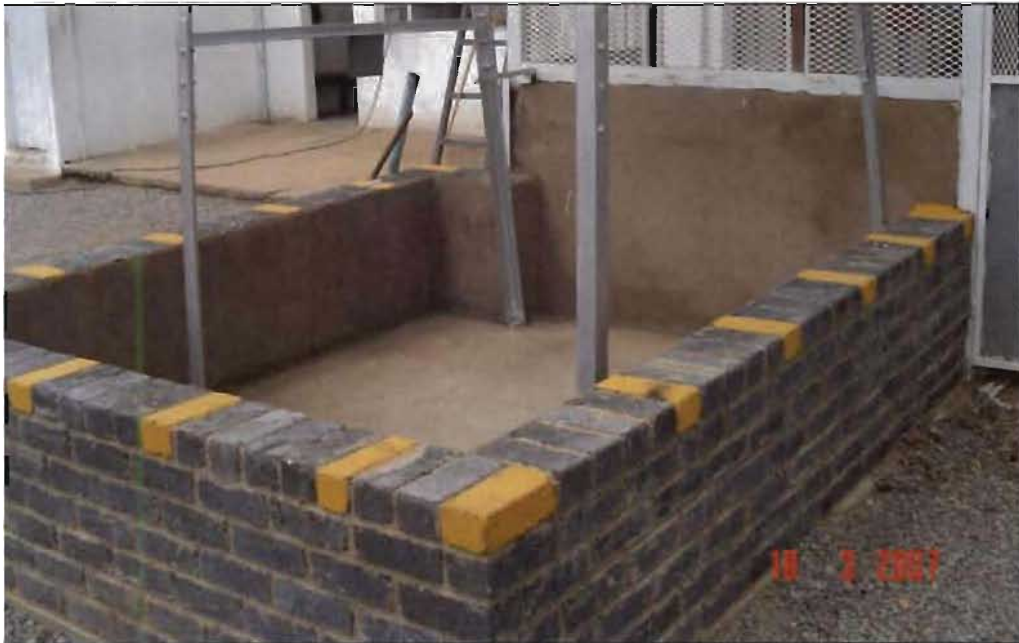
Site 1:

All the eight ASTs at this site were observed to be bunded. The bunds were constructed of masonry within an inner cement lining making them impervious. Each of the bunds were determined to be of adequate capacity, i.e. capable of accommodating 110% of volume of the largest tank in the bund. The integrity of the bunds was generally good, although one of the bund walls was cracked at Site 3 (see photo below). It was observed that the bunds did not have valves or associated oil-water separators as is required in terms of SANS 10131. Stormwater would potentially accumulate in the bunds and any contaminated water would have to be manually removed.
