# Black Spot Analysis

Infrastructure impacts on the occurrence of black spots on  
the N1 highway in the Western Cape

Submitted to the Department of Civil Engineering at the University of Cape Town in partial fulfilment  
of the academic requirements for a Master of Science degree in Transport Studies

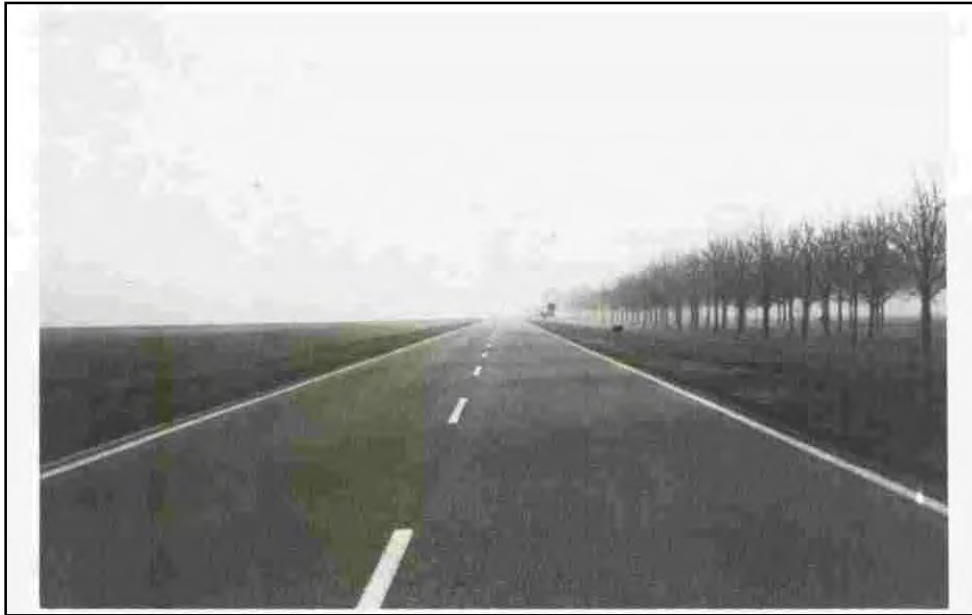
**Figure 2.1: Polder Road**

Figure 2.1 shows Polder Road. It is, absolutely, flat, the horizon is a horizontal line and the road has very few curves, which can be seen for kilometres ahead. This road type has vegetation mainly on one side, consisting of low trees and bushes of equal height (Frank et al. 1994)

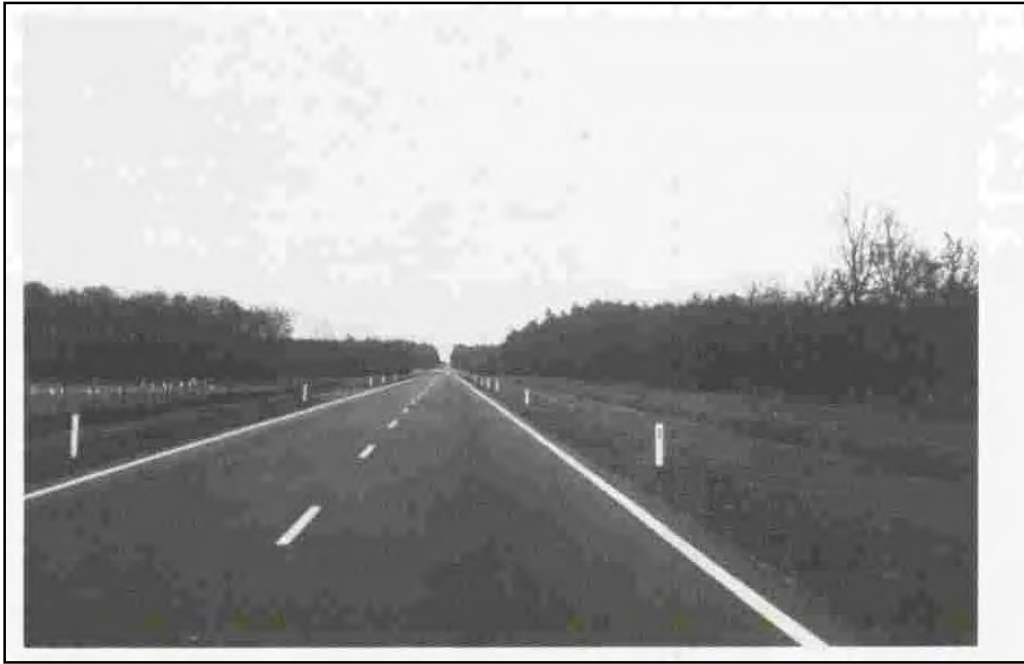
Figure 2.2: Drente Road

The other road, Drente Road,( see Figure 2.2) had a road environment that ‘had bushes in groups, a small forest with high fir-trees, open spaces and a horizon that was not a horizontal line but consisted of the contours of bushes and forests’(Frank et al. 1994). More green vegetation was present on Drente Road as compared to Polder Road, which had vegetation, which was not as variable as Drente Road. The road also consisted of a certain number of modest slopes curves were similar to Polder Road.

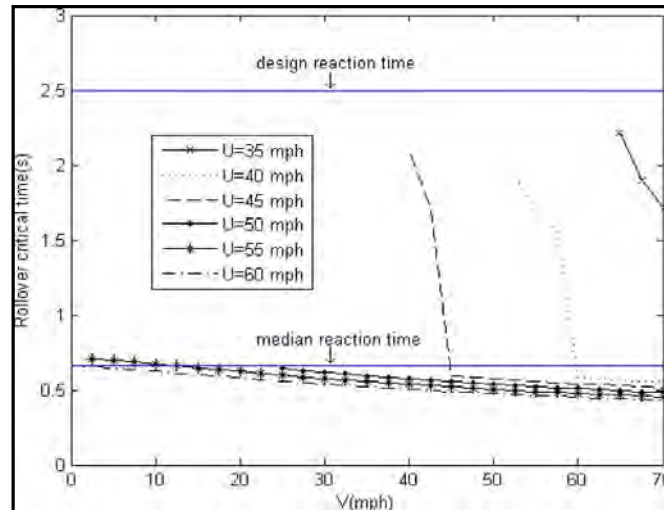
**Figure 2.3: Rollover accidents with different wind speeds**

Large vehicles such as trucks and SUV's are specifically prone to single-vehicle accidents (roll-over or sideslip) under hazardous driving environments on rural roads (such as highways). When a truck travels on a straight road with a dry road surface, roll-over accidents tend to occur first. This can be attributed to wind effects on the vehicle. The relationship between wind speed  $U$  and Critical Sustained Time (CST) of rollover is shown in Figure 2.3 (Chen and Chen, 2010).

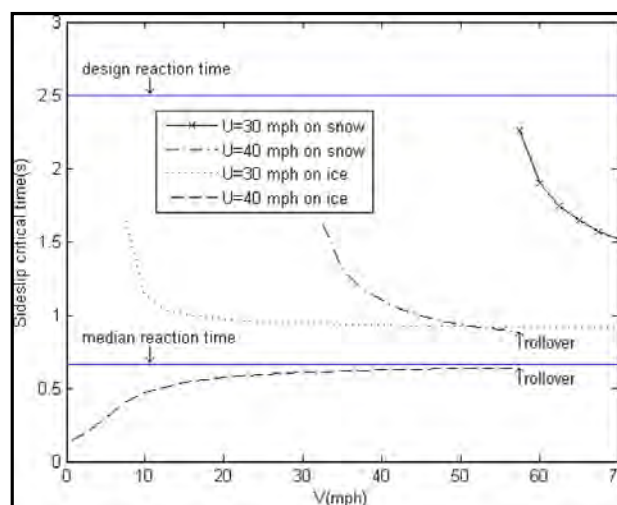
**Figure 2.4: Sideslip accidents with different wind speeds**

When a truck is driven on a straight road with an ice or snow surface, sideslip accidents tend to occur first. Figure 2.4 illustrates the relationship between driving speed and the wind speed. When the wind speed exceeds 65 km/hour, sideslip accidents start to occur.

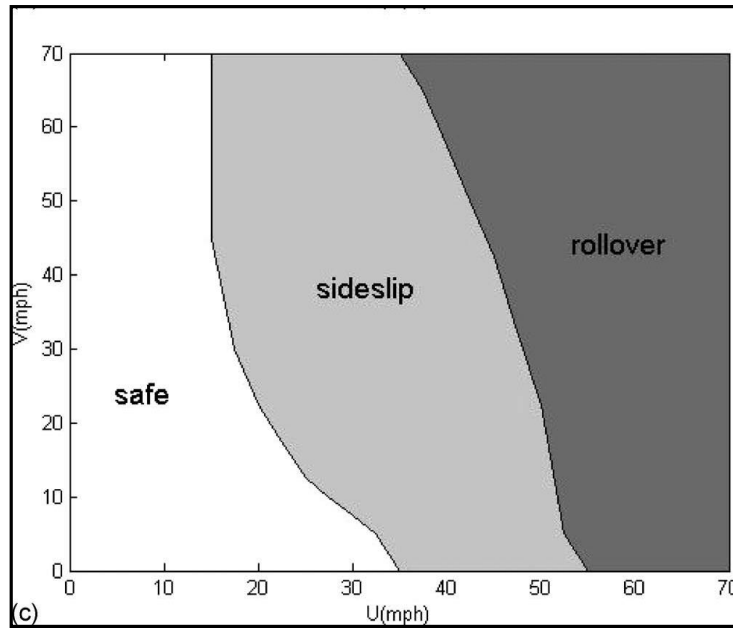
**Figure 2.7: Accidents on an ice-covered road**

more likely to occur when the driving speed reaches 32km/hour as shown in the figure. Rollover accidents occur when the wind speed reaches 89 km/hour. Figure 2.7 shows the relationship between vehicle and wind speed on an icy road. Sideslip accidents can occur when the wind speed is below 32km/hour and the vehicle speed is 40km/hour on icy roads.

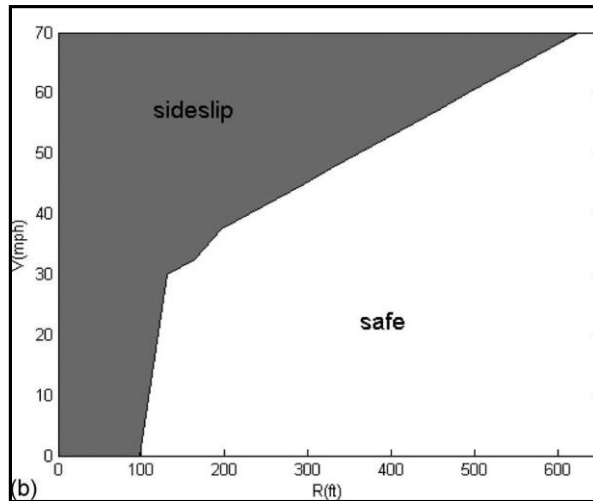
**Figure 2.8: Road accidents and road curvature on snow-covered roads** *Source: Chen and Chen (2010)*

Figure 2.8 shows the relationship between different curve radii and CDS when the road is covered in snow. Sideslip accidents will most likely occur first. Depending on the driving speed, the curvature of 180 metres or lower with a wind speed of 32 km/hour will result in a sideslip accident.

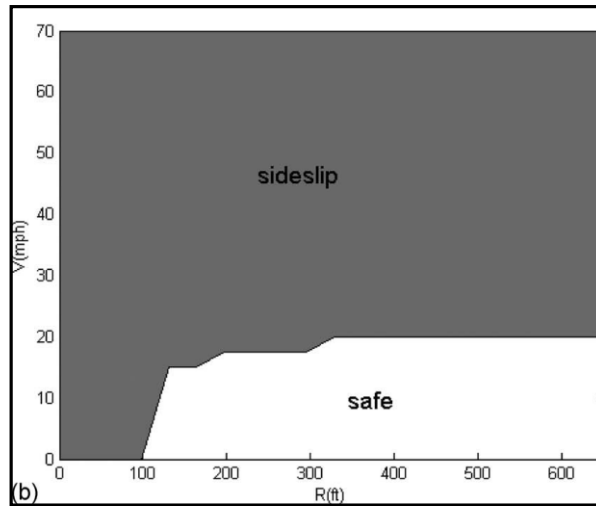
**Figure 2.9: Sideslip accidents at 100 metres road curvature**

Figure 2.9 shows that sideslip accidents will most likely happen to trucks if they are driven at a speed of 96 km/hour on a curved road with radius of 100 metres on an ice-covered road. The same results can be seen when a vehicle is driven at 40 km/hour on an ice-covered curved road with radius 40 metres. This shows that moderate wind can greatly affect the stability of a vehicle on ice covered curved roads. Once a sideslip accident occurs, there is very little a driver can do to stop the accident from occurring.

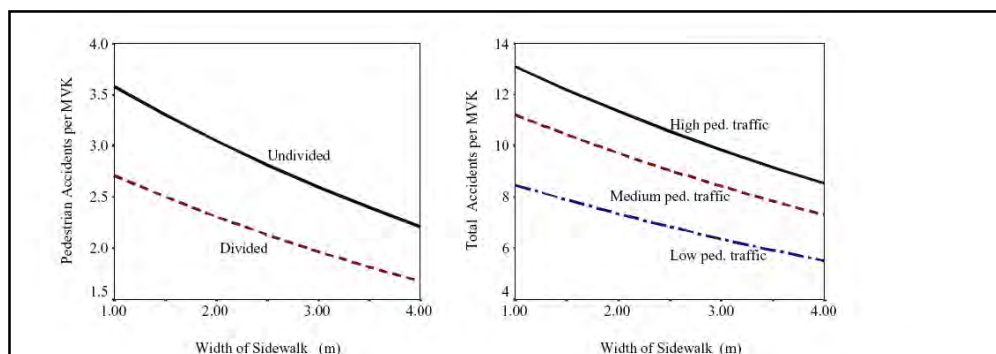
**Figure 2.13: Pedestrian accidents against width of sidewalk**

It was also found that in order to increase pedestrian safety, increasing the width of the sidewalk can greatly decrease pedestrian accidents. This relationship is shown in Figure 2.13.

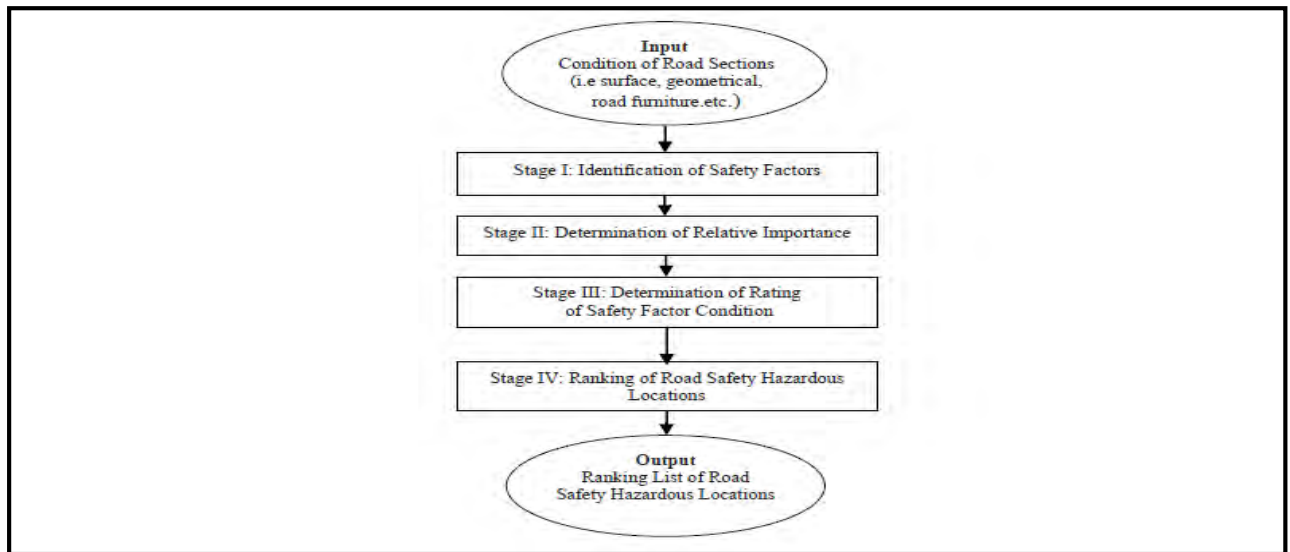
Figure 2.14: Framework for the proposed methodology for Ranking Road Safety Hazardous Locations

A framework for ranking hazardous locations is presented in the following figure 2.14

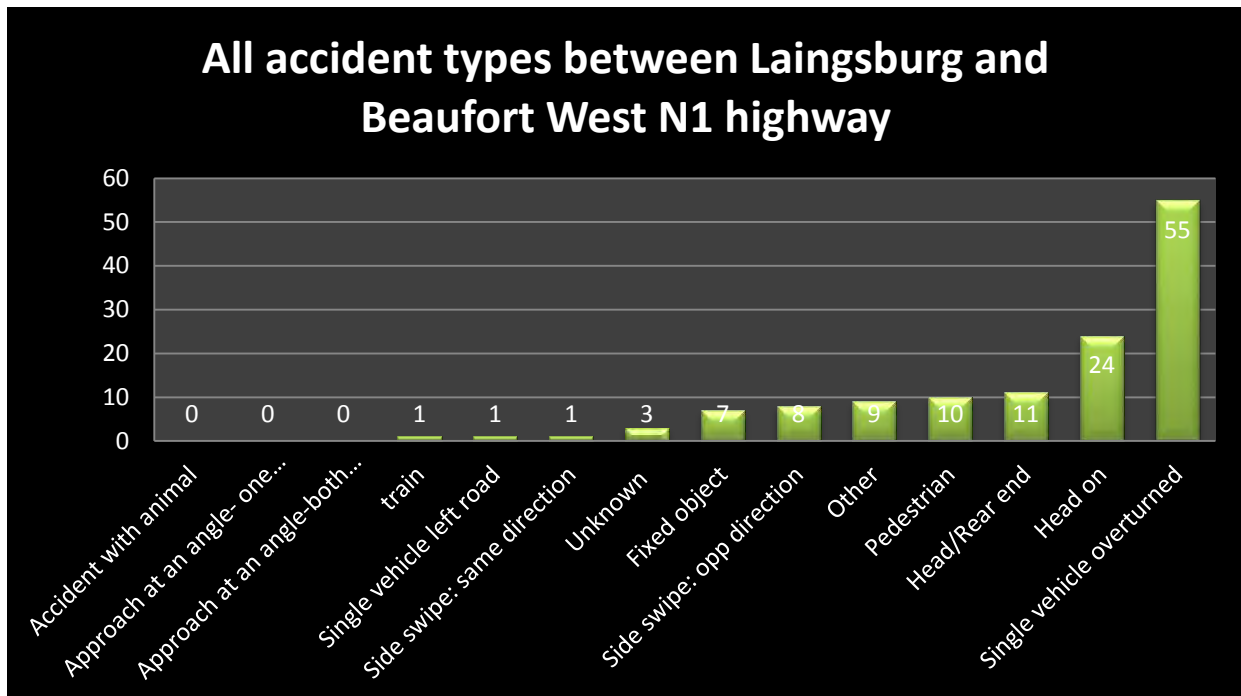
Figure 4.1: Laingsburg Beaufort West single-vehicle overturning accidents

Figure 4.1 shows the different types of fatal accidents that occurred in the road section. It can be seen that single vehicle overturning accidents have a high incidence than all other accident types

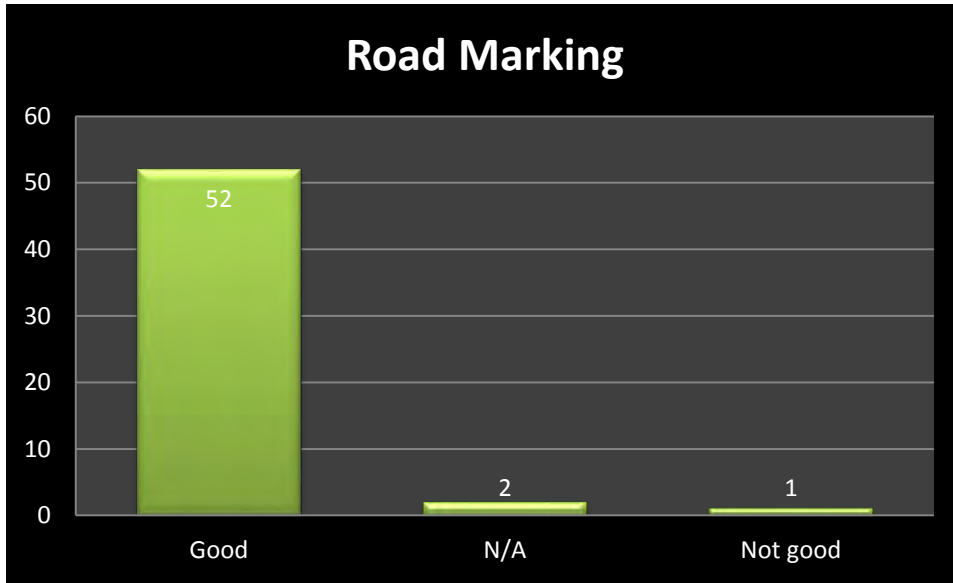
**Figure 4.5: Condition of road marking**

Figure 4.5 shows that the road markings were found to be in good condition when 52 of the accidents occurred. Only 1 incident was recorded as the road marking being ‘Not Good’

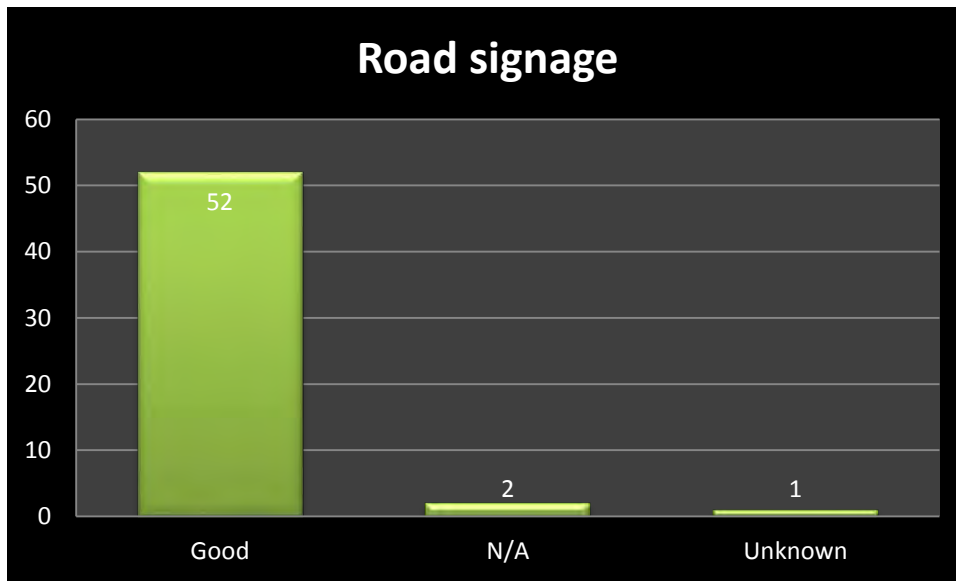
**Figure 4.8: Condition of road signs at accident locations** *Source: iPas*

Some 52 fatal accidents were found to have occurred with proper road signage in place, and only one accident was found to have occurred in an area with no road signs.

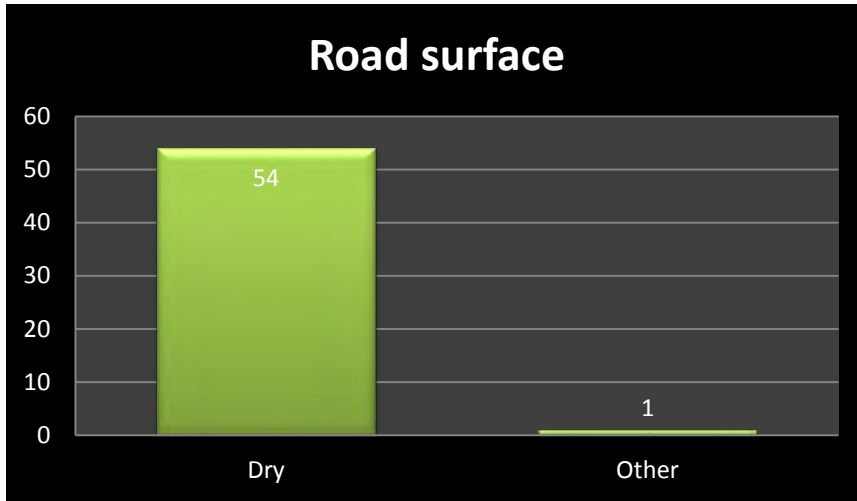
**Figure 4.9: Condition of road surface at time of accident occurrence**

Figure 4.9 shows that in 54 of the 55 accidents, the road surface was dry.

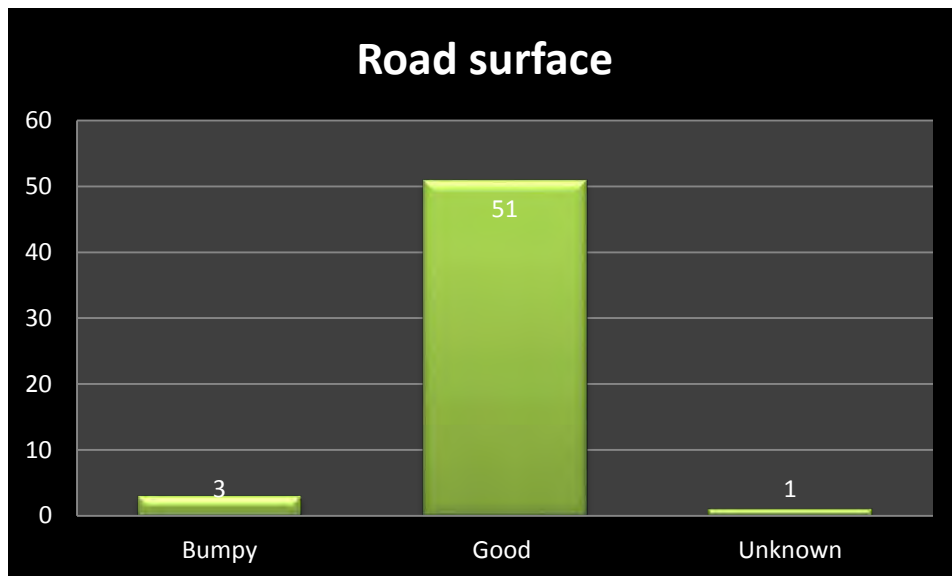
**Figure 4.10: Road surface condition at accident location**

Figure 4.10 shows that 51 accidents occurred on a good road surface. A total of 3 accidents occurred on a bumpy road surface and for 1 accident the road surface quality was recorded as unknown.

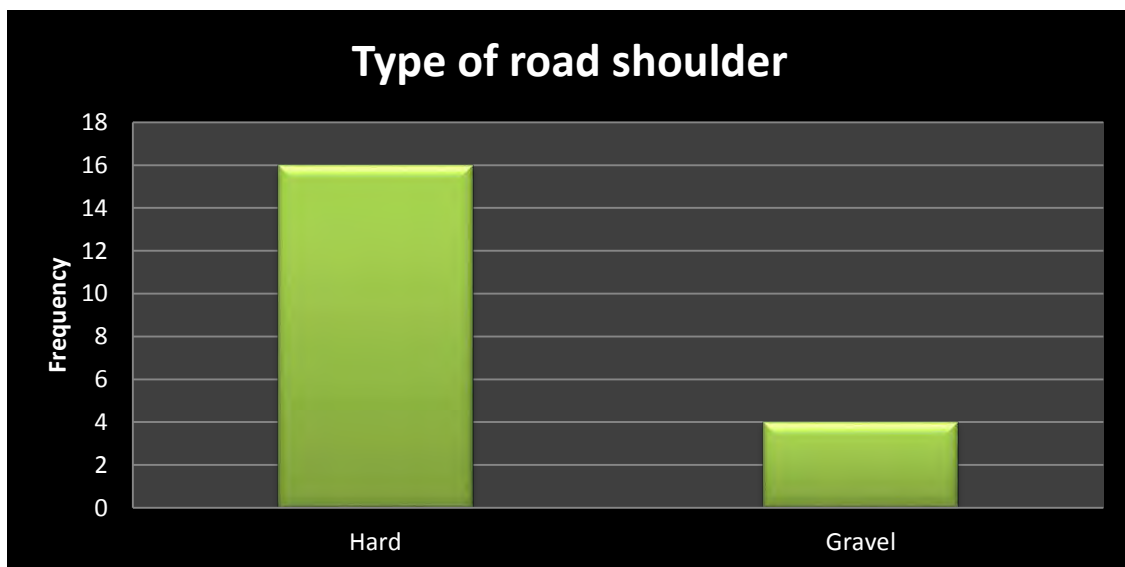
Figure 4.16: Road shoulder types on highway

Figure 4.16 shows the road shoulder types on the N1.

Figure 4.16 of the road audit shows that four observations were made indicating a presence of a gravel shoulders. These were at 10-20 kilometres, 50-60 kilometres, 80-90 kilometres and 110-120 kilometres. The average width of road shoulders was also greater than 0.5 metres, as observed in the audit. The edges of road shoulders were observed to be made of gravel material (stones), and not hard shoulders. The figure 5.5 shows the material used in constructing the road shoulders.

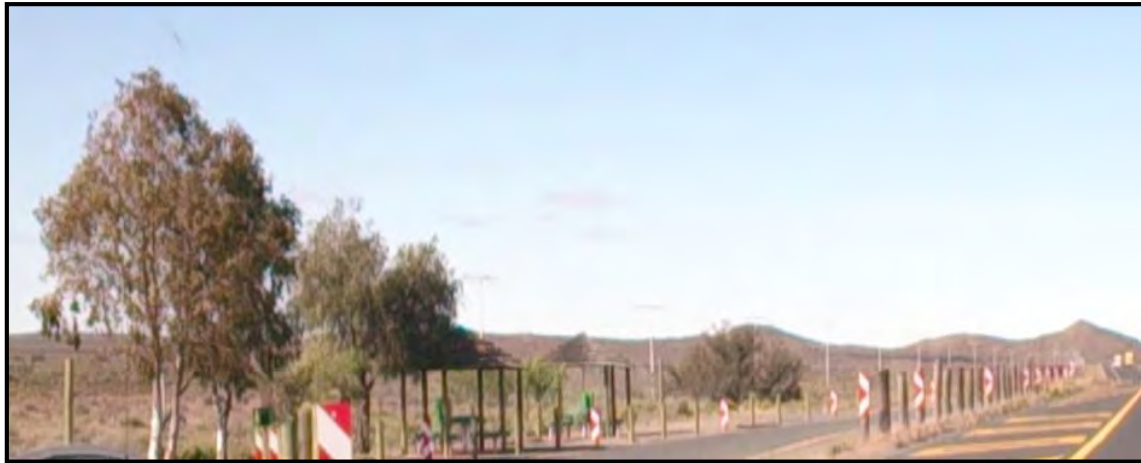
**Figure 4.25: Rest area situated along the N1 hotspot outside Laingsburg**

The route is well-equipped with service and rest areas, along with parking facilities on both sides of the road. This is shown in Table 4.6 and Table 4.9. These rest areas are located every 10 kilometres of road travelled. However, the sizes of these areas do not include sufficient parking for trucks, buses and passenger vehicles. The parking and rest areas are also not separated according to vehicle type. These areas are clearly marked and demarcated from the carriageway, with delineators prominent across the rest areas.

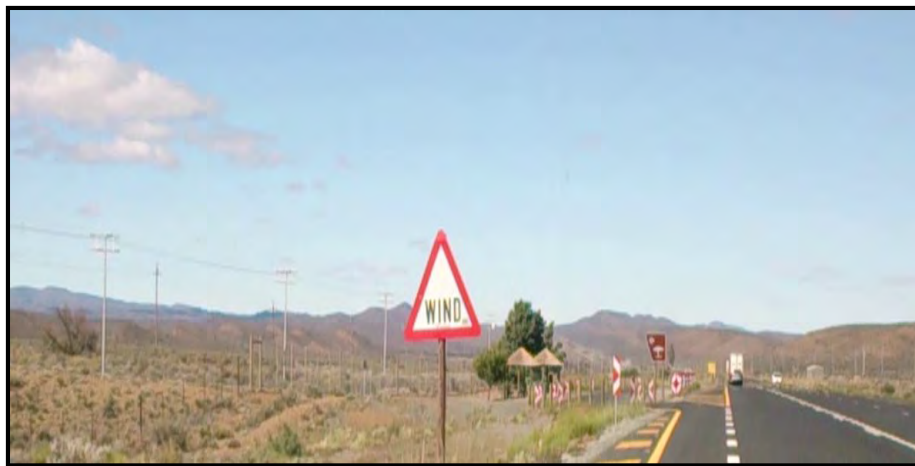
Figure 5.1: Warning sign for prevailing wind along the highway

investigated, the speed limit was set at 120 km/h. Road curvature was revealed to pose a problem for heavy vehicles, as it may result in rollover and side-slip accidents, especially when wind speed effects are also considered (Chen and Chen, 2010). The authors also revealed that when a truck travels on dry road surface, rollover accidents tend to occur first, especially on rural roads (highways), as this is also due to wind effects. The route investigated between Laingsburg and Beaufort West, was considered to be a rural road. The findings of the literature review and site investigation are consistent with the ArcGis analysis on roll-over accidents, as wind effects were prevalent on the N1. The risk of roll-over still exists even when the truck is not in motion. Figure 5.1 shows a warning sign for motorists to be aware of the prevailing wind effects on the highway.

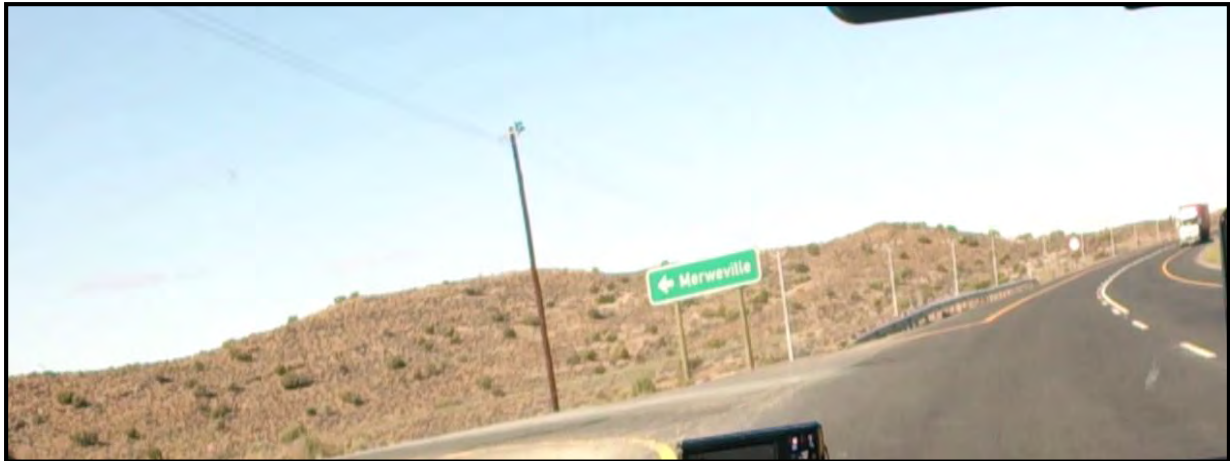
**Figure 5.2: Junction along N1 highway**

The Road Audit revealed three junctions that were perpendicular to the highway. These were located at 10-20 kilometres, 110-120 kilometres and 120-130 kilometres from the town of Laingsburg. No warning signs were observed prior to reaching the junction.

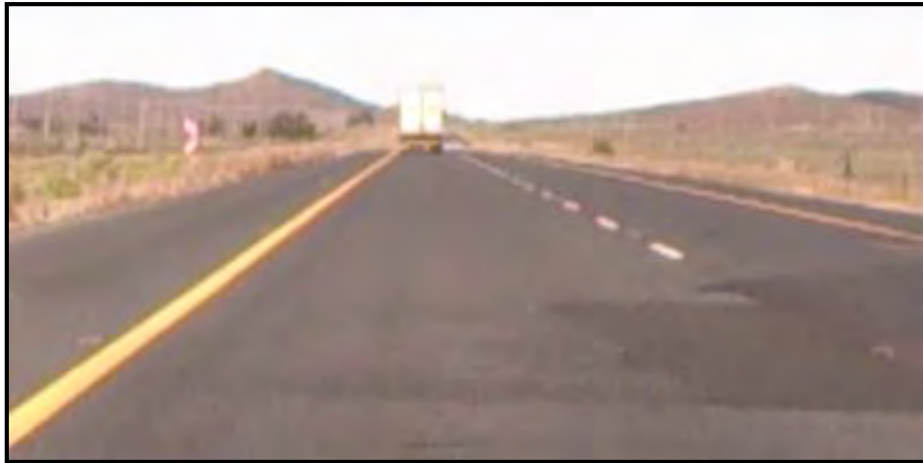
Figure 5.3: Obscured road marking on N1 highway

Figure 5.3 shows part of the road markings affected by surface bleeding

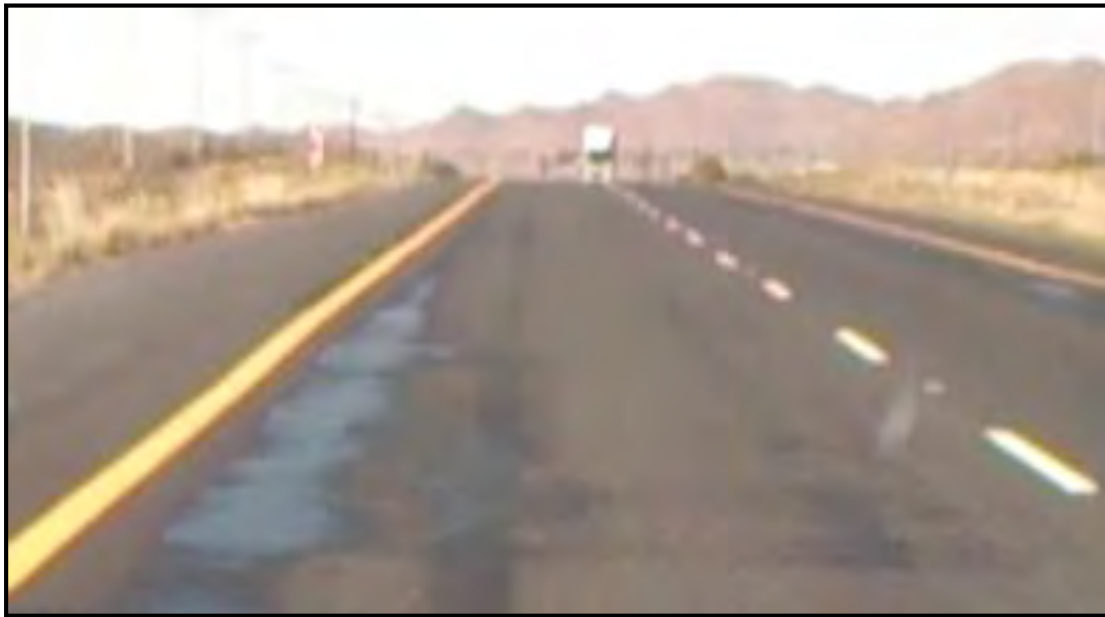
**Figure 5.4: Road section affected by road surface bleeding**

Road surface bleeding also affects the driving experience as there is less friction between the vehicle and road surface. Observations of surface bleeding were made at 10-20 kilometres and 110-120 kilometres as shown in Table 4.5 and Table 4.8.

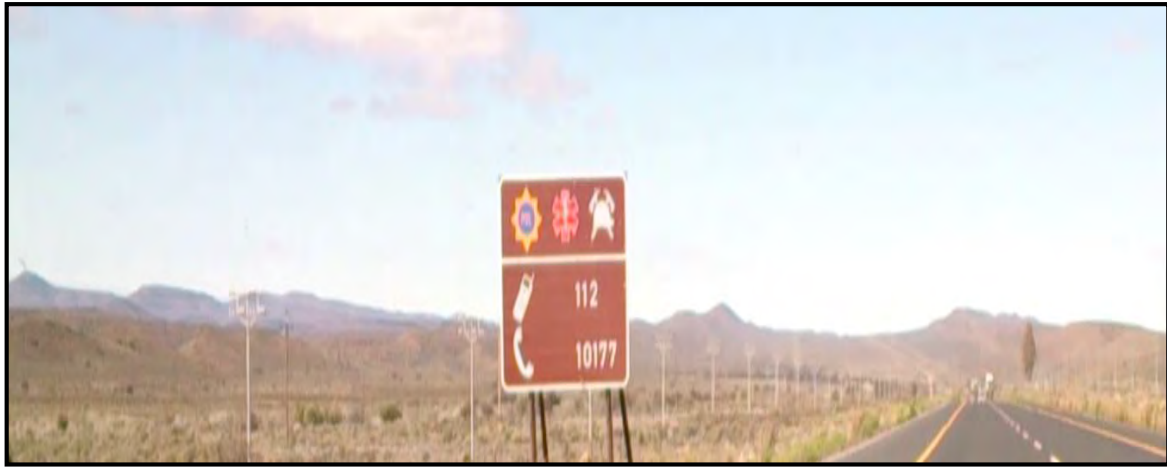
**Figure 5.6: Road sign location relative to the highway**

Figure 5.6 shows the location of road signs relative to the single-carriageway highway. This image clearly shows that the road signs are located too close to the carriageway. This renders them a high risk problem as road signs have the potential of being an obstacle that worsens the severity of a collision, should a vehicle veer of the road. They also have the potential of obstructing the motorists' line of sight.

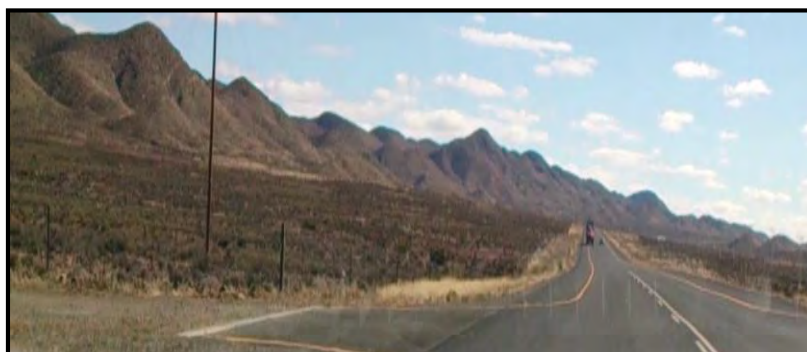
**Figure 5.7: Absence of streetlighting on the N1 highway**

Table 4.6 and Table 4.9 of the road audit reveal that street lighting is only located in the 0-10 kilometre section of the highway. The lack of street lighting is shown in figure 5.7. Insufficient lighting is a problem for motorists who use the highway, especially at night. Not only will motorists not be able to see pedestrians travelling on the highway at night, but other hazardous objects and important information signs may be missed. Currently, the reflectors on the road surface can be observed, but these are not sufficient to provide proper illumination. The presence of streetlighting may serve to both reduce accidents and accident severity, especially at night.
