Condition Assessment Methods for Prestressed Concrete Railway Sleepers: Feasibility for South African Applications

FOR PARTIAL FULFILMENT OF THE MASTER OF ENGINEERING SPECIALIZING IN CIVIL INFRASTRUCTURE
MAINTENANCE MANAGEMENT

Author: Engineer Astrid Lambrechts
University of Cape Town

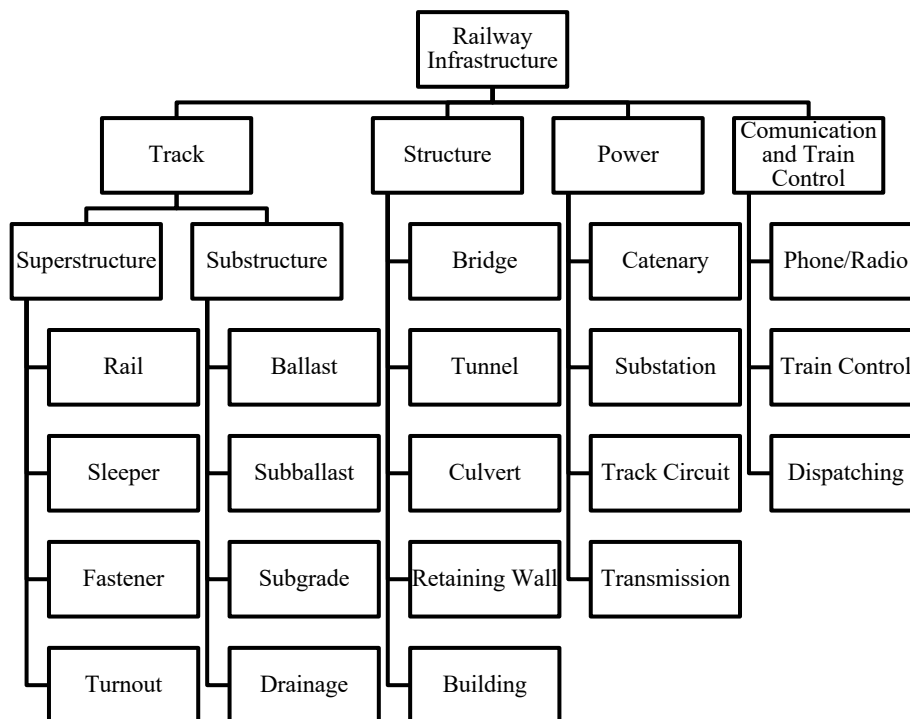
Figure 2-1: Elements of Railway Infrastructure (Li et al., 2016)

Railway infrastructure needs collaboration from multiple disciplines to ensure its continued operations (Li et al., 2016). Track, structure, power distribution and communications are the broad categories of systems that are used to describe the railway infrastructure, as shown in Figure 2-1.

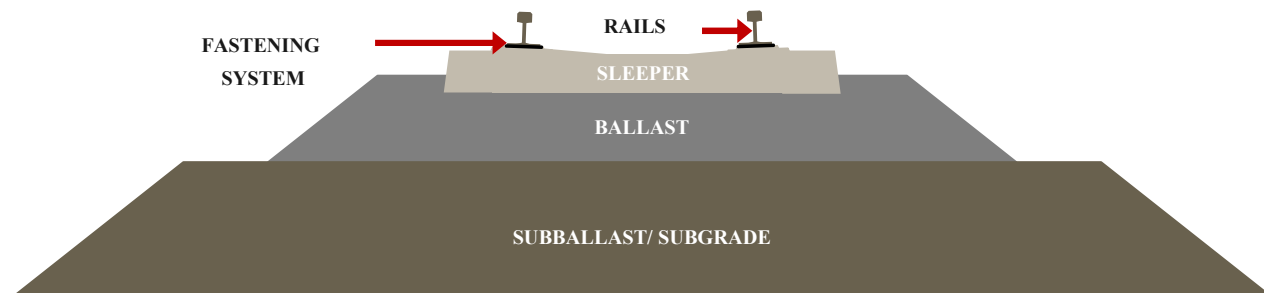
Figure 2-2: Traditional Ballasted Track Structure adapted from Selig (1994)

The superstructure is the immediate load-bearing system of components that transfers the weight of the train to the substructure components. Figure 2-2 shows a basic cross-section of the linear track components. The components such as turnouts and drainage are often discussed independently as they are discrete components and have a different assessment strategy to linear assets.

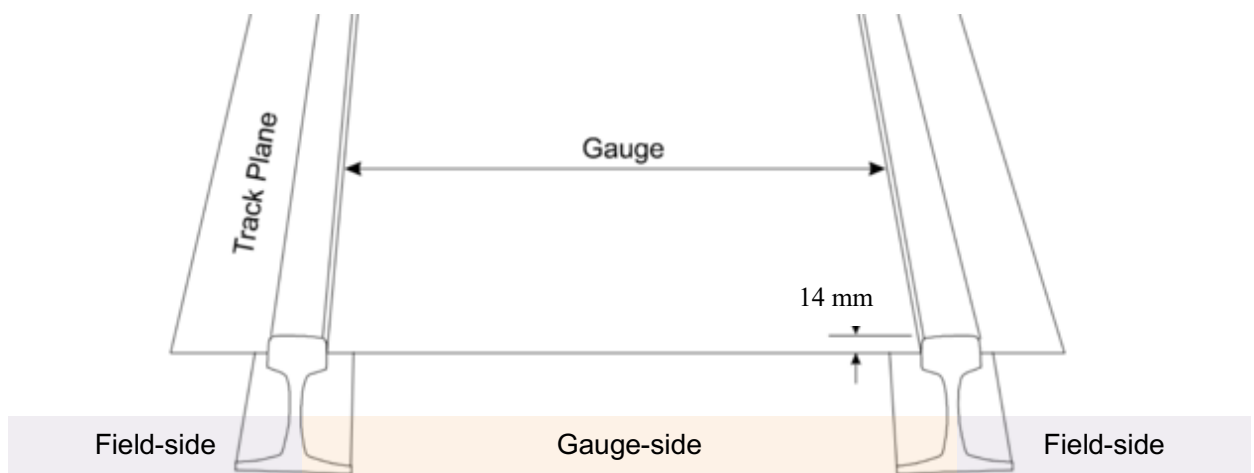
Figure 2-2: Track Gauge Definition (Grabe, 2017)

Track gauge has always been the ultimate Go/No-Go criteria for trains, as too wide or too narrow results in the wheelset being incompatible for the movement. Gauge is defined as the point of reference measured at 14 mm below crown wear of a rail, as shown in Figure 2-3 (Transnet Freight Rail, 2012).

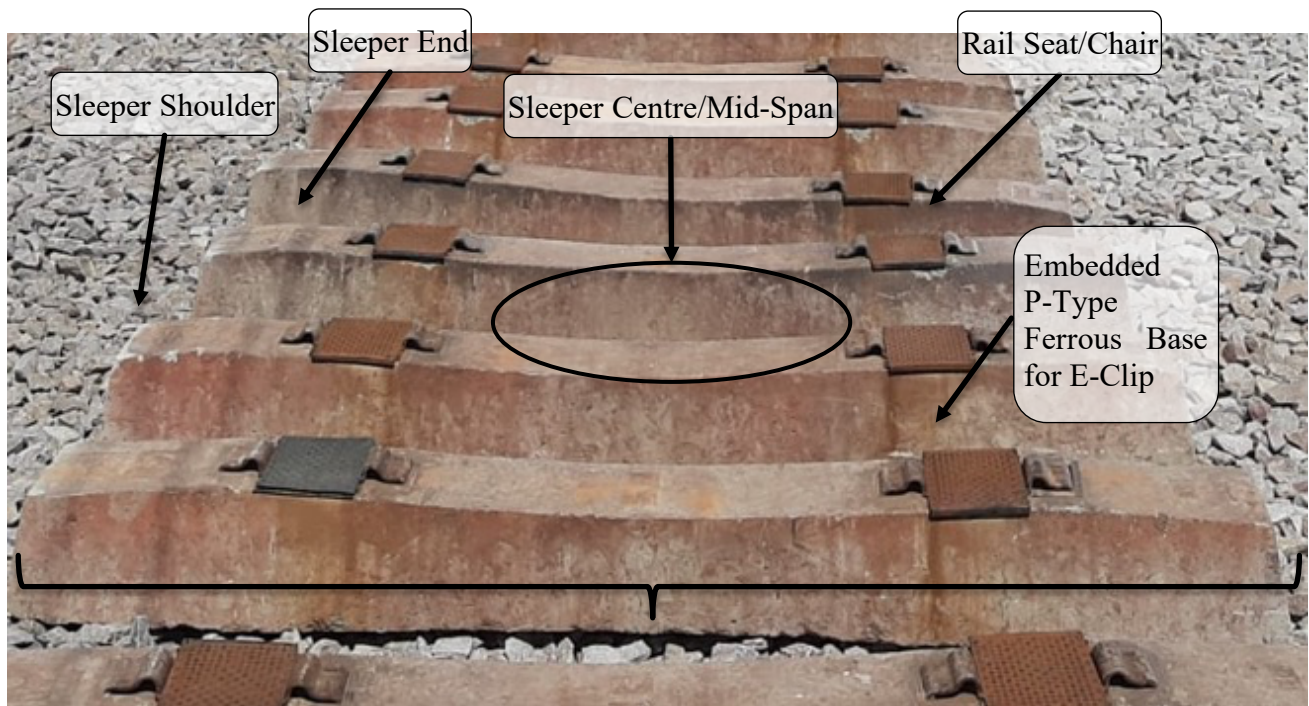
Figure 2-4: Example of Sleeper Regions (Photo by Author)

Specialized sleepers, as opposed to the open track sleepers, are used when encountering turnouts, bridges, and tunnels, as they require different dimensions and loading configurations. A typical description of the sleeper regions is shown in Figure 2-5.

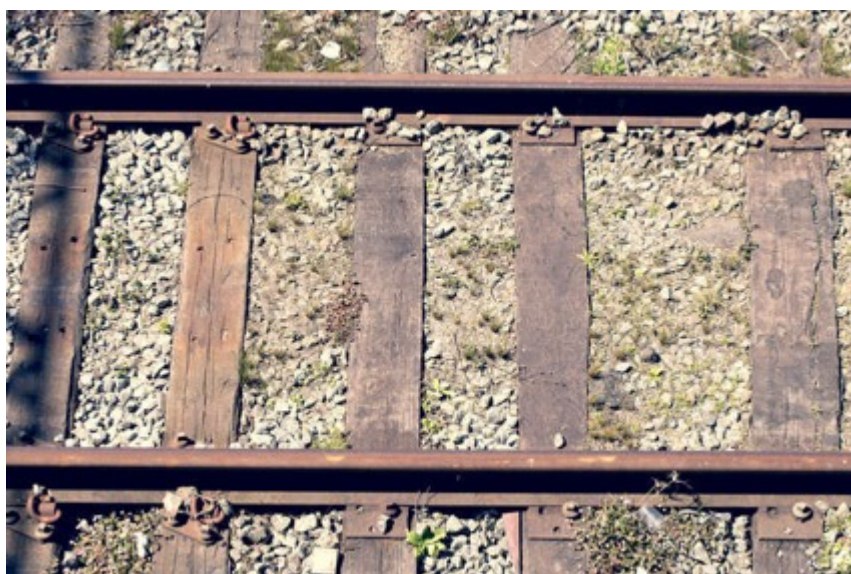
Figure 2-5: Example of Wooden Sleepers (Theos Timber Limited, 2017)

Wooden sleepers are either made of a hard wood or a laminated wood and have the typical dimensions of 2100 mm x 250 mm x 195 mm (Transnet Freight Rail, 2012). Figure 2-6 shows a typical wooden sleeper.

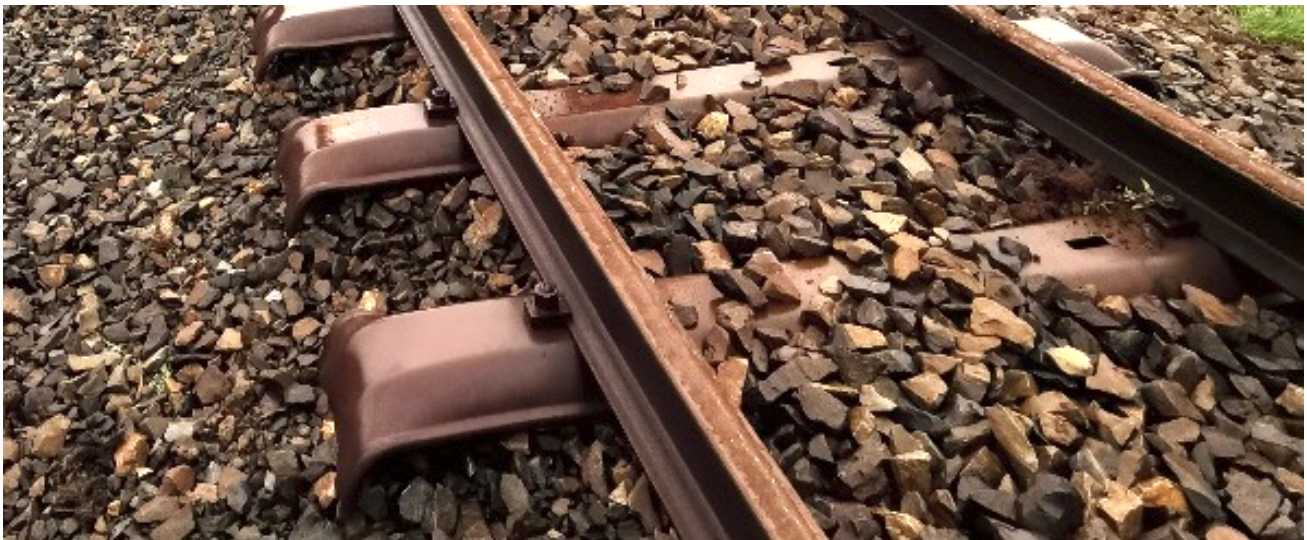
Figure 2-6: Example of Steel Sleeper with Exposed Shoulder (Photo by Author)

Steel sleepers were used for a period but are no longer manufactured for installation within the South African network. An example of steel sleepers is shown in Figure 2-7.

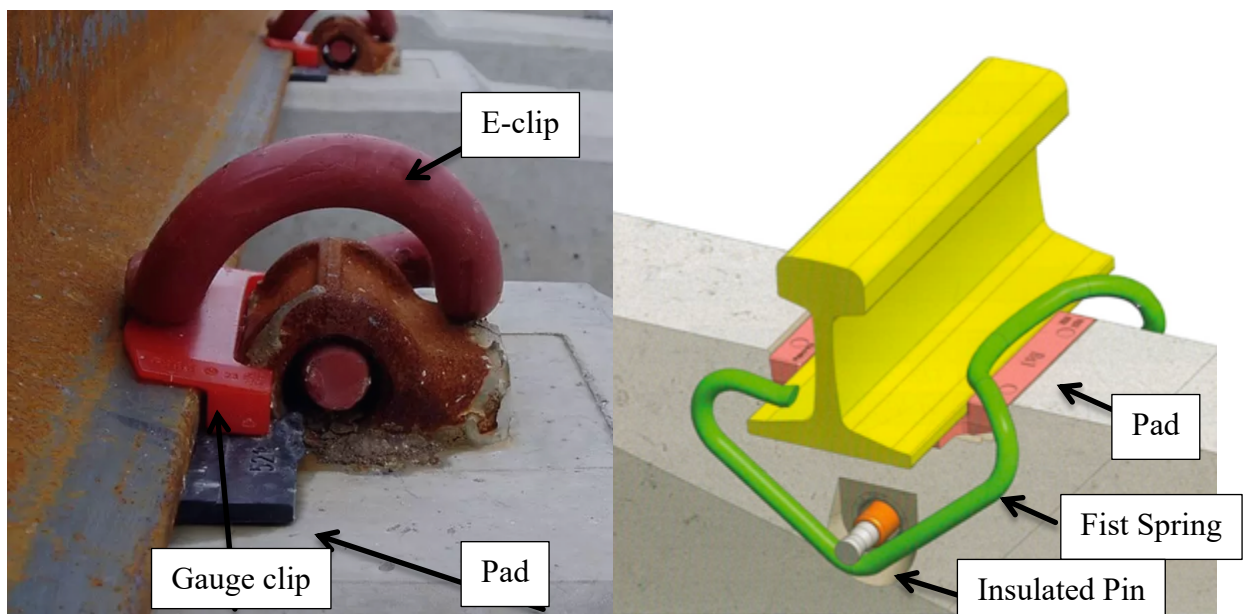
Figure 2-7: P-Type Sleeper Fastening using e-clip system, Left; F-Type Sleeper Fastening, Right (Pandrol, 2024; Aveng Rail, 2017)

The four types are P2, F4, PY and FY. The main differences are in their structural bearing capacity and the fastening system. The P2 and F4 have a lower bending moment resistance at the centre, where the PY and FY sleepers resist higher bending moments. The P and F denote the fastening system required for each with the P-type referring to the Pandrol Spring system and the F-type referring to the Fist Fastening System. The Pandrol systems make use of an e-clip, gauge clip and HDPE pad, as shown in Figure 2-8 (Left). The Fist system as shown in Figure 2-8 (Right) uses an insulated pin, fist clip and base plate to tension to clamp the rail to the sleeper.

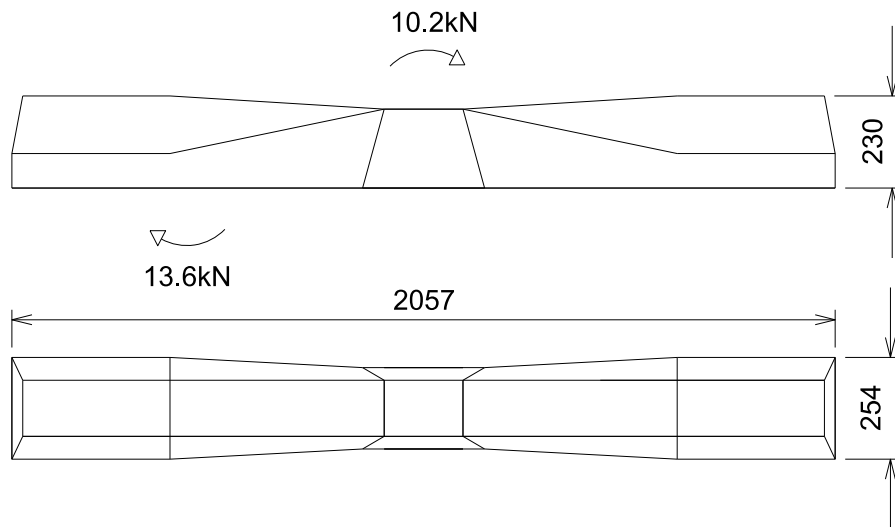
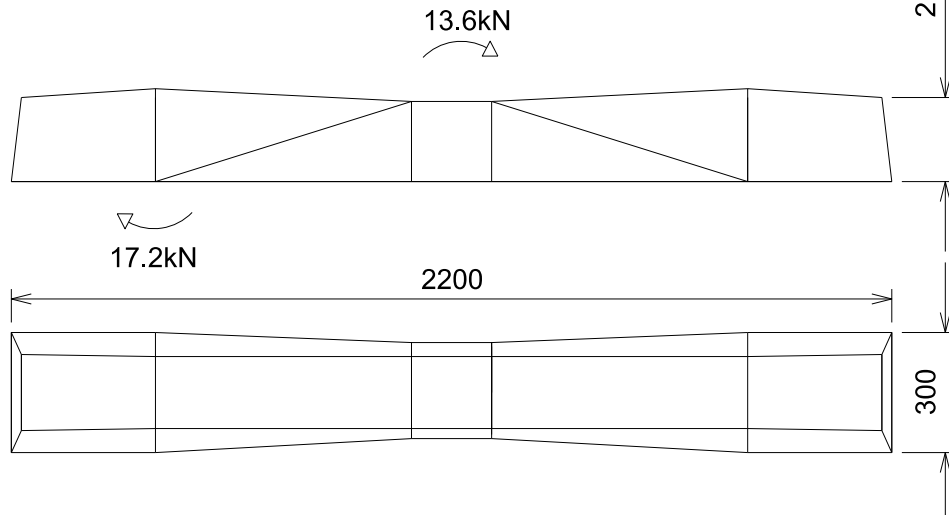
P2 AND F4 (217kg)

PY AND FY (282kg)

Figure 2-8: South African Open Track Sleepers (Wildenboer et al., 1989)

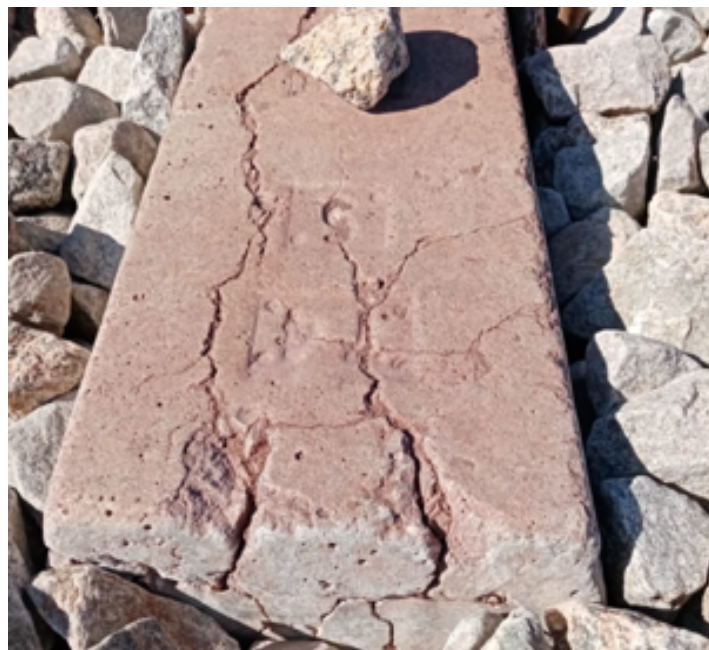
Figure 2-11: Examples of ASR Map Cracking from Sleeper Manufactured in 1974 in Saldanha PPC (Photo by Author)

Map cracking typically presents in a random orientation on the surface of a concrete element that is unconstrained and is a classic symptom of Alkali-silica reactions (Thomas et al., 2011). An example is shown in Figure 2-12.

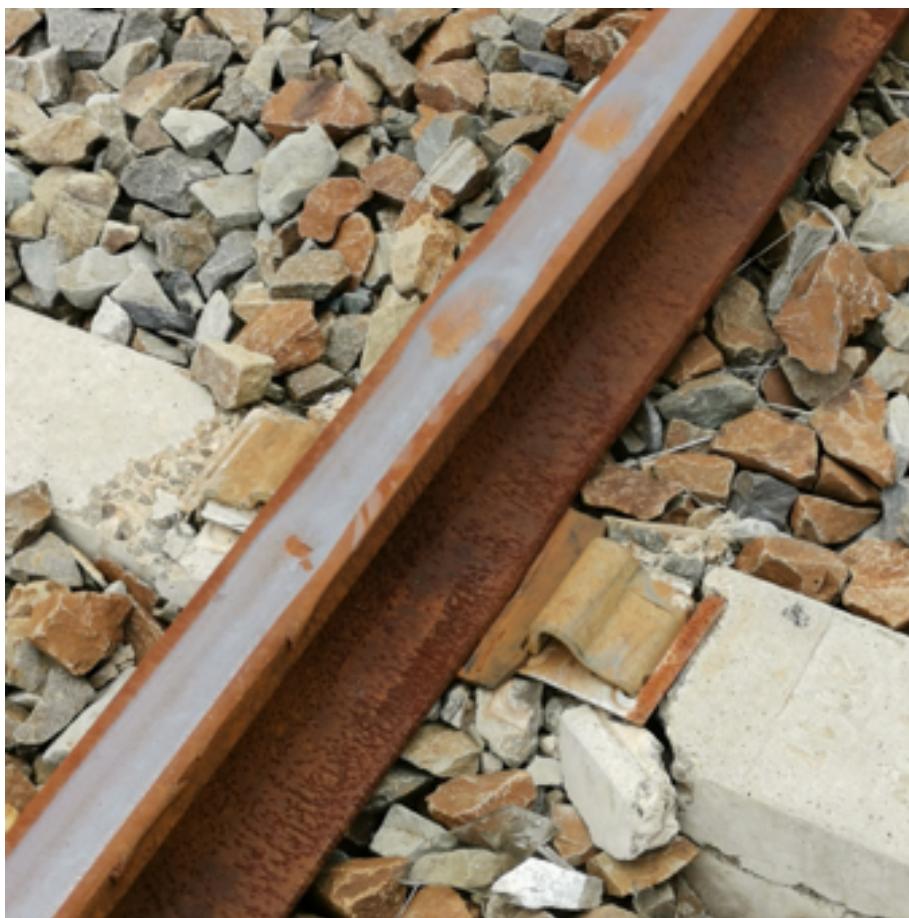
Figure 2-12: Sleeper Cracking under rail defect near East London (Picture by Author)

Cracking originating from the fastener down is attributed to increased forces, and typically induced by defects in the track or train configurations (Thun et al., 2008). Typical defects that cause these cracks are rail defects such as engine burn fractures (skidmarks), discontinuities in track joint levels, rail surface corrugation, cant defects, wheel flat defects, skew bogies on locomotives or wagons, and rail hunting are often initiators of rail chair cracking. Figure 2-13 shows a severe rail chair cracking from the fastener down due to engine burn fractures.

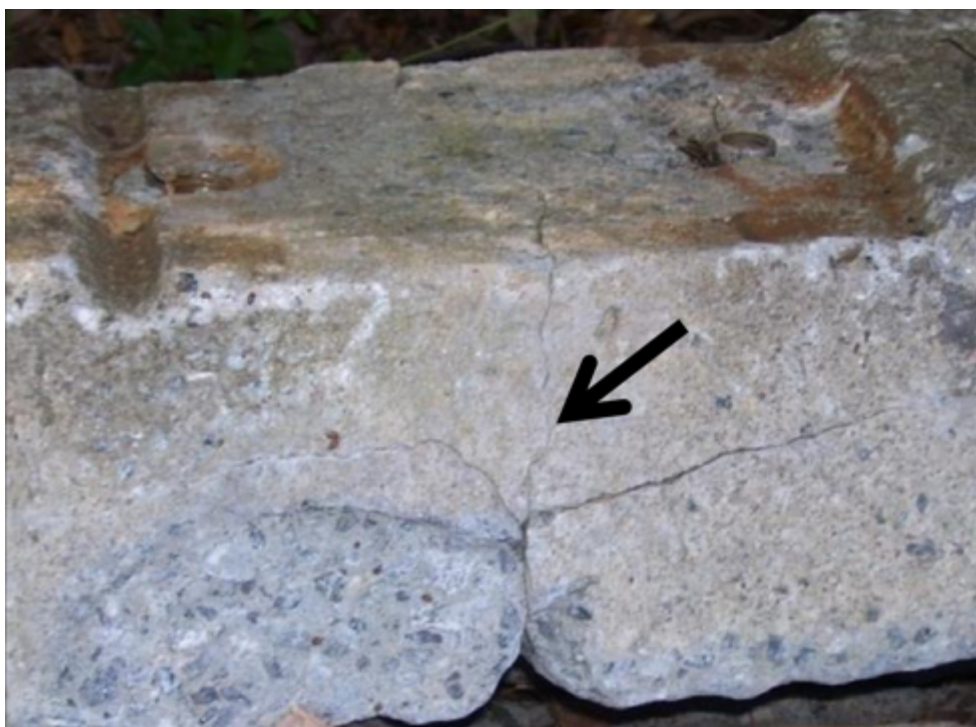
Figure 2-13: Example of a severe rail seat positive flexural crack (Zeman, 2010)

High-impact forces, while short in duration, create a high positive moment at the bottom of the sleeper directly below the rail seat (de Souza Lima & Carneiro, 2022; Zeman, 2010). The positive moment will induce a bending crack when the tensile strength of the concrete is exceeded, starting at the base of the sleeper and extending upwards. Figure 2-14 shows a typical crack at the base of the rail seat.

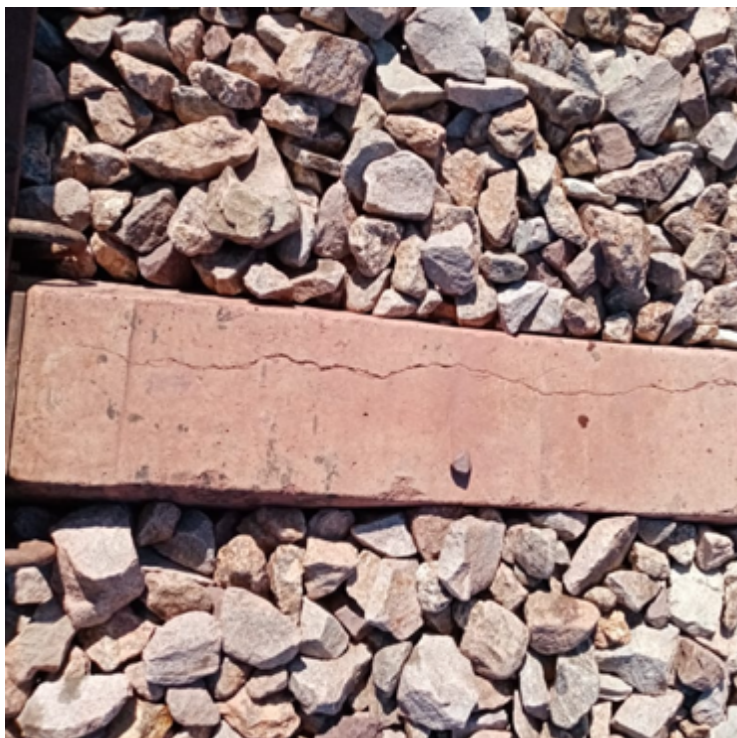
Figure 2-14: Long Horizontal Cracks on Sleeper in Northern Cape (Photo by Author)

Horizontal cracks, as shown in Figure 2-15 are found either on the side of the sleeper or top in a direction perpendicular to the train movement. Long horizontal cracks appear through the sleeper due to three main causes: cracking due to Delayed Ettringite Formation, cracking due to high-impact loads induced, or manufacturing defects (de Souza Lima & Carneiro, 2022; Kaewunruen & Remennikov, 2009).

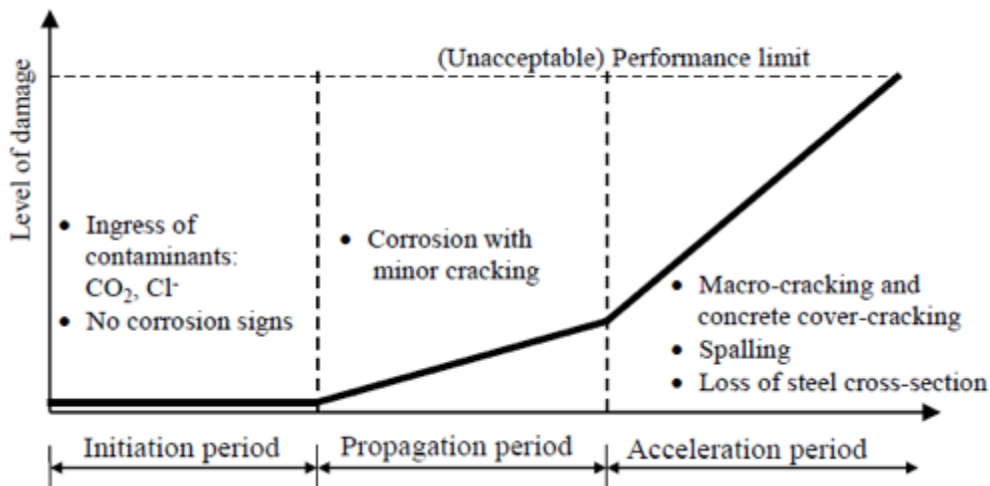
Figure 2-16: Damage Deterioration Mechanism (Heckroodt, 2002)

Prestressing steel corrosion is a common deterioration mechanism for concrete assets (Alexander et al., 2012). Long before failure occurs, signs of distress will typically be visible with an increasing extent of damage. Figure 2-17 shows a schematic of the typical three damage periods during the lifespan of a structure.

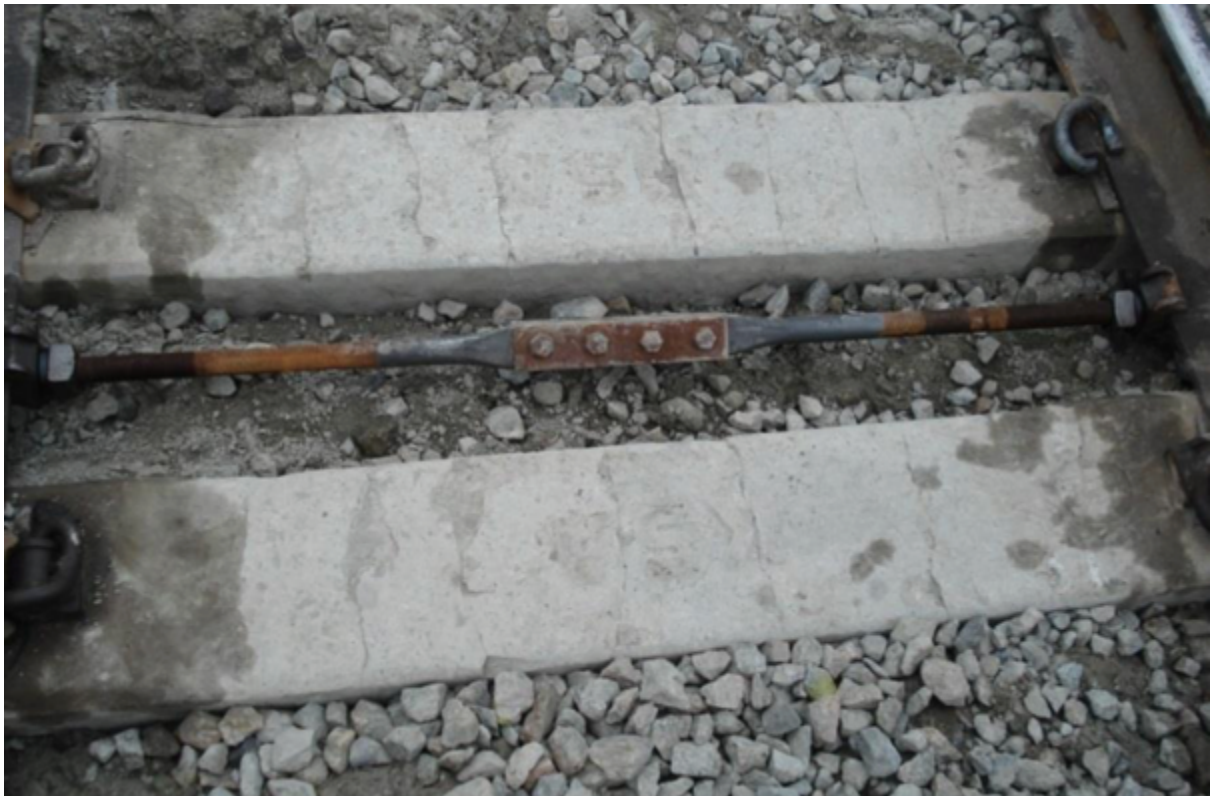
Figure 2-18: Example of Centre Binding of Concrete sleepers (NTSB, 2014)

Cracks that form in the mid-span of the sleeper and are perpendicular to the sleeper length are often referred to as centre-binding (de Souza Lima & Carneiro, 2022). The root cause of this sleeper centre-binding is attributed to an internationally documented group of defects called ballast voiding, when ballast under a sleeper permanently displaces, leaving the sleeper in an unsupported condition (Remennikov & Kaewunrunen, 2007). The damage mechanism that leads to centre-binding cracks typically occurs when the ballast supporting the ends of the sleepers displaces due to repeated loading actions. This leaves no supporting shoulder ballast and leads to the sleeper only being supported in the centre (Zeitouni et al., 2018). Figure 2-19 shows typical Centre Binding cracks, while Figure 2-20 shows the typical loading and support configurations of sleepers due to ballast voiding conditions from international research.

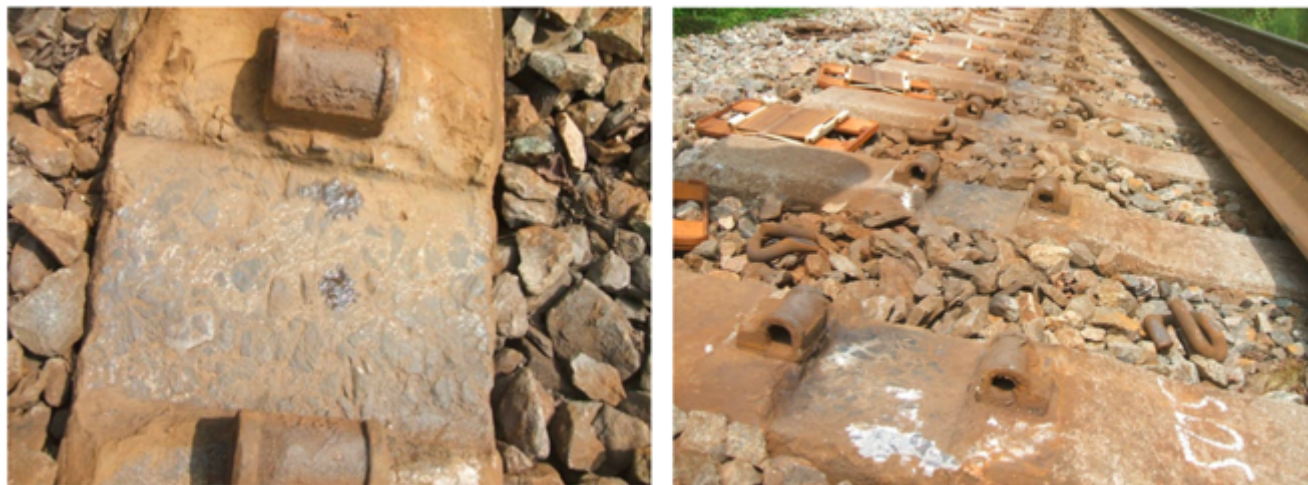
Figure 2-20: Typical Rail Seat Deterioration (RSD) (Federal Railroad Administration, 2019)

RSD can arise from various deterioration mechanisms, such as: mechanical abrasion between the rail and sleeper, concrete crushing of the sleeper chair by the rail, hydraulic pressure cracking and hydro-abrasion from trapped water between the rail, pad, and sleeper. Figure 2-21 shows typical RSD.

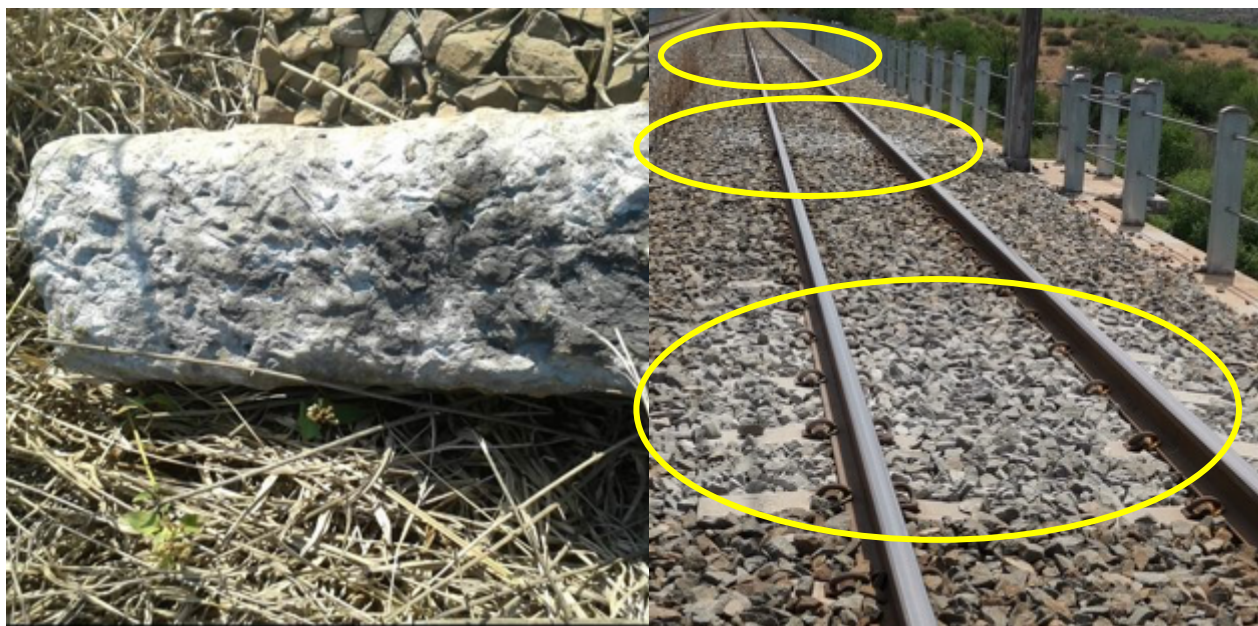
Figure 2-21: Sleeper Base Rounding due to abrasion near East London, Left; Localised Ballast/Sleeper abrasion and crushing near Kimberley, Right (Photos by Author).

The interface between the ballast and the sleeper can suffer from mechanical and hydro-abrasion of both sleeper and ballast. This base abrasion was not mentioned as a typical defect in the international meta-analysis and surveys, but is commonly seen in the South African freight industry (de Souza Lima & Carneiro, 2022; Taherinezhad et al., 2013; Thun et al., 2008). In South Africa this abrasion at the base of the sleeper is often visible in conjunction with visible localised ballast and sleeper abrasion and/or crushing, as shown in Figure 2-22.

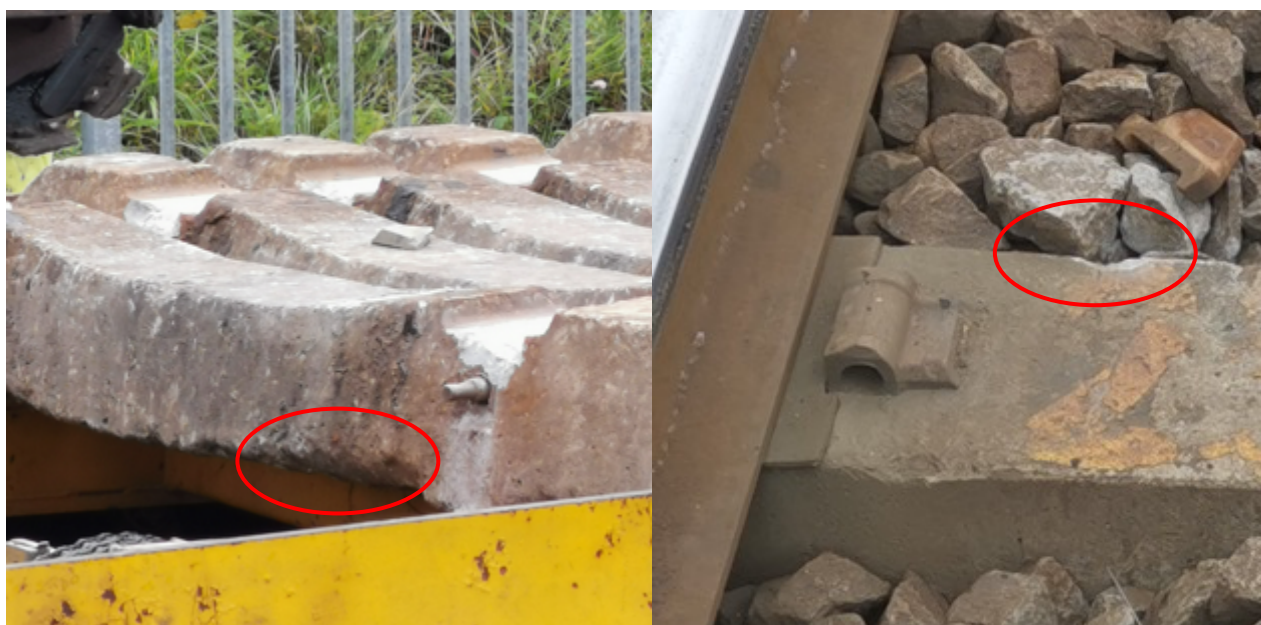
Figure 2-22: Base abrasion around rail seat due to Mechanized Ballast Tamping near East London, Left; Tamping Tine damage of sleeper near De Aar, Right. (Photos by Author)

A mechanized ballast tamper is an important part in the maintenance of a track system used to correct the geometric profile and provide a smoother running surface for trains (Li et al., 2016). The ballast tamping machine will lift the rail and sleeper to the correct geometric alignment thereby creating a void in the ballast under the sleeper, then use vibrating metal tines to liquify then squeeze the ballast into the void (Plasser South Africa, 2024). This maintenance does come with certain trade-offs, such as ballast and sleeper deterioration over time (Selig, 1994). Typical damage is seen where the tamping tines enter the ballast, to the left and right of each rail. Figure 2-23 shows an example of this damage.

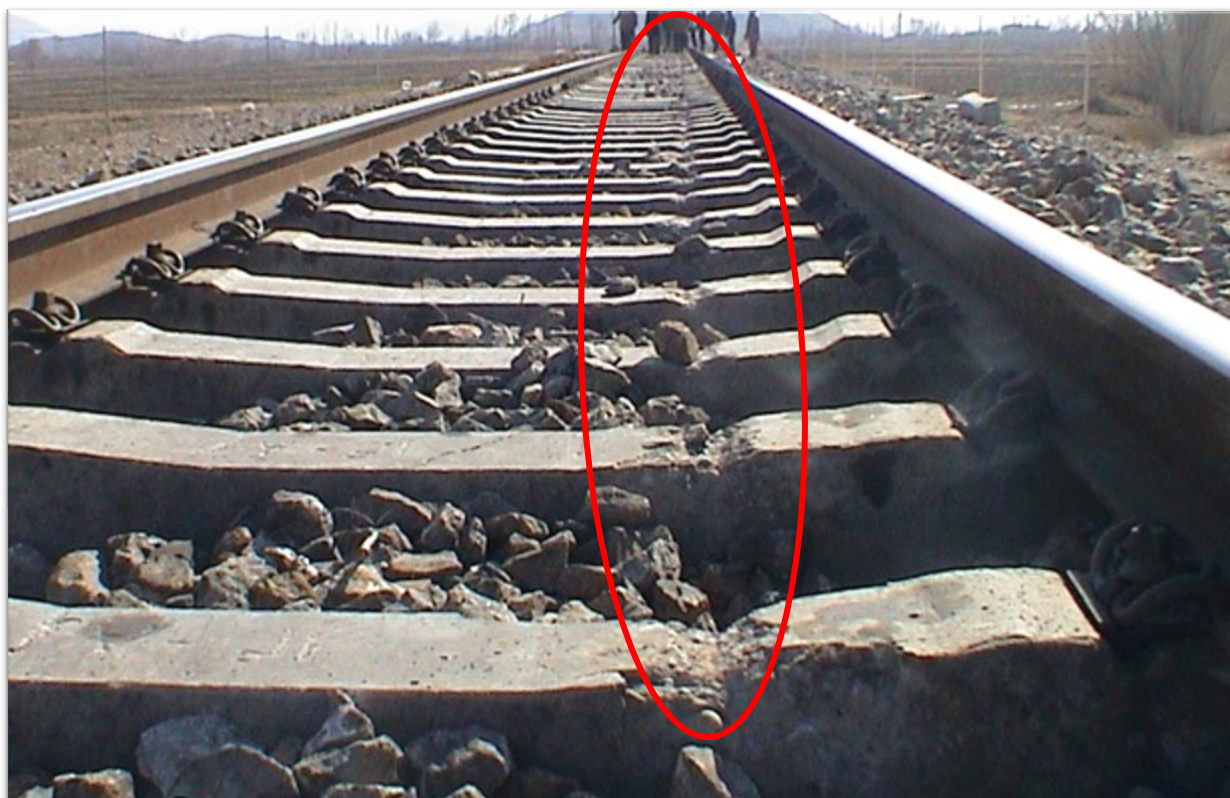
Figure 2-23: Derailment Damage from Wheel Dropping on the Gauge Side (Zakeri & Rezvani, 2012)

Damage to a sleeper due to a derailment is typically seen in two places; on the gauge side of the rail as a train wheel drops on the sleeper, or on the field side of the rail where the train wheel has climbed over the rail before dropping on the sleeper. The manner and severity of the derailment may result in thousands of sleepers requiring replacement (Taylor, 2010). This is seen within the South African industry, as well as globally such as the derailment in New Zealand described by Taylor (2010) where two loaded coal wagons derailed but travelled undetected for 17 km resulting in the damage of 20 000 concrete sleepers. Figure 2-24 shows an example of damage created by a wheel dropping to the gauge-side of the rail.

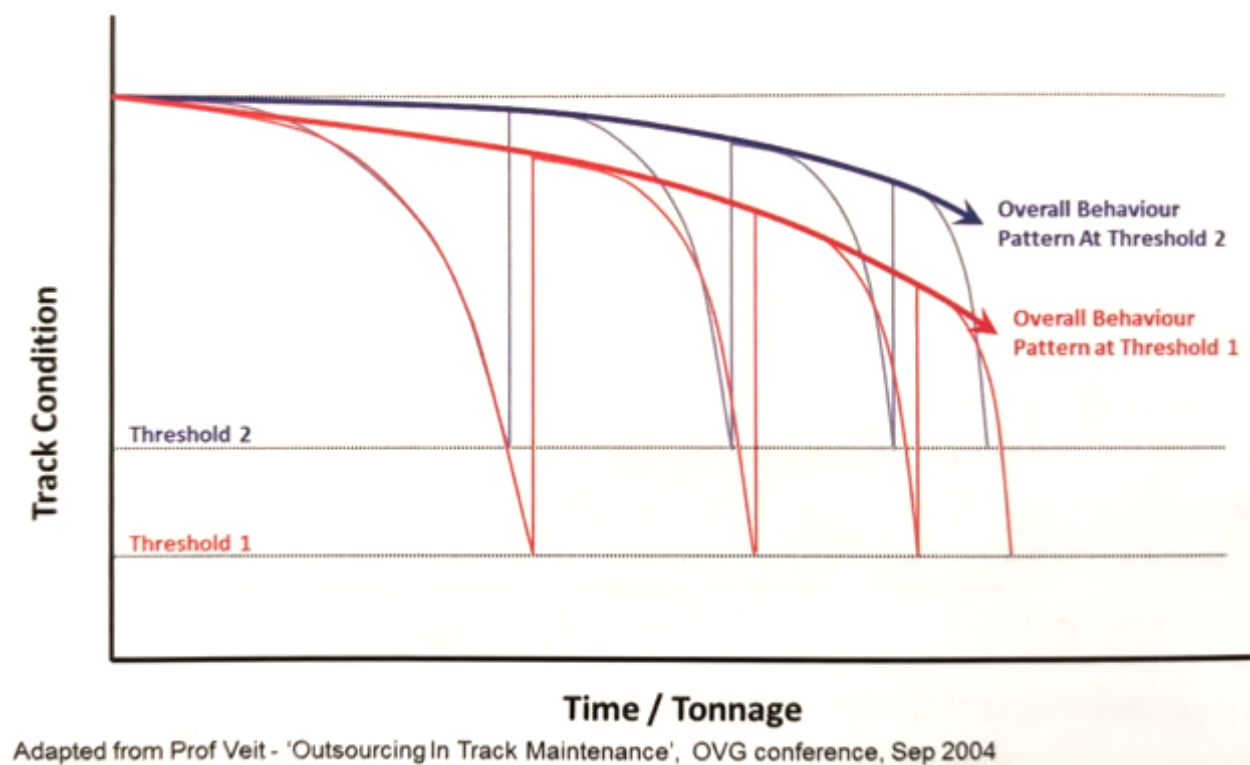
Figure 2-24: Example of Track Behaviour with Different Thresholds (Zaayman, 2013)

Figure 2-25 shows an example of how setting maintenance thresholds can affect the overall pattern of track behaviour.

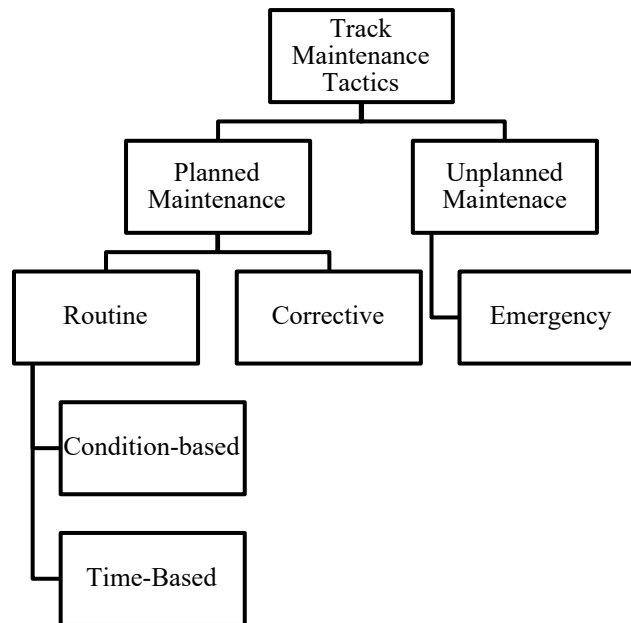
Figure 2-25: Maintenance Tactics Diagram (Zaayman, 2013)

Track maintenance tactics as a whole fall into two main categories: planned and unplanned maintenance. Figure 2-26 shows an overview of the structure.

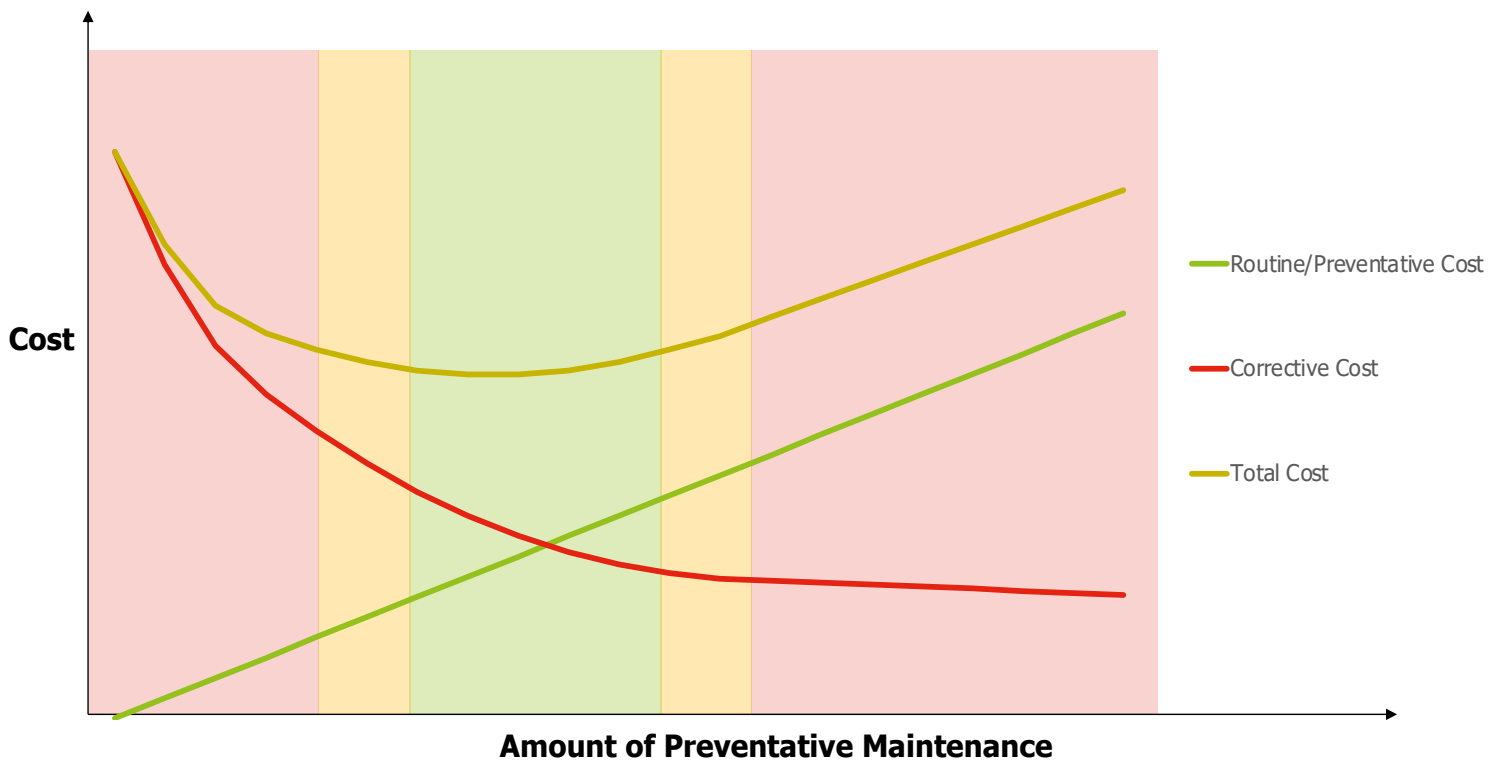
Figure 2-26: Preventative vs. Corrective Maintenance Costs Adapted from Douglas (2017)

Ideally the track system should employ a balance of planned and unplanned maintenance to optimize cost, while operating at an acceptable level of risk. Erring at either end of this spectrum will see a rise in direct or indirect cost of operations. Figure 2-27 shows how a typical track system balances routine and preventative maintenance costs.

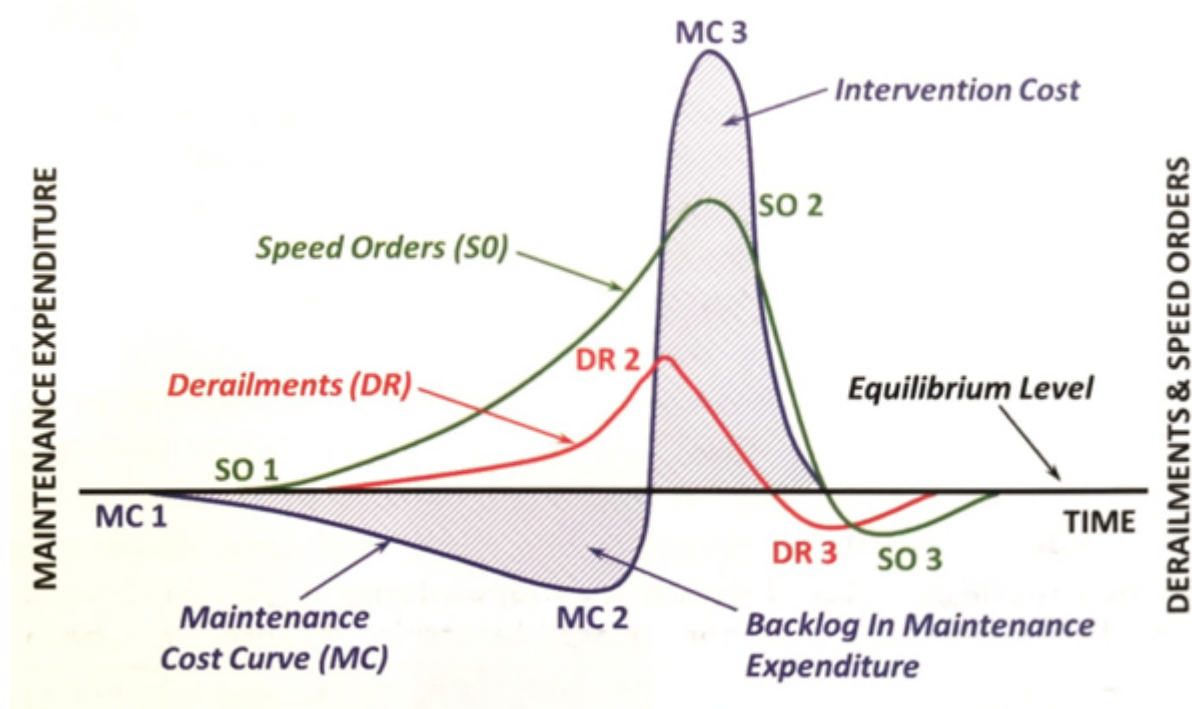
Figure 2-27: Maintenance Cost Curve of an Under-Invested Network (RT-CAP Project, courtesy of Plasser South Africa) (Zaayman, 2013)

Figure 2-28 illustrates how an under-invested system will see an increase in speed restrictions (speed orders) and derailments, up until a point where a maintenance injection (MC2) is required to mitigate further losses.

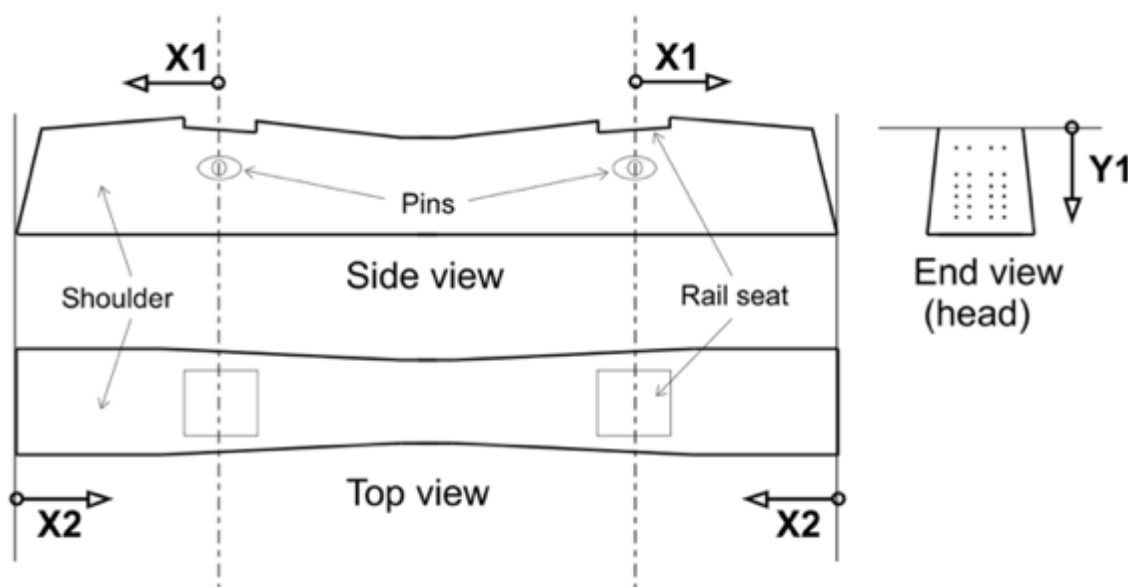
Figure 2-28: Sishen to Saldanha ASR Cracking Axes of Identification (Grabe & Oberholster, 2000)

Walking inspections are more suited to areas that have already been identified as concerns. The ASR cracking on the Sishen to Saldanha line used manual categorization that allowed detailed information on crack widths and location. Figures 2-29 and Table 2-5 show how this assessment used categorised the defects and their corresponding locations.

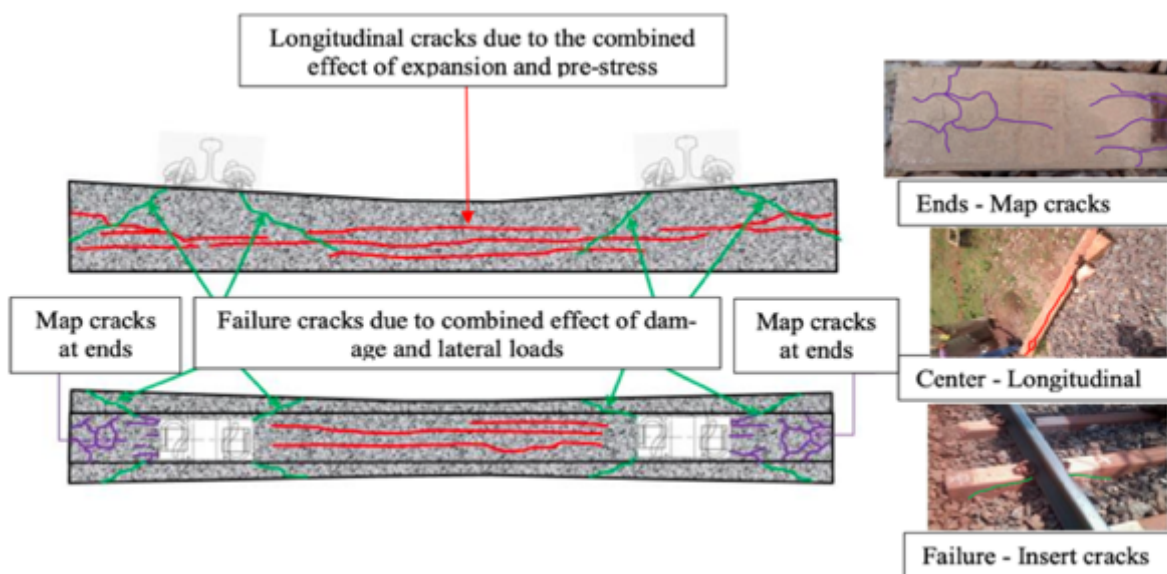
Figure 2-30: Typical Cracking Inspection due to ASR and DEF at the Indian Railways (Sundaram, et al., 2018).

Similar assessments, as in Figure 2-31, have been conducted manually through visual methods, such as on the Indian Railways. These have been similarly successful at categorizing small sections of track and better understanding the challenges in order to plan maintenance and corrective tactics.

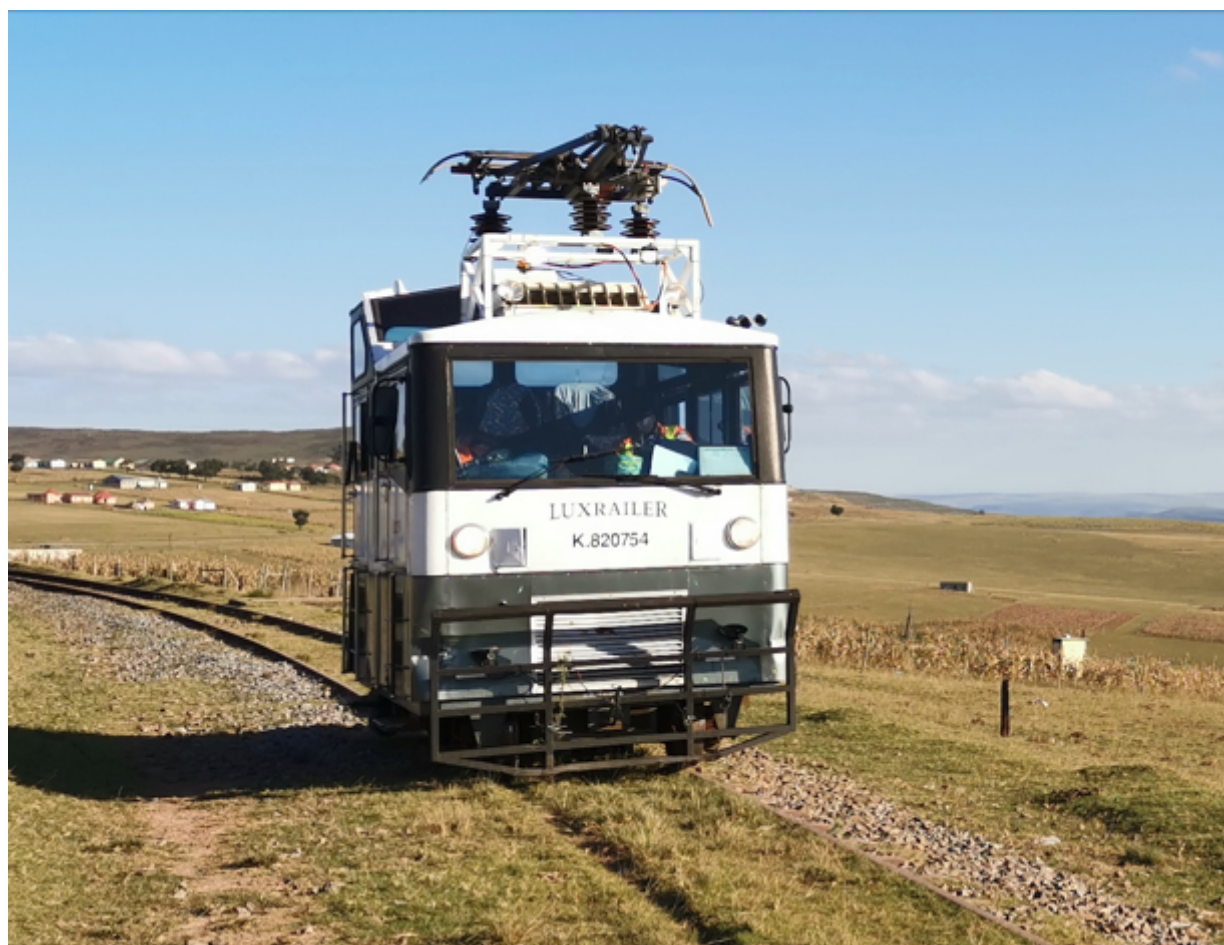
Figure 2-31: LuxRailer Inspection Trolley (Photo by Author)

Visual inspections can be done more quickly using a rail-mounted vehicle instead of walking. An example of a rail-mounted inspection vehicle is seen in Figure 2-32.

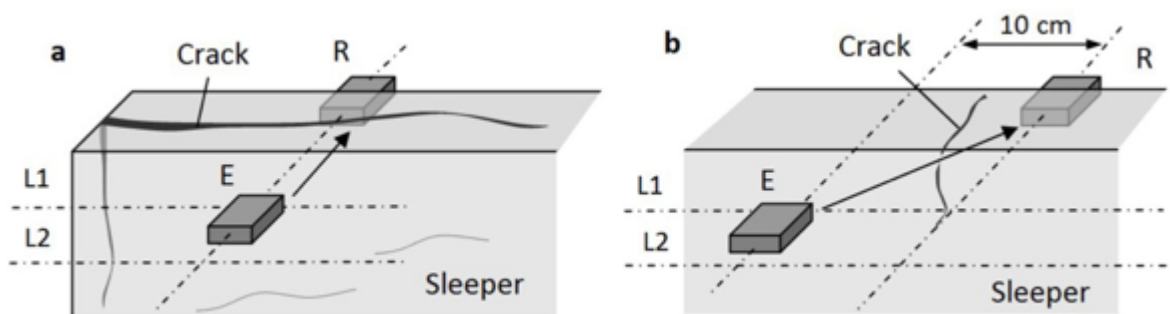
Figure 2-34: Diagram of Testing Arrangements to detect cracks in the Latvian Railway Network (Tatarinova et al., 2018)

Singular testing methods are possible using classic concrete testing, such as the crack mapping shown in Figure 2-34 and illustrated in Figure 2-35.
