Condition Assessment Methods for Prestressed Concrete Railway Sleepers: Feasibility for South African Applications

FOR PARTIAL FULFILMENT OF THE MASTER OF ENGINEERING SPECIALIZING IN CIVIL INFRASTRUCTURE
MAINTENANCE MANAGEMENT

Author: Engineer Astrid Lambrechts
University of Cape Town

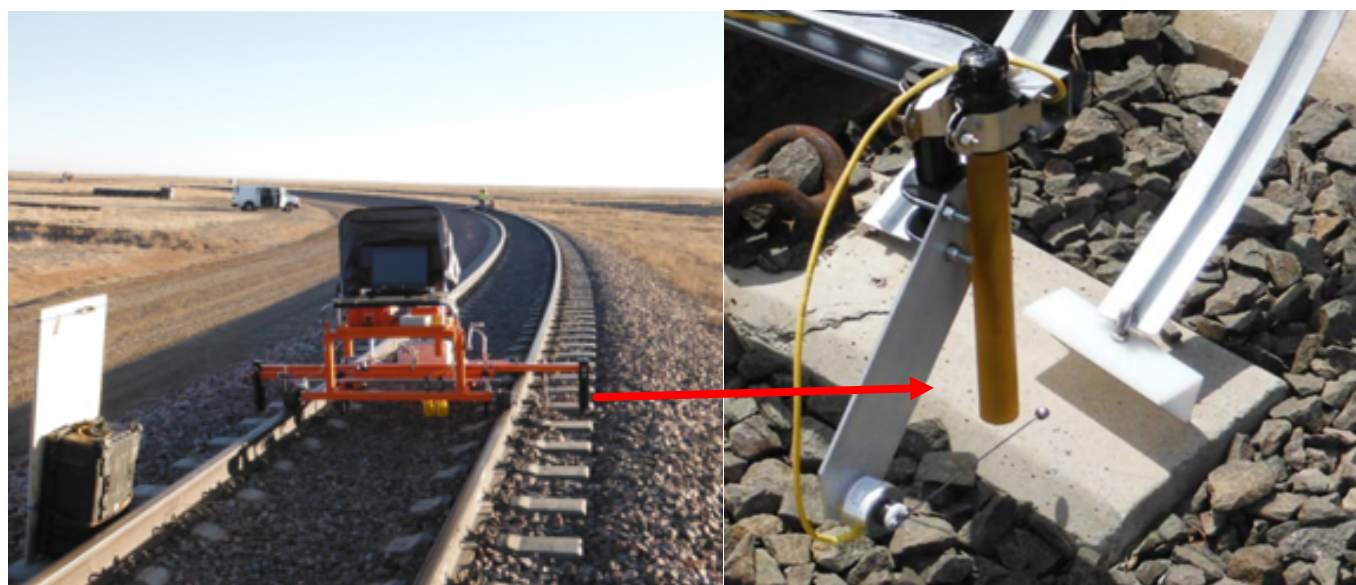
Figure 2-35: Ultrasonic Rail-Mounted Sleeper Assessment, Left; Ball-end tapper Inducing Pulse on Sleeper End, Right (Federal Railroad Administration, 2018)

The American Railroad Federation has put forward a railroad vehicle-mounted ultrasonic configuration that uses a ball-end tapper to induce a pulse and then measures Raleigh waves to identify cracks in the sleeper. Raleigh waves are tested within a range of 20 kHz, and this method shows optimum results at 17 kHz using a -58 DBV/microbar. Figure 2-36 shows the prototype of the fully mounted device, with the ball end tapper shown closer in the image on the right.

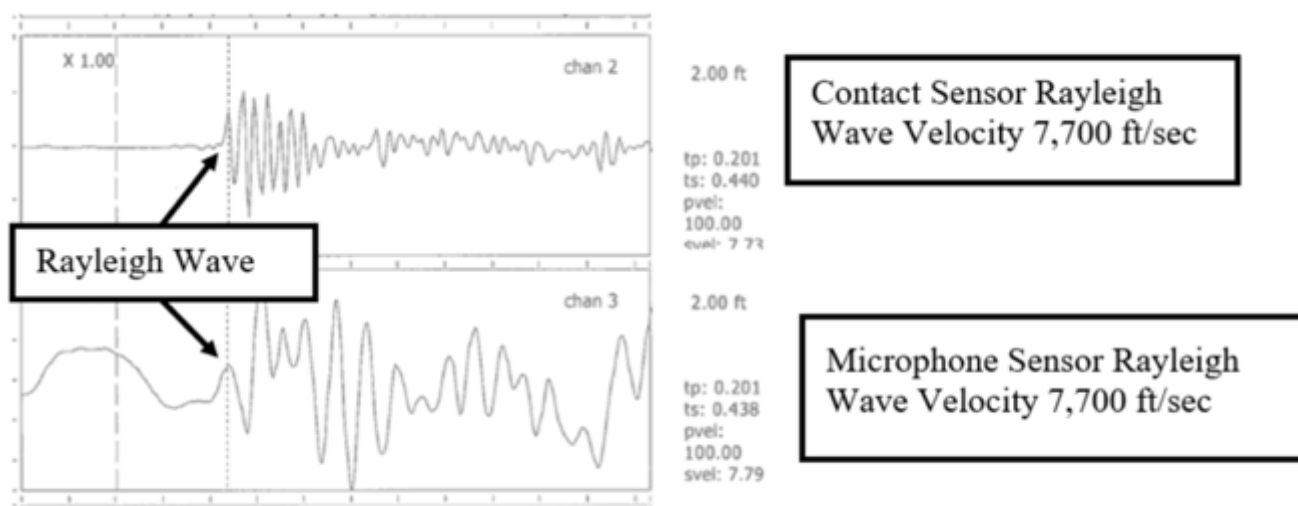
Figure 2-36: Raleigh Wave Sensor Response Testing for Concrete Sleepers (Federal Railroad Administration, 2018)

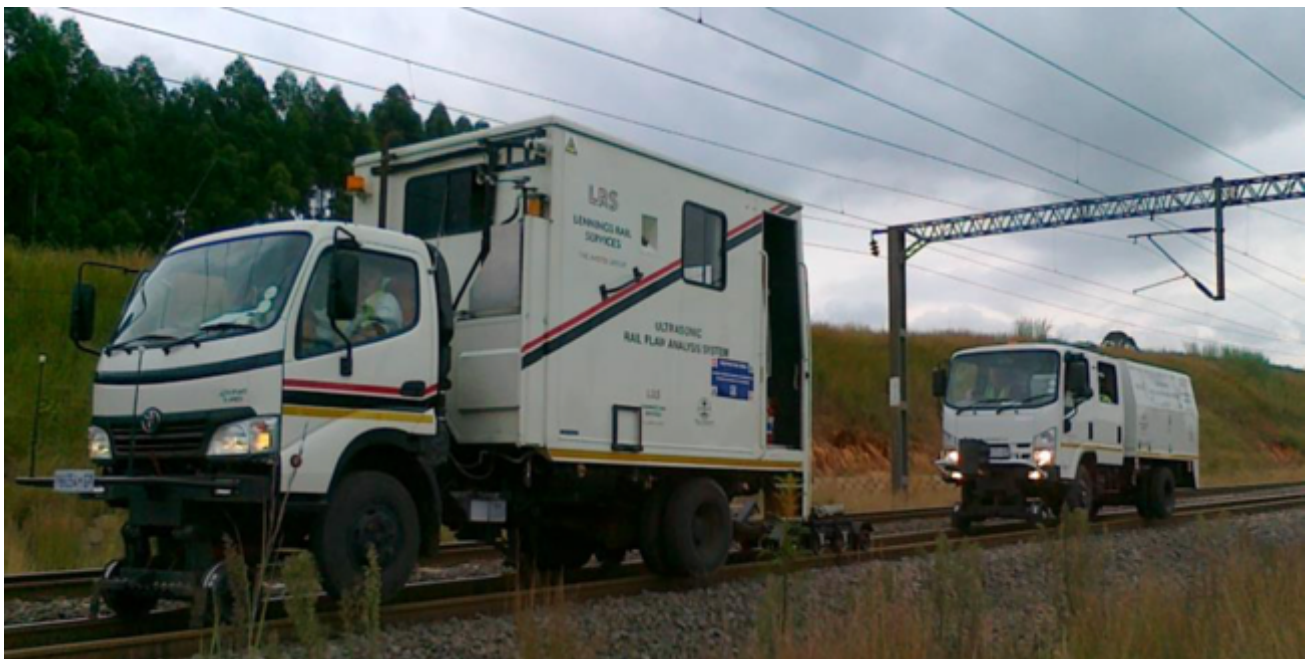
Figure 2-37: Ultrasonic Rail Testing Vehicle and Chaser (Lennings Rail, 2020)

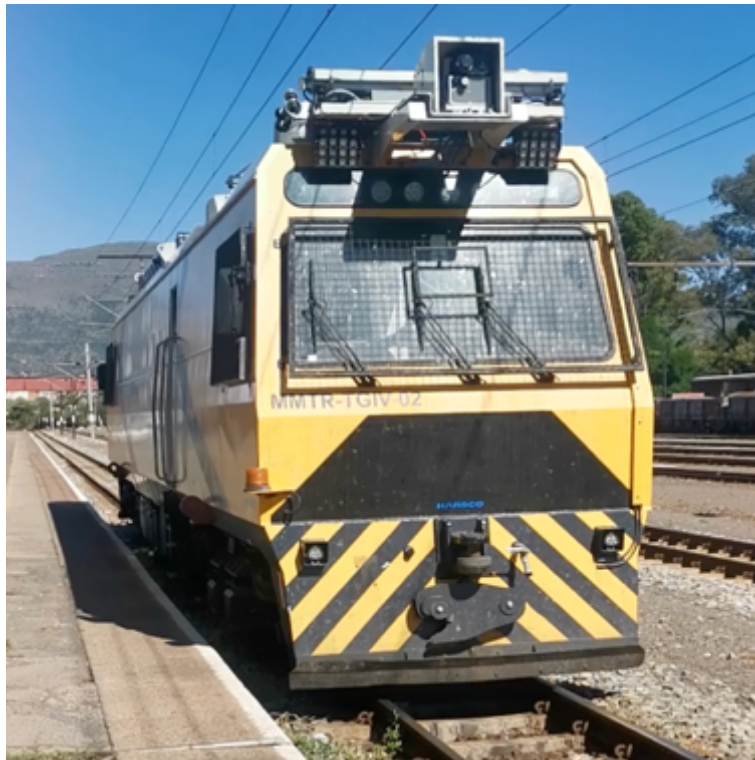
Figure 2-38: Infrastructure Measuring Vehicle near Queenstown (TGIV) (Photo by Author)

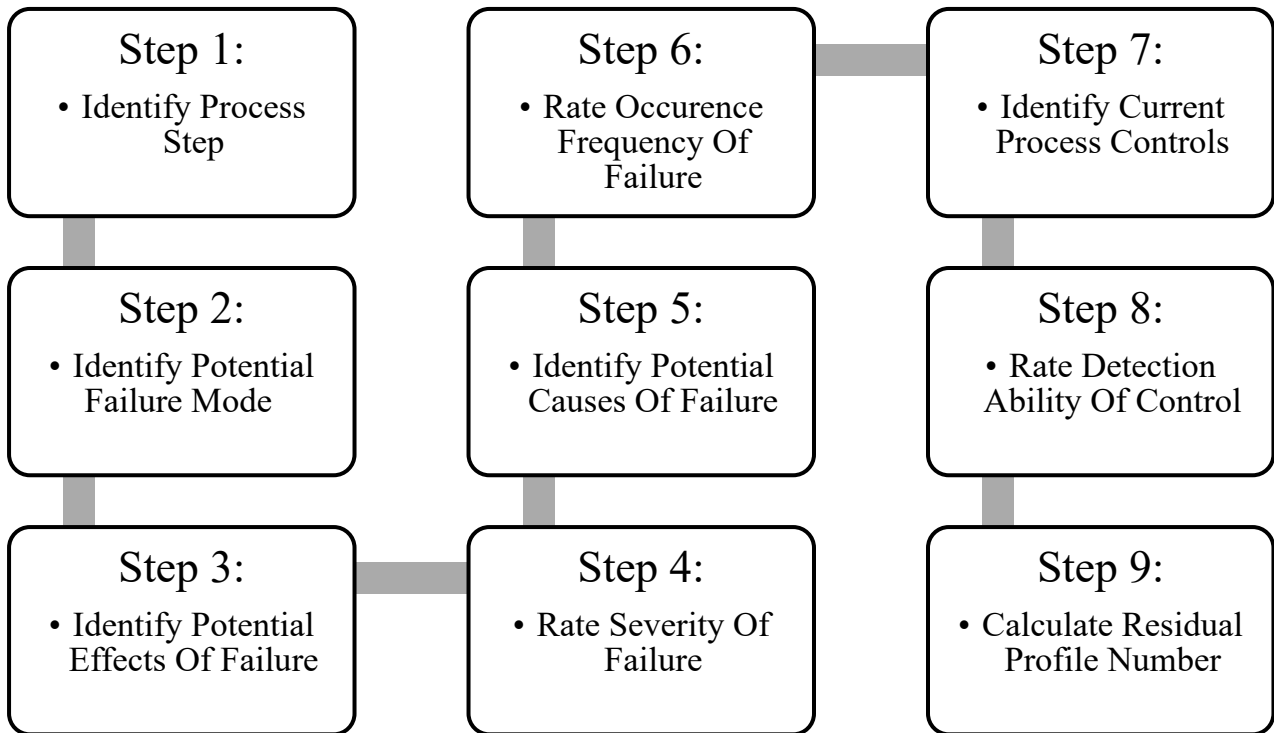
Figure 3-1: Failure Mode and Effect Analysis Process

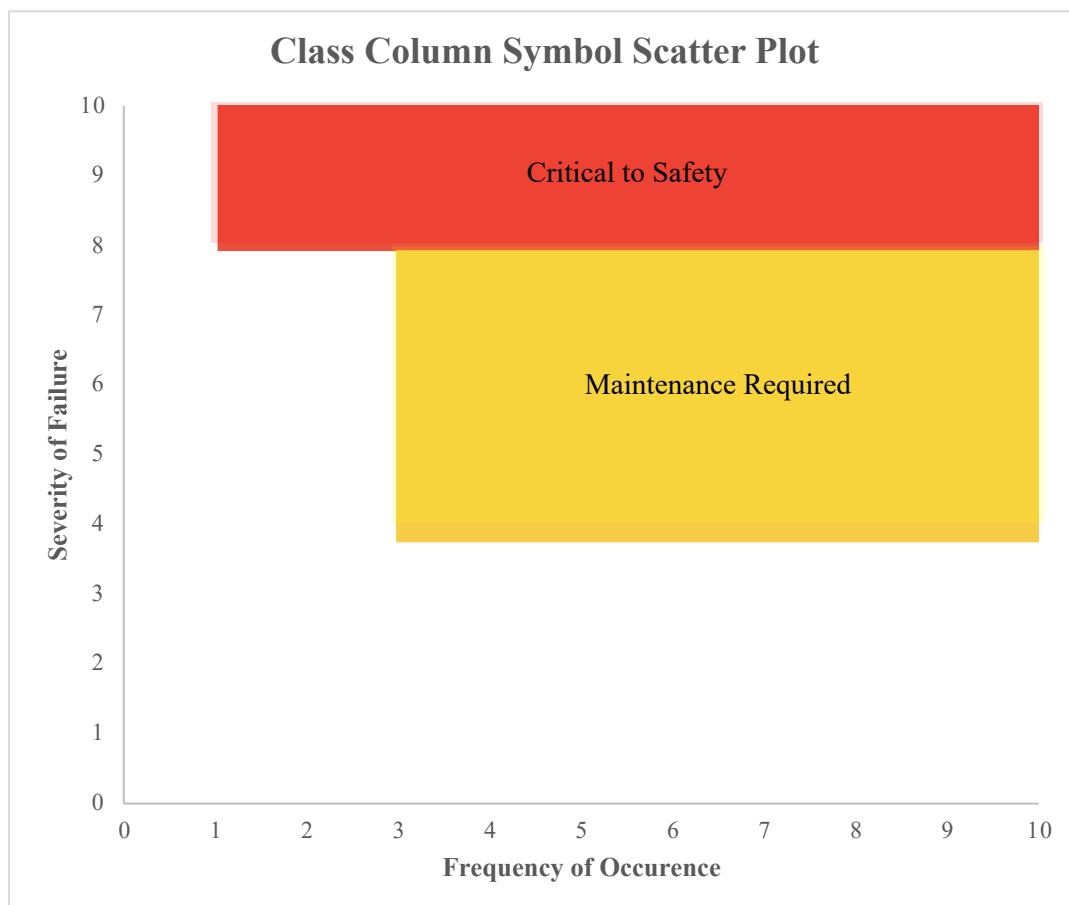
Figure 3-2: Example of Class Column Symbol Diagram Adapted from Harpster (2024)

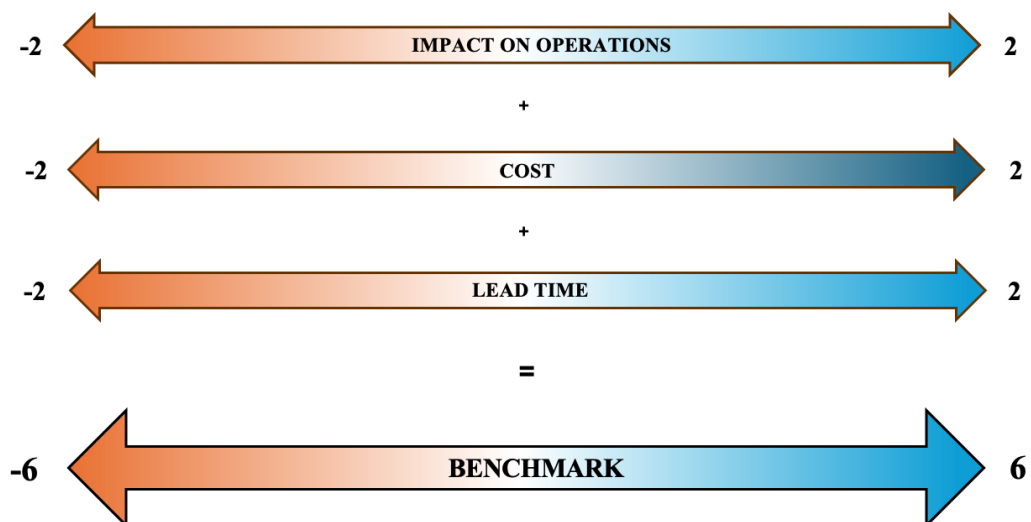
Figure 3-4: Illustration of benchmarking rating scales for condition assessment methods

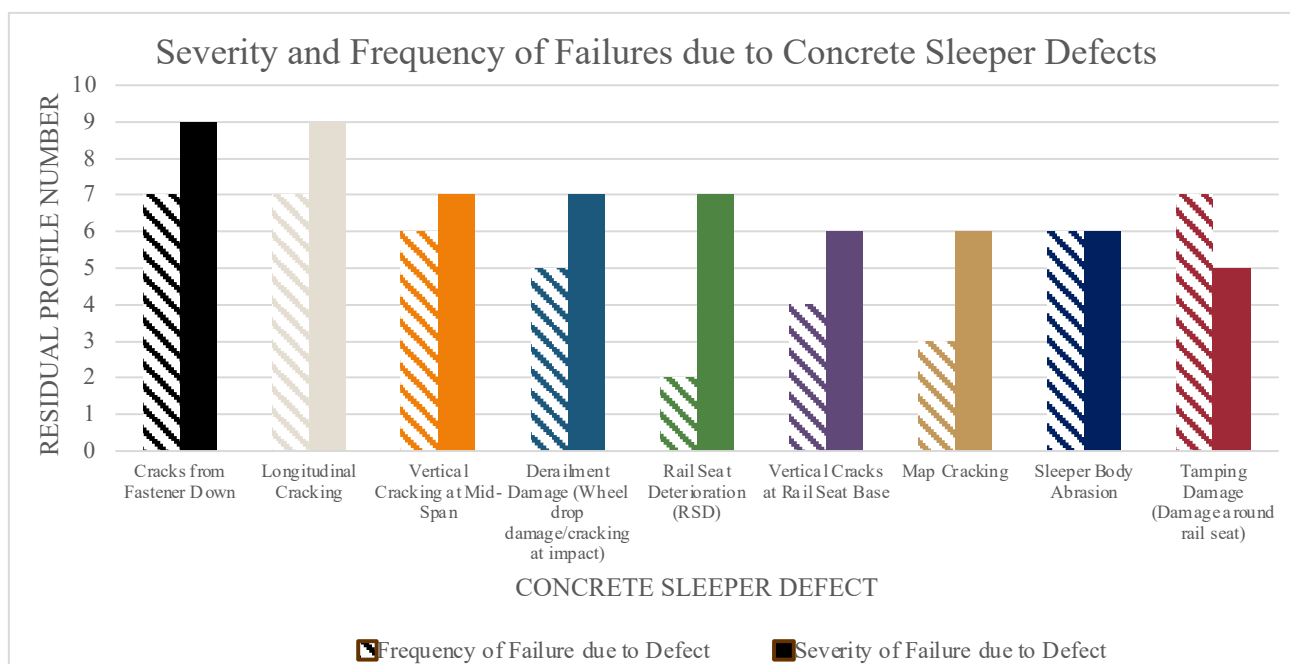
Figure 4-1: Severity and Occurrence of Failures per Concrete Sleeper Defect

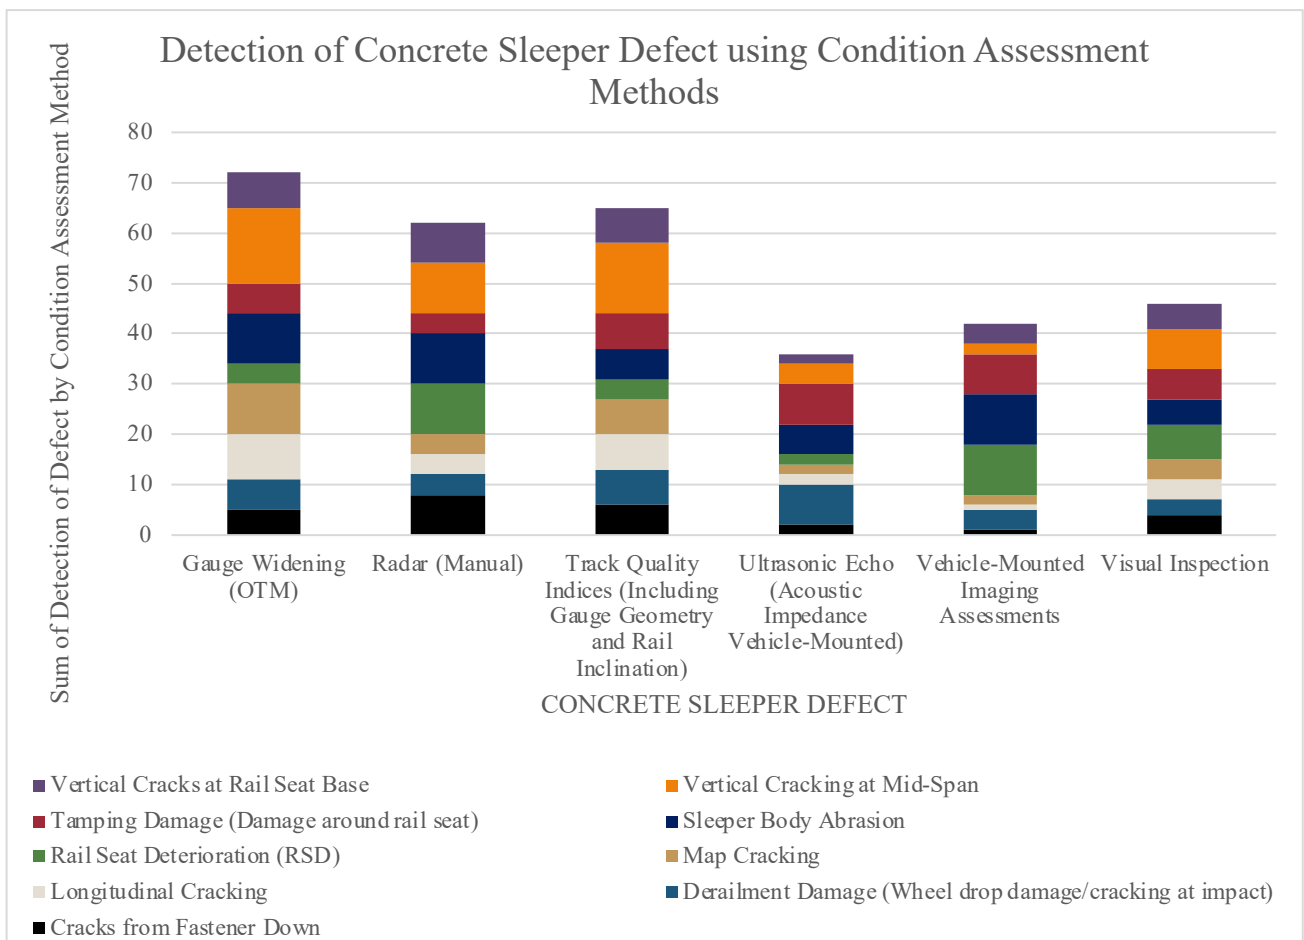
Figure 4-2: Detection of Concrete Sleeper Defects using Condition Assessment Methods

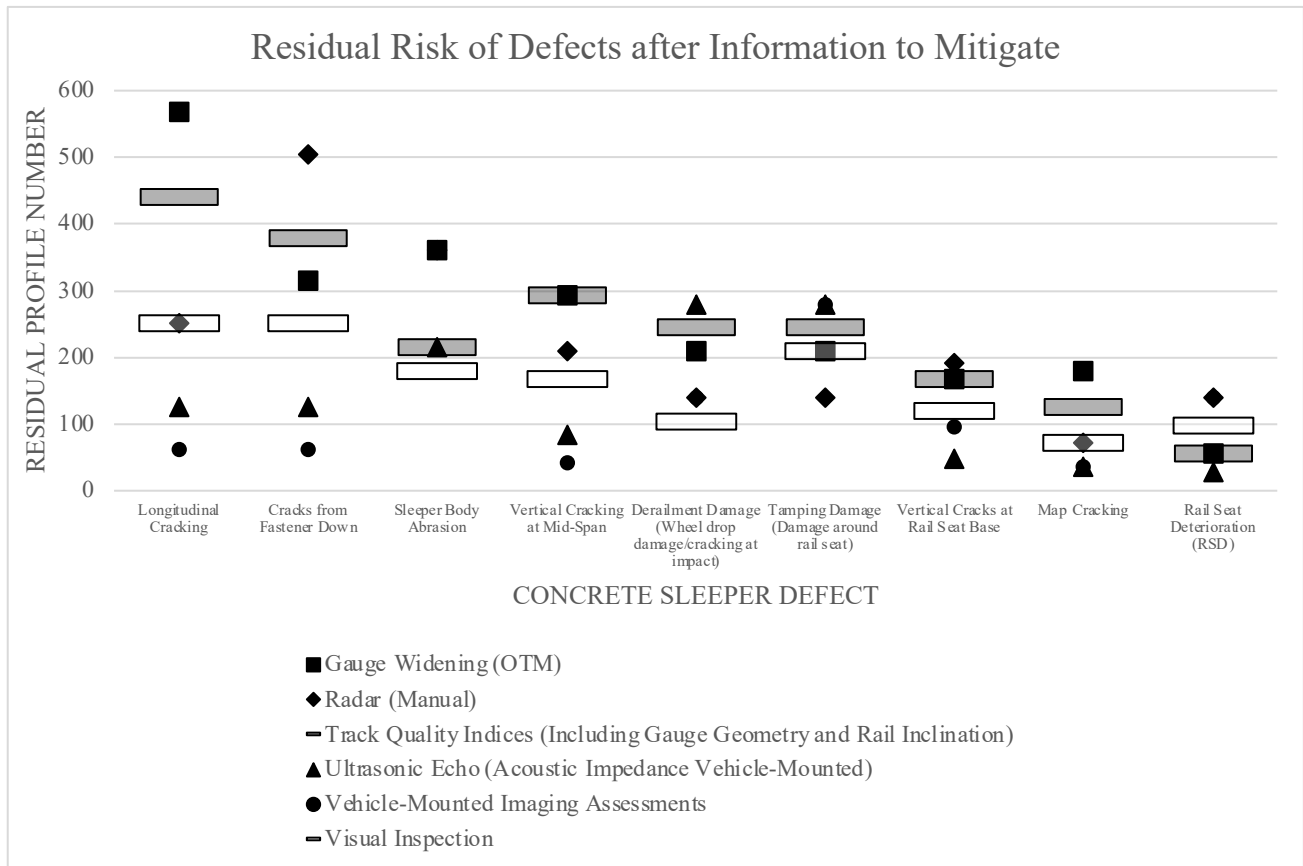
Figure 4-3: Residual Risk of Concrete Sleeper Defect after Information to Mitigate

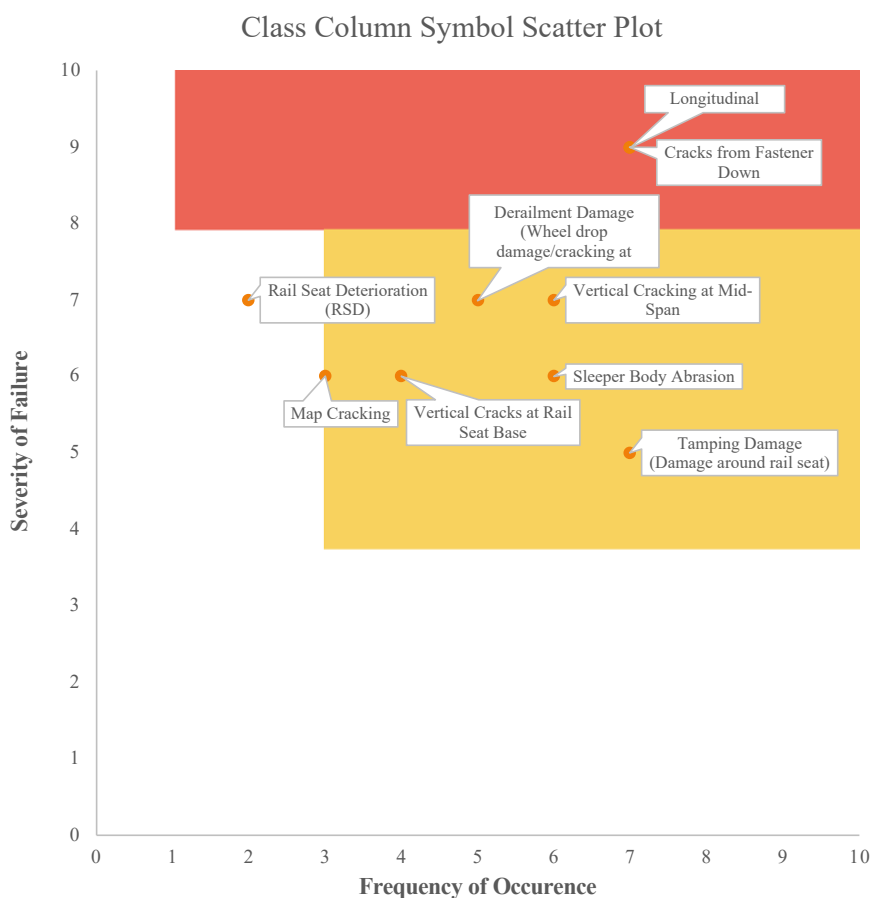
Figure 4-4: Class Column Symbol Scatter for Concrete Sleeper Defects

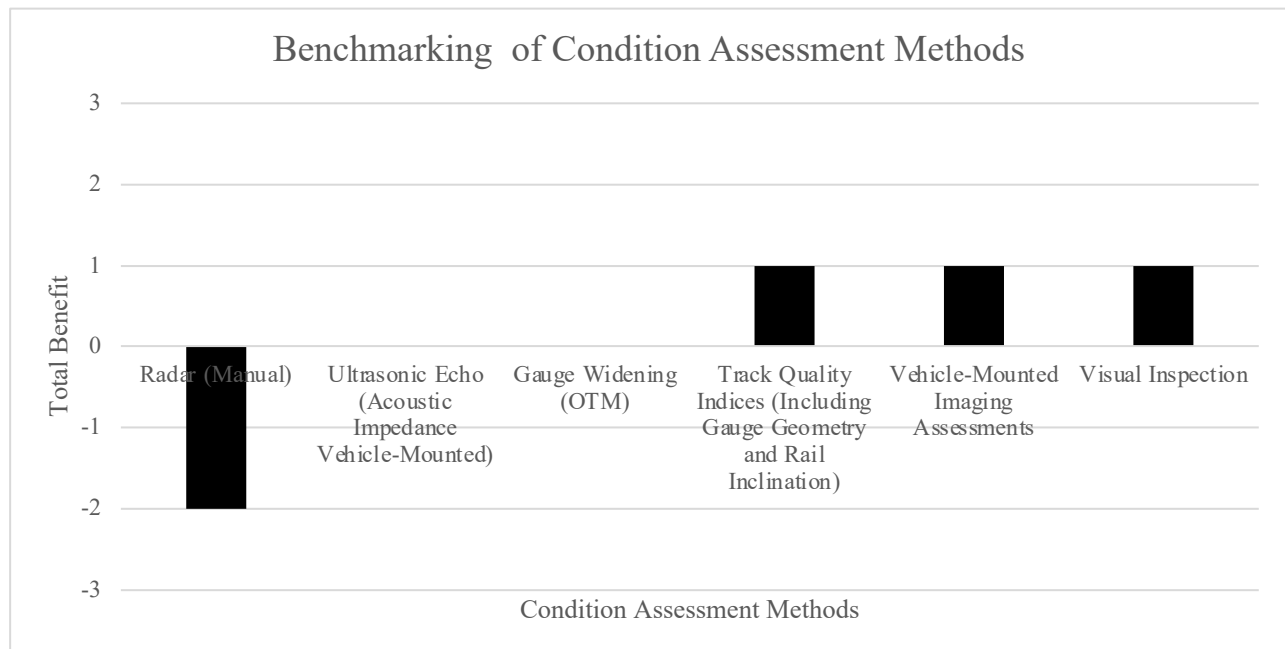
Figure 4-5: Benchmarking of Concrete Sleeper Condition Assessment Methods
