**Analysing the road reserve encroachment in Maseru  
Lesotho using remote sensing and image analysis**

*MSc Dissertation*

*Faculty of Engineering & the Built Environment*

*Geomatics Division*

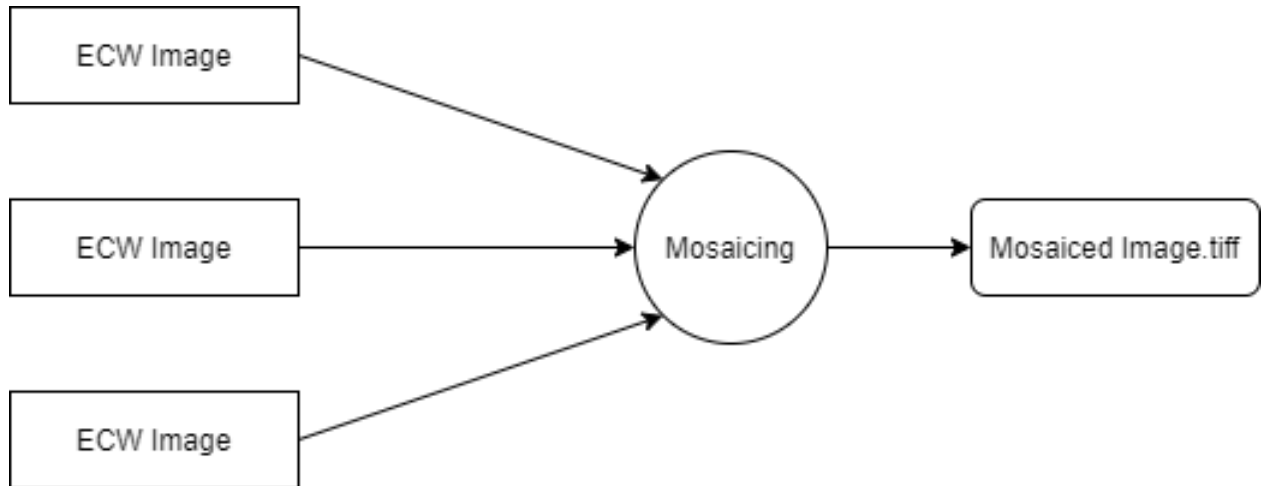
Figure 3.3: Data mosaicing process the study followed. The input was the series of images in ECW image format. They were mosaiced together to make bigger single image.

Figure 3.3 below shows the stages of image enhancement that the study used. The images that were collected from NGI were ECW format and they already had WGS 84 coordinate system so they were mosaicked together using ArcGIS software and the final image format was Tiff file.

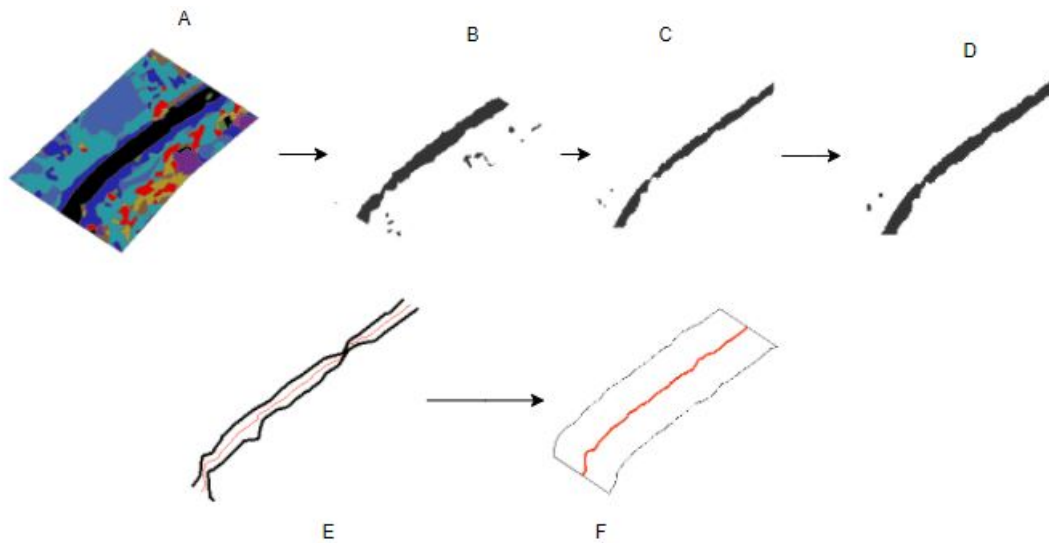
Figure 3.14: This is a Morphological process followed. (A) shows the classified image where the road will be extracted from, (B) shows the extracted road layer that was then taken in erosion as input, (C) this is the erosion process where extracted road layer is processed to remove misclassified objects and peninsulas. (D) the dilation process expands the boundary of the eroded object. (E) The output of the dilation process was converted from raster to vector (polygon), then a tool Collapse dual line to a line. Here the polygon was used to find the centerline of the polygon. (F) The centerline here was used to find the road reserve, it was buffed to 10 meters.

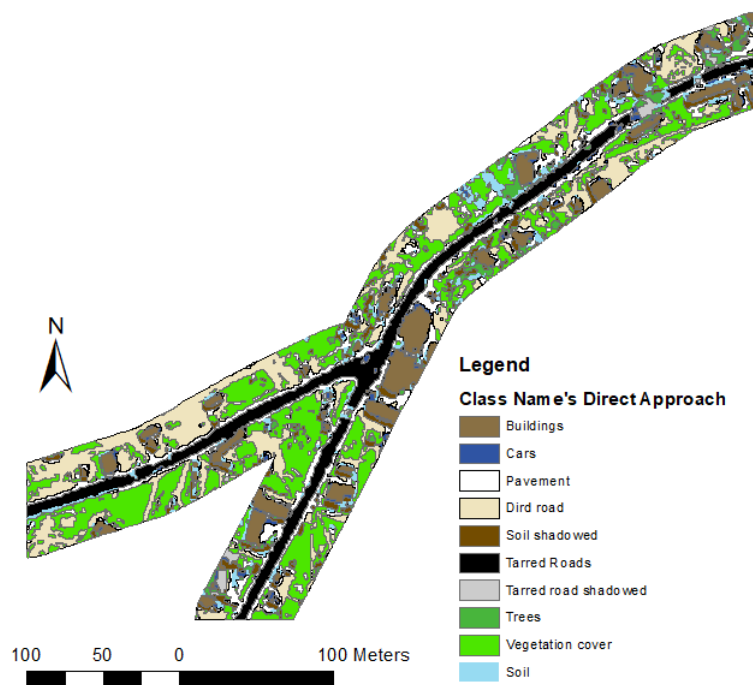
Figure 4.1: Direct Approach Goaling land use of 2015. The classes shown here are buildings, cars, pavement, dirt road, soil shadowed, tarred road, tarred road shadowed, trees, vegetation cover and soil.

In this area, the objects that are found to have encroached the road reserve in 2015 and 2017 were classified using the Maximum likelihood supervised classification. The direct approach looked for every object that was in the road reserve at a particular point in time and 10 classes were identified. The assumption here was that there was more ground than encroachment. The (figure 4.1) below shows the Qoaling land use in 2015 and (figure 4.2) shows Qoaling land use in 2017.

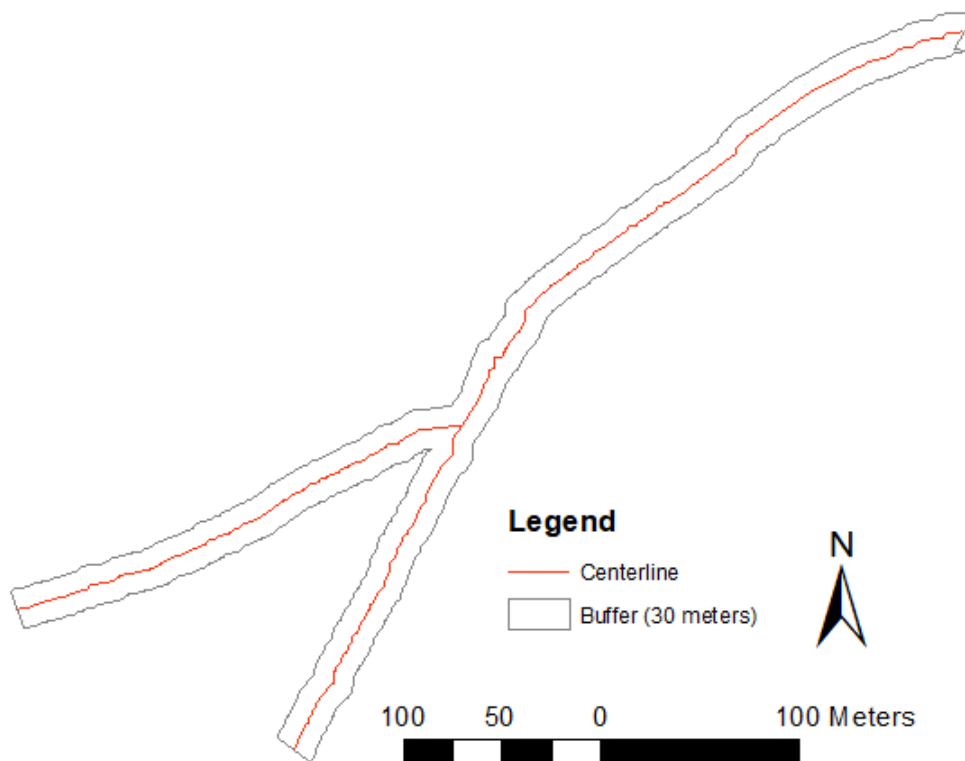
Figure 4.4: Qoaling road centerline created using morphological processes called erosion and dilation. Show here are the centerline and the road reserve used by direct method.

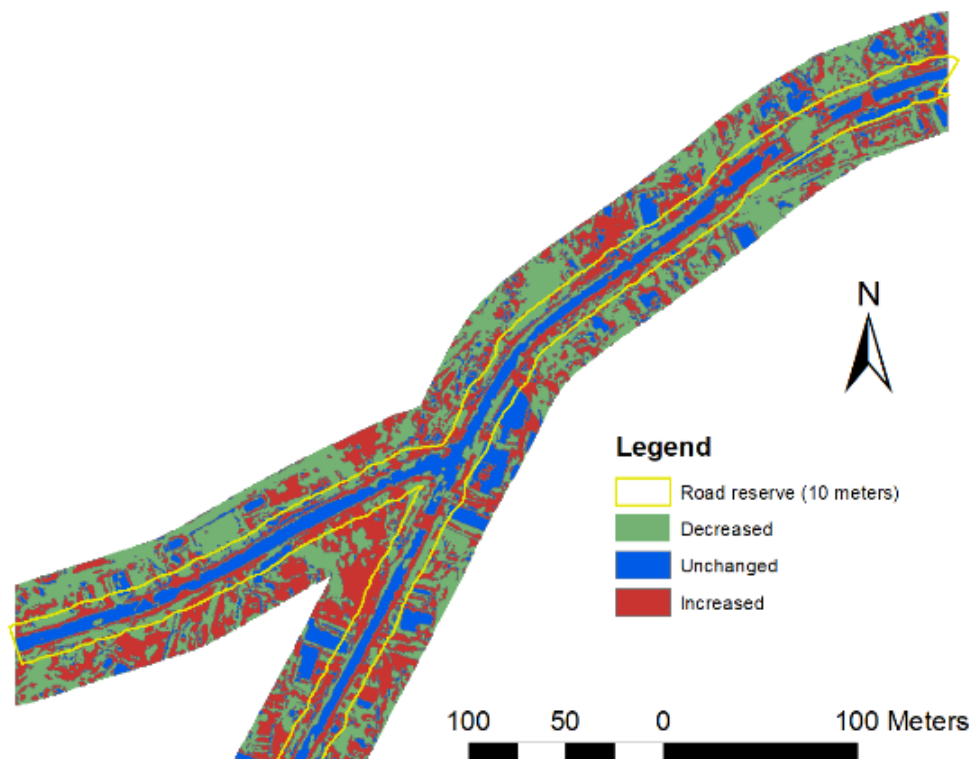
Figure 4.5: Goaling direct approach method to testing accuracy of change detection. The road reserve from the morphological process is overlaid on change detection map to see its accuracy.

The results of the change detection were overlaid with the road reserve shown in (figure 4.5). It shows the objects that declined in green and those that increased in red. The objects that did not change were shown in blue between 2015 and 2017. It shows that the road reserve boundary of 10 meters in yellow colour and all the buildings that are found to be in the road reserve, which is 10 meters on both sides of the road from the centerline.

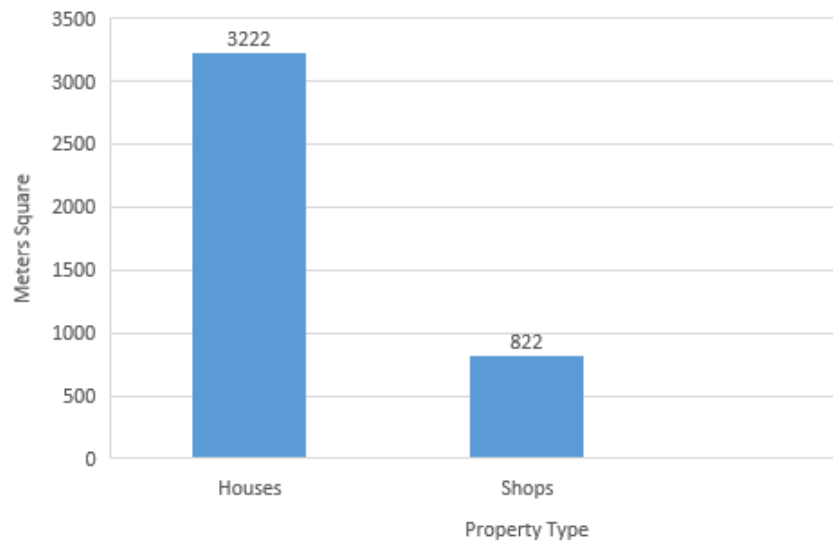
Figure 4.7: Qoaling direct approach results, where the houses encroached the road reserve by 3222 m<sup>2</sup> and the shops encroached by 822 m<sup>2</sup>.

The size of the road reserve affected by encroachment is shown in (figure 4.7) below where property type is put against meters square do determine the area they occupy in the road reserve. The results of the objects found in the road reserve direct classification show that the permanent objects that are in the road reserve are houses and shops. The houses are found to occupy an area of 3222 m<sup>2</sup> while shops occupy an area of 822 m<sup>2</sup>. This shows the road reserve that has been encroached by buildings in Qoaling to be a total area of 4044 m<sup>2</sup>.

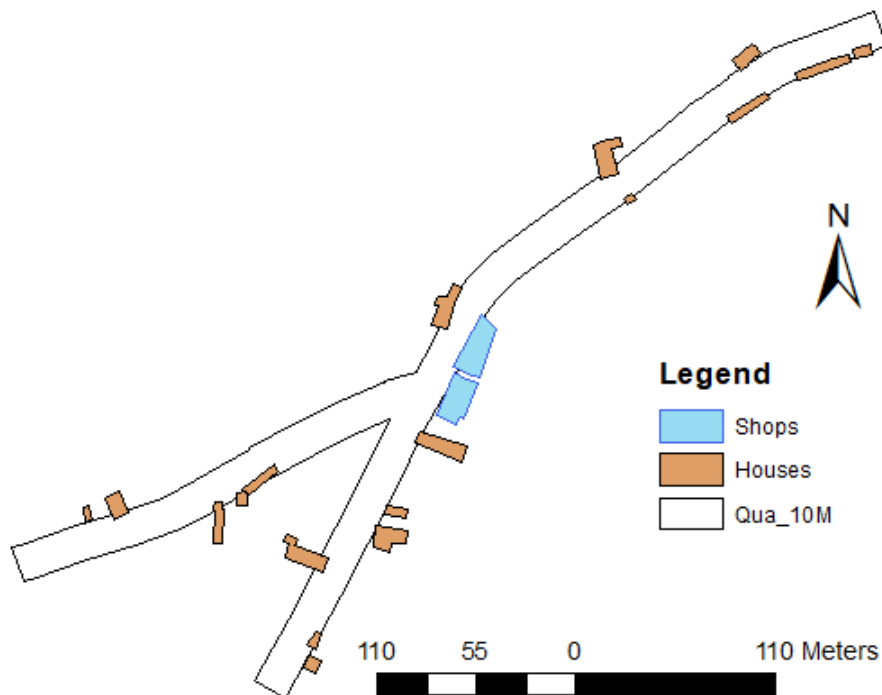
Figure 4.13: .Qoaling indirect road reserve encroachment shows the permanent digitized objects that have encroached the road reserve, which is shops in sky blue and houses in orange as well as the road reserve which is 10 meters. This shows the number of objects that have encroached the road reserve as 18 houses and 2 shops.

In (figure 4.13) the study digitised houses and shops that were found to be in the road reserve. The buildings were classified using shape analysis into houses shown in orange and shops in light blue. The digitised objects are those that did not change over time and were considered permanent objects. Eighteen houses and two shops that have encroached the road reserve in Qoaling using the Indirect method were digitized.

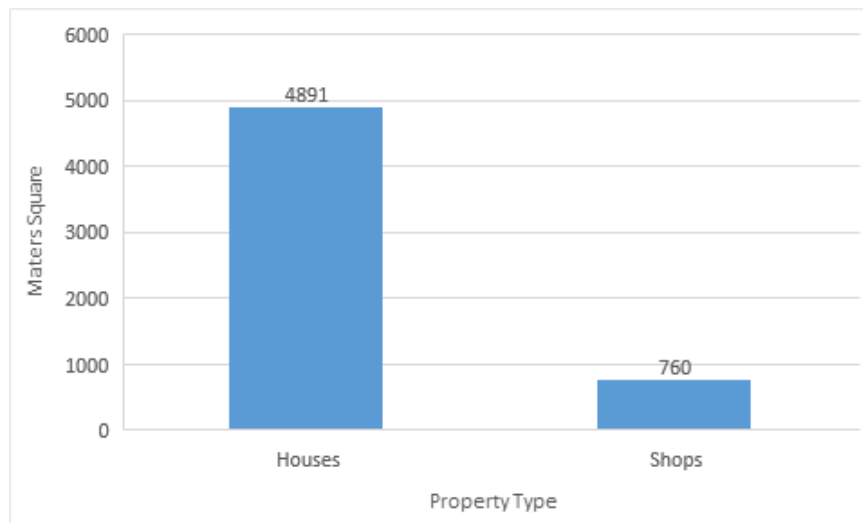
Figure 4.14: Qoaling indirect approach results show houses have encroached 4891 m<sup>2</sup> of the road reserve in Qoaling while the shops have occupied 760 m<sup>2</sup>.

The size of the road reserve affected by encroachment in Qoaling is shown by (figure 4.14) where property type is put against the square meters the properties occupy in the road reserve. The results show that the permanent objects that are found in the road reserve are houses and shopping centers. The houses in the road reserve are found to have encroached on an area totaling to 760 m<sup>2</sup> while the shopping centers have encroached the space of 4891 m<sup>2</sup>. The total road reserve encroached by houses and shopping centers is 5651 m<sup>2</sup>.

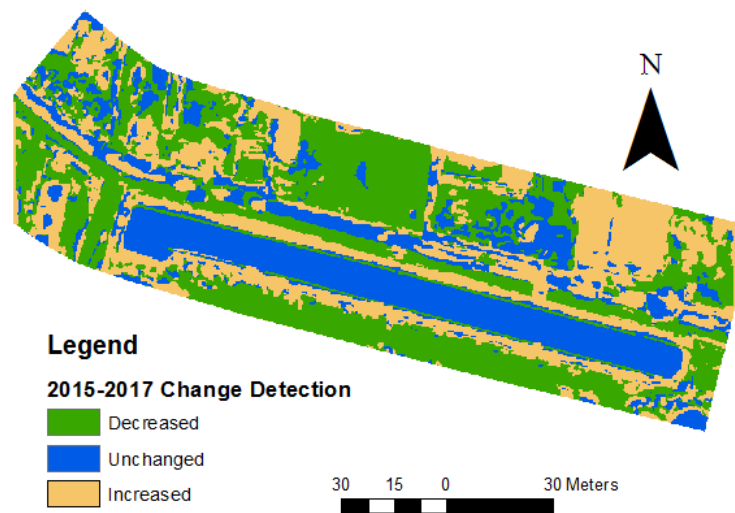
Figure 4.24: Maqalika direct approach Change detection 2015 - 2017 showing areas where there was decrease of encroachment and increase of encroachment. The unchanged objects are shown blue colour.

Figure 4.24 below shows the results of the change in objects in the road reserve that took place between 2015 and 2017 in Maqalika village. They show that some objects decreased in the road reserve, shown in green colour while other objects increased in the road reserve, shown in med yellow. The objects that did not change during this period are shown in blue colour. The objects that did not move over time were identified as buildings and tarred roads. They were easily identified because of image interpretation elements, the road was found to be elongated and the buildings because of their rectangular and square shapes. The buildings were classified further using shape and the study found that there were a shopping center and private houses identified.

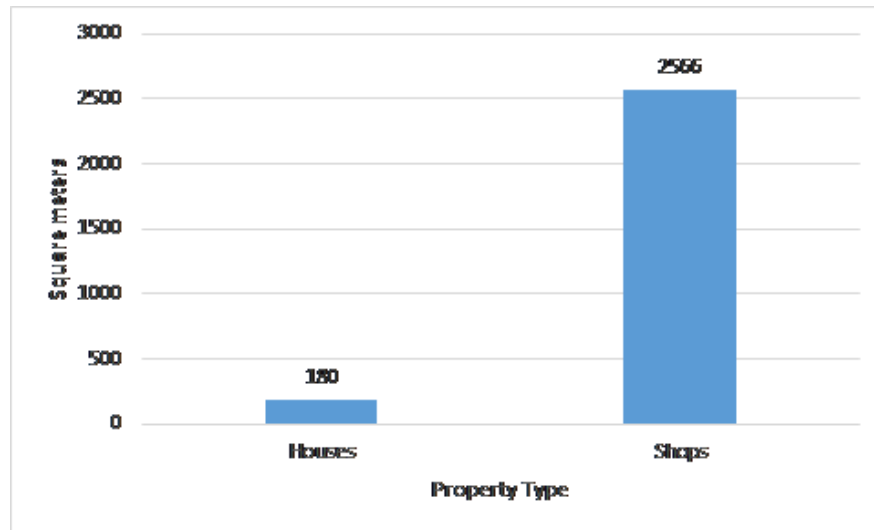
Figure 4.28: Maqalika direct method results showing the area encroached by houses as 180 m<sup>2</sup> and shops encroached an area of 2566 m<sup>2</sup>.

The size of the road reserve affected by encroachment in Maqalika is shown by (figure 4.28) where property type is put against the square meters the properties occupy in the road reserve. The results show that the permanent objects that are found in the road reserve are houses and shopping centers. The houses in the road reserve are found to have encroached on an area totaling to 180 m<sup>2</sup>s while the shopping centers have encroached the space of 2566 m<sup>2</sup>. The total road reserve encroached by houses and shopping centers is 2746 m<sup>2</sup>.

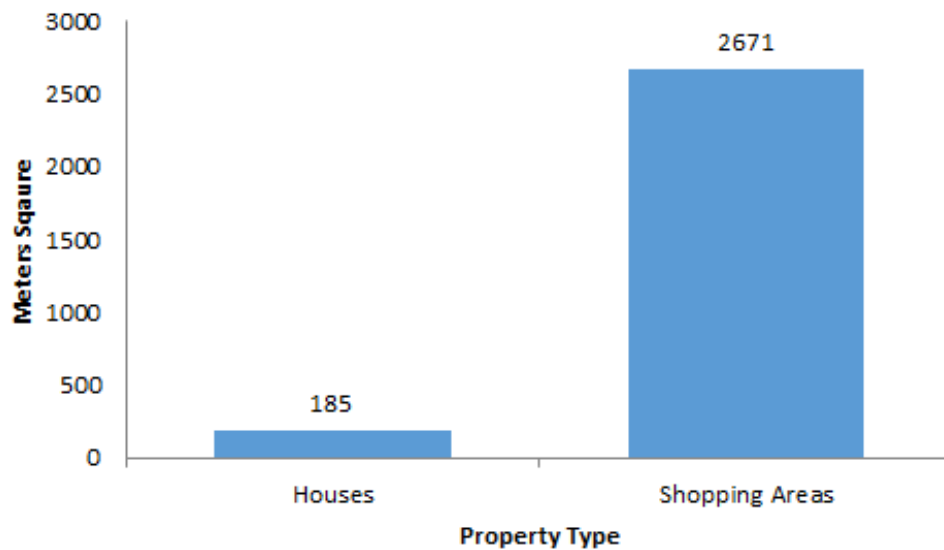
Figure 4.35: Maqalika indirect results showing area encroached by the properties. Houses encroached the road reserve by 185 m<sup>2</sup> and shopping areas/shops by 2671 m<sup>2</sup>.
