# The History, Form and Context of the 19th Century Corbelled Buildings of the Great Karoo

Patricia Anne Kramer

Thesis presented for the the degree of Master of Philosophy  
in the Department of Archaeology  
University of Cape Town

February 2012

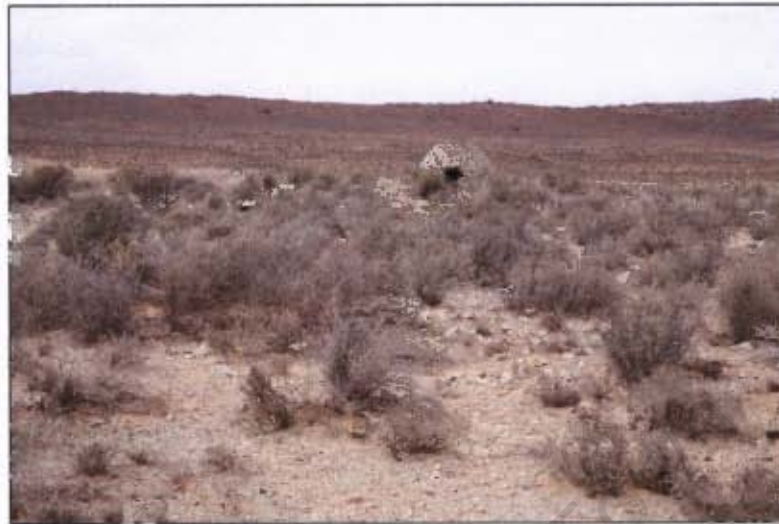
**Figure 1.1** The corbelled building at Koppiesfontein is almost invisible in the surrounding environment.

Corbelled buildings are typical vernacular buildings – they literally rise out of the ground, built from the very materials as the landscape itself, so much so that unless they have been painted white, it is almost impossible to see the buildings, so thoroughly do they merge with their surroundings (Fig. 1.1).

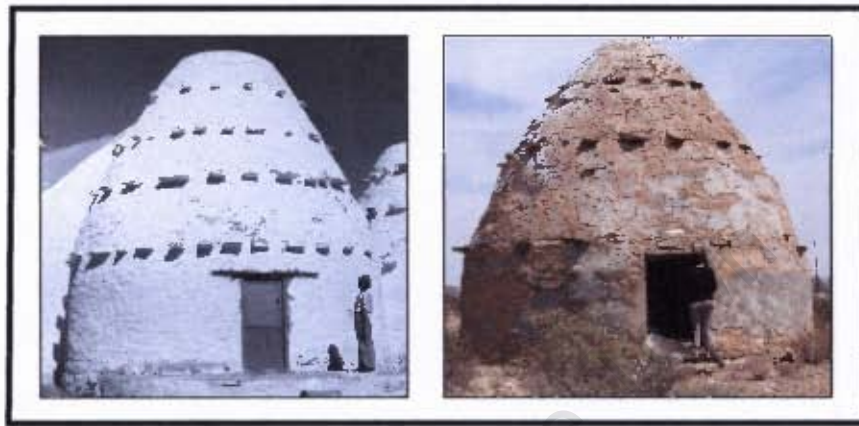
**Figure 2.5** Stuurmansfontein IA (*left*) and Slingersfontein (*right*). (Photograph of Stuurmansfontein: Walton, n.d.).

Figure 2.4 clearly illustrates that there is some relationship between date of grant and the height of the building. The evidence is even stronger if one removes Slingersfontein, the single building in the 1830 group which has a roof height between 6 and 7 metres, for although the grant for Slingersfontein is dated 1838, the style and size of the building point to it being built at a much later date. This is particularly clear because a comparison between Stuurmansfontein IA, (granted in 1874) and Slingersfontein, shows that they are stylistically identical (Fig. 2.5) and they could have been built by the same person.

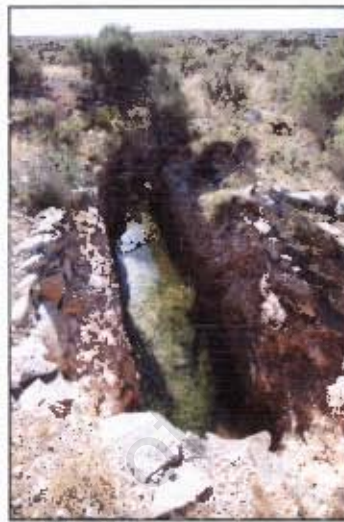
**Figure 3.6** *Put* dug through solid rock at Aasvoelsvlei.

In extreme cases the strategy used to get water was to dig through solid rock using the crude tools available at the time, to find the water table and create a *put*, hopefully with water that was not “brak” or mineralised (Fig 3.6). The quality of the water depends on the concentrations of soluble salts in the rock and in this way the geology determines whether the water is usable or not. Some *puts* were up to four metres deep and getting the water to the surface was a labour intensive and time-consuming problem. Various devices from the simple bucket and rope, to *wipput* (*shaduf*) to the later donkey-driven *bakkiespomp* (bucket pump) were used. The *bakkiespomp* was introduced in the late 1880s and made raising water from the *put* much easier with the result that vegetable gardens could be established more easily (Ferreira, 1986: 66).

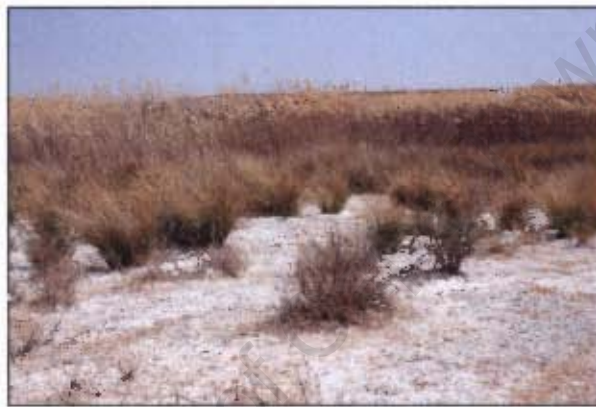
**Figure 3.7** Old crop lands on the aptly named farm Bitterwater. The buildup of salts from the water used for irrigation has rendered the soil unusable.

The geology, apart from influencing the availability of water, also affected the planting of crops. The problem for Karoo agriculture is thin soil and bedrock that lies close to the surface, if not actually on the surface. Most arable soil is alluvial and found adjacent to riverbeds. This soil, however, soon became depleted or rendered unusable due to the buildup of alkaline salts present in the water used for irrigation and arable soil soon became “verbrak” or mineralised (Fig 3.7). One farm near Prince Albert became “verbrak” within 30 years (Judy Maguire, pers.comm.).

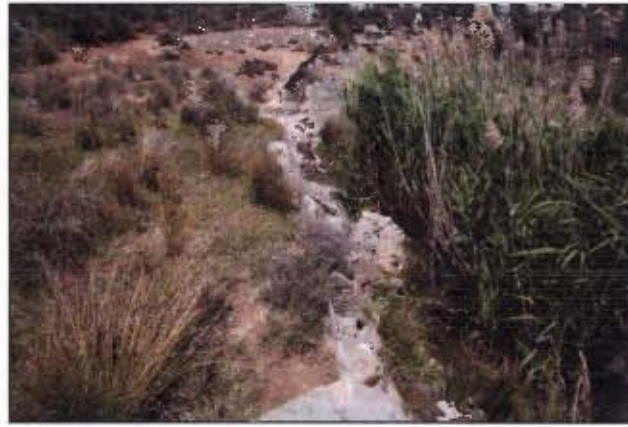
**Figure 3.8** The riverbed at Hondefontein was blocked by a low wall made of flat pieces of stone.

In order to capture and store what little water there was, riverbeds which were usually dry, but flowed after summer rainfall, were dammed from a very early period (Fig 3.8). There is no sign of dams on the 1830 diagrams, but as soon as they were settled on their farm, the farmer would have started to make provision for water by the easiest means possible, that is, by blocking a riverbed. The surveyors' diagrams of the 1860s clearly indicate dams. But dam failure, especially in larger earth dams (Fig 3.9), had dire consequences as the resultant flood of water could wash away alluvial soils next to the river. Thus in one stroke a farmer could lose all his alluvial land. In this way ploughing land in the Karoo to plant crops has “changed the structure and composition of the soil of Karoo habitats and biota” and been a “largely unsuccessful experiment during the first 150 years of occupation” (Dean & Milton, 1999: xxi).

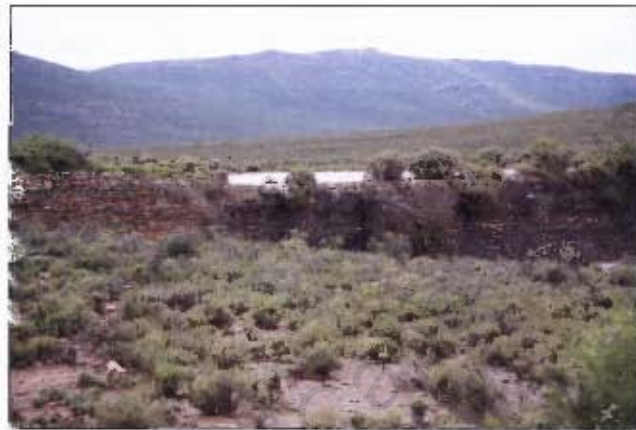
**Figure 3.9** Large earth dam clad with stone built to block the river on Hondefontein.

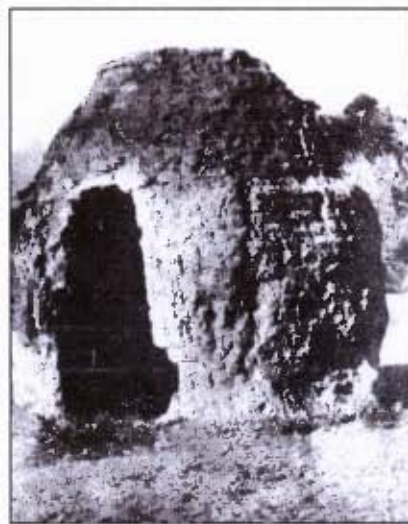
**Figure 4.1** Old photograph of the charcoal kiln on the farm Voorhuis in the Swellendam district. (From: Tomlinson, 1943: 33.)

The trekboers might have been aware of corbelling as a construction technique. Corbelled charcoal kilns were present at the Cape in the 18th century. One such example of a corbelled kiln occurs on the farm Voorhuis in the Swellendam District (Fig 4.1). A replica has been built at the Drosdy Museum in Swellendam (Fig. 4.2), the interior of which clearly shows brick corbelling similar to that in the corbelled building at Rietfontein in the Karoo (Fig. 4.3).

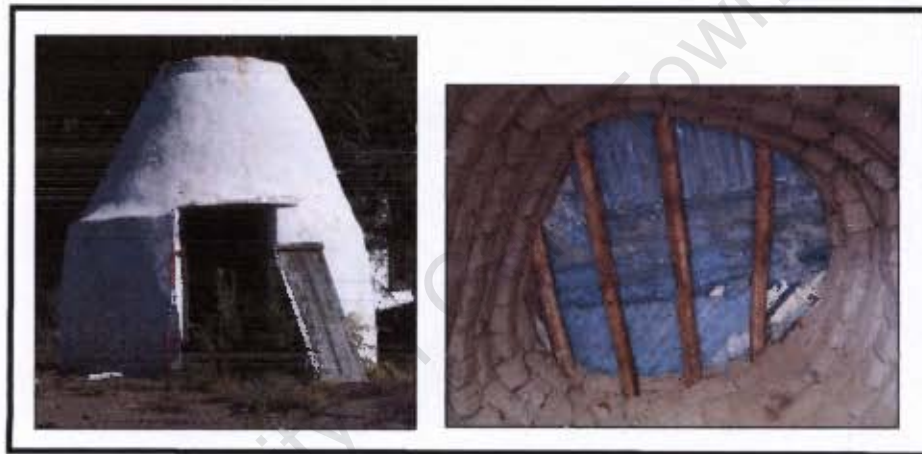
**Figure 4.3** Rietfontein I. The same shape as the charcoal kiln and the same Dutch Bond style of brick corbelling with mud mortar in this building south of Carnarvon.

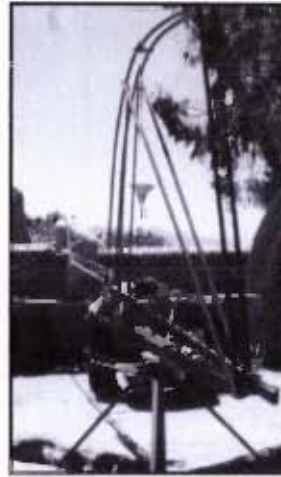
**Figure 4.5** Rotational guide – a more advanced version of Mr Maritz's simple, but effective, bent pole. (Photograph: Minke 2001: 44.)

Mr Gert Maritz, a retired farmer from Hondefontein, south of Fraserburg, has built his own corbelled building and explained his method. First he placed a stick on the centre point of the proposed building, then he tied string to the stick and marked a circle out in the ground. He bent a long piece of metal pole to form the outline of the shape of building that he wanted and the builder simply followed the profile, keeping the base of the pole on the line on the ground and working from the inside, that is, placing the stones **against** the profile created by the pole (Gert Maritz, pers. comm). Ironically, Minke (2001: 44), in his construction manual for earthquake-proof earthen houses, suggests the use of just such a device, which he calls a “rotational guide” (Fig. 4.5). The mason lays the bricks up against the angle of the rotating arm.

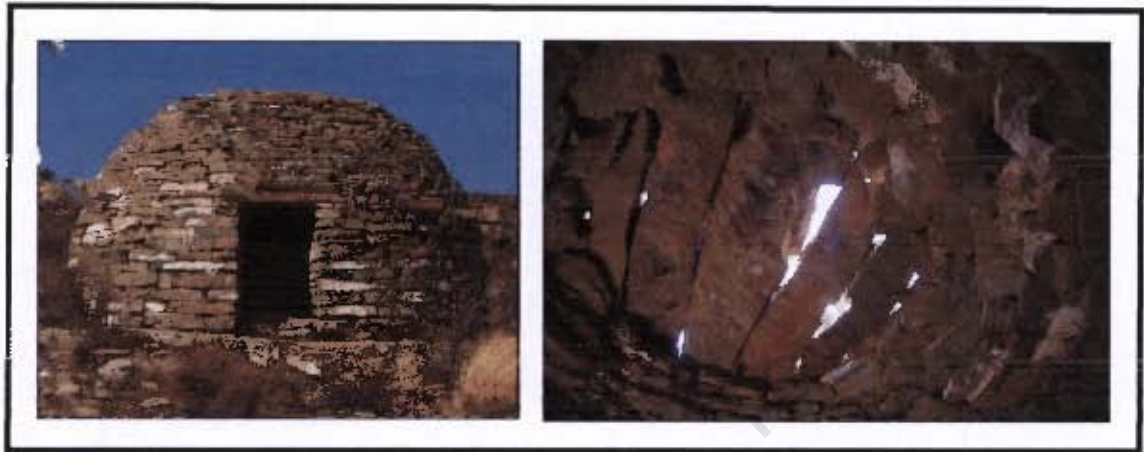
**Figure 4.6** Mooskloof. The height to floor diameter ratio of 0.63 verges on an unstable semi-circle shape. The builder had to use five roof stones to close the roof hole.

Mooskloof I, with a height to floor diameter ratio of 0.63, has the lowest ratio of all the round roof buildings on a round base (Fig 4.6). It has a very wide roof hole as the builder did not have enough height to narrow the roof sufficiently. As a result he had to use five roof stones to close the roof hole. Cone roof buildings obviously have a ratio of more than 1 as the floor diameter is smaller than the roof height but again the ratio does not vary too far from the central point.

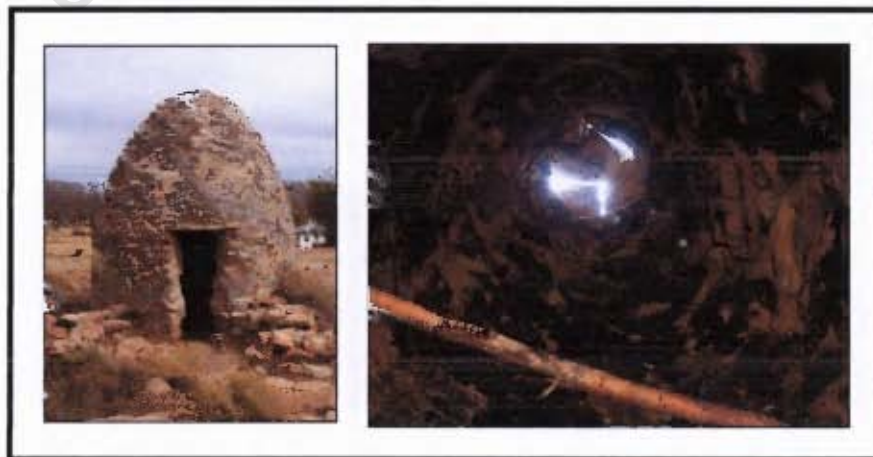
**Figure 4.7** Onderplaas. The height to floor diameter is 1.5, resulting in a narrow, pointed building with a small roof hole.

Stuurmansfontein I has the highest ratio of 1.36, except for the unusual buildings at Onderplaas in the Roggeveld (Fig. 4.7). They have a ratio of 1.5, the result of a small base diameter (2.56m) which left the builder with two options – a low, impractical building or a very high narrow building – he chose the latter option. This building has a small roof hole, an indication that the building could not go much higher because a ratio of 1.5 or more would also be unstable.

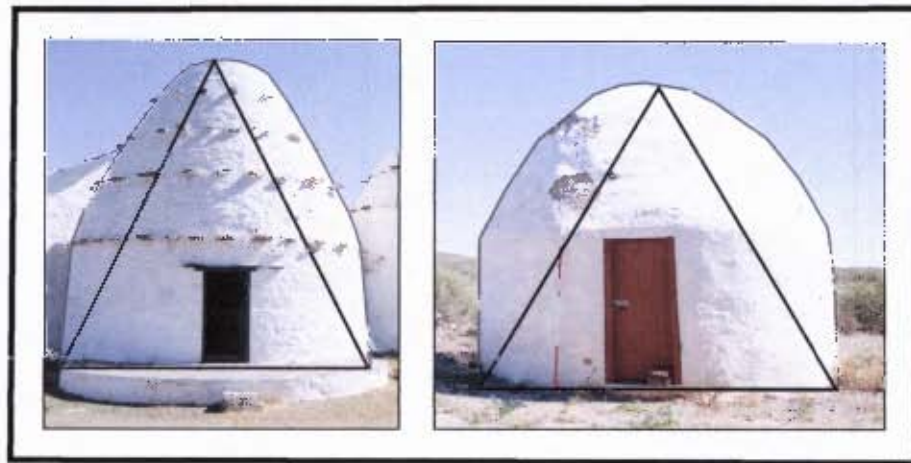
**Figure 4.8** Illustrates the variability within the basic triangular shape of the round base corbelled buildings – Stuurmansfontein (*left*) and Dawidskolk (*right*).

This variability defines vernacular – it is not construction according to design or exact formulae: the builder has to solve problems as he encounters them (Fig. 4.8).

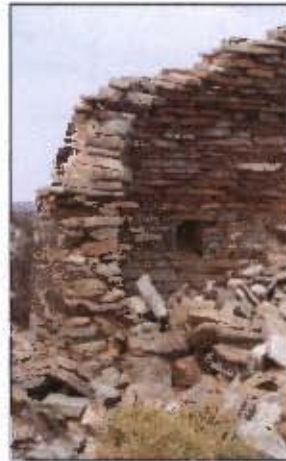
**Figure 4.12** Boplaas. Section through the wall of a collapsed corbelled building shows the vertical double-skinned lower wall and the curved roof with its inward tilting layer of stones and outer revetment (Fig. 4.11).

The internal construction involves balancing each stone on the centre of gravity of the stone below it. But these stones need a counterweight, or revetment, to keep the roof structure steady and act as a counterweight (Fig. 4.12).

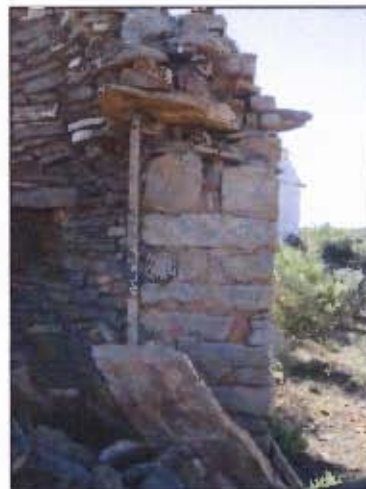
**Figure 4.13** Spoorolk. The linking stone can be seen spanning the width of the wall.

In many European and Middle Eastern corbelled buildings, the inner layer of stones follows the dome shape, but the outer layer can take on many forms, often with a gap between the two layers filled with stone or rubble. In the corbelled buildings of the Karoo, however, the two layers of stone lie tight up against each other and are even joined by means of linking or throughstones (Fig. 4.13).

The linking or throughstones, also called key stones, are used intermittently and run right through the two layers of stone, thus linking them together. (Fig. 4.13). Crossband stones, that

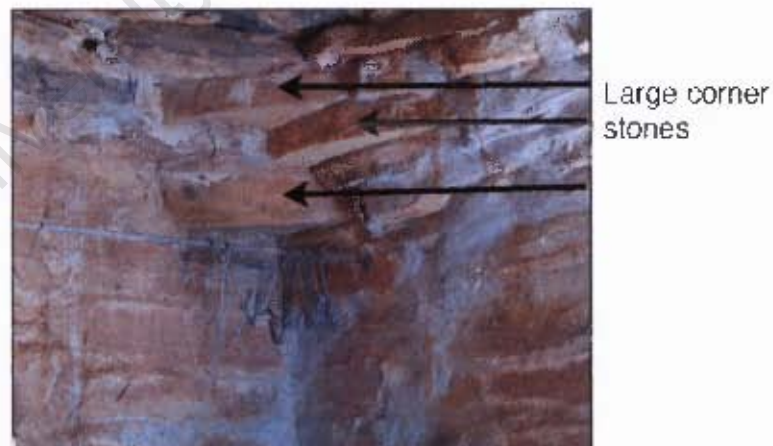
**Figure 4.14** Brownslaagte. Large corner stones enable the square base to carry the round roof.

One major problem occurs when placing a round corbelled roof onto a square-base. In the old buildings of Europe stone devices called a squinch, and later, pendentive, were used to solve the problem, of fit and weight distribution (Essential Humanities, 2008, para 3 & 4). These help distribute the weight of the dome on the corners of a square base. Karoo corbelled buildings used a series of large stones placed onto the corners of a square base, each stacked slightly inwards to enable the builder to start shaping the roof inwards and to help to distribute the weight (Fig. 4.14).

**Round roof on square base requires special attention at the corners** where all the pressure of the weight of the roof converges, unlike a round base where the forces would be evenly distributed over the entire building. The corners of a square base must be reinforced with a large cornerstone where the roof meets the wall. This will help to spread the weight it is supporting (Fig. 4.14).

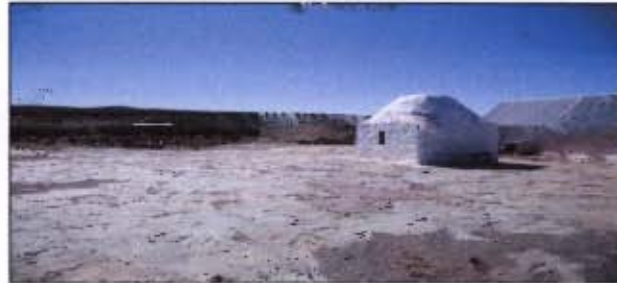
**Figure 4.15** Driefontein. The ideal bedrock foundation for this soap house.

**Sturdy, level site.** It is quite common to find Karoo corbelled buildings constructed on sheets of level bedrock (Fig. 4.15). If necessary, the soil was excavated down to bedrock where the first layer of stones was placed. This prevents sagging and the gradual displacement of stones (Fig. 4.16). I have only seen three corbelled buildings built on a slope. At Vinkfontein this problem was overcome by levelling with rows of stone on the downslope to provide a level base. The other buildings with an uneven base occurred at Middelpoos and Gorras IV and in both the base was levelled before building commenced.

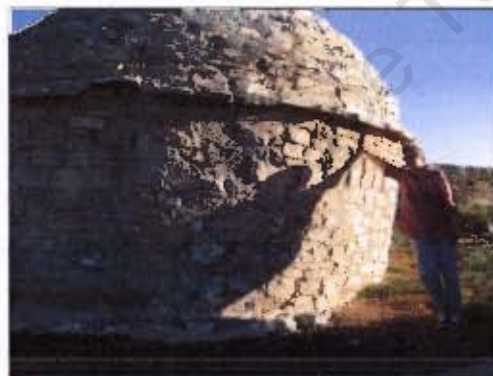
**Figure 4.16** Rietpoort. Poor foundations have resulted in this building leaning to one side.

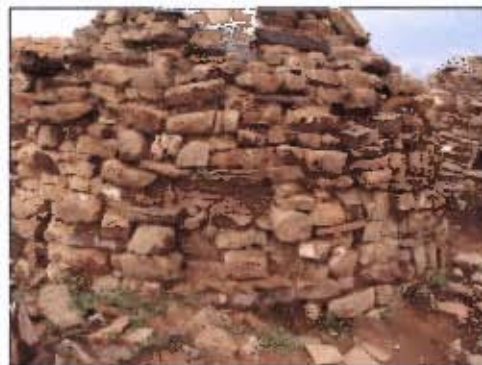
**Figure 4.17** Krabfontein III. The use of uneven blocks of stone has led to collapse.

**Shape of the stone.** The stones used should be flat and more or less the same thickness. The stones forming the curved roof should be as uniform as possible. One or two buildings which used less tabular stones are still standing, but suffer from structural stresses (Fig. 4.17).

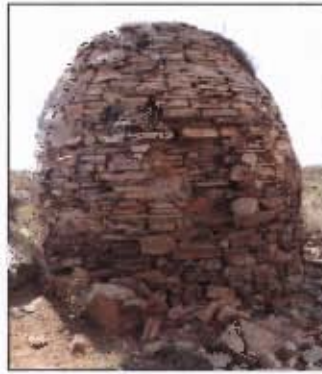
**Figure 4.18** De Wilg. The outer layer of the wall has not been tied to the inner layer and is consequently peeling away.

**Linking stones.** Karoo buildings are made of up two layers of stone packed close together. In order to prevent the outer layer from peeling off (Fig. 4.18), linking stones, or throughstones, are used. These run right through the wall, effectively tying the two layers together.

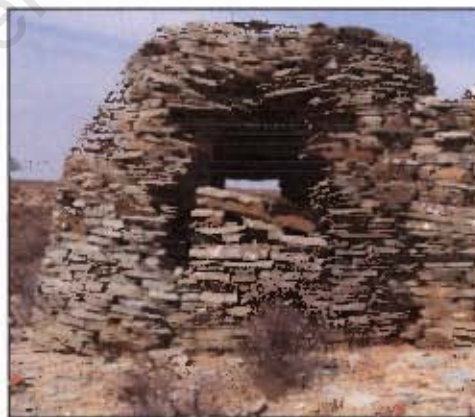
**Figure 4.19** Aasvoelsvlei II. Broken stone window lintel.

**Sturdy lintels to span the door and window openings.** Because the lintel bends under the weight of the roof bearing down on it, it is subject to both tension and compression. Stone can handle compression well (upper surface of the lintel) but does not handle tension, or stretching well (lower half of the lintel). This means that a slab of stone cannot span an opening which is too wide for its relative size. Cracked or broken lintels cause the collapse of the building (Fig. 4.19). In cases where a new door has been opened up, usually because another room has been attached to the corbelled building, the tricky task of pushing a lintel into the existing stonework was done using wooden logs or pieces of metal.

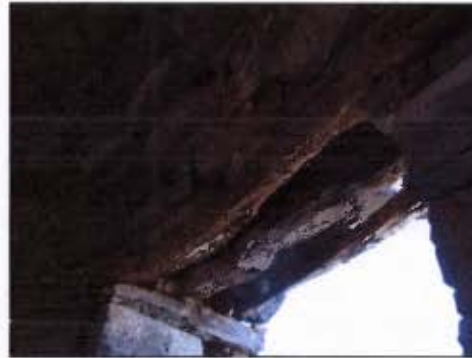
**Figure 4.20** Stuurmansfontein III. The wooden lintel is beginning to bend.

in compression, but handles tension (or stretching) better than stone. Nevertheless, wooden lintels are weak points in corbelled buildings and are a common cause of structural failure (Fig. 4.20).

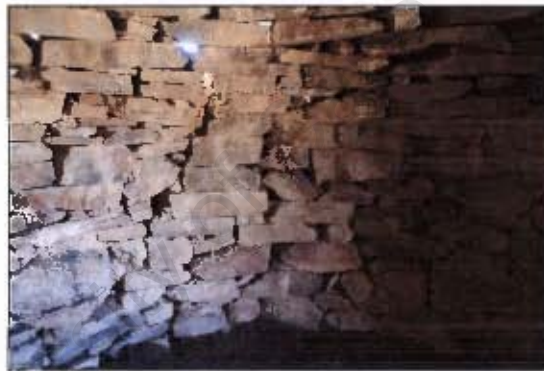
**Figure 4.21** De Brak. Cracking, unstable wall caused by running joints.

**Staggering of joints.** The laying of stones should resemble the laying of bricks where one joint is not placed directly above the one below. Lines of joints, if too close together, can lead to cracking. Linking stones help avoid this (Fig. 4.21).

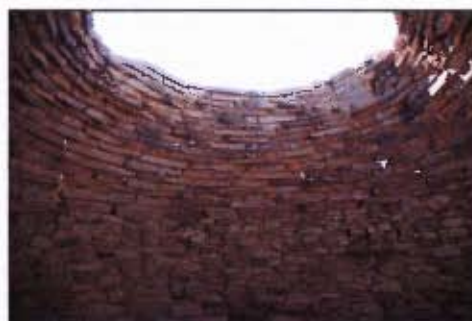
**Figure 4.22** De Kolke. The centre of the roof has collapsed.

**Careful balancing of the stones which make up the roof.** Each stone has to be carefully balanced on the centre of gravity of the stone below it. Roof collapse is often due to this failure (Fig. 4.22).

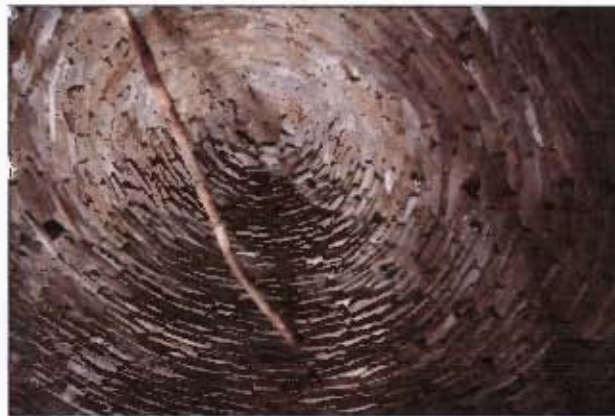
**Figure 4.23** Brakvlei Perfectly built roof with a small root hole.

**Making the roof hole small enough to support the roof stones.** If the top hole is too big, that is, the dome has not been brought to a point which could be closed easily, various design devices have been employed to strengthen the top and hold the roof stones. (Figs. 4.23 & 4.24).

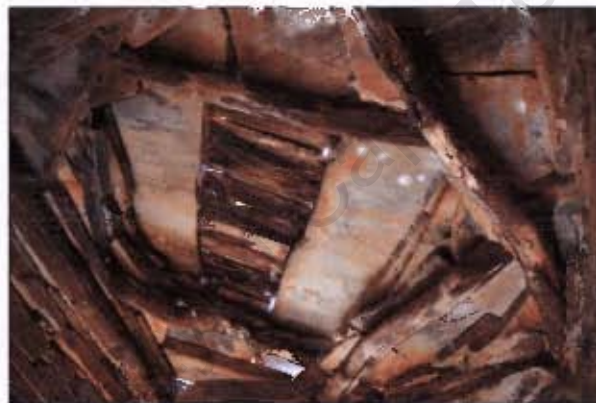
**Figure 4.24** De Val. The roof hole is large and timber supports have been used to support the roof stones.

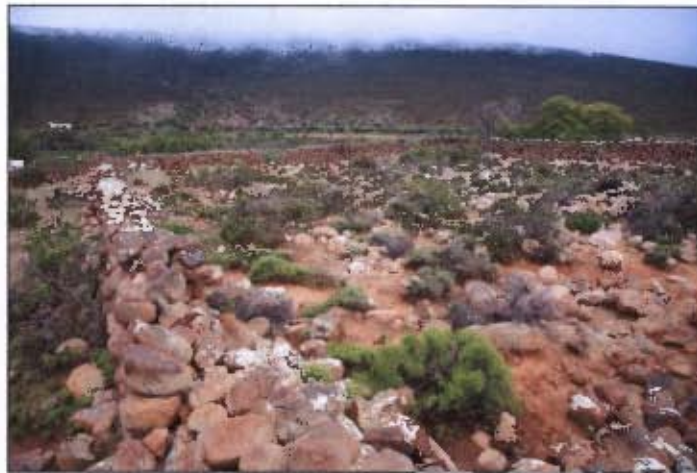
**Figure 4.25** Renoster Valley. Dolerite kraal walls.

Dolerite intrusions which are found in some areas, such as De Rante on the Fraserburg-Sutherland Road, were not used for constructing buildings as the round and uneven stones are

unsuitable, although there are cases of farm walls and kraals being built of this material, for example at Renoster Valley, south of Frasersburg (Fig. 4.25).

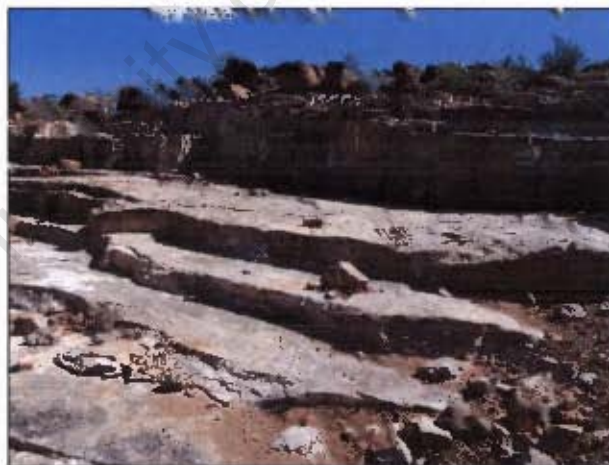
**Figure 4.26** Gorras. A "quarry" in the Gorras riverbed.

Ferreira (1986: 78) points out that big, established stone quarries do not exist because the stone is obtainable all over the countryside. Most of the stone used in building the corbelled buildings is not just picked up on the surface, it had to be chiselled out of bedrock and cut into blocks. Riverbeds are a good source of stone (Fig. 4.26), although a few land-based quarries where the stone has been mined from an outcrop have been located.

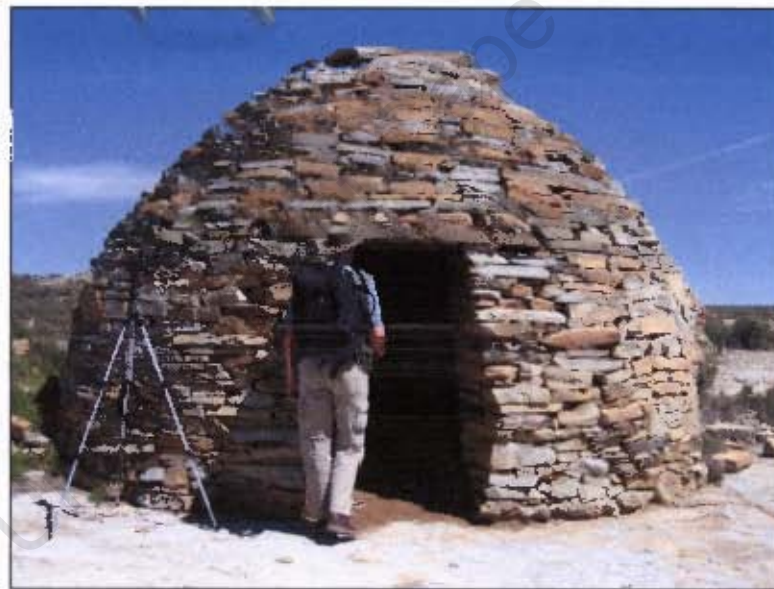
**Figure 4.28** Leyfontein II. A finely built corbelled building.

The sizes and shape of stones used in walls up to the start of the dome vary from building to building. Some buildings have fairly uniform-sized and shaped stone from the bottom to the top (Fig. 4.28), while others have big boulders along the base (Fig. 4.29) and *in situ* rocks have even been incorporated into the wall on occasion to create an outside seat (Fig. 4.30). Some have both large and small stones intricately fitted together, while two buildings on the farm Koppiesfontein have a very distinctive “crazy paving” or uncoursed style on the lower level of the corbelled buildings (Fig. 4.31). Two corbelled buildings on the Krabfontein *werf* (III and IV) have been built with square-shaped blocks of sandstone (with resultant deterioration), possibly indicating a lack of knowledge for selecting suitable stone (Fig. 4.17). In the “better built” buildings, the stones have been selected to run in fairly obvious concentric circles around the building.

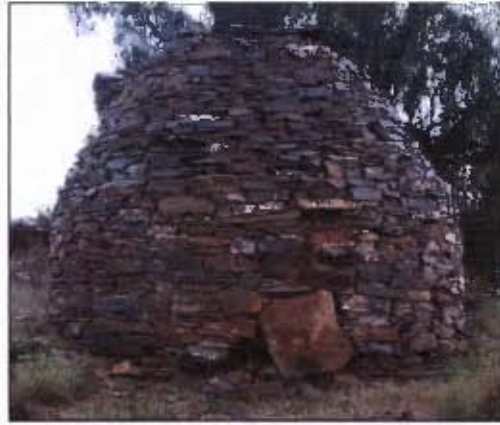
**Figure 4.29** Aasvoetsvlei I. Large rocks incorporated into the base.

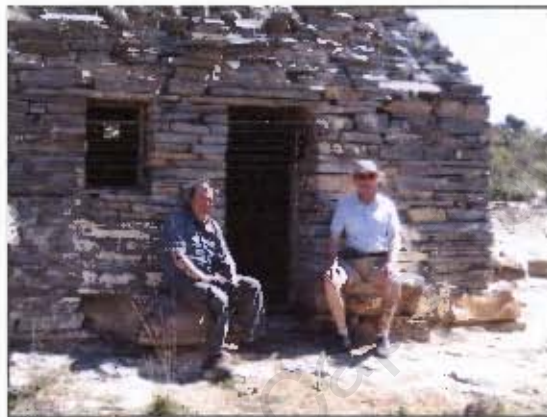
**Figure 4.30** Leyfontein IV. Large rocks incorporated into the wall to form outside seats.

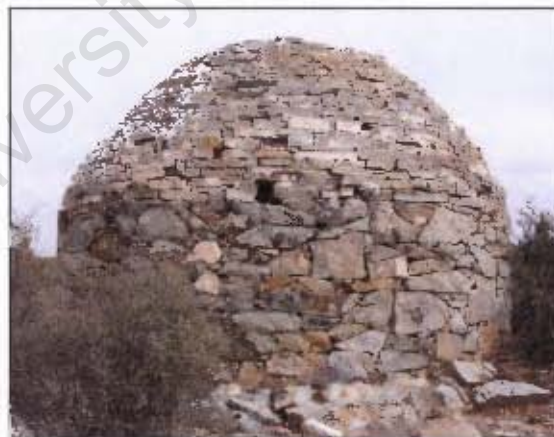
**Figure 4.31** Koppiesfontein I. The wall of the *kathok* has a distinctive "crazy-paving" style.

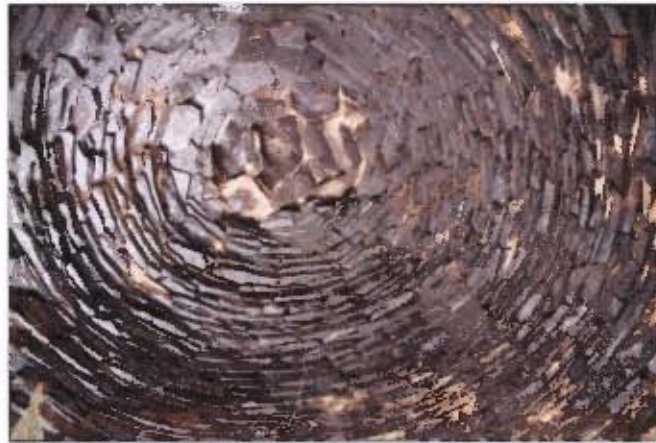
**Figure 4.32** Silvery Holme. Consistently selected stone resulted in this fine roof.

The shape of the stones for the base of square-based corbelled buildings is not as crucial as that for round-based buildings. As long as the walls are strong and sturdy, have good lintels and substantial corner stones, they will carry the roof weight. But once the turn for the curving roof begins, the stone had to be chosen very carefully because each course shifts

inwards by about a third of its width, balancing on the centre of gravity of the stone below. Similarly sized and shaped stone were used in order to lock the stones together under compression (Fig. 4.32).

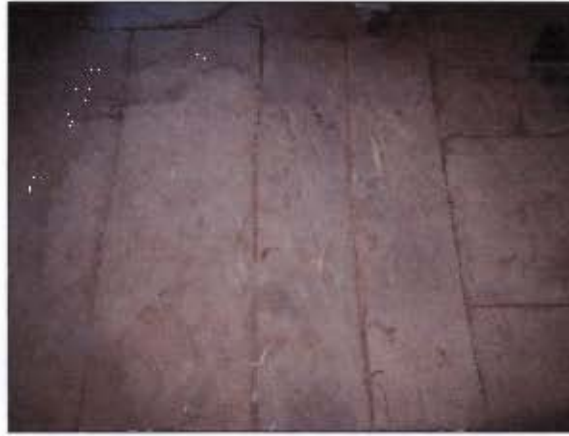
**Figure 4.33** Vastrap. Floor made out of stone slabs.

Although it was almost impossible to determine the type of floor in many of the buildings, two floors were laid with stone flagging (Fig. 4.33).

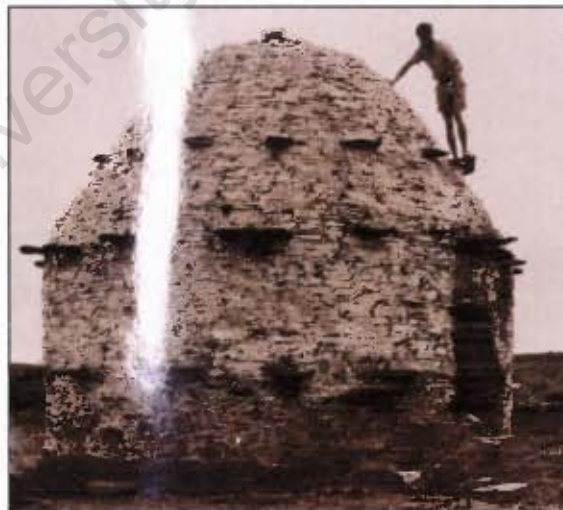
**Figure 4.34** Biesiesdam. James Walton’s photograph of Gawie Fagan demonstrates how the projecting stones could have been used. (Photograph: Walton, 1960.)

A structural puzzle is the purpose of the projecting stones which occurs on some of the corbelled buildings (Fig 3.34). This feature is not uniquely South African, and also occurs on corbelled buildings in Ireland and Portugal. The most frequent interpretation is that they helped in the construction of the building and subsequently could be used in the maintenance of the exterior of the buildings – perhaps to rest scaffolding. According to Walton (1989: 124), “These stones serve as steps and as anchors for scaffolding and were no doubt used by the builder when building the hut, but they are still useful when repairs are being carried out or when the building is being whitewashed”. Ferreira (1986: 81) also states that the protrusions or “stellasies” were used for resting planks or standing on when building or repairing.

This is a convincing argument. Walton's image (Fig. 4.34) suggests that these projecting stones would certainly be helpful in maintaining the building, particularly for the roof. However, it is unlikely that they were steps when the roof was being built as the structure is unstable until the dome has been completed. Furthermore, I am convinced that the roofs were built from the inside. This would be the only way in which the neat interior rows of stone in the dome could be achieved.

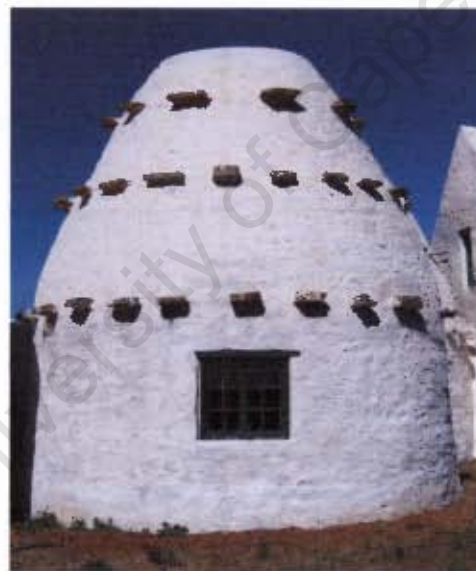
**Figure 4.35** Stuurmansfontein I. The rows of projecting stones are too far apart to allow the builder or repairer to easily step up from one level to the next.

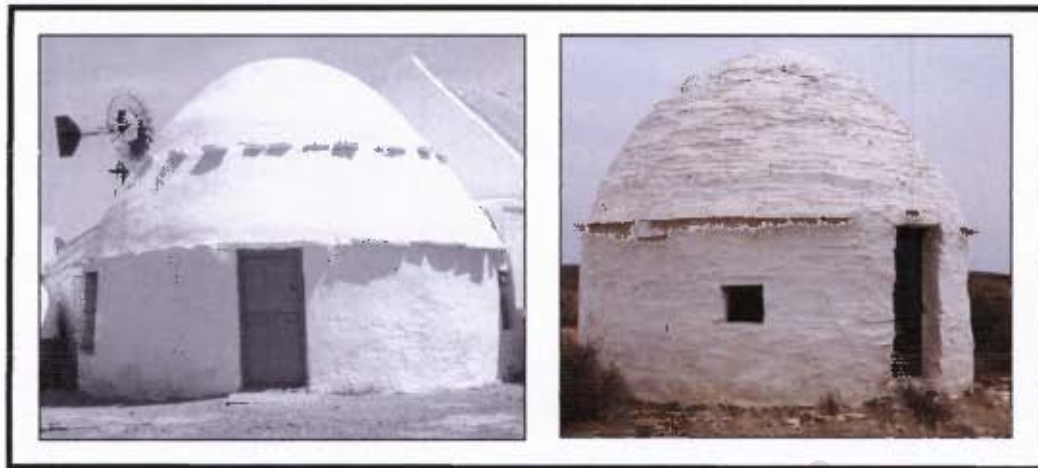
**Figure 4.36** Krabfontein (*left*) and Modderfontein (*right*). Both have a stone ledge all around the building.

Some buildings have a continuous line of stones which encircles the whole building at door height (Fig. 4.36), but it is unlikely that they were for maintenance. In this case they may have served the purpose of deflecting rainwater from the walls.

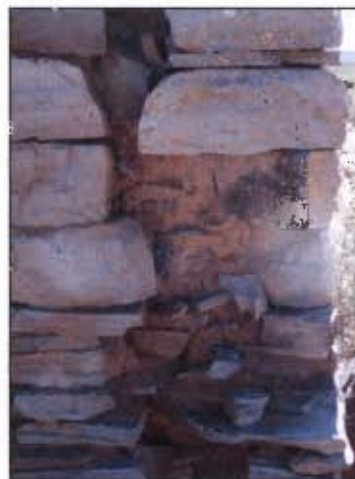
**Figure 4.37** De Kolke. Mortar "hidden" in the wall.

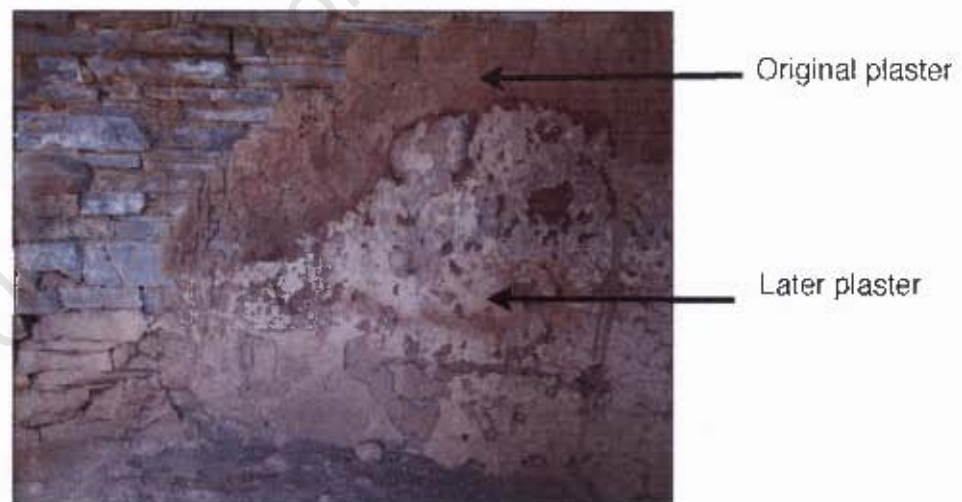
**Figure 4.38** Karelsgraf II. Example of original plaster and later replastering.

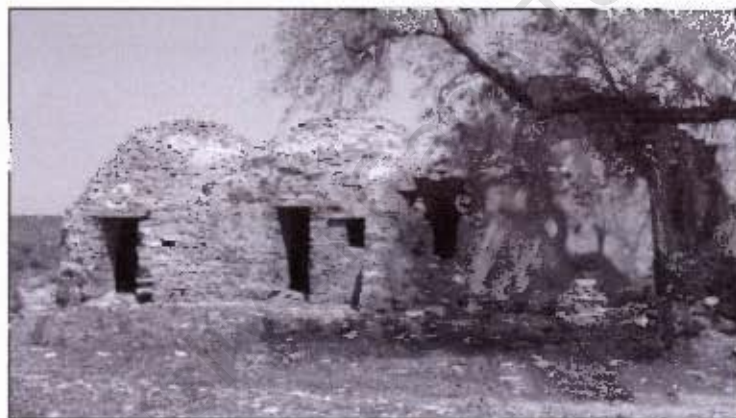
**Figure 4.39** Aasvoelsvlei I. Walton's photograph taken in 1960 with vestiges of plaster still present. (Photograph: Walton, 1960.)

Photographs taken by James Walton in 1960 show some buildings with traces of external plaster but now there is no longer any trace of this plaster (Fig. 4.39). Those that were plastered would have required constant upkeep and replastering to repair rain damage. Slingersfontein (Fig. 4.41) still has traces of both external plaster and paint.

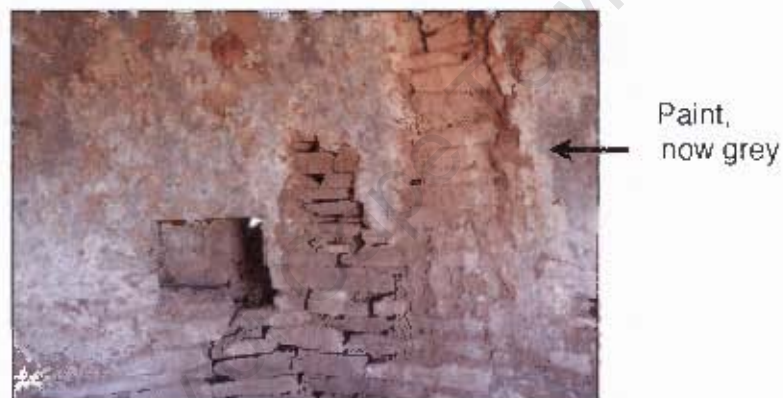
Figure 4.40 Omkeerkolk. Traces of paint.

The interior layer of clay plaster was often sealed and protected with paint. This survives as a greyish colour, probably due to age and smoke (Fig. 4.40), although at Leeuwkranz, traces of blue paint are still discernable under a ledge. The paint is a lime wash, obtained from the same source as the lime plaster. It is unknown whether all exteriors were painted.

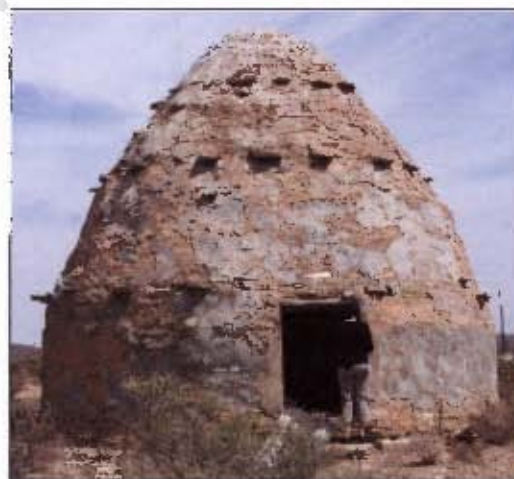
Figure 4.41 Slingersfontein. Remnants of exterior plaster and paint are still present.

Slingersfontein appears to preserve remnants of original paintwork (Fig. 4.41), but in most cases the exterior paint (and plaster) has worn off. The distinctive white lime-washed corbelled buildings have all been painted recently by the present-day farmers.

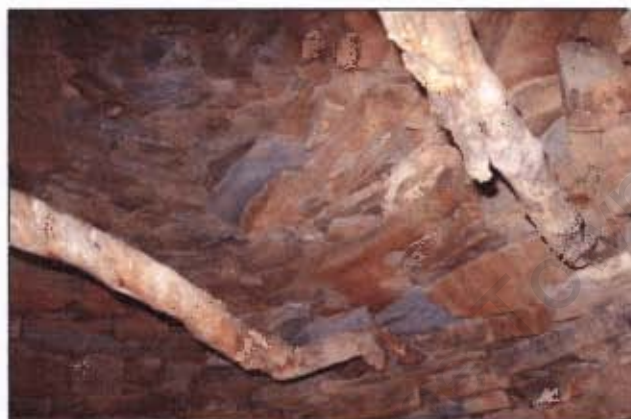
**Figure 4.42** Stuurmansfontein II. Karee wood cross beams.

When available, wood was used in corbelled hut construction in a variety of ways. Roughly trimmed tree branches were used as cross beams in many of the smaller buildings. These were inserted into the opposing walls at the time of construction (Fig. 4.42). Where the beams have been removed, probably for reuse elsewhere on the farm once the corbelled building fell into disuse, the original sockets remain in the walls. Most buildings had two of these beams that were used for hanging clothes, herbs or even drying meat. Wire hooks still hang from many of the beams to this day. It is also possible that where two or more beams were inserted at the same height, boards might have been placed across them to form an upper loft or storage area.

The different types of corbelled buildings at Stuurmansfontein show the variable use of rough and planed wood. The *kafhok* at Stuurmansfontein has rough beams (Fig. 4.42) in contrast to the purchased and highly valued machined beams of yellowwood used in the large corbelled buildings on the *werf* (Fig. 4.45).

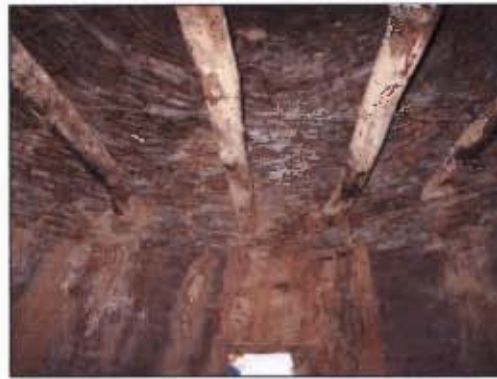
**Figure 4.43** Karelsgraf II. Poplar beams at Karelsgraf, north of Carnarvon.

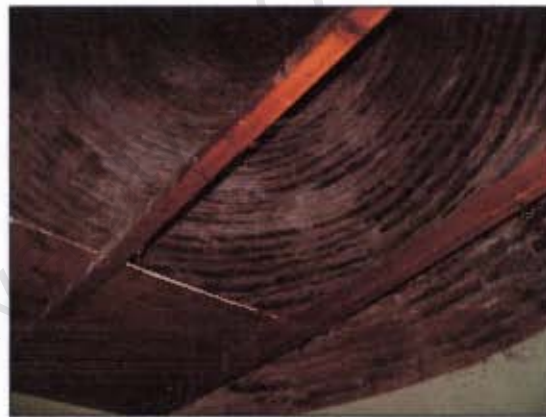
**Figure 4.44** Konka. Machine-cut beams form the base of the loft

In a clear indication of improving transport, and possibly the emergence of more prosperous farmers, some of the big corbelled buildings in the north have machine-planed beams spanning the room, some with an enclosed loft above, also made of machine-planed planks (Fig. 4.44).

At Grootfontein, however, despite its size and late 19th century date, rough karee wood beams were still used (Fig. 4.46) when machined wood would have been expected, based on the situation at Stuurmansfontein (Fig. 4.45) and Konka (Fig. 4.44). The use of rough wood does not, therefore, indicate an earlier 19th century date. It might have been the builder's preference to use locally available wood at no expense, or he might not have been able to afford to "import" yellowwood beams.

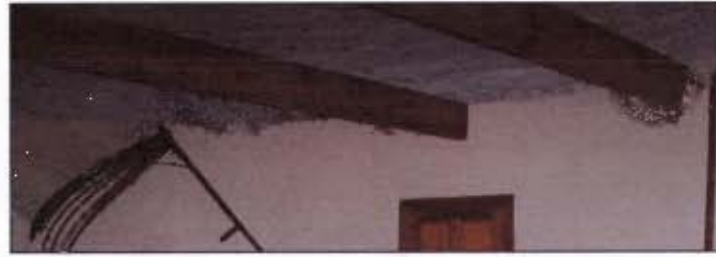
**Figure 4.45** Stuurmansfontein I. Machine-planed yellowwood beams.

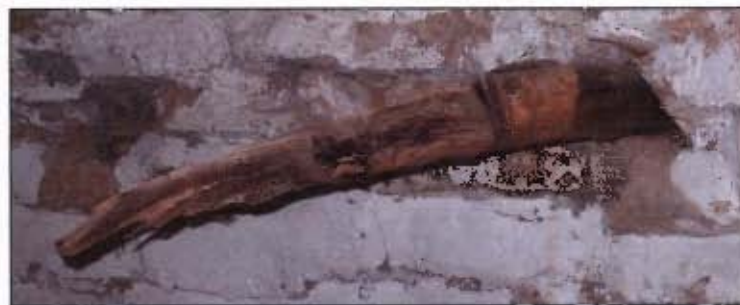
**Figure 4.47** Kareekloof. Remains of a beam sawn off for reuse.

Because of the shortage of wood, it was often recycled when the building was no longer used or its function changed. Many buildings have empty beam holes where the poles have been removed to be used elsewhere (Fig. 4.47).

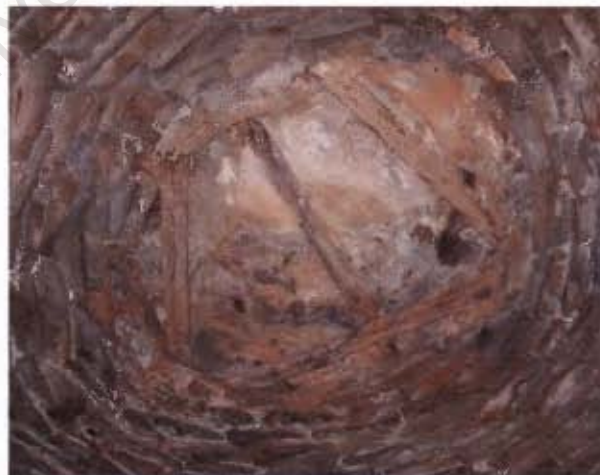
**Figure 4.49** Krugerskolk. A miscalculation at Krugerskolk required a timber structure to support the roof stones.

In a few cases, high beams served a clear structural purpose. Where the builder had trouble closing a roof hole, he gave the roof extra support with wooden beams (Fig. 4.49).

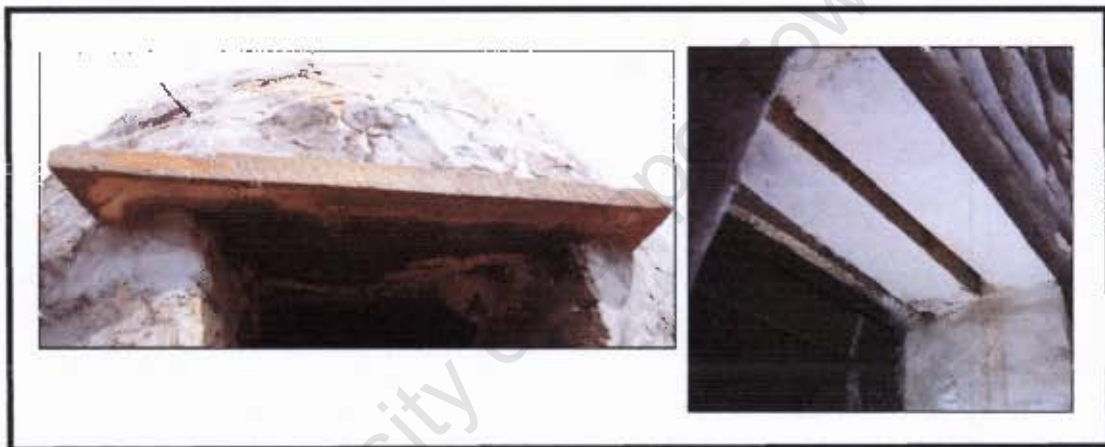
**Figure 4.50** Onderplaas (*left*) and Arbeidersfontein (*right*). Onderplaas has a single large stone lintel, while Arbeidersfontein has two stone lintels.

Most of the original door openings are straddled by one large lintel, or in a few cases, two narrower lintels placed side by side (Fig. 4.50).

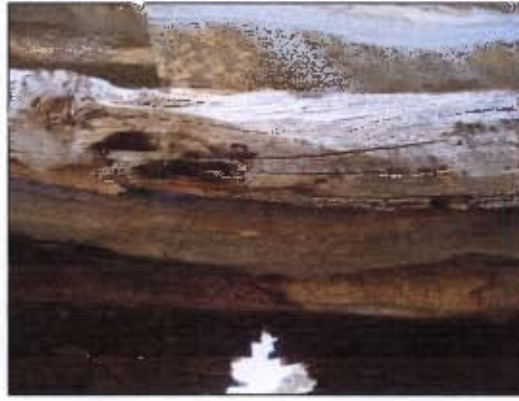
**Figure 4.51** Stuurmansfontein III. Logs used for a lintel.

Further north in the Ecce area, slabs of stone large enough to span a doorway are no longer available to the builder and wooden beams are used instead (Fig. 4.51). This may reflect a later 19th century date when large beams of poplar and gum trees were now available as well as the improvement of the road network and the construction of a railway line from Tutchinson to Camarvon.

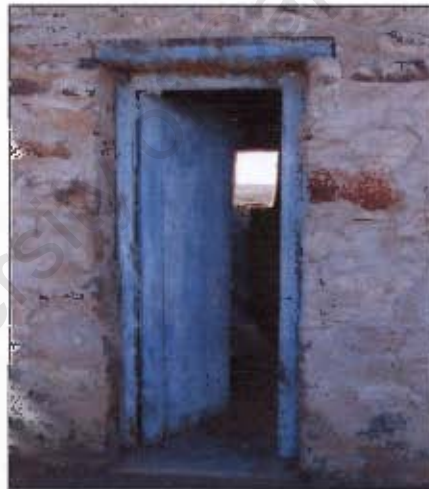
**Figure 4.52** Janklaasleegte II. A piece of railway track has been used for a lintel.

The pieces of railway track at Janklaasleegte (Fig. 4.52) are interesting because the construction of the railway in the area can be dated. The line to Kimberley reached Beaufort West in 1890 – a fair distance from Janklaasleegte (about 180 kms). However, a branch line reached Victoria West Road (later renamed Hutchinson) by 1881 and the line to Carnarvon was opened in 1906 (Burman, 1984: 162). These dates do tend to correlate with the idea that the buildings at Janklaasleegte were constructed quite late in the corbelled building period.

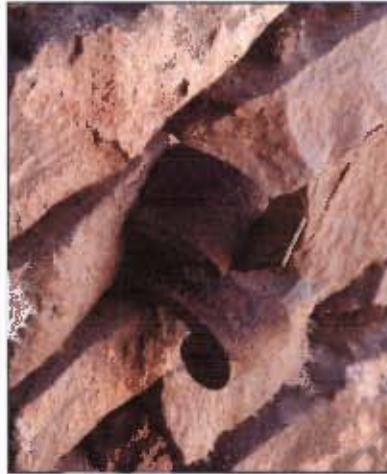
**Figure 4.53** Omkeerkolk. Metal in the doorway used to attach a form of door.

Doorway modifications combine various materials and frequently compromise the structural integrity of the building. The location and sizes of doorways have been altered in many buildings over the years as the use of the building has changed. Doorways fall into two categories – those that were part of the original building and those that are later additions. When a new door was opened, metal was often used as additional support for the door lintel.

Metal was also used in modified doorways for hinges or brackets. The insertion is limited by the stone and the metal could only be inserted between stones (Fig. 4.53).

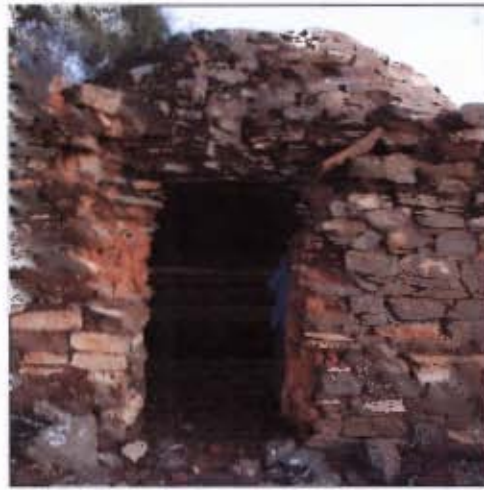
**Figure 4.54** Aasvoelsvlei I. Brick-lined doorway which led into the later brick extension building

New piercings are also finished off with bricks, for example if the doorway was adapted to take new fittings or a new doorway was opened up. These mud or clay bricks are only sunbaked and as a result very friable and on exposure to the elements they disintegrate very quickly. Brick in corbelled buildings usually indicates later changes or extensions to the original stone building and were not part of the original construction. At Aasvoelsvlei I a later brick extension was added and a new doorway made to connect the old and the new buildings, and this doorway has some brick edging (Fig. 4.54).

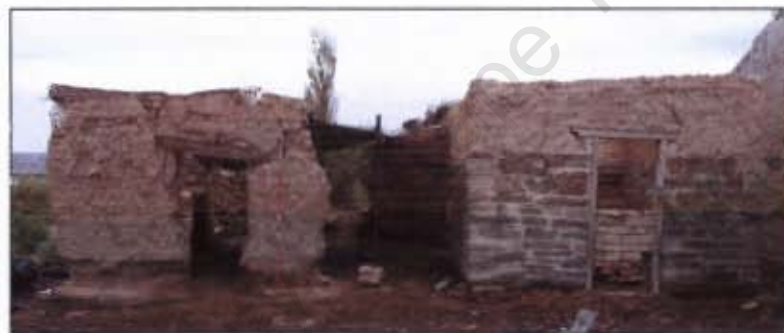
**Figure 4.55.** Krabfontein. Badly deteriorated brick walls of the extension buildings.

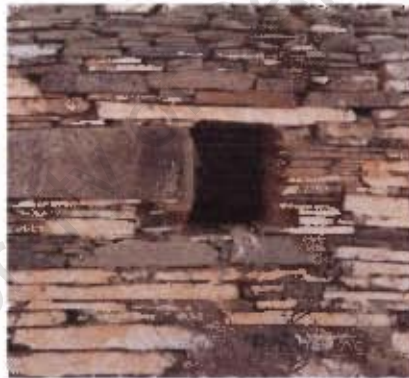
**Figure 4.56** Tiervlei. Small, simple square window.

It has been noted that the windows of smaller (“earlier”) buildings have the same width on both the outer and inner wall surface (Fig. 4.56). In contrast, the thicker walls of the big (“later”) corbelled buildings, such as Stuurmansfontein, Grootfontein and Janklaasleegte require that the windows are embrasured, that is, they widen in the inner wall – an architectural trick to let more light into the room while still presenting a small opening to the outside (Fig. 4.57).

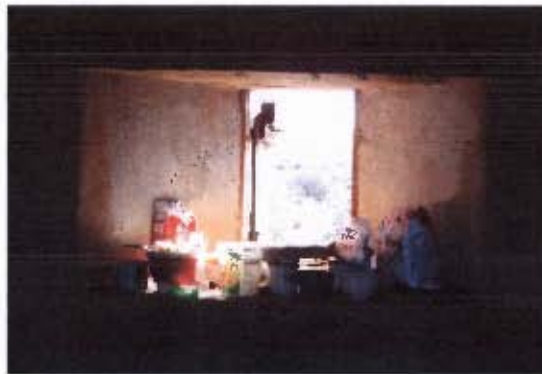
**Figure 4.57** Janklaasleegte I. Embrasured window with the deep windowsill used for storage.

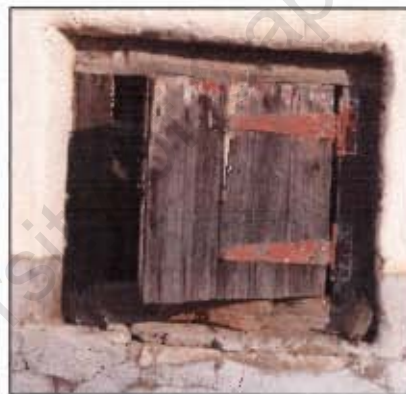
**Figure 4.58** Silvery Holme. Wooden shutters were used to close windows.

Window openings were initially closed with perishable materials such as skin or fabric, but many wooden shutters still remain (Fig. 4.58).

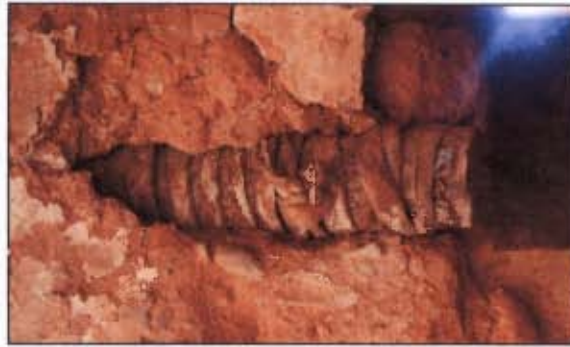
**Figure 4.59** Aasvoelsvlei I. Strips of antelope hide wrapped around a wooden pole.

The only contemporary piece of skin located to date was wrapped around a wooden pole and lodged above the door at Aasvoelsvlei I (Fig. 4.59).
