# The History, Form and Context of the 19th Century Corbelled Buildings of the Great Karoo

Patricia Anne Kramer

Thesis presented for the the degree of Master of Philosophy  
in the Department of Archaeology  
University of Cape Town

February 2012

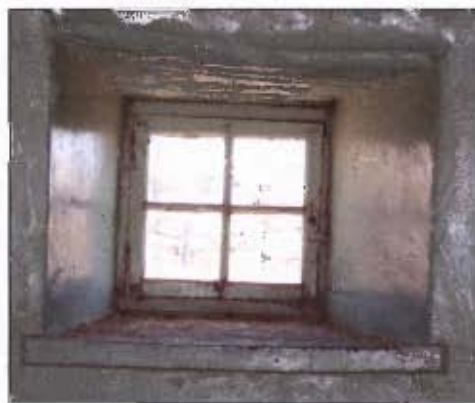
**Figure 4.60** Konka. Old glass in the window frame.

Earlier in the 19th century window glass would have been a rare and expensive commodity and difficult to transport to the Karoo unbroken. However, the larger, and by implication later, corbelled buildings do have small glass panes set into window frames, though they might not have had these when the building was first constructed (Fig 4.60).

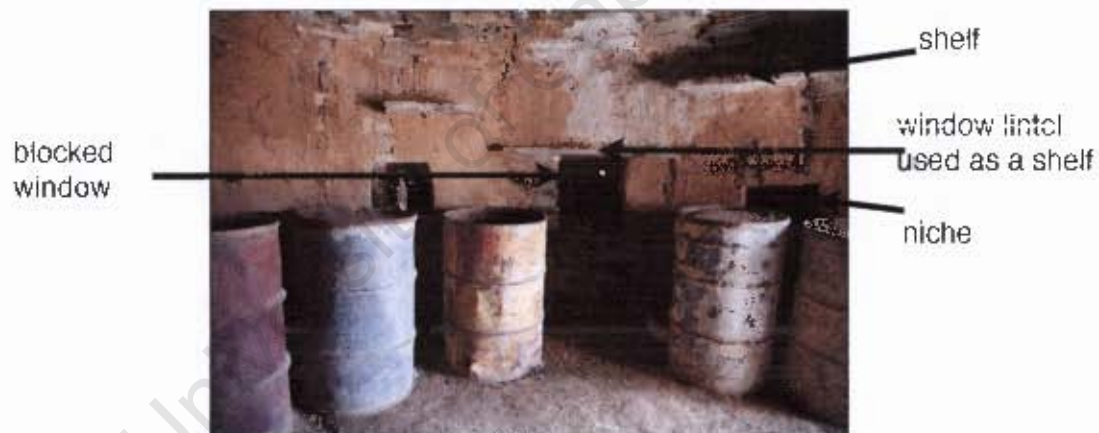
**Figure 4.61** Brakvlei. Shelves, niches and a blocked window with a lintel which also served as a shelf.

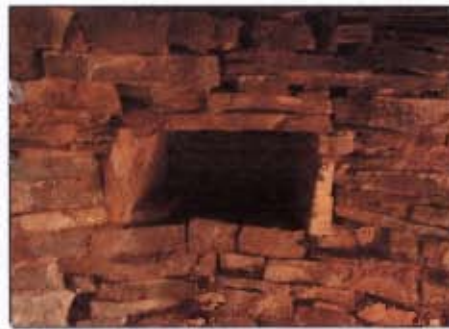
**Figure 4.62** Aasvoelsvlei I. A simple wall niche (0.6m x 0.32m).

Wall niches, or “keeping holes” are another attribute of domestic corbelled buildings. They are the answer-in-stone to the old wood-lined *muurkas* of the Cape. Niches are found in corbelled buildings of all ages, large and small, and are a more consistent feature in the home than stone shelves (Fig. 4.62). Walton (1989: 124) asserts that niches are built into the wall on the left hand side of the front door, but my observations show that this is not so in all cases. Additionally, some buildings have more than one niche (Fig. 4.61).

Since walls of corbelled building are made of two layers of stone, the niche is made by omitting the inner layer. Niches may be simple with no shelves (Fig. 4.62), or have two or even three shelves (Fig 4.63). At Stuurmansfontein, the niche has a door and has evolved into a *muurkas* or wall cupboard (Fig. 4.64).

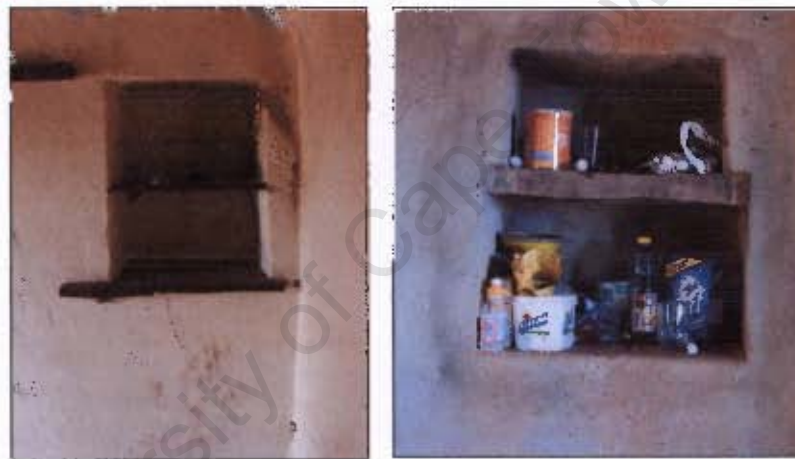
**Figure 4.63** Brakwater (left) and Janklaasleegte I (right). Double wall niches with a shelf.

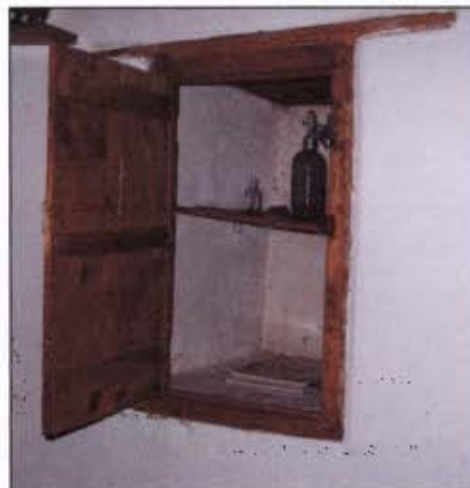
**Figure 4.64** Stuurmansfontein I. The niche has a door and has become a *muurkas*.

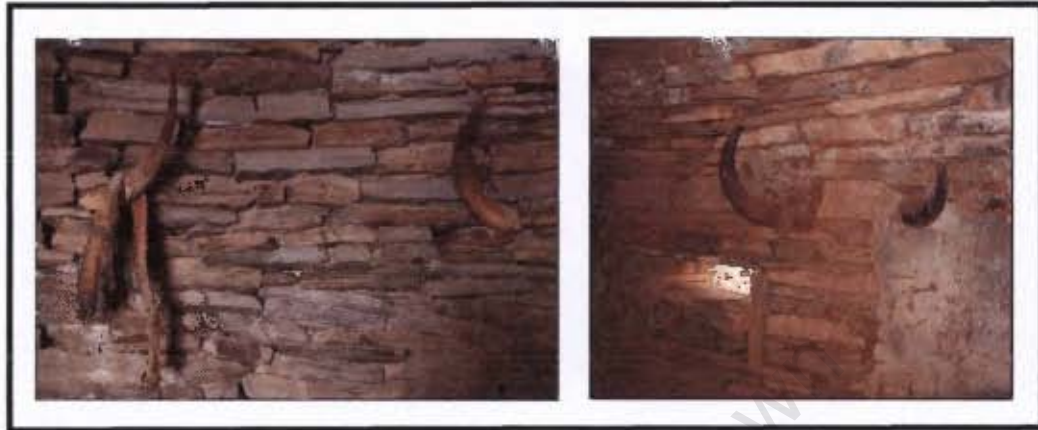
**Figure 4.65** Bitterwater (*left*) and Tiervlei (*right*). Horns used as hooks.

Ox, ram and springbok horns are found in many corbelled buildings. It would appear that these were slotted into the wall at the time of the construction of the building and were used as hanging devices (Figs. 4.65).

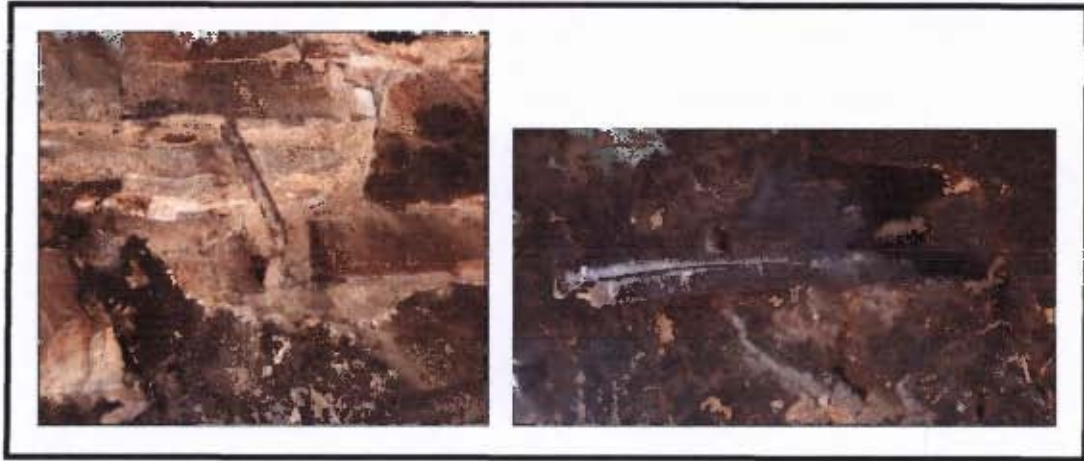
**Figure 4.67** Eendefontein II. Fencing used as hanging devices.

Metal hooks are old farm equipment, fencing or metal from wagons that have been stuck into the wall to act as hooks or hanging devices (Figs 4.66 & 4.67). Most were inserted into the wall mortar after the building was constructed, probably when occupied at a later date by farm workers. Fence droppers, particularly, are often found, but would only have become available after fencing of farms began in the late 1890s when fencing as a measure to restrict the movement of animals and the spread of rinderpest began to be enforced. Fencing only began on a large scale in 1910 and the first Fencing Act was passed in 1912 (Talbot, 1961: 324).

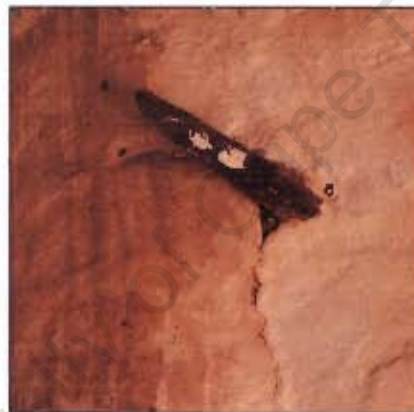
**Figure 4.68** Vinkfontein. Piece of wood used as a hanging device.

Finally, small pieces of wood were inserted into the walls of some of the corbelled buildings to form hooks, such as this one at Vinkfontein (Fig. 4.68).

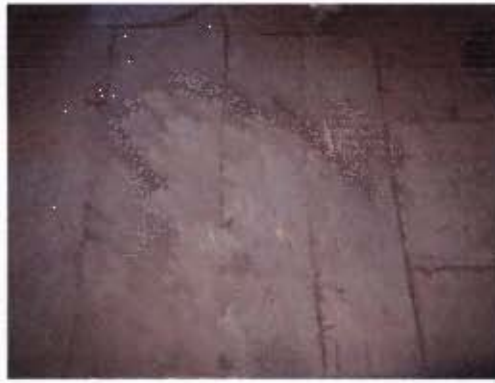
**Figure 4.69** Vastrap. Floor laid with stone slabs.

According to Ferreira: “Die korbcelhuise het sonder uitsondering grondvloere gehad wat met ‘n mengsel van klei en beesmis gesmeer was” (2000: 82).<sup>41</sup> It is difficult to see the original floor in the corbelled buildings as they are either full of farming equipment or had a deep layer of *kaf*, soil or sheep droppings. In those cases where the farmer still used the building, the floor often had a layer of modern cement. In two corbelled buildings (Langbaken and Vastrap) the farmer has cleaned out the building to reveal a floor of stone slabs (Fig. 4.69).

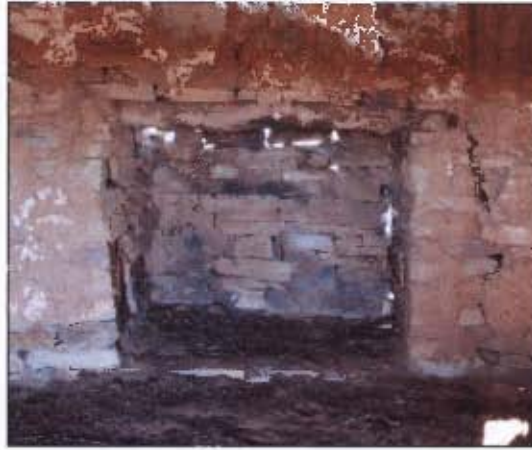
**Figure 4.71** De Val. This space was previously occupied by the hearth.

So far only three (Figs. 4.70 & 4.71) hearths, or signs of a hearth, have been found. One of these is at De Val, where the farmer relates that the corbelled building on his farm was built for the schoolteacher – a lady from England (Pieter le Roux, pers comm.) (Fig. 4.71). The building itself is neatly built with dressed stone, indicating that special effort was made in the construction, which included an interior hearth.

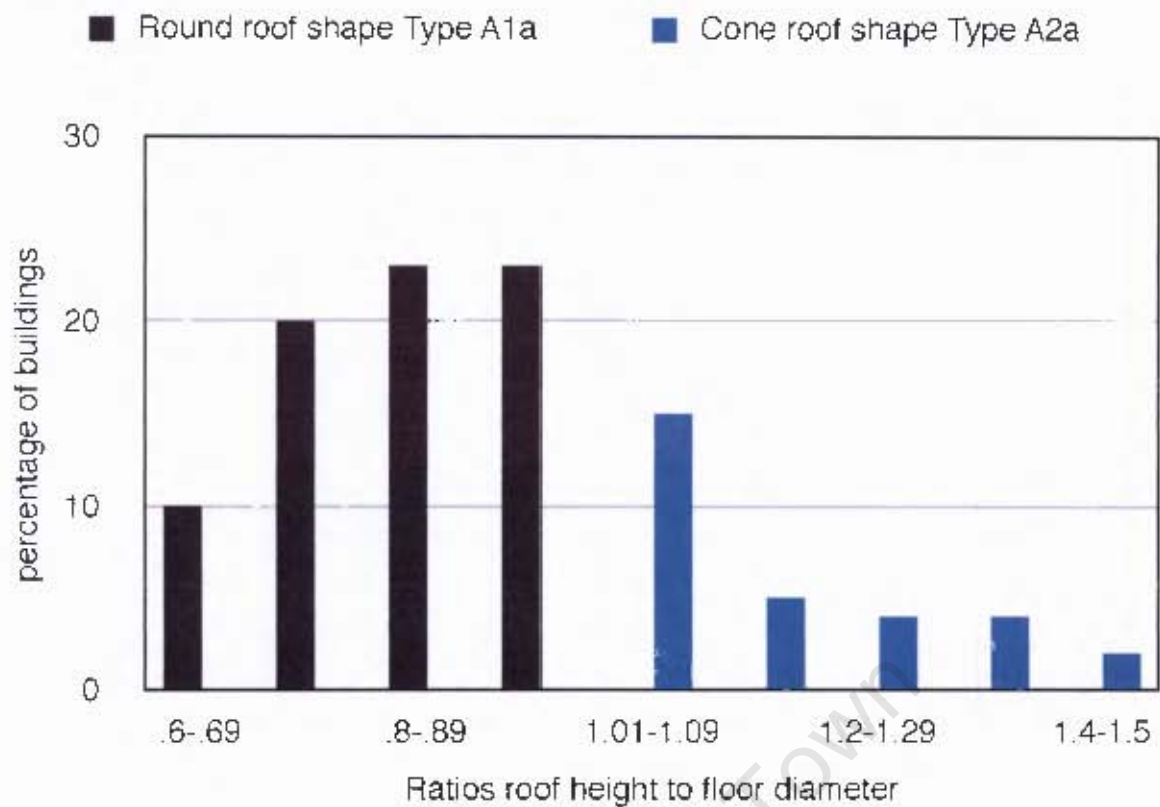
**Figure 5.2** A comparison of roof height to floor diameter ratios in round roof buildings and cone roof buildings (percentage based on total of 70 buildings).

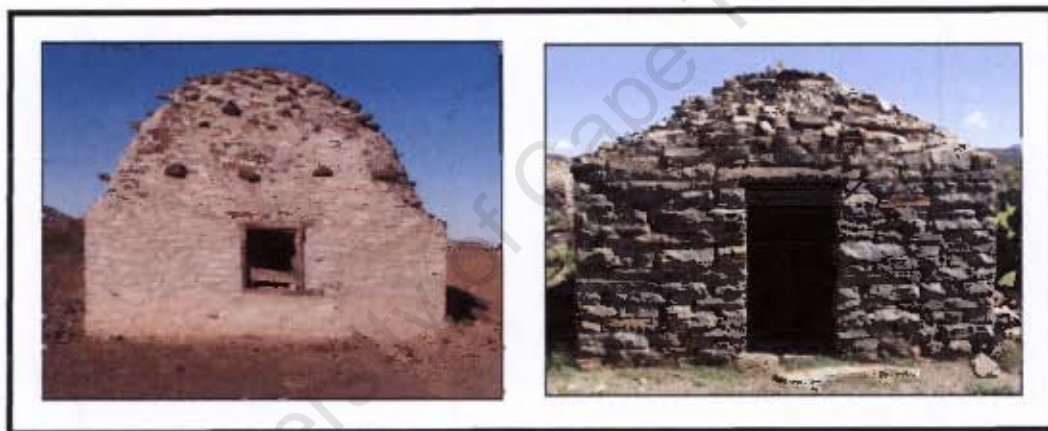
**Figure 5.5** Type B1: Square base with round roof. Rondom B1 (left) and Wifontein B1 (right).

There are 8 square based buildings with a round roof, and these tend to be small (Table 5.3). Roofs tend to be low and squat with low height to floor diameter ratios (Fig. 5.5). The reasons for this are practical. First, it is technically more difficult to build a round roof onto a rectangular base form. Second, should the builder decide to build a round roof, the square or rectangular base form means that the bigger the building, the more unstable the roof because the walls would burst out sideways from the forces being applied to it (Fig. 5.6).

Farm	Height	Length x breadth	Ratio height to floor diameter
Aasvoelsvlei IB	2.88m	2.37 x 2.9m	0.70
Aasvoelsvlei IC	3.23m	3.41 x 3.37m	0.67
Blouhoogte	3.9m	3.8 x 3.8m	0.73
Brownslaagte	4.1m	3.67 x 3.67m	0.79
Koppiesfontein II	2.28m	3.16 x 3.11m	0.79
Rondom	3.77m	3.86 x 4.76m	0.61
Tiervlei I	3m	3.22 x 2.94m	0.68
Wifontein II	2.45m	2.55 x 2.55m	0.68

The height to floor diameter ratios for these small buildings all fall within a limited range.

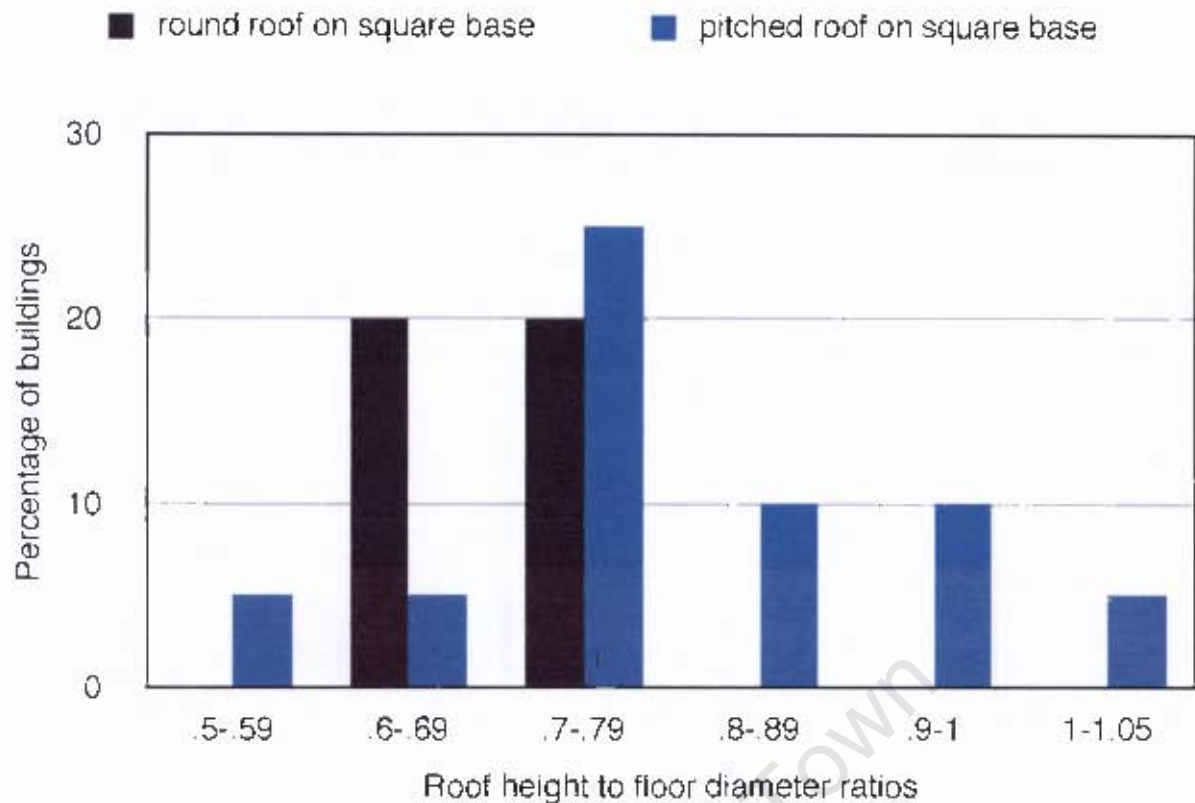
**Figure 5.7** Comparison between round roof height on a square base and pitched roof height on a square base.

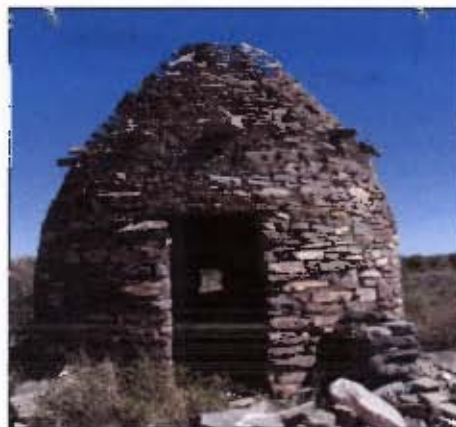
**Figure 5.8.** Omkeerkolk. The only oval base building located to date.

Farm	Height	Diameter	Ratio height to floor diameter
Omkeerkolk	3.56m	4.46 x 3.21m	0.93

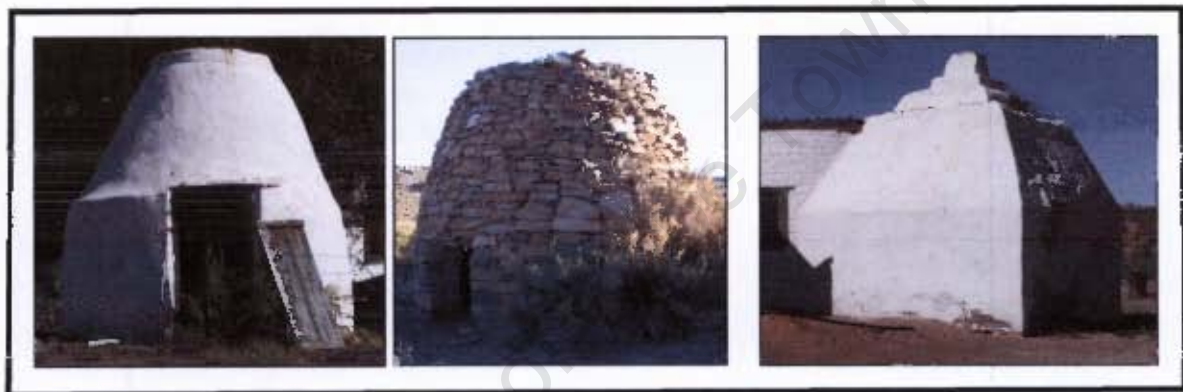
**Figure 5.9** Unusual buildings: Rietfontein I (A2a) (left), Knegsbank (A2a) (middle) and Voorstevanzylsplaas (B3a) (right).

Vernacular buildings are subject to the competence and even whims of the builder, and there are examples of corbelled buildings which have unusual exterior features and are marginal to the types defined, although they do still obey the rules of construction of a corbelled building. There are not many of these, in fact, fewer than might be expected. One is at Rietfontein I (A2a), where the roof from the ledge upwards is corbelled, but built of mud bricks laid in the Dutch bond style. A second is from Knegsbank (A2a) which has a very low door and seven niches at floor level in the interior wall and is a chicken coop. A third is from Voorstevanzylsplaas (B3a) which has a stepped exterior (Fig. 5.9).

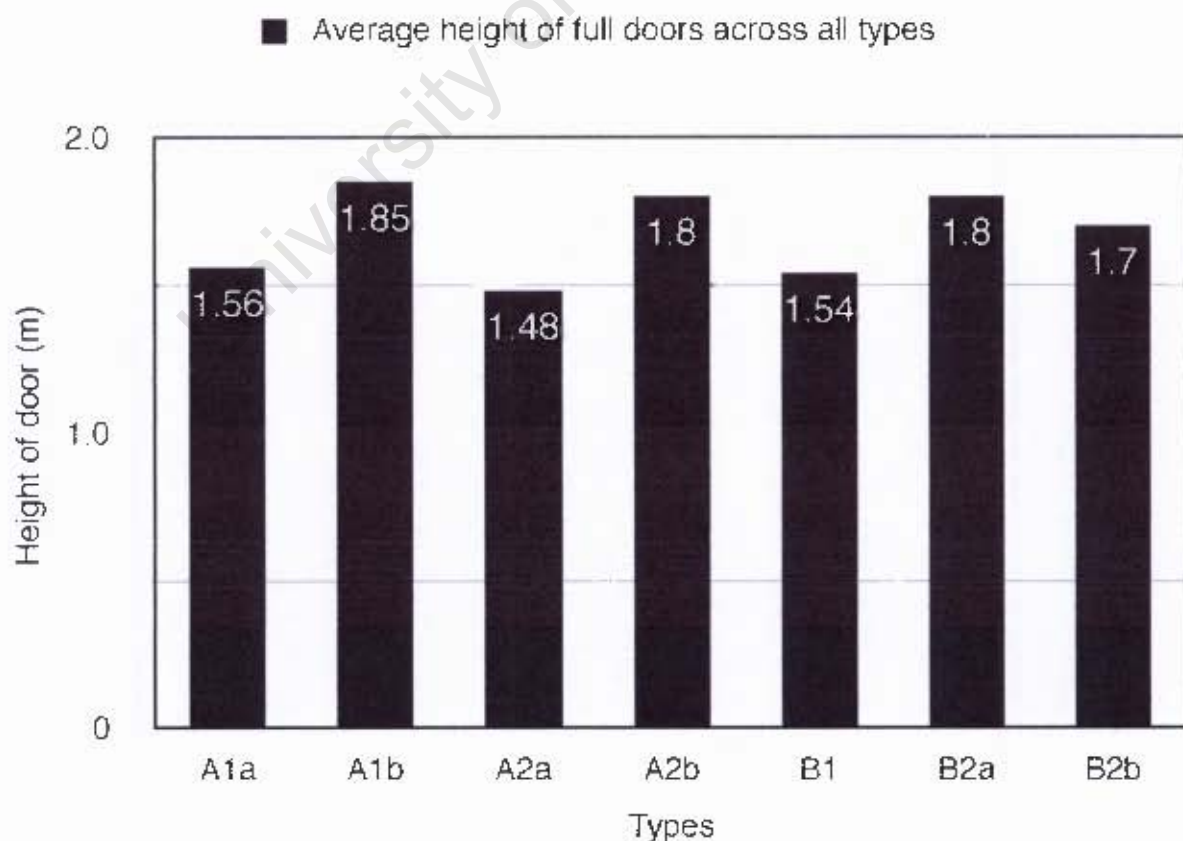
**Figure 5.11** The average height of full-door openings across all Types.

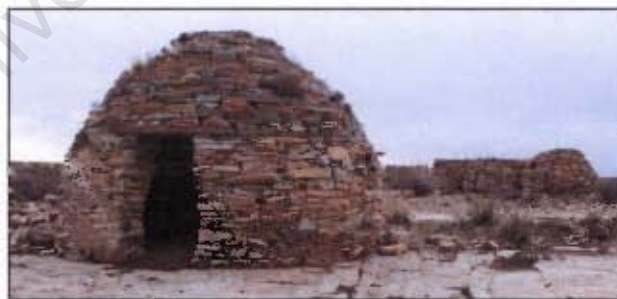
**Figure 6.12** Leyfontein II with Leyfontein III in the background.

The corbelled building itself is small – the internal roof height is only 1.8 metres. There are no windows but there is one horn hook. The whole complex is roughly built, unlike the corbelled building (Leyfontein II) 22 metres away (Fig. 6.12) which is a finer structure.

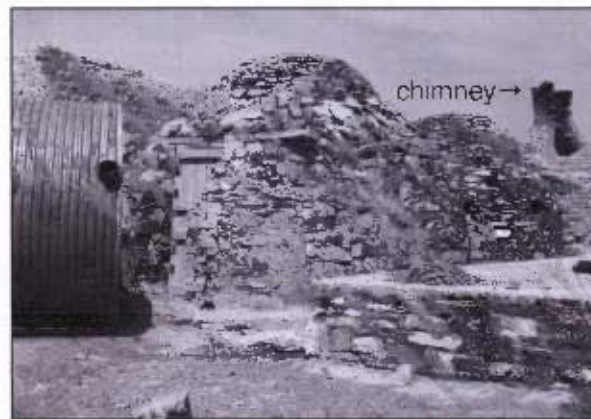
**Figure 6.15** Photograph by Walton which shows the brick chimney in the background (Walton n.d.:66).

In the photograph taken by Walton about 40 years ago (Fig. 6.15), there is a brick building with a chimney either next to or attached to A2. There is no longer any sign of this at all, including a foundation.

All domestic features in C have disappeared, but B has niches and a window. A brick chimney which appears in Walton's photograph (Fig. 6.15) suggests that cooking was done at the rear of the complex, and A1 and A2 were possibly connected to food preparation. It is possible that the complex forms two domestic units, each consisting of a corbelled building at the rear and a rectangular extension in the front.

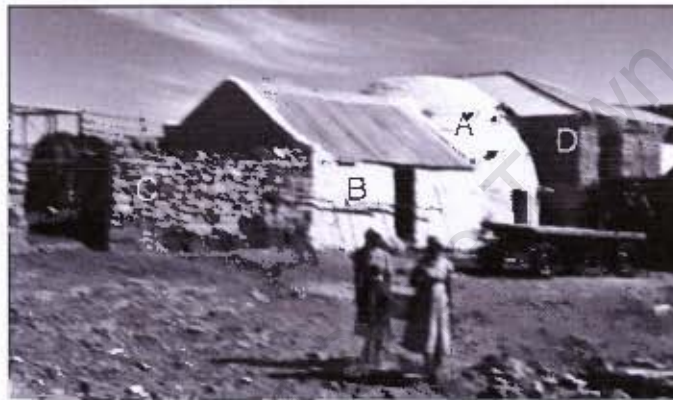
**Figure 6.18** Walton's photograph shows the second extension (C) walls still standing. A door connected extensions B and C (Walton n.d.).

Attached to B is another rectangular extension (C), now completely disappeared. The remnants of it were still visible when Walton photographed the buildings in 1960 (Fig. 6.18) (Walton, n.d.). There was a connecting door between the two extensions. On the northern side of the corbelled building is a large barn made of beautifully dressed stone that is probably late Victorian in date (Fig. 6.17, D).

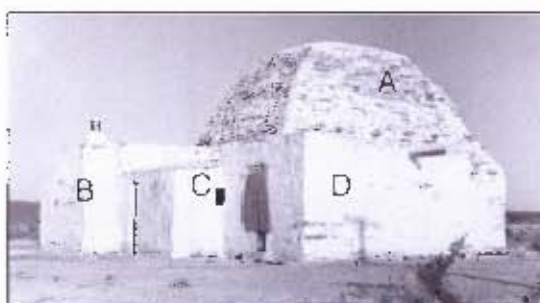
**Figure 6.31** Arbeidersfontein. Walton's 1960 photograph of the corbelled building and three extensions, two of which have since been demolished (Walton, n.d.).

When Walton saw Arbeidersfontein in 1960, he was told that it had been divided into two rooms by a wooden partition (Walton 1989: 125). Since his visit two of the small extensions to the side and rear (C and D) have been demolished, although the foundations still remain (Fig. 6.31). The third extension, a small room with a hearth still exists (Fig. 6.33, B). The original front of this large purpose-built house has been retained and the extensions were all small and arranged around the side and back of the original building, creating a block-shaped complex.

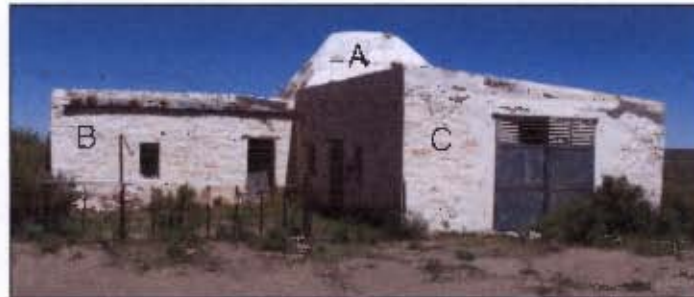
**Figure 6.39** Klipkolk. Rear of the building.

The arrangement of the extensions B and C result in an L-shaped house (Fig. 6.39), but the approach from the front has retained the corbelled building as the main building. Over the years the building has been altered inside, so it is difficult to ascertain exactly what the internal arrangements were with regard to internal walls, doors, niches and so on. The dump is at the rear of the building, thus reinforcing the arrangement of front and rear (Fig. 6.37).

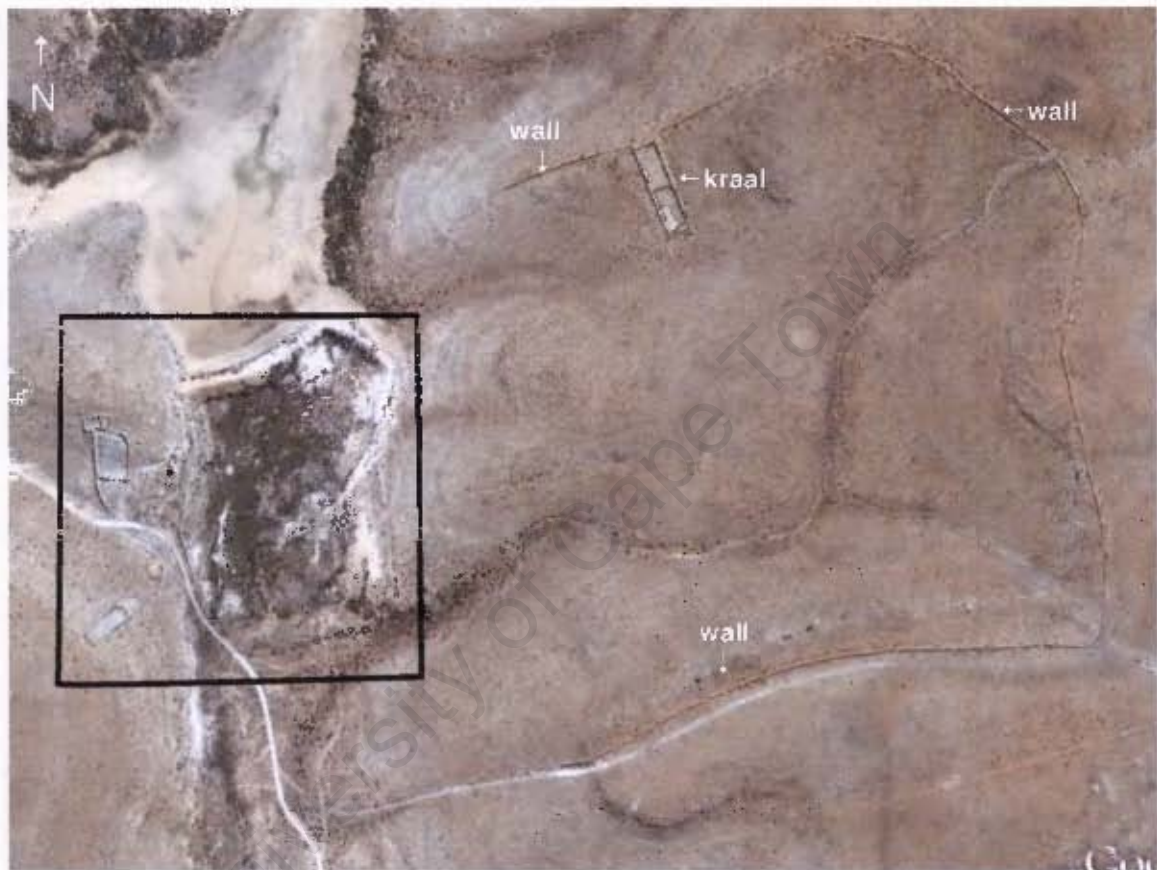
**Figure 6.40** Leeuwkrantz. Large camp surrounded by stone walls (Fig. 6.41 inset). Google Earth image.

Leeuwkrantz is now an abandoned site (Fig. 6.40) which also has kraals, extensive stone walling, a *trapvloer* and cultivated lands. The corbelled building was constructed on a ridge and the two extensions (B and C) were built on either side of it (Fig. 6.41). There are no other buildings in the vicinity and the house seems to have been abandoned at which point the corbelled building was converted into a *kafhok* by turning the full door into a half-door. The modern farm buildings are some 1.25 kilometres away.

In contrast with the meandering walls of the camp are the precise right angled stone kraals within the camp (Fig. 6.40). This may have been built later, but its purpose was to separate certain animals from the rest of the flock. There is also a small kraal in front of the corbelled building (Fig. 6.41).

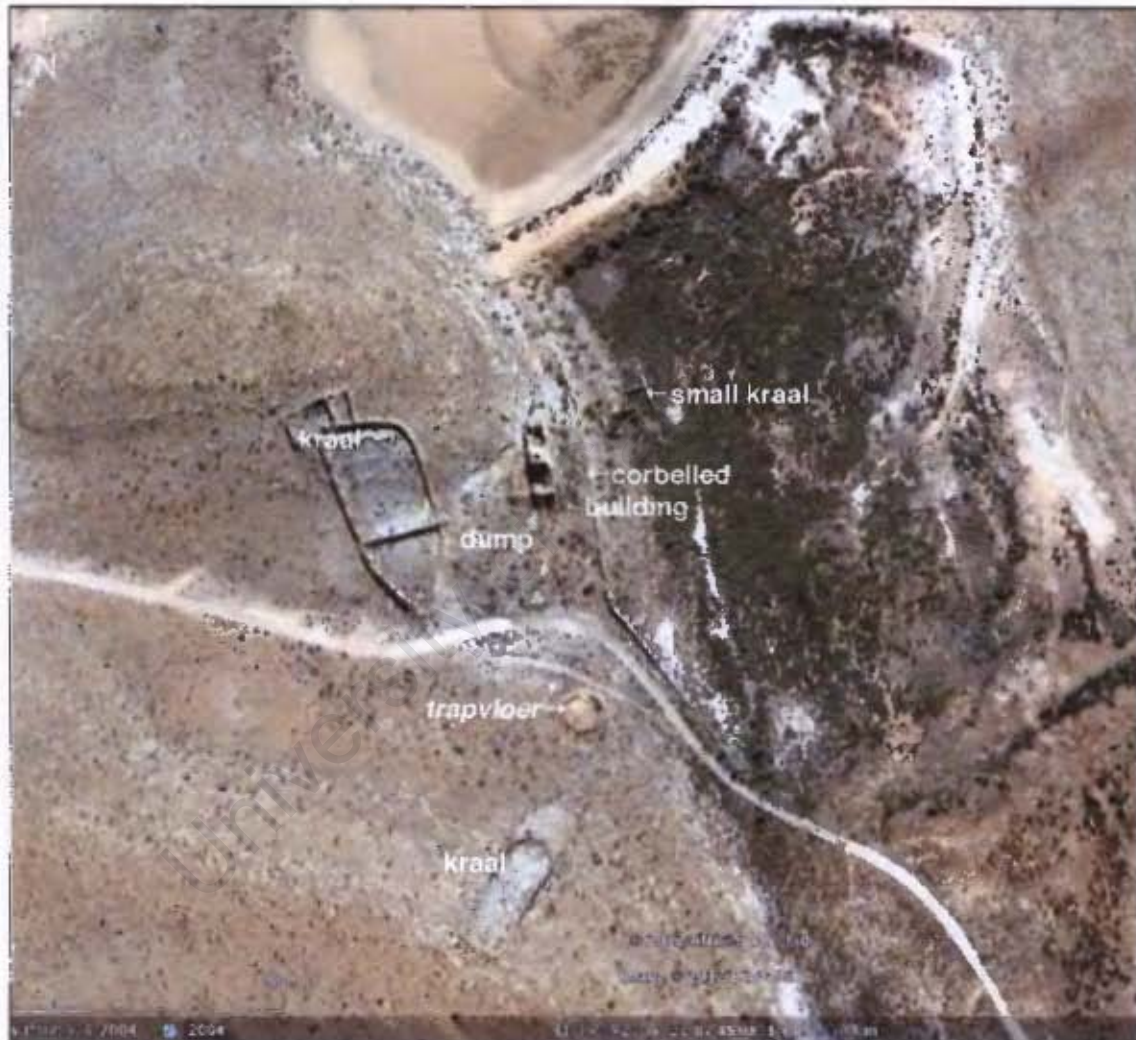
**Figure 6.41** Leeuwkrantz *werf* (inset of Fig. 6.40). Google Earth image

There are some interesting points to be made here about the kraals. There are two large kraals behind the complex – one directly behind and the other towards the south. However, a large area to the east of the complex has been enclosed by a long meandering dry stone wall (Figs. 6.41 and 6.42).

The complex is linear and faces east and the corbelled building retains its position in the front. The whole complex is on a rise overlooking kraals, old cultivated lands and the approaching road (Fig. 6.41). There is a dump at the rear, western side of the building, which because of the slope, has eroded downhill.

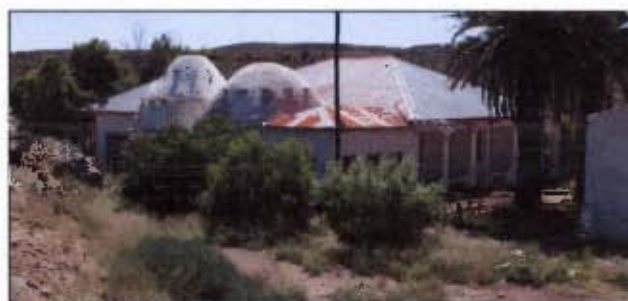
**Figure 6.45** Konka. The corbelled buildings have been enveloped by the 1950s building.

If the information above is correct, the square base corbelled building faced west and the round-based building did not have a door which led to the outside. Both had windows at the rear (east). The corbelled buildings now open directly into the new building and have been reduced to the status of bedrooms on the side of the house (Fig. 6.45).

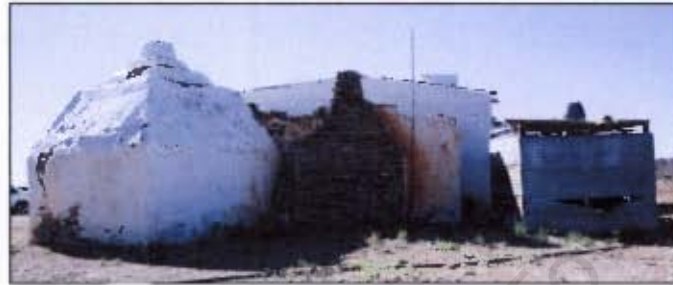
**Figure 6.48** Voorstevanzylsplaas. Side view of the complex showing the chimney.

The combined effects of the construction of D and E on the complex is profound. The corbelled building and extension B are both pushed to the side of the complex (Fig. 6.48) and a new front was created (E). The corbelled building has been reduced in status to a storage room and chicken coop.

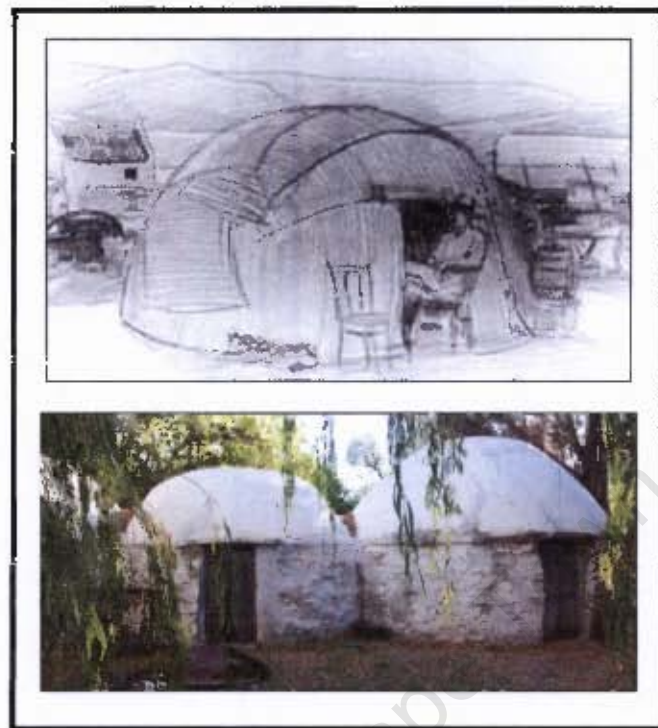
**Figure 7.1** Trekboers were used to living in small, round structures. *Matjieshuis* (top) sketch by Erich Mayer, and similar shape and size of stone building at Eendefontein (bottom). (Sketch: National Cultural History Museum.)

Furthermore, by this date trekboers already had a cultural experience of living in round buildings as many living in Khoe influenced *matjieshuise*. Therefore, they were 'pre-adapted' to living in stone buildings of similar shape (Fig. 7.1).

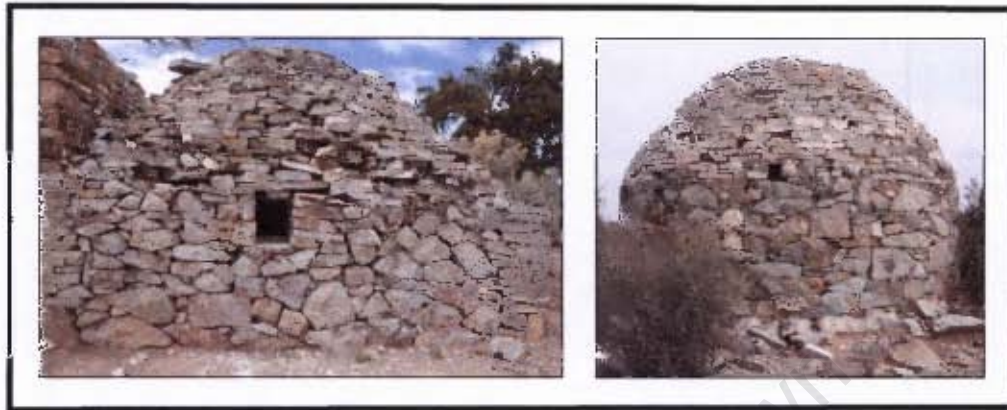
Irrespective of who exactly the builders were, stylistic similarities between structures suggest that a builder’s individual style can be recognised. The two Koppiesfontein corbelled buildings (Fig. 7.2), for example, were built by the same builder because the base has a

particular “crazy-paving” arrangement of stone which is quite distinctive and has not been seen elsewhere. This builder also built both square and round based buildings, although the square base building still has a round and not a pitched roof. This shows that round and square-based buildings appear to have been constructed at the same time and that the intuitive sequence of round to square bases does not hold universally.

**Figure 7.2** Koppiesfontein. Square base building (*left*) and round base building (*right*).

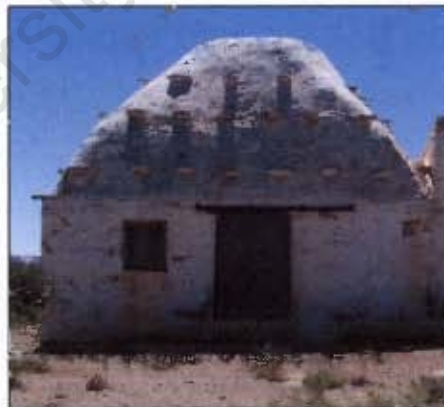
It is, however, unlikely that the builder of this square-based building at Koppiesfontein had the skills required to build the large square-based buildings that are located further north, for example at Klipkolk (Fig. 7.3). This is an example of an initial idea that was elaborated and enlarged to create a substantial house.

**Figure 7.3** Klipkolk. Large square base building which required a particular skill to build.

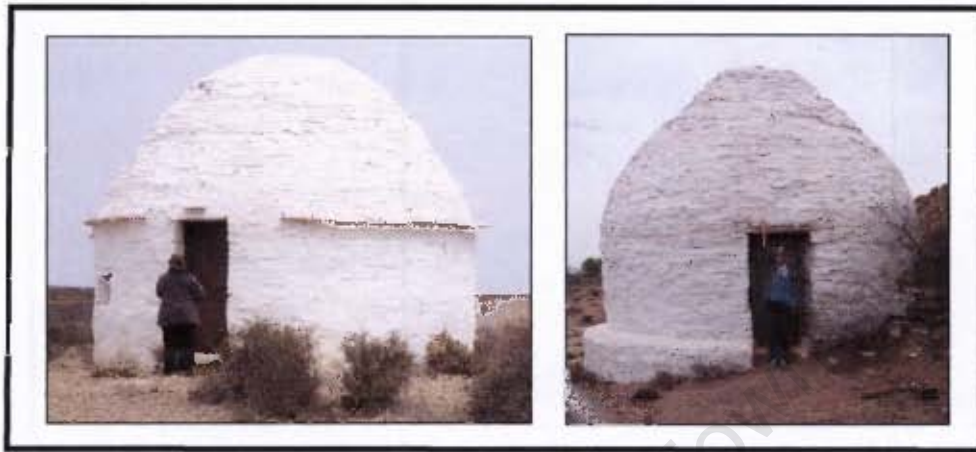
A common builder may also be identified through building dimensions. At Modderfontein (Fig. 7.4) there are three corbelled buildings, all within a few hundred metres of each other. The smallest was a *kafhok*, and the other two were built as habitations. The two dwellings are about 240 metres from each other and although outwardly, they appear to have distinctly

different stylistic features, their dimensions are almost identical. The internal features are also almost identical with windows, stone shelves and niches in both buildings. Finally, the construction of the roof is very fine and in both cases the roof holes have been closed with a single roof stone, which is a difficult feat. It appears that the same builder constructed both buildings, but each with a distinctive external style.

**Figure 7.4** Modderfontein (*left*) and Brakvlei (*right*). Their dimensions are identical.

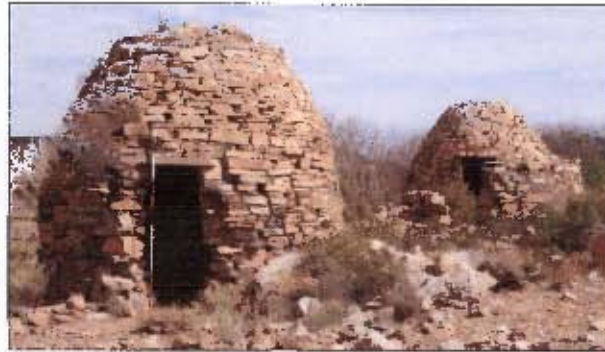
De Wilg (Fig. 7.6) is another case in which two corbelled buildings occur close to each other, but appear to have been built by different people. The building in the foreground is a different shape and flat stone slabs were used, whereas the builder of the structure in the background used square blocks of stone and created a different shape.

**Figure 7.6** De Wilg. Different shapes of stone have resulted in different buildings.

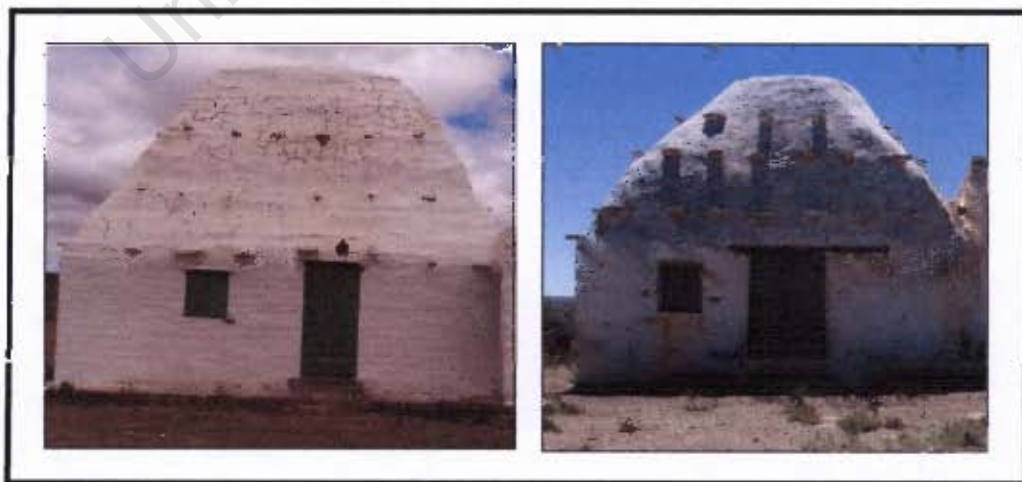
The examples above illustrate a number of points about the builders. First, in some cases the same builder could build both round and square base buildings. Second, a few of the builders had an identifiable, distinctive style. Third, proximity of buildings to one another does not mean that they were built by the same person or the same time. These comparisons also demonstrate different levels of ability amongst the builders. When one considers the large square base corbelled buildings with pitched roofs (B3b), the “hand” of the builder can also be seen. For example, it is quite possible that Arbeidersfontein and Klipkolk were built by the same person or group of people. Unfortunately, the interior of Klipkolk has been altered, but the exteriors can still be compared. (Fig. 7.7)

**Figure 7.7** Arbeidersfontein (left) and Klipkolk (right) have similar construction styles.

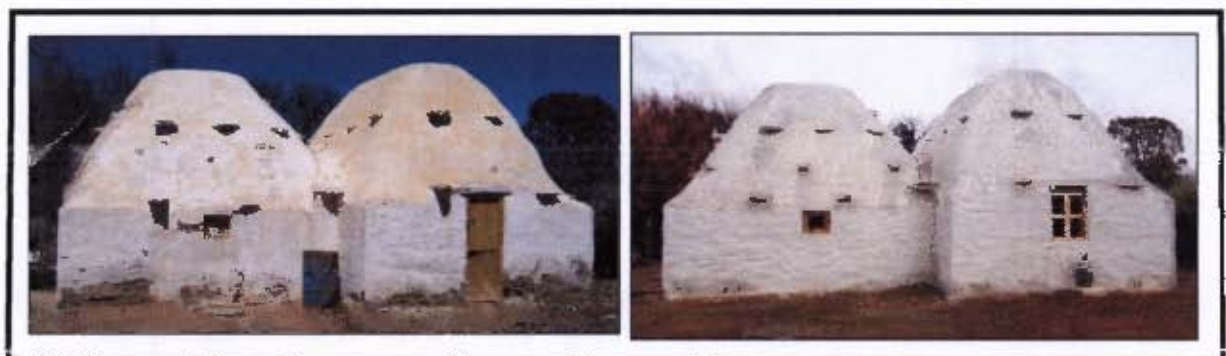
When Walton was invited to inspect the corbelled buildings in the Karoo in the 1960s, preservation and conservation of them was clearly on the agenda. This concern still applies, but the addition of this work may contribute to a change in the perception of their significance. What, though, does the future hold for corbelled buildings? On the whole farmers tend not to demolish them as every building on the farm is valuable and can be used for some purpose, such as storage. There are increasing signs among the farming community, however, that the buildings are being redefined as heritage in relation to their potential earning power and their use for tourist accommodation. This has been encouraged by the increased activity in the area linked to the Meerkat radio telescope currently under development, and the possibility that the Square Kilometre Array (SKA) telescope will be awarded to South Africa. For example, Droogeputs, a wonderful corbelled building complex which retained its old character and texture, has now been renovated and “fixed up”. All the woodwork has been sanded, the roof has been cemented, plumbing installed and the “back” door which faced the *kookhuis* has been converted into a window (Fig. 8.1).

**Figure 8.1** Droogeputs. Side view. The back door has been blocked and converted into a window (*right*). (Photograph on right: Judy Maguire.)

One could argue that this is the owner's prerogative, but the new roof covering is not sympathetic to the original structure and in the longer term will result in the breakdown of the entire building.

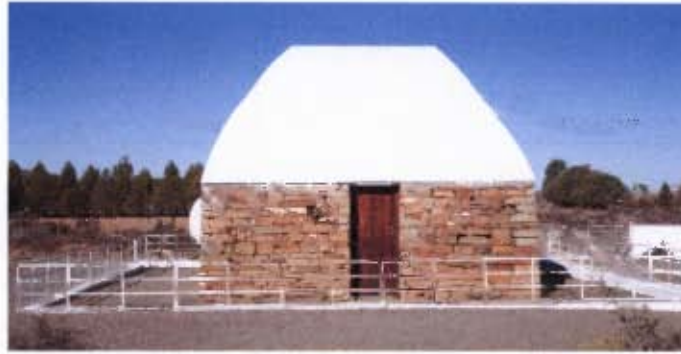
On the whole farmers have tended to leave the corbelled buildings alone, particularly if they are in isolated parts of the farm or on abandoned *werfs*. Corbelled buildings on an operational *werf* are more likely to be "tidied up" (Fig. 8.3) as there is pride and respect for what they represent in terms of local history.

**Figure 8.3** Ystervarkspoort. On the one hand the building is being cared for and protected, on the other hand it and its surroundings have been sanitised.
