UNIVERSITY OF CAPE TOWN
FACULTY OF ENGINEERING AND THE BUILT
ENVIRONMENT

Department of Civil Engineering

*Effect of anti-corrosive coatings on the bond between
corrosion-damaged rebar and concrete repair materials*

A dissertation submitted to the Department of Civil Engineering, University of Cape Town, in partial fulfilment of the requirements for the degree of Master of Science in Civil Engineering.

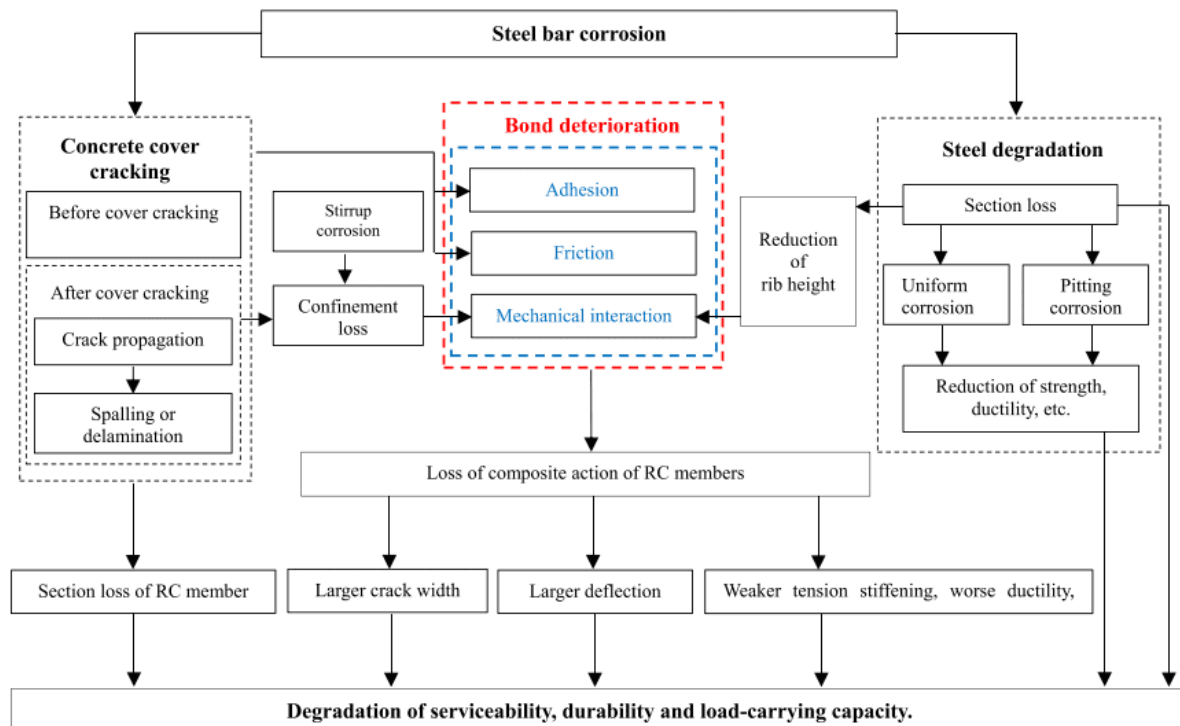
The influence that reinforcement corrosion has on a RC member's structural behavior arises mainly from degradation of the bond at the steel-concrete interface. It is commonly known that reinforcement corrosion destroys the ribs and lugs which largely comprises the bond in uncorroded deformed rebar (Lin *et al.*, 2019). The cross-sectional diameter of the steel is reduced and thereby the strength of the member is affected by corrosion activity. Deterioration of the bond due to corrosion therefore has a significant effect on reducing the service life of RC members where the serviceability and ultimate load-carrying capacity are altered as a result. Furthermore, in instances where corrosion progresses to high levels, the failure mode of the concrete can be changed from ductile to brittle failure, which can be a major problem for in-service RC structures if no remedial action is taken. Figure 9 displays an overview of the damaging effects due to reinforcement corrosion on the bond that exists in RC members.

Figure 9: Reinforcement corrosion effects on structural performance (Lin et al., 2019)

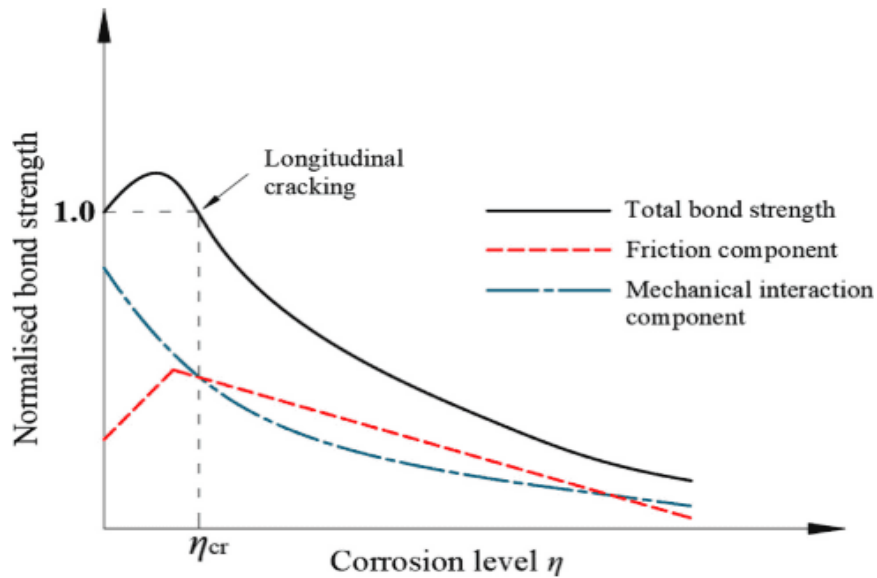
The effects of reinforcement corrosion on deterioration of the bond have been widely investigated by many authors. The relationship between bond strength and corrosion level in terms of mass loss is shown in Figure 10. A general trend is noticed, where the bond strength is increased during the initial stages of corrosion, till a critical corrosion threshold is reached. Thereafter, the bond strength decreases as the corrosion level increases (Lin *et al.*, 2019). During the initial stages of corrosion, up to about 5% steel mass loss, the expansive corrosion products seep into open pores, creating a denser and stronger ITZ between the corroded steel and concrete. This seepage also creates a confining pressure, thereby further enhancing the frictional component of the bond (Lin *et al.*, 2019). Almusallam *et al.*, (1996) noted that, at this corrosion level, the ultimate bond strength had increased by 13% of its original bond strength, before corrosion had occurred.

Figure 10: Idealized bond strength relationship with corrosion level (Lin et al., 2019)

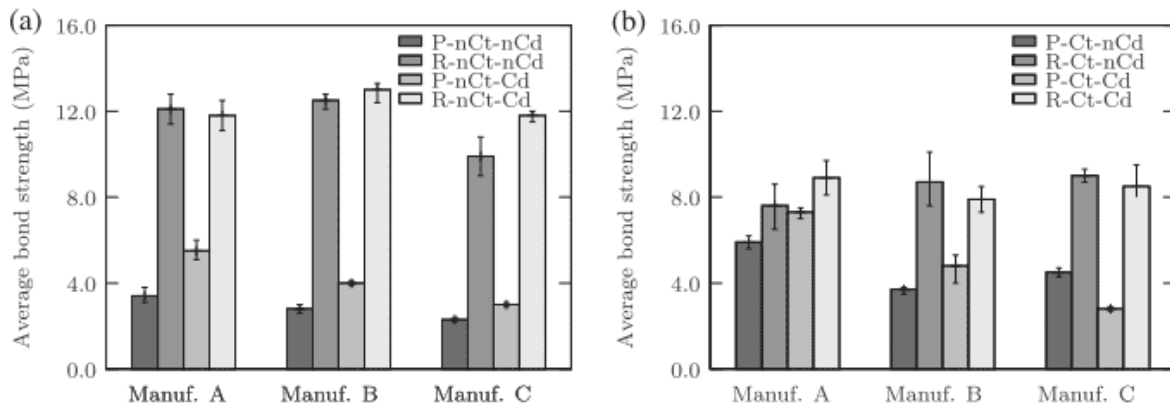
Figure 16 depicts the average bond strengths achieved by pull-out testing of a variety of commercial repair systems presented by Jorge, Dias-da-Costa and Júlio (2012).

Figure 16: Bond strength of uncoated (left) and coated (right) series for plain (P) and ribbed (R) rebar with cementitious coatings - coated (Ct), uncoated (nCt), corroded (Cd) or uncorroded (nCt), (Jorge, Dias-da-Costa and Julio, 2012)

The repair systems included cement-based epoxy-modified resin, cementitious mineral and synthetic resin coatings on plain and deformed steel bars, corroded to 5% and 3% mass loss, respectively. Coating thicknesses of 1.8 mm and 1.5 mm were applied to the plain and deformed bars, respectively, recommended by manufacturer specifications. In this investigation, repair concretes including cementitious grout with silica fume, fibre-reinforced plain cement and a hydraulic binder with silica fume were considered. Three combinations of a single coating and repair mortar was adopted, namely Manufacturers A, B and C. For the uncoated steel, the initial bond failure mechanism in plain bars was controlled by adhesion loss whereas for deformed bars it was governed by mechanical interaction of the ribs and concrete. For plain bars, the bond strength was observed to increase by application of the coating due to an enhanced surface roughness (Jorge, Dias-da-Costa and Júlio, 2012). Hence, anti-corrosive cementitious coatings should be applied to plain bars, as this would strengthen the frictional component of the bond. For deformed bars, however, the use of these cementitious coatings reduced the bond strength by up to 40% of the original capacity (Jorge, Dias-da-Costa and Júlio, 2012). This observation was, however, for a low corrosion degree of 3% steel mass loss. Natino *et al.*, (2021) investigated the effect of anti-corrosive coatings on the bond behavior of repaired rebar at higher corrosion levels. Figure 17 displays the bond-slip curves for anti-corrosive cementitious coatings used on bars corroded up to 13% steel mass loss.

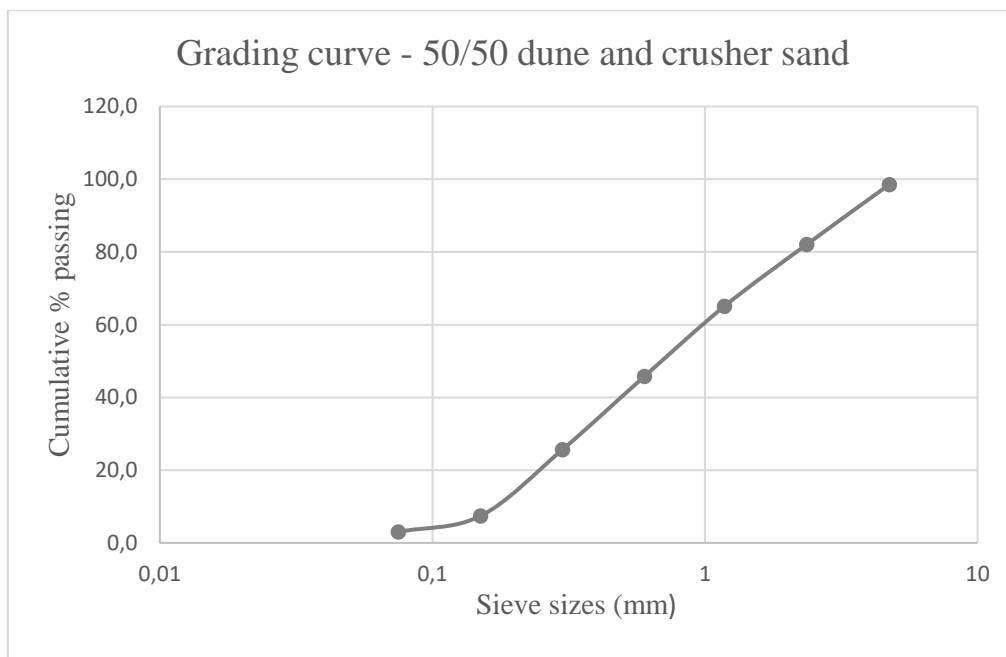
For the sieve analysis, the dust content in the selected sample was removed by wet sieving, as recommended by the standard. The grading curve for the fine aggregates is shown in Figure 19. The grading curves for the individual aggregates is provided in Appendix B. Only fine aggregates were used for the mortars, M65 and M45. The concrete C45 included Greywacke stone of 19 mm, which is commonly referred to as Malmesbury Shale in the Western Cape Province. Furthermore, mixes supplemented with stone aggregate for concrete can account for reduced costs associated with the repair material, especially when large sections are restored (Morgan, 1996).

Figure 19: Grading curve for fine aggregate

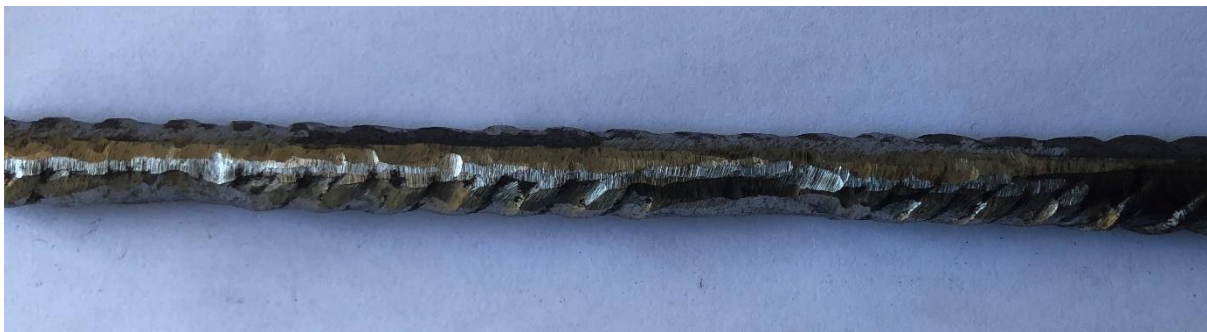
Corrosion was simulated using an angle grinder. The condition of the steel surface was analysed and measured by weight loss using a digital scale to an accuracy of 0.1 g. This method of corrosion damage simulation was chosen due to time constraints and was considered to not significantly deviate from natural corrosion damage. Hence, the state of the steel surface should represent that of a corroded cleaned bar, after the rust has been removed. To achieve a desired corrosion degree of an equivalent 10% mass loss, some of the ribs were removed and an uneven surface created, shown in Figure 20. For 20% mass loss, all the ribs were removed, and an uneven surface created, shown in Figure 21. To accurately remove the correct amount of steel, the bars were grinded and weighed continuously until they were $\pm 1.5\%$ steel mass loss from the respective corrosion target levels. Furthermore, when all the ribs were removed the surface profile of the steel was smooth and similar to a plain bar, hence it was decided to create minor indentations along the bar surface to represent chloride -induced corrosion damage. The mass of the grinded steel bars used in this study is provided in Appendix C.

Figure 20: 10% cleaned corroded steel

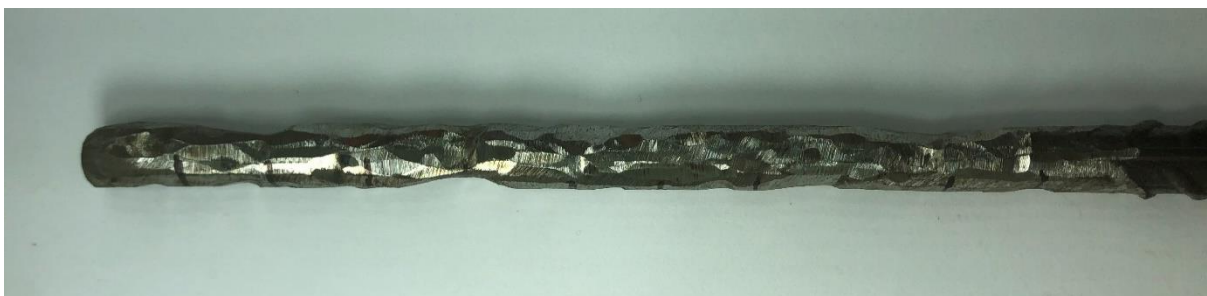
Figure 21: 20% cleaned corroded steel

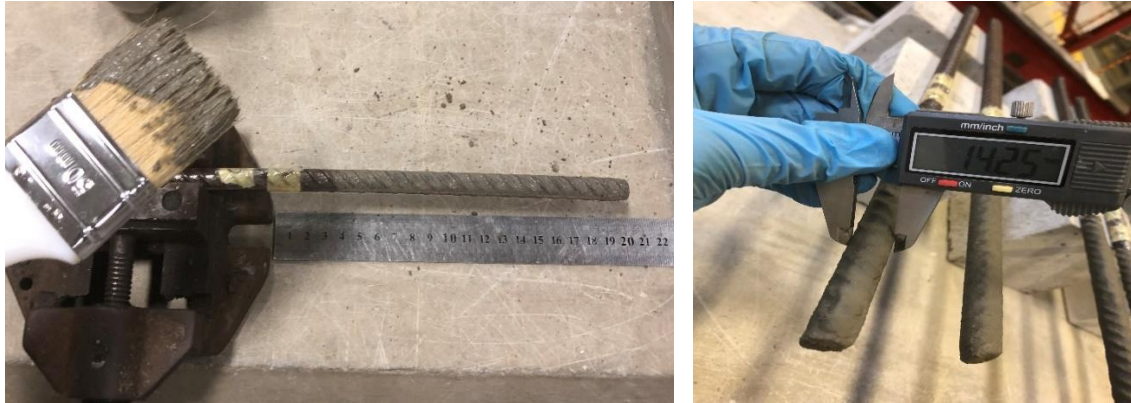
thickness of the bars was measured using a Vernier Calliper, as seen in Figure 22. Readings were taken at 15 mm intervals along the length of the steel by comparing the diameter of the uncoated bar to the coated bar at the same location. The detailed rebar diameter measurements and coating thickness measurements for each bar can be found in Appendices D and E.

Figure 22: Coating application and thickness measurement

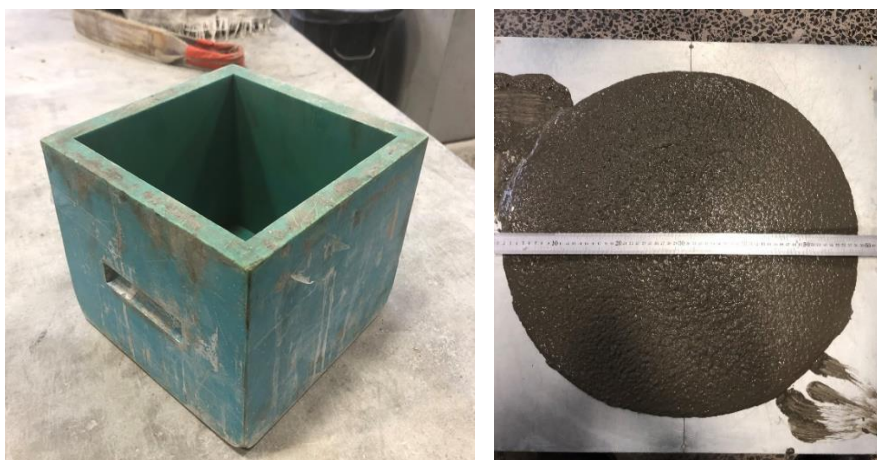
Mixing of the mortar and concrete was conducted by firstly mixing the dry materials sufficiently, thereafter, adding small quantities of mortar to the mix in increments till the desired workability of the mix was achieved. The mixing of fresh mortars and concrete was performed in accordance with SANS 6255: 2006 and SANS 5861-1: 2006, respectively. Before the fresh mixes were placed into moulds, see Figure 23 (a), their workability was assessed by means of the slump test for concrete and the flow test for mortars, which was conducted in accordance with SANS 5862-1:2006 and SANS 5862-2:2006, respectively. Figure 23 (b) displays the spread from M65 mortar of high workability from the flow test.

Figure 23: (a) Plastic mould, and (b) mortar flow

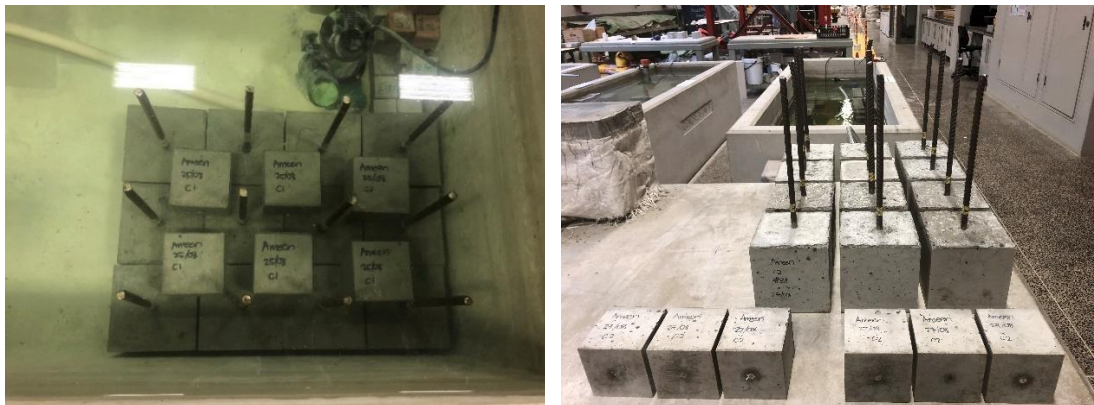
The specimens used for this investigation were cast in 150 x 150 x 150 mm cubic specimens for pull-out testing and 100 x 100 x 100 mm cubic specimens for compressive strength testing. Once the repair material was placed into the moulds, the rebar was positioned perpendicularly to the top surface of the pull-out specimen and left to cure in laboratory conditions for 24 hours before de-moulding. Adequate compaction was achieved by means of a vibrating table for a duration of 10 seconds for the concrete (C45), five seconds for the higher strength mortar (M45) and no compaction for the low strength mortar (M65), due to its high workability. Once the repair concrete was placed, compacted, and demoulded after 24 hours, the specimens were cured in a moisture curing tank until seven days of age to obtain the pull-out specimens for testing, shown in Figure 24. The specimens were cured until 7 days of age to shorten the testing period. The ACI Committee 301 suggests that 70% of the compressive strength is achieved after 7 days age.

Figure 24: Test specimens after demoulding and curing

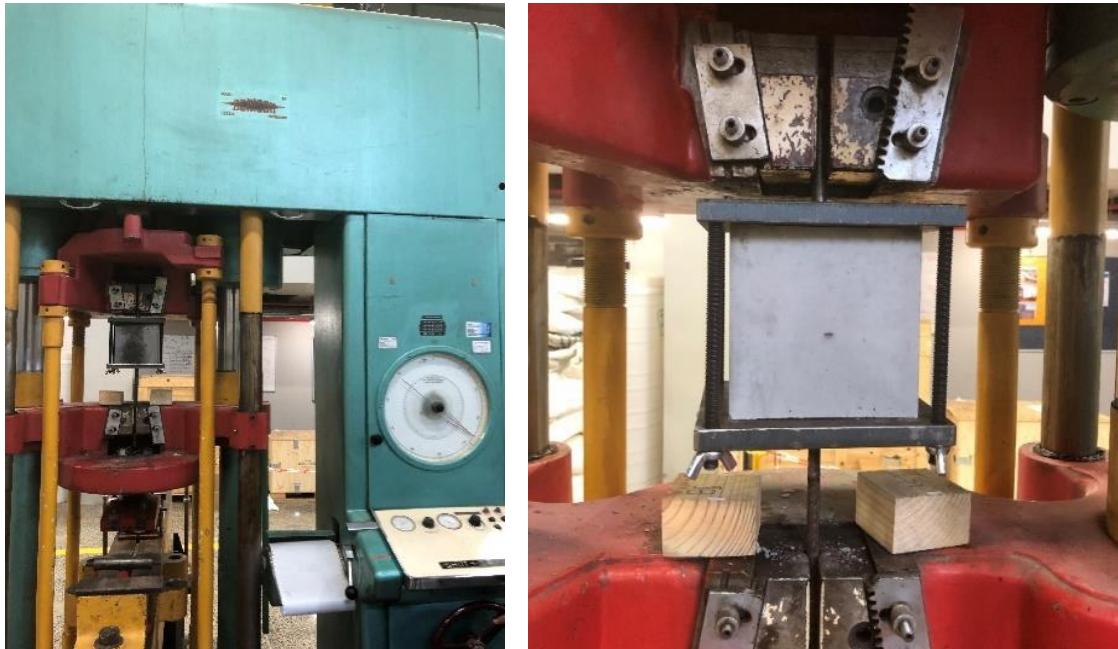
The pull-out test is a well-known method that has been used successfully to assess the bond strength between steel and concrete. RC specimens are cast with an embedded steel rod in the centre of the mould. This involved testing the tensile pull-out force between a cast-in reinforcing bar and concrete. The maximum load is measured as the load corresponding to failure of bond between the steel and concrete. Figure 25 (a) displays the Dension Universal Testing Machine used for pull-out testing. The pull-out test was carried out with a carbon steel chamber (16 mm plates) constructed and used for placement and fitting of the pull-out specimens, displayed in Figure 25 (b). A tensile load was applied to the steel manually in increments to carefully achieve a constant load rate of 0.1 MPa/s.

Figure 25: (a) Pull-out test machine (left), and (b) Specimen arrangement (right)

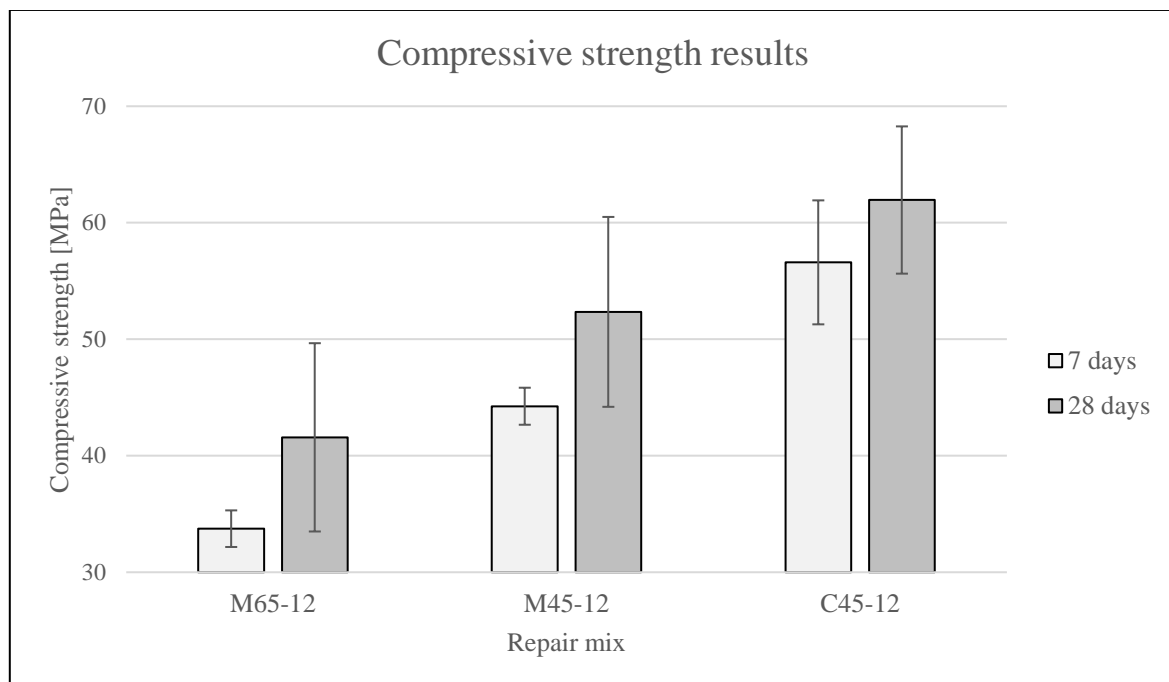
The compressive strength was determined for the three mixes used in this study. This included a total of nine batches that were casted, consisting of two mortars (M65 and M47) and a concrete (C45). For each batch, three cubes each were tested after 7 and 28 days to determine the compressive strength development of the repair materials. The detailed compressive strength results for each batch are provided in Appendix F. Figure 26 shows the average compressive strength for M65, M45 and C45 at 7 and 28 days. The values for M65-12 represent the average compressive strength of five 45 L batches, whereas M45-12 and C45-12 displays the average compressive strength of two 45 L batches each.

Figure 26: Average compressive strength results for each mix

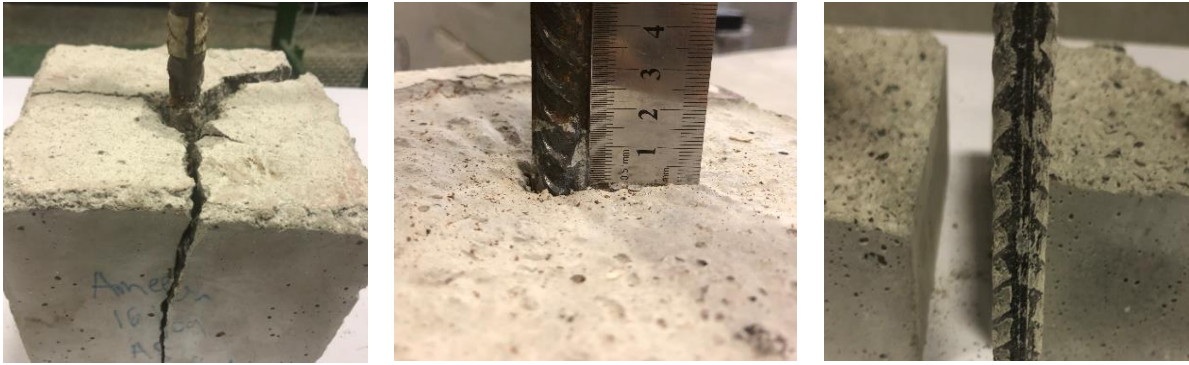
The specimen failure modes were categorized as either splitting of the repair material or slip of the rebar. Figure 27 (a) and (b) shows splitting and 15 mm slip from uncorroded rebar, respectively. Figure 27 (c) shows remnants of the uncorroded coated specimens after splitting failure.

Figure 27: Splitting (a), 15 mm slip (b), splitting with coating failure (c)

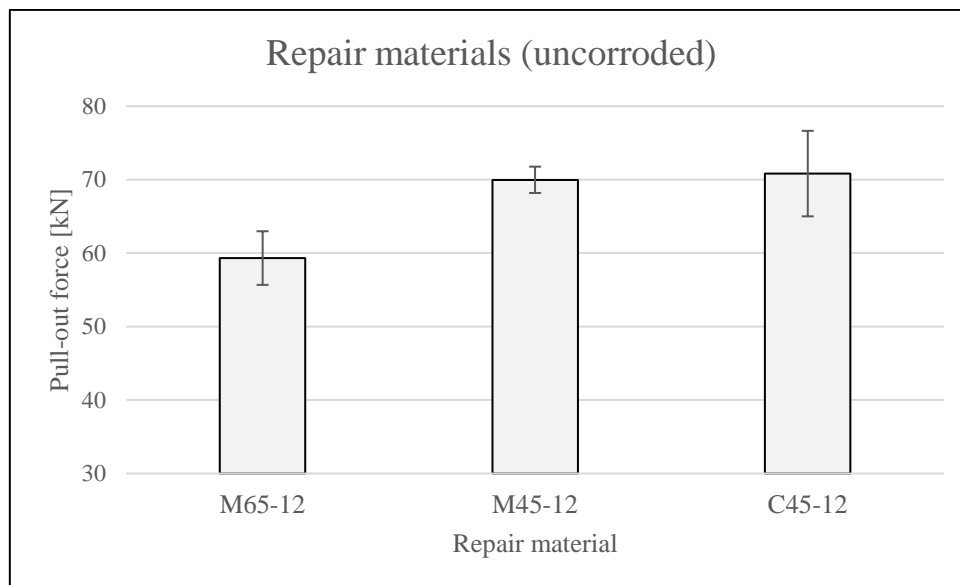
Figure 28 displays the pull-out results for the uncorroded untreated specimens with different repair mixes. There was an increase of 18% in the pull-out force when the w/b ratio was reduced from 0.65 to 0.45 for the mortars (M65 and M45). This difference is significant, indicated by the p-value (0.004). M45 contained a higher cement content than M65 but had the same water content, which led to a higher pull-out strength for M45. As the strength of the mix increased, the bond strength also increased as a result of a lower porosity in the interfacial transition zone (ITZ) between the steel reinforcement and cement paste (Teresa *et al.*, 2008).

Figure 28: Pull-out test results for uncorroded specimens (Control)

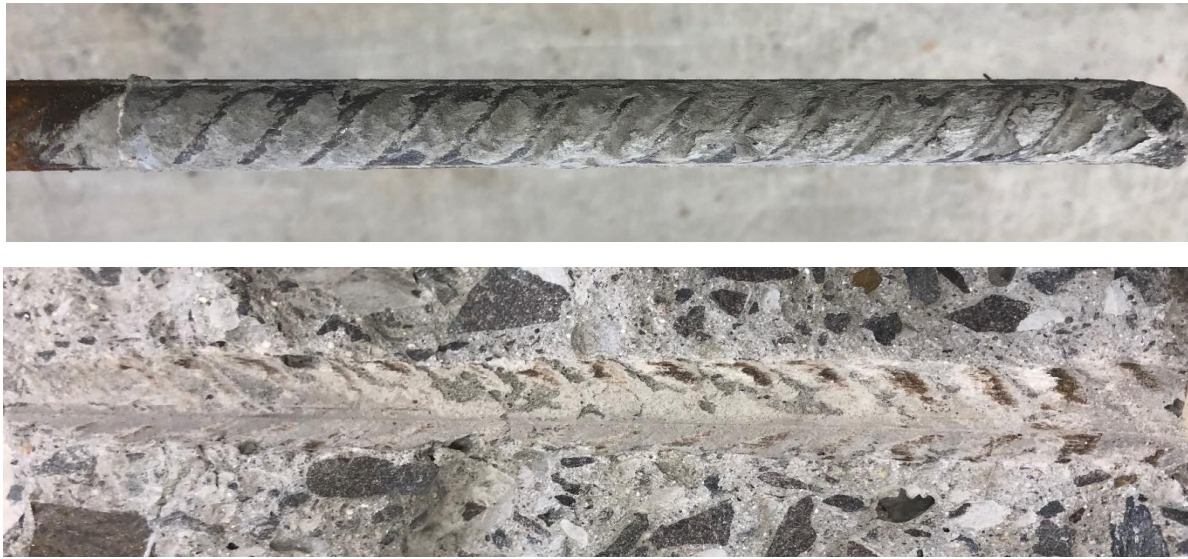
as the compressive strength of the repair materials was higher than the coating. Therefore, it can be assumed that the coating acted as a weak link between the steel and repair material.

Figure 33: Coating remains and concrete-steel interface after failure

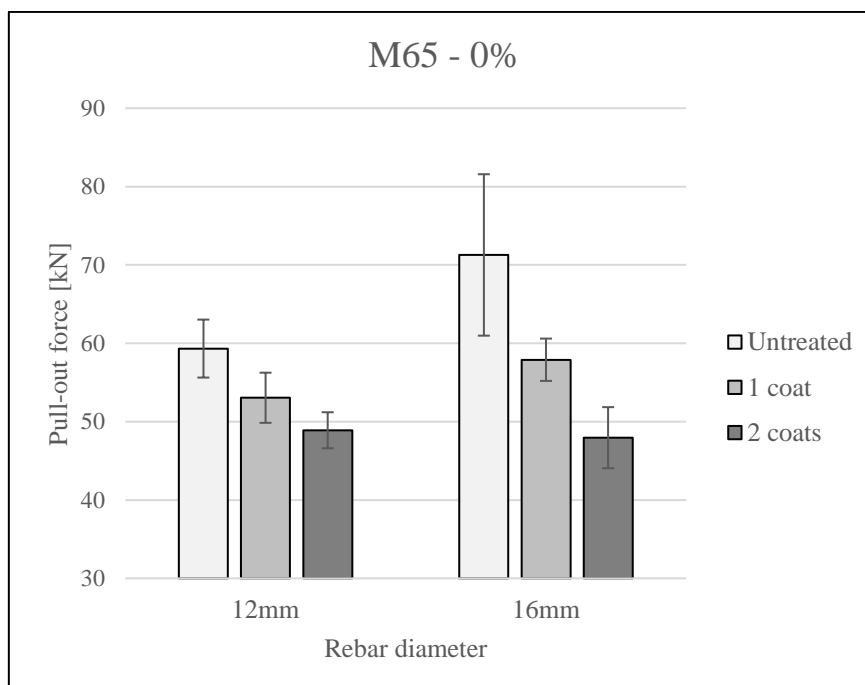
Figure 34 displays the pull-out test results for the 12 mm and 16 mm bars with no corrosion and all coating treatments. The results for M65-12 have already been discussed at the start of Section 4.2.5.

Figure 34: Pull-out test results for uncorroded M65-16

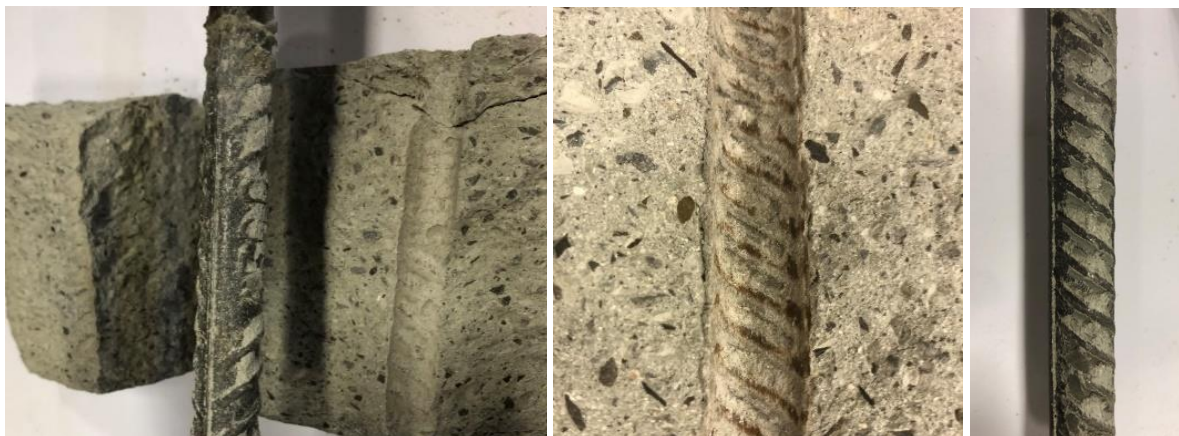
Figure 35: Coating failure with 10% corroded steel

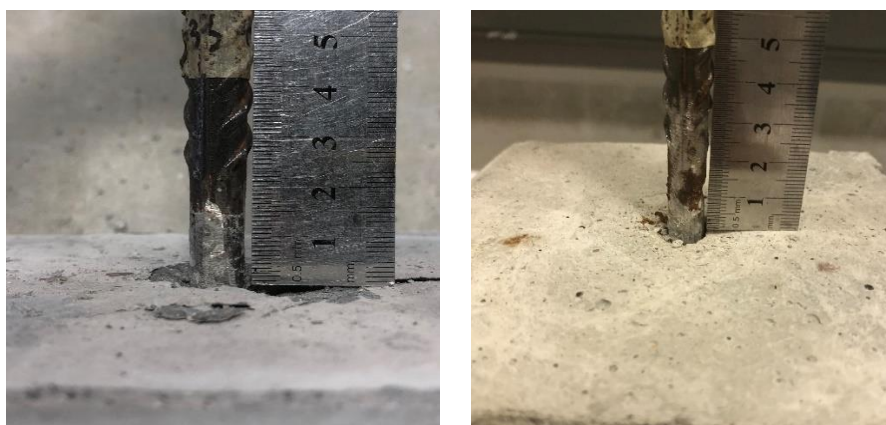
Figure 37: (a) Untreated 20% corroded steel with 15 mm slip, and (b) 30 – 35 mm slip

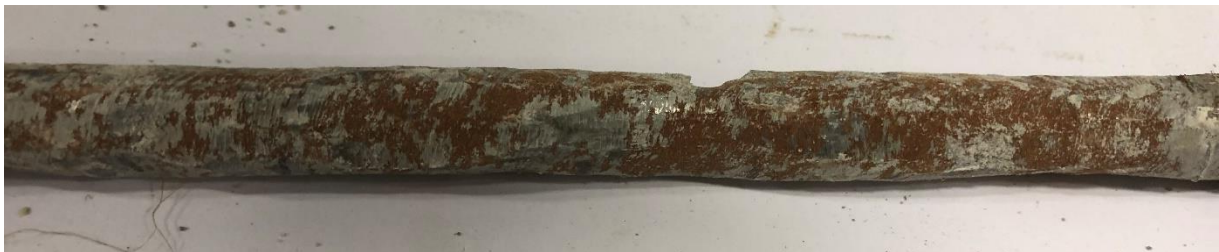
Figure 38: Corrosion effects of untreated steel after 7 days wet curing

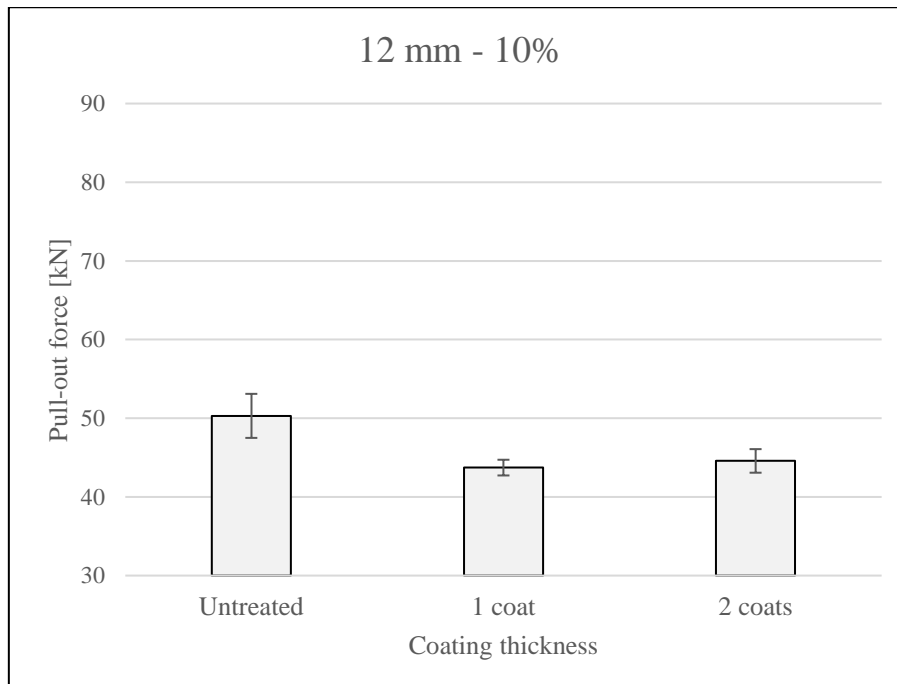
Figure 40: Pull-out test results for 10% corroded M65-12

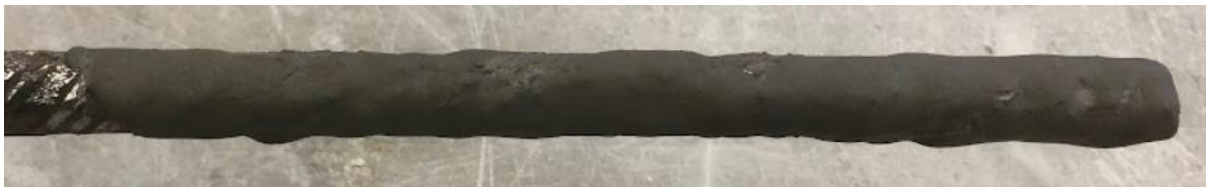
Figure 41: 10% corroded steel with two coats

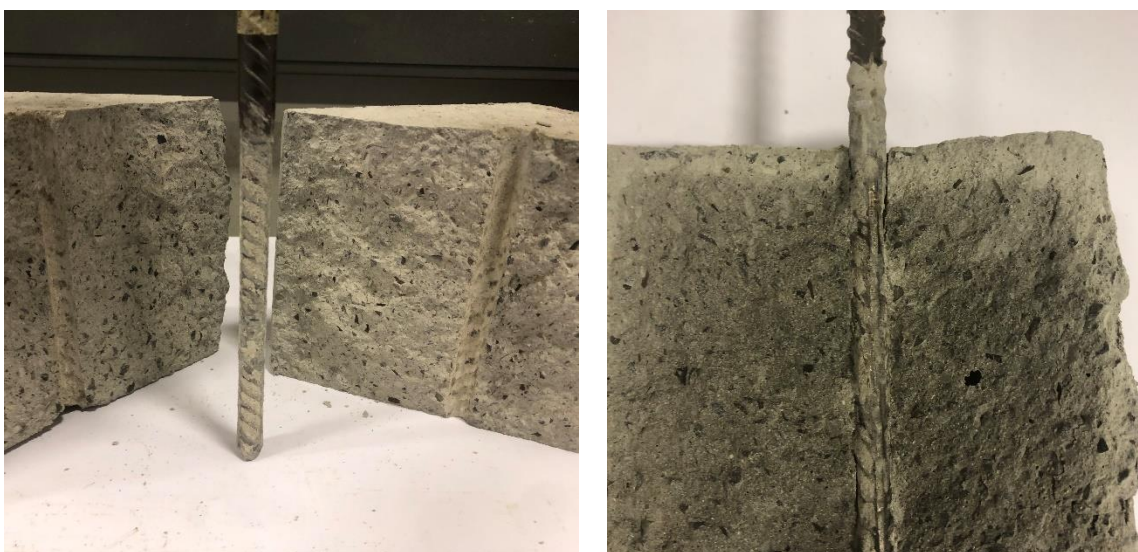
Figure 42: Splitting failure with coating shear for 10% corroded specimens

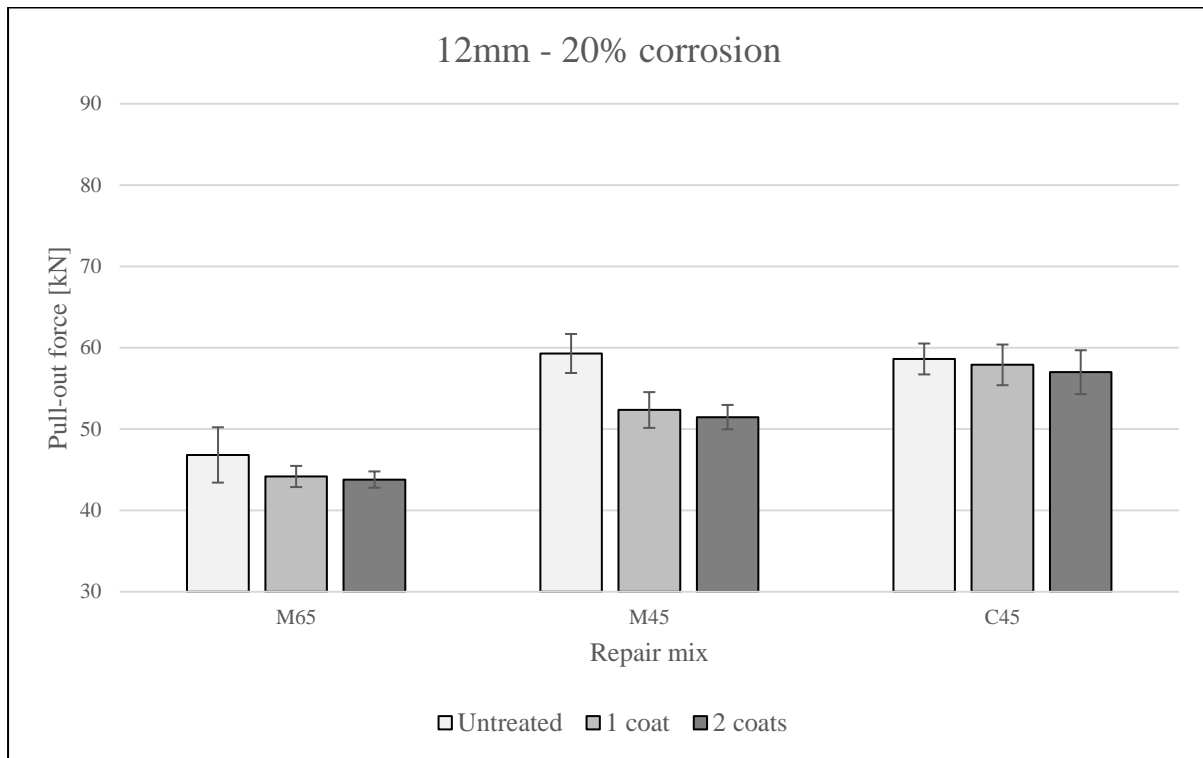
Figure 43: Pull-out results for 20% corroded 12 mm specimens

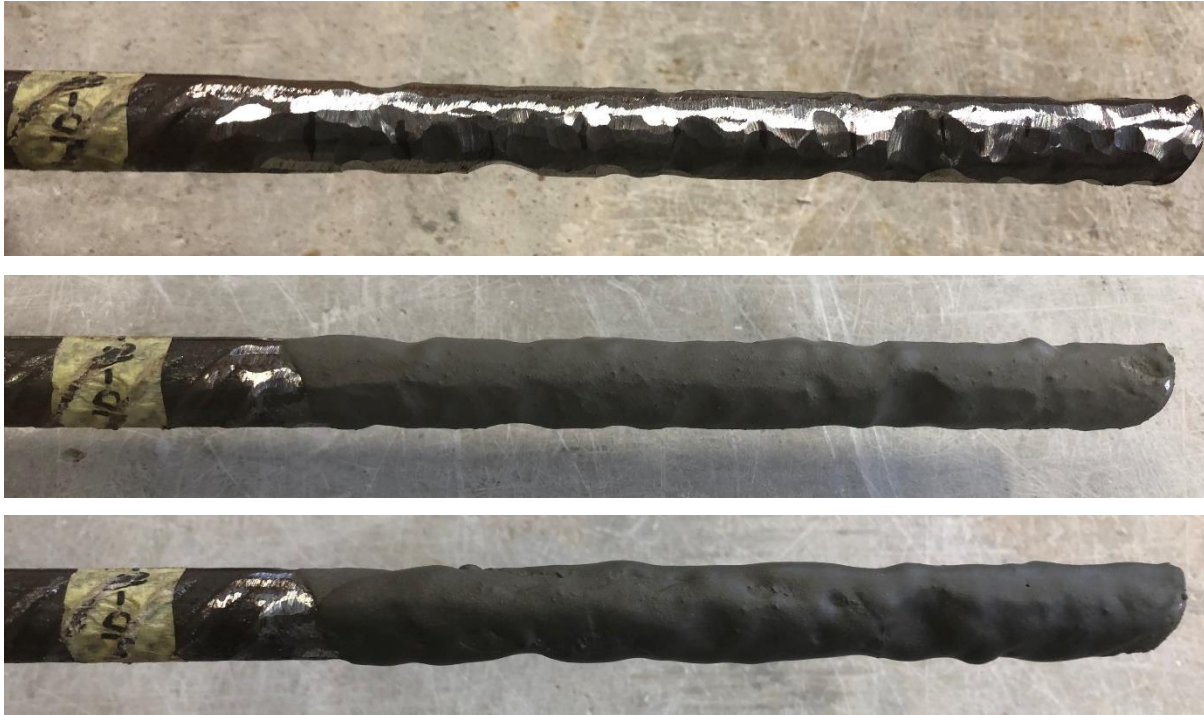
Figure 44: 20% corroded untreated (top), one coat (centre), two coats (bottom)

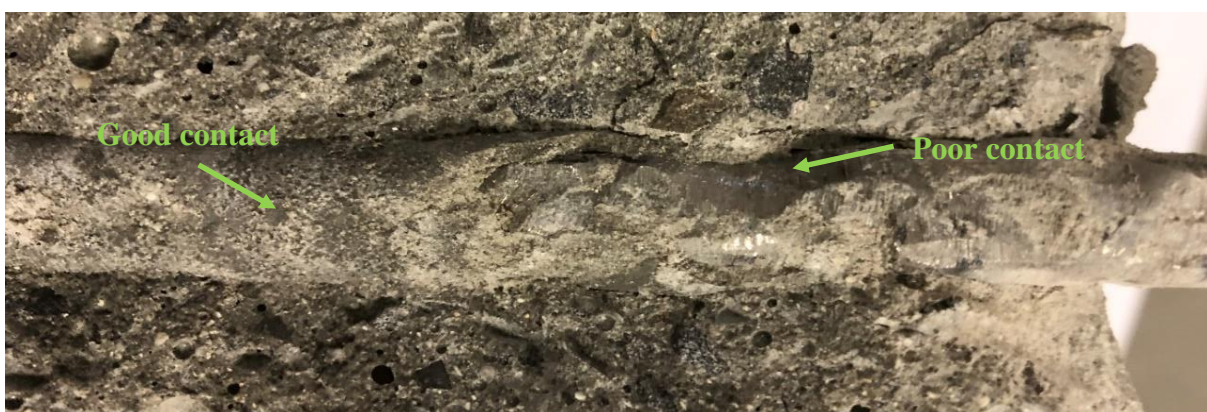
Figure 45: 20% corroded coated steel after failure

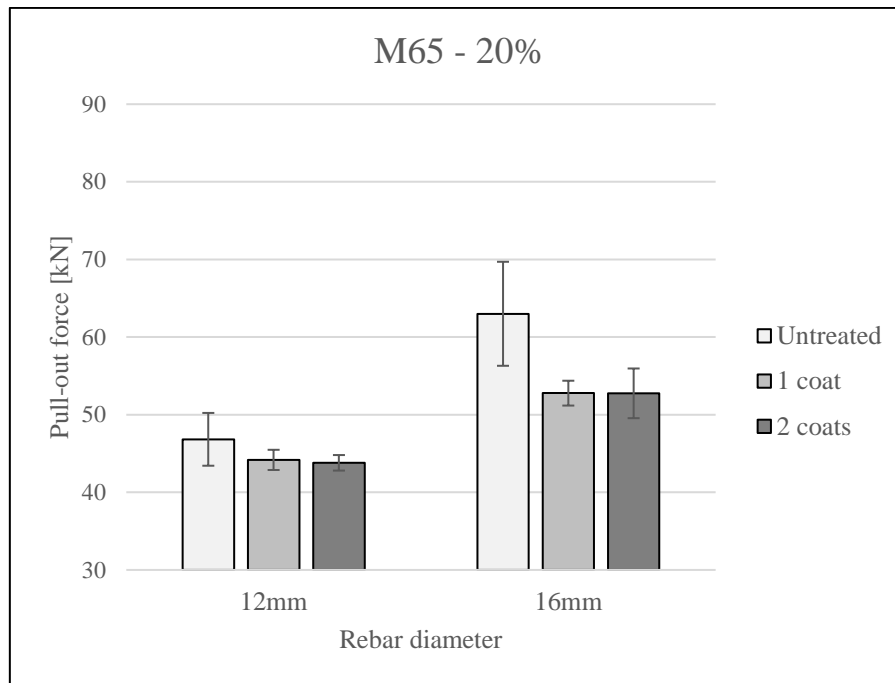
Figure 46: Pull-out test results for 20% corroded M65 specimens of different bar sizes
