# Review of Different Practices to Reduce Reinforcement Corrosion in Concrete Structures Managed in the City of Cape Town

**Prepared by:** Gesant Abed  
**Prepared for:** MEng Dissertation  
**Supervisor:** Professor MG. Alexander, Department of Civil Engineering (UCT)  
**Department:** Civil Engineering (Concrete Materials & Structural Integrity Unit)  
**Research Field:** Repair and Rehabilitation of Concrete Structures  
**Duration:** 2016 -2017

Faculty of Engineering  
& the Built Environment  
The University of Cape Town

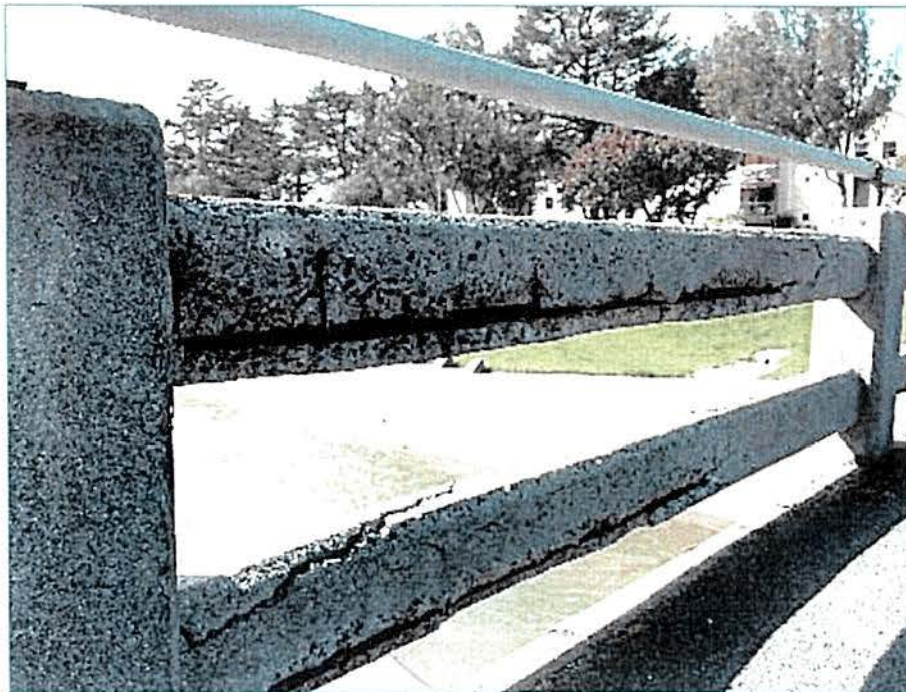
Figure 2 : Concrete deterioration and damage takes place in the form of spalling of the concrete cover and steel corrosion in Pinelands, Cape Town. The cracks normally develop above the steel and as the corrosion progresses the cover concrete is detached. In this case the deterioration was caused by low concrete cover and porosity concrete.

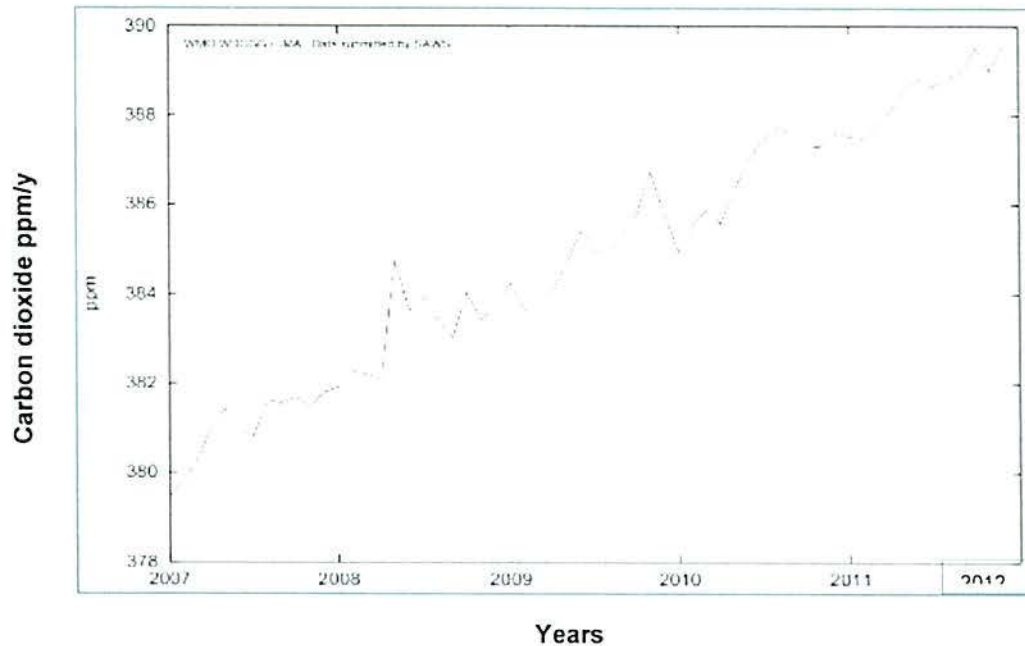
Figure 3: Carbon dioxide levels measured at Cape Point between 2007 and 2012 (World Meteorological Organisation, 2012)

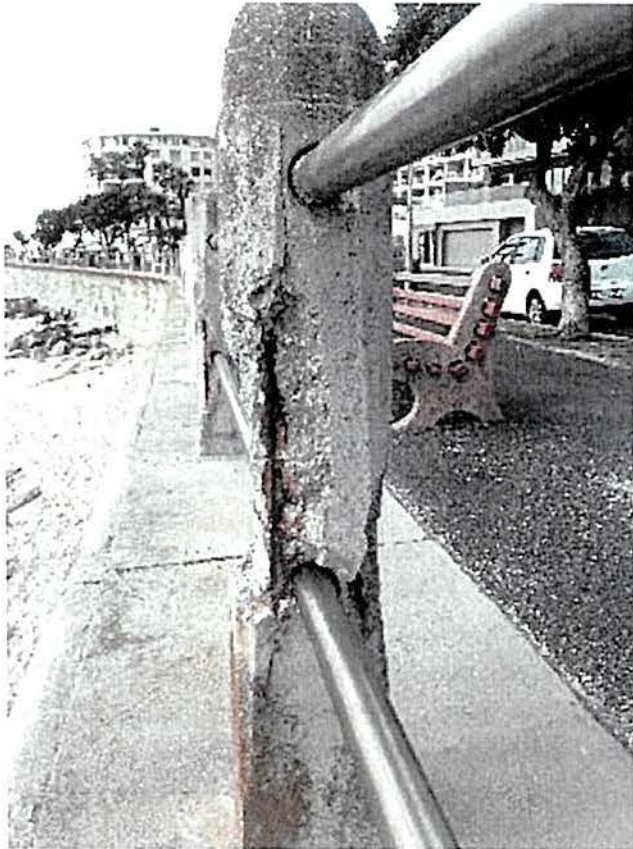
Figure 4: Concrete bollard located on the Atlantic Seaboard in a Spray Zone. The Concrete bollard shows heavy corrosion damage on the coast of Sea Point (Taken Oct 2016)

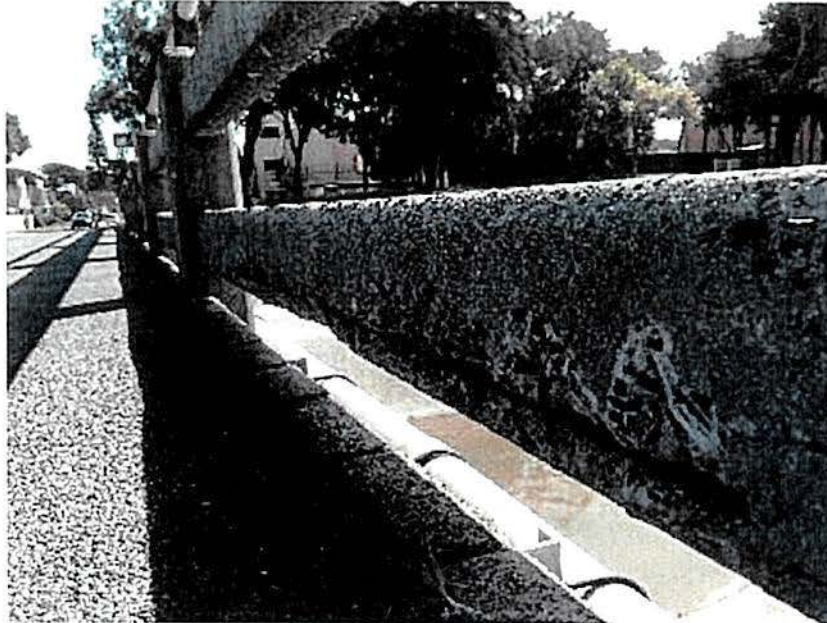
Figure 5. Pinelands road bridge spalling and rebar corrosion. Taken September 2016

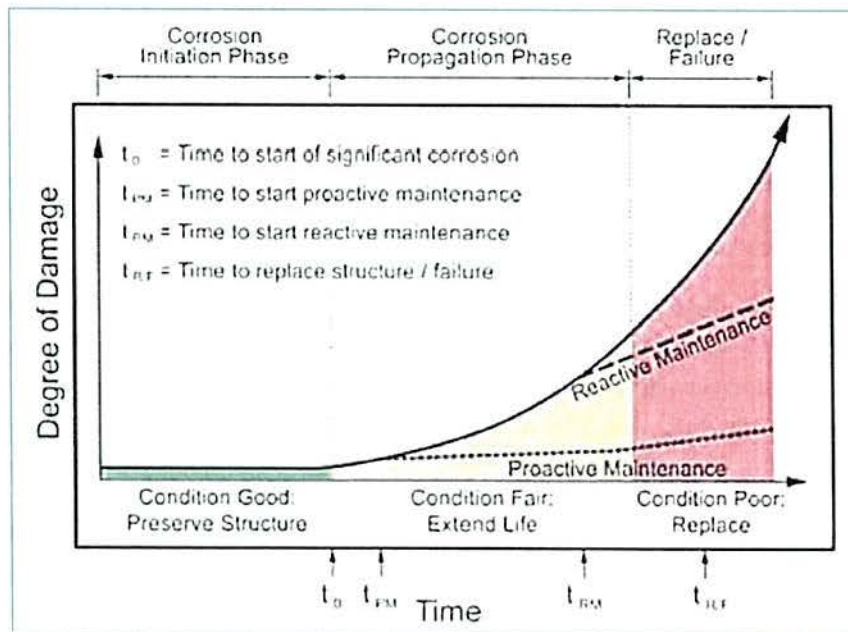
Figure 9: The degree of damage as a function of time (The Concrete Society , 2000).

Figure 9 below illustrates the lifecycle of a reinforced concrete structure and its relationship with concrete deterioration caused by the formation of cracks, delamination and spalling; eventually the structure will experience extensive corrosion, which would require repair or replacement. Damage due to corrosion is firstly seen by rust staining on the concrete's surface, then by the appearance of cracks, followed by delamination and spalling of the concrete cover. If left unrepaired the corrosion would continue causing spalling to be extensive and too costly to repair. The graph below shows the relationship between the degree of damage and the corrosion phases, comparing those factors to the overall service life of a structure. The graph also illustrates the best time for effective proactive maintenance and reactive maintenance.

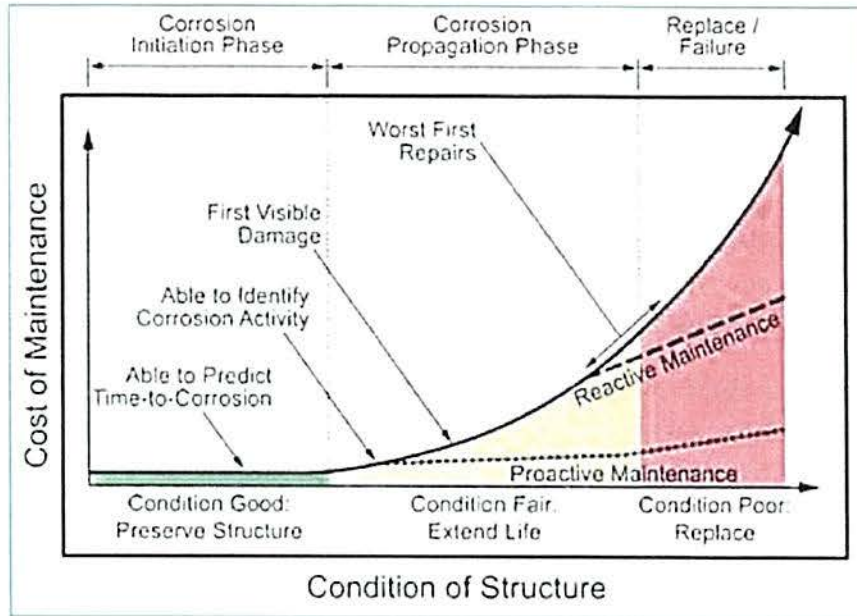
Figure 10: Bridge condition of time and the associated maintenance costs (The Concrete Society , 2000).

The graph (figure 10) illustrates the relationship between the cost of maintenance to the condition of the structure, and its relation through different corrosion "zones", estimating when concrete deterioration would be visible. These two graphs are closely related and indicate the required management and maintenance of a reinforced concrete structures over its service life.

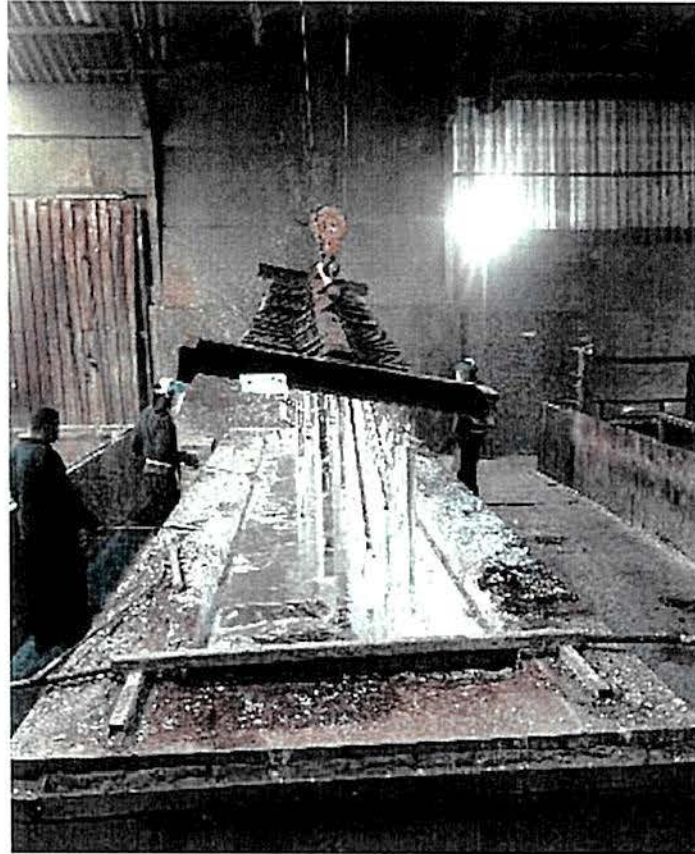
Figure 12: Steel sections lifted from the zinc bath at Galvatech (HDG plant tour 10/08/2016)

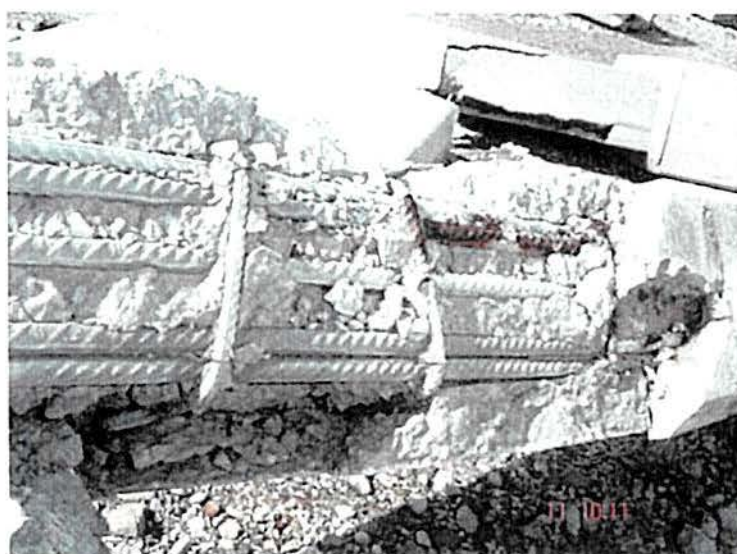
Figure 15 Isolated rust in regions of minimal concrete cover. (HDGASA, 2015)

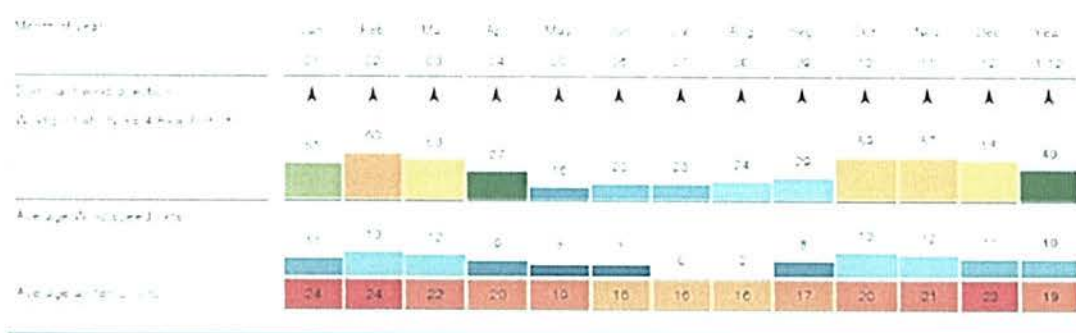
Figure 23: The annual wind and temperature patterns recorded at Muizenberg beach (windfinder, 2016)

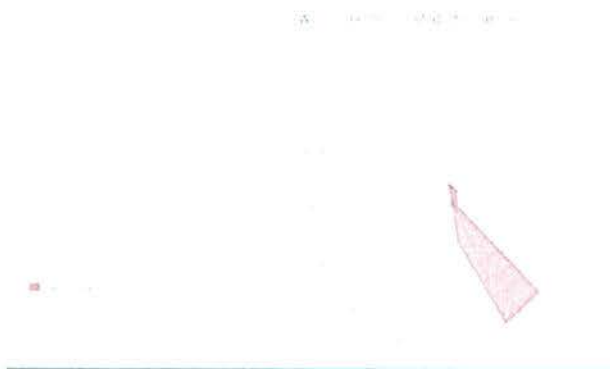
Figure 24: Wind direction, speed and distribution during winter months on the Atlantic Seaboard ([www.windfinder.com](http://www.windfinder.com)).

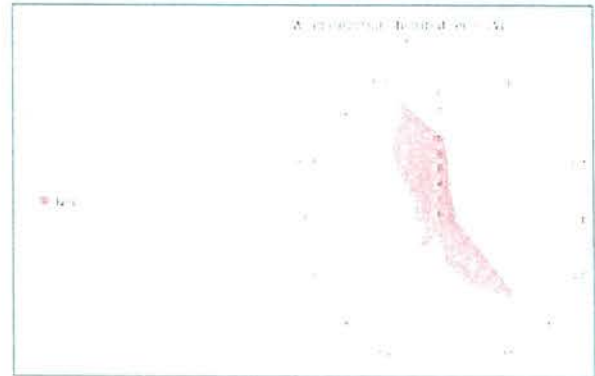
Figure 25: Wind direction, speed and distribution during the summer month on the Atlantic Seaboard (windfinder, 2016).

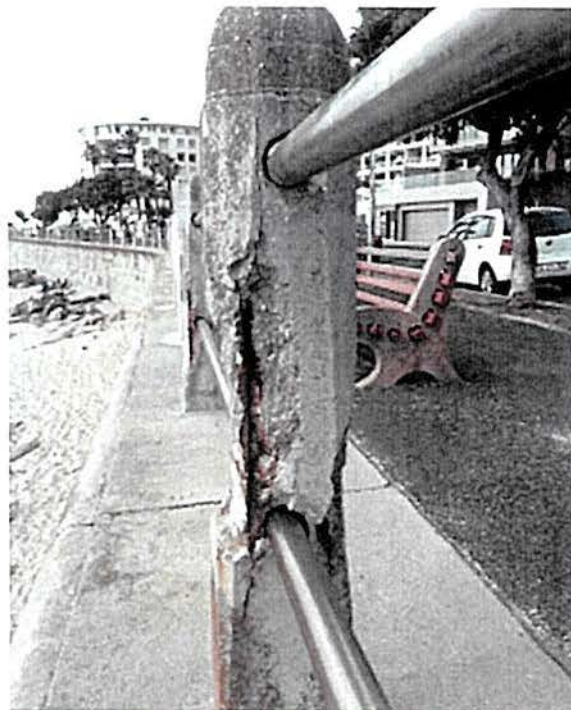
Figure 36: Rebar corrosion of a bollard on the sea point sea wall. (2016)

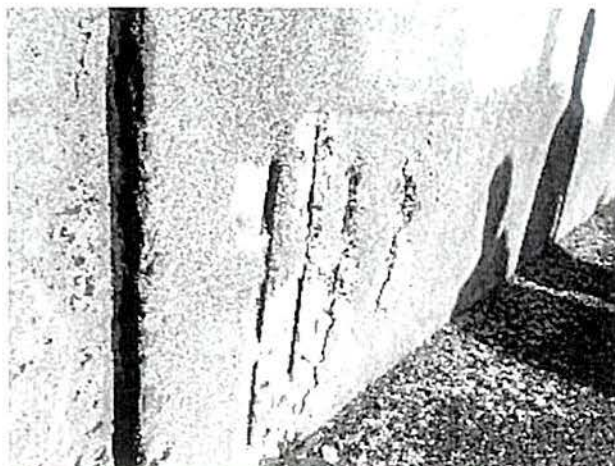
Figure 37: De Waal road bridge showing signs of concrete spalling and rebar corrosion with inadequate concrete cover. (taken 2016)

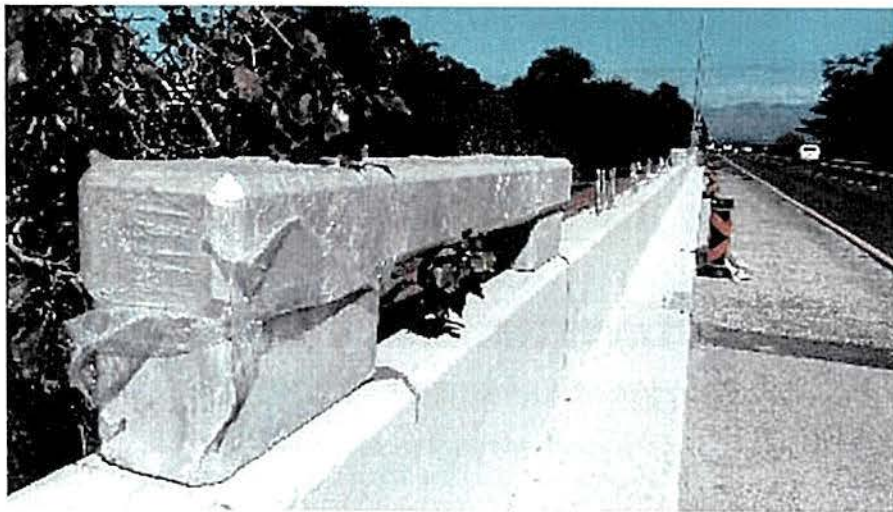
Figure 38: A precast concrete handrail delivered and installed on site. The handrails are steam cured and wrapped in plastic before delivery to site.

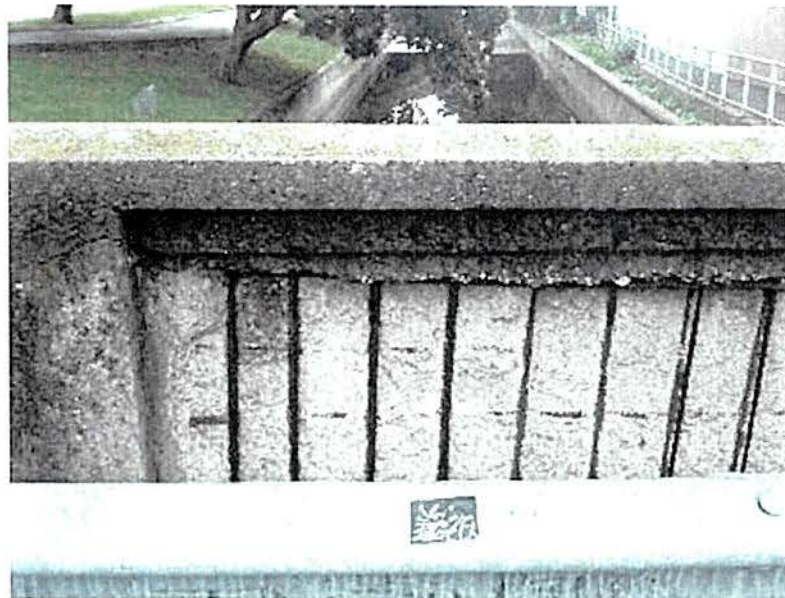
Figure 39: Extensive concrete spalling on existing concrete balustrade  
of Alma Road Bridge (Fatima Adams, July 2016)

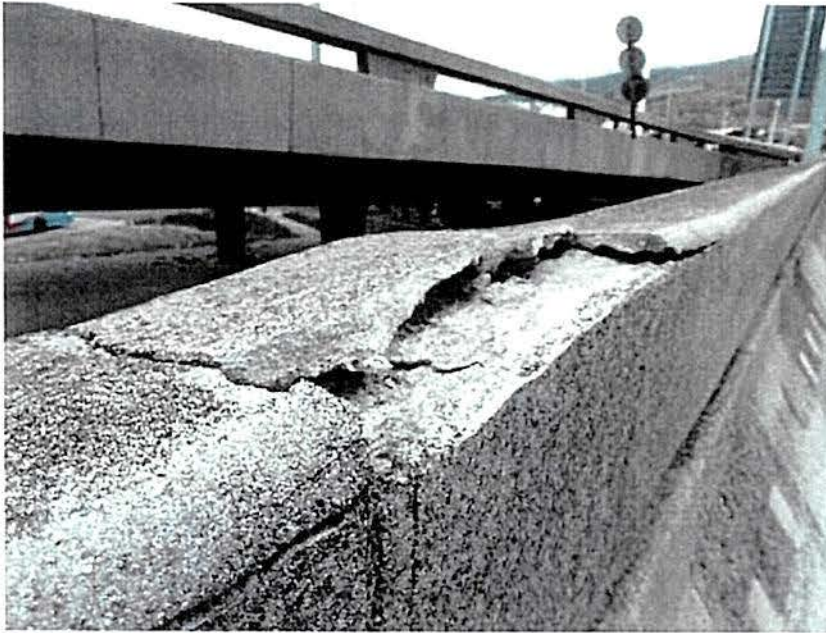
Figure 41: Concrete spalling on existing balustrade of the Foreshore Freeways, Cape Town (2015)

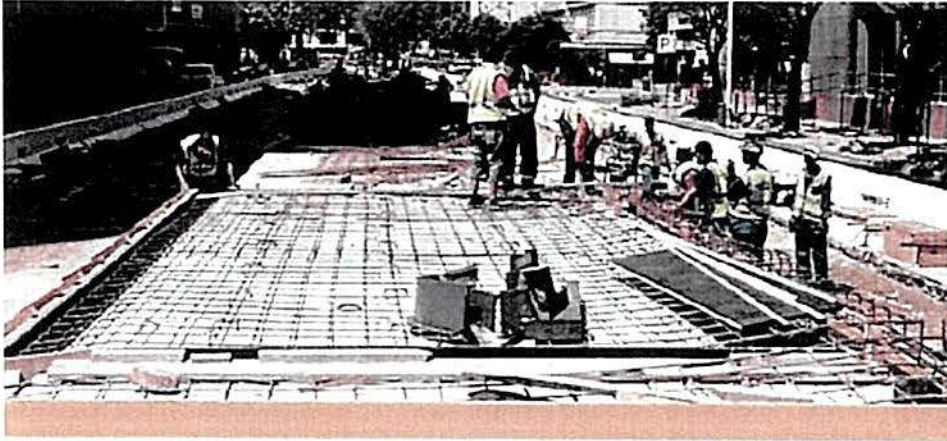
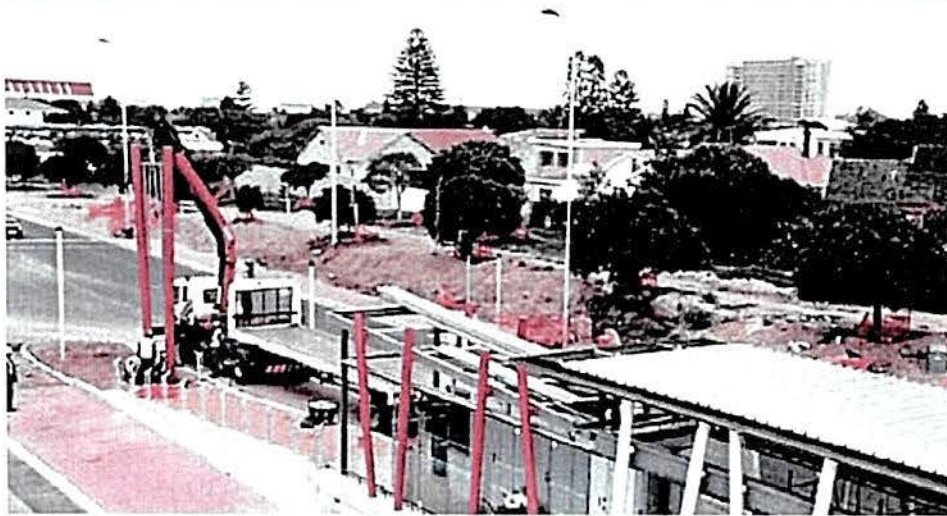
Figure 43: Concrete used for the bus way and the bus stations (City of Cape Town , 2007)
