**UNDERSTANDING RAILWAY TRESPASSING  
IN A  
SOUTH AFRICAN CITY:  
THE CASE OF CAPE TOWN**

**Faizel Williams  
WLLFAI003**

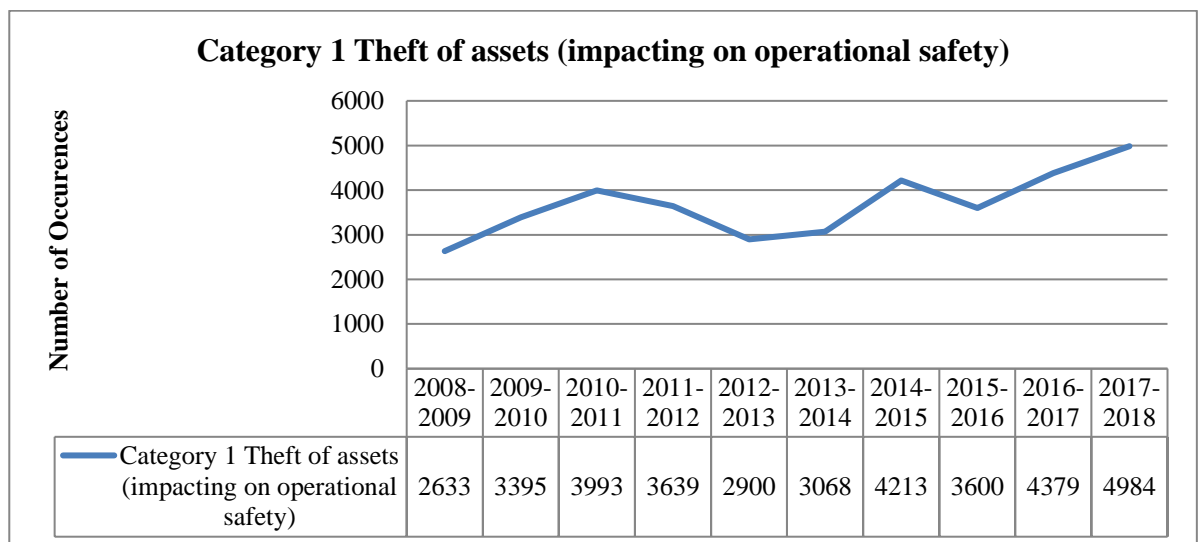
**Figure 2: Category 1 Theft of assets**

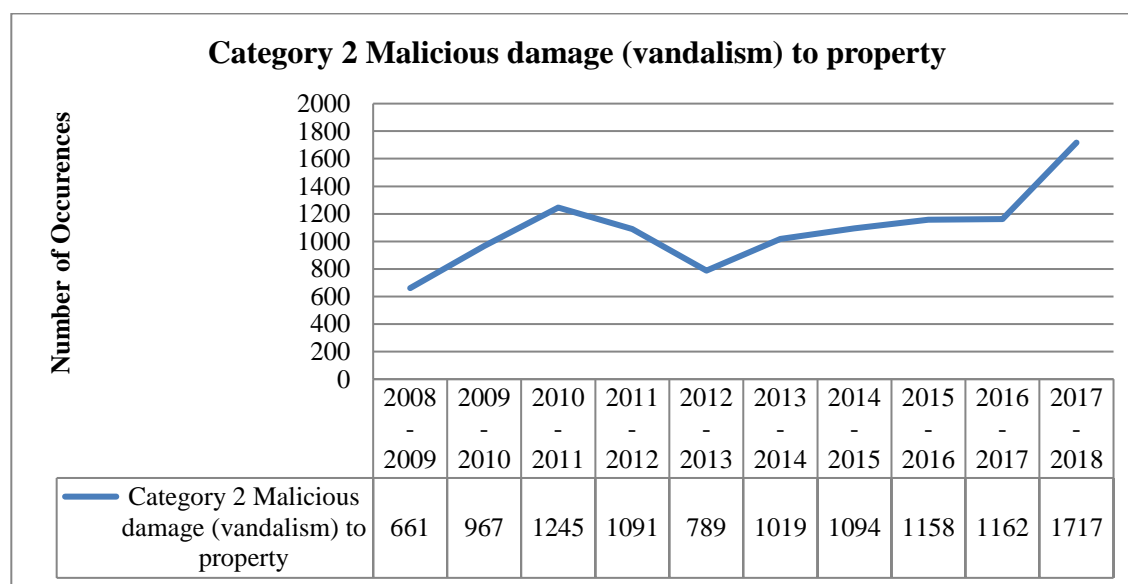
**Figure 3: Category 2 Malicious damage to property**

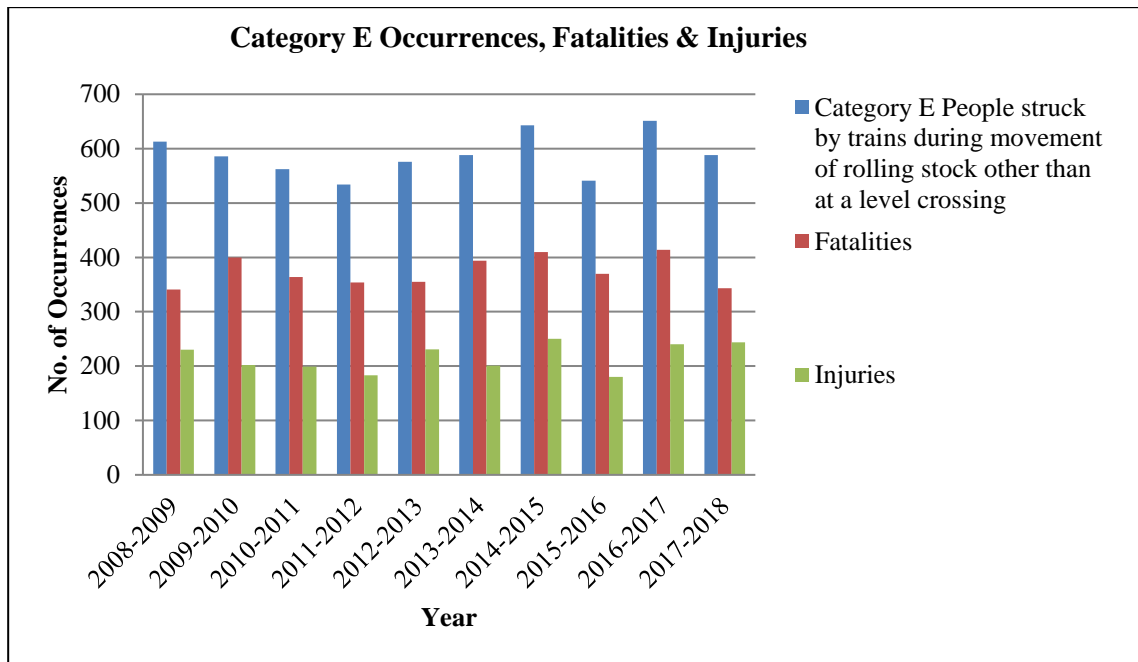
**Figure 9: Category E Occurrences, Fatalities and Injuries**

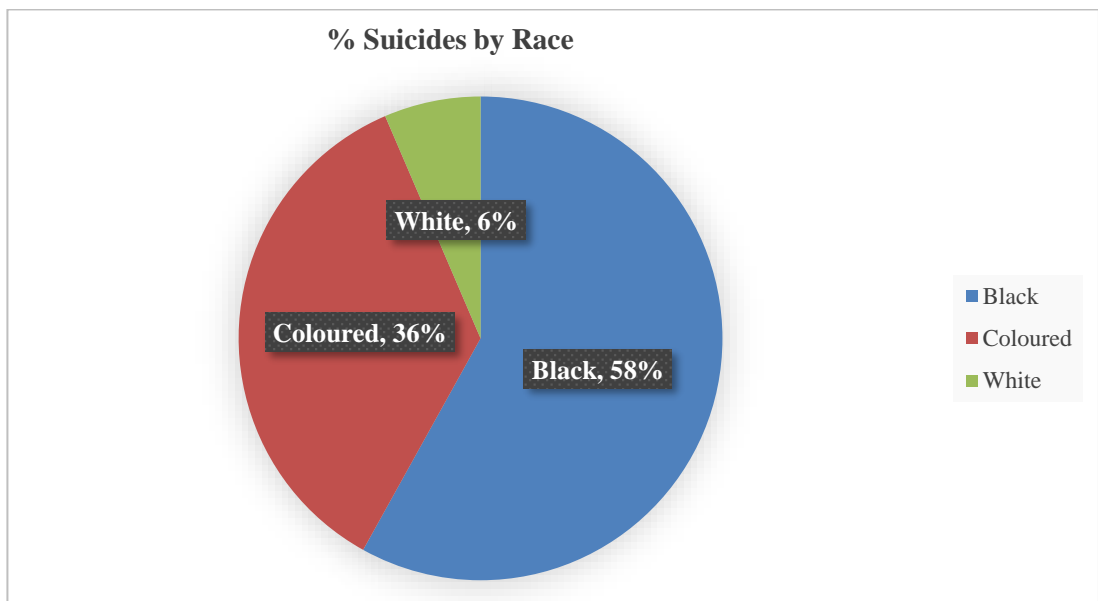
**Figure 20: Suicides by race**

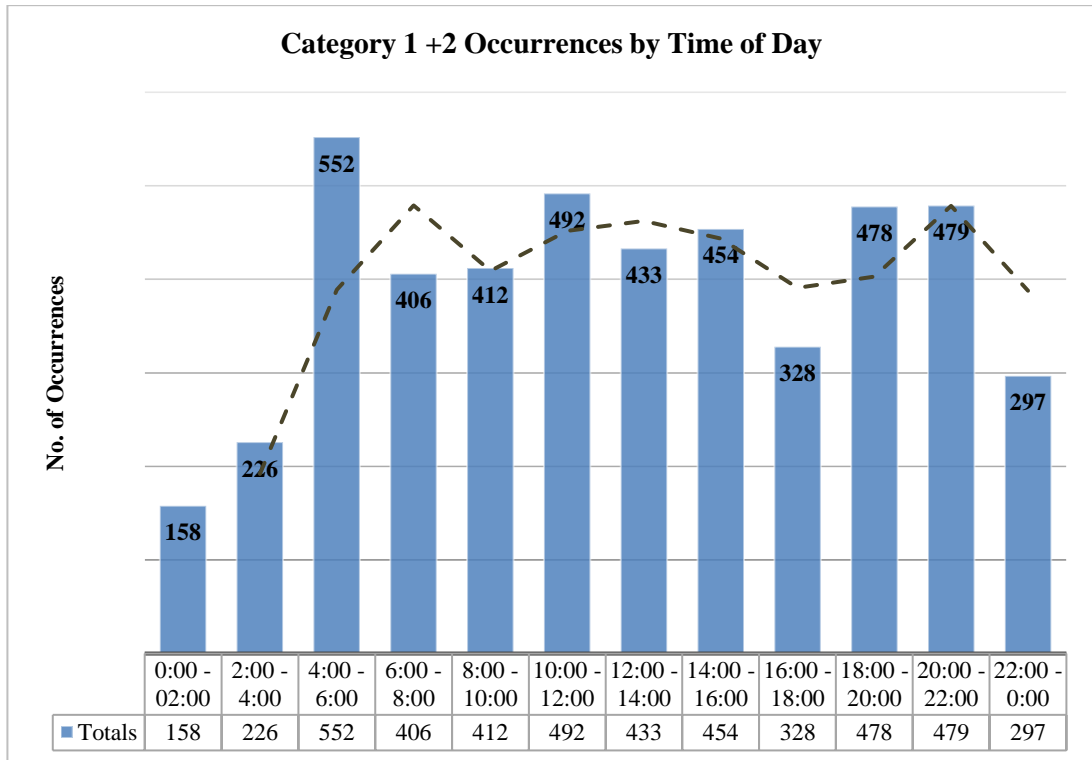
**Figure 29: Category 1 & 2 occurrences by time of day**

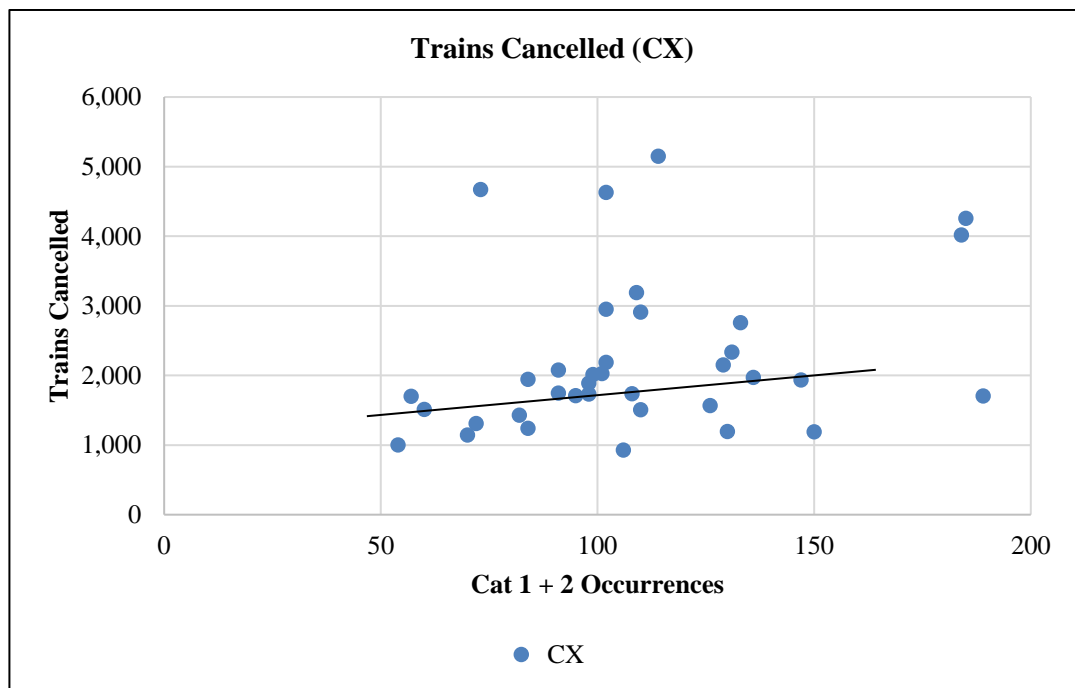
Figure 31: Trains cancelled vs occurrences scatterplot

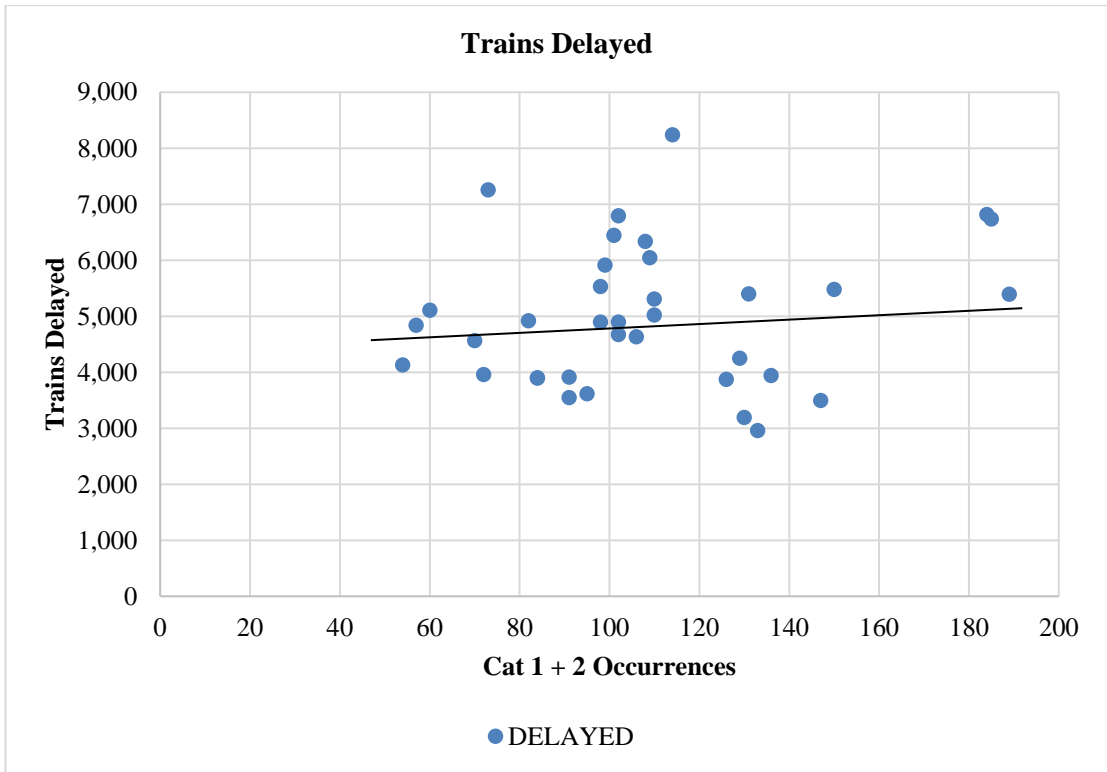
**Figure 32: Trains delayed vs occurrences scatterplot**

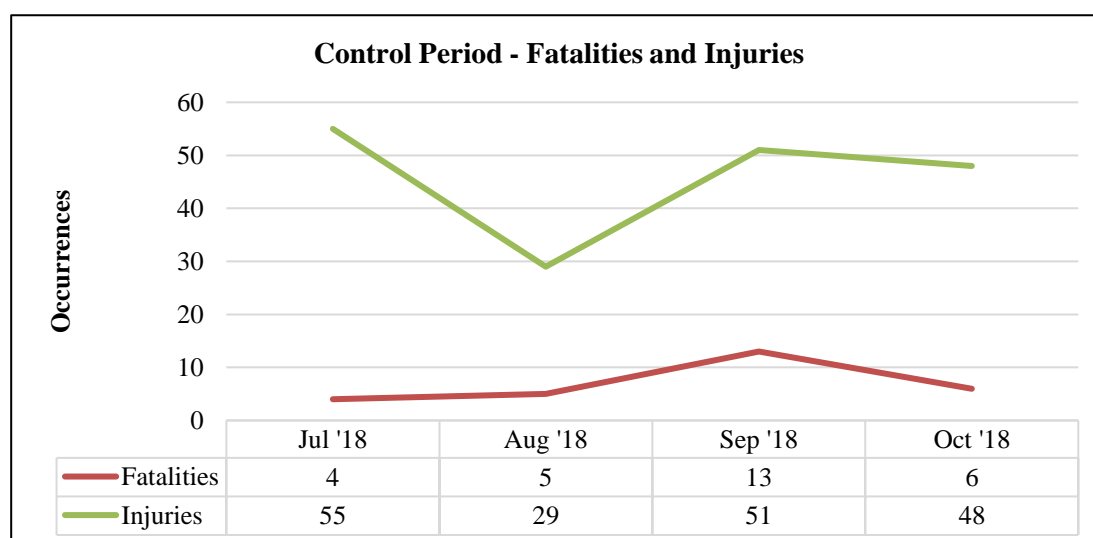
**Figure 47: Control period – Fatalities and injuries**

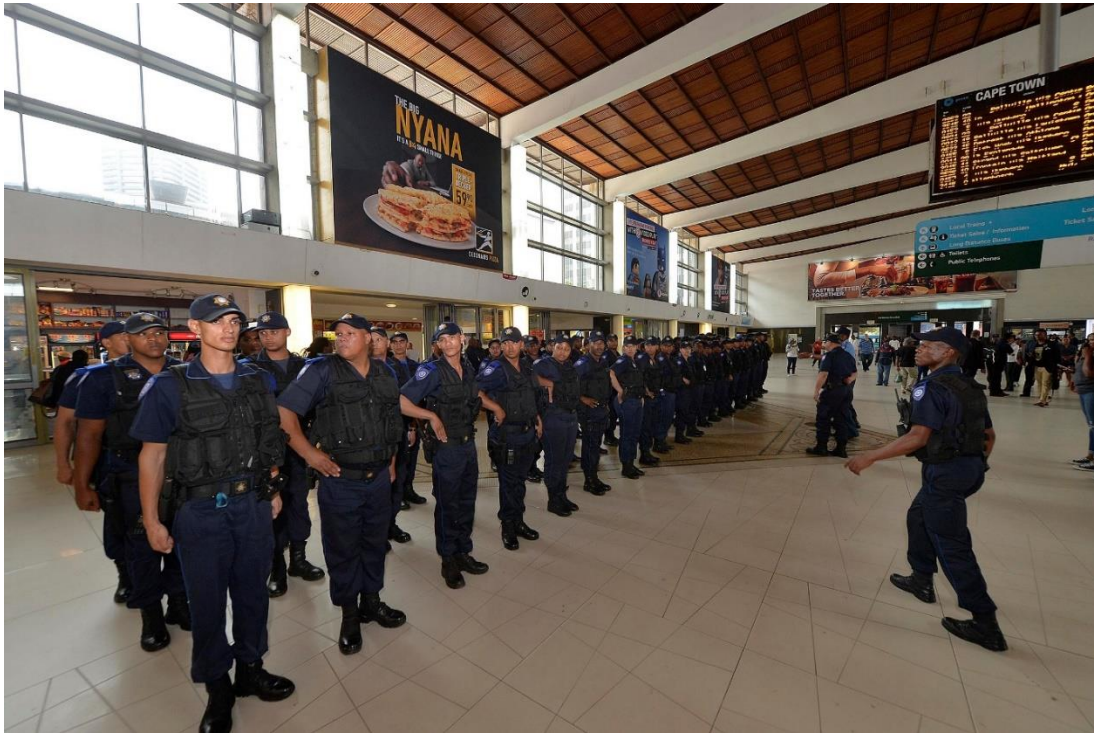
**Figure 51: Rail Enforcement Unit officers at Cape Town Station**

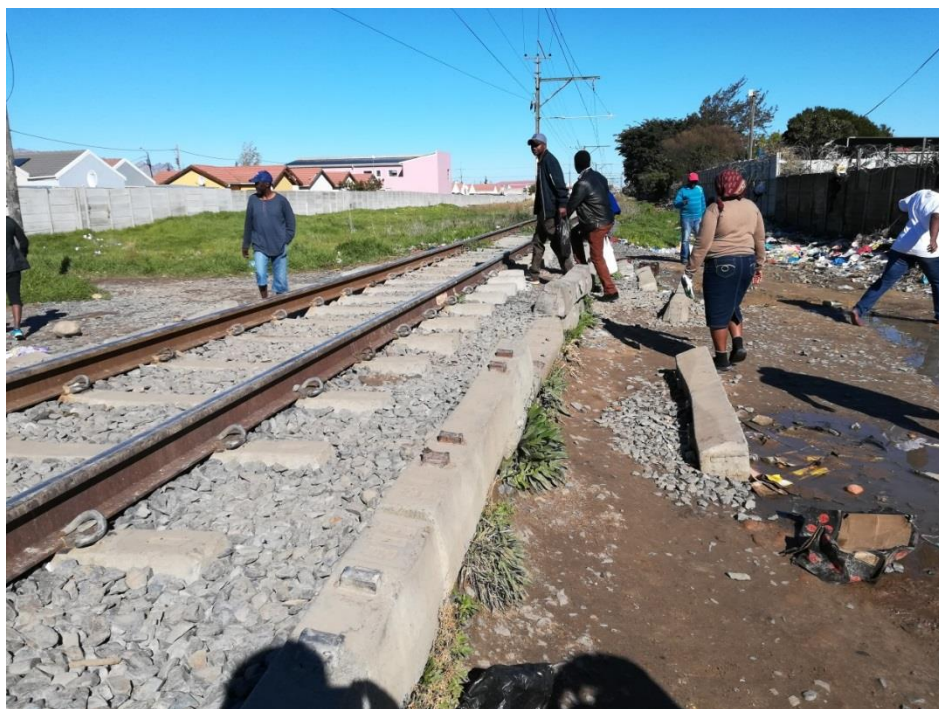
**Figure 57: Railway sleepers used to shore up track ballast at the Nomzamo informal crossing**

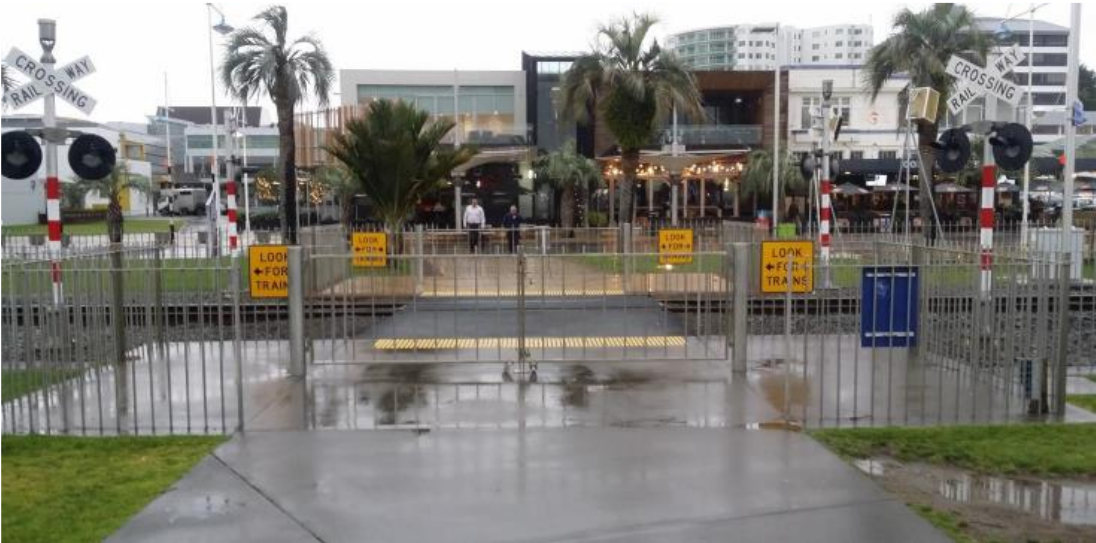
**Figure 58: Double maze layout at a busy at-grade crossing in New Zealand**

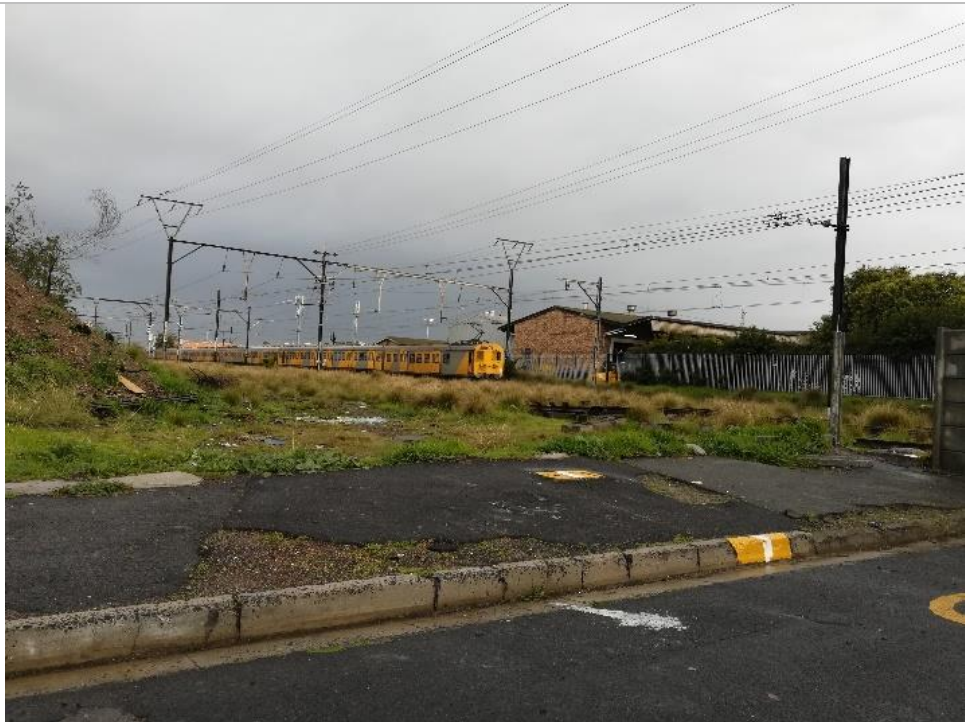
Fig.2 Entire sections of fencing missing providing unobstructed access to the running rails

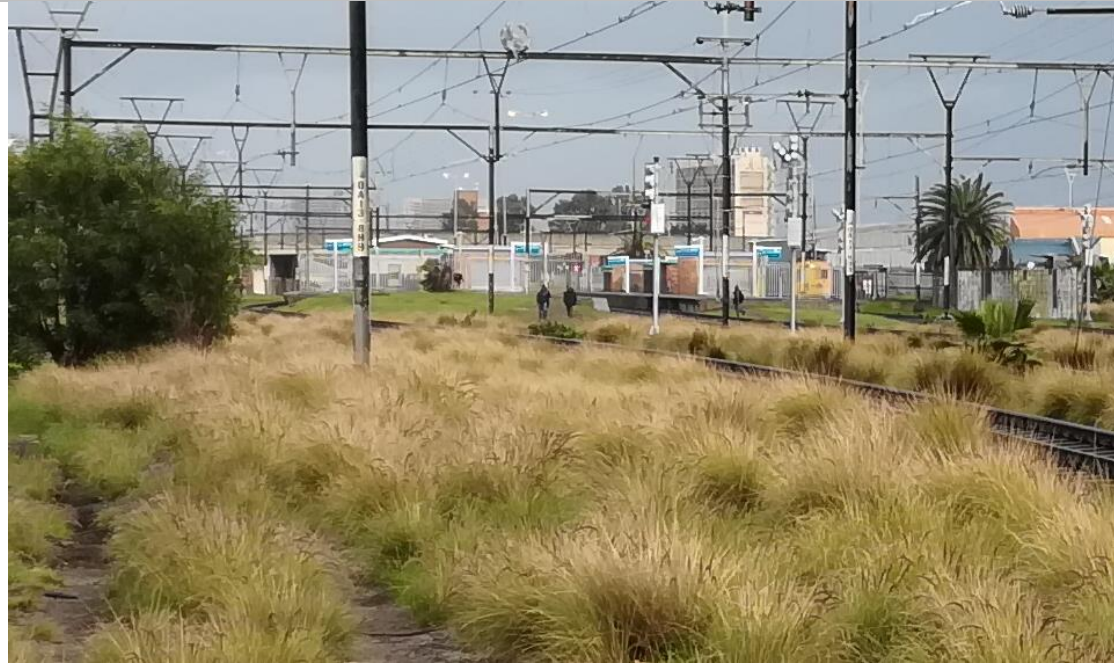
Fig.3 Dense vegetation makes visibility poor for surveillance purposes as well as train drivers

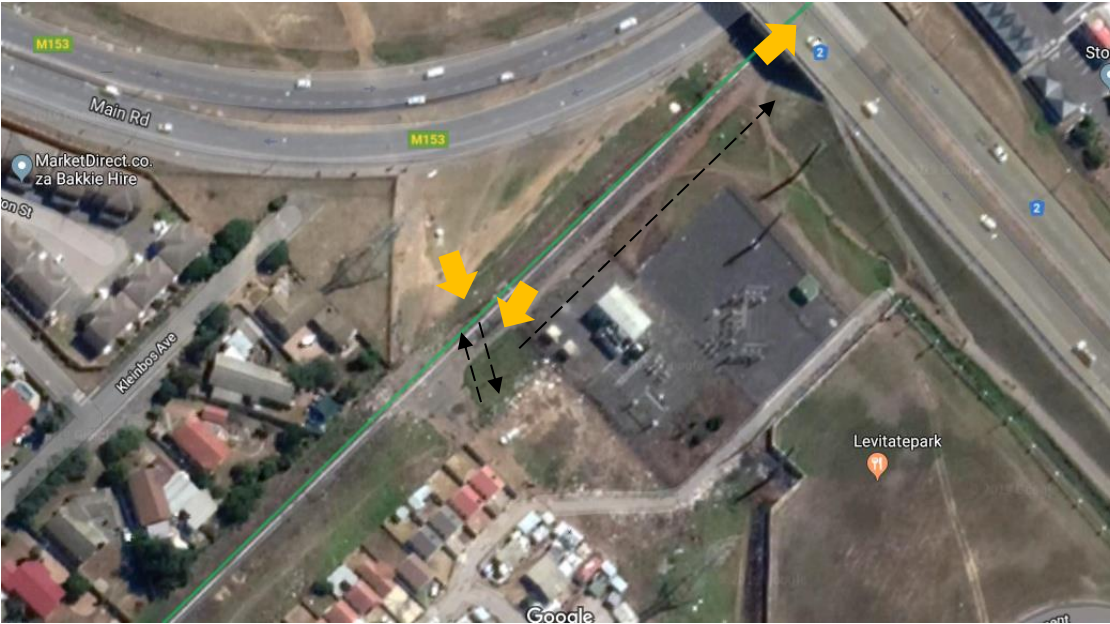
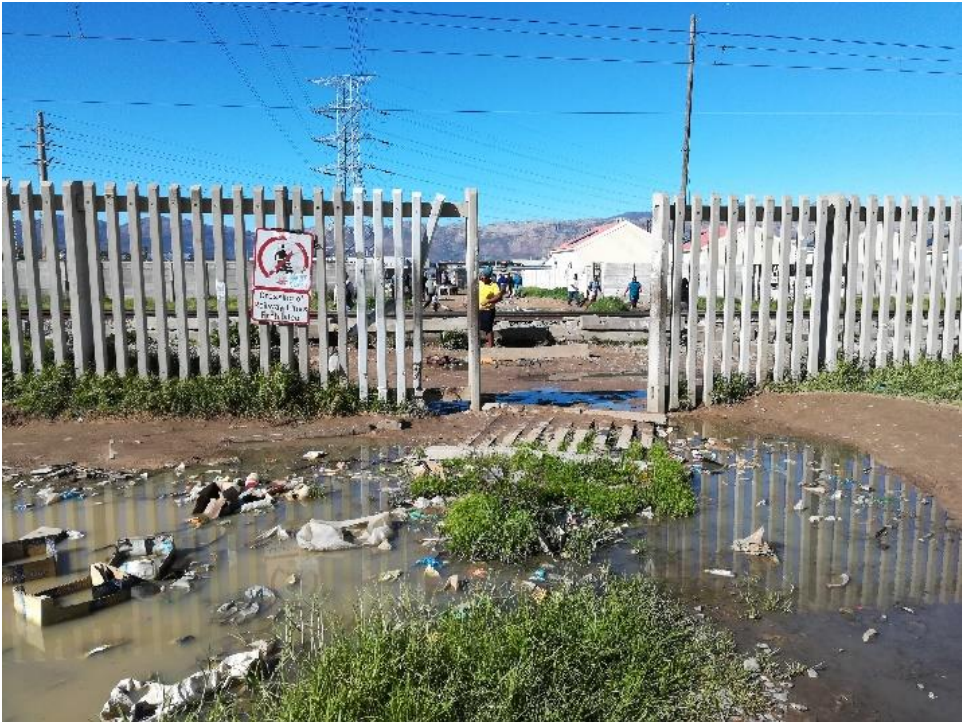
Fig.1 Photograph showing fencing removed, no trespassing signage, and ponding water
