THE USE OF AIRPHOTO INTERPRETATION AS AN AID
TO PROSPECTING FOR ROAD BUILDING MATERIALS
IN SOUTH WEST AFRICA.

J.H. CAIGER

Materials Engineer

Roads Branch

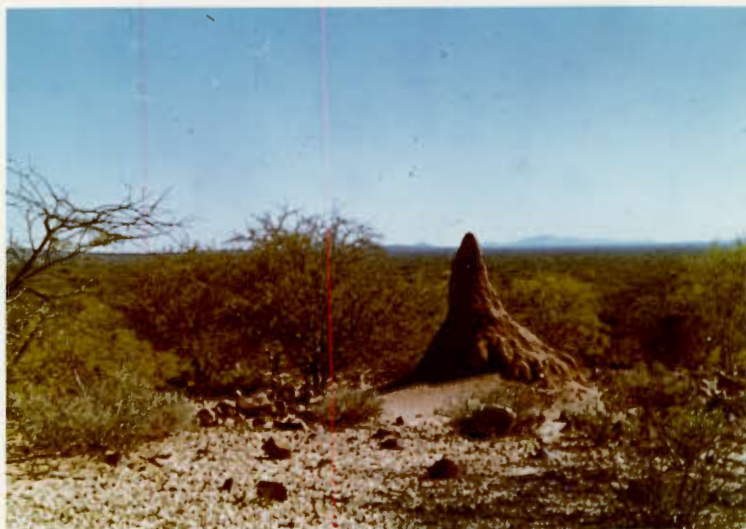
(Photo by J.H. Caiger)
Photo 1 : Flat terrain with dense tree and bush cover. (Between Sukses and Otjiwarongo)

3.1.2. Conditions: Metamorphic processes have resulted in the geology of many parts being variable, and subsequent weathering, transportation and deposition, have in addition, created numerous surface gravel deposits. These deposits vary in quality from totally unsuitable, to suitable for use in the basecourse layer of a bitumen surfaced road. Accurate geological maps, especially those indicating such surface deposits, are not available. Due to this, and to the fact that South West Africa is sparsely populated and is in an early stage of development, these deposits remain virtually untouched, and their existence has largely still to be discovered. To complicate the position still further, large regions of South West Africa are very flat. In the central and northern parts of the territory, where these flat areas are densely covered by trees and bush, and after rain by thick high grass too, visibility is reduced to a minimum (see Photos 1, 2 and 3). In such areas as these,

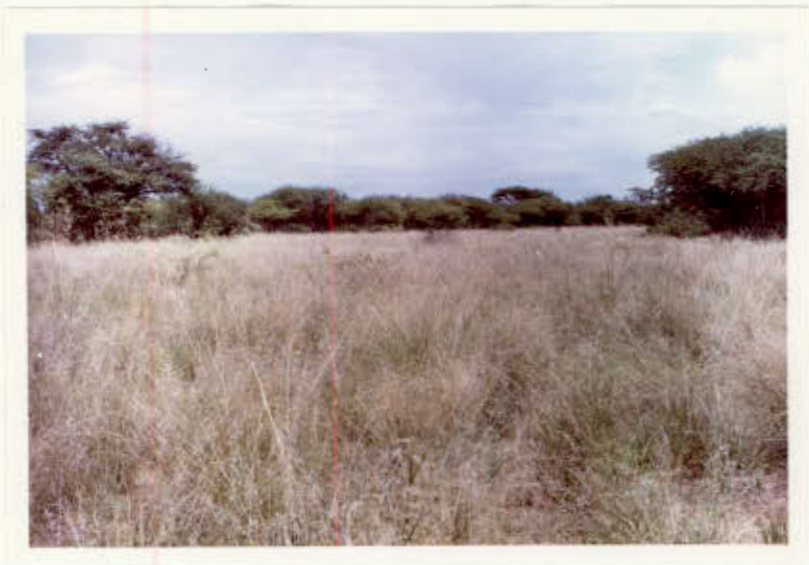
Photo 3: Thick high grass after rain. (Between Sukses and Otjiwarongo)

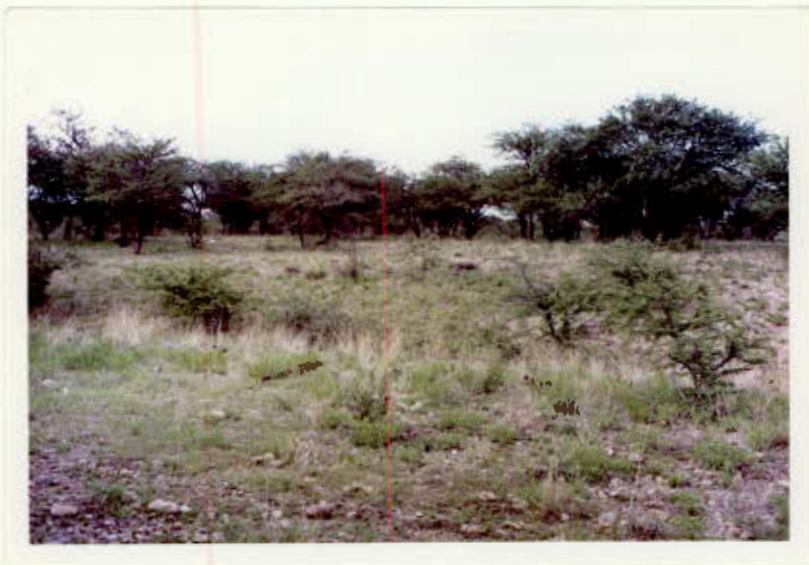
Photo 4: A ground view within area A in Stereogram 1. A depth of up to 4 feet of gravel overlies the mica-schist formation (see Test Result Sheet 1).

3.1.6. Within area A in Stereogram 1, which shows the road near Brakwater, a good natural basecourse gravel has recently been located (see Test Result Sheet 1 and Photo 4). Area B contains similar gravel, as yet untested due to the present lack of demand. In fact, suitable natural gravel is plentiful in the vicinity of area B, and extending downstream.

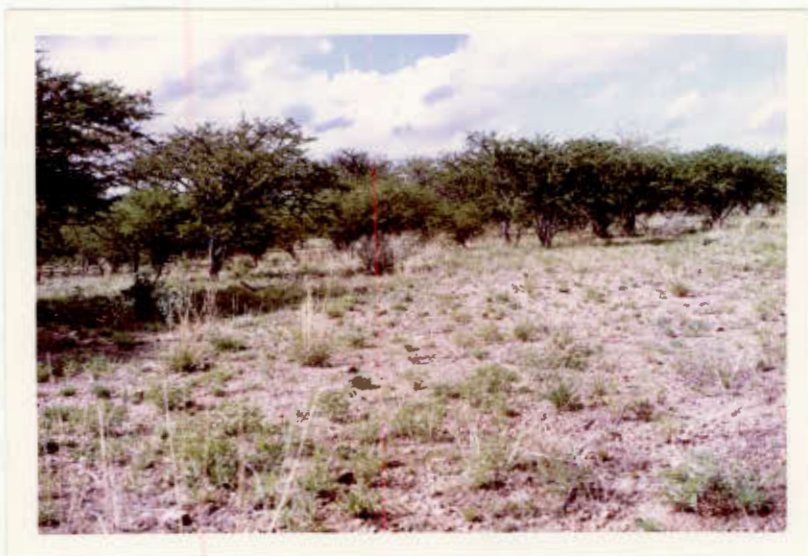
Photo 5: A ground view at the point of arrow C in Stereogram 1. Despite the surface signs the gravel is no more than a few inches thick at this site.

- (i) Area A contains natural basecourse gravel (see Test Result Sheet 1).
- (ii) Area B contains gravel similar to that found in Area A.
- (iii) The arrow C points to the locality illustrated in Photo 5.

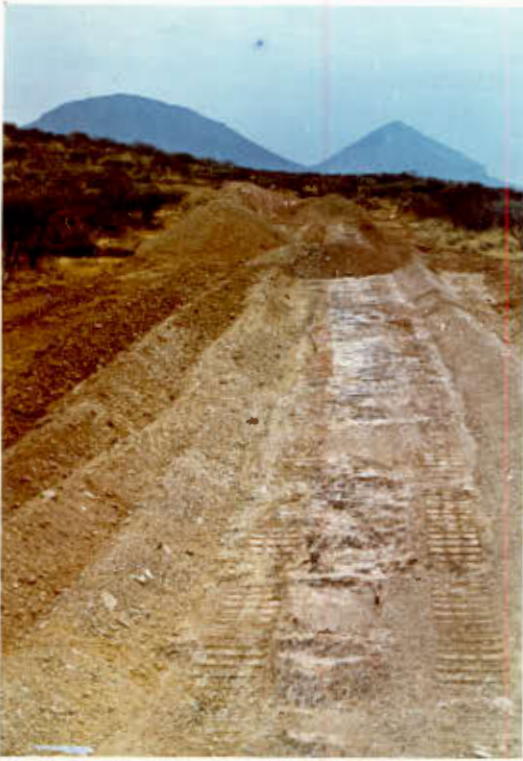
Photo 6: A dolerite outcrop of barely 12 to 15 feet in surface width, which was located from air-photos. In the background the Omatako Mountains can be seen.

heavily vegetated, is also apparent (4.5.1 and 4.5.4). The dolerite gravel is of sufficiently good quality to have been used as a lime-stabilized base, but unfortunately the material along the contacts is of such inferior quality, that the admixing of even a small percentage thereof, would render the source useless. The narrowness of the outcrop therefore, precluded the practical possibility of its use as a basecourse material. The exposure does serve to illustrate, however, the size of source which can be located by this method (3.2.4 to 3.2.6).

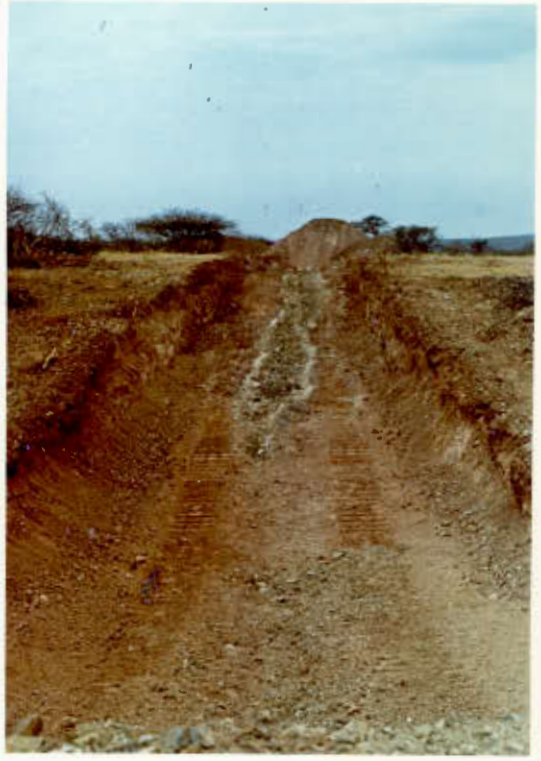
Photo 7: A subsidiary to the exposure of dolerite shown in Photo 6. The dolerite is the centrally placed, dark coloured, formation bordered by reddish material. The width of the occurrence is 3 foot.

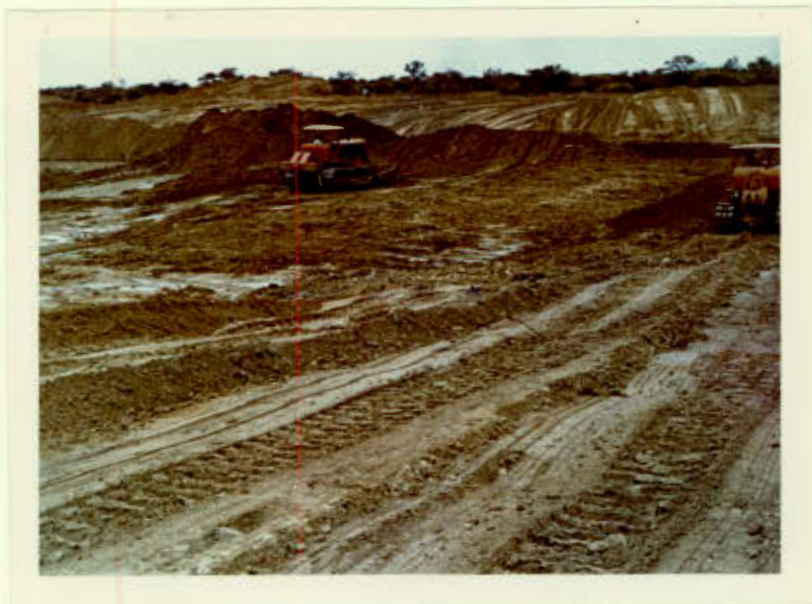
Photo 8: Quartzose lateritic gravel near Suk-ses being stock-piled for use in the basecourse. Note standing water due to poor drainage conditions.

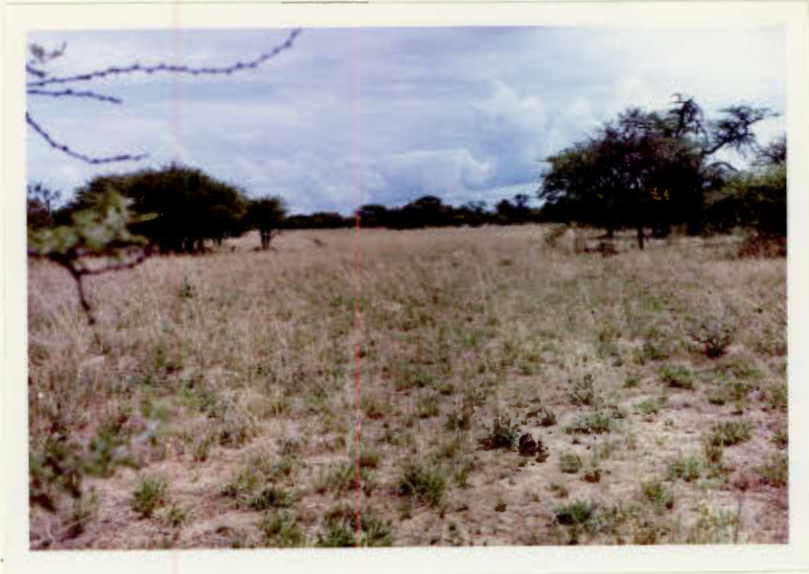
Photo 9: Site of proposed base and subbase borrow pit 75.5 on the farms Somerkoms and Apostle. Note the lack of surface sign, and of tree and bush vegetation.

3.5.8. Re-location, Eastern Route: Prospecting now started along the Existing Route. One of the first borrow pits sampled (B.P. 75.5) is about three-quarters of a mile East of the centre line and on the farms Somerkoms and Apostle. The gravel layer, consisting essentially of quartz pebbles and decomposed granite, is approximately 2 feet thick, and occurs under a 3 to 4 ft. layer of sand. Test results showed the gravel to be of good subbase quality, a portion of the borrow pit even being suitable for use in the base (see Test Result Sheets 10 and 10 A). There is very little surface sign to betray the presence of the gravel, but the feature in which the borrow pit is located, is easily recognizable on the airphotos. It forms a slight depression and is free of tree and bush vegetation (see Stereogram 16 and Photo 9).

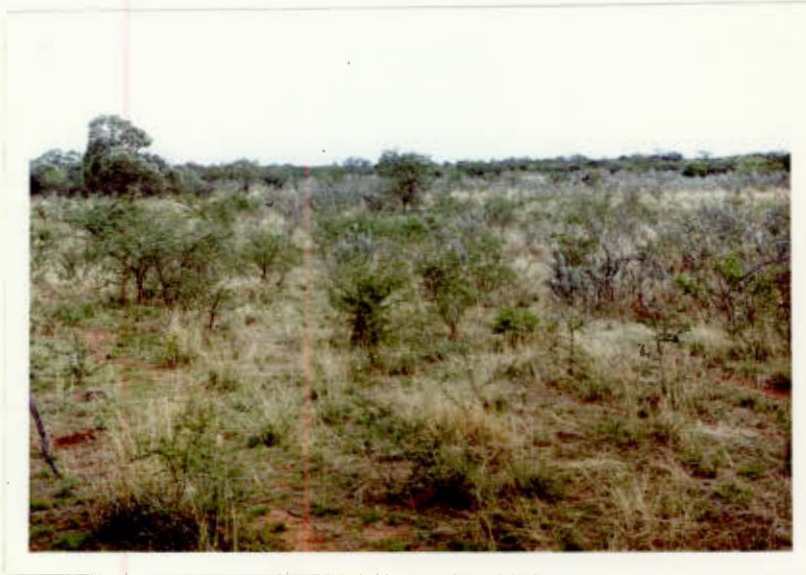
Photo 11: Scrub bush and stunted acacia trees growing over a band of crystalline limestone near Otjiwarongo. Note the larger trees in the background which grow on granitic formation.

In Stereogram 20 where two bands of crystalline limestone have been delineated. The position of an area tested during the initial investigation along the Western Route is indicated by arrow A (see Test Result Sheet 18). This source is too far away to serve the Eastern Route. In consequence borrow pit 99.6 was established along the same band of crystalline limestone, but adjacent to the new centre line (see Test Result Sheets 19 and 19 A). The quality of this gravel was found to be similar, and if anything more consistent, than that previously test. Thus the time which would normally have been required for further prospecting, was saved. These granitic sources of possible subbase gravel, are not directly distinguishable in the airphotos as are most other occurrences of road building material described in this thesis; but have to be established by prospecting for suitable areas along the contacts with the bands of crystalline limestone. Potential areas are therefore recognized from the airphoto indicators responsible for showing up the bands of crystalline limestone. These are, (i) the linear form of the bands themselves (4.5.1 and 4.5.4), (ii) their darker grey tone, probably due to the relatively poorer drainage conditions and, (iii) their texture of vegetation due to the predominance of scrub bush and to the sparsity and small size of the acacia trees. Solid crystalline limestone exposures are common in these bands, and soil cover, where it does exist, is often shallow. The bands thus tend to support more scrub bush and less thorn trees, especially those of comparable size, than the bordering granite formation (see Photo 11).

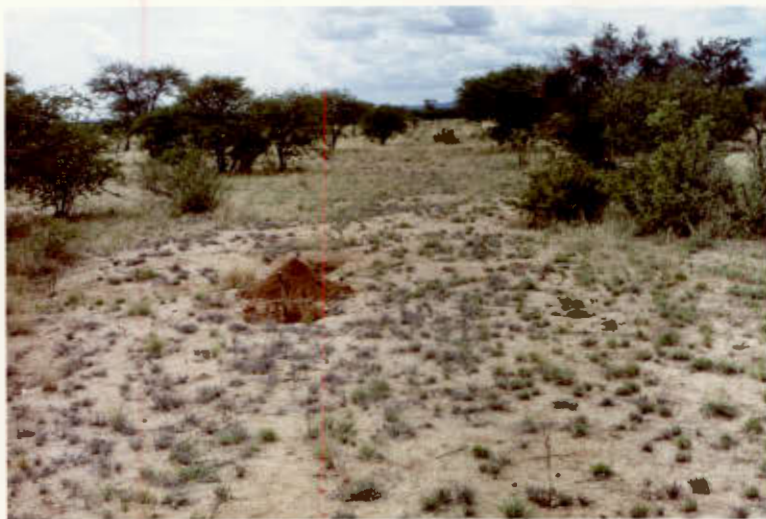
Photo 12: A downstream view along a section of the old raised river bed West of the Sukses Omuramba. River sand from a hole can be seen in the foreground. Note the slightly raised topography and the concentration of vegetation towards the boundaries of the river bed.

3.5.20. If prospecting with the aid of airphotos, the old raised river beds West of the Sukses Omuramba also become obvious potential sources of suitable sand. From the ground however, the limited areal view precludes the possibility of observing the drainage pattern, and makes recognition of the true nature of the deposits much more difficult. This is assuming of course, that at least a portion of the river beds would be found if prospecting entirely by normal methods (see Stereogram 15 and Photo 12). The old river bed adjacent to the sand surface dressing deposit (68.5) established in the Sukses Omuramba, was sampled at the same time as the latter, and to a depth of about 6 feet. The top 3 to 4 feet of sand at this locality, is too finely graded for sand surface dressing, but it becomes progressively coarser with depth and would probably have met specifications below a depth of 6 foot. On account of the suitable sand nearer to the centre line in the bed of the Sukses Omuramba, further testing of the old river deposits was not pursued.

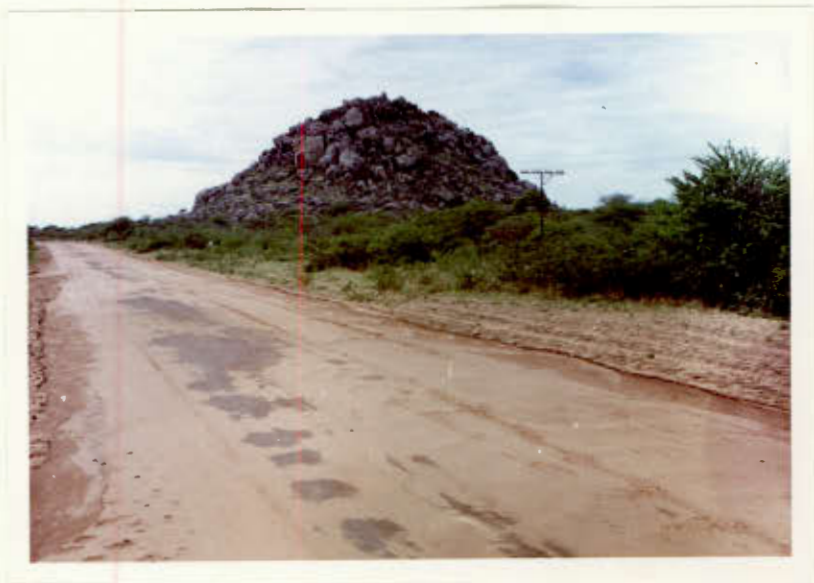
Photo 13: One of the two granite hills known as Tweekoppies (see Stereogram 20). Note the rough texture caused by the granite boulders.

Photo 14: A crystalline limestone hill near Otjiwarongo. Note the smooth texture and flat side slopes compared with those of the granite hill shown in Photo 13.

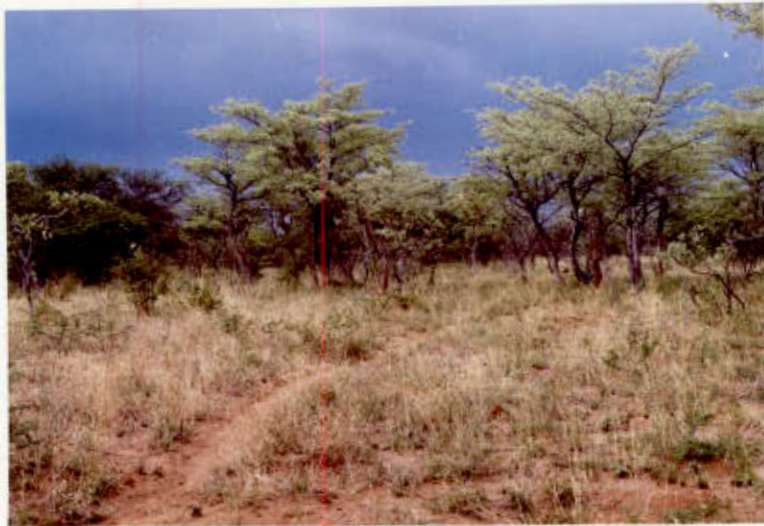
Photo 15: Yellow wood trees growing over the lateritic gravel deposit in which borrow pit 21.1 is established (see Stereogram 25 and Test Result Sheets 28 and 28A). Note the boundary of the deposit towards the left of the picture. This is marked by the appearance of the acacia tree in front of which a figure is standing.

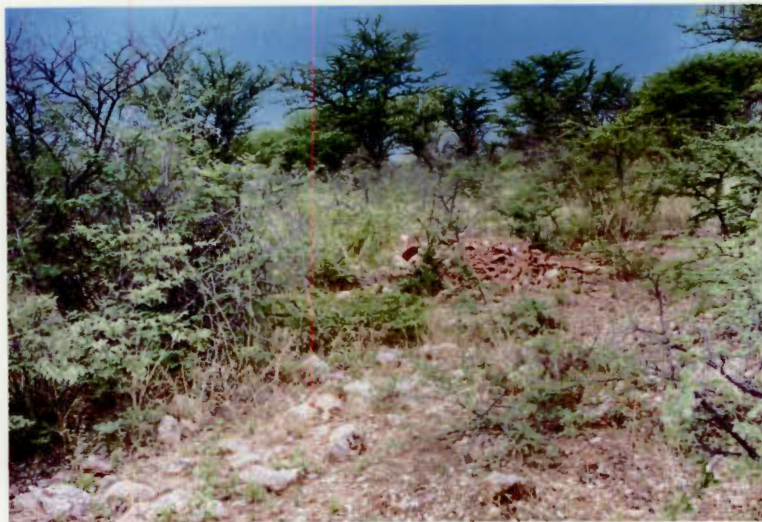
Photo 17: A weathered quartzite outcrop near Otjikango, in which subbase borrow pit 23.9 is established (see Stereogram 24).

3.6.18. Apart from these granite borrow pits, gravel from calcrete borrow pit 1.3, and from a weathered quartzite borrow pit $1\frac{1}{2}$ miles West of mileage 23.9, will also be utilized in the construction of the subbase (see paragraph 3.6.2, Test Result Sheets 25, 25A to 25D, 32, and Fig. 9). The quartzite outcrops, forming minor rises in the terrain, were first noticed in the airphotos from their difference in topographic relief (see Stereogram 24 and Photo 17).

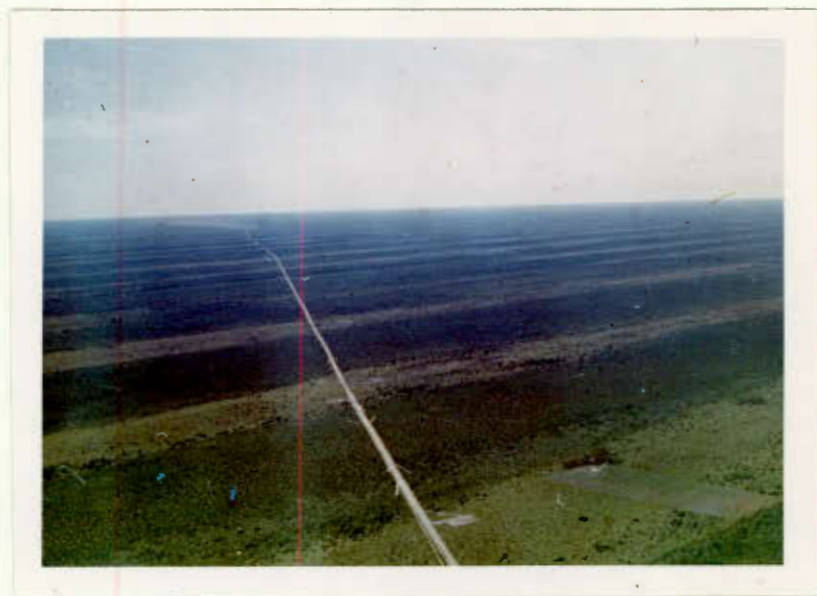
Photo 18: The road South of the Gaza Line showing the regular pattern of streets and dunes. The dunes are the darker-green wooded sections, while the streets support essentially scrub bush and grass, and are lighter-green in colour.

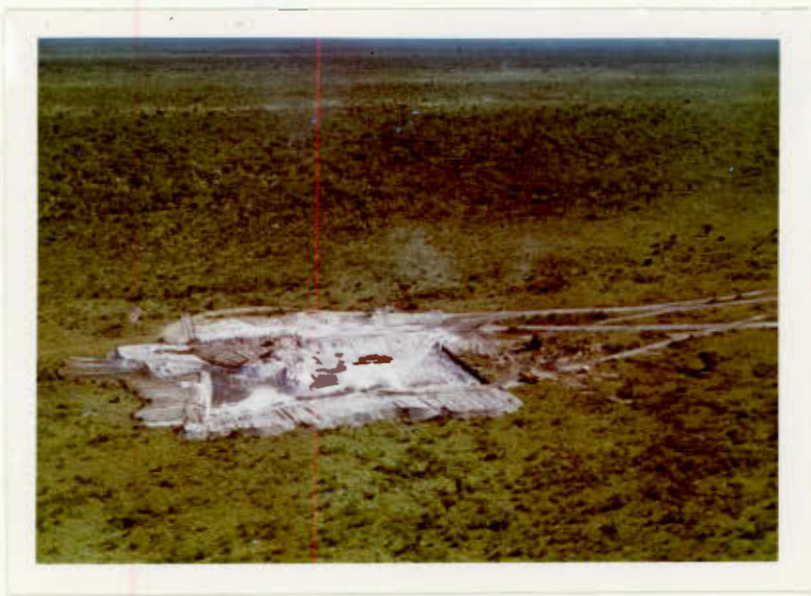
Photo 19: A well-developed calcrete deposit situated immediately North of the Gaza Line in the Okavango Native Territory. It is being worked for wearing course material.

fact that the Officer-in-charge of the second prospecting party actually stayed at the camp for a month or more, the deposit still remained undetected nine months after construction had commenced (see Stereogram 27 and Fig. 10). The deposit consists of a well developed calcrete similar to those found South of the Gaza Line, and is in fact the last of its kind on the way to Runtu, and within the area covered by the airphoto strip (see Photo 19). The source is easily recognizable in the airphotos from its general relief, and from the limited drainage development which culminates in an obvious pan (see Stereogram 27). The good quality calcrete has formed along the slopes and high spots of this feature. The pan and other low lying areas contain, for the most part, a fine powdery lime with a relatively high Plasticity Index (see Test Result Sheet 34). The occurrence was covered in places by a scrub bush usually associated with surface limestones, and which often imparts a distinctive textural appearance to the airphotos (3.4.3). However, either the scale of these particular photos is too small to allow detection of any slight difference, or their obviously impaired clarity, most probably due to haze or smoke from bush fires, or possible to both, has obscured any differences in the texture of the vegetation there might otherwise have been. Also clearly noticeable in Stereogram 27, are borrow pits 1 and 2 which were located during the initial materials investigation, but which subsequently produced the soft calcrete aggregate to which reference has already been made (refer to paragraphs 3.7.4, 3.7.6 and to Test Result Sheet 33).

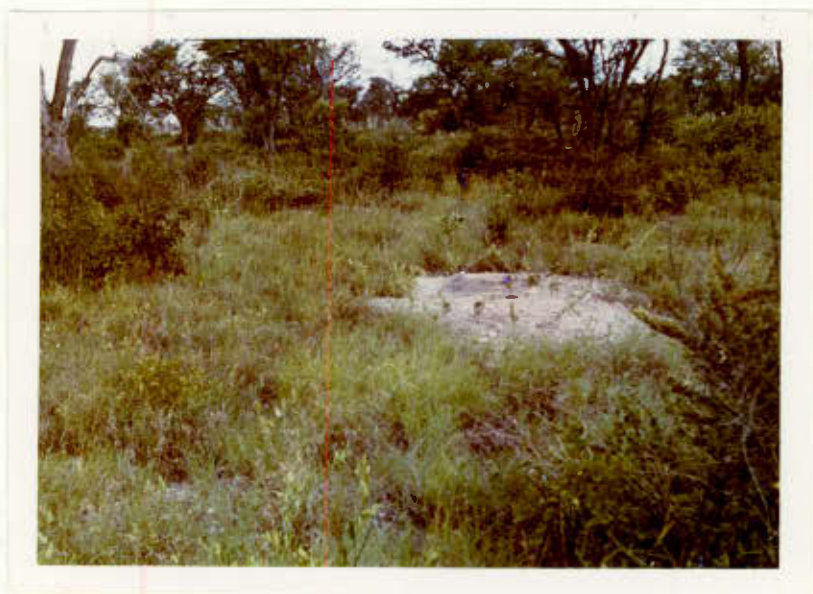
Photo 20: A view of a reef-type calcrete deposit in the Okavango Native Territory, 29.0 miles from the Gaza Line. Note the calcrete nodules in the foreground.

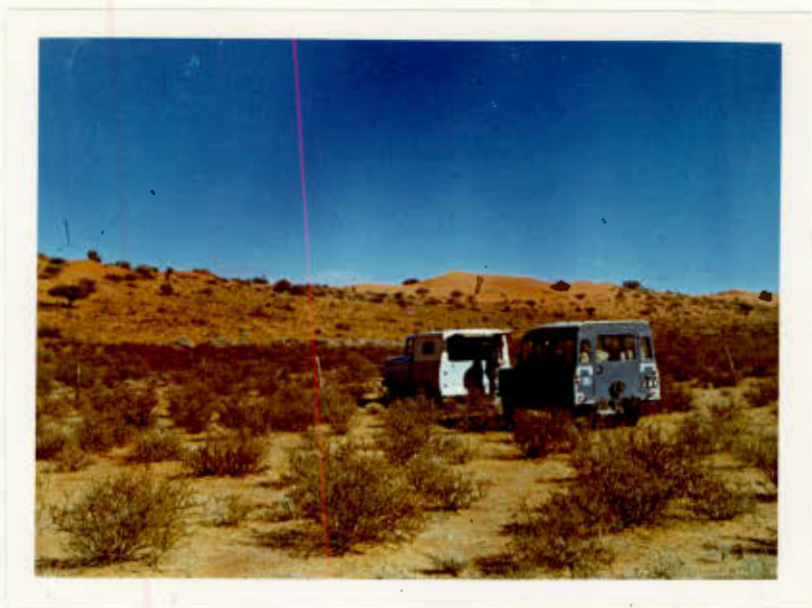
Photo 21: A typical Kalahari sand dune and street.

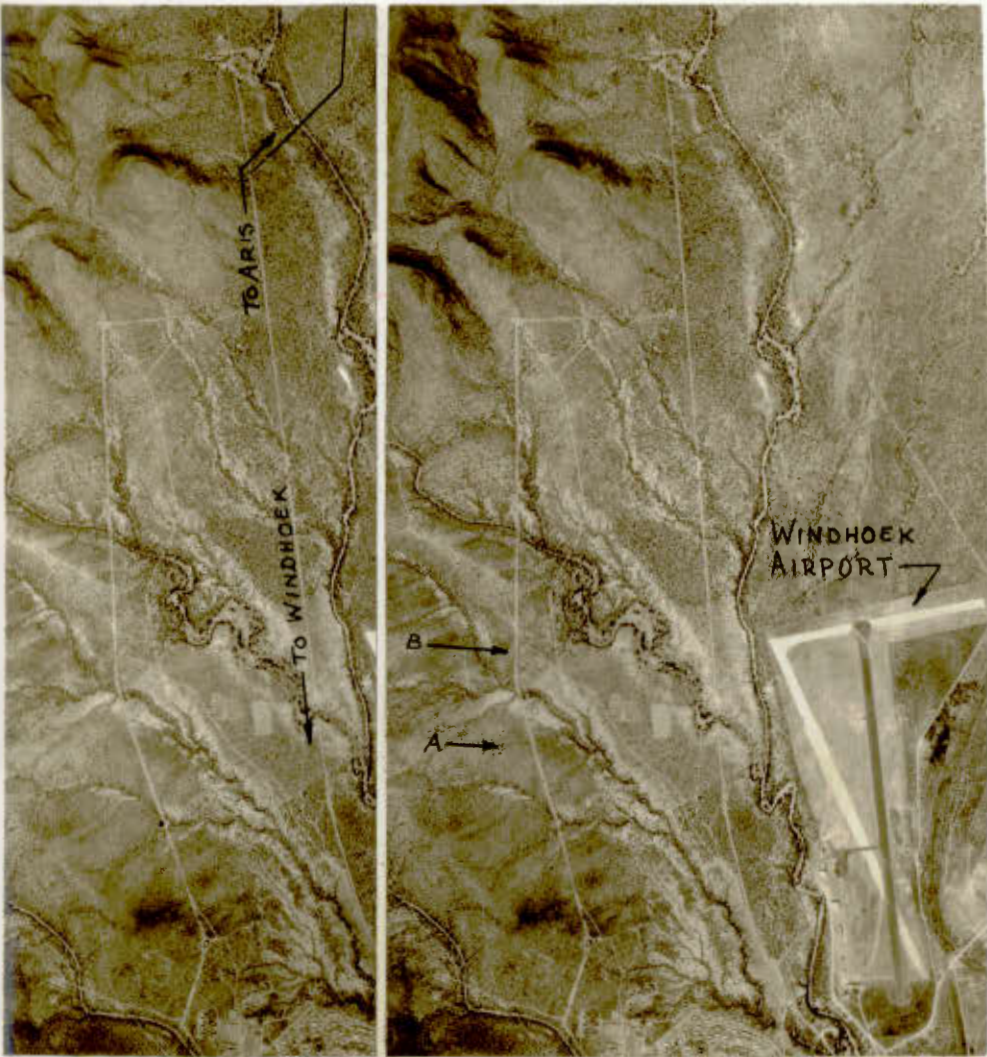
STEREOGRAM 5

A and B indicate the localities from which lime-stabilised subbase gravel was derived.

3.1.11. However, the requirements for good gravel sources, also provide superior water absorption and retention qualities to those generally pertaining in the surrounding terrain. This fosters the growth of vegetation, resulting in a greater size and intensity of growth, of both trees and scrub bush. To the trained observer, such areas are readily discernible on the airphotos, from their distinctive surface textural appearance (2.3.6). A close stereoscopic study of the areas embracing good gravel occurrences, in relation to the surrounding terrain, and more specifically, in relation to area B in Stereogram 3 and areas A and B in Stereogram 5, all of which contained inferior gravel of workable depth,

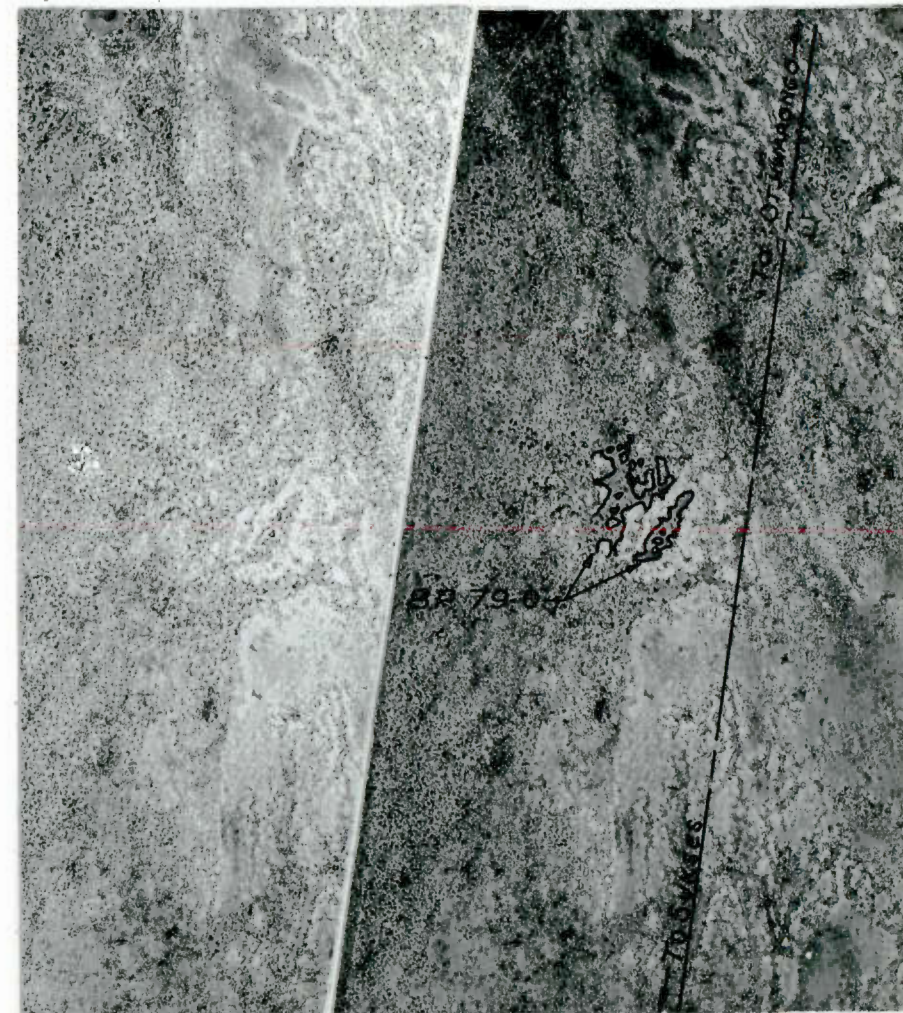
STEREOGRAM 18

The positions of Borrow Pit 79.0 are shown.—
The area is very broken and exact demarcation on this scale of photography is not possible. (See Test Result Sheet 13).

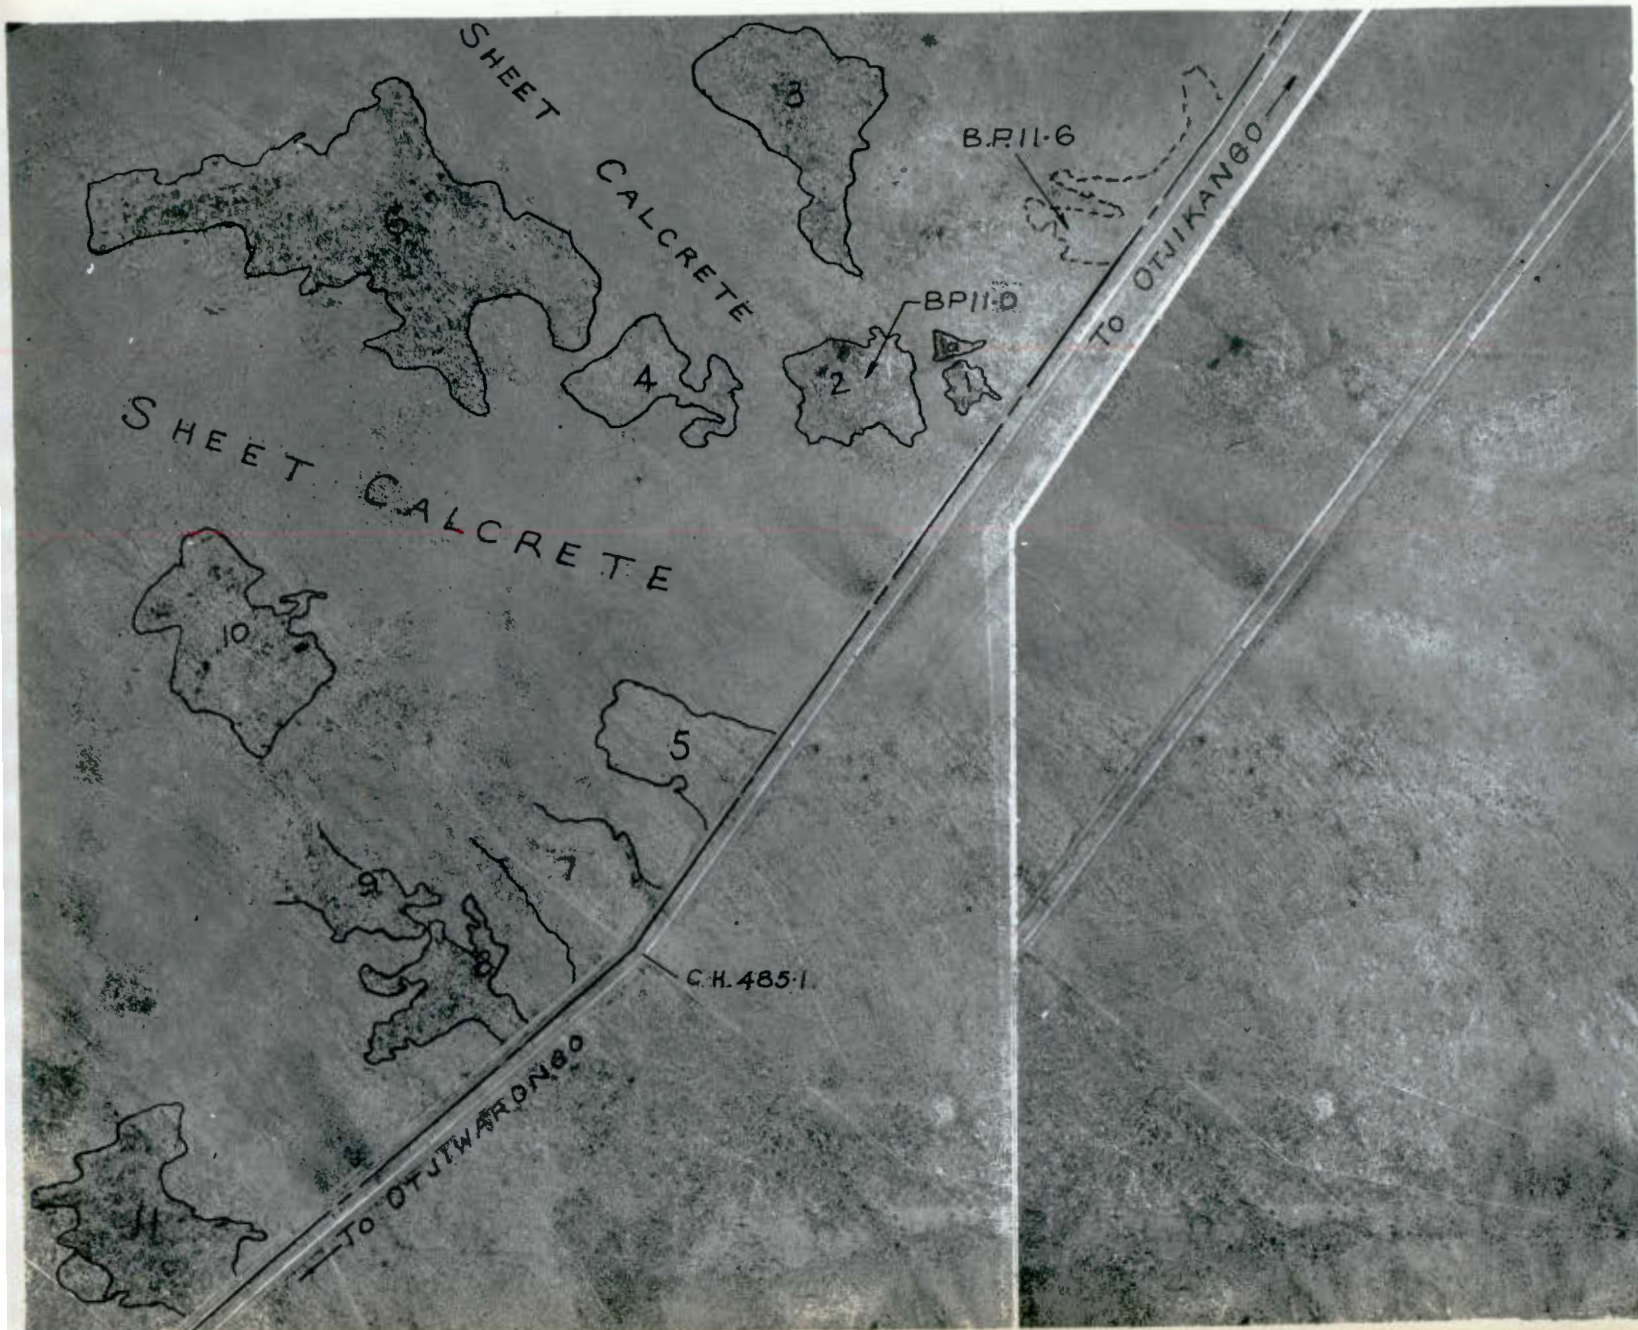
STEREOGRAM 22

The position of subbase Borrow pit 6.9 within the demarcated limits of a granite occurrence is indicated by the point of the arrow. (See Test Result Sheets 29 and 29A).

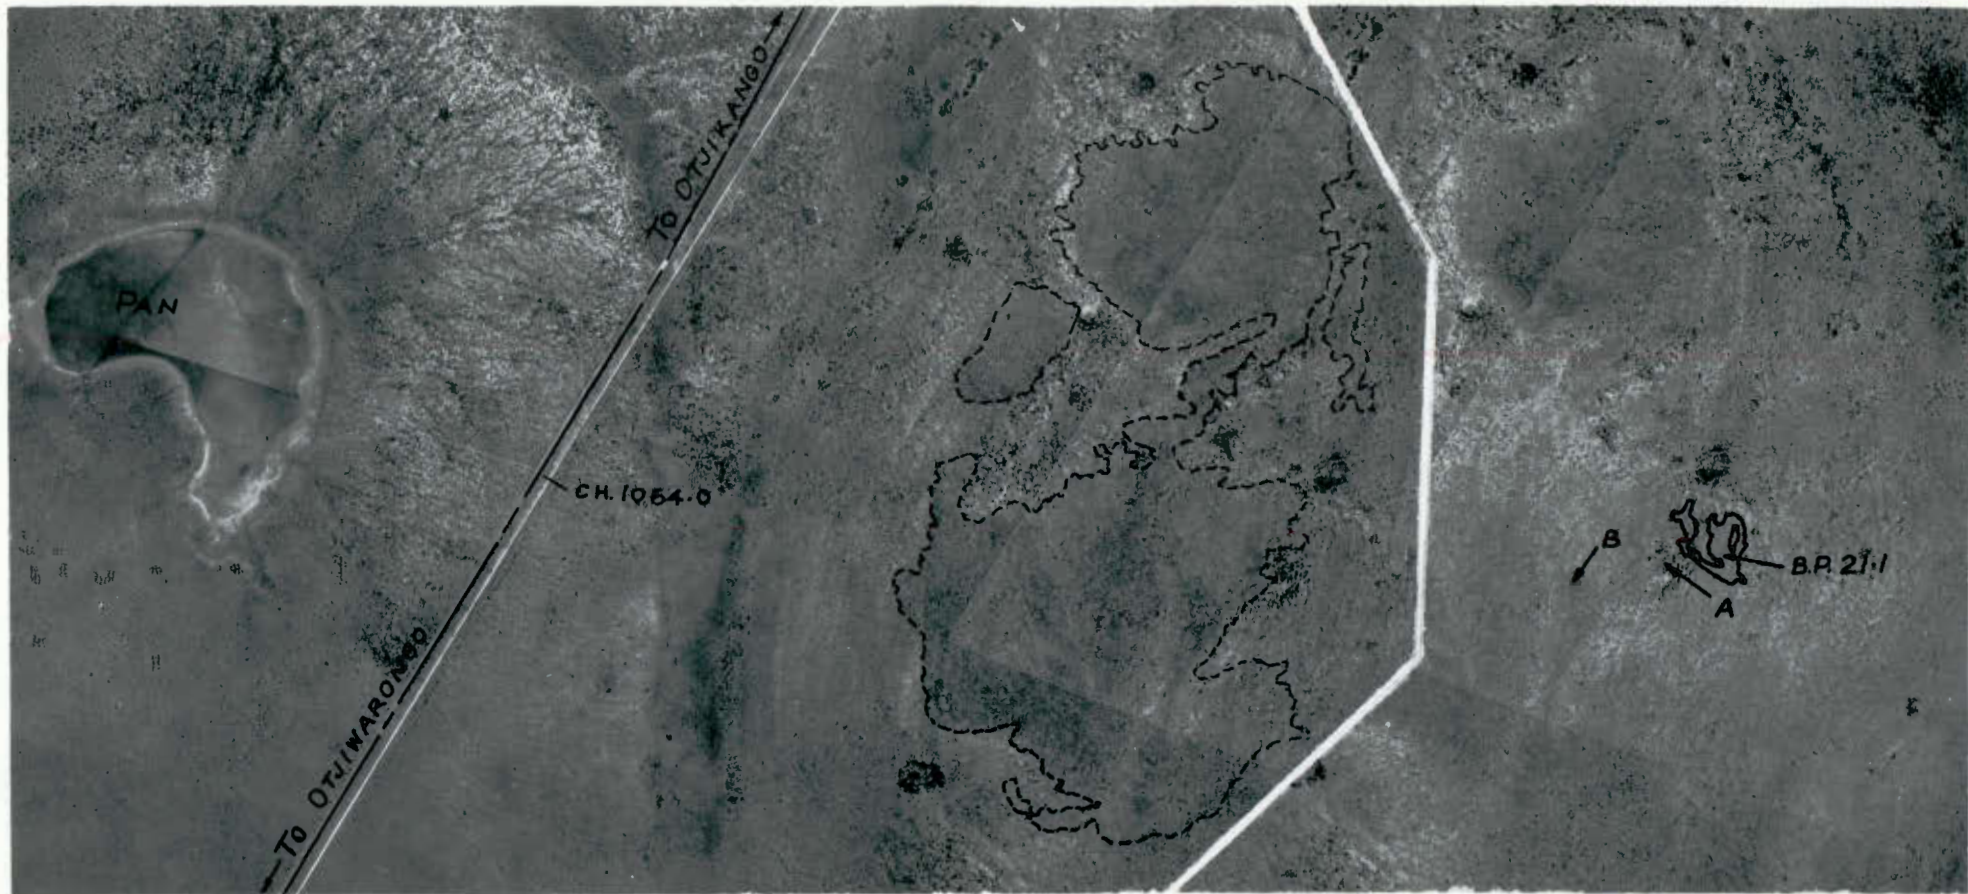
- (iii) Apart from other similar granite occurrences, the remaining terrain flanking the band of crystalline limestone consists of surface limestone, which in places is covered by a thick layer of sand. The nodular calcrete basecourse Borrow Pit 22.6, is located in this surface limestone deposit in the area indicated by the arrow. (See Test Result Sheets 27 and 27A). However, much of the surrounding similar looking area contains unsuitable calcrete in either boulder or powdery forms.

- (iv) Demarcated areas A and B are quartzite outcrops. Within area B a workable subbase Borrow Pit (23.9) was tested and proved but the exposure indicated as A is harder and workable gravel has not yet formed. (See Test Result Sheet 32).
