**THE BEHAVIOUR OF PATCH REPAIRED AND FRP
STRENGTHENED REINFORCED CONCRETE BEAMS: AN EX-
PERIMENTAL INVESTIGATION**

**THIS THESIS HAS BEEN SUBMITTED TO THE DEPARTMENT OF CIVIL ENGINEERING, FAC-
ULTY OF ENGINEERING AND BUILT ENVIRONMENT, UNIVERSITY OF CAPE TOWN, IN PAR-
TIAL FULLFILLMENT OF THE REQUIREMENTS FOR AN MSc DEGREE IN CIVIL ENGINEER-
ING**

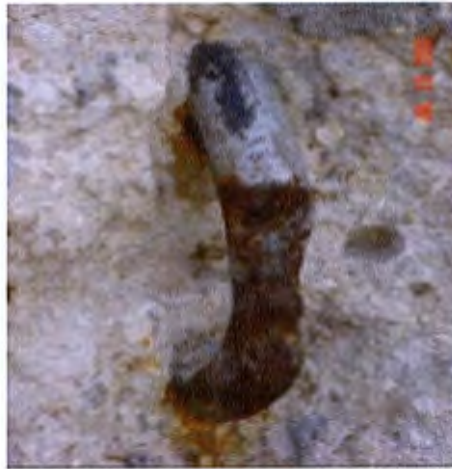
Figure 2.1: Pitting corrosion of reinforced concrete

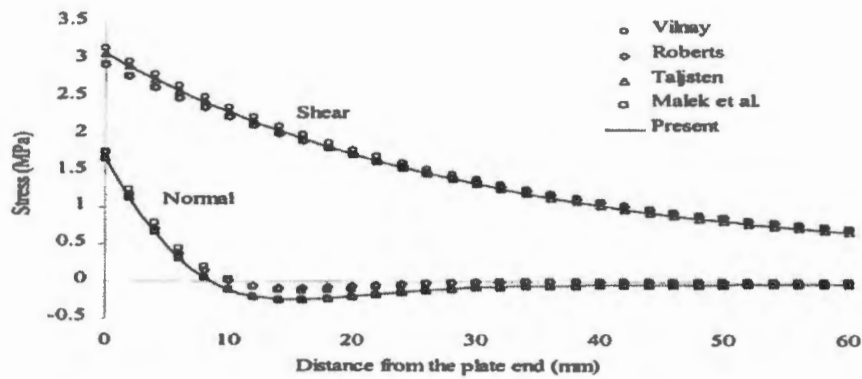
Figure 2.8: Comparison of some of the interfacial stress model that have been developed (Smith and Teng, 2001)

From the covered literature two approaches have been mentioned: the strength approach and the fracture mechanics approach. Smith and Teng (2001) describes the strength models as solutions that are defined by linear elastic materials only and are based on the assumption that shear and normal stresses remain constant across the thickness of the adhesive layer. The aforementioned assumption enables for simple closed form solutions to be developed. Several methods have been developed using the strength approach with the majority providing simple and accurate results whereas others involve higher-order analysis, the latter providing more accurate and more involved solutions. The difference between the approximate and the higher-order analysis based on the assumption of the adhesive layer, the former assumes constant interfacial stresses and the latter considers stress variations of stresses in the adhesive layer. Smith and Teng (2001) mention that the approximate solutions which assume linear elastic materials can be divided into two groups based on the different assumptions which are: the staged analysis approach and the deformation compatibility approach. Figure 2.8 shows the interfacial stresses behaviour of the different models. The diagram indicates that shear stresses decreases in a gentle parabolic manner from the FRP plate end, likewise with the normal stress behaviour but the decrease is drastic initially from the FRP plate end but tends to zero towards the FRP plate centre.

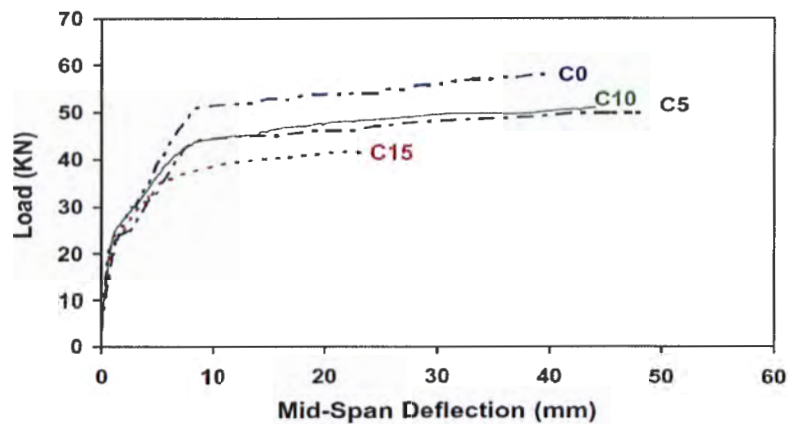
Figure 2.13: Load deflection behaviour of the control beam and corroded beams (Al-Saidy et al., 2010)

The difference between the corroded beams was the extent of corrosion to which the beam had been subjected to. The general trend of the corroded beams was lower yield load and ultimate load compared to the control beam (Al-Saidy et al., 2010). Al-Saidy et al. (2010) also observed that the corroded beams with 5% and 10% corrosion had similar yield and ultimate load, as shown in Figure 2.13 below.

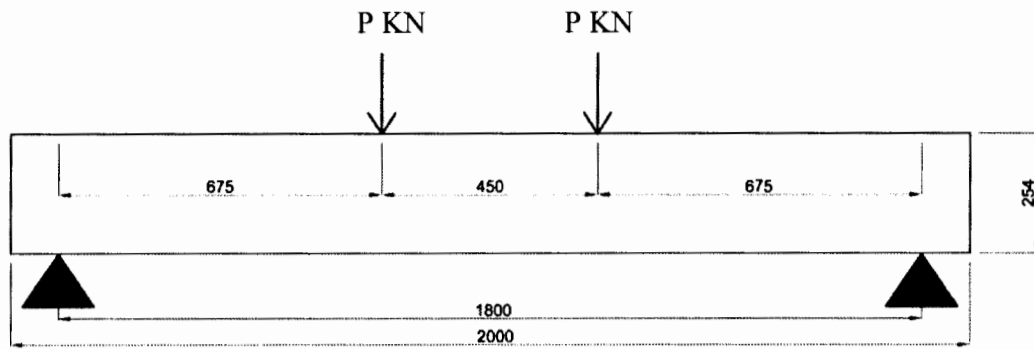
Figure 3.1: Beam under four point loading including cross sectional dimensions

The designed failure mechanism of the control beam was by compressive concrete crushing in the critical moment region and yielding of longitudinal reinforcement. The design was based on SANS 10100-1 to achieve under reinforced behaviour so as to attain good ductility of the beams before failure. The beam was simply supported with a span of 1800mm as shown in Figure 3.1. The bending moment diagram as a result of the four point loading is shown in Figure 3.4. In between the loads exists the region of maximum moment and zero shear whereas at the beam ends is the region of zero moment and maximum shear. The shear span to effective depth of 3.2 was the result of the design, which according to SANS 10100-1 is the region of shear- flexural crack formation. The design calculations of the beam can be found in Appendix A.

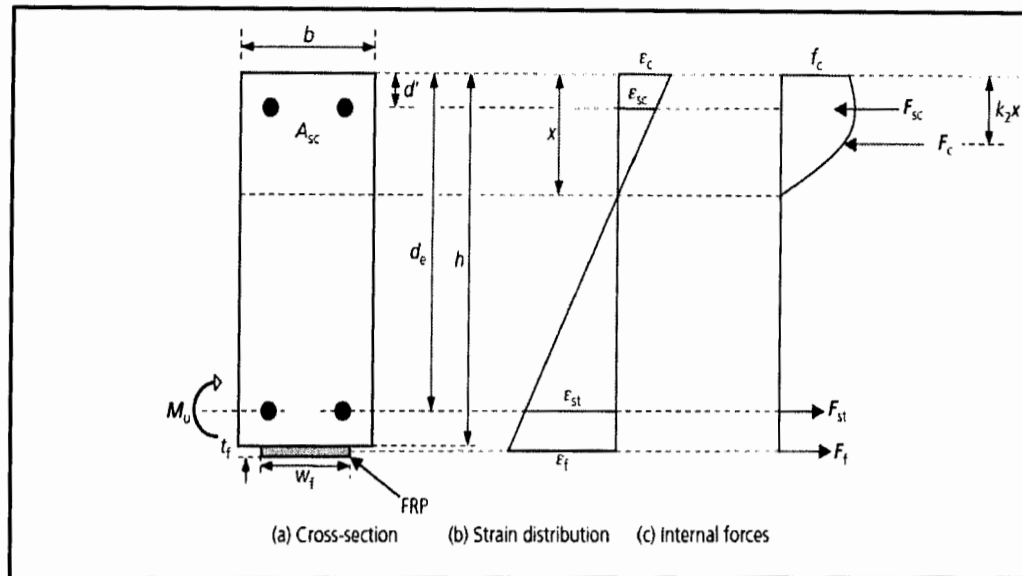
Figure 3.4: Strains and internal forces on CFRP-repaired RC beams at failure (Malumbela et al., 2011)

yield at failure. The CFRP debonding strain was used to ensure failure didn't occur prematurely before the yielding of tensile reinforcement. The assumed ductile failure criterion was found to be true by the strain analysis which meant that the assumed failure method was correct.

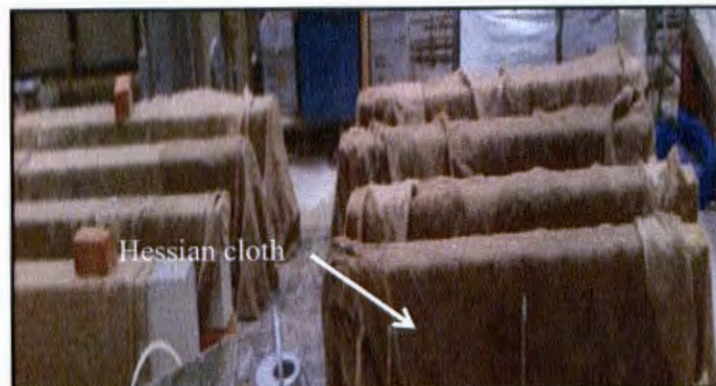
Figure 3.8: Beams being cured by covering with hessian cloth

Once polystyrene had been installed on all 12 damaged beams, 25mm cover blocks were attached to the sides of reinforcement cages at strategic points so as to maintain constant cover around the beams. The beams were kept in the steel mould for 7 days to ensure that enough strength had been gained for stripping. A damp hessian cloth was used to cover the exposed portion of the beams while they were in the mould. After stripping was performed the beams were stored upside down at the back of the laboratory and wrapped in a moist hessian cloth, as shown in Figure 3.8 and Figure 3.9. The hessian cloth was kept damp by a watering can which was applied to all the beams every morning up to 28 days.

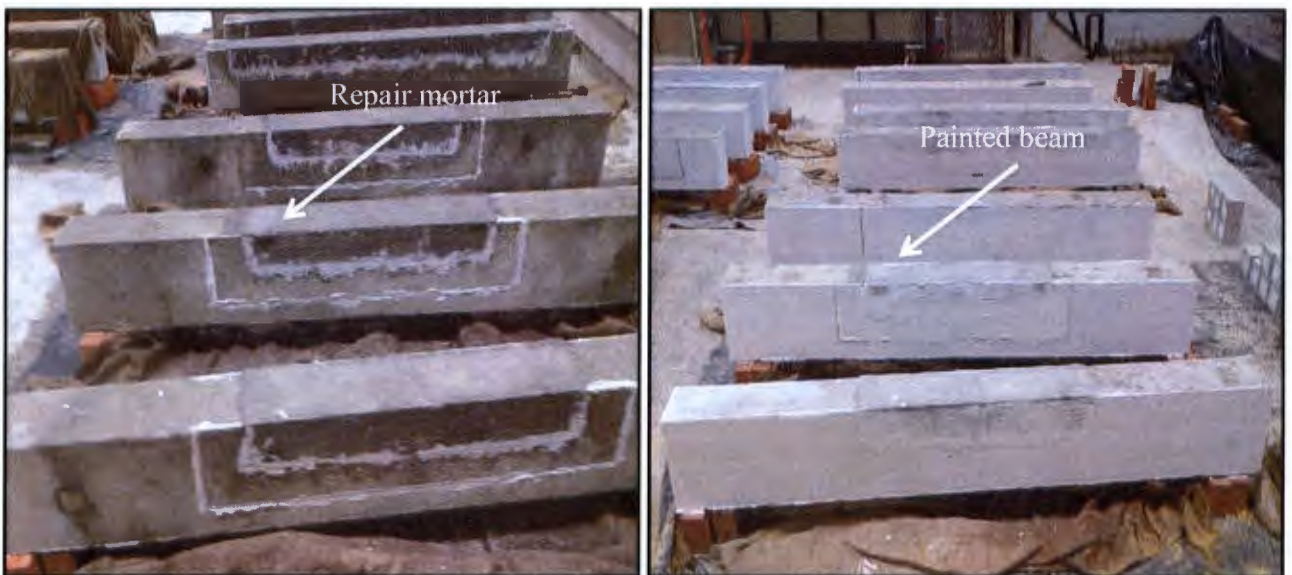
Figure 3.13: Beams after 28days (left) and beams after being painted white (right)

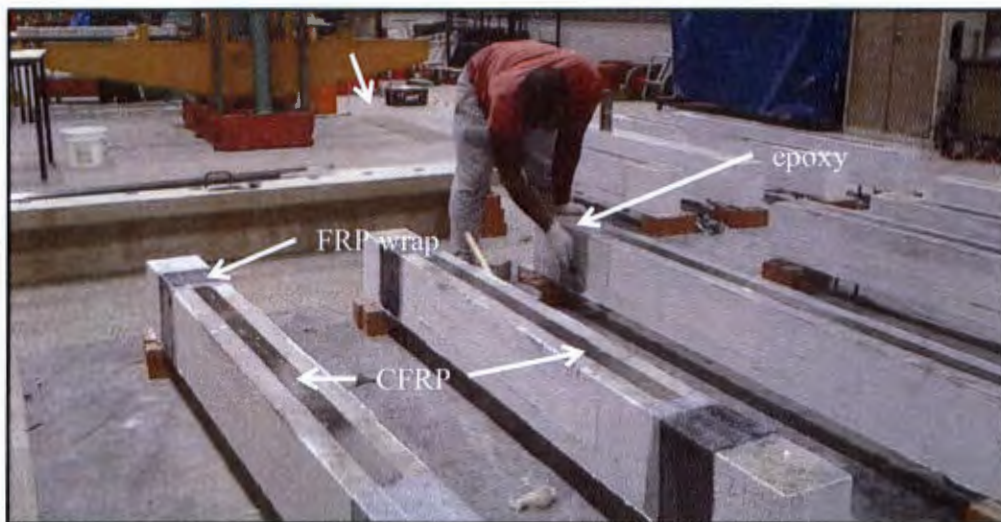
Figure 3.15: CFRP plate and FRP wrap configuration

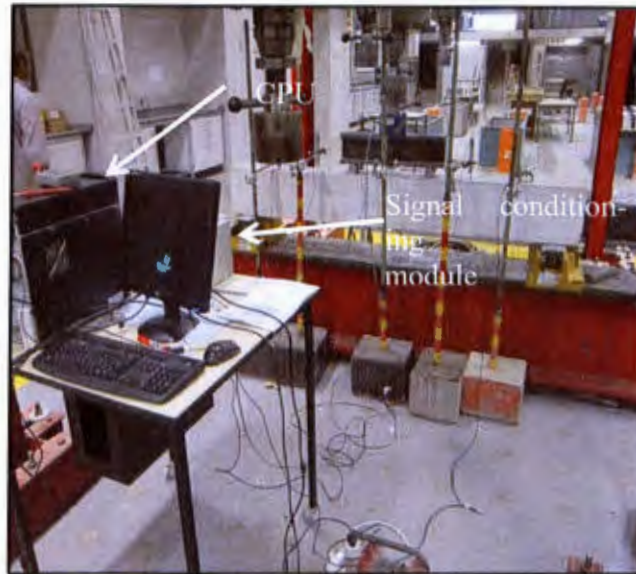
Figure 3.18: Electronic setup for the load and deflection measurements

The load-deflection results were electronically collected by a data acquisition system, as shown in Figure 3.18 below. Five LVDTs and a load cell were connected to a signal conditioning module, refer to figure 3.19. The signal conditioning module was connected to the computer from which a program called Labview was used to extract the deflection and load results as a function of time.

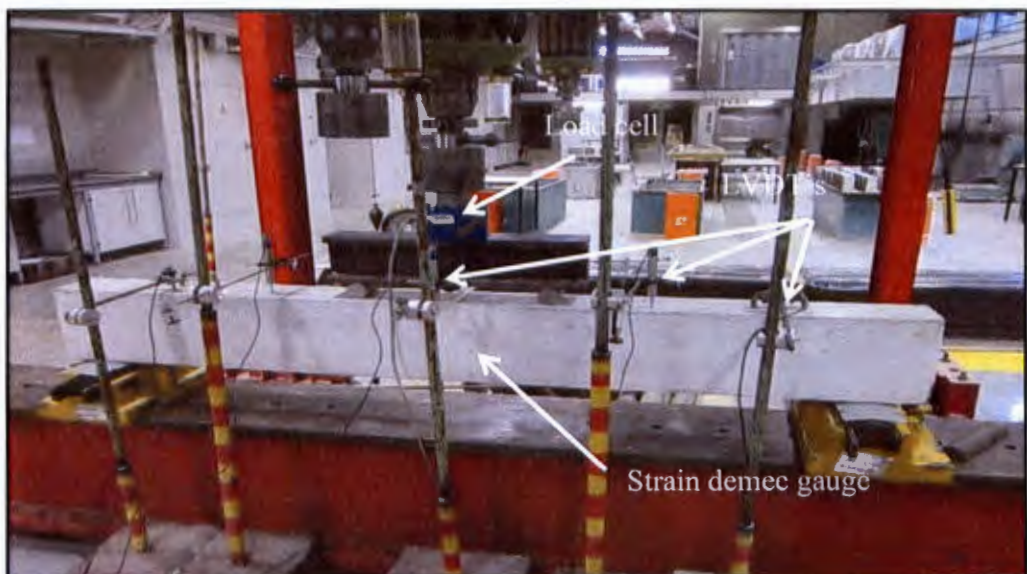
Figure 3.19: Experimental setup for the deflection and load results

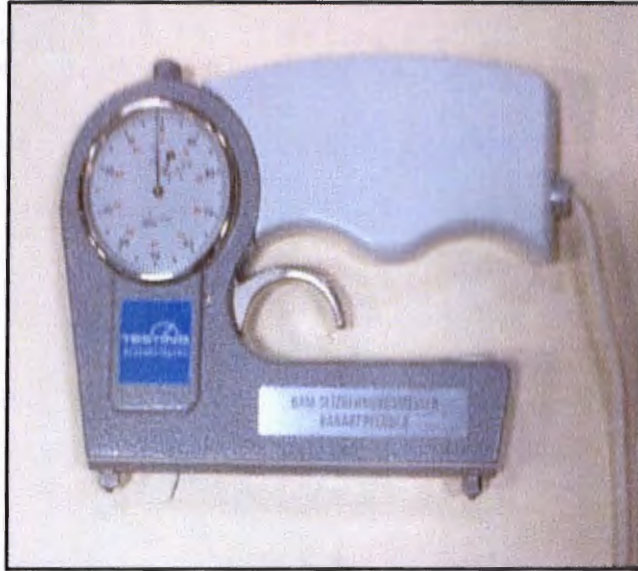
Figure 3.21: The extensometer used for the strain measurements

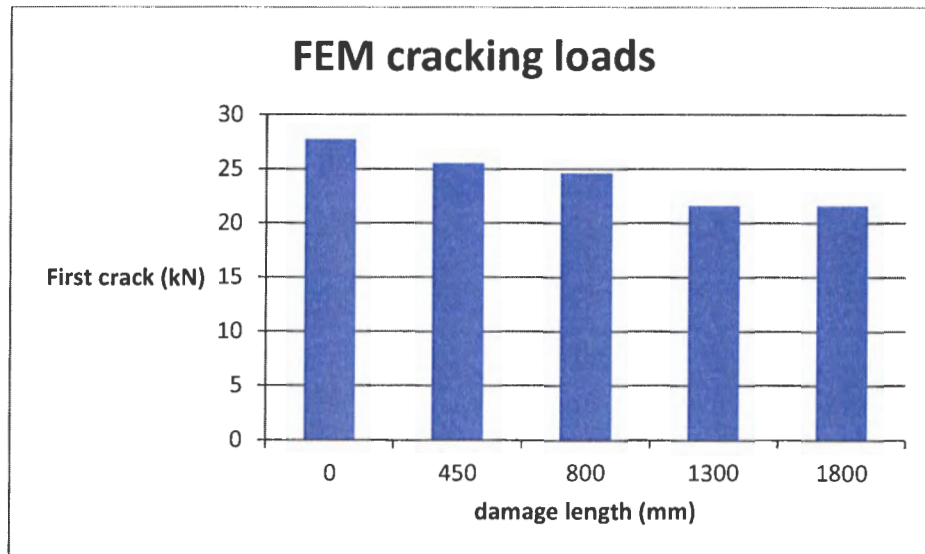
Figure 4.19: FEM cracking loads

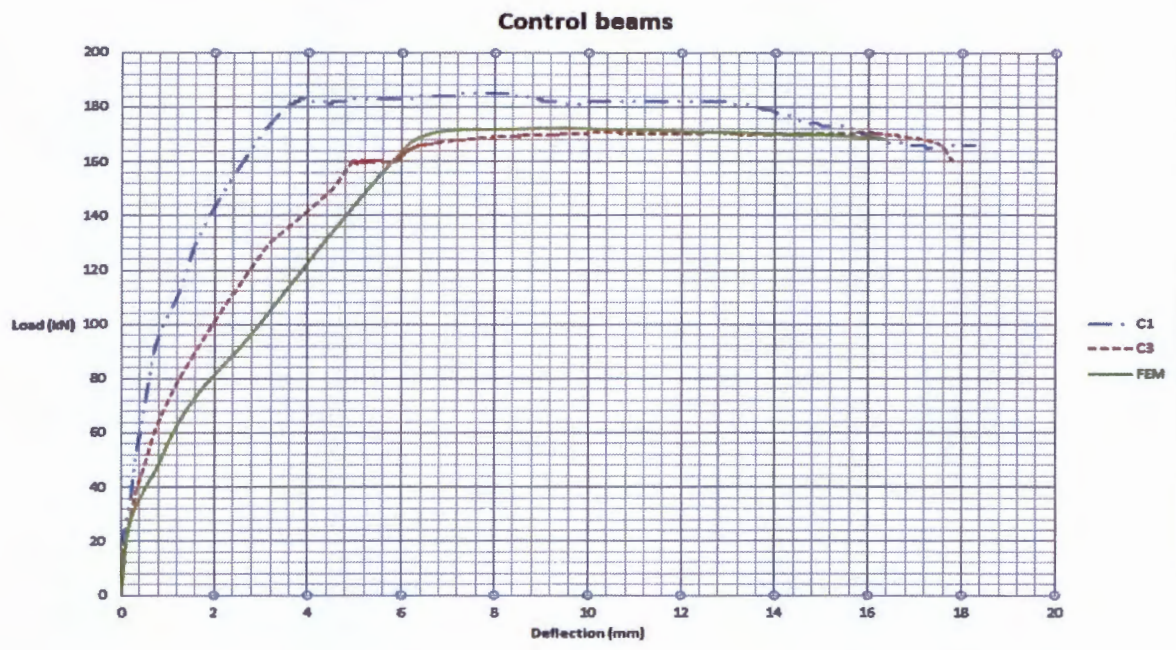
Figure 4.22: Load-deflection behaviour of retrofitted beams C1, C2 and C3

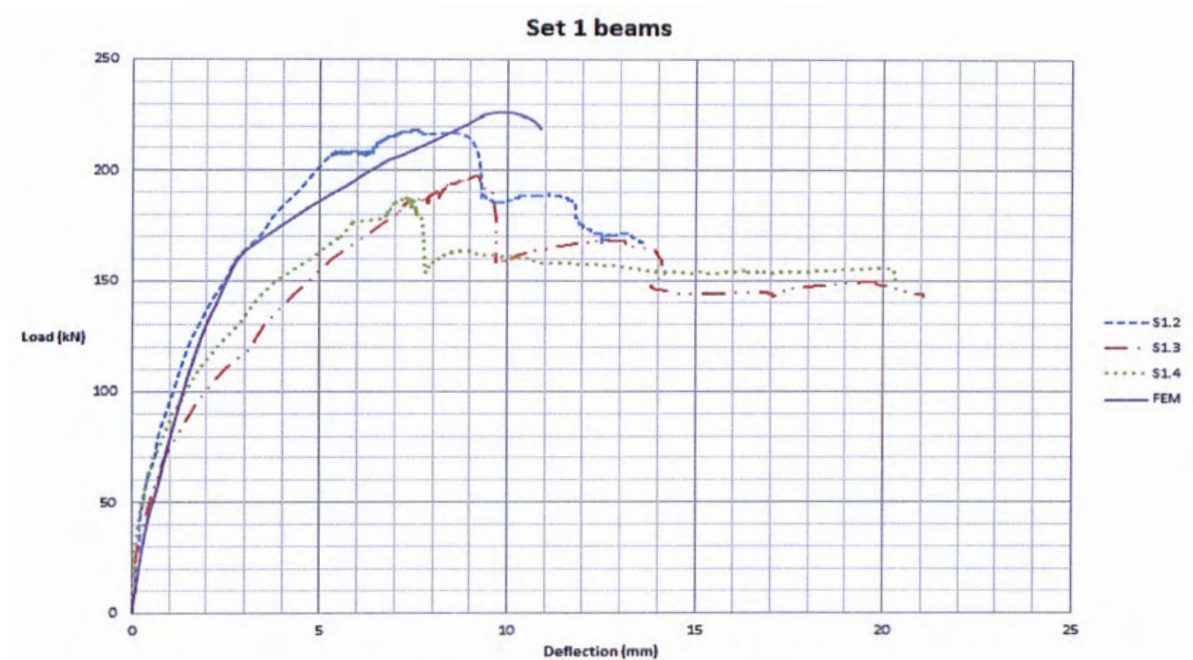
Figure 4.23: Load-deflection behaviour of RS experimental beams S1.2, S1.3 and S1.4 and FEM

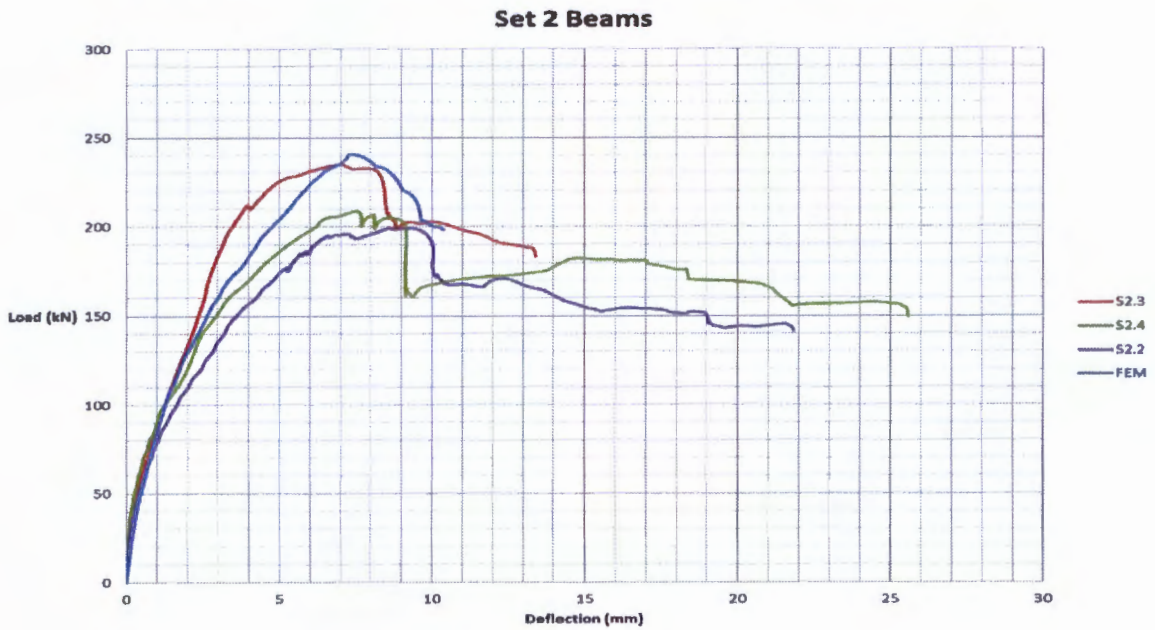
Figure 4.26: Load-deflection behaviour of RS beams S2.2, S2.3, S2.4 and FEM

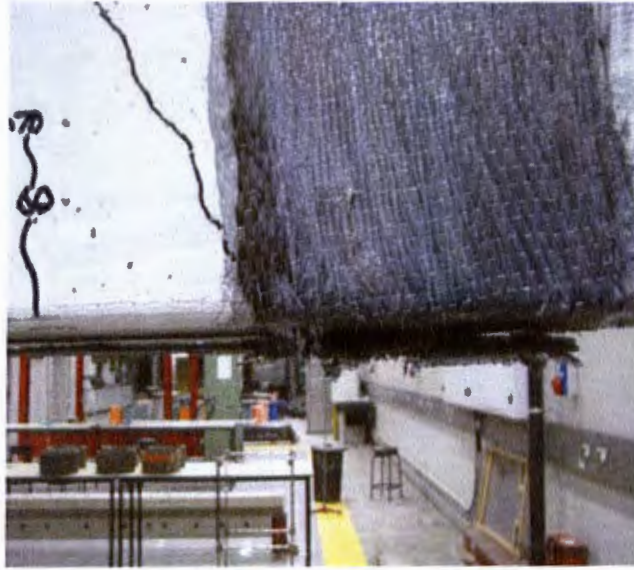
Figure D.1: Fractured FRP wrap near the right end support (beam S1.2)

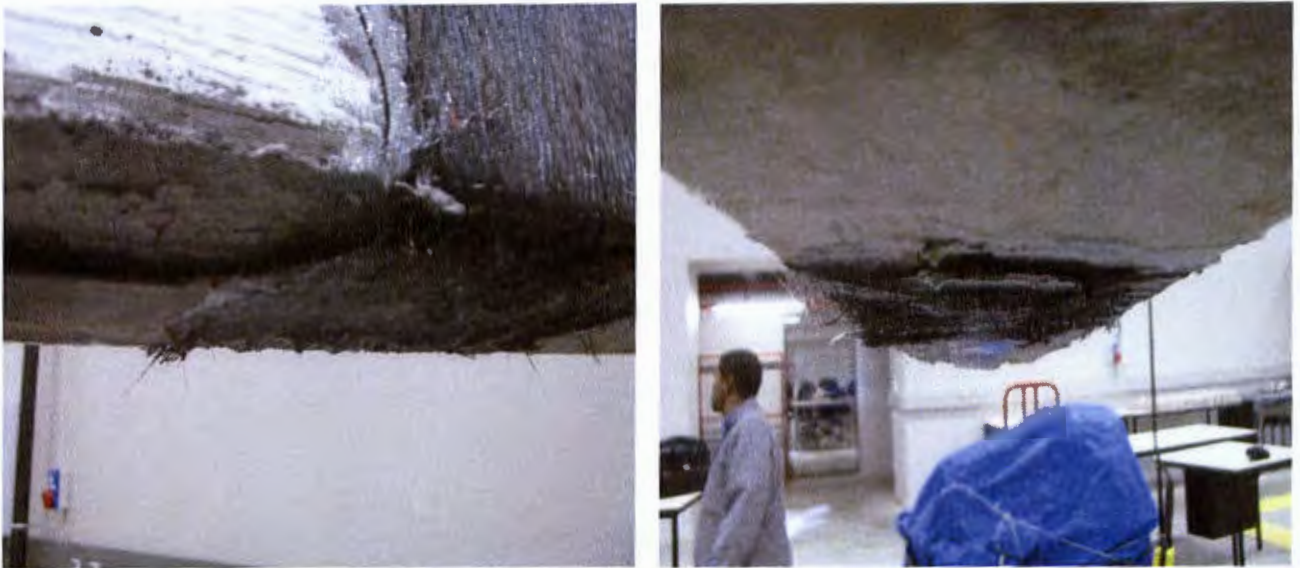
Figure D.2: Debonding of FRP wrap with partial fracturing of FRP wrap (BeamS3.4)
