MSc. Dissertation

**Behaviour of FRP Strengthened RC Beams with
Concrete Patch Repairs Subjected to Impact Loading**

March, 2017

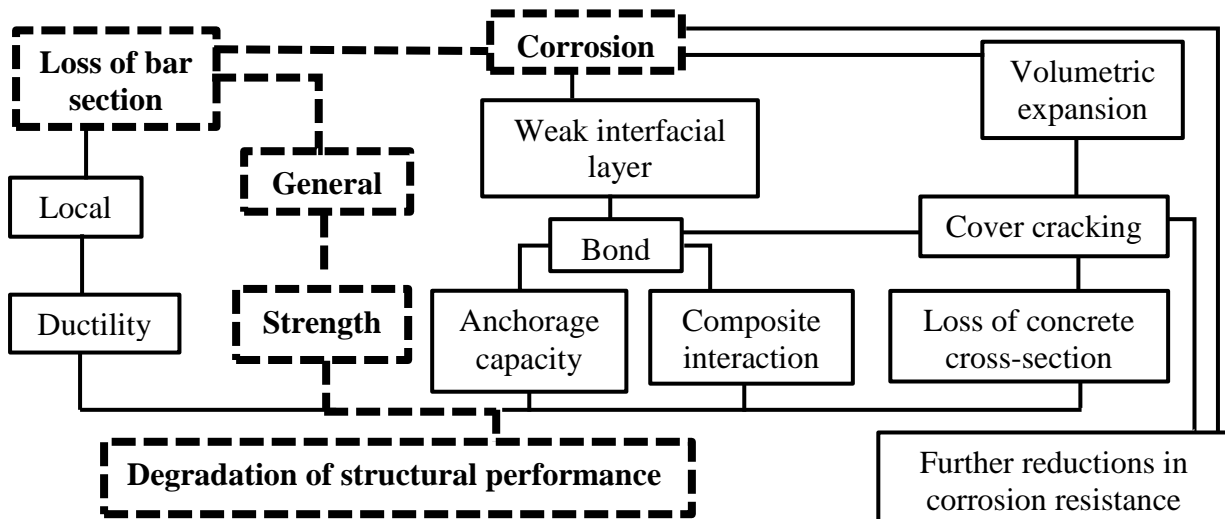
Figure 2.1. Effects of reinforcement steel corrosion on the residual structural capacity (Crains, et al., 2008).

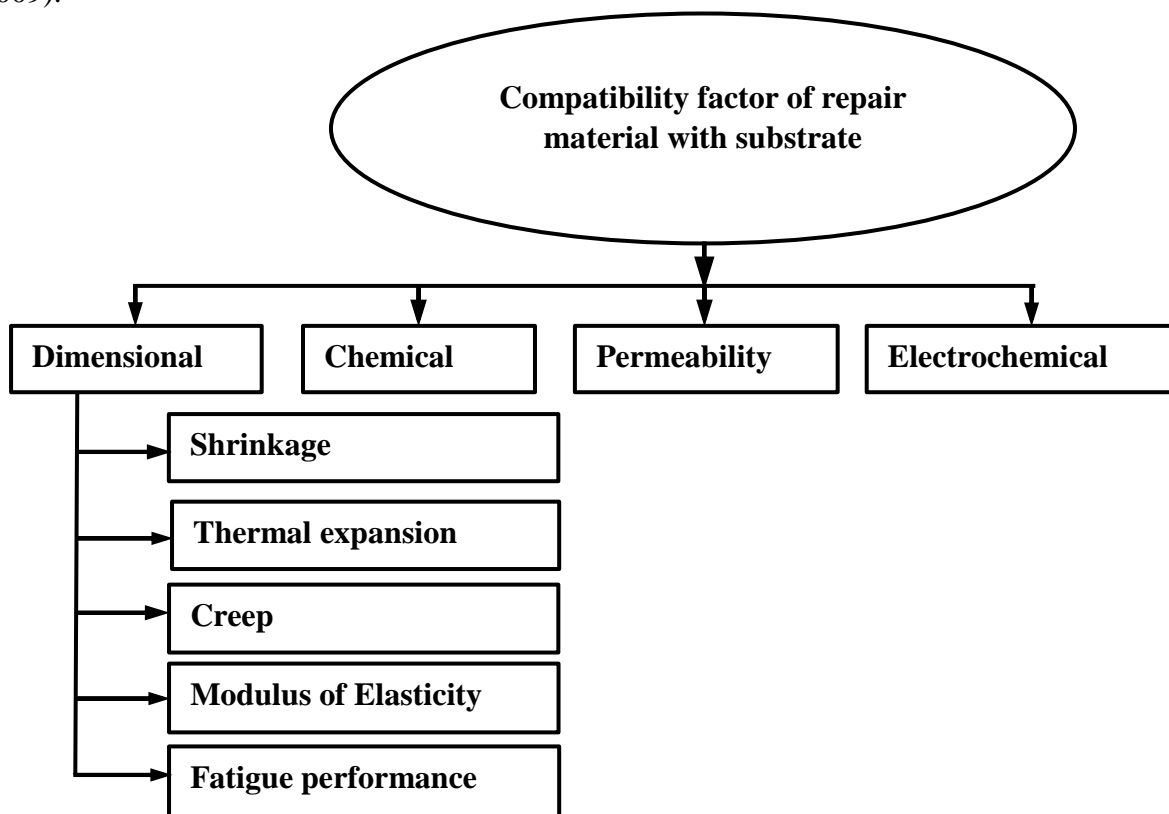
Figure 2.2. Compatibility factors in a concrete repair system adapted from Vaysburd, (2006).

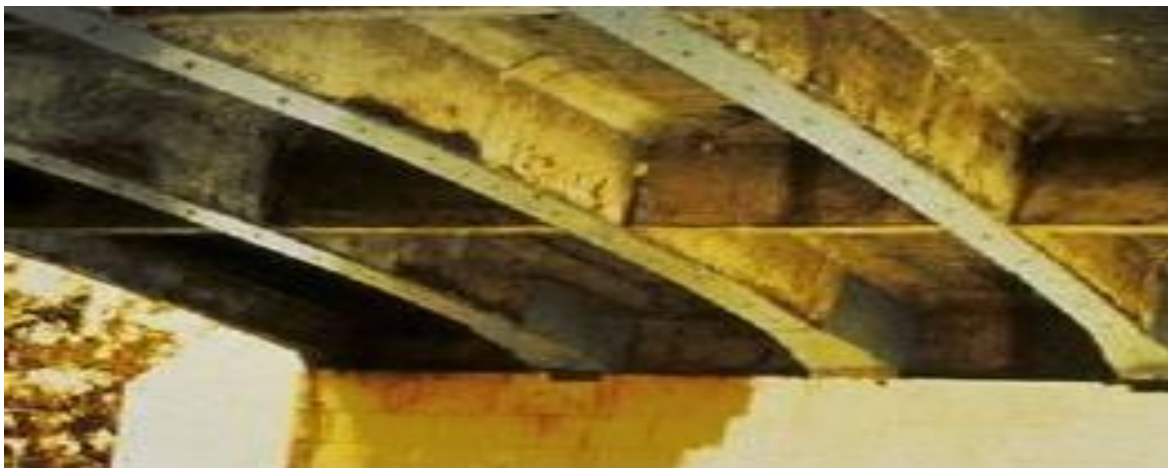
Figure 2.8. Typical steel plate bonding for flexural strengthening RC beams of a RC bridge (Alkhrdaji, 2013).

It has been reported by a considerable number of researchers that the steel bonding to the RC beams can substantially contribute to the flexural stiffness, reduce cracking density and structural deformations at all load levels, as well as contribute positively to the ultimate flexural capacity (Jumaat & Alam, 2006; Arslan, et al., 2008). The ultimate and cracking loads of the strengthened RC beams glued steel plate depend mainly on the following parameters: (i) the compressive strength of concrete; (ii) nominal strength of the web reinforcement ratio; (iii) the yield strength of longitudinal reinforcing bars; (iv) the tensile reinforcement ratio; (v) the shear span-to-depth ratio; (vi) the strength of steel plates; (vii) mechanical properties of epoxy adhesive and (viii) friction coefficient between concrete and steel plate (Arslan, et al., 2008). The effectiveness of the steel plate bonding as a strengthening method of RC beams depends on the surface preparation, bonding materials and methods used between steel plates and the existing beam (Jumaat & Alam, 2006). Figure 2.8 shows steel plate material bonding for the flexural strengthening of a RC bridge.

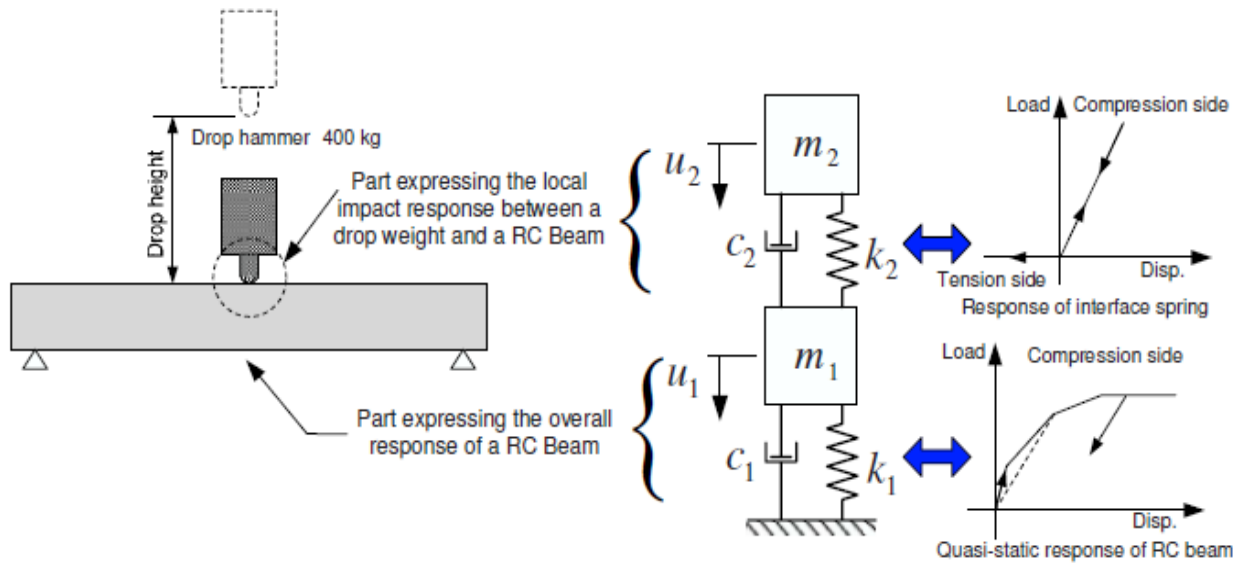
Figure 2.29. Two-degrees-of-freedom mass-spring-damper system model (Fujikake, et al., 2009).

While testing RC beams under impact loading, the system can be considered as a two-degrees-of-freedom model. According to Fujikake, et al., (2009), this model can represent not only the of overall response of the tested RC beam, but also the local response recorded at the contact point between the drop hammer and the RC beam under study with the least degree-of-freedom. Figure 2.29 illustrates the impact testing system with two-degrees-of-freedom. The said model successfully represented the impact loading test of RC beams by taking into consideration local and global failures.
