# ROAD RECONSTRUCTION IN CAPE TOWN

HALF THESIS FOR THE MASTERS DEGREE IN CIVIL  
ENGINEERING  
UNIVERSITY OF CAPE TOWN  
DEPARTMENT OF CIVIL ENGINEERING  
March 2002

Author: Mark Bondietti  
Supervisor: Prof Nicholas Marais

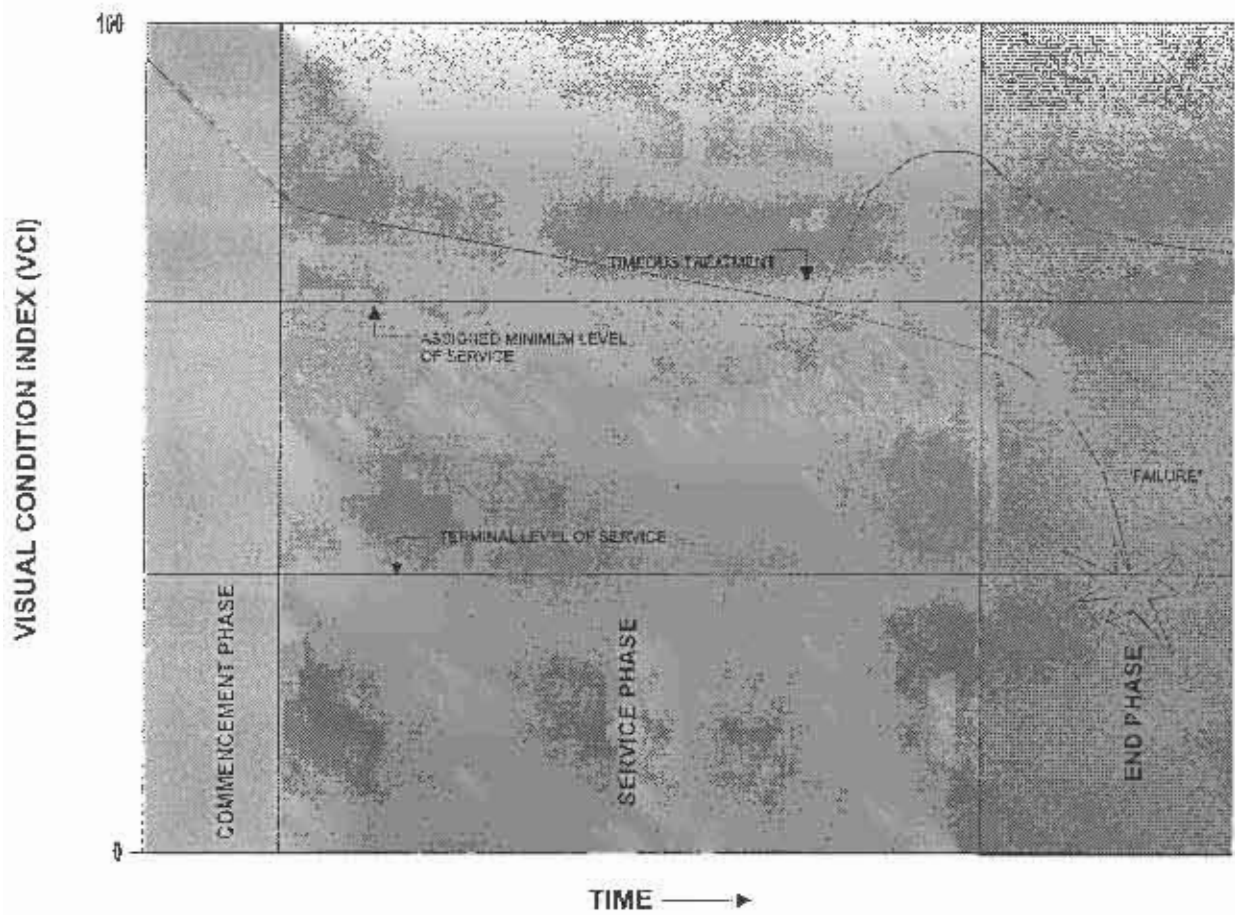
Figure 4.1: Schematic description of the Life of a road

It is the condition of the pavement that needs to be monitored in order to assess the structural state of a road. Various defects in the road pavement will manifest as the road ages through the different life cycle phases. These defects usually occur long before the road user is aware of any problem. The condition of the pavement can be quantified by observing the degree and extent of defects that are present in the road surface. These defects may be in the form of one or more of the following:

The road condition can thus be monitored by observing the type, degree, extent and spacing of these defects. The type of defect can also give clues as to what is causing the problem and consequently the type of treatment required. For example, if there is extensive crocodile cracking with pumping and deformations, this indicates that the pavement layers are failing. While ravelling and polishing indicate that the surface is failing.

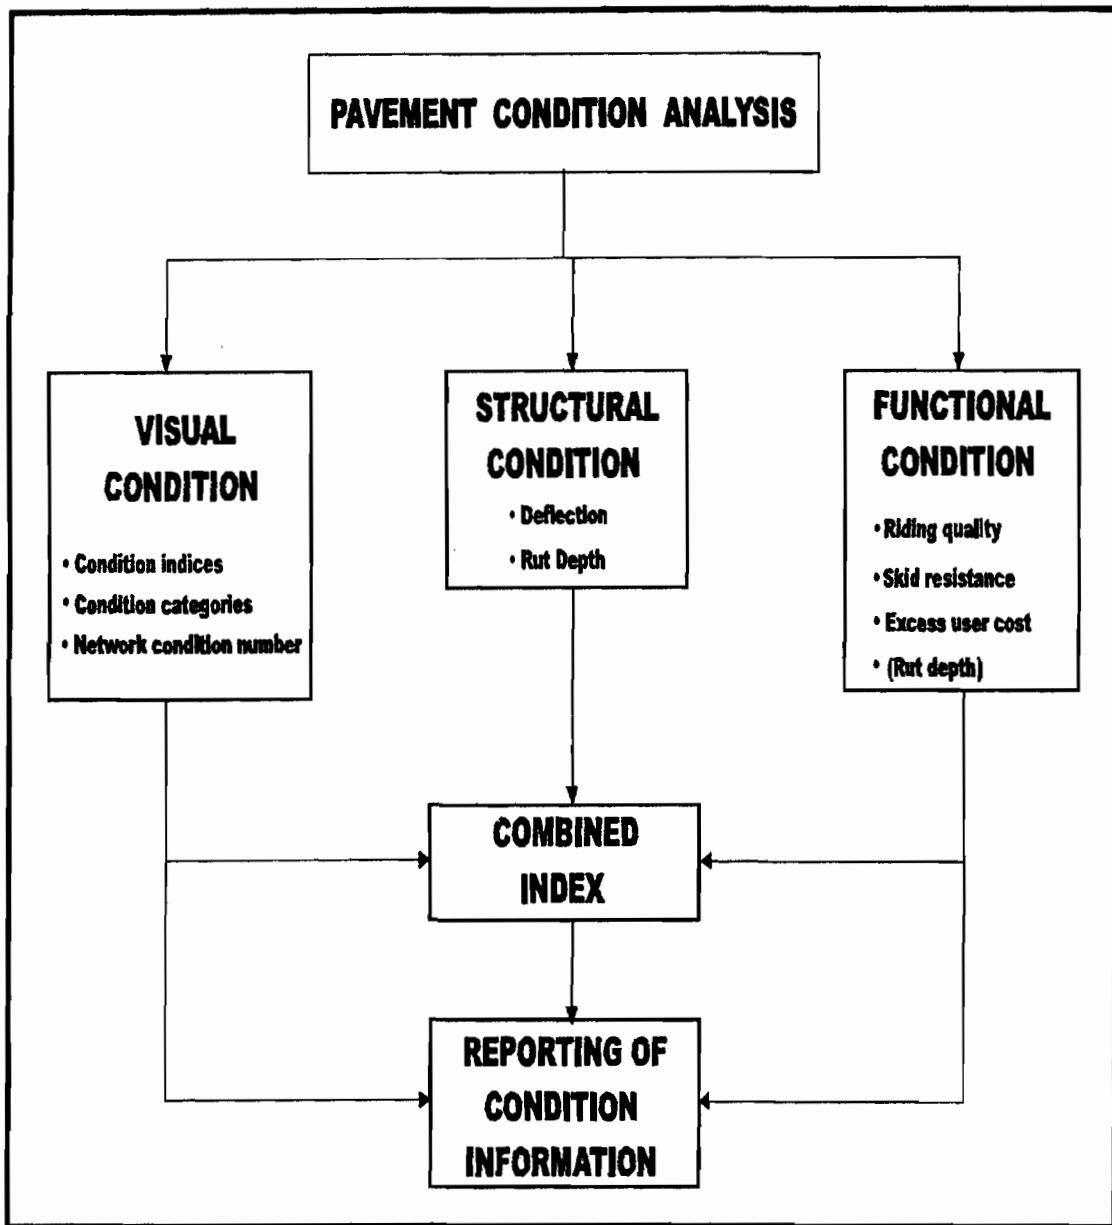
Figure 4.2: Pavement condition analysis [25]

Many different methods of calculating a visual index have been developed. The method used in Cape Town is based on the TRH 22 method which was developed by the Committee for Compatibility of Pavement Management Systems [25]. The Committee developed this system for South African conditions, after investigating all the available methods. The objective was to produce a method giving results that have a good correlation with the judgement of an expert panel of raters [25].

The visual condition index (VCI) and the priority index (PI) are used to produce an initial list of roads to be considered for rehabilitation.

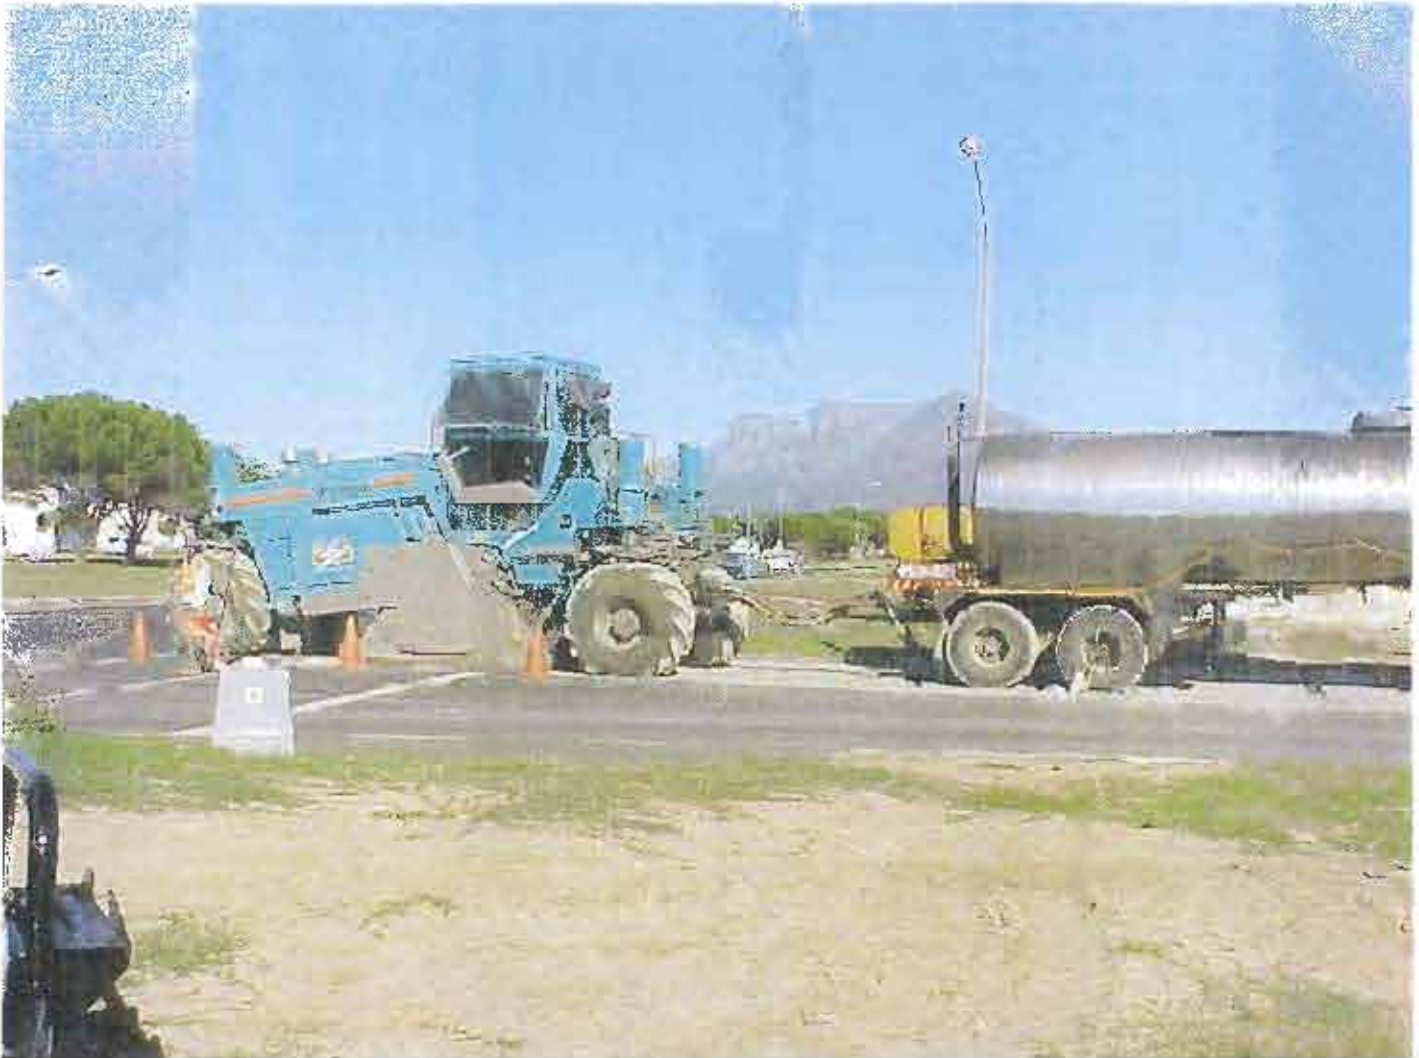
Plate 1 : CTR machine on site

Plate 1 shows the CIR machinery on site. Note that expensive specialised equipment and skilled operators are essential for this form of rehabilitation.

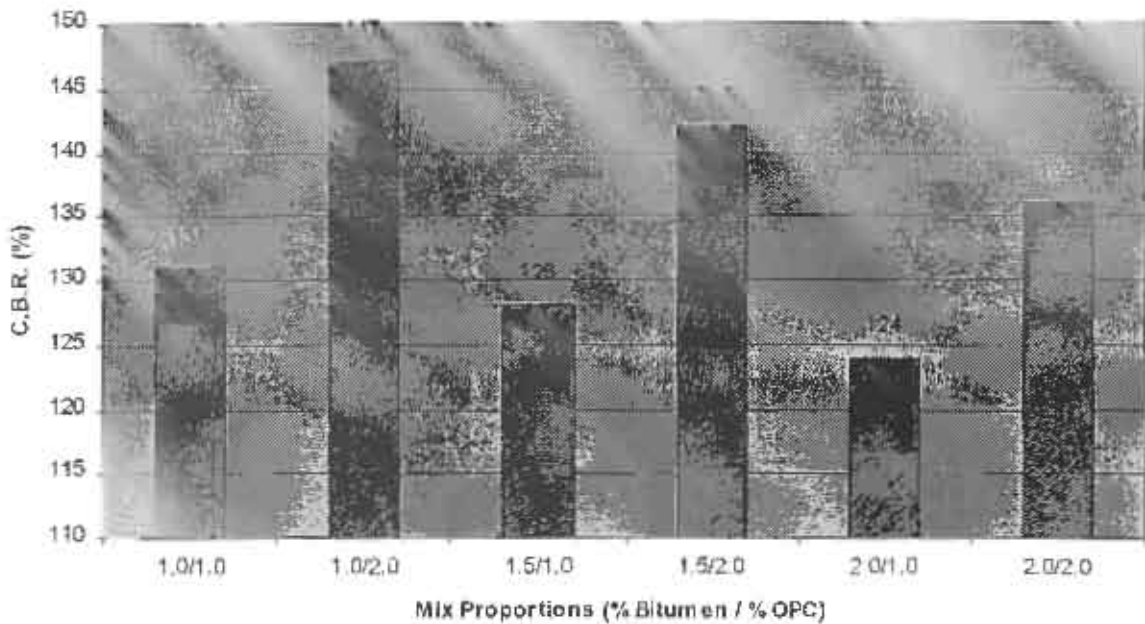
**Figure 5.3: CIR trial mixes**

As seen in the above figure, there is an increase in CBR with an increase in cement content, but a decrease with increasing emulsion content. The strength requirement must therefore be balanced with the benefits of increased emulsion content. Experience has shown that emulsion contents of above 2% result in compaction problems because of the associated high moisture content caused by the 40% water content of the emulsion mix. It is therefore best to aim at achieving the required strength at 1.5% to 2.0% emulsion content. However, in dry environments lower emulsion contents are adequate and more economical.

The constituent materials design to convert the existing parent material to an equivalent G2 (in the case of Signal Hill Road) is achieved by testing different emulsion/cement trial mixes in the laboratory. The mixes are then tested for CBR and UCS to determine which mix best meets the design strength criteria as determined in the layer design. An output example is shown graphically in the figure 5.3 below:

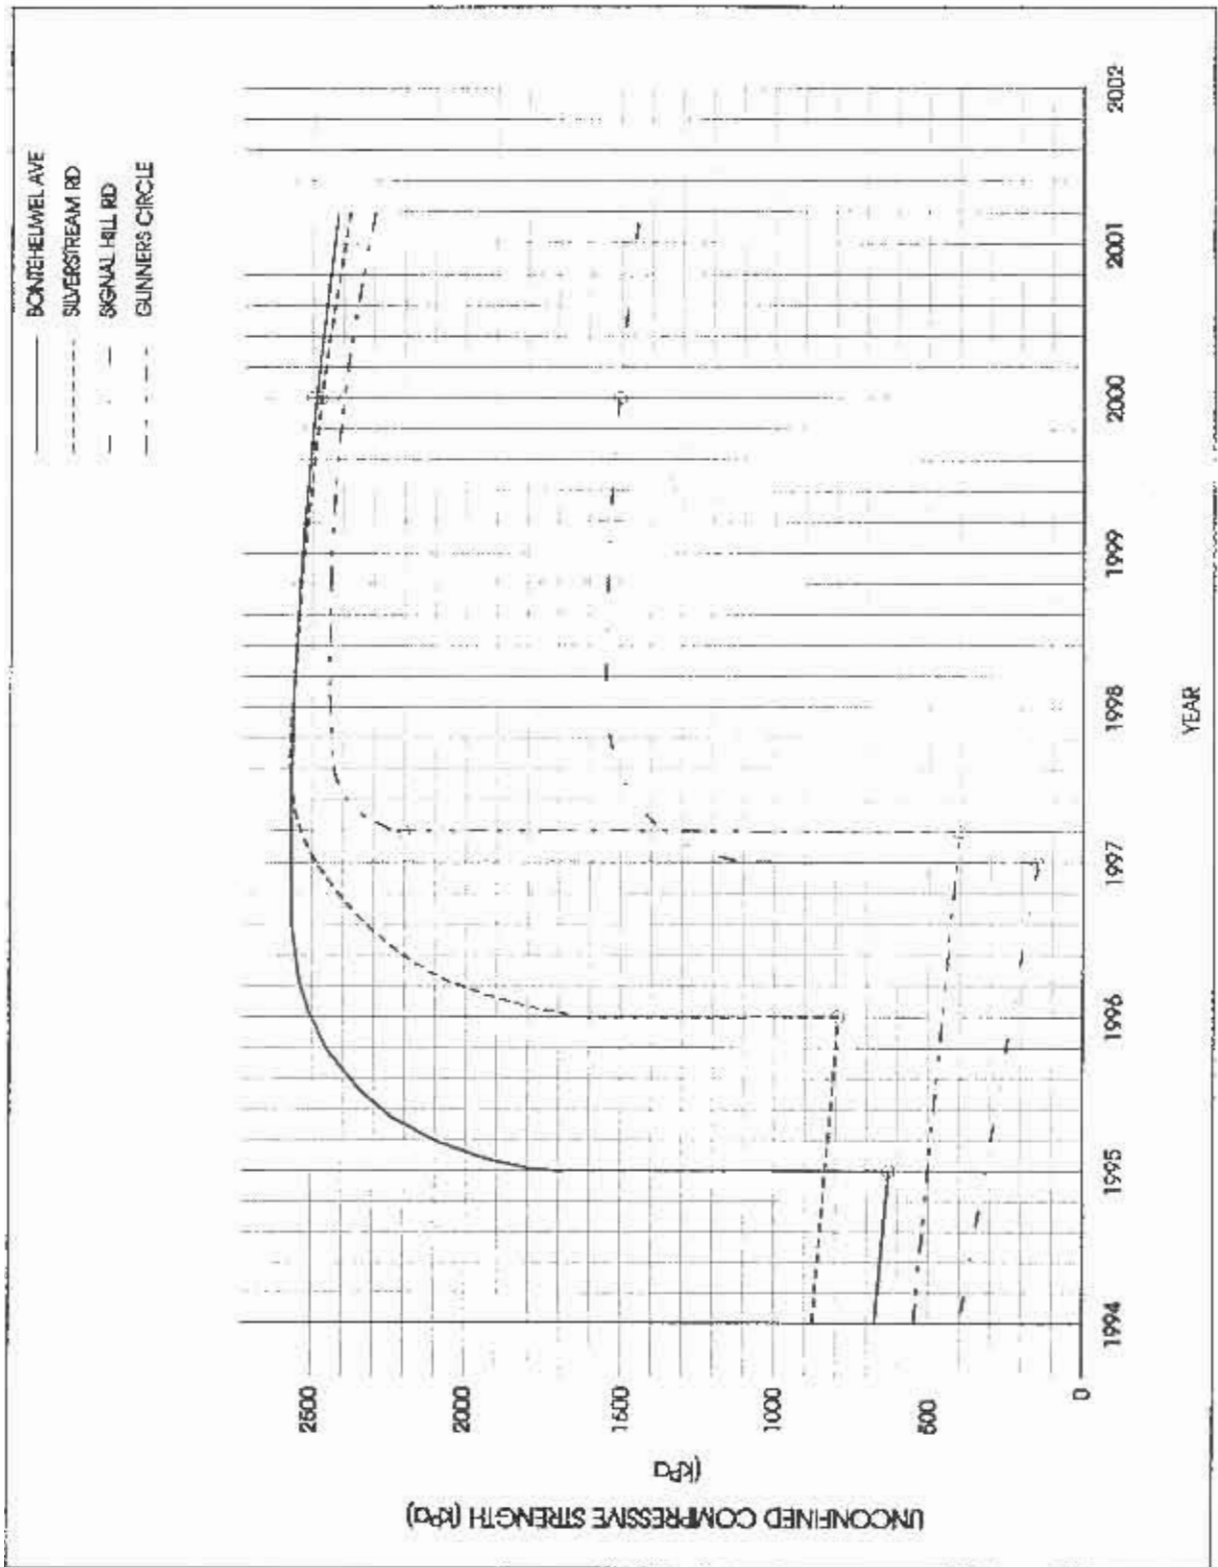
Figure 5.6: UCS values for CIR base

Insitu strengths were determined using the dynamic cone penetrometer (DCP). A list of DCP surveys that were done is shown in **Table 5.2** (see Annexure 9 for a sample survey). This information gives perspective on the frequency of available data and its relationship to the rehabilitation actions. The three year interval in testing seems to give sufficient detail to plot change in condition but more future data is required to verify this (see **Figure 5.6**, p 58).

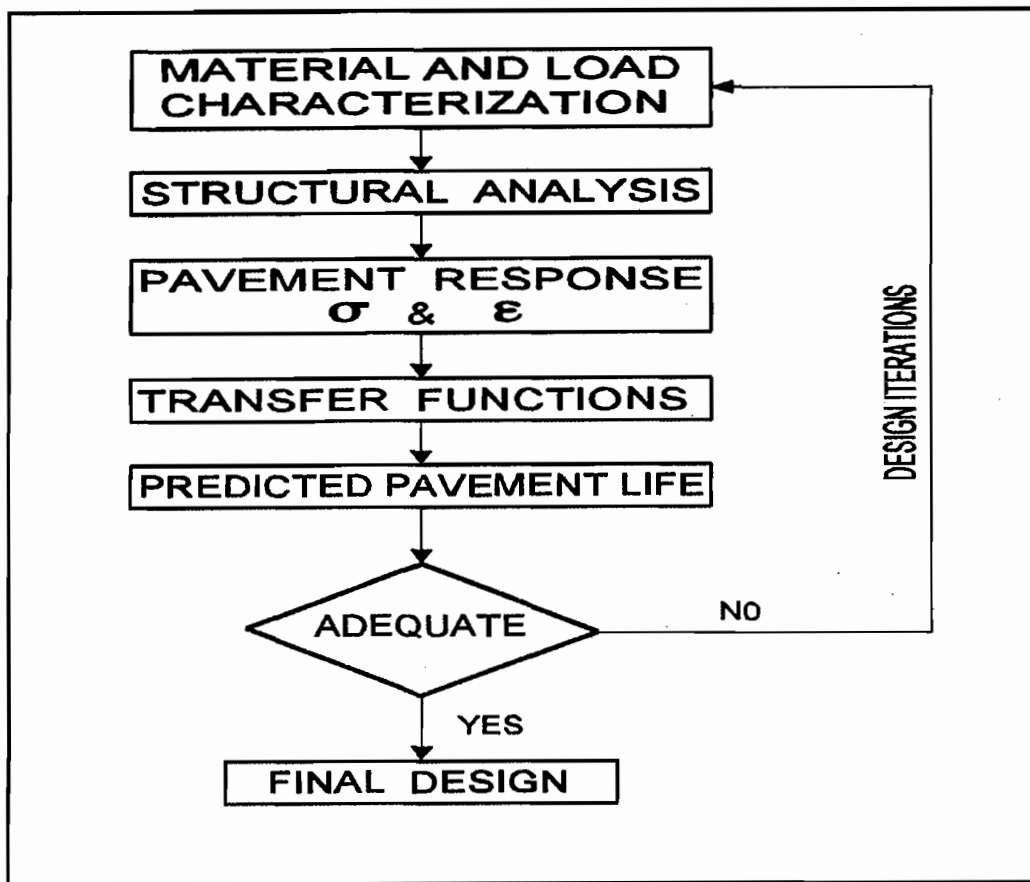
Figure 5.7: Flow diagram for a mechanistic design analysis procedure [33]

The structural analysis carried out by the method involves a linear elastic, static analysis of a multi-layer system. The modulus of elasticity and cohesion of the pavement materials are used to calculate the pavement response to the loading condition. The response is expressed in terms of stresses ( $\sigma$ ) and strains ( $\epsilon$ ) at critical positions in the pavement structure. Transfer functions are then used to relate the stress-strain condition to the number of loads that can be sustained at that stress-strain level before a certain terminal condition is reached. The flow diagram below (figure 5.7) shows how the design process is implemented.

The SAMDM is the state of the art pavement design method in use in South Africa at present. It has been used to develop TRH 4: Structural design of flexible pavements for inter urban and rural roads [37] and TRH 12 : Bituminous pavement rehabilitation design [38], both of which are widely used by rehabilitation engineers throughout South Africa. In this thesis the ELSYM 5 [27] and PADS [36] computer programmes are used for the analysis.

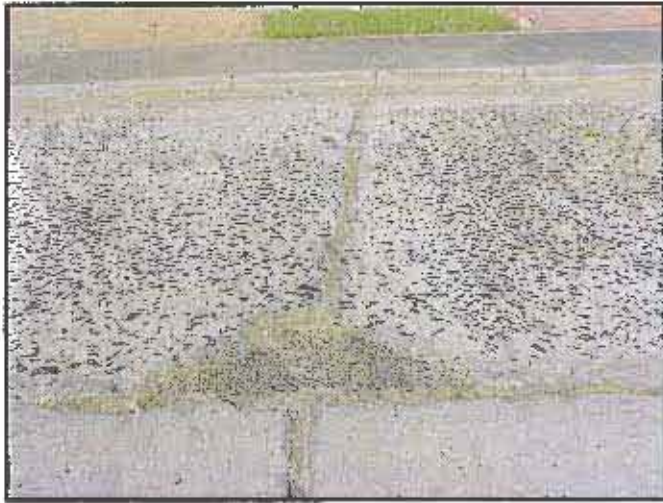
Loss of support resulting in cracking  
of slab corners  
PLATE 2

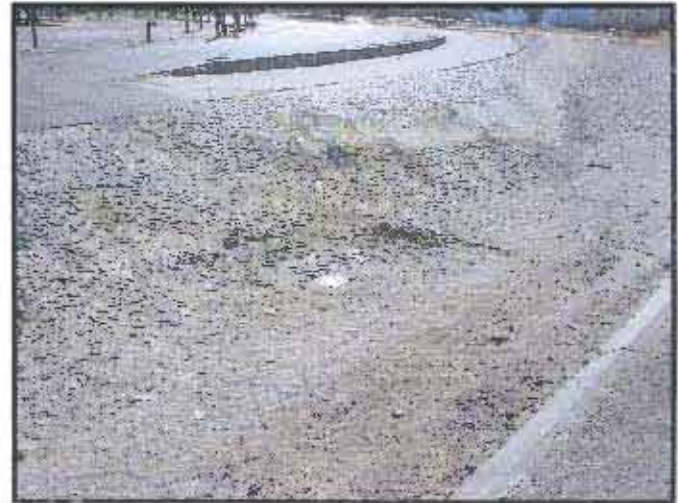
Lack of support, raveling and joint disintegration.  
PLATE 3

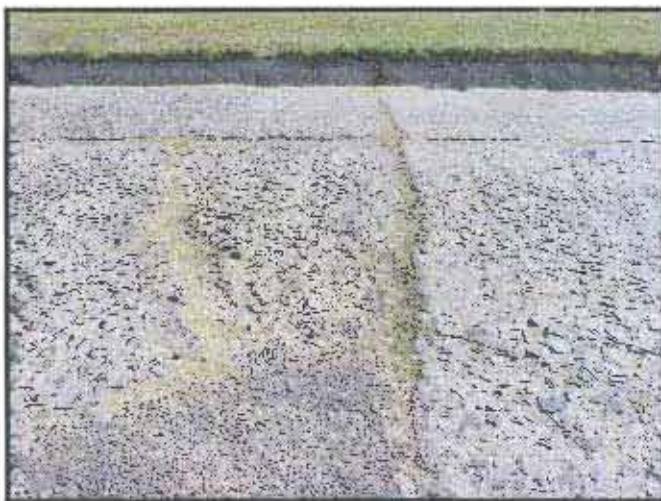
Joint disintegration and raveling resulting  
in exposed aggregate  
PLATE 4

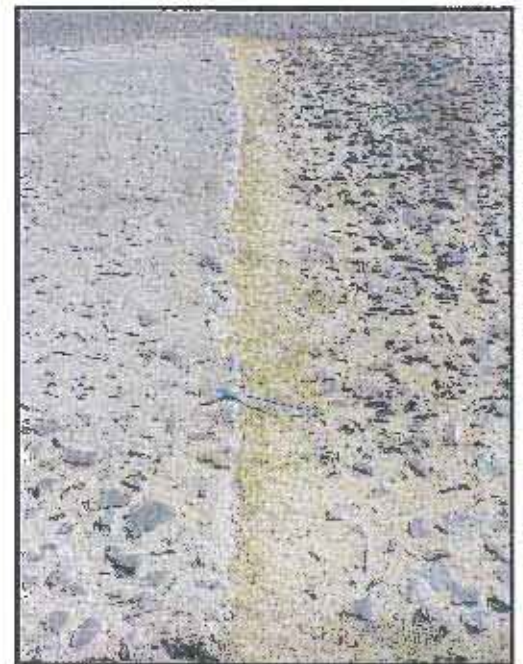
Slab faulting and exposed aggregate.  
PLATE 5

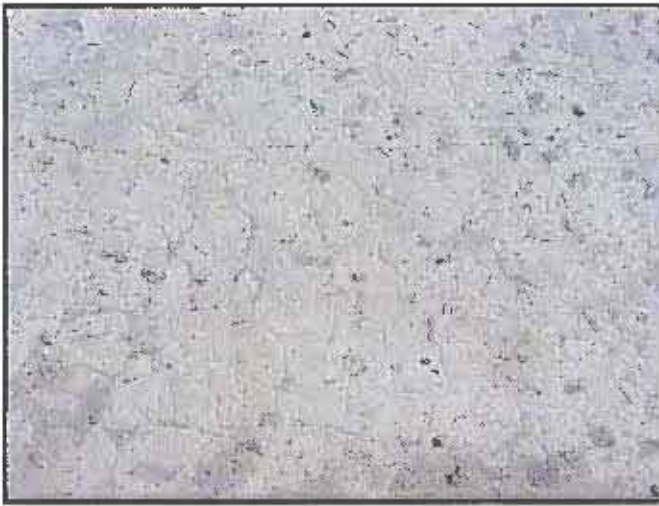
Alkali aggregate reaction  
PLATE 6

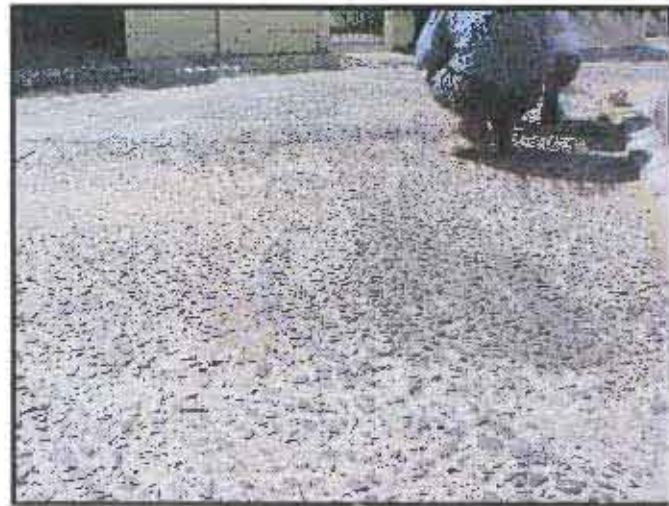
Ravelling resulting in exposed aggregate.  
PLATE 7

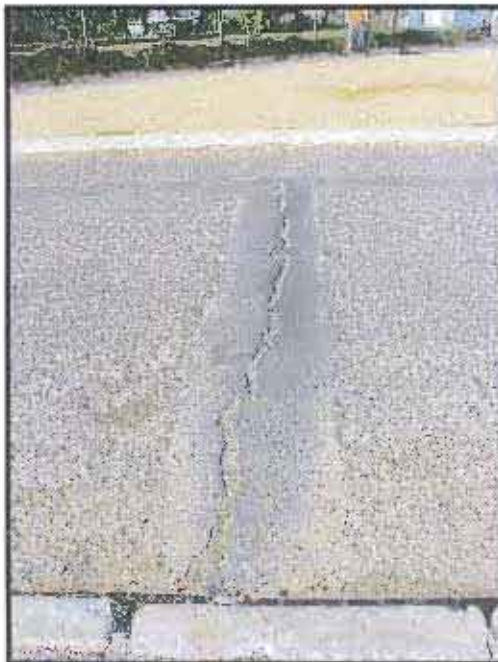
Movement at joint causing cracking  
in asphalt overlay.  
PLATE 8

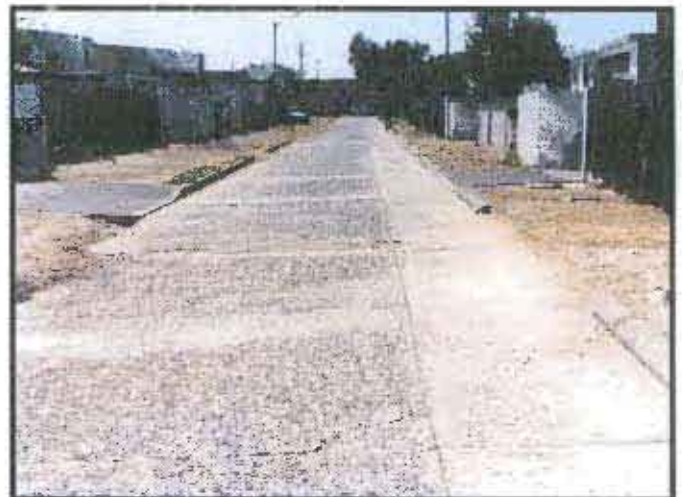
Various defects -- exposed aggregate, loss of  
support, joint disintegration  
PLATE 9

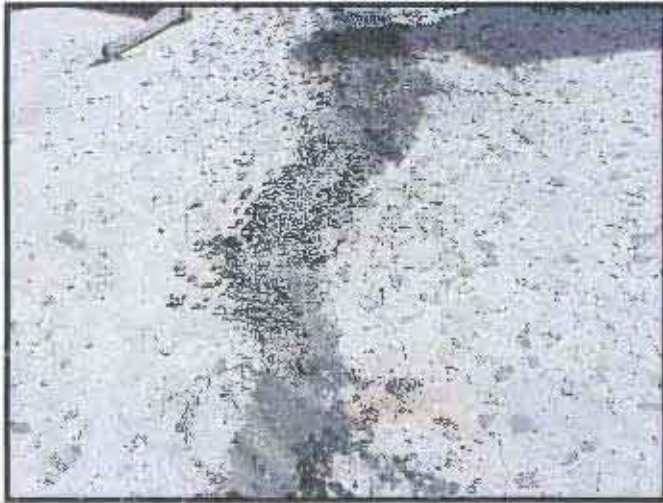
Crack sealing  
PLATE 10

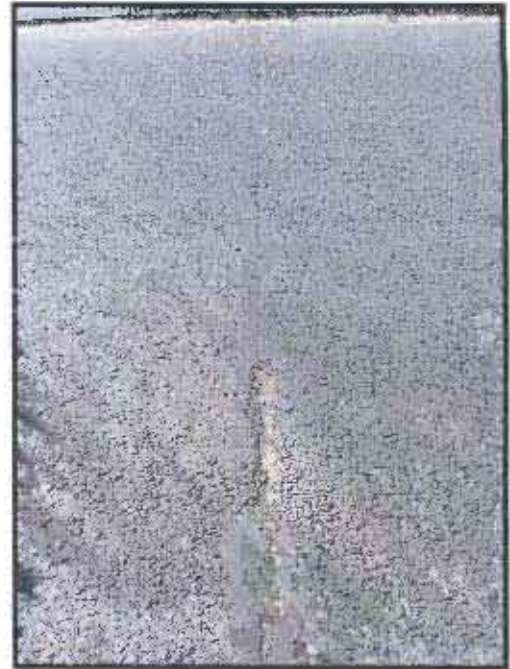
Saw cut joint.  
PLATE 11

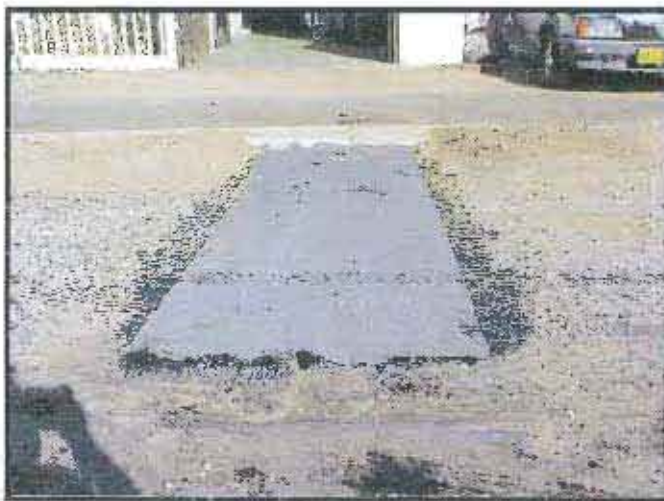
Geofabric bandage over crack.  
PLATE 12

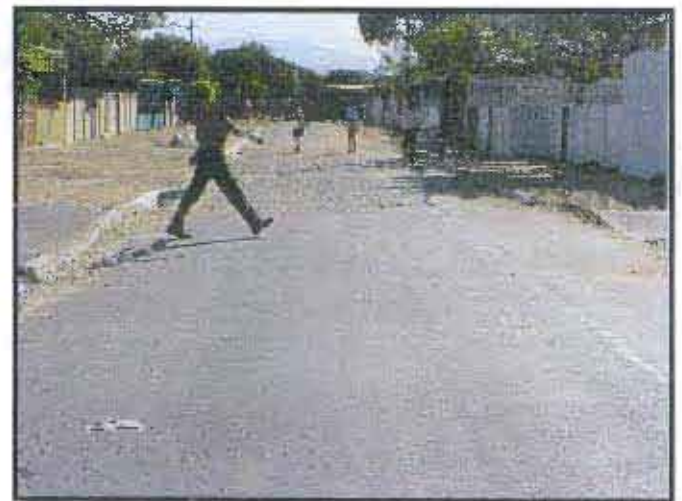
Rubber bitumen asphalt overlay.  
PLATE 13

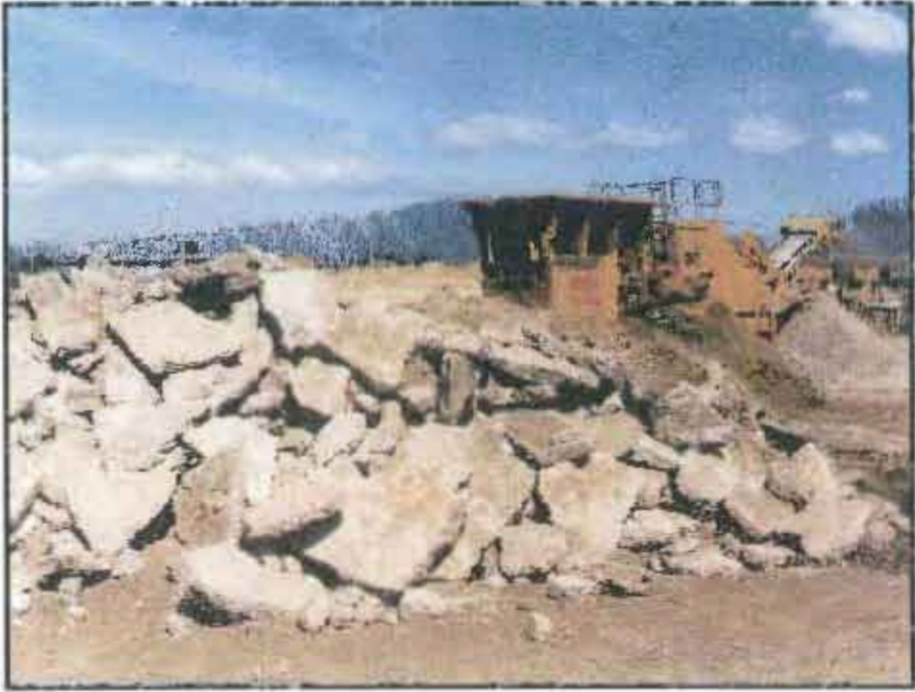
Concrete crusher.  
PLATE 14

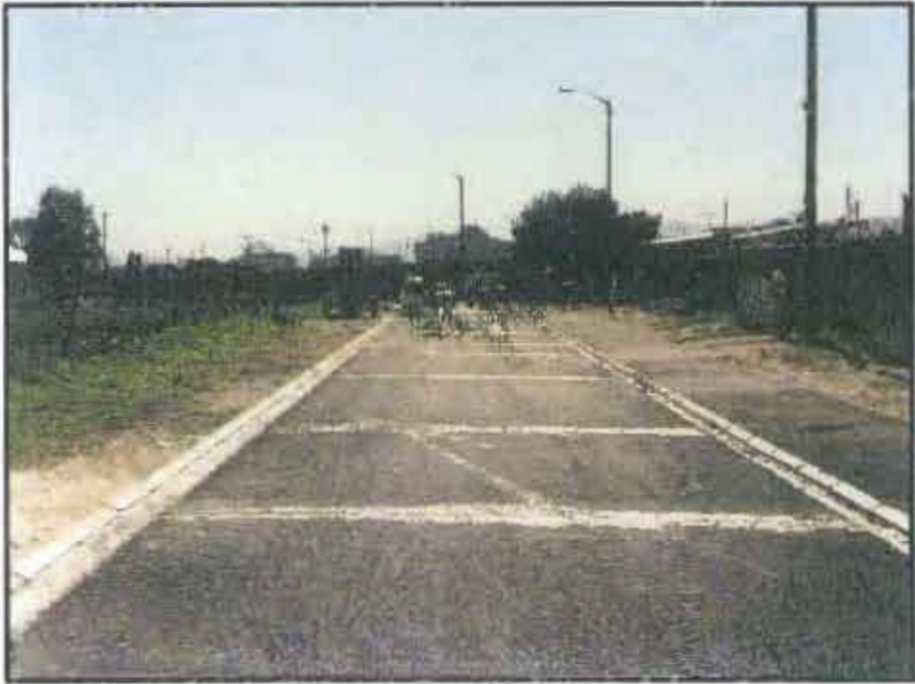
Saw cut joints.  
PLATE 15

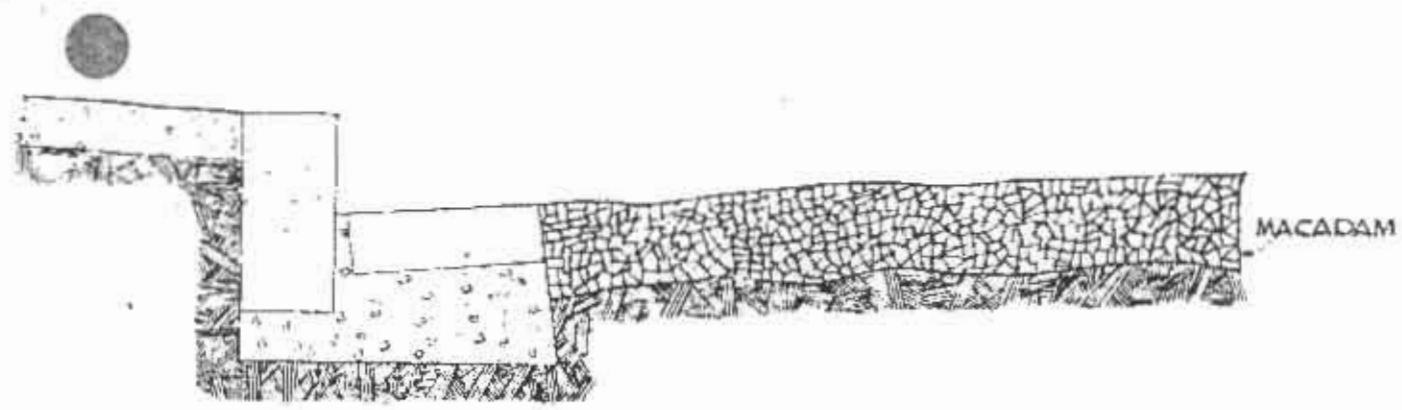
EXISTING MACADAM ROAD — NO FOUNDATION  
TO BE ABANDONED

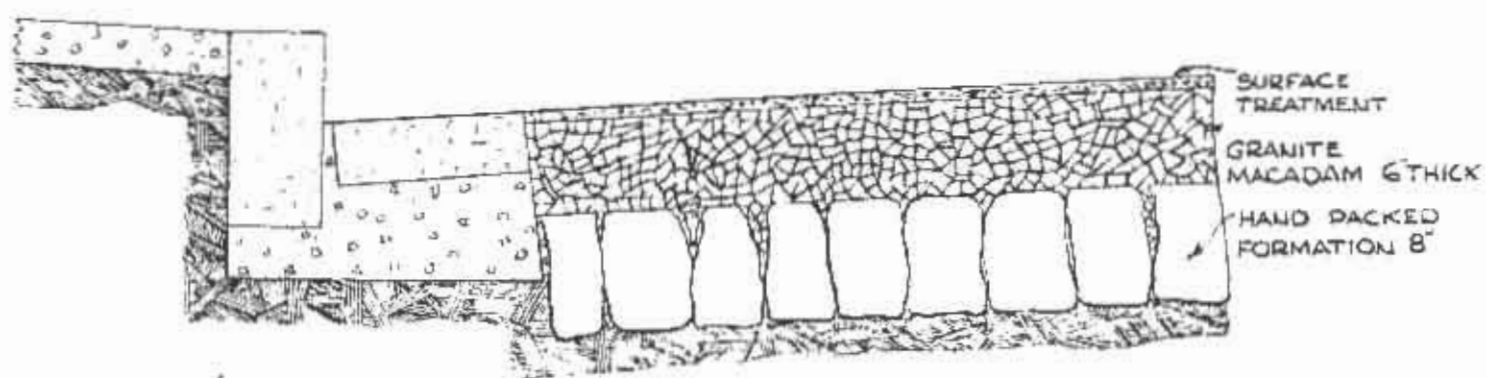
STANDARD TYPE SECONDARY ROAD  
COST PER SQUARE YARD - 8/-

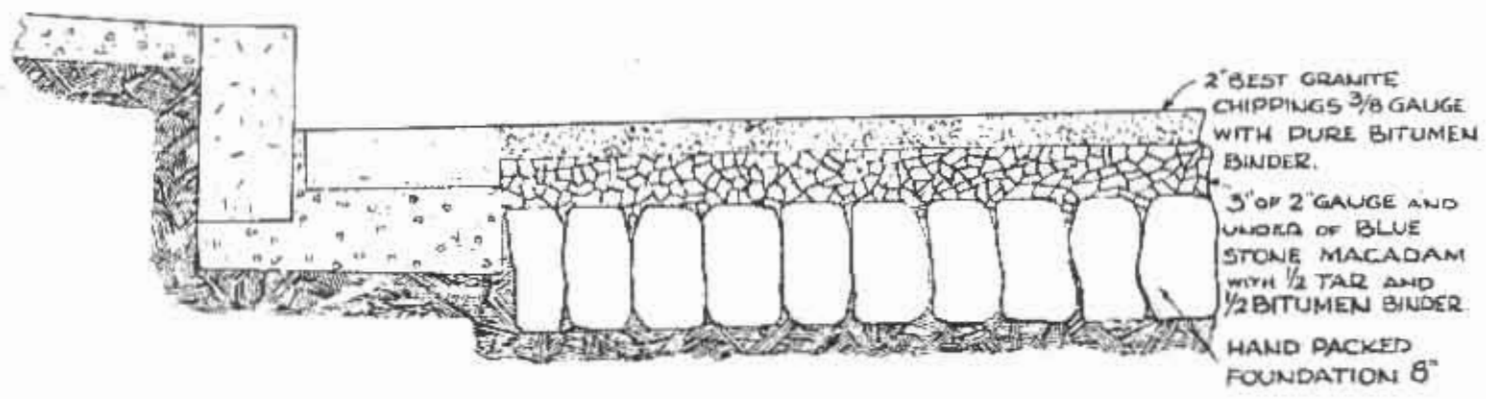
FIRST CLASS MAIN MOTOR ROADS STANDARD TYPE-A  
COST PER SQUARE YARD 11/-

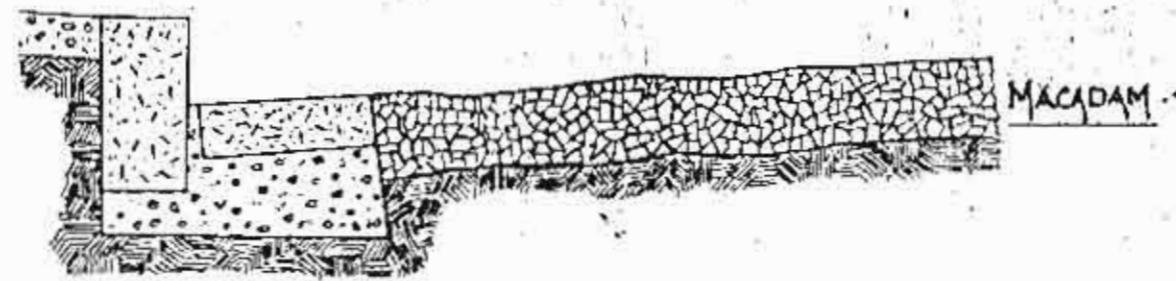
1. EXISTING MACADAM ROAD - NO FOUNDATION

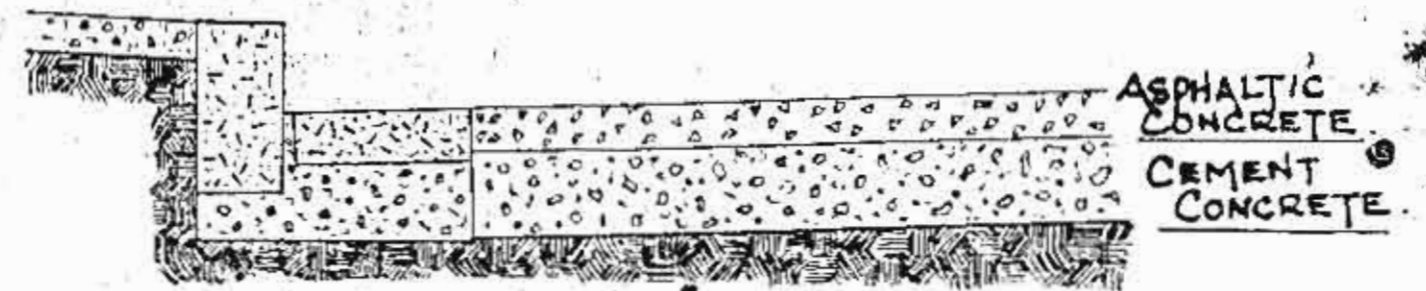
No. 4. 3" ASPHALTIC CONCRETE ON 6" CEMENT CONCRETE.

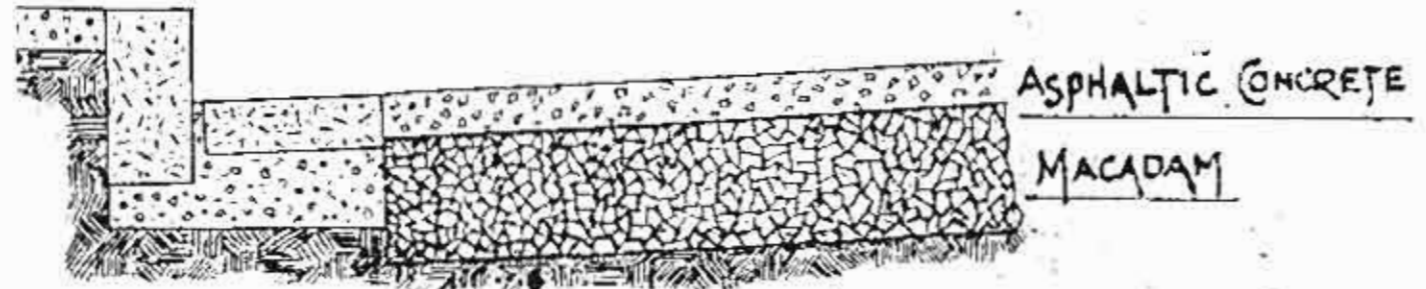
2. 3" ASPHALTIC CONCRETE ON 9" ORDINARY MACADAM AS EXISTING.

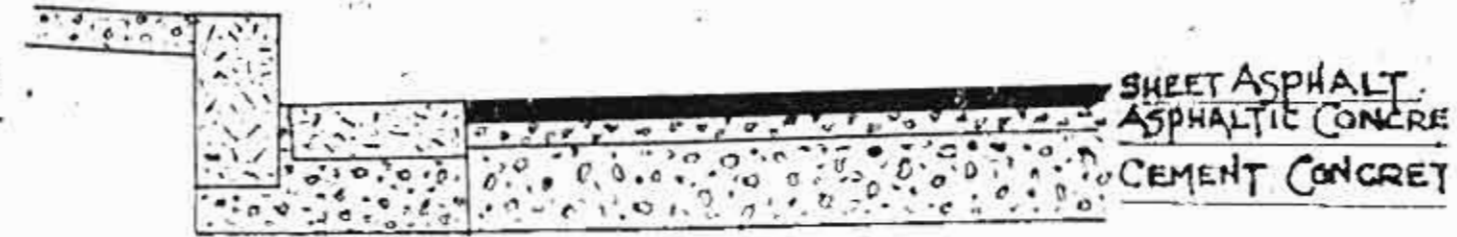
No. 5. 1/2" SHEET ASPHALT } ON 6" CEMENT CONCRETE.  
2" ASPHALTIC CONCRETE

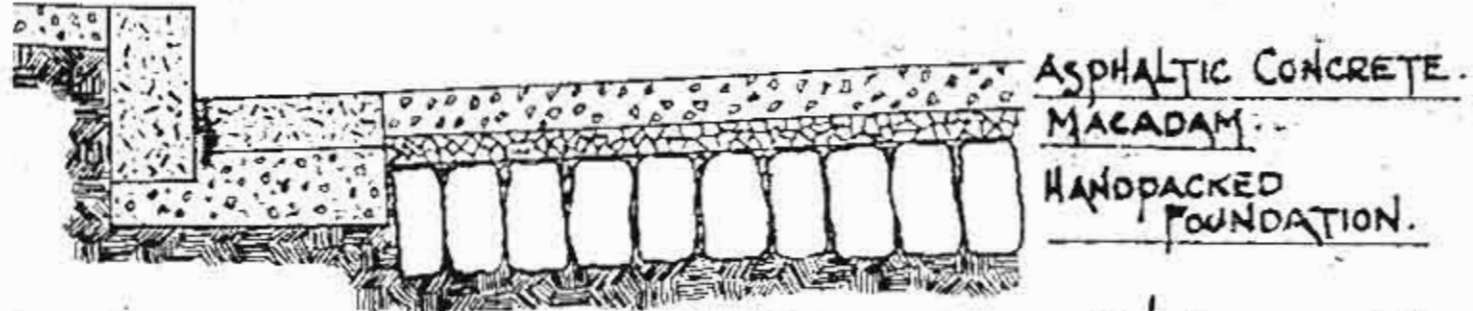
3. 3" ASPHALTIC CONCRETE ON 2" MACADAM ON 8" HANDPACKED FOUNDATION.

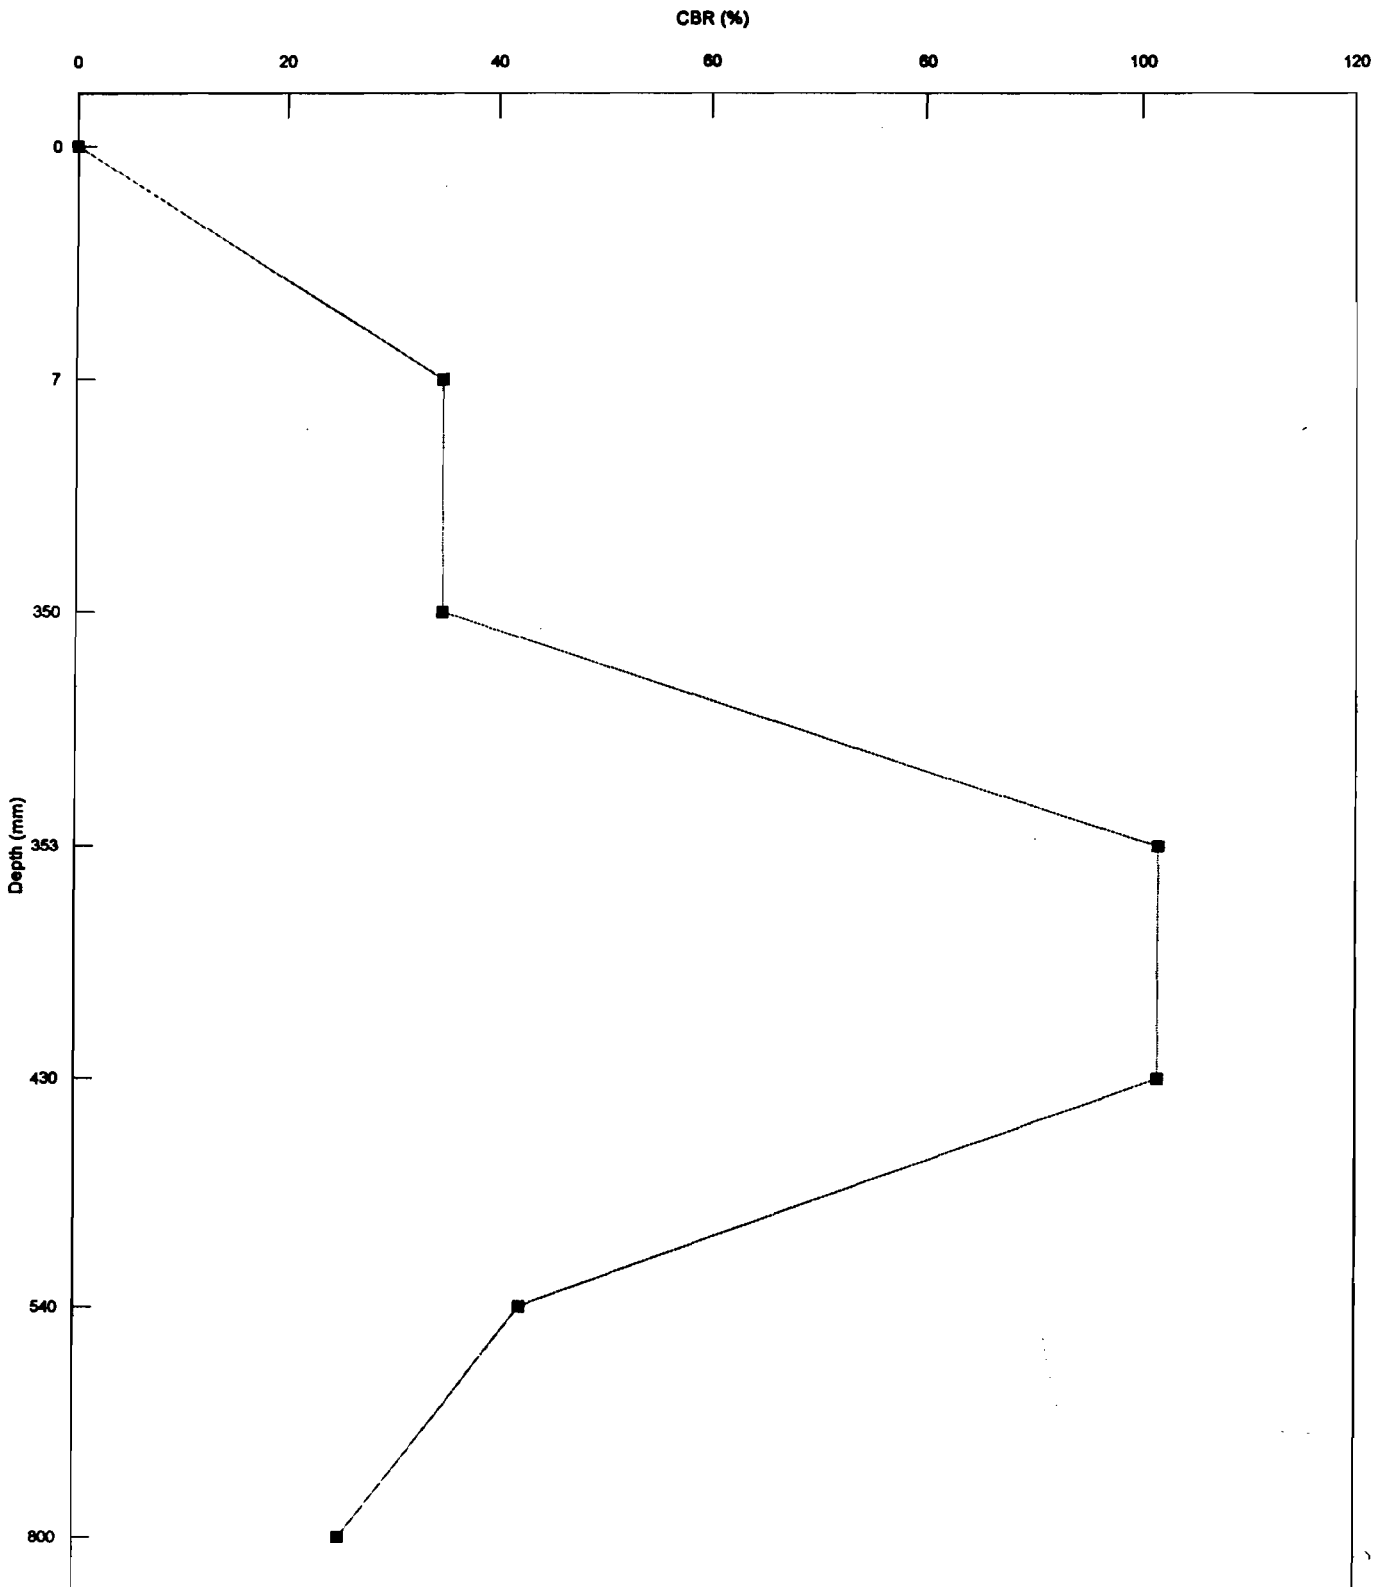
# CBR vs. DEPTH

Signal Hill Road

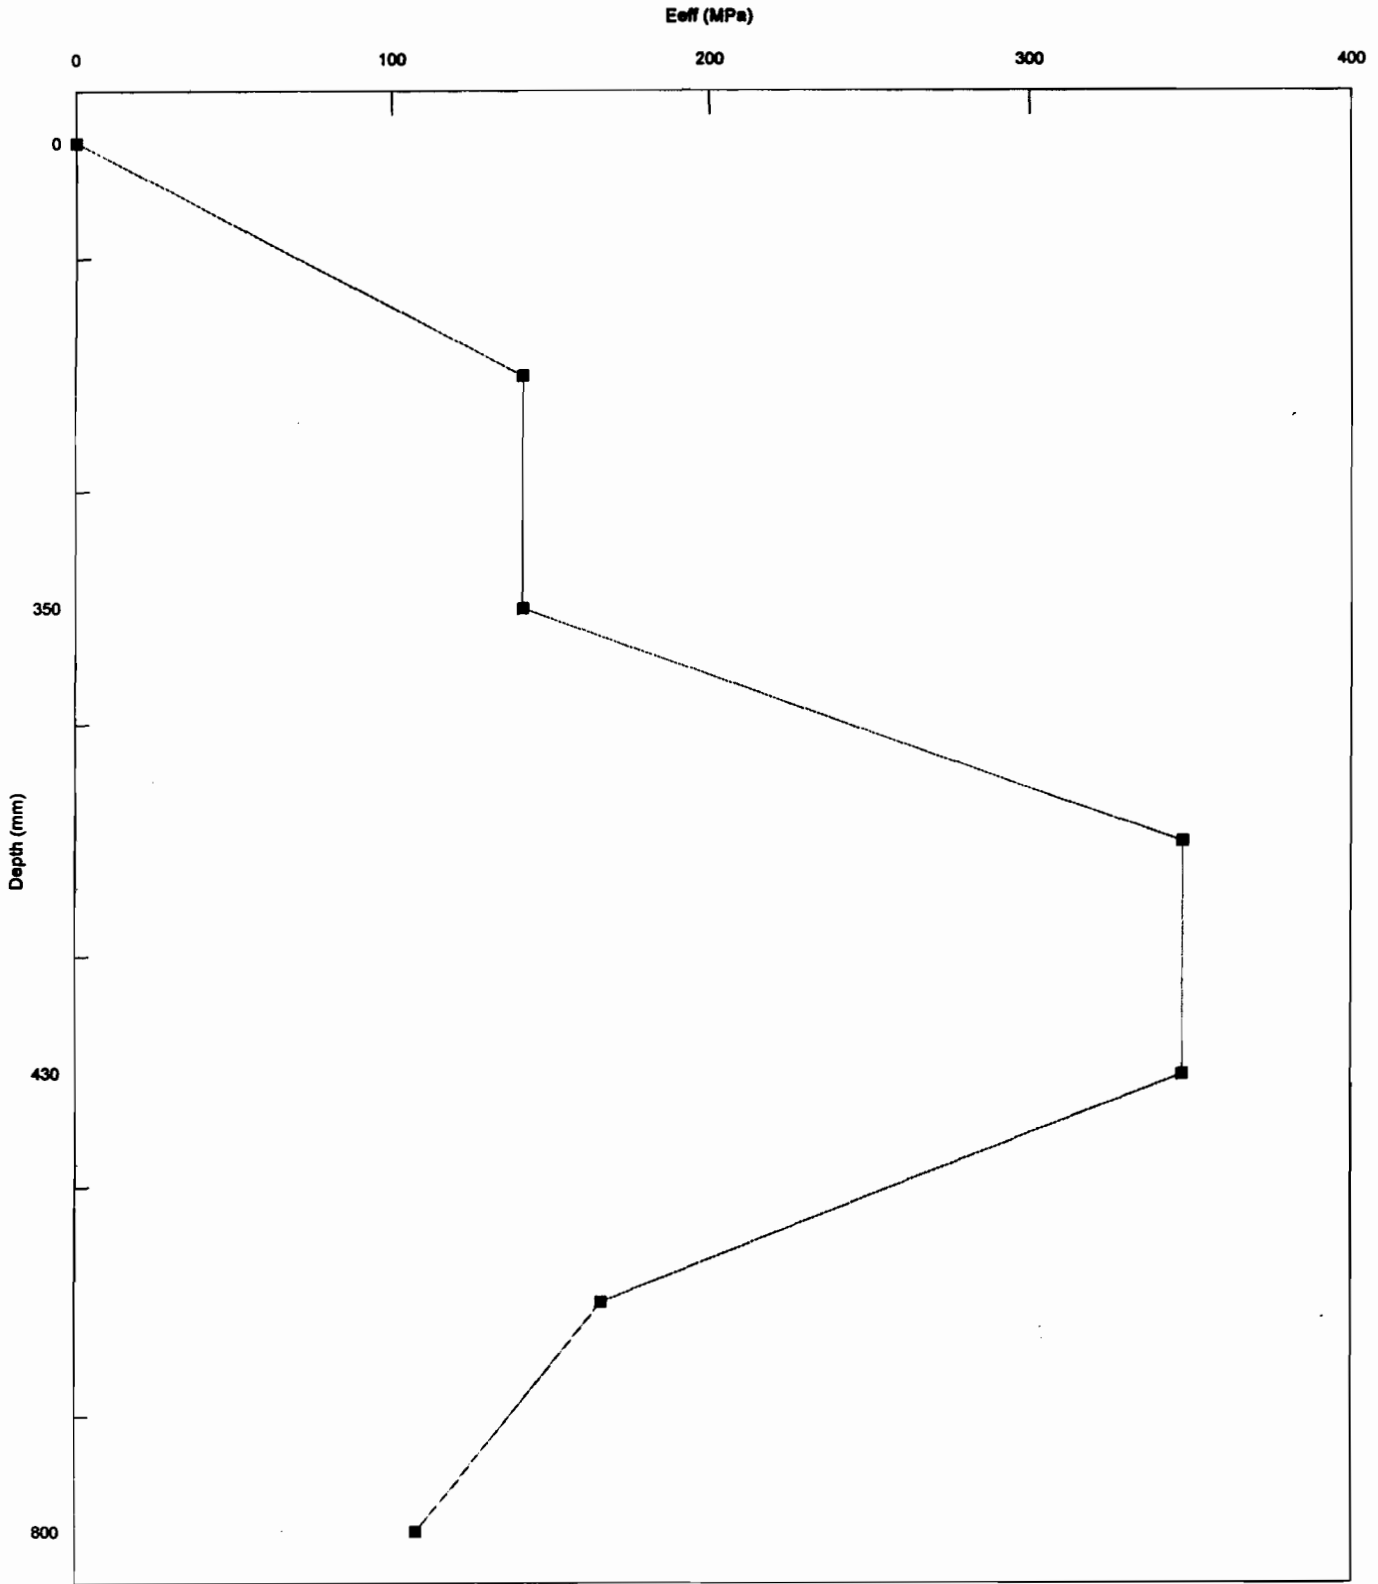
# Elastic Modulus (Eeff) vs. Depth

Signal Hill Road
