Fatigue Behaviour of CFRP Strengthened Reinforced
Concrete Beams

Theoretical and Experimental Investigation

Prepared by: Valantino Ruwhellon James (JMSVAL001)
Supervisor: Professor Pilate Moyo
Submission Date: 28 February 2020

This dissertation has been submitted to the Department of Civil Engineering, Faculty of Engineering and the Built Environment, University of Cape Town, in partial fulfilment of the requirements for a Master of Science degree in Structural Engineering.

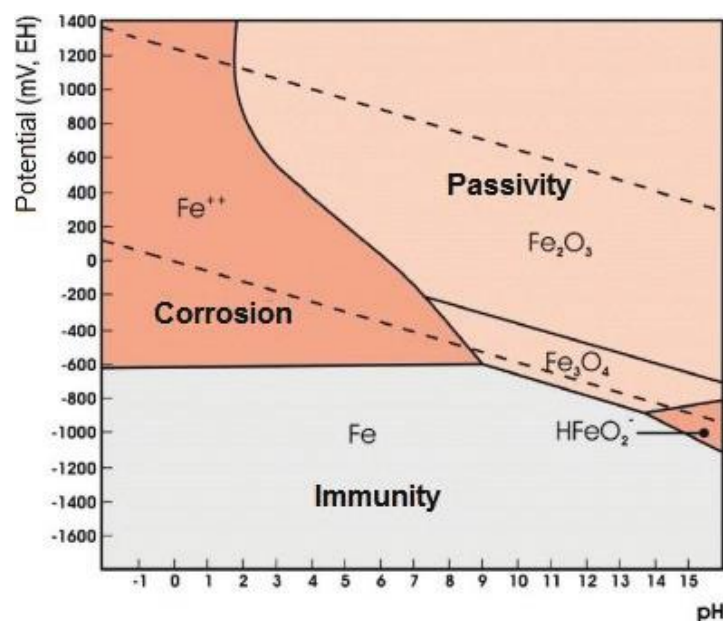
Figure 2.3 Pourbaix diagram illustrating ideal conditions to induce corrosion (Rivetti et al., 2018)

Requirements for initiation have been detailed in the previous paragraph. The propagation phase is dependent on the corrosion thermodynamics, which is best explained through the Pourbaix diagram of steel as shown in **Figure 2.3**. The diagram establishes possible stable phases of an aqueous electrochemical system (Alhozaimy et al., 2014; Arito, 2012). There are certain ideal conditions under which the corrosion process will thrive; that is a low pH and high potential difference.

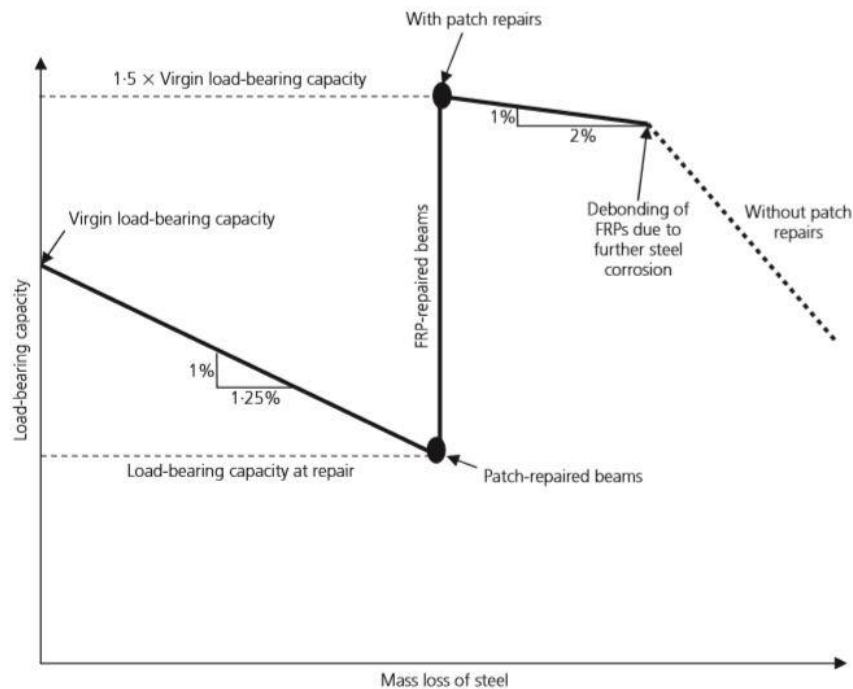
Figure 2.8 Effect of FRP strengthening and patch repairs on corrosion damaged RC beams (Malumbela et al., 2011)

Reinforcement corrosion, especially in the accelerated phase, leads to rapid loss of steel cross-section that reduces structural load carrying capacity (Lee et al., 1999). Malumbela et al., (2011) studied 20 quasi-full-scale patch repaired and FRP strengthened RC beams that were corrosion damaged to various degrees, tested under sustained loading. Their results found that a 1% mass loss in steel diminishes load carrying capacity by 0.8%. They further found that FRP strengthening was able to significantly increase the flexural capacity to 50% more than the uncorroded specimens, as shown in **Figure 2.8**. Although their findings showed that the patch repair contributed insignificantly to increasing flexural capacity compared to FRP strengthening, more importantly it showed that the rate of load bearing capacity reduction was reduced after patch repairing and FRP strengthening.

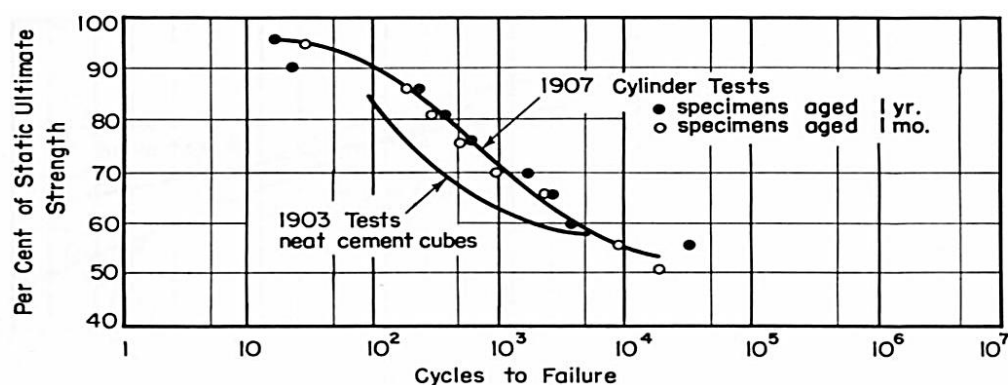
Figure 3.2 S-N curves for concrete subjected to repeated axial compression loading; based on Van Ornum (Ahsan, 2014)

As plain concrete experiences repeated cyclic loading, various studies have observed a reduction in material mechanical properties and ultimately the performance of the structure (Ahsan, 2014; Amesu, 2016; Gylltoft, 1984; Van Ornum, 1907). Van Ornum conducted compression tests in two separate studies in 1903 and 1907 on concrete cubes and prisms, after subjecting the specimens to cyclic loading at test frequencies ranging between 2 and 4Hz. Although he considered various aging periods in his experimental research, as shown in **Figure 3.2**, the results showed a consistent reduction in fatigue strength.

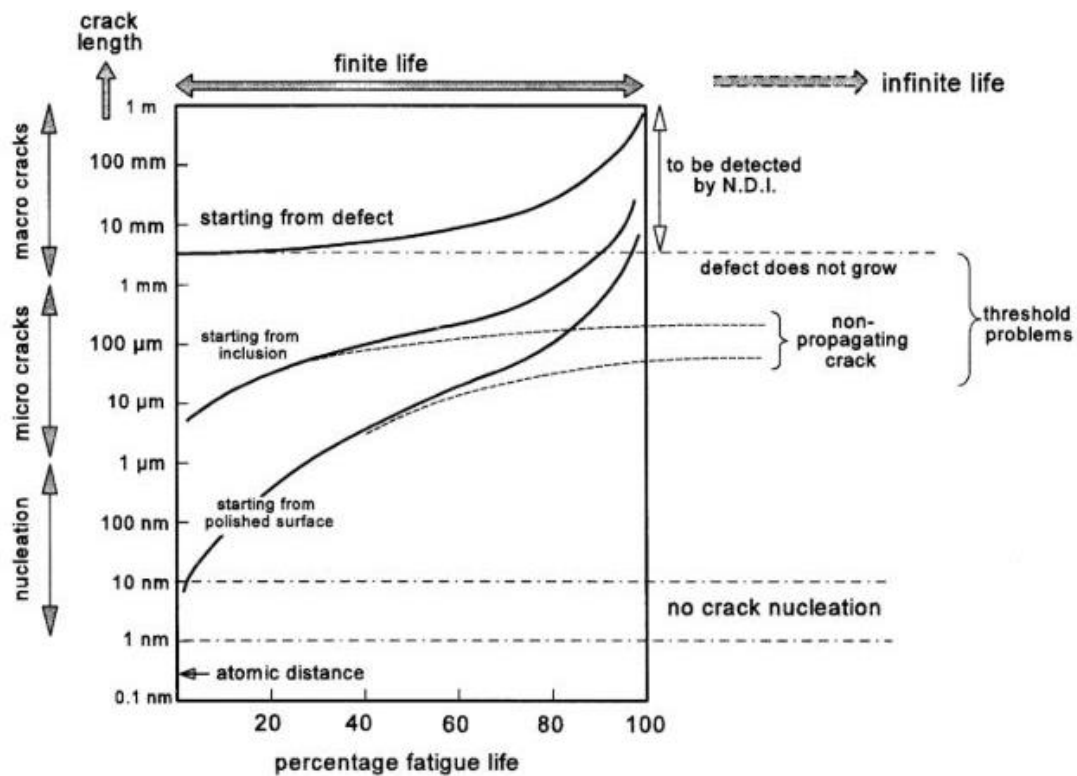
Figure 3.8 Fatigue crack propagation for steel with various material defects (Sharif, 2014)

During microcracking the crack growth rate is still low, and it may progress for more than 90% of the structures fatigue life as shown in **Figure 3.8**. The figure below shows how well manufactured, smoothly polished steel surfaces are characterized by non-propagating cracks, which allow for a possibly infinite fatigue life, whereas surfaces with defects such as corrosion pits have a definite fatigue life as it already starts in the macrocracking phase.

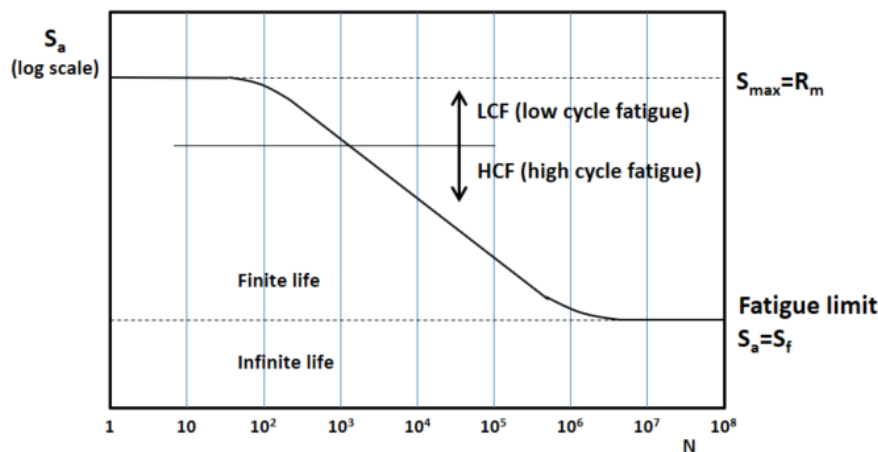
Figure 3.11 Fatigue test results of a low-alloy steel

The plots of these results are referred to as S-N curves, where S is the stress range and N is the number of cycles. **Figure 3.11** shows a typical S-N for a low-alloy steel fatigue test.

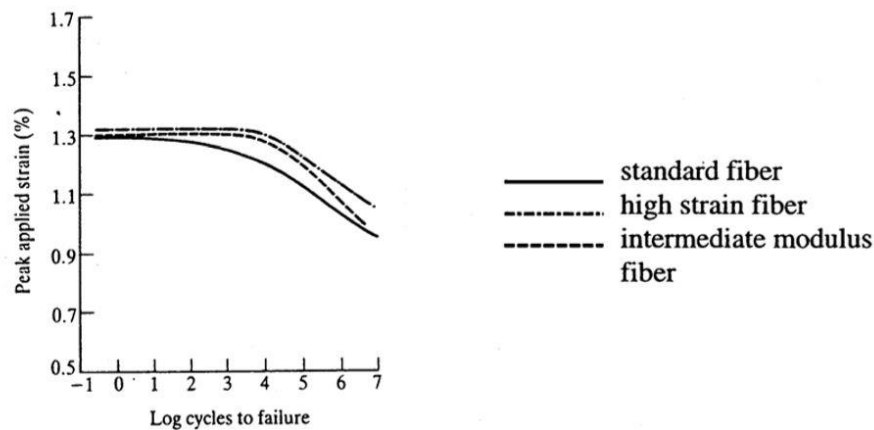
Figure 3.12 S-N curves for various types of FRP materials (Täljsten, 2006)

FRPs can be either isotropic or anisotropic materials that exhibit multiple failure modes if considered in isolation (Täljsten, 2006). Although fatigue of isotropic materials is well apprehended, the fatigue of composite materials is very complex and not easily predictable. For long FRP composite materials have been regarded insensitive to fatigue. If considered as part of a RC composite system, fatigue will most likely cause a breakdown of the entire composite before the FRP fails (Täljsten, 2006). However, many new composite materials, such as the carbon fibre reinforced polymers (CFRP), which were designed to have a higher failure strain with sustained strength under higher temperatures, unfortunately exhibit unfavourable fatigue conditions.

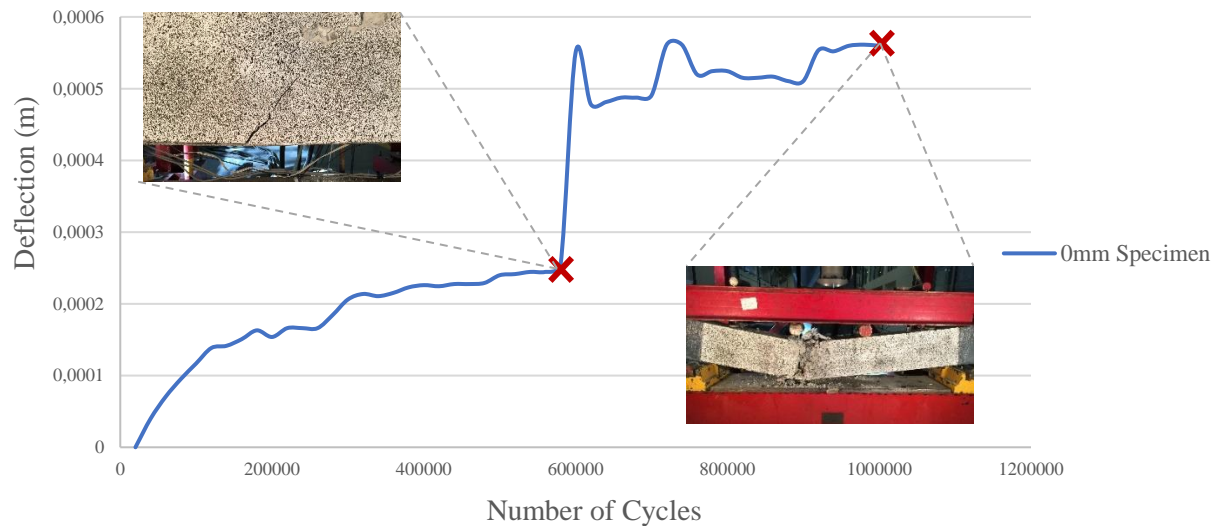
Figure 5.37 Midspan deflection of 0mm specimen during 40% stress range fatigue testing

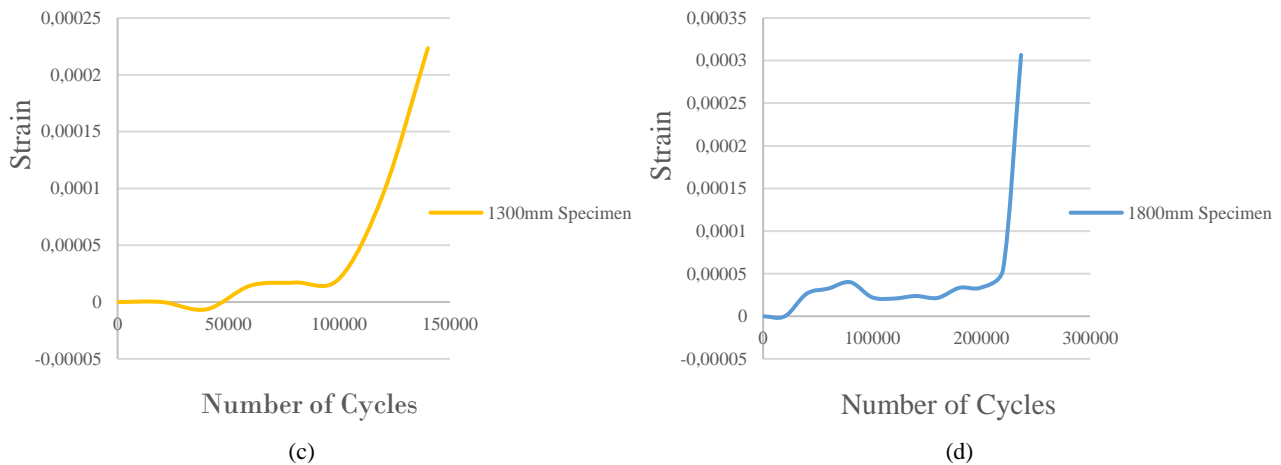
Figure 5.54 Tension steel strain behaviour during 60% stress range test

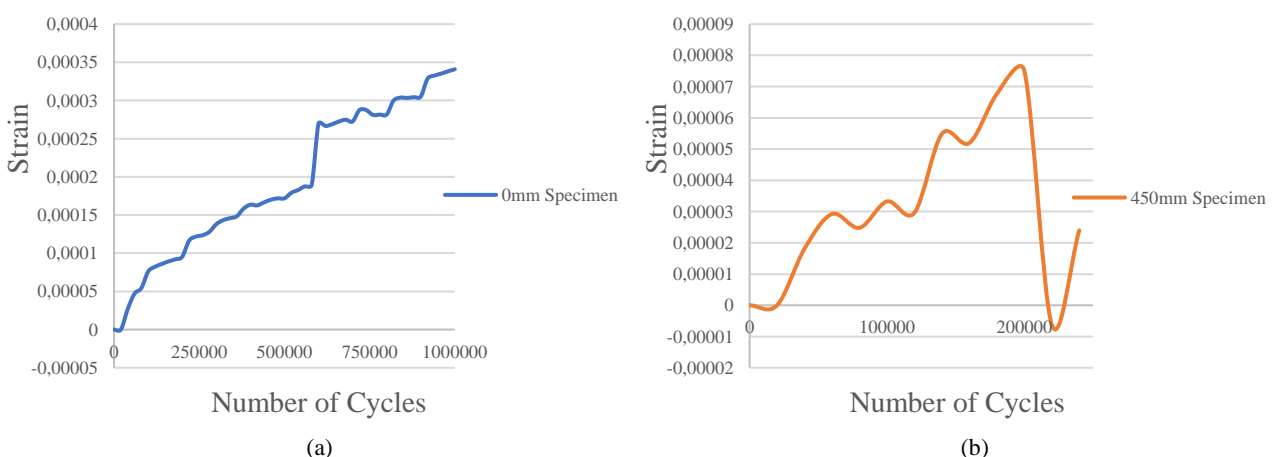
Figure 5.55 Carbon fibre strain behaviour during 40% stress range test
