Department of Civil Engineering

**An Investigation into the Volume Change Characteristics of
Loess Like Soil in Mount Moorosi Village in Lesotho**

A thesis submitted in partial fulfilment of the requirement for the award of the degree of Master of Science in
Engineering Specialising in Geotechnical Engineering at the University of Cape Town

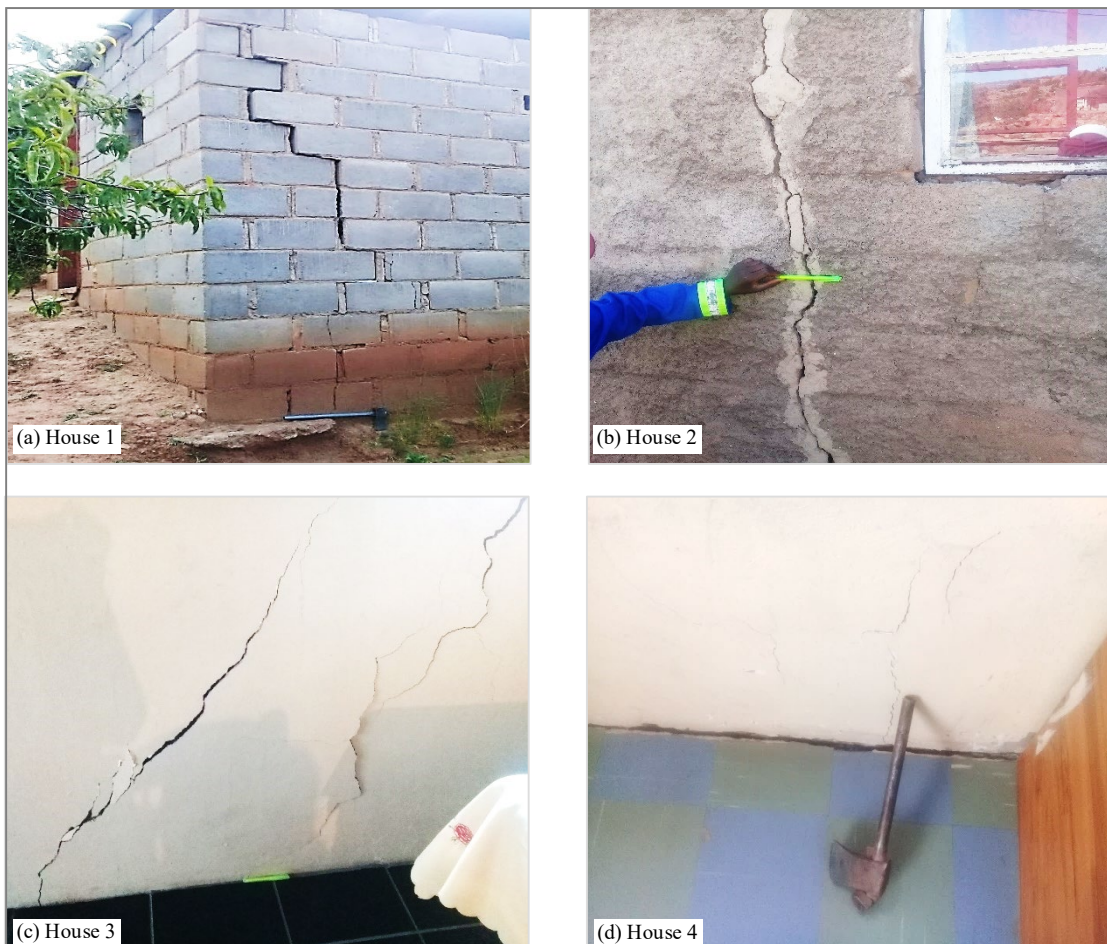
Figure 1-1, Cracks on some of the selected houses in the Mount Moorosi village

Nearly all houses in the Mount Moorosi village have sustained cracks, which undermine both their aesthetic appearance and structural integrity. In civil engineering, a relatively thin breakage on the surface of masonry (that is, units of bricks or stones bonded with mortar) and concrete is termed a ‘crack’. Cracks on structures in this village had various patterns, including the hairline, diagonal, vertical and stepped (Figure 1-1). They were observed above and below building windows, adjacent to the door frames, on concrete flooring and ceramic tiles. In some houses, they were followed by interior plaster spalling, slight wall leaning, and were recurrent. According to the South African Home Building Manual (2014), cracks less than 5 mm wide are characterised as minor damage, while the greater sizes indicate a significant structural failure. Accordingly, cracks noted were considered a mixture of minor and major deformations. Therefore, the serviceability limit state, one of the principle criteria to ensure the stability of structures, was affected.

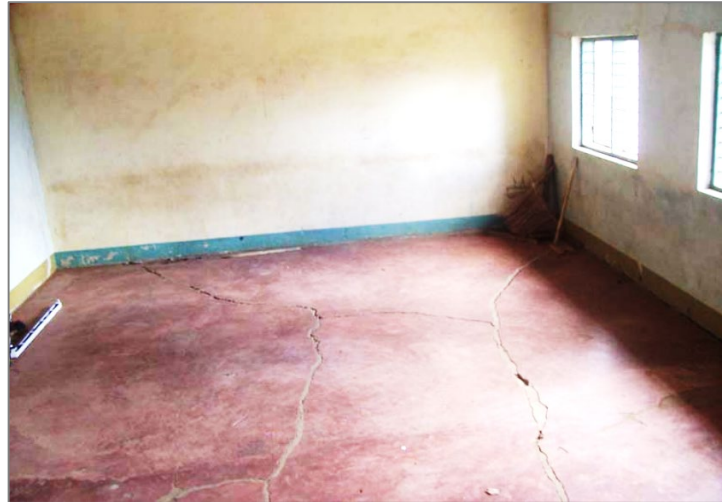
Figure 2-3, Concrete floor crack caused by expansive soil in Tanzania (Source: Lucian, 2006)

Expansive soils expand when wet and reduce in volume when dry. These properties are attributed to the type of clay mineral present in soil. Montmorillonite is the most problematic of all clay minerals because of its weak oxygen bonds between structural units, while kaolinite is the least harmful (Fredlund, 1975). During shrink and swell cycles, exerted stresses result in the formation of cracks on structures. Expansive soils can apply pressure as high as 263 kPa (Rogers et al., 2015). Figure 2-3 shows cracks on a concrete floor caused by expansive soil in Kibaha, Tanzania.

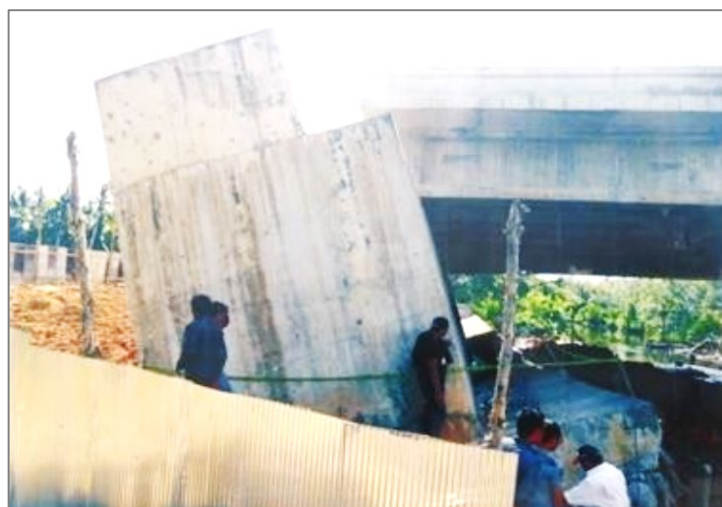
Figure 2-4, A tilted bridge abutment in Indonesia (Source: Rahardjo, 2014)

Soft clay is characterised as a soil that generally gives compressibility, shear strength and settlement time-related problems. Its significant consolidation is related to its high-water content. In fact, Jone & Davies (1985) pointed out that soft clays are normally consolidated. In this state, an increase in effective stress causes higher pore pressure and successive deformation rates. Figure 2-4 depicts a failed bridge abutment that occurred due to the excess pore pressure in the underlying soft soil.

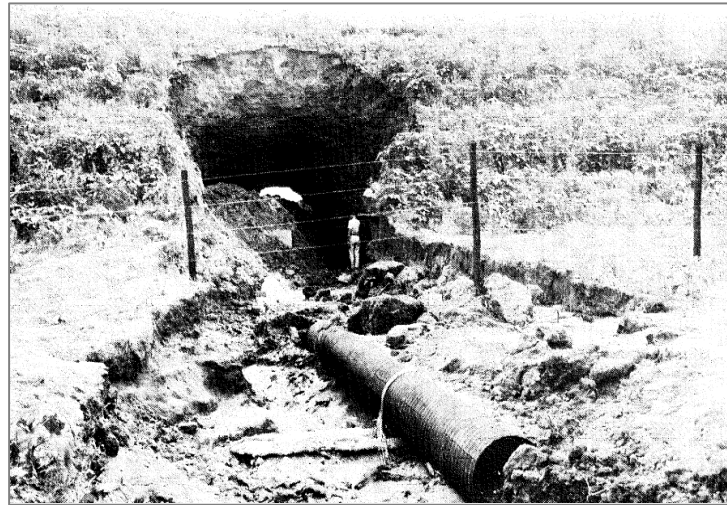
Figure 2-6, A damaged embankment constructed of dispersive soil (Source: Edgar, 1991)

In a dispersed state, soil can easily be eroded by flowing water and thus initiate the formation of piping. This kind of failure has been observed in natural slopes, embankments and earth dams (Elges, 1985). Figure 2-6 depicts the eroded dispersive soil on an embankment.

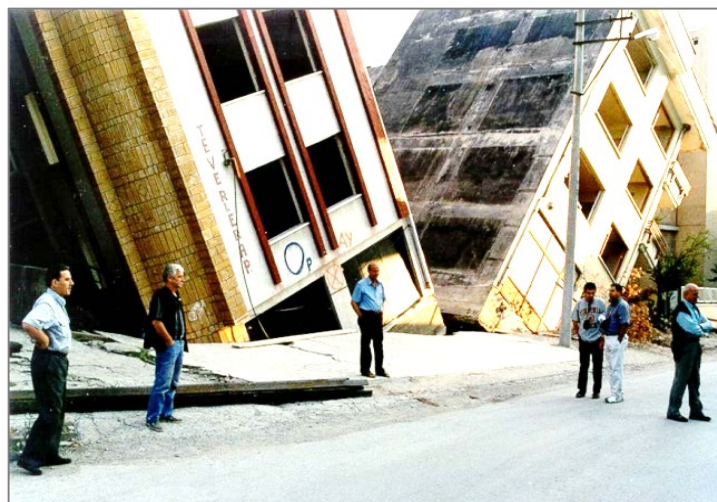
Figure 2-7, Tilting of buildings induced by foundation soil liquefaction in Chile (Source: Bray et al. 2000)

Liquefiable soils are major problems in earthquake-prone zones, particularly in areas with high-water table. During earthquakes, cyclic pore pressure generated by seismic waves causes significant loss of strength and stiffness in the soil, resulting in disastrous destruction of superimposed objects (Seed et al., 2001). The types of soil that can be affected by this natural hazard remains a topic of controversy. Finn & Fujita (2002) reported that the phenomenon is induced in sands and silts. In contrast, Seed et al. (2001) mentioned the cases of liquefaction in gravelly and clayey soils. Figure 2-7 shows tilted buildings in Chile, due to liquefaction induced by earthquake.

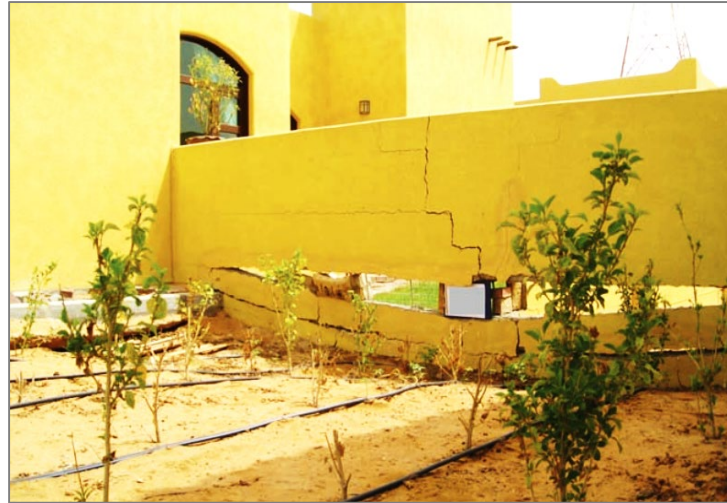
Figure 2-8, Damage on boundary wall as a result of settlement induced by collapsible soils in Abu Dhabi (Source: Vandanapu et al., 2016)

Collapsible soils can withstand relatively large imposed stresses with minor settlement at low moisture content, but display significant volume decrease at higher water content, under the same loading conditions (Schwartz, 1985). Vandanapu et al. (2016) reported a water-induced settlement of up to 260 mm on the boundary wall underlaying a collapsible soil (Figure 2-8).

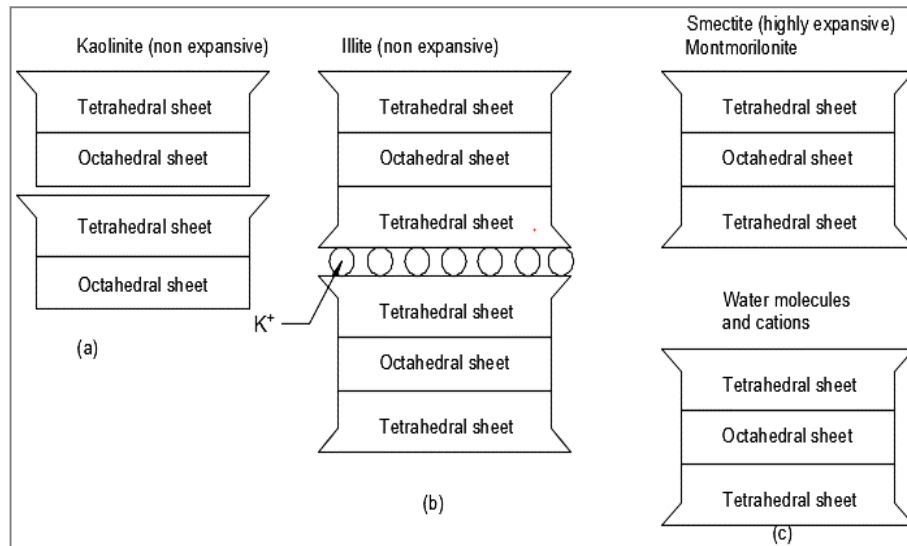
Figure 2-13, Clay minerals (Source: Craig & Knappett, 2012)

combined sheets are linked by weak bonding due to non-exchangeable potassium ions (Grim, 1953). The basic structure of montmorillonite (Figure 2-13 c) is similar to that of illite, with the only difference being that the interlayer of the combined sheets has exchangeable cations and water. The high susceptibility of montmorillonite to isomorphous substitution makes it the most active clay mineral (Fredlund, 1975).

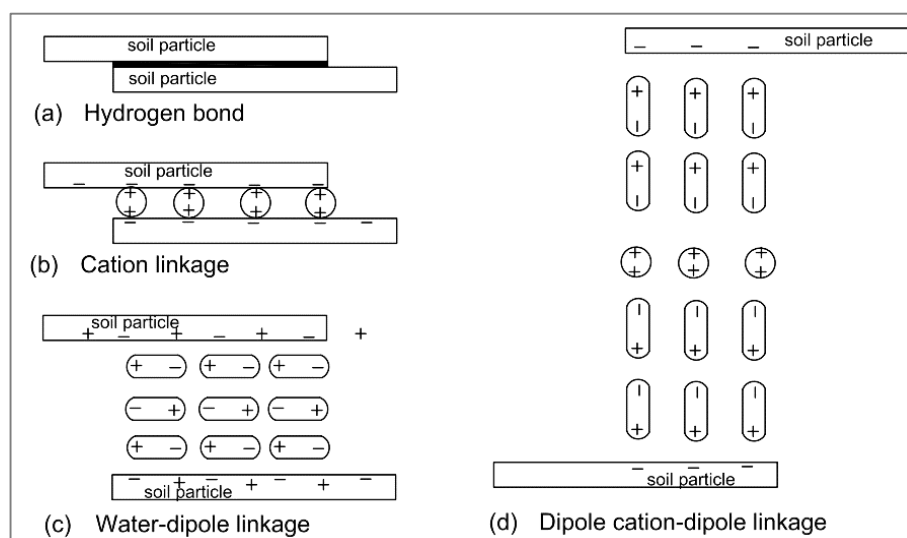
Figure 2-14, The attraction interparticle forces in soil (Source: Lambe, 1953)

Clay particles are negatively charged due to the isomorphous substitution, and attraction forces exist between them and water. Furthermore, electric moments in soil molecules develop hydrogen bonds and Van der Waals forces (cohesive forces) that flocculate particles (Punmia et al., 2005). Figure 2-14 illustrates some attractive forces recognised by Lambe (1953) who conducted an intensive study on the interparticle forces. It is noted that grains are aggregated around water by water-dipole linkages, cations and dipole cation-dipole. The resulting clay aggregations act as connectors between larger sized-soil grains (sand and silt).

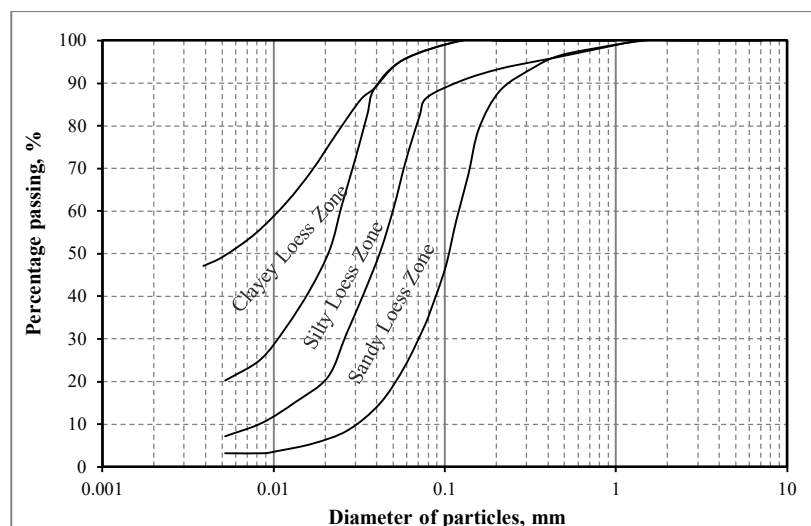
Figure 2-15, Particle size gradation curves for loess in the United States of America (Source: Sheeler, 1968)

Soil size particle distribution is determined by sieve and sedimentation analysis. Sheeler (1968) reported gradation envelopes of loess in the United States of America (Figure 2-15). It was observed that it consisted of clayey loess, sandy loess and silty loess zones. Loess with clay and sand composition less than 20 % is regarded as silty loess; however, when either of these particles is more than 20 %, the soil is considered as clayey or sandy loess, respectively (Pye, 1987). Nevertheless, loess predominantly consists of silt particles ranging from 50 to 70 % by weight (Assallay, 2001; Nouaouria et al., 2008).

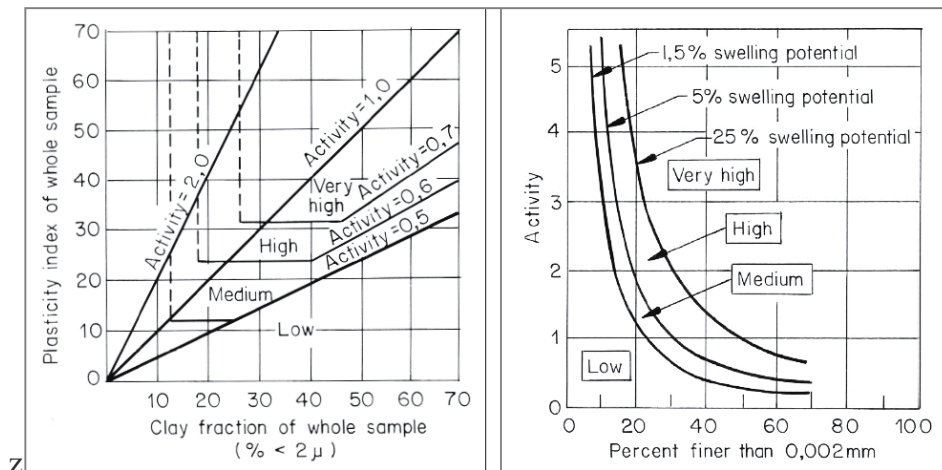
Figure 2-17, Activity of expansive soils given by Donaldson & Williams, 1973 and Seed, 1978. (Source: Byrne & Berry, 2008)

Atterberg divided the behaviour of soil finer than 0.425 mm into solid, semi-solid, plastic and liquid states, in terms of moisture content measured at their boundaries (South African Pavement Engineering Manual, 2013). The minimum moisture content at which a solid soil transforms to semisolid is termed ‘shrinkage limit’, while it is referred to as ‘plastic limit’ when the soil changes from a semi-solid to a plastic state. The minimum moisture content at which the soil starts to flow is the ‘liquid limit’. The difference between liquid and plastic limits indicates soil plasticity. This parameter is used along with the clay fraction to predict possible soil volume increase (Figure 2-17). Holtz & Gibbs (1956) also provided a quick soil swell potential, based on the Atterberg limits (Table 2-5).

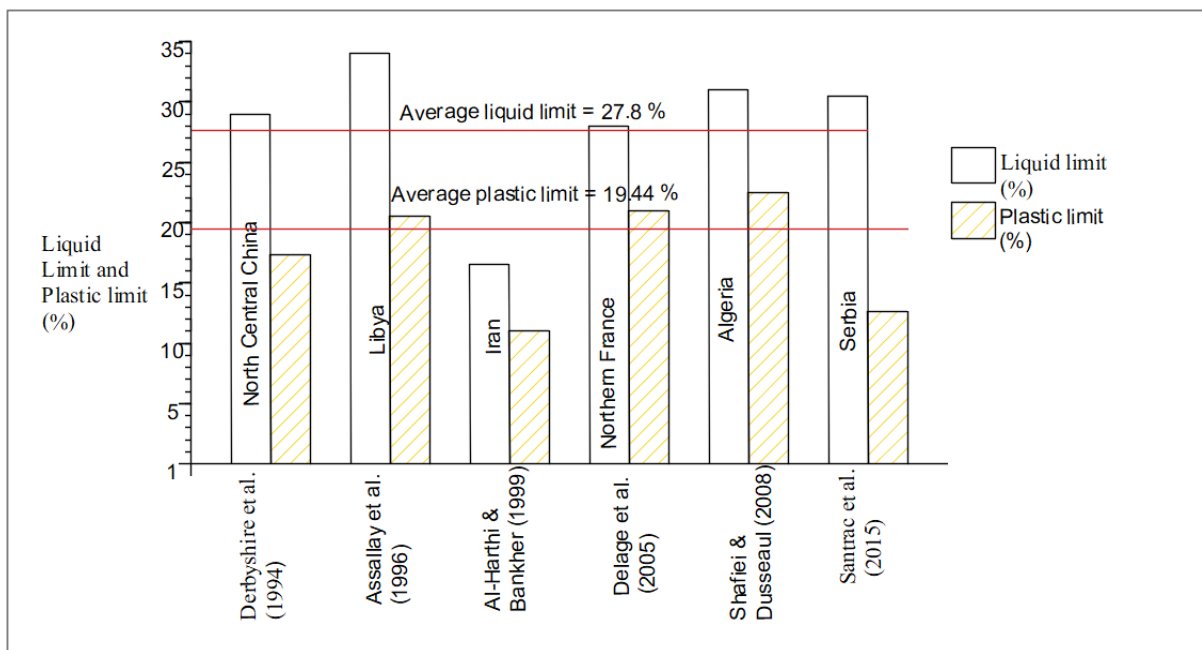
Figure 2-18, Plasticity index values in loess (Source: compiled from the literature)

Figure 2-18 demonstrates plasticity index values reported in loessal soils from the literature. Based on this, the average liquid limit is 27.8 % and plastic limit is 19.44 %. However, these limits are only confined to the referenced literature and are inclined to change based on the clay minerals present in the soil.

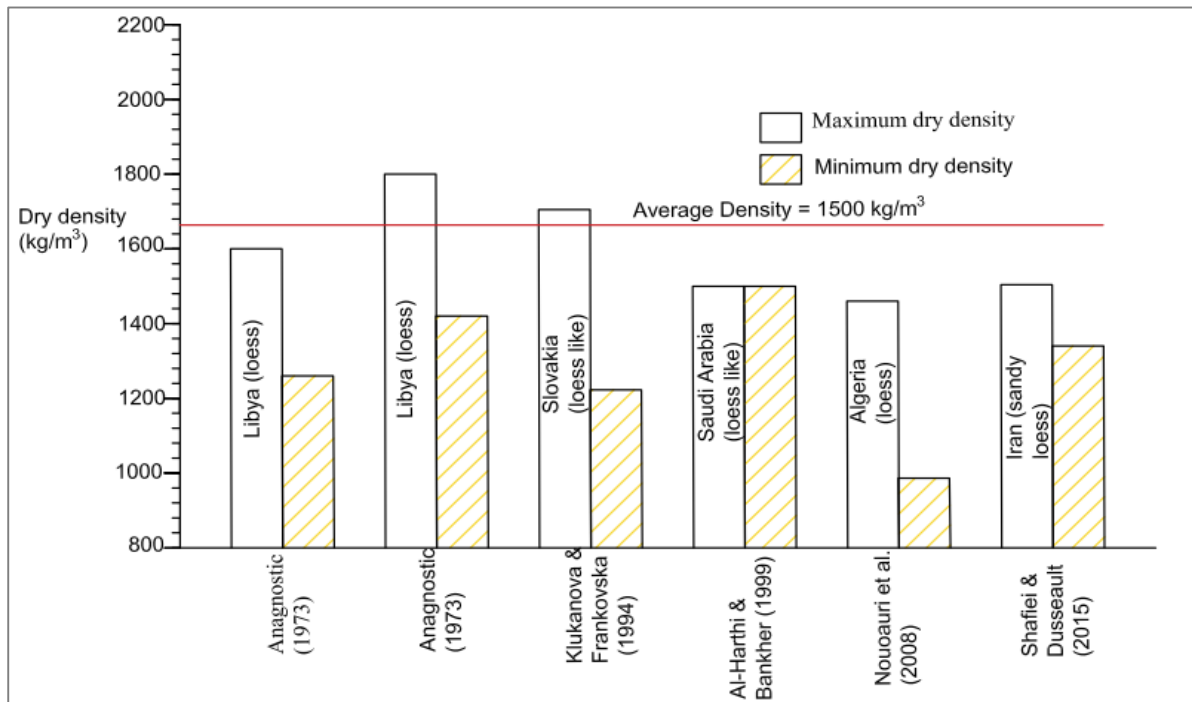
Figure 2-19, Density values in loess (Source: compiled from the literature)

1270 to 1540 kg/m³ in sandy loess of Iran. Nouaouri et al. (2008) established values from 1420 to 1430 kg/m³ on silty loess in Algeria. Anagnosti (1973) reported densities from 1300 to 1800 kg/m³ in Libya. In loess like sediments, Klukanova & Frankovska (1995) indicated densities from 1230 to 1700 kg/m³, Al-Harathi & Bankher (1999) later established values varying from 980 to 1500 kg/m³ in loess like deposits in western Saudi Arabia. Figure 2-19 presents the densities in loessal sediments from around the world with an average value of 1500 kg/m³.

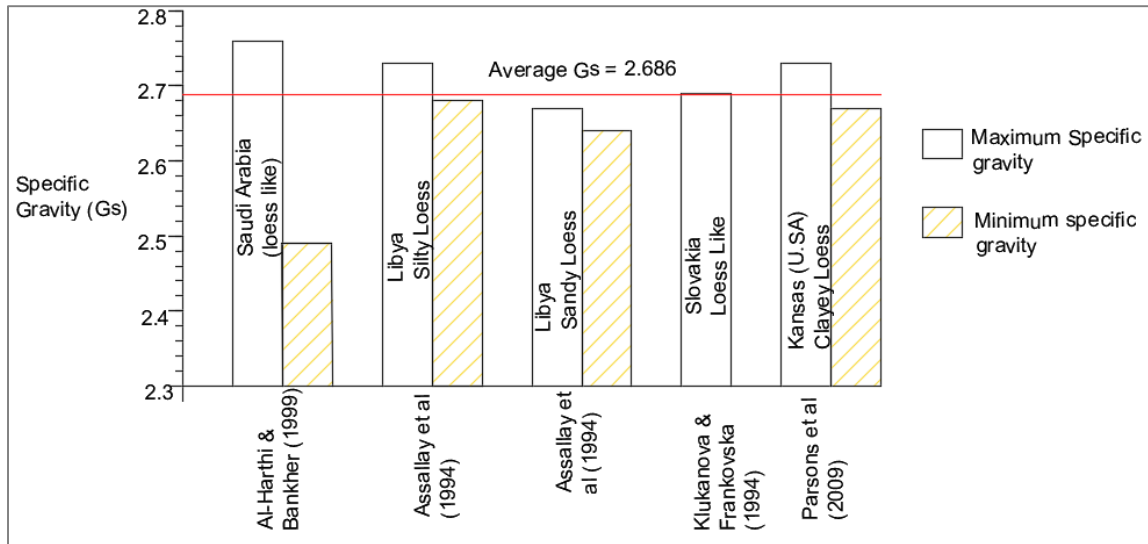
Figure 2-20, Specific gravity in different types of loess (Source: compiled from the literature)

Specific gravity (Gs) is a ratio of soil mass to that of water at an equivalent volume and specific temperature (Craig & Knappett, 2012). This property is a critical parameter in the analysis of hydrometer test results and void ratio calculation in the oedometer consolidation test. In Libya, a silty loess with a Gs of 2.68 to 2.73 g/cm³ and sandy loess with Gs from 2.66 to 2.67 g/cm³ were reported by Assallay et al. (1994). Al-Harathi and Bankher (1999) noted a minimum specific gravity of 2.49 g/cm³ and a maximum of 2.76 g/cm³ in loess like-soils in western Saudi Arabia. In Iran, a loess with a Gs reaching 2.67 g/cm³ was reported by Dusseault and Shafiei (2008). Figure 2-20 demonstrates the specific gravity in loess from different parts of the world, with an average value of 2.686 g/cm³.

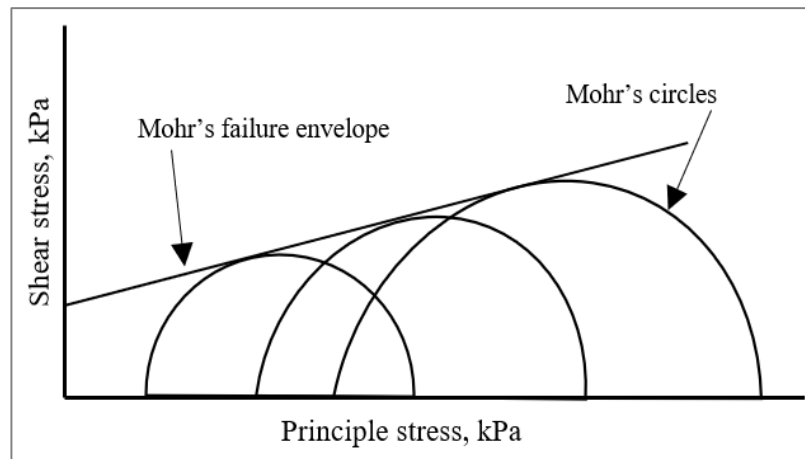
Figure 2-21, Typical Mohr's circles and failure envelope for shear strength determination

Shear strength, τ , is the ability of soil to resist shear stresses generated by applied loads. Components contributing to shearing resistance are particle interlocking, frictional resistance among individual soil grains and cohesion (Punmia et al., 2005). Essentially, the parameters contributing to shear strength are determined from Mohr's failure envelope (Figure 2-21). This envelope is a common tangent to Mohr's circles, drawn from peak stresses produced from different confining pressures in shear tests. The intercept of the envelope indicates soil cohesion, c , while the slope gives the friction angle, ϕ .

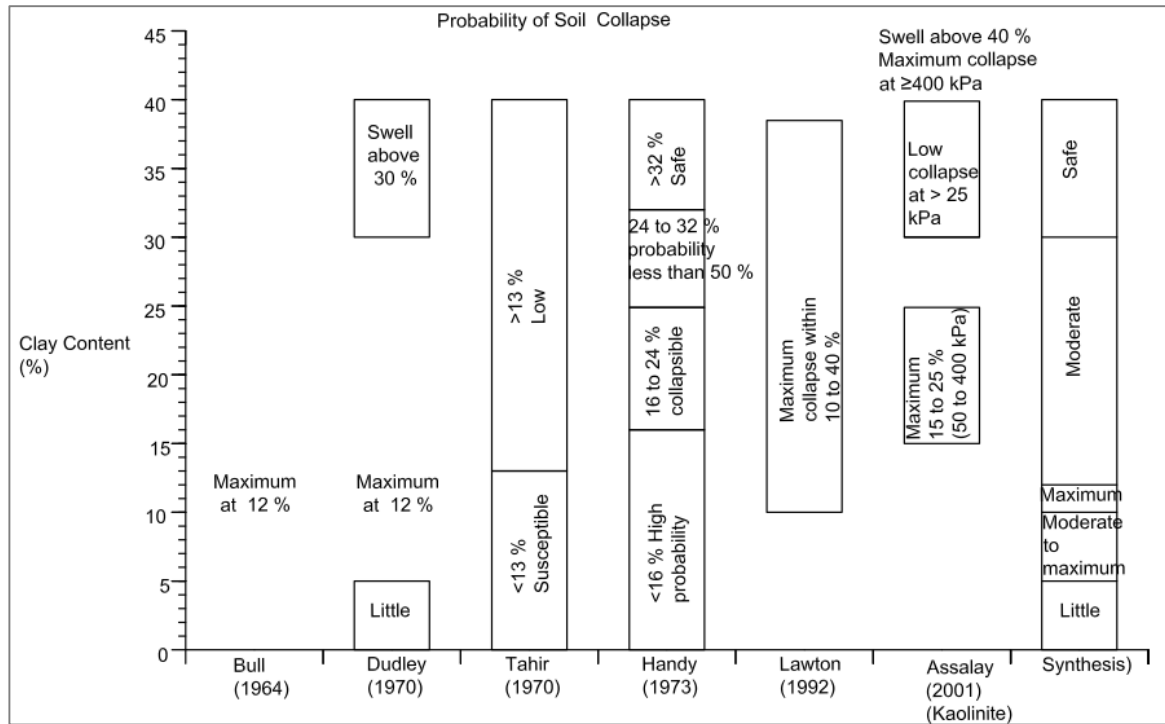
Figure 2-25, Probability of soil collapse based on the variation of clay content (Source: compiled from Assalay, 2001)

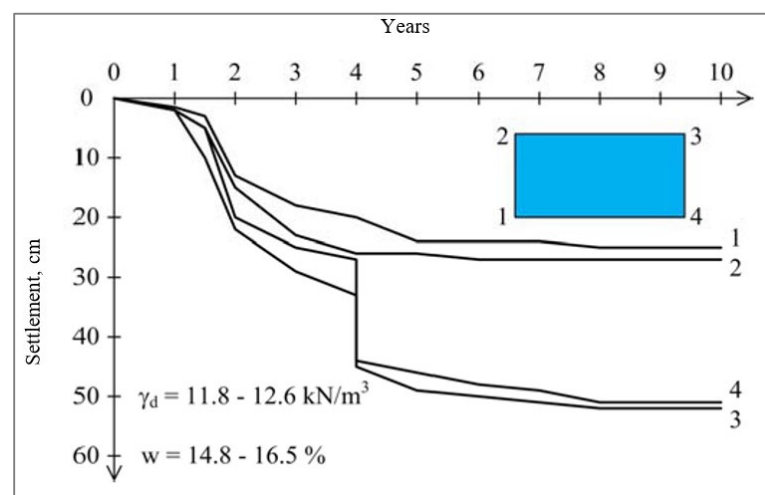
Figure 2-26, Hydrocollapse differential settlement on various corners of a building (Source: Djogo & Milović, 2013)

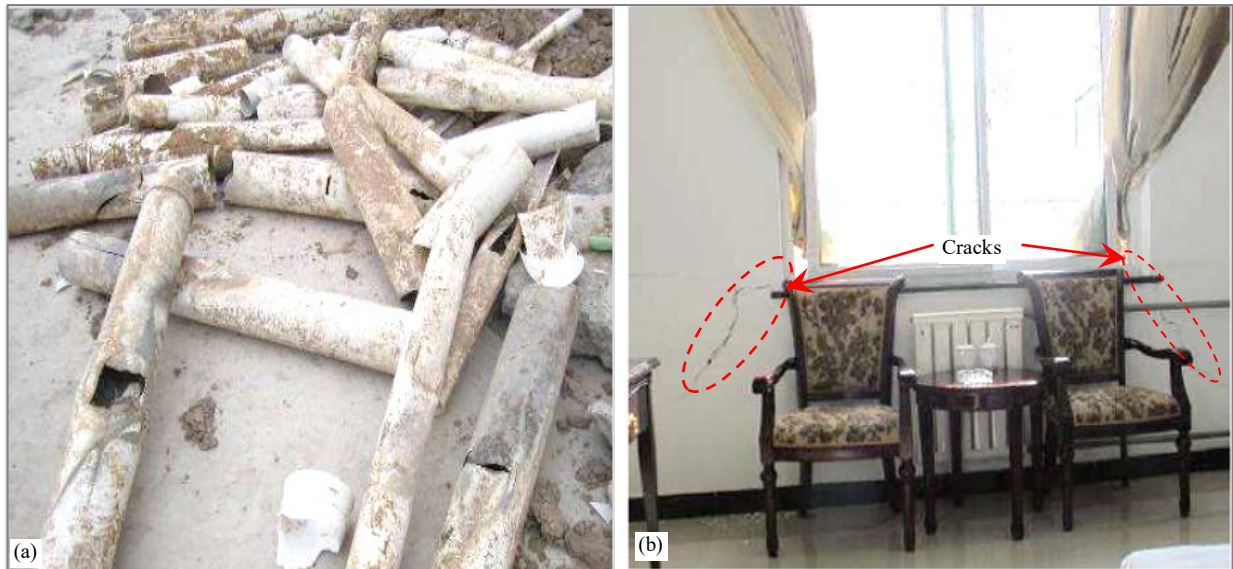
Figure 2-27, Hydrocollapse settlement triggered by heavy rainfall: (a) ruptured water pipes and (b) cracks below the window (Source: Yuan-xun et al., 2013)

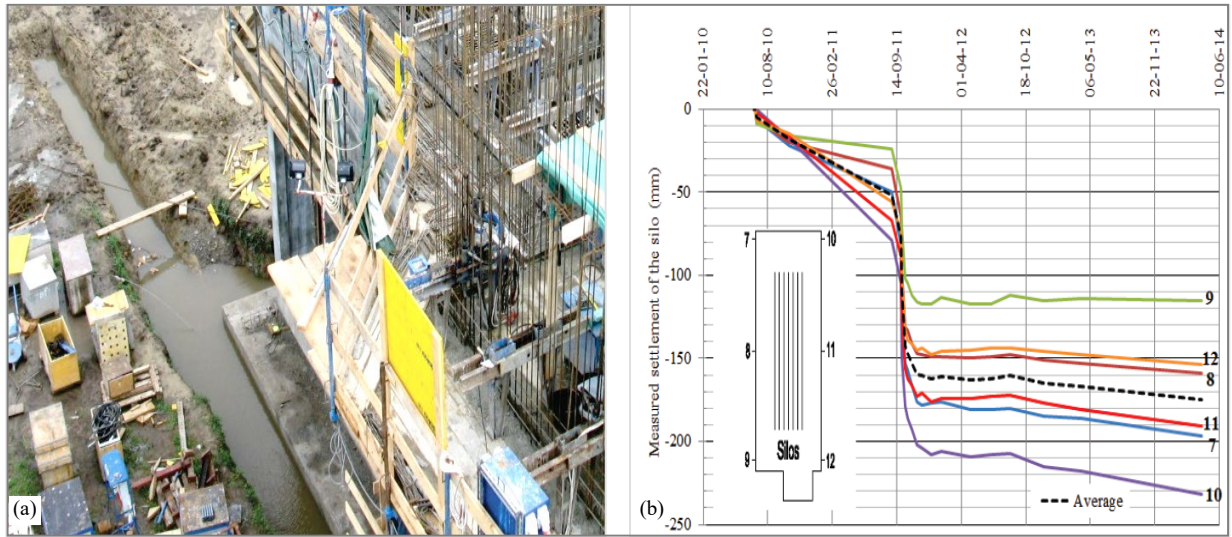
Figure 2-28, Hydrocollapse settlement triggered by heavy rainfall: (a) A flooded foundation pit and (b) Measured differential settlement at different corners of silos (Source: Santrač et al., 2015)

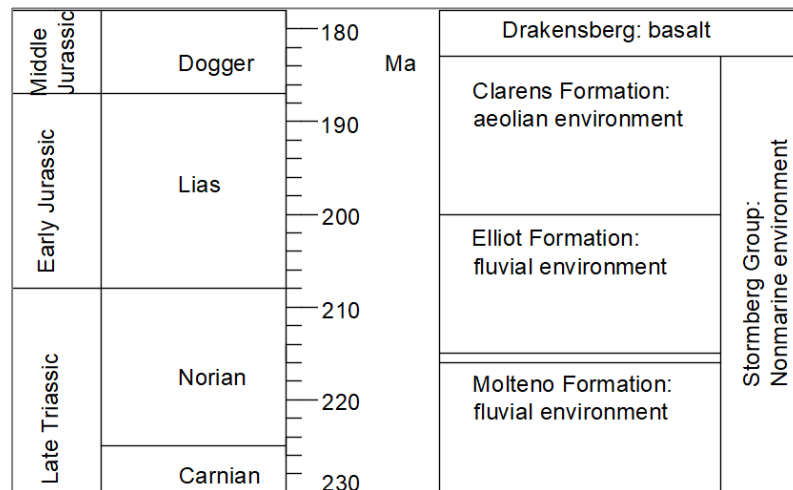
Figure 3-6, Stratigraphy of the Stormberg group (Extracted from Catuneanua & Elango, 2001)

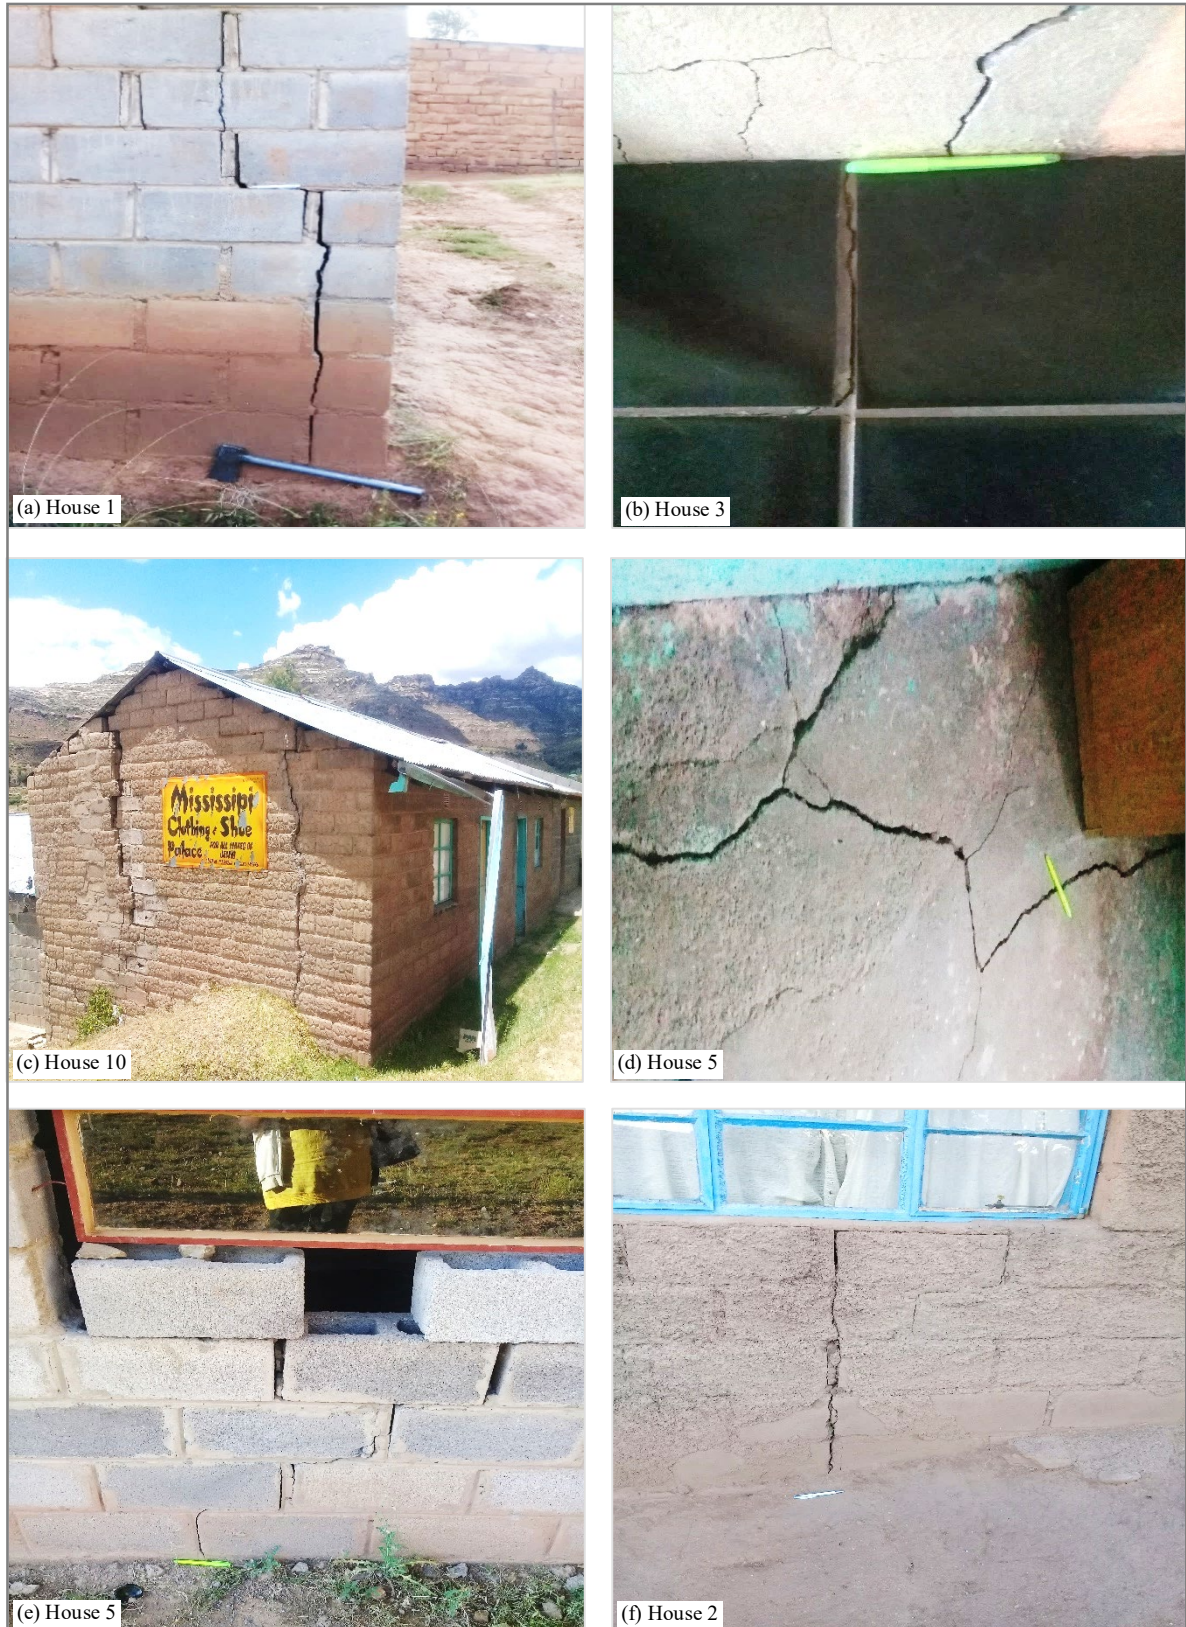
Figure 3-11, Cracks on some of the selected houses in the Mount Moorosi village

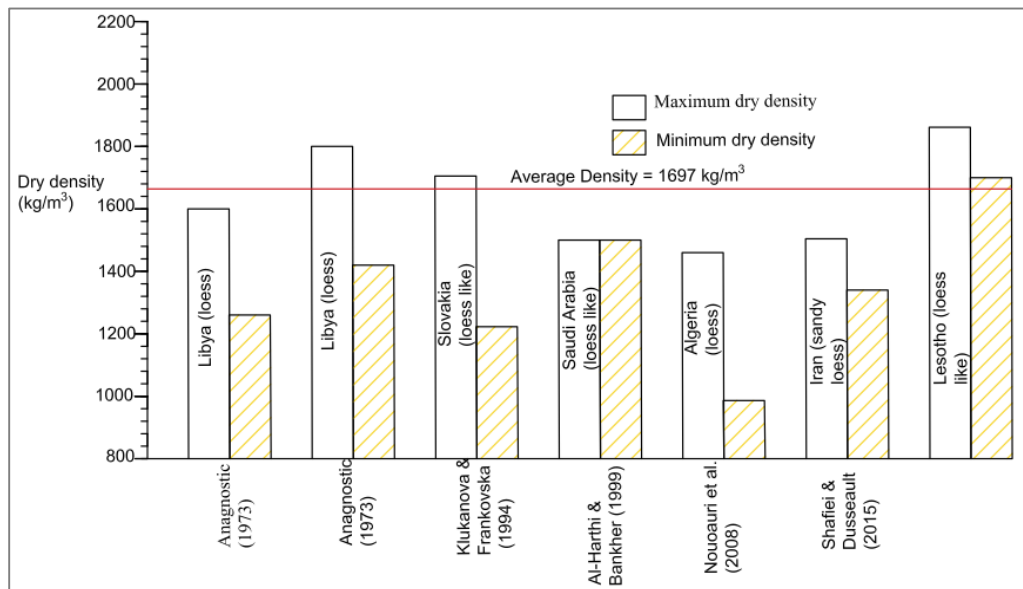
Figure 5-4, Comparison of dry density of loess from different parts of the world (Source: compiled from the literature)

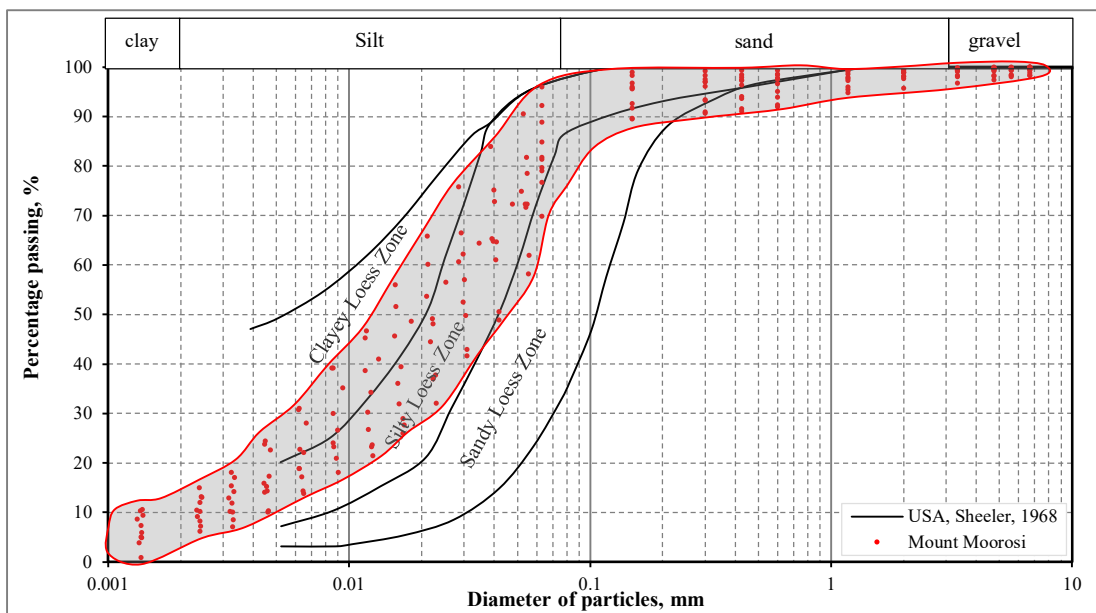
Figure 5-5, Comparison of particle size distribution of Mount Moorosi loess-like soil and USA loess (After Sheeler, 1968)

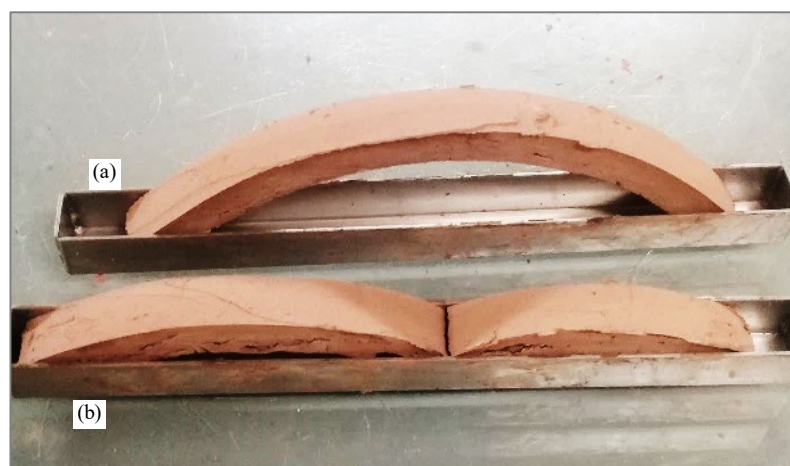
Figure 5-9, Warping during linear shrinkage: (a) intact specimen and (b) broken specimen

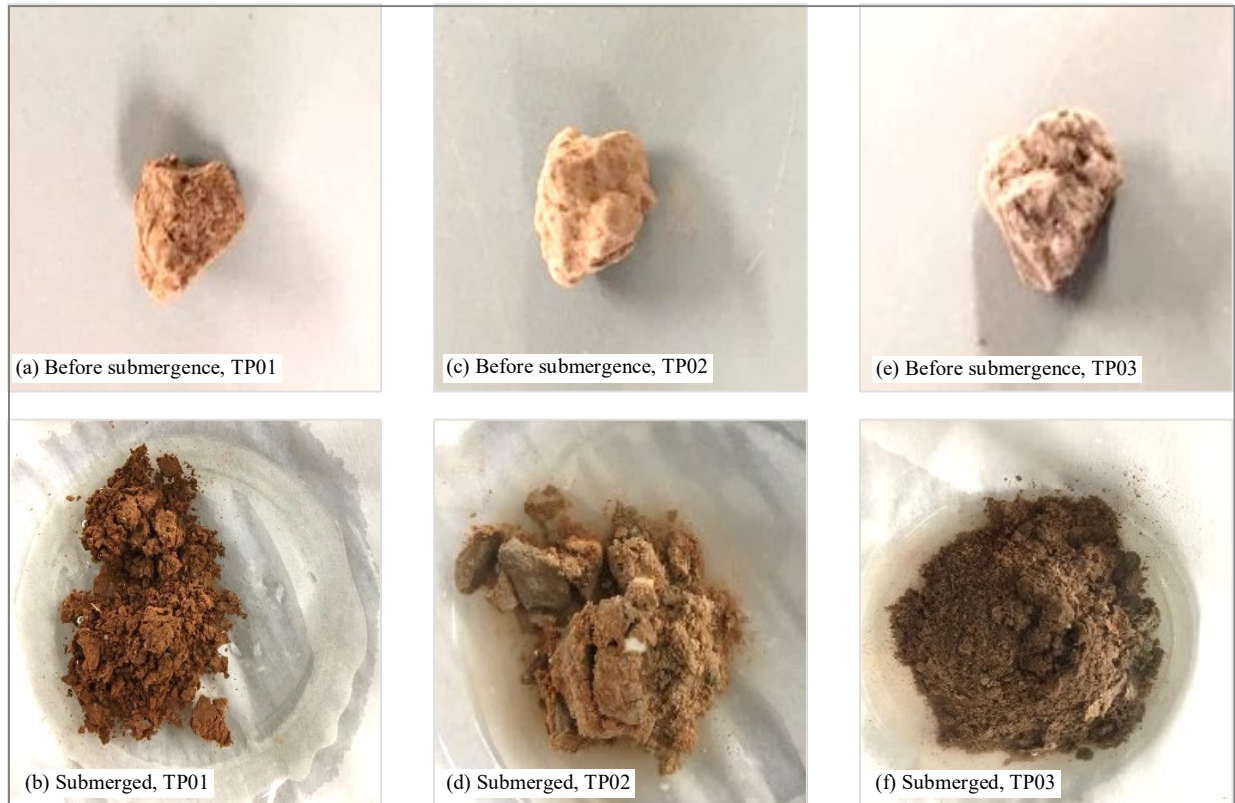
Figure 5-20, Slaking test for samples from the three pits

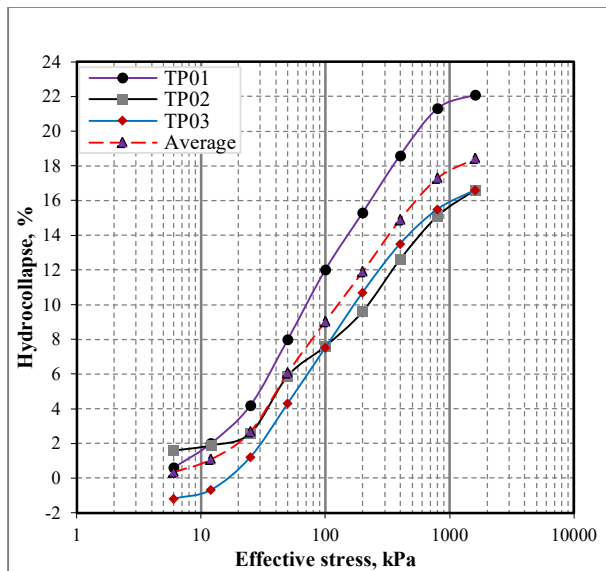
Figure 5-23, Effective stress against a hydrocollapse relationship

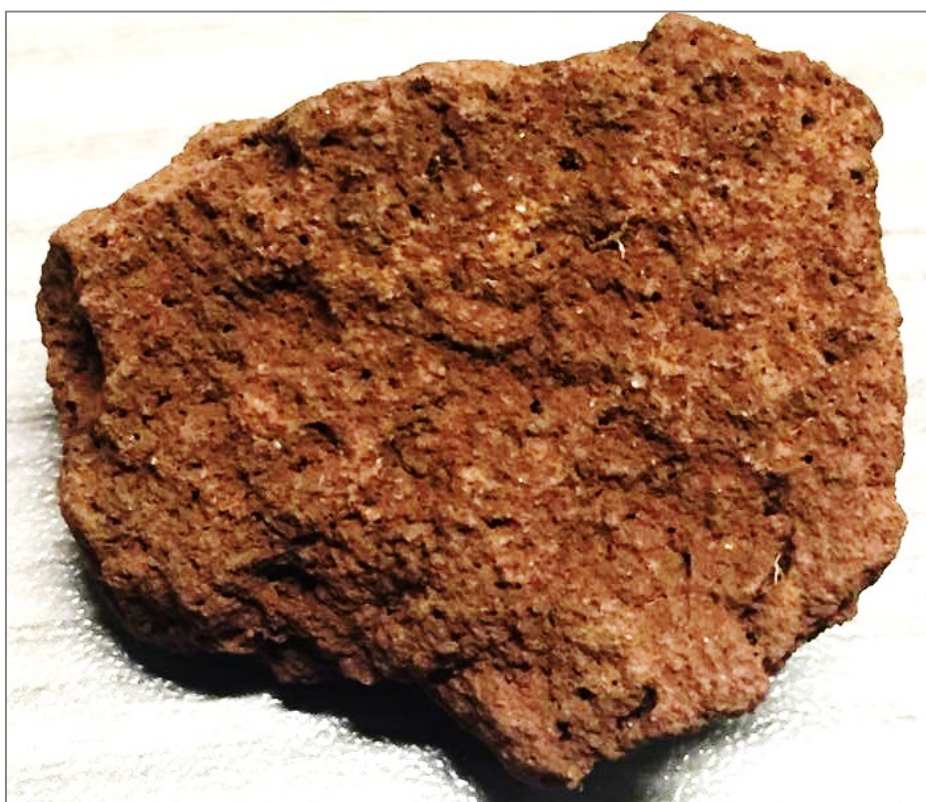
Figure 4, A pinholed soil aggregate, TP01

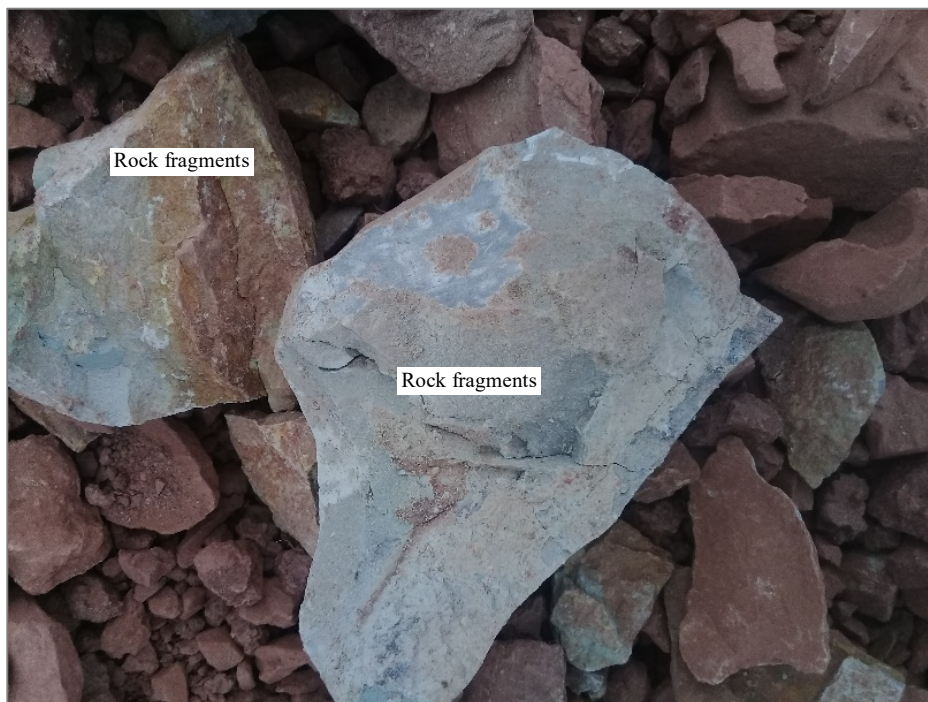
Figure 6, The green to grey boulders extracted from the bedrock at the base of the pit, TP01

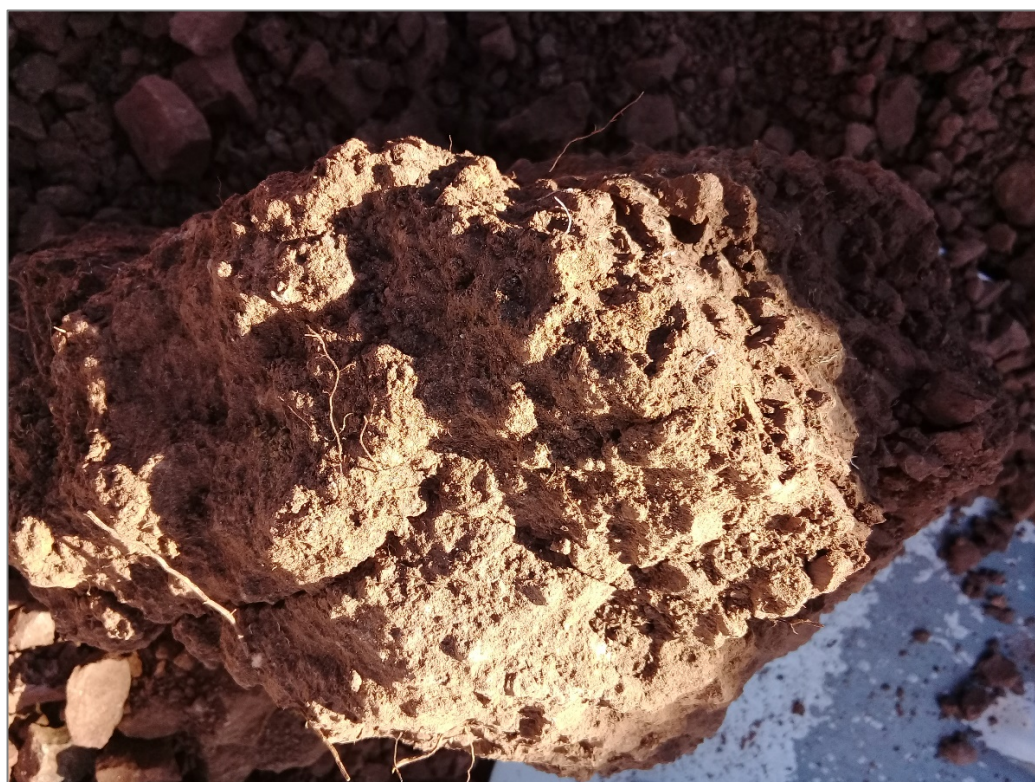
Figure 8, A soil aggregate, TP03
