Evaluation of Corrosion Behaviour of Hot Dip Zn and
Zn-Al Alloy Coatings on Steel Wire using Laboratory
and Field Tests

Centre for Materials Engineering

Masters Dissertation

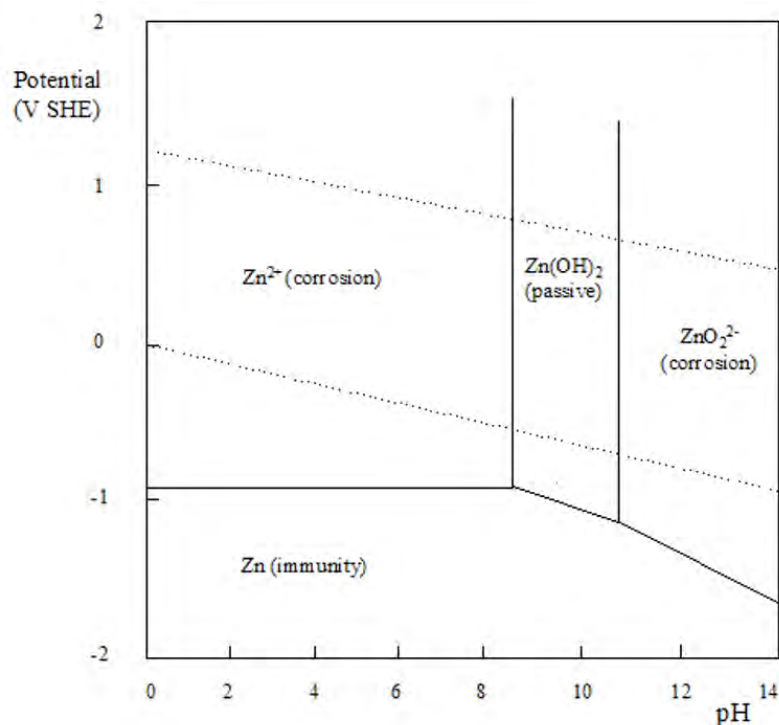
Figure 2.13: Eh-pH diagram for Zn at 25°C ^{28, 29}

The pH of aqueous solutions that contact Zn have an impact on its corrosion rate ³⁰. The Eh-pH diagram of Zn at 25°C is shown in **Figure 2.13**. Eh-pH diagrams show the equilibrium potential (Eh), with respect to the standard hydrogen electrode (SHE), between a metal and its various oxidized species as a function of pH ²⁸. Eh-pH diagrams are used in corrosion engineering to study the dissolution and passivation behaviour of different metals in aqueous environments ²⁸. It can be observed from **Figure 2.13** that within a pH range of approximately 8.5 to 11.0, Zn corrosion products, mainly Zn(OH)₂, form a passive protective barrier on the surface of Zn ²⁸. Zn would therefore be expected to exhibit a low corrosion rate when exposed to environments within this pH range ³⁰. Outside of this pH range, Zn is expected to corrode readily, forming Zn²⁺ ions below pH 8.5 and ZnO₂²⁻ ions above a pH of 11.0. A higher corrosion rate is predicted for Zn exposed to these pH ranges ³⁰.

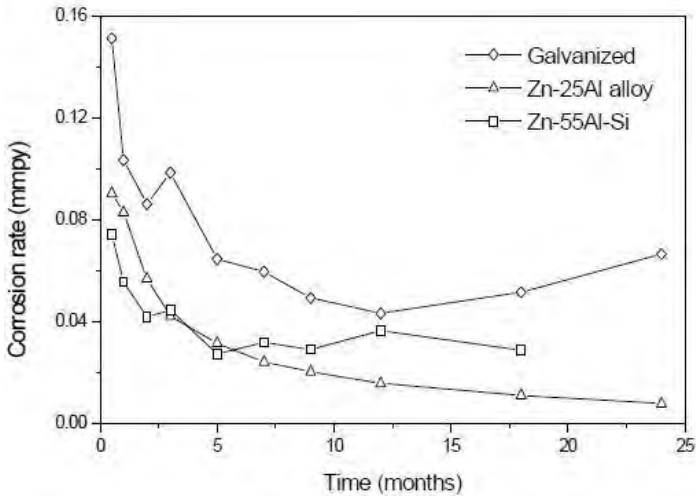
Figure 2.22: Corrosion rate as a function of time for hot dip coatings in immersion zone.³².

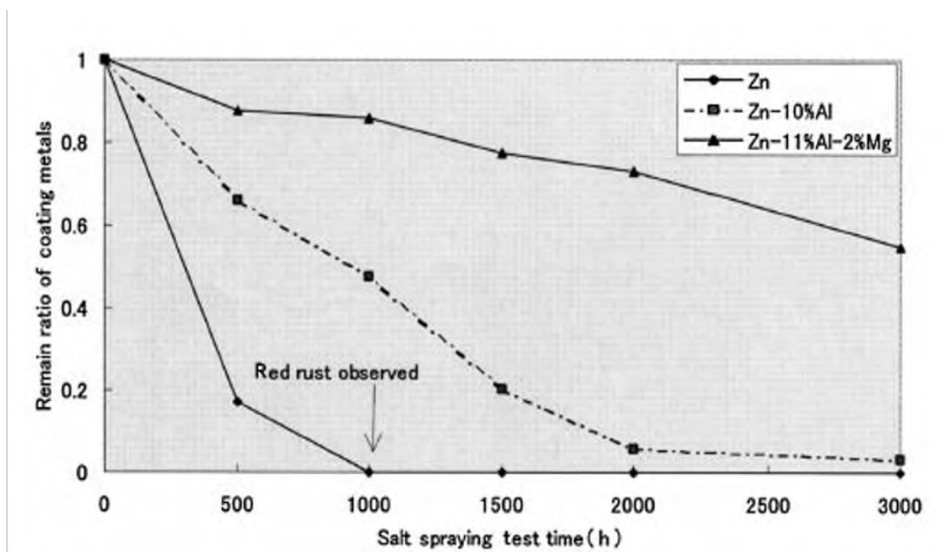
Figure 2.24: Remain ratio of coatings after salt spray test exposure⁴⁶.

minutes⁴⁶. Residual corrosion products were removed by rinsing the specimens under running water⁴⁶. Following this, the dried specimens were reweighed and weight decrement was determined by the difference between the weight of the specimens before and after the salt spray test⁴⁶.

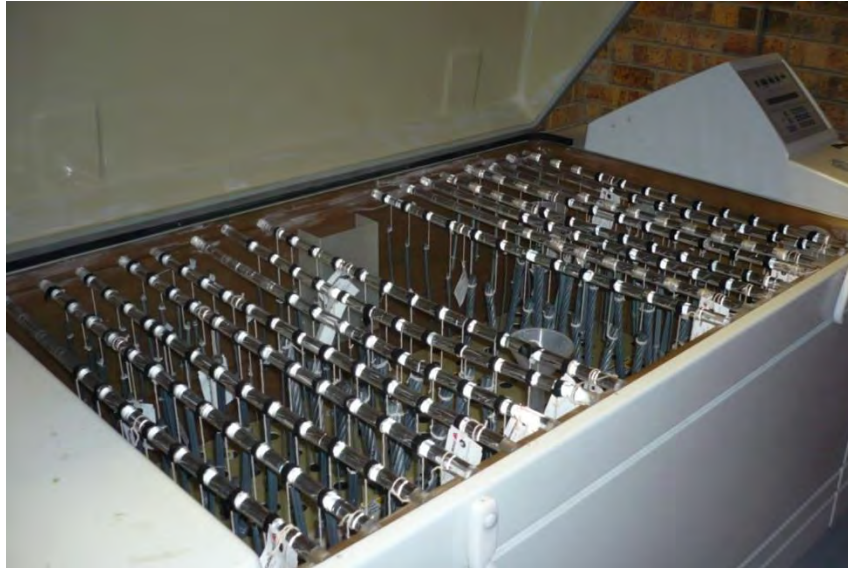
Figure 3.10: Specimens set-up inside Q-Fog 1100 cyclic corrosion tester at the beginning of the ASTM B117 test.

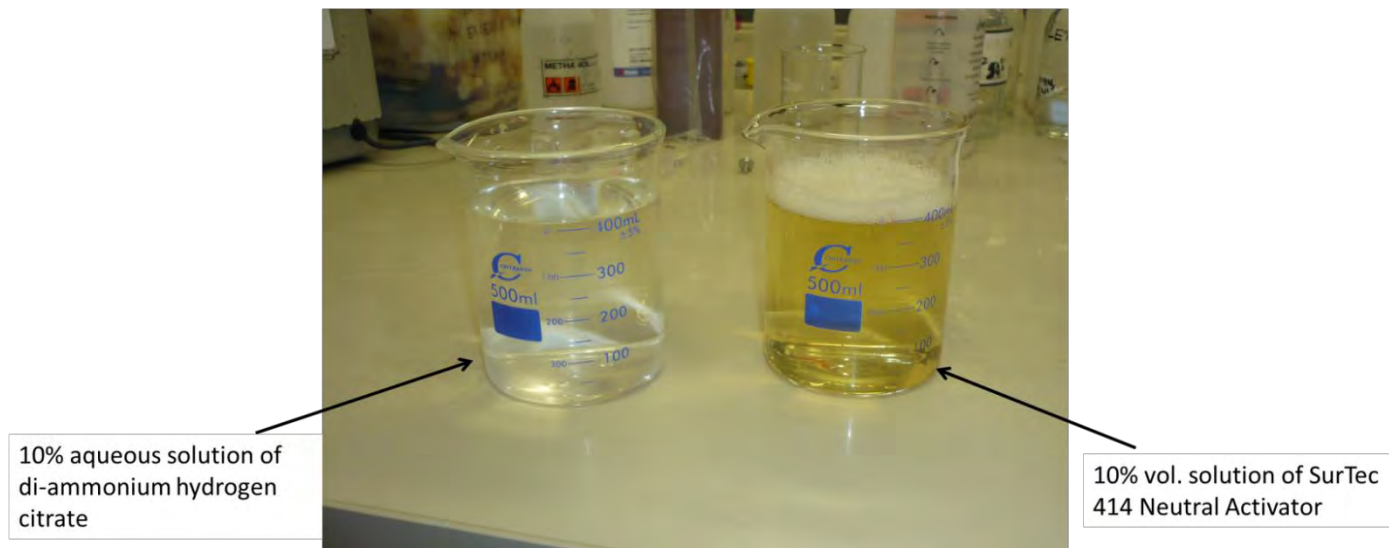
Figure 3.15: Solutions of 10% di-ammonium hydrogen citrate and 10% vol. solution of SurTec 414 Neutral Activator used to clean corrosion products from wire specimens following their extraction from the Q-fog cyclic corrosion tester.

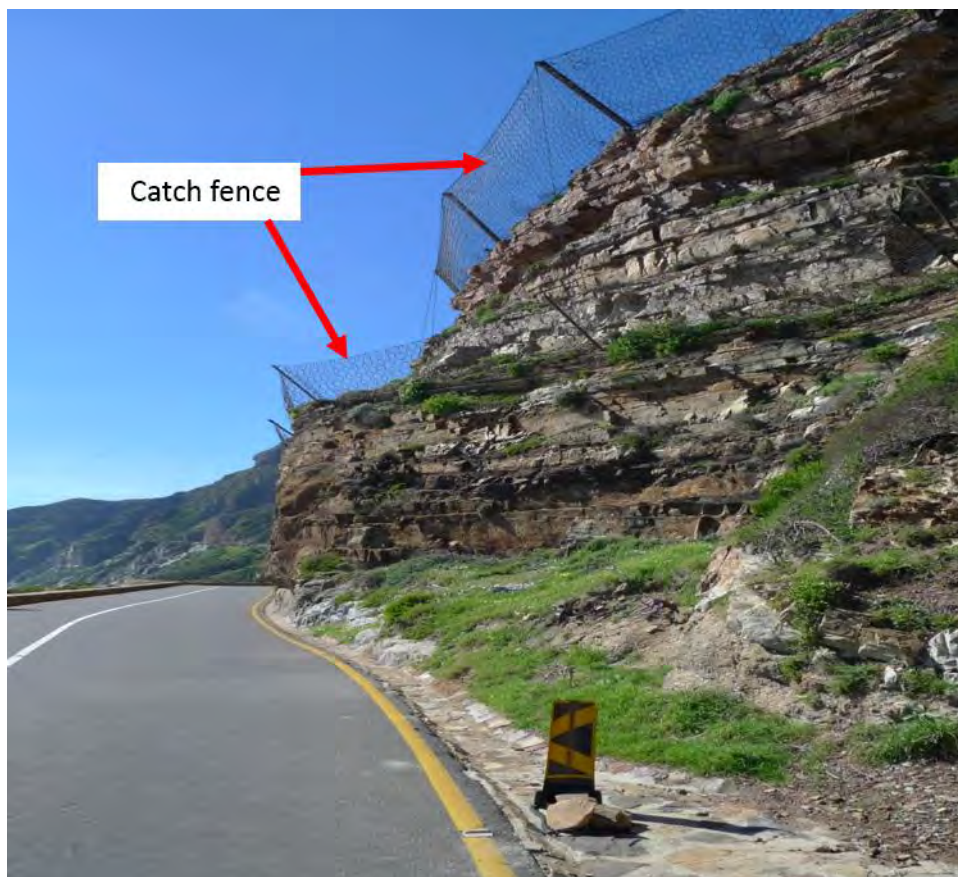
Figure 3.17: Catch fences installed along Chapman's Peak Drive to protect motorists from rock falls

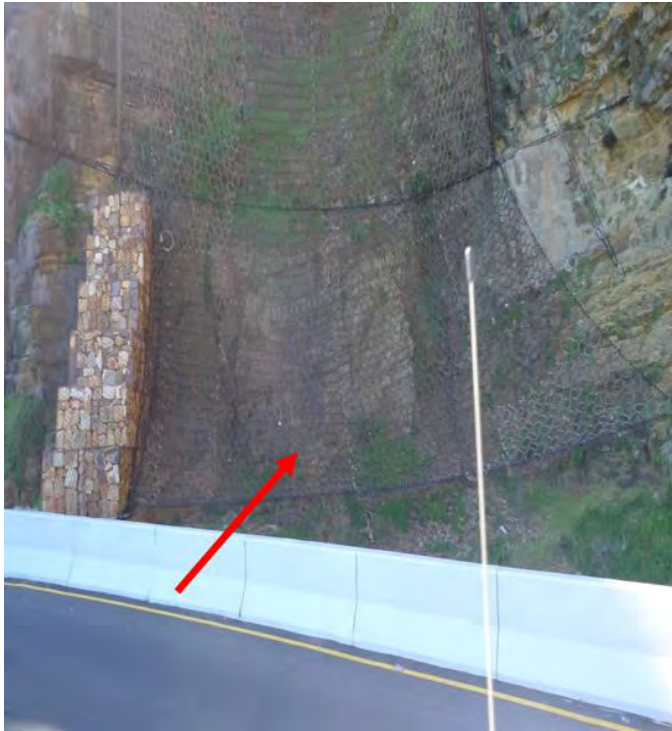
Structure	Coating Type	Coating Mass Distribution (g/m ²)	Wire Diameter (mm)
Bundles			
12-strand bundle	Zn Class A	235	3
	Zn Class B	235	3
	Zn-5Al	150	3
	Zn-5Al-xMg	150	3
	Zn-10Al	300	3
Rope			
8mm dia. rope	Zn	70	0.9
	Zn-5Al	70	0.9
22mm dia. rope	Zn	90	1.3
	Zn-5Al	90	1.3

Figure 3.19: Image showing position of catch fence 2 (indicated by arrow). The accompanying table describes the specimens installed at catch fence 2 for the environmental exposure test.

Catch fence 2 is located at the base of the mountain along road level. Test specimens installed at catch fence 2 were in constant shade based on the location of catch fence 2.

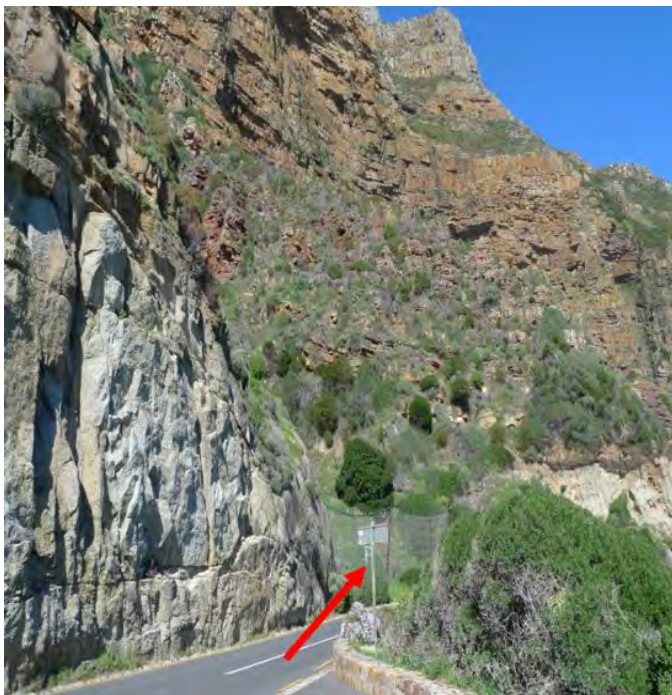
Structure	Coating Type	Coating Mass Distribution (g/m ²)	Wire Diameter (mm)
Rope			
8mm dia. rope	Zn	70	0.9
	Zn-5Al	70	0.9
22mm dia. rope	Zn	90	1.3
	Zn-5Al	90	1.3

Figure 3.20: Image showing position of catch fence 23C (indicated by arrow). The accompanying table describes the specimens installed at catch fence 23C for the environmental exposure test.

Catch fence 23C is also situated at road level similar to catch fence 2. However, specimens were fully exposed to weather elements at this location unlike at catch fence 2 where the mountain served as barrier to some weather elements, such as direct sunlight exposure. The limited space for Catch Fence 23C only allowed for rope specimens to be installed there.

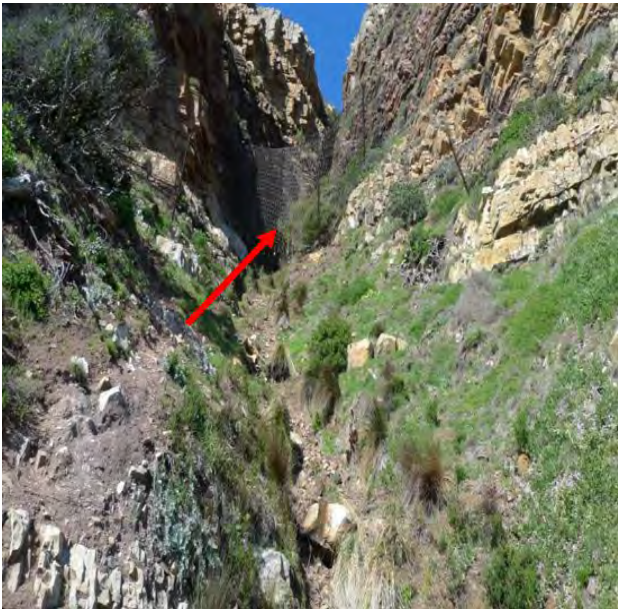
Structure	Coating Type	Coating Mass Distribution (g/m ²)	Wire Diameter (mm)
Bundles			
12-strand bundle	Zn Class A	235	3
	Zn Class B	235	3
	Zn-5Al	150	3
	Zn-5Al-xMg	150	3
	Zn-10Al	300	3
Rope			
8mm dia. rope	Zn	70	0.9
	Zn-5Al	70	0.9
22mm dia. rope	Zn	90	1.3
	Zn-5Al	90	1.3

Figure 3.21: Image showing position of catch fence 38 (indicated by arrow). The accompanying table describes the specimens installed at catch fence 38 for the environmental exposure test.

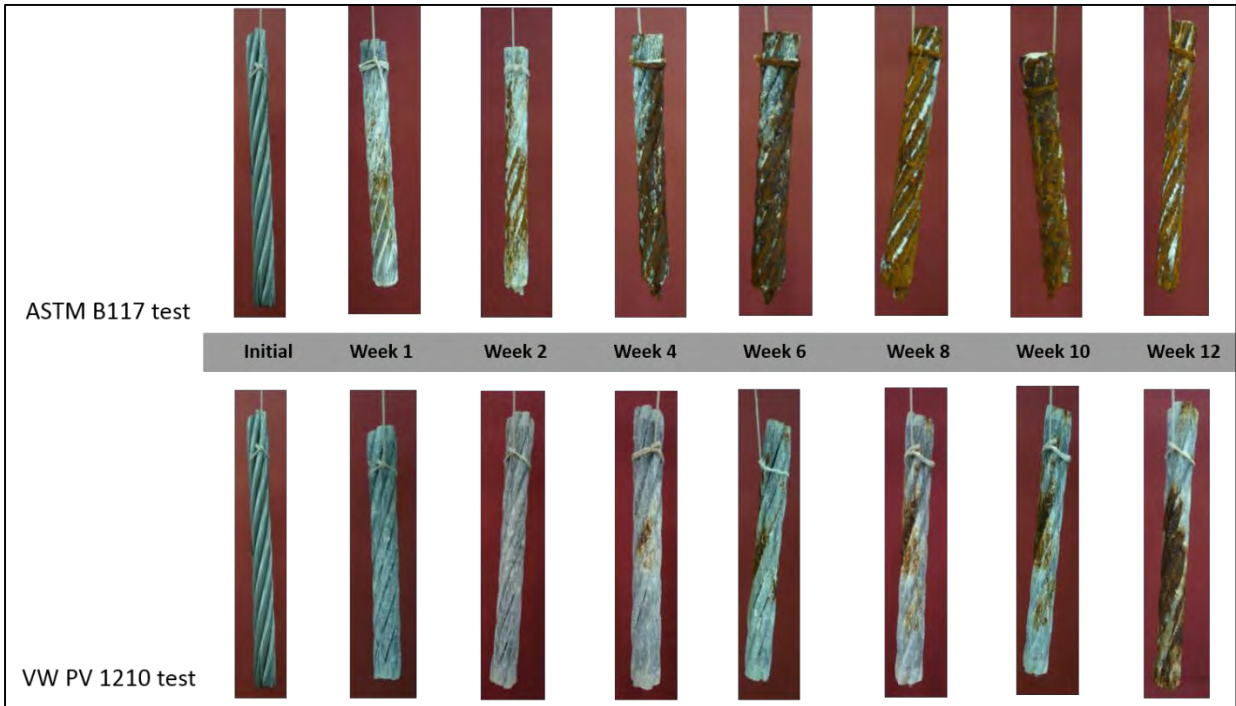
Figure 4.1: Development of corrosion products on Zn (90g/m²) Class B coated wire in 22mm diameter rope during ASTM B117 and VW PV 1210 salt spray tests.

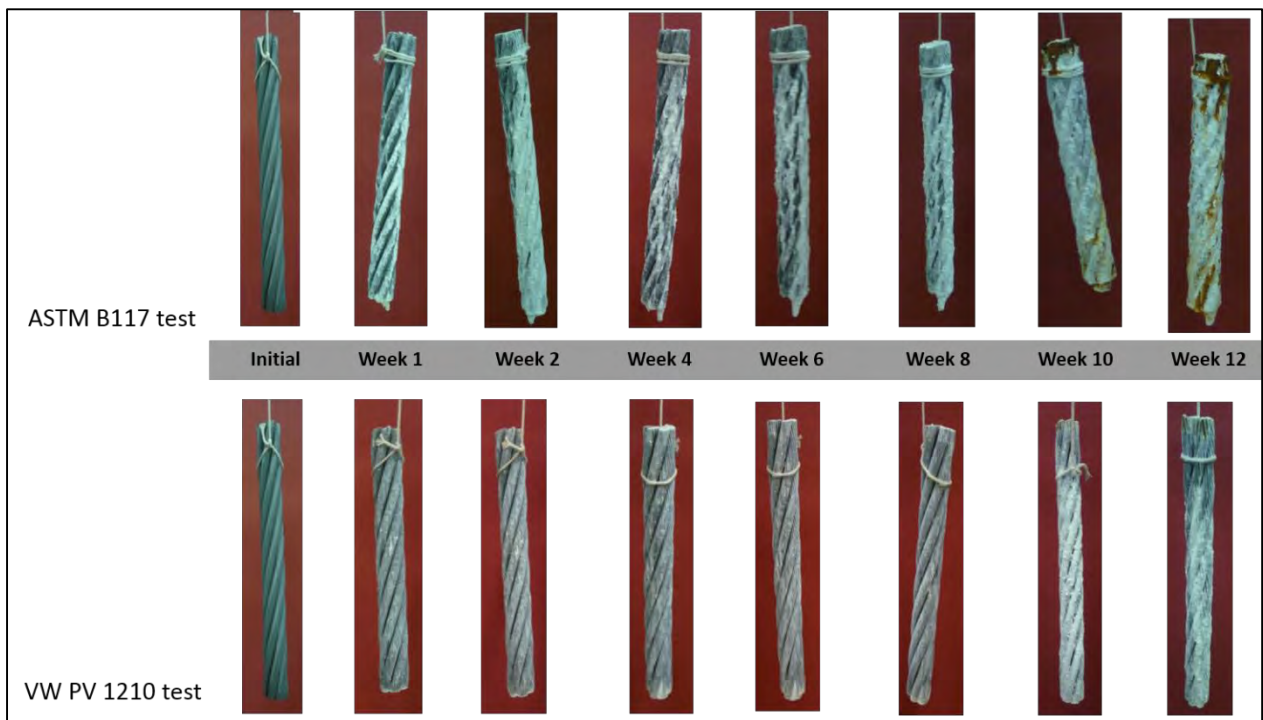
Figure 4.2: Development of corrosion products on Zn-5Al (90g/m^2) Class B coated wire in 22mm diameter rope during ASTM B117 and VW PV 1210 salt spray tests.

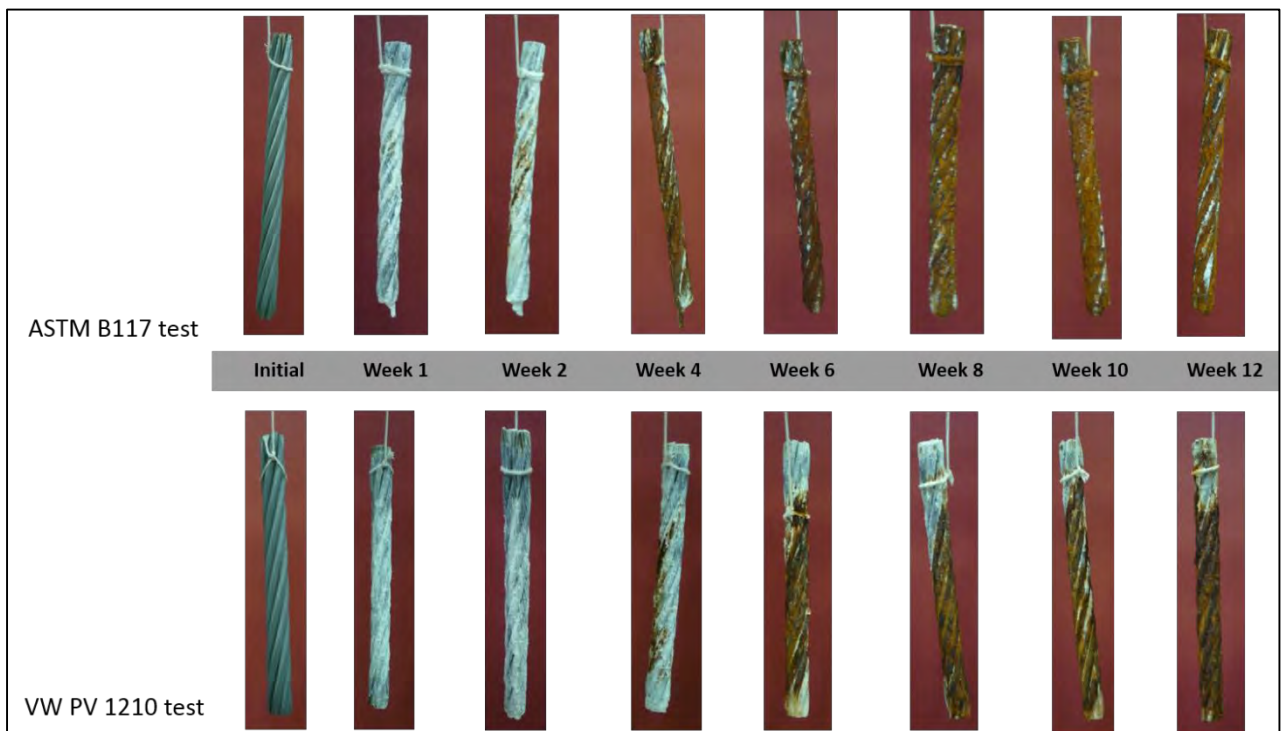
Figure 4.3: Development of corrosion products on Zn (80g/m^2) Class B coated wires in 16mm diameter rope during ASTM B117 and VW PV 1210 salt spray tests.

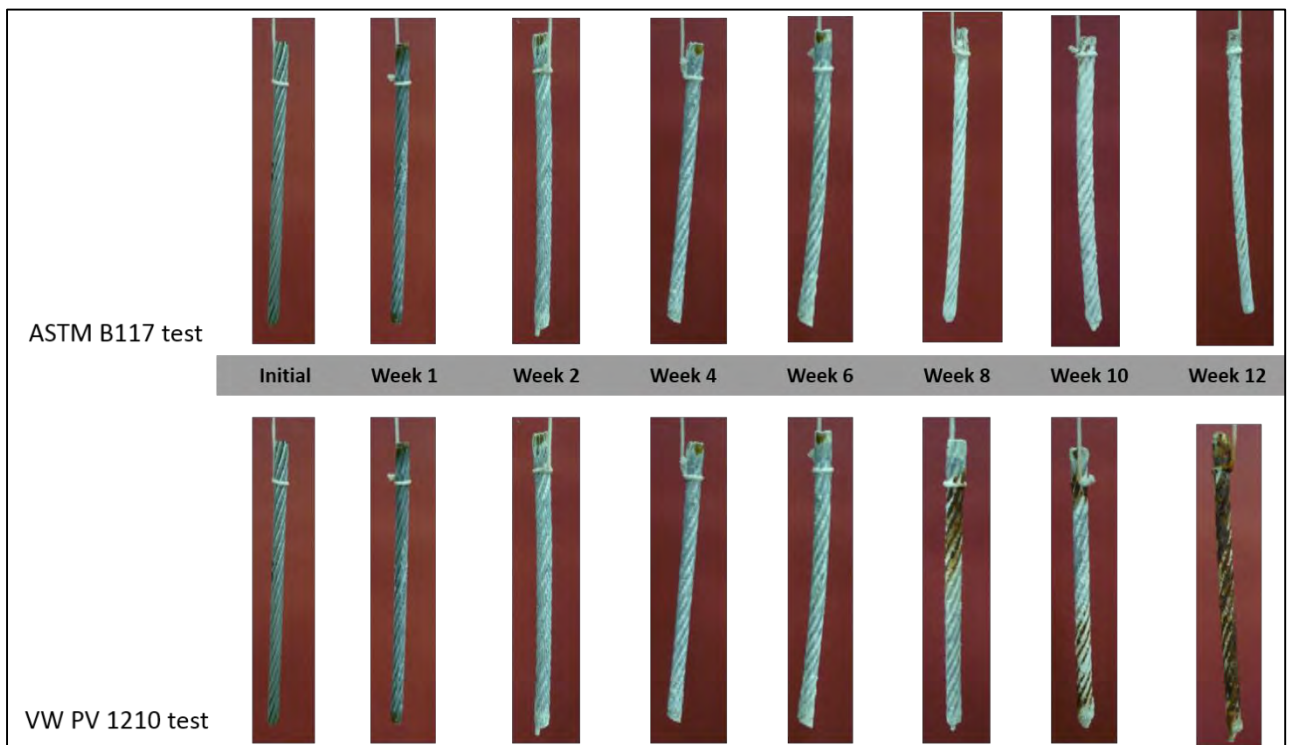
Figure 4.5: Development of corrosion products on Zn ($70\text{g}/\text{m}^2$) Class B coated wires in 8mm diameter wire rope during ASTM B117 and VW PV 1210 salt spray tests.

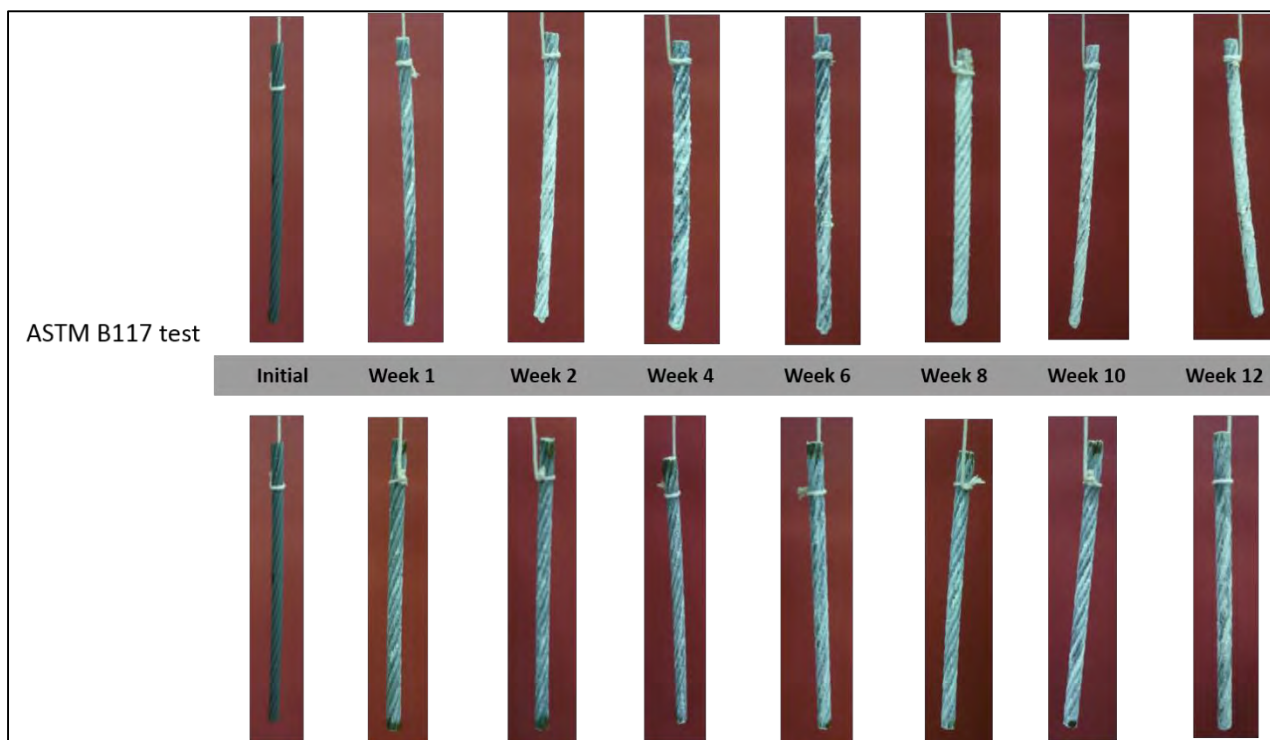
Figure 4.6: Development of corrosion products on Zn-5Al (70g/m²) Class B coated wires in 8mm diameter wire rope during ASTM B117 and VW PV 1210 salt spray tests.
