ABRASIVE WEAR TESTING OF STEELS IN SOIL

A thesis submitted to the Faculty of Engineering,
University of Cape Town in fulfilment of the degree
of Master of Science in Applied Science.

Department of Materials Engineering
University of Cape Town

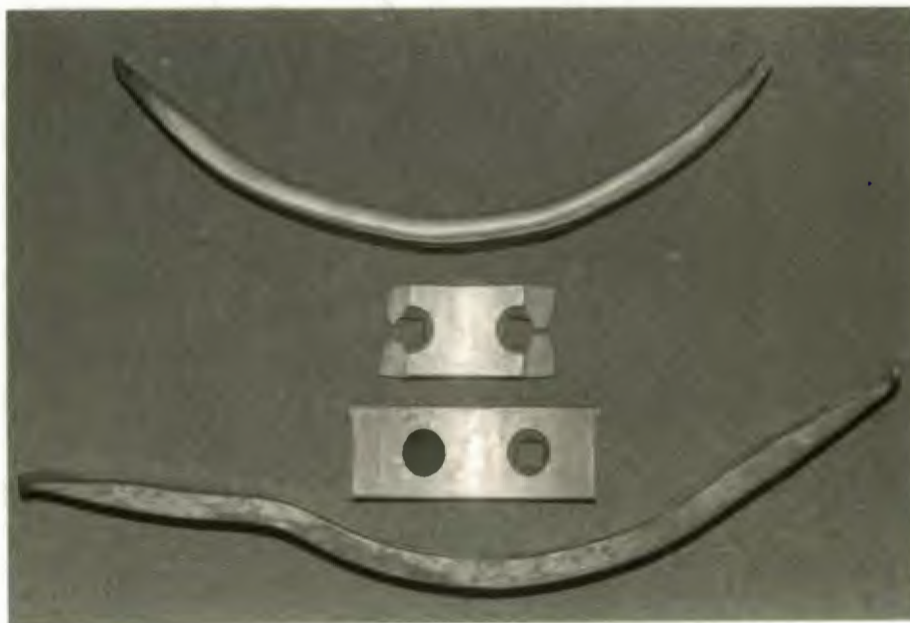
FIGURE 2.1 : A normal ripper point compared with points bent or fractured during use.

It was later established that ripper points used in the Swartland of the Western Cape lose approximately 1 g of steel to the soil for every five metres of ploughing (Quirke 1983). Failures due to bending and fracture were also recorded regularly by farm managers as shown in figure 2.1.

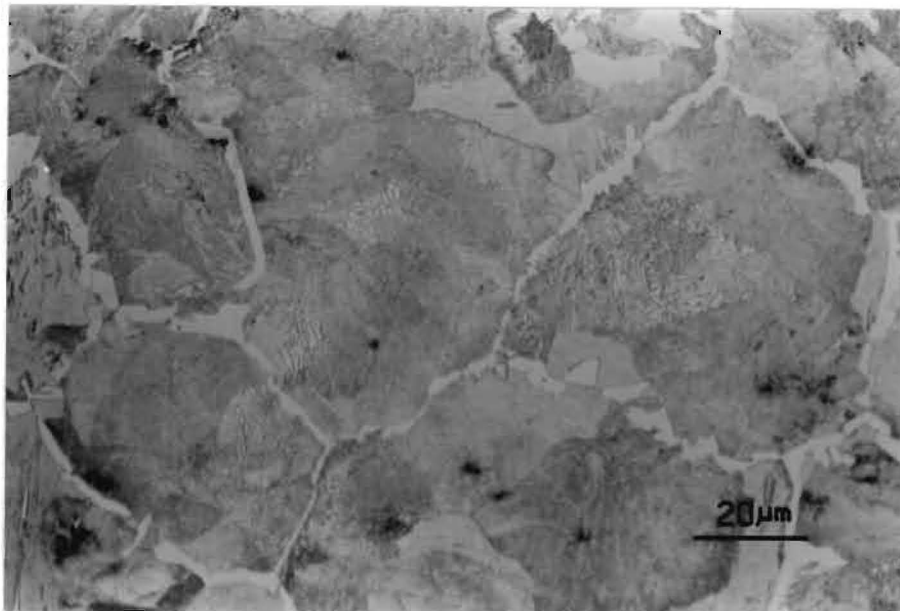
FIGURE 2.2 : Microstructure of an SS10/200 point with a hardness of 270HV30, etched in Nital.

The brittleness or ductility responsible for such behaviour indicated that similar tooling material was receiving variable heat treatment. Two worn ripper points selected at random from one farm highlighted this problem of inconsistent quality. Both of these points had been produced by the same manufacturer, using the same 0.42 per cent plain carbon steel bar. The composition of this steel is given in Table 2.1. One point, shown in figure 2.2, had a microstructure consisting of ferrite and pearlite and a hardness of 270HV30. The second point, shown in figure 2.3, had a microstructure consisting predominantly of bainite and martensite with a hardness of 550HV30.

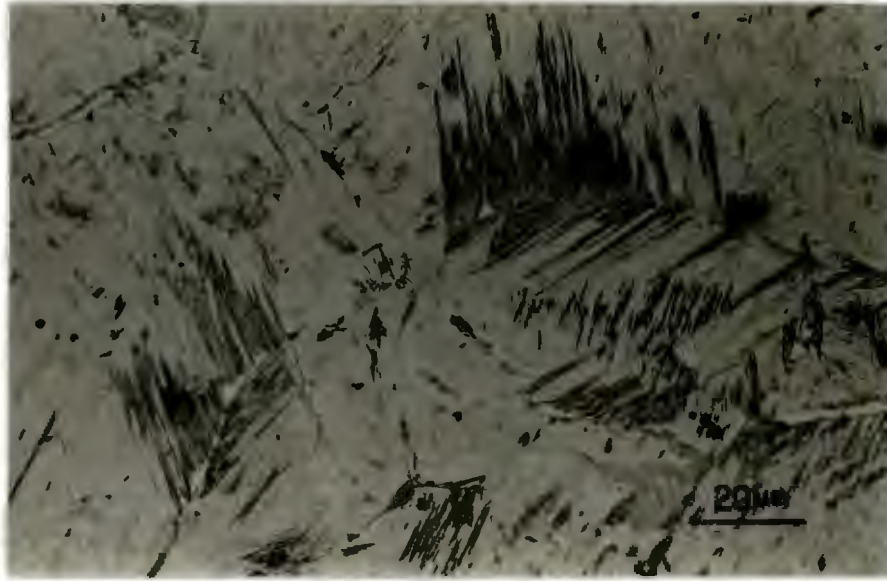
FIGURE 2.3 : Microstructure of an SS10/200 point with a hardness of 550HV30, etched in Nital.

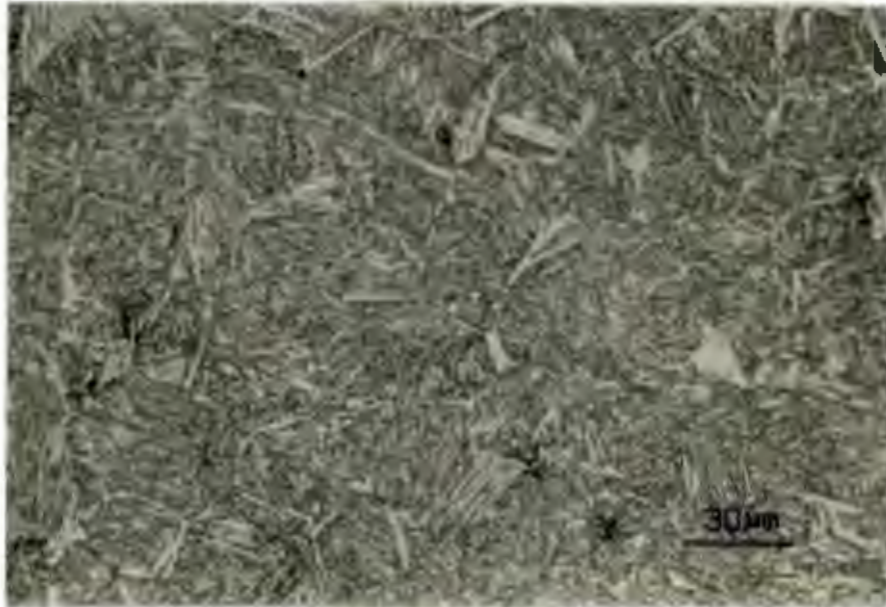
FIGURE 2.4 : Microstructure of an austempered point. Hardness 427HV30, etched in Nital.

The first tool had a fine grained, bainitic microstructure with a hardness of 427HV30 (fig. 2.4). The point was recorded to have performed

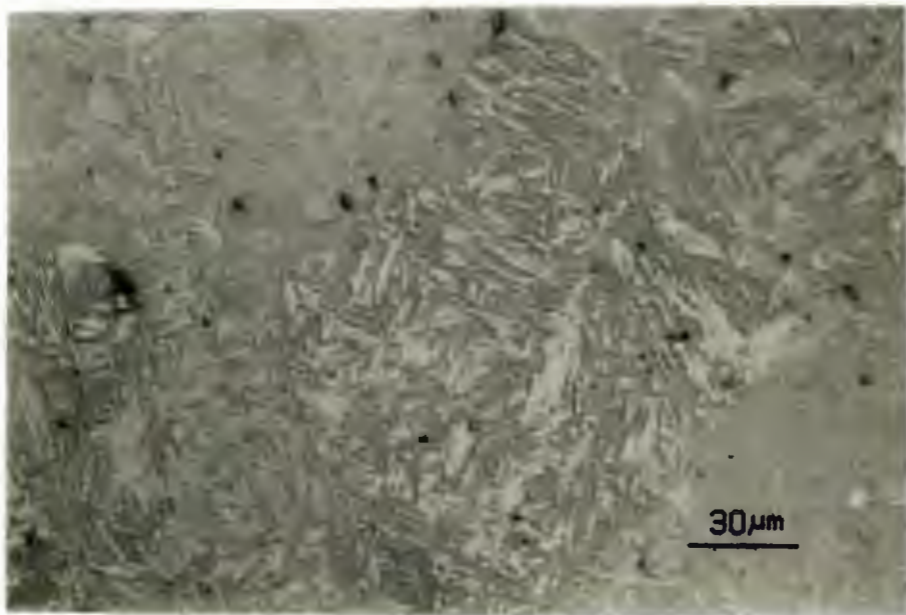
FIGURE 2.5 : Microstructure of a ripper point made from SAE 2955. Note the influence of large austenite grain size. Hardness 422HV30, etched in Nital.

adequately in service. It was assumed that an austempering process had been carried out on this ripper point to produce such a microstructure. The second point also had a microstructure consisting of bainite, but with a much larger grain size. This indicated that the tool had been held at a high temperature for an excessive period (fig. 2.5).

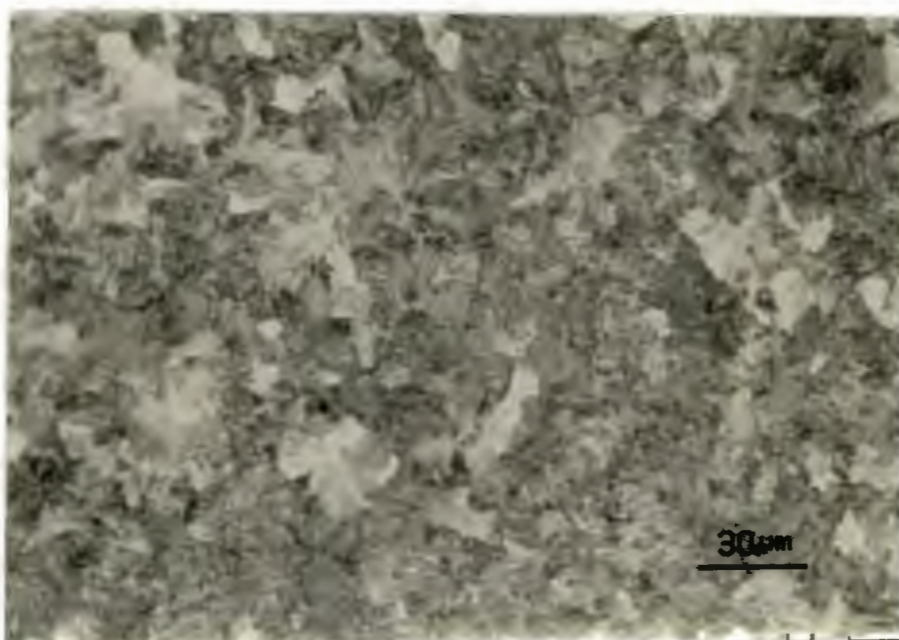
FIGURE 2.6 : Microstructure of a point allegedly made from SAE 2955 - note the unresolved pearlite. Hardness 390HV30, etched in Nital.

Both of these points had compositions within SAE 2955 specifications. The third point was found to have a carbon content of 0.79 per cent and a silicon content of 0.15 per cent rather than 0.5 per cent carbon and 1.52 per cent silicon, as specified for SAE 2955. The microstructure consisted of unresolved pearlite and ferrite and had a hardness of 390HV30 (fig 2.6). The point had probably been air cooled.

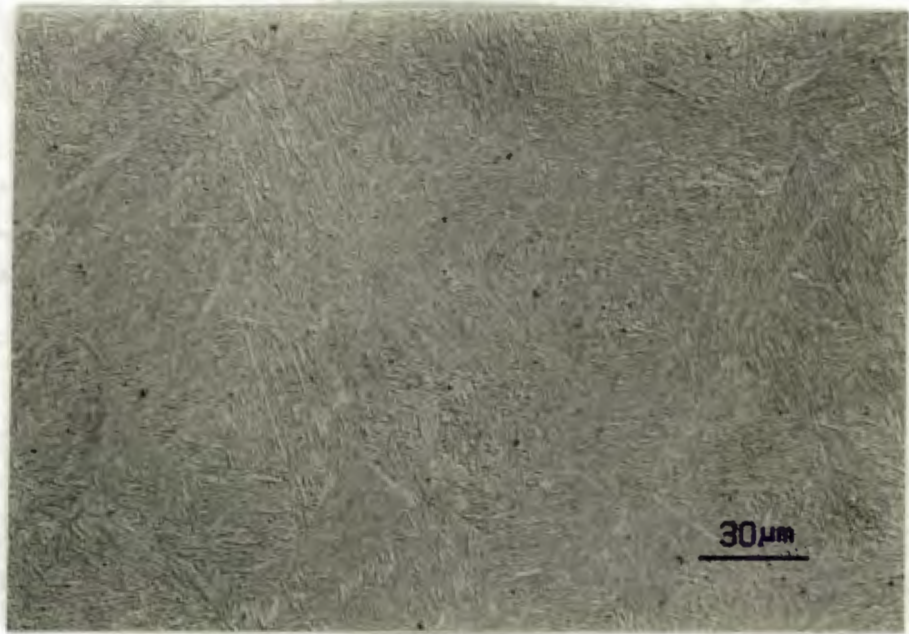
FIGURE 2.7 : Microstructure of a spring tyne manufactured from SAE 2955. Hardness 385HV30, etched in Nital.

Some manufacturers were using these methods on "spring steels" with increased silicon contents. These steels are very sensitive to overheating and decarburization. The coarse grain and decarburized surface are detrimental to the high elastic limit and fatigue resistance properties for which this steel is designed. Because of this, some spring tynes for tools either cracked or bent. The microstructure of a spring tyne that failed during use is shown in figure 2.7.

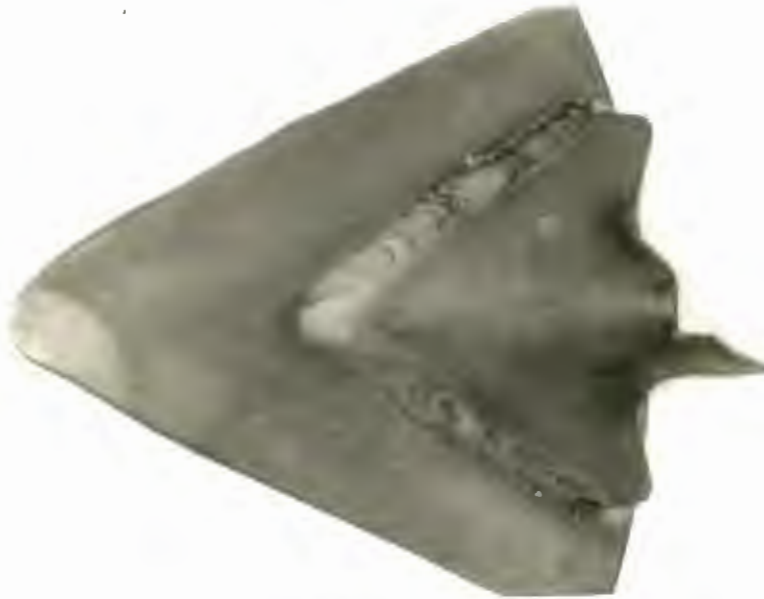
FIGURE 2.8 : A section of a disc welded to the bottom of a scarifier point. This eventually failed at the point of attachment.

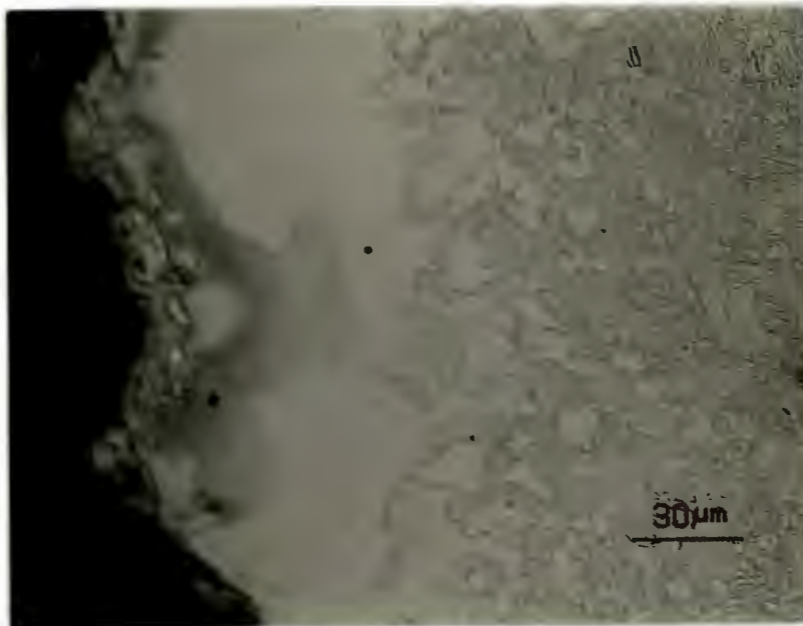
FIGURE 2.9 : Excessive decarburization in cast medium carbon steel ripper point. Bulk hardness 561HV30, etched in Nital.

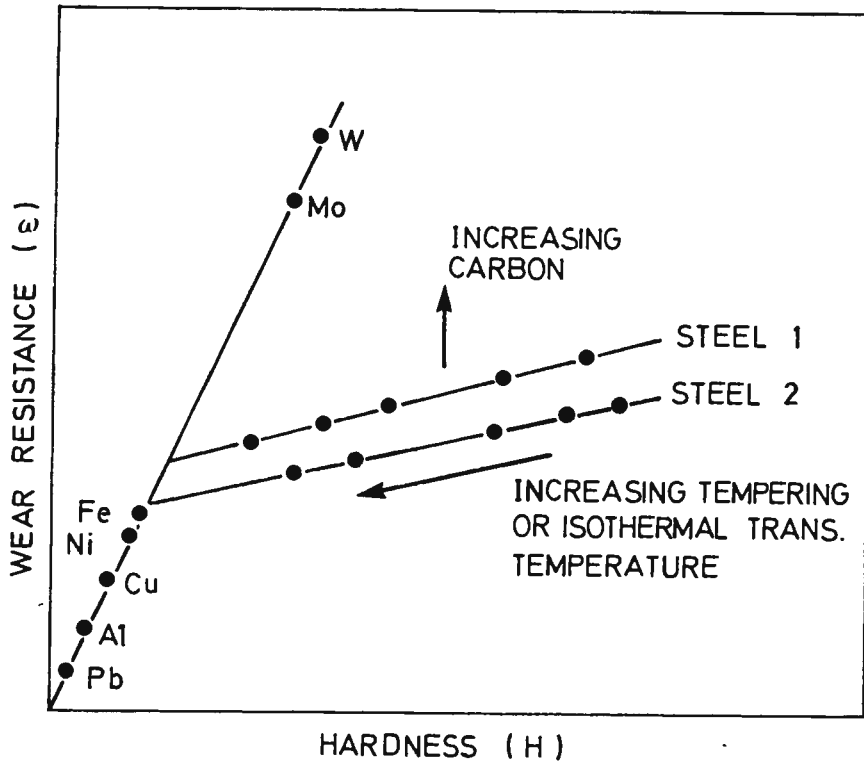
FIGURE 4.2 : Wear resistance as a function of bulk hardness for pure metals and heat treated steels (Kruschov, 1957).

- The line of wear resistance against hardness was displaced to higher wear resistance values as the carbon content of the steels was increased.

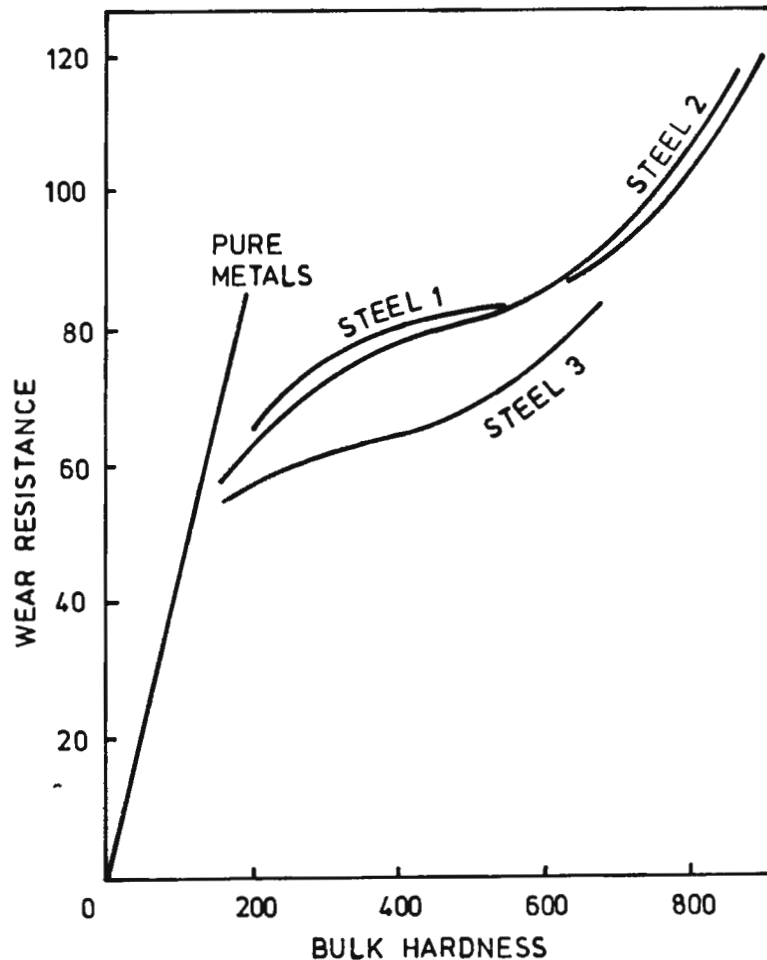
FIGURE 4.3 : The wear resistance of three steels quenched and tempered to different hardness levels. The sigmoidal shape of the plots is characteristic for carbon steels (Murray, Mutton and Watson, 1979).

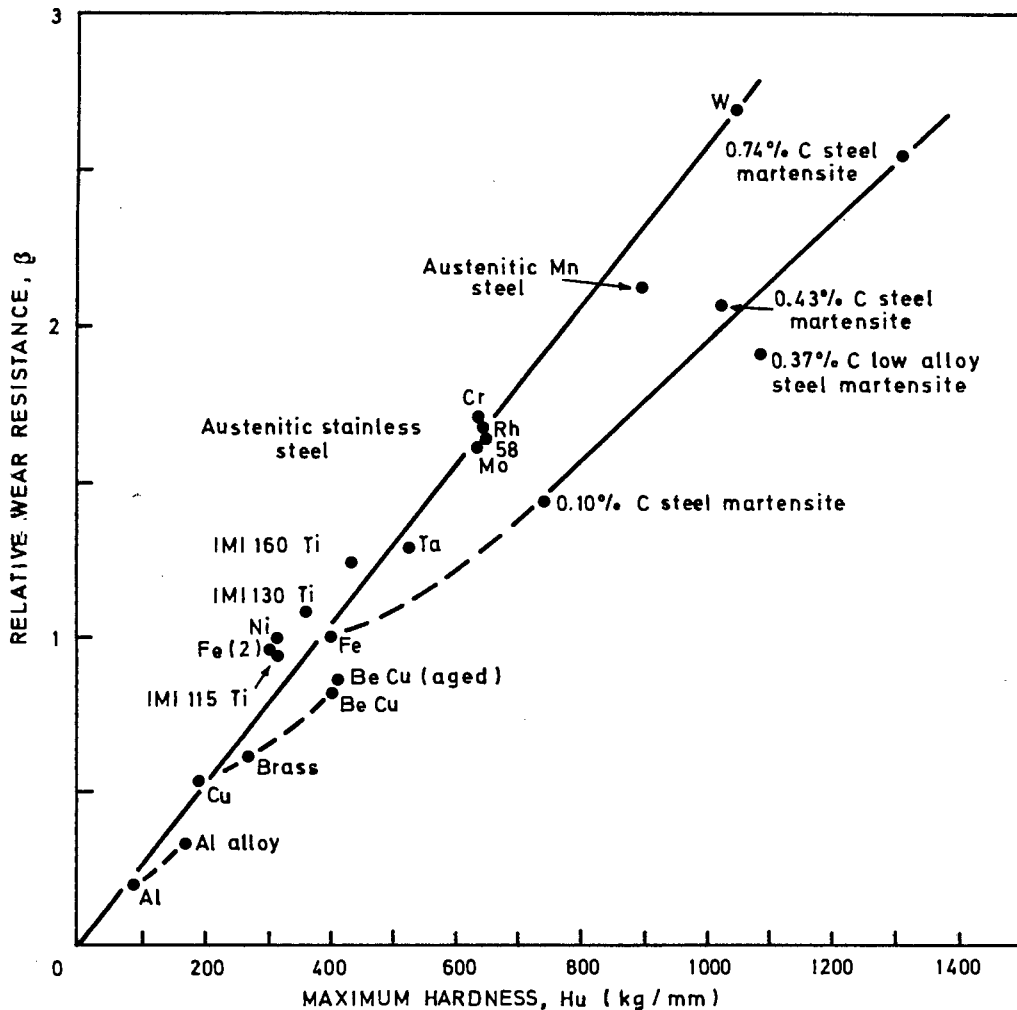
FIGURE 4.4 : Plot of relative wear resistance on 180 grit corundum cloth against maximum hardness of strained surfaces - Richardson (1967).

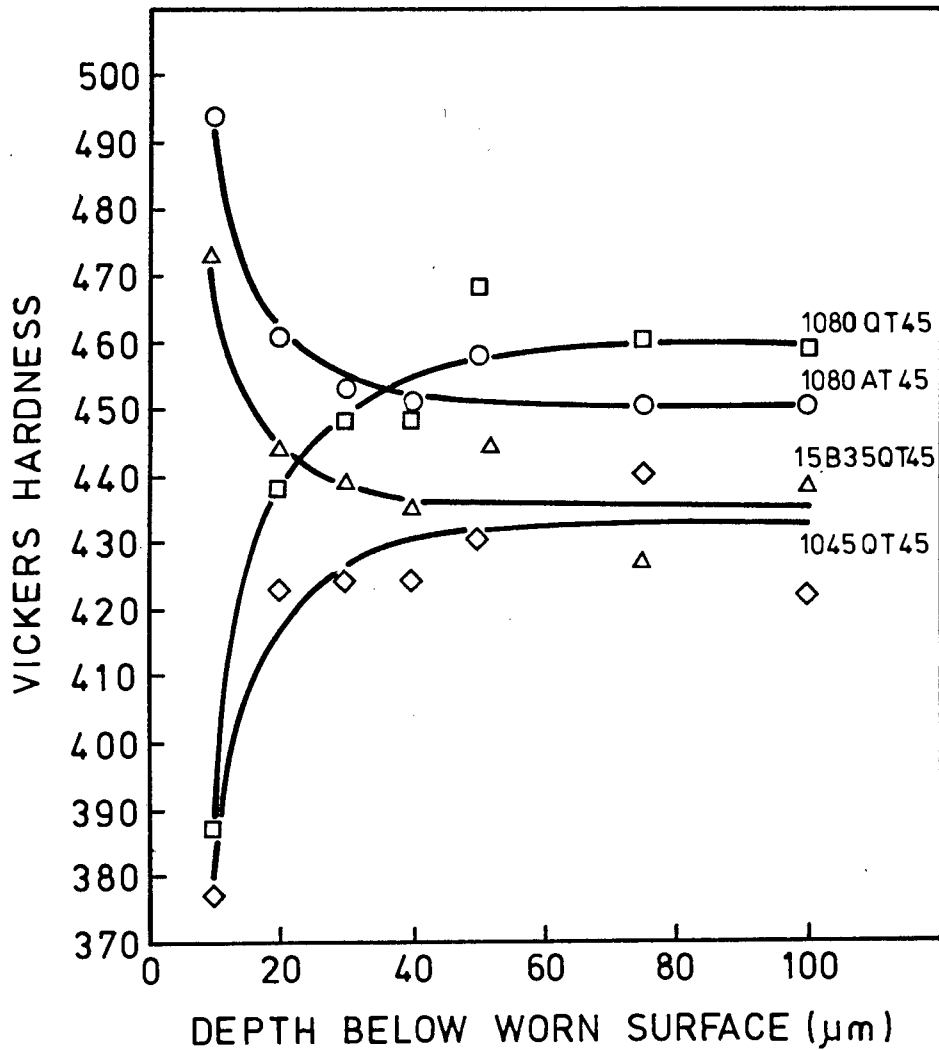
FIGURE 4.5 : Comparison of hardness versus depth for 1080 quenched and tempered to 450HV30 as well as austempered to 450HV30. Also for steels 15B35 and 1045, both quenched and tempered to 450HV30 (Moore, 1985).

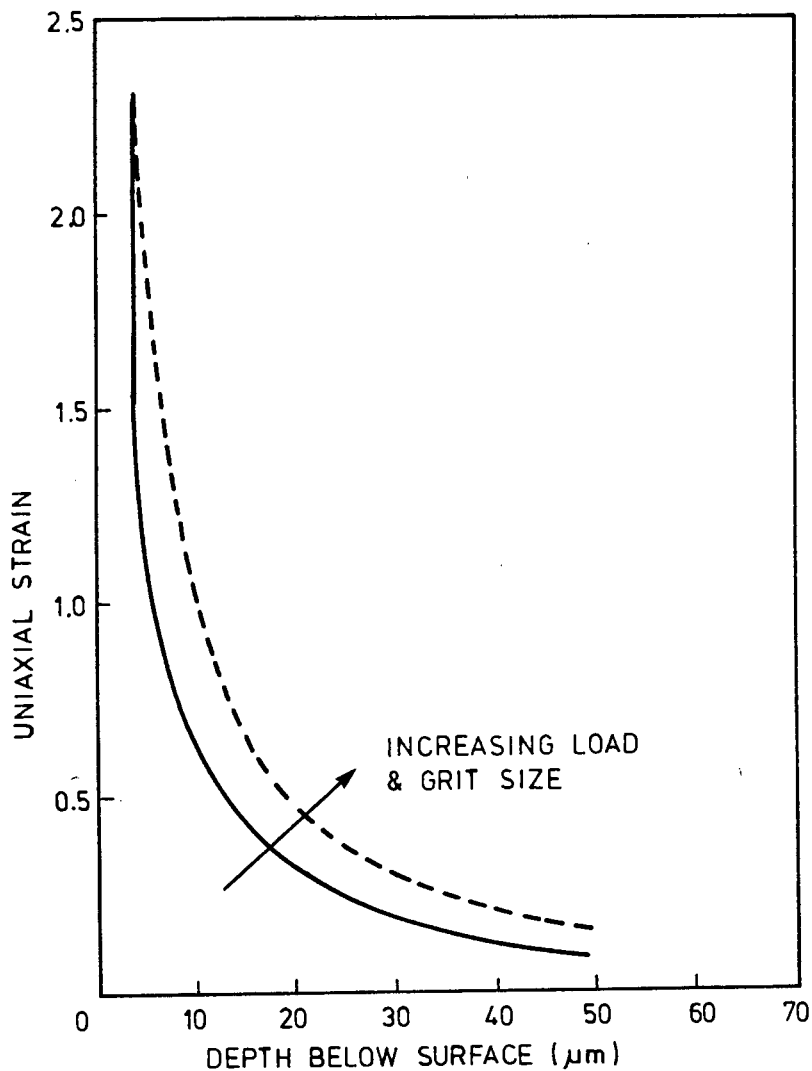
FIGURE 4.6 : The effect of load and grit size on subsurface strain during wear.

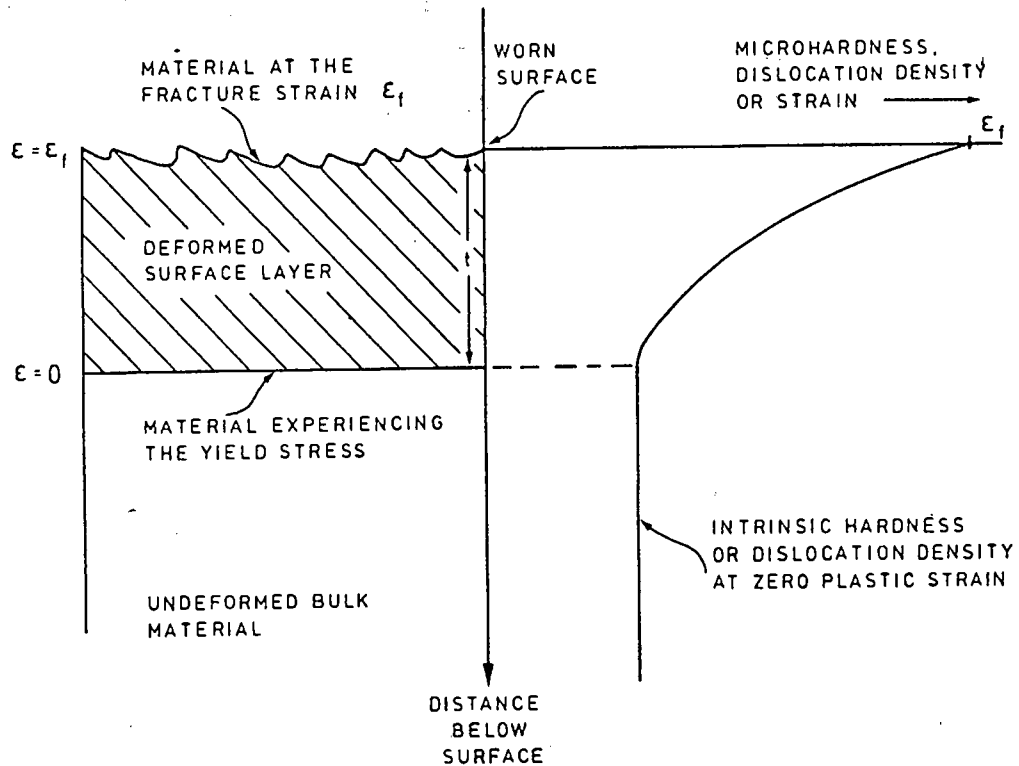
FIGURE 4.7 : Schematic illustration of the deformed surface layer of an abraded material. The curve on the right indicates change in microhardness, dislocation density or strain, with depth.

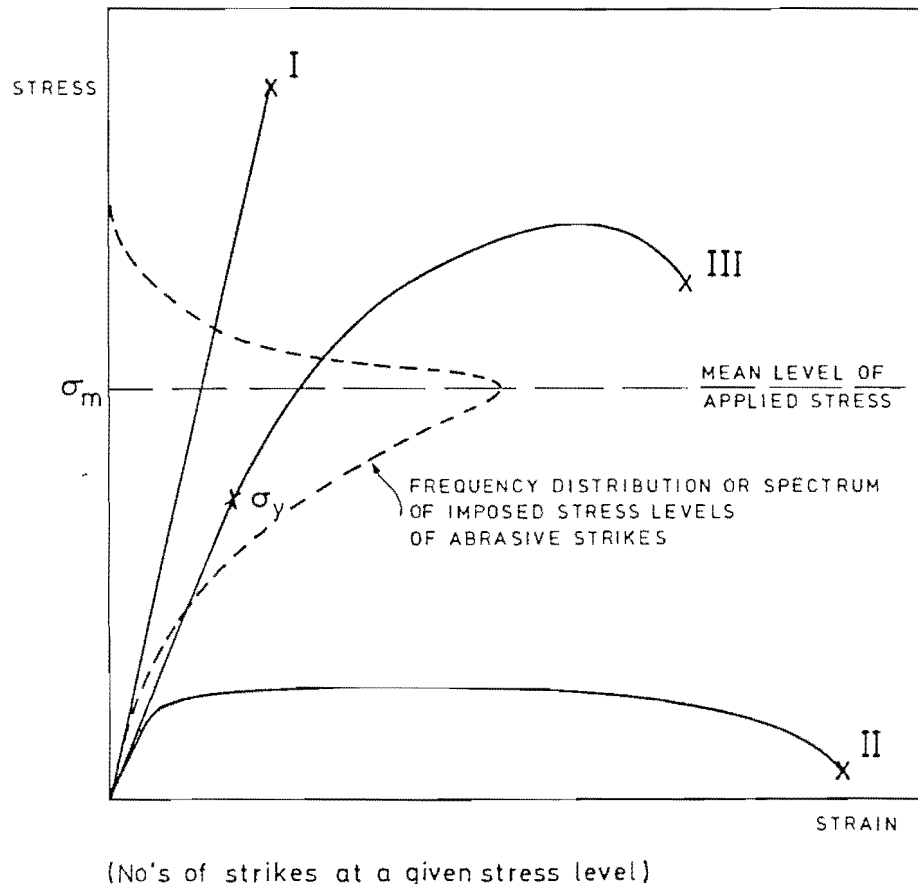
FIGURE 4.8 : The hypothetical stress-strain curves for the wear of three classes of materials. These are superimposed on the frequency distribution of abrasive or erosive strikes of a given stress magnitude.

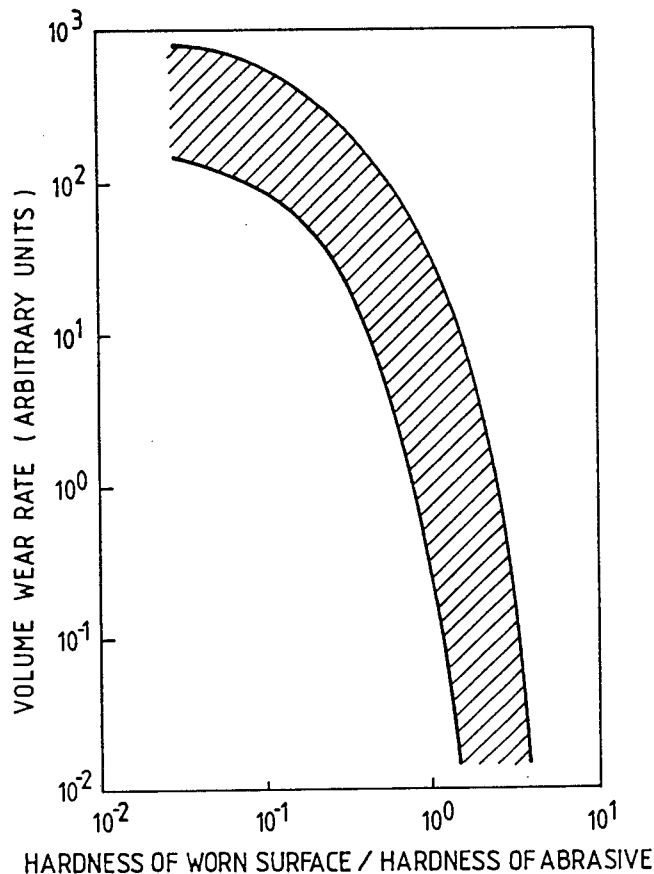
FIGURE 4.9 : Effect of abrasive hardness on the wear of metallic materials and ceramics (Moore, 1980). Note the drastic drop in wear rate at the point where the material hardness is about 0.8 times the abrasive hardness.

Moore (1980) illustrates a relationship between wear volume and the ratio of the hardness of the worn surface and the hardness of the abrasive. This is shown in figure 4.9.

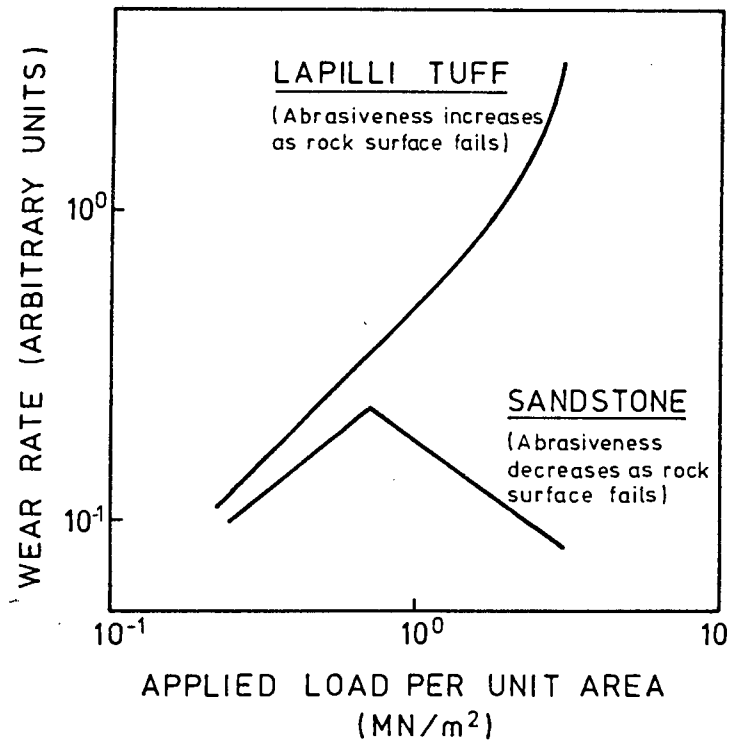
FIGURE 4.10 : The effect of surface failure for hard and soft abrasives. The abrasiveness of the lapilli tuff increases as the rock surface fails whereas the abrasiveness of the sandstone does not (Moore, 1980).

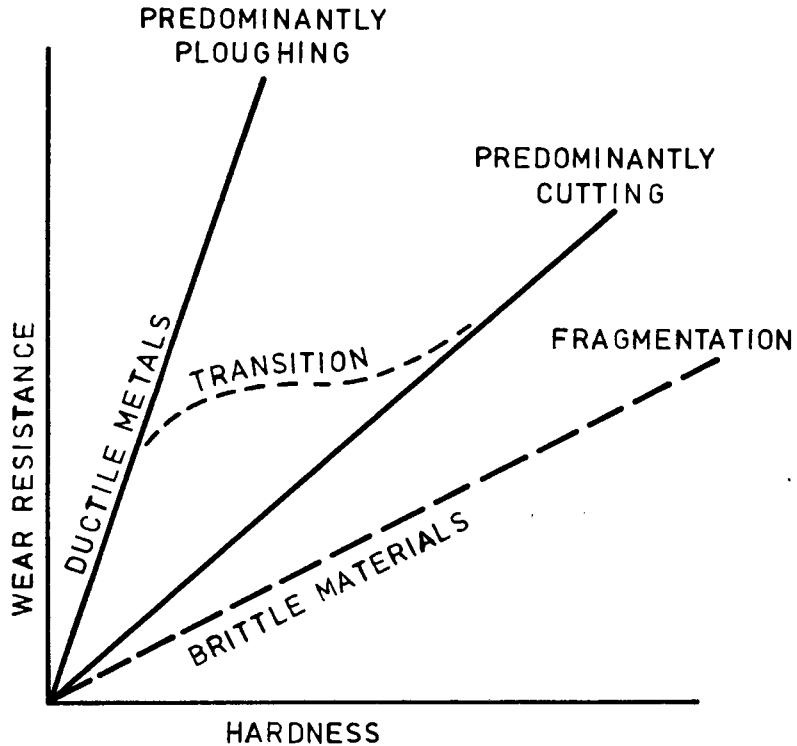
FIGURE 4.14 : The sigmoidal shape of hardness vs wear resistance curves is shown to be related to the change in the mode of material removal from predominantly ploughing to predominantly cutting as the hardness of a steel is increased.

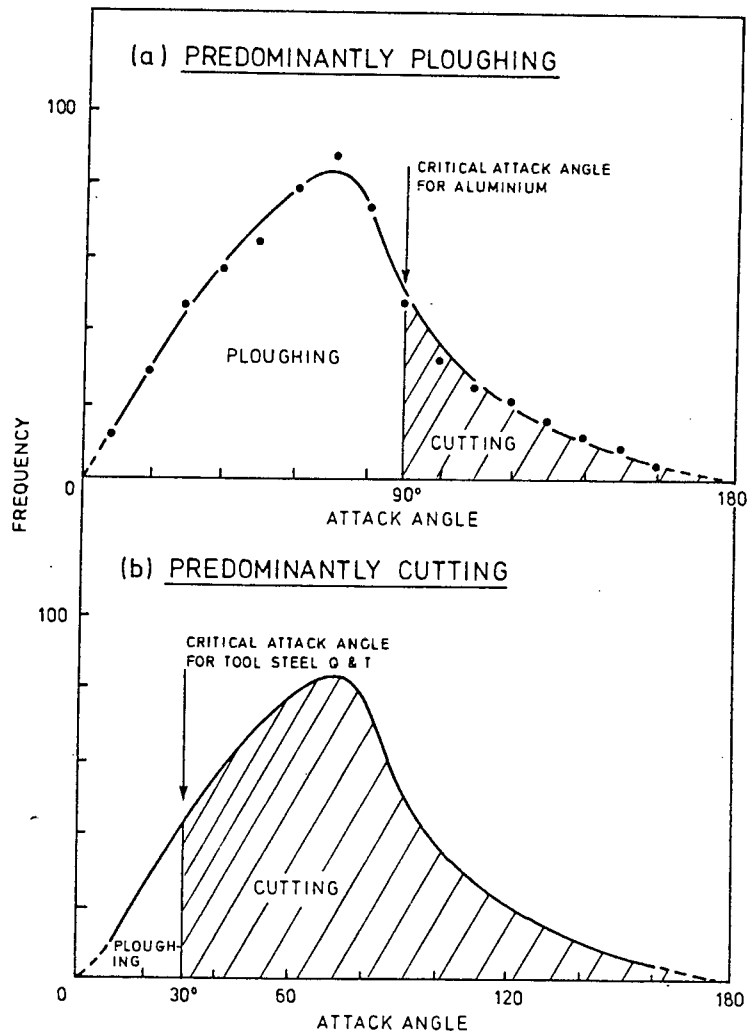
FIGURE 4.16 : The influence of the critical attack angle on the mechanisms of groove formation.

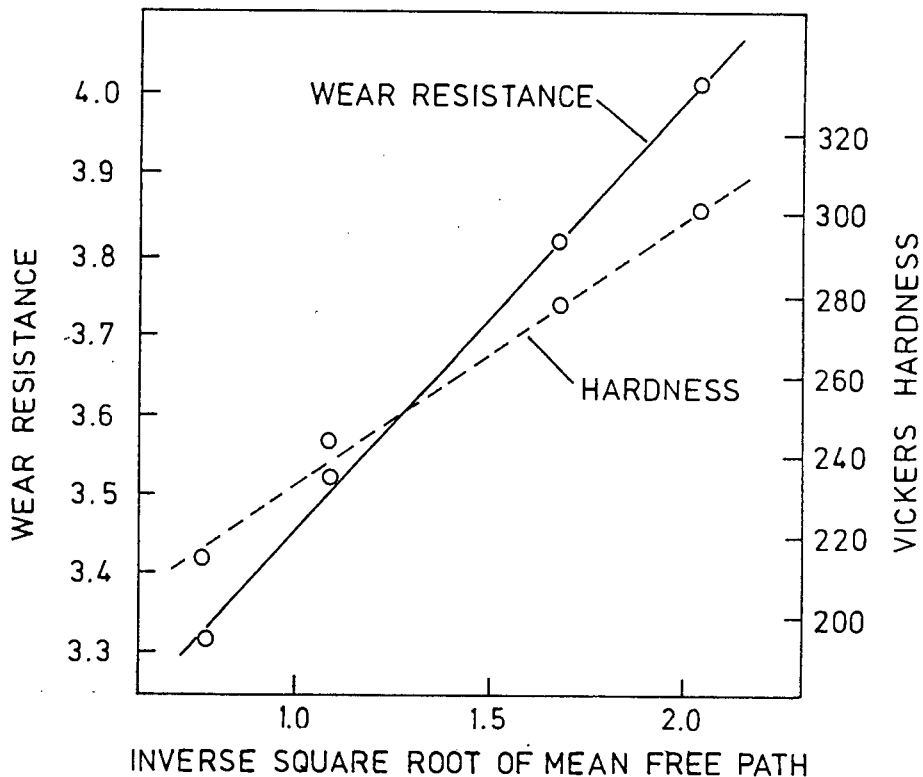
FIGURE 4.17 : Relationship between abrasion resistance and mean free path through the matrix (Zum Gahr, 1979).

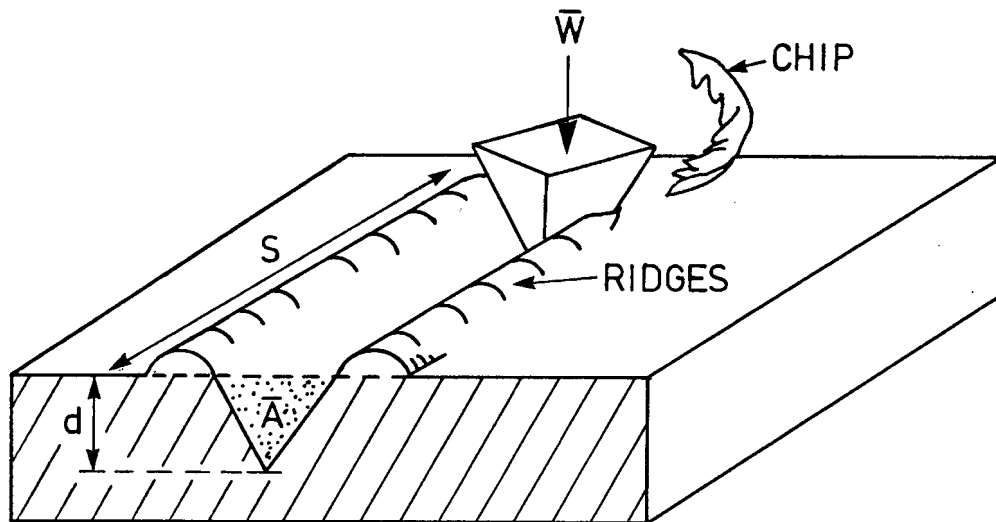
Figure 4.18 : Model of abrasive wear

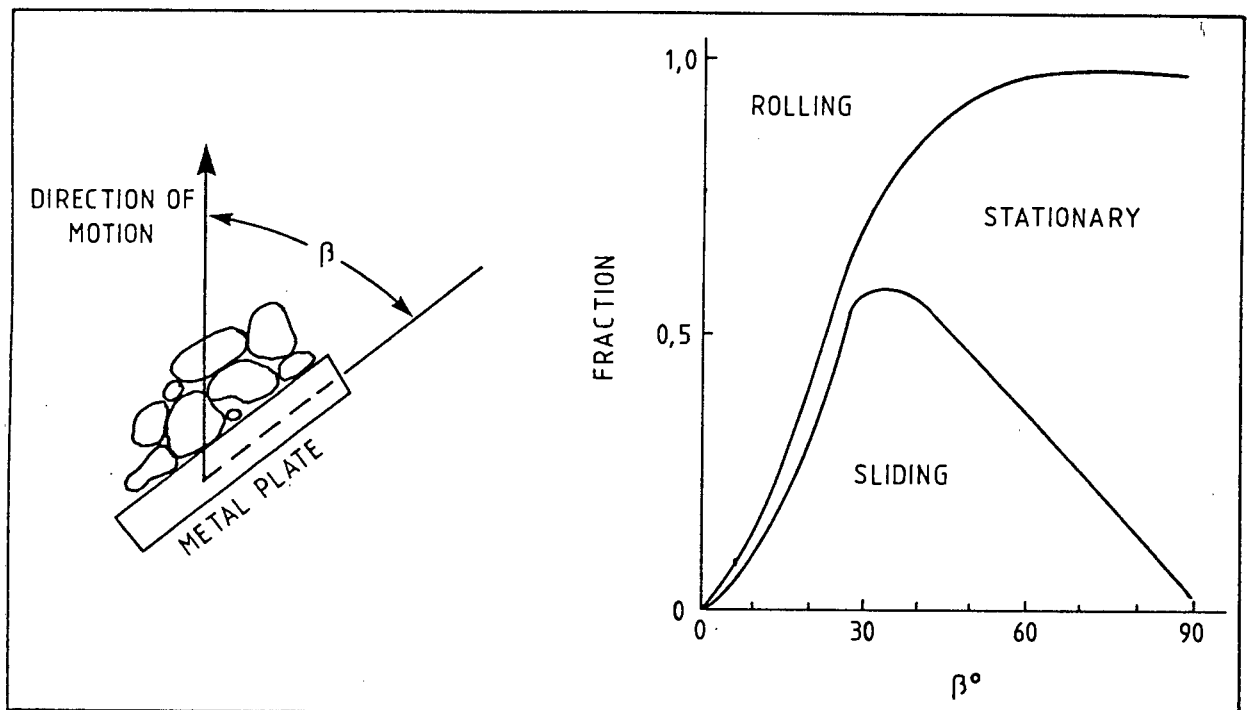
FIGURE 4.20 : The relationship between the orientation of a flat plate moving through the soil and the reaction of soil particles.

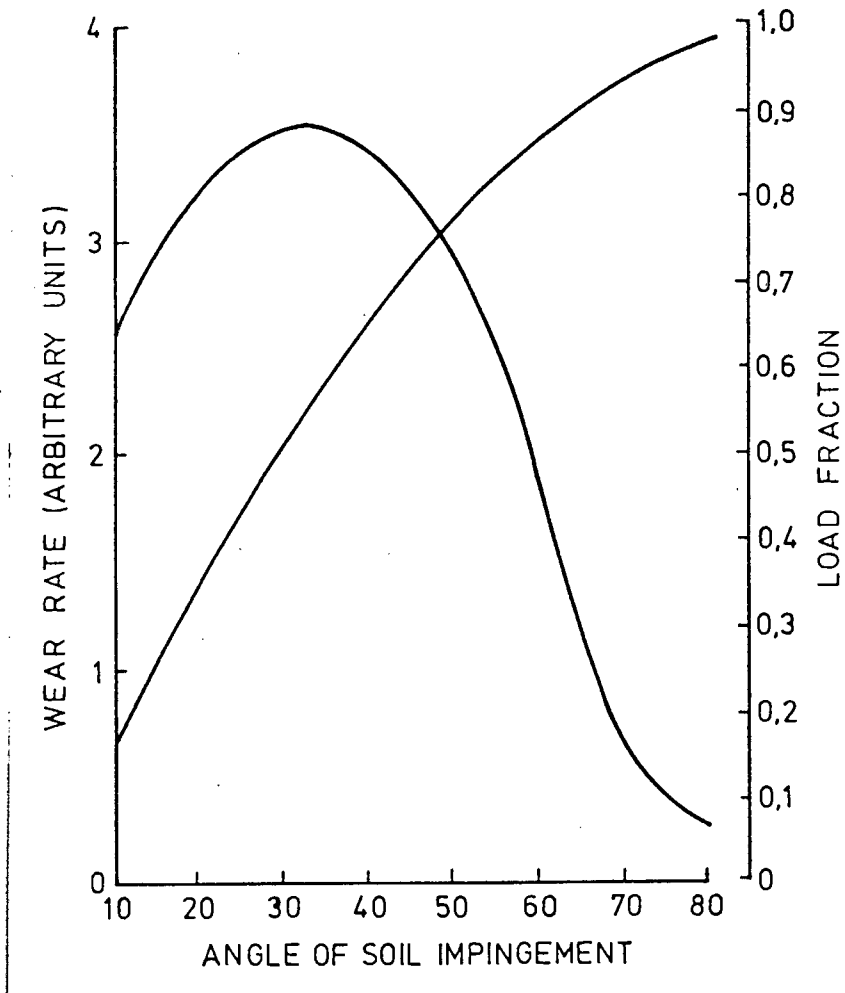
FIGURE 4.22 : Comparison of the change in wear rate and load on a plate with change in angle of soil implement (Moore, 1985).

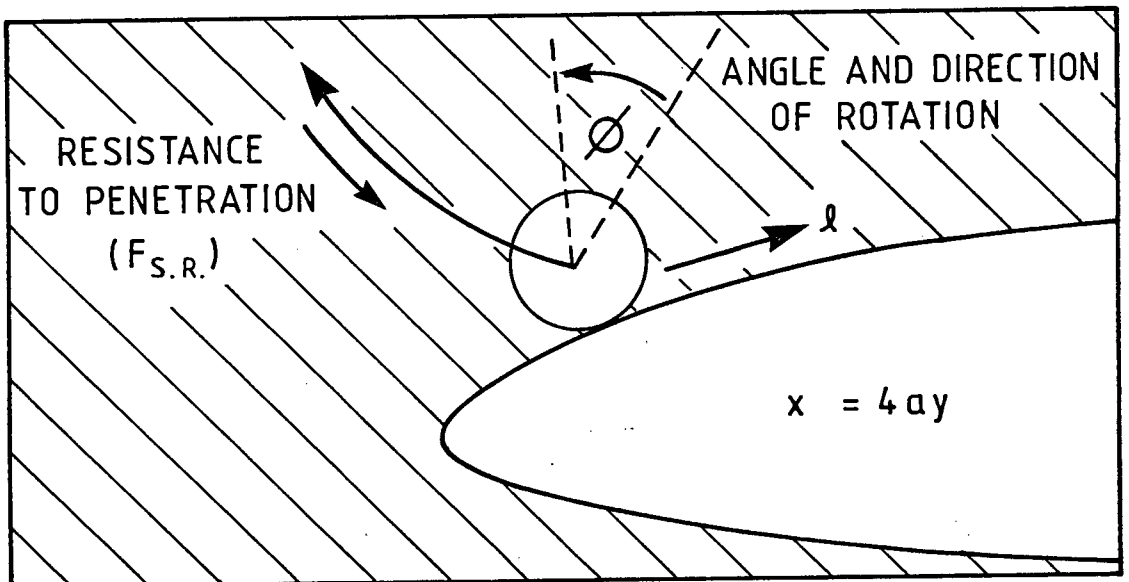
FIGURE 4.23 : Wear of a parabolic profile in stony soil. Rotation of a stone across the surface.

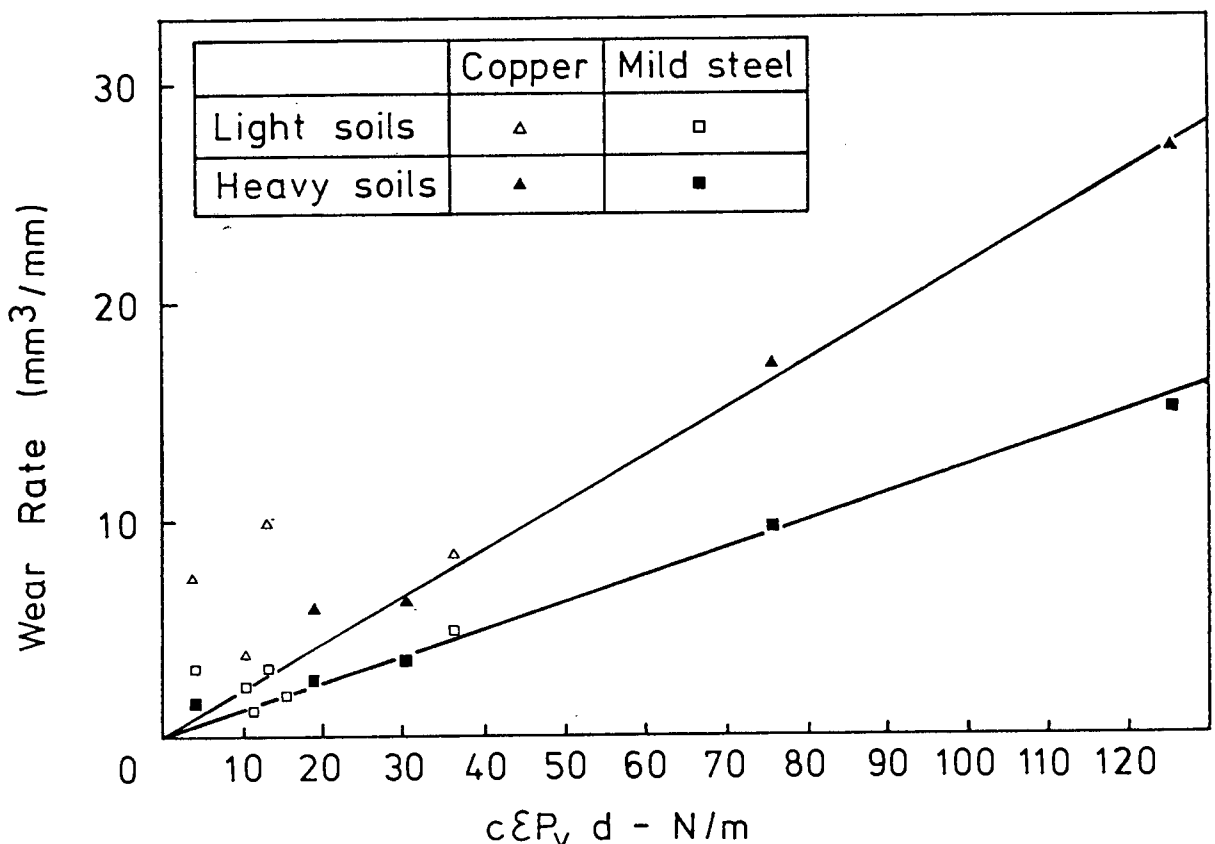
FIGURE 4.24 : Correlation between wear rate and the soil cohesive strength and the sum of the products of stone diameter and volume fraction in soil $C \sum P_v d$ (Moore, 1975).

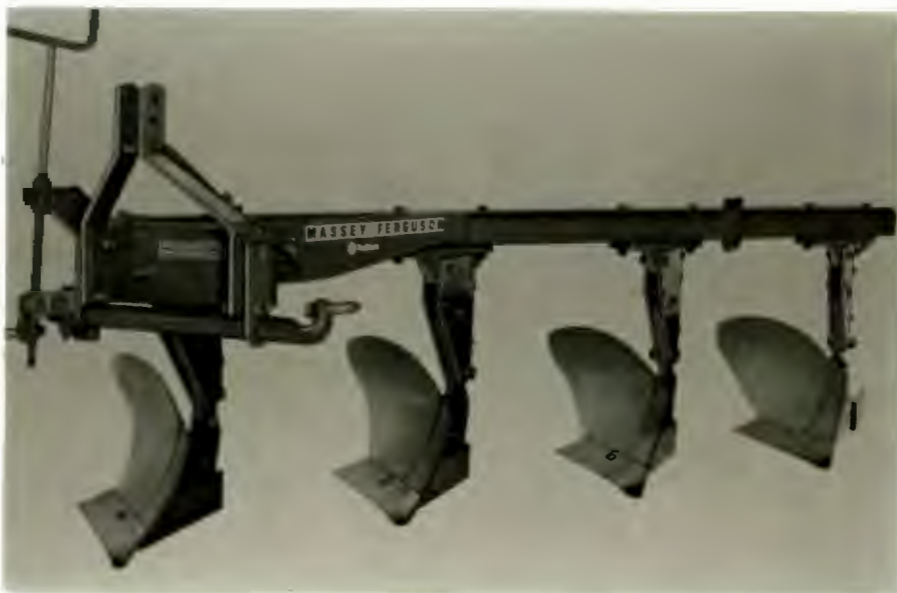
This is an implement used to lift and invert the soil. The four elements comprising this tool each play a role in the production of straight, evenly spaced furrows, namely:

1. A share : A share undercuts the soil and lifts it onto the mouldboard.
2. A shin : The shin is a vertically set blade that neatly cuts the width of each slice of soil.
3. A mouldboard: This is a curved plate designed to turn the slice of soil over in the most efficient manner possible.
4. A landside : A landside is a straight plate which runs along the edge of the cut produced by the shin. This keeps the implement aligned, making it possible to plough along straight furrows.

FIGURE 5.1 : The mouldboard plough.

The theory of operation may be easy to state but in practice design and setting is fundamental to performance. There exists a complex relationship between the four elements comprising the plough. Each one plays a role in the production of straight evenly shaped furrows.

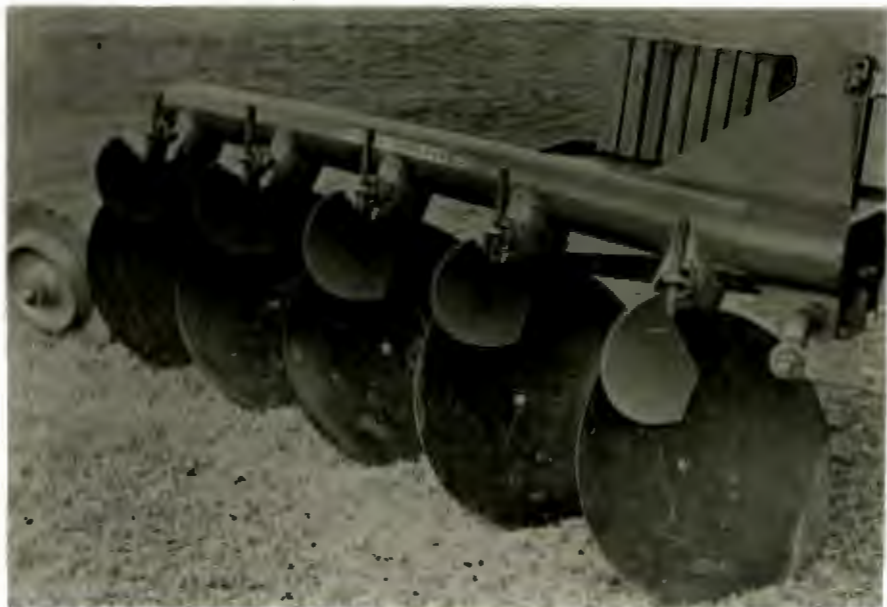
This is an implement used to invert the soil. It is used where soils are very hard and resist penetration by a mouldboard. A series of concave discs are set on a frame. For greater efficiency the plane in which their circumference lies may be set at a predetermined angle to the direction of movement of the tractor.

FIGURE 5.2 : A disc plough.

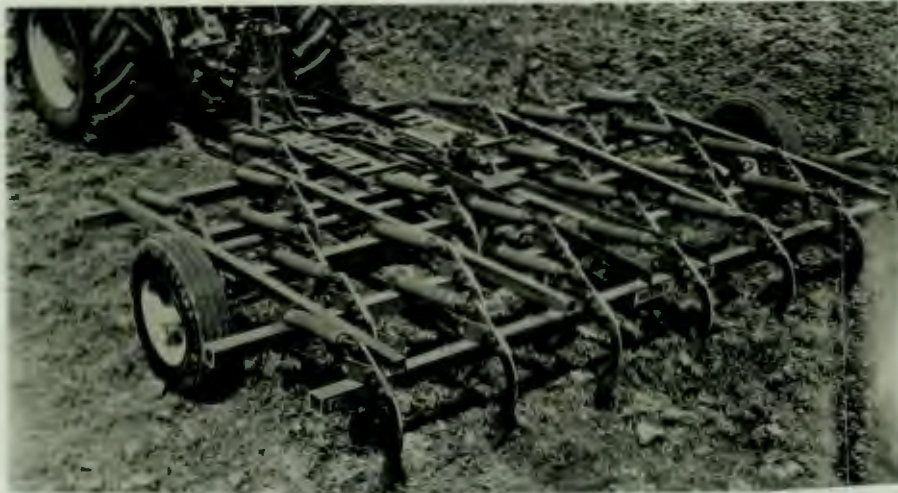
This is a light shallow working tool with flanged points. It may be used in conjunction with heavier tools for final seed bed preparation as well as weed control in vineyards and orchards. The point works at a depth of approximately 10 cms to cover seed or uproots weeds which then die in the sun (fig. 5.3).

FIGURE 5.3 : A scarifier.

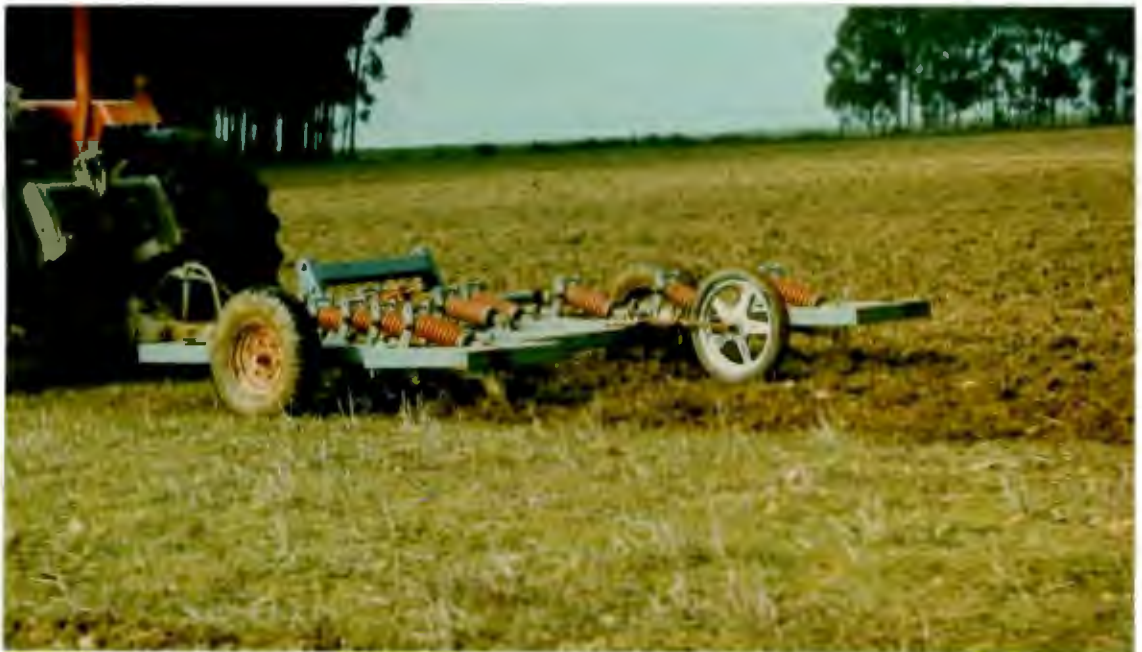
FIGURE 5.4 : Ripper plough used in tests.
