ABRASIVE WEAR TESTING OF STEELS IN SOIL

A thesis submitted to the Faculty of Engineering,
University of Cape Town in fulfilment of the degree
of Master of Science in Applied Science.

Department of Materials Engineering
University of Cape Town

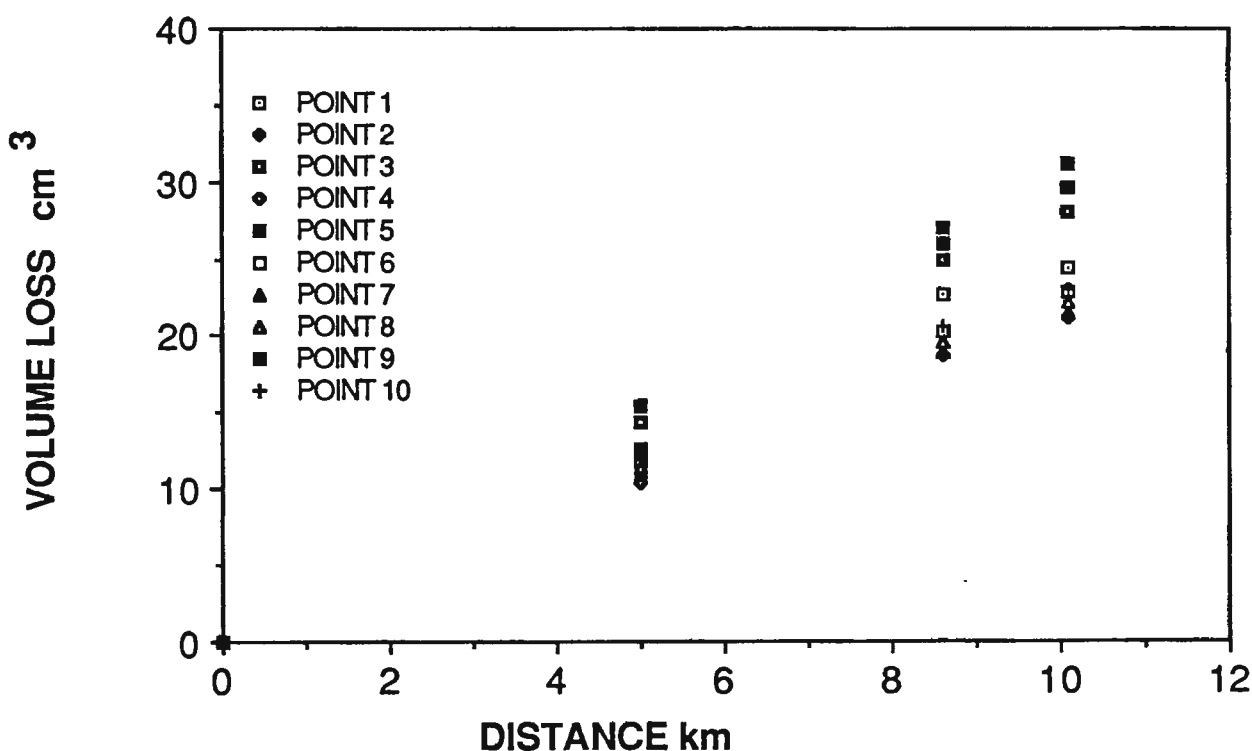
FIGURE 5.6 : Results of field test.

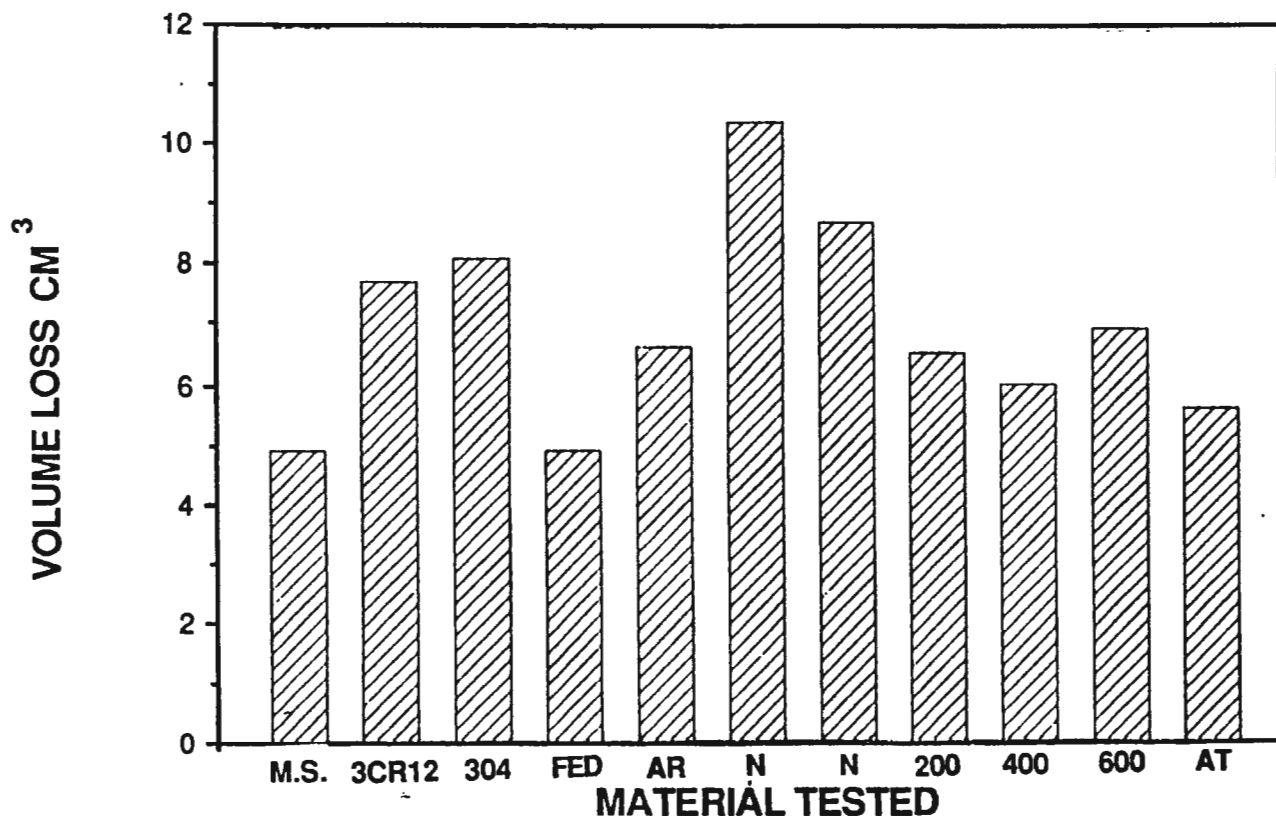
FIGURE 5.8 : Results of tests on various materials on ripper plough.

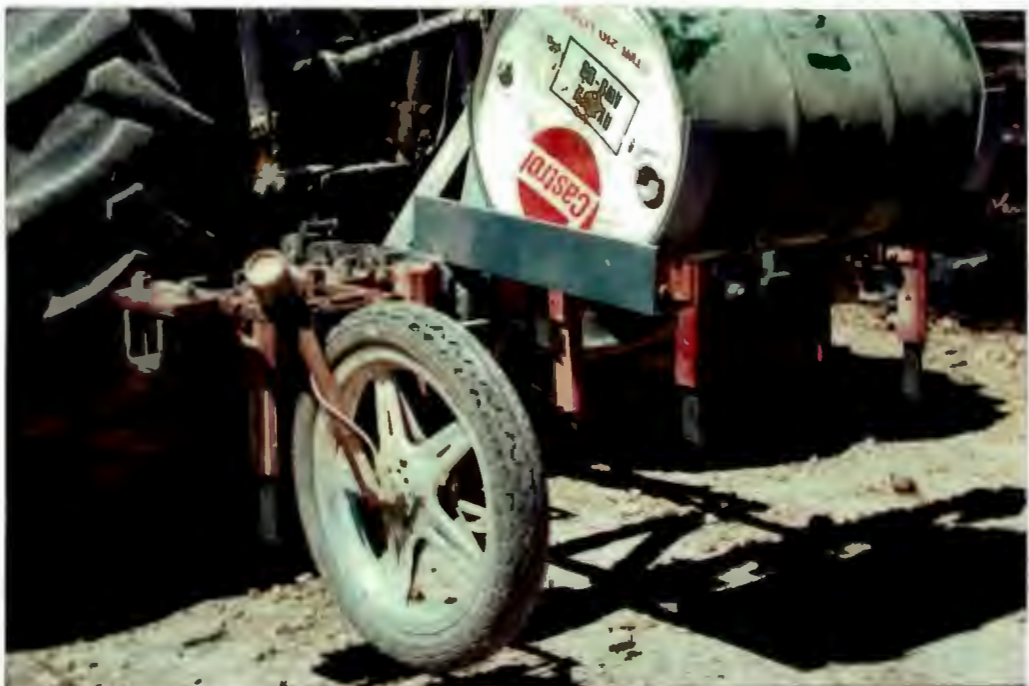
The design chosen for the field test rig consisted of six welded sleeves into which sections of flat bar, 16 x 50 mm, could be fitted. These specimens were held in position by means of a 20 mm diameter bolt. The sleeves then were bolted firmly onto a 2 m long section of 100 x 100 mm square tubing. The tubing was mounted onto a tractor tool bar with three point linkage, perpendicular to the ploughing direction. The rig is shown in figure 5.11.

FIGURE 5.11 : The field abrasion test rig.

Abrading six specimen of manageable size simultaneously is a simple, quick and controlled method of testing with a high rate of data production.

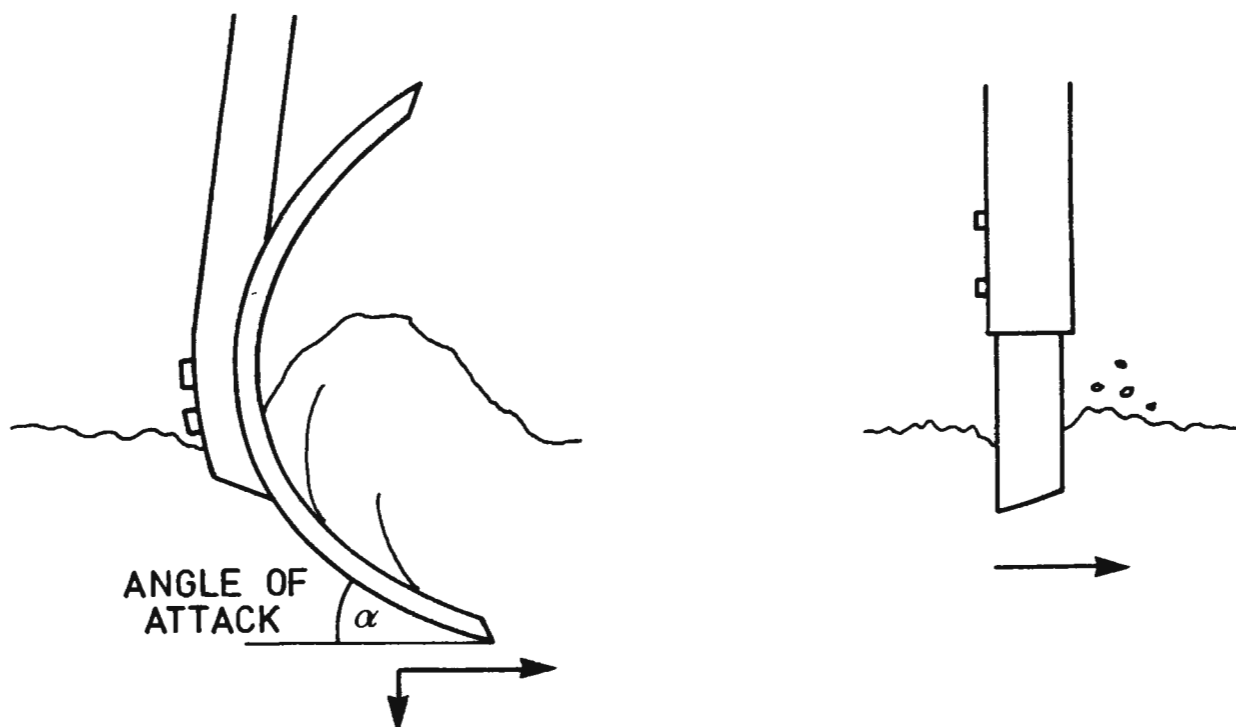
FIGURE 5.12 : A ripper point is drawn down into the soil. The points on the test rig however tended to be forced out of the soil.

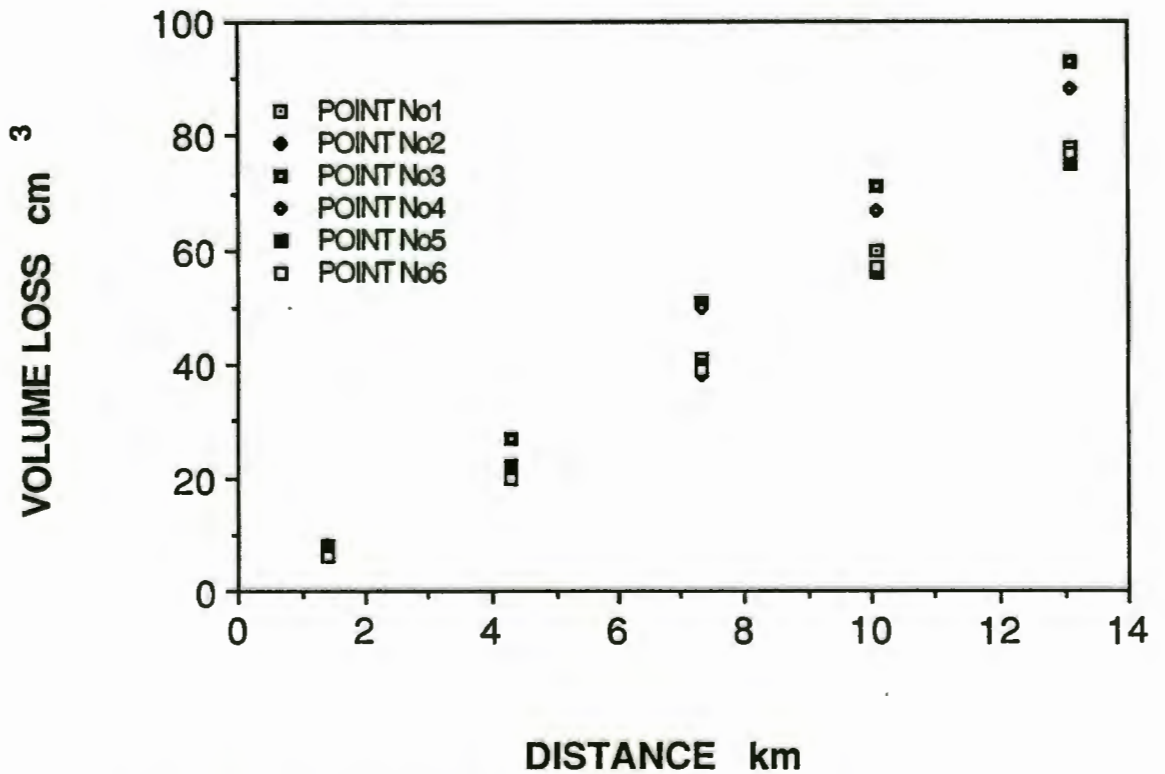
FIGURE 5.13 : The volume loss on the specimens in the new test rig.

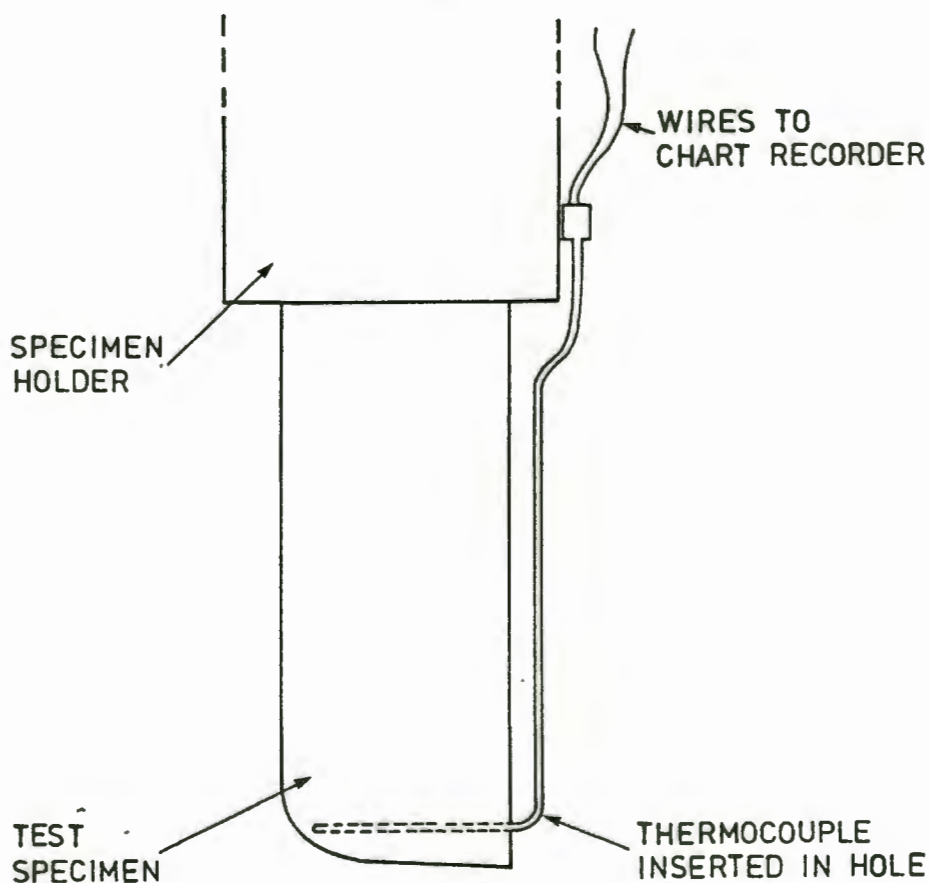
FIGURE 5.14 : Specimen with thermocouple in place.

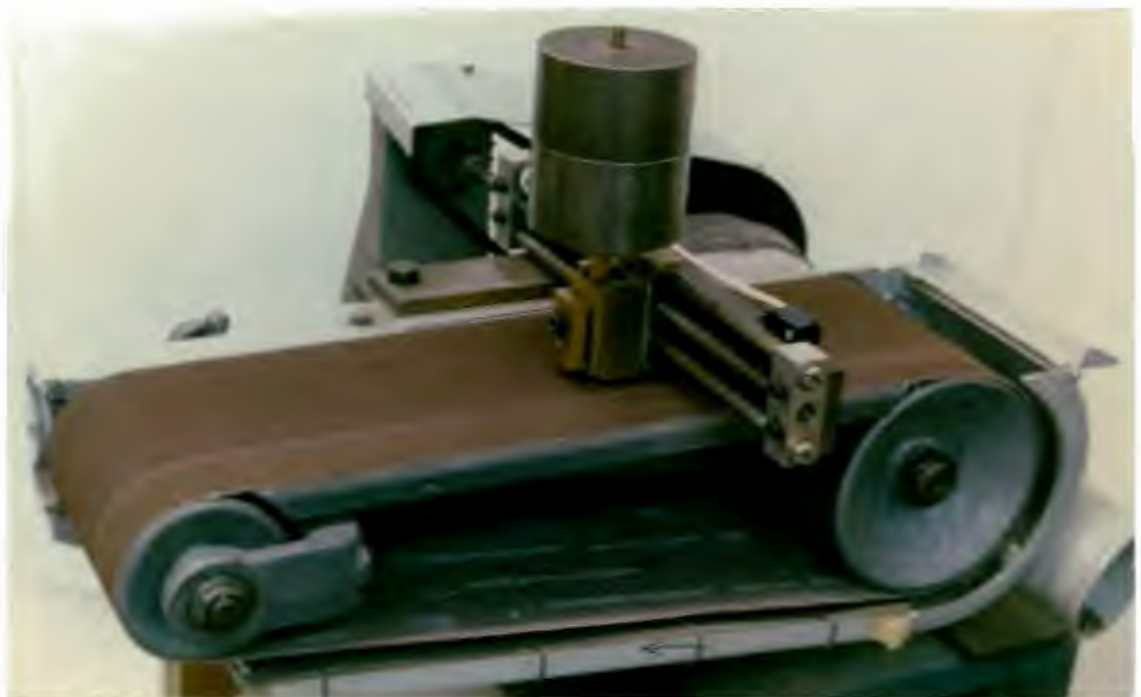
FIGURE 5.15 : The laboratory abrasion test equipment.

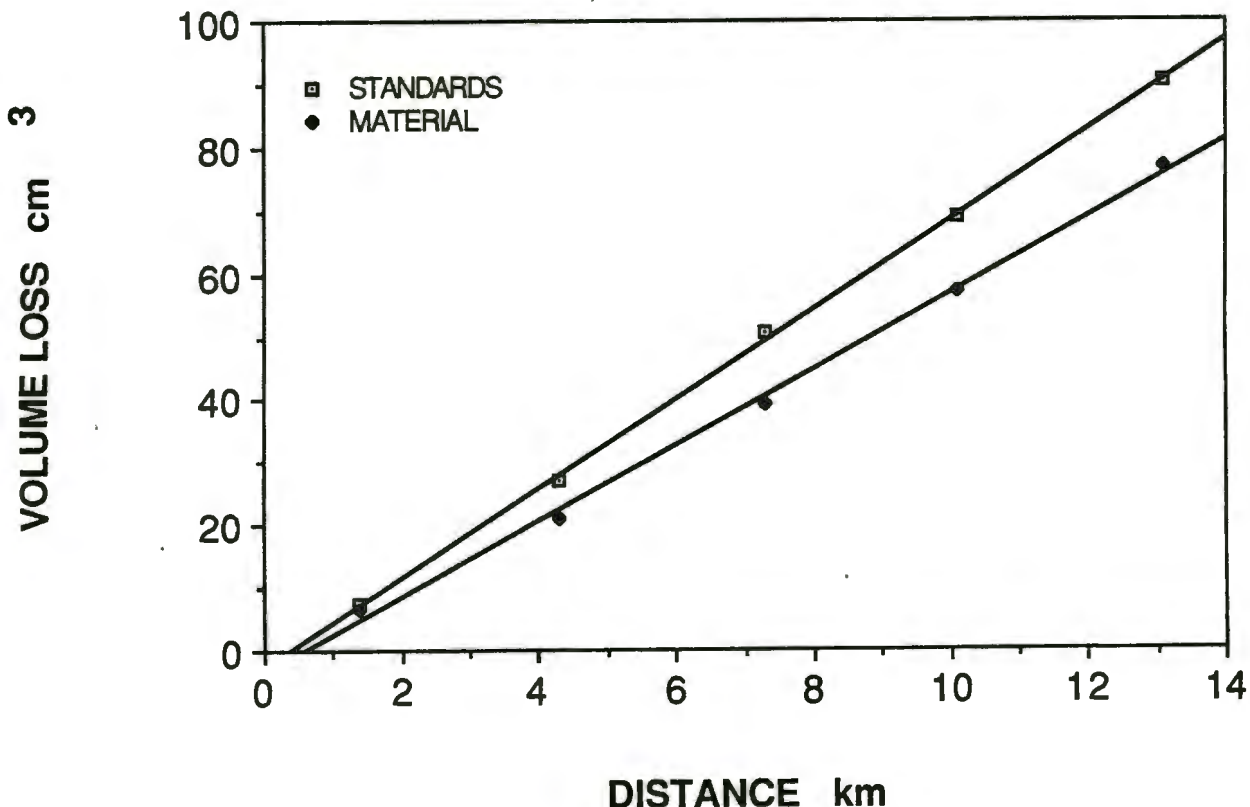
FIGURE 6.1 : Results of a field test on normalized SS 10/200. This clearly shows the higher wear rates registered on points 3 and 4.

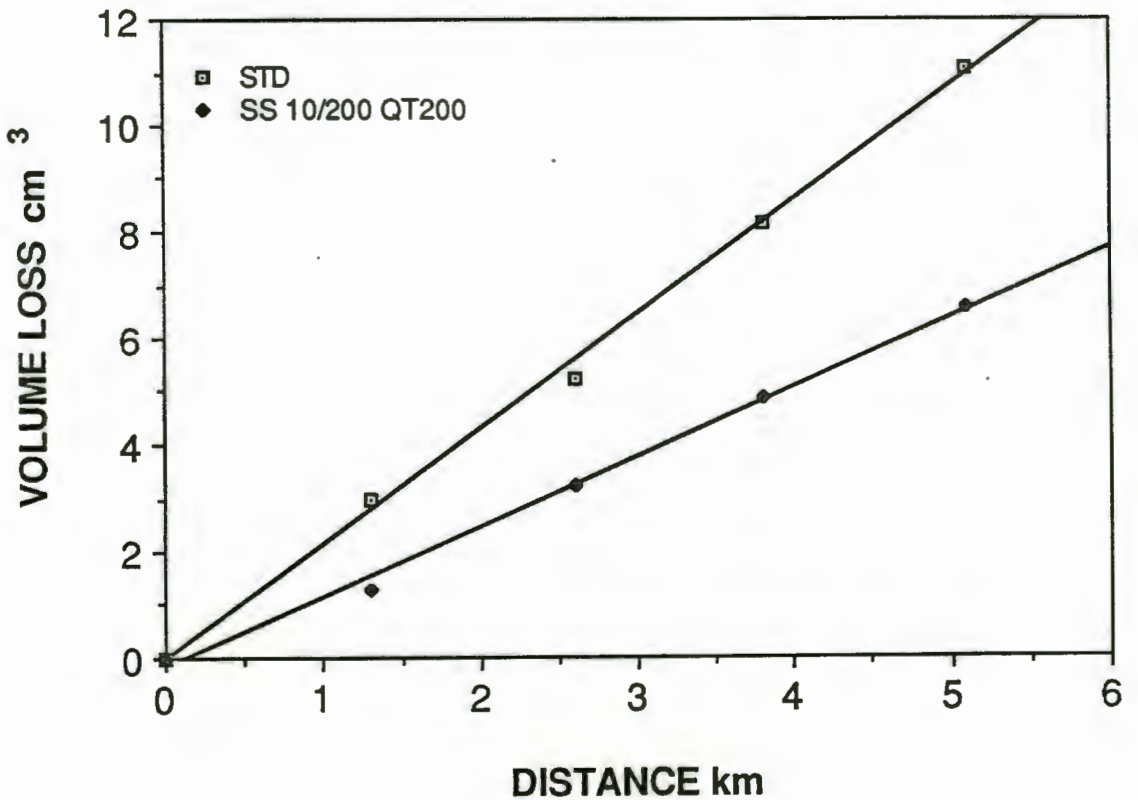
FIGURE 6.2 : The test on SS 10/200 quenched and tempered at 200°C. The correlation coefficient for both the material and the standard was 0,994.

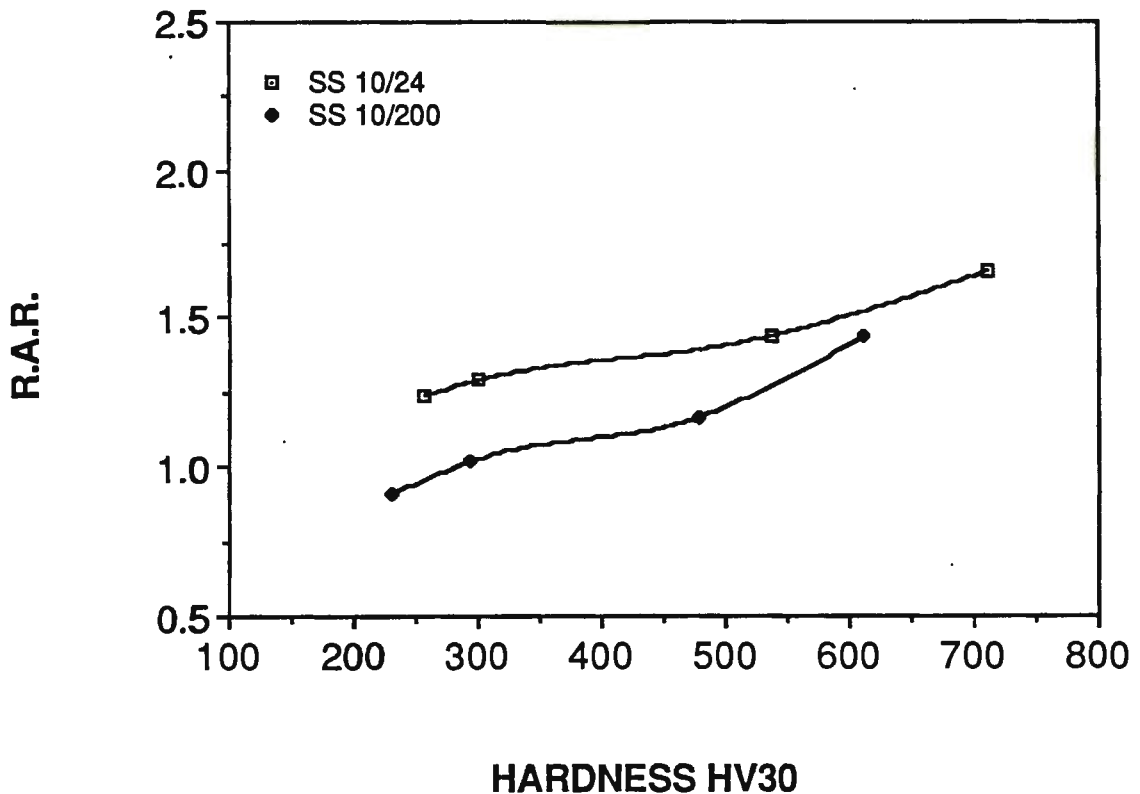
FIGURE 6.5 : Plot of hardness against RAR for SS 10/200 and 10/24.

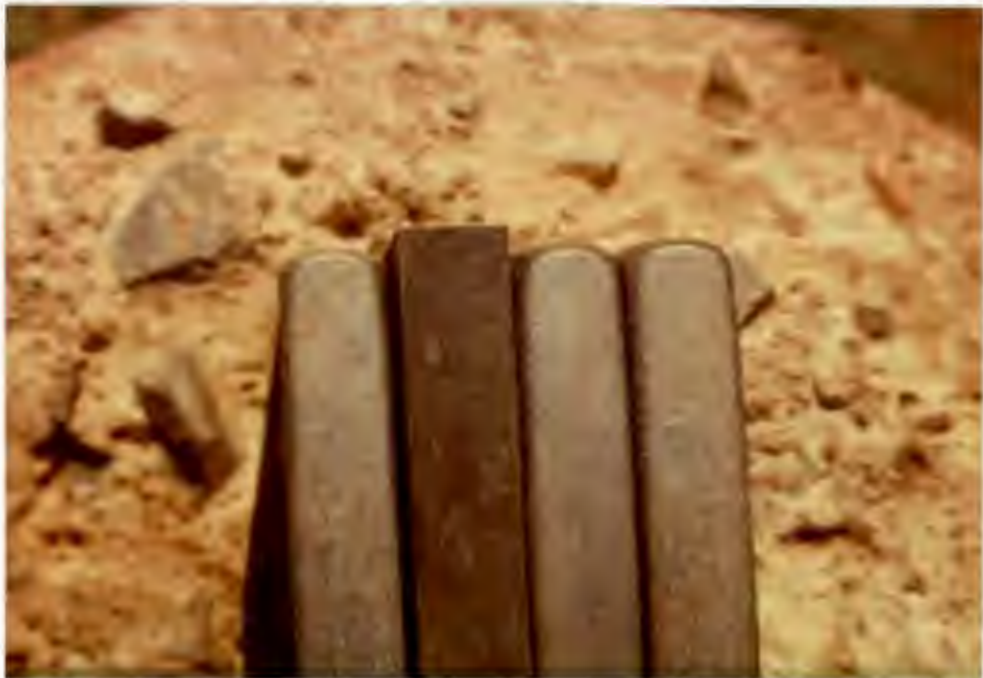
FIGURE 6.7 : Specimens after one run in the field, compared with an unworn sample.

During testing a parabolic profile formed on each specimen, as depicted in figure 6.6 and illustrated in figures 6.7 and 6.8. However, the high rate of material loss at the bottom of each bar during ploughing retarded the process. Each specimen was shorted by approximately 2 mm with each run, depending on wear resistance. The difference between the shape of each sample for each test run was minimal after the first run. A parabolic profile then gradually took form from the front face of the specimen. Initially, the only effect noticeable was a rounding of the bottom edges of the bar. The slow change in shape was ideal for comparing wear rates. Generally, after many tests the specimen profile became quite sharp. The leading edge became quite narrow. An example of this is shown in figure 6.8.

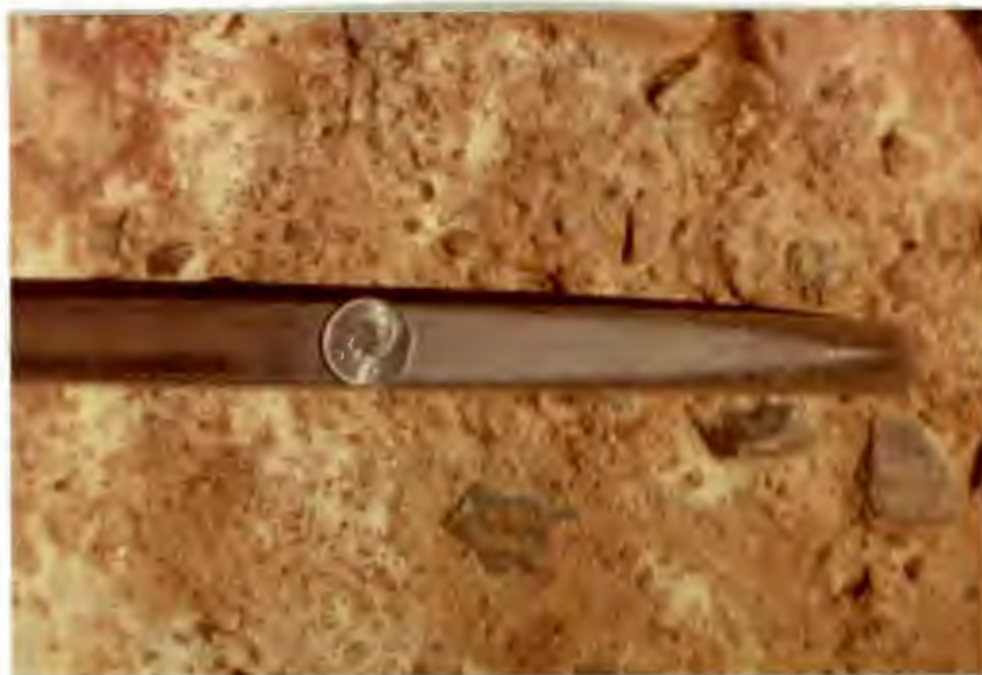
FIGURE 6.8 : The profile became well developed after many tests.

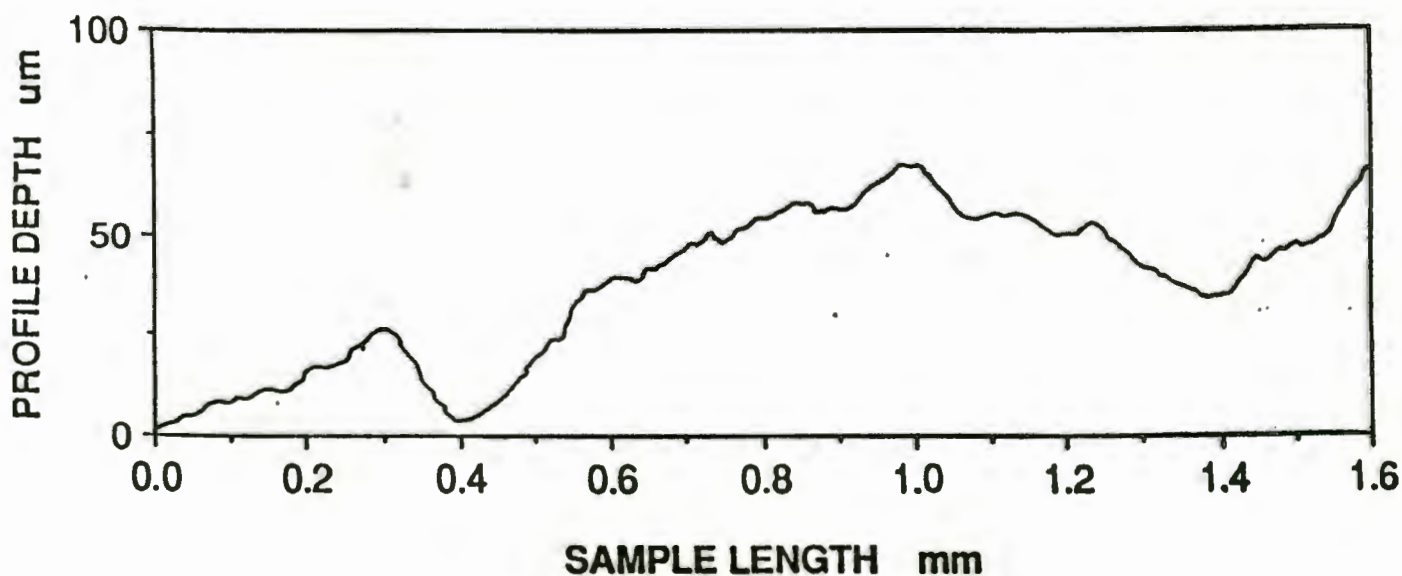
FIGURE 6.9 : The surface of the mild steel specimen.

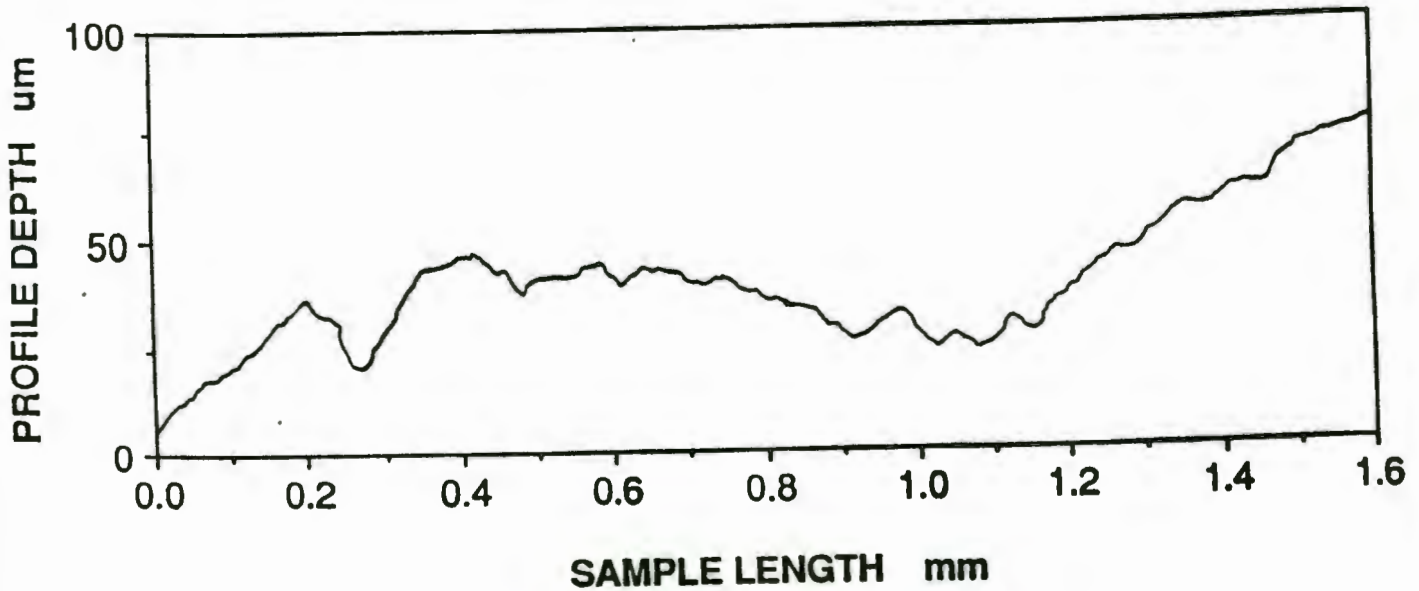
FIGURE 6.10 : The surface of the SS 10/24 quenched and tempered at 200°C.

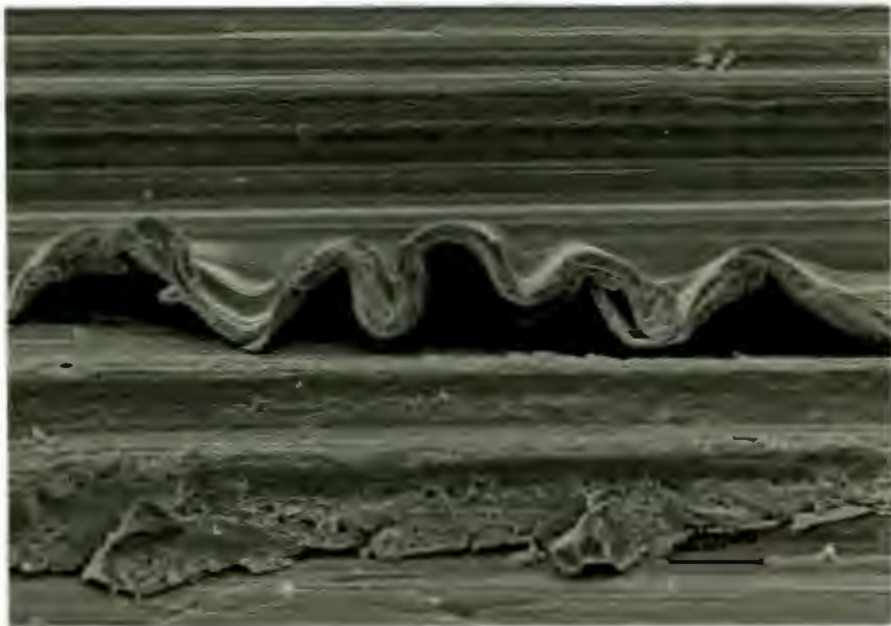
FIGURE 6.11 : Ploughing structures on an SS 10/200 specimen quenched and tempered at 200°C. Hardness 610HV30.

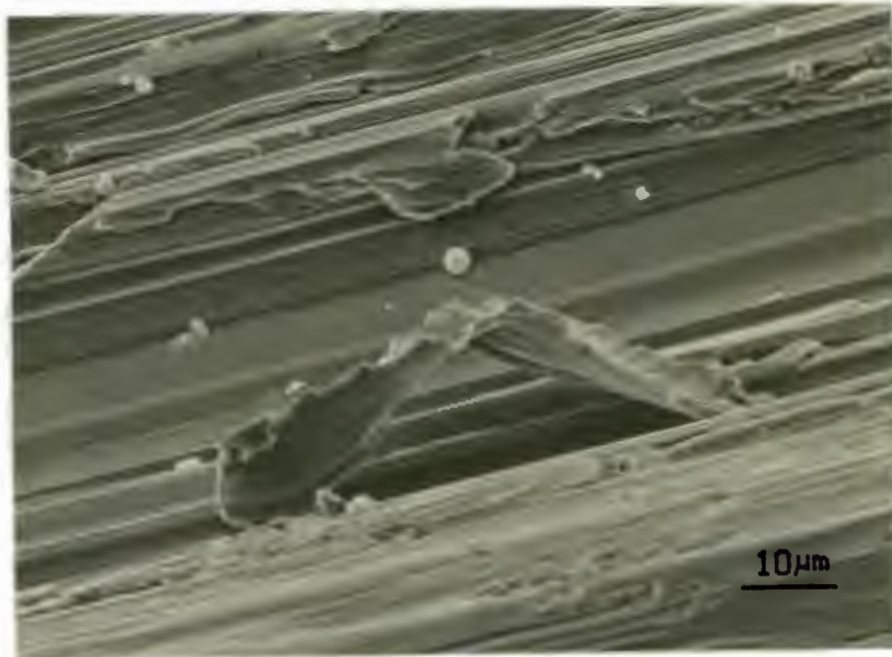
FIGURE 6.12 : A microchip formed by cutting on an SS 10/200 field specimen quenched and tempered at 200°C. Hardness 610HV30.

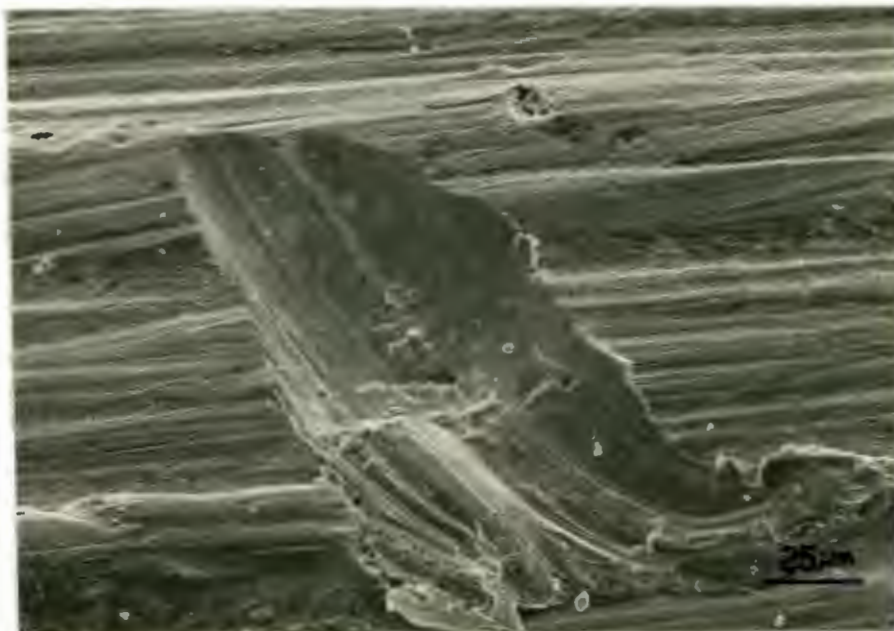
FIGURE 6.13 : A gouging structure on a normalized SS 10/24 field test specimen.

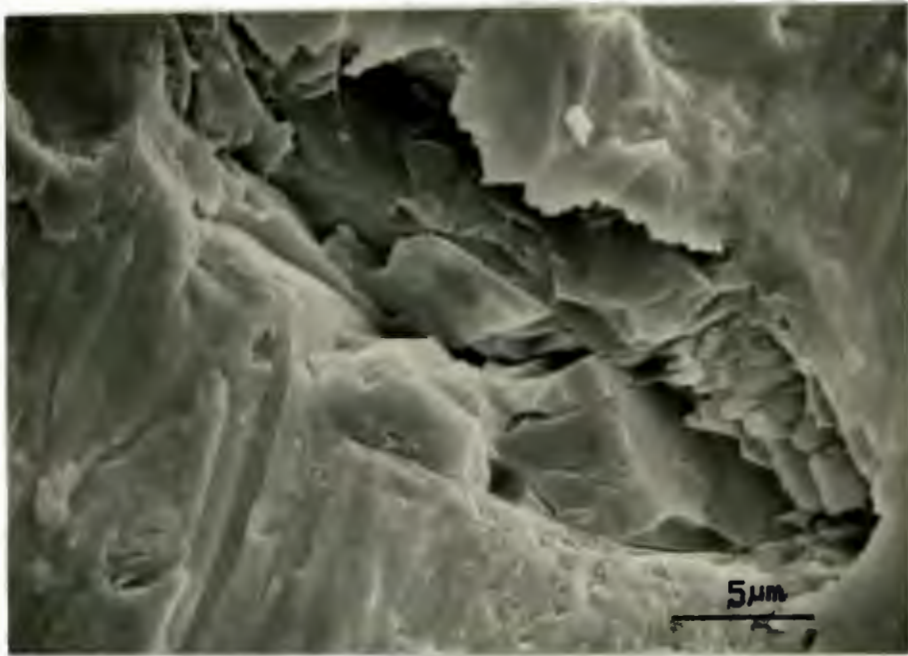
FIGURE 6.16 : A manganese sulphide particle in a mild steel field test specimen. This shows how it shatters at the surface producing chips that may be confused with rock chips. This also illustrates how the wear resistance of a steel may be impaired by brittle fracture of impurities. Hardness 108HV30.

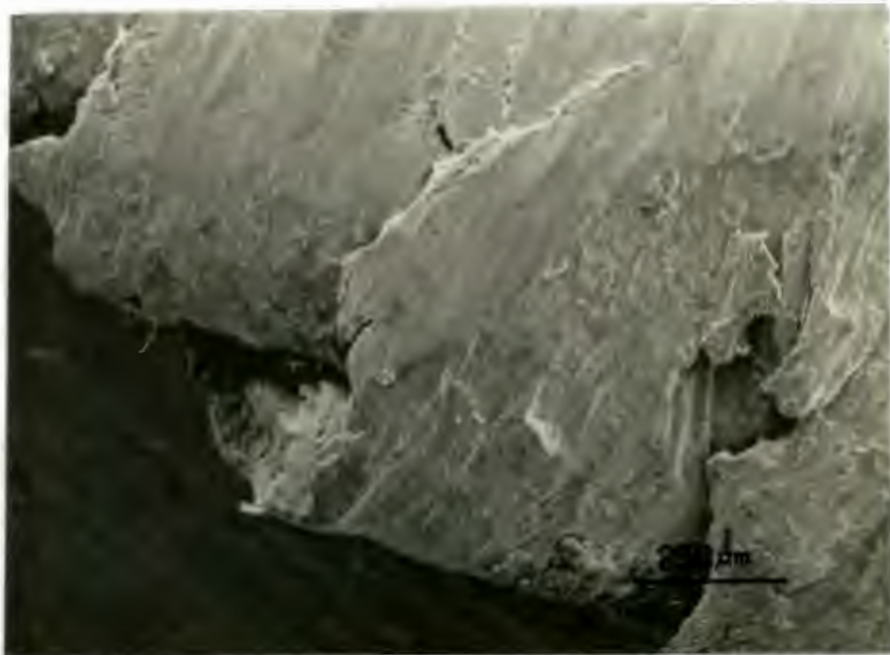
FIGURE 6.17 : Scanning electron micrograph of the burr on a field test specimen. The material is SS 10/24, hardness 257HV30.

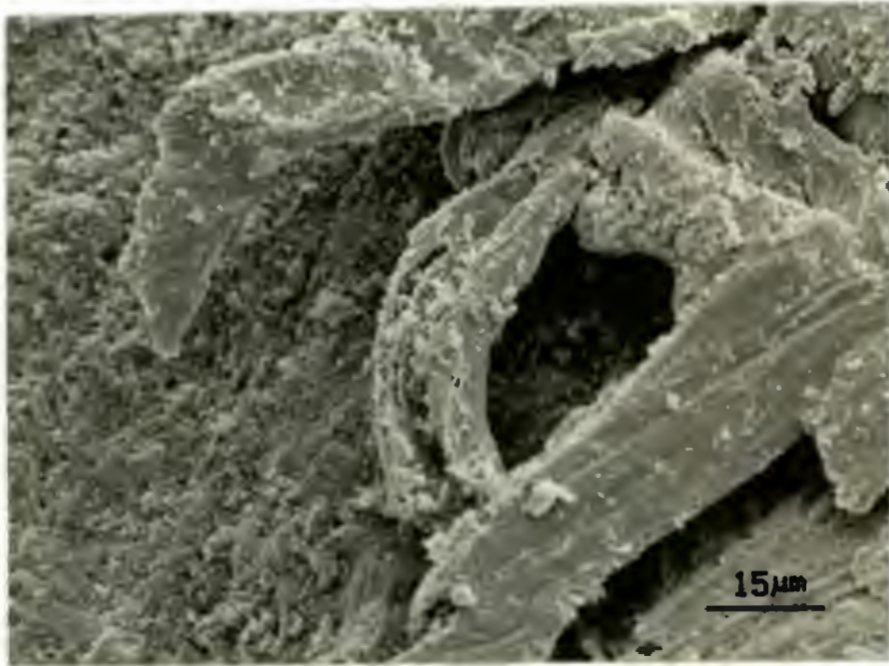
FIGURE 6.18 : Wear debris on a rock found in the field. The morphology of the debris is similar to that produced by a cutting mechanism during wear in the laboratory.

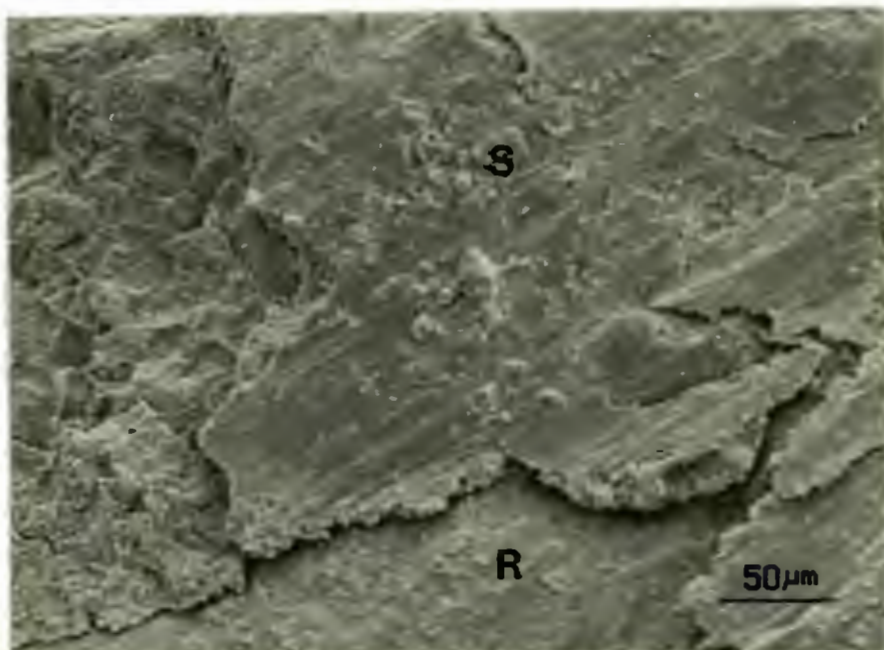
FIGURE 6.19 : Steel (S) smeared onto the rock (R).

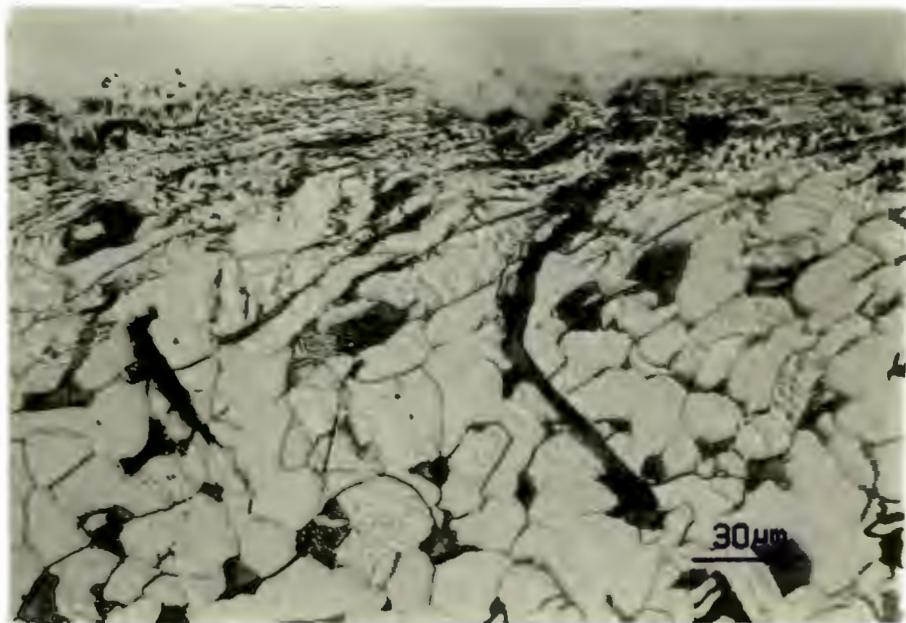
FIGURE 6.20 : A cross section normal to the worn surface of a mild steel specimen in the direction of wear. The depth at which flow begins is clearly illustrated by the deformation in a manganese sulphide stringer. Hardness 108HV30, etched in Nital.

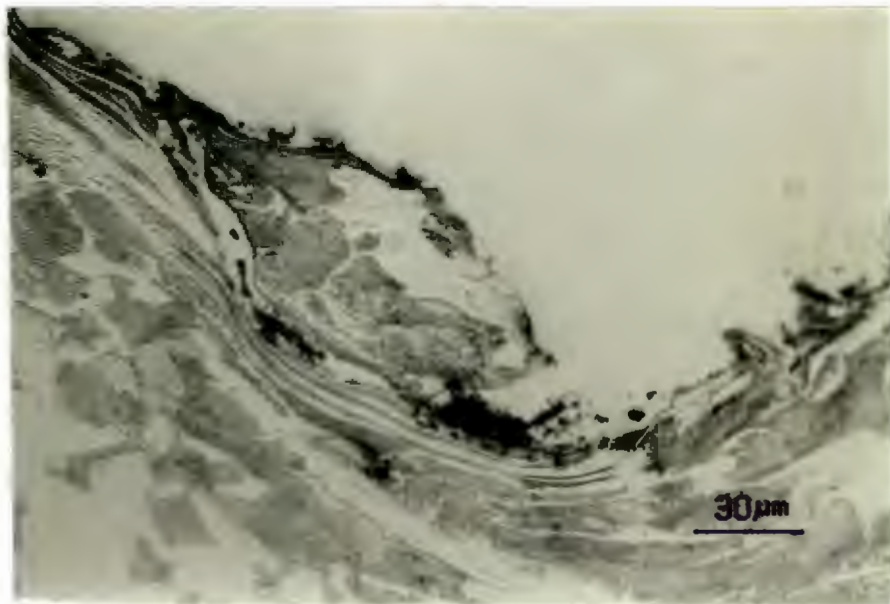
FIGURE 6.21 : The microstructure of a smearing structure similar to the one shown in figure 6.14. The material is normalized SS 10/200. Hardness 230HV30, etched in Nital.

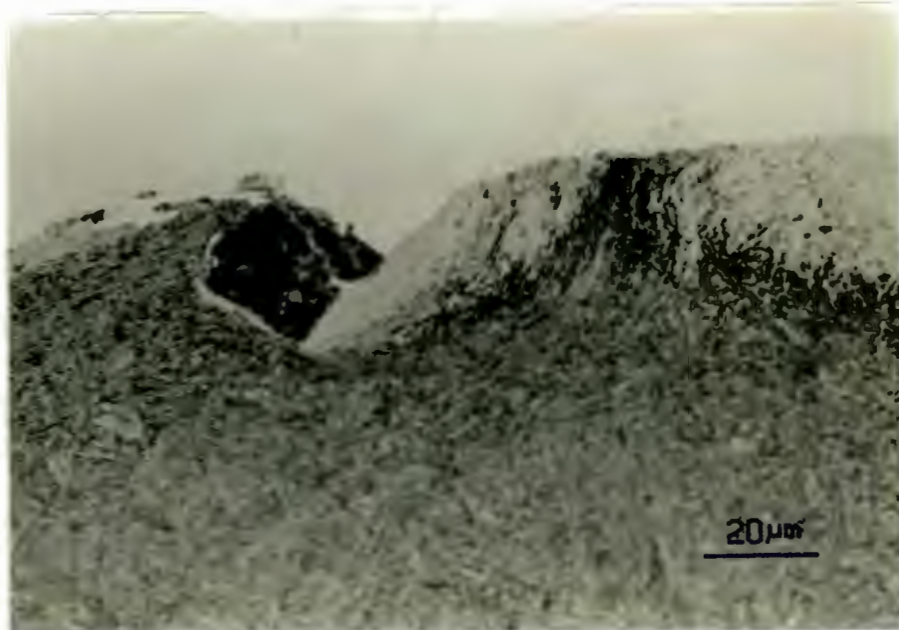
FIGURE 6.22 : Inclusion of abrasive in an SS 10/200 specimen quenched and tempered at 400°C. Hardness 479HV30, etched in Nital.

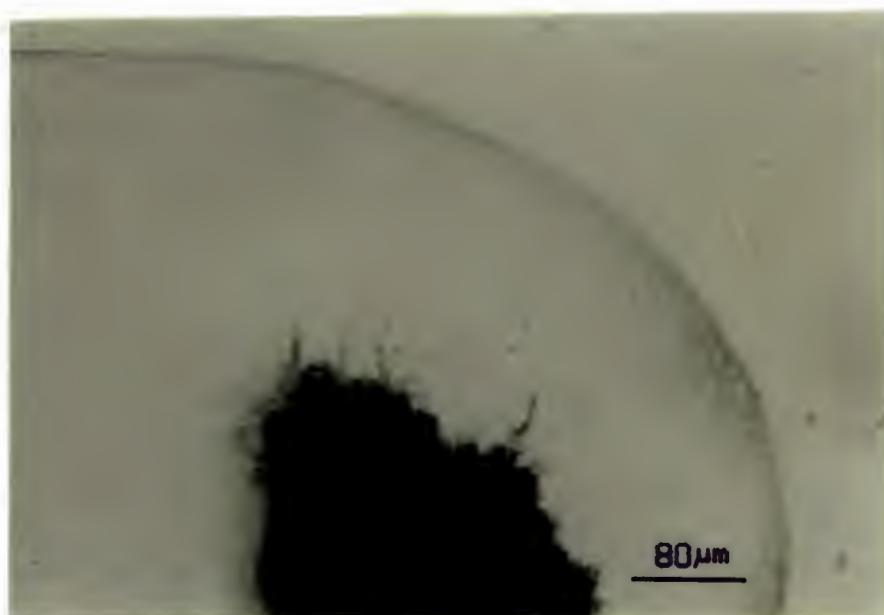
FIGURE 6.23 : Burr on the back of the Boron C8 field test specimen. Hardness 564HV30, etched in Nital.

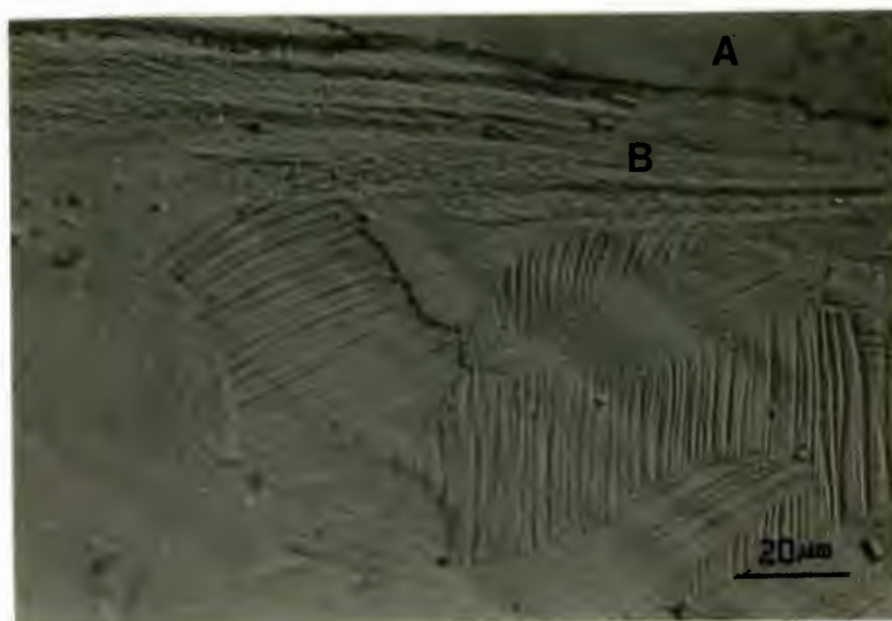
FIGURE 6.24 : The stain bands formed in AISI 304 during a field test. Region A is the nickel plate used for edge retention. B is a region of high strain similar to white layers found in plain carbon steels. Hardness 152HV30, electrolytically etched in oxalic acid.

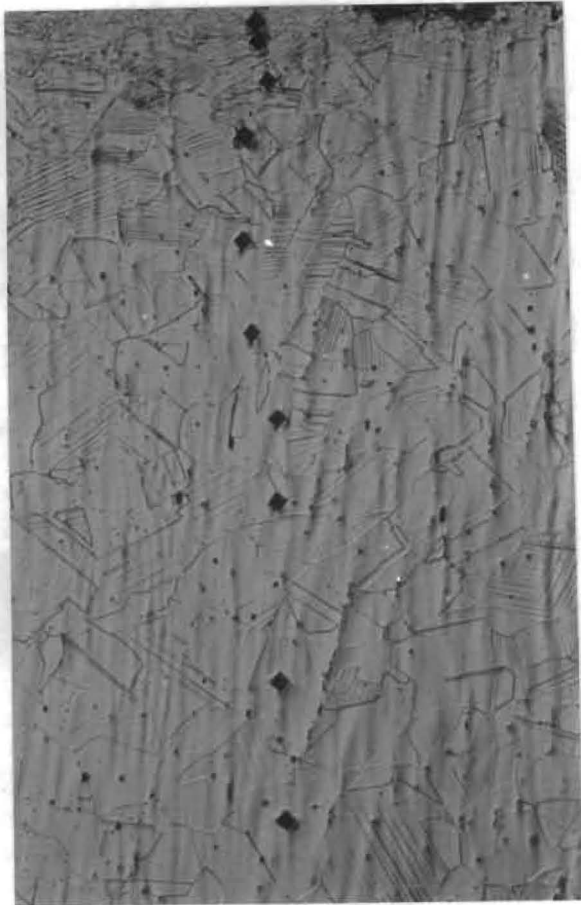
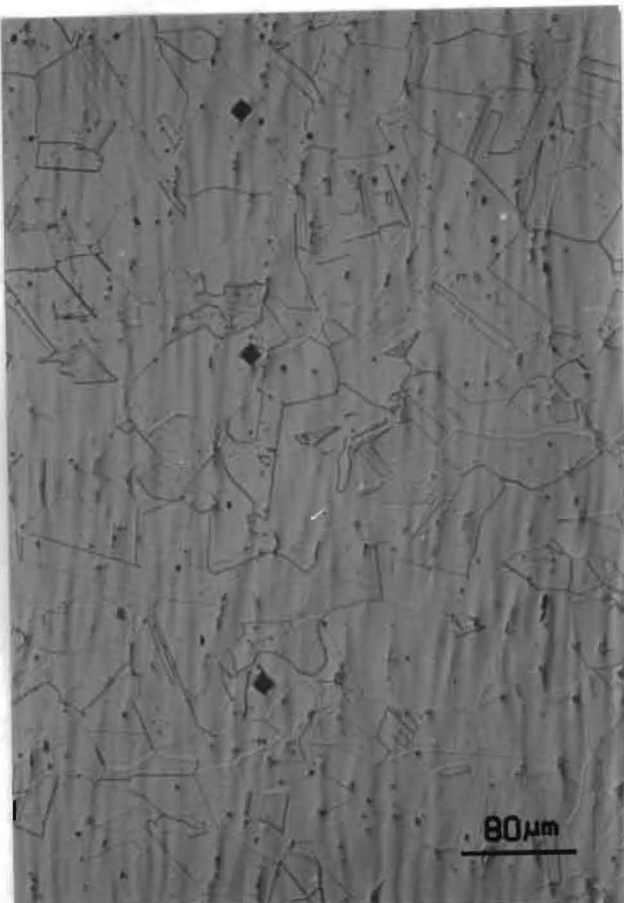
FIGURE 6.25 :

The depth to which strain hardening had occurred could be measured simply by using the optical microscope. Microhardness testing on taper sections was also utilized to establish the extent of surface deformation in worn surface layers, as illustrated in figure 6.25.

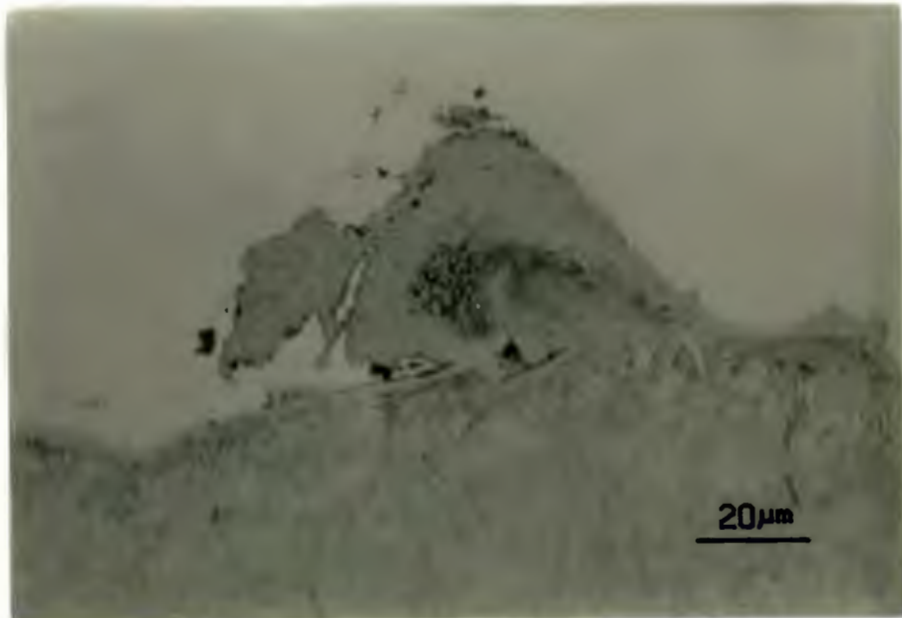
FIGURE 6.26 : The formation of white layer on a smearing structure on a Boron C8 field test specimen. Hardness 564HV30, etched in Nital.

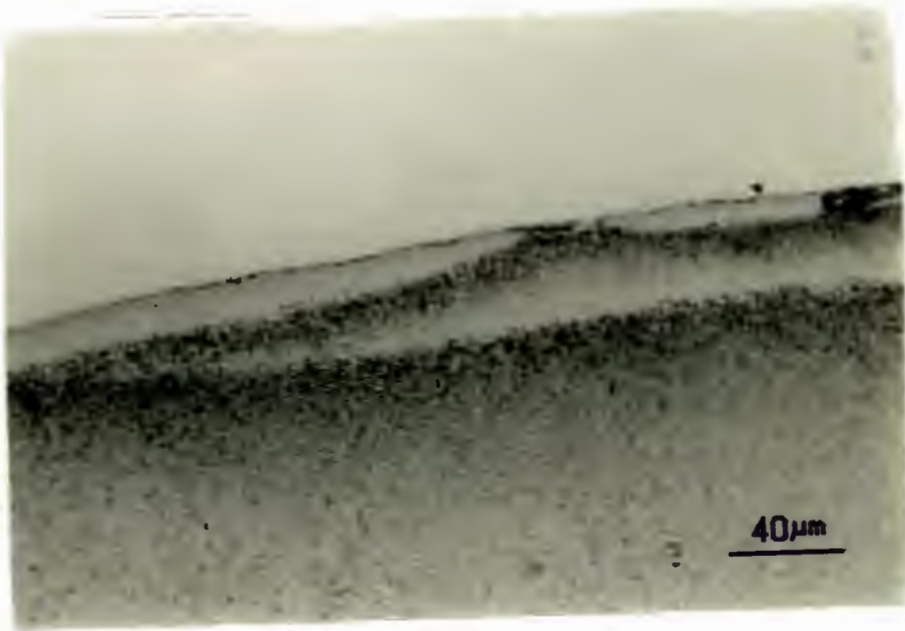
FIGURE 6.28 : The formation of a double thickness of white layer in a situation where there is no surface indication of high strain. The specimen is SS 10/200, quenched and tempered at 200°C. Hardness 610HV30, etched in Nital.

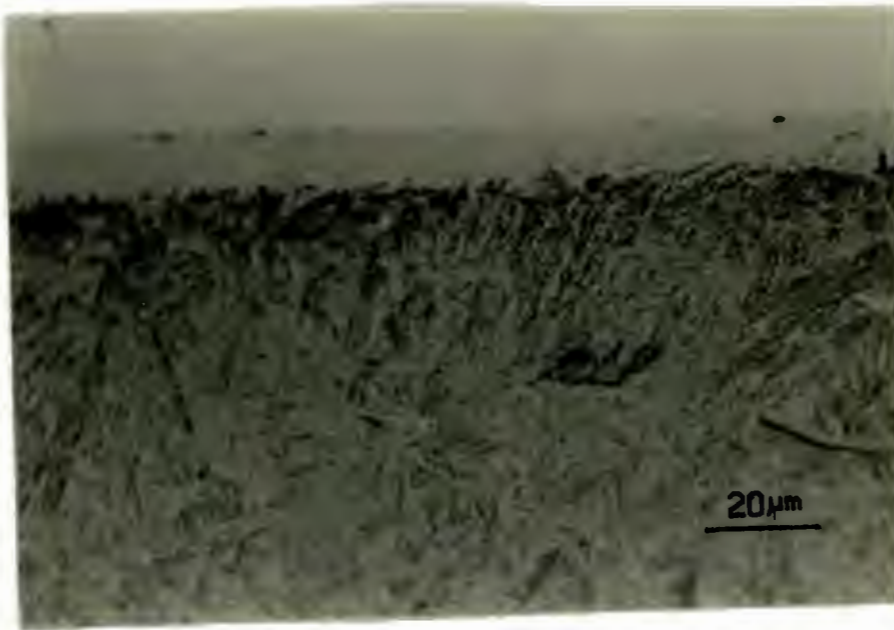
FIGURE 6.29 : A specimen of SS 10/200 quenched and tempered at 200°C showing how all the phases in the microstructure are absorbed in the white layer. Hardness 610HV30, etched in Nital.
