ABRASIVE WEAR TESTING OF STEELS IN SOIL

A thesis submitted to the Faculty of Engineering,
University of Cape Town in fulfilment of the degree
of Master of Science in Applied Science.

Department of Materials Engineering
University of Cape Town

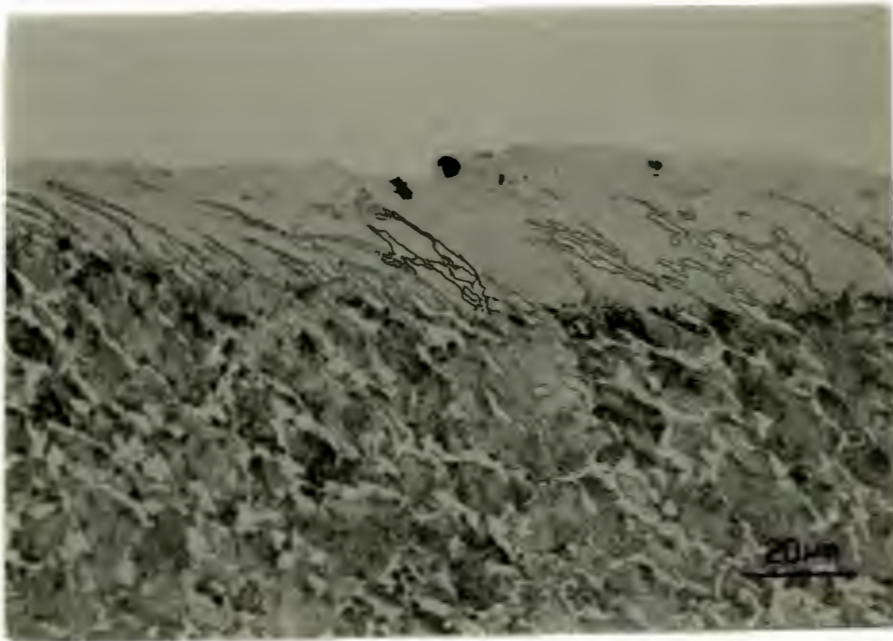
FIGURE 6.30 : A well developed non-etching layer in an annealed SS 10/200 specimen. The ferrite in the matrix is not absorbed into the white layer. Hardness 230HV30, etched in Nital.

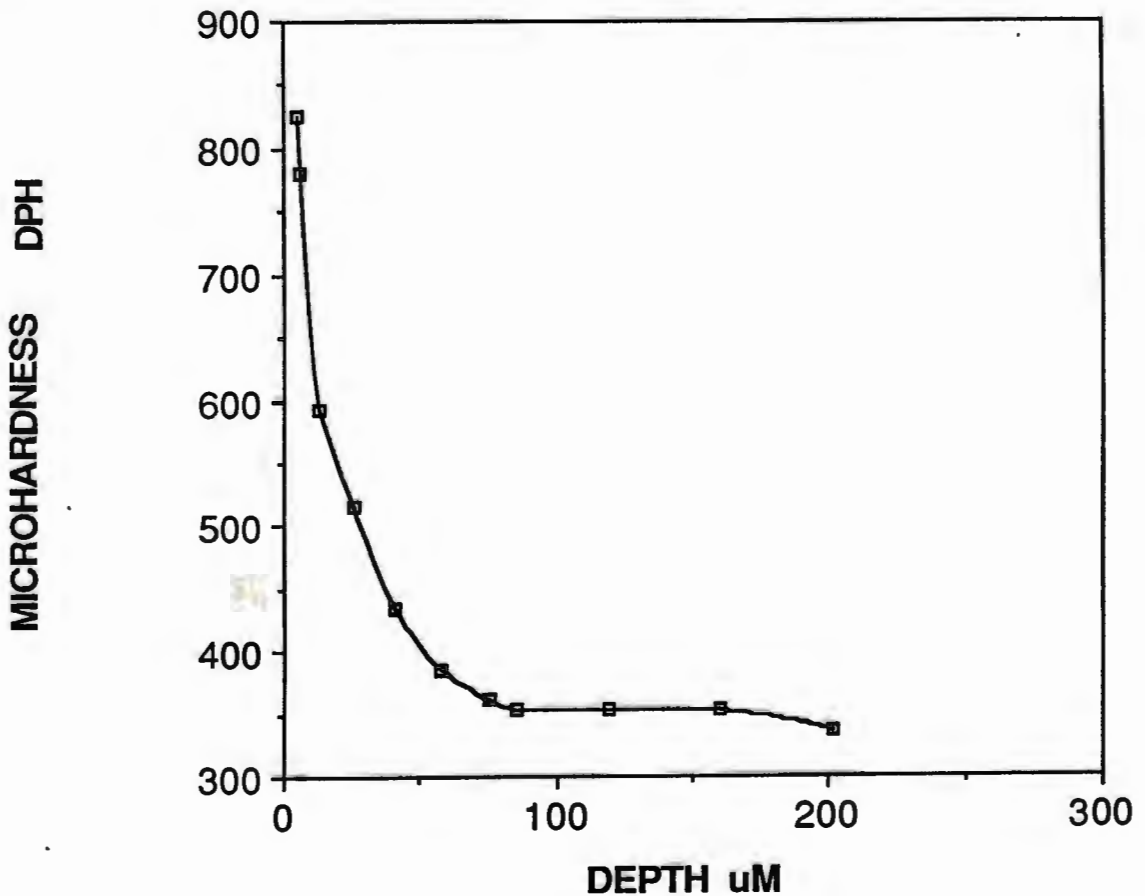
FIGURE 6.33 : The change in hardness with depth through white layers occurring in an SS 10/200 specimen quenched and tempered at 600°C.

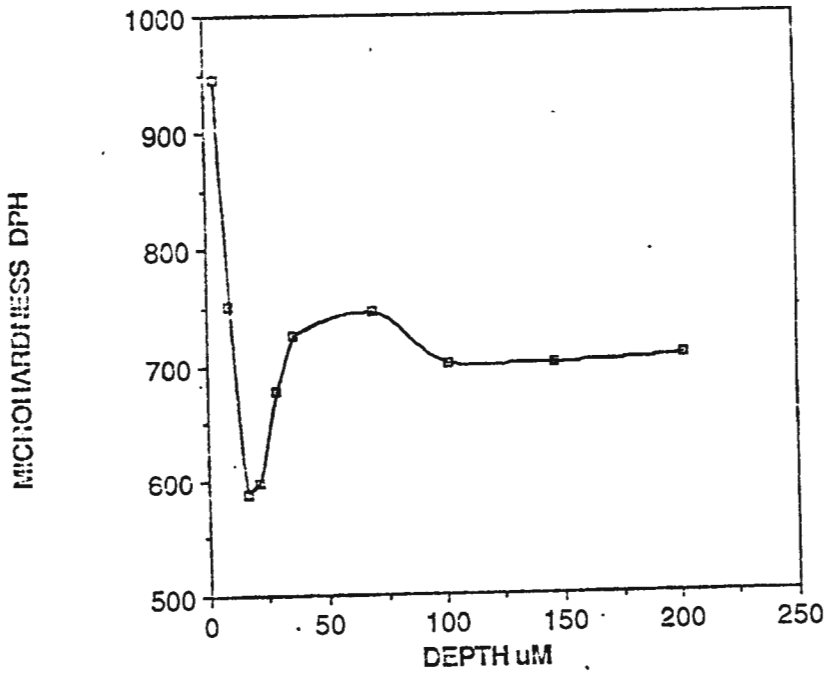
FIGURE 6.34 : The extent to which the hardness decreases in the transition zone between the white layer and the bulk microstructure. The specimen is SS 10/200 quenched and tempered at 200°C, tested in the field.

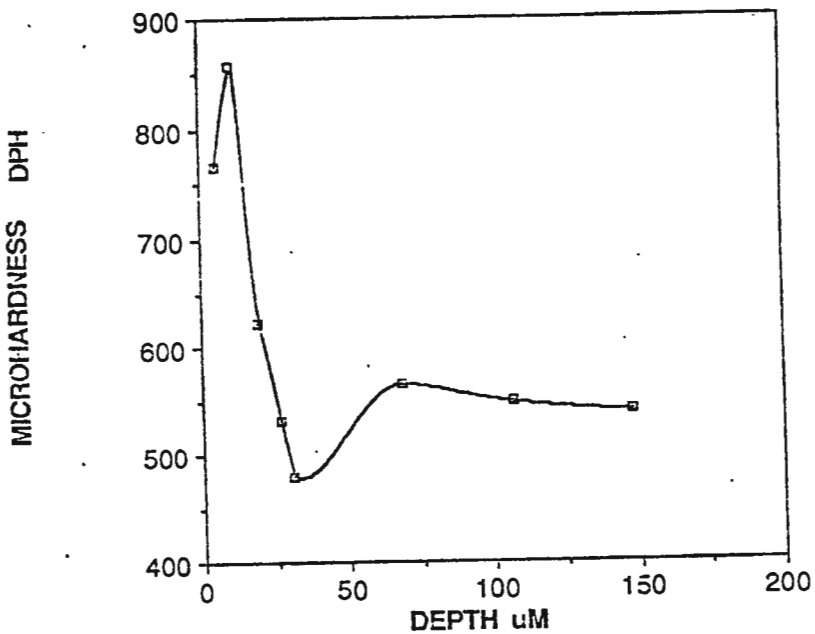
FIGURE 6.35 : Microhardness traces fit in between the two extremes described. The measurements were carried out on an SS 10/200 specimen quenched and tempered at 400°C and tested in the field.

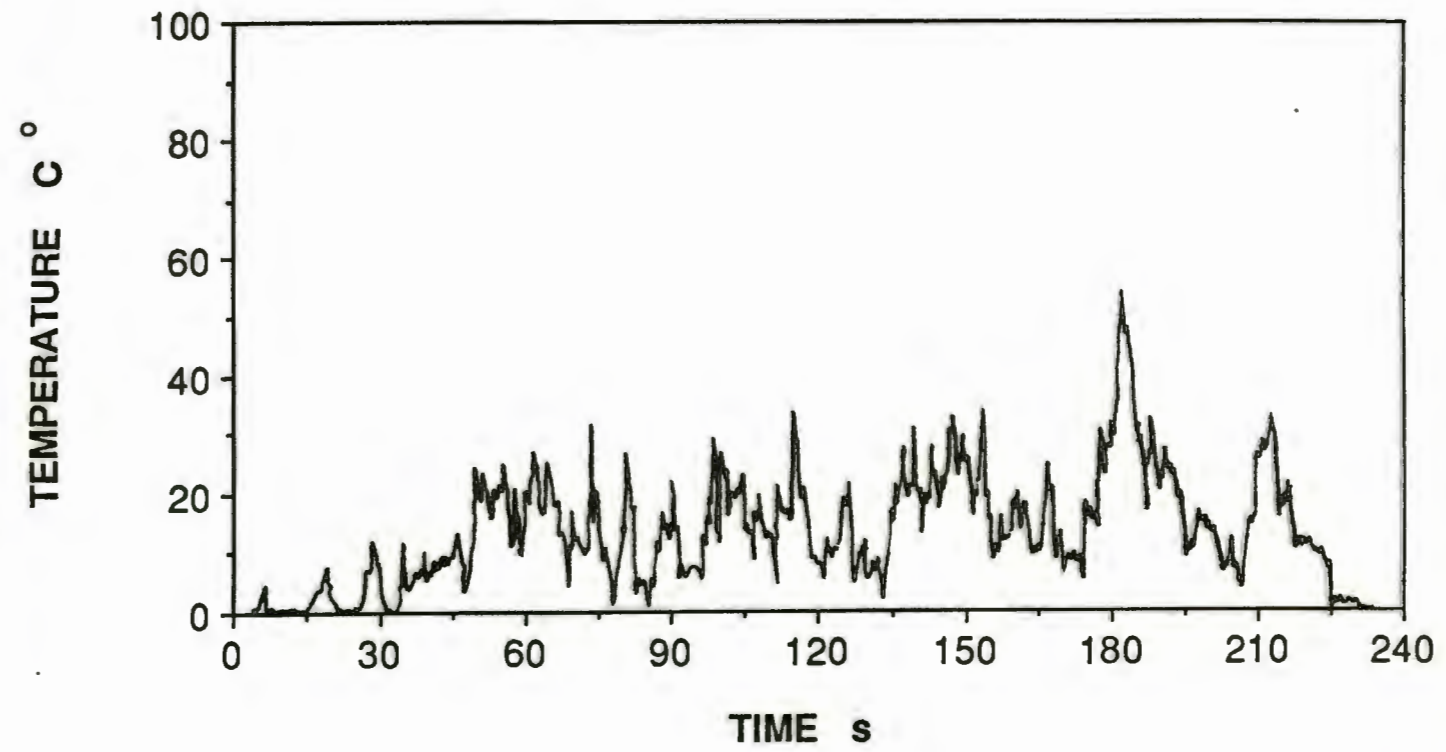
FIGURE 6.38 : A typical temperature trace from the field test.

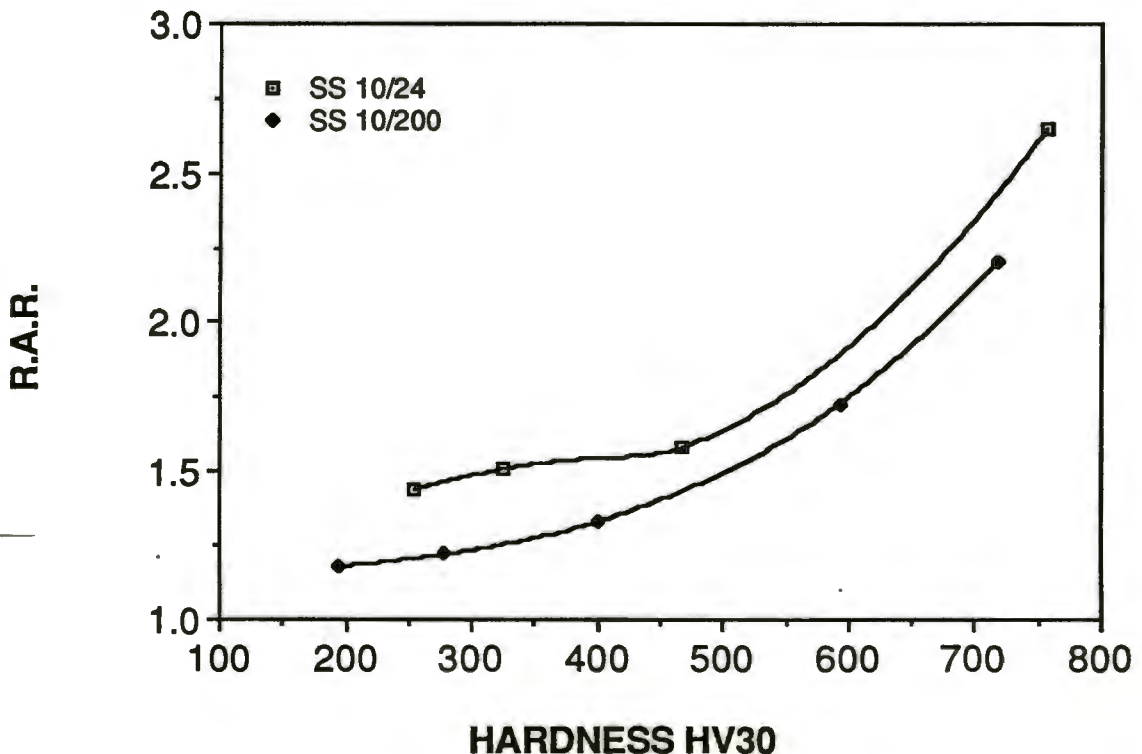
FIGURE 6.40 : RAR plotted against hardness for the 80 grit laboratory test.

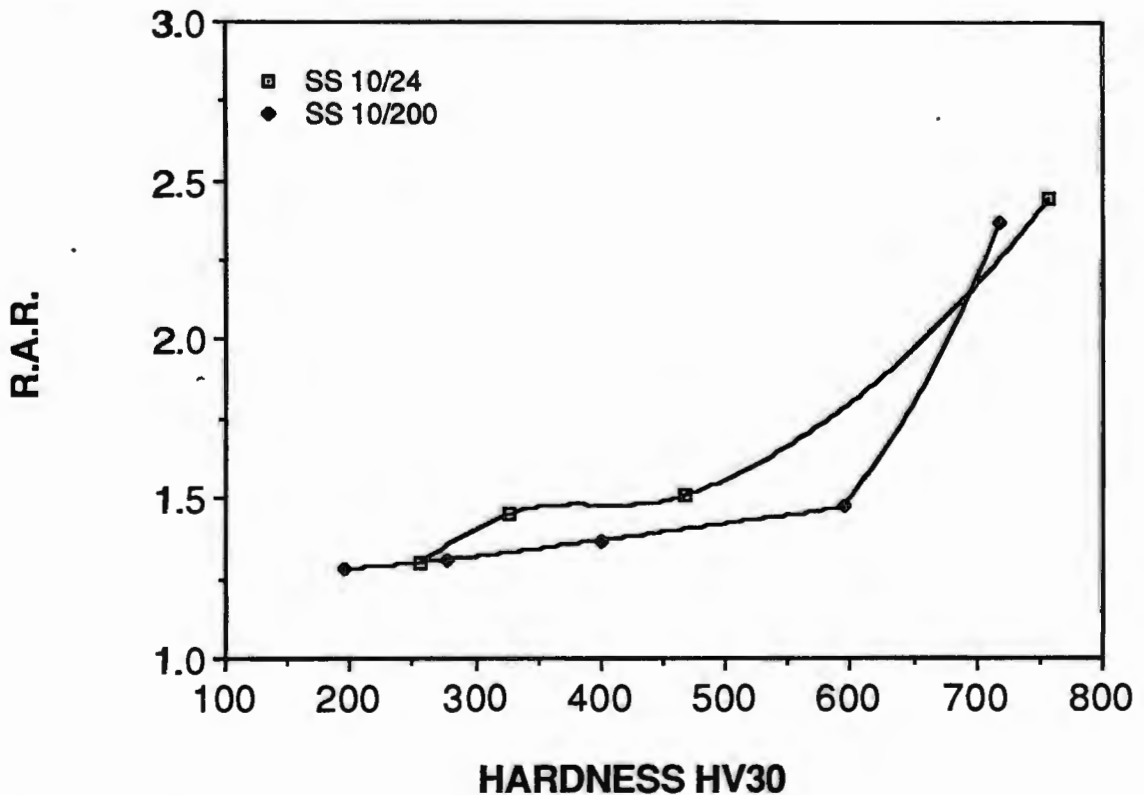
FIGURE 6.41 : RAR plotted against hardness for the 40 grit laboratory test.

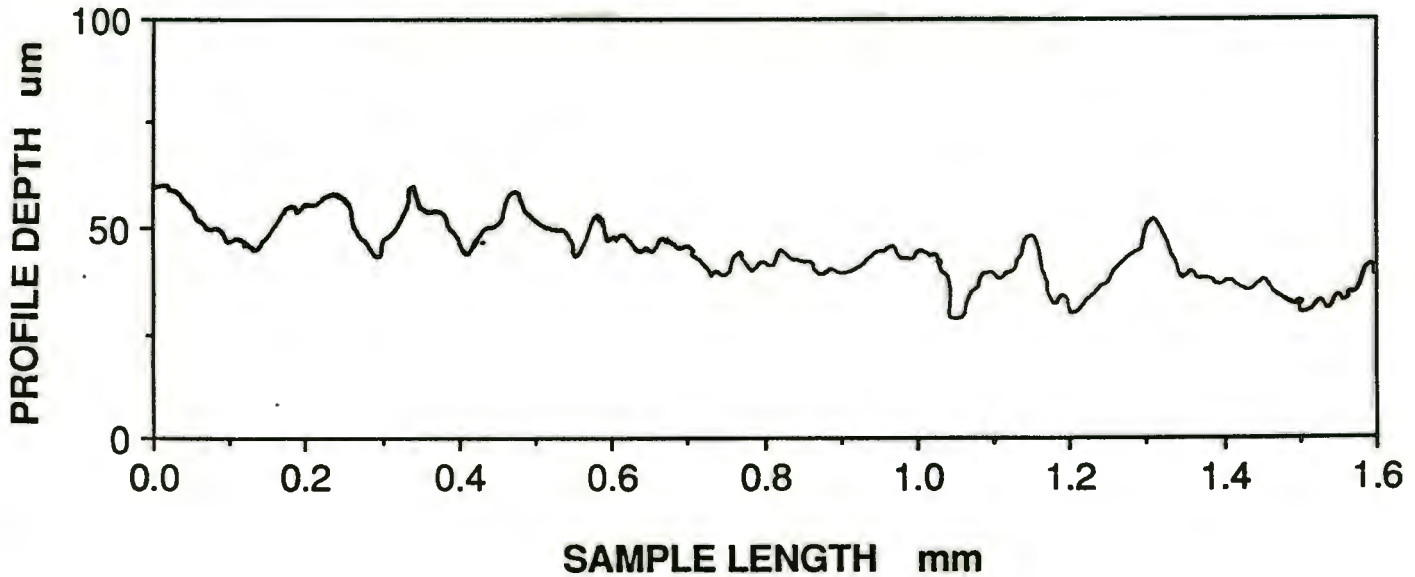
FIGURE 6.42 : Worn surface profile of a mild steel specimen tested in the 80 grit laboratory test (grain size 177-210 microns).

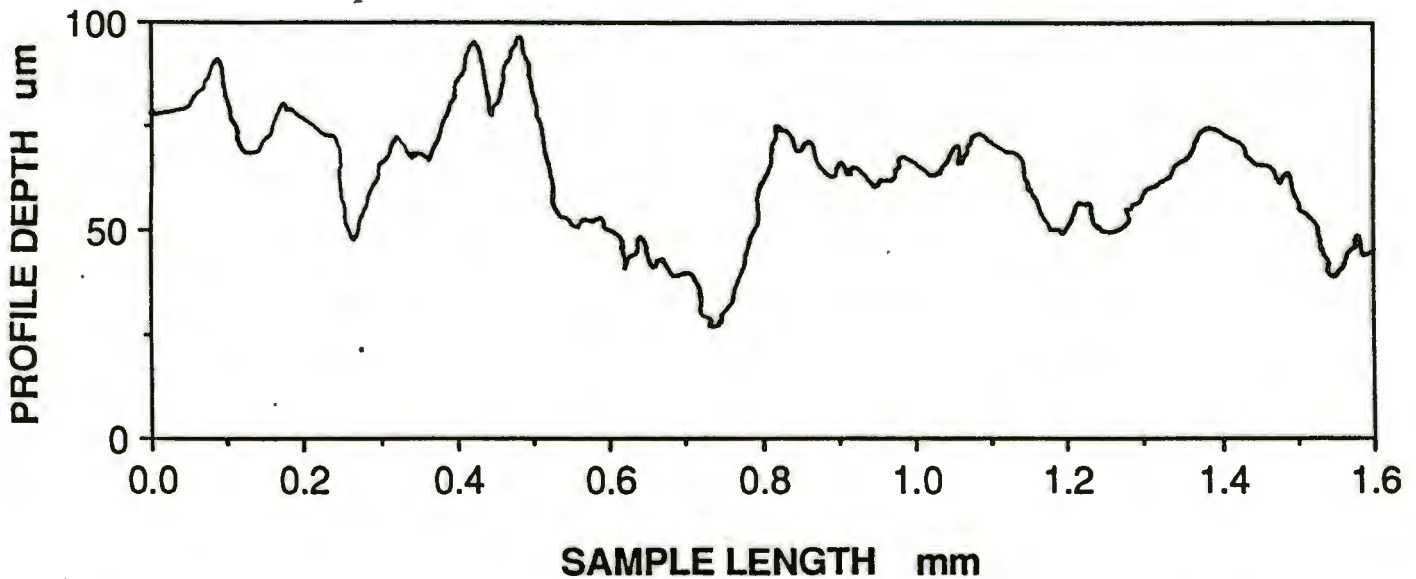
FIGURE 6.43 : Profilometer trace on a mild steel specimen from the 40 grit laboratory test (grain size 420-500 microns).

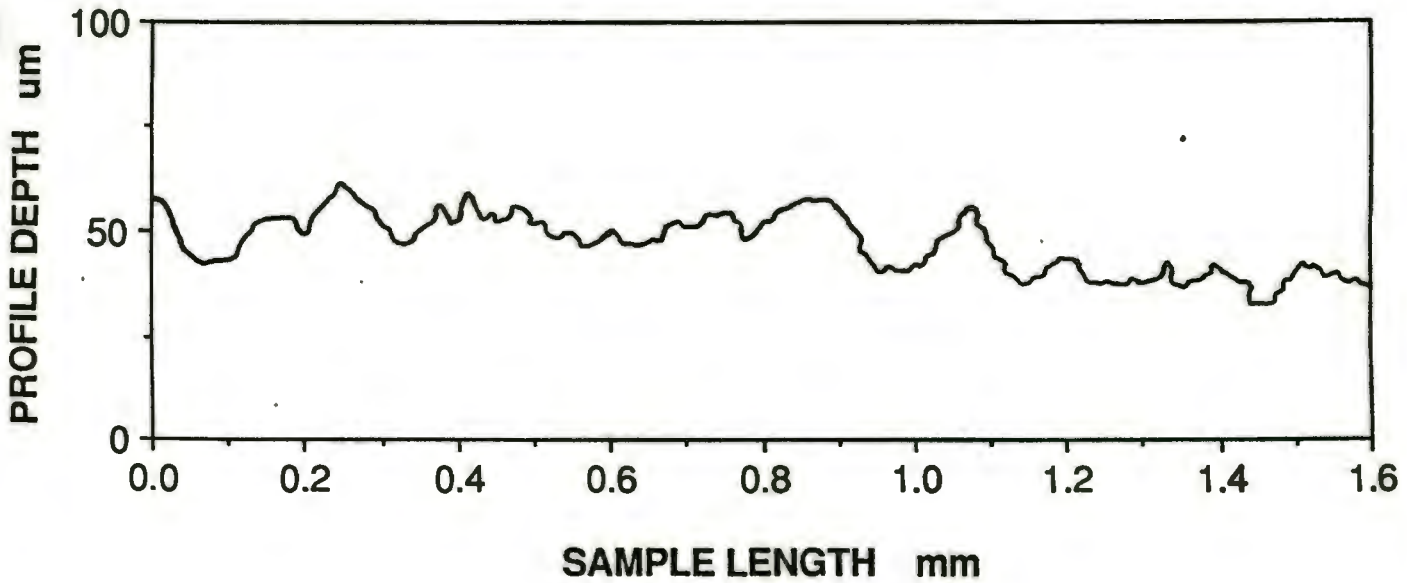
FIGURE 6.44 : Profilometer trace on an SS 20/24 specimen quenched and tempered at 200°C and subjected to the 40 grit laboratory test.

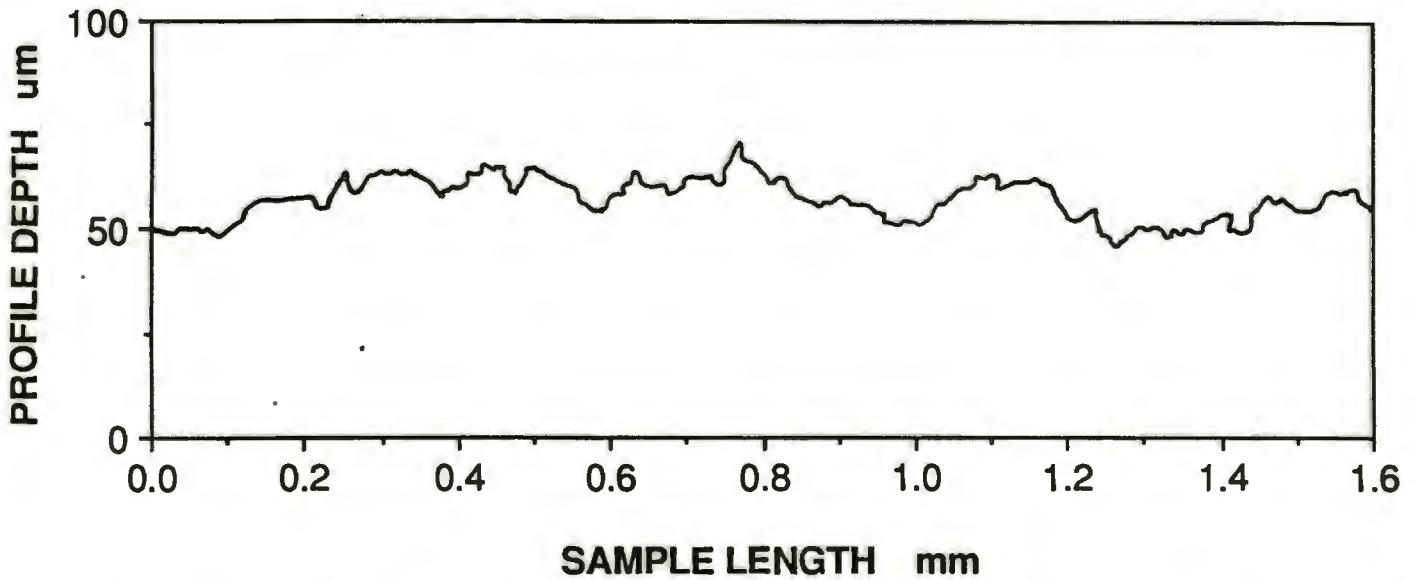
FIGURE 6.45 : Worn surface profile of an SS 10/24 specimen quenched and tempered at 200°C from the 80 grit laboratory test.

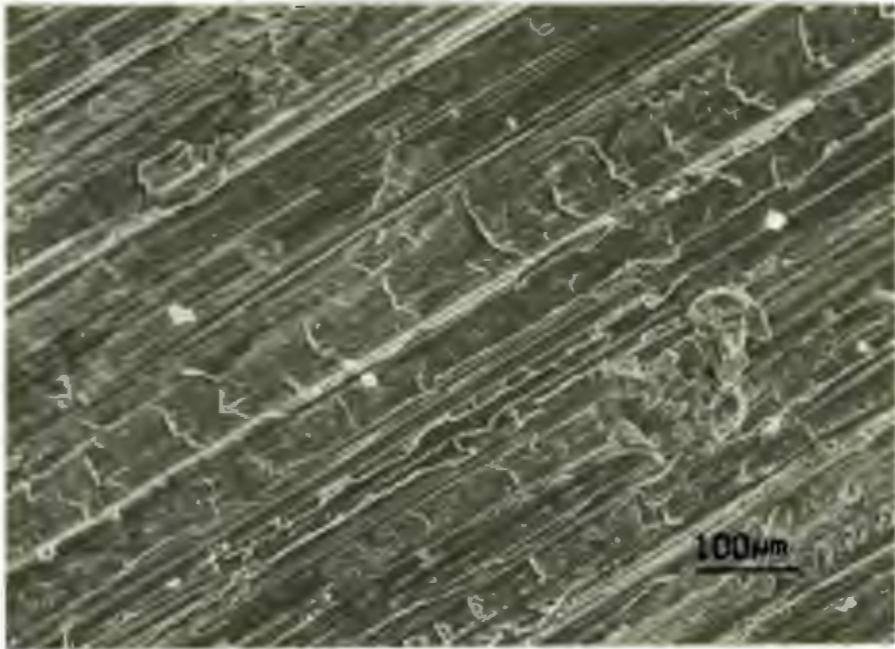
FIGURE 6.46 : Micrograph showing a ploughing mechanism on normalized SS 10/24 worn on 40 grit abrasive. Hardness 255HV30.

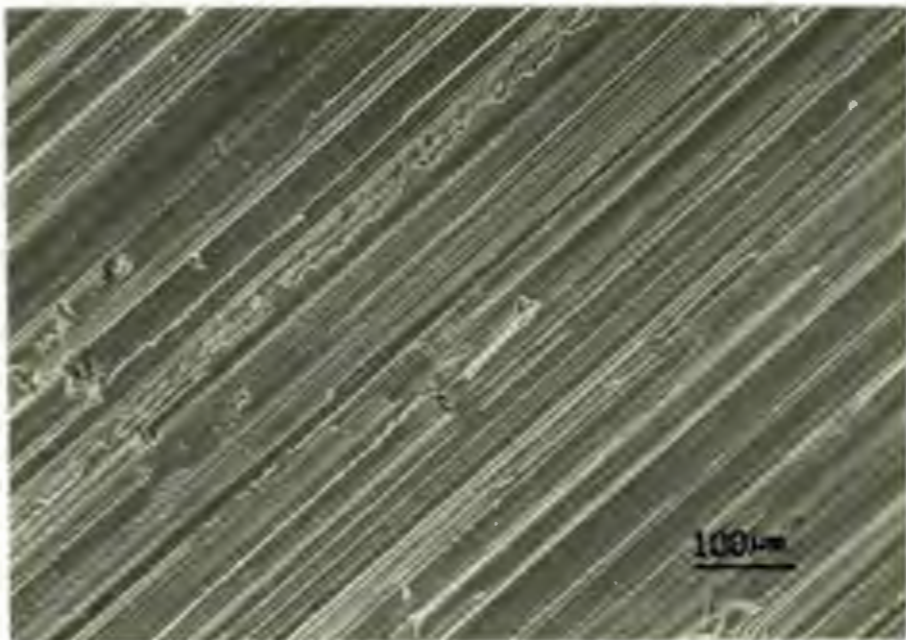
FIGURE 6.47 : The worn surface of an SS 10/24 specimen quenched and tempered at 200°C and tested in the 40 grit laboratory test. Hardness 467HV30.

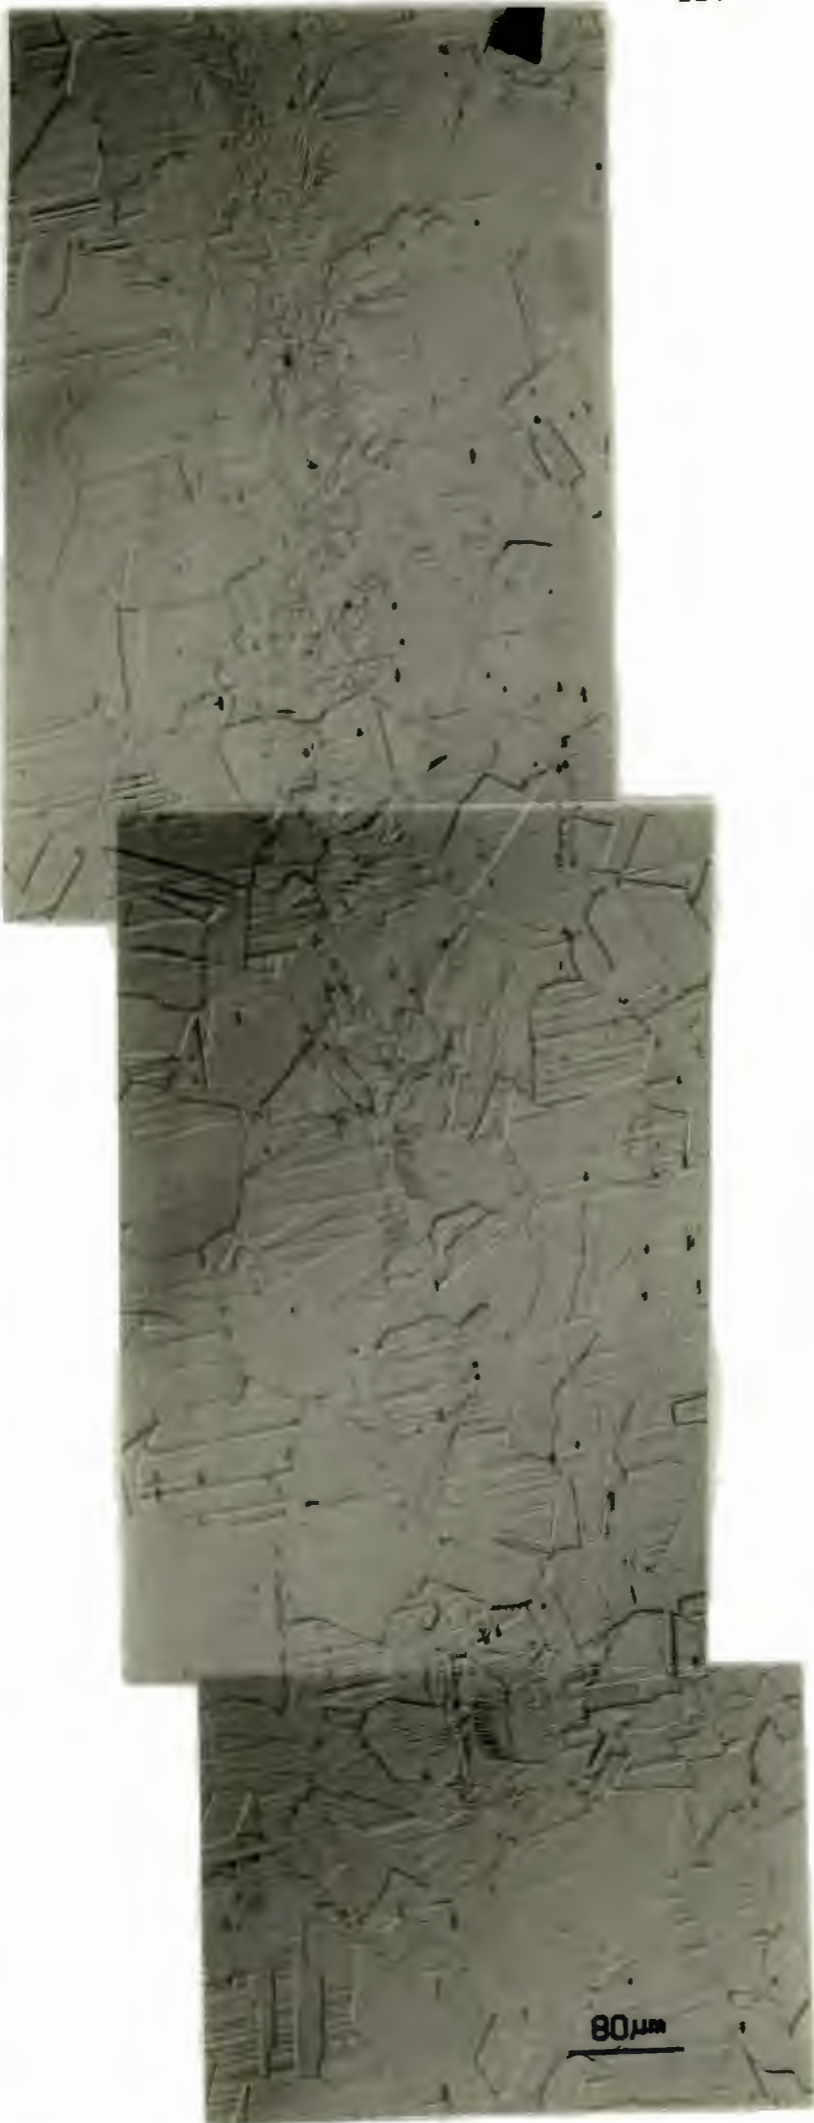
Apparent depth of
deformation: 697 microns
True depth: 24 microns

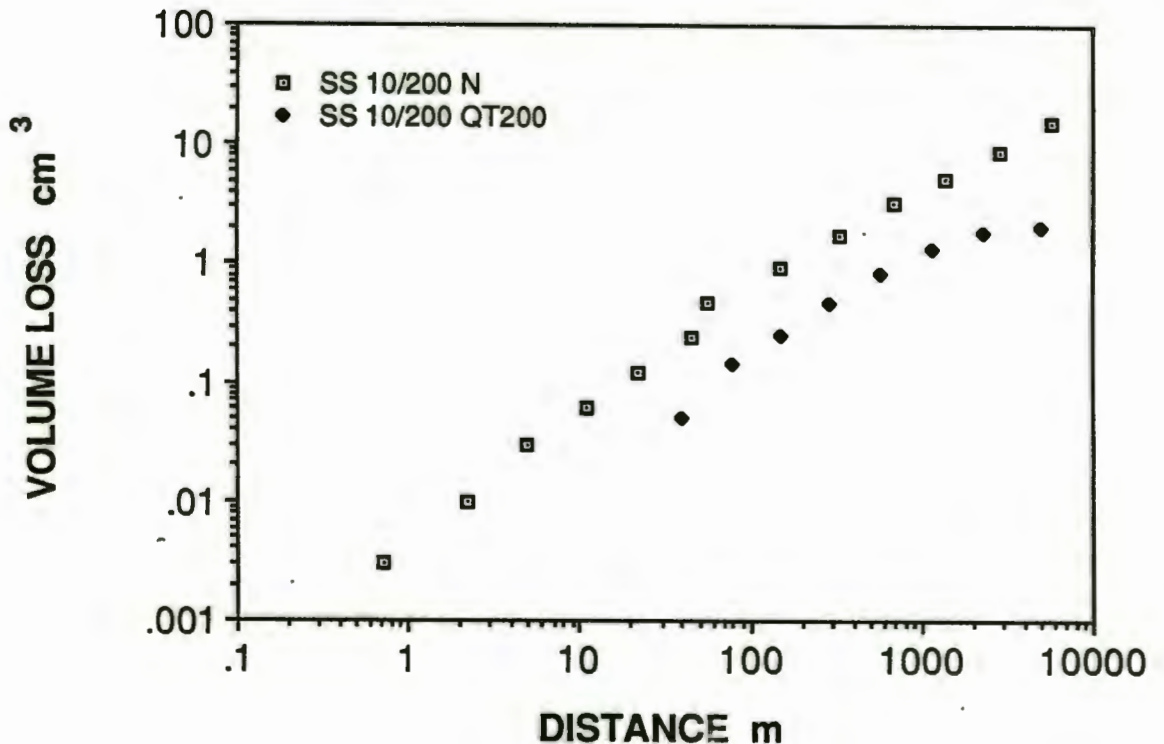
FIGURE 6.49 : A log/log plot from the rubbing test on normalised SS 10/200 and SS 10/200, quenched and tempered at 200°C.

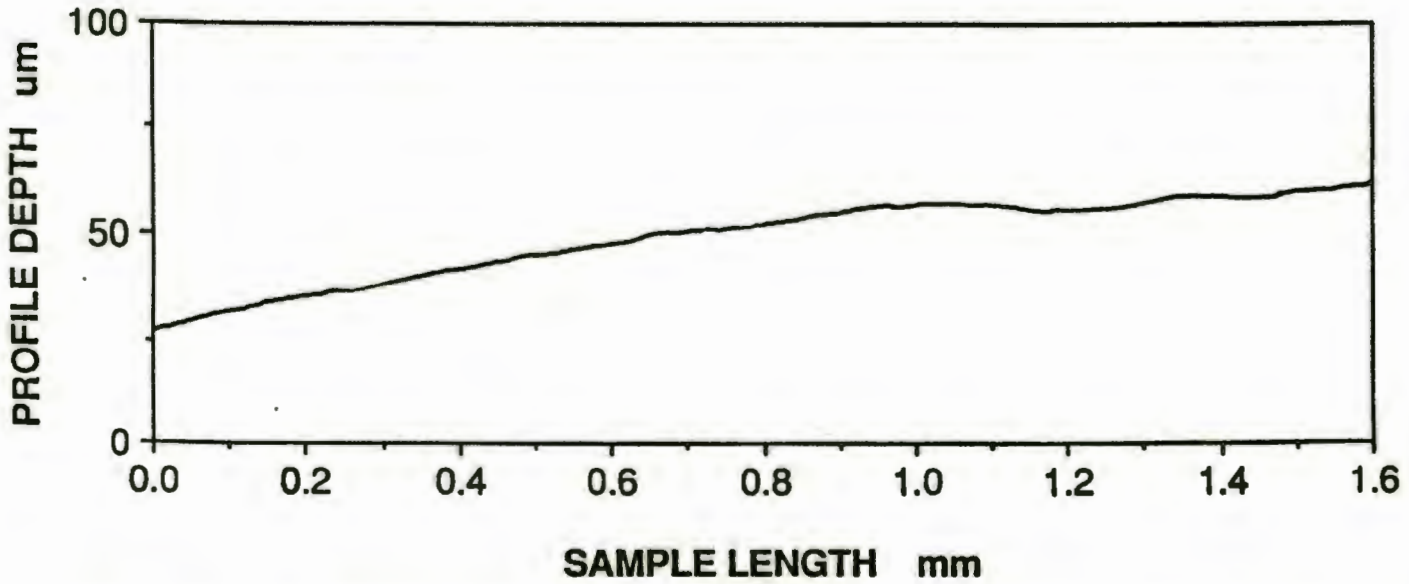
FIGURE 6.50 : The smooth surface on the SS 10/200 specimen quenched and tempered at 200°C and tested for almost 5500 m.

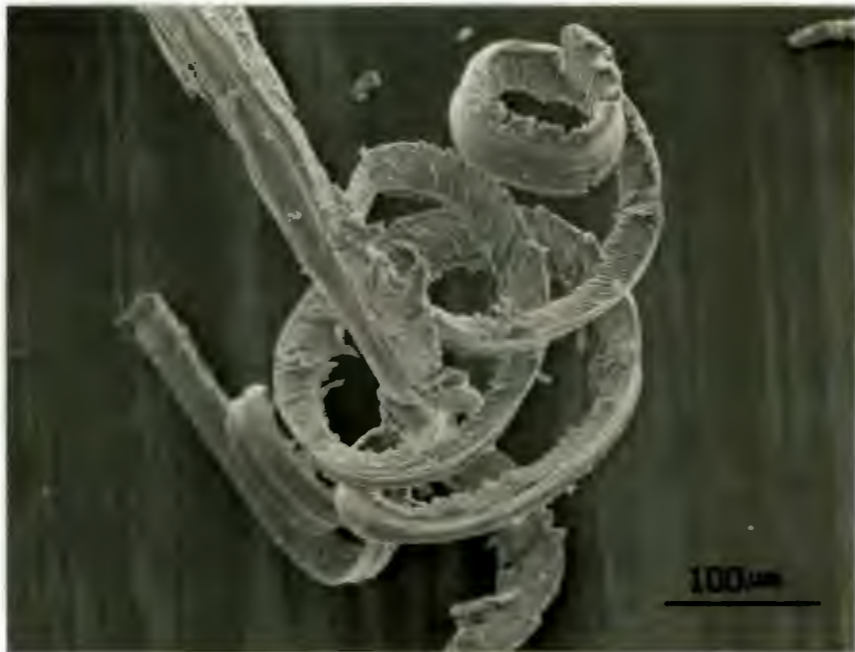
FIGURE 6.52 : Wear debris from fresh abrasive on the wear rig.

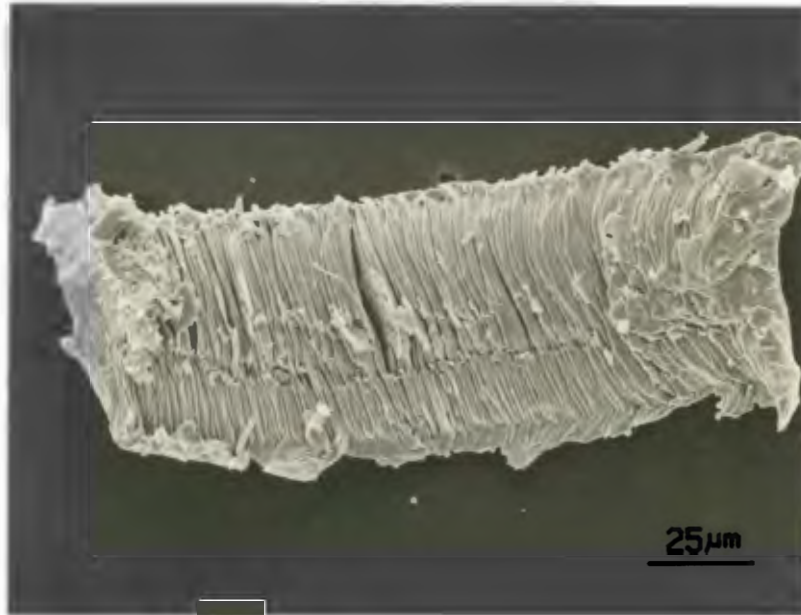
When the weight loss in the test decreased to the point at which it became insignificant, the wear debris changed accordingly. Short and stumpy segmented chunks were produced. These are shown in figure 6.54.

FIGURE 6.54 : Wear debris from the well-advanced rubbing test.

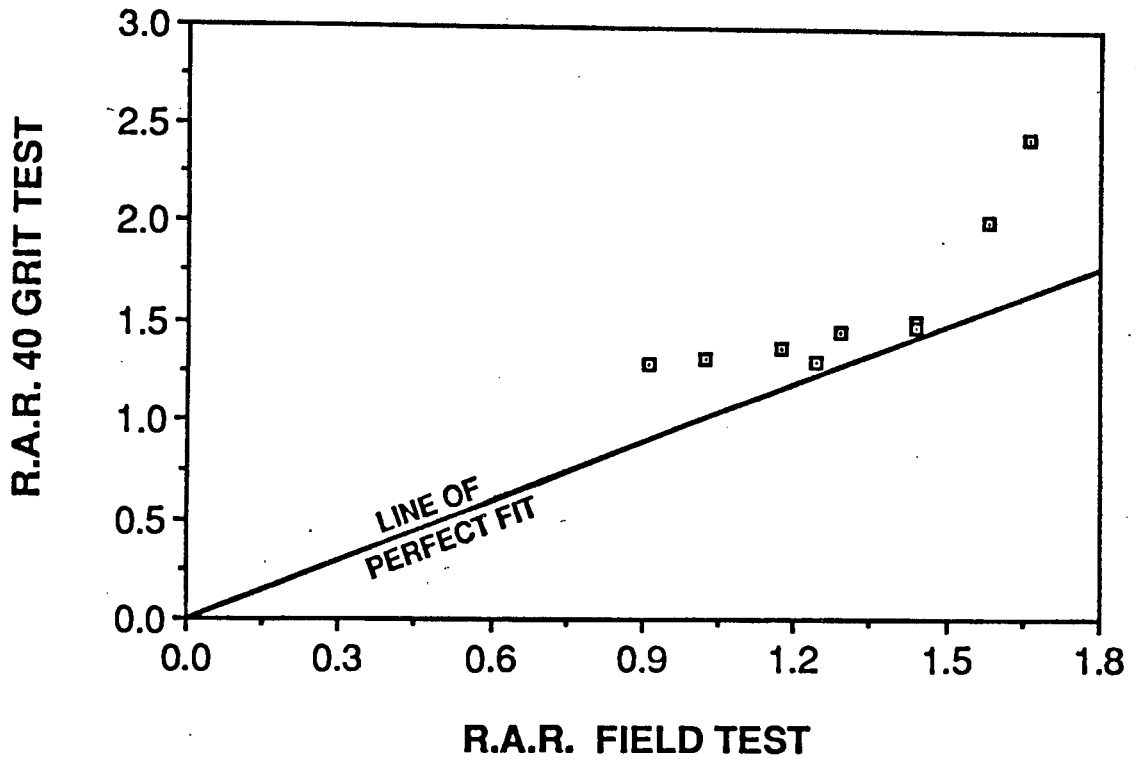
FIGURE 6.55 : Plot of the RAR for the 40 grit test for each material plotted against the RAR for the same material from the field test. The coefficient of correlation is 0.62.
