THESIS REPORT

The influence of various factors on the results of carbonation, cover depth, half-cell potential and resistivity tests that are used in the assessment of reinforcement corrosion

MOHAMMED FARAAZ AKHALWAYA (AKHMOH003)

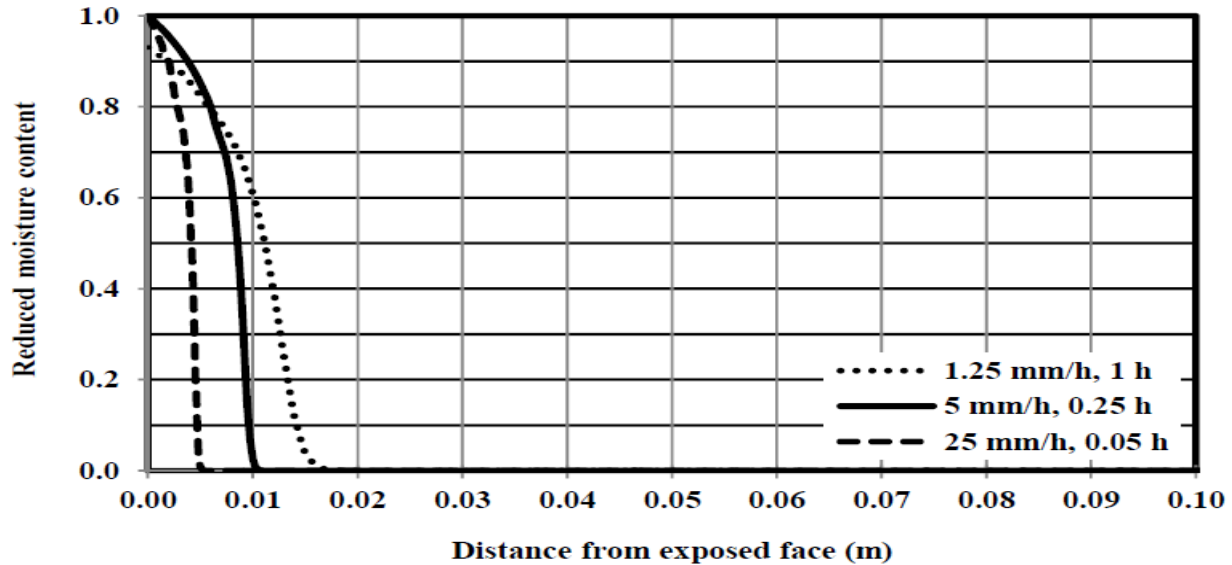
Figure 4: Profiles of moisture penetration for concrete exposed to light, medium and high-intensity rain each with the same quantity of impinging water due to decreasing exposure times with increasing intensity. (Sarkar & Bhattacharjee, 2014)

A second set of experiments by Sarkar & Bhattacharjee (2014) were carried out to determine how the moisture penetration depth is affected by different intensity-duration combinations where an exposed surface is subject to the same quantity of incident water. The combinations that were tested includes an intensity of 1.25 mm/h over 1 hour, 5 mm/h over 0.25 hours and 25mm/h over 0.05 hours. The moisture penetration profiles for these combinations are shown in Figure 4. These results show that for impinging rains of the same quantity, the higher intensity rains that fall over shorter spells result in a smaller degree of penetration. This relates well to real-life conditions where high-intensity rainfalls usually occur over shorter periods and lighter intensity rainfalls occur over longer periods.

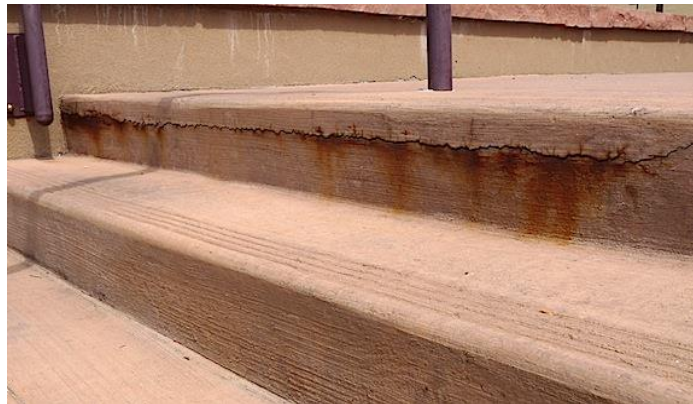
*Figure 5: Reinforcement corrosion-induced cracking.
(Gromicko & Shepard, 2006)*

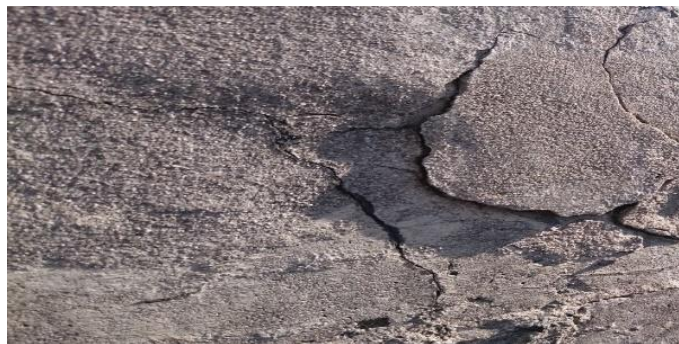
Figure 6: Delaminated concrete

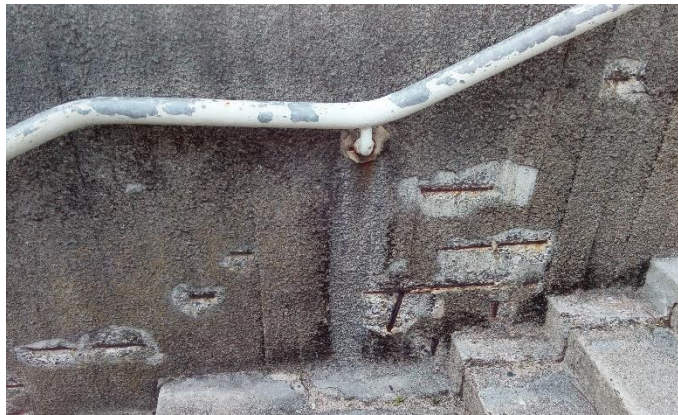
Figure 7: Concrete, which has spalled

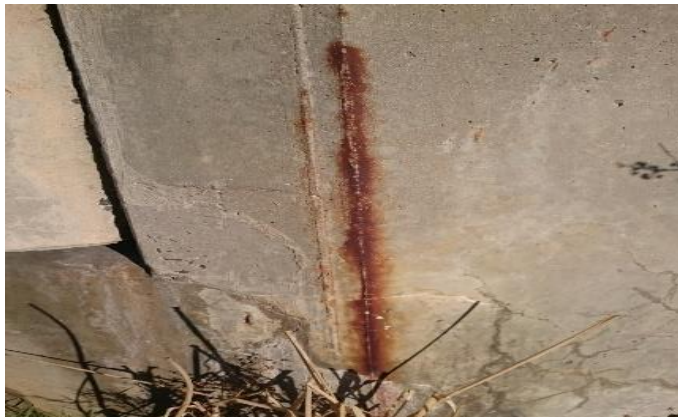
Figure 8: Rust staining

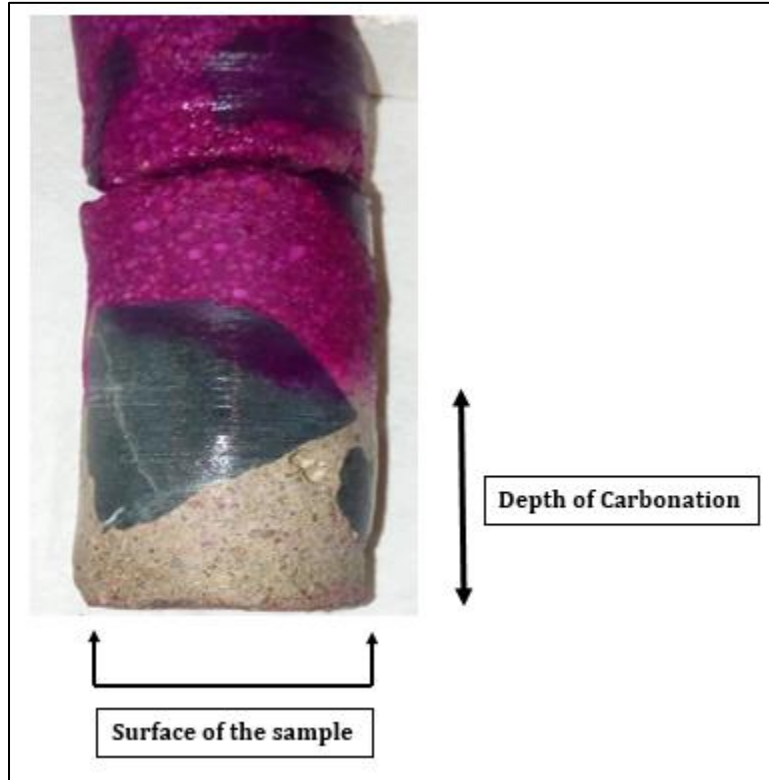
Figure 9: Indicator colour change on a carbonated concrete sample

The use of the Phenolphthalein indicator has its shortfalls. The indicator turns to the pink/purple colour when applied to concrete with a pH greater than 8.6 and so will remain colourless when the pH is below this value. Depassivation of the corrosion protective layer begins to occur at pH levels below 11 and so concrete at a pH level where depassivation has already begun to occur may still display a pink/purple colour down to pH levels of 8.6. The change in colour at pH levels closer to 8.6 is usually of a faintly discernible slightly pink colour and so this is easier to identify as likely carbonated than pH levels above 9 or 10 which show a strong colour change when the indicator is applied. The indicator test is thus likely to underestimate the actual depth of carbonation (Lo, 2005; Tuutti, 1982; Winter, 2012). The phenolphthalein indicator remains very popular although it has deficiencies. This is in part because it is quick, simple and the cheapest and easiest method to carry out (Dayaram, 2010). It also creates a continuous line representing the carbonation front thus creating a good visual aspect, especially for initial assessments (Winter, 2012).

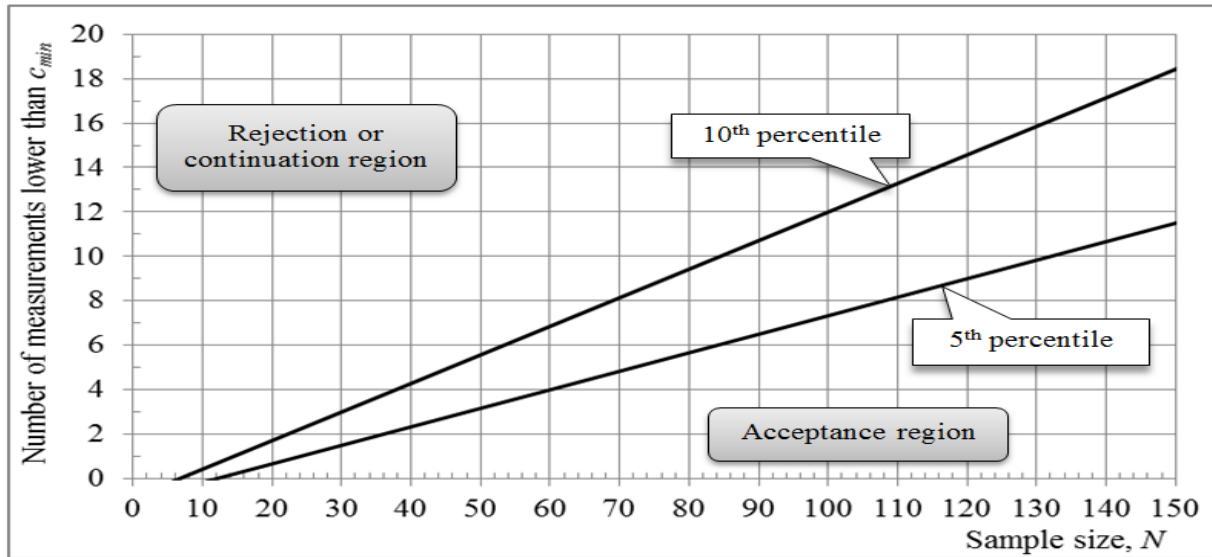
Figure 10: Graph to obtain the acceptance number for German qualitative procedure (Monteiro, et al., 2015).

sample size must contain at least 20 measurements. Once all the measurements have been taken, the sample median and smallest value must be determined in order to calculate the upper limit. Should any measurement fall above this upper limit then it will be considered as an outlier and will be left out of the sample, requiring a new median to be determined.

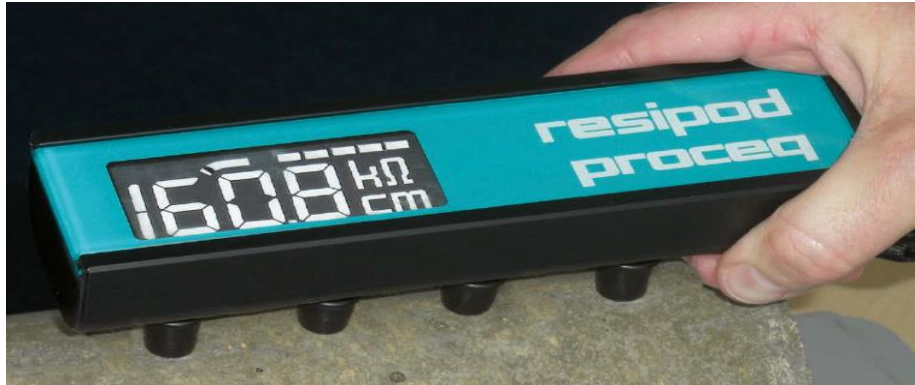
Figure 15: Resipod Wenner 4-probe meter (Proceq, 2017)

The method for measuring surface resistivity using a four-probe set-up often has the pins spring-loaded with water reservoirs in order to achieve the required electrical connectivity (Kevern, et al., 2015). An example of such a device is the Resipod, which can be seen in Figure 15. The Resipod is fast to use, stable and convenient for use under various conditions, as it is both robust and waterproof (Proceq, 2017).

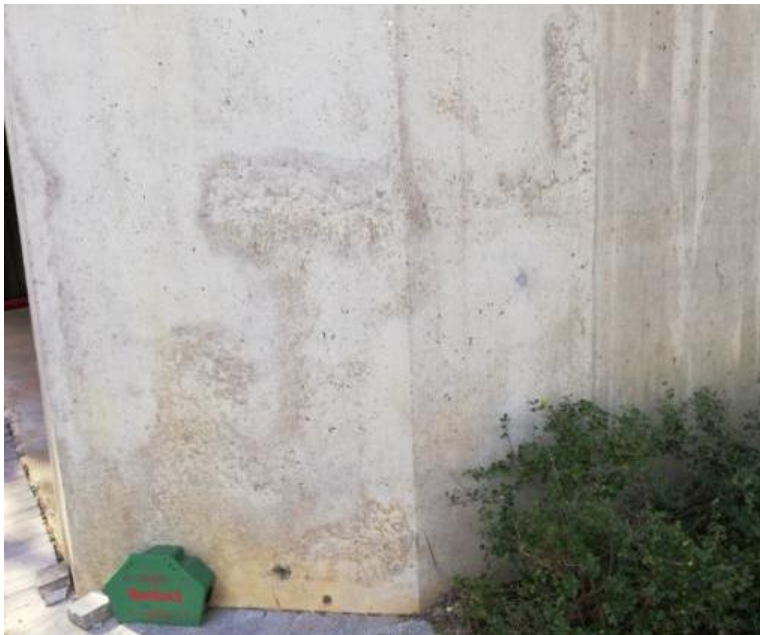
Figure 27: Location from which a core was extracted on the ground floor of the South side of the Neville Alexander building

- I. Locations for removing cores:
 - The 5 locations shown in Figures 22-26, that were selected for comparing the results of the different tests.
 - Four cores from different locations along the Neville Alexander building. Cores were taken from each face of the building. The locations from which these cores were taken are shown in Figures 27-30.
 - An additional core from a location on the west side of the Hoerikwaggo building as shown in Figure 31.

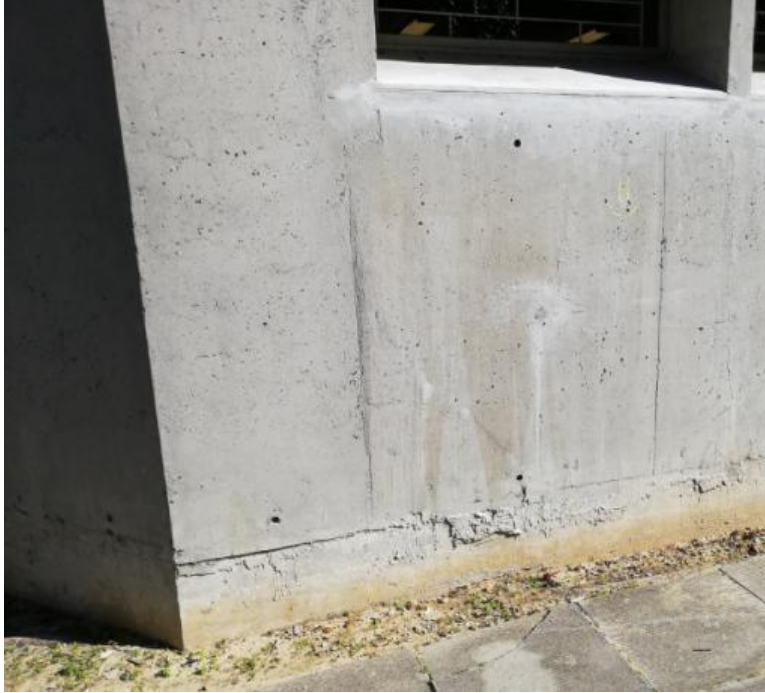
Figure 28: Location from which a core was extracted on the ground floor of the East side of the Neville Alexander building

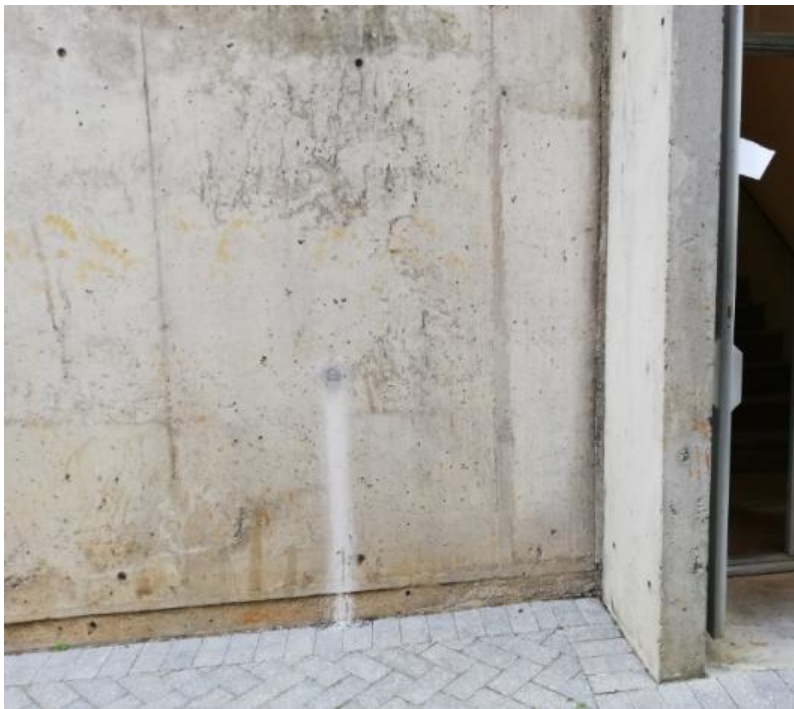
Figure 29: Location from which a core was extracted on the ground floor of the West side of the Neville Alexander building

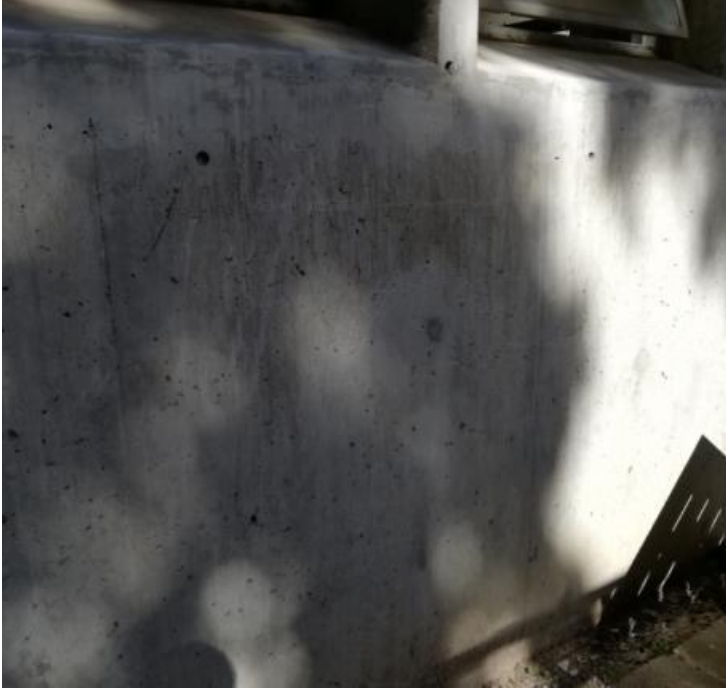
Figure 30: Location from which a core was extracted on the ground floor of the North side of the Neville Alexander building

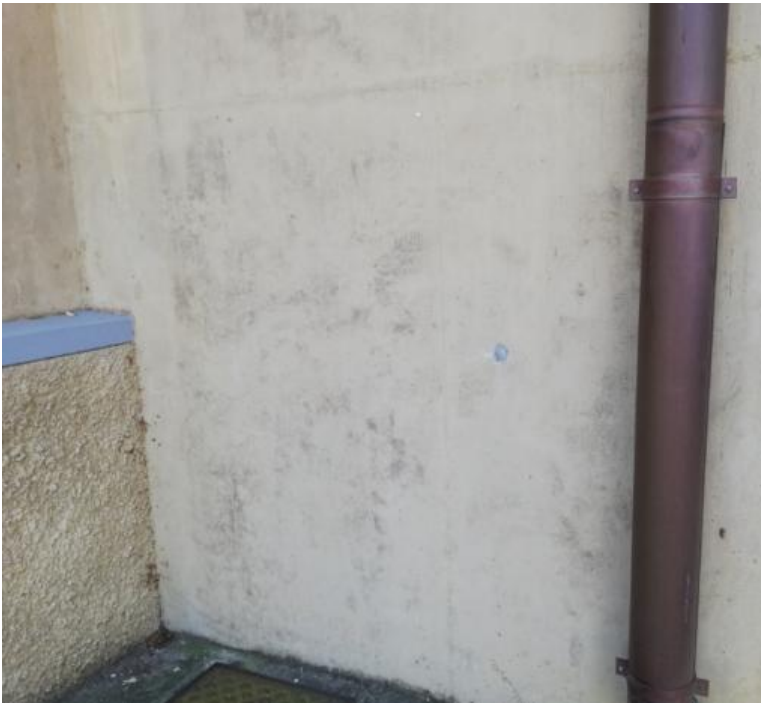
Figure 31: Location from which a core was extracted on the ground floor of the West side of the Hoerikwaggo building

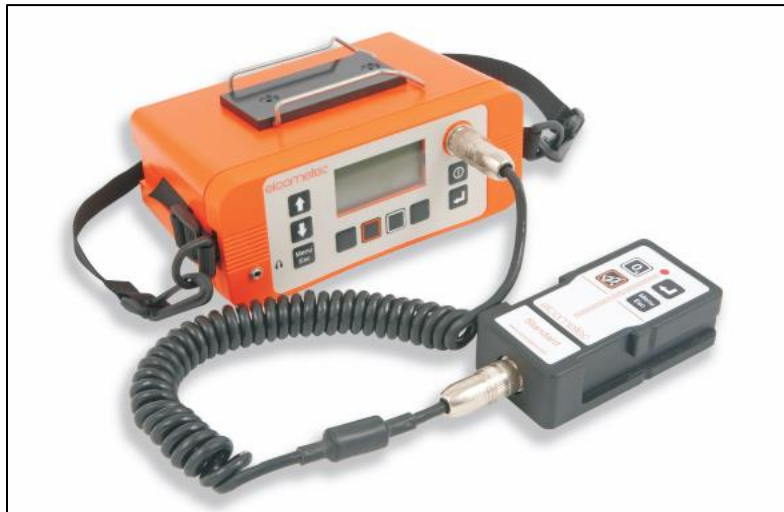
Elcometer 331 Concrete Covermeter. This covermeter is used as a gauge for determining the location of reinforcement bars and metal pipes and for measuring the thickness of the concrete cover above the reinforcement and pipes. The covermeter uses interchangeable search heads, such as for measurements in locations where the concrete cover is deep. The covermeter can be used in accordance with a number of standards including British and ASTM standards. An image of this covermeter can be seen in Figure 32 (Elcometer, 2012).

Figure 32: Elcometer 331 covermeter (Elcometer, 2012)

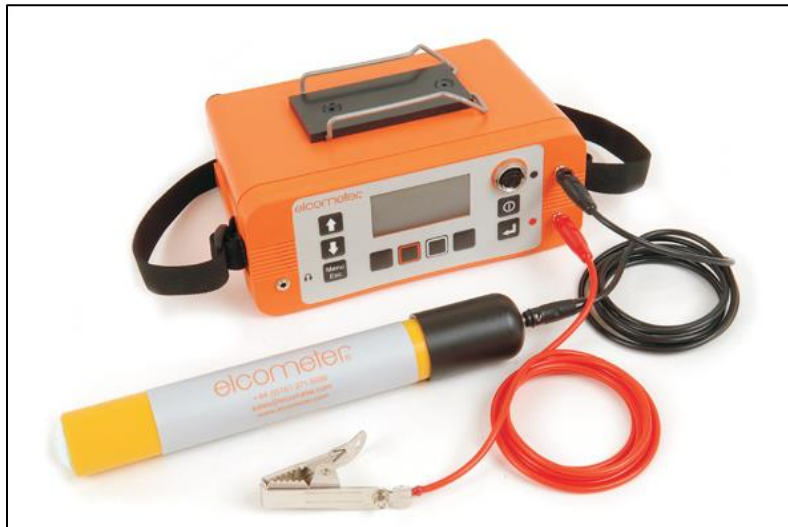
Elcometer 331 Concrete Covermeter with half-cell probe. The Elcometer 331 can be used as a half-cell gauge that measures half-cell potential values in millivolts. The covermeter comes with a half-cell kit that contains a half-cell probe with a silver electrode in a silver chloride solution as well as a crocodile clip extension for connection to the rebar. The covermeter can be used in accordance with a number of standards including the ASTM C876 standard. An image of the covermeter with the half-cell probe connection can be seen in Figure 41.

Figure 41: Elcometer 331 covermeter with half-cell probe connection (Elcometer, 2012)

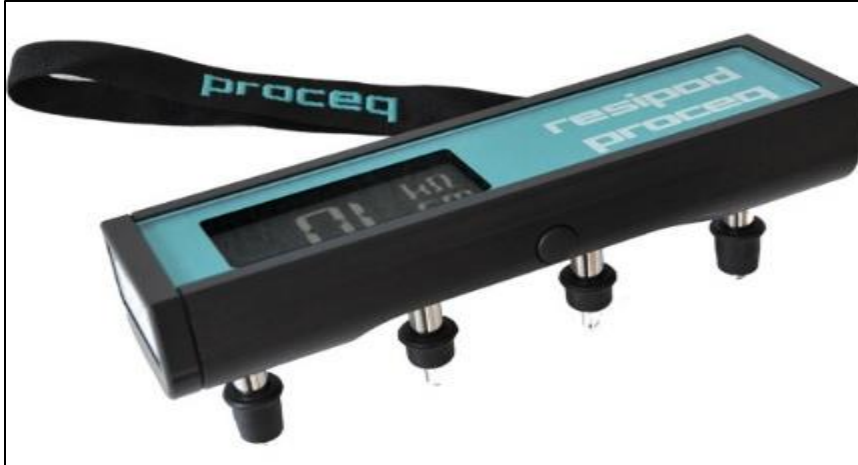
Proseq Resipod 4-probe Resistivity meter. The Resipod functions on the basis of the Wenner probe principle to measure the electrical resistivity of the concrete. The version of the Resipod that was used has a 50 mm probe spacing that conforms to the industry accepted standard. The resistivity measurements are shown on a display screen in units of kilo Ohm-centimeter. An image of the Proseq Resipod can be seen in Figure 42 (Proceq, 2017).

Figure 42: Proceq resipod 4-probe Resistivity meter (Proceq, 2017)

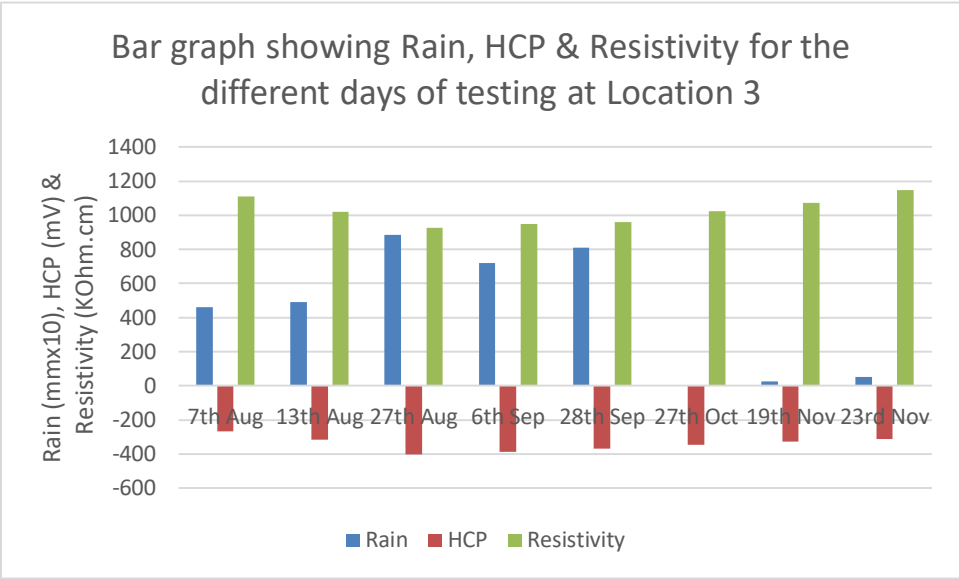
Figure 45: Bar graph showing the rainfall, average HCP & average resistivity for the different days of testing at Location 3.

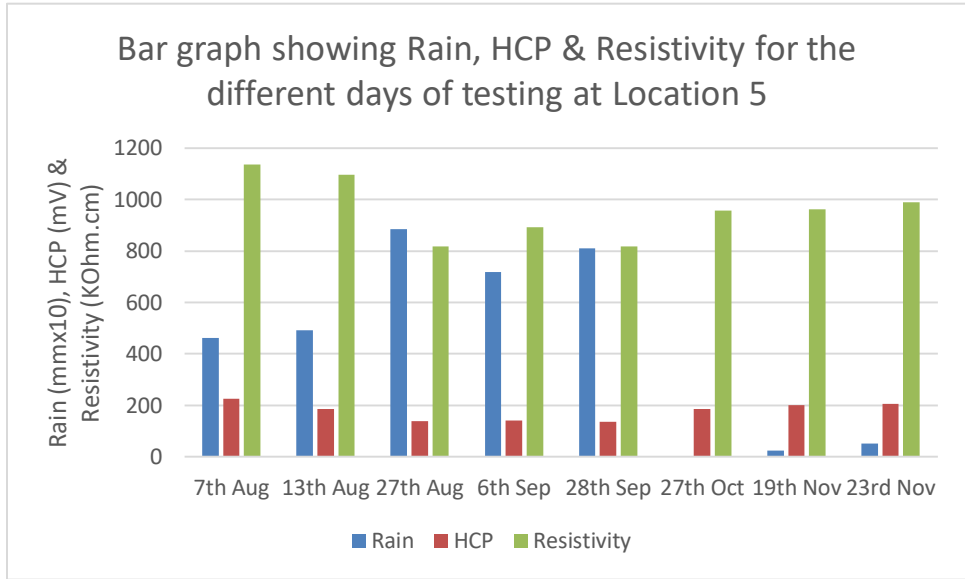
Figure 47: Bar graph showing the rainfall, average HCP & average resistivity for the different days of testing at Location 5.

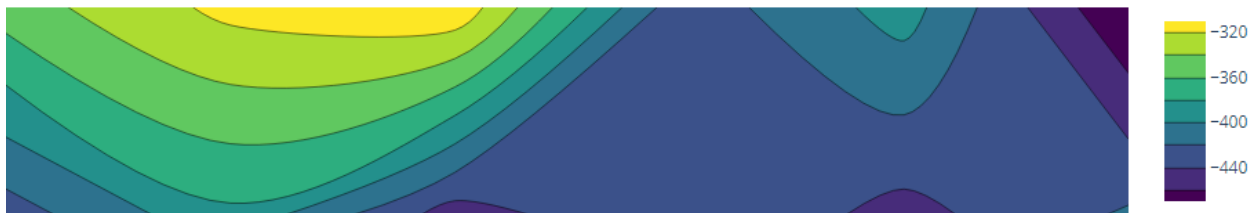
Figure 50: Location 3 contour plot on the 27th of August.

The comparison of the potential plots will be used to determine whether the shift in values due to the exposure conditions leads to any significant change in the contour patterns or whether the changes are limited to absolute measurements, thus supporting the use of a contour analysis instead of the prescribed value ranges.

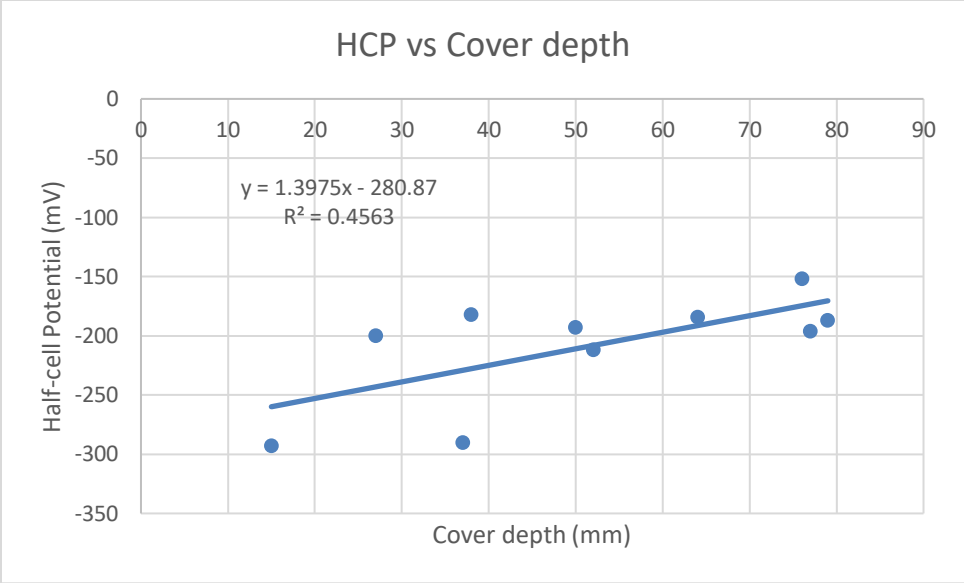
Figure 58: Graph of the minimum measured Half-cell potential (mV) vs Cover depth (mm) for location 2

Figure 59: Graph of the maximum measured Half-cell potential (mV) vs Cover depth (mm) for location 2

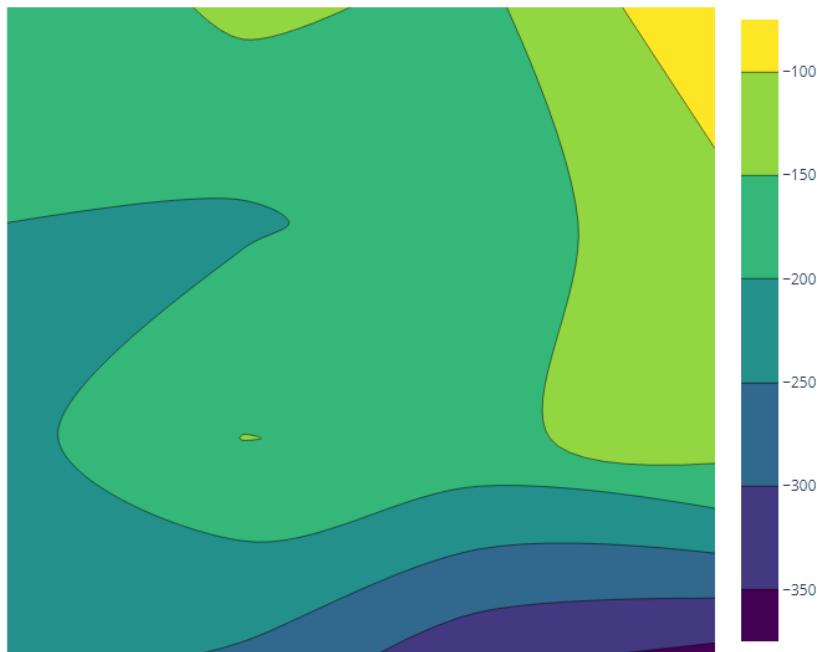
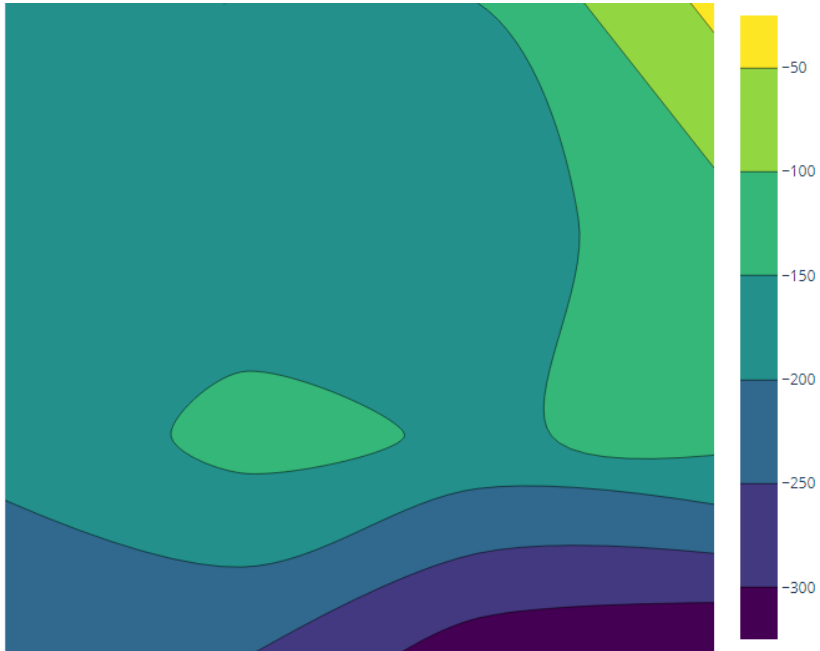
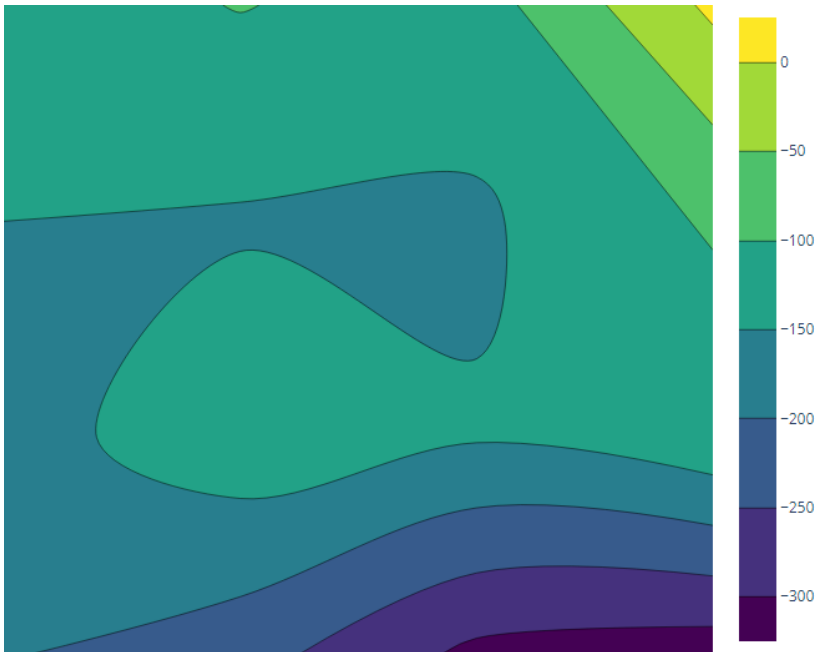
Location 1: Rachel Bloch House Column

Figure 89: Location 1 contour plot on the 7th of August

Figure 90: Location 1 contour plot on the 13th of August

Figure 91: Location 1 contour plot on the 27th of August

Figure 92: Location 1 contour plot on the 6th of September

Figure 93: Location 1 contour plot on the 28th of September

Figure 94: Location 1 contour plot on the 27th of October

Figure 95: Location 1 contour plot on the 19th of November

Figure 96: Location 1 contour plot on the 23rd of November

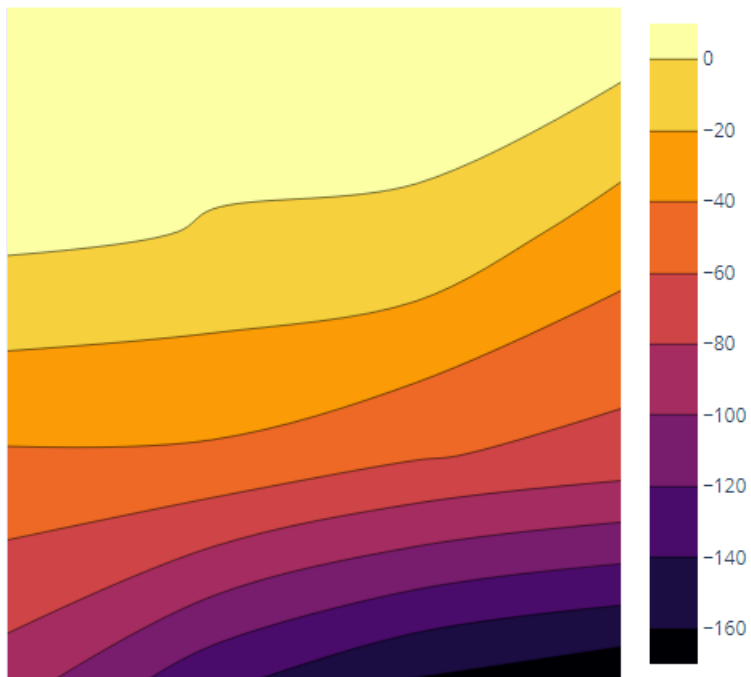
Figure 105: Location 4 contour plot on the 7th of August

Figure 106: Location 4 contour plot on the 13th of August

Figure 107: Location 4 contour plot on the 27th of August

Figure 108: Location 4 contour plot on the 6th of September

Figure 109: Location 4 contour plot on the 28th of September

Figure 110: Location 4 contour plot on the 27th of October

Figure 111: Location 4 contour plot on the 19th of November

Figure 112: Location 4 contour plot on the 23rd of November
