Development of High Performance and Efficient Coating Repair Systems for Offshore Tropical Marine Environment

A Dissertation Submitted in Partial Fulfilment of the Requirements for the Degree of
Masters of Science in Engineering to the Faculty of Engineering and Built
Environment of the University of Cape Town

Centre for Materials Engineering
Department of Mechanical Engineering
University of Cape Town
2017

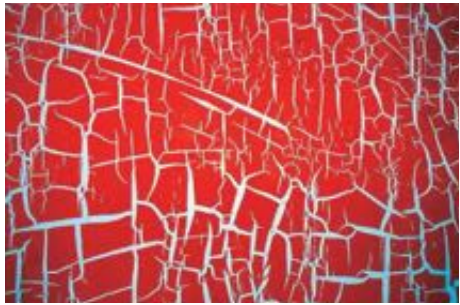
<p data-bbox="323 618 641 651">Alligatoring (Crocodiling)</p>	<p data-bbox="738 360 1019 607">“Very large (macro) crazing/cracking that resembles the skin of an alligator or crocodile. Cracks may penetrate through to the undercoat or down to the substrate. “</p>	<p data-bbox="1043 282 1337 685">“Internal stresses in the coating where the surface shrinks faster than the body of the paint film. Excessive film thickness and limited paint flexibility. Application of a hard topcoat over a more flexible softer undercoat. Application of topcoat before the undercoat has dried.”</p>

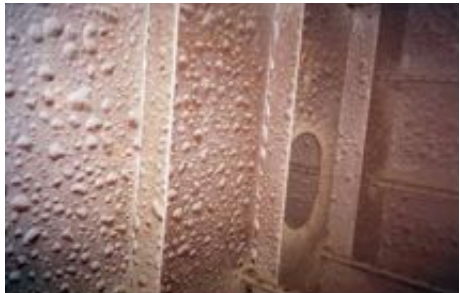
<p data-bbox="421 1032 544 1066">Blistering</p>	<p data-bbox="738 752 999 1066">“Dome-shaped projections or blisters in the dry paint film through local loss of adhesion and lifting of the film from the underlying surface. Blisters may contain liquid, vapor, gas, or crystals.”</p>	<p data-bbox="1043 685 1337 1122">“Many mechanisms can be involved, including osmotic gradients associated with soluble salts, soluble pigments, corrosion products, retained solvents, and solvents from cargoes. Non-osmotic blistering is associated with cathodic disbonding, thermal gradients related to cold-wall effects, and compressive stress.”</p>

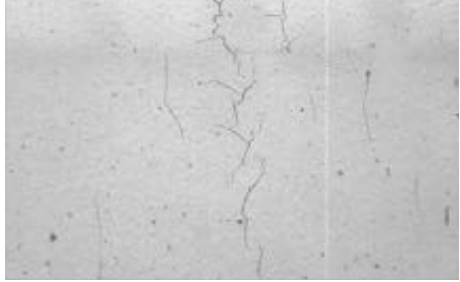
<p data-bbox="427 1413 537 1447">Checking</p>	<p data-bbox="738 1178 1019 1391">“Fine cracks that do not penetrate the topcoat of a paint system. Some checking can be so minute that it is impossible to see without magnification.”</p>	<p data-bbox="1043 1144 1337 1424">“Typically, a formulation and/or a specification problem. As with cracking, stresses are developed that cause the surface of the paint film to become brittle and crack. Limited paint flexibility.”</p>

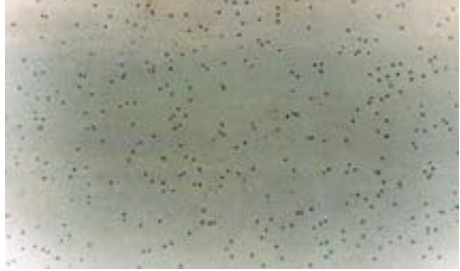
<p data-bbox="437 1727 528 1760">Cissing</p>	<p data-bbox="738 1480 1019 1727">“Surface breaks in a wet paint film, where the paint has receded to expose the underlying substrate. The paint is unable to wet-out the substrate. Can be very large.”</p>	<p data-bbox="1043 1491 1337 1715">“Surface contamination by either moisture or foreign matter such as oil, grease, or silicone. Also known to happen when incorrect solvent blends have been used.”</p>

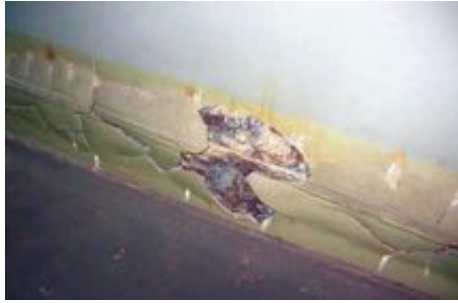
<p data-bbox="427 533 539 566">Cracking</p>	<p data-bbox="738 259 1018 539">“The splitting of a dry paint film through at least one coat to form visible cracks, which may penetrate down to the substrate. Cracking comes in several forms, from minute cracking to severe cracking.”</p>	<p data-bbox="1050 232 1337 562">“Cracking is generally a stress-related failure and can be attributed to surface movement, aging, absorption and desorption of moisture, and general lack of flexibility of the coating. The thicker the paint film, the greater the possibility it will crack.”</p>

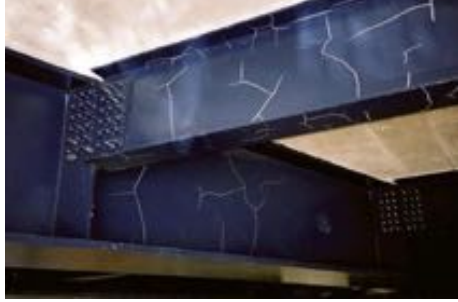
<p data-bbox="427 873 539 907">Crazing</p>	<p data-bbox="738 678 1018 801">“Similar to checking but the cracks are generally wider and penetrate deeper into the film.”</p>	<p data-bbox="1050 663 1321 813">“Application temperature too low, incompatibility with previous coating, aging, or high film thickness.”</p>

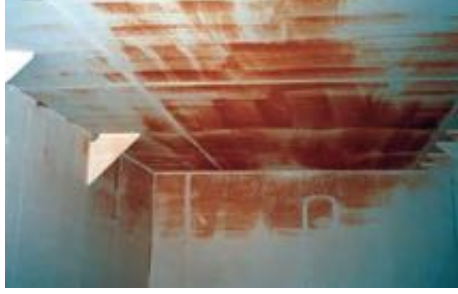
<p data-bbox="427 1205 539 1232">Rust Rashing</p>	<p data-bbox="738 918 1018 1220">“Fine spots of rust that appear on a paint film, often a thin primer coat. The initial spots rapidly spread over the surface, resulting in a film of rust through which the individual spots are difficult to discern. Also from holidays.”</p>	<p data-bbox="1050 1014 1289 1126">“Low film thickness, often in combination with a high surface profile.”</p>

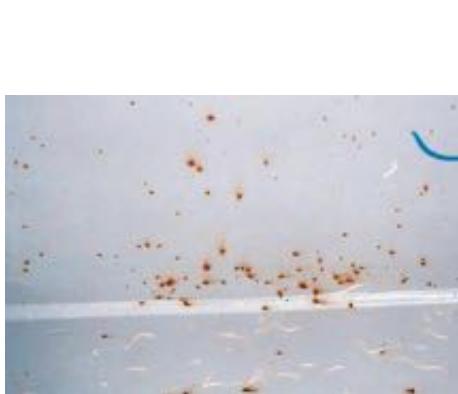
<p data-bbox="427 1630 539 1664">Rust Spotting</p>	<p data-bbox="738 1406 1018 1597">“Individual spots of rust that appear on a paint film and frequently start as localized spotting but rapidly increase in density.”</p>	<p data-bbox="1050 1238 1337 1760">“Low film thickness (more likely creating rust rashing), voids and holidays (more likely creating rust rashing), but also defects in the steel, such as laminations and inclusions. Too high a surface profile may cause penetration of peaks through a paint film and cause rust spotting. May also occur from metallic contamination of a coated surface by grinding dust and so on.”</p>

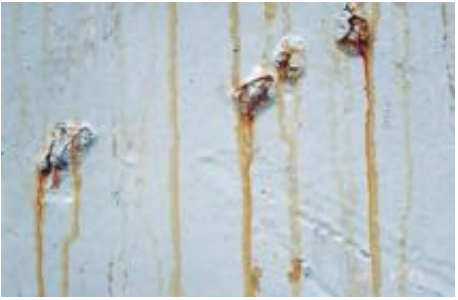
<p data-bbox="400 562 568 593" style="text-align: center;">Rust Staining</p>	<p data-bbox="740 338 1018 517">“A light staining on the surface of the paint caused by the precipitation of ferrous oxide from adjacent exposed steel.”</p>	<p data-bbox="1050 226 1337 629">“Water runoff from a rusty surface above a soundly coated surface. Rust staining occurs when the rust is wetted-out and contaminated water runs over and discolors other items or locations. Usually more of an eyesore than a defect. The coating itself may not be defective, only stained.”</p>

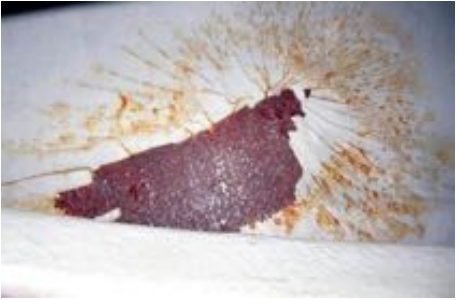
<p data-bbox="384 983 584 1014" style="text-align: center;">Stress Cracking</p>	<p data-bbox="740 786 1011 909">“Paint coatings with visible cracks, which may penetrate down to the substrate.”</p>	<p data-bbox="1050 629 1337 1066">“Stress cracking can be attributed to surface movement, aging, absorption and desorption of moisture, thermal cycling, and general lack of flexibility of the coating. The thicker the paint film, the greater the possibility that cracking may occur. Often occurs around welds and changes in section.”</p>

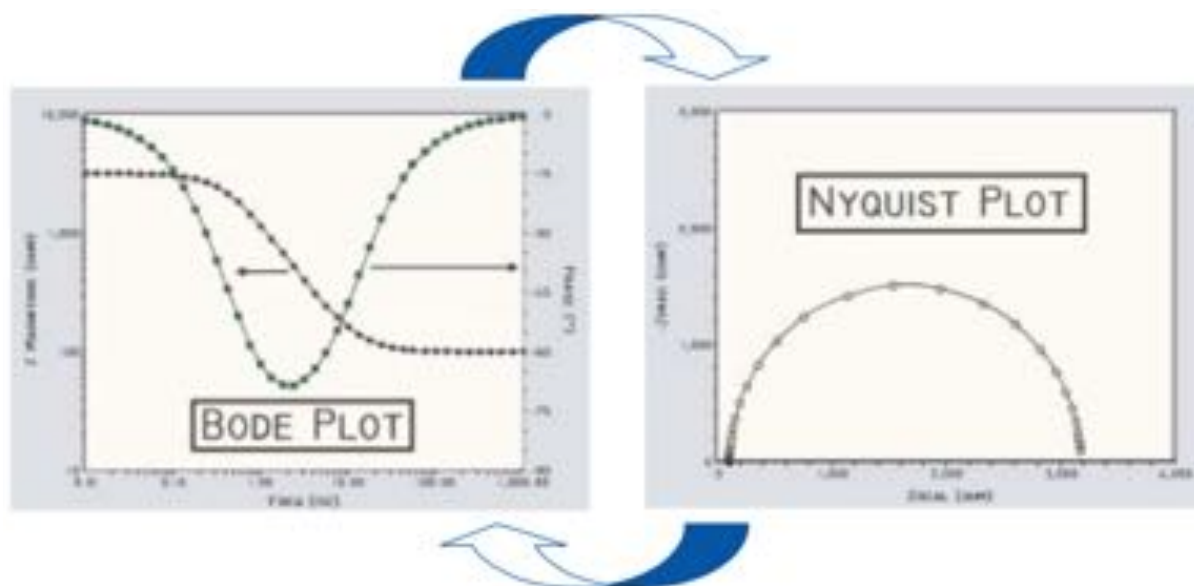
Figure 2: Magnitude and phase angle representation in Bode plot (left) and Nyquist plot representation (right) (David Loveday, Peterson and Rodgers, 2004)

There are various ways to plot the impedance data. The most used are the Nyquist plot, where it is measured at different frequencies and plotted in a complex plane, and the Bode plot that presents the logarithm of the modulus of the impedance and the phase angle as a function of the logarithm of the frequency (Figure 2).

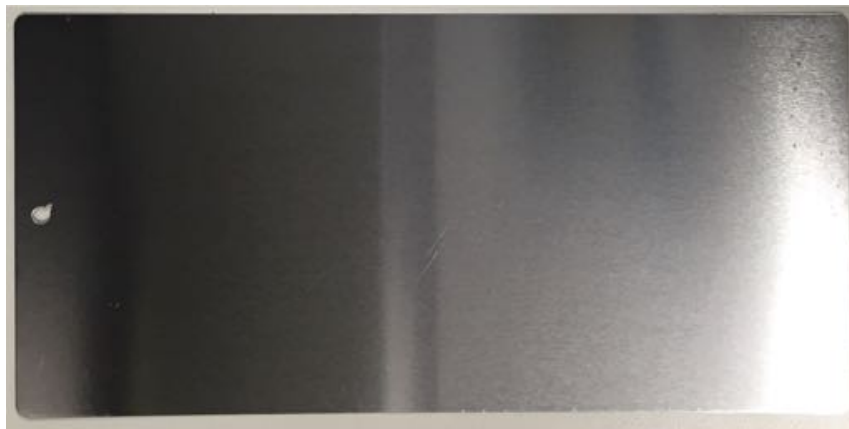
Figure 3: Reference new (RN) sample prior to coating application

A set of brand new samples was used as reference. Figure 3 below shows the appearance of the surface of the RN samples prior to testing.

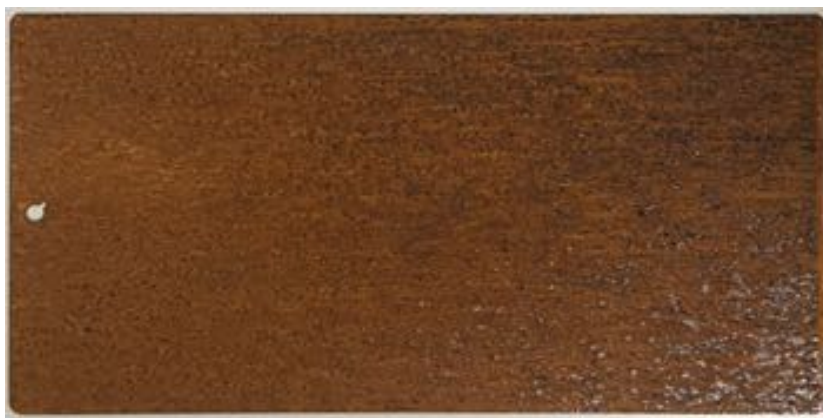
Figure 4: Sample with salt contamination and no rust-cleaning attempt (SN) prior to coating application

All other surface condition involved exposing the samples so as to corrode and contaminate the plates, so that the additional preparation methods could be carried out. Figure 4 below shows the appearance of the samples after exposure.

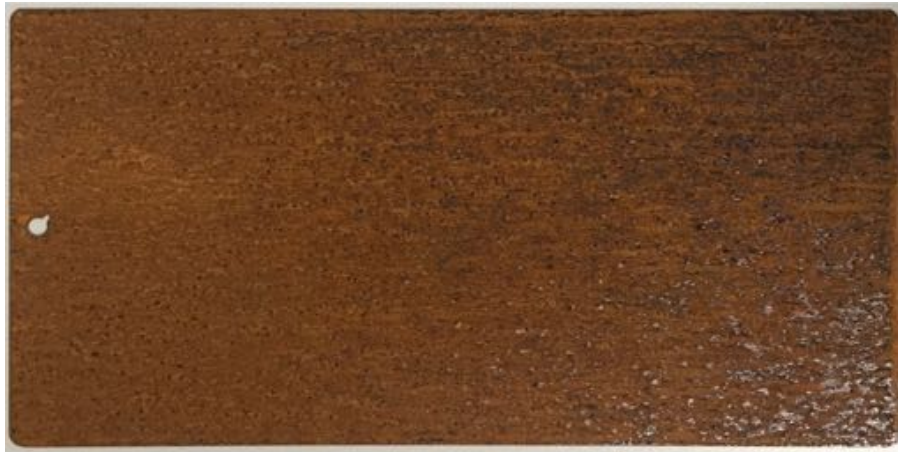
Figure 5: Sample with no salt contamination and no rust-cleaning attempt (NN) prior coating application

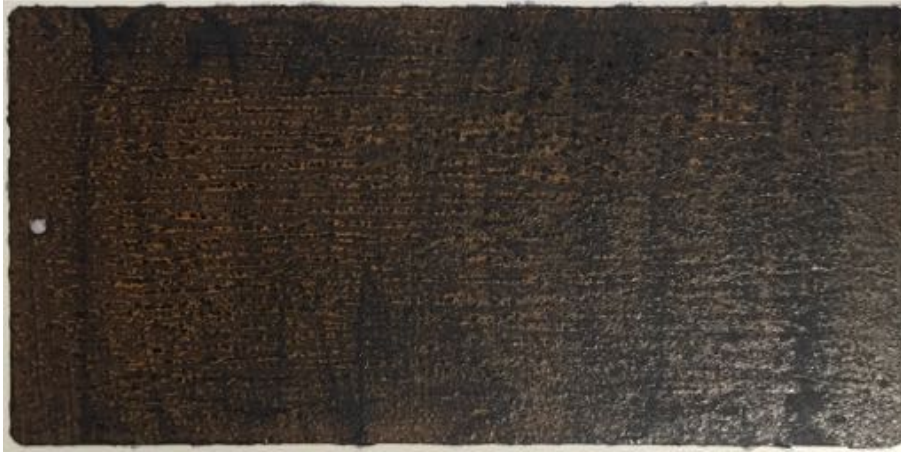
Figure 6: Sample with no salt contamination and chemical (rust converter) surface preparation (NC1) prior coating application

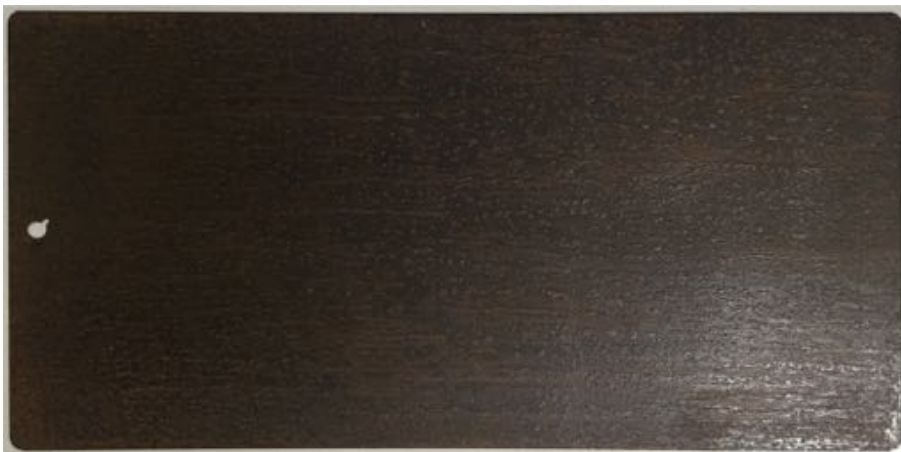
Figure 7: Sample with no salt contamination and mechanical surface preparation (NM) prior to coating application

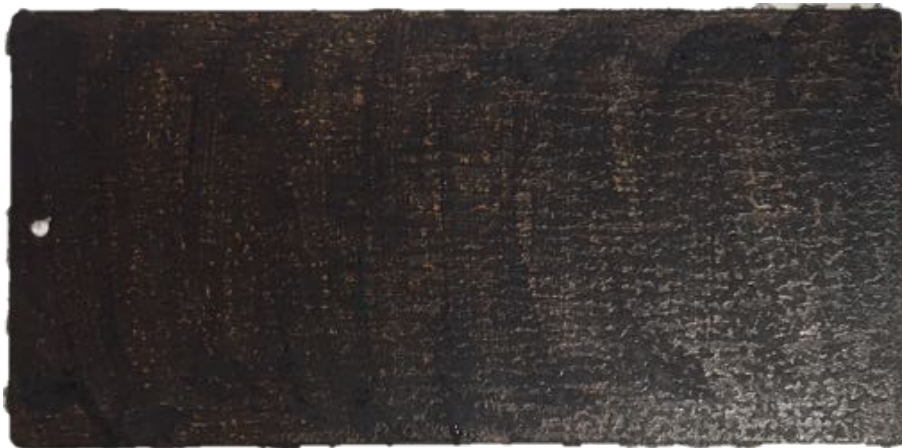
Figure 9: Sample with salt contamination and chemical (rust converter) surface preparation (SC1) prior to coating application

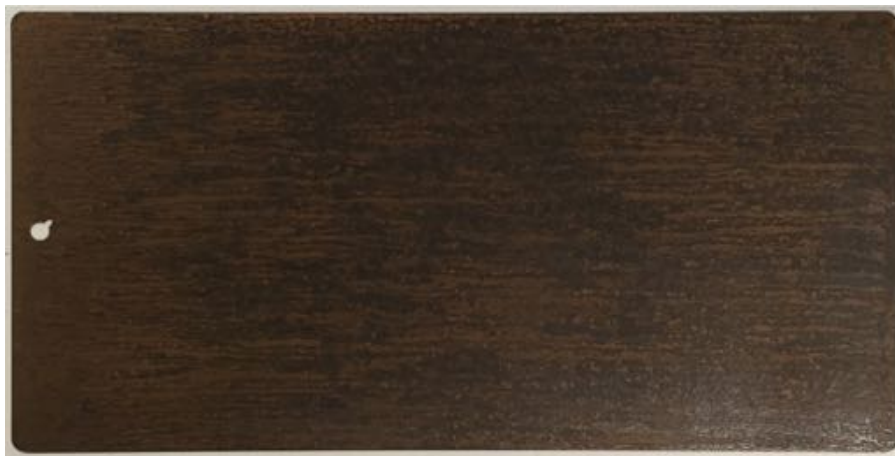
Figure 10: Sample with salt contamination and mechanical surface preparation (SM) prior to coating application

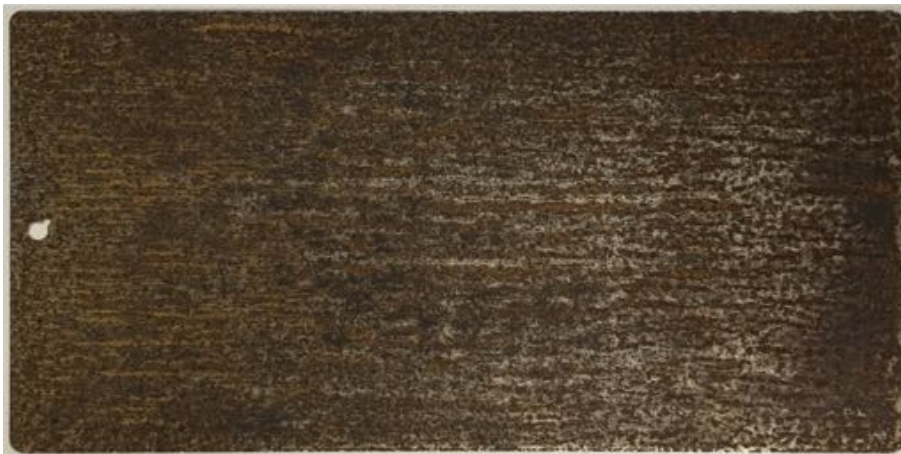
Figure 12: Samples with salt contamination and both mechanical and chemical (rust remover) surface preparation (SB2) prior to coating application

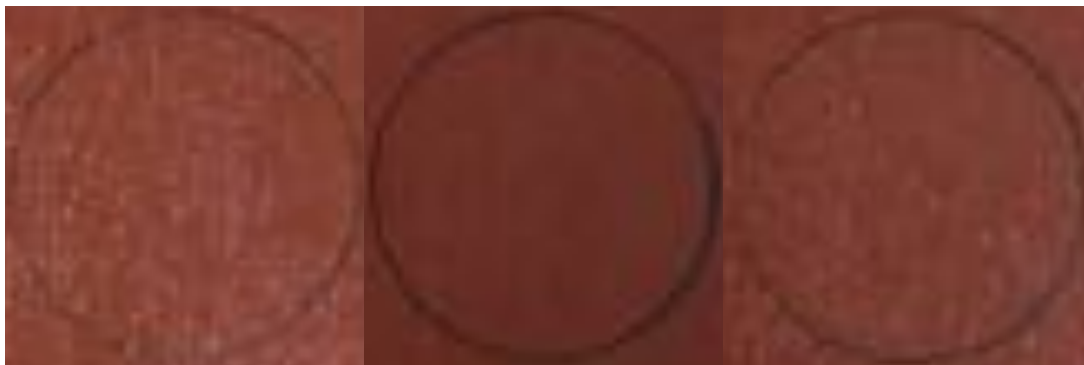
Figure 18: Variation in performance of SN samples at 34 hours of exposure (from the left SN-06, SN-12 and SN-14)

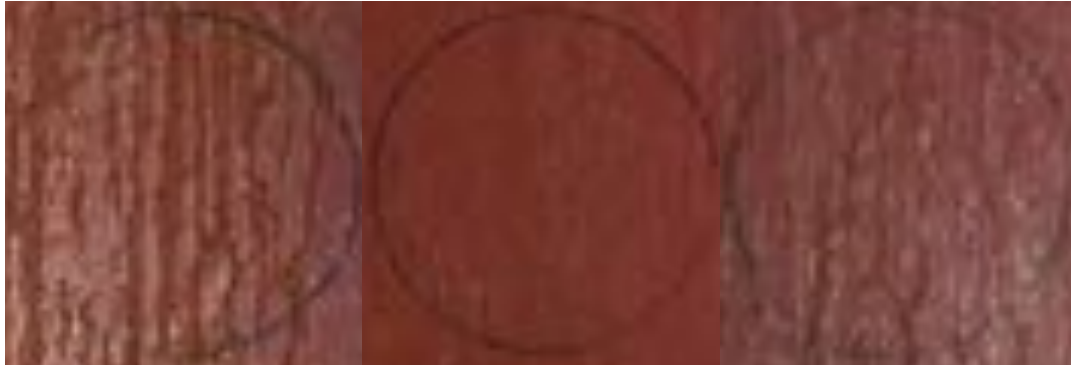
Figure 19: Variation in performance of SM samples at 68 hours of exposure (from the left SM-06, SM-09 and SM-12)

The plates shown in Figures 18 to 22 were used for EIS testing, so the focus is on the testing areas within the marked circle. The difference in performance across the samples with identical pre-treatment is minimal and shows good consistency across the plates i.e. similar appearance in terms of type and degree of failure.

The edge of the test plates is a critical region where corrosion initiates and corrosion initiation is a catalyst for complete failure. Figures 18 to 27 illustrate that coating deterioration could consist of different types of failure, occur at different locations on

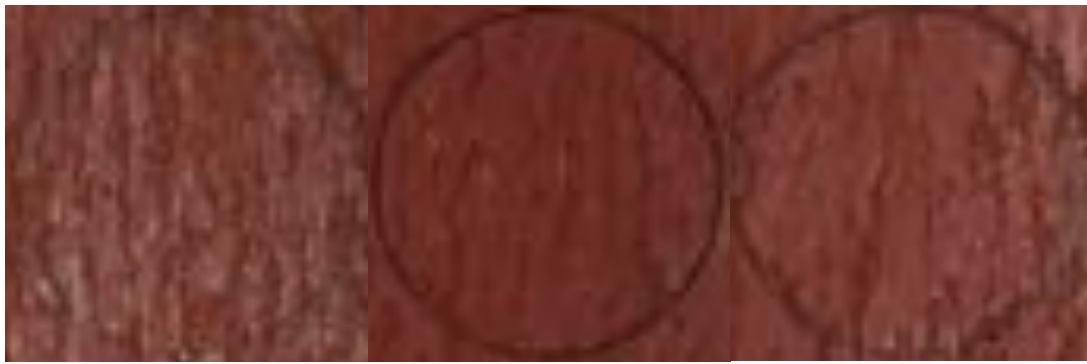
Figure 20: Variation in performance of NN samples at 136 hours of exposure (from the left NN-05, NN-09 and NN-10)

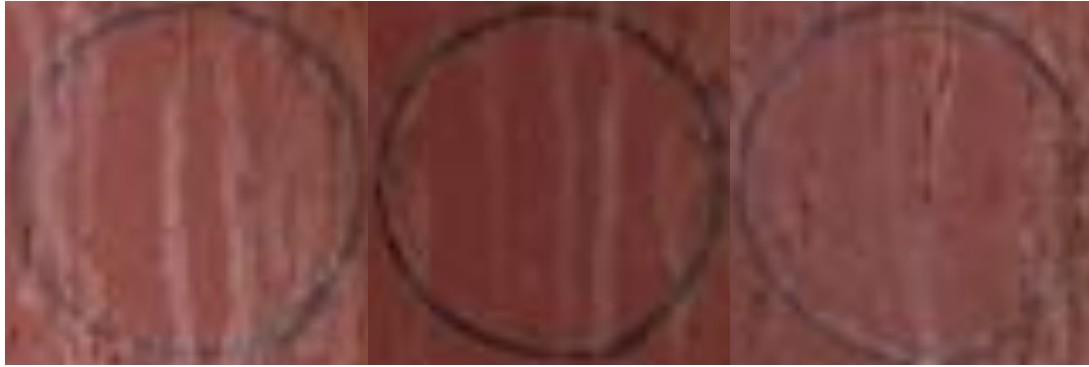
Figure 22: Variation in performance of SB2 samples at 136 hours of exposure (from the left SB2-05, SB2-06 and SB2-09)

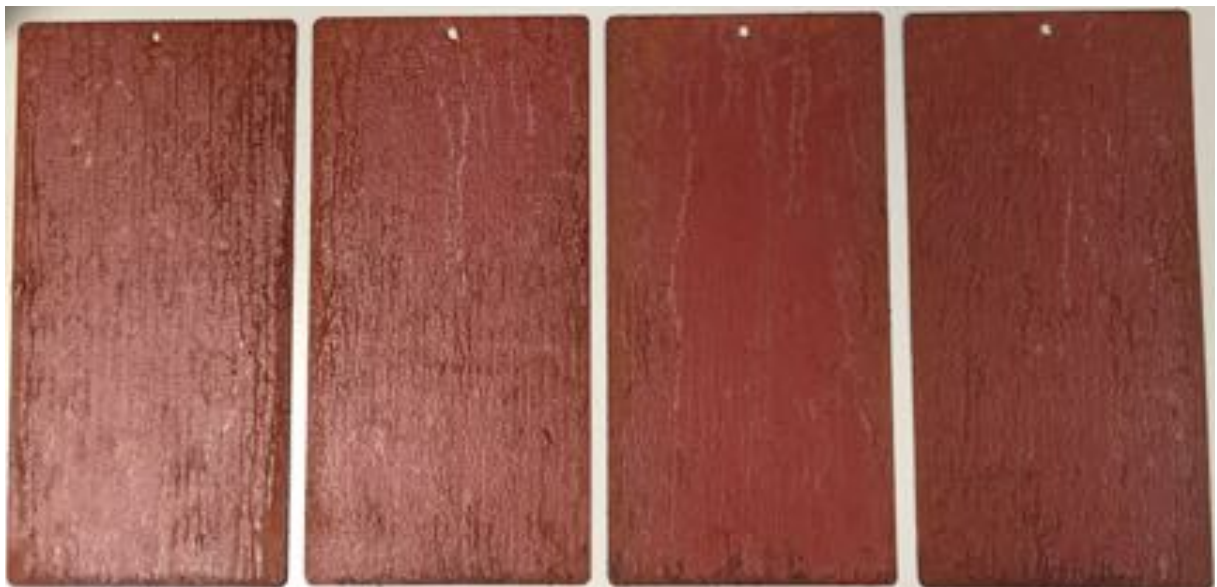
Figure 23: Variation in performance of SC1 samples at 264 hours of exposure (from the left SC1-01, SC1-02, SC1-03 and SC1-04)

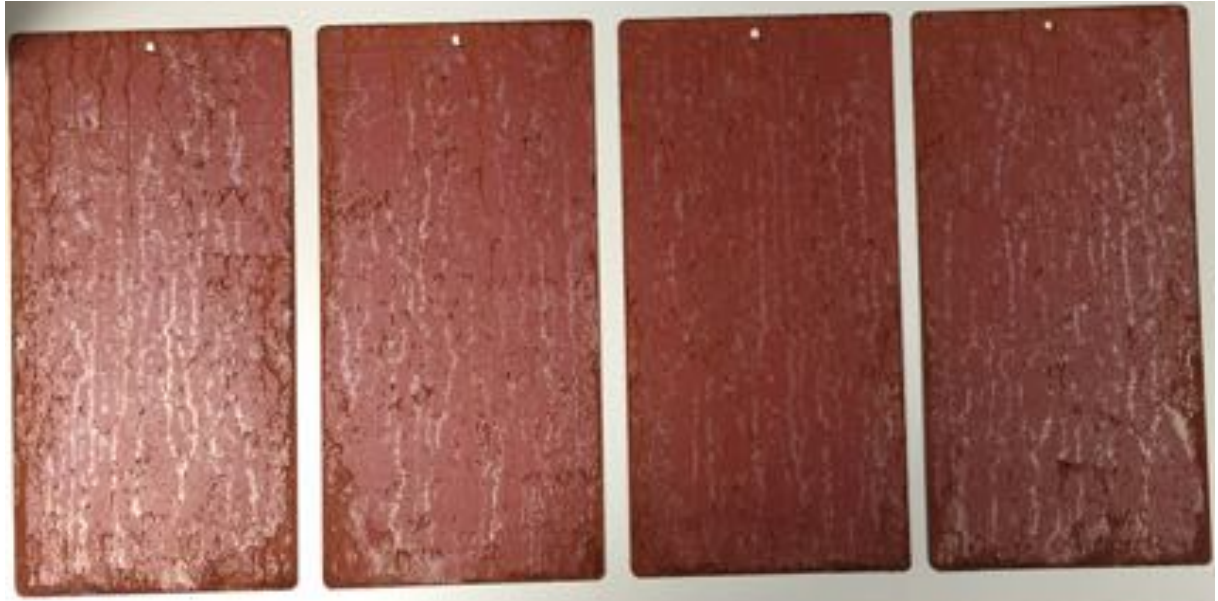
Figure 24: Variation in performance of SB1 samples at 264 hours of exposure (from the left SB1-01, SB1-02, SB1-03 and SB1-04)

While Figures 18 to 22 show the zone on the test plates that was tested by EIS, Figures 23 to 27 show the entire test plate. Here the visually assessed test plates are presented as opposed to the EIS tested plates, since by the time they showed visual signs of coating deterioration, EIS measurement was no longer being performed.

Figures 23 to 27 show that although coating degradation can vary across a single plate, the outcome from one plate to another within each pre-treatment type is very similar, thus showing a consistency in the test results.

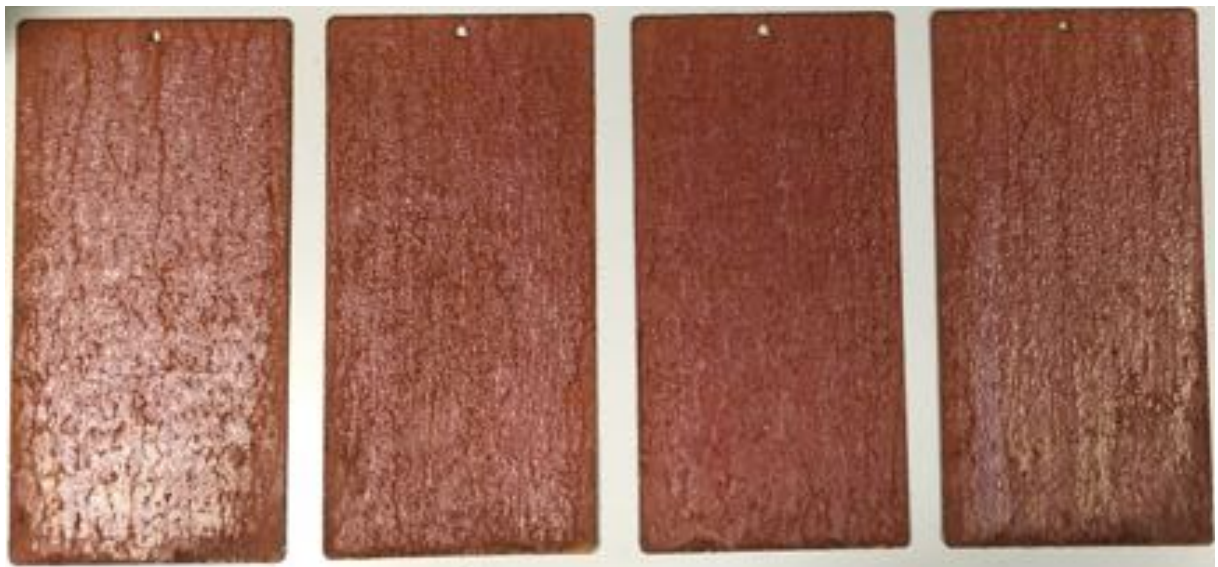
Figure 25: Variation in performance of NB1 samples at 710 hours of exposure (from the left NB1-01, NB1-02, NB1-03 and NB1-04)

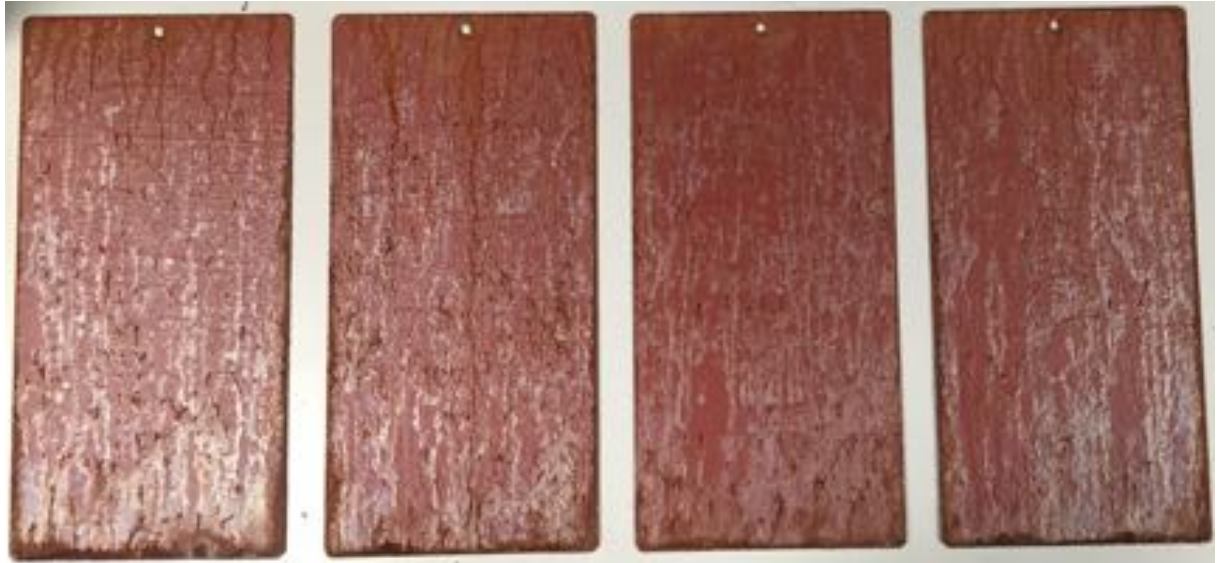
Figure 26: Variation in performance of NC1 samples at 710 hours of exposure (from the left NC1-01, NC1-02, NC1-03 and NC1-04)

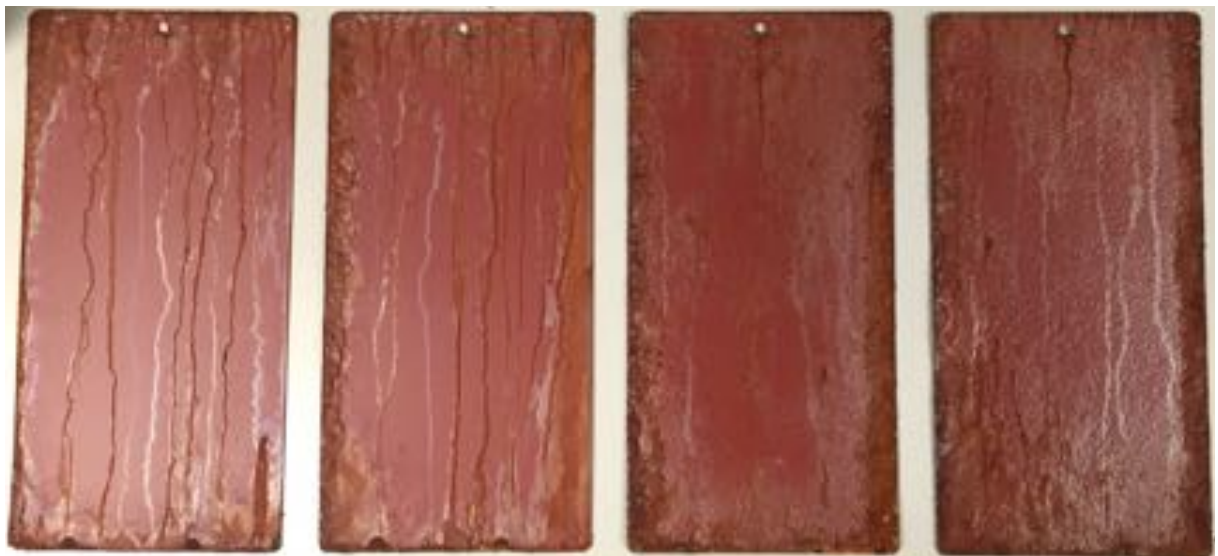
Figure 27: Variation in performance of RN samples at 710 hours of exposure (from the left RN-01, RN-02, RN-03 and RN-04)

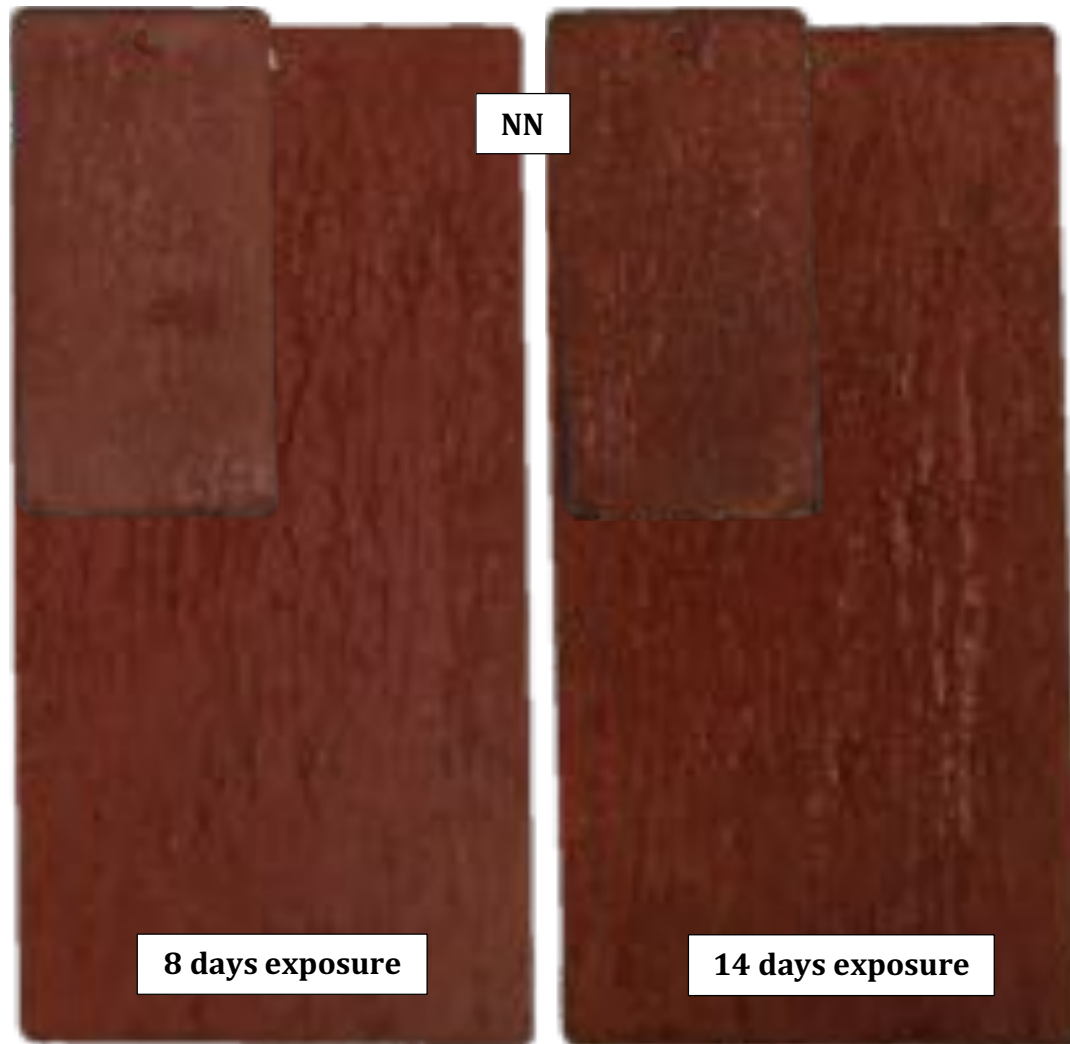
Figure 35: Samples with no salt contamination but no surface preparation (NN), a small sample on the top left corner of the larger one at exposure periods of 8 days (left) and 14 days (right).

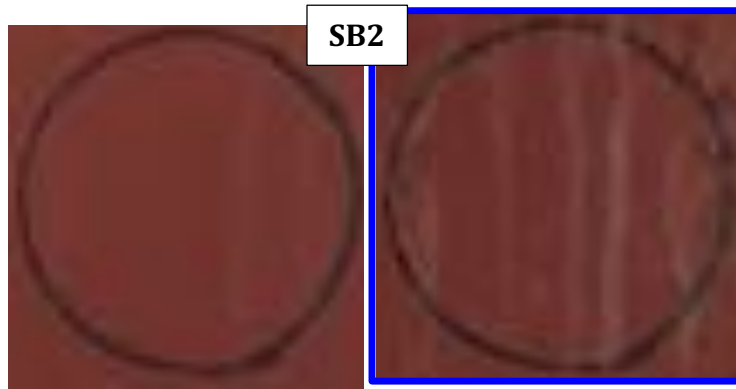
Figure 43: Failure of an SB2 sample at 68 (left) and 136 (right) hours of CCT1 exposure

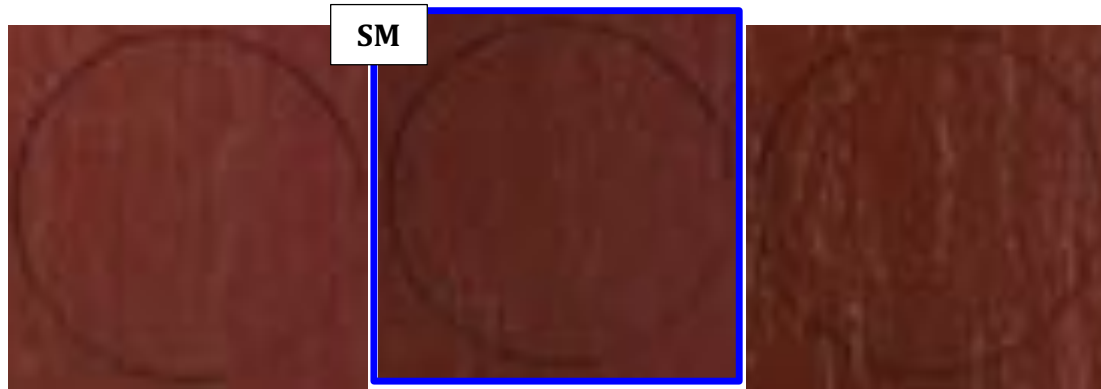
Figure 46: Failure of an SM sample at 34 (left), 68 (middle) and 136 (right) hours of CCT1 exposure

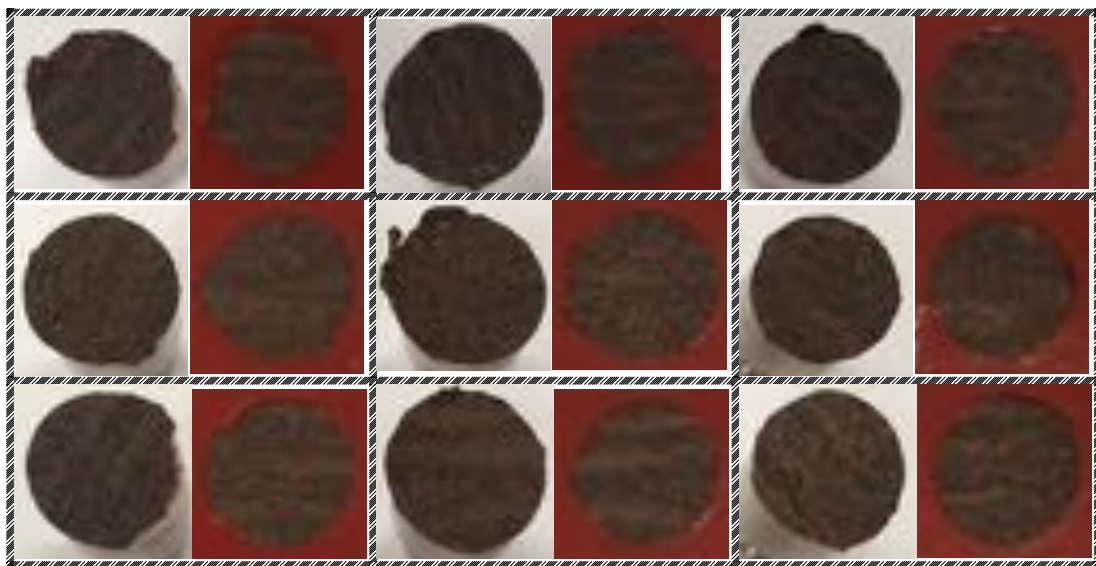
Figure 59: All NC1 samples test sites showed cohesive failure in the converted corrosion product underneath the coating, each row is a sample, and the dollies are on the left of the corresponding test sites.

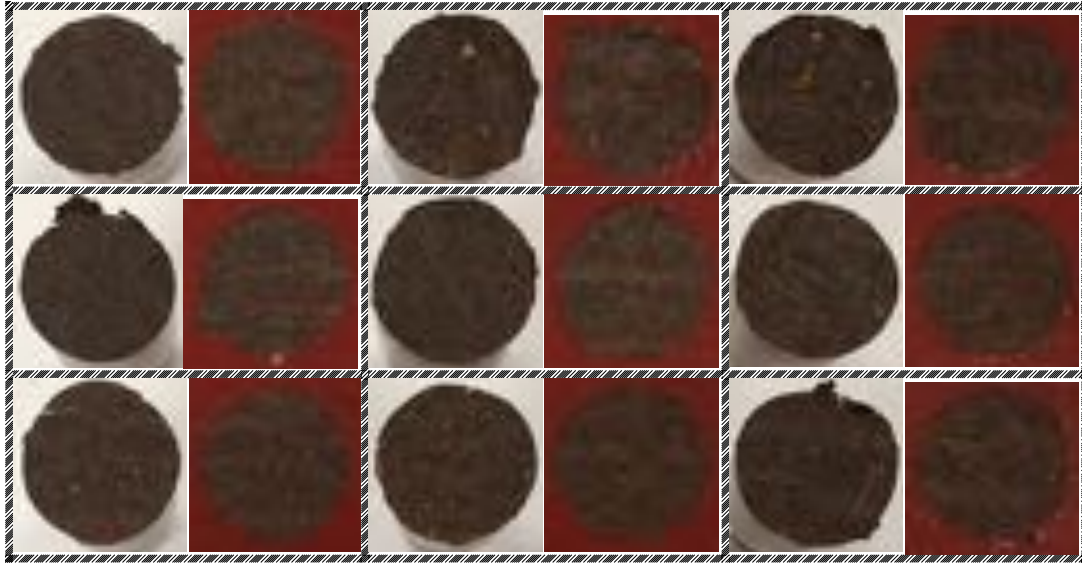
Figure 62: All SC1 samples test sites showed cohesive failure in the converted corrosion product underneath the coating, each row is a sample, and the dollies are on the left of the corresponding test sites.

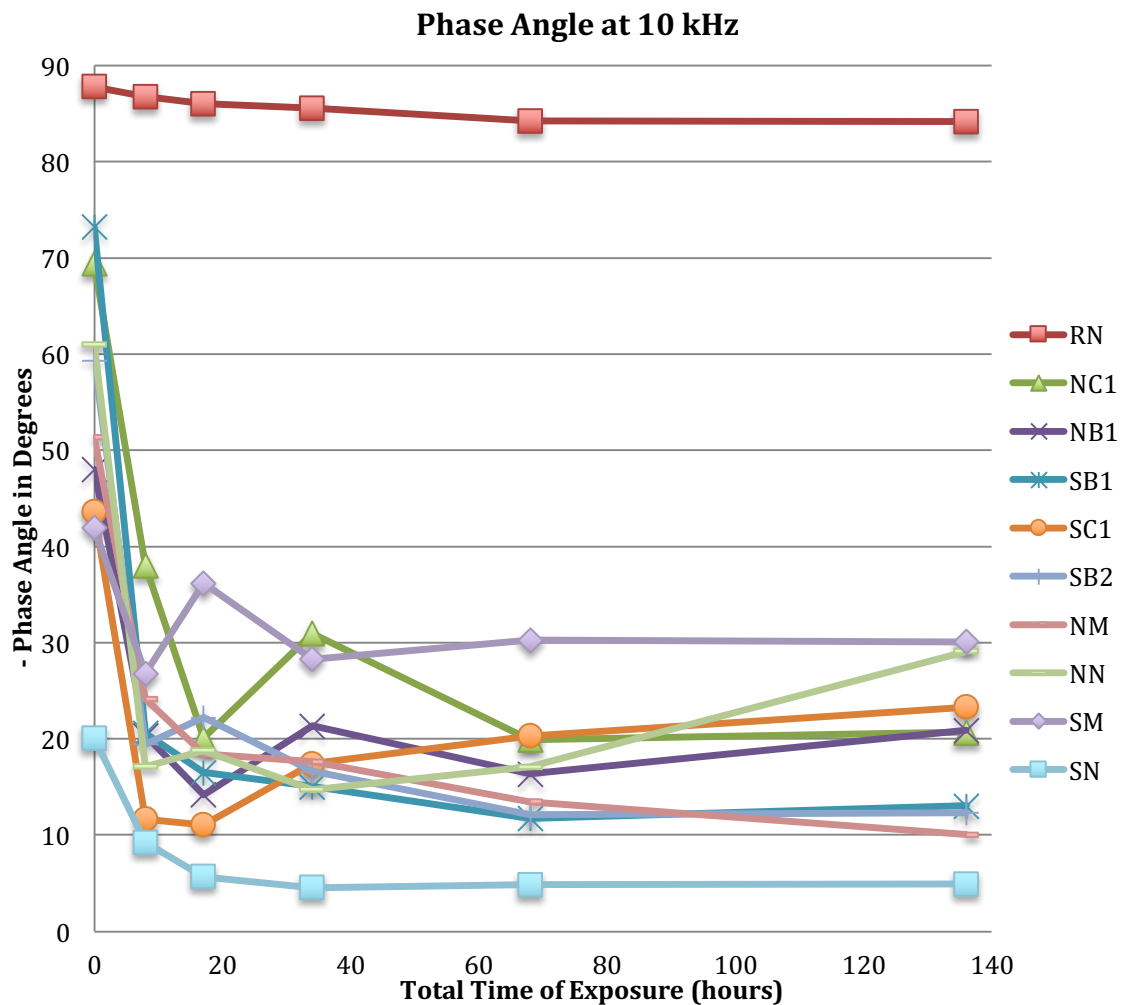
Figure 71: Change of phase angle at high frequency (10kHz) with time of exposure

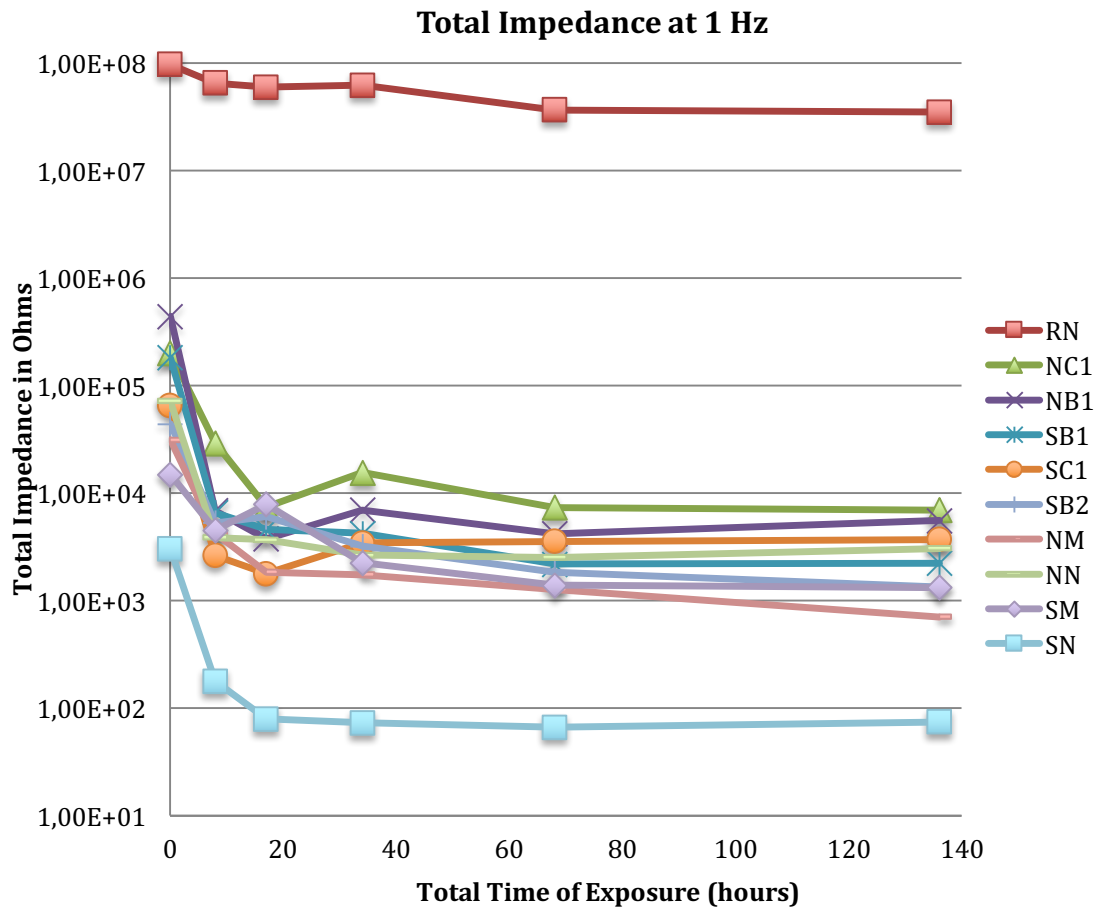
Figure 73: Change of total impedance at low frequency (1 Hz) with time of exposure

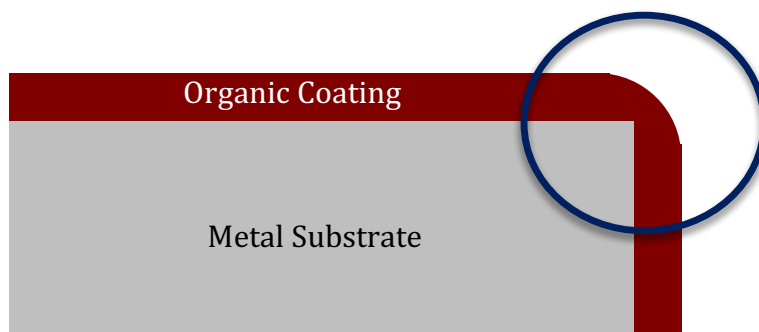
Figure 74: Cross section of a coated sample showing how the paint can be thinner on the edges (top right corner)
