UNIVERSITY OF CAPE TOWN

CIV5000Z: MASTERS THESIS

“Alternative patch repair materials for rebar corrosion damage”

Compiled By: Primesh Jassa
Student Number: JSSPRI001
Supervisor: Professor Hans Beushausen
Co-Supervisor: Dr Ines Tchetgnia Ngassam
Department: Concrete materials and structural integrity research unit (CoMSIRU)
Date: May 2017

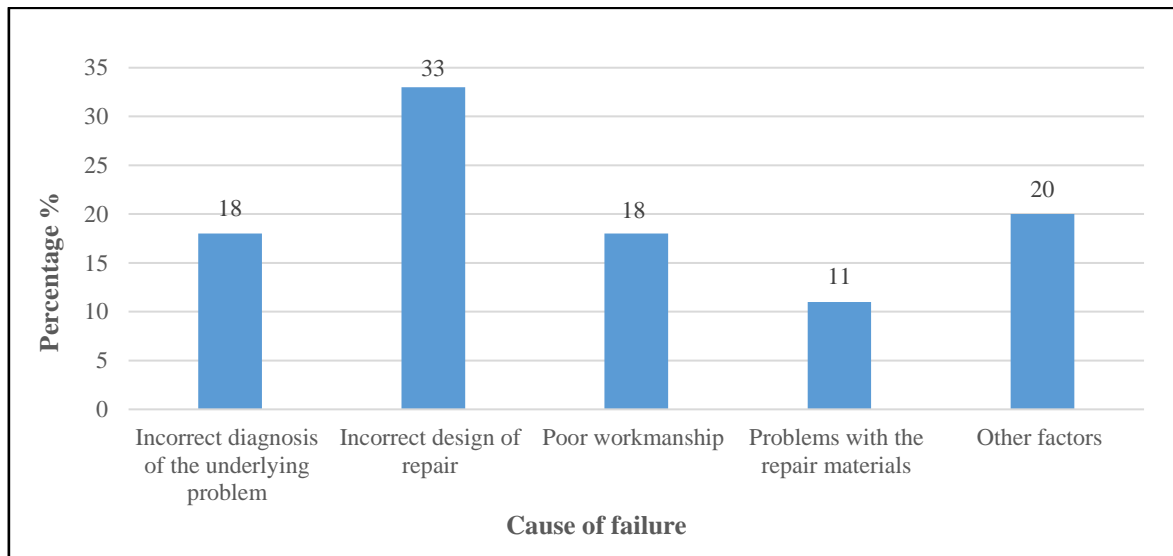
Figure 2-2: Main cause of repair failure (Matthews *et al.*, 2003)

Based on these findings it can be identified that the premature failure of concrete repairs may not always be solely attributed to repair material failure, but rather the incorrect application of the repair material and not adhering to proper repair procedures. Therefore, it may be possible to substitute specialised proprietary repair materials, which are relatively expensive and exhibit unnecessary properties such as high compressive strength, with seemingly sub-standard repair materials. On condition that a repair procedure is properly executed, it is expected that such a substitute repair material would effectively serve the primary purpose of restoring the serviceability and durability of a deteriorated structure.

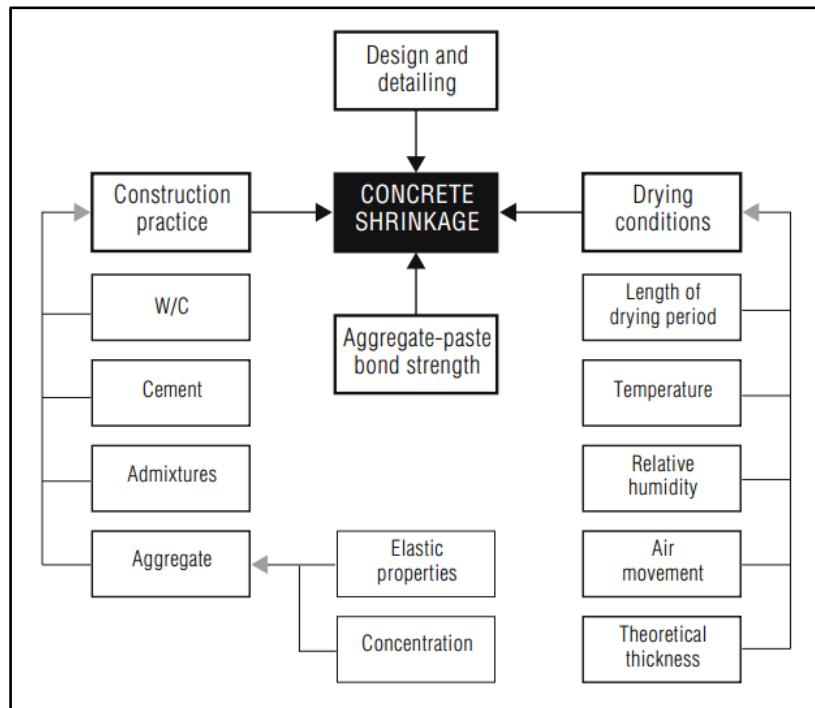
Figure 2-19: Factors influencing drying shrinkage (CCAA, 2002)

As a consequence tensile stresses developed in the repaired layer may ultimately lead to cracking, if the tensile capacity of the repair material is exceeded (Banthia & Gupta, 2009). Cracks may develop at the surface of the repair which then propagate along the cross section. With crack propagation surface crack width will widen thereby, affecting the durability of the repair. The initiation of cracking will fundamentally depend on the material properties and severity of moisture loss. There are numerous factors influencing the extent of drying shrinkage in concrete structures and these are identified in Figure 2-19. Tensile forces developed within a patch repair due to deformations, including free and restrained shrinkage and volume changes, are typically accepted to be the chief parameters responsible for cracking in repairs (Mauroux, 2012). Cracking is of major concern in patch repairs, especially with chloride ion affected structures, since it dramatically alters the movement of deleterious substances into concrete. This facilitates rapid deterioration of concrete and premature repair failure.

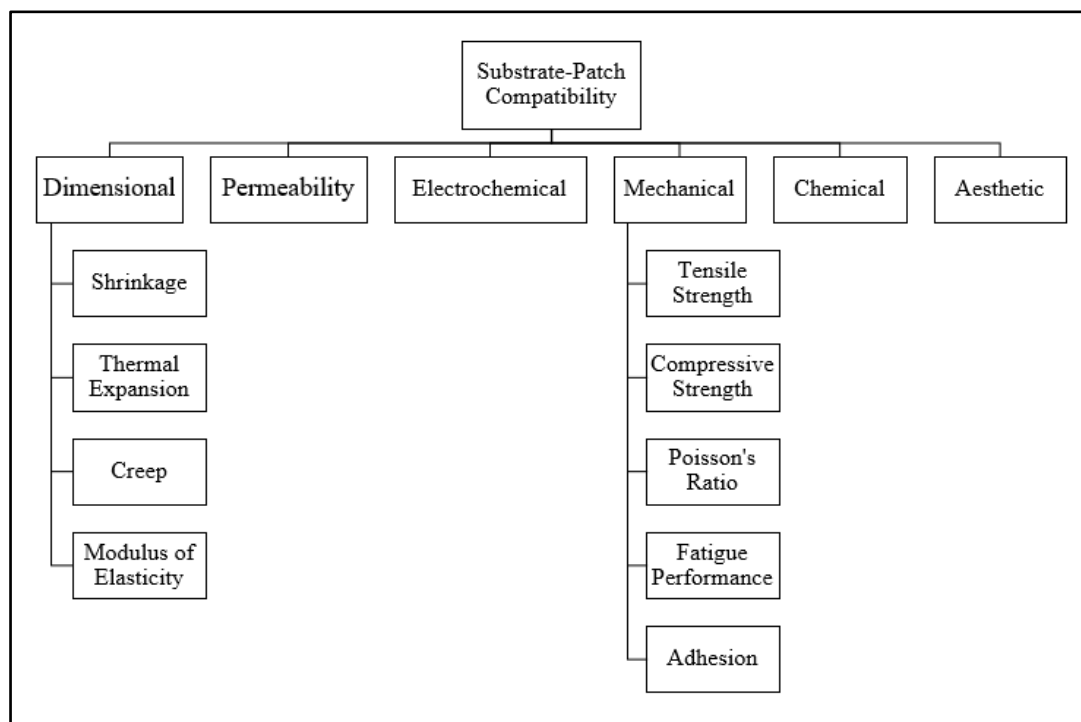
Figure 2-23: Compatibility factors considered for repair materials (Vaysburd, 2006)

Dimensional, mechanical, chemical, permeability, electrochemical and aesthetic parameters are the key compatibility aspects identified in literature as summarised in Figure 2-23.

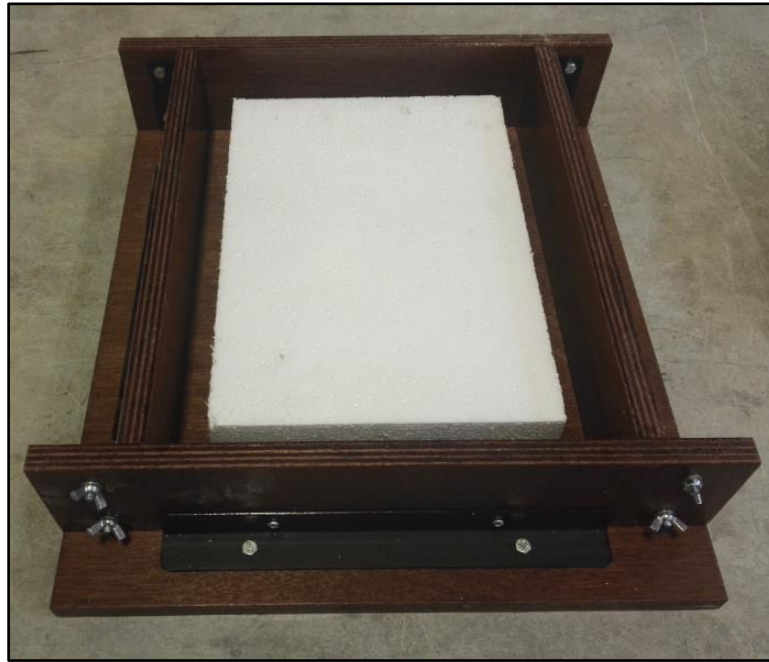
Figure 3-20: Wooden mould used to cast substrate concrete slabs (with styrofoam insert to create the cavity for mortar application)

With respect to the theme of this research project it was paramount to experimentally investigate into the ease and process of application of the selected repair materials to non-structural patch repairs as well as the aesthetics of a repaired element. These tests were essential to determine the practicality of using the repair materials developed. To test the application of the new repair materials on patch repairs, custom concrete moulds were manufactured to mimic a typical substrate. A characteristic substrate requiring a patch repair would have all deteriorated concrete removed from the vicinity of the corroded steel, creating a cavity with exposed steel. Therefore, to manufacture concrete elements representative of such substrates, special wooden moulds were developed to make concrete slabs as shown in Figure 3-20.

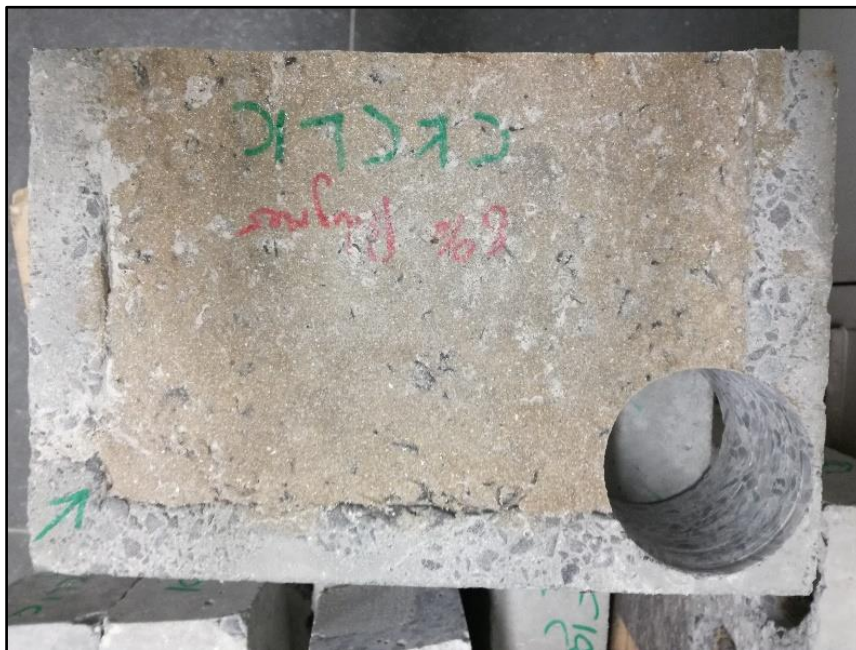
Figure 3-38: Core for SEM taken from corner of substrate mould

Microscopic analysis was conducted on the different repair materials to investigate into the bond characteristics between the patch repair material and the substrate concrete. Material specimens were cored from the patch repair moulds. 70 ± 2 mm diameter cores were taken and these were cut into 8 ± 2 mm discs. The cores were taken from a corner of the patch repair mould as shown in Figure 3-38.

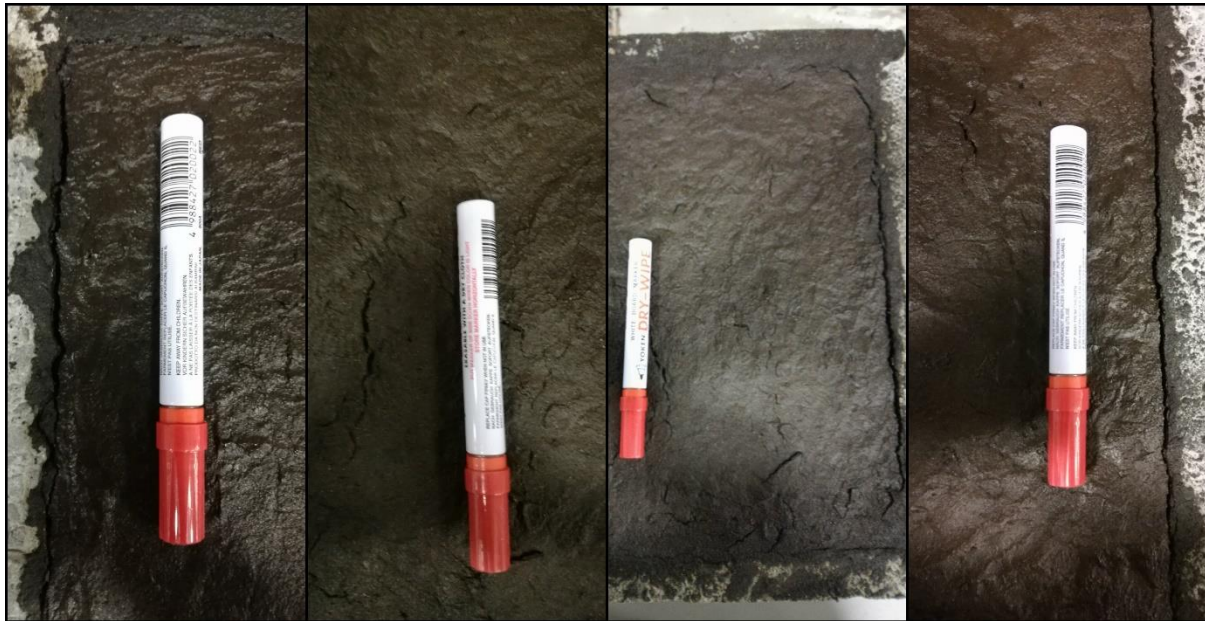
Figure 4-2: Excessive cracking and debonding occurrence on bitumen patch repairs

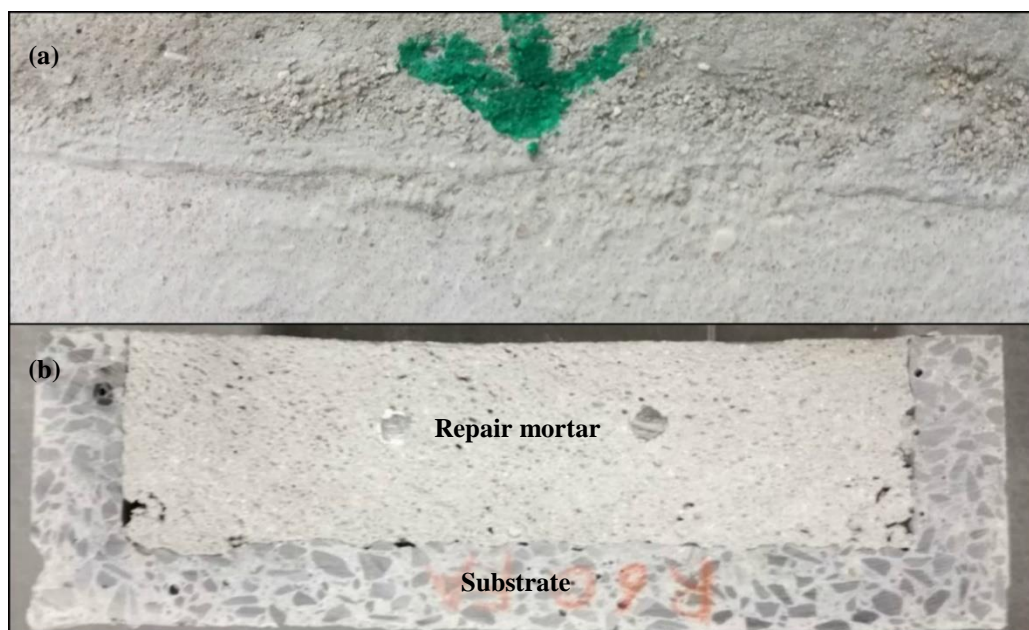
Figure 4-19: (a) Case of debonding and (b) cross-section of 60% FA patch repair

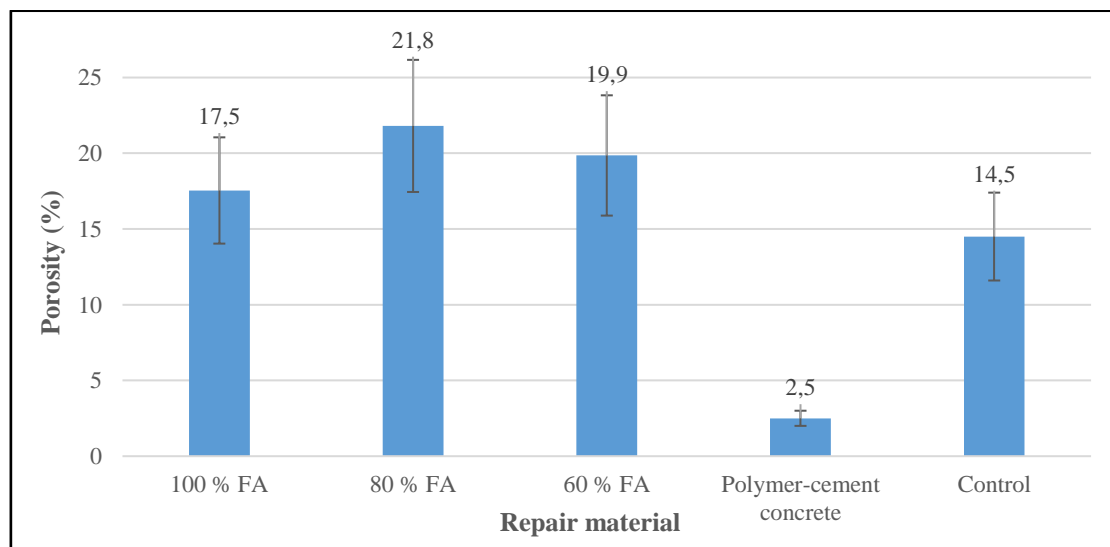
Figure 4-40: Porosity results from WSI tests

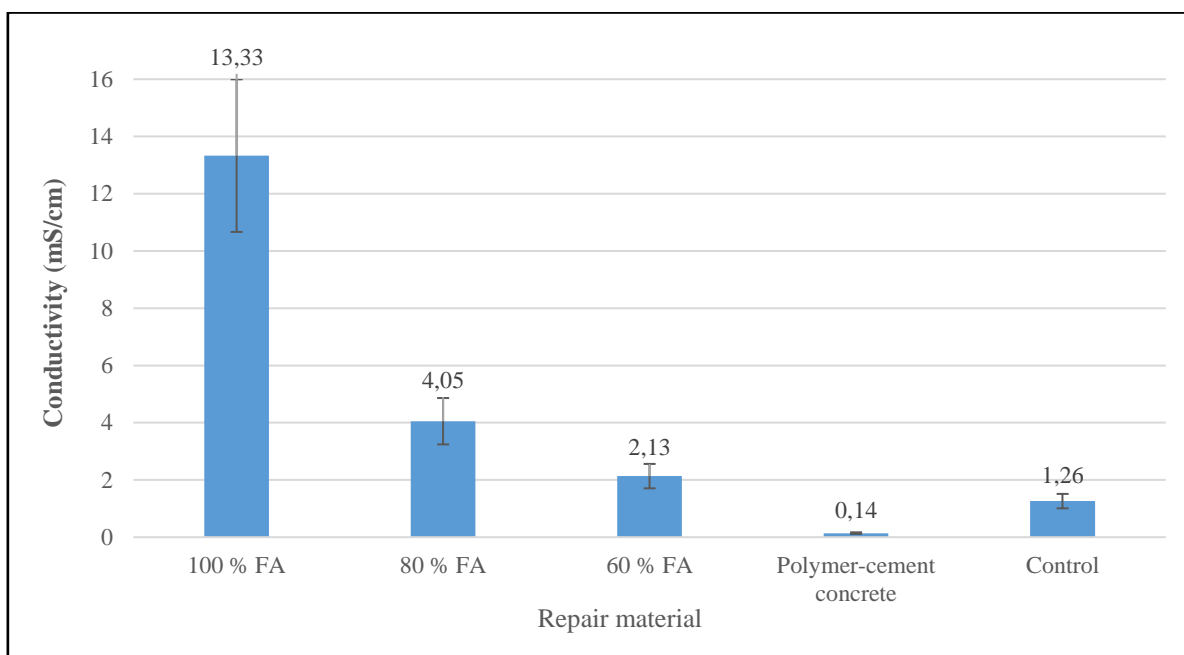
Figure 4-41: Chloride conductivity of different repair materials

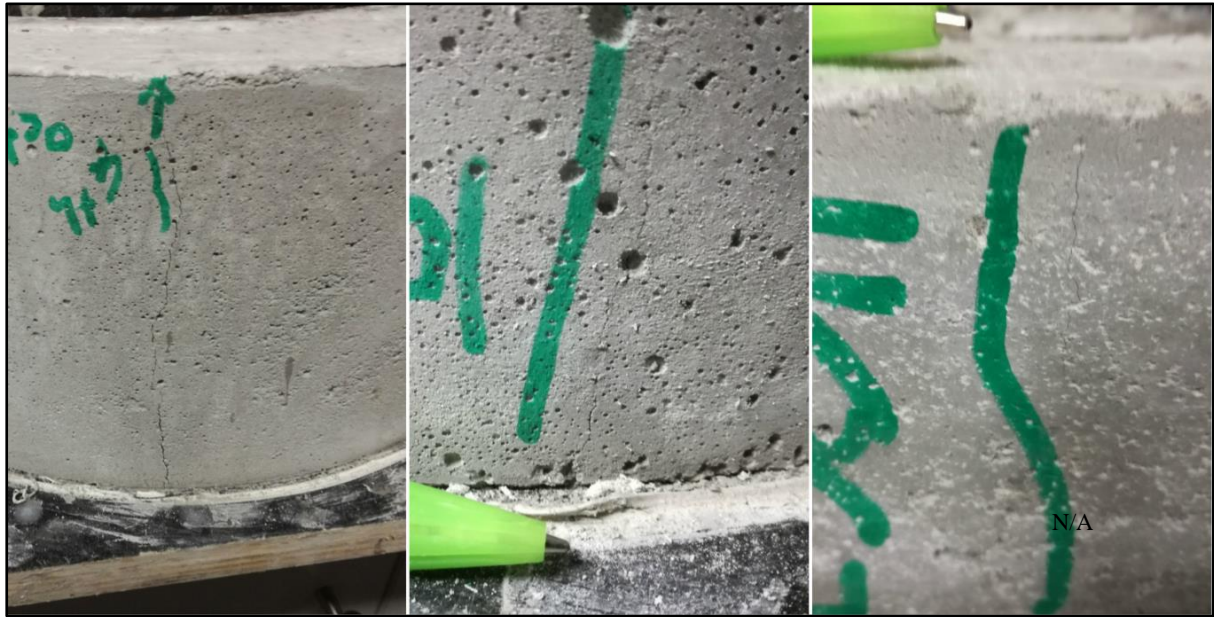
Figure 4-44: Crack distribution on 100% FA rings

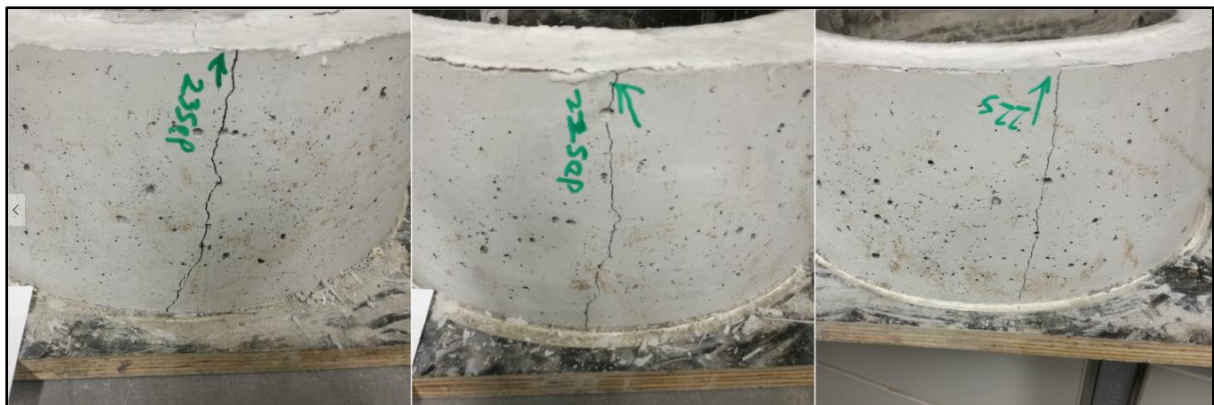
Figure 4-46: Crack distribution on 60% FA rings

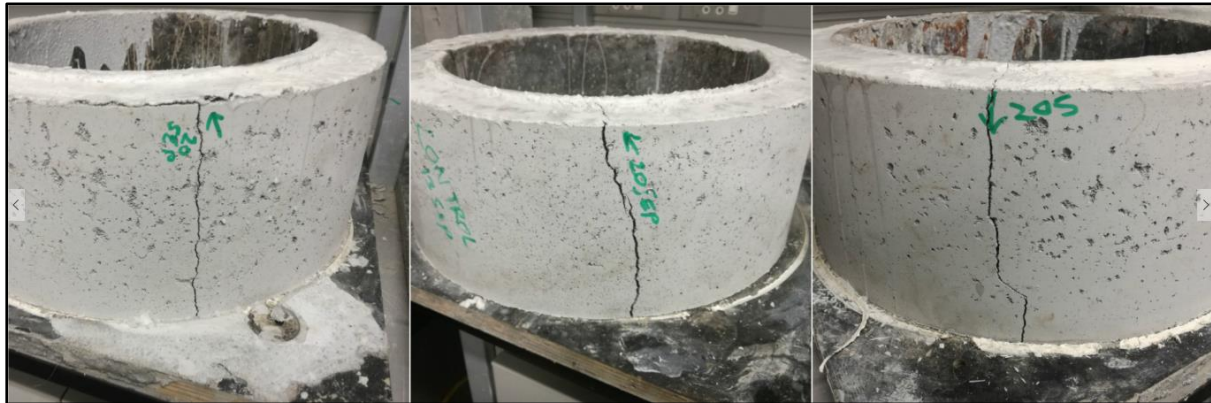
Figure 4-47: Crack distribution on control rings
