AN INVESTIGATION OF WEAR AND THE
PERFORMANCE OF STEELS IN THE GOLD
MINING INDUSTRY

A thesis submitted to the Faculty of Engineering,
University of Cape Town in fulfilment of the degree
of Master of Science in Applied Science (February 1983).

Department of Metallurgy and Materials Science, University
of Cape Town

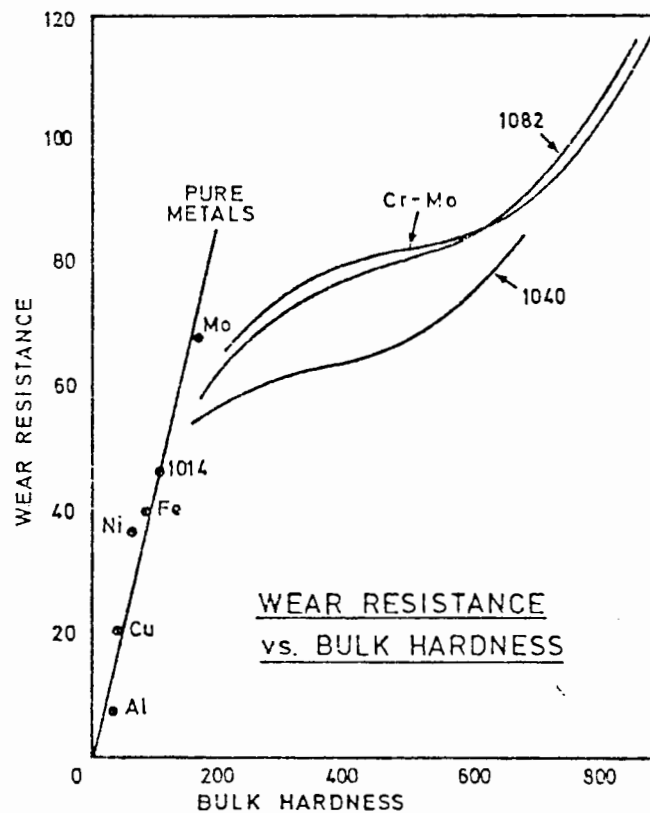
Fig. 2.5 Wear resistance as a function of bulk hardness for pure metals and heat treated steels (after Murray et al (8)).

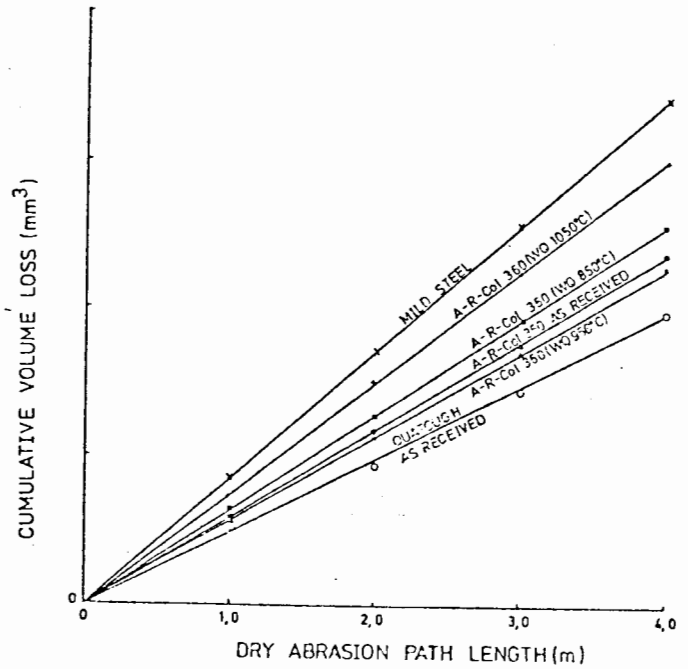
Fig. 4.2

EFFECT OF VARYING DRY ABRASION PATH LENGTH ON THE ABRASIVE WEAR OF A-R-CoI 360 (for a 2Kg load)

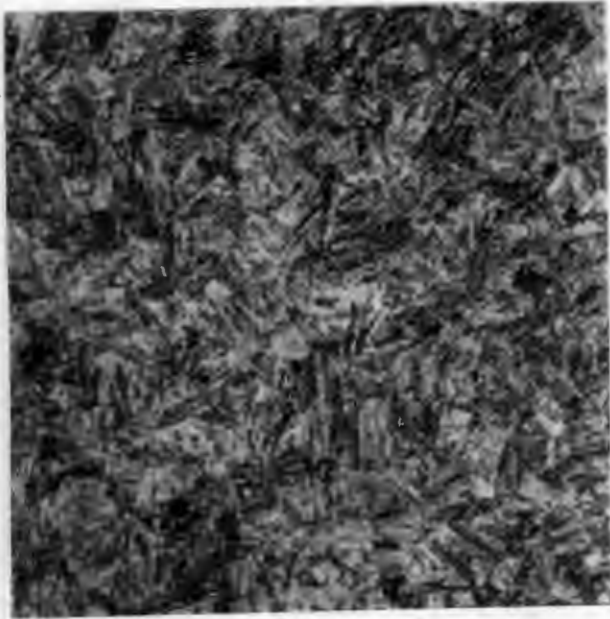
(a) As-received condition
R.A.R. 1,44 Hardness 50VPN 399 10 μm

The major difference in microstructure (Fig. 4.8) between the as-received and S.H.T. condition of Quatough is that there appears to be some sort of overall grain refining action (Fig. 4.8(b)) of the finely divided acicular martensite. The martensite laths of the D.H.T. condition are broader and fatter than those of the as-received and S.H.T. conditions due to the extra re-austenitize sequence. The fine pronounced needles of Quatough (S.H.T.) produce superior wear resistance compared to the softer D.H.T. condition. A-R-Col 360 in the as-received condition as well as in the heat treated conditions exhibit microstructures of fine needle-like martensite (Fig. 4.9) which become more pronounced as the steel is quenched from higher temperatures and subsequently yield less resistance to abrasive wear. Fig. 4.10 demonstrates evidence of

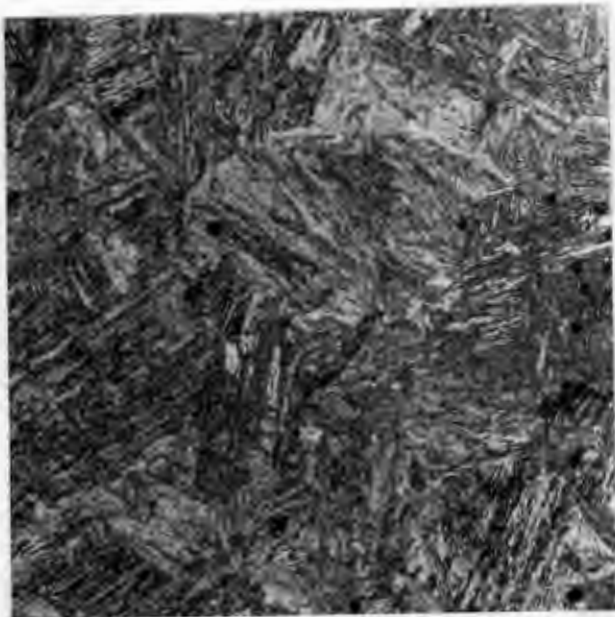
Fig. 4.9 Optical micrographs of A-R-Col 360
(Etched in 5% Nital for 30 seconds.)

(d) WQ 1050°C
R.A.R. 1,12 Hardness 50VPN 347

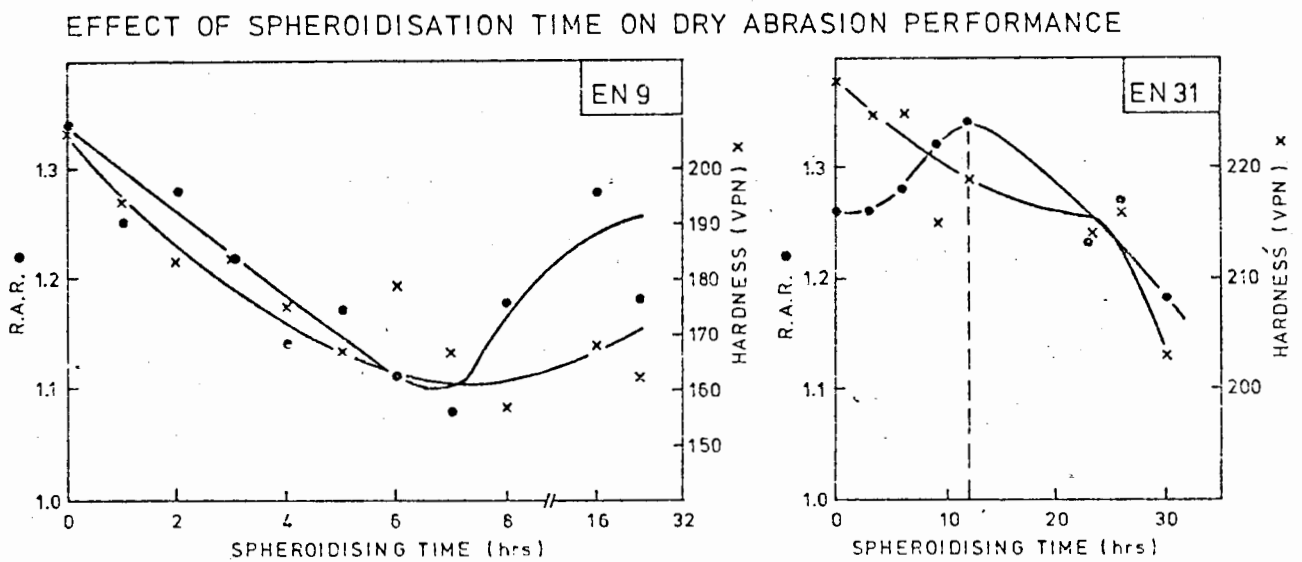
Fig. 4.13 The effect of spheroidisation time on dry abrasion performance.

- (i) the preferential removal of the harder spheroidal cementite fraction from the softer ferrite matrix leaving behind voids or cavities (a) within the worn surface, and
- (ii) the grooving (b) of the ductile ferrite matrix by brittle cementite spheroids which become trapped within the abrading medium and which subsequently act themselves as abrading particles.

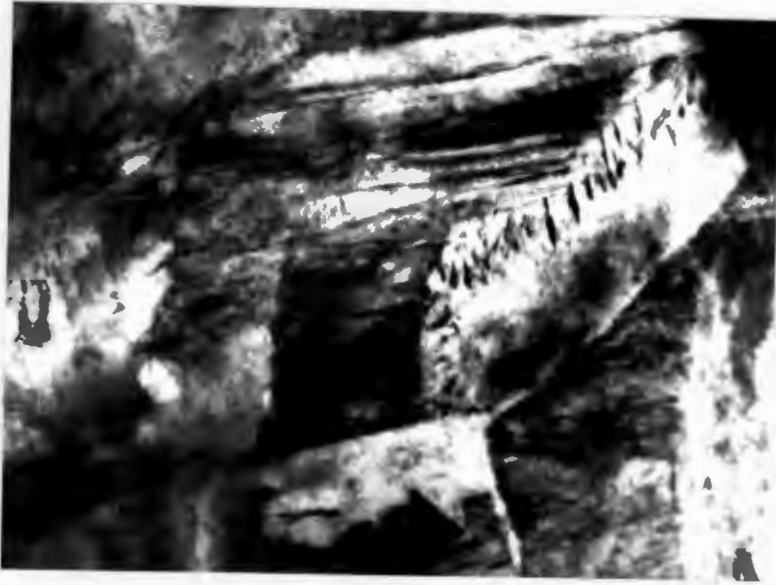
Fig. 4.58 T.E.M. micrographs Wearalloy, a martensitic proprietary wear resistant alloy showing internal twinning and dislocated lath martensite.

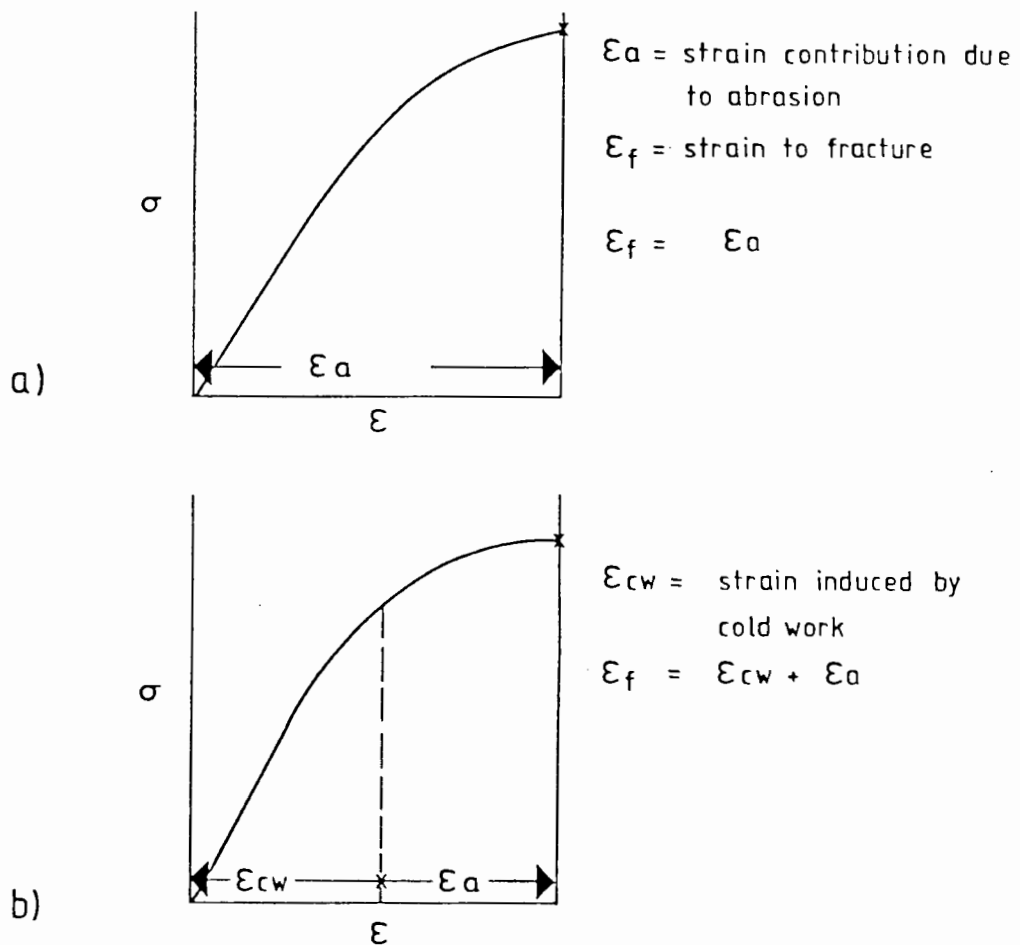
Fig. 5.1 Idealized stress-strain curves for a normalised (a) and cold worked (b) material subjected to abrasive wear.

cold worked to yield a 30 percent increase in bulk hardness resulted in a 10 percent decrease in wear resistance relative to a normalised heat treatment of the identical steel. Reduced wear resistance due to prior cold work can be explained by considering the idealized stress-strain curves below (Fig. 5.1).

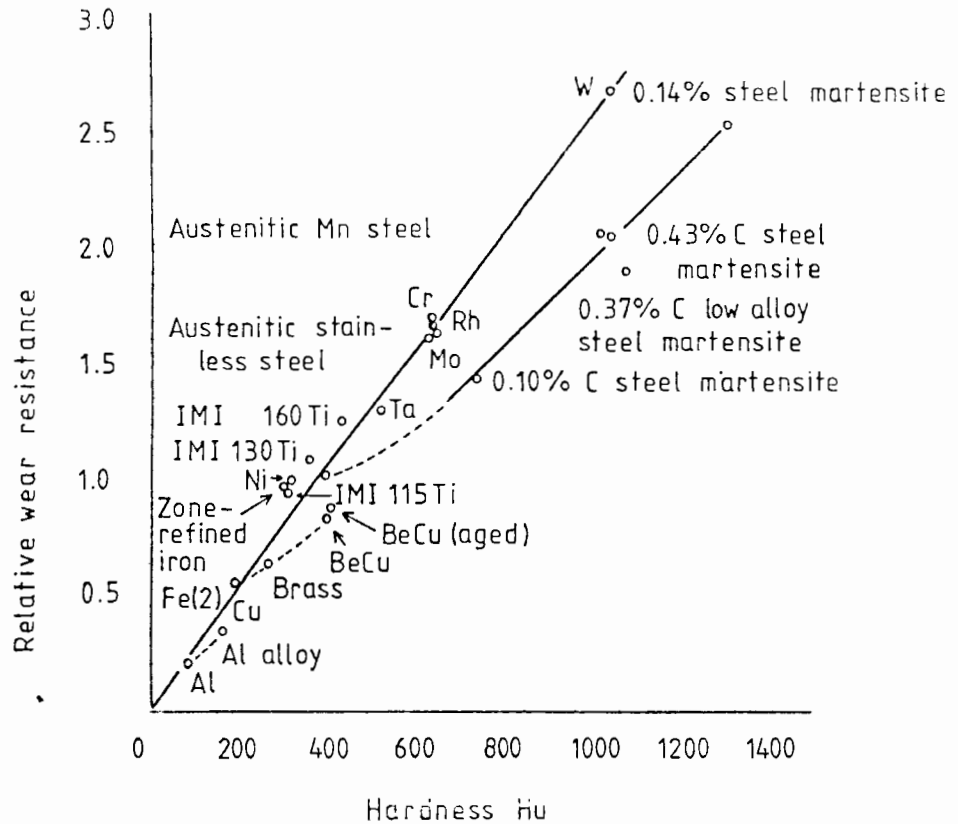
Fig. 5.7 Relative wear resistance on 180 grit corundum cloth as a function of maximum surface hardness (after Richardson (45)).

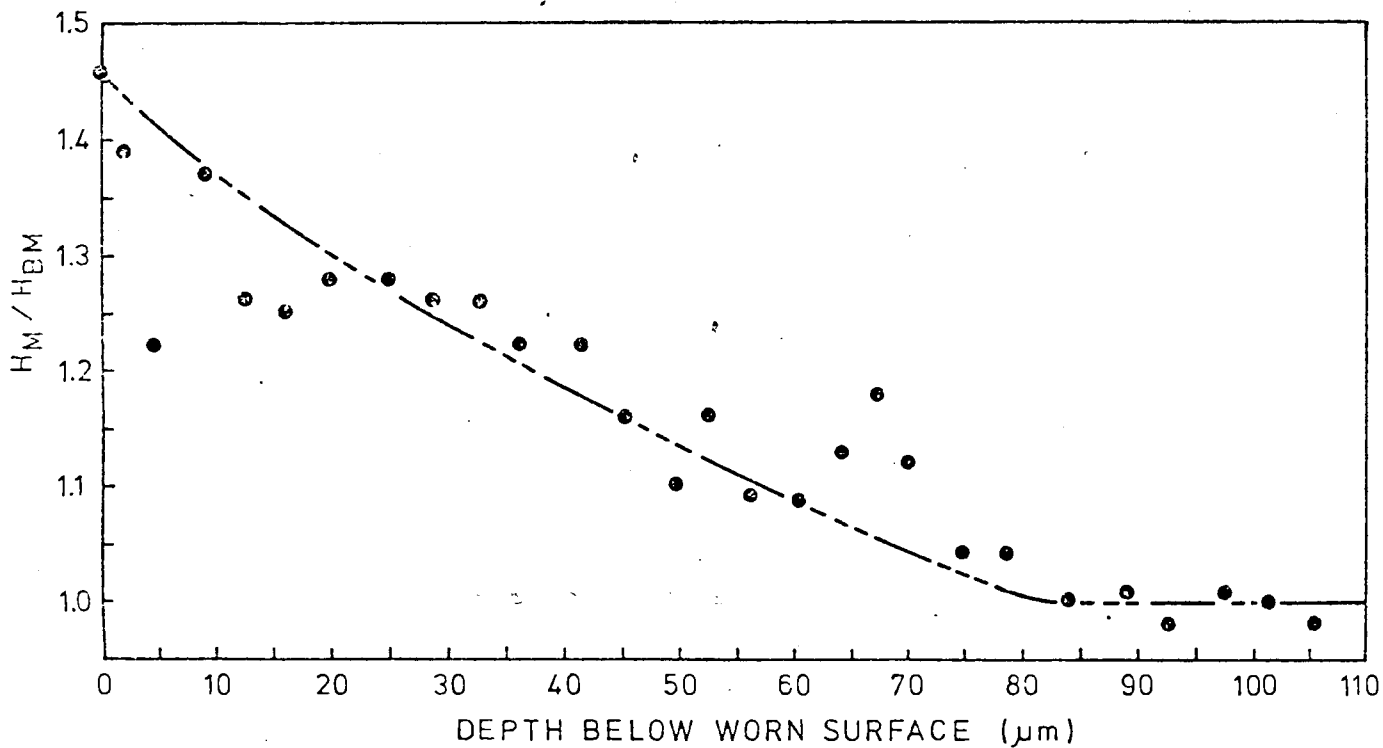
MATERIAL: HADFIELD BW10
 TAPER: 2°
 ENVIRON: IN SITU-HIGH STRESS
