**Gas and Grain:
The Conservation of Networked Industrial Landscapes**

Thesis Presented for the Degree of
Doctor of Philosophy
in the Department of Archaeology
University of Cape Town

February 2004

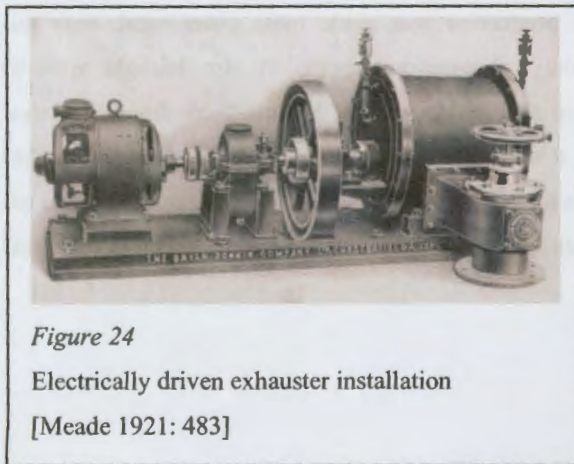
Figure 24
 Electrically driven exhauster installation
 [Meade 1921: 483]

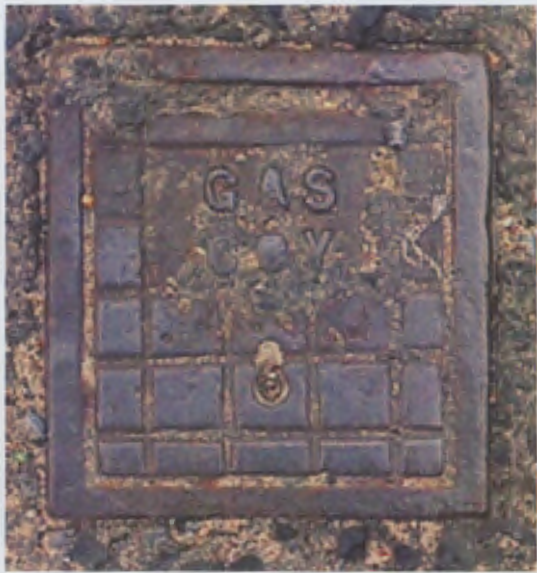
Figure 42
Typical gas company inspection plate, 2001.

It is understood that upon the closure of the company, the network of supply pipes was sold to Telkom, South Africa's parastatal telecommunications provider. Few traces remain above ground, with the exception of some inspection and access plates still to be found set into the town's pavements and streets (Figure 42).

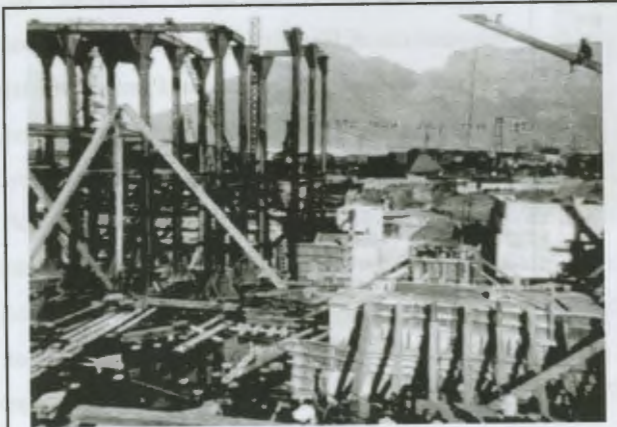
Figure 51
Cape Town: construction of the working house and track shed. 17 July 1923.
[Port Engineer, Table Bay Harbour]

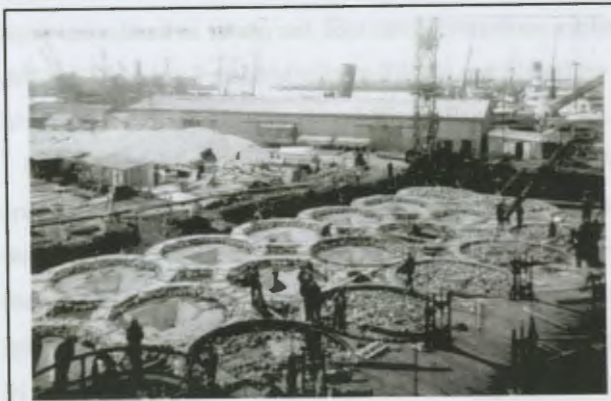
Figure 52
Cape Town: construction of the storage annexe. 31 July 1923.
[Port Engineer, Table Bay Harbour]

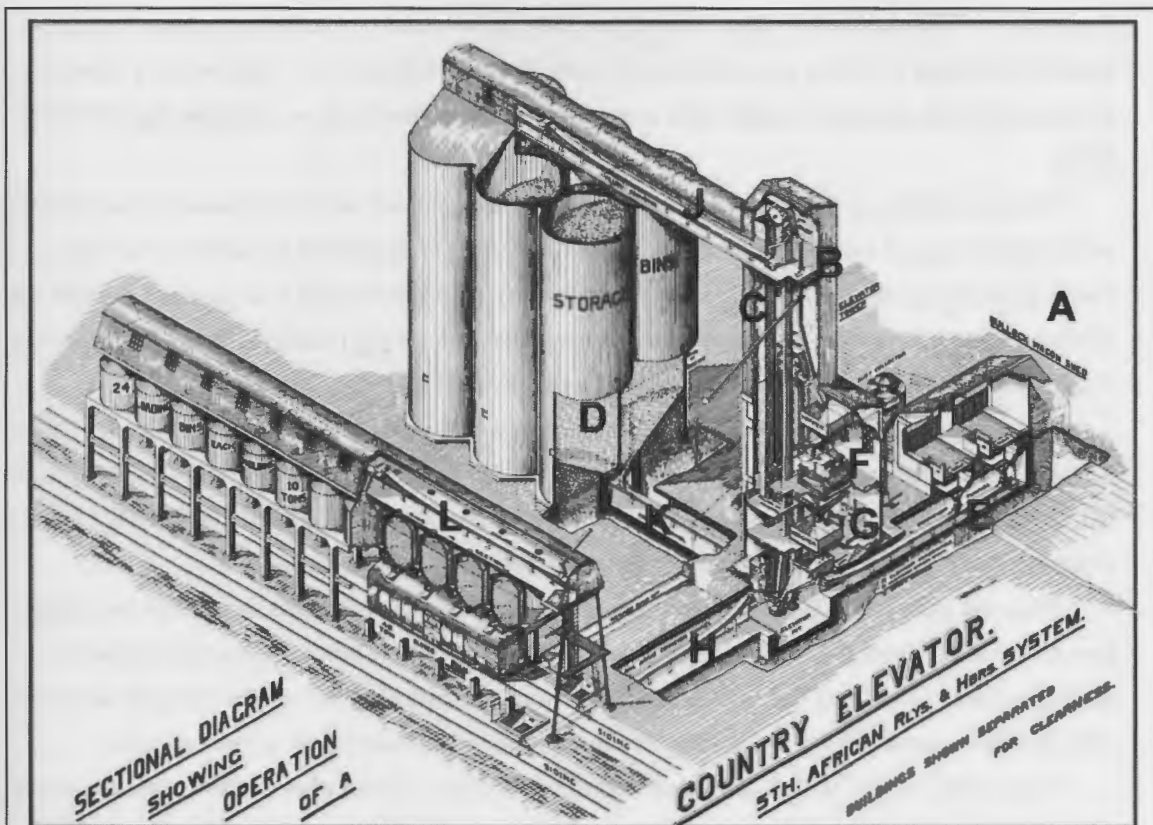
Figure 59

Each working house contained two bucket elevators. The 'short leg' [B] ran from the basement to the top of the cleaning machines, and the 'long leg' [C] from the basement to the very top of the structure, in order to transfer grain to the storage bins [D].

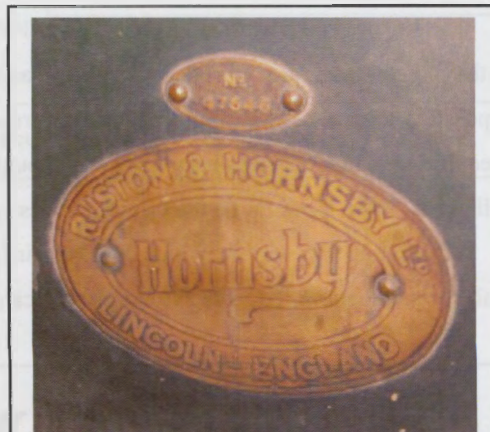
Figure 66

Ruston & Hornsby maker's plate (number 47646) at Potchefstroom, 2001.

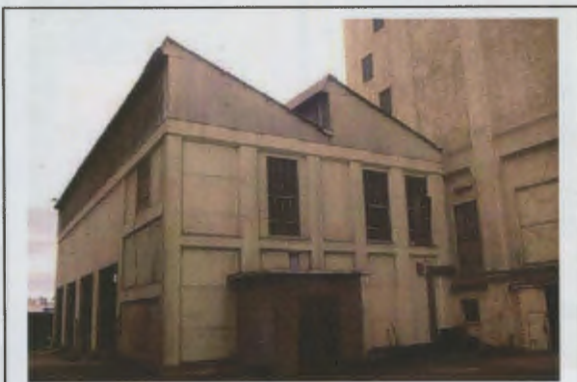
Figure 80
Cape Town: the hydraulic accumulator house,
1995.

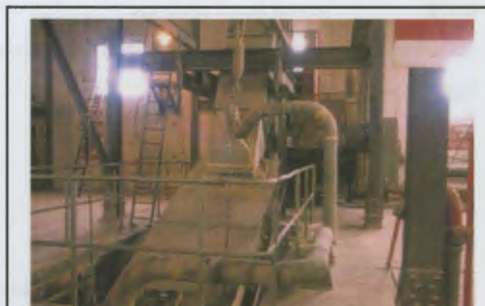
B014: maize chute from elevator head to pre-weigher floor.

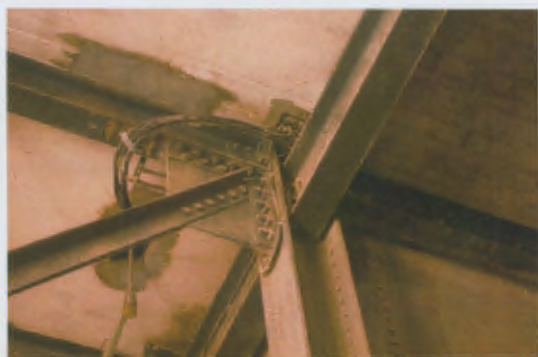
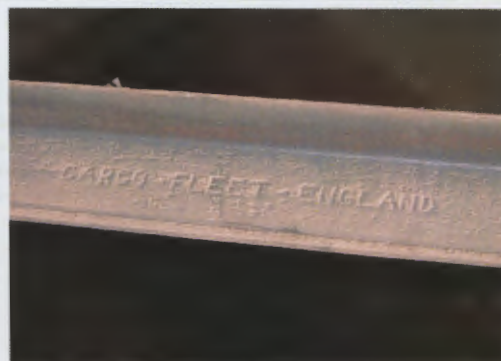
B023: details of structural steel framing.

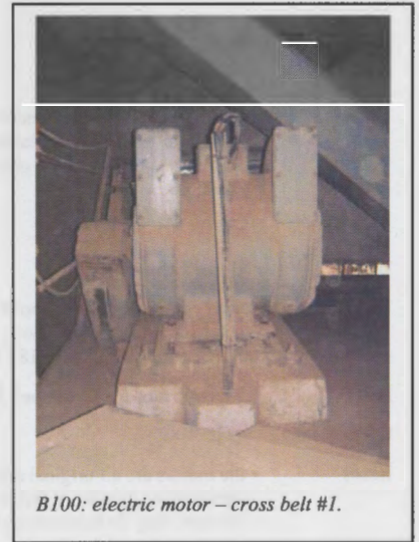
B100: electric motor – cross belt #1.

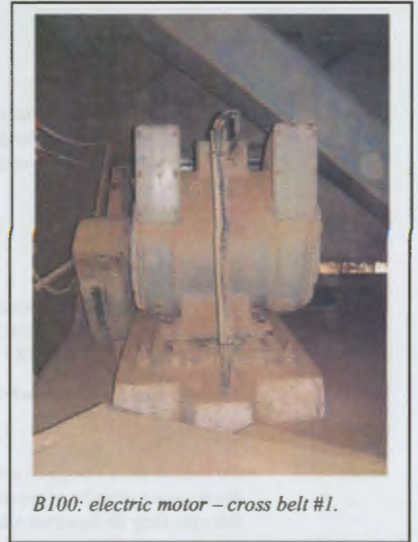
B100: electric motor – cross belt #1.

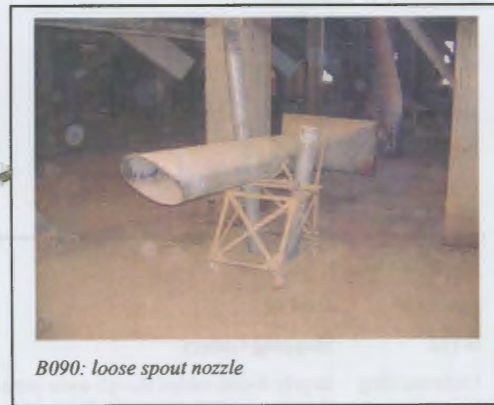
B090: loose spout nozzle

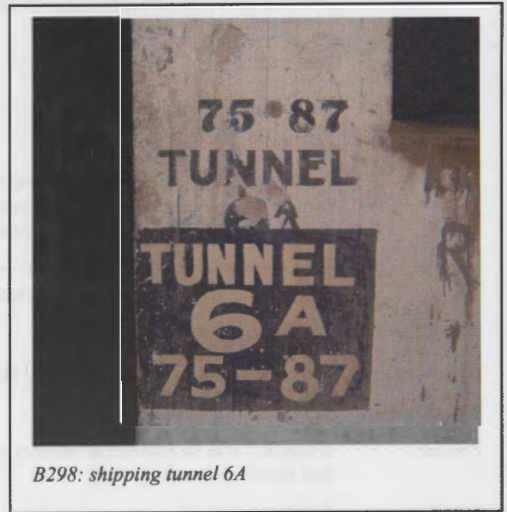
B298: shipping tunnel 6A
