# **Performance of a Penetrating Corrosion Inhibitor in Controlling Carbonation-induced Corrosion in Reinforced Concrete**

Thesis submitted to the Faculty of Engineering, University of Cape Town, South Africa, in partial fulfillment of the requirements for the degree of Master of Science in Engineering.

Cape Town, 2002

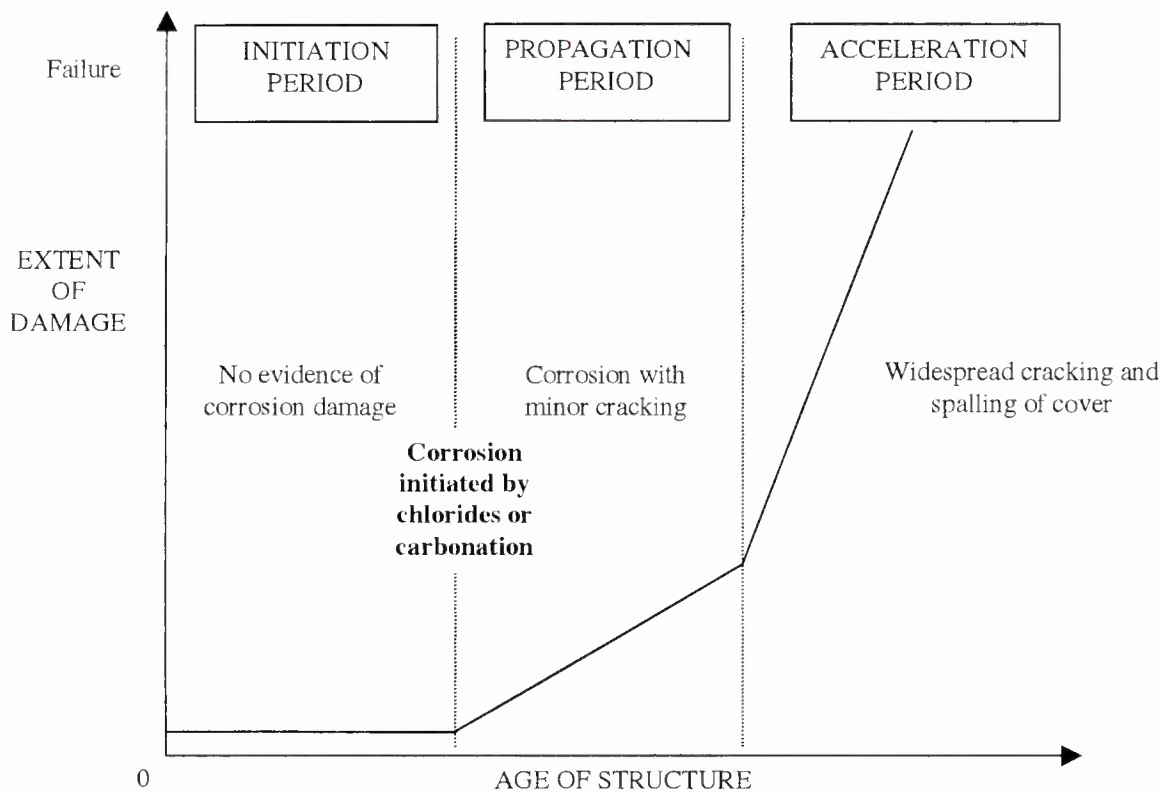
Figure 2.2: Three-phase corrosion damage model [5].

Serviceability is defined as the capability of a building product, component, assembly, or construction [5] to perform the function or functions for which it is designed and constructed [5]. The loss of serviceability of corroding concrete structures can be represented by the three-phase damage model shown in figure 2.2.

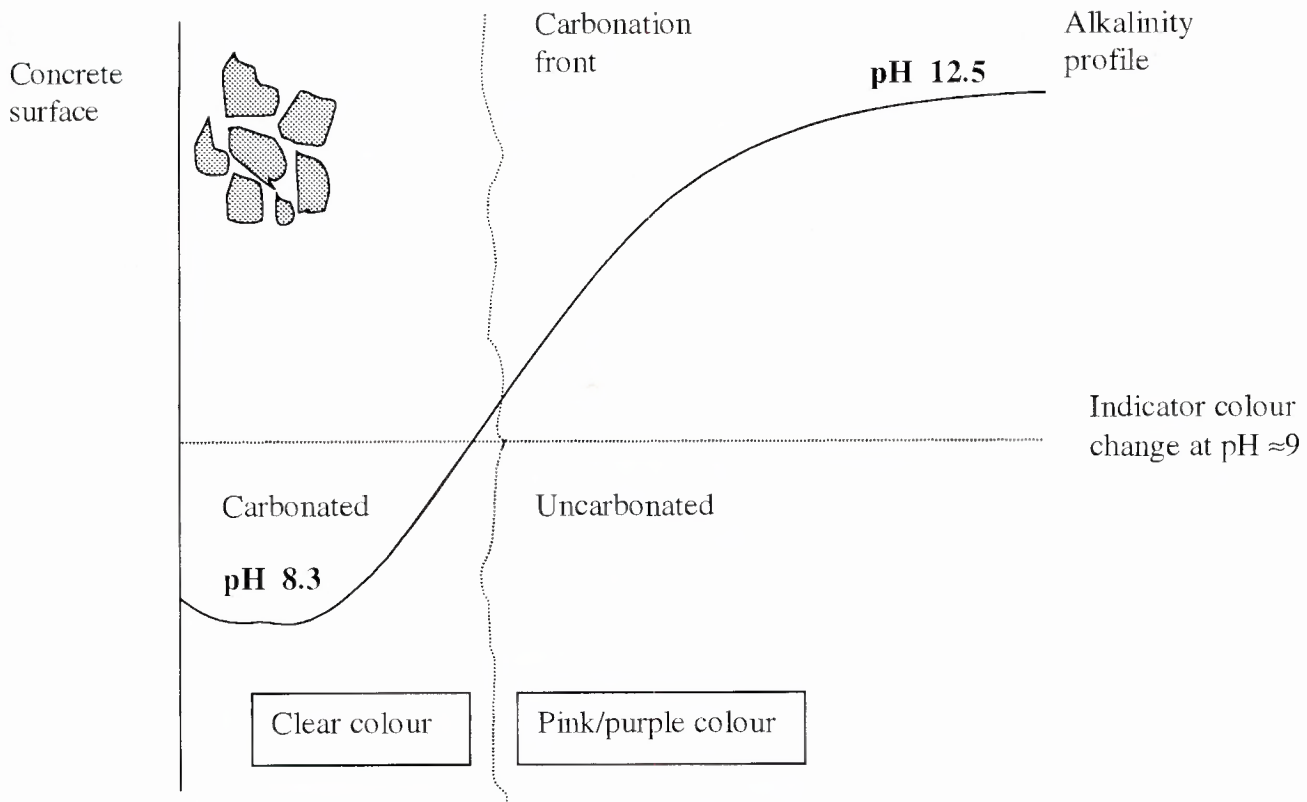
**Figure 2.6: Schematic of the carbonation front [4].**

When the carbonation front reaches the reinforcing steel, the low pH causes the gamma-ferric oxide layer (passivating layer) to become unstable and thus the steel is depassivated. In the presence of oxygen and moisture this leads to corrosion followed by corrosion-induced cracks parallel to reinforcement, followed by spalling which eventually leads to loss in the load bearing capacity of the structure. Cracks and spalling are induced because the corrosion product that forms can be up to seven times the volume of the steel before it is oxidised.

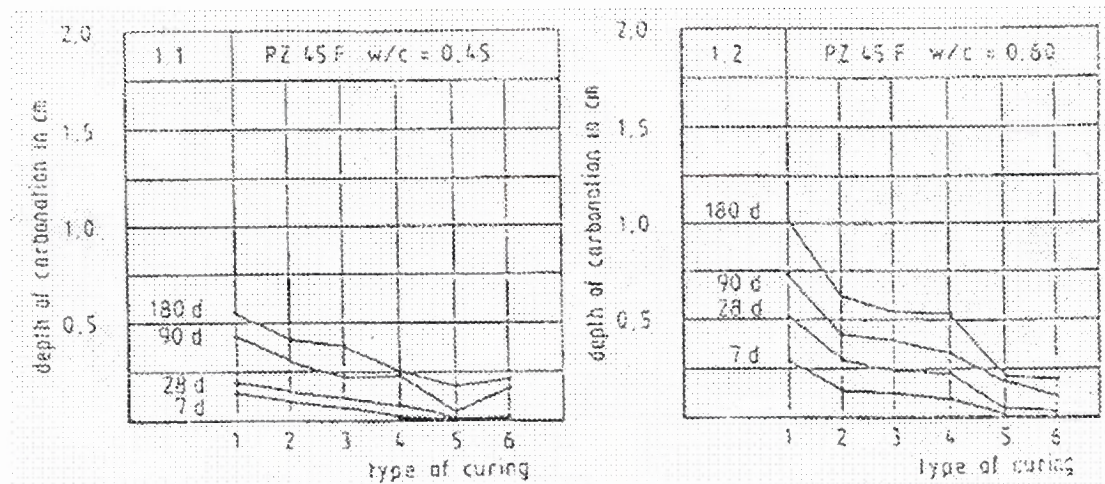
Figure 2.7: Average depths of carbonation after 7, 28, 90 and 180 days for the types of curing shown in table 2.1 [12].

Research carried out on the effects of different curing periods and curing methods on carbonation rate showed that carbonation depths of specimens after ten years exposure in air with no curing were on average four to five times greater than for 90 day water cured specimens [10]. Kurtz [12] investigated the influence of extremely short-term curing on the rate of carbonation of concrete specimens,  $w/c = 0,45$  and  $0,60$ , subjected to different types of curing. The results of this work are shown in figure 2.7.

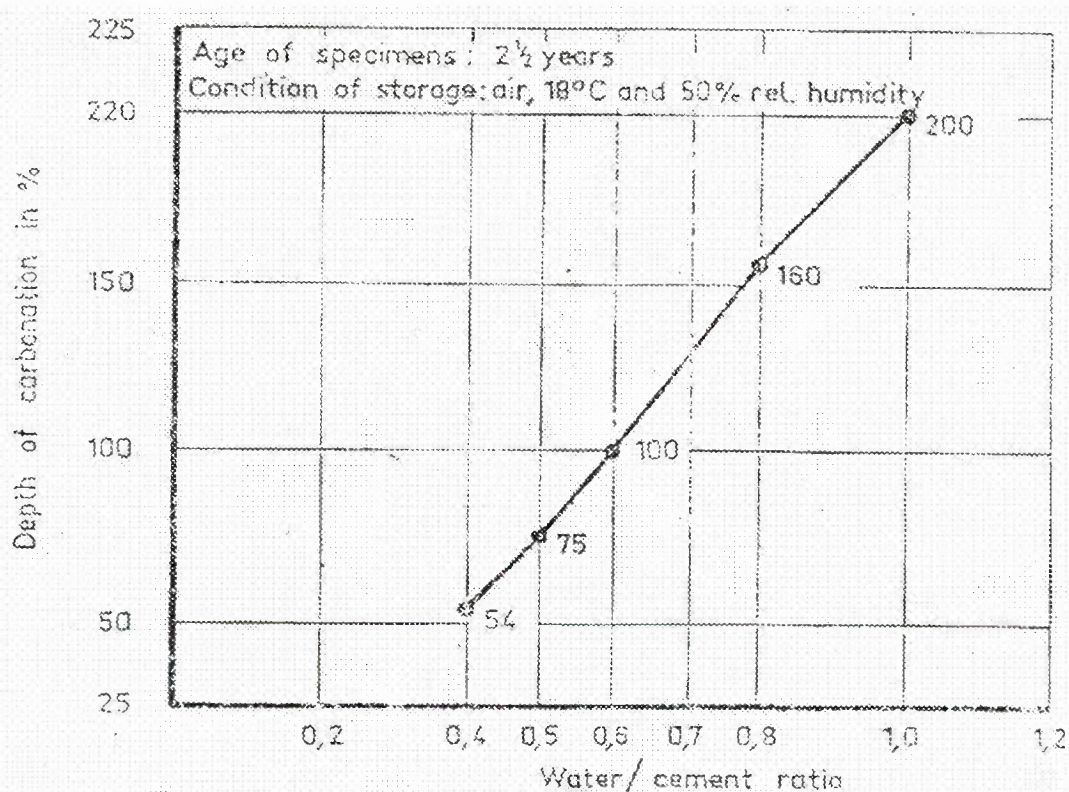
**Figure 2.10: Effect of water/cement ratio on the rate of carbonation [14].**

**Water/Cement ratio:** Concrete durability is influenced to a large degree by the permeability of the concrete to air and water and it is generally accepted that durability is inversely proportional to permeability. Since the rate of carbonation is dependent on the permeability of the concrete, the rate of carbonation will increase with increasing water/cement ratio. Figure 2.10 shows a typical relationship between water/cement ratio and rate of carbonation [14].

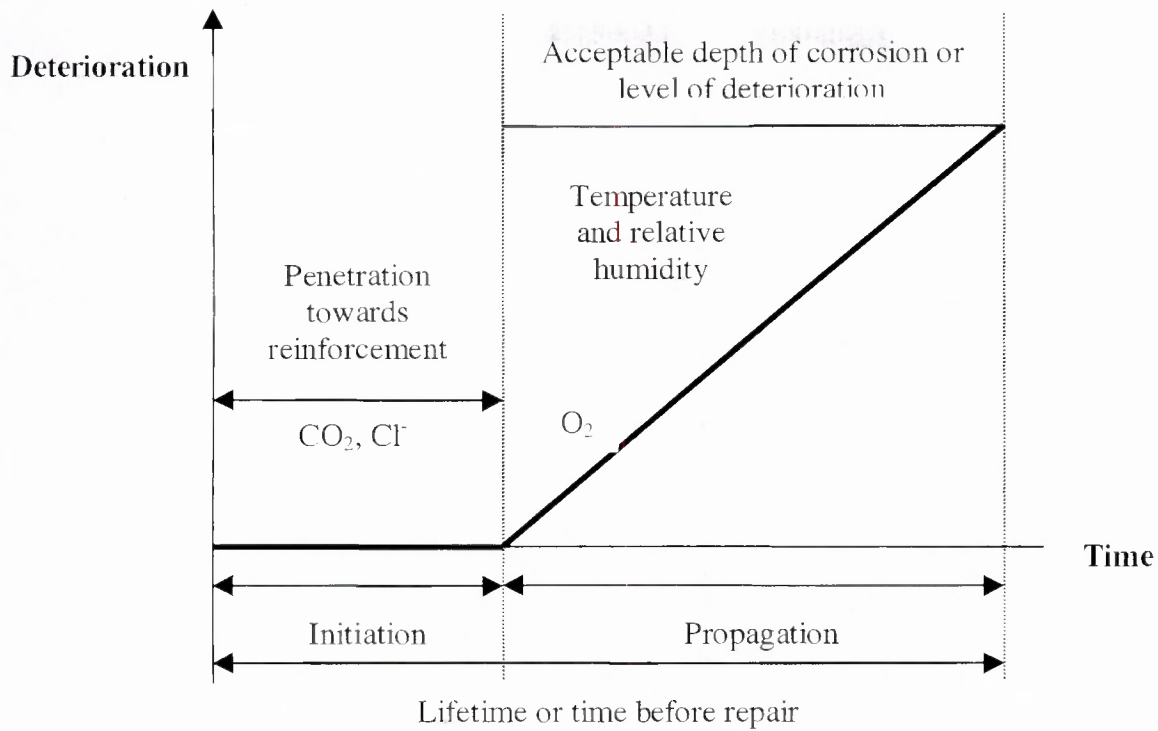
Figure 3.7: Schematic of progress of steel corrosion in concrete [38]

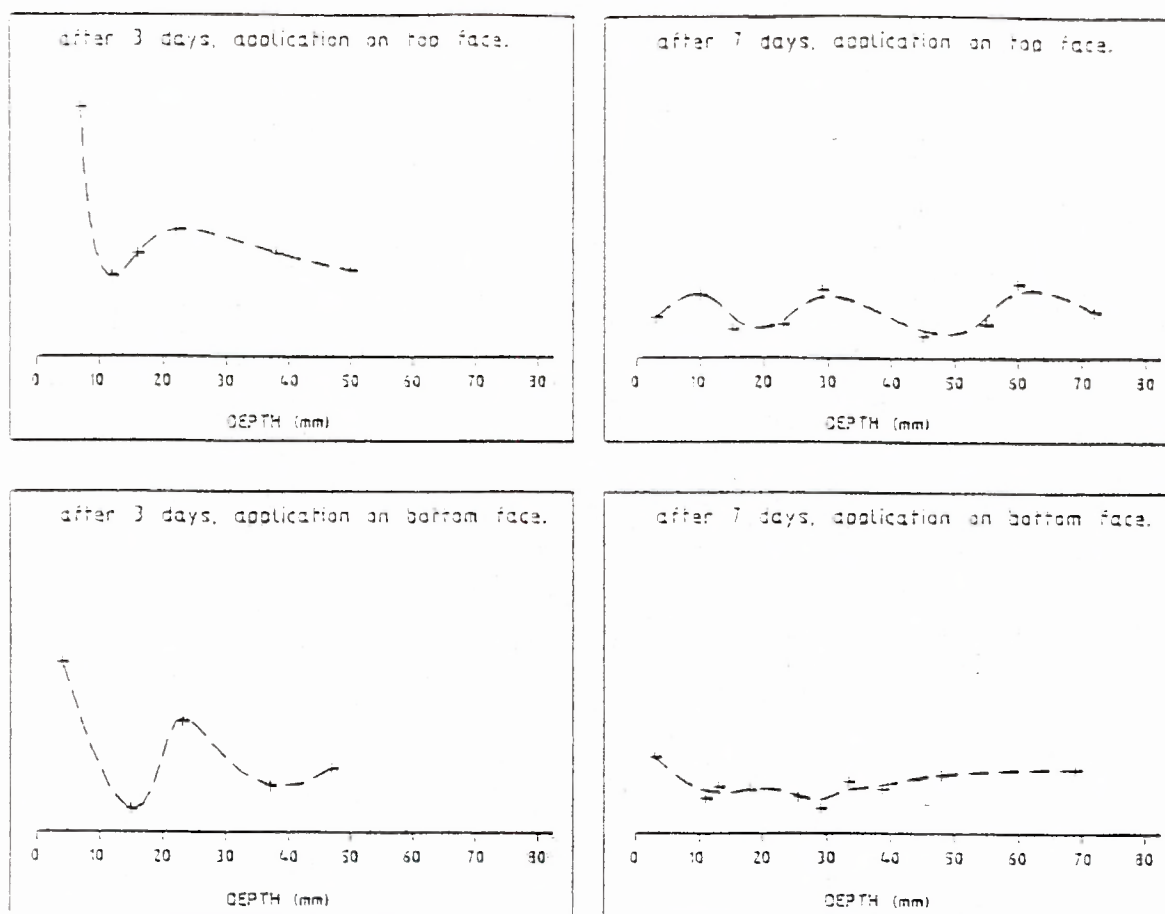
**Figure 3.10: Transport studies of penetrating organic corrosion inhibitor in concrete blocks expressed as atomic concentration ratio of nitrogen to silicon versus depth of penetration [53].**

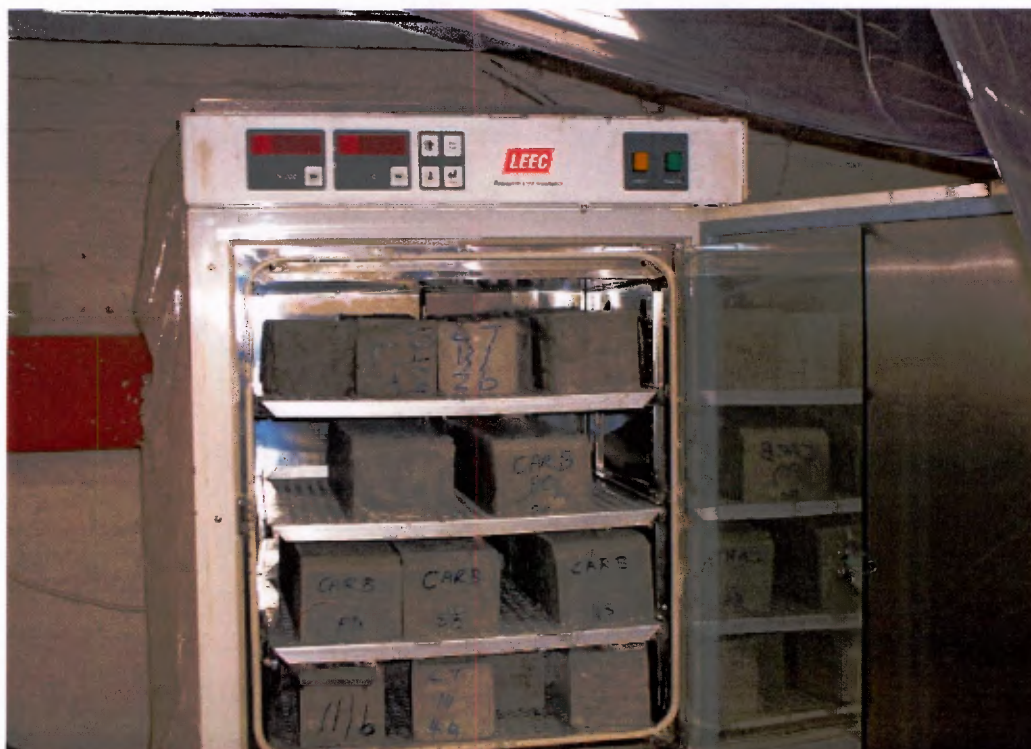
**Figure 4.7: Set up of test specimens in carbonation chamber**

The set up in the carbonation chamber is shown in figure 4.7.

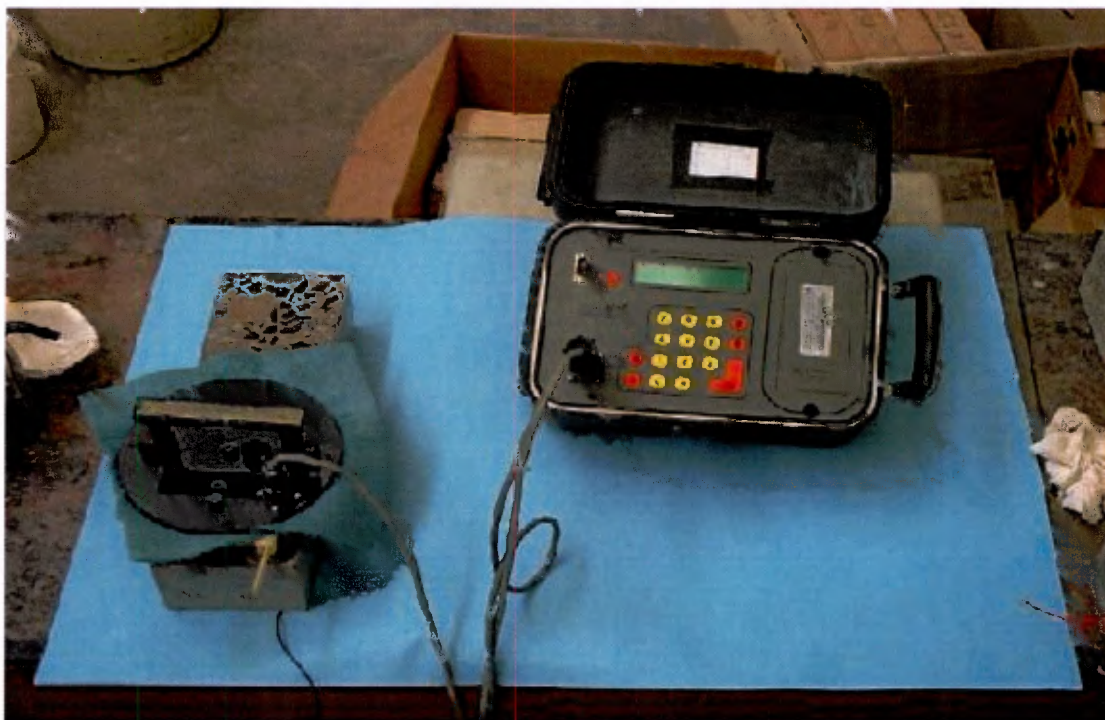
**Figure 4.13 Typical Gecor measurements using sensor A on test specimens**

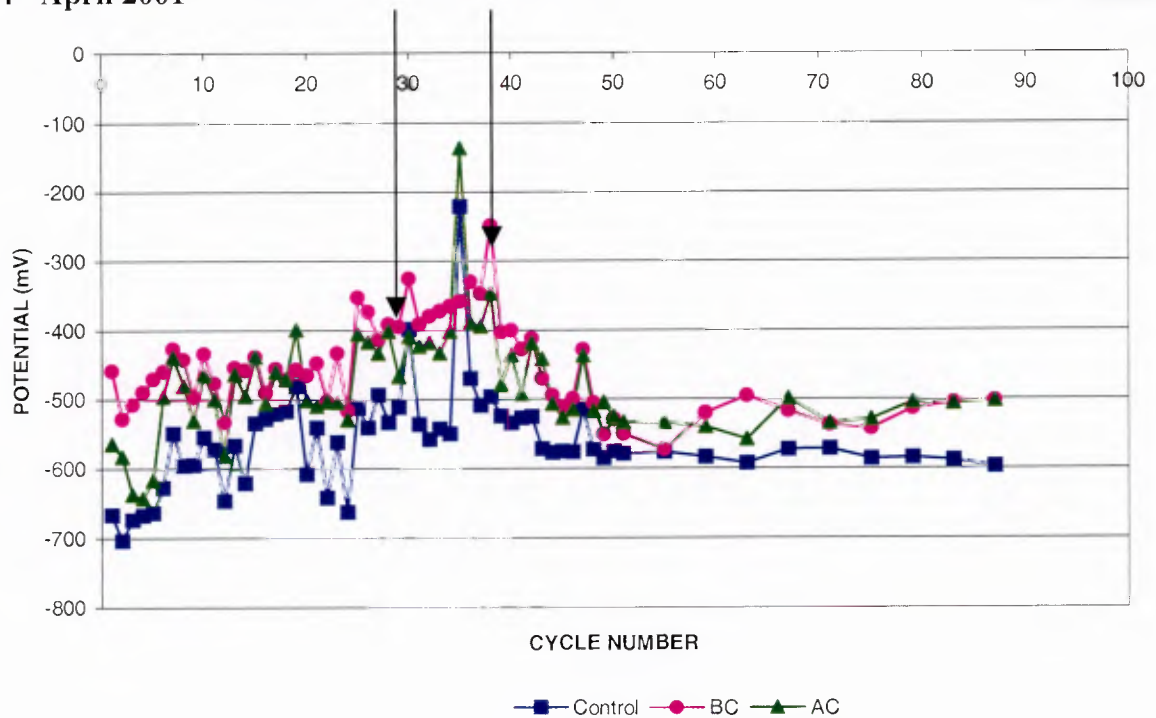
Figure 5.3: Half-cell potential measurements for 10 mm cover specimens.

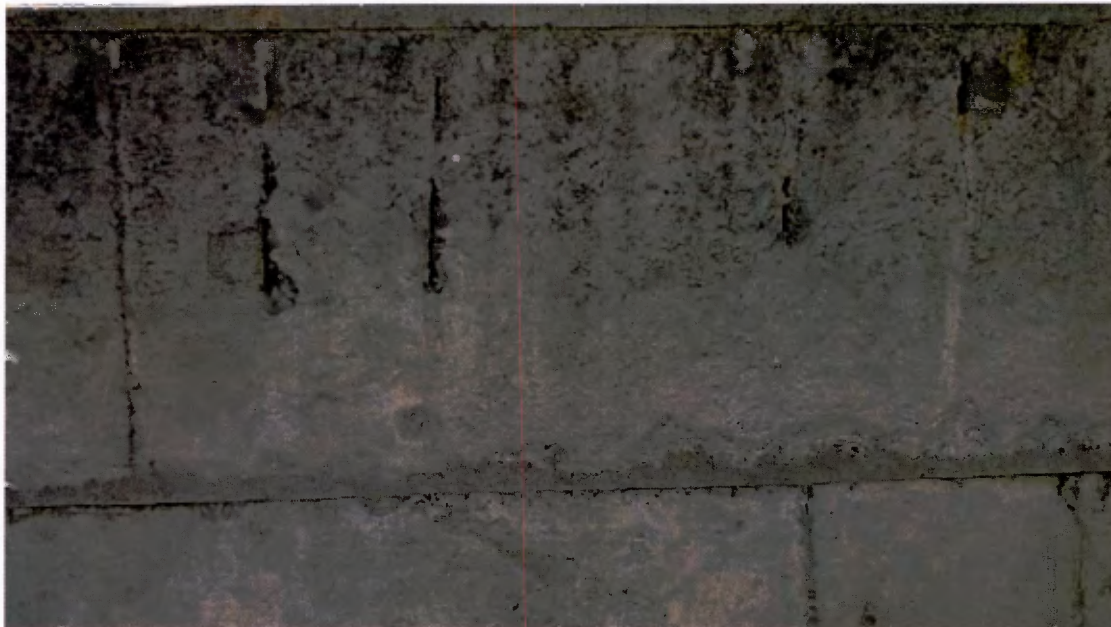
**Figure 6.3: Damage caused by carbonation-induced corrosion, Parapet walls 1, Sports Centre Building, UCT**

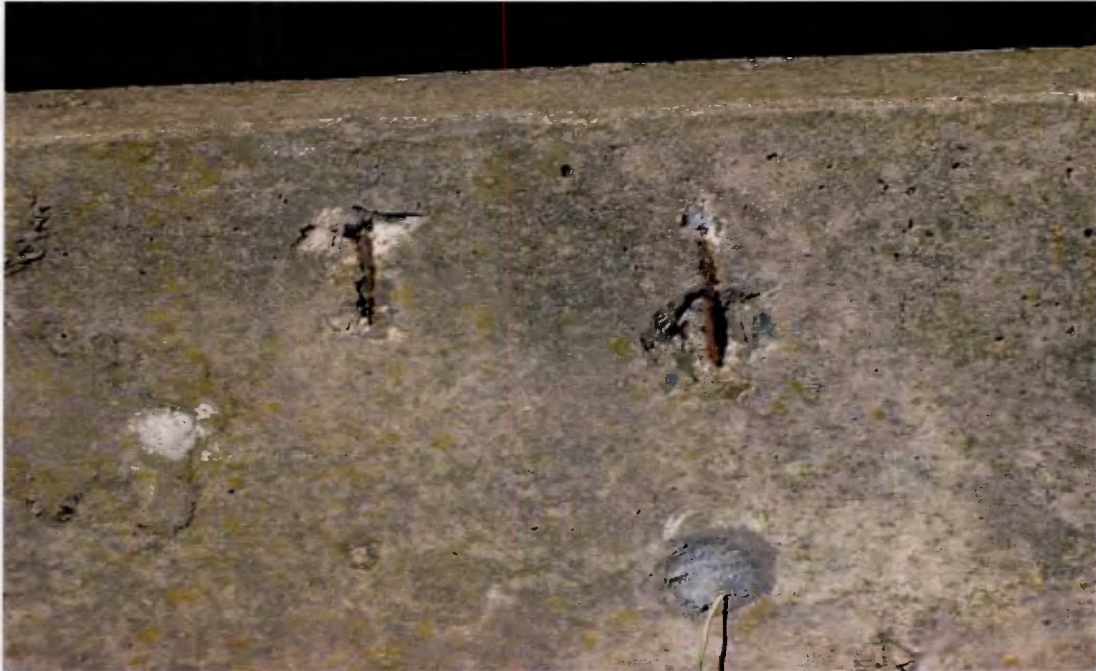
Figure 6.8: Damage caused by carbonation-induced corrosion, 2<sup>nd</sup> Parapet wall, Sports Centre Building, UCT

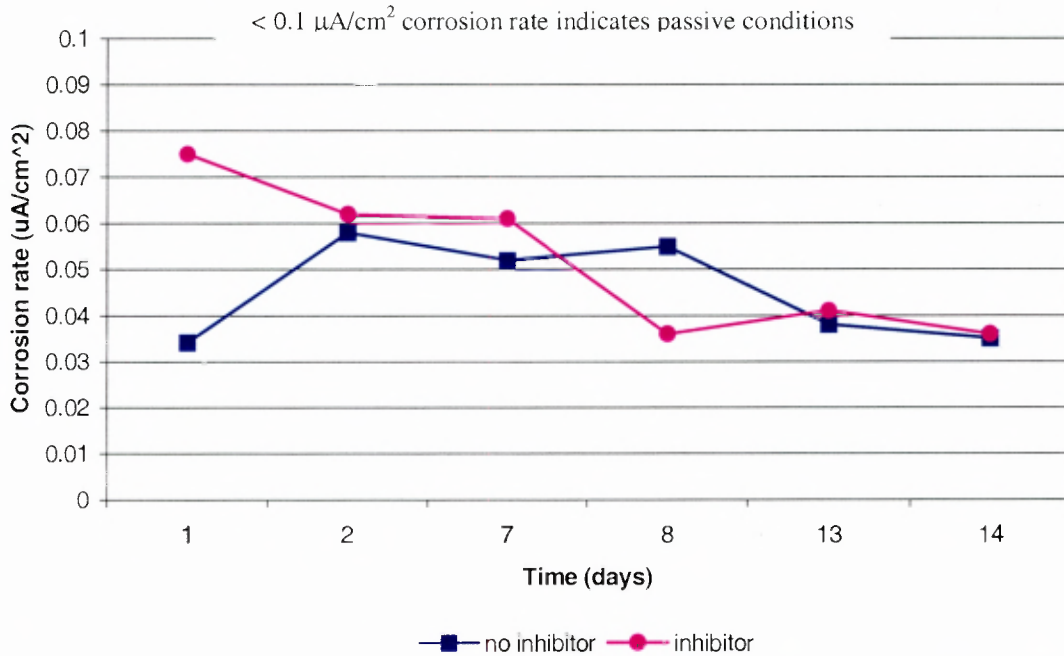
Figure 6.15: Corrosion rate measurements, Concrete slabs, Civil Engineering Department, UCT

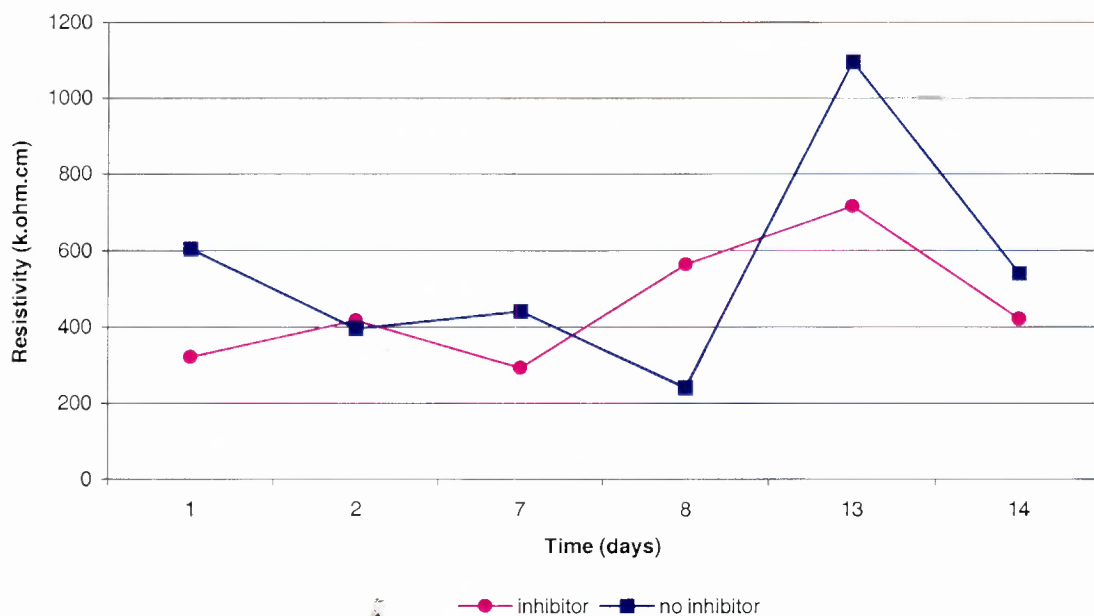
**Figure 6.17: Resistivity measurements, Concrete slabs, Civil Engineering Department, UCT**

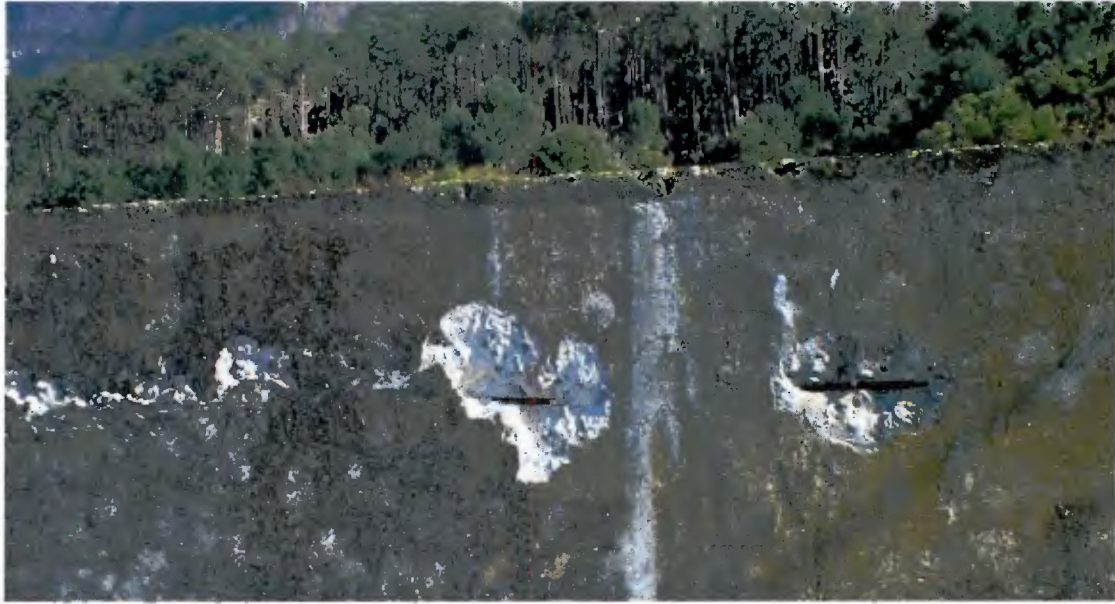
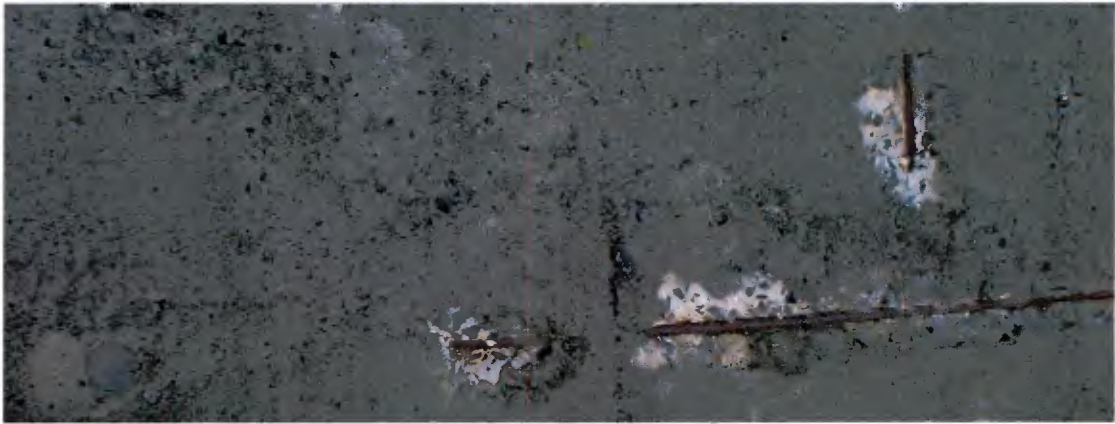
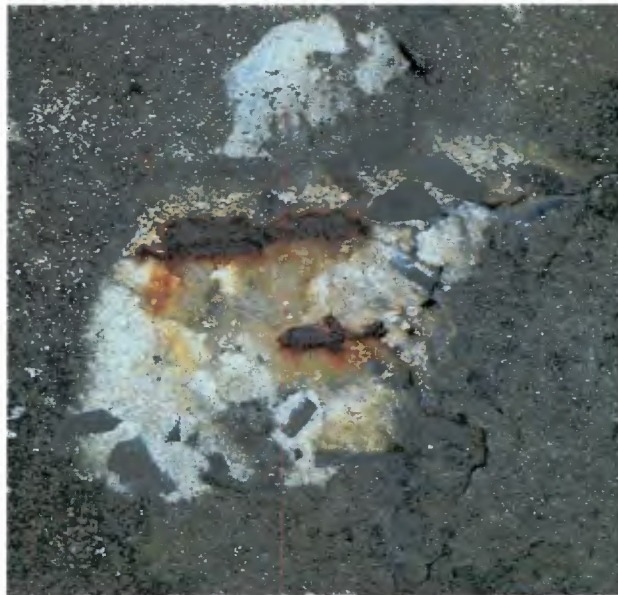
**Figure 6.18: Spalling and cracking of concrete due to carbonation-induced corrosion on parapet walls at the Menzies site.**

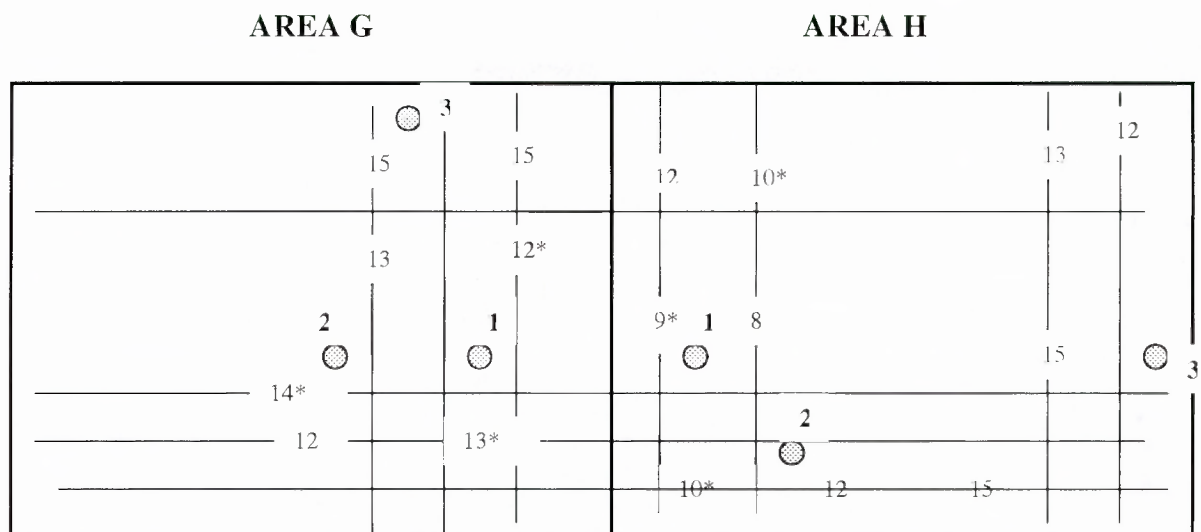
\* Indicates position where corrosion monitoring took place (i.e. Corrosion rates, half-cell potentials and resistivity measurements).

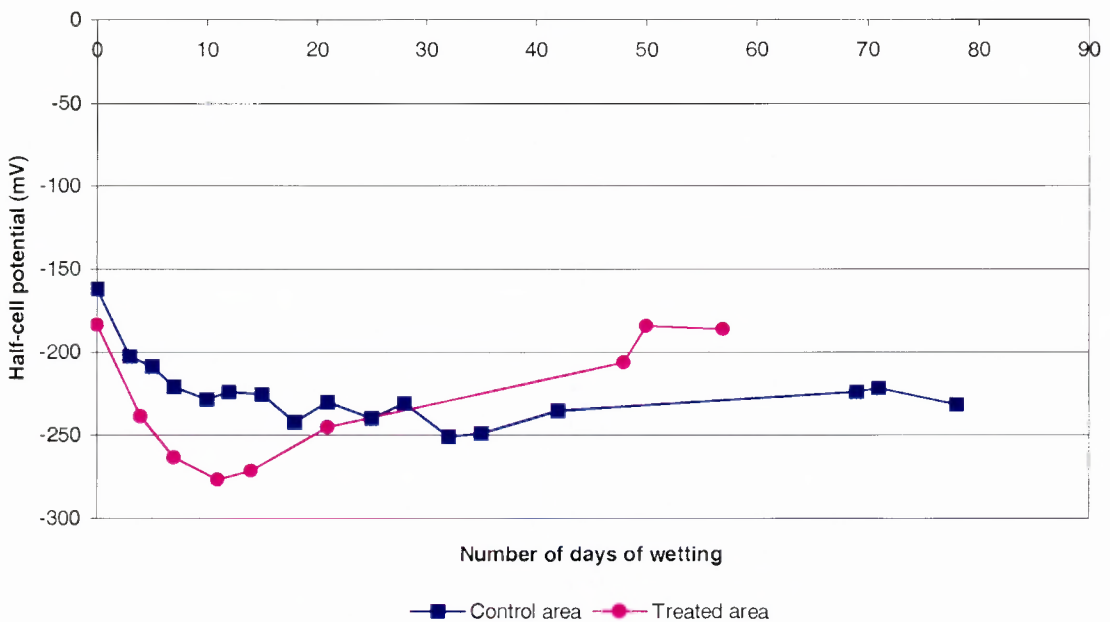
Figure 6.26: Half-cell potentials for areas undergoing wetting
