DEGRADATION OF THE BETA-ALUMINA ELECTROLYTE IN A ZEBRA CELL

A thesis submitted to the Faculty of Engineering,
University of Cape Town in fulfillment of the
degree of Master of Science in Applied Science.

Department of Materials Engineering
University of Cape Town

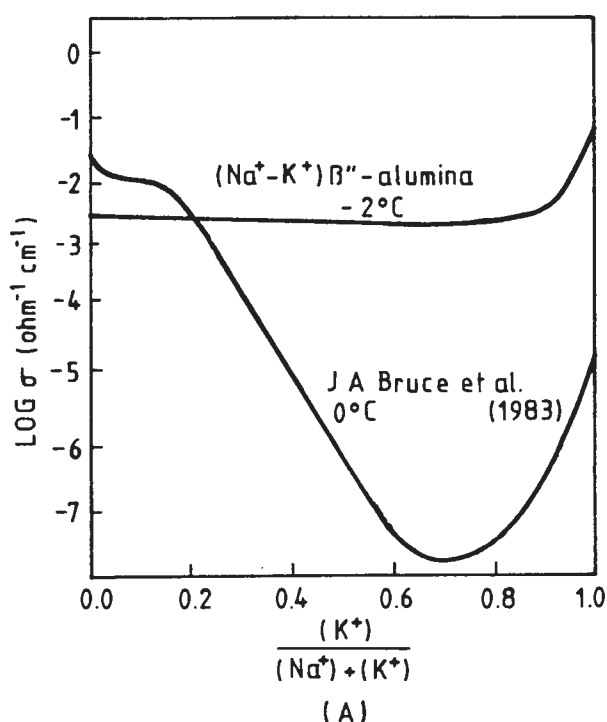
K- β alumina has a much lower ionic conductivity than Na- β alumina. This is due to the large size of the K^+ ion relative to the Na^+ ion (1.4Å for K^+ as opposed to 0.95Å for Na^+). The restricted size of the mO site in the conduction plane, through which the migrating cation passes during conduction results in an increase in the activation energy required for K^+ diffusion.

FIGURE 4.2. GRAPH OF THE IONIC CONDUCTIVITY OF Na/K- β ALUMINA AND Na/K- β'' ALUMINA AS A FUNCTION OF THE AMOUNT OF Na^+ IN THE CONDUCTION "PLANE" ION EXCHANGED WITH K^+

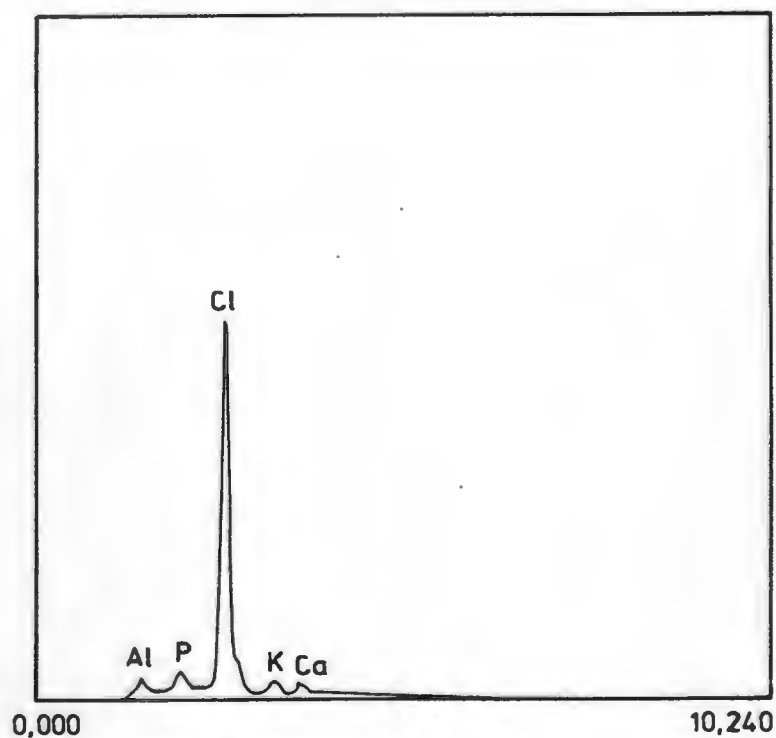
FIGURE 7.4. (a) AN SEM MICROGRAPH OF THE CATHODE ELECTROLYTE INTERFACE OF A GOOD CELL SHOWING ADHERENT GRAINS.
(b) THE EDS SPECTRUM FORMED BY SUBTRACTING THE BACKGROUND BETA-ALUMINA SPECTRUM FROM THAT OF THE ADHERENT GRAINS (WHICH INCLUDE SOME COUNTS FROM THE BACKGROUND). THE SPECTRA ARE NORMALISED WITH RESPECT TO Al PEAK INTENSITY.

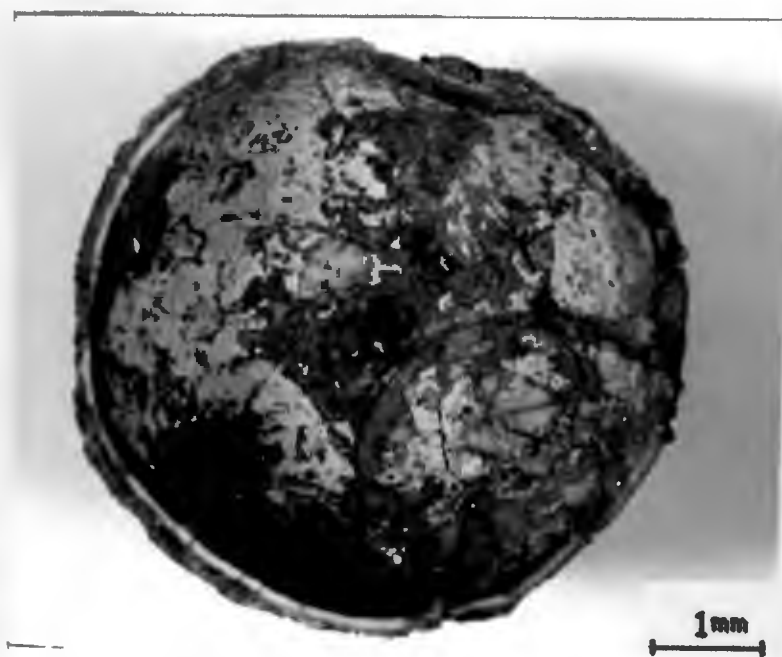
On removal from the cell large amounts of cracking of the beta-alumina tube was found to have occurred. Unfortunately, severe mechanical damage occurred during the removal of the electrolyte from the cell. It was thus difficult to distinguish between cracking which had occurred during cell operation, and cracking caused by removal of the electrolyte from the cell. It was, however, possible to remove the dome of the tube relatively intact from the cell. The dome of the tube, prior to cleaning in ethanol, is shown in figure 7.5.

FIGURE 7.5. AN OPTICAL PHOTOGRAPH OF THE DOME OF AN ELECTROLYTE TUBE FROM A CELL WHICH FAILED AFTER ONLY TWO CYCLES.

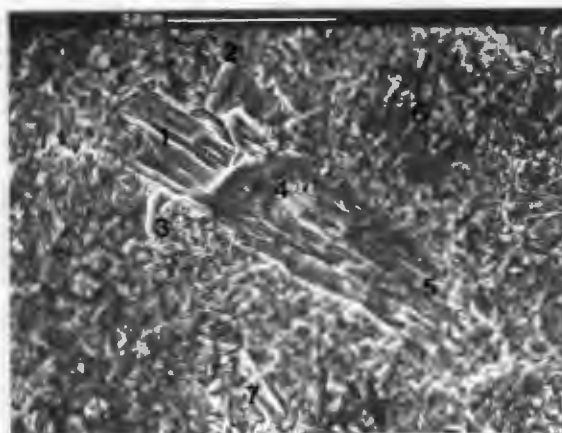
FIGURE 8.4. AN SEM MICROGRAPH OF AN Na/ELECTROLYTE INTERFACE. THE FIGURES ON THE MICROGRAPH CORRESPOND TO THOSE IN TABLE 8.1.

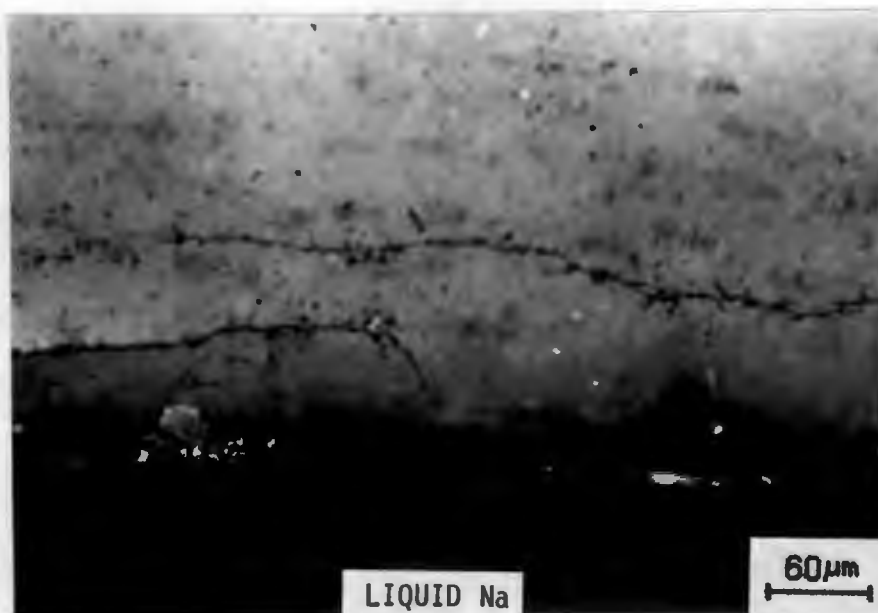
FIGURE 9.4. AN OPTICAL MICROGRAPH OF INTERNAL DAMAGE IN THE REGION OF THE Na/ELECTROLYTE INTERFACE OF A CYCLED BETA-ALUMINA ELECTROLYTE,
