**A STUDY ON SLOPE INSTABILITY  
ABOVE CHAPMAN'S PEAK DRIVE,  
CAPE PENINSULA, SOUTH AFRICA.**

**Submitted in Fulfillment of the Requirements for the Degree of  
MASTER OF SCIENCE**

**Department of Environmental and Geographical Science  
University of Cape Town  
Rondebosch 7701  
South Africa**

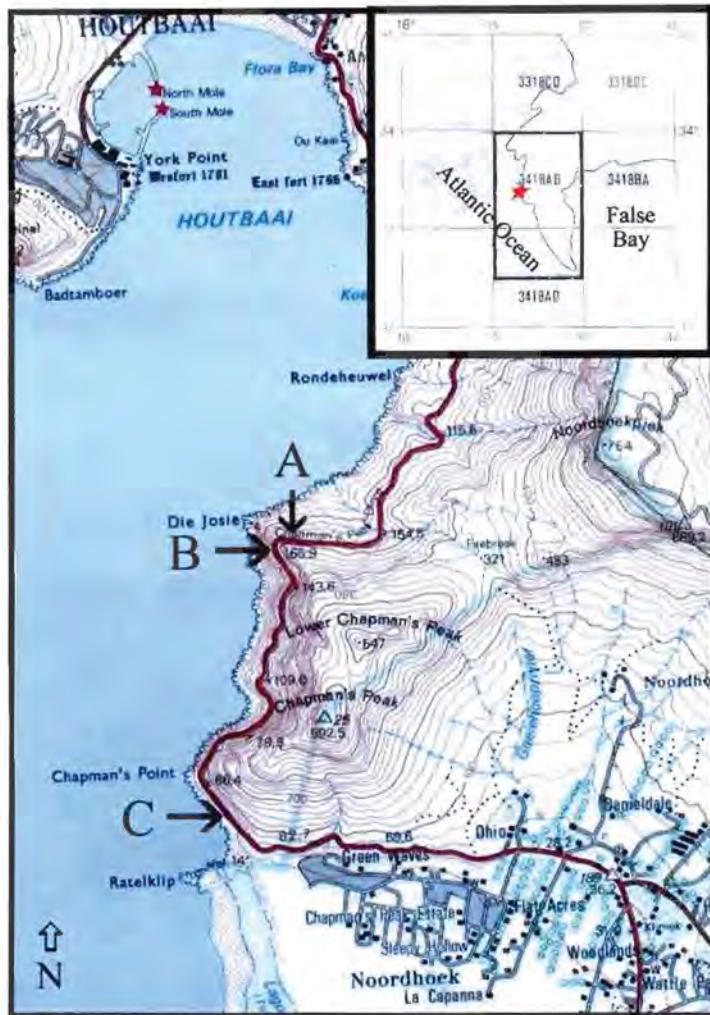
**Figure 1.2: The study locality. Arrow A indicates the position of control slopes investigated during this study. Arrows B and C point to the beginning and end, respectively, of the other section of Chapman's Peak Drive monitored. Inset: Star indicates the position of Chapman's Peak on the Cape Peninsula.**

Chapman's Peak Drive, the setting for this investigation, overlooks the Atlantic coast between Hout Bay and Noordhoek (Figure 1.2). The study area comprises the slopes and cliffs above the section of Chapman's Peak Drive from just before "the Lookout", when travelling from Hout Bay (Figure 2.1), and ends at the point at which the drive leaves the peak at its southern end. Chapman's Peak is part of a series of high cliffs that rise directly from the ocean surface to their summits at an altitude of 700m. The two sites under investigation for sediment and clast movements were situated on the slopes just before "the Lookout" when traveling from Hout Bay. One is unbarred and the other a barred slope cleared of potentially unstable rocks. This barring/clearing was done in the attempt to remove all rock material thought to pose a risk of movement from the slope down onto Chapman's Peak Drive. The two sections are located directly adjacent to each other and have equal gradients of  $32^{\circ}$ . Both slopes face in a Northerly direction and are 50 metres in length. The regolith is a mixture of soil matrix and pebble to boulder sized sandstone rocks and is between one and two metres deep. There is no distinct gullying but a few rills are evident. At the head of each slope are cliffs of approximately five metres in height (Figure 2.2). The explanation for the choice of these two slopes for investigation is given in detail in a later section.

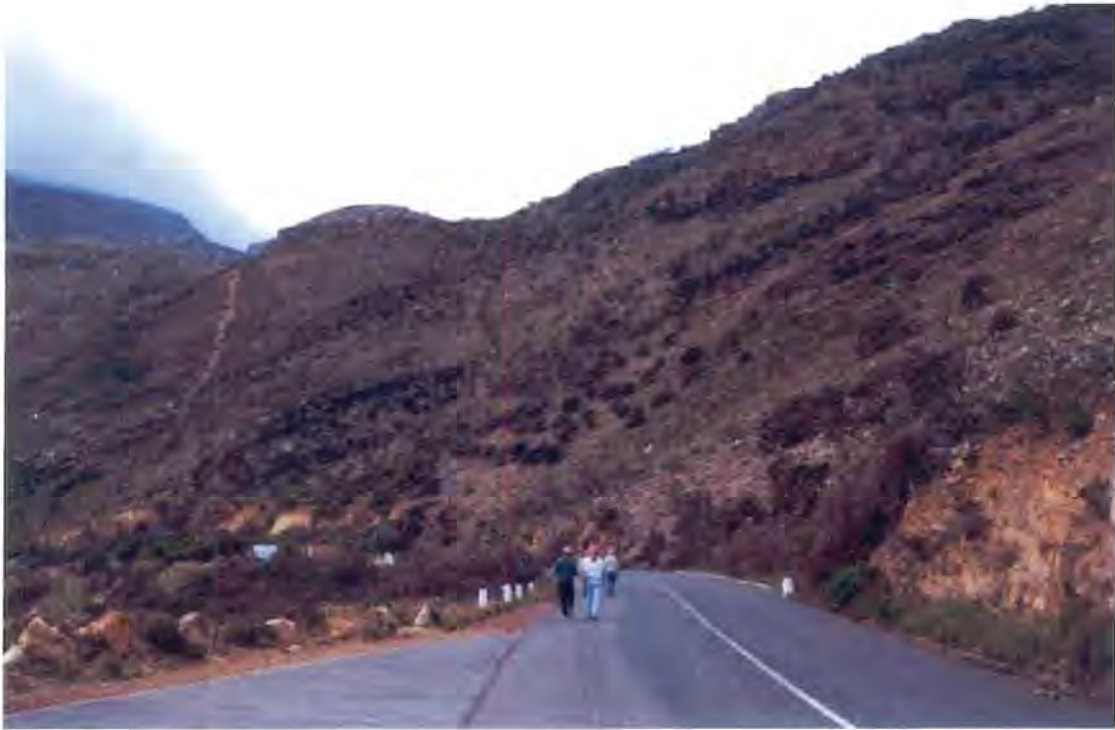
**Plate 4.1: Indicates the degree to which slopes on Chapman's Peak had been burnt during the wildfires of 2000 (5/3/2000).**

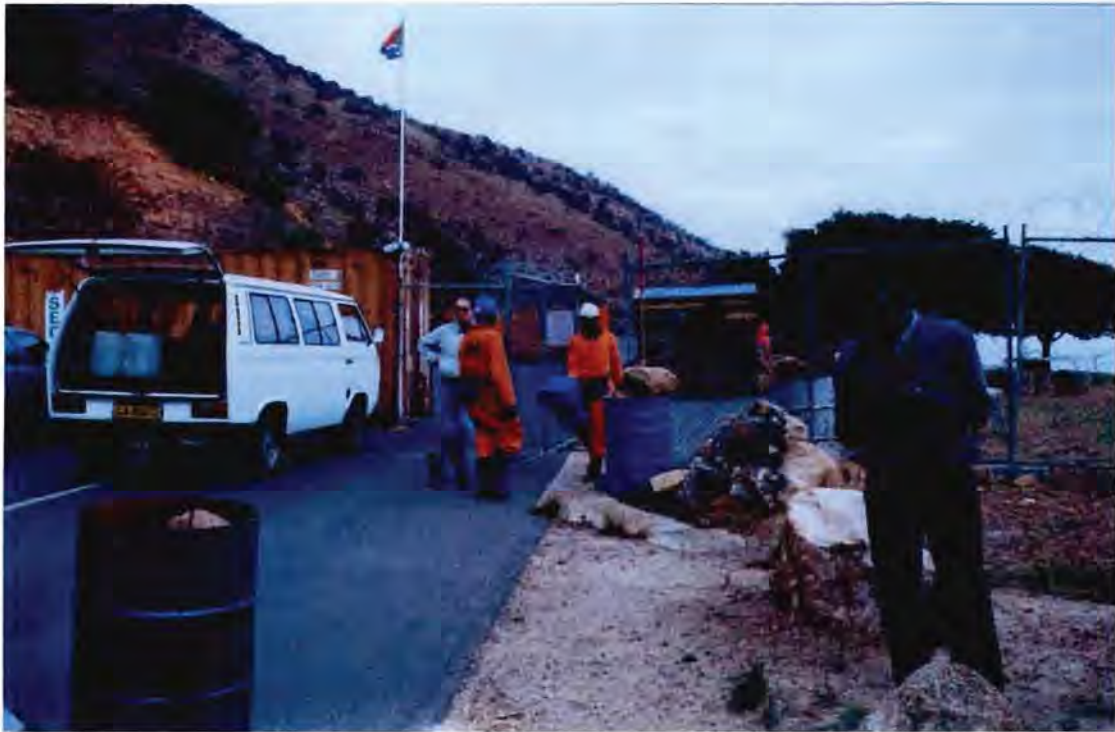
**Plate 4.2: Access restrictions that led to the delay and interruption of monitoring on site (5/3/2000).**

appropriate slope was prohibited at this time (Plate 4.2). This meant that no monitoring was possible during the first half of the winter of 2000 and made it necessary for further observations during the first half of winter 2001. Slope process monitoring was also interrupted during 2000 because of these access restrictions, resulting in a gap of just over a month between the first and second recorded dates of collection of rockfall, rainfall and sediment data. This however did not have a particularly strong negative impact on the effectiveness of the study as it facilitated the comparison between a slope denuded of its vegetation cover (Plate 4.3) and the same slope with some degree of revegetation later (Plate 4.4). Eight sediment traps were employed in the capture of slopewash erosion on the barred and unbarred slopes. These were left in place until one of the eight had filled to maximum capacity, until the winter rainfall season had ended or, as on the last occasion, the traps needed to be removed due to time constraints. The time between the traps' placement on the slope and their removal, for whichever reason, was termed a period and these periods are used as mechanisms for the grouping of trapped sediment data in this study.

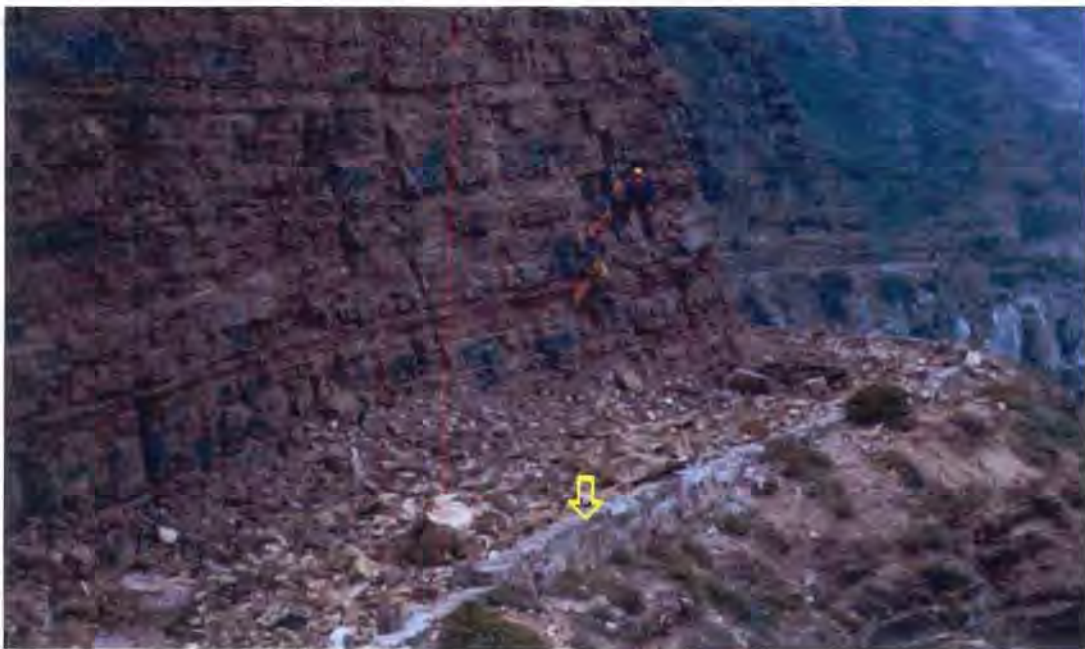
**Plate 4.5: Barring activities released large amounts of slope material onto Chapman's Peak Drive making the identification of material falling after these activities had ceased very difficult. The arrow, indicating the road-side barrier, gives some indication to the depth of material left on the surface of the Drive (5/3/2000).**

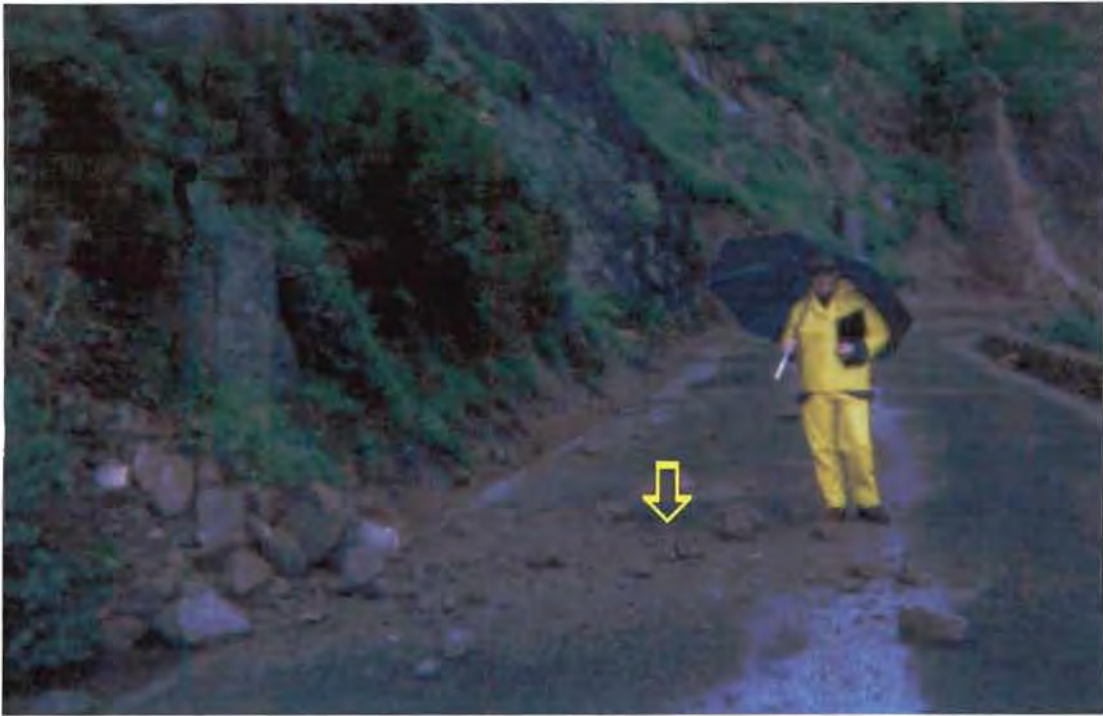
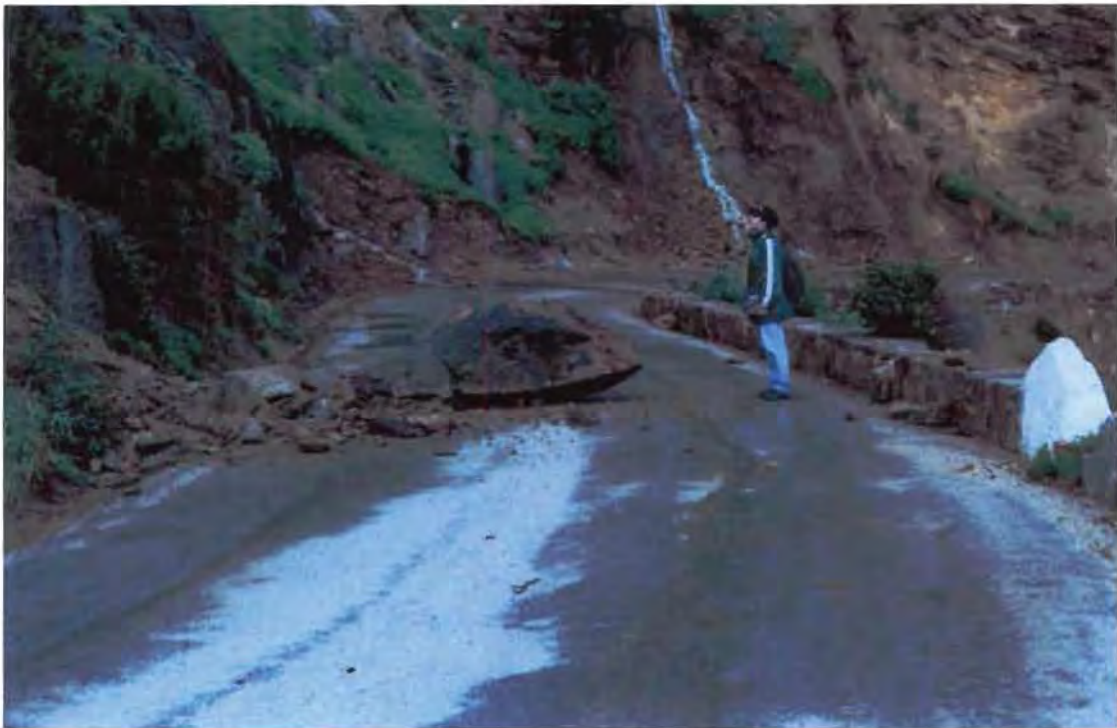
**Plate 4.6: A (Top): Day 2 of monitoring and only a few smaller clasts along the Drive (30/6/2001).**

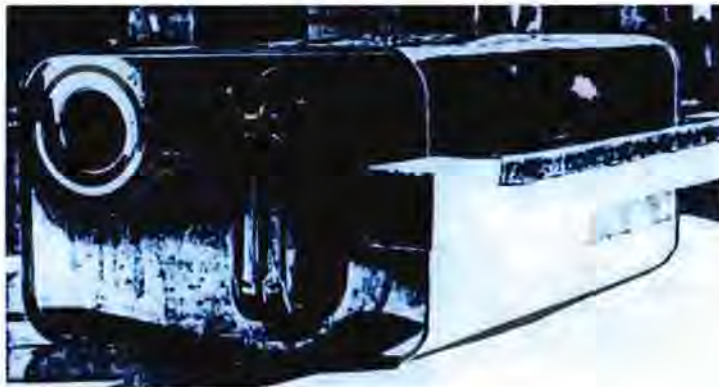
**Plate 4.7: Modified Gerlach trap used in this study.**

For the purposes of this part of the investigation, modified Gerlach troughs were created from oil tins measuring 30cm, 20cm and 15cm along their respective axes. Eight of these modified troughs were constructed in total. The tins were cut open along one of their sides (Plate 4.7), as per the method described by Reynhardt (1979), creating an entrance point for sediment to enter the trap. This left the upper part of the tin intact as a lid prohibiting the collection of splashed material. The traps were dug into the ground with the upslope lip of the openings aligned flush with the ground surface and care was taken not to disturb the area of slope above each trap. In so doing any overland flow moving down the slope toward the sediment trap is captured, in the process also capturing any entrained sediment. By leaving the spouts of each oil tin open, water is allowed to escape thereby preventing the trap from overflowing also preventing the loss of finer grain sized particles.

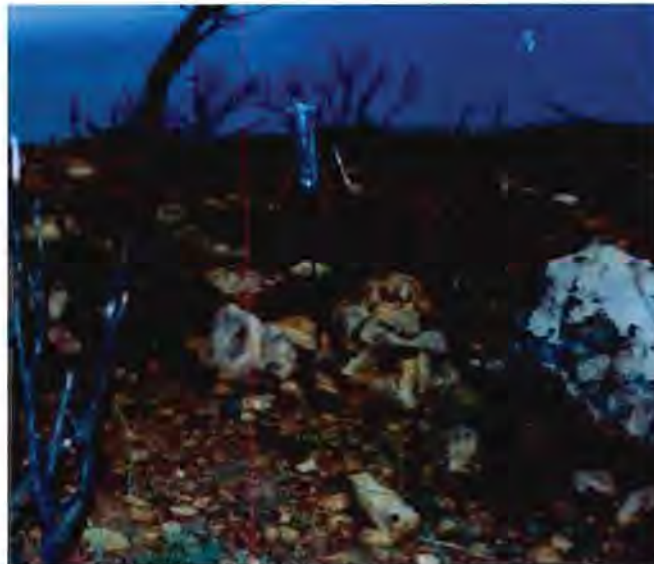
**Plate 4.8: The standard manual rain gauge used in this study (2/8/2000).**

A standard manual rain gauge (Plate 4.8), positioned on the slope into which the sediment traps were dug, captured this data. Rainfall readings were taken as close to 08h00 as possible in the morning if rainfall had occurred during the previous 24 hours. This is why the rainfall event dates in the tables in Chapter Five (Tables 5.1 and 5.2) record two dates for a single event as it was impossible to identify whether the rain had in fact fallen during the first date shown, the early hours of the following morning or both.

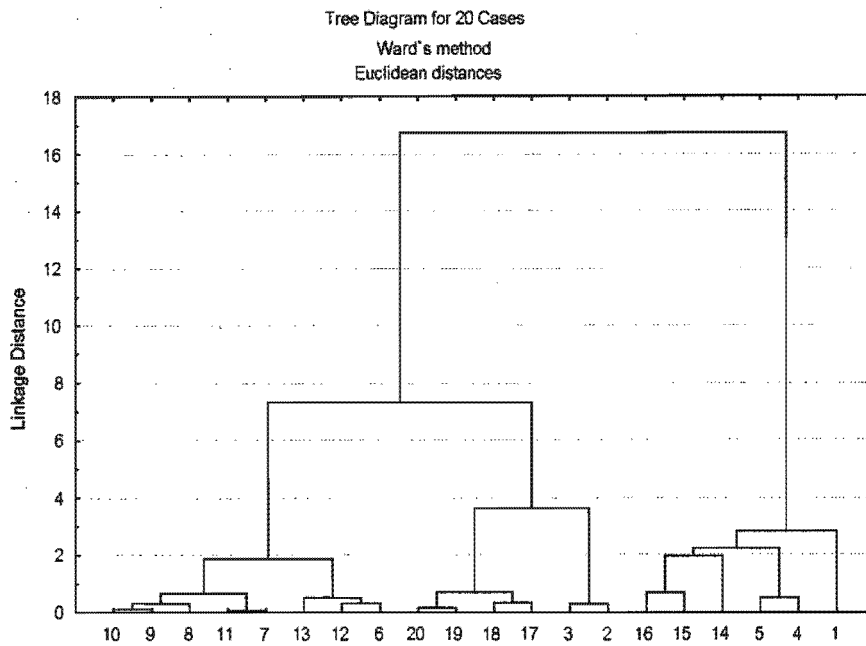
**Figure 5.9: Cluster analysis of standardised data (from 50mm rainfall) event by Ward's method.**

which is in agreement with the results from the 50mm event's results (Figure 5.9). The Ward's method analysis once again identified two main groupings with sample points (cuttings) 1, 4, 5, 13, 14, 15 and 16 grouped separately (Figure 5.11).
