Dissertation submitted in fulfilment of the requirements for the degree

Department of Mechanical Engineering
University of Cape Town

INFLUENCE OF LASER SCAN RATE ON THE MECHANICAL PROPERTIES OF SLM Ti6Al4V ALLOY

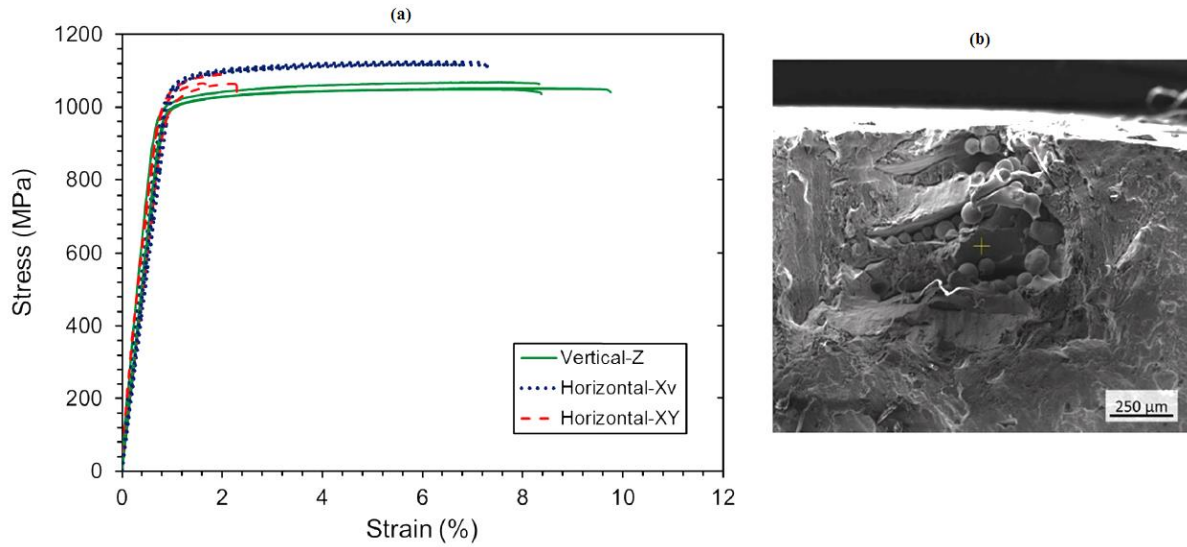
Figure 20: Tensile results and SEM Fractographs of Ti6Al4V alloy fabricated in XY direction by EBM [41]

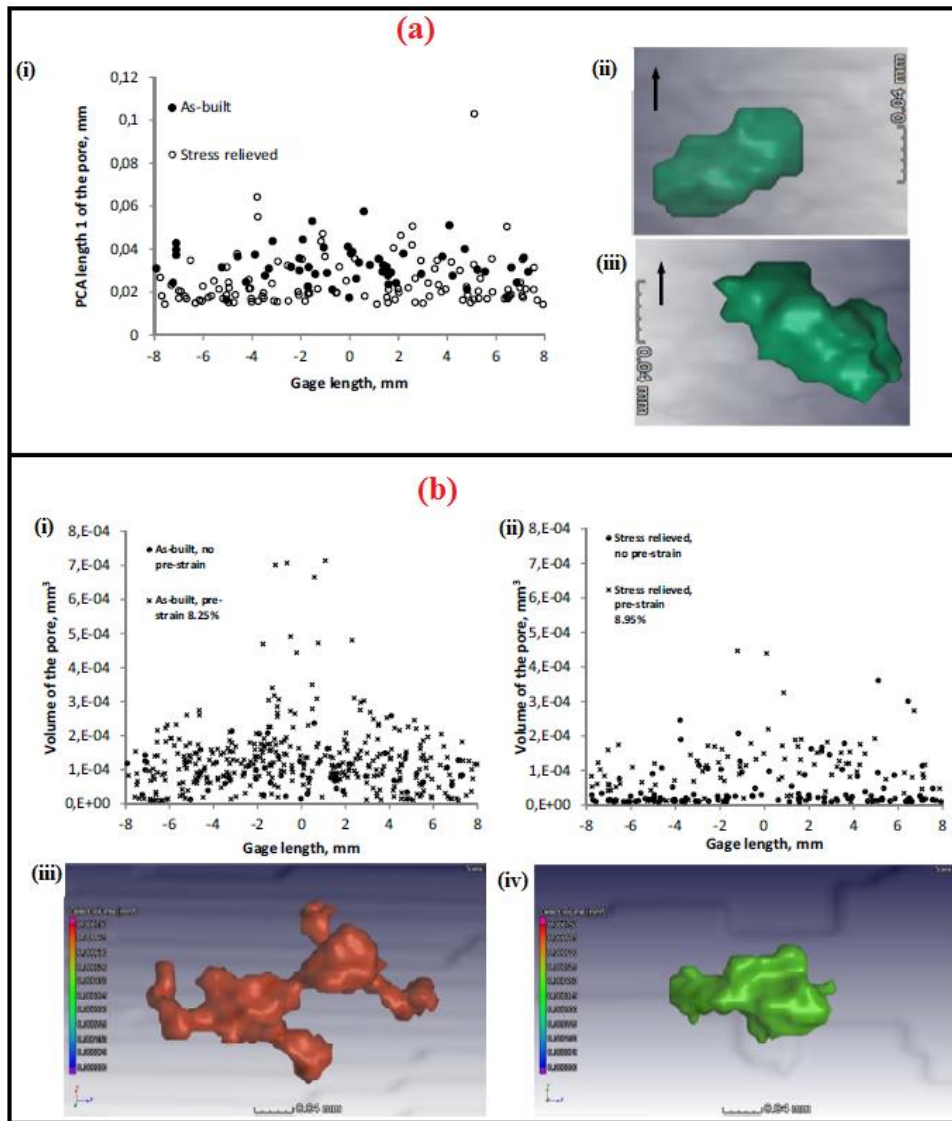
Figure 23: Evolution of micro pores: (a) as-built and stress relieved before pre-strain; (b) after 8.25% pre-strain in as-built (i & iii) and after 8.95% pre-strain in stress relieved state (ii & iv) [43].

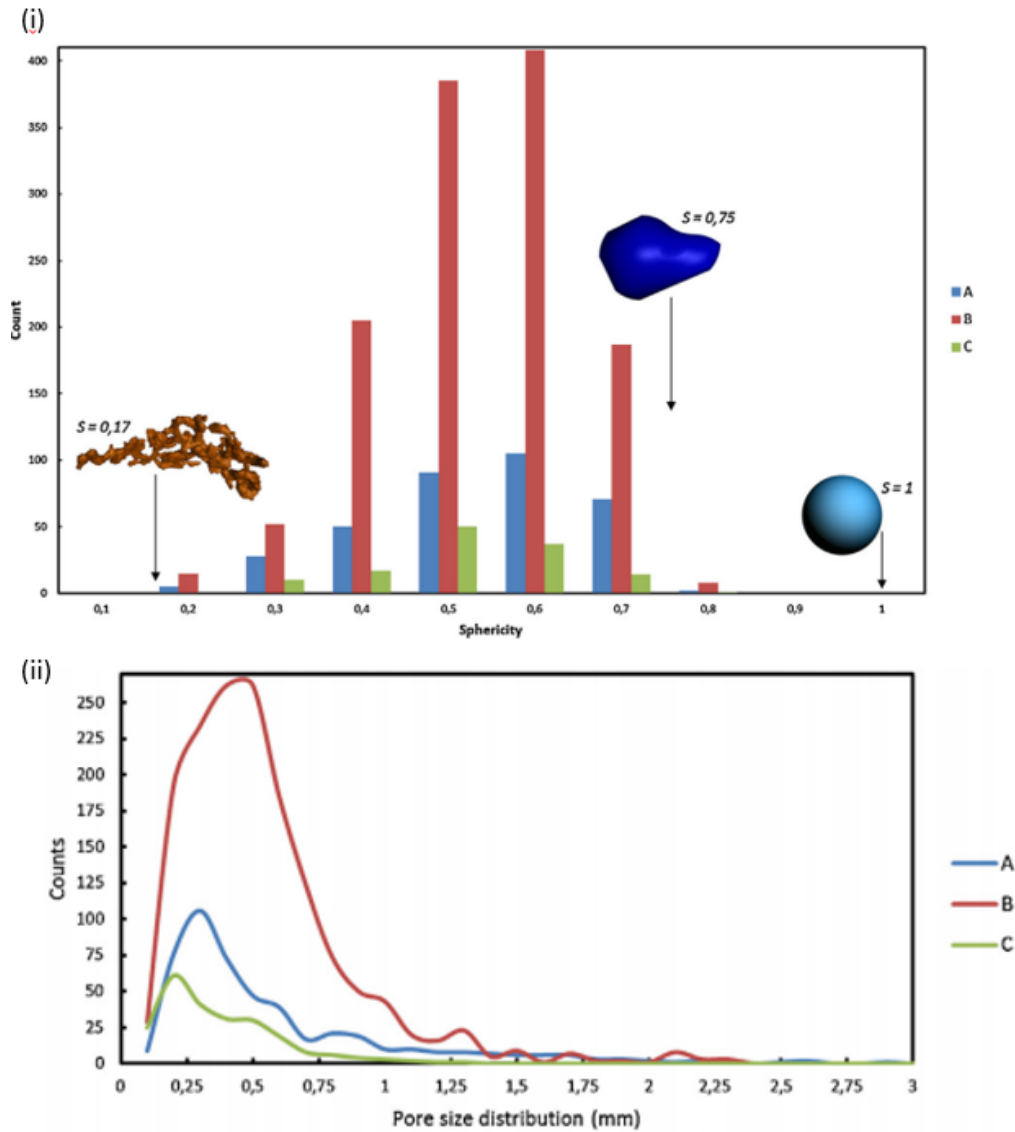
Figure 28: Porosity characterisation in SLM 316L steel: (i) sphericity distribution; (ii) pore size distribution histogram; [50].

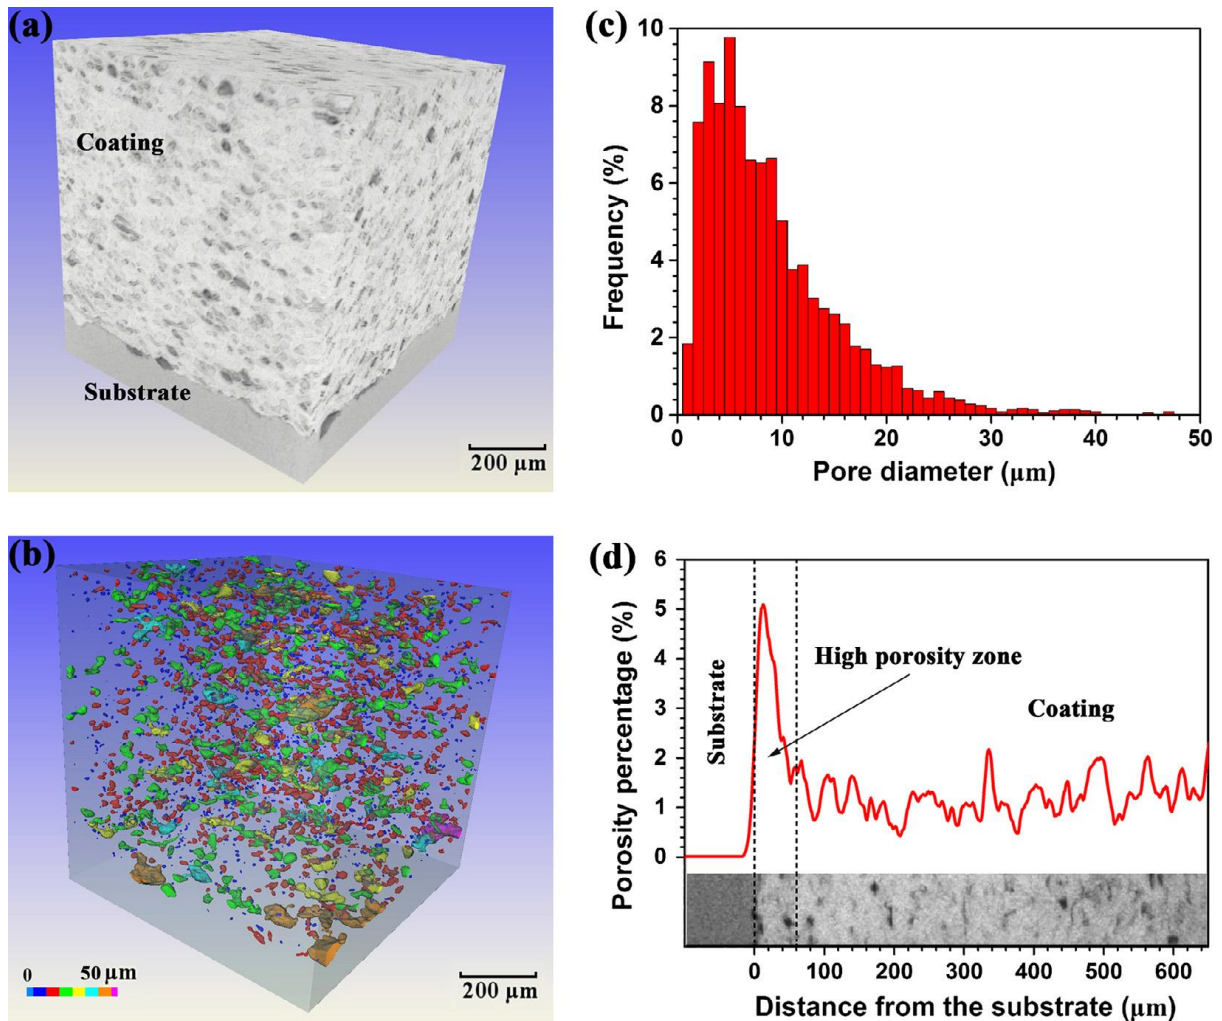
Figure 31: Porosity distribution in Fe-based amorphous coating: (a & b) X-ray CT 3-D reconstruction showing the coating and substrate together with porosity distribution; (c) porosity size distribution; (d) porosity percentage change along the coating [51].

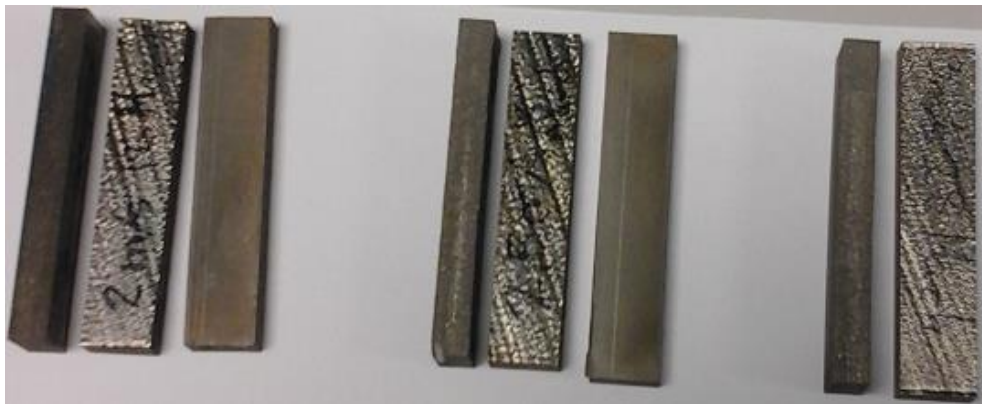
Figure 49: The SLM Ti6Al4V tensile samples fabricated in the X-Y direction

The SLM Ti6Al4V tensile samples were fabricated as bars with dimensions of 67 mm x 14 mm x 7 mm (as depicted in Figure 49) and were machined to dog-bone tensile specimens, shown in Figure 50, in line with the ASTM E8/E8M standard. Because of the poor surface integrity of the SLM fabricated parts, tensile specimens were machined and ground to a fine surface finish to reduce or eliminate poor ductility that could have arisen owing to poor surface finish, as reported by Formanoir *et al.* [41].

The SLM Ti6Al4V samples were manufactured using parameters as presented in Table 5. All samples were produced with the tensile axis in the XY-direction (parallel to the scan direction, X-axis) with respect to the build direction (Z-direction) as shown previously in Figure 47(b).

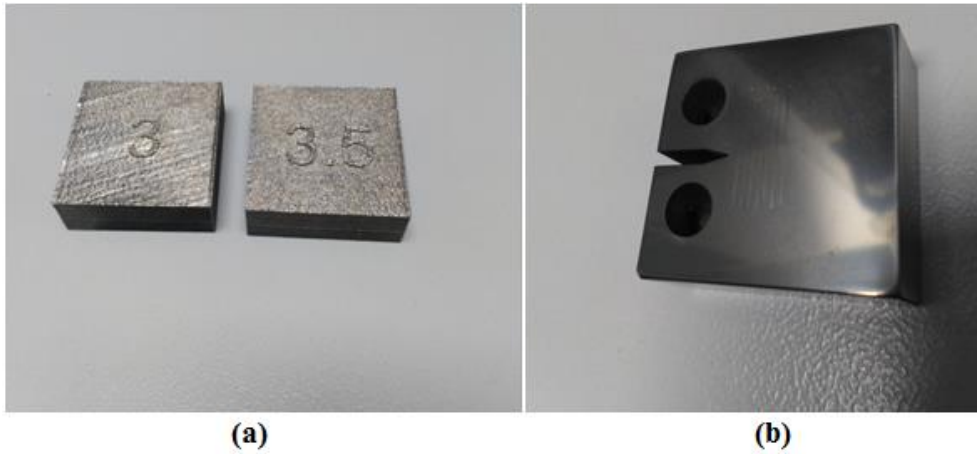
Figure 55: The SLM Ti6Al4V fracture toughness samples: (a) as build; (b) After machining

Fracture toughness specimens were produced using parameters as presented in Table 6, with variation in laser scan speed from 3.0 m/s to 4.0 m/s (3.0, 3.5 and 4.0 m/s) and in the XY plane, parallel to the scan direction (X-axis) with respect to the build direction (Z-axis), as indicated in Figure 47. Fabricated blocks with dimensions of 40 mm x 40 mm x 15 mm were machined in line with the ASTM E399 standard, as shown in Figures 55(a) and 55(b). The sample notch was produced using Electric Discharge Machining (EDM) wire cutting technology.

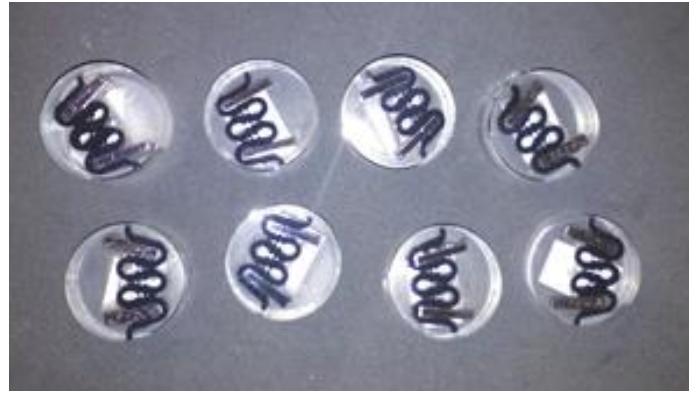
Figure 59: Mounted samples

Samples were selected and mounted using polymeric powder under the influence of both pressure and heat for a short time (14 minutes at 2kN load). This facilitated ease to handle the specimens during grinding and polishing. Sample clips were employed to hold specimens in chosen appropriate positions during mounting, as shown in Figure 59.

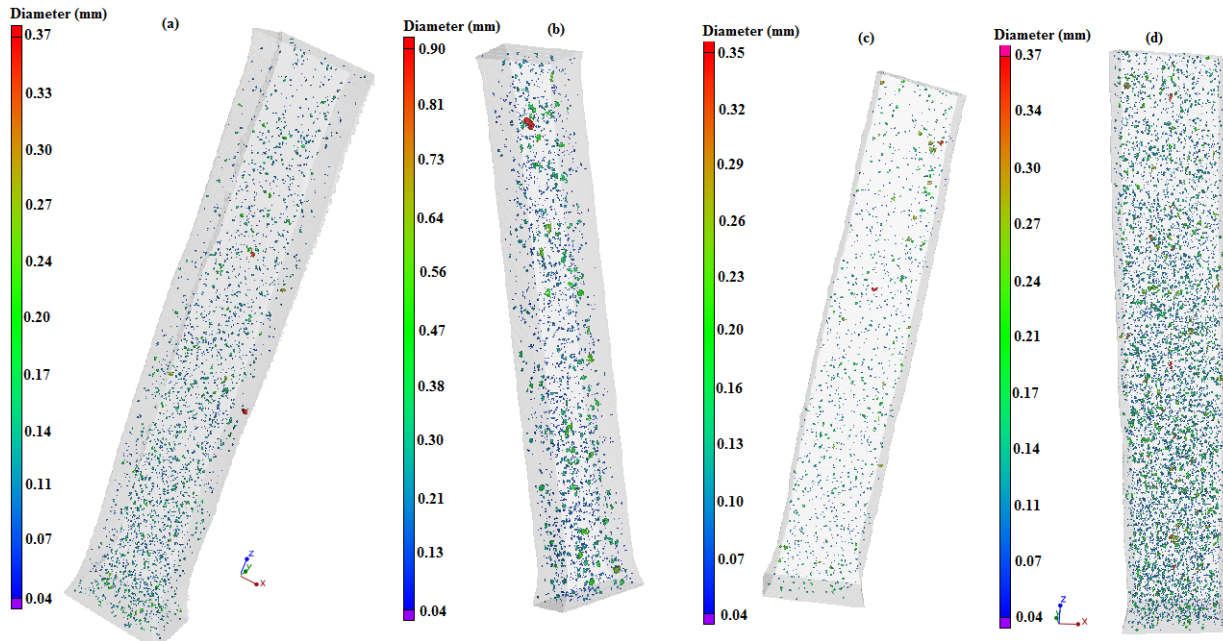
Figure 68: The X-ray CT scan of stress relieved SLM Ti6Al4V uniaxial tensile samples fabricated at 4m/s: (a) Sample 4; (b) Sample 3; (c) Sample 2; (d) Sample 1

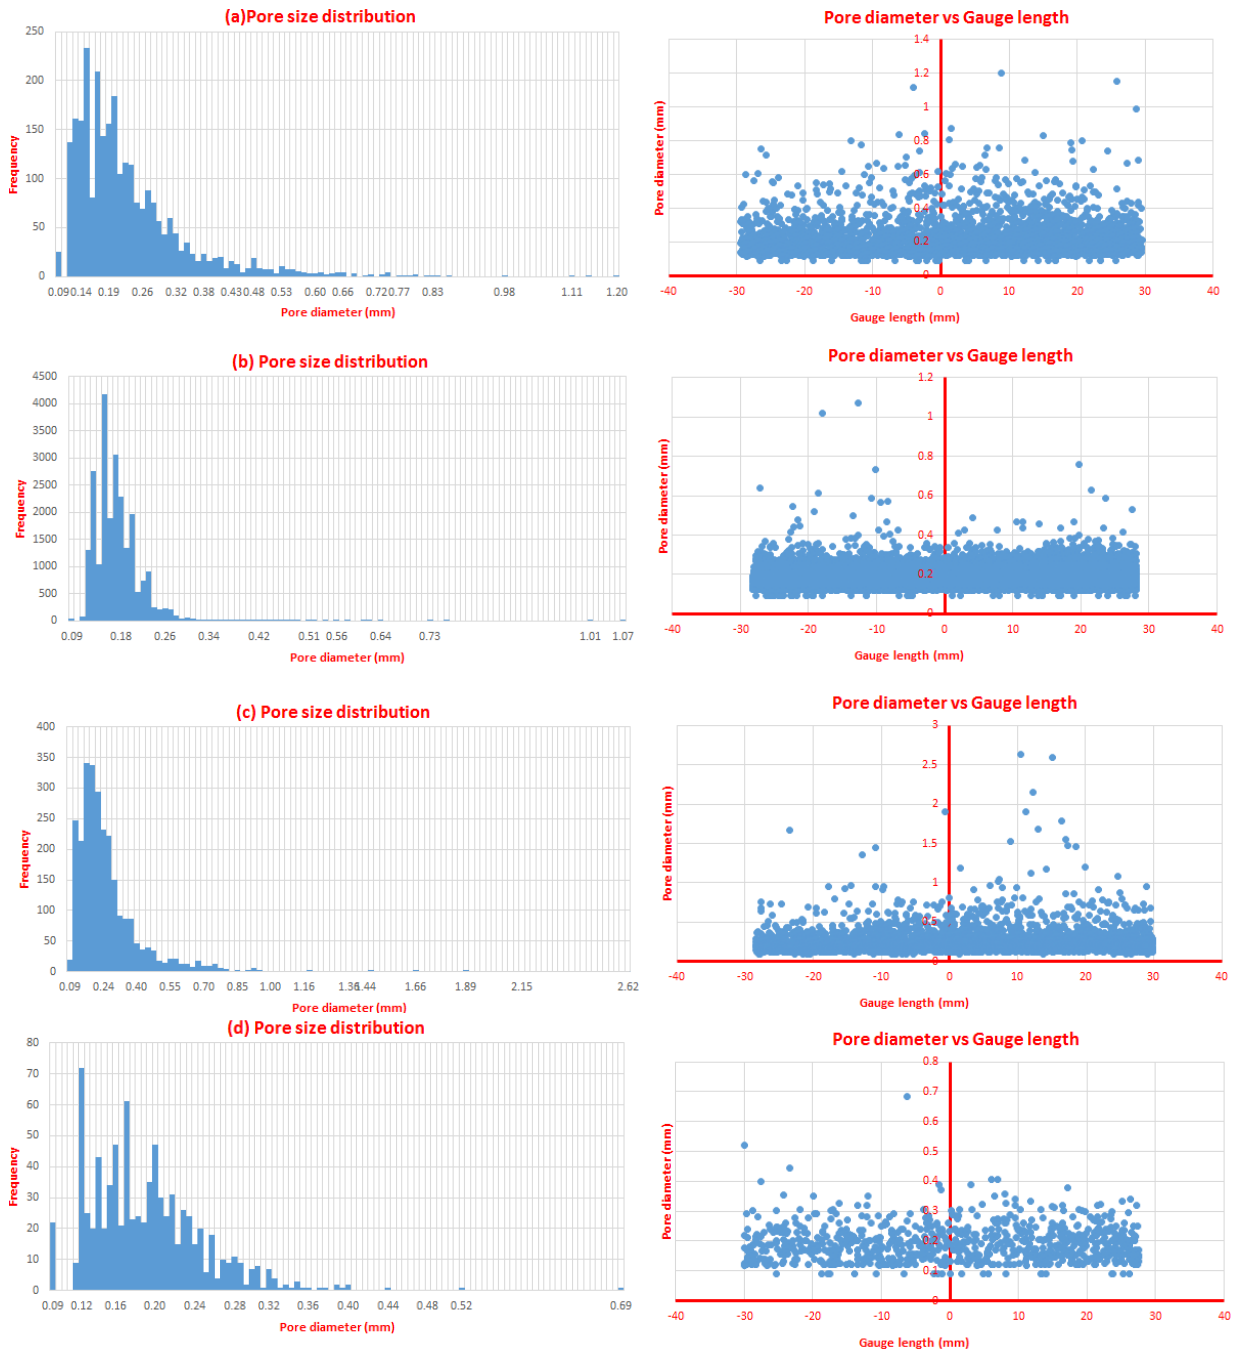
Figure 72: Pore size distribution for stress relieved SLM fatigue crack initiation samples fabricated at: 3 m/s (a- Sample 4 ,b- Sample 1, d- Sample 2); 4 m/s (c-Sample 2)

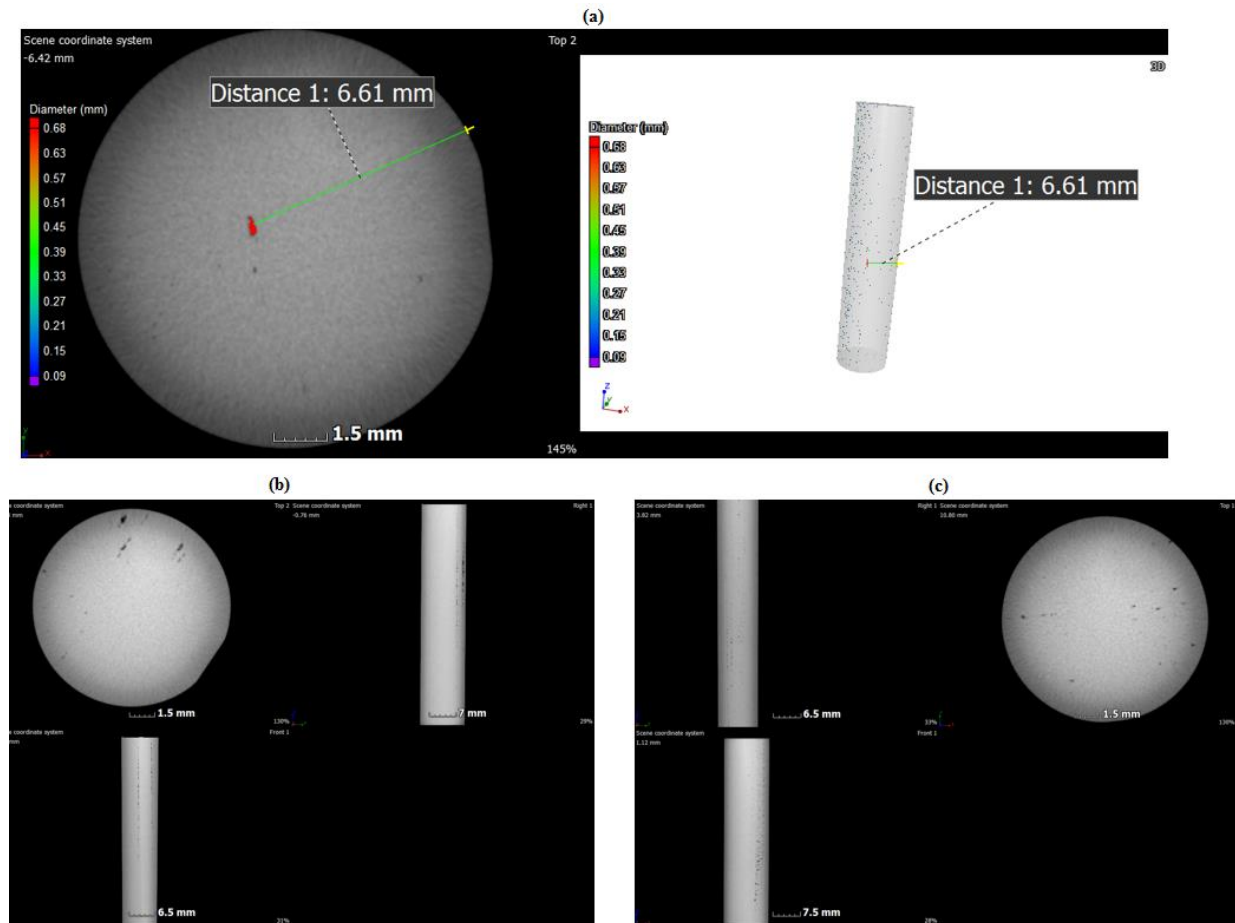
Figure 73: 2-D slices for the stress relieved SLM Ti6Al4V tensile samples fabricated at: (a) 3 m/s (sample 2); (b) 3 m/s (sample 1); 4 m/s (sample 2).

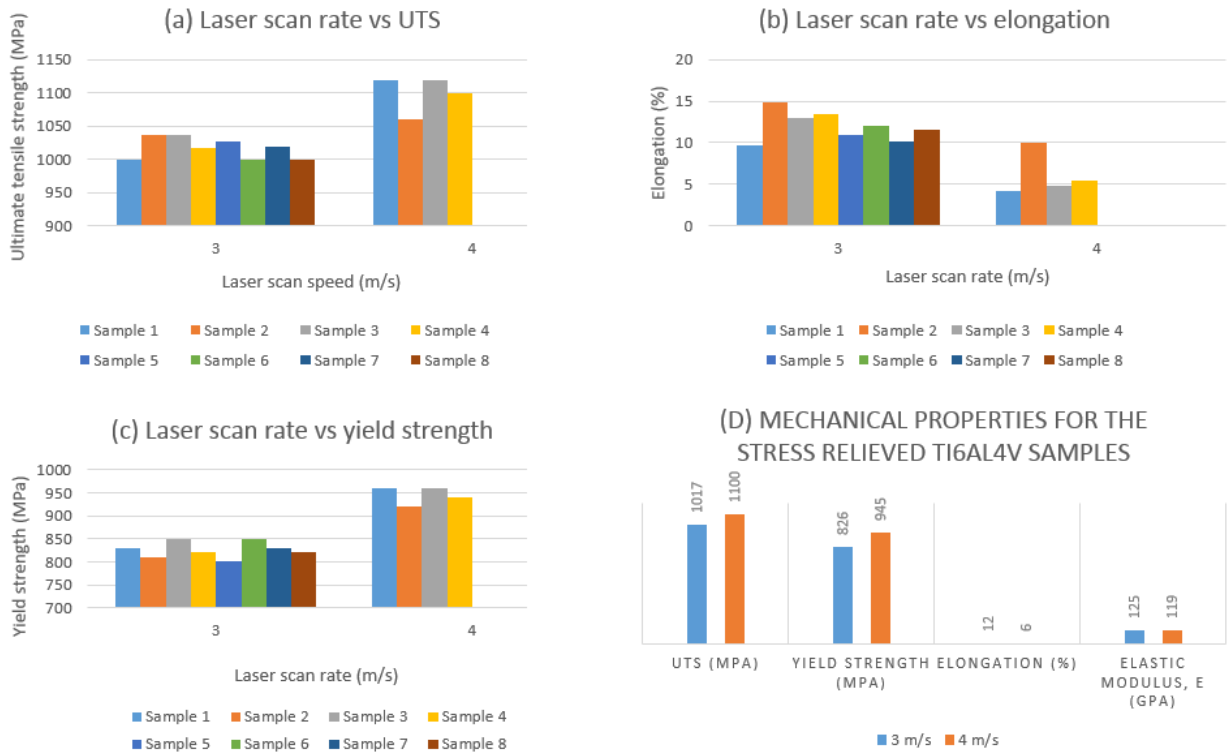
Figure 84: Measured tensile mechanical properties for the stressed relieved SLM Ti6Al4V samples fabricated at 3 m/s and 4 m/s: (a) UTS; (b) elongation; (c) 0.2% proof stress; (d) comparison of average mechanical properties for each laser scan speed.
