# **Condition Assessment Using Dissolved Gas Analysis on Transmission Power Transformers**

**MSc (Eng) Thesis**

**Prepared by: Mphikiseni Michael Ngubane**

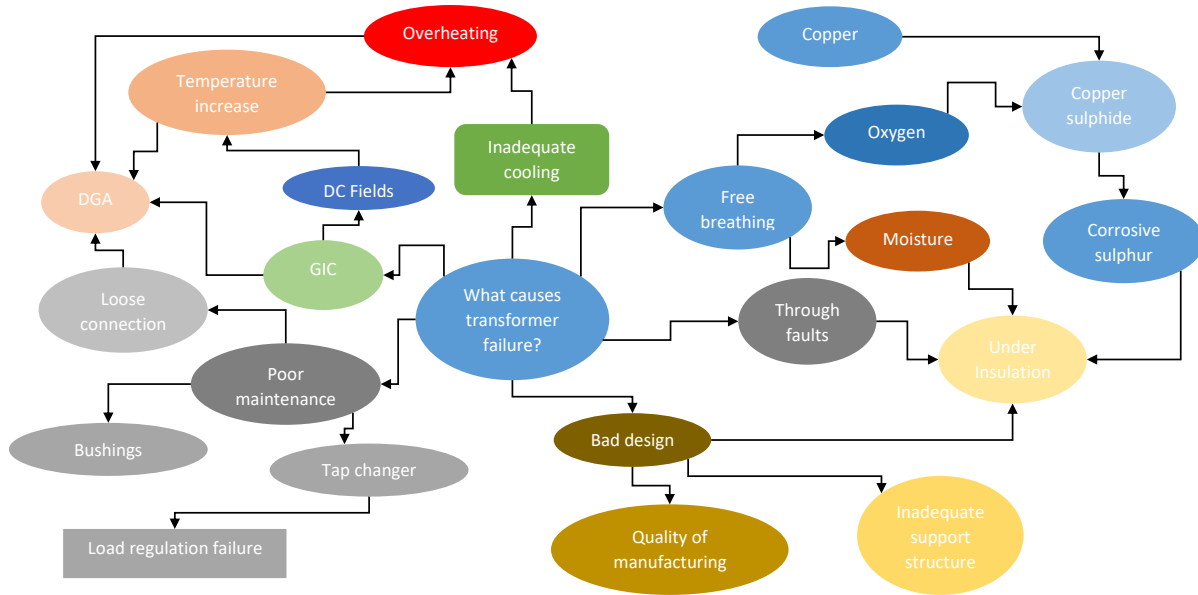
**Figure 1-1: Causes of failures.**

The flow chart in Figure 1-1. shows the possible causes of the transformers/reactor's failure from transmission and distribution network. The data was gathered from literature research, case study investigations and from IEC/IEEE guidelines [IEC 60599]. These causes can contribute to different types of faults in the oil-filled transformers/reactors such as thermal and electrical faults. Furthermore, these processes generate dissolved gases

that can reduce or reflect reduction of the dielectric strength of the insulation. This figure can assist in identifying the root cause of failures.

The key elements that need close attention in the transformer are electrical, mechanical, and thermal faults. The mechanical problems cause the solid insulation to collapse, and the electrical problems start electrical discharges because of clearance compromised. Mostly, thermal problems are caused by loose components or high resistance which cause overheating in the transformer. The core and windings can also overheat because of over fluxing and over loading. All these mentioned problems produce dissolved gasses which affect the dielectric strength of oil insulation.

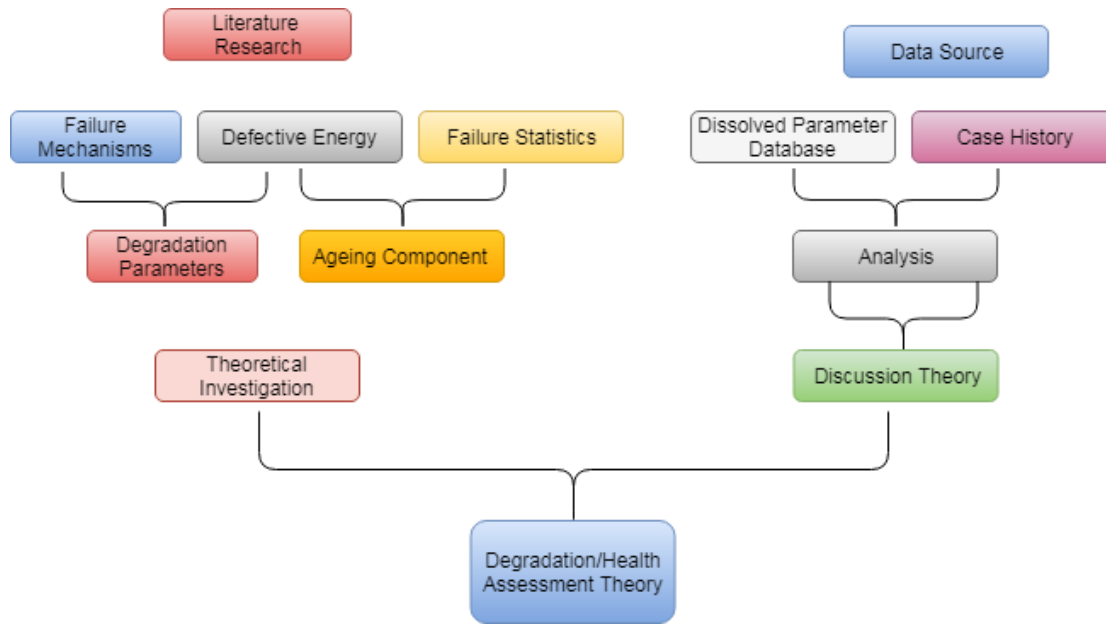
Figure 1-2: Research methodology flow chart

The focus of this research is to investigate the existing methods for interpreting dissolved gas analysis results from mineral and esters insulation fluids. The approach taken will be based on an extensive literature review and testing the revealed ideas in the context of case studies of failed transmission transformers using data and records from the Eskom Laboratories. The approaches applied to the interpretation of results from mineral oils will be extended to ester oils on the basis of what the literature review provides. Various methods of interpreting DGA results will be compared with each other. The approach to the research is illustrated in Figure 1-2.

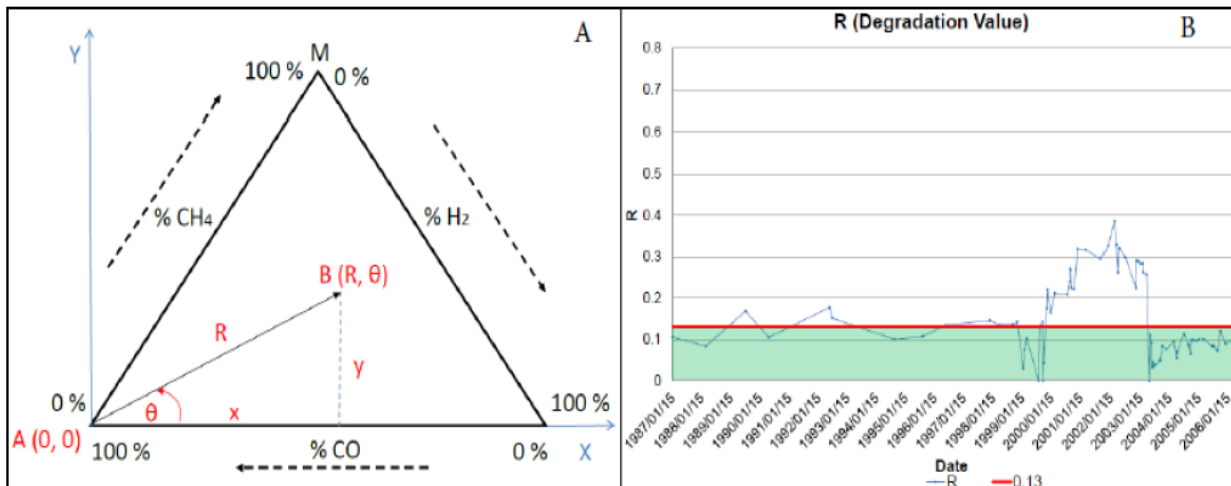
Figure 3-2: LEDT as a Polar Plot [Moodley 2017]

From empirical data the normal/healthy region of the LEDT was initially set as R=0.17, but with more operational experience it is now considered in Eskom to be R < 0.13, representing the point (H<sub>2</sub>, CH<sub>4</sub>, CO) adjusted to 7.5%, 7.5% and 85% respectively. When the R-value exceeds the value of 0.13, close monitoring is required as this is an indication of unacceptable insulation degradation.

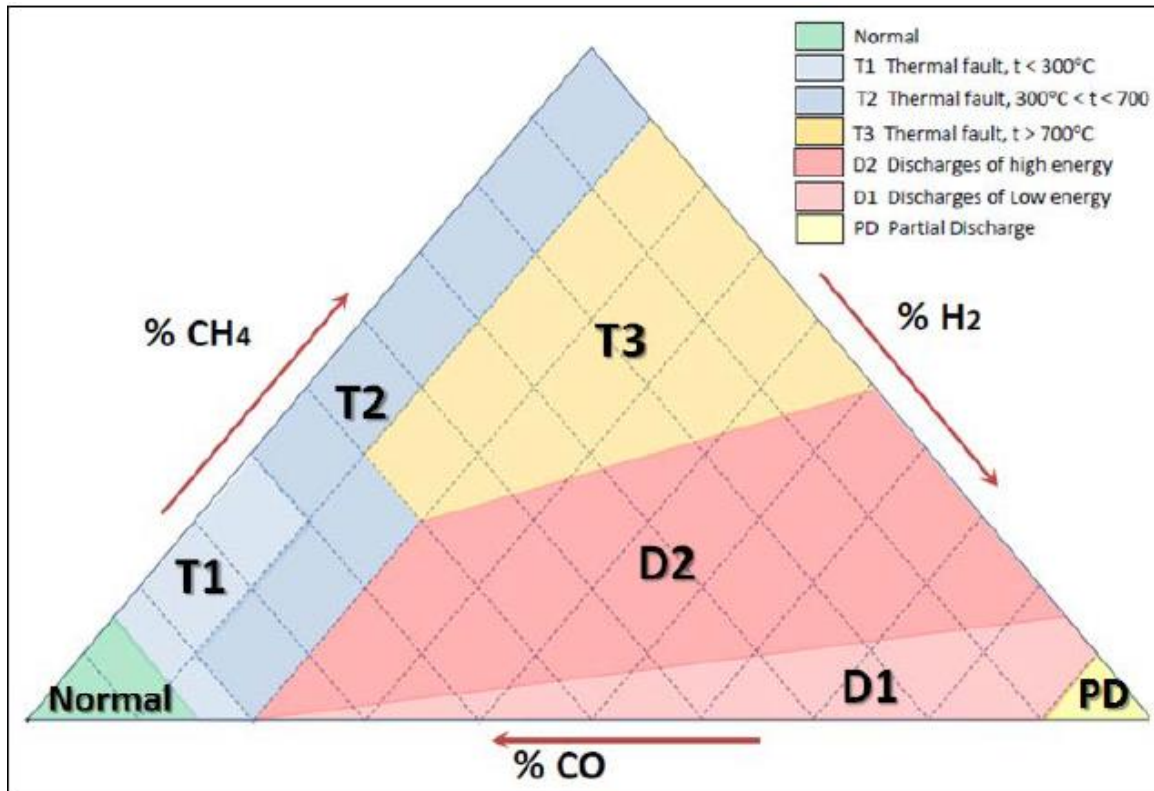
Figure 3-3: LEDT Fault Regions

A benefit of the LEDT is that it has regions that indicate different types of faults and indicates when different modes of degradation generally start. Figure 3-3 shows the different regions for the low energy degradation triangle. The demarcation of the regions is comparable with similar regions in the Duval’s Triangle 1. In addition, there is a normal region where the transformer is in a satisfactory condition and there is no need for frequent monitoring. The Duval’s Triangle 1 does not have a region corresponding to the healthy region of the LEDT.

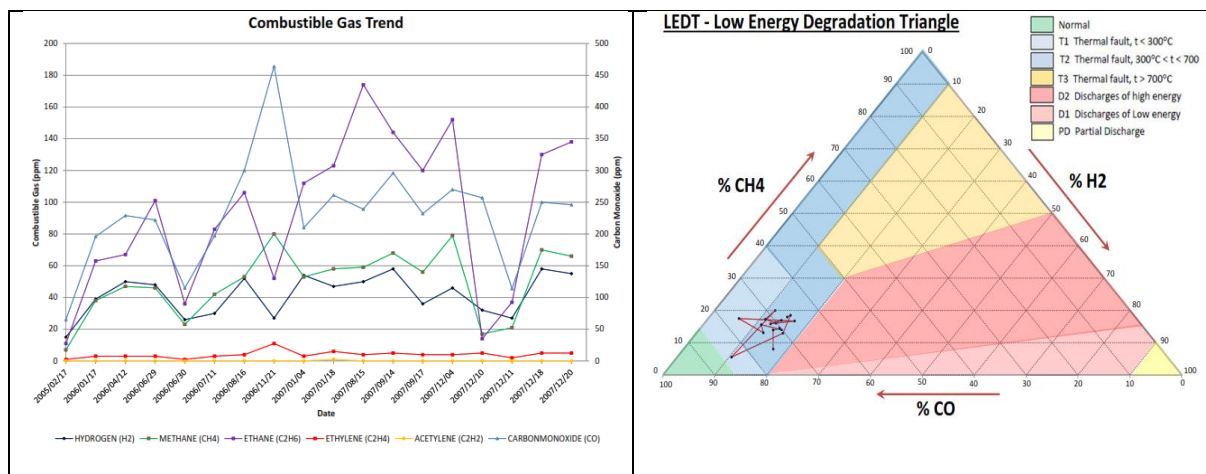
Figure 3-4: Combustible Gas Trend Versus LEDT Representation

The benefit of the LEDT is that even with erratic dissolved gas results it is still able to maintain the diagnosis according to the percentage of gasses and to clearly indicated the prevailing fault condition. This is evident in the corresponding LEDT representation of the combustible gas trend in Figure 3-4.

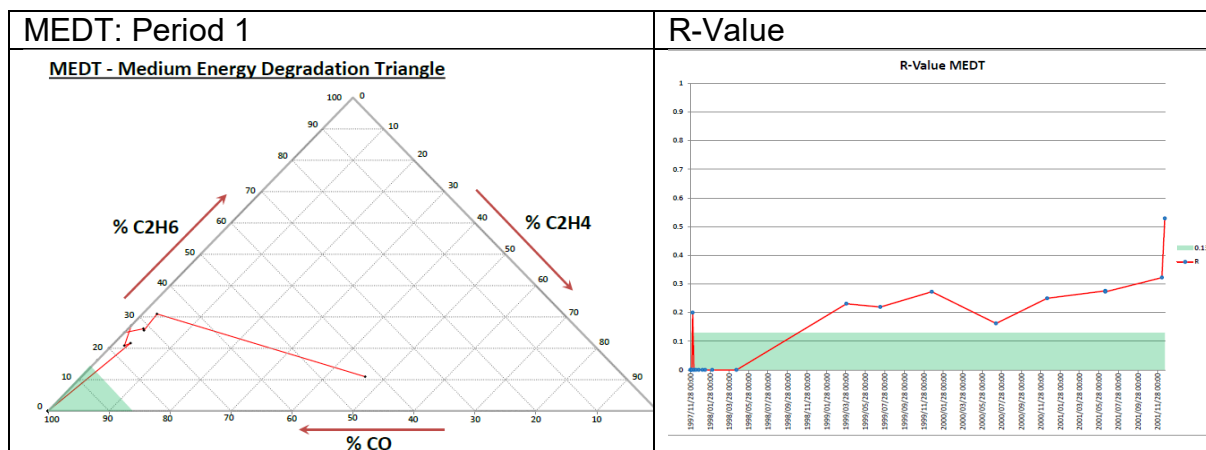
Figure 3-5: MEDT and R-Value

See an example in Figure 3-5, both MEDT and associated R-Value indicated a medium energy incipient fault in the operating transformer with the R-Value indicating a developing fault from the normal region up to where the fault was in the visible state to be investigated.

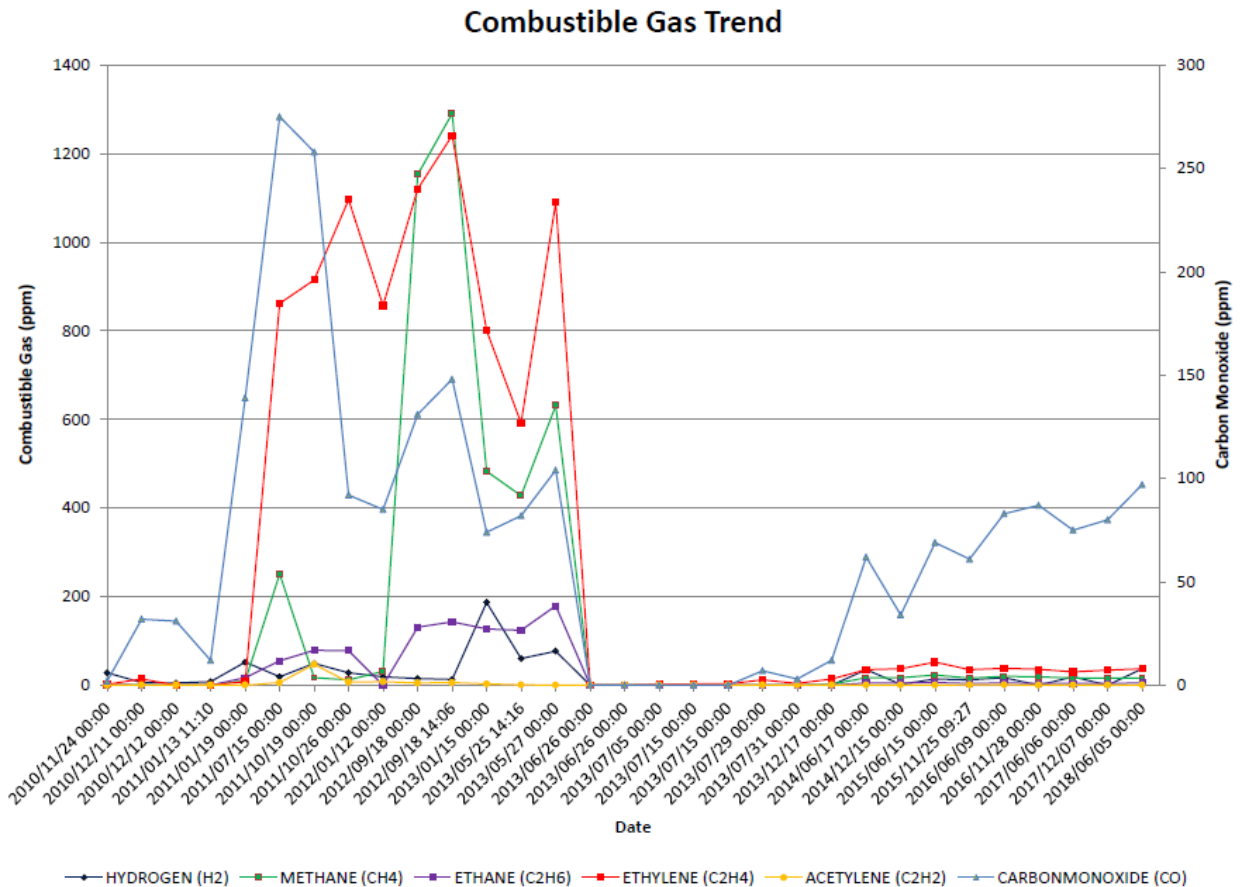
Figure 4-1: Case Study A - Combustible Gas Trend

Figure 4-1 provides a combustible gas trend of the dissolved gas results over the period.

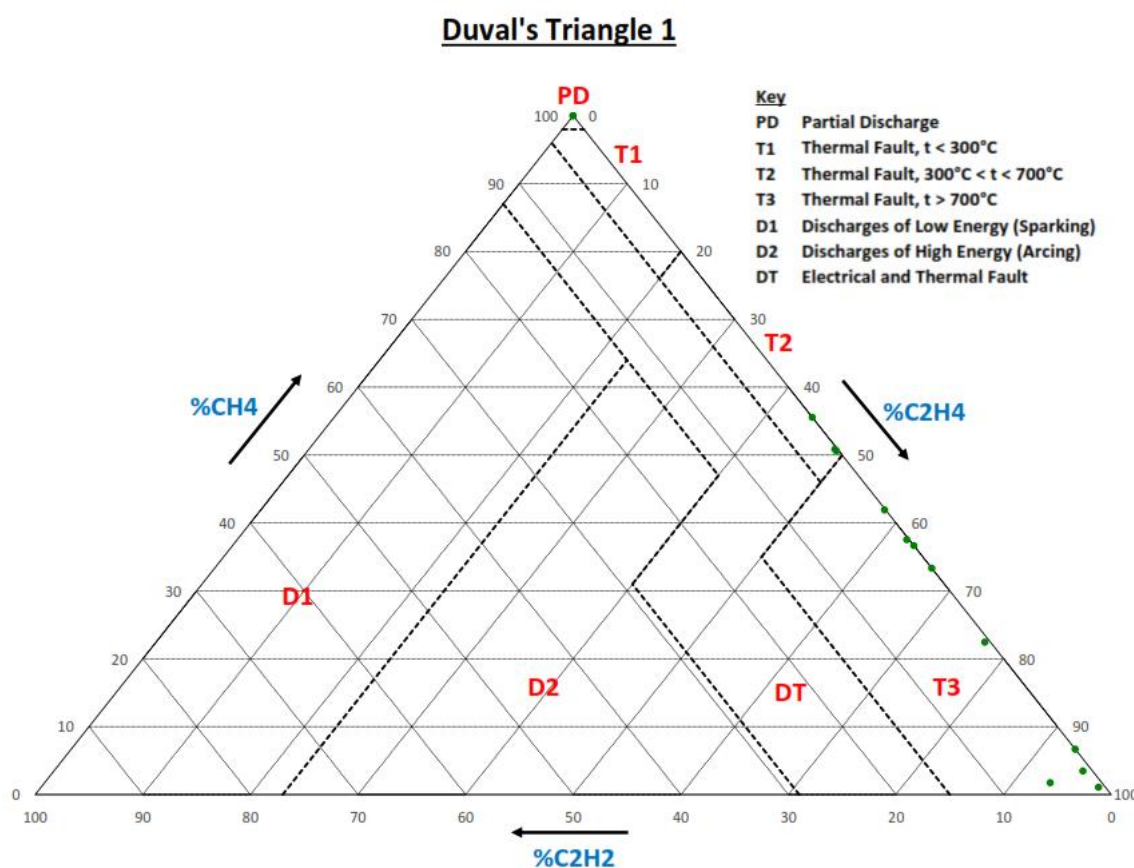
Figure 4-2: Case Study A - Duval's Triangle 1 - Period 1

The Duval's Triangle 1 method for Period 1 (Figure 4-2) indicated the transformer started with discharge and because the transformer was not attended too, the fault gases escalate to high thermal energy greater than 700°C.

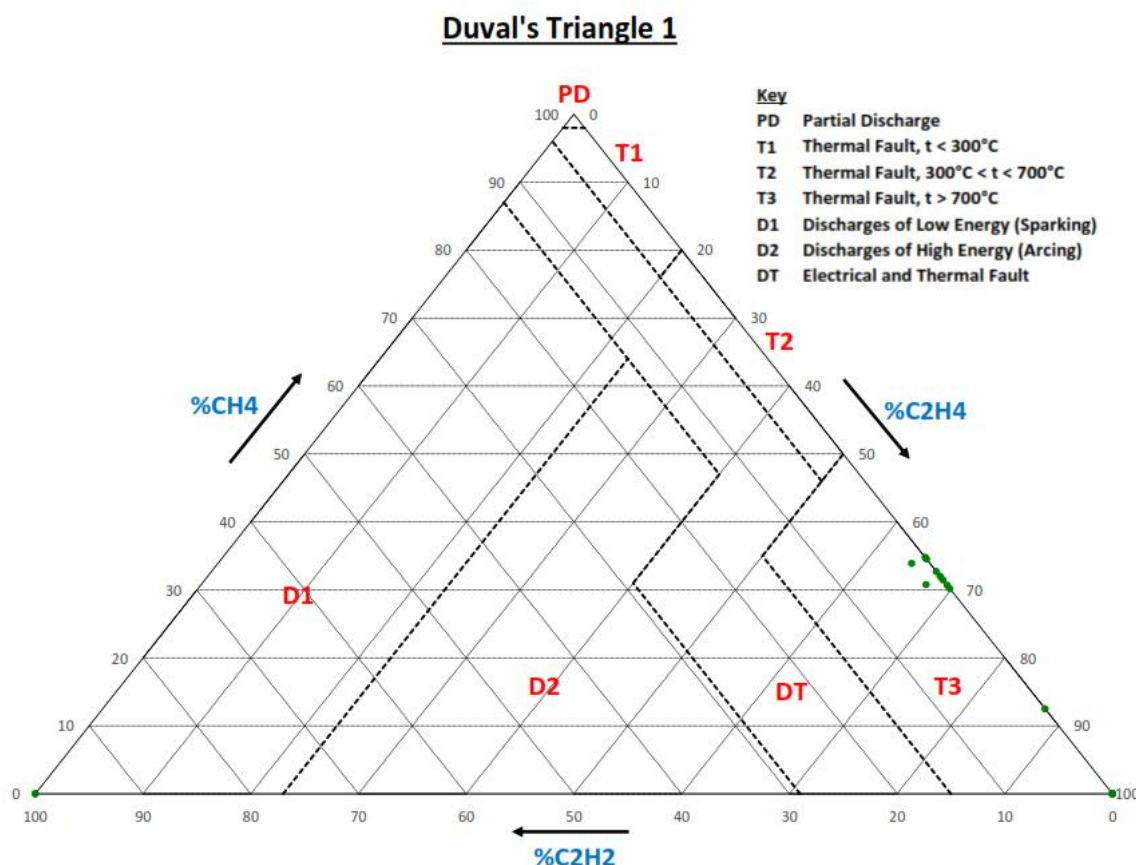
Figure 4-3: Case Study A - Duval's Triangle 1 - Period 2

Period 2 (Figure 4-3) indicated that the fault was on T3 region where thermal fault exceeded 700°C. This supported the LEDT diagnosis. The cause of the escalation of fault gases is thermal fault generated on the active part of the transformer.

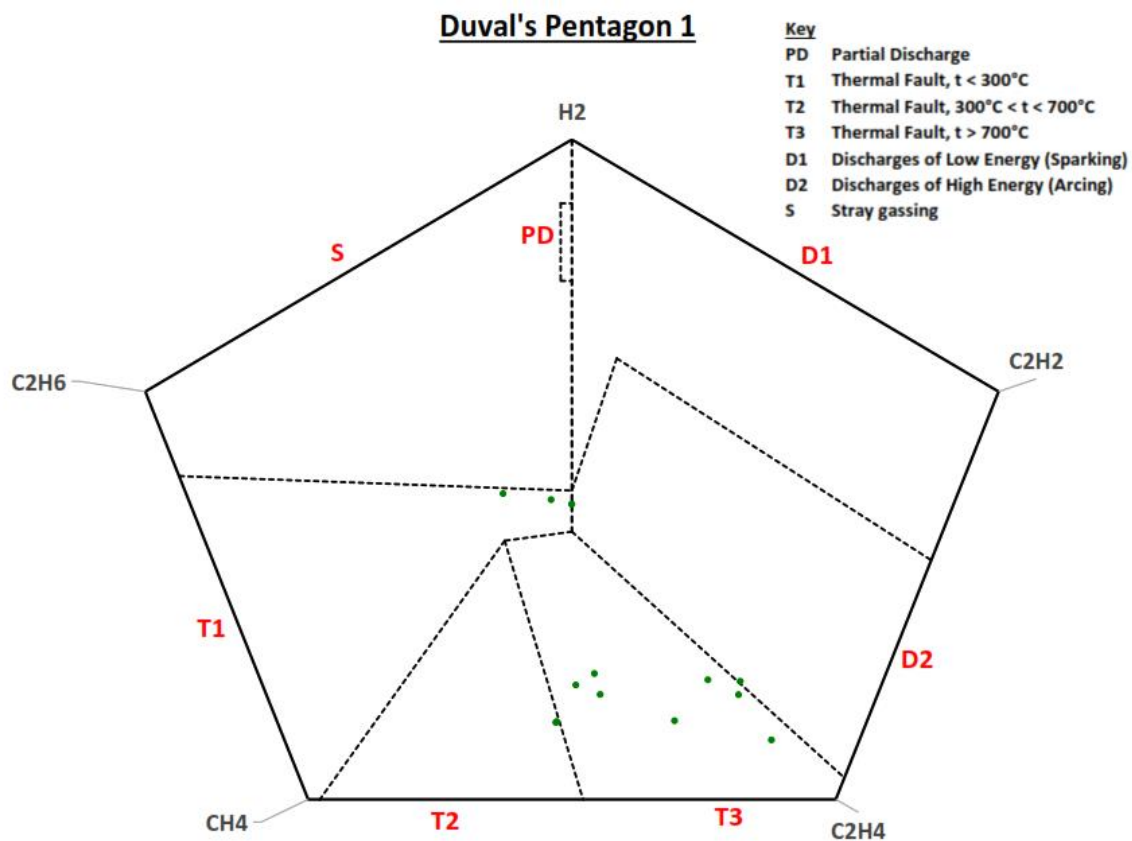
Figure 4-4: Case Study A - Duval's Pentagon 1 – Period 1

The Duval's Pentagon 1 for period 1 (Figure 4-4) indicated a T1 and T3 fault condition which suggests an overheating problem. The fault at T3 region is for temperatures greater than  $> 700^{\circ}\text{C}$ . Duval's Pentagon 1 Method diagnoses complemented by the diagnoses result from Duval's Triangle 1 on Figure 4-3 for Period 1 and Period 2.

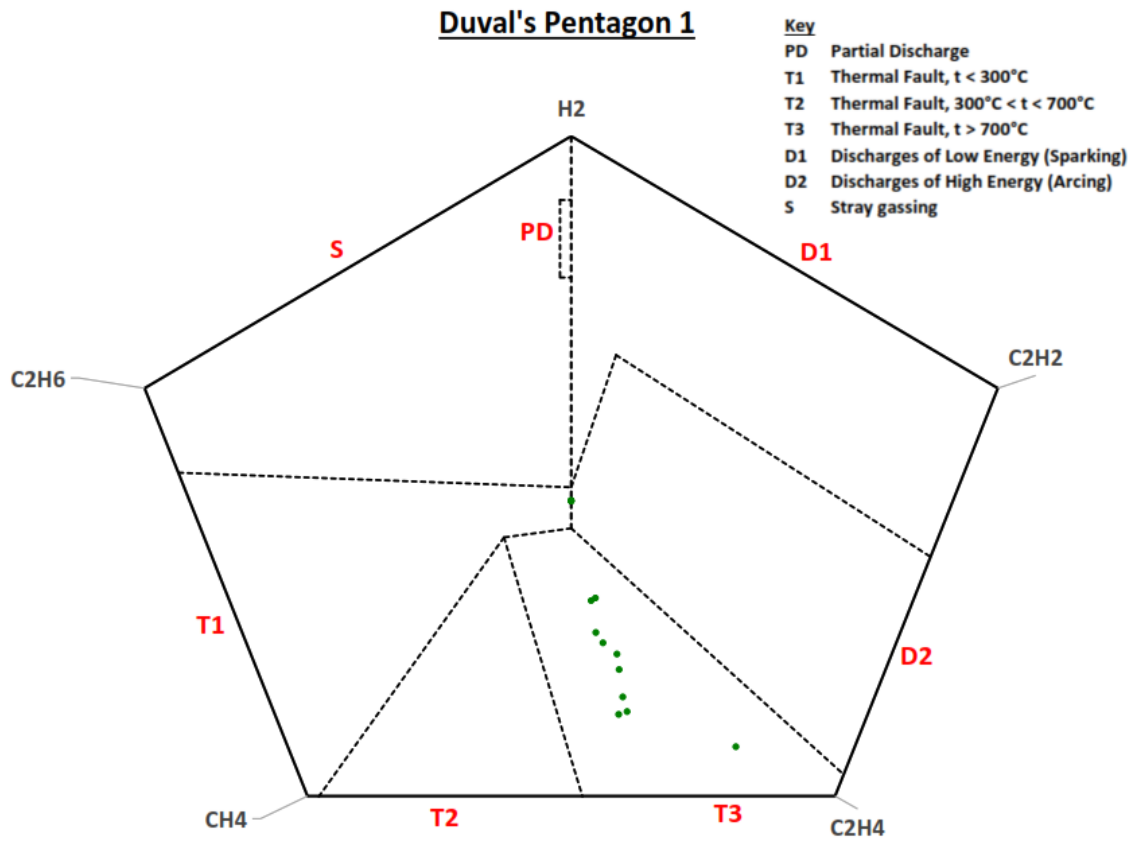
Figure 4-5: Case Study A - Duval's Pentagon 1 – Period 2

The Duval's Pentagon 1 for period 2 (Figure 4-5) indicated mainly a T3 fault condition which was in line with the Duval's Triangle 1 method.

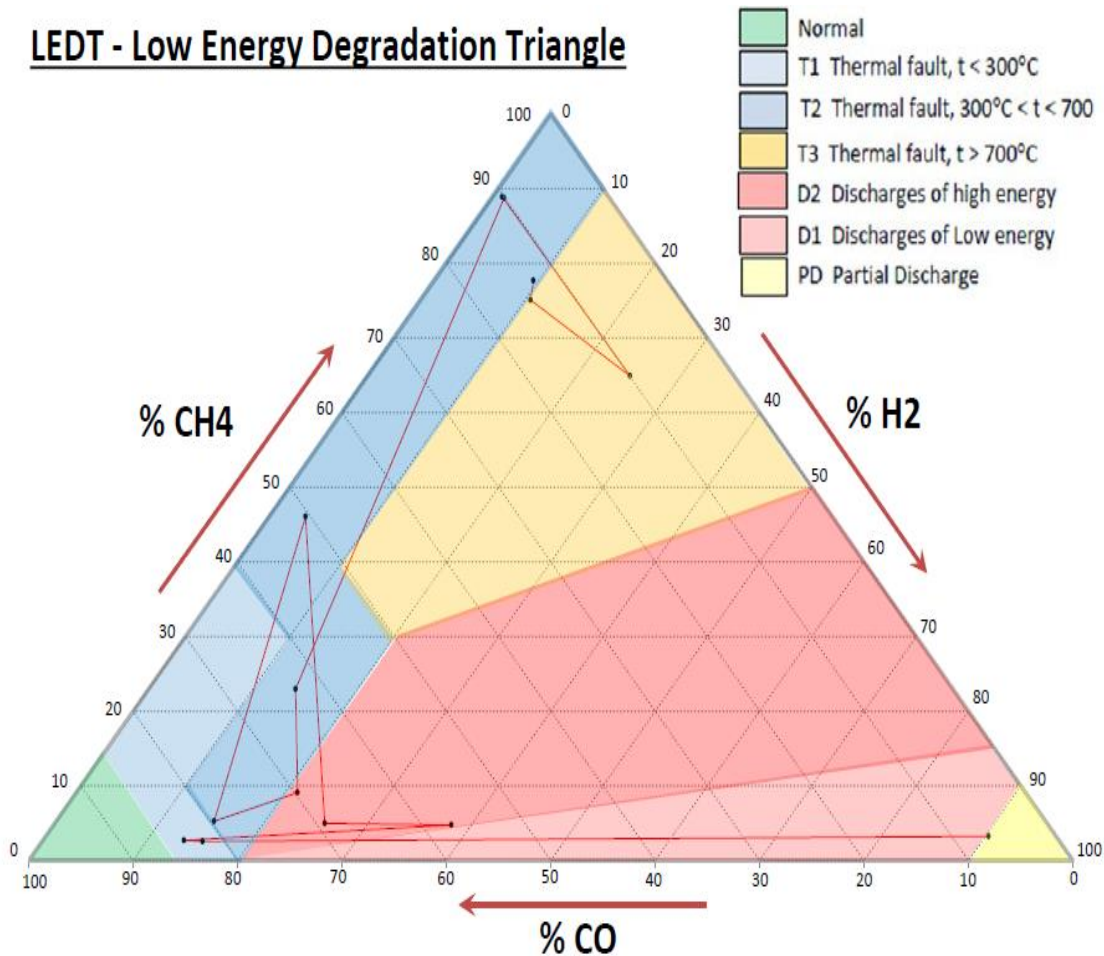
Figure 4-6: Case Study A - LEDT - Period 1

The LEDT is presented for two periods: before and after it was inspected in June 2013. The LEDT during Period 1 showed that this transformer probably had a defect on the active part before the first energization. The combustible gases escalated until the transformer was taken out from service.

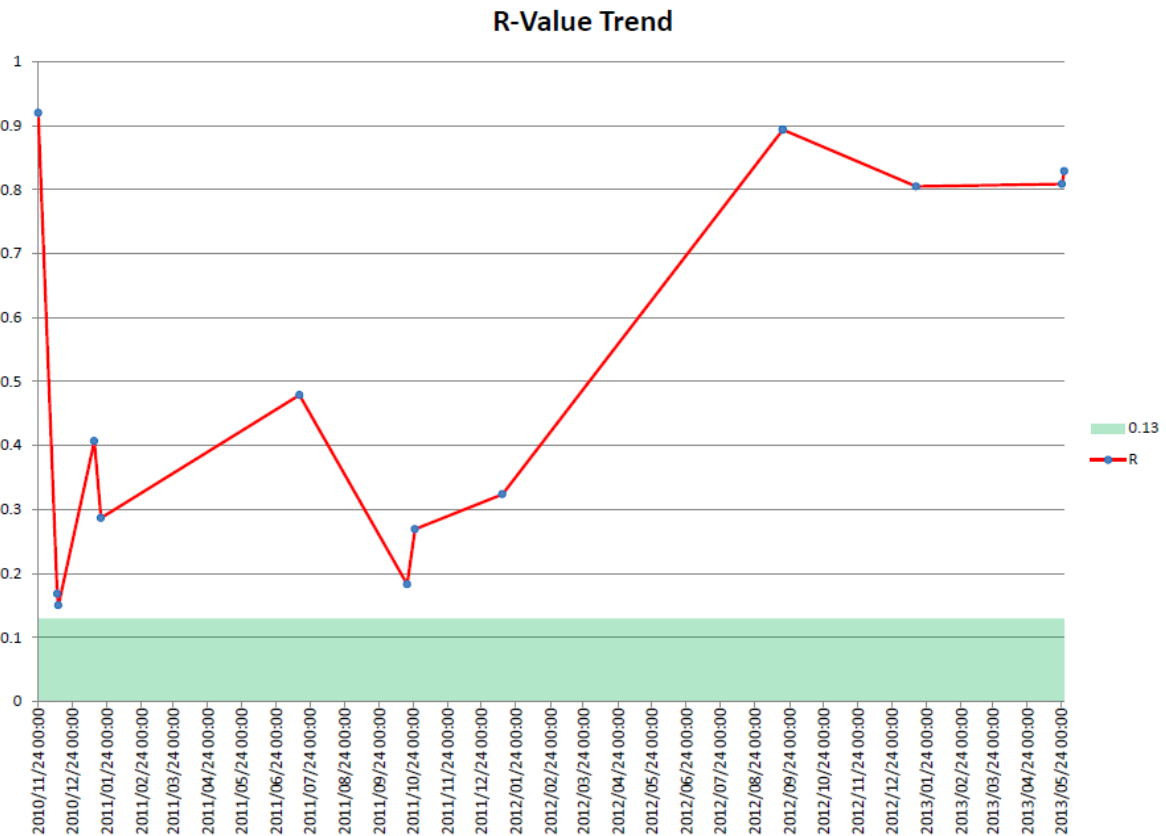
Figure 4-7: Case Study A - R-Value - Period 1

Figure 4-7 depicts the R-Value providing a clear trend of the fault development which was present from first commissioning.

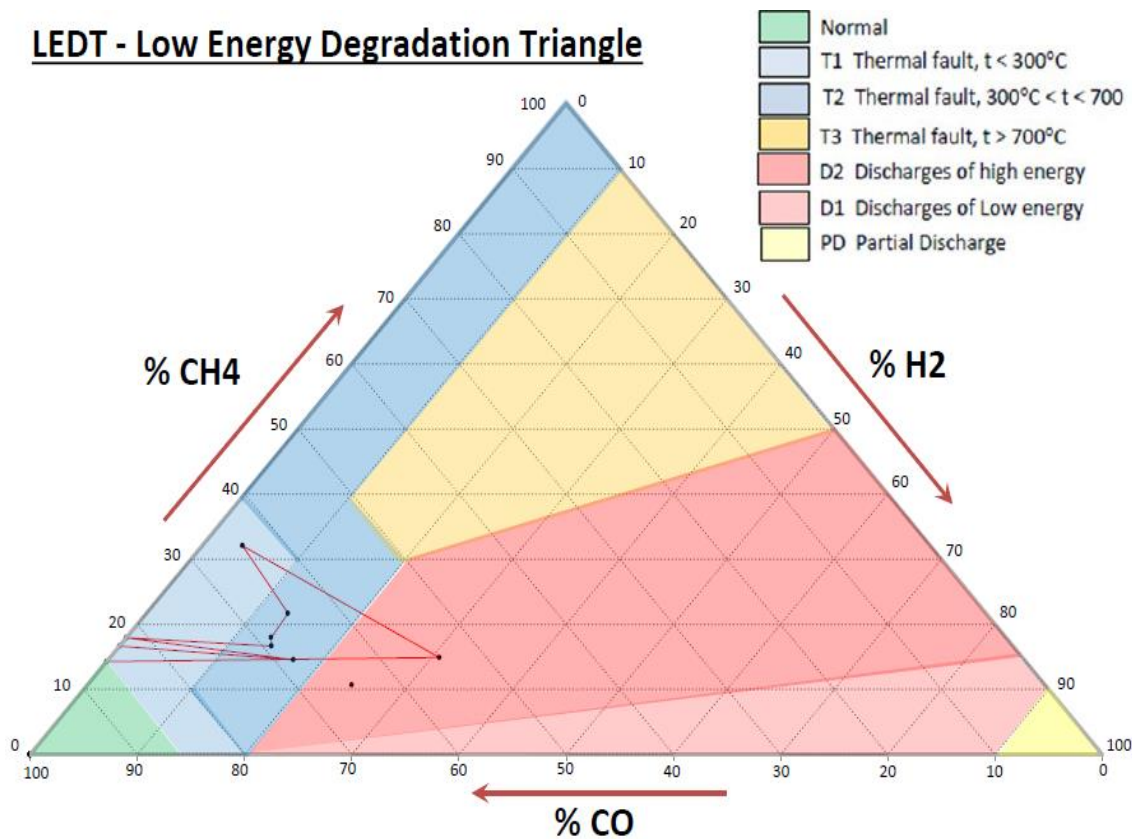
Figure 4-8: Case Study A - LEDT Period 2

fault immediately when to the T1 and T2 regions indicating a thermal fault with some discharges in oil.

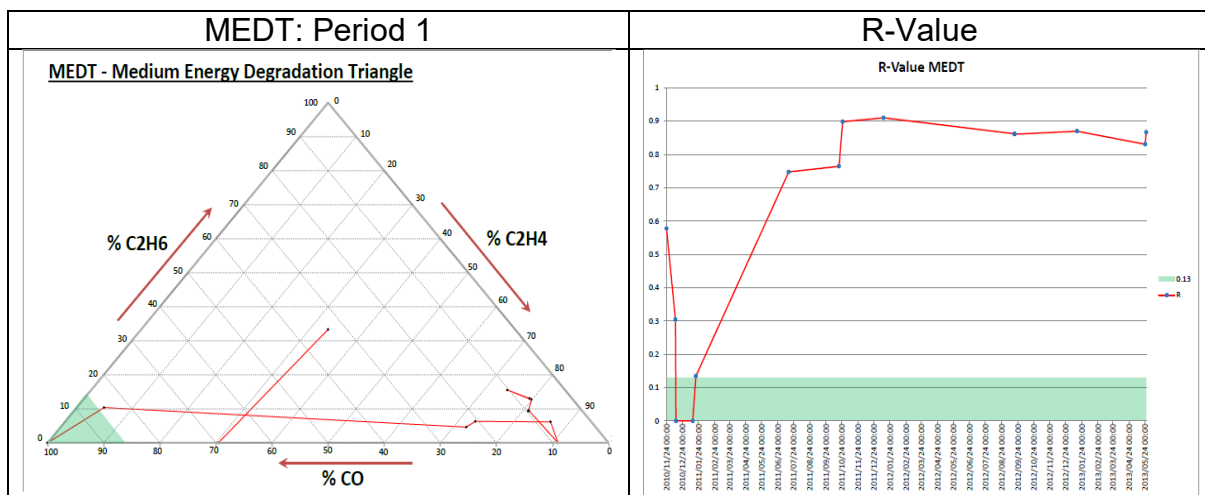
The MEDT for Period 1, as depicted in Figure 4-10, indicates a complementary diagnosis with that of the LEDT Period 1 diagnostic results. In December 2010, the transformer was taken out of service to perform 380V electrical tests.

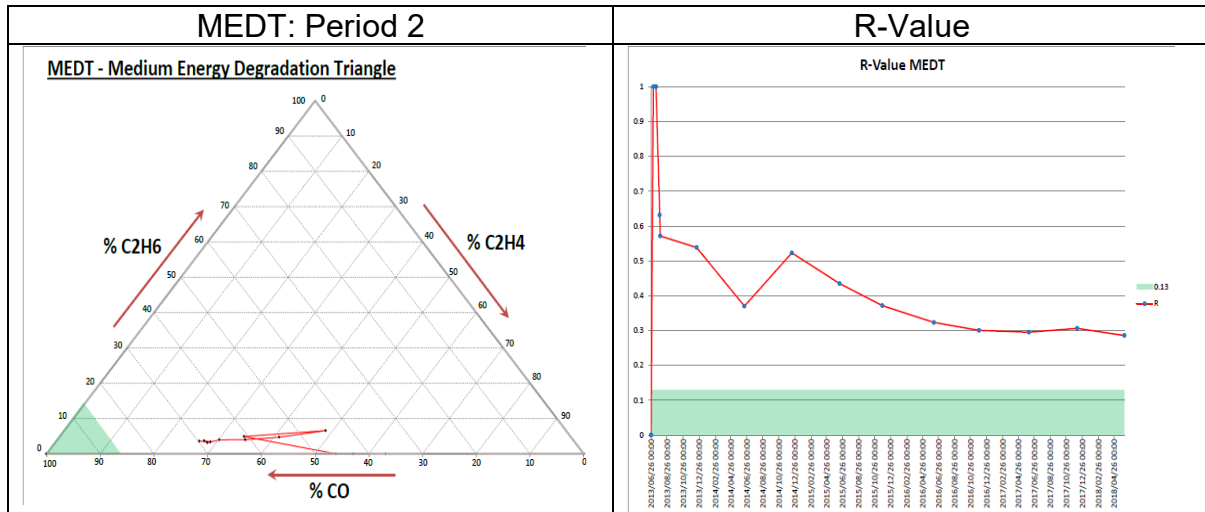
Figure 4-11: Case Study A - MEDT and R-Value - Period 2

thermal as confirmed by LEDT Period 2 (Figure 4-11) and Figure 4-12 showed discolouring signs on the failed component.

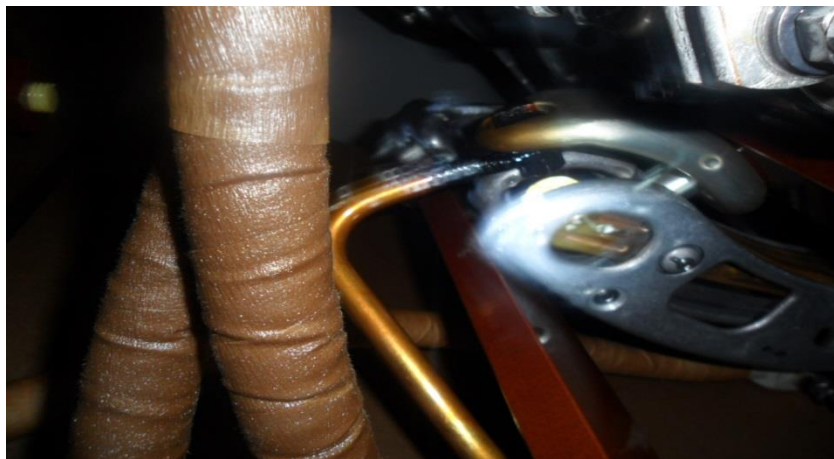
Figure 4-12: Signs of overheating on copper link A-phase selector switch

An internal inspection was conducted on the transmission substation transformer. Severe overheating was observed on the copper link on the tap-changer for the A-phase selector switch. See the damage component in Figure 4-12.

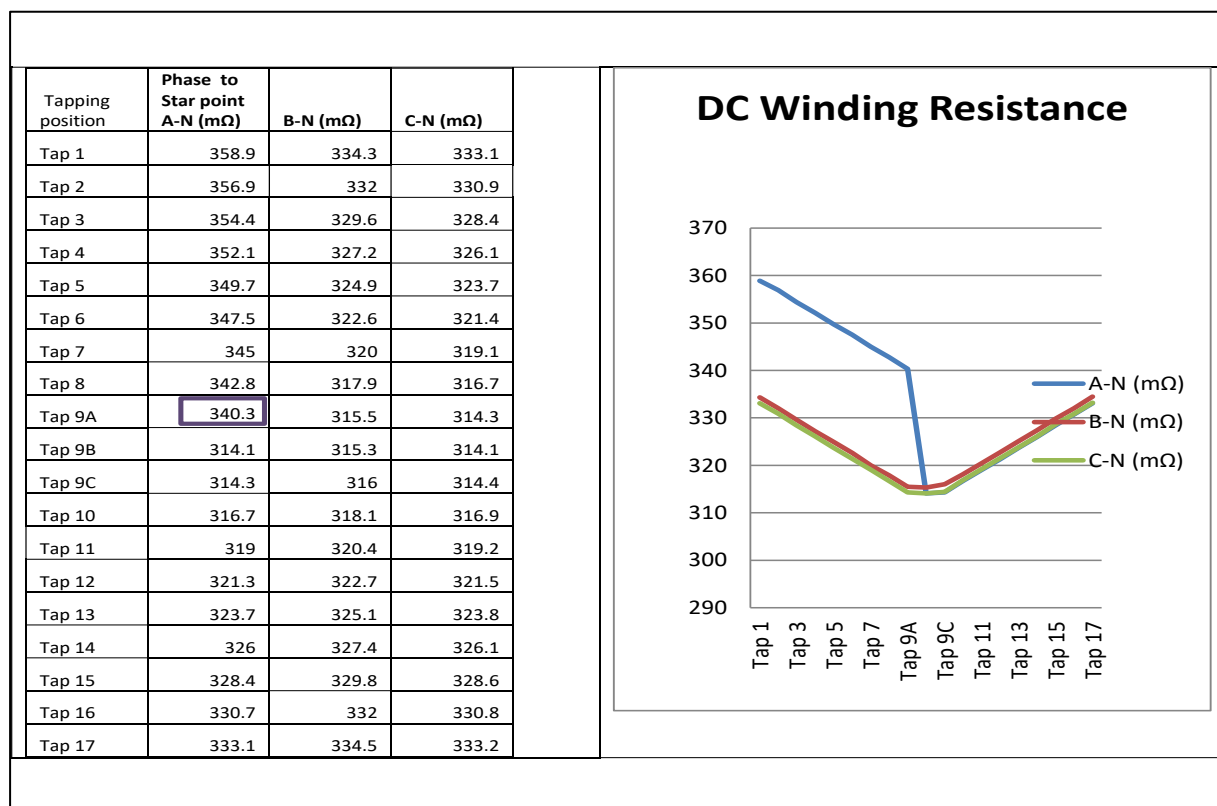
Figure 4-13: DC Winding Resistance results

deviations on the A-phase selector switch. Figure 4-13 shows the test results of the DC winding test that was performed before draining the oil from the transformer, the graph indicating the fault on the A-phase.

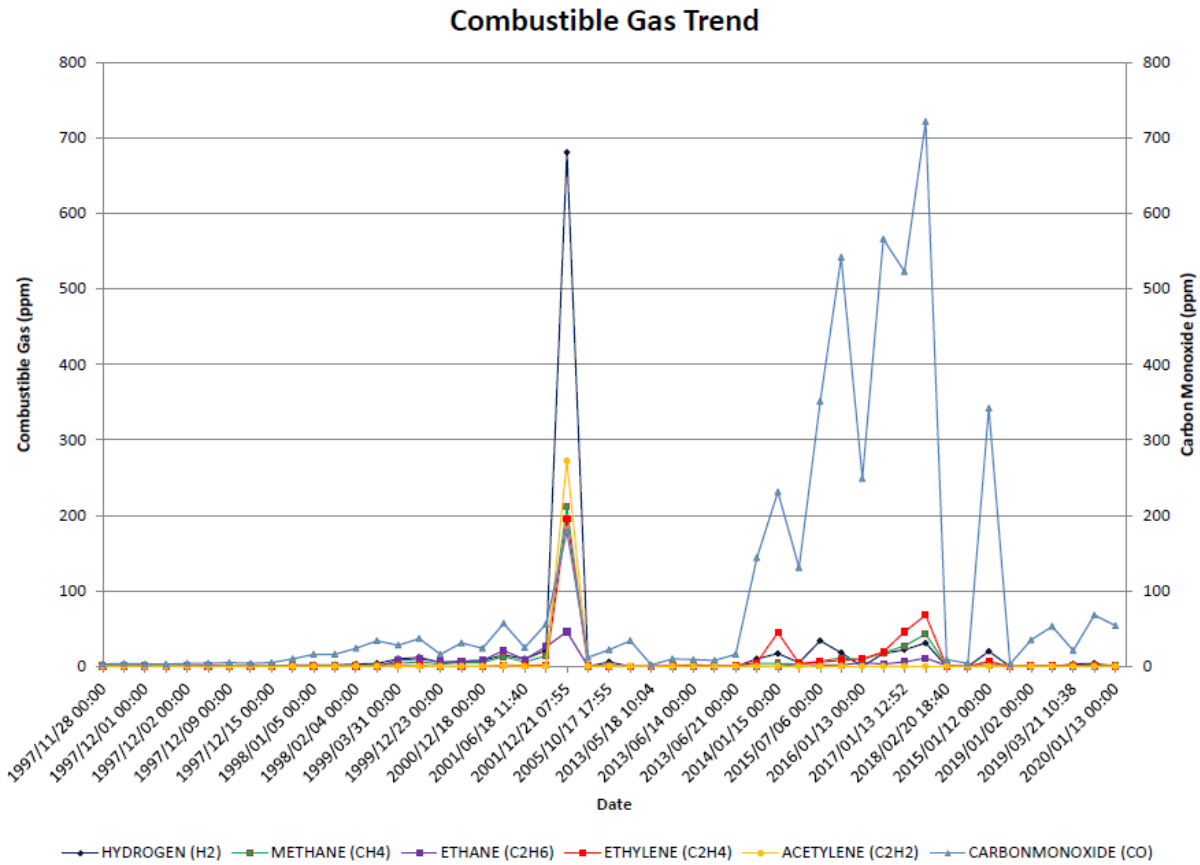
Figure 4-14: Case Study B - Combustible Gas Trend

Figure 4-14 provides a combustible gas trend of the dissolved gas results over the period when the transformer started operating on the network. The gas trend showed all intervention points when the transformer was on the outage and when the fault gases started to increase.

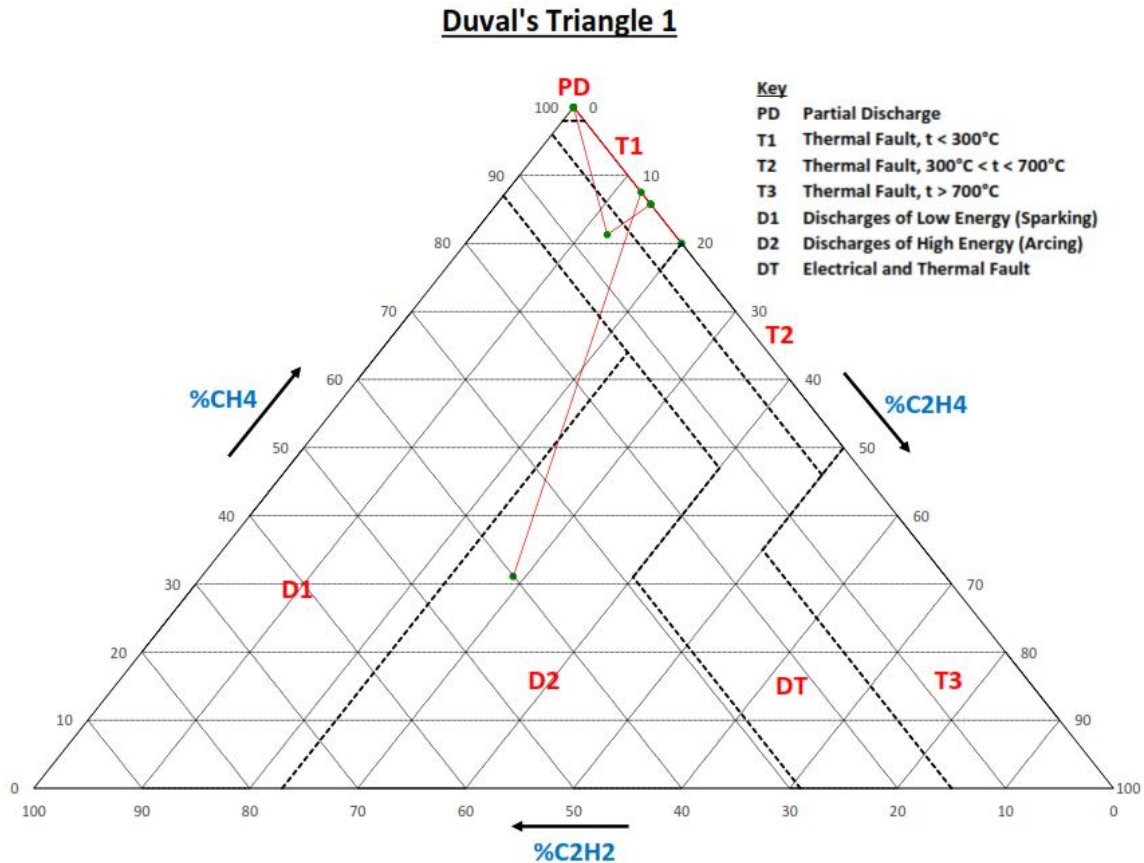
Figure 4-15: Case Study B - Duval's Triangle 1 - Period 1

Figure 4-15 provides the Duval's Triangle 1 for Period 1 where it is observed that the fault gas escalated from D2 high energy discharge zone to the PD and T1 region.

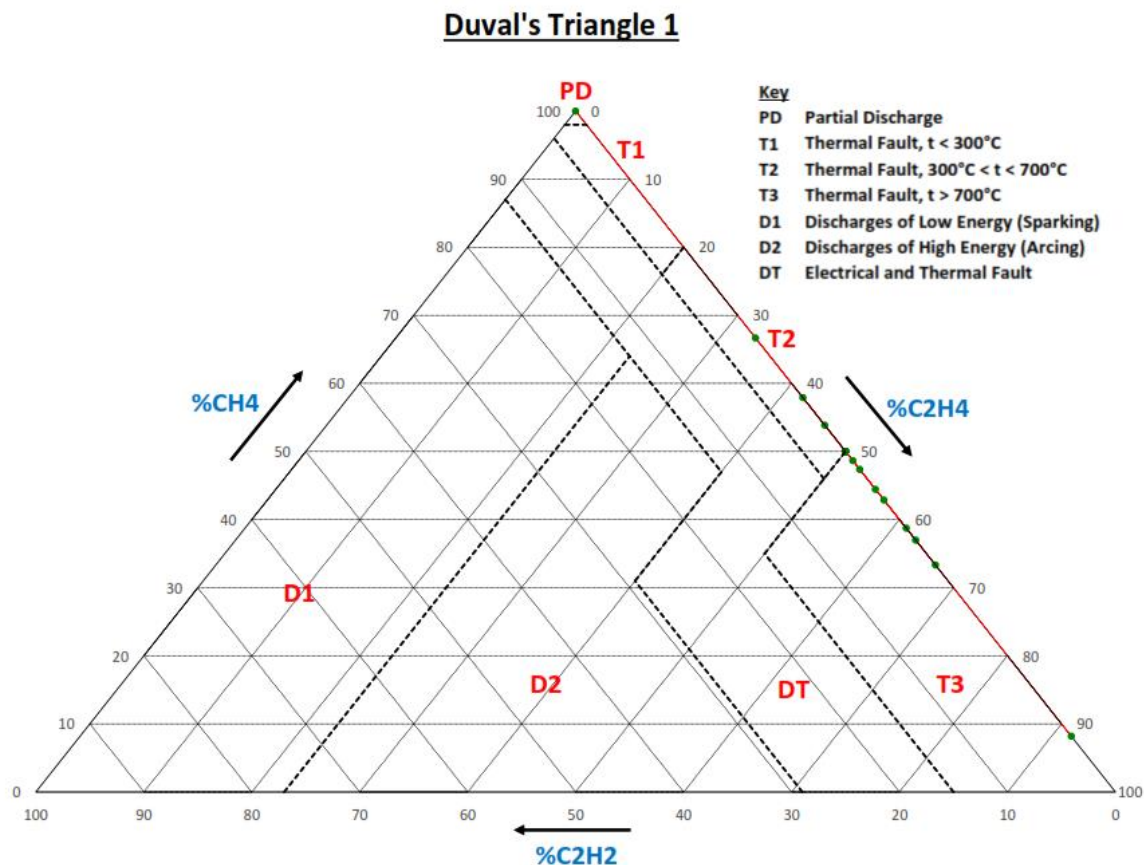
Figure 4-16: Case Study B - Duval's Triangle 1 - Period 2

Period 2 is reflected in Figure 4-16 with samples taken after the transformer was returned to service and the fault was repaired, however, it seems like the fault was not adequately resolved because fault gases appeared on PD zone to T3 fault zone.

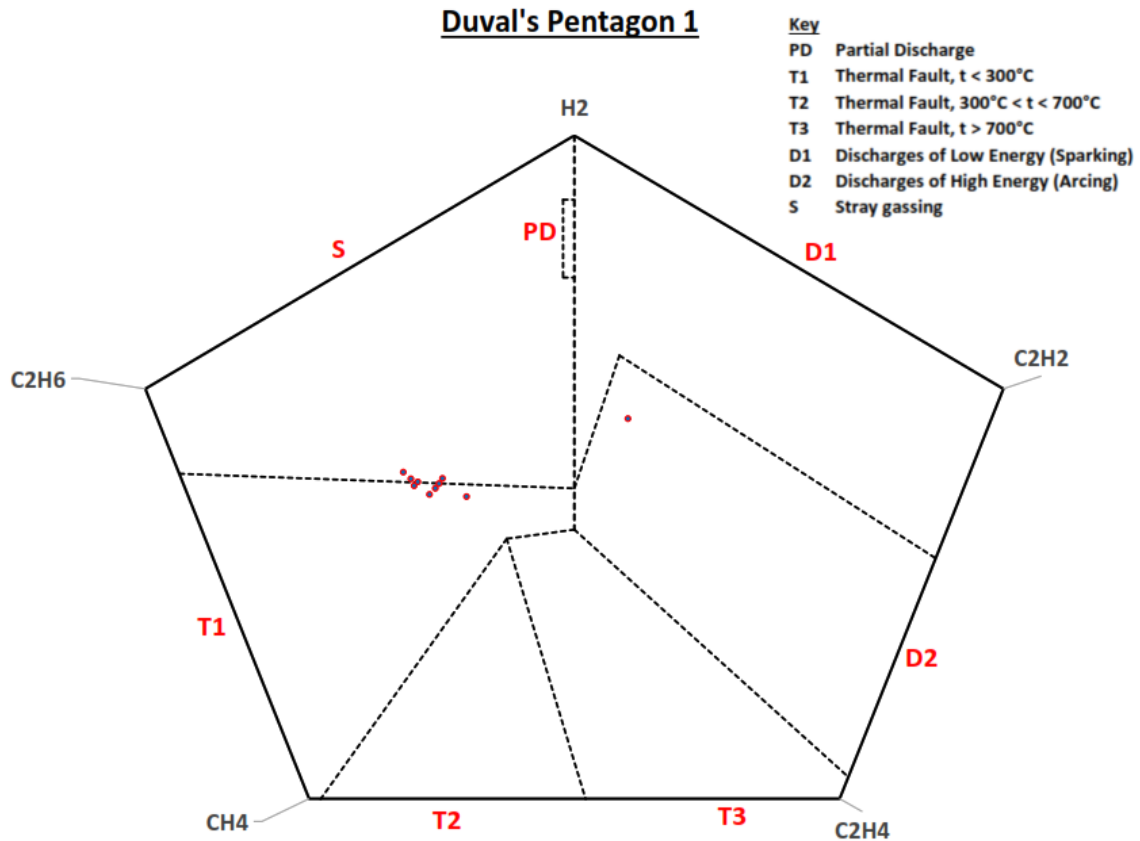
Figure 4-17: Case Study B - Duval's Pentagon 1- Period 1

The Duval's pentagons in this case study, in Figure 4-17, indicated that this transformer has a T1 overheating problem. Duval's Triangle 1 and Duval's Pentagon 1 complement each other on the diagnoses results for this case study.

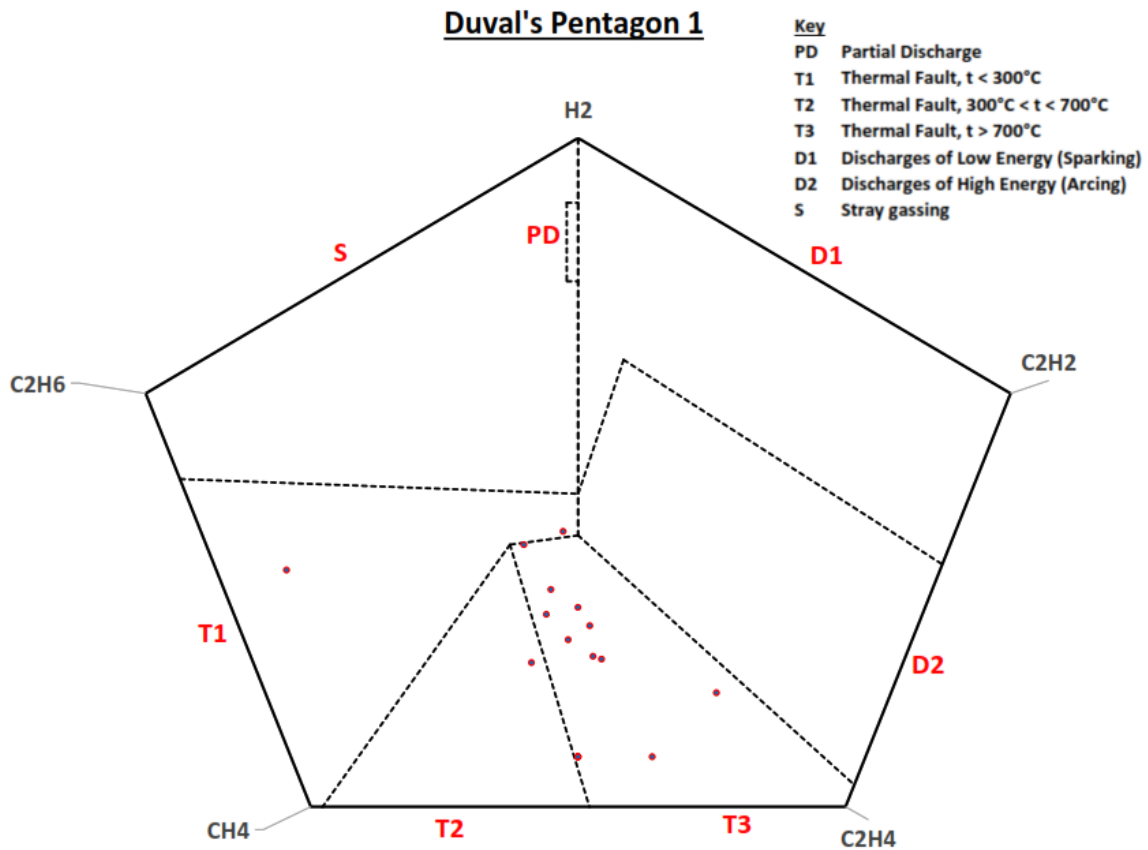
Figure 4-18: Case Study B - Duval's Pentagon 1- Period 2

Figure 4-18 is the Duval's Pentagon 1 for period 2. This indicates a progression from T1 to T3 fault where the fault is greater than  $> 700^{\circ}\text{C}$ . It is also identified that the Duval's Triangle 1 and Duval's Pentagon 1 complement each other on the diagnoses results for this case study.

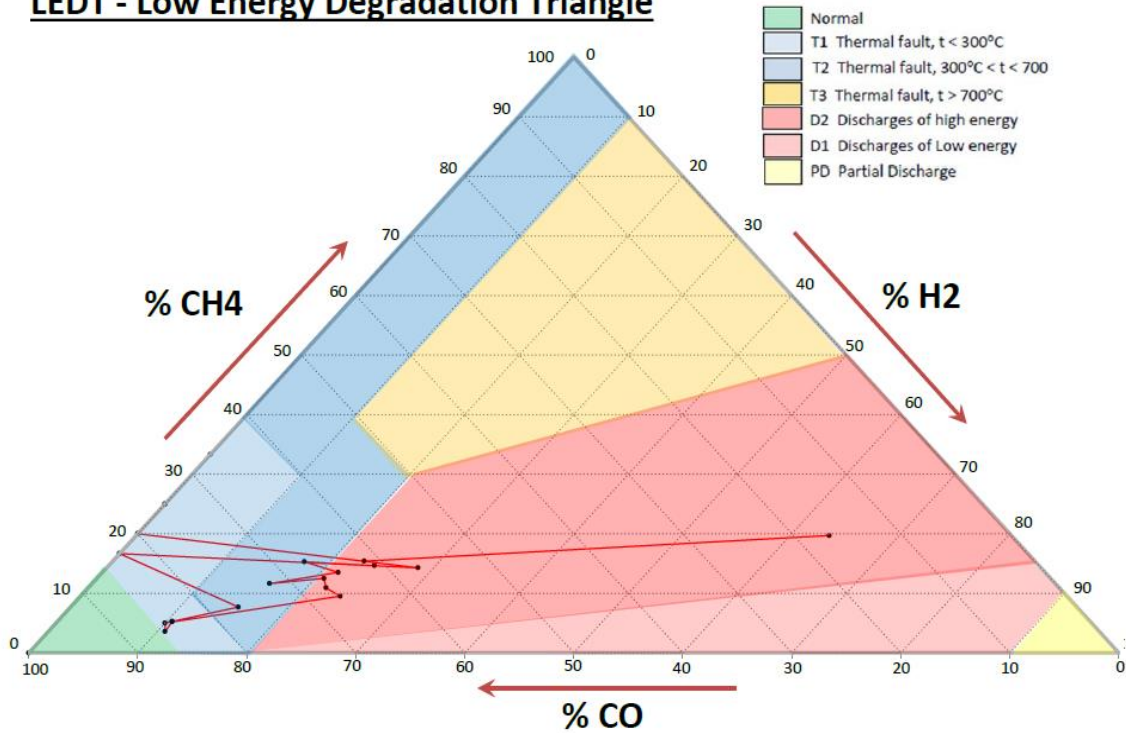
**Figure 4-19: Case Study B - LEDT Period 1**

LEDT Period 1 indicated thermal faults started at low thermal fault T1 and escalated to medium thermal fault T2 with the transition of thermal/electrical discharges D2 zone. The R-Value trend complemented this diagnosis results with time escalation of this period until the transformer was taken out of service.
