# **Condition Assessment Using Dissolved Gas Analysis on Transmission Power Transformers**

**MSc (Eng) Thesis**

**Prepared by: Mphikiseni Michael Ngubane**

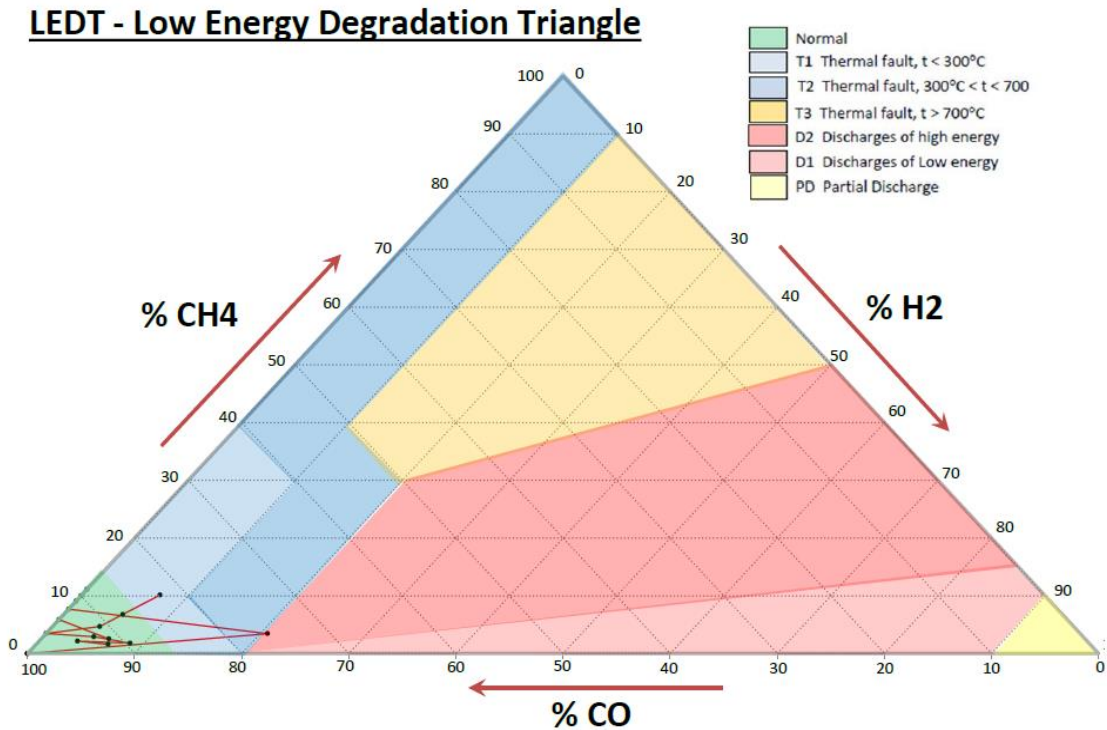
Figure 4-21: Case Study B - LEDT - Period 2

The LEDT for Period 2 although mostly in the green region indicated some movement towards the abnormal regions of thermal T1 and discharges D2. This provides some evidence that although the transformer was repair there was still a problem present.

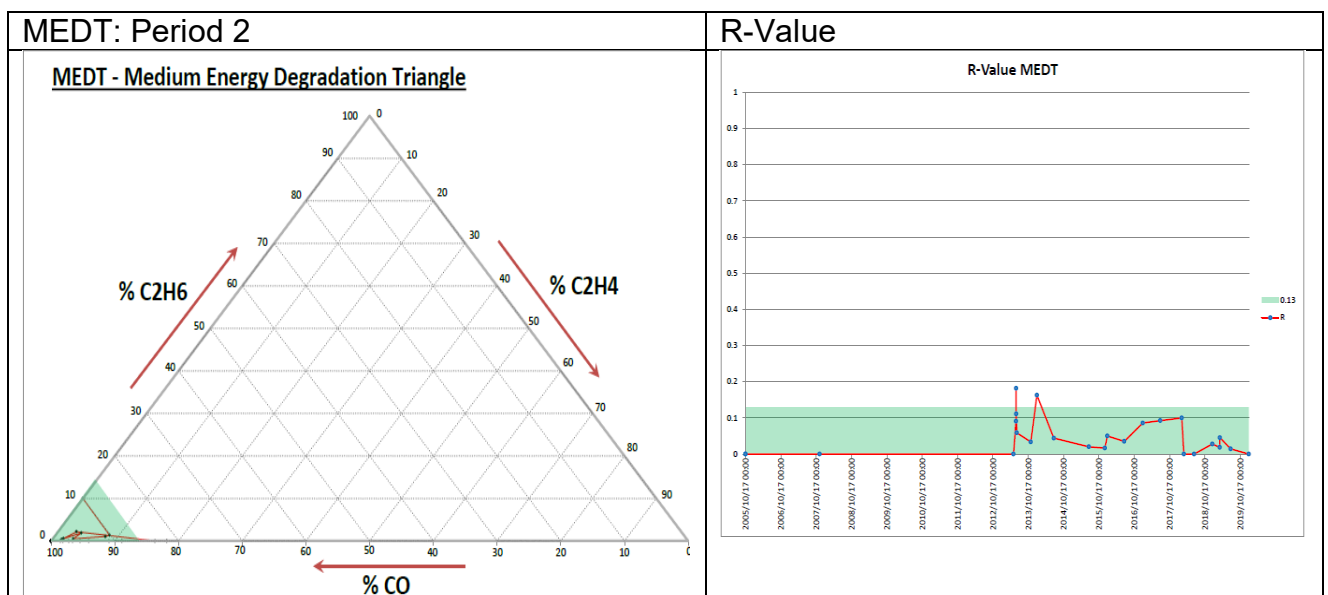
Figure 4-24: Case Study B - MEDT and R-Value - Period 2

The MEDT for Period 2 (Figure 4-24) also indicated some activity within the normal region with an increasing trend indicating medium energy discharges or heating. is the perfect complement to the LEDT method in terms of showing the fault direction in the transformer.

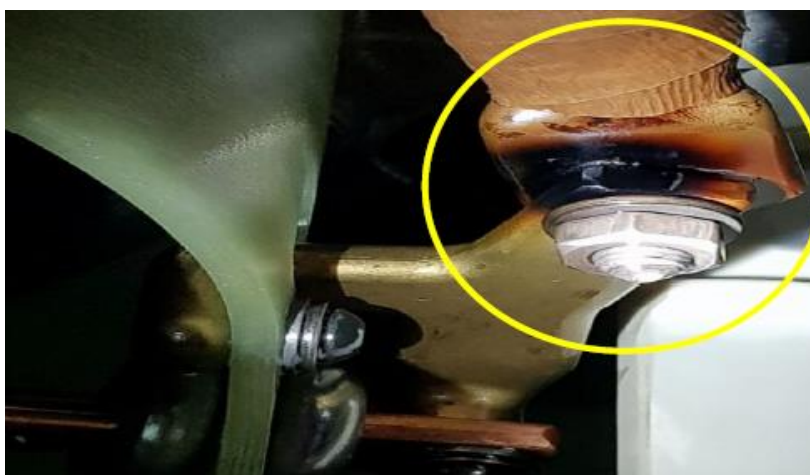
**Figure 4-25: Overheating on changeover connection**

The internal inspection on the transformer indicated signs of overheating on the connection of the current collector on the tap-changer for the blue-phase selector switch and no lock nut was observed on the bolt, which caused the problem of high resistance. See the damaged component in Figure 4-25.

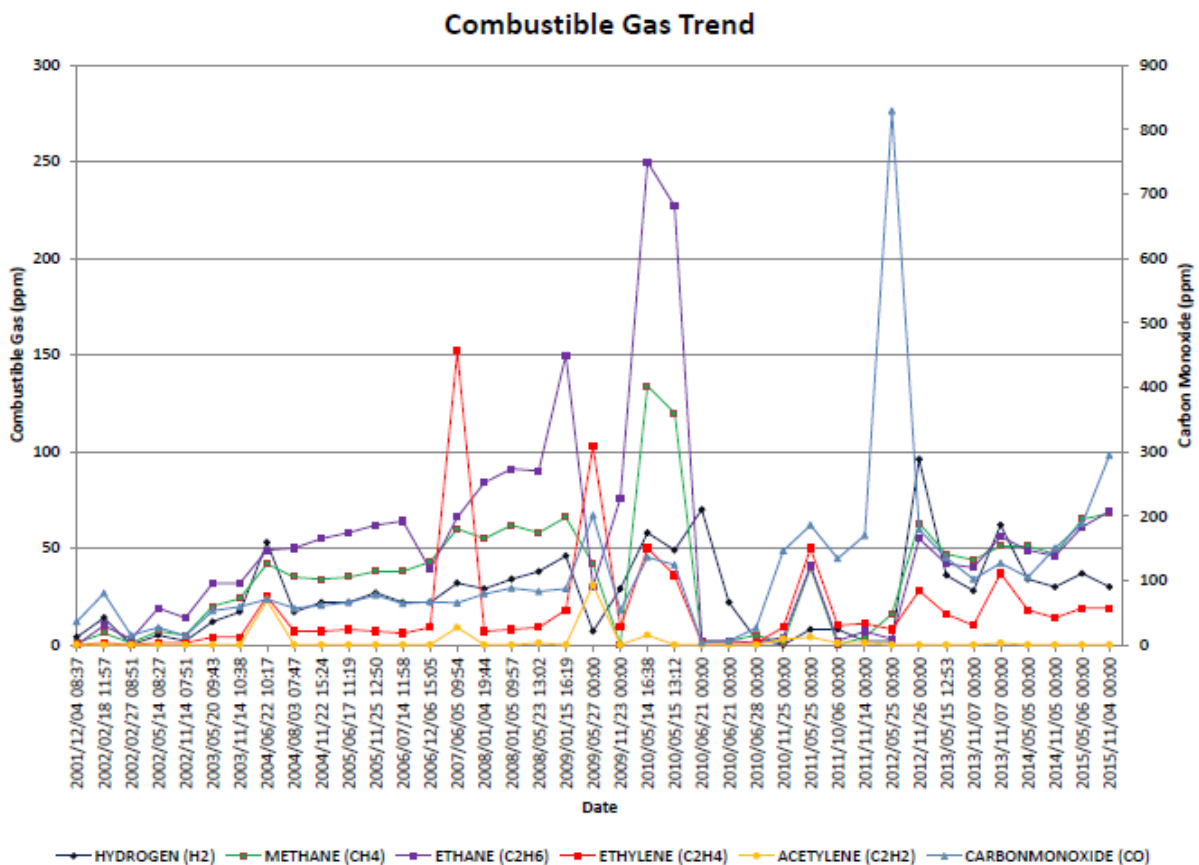
Figure 4-26: Case Study C - Combustible Gas Trend

The transformer was put back into service in 2012 where the combustible gases started increasing again but at the acceptable level except for carbon monoxide which continued escalating. The combustible gases were fluctuating due to the reduced loading (304MVA) of the transformer up until the transformer failed on the 15 November 2015.

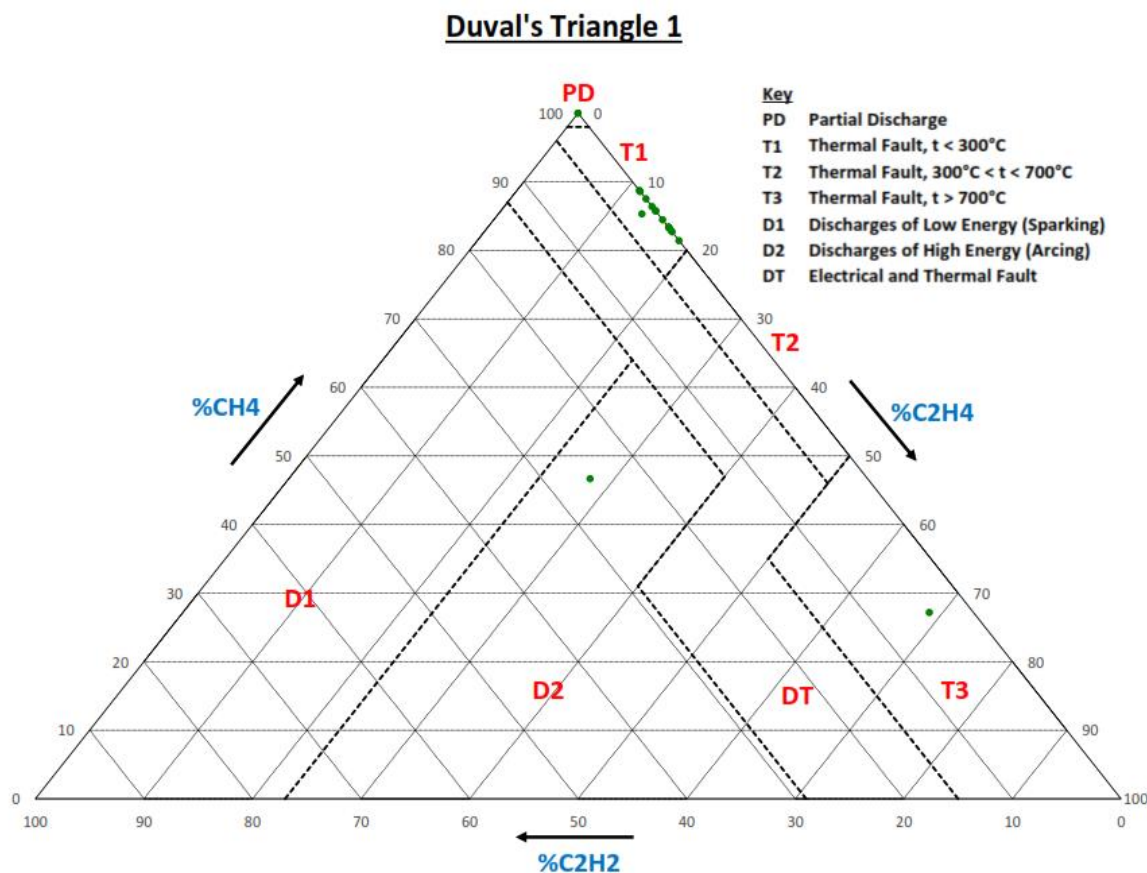
Figure 4-27: Case Study C - Duval's Triangle 1 - Period 1

Duval's Triangle 1 method on Period 1 (Figure 4-27) indicated that the fault started by discharging at low temperatures. The combustible gases then moved towards T3 which is a thermal fault greater than 700°C meaning that there was severe overheating in the transformer.

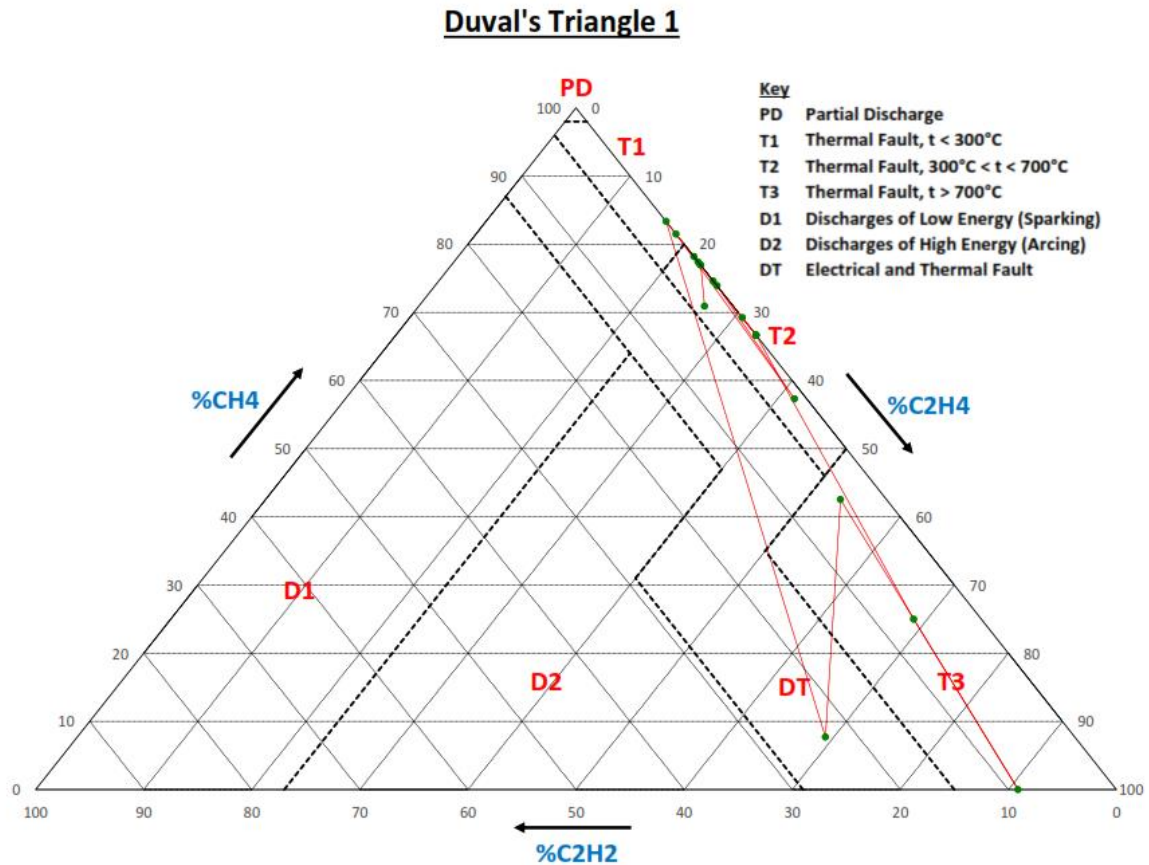
Figure 4-28: Case Study C - Duval's Triangle 1 - Period 2

In Period 2 (Figure 4-28), Duval's Triangle 1 indicated that the combustible gases detected fault at T2 and escalated to T3. Duval's Triangle 1 showed the fault escalated to DT zone where the transition of thermal and electrical fault occurred and on DT zone where the transition fault caused the transformer failure.

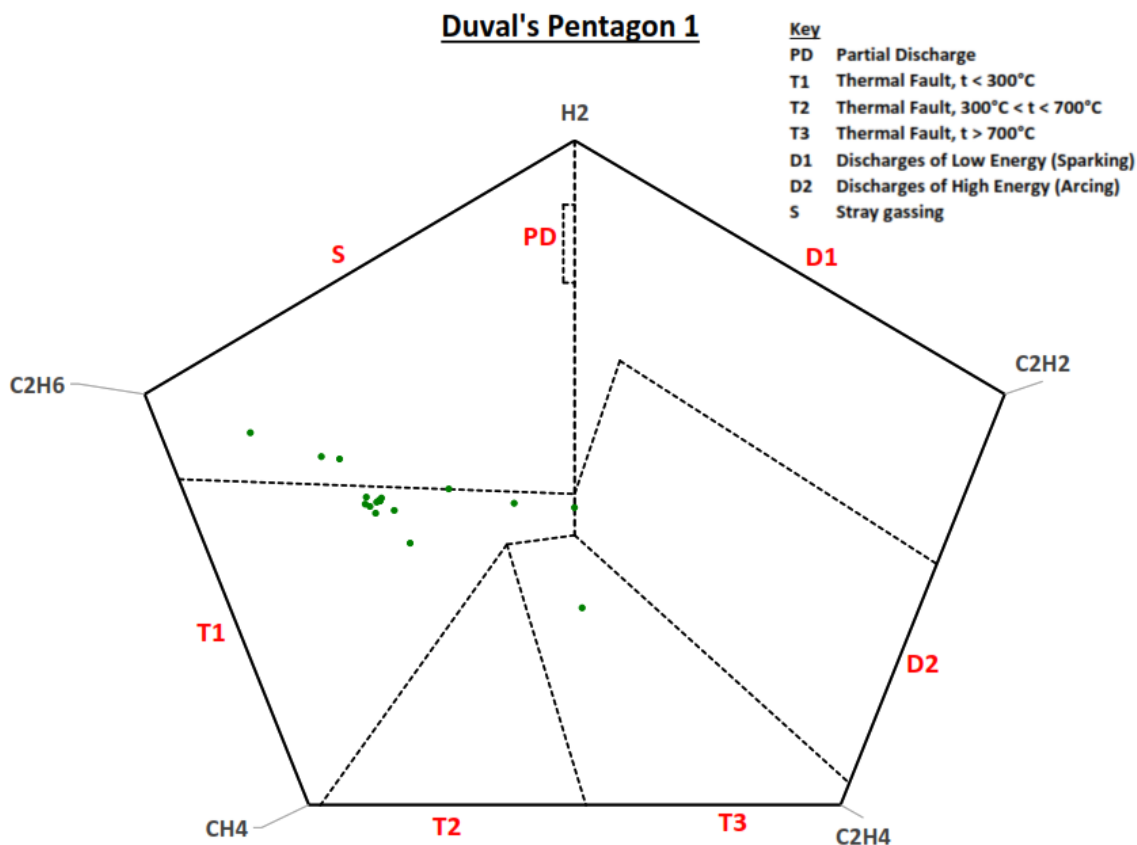
Figure 4-29: Case Study C - Duval's Pentagon 1 - Period 1

This method (Figure 4-29) detected the fault gases from low temperature mainly in the T1 region. The diagnose results were similar with the fault result from Duval's Triangle 1 except Duval's Pentagon 1 does not have DT zone where it showed the mixture of two different types of which was thermal and electrical fault.

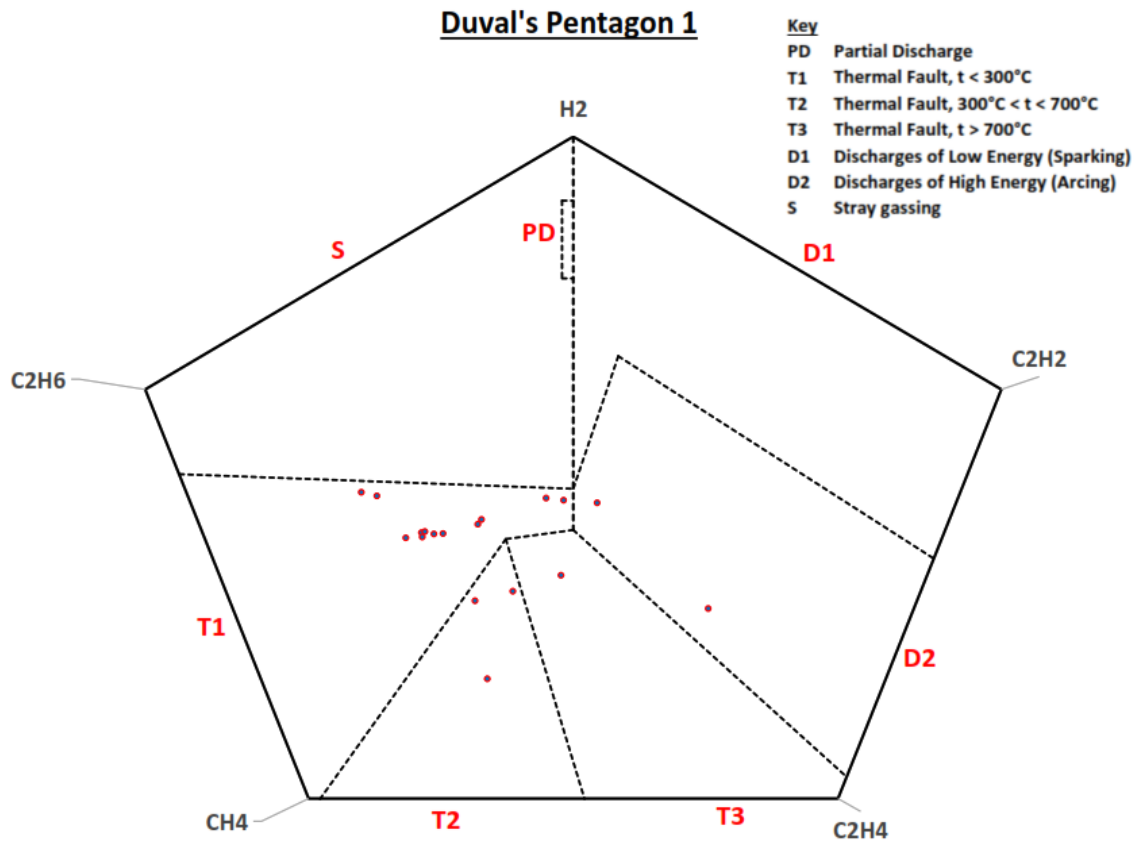
Figure 4-30: Case Study C - Duval's Pentagon 1 - Period 2

Period 2 (Figure 4-30) indicates the fault in the T1 region and progression to the T2 and T3 regions. The diagnose results were similar with the fault result from Duval's Triangle 1 except Duval's Pentagon 1 does not have DT zone where it showed the mixture of two different types of which was thermal and electrical fault.

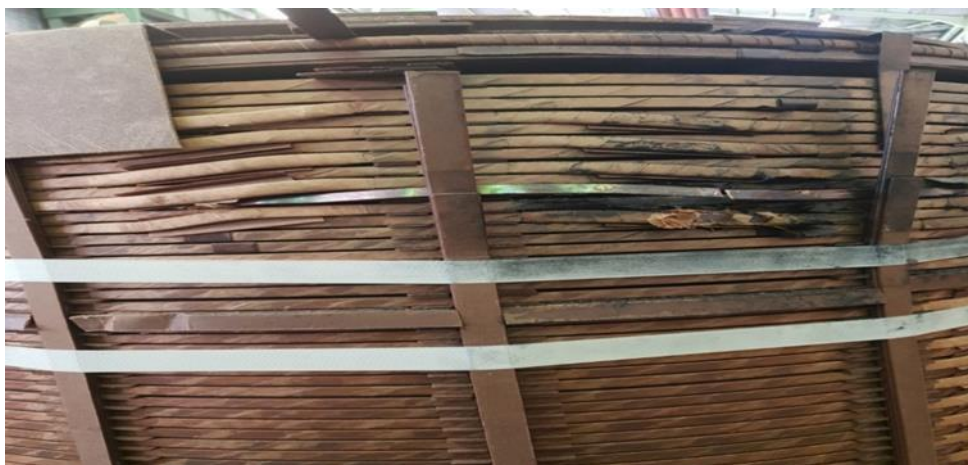
Figure 4-47: Faulted HV Winding

The internal investigation was undertaken at the distribution substation identified a damaged disc winding on the white phase HV winding as picture in Figure 4-47. Furthermore, the copper of the winding had corrosive sulphur discolouration. When the transformer electrical was tested on-site, DC winding test results failed.

Both Duval's Triangle 1 and LEDT Method shows two T2 results medium thermal fault and high energy discharge D2 result zone. Whereas Duval's Pentagon 1 shows normal state result escalated to medium thermal fault T2 zone.

In this case study, the Roger's and Doernenburg ratios do not offer a consistent interpretation of the degradation or its trend. The Duval's Triangle 1 and pentagon indicate a trend in the type of damage occurring, but there is no indication of time. The LEDT and MEDT (each with R) indicate time-trends of different types of degradation, which can give an early indication of a problem and aid inspection. Duval's Pentagon 1, LEDT Method 1 and Duval's Triangle 1 all showed that they complementary each other with their diagnose results and all started at PD zone and end at high energy discharge zone.

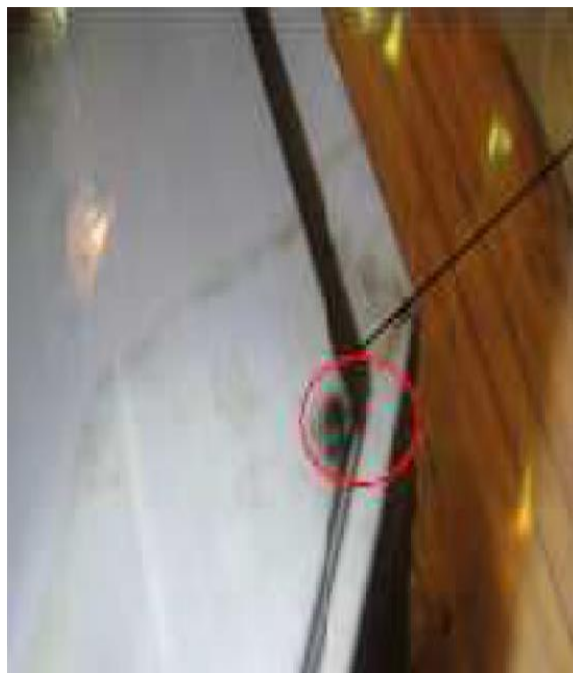
**Figure 4-54: Short lamination on return limb**

A visual inspection was undertaken at the transmission substation before an internal inspection was carried out. Externally, closed cooler banks were observed and internally damage components were also observed. See Figure 4-54 and Figure 4-55 respectively. The defects observed were in line with the gas pattern that was elevated in the shunt reactor from first commissioned. LEDT Method1 complementary the diagnose results from Duval’s Pentagon 1. Their fault gas started from normal zone to low temperature rate. However, Duval’s Triangle 1 and Roger’s Ratio does not detect the fault at low temperature as mentioned at IEEE C57.104-2008 guidelines and they started at PD discharge zone.

The root cause was loose nuts from the shunt and the thermal fault started led the elevation of the fault to partial discharge.

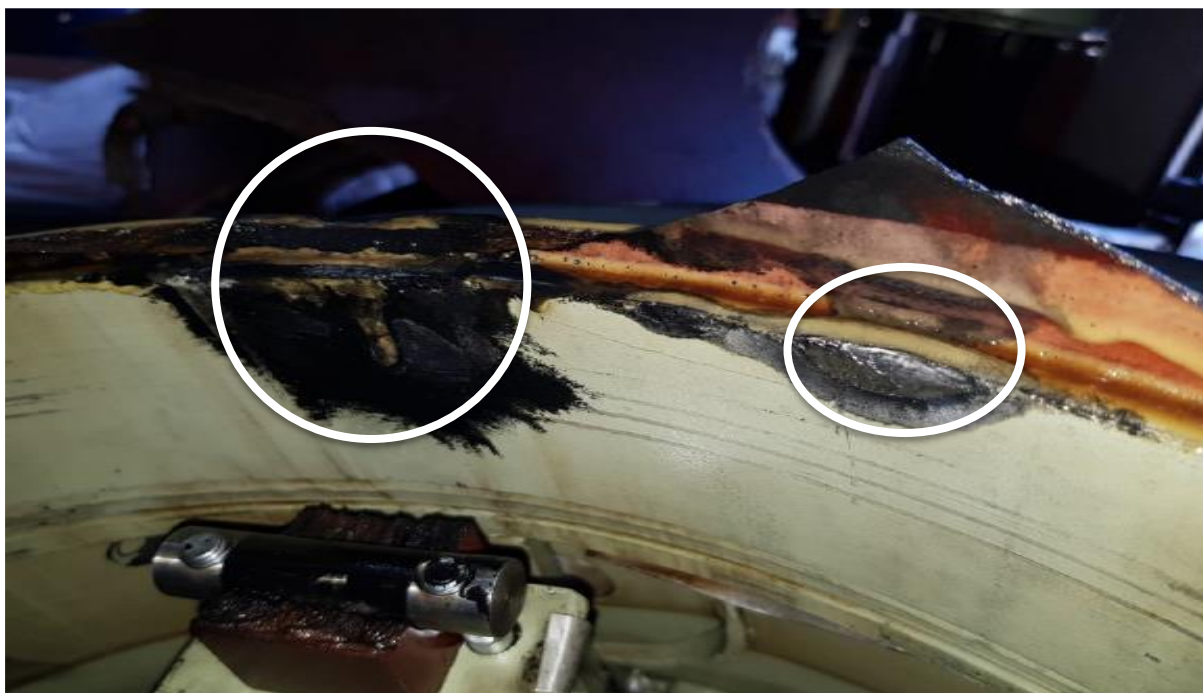
**Figure 4-62: Damaged tap changer barrel**

During an internal investigation, many active components were found damaged inside the transformer tank. Figure 4-62 indicated the severe arc mark on the base of the tap changer barrel. The failure of this transformer was unexpected. The root cause of failure for this transformer was given as the end of life, concluding that the failure was first mechanical, and clearance compromised and electrically arced to another potential different component.

This transformer did not show any sign of unhealthy before it failed, however, the DGA pattern was indicating the low energy thermal fault. It is, therefore, concluded that the failure of this transformer was sudden and unexpected.

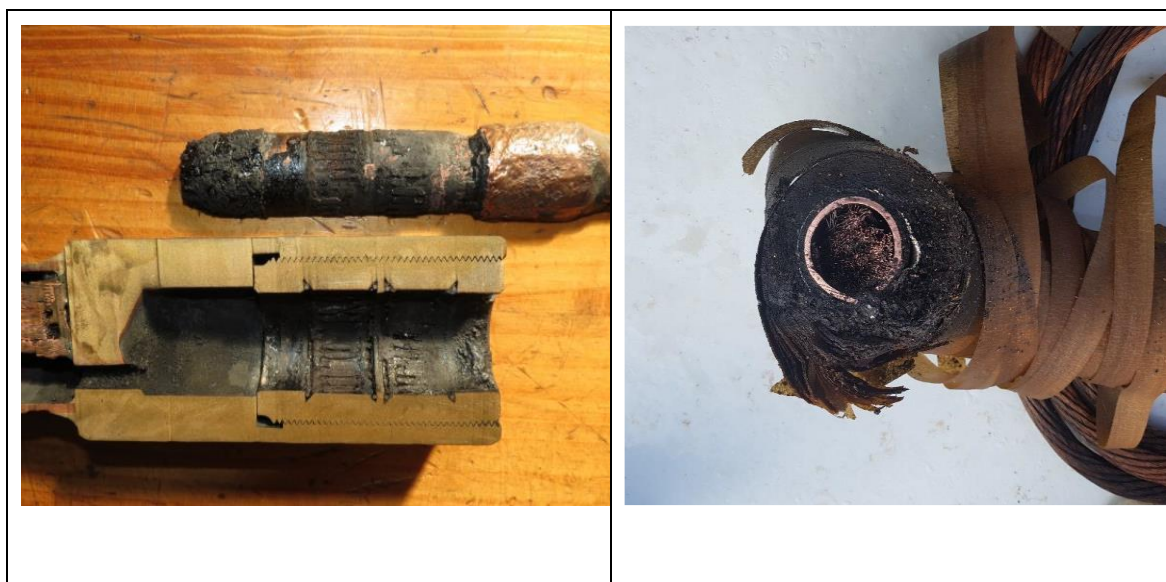
**Figure 4-69: Centre fed lead (400 kV)**

From the internal inspection conducted in the transmission substation there was evidence of severe overheating on the 400kV HV lead and burnt paper insulation on the HV lead joints were observed. See the damaged component in Figure 4-69.

One explanation for the low gassing levels, considering the type of fault, was because the lead was heavily insulated with paper which may have restricted the gas diffusion into the oil. Another possible reason the hydrocarbons remained low is the fact that there was not much mineral oil to burn around the lead, except the tiny film between the first layer of paper and the copper body and the one absorbed in the paper.
