**Power Transformer Health Assessment
Derived From Low Energy and Dissolved Parameters**

**N Moodley Pr. Eng.
University of Cape Town**

**Department of Electrical Engineering
University of Cape Town**

A Thesis submitted to the Faculty of Engineering and the Built Environment in fulfilment of the requirements for the degree of Doctor of Philosophy in Engineering

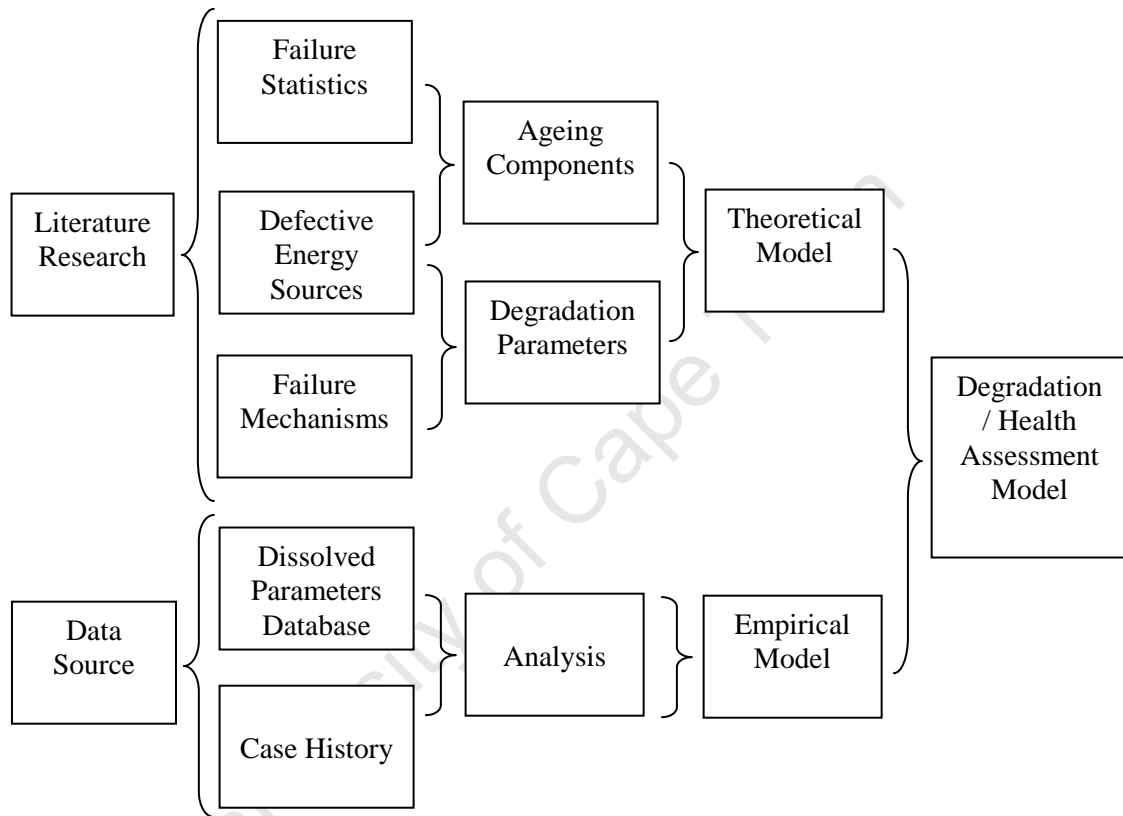
Figure 1-1: Study Methodology

Figure 1-1 provides a diagrammatic overview of the structure of this study. Literature research forms the basis of the first part of the study, which starts with the general research on transformer health and failure statistics of transformers around the world and within South Africa. From this research, a baseline is formed on the failure mechanisms, types of faults and ageing trends that are used for the health assessment model.

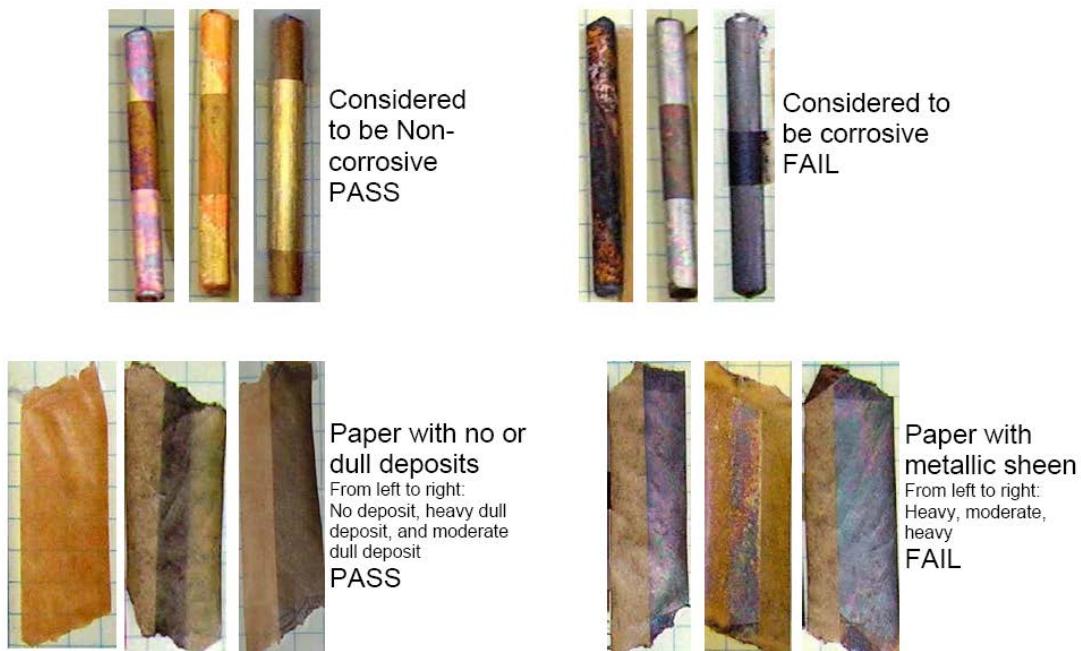
Figure 3-2: Copper Rods and Kraft paper insulation after testing [Lewand1]

This process does not usually result in the production of fault gases and thus failure is unexpected and virtually undetectable. Copper sulphide production has been found to be a localised phenomenon.

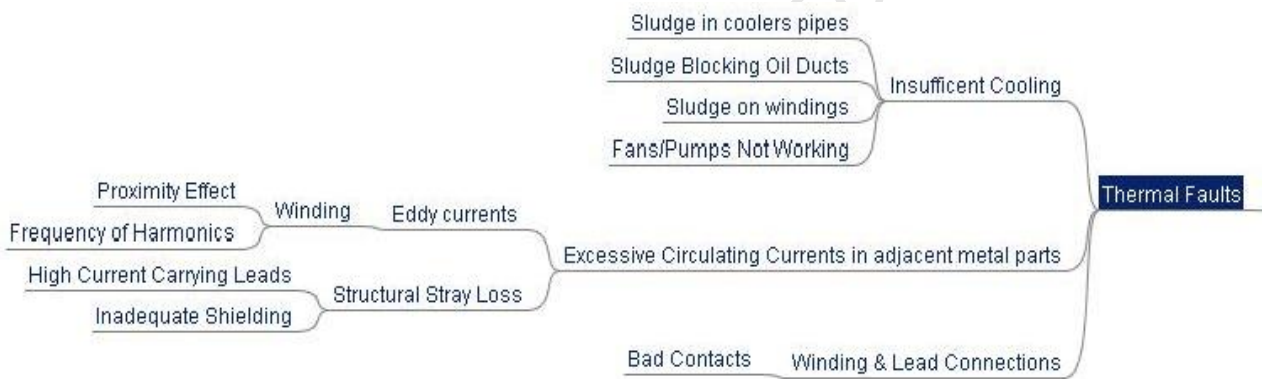
Figure 3-5: Origin of Thermal Faults in Power Transformers

Thermal faults are as a result of a build-up of defective energy levels in a contained area or from the transfer of elevated levels of energy across a medium. IEC 60599 defines a thermal fault as an excessive temperature rise in the insulation caused typically by insufficient cooling, excessive circulating currents in adjacent metal parts or through the insulation and overheating of internal winding or bushing connection lead [IEC 60599]. Figure 3-5 provides a mind map representation of possible sources of thermal faults in power transformers.

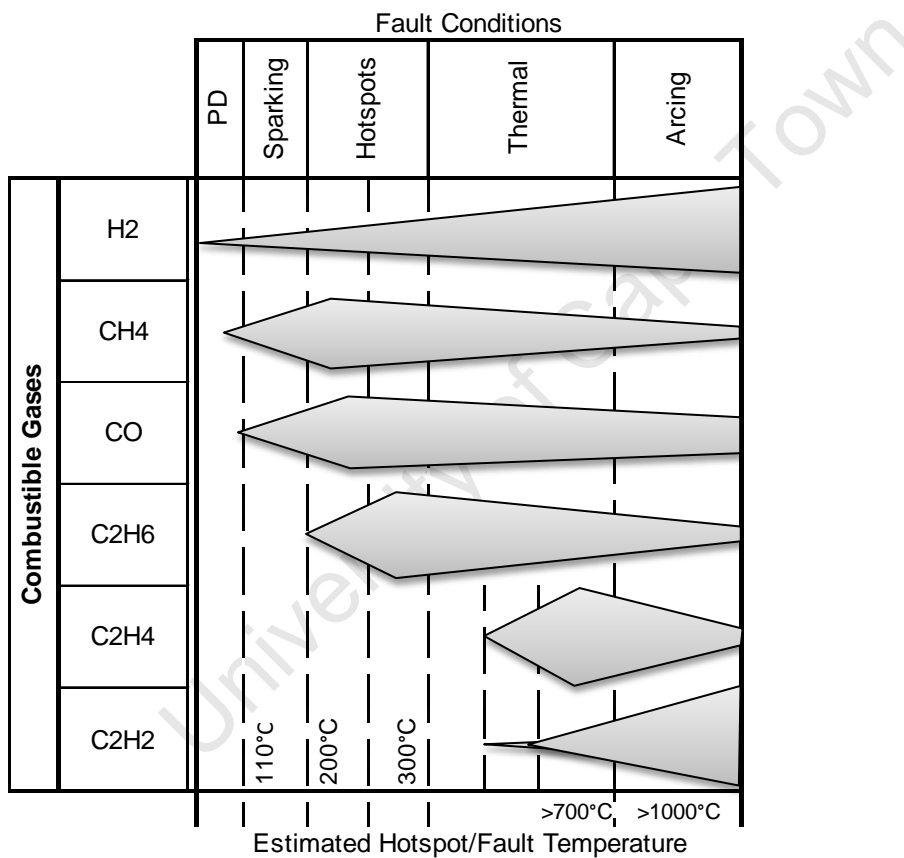
Figure 3-6: Combustible Gas Temperature Production Rates [Duval3, Oommen4]

Figure 3-6 provides an indication of the gas production rates of the combustible dissolved gases within the oil for increasing temperature. It is noted that hydrogen starts to form at low temperatures and maintains the increasing rate of production even well above 1000°C. It provides some correlation to the amount of energy and the levels of hydrogen produced. It is also noted that both hydrogen and methane start to form at low temperatures where methane reaches a maximum value after which further increases in energy results in a decrease in the production rate due to the chemical reactions of hydrocarbon production favouring the higher bonds like ethane and ethylene.

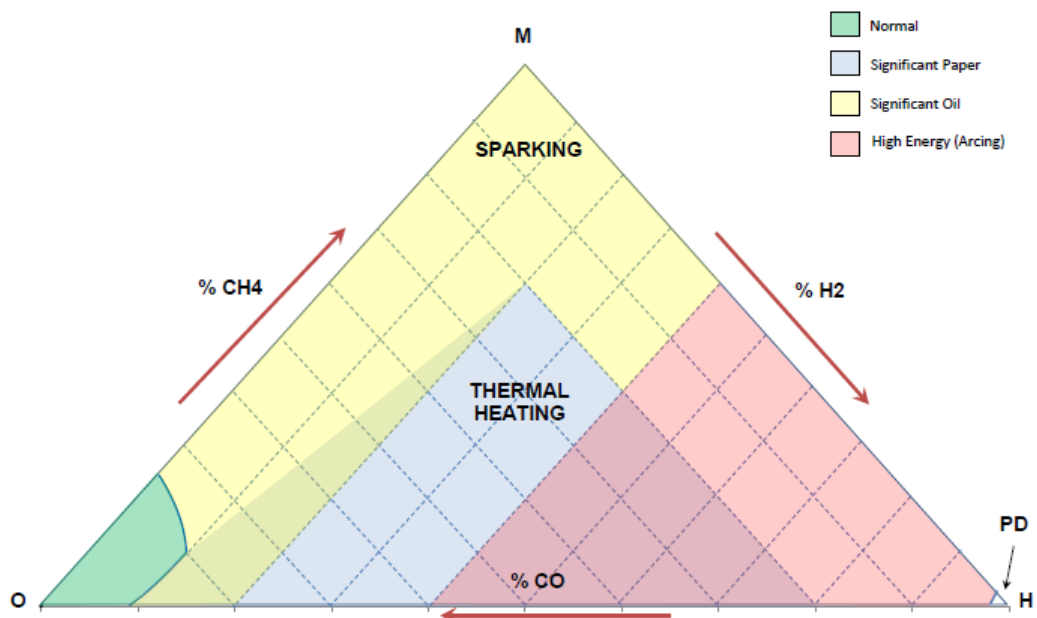
Figure 4-2: Low Energy Degradation Triangle - Regions

The important aspect of the Low Energy Degradation Triangle is that it offers a visual trend of deteriorating insulation condition. During the preliminary analysis of data, a few prominent regions were identified. These are explained below with reference to figure 4-2.

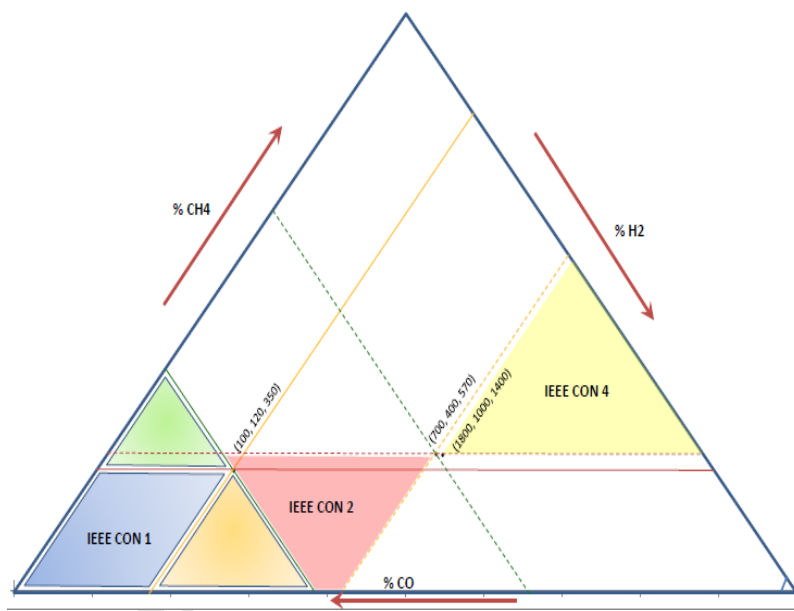
Figure 4-8: IEEE Conditions

IEEE condition 1 in figure 4-8 displays dissolved gas concentrations below which the transformer is operating satisfactorily where any individual gas exceeding the individual limits requires more investigation. The upper limit value for H₂ is 100 ppm; CH₄ is 120 ppm and CO being 350 ppm. Using these values in the energy triangle the respective percentages are H₂ 17.54%, CH₄ 21.05% and CO 61.40%. These values are plotted in Figure 4-8. The blue shaded region meets the criteria for H₂ and CH₄. The green shaded area is within the H₂ and CO limits but is above the CH₄ limit. The orange shaded area is within the CO and CH₄ limit but is outside the H₂ limit.

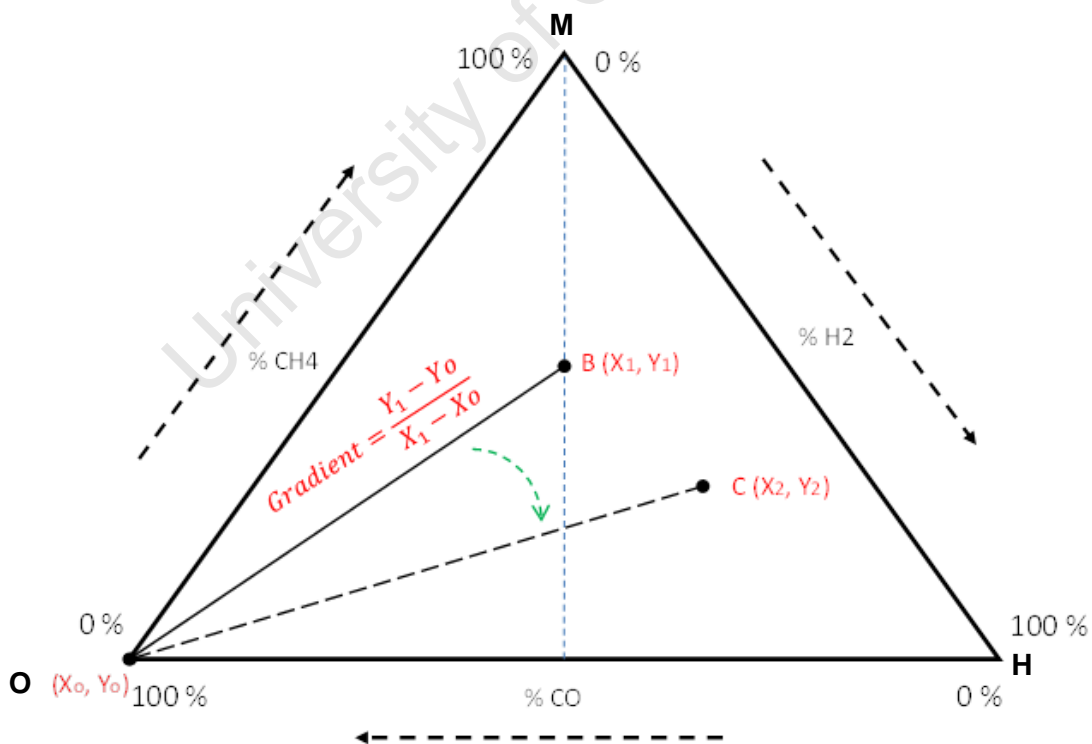
Figure 5-1: Different Points with Varying Gradients

The amount of fault energy present may correlate with the amount of H₂ gas generated. Increase in %H₂ causes the points to move (from point B to point C) towards the bottom point H of the triangle. This area may be indicative of arcing conditions where the amount of energy is also increasing accordingly with the gradient of the line decreasing.

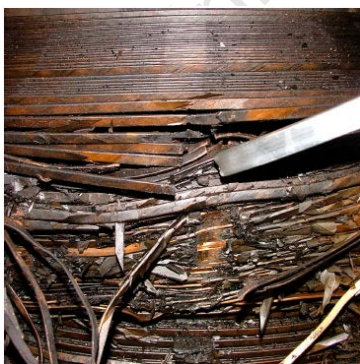
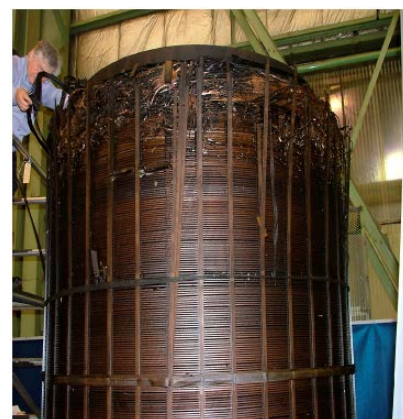
There was no evidence of oil expulsion but the accumulated gas was clearly visible inside the Buchholz Relay. The post mortem internal inspection revealed a conductor inter-turn short on the top HV C-phase winding between layers 14 to 42. The insulating paper on the copper conductors (strands) in the fault area below clack was damaged and in some cases indicated short circuits between strands with visual evidence of free copper particles and hammering on various clacks due to loose winding. Figures 6-4 and figure 6-5 provide visual evidence of the damaged areas as described above.

Figure 6-4: Inter turn Damage on HV Winding

Figure 6-5: Damage on Top HV C Phase

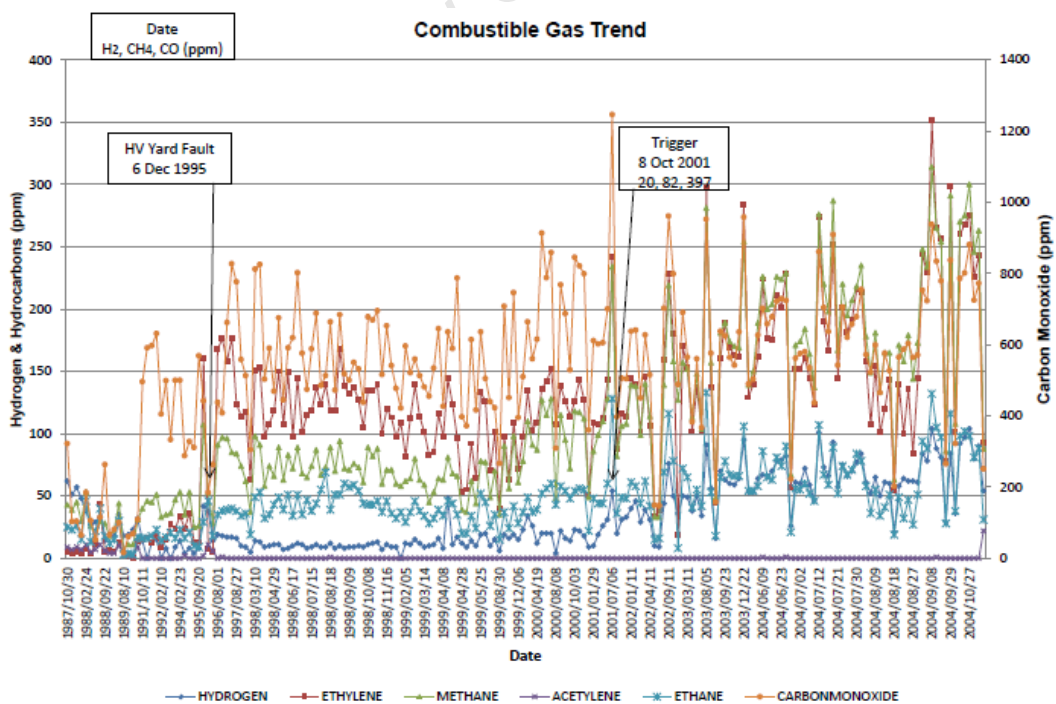
Figure 6-7: Combustible Gas Trend - Case Study B

On the 6 December 1995 two faults occurred in the HV Yard, relatively close to this transformer when portable three phase earths were left on the HV Yard bus bar. This event caused a step increase in combustible gas levels in the oil. The hydrogen levels however did not have an increasing trend. The load of the transformer was adjusted to enable the unit to be in operation. The production of dissolved gases correlated to the increase and decrease in the loading. This kept the samples within the normal region. It was only when the first trigger was received on the R-value on the 8 October 2001 that the hydrogen levels started to increase. The CO levels were high in the region of 750 to 1000 ppm indicating severe paper degradation.

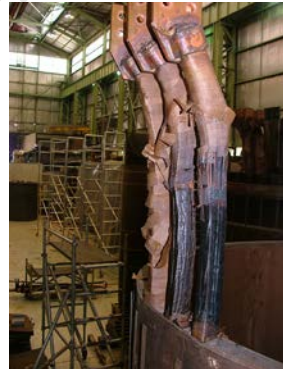
Figure 6-10: Thermal Heating LV Exit Leads

The post mortem revealed damage to HV C-phase winding in the form of inter-strand and inter-turn short circuits. Figure 6-9 and figure 6-10 captures some of the damage experienced on the HV C phase windings and LV exit leads.

The post mortem design review revealed inadequate cooling on the top and exit leads of the winding. The acidity level increased from 0.06 to 0.11 mg KOH/g within the year which was supported by the high levels of sludge on the windings. The interfacial tension also decreased over this period. The LEDT was able to detect the defective state of the transformer with the last significant trigger received at least four and a half years before the failure occurred. In this case study it was found that θ did have an influence on the level of energy that was present. Although the latter R-values were below the 0.173 limit, due to the effect of θ , on the LEDT they were in the defective region. This emphasises the importance of using the θ compensation on the LEDT plot. It was also noted that the oil change out, only had the effect of masking the dissolved gas values as the imminent defective state was still present within the transformer.

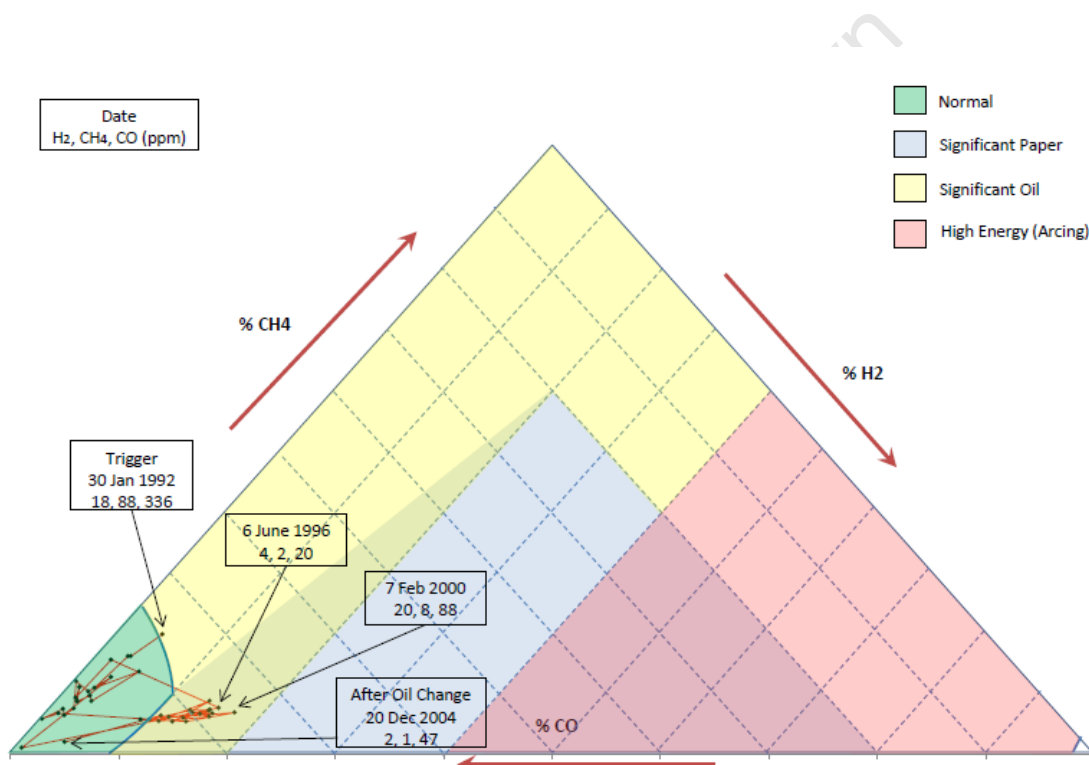
Figure 6-11: LEDT Case Study C

Figure 6-11 provides the LEDT representation leading up to this incident. It was observed that the transformer moved to an out of normal state on 7 February 2000 where the condition remained in this area until it was relocated to the other unit. This was a clear indication that even though the conventional DGA did not indicate any major concerns the Low Energy Degradation Triangle identified a budding fault condition. The oil change out as evident in the oil sample taken on the 20 December 2004 also masked the defective state due to the sample point now being within the normal region of the LEDT.

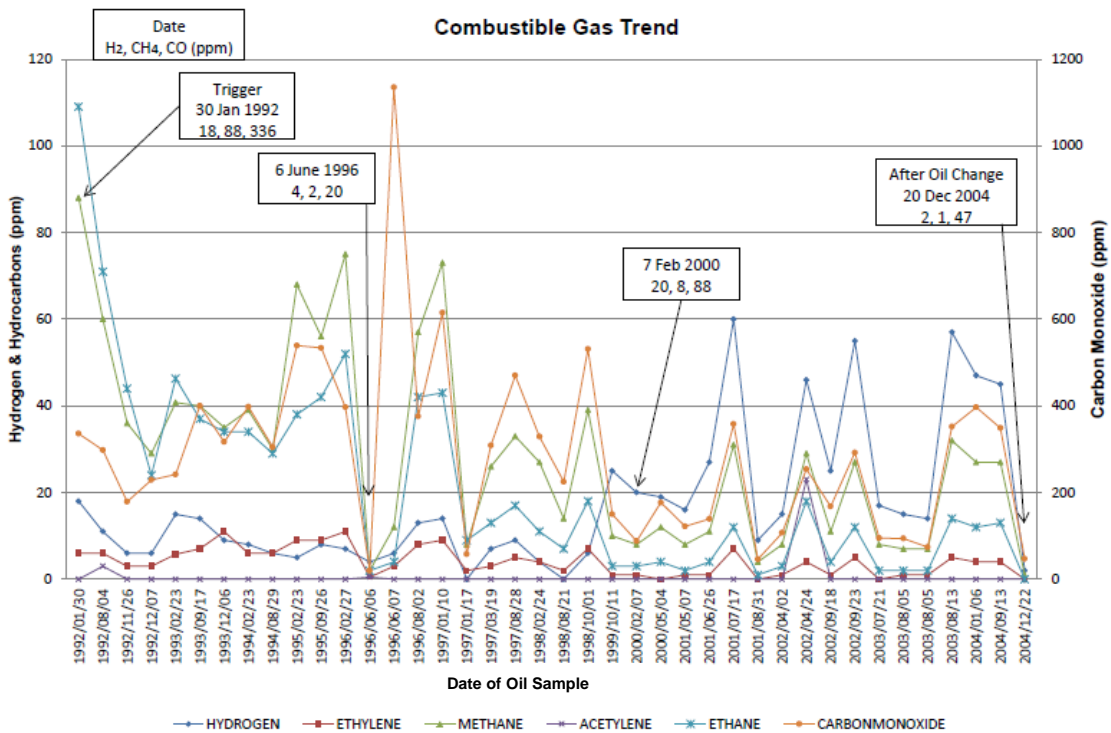
Figure 6-12: Combustible Gas Trend - Case C

From the combustible gas trend in figure 6-12 it is observed that the first oil sample on record was on 30 January 1992 which was already in the defective region with H₂, CH₄ and CO being 18 ppm, 88 ppm, and 336 ppm respectively. Subsequent results over the next year were within the normal region. The methane levels were initially high but then started to be moderate around 20 ppm. The hydrogen levels started to increase but were still within 60 ppm. It is also interesting that the carbon monoxide levels were low. The last sample recorded in this case study on the 20 December 2004 indicated a drastic decrease in the combustible gases due to the oil change out.

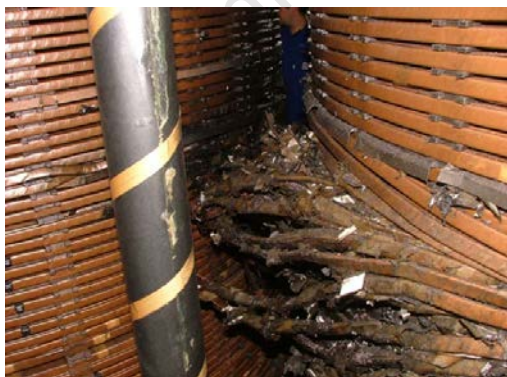
The transformer was then installed on 14 June 2004. Between September-December 2004 the on-line DGA indicated an upward trend. The unit was then shut down for the generator replacement project and the last sample was taken on 22 December 2004. The transformer was returned to service on 25 March 2005 before undergoing oil purification where it failed on 15 May 2005. After the failure the internal inspection revealed damage to the C-phase HV winding as depicted in figure 6-14.

Figure 6-14: Case Study D - Damage on C phase HV winding

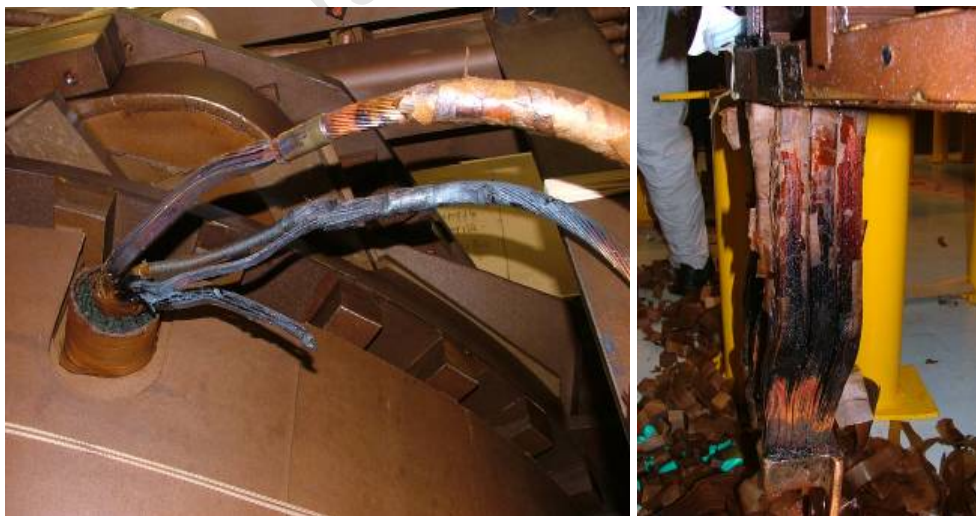
Figure 6-23: Evidence of Failure

On 16 May 2004 the transformer was taken off line for an internal inspection. During the internal inspection it was found that the blue phase HV exit lead conductors had burnt away. Upon further inspection it was also found that the LV winding exit leads showed signs of severe overheating. See pictures in figure 6-23 for the extent of the damage.

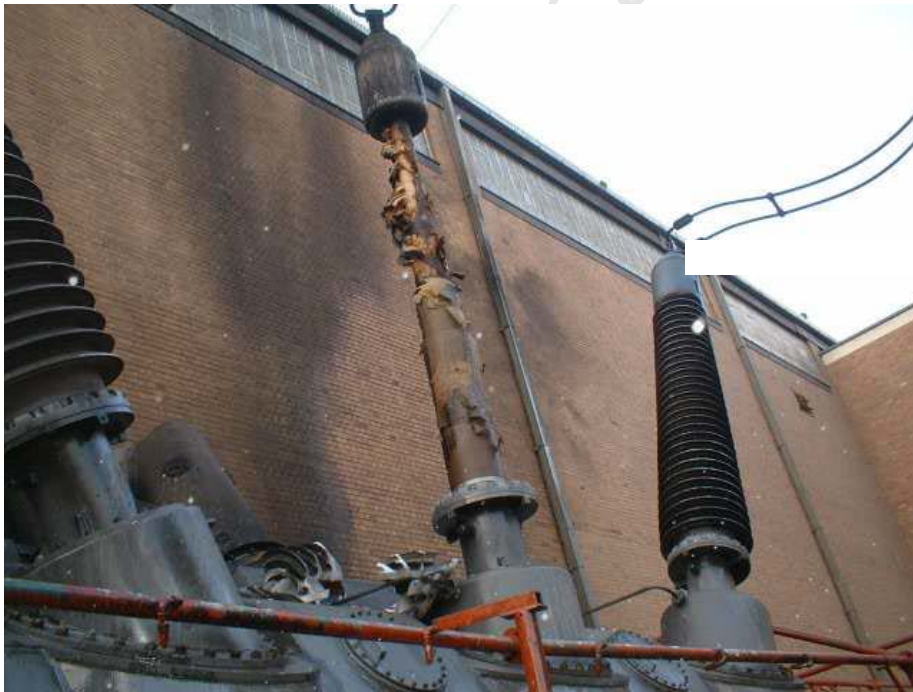
Figure 6-33: Damage B phase HV Bushing

On the 14th of May 2005 this GSU transformer failed with a fire on the white phase HV bushing. It was found that both the left and right PRVs had operated resulting in oil spillage into the bund area. The transformer tank was also significantly damaged with bulging and cracks. Inherently the transformer (and those of the same make) was identified to be suffering from poor internal oil flow and cooling, as well as LV winding and tail-lead overheating problem.

Internal inspection revealed that the blue phase HV winding lead was pulled out of the bushing damaging the bushing with evidence of a flash over between the main tank and the corona ring (Figure 6-33). All the bushings were damaged. Inspection of LV leads showed no signs of overheating.

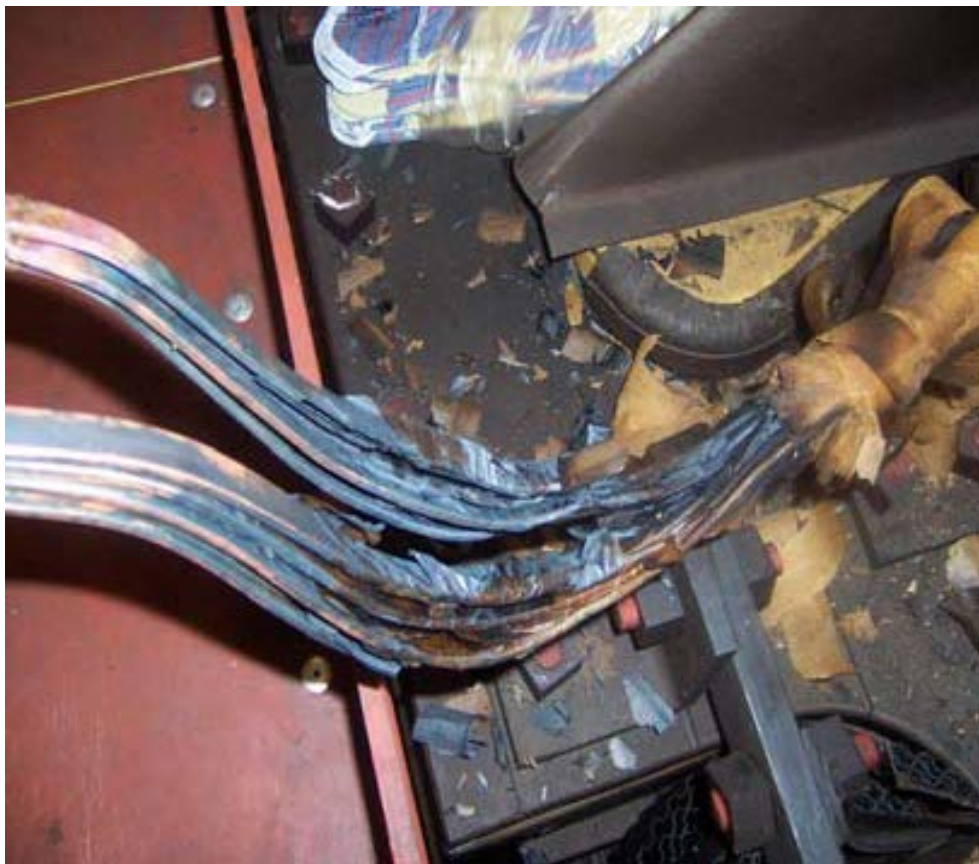
Figure 6-37: Damage to HV Leads

On the 30th September 2005 this 700 MVA GSU transformer tripped on Buchholz protection. From the fault recording there was indication that there was a problem with the White Phase HV winding. The internal inspection confirmed this as indicated in figure 6-37 with damage on the HV leads.

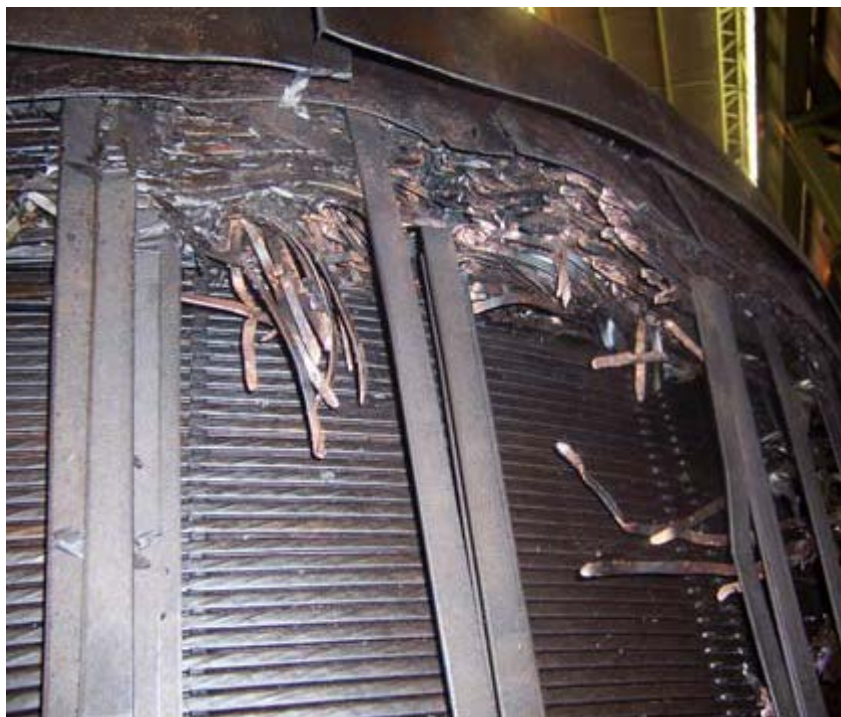
Figure 6-41: Damage to HV Winding

On Sunday, 27 February 2005, this GSU Transformer tripped on Generator Differential protection, HV restricted earth fault protection and Buchholz protection. No external damage was noted but the internal inspection of the active parts of the transformer revealed heating around the top of the HV windings and exit leads which caused accelerated paper degradation. This damage was evident in figure 6-41.

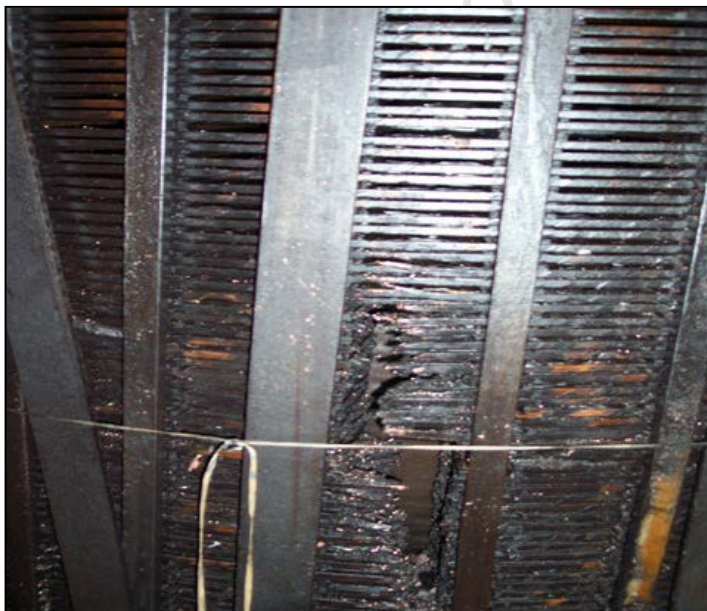
Figure 6-45: Damage C Phase LV Winding

A 100 MVA GSU transformer failed on 28 November 2001, resulting in the electrical protection and pressure relief device operating. On site, internal inspection revealed tiny copper particles distributed over the transformer connections, insulation and windings especially in the area of the C phase winding.

Internal inspection of the transformer revealed distortions on the C phase windings. There were black spots on the paper insulation of the tap changer leads with damage to the support structure of the delta connection. A loose clamping bolt on the C phase LV winding was found with winding spaces in the damaged area showing marks of “hammer effect”. Figure 6-45 provides a picture depicting the failure on the C phase LV winding. Evidence of an inter turn failure was present. One of the frame bolts on the C phase LV side connection was loose, and mechanical clamping device marks were noticed. This may have resulted in insufficient torque being applied during the assembly process and vibration was then transferred to the windings causing insulation failure and the inter turn fault.
