FACULTY OF ENGINEERING AND THE BUILT ENVIRONMENT
THE DEPARTMENT OF CIVIL AND ENVIRONMENTAL ENGINEERING
**Applying the DER Rating System for the Visual Assessment of
Defects on Concrete Dams**

MASTER OF ENGINEERING

(Civil Infrastructure Management and Maintenance)

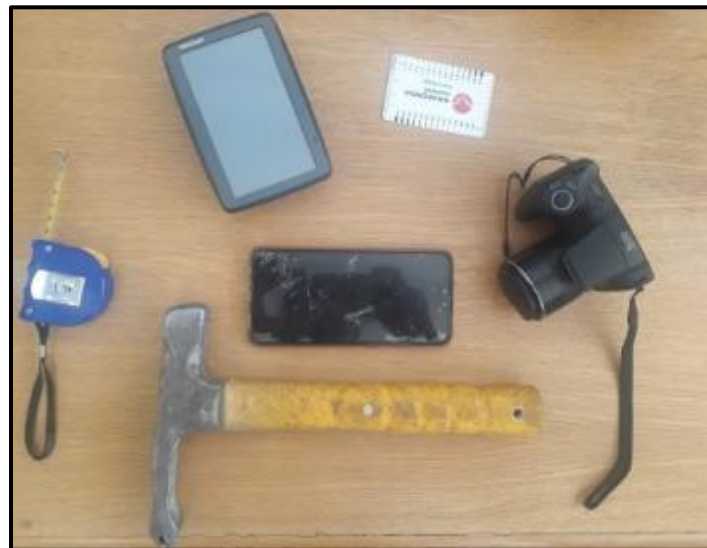
Figure 2: Tools used for the Visual Condition Assessment

The approach was to identify with the eye the surface defects on the identified equivalent dam components. Pictures were captured and crack widths measurements taken where possible. The following basic tools (**Figure 2**) were used for the condition assessment on site:

- Crack width ruler
- Camera
- Mobile phone camera
- Tape measure
- Hammer
- Hand-held GPS

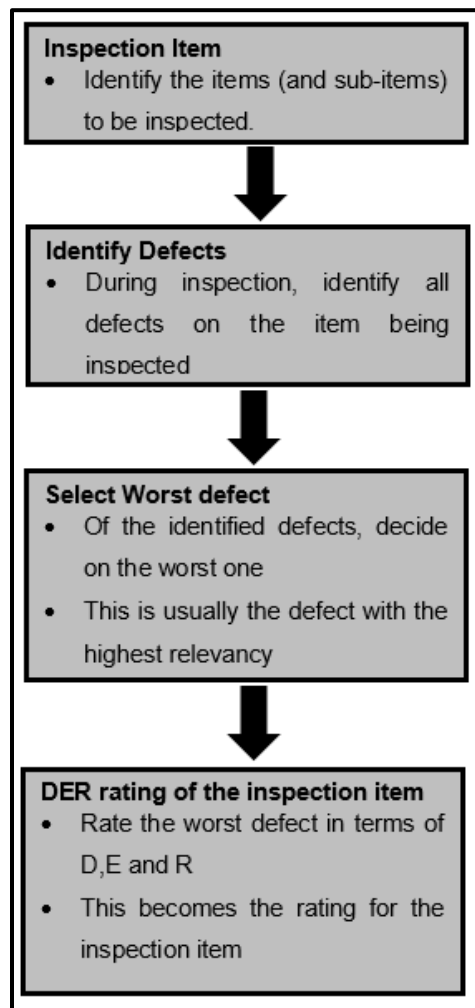
Figure 17: Procedure for rating defects using the DER system

Figure 17 gives a summary of the procedure for the rating of defects using the DER rating system, as derived from TMH19A (Committee of Transport Officials, 2016a:4-3). As can be seen from **Figure 17**, the DER ratings are only applied to the worst defect as this is usually the defect with the highest relevancy. That is why, particularly for the relevancy rating, inspectors with appropriate design and rehabilitation experience are required. The inspector should understand how the structure behaves and how the defect will interfere with the load path of the structure and the impact the defect will have on the safety of the users of the structure (Committee of Transport Officials, 2016a:4-1) in order to make a reasonable rating of the relevancy. It is however

recommended that the rest of the defects on the inspection item are recorded merely for the purpose of repair and maintenance.

Despite being a rating system for rating defects on a structure, the DER rating system is not intended to have the bridge inspector rate the condition of the inspection item or the structure as a whole, but rather to focus on the identified defects (Committee of Transport Officials, 2016a:4-1). From the above descriptions of the DER rating system, it seems logical to assume that it may be applicable to defects on any concrete structure. It is for this reason, and it's potential to improve decision making and prioritisation of the repair and maintenance of dam structures which may consequently contribute to the overall improvement of asset management within NamWater, that this study intends to assess its applicability for assessing surface defects on concrete dams.

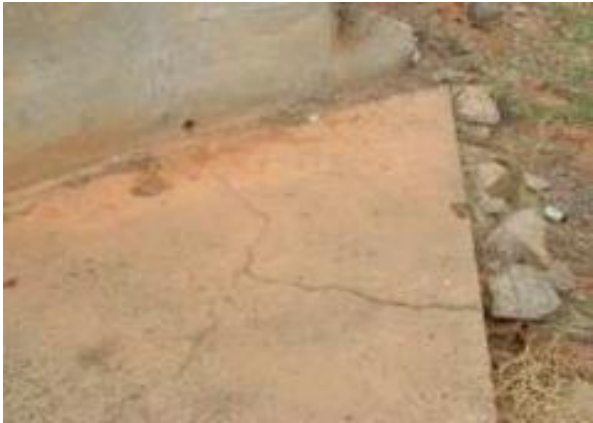
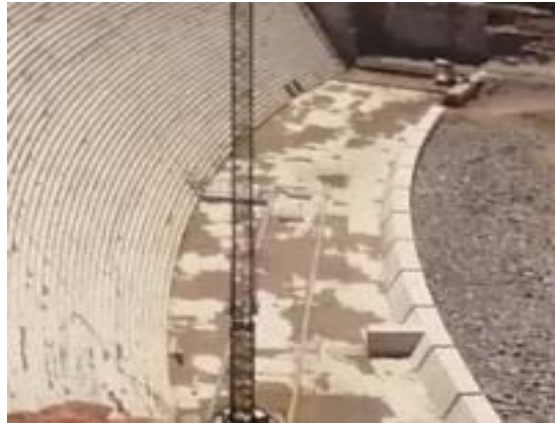
Table 13: Apron Slab and Cut-Off Wall Defects

| TMH19 Bridge Item(s) | Dam Equivalent Item |
|--|--|
| <p>Typical Loads: Self-weight</p> | <p>Typical Loads: Mostly Self weight and pressure from the flood water.</p> |
| <p>Typical Deterioration/defects: Cracks, Scour, spalling etc. (See item 6, table 2.1 and items 1 and 3 from table 2.2 of TMH19)</p> | <p>Typical Deterioration/defects: Erosion or loss foundation at outlets and spillways, cracks, spalling</p> |

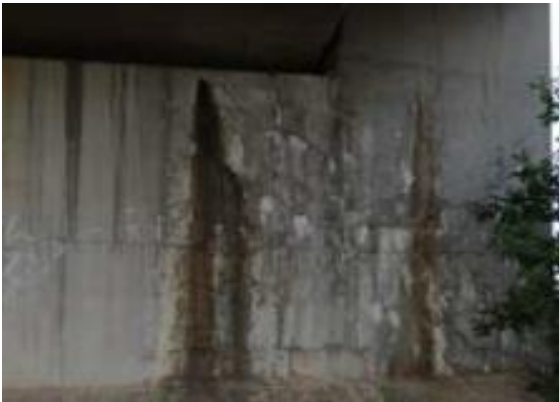
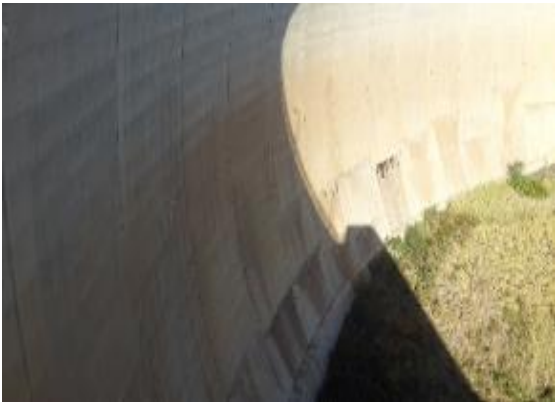
Table 18: Dam Wall (Upstream/Downstream) Defects Equivalent Guiding Table

| TMH19 Bridge Item(s) | Dam Equivalent Item |
|---|---|
| <p><u>Typical Loads:</u> Lateral loads from approach earth backfill and loads from superstructure</p> | <p><u>Typical Loads:</u> Lateral hydrostatic loads from the upstream water, self-weight</p> |
| <p><u>Typical Deterioration/defects:</u> Cracks, spalling (see item 6, table 2.1 TMH19)</p> | <p><u>Typical Deterioration/defects:</u> Cracking, crazing and spalling, leakage, movement, development of off-sets, settlement</p> |

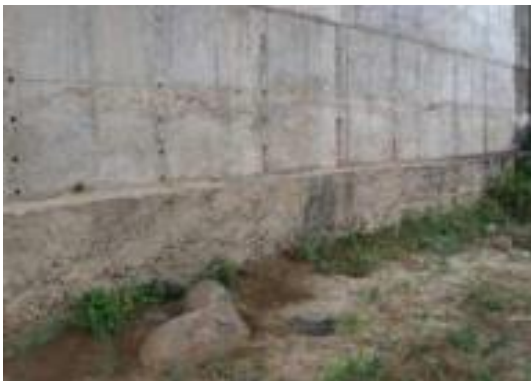
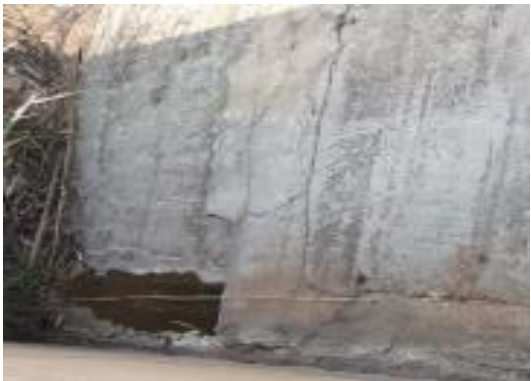
Table 20: Abutment Foundation Defects

| TMH19 Bridge Item(s) | Dam Equivalent Item |
|---|--|
| <p>Typical Loads: Loads from superstructure and lateral loads from approach via the abutment wall.</p> | <p>Typical Loads: Loads from dam wall</p> |
| <p>Typical Deterioration/defects: Cracks, spalling (see item 5, table 2.1 of TMH19)</p> | <p>Typical Deterioration/defects: Cracking, spalling, leakage, movement, settlement</p> |

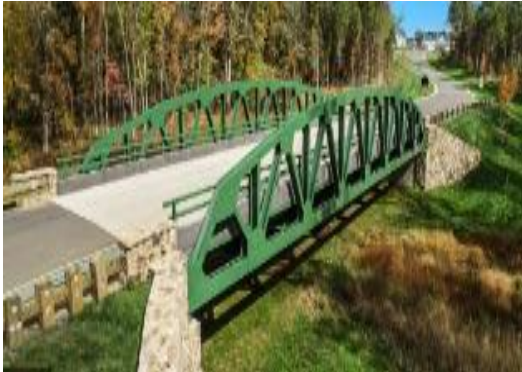
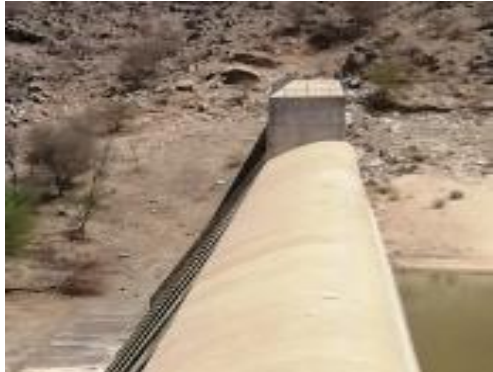
Table 24: Deck and Slab Defects

| TMH19 Bridge Item(s) | Dam Equivalent Item |
|---|--|
| <p><u>Typical Loads:</u> Traffic loads, thermal loads</p> | <p><u>Typical Loads:</u> Traffic loads, thermal loads</p> |
| <p><u>Typical Deterioration/defects:</u> Cracks, spalling (see items 11,17 & 20, table 2.1 TMH19)</p> | <p><u>Typical Deterioration/defects:</u> Cracking, crazing and spalling, leakage, movement, development of off-sets, settlement</p> |

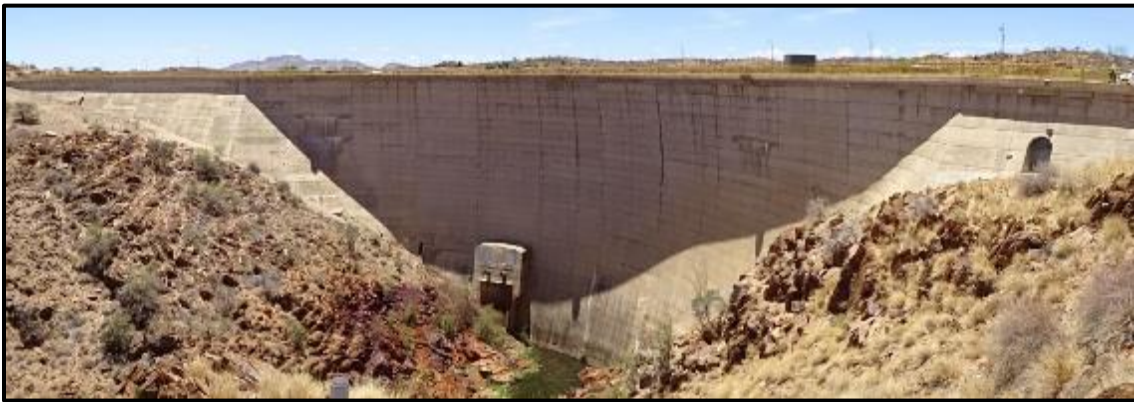
Figure 18: Oanob Dam Main Wall

The Oanob dam (**Figure 18** and **Figure 19**) is a double curvature arch dam with gravity flanks that kinks upstream, located in the Hardap region, upstream of the town of Rehoboth. The dam height above the riverbed is 52.9 m and is categorised as a class III dam, accordingly to the DWA dam safety regulations. The dam was constructed in 1991 and its capacity is estimated at 34 million m³. The dam spillway is provided on a separate location and not on the main dam wall, even though the main dam wall is provided with some outlet pipes (**Figure 20**). This study however only focused on the components at the main dam wall of the Oanob dam.

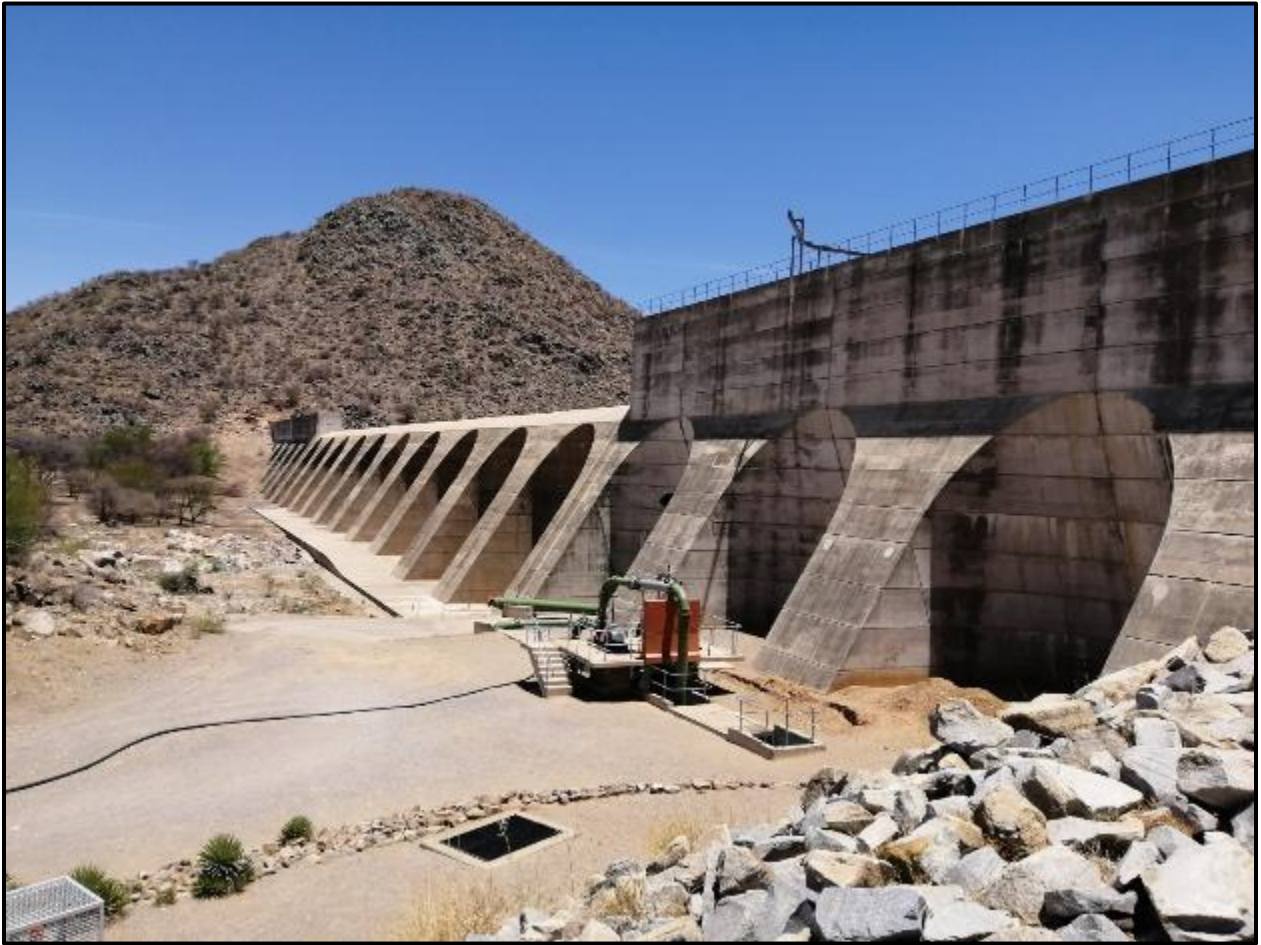
Figure 24: Otjivero Dam Wall

The Otjivero dam (**Figure 24**) is a mass concrete multiple arch buttress dam, completed in 1984 and its main purpose is to impound water on the white Nossob River for the domestic use of Gobabis. It is located about a 100 km west from the town of Gobabis in the Otjozondjupa Region. An aerial view of the Otjivero dam is shown in **Figure 25**. The main dam wall is composed of an uncontrolled spillway in the middle, between an accessible non-overspill crest (**Figure 26**). The

total height of the dam is 16 m and its capacity is estimated at 18 million m³. A concrete apron Slab is provided at the dam toe (**Figure 27**).

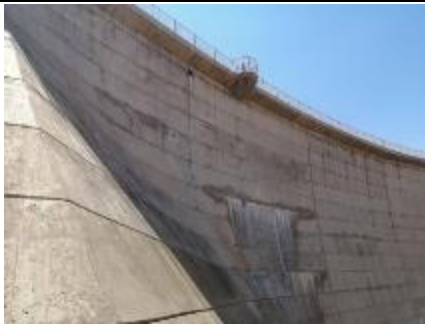
| Dam Item 3: Dam Wall (Downstream) | | | |
|---|---|--|---|
| Spalling (All loose concrete must be broken away to expose extent of spall) | (0, , - R) | | No clear visible signs of spalling could be identified on the dam. There was however some lime leaching, especially between the horizontal lift joints. |

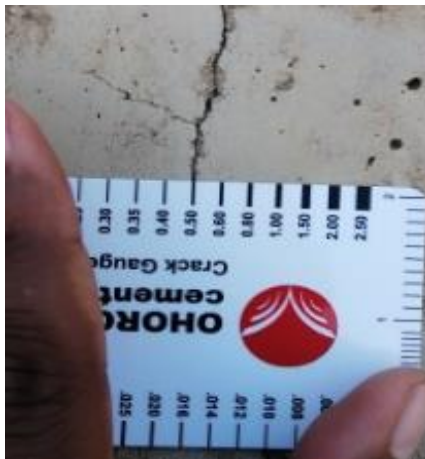
| Dam Item 3: Dam Wall (Downstream) | | | |
|---|---|--|---|
| Shrinkage and restraint cracks including AAR (Crack should be cleaned. Its width and if possible its depth ascertained) | (2, 2, 1 - 0) | | Random cracks of varying widths (range 03-06mm) on downstream dam wall. May be attributed shrinkage and potentially ASR. |

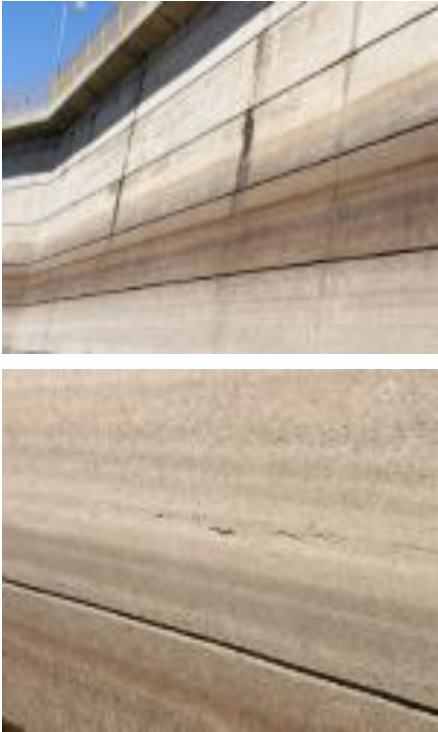
| Dam Item 3: Dam Wall (Upstream) | | | |
|---|---|--|--|
| Spalling (All loose concrete must be broken away to expose extent of spall) | (0, , - R) | | No clear visible signs of spalling could be identified on the dam. |

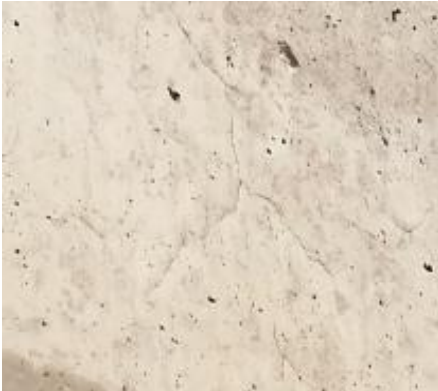
| Dam Item 3: Dam Wall (Upstream) | | | |
|---|---|--|--|
| Shrinkage and restraint cracks including AAR (Crack should be cleaned. Its width and if possible its depth ascertained) | (1, 1, 1 - 0) | | Minor Random hairline cracks on downstream dam wall. May be attributed shrinkage during construction stage |

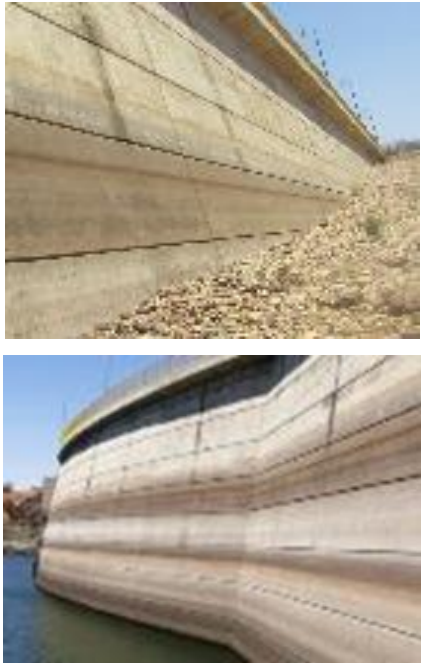
| Dam Item 4: Dam Wall Foundations | | | |
|---|---|---|--|
| Shrinkage and restraint cracks including AAR (Crack should be cleaned. Its width and if possible its depth ascertained) | (U, , - R) | | Unable to inspect due to the fact that the foundations are either fully covered by the stone pitching on the abutment-dam interface or fully submerged in water both on the upstream and downstream |

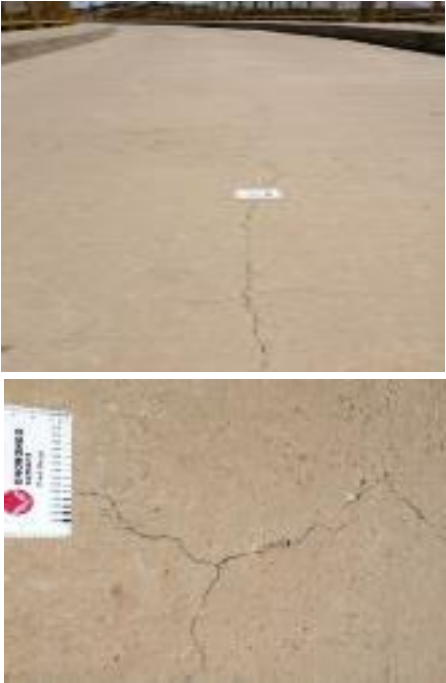
| Dam Item 5: Dam Crest (Top of Crest) | | | |
|---|---|--|--|
| Shrinkage and restraint cracks including AAR (Crack should be cleaned. Its width and if possible its depth ascertained) | (4, 3, 1 - 0) | | Crack along the centreline of road of large width. Depth to be ascertained by further tests. Intersecting cracks at the middle of expansion joints may indicate inadequate expansion joint spacing |

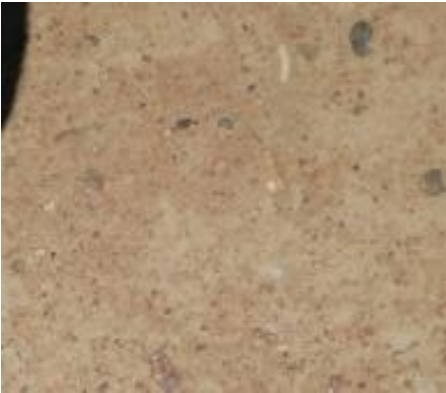
| Dam Item 5: Dam Crest (Top of Crest) | | | |
|---|---|--|--|
| Spalling (All loose concrete must be broken away to expose extent of spall) | (0, , - R) | | No visible signs of spalling even though abrasion/weathering of the concrete due to water is visible by the exposed aggregate stones |

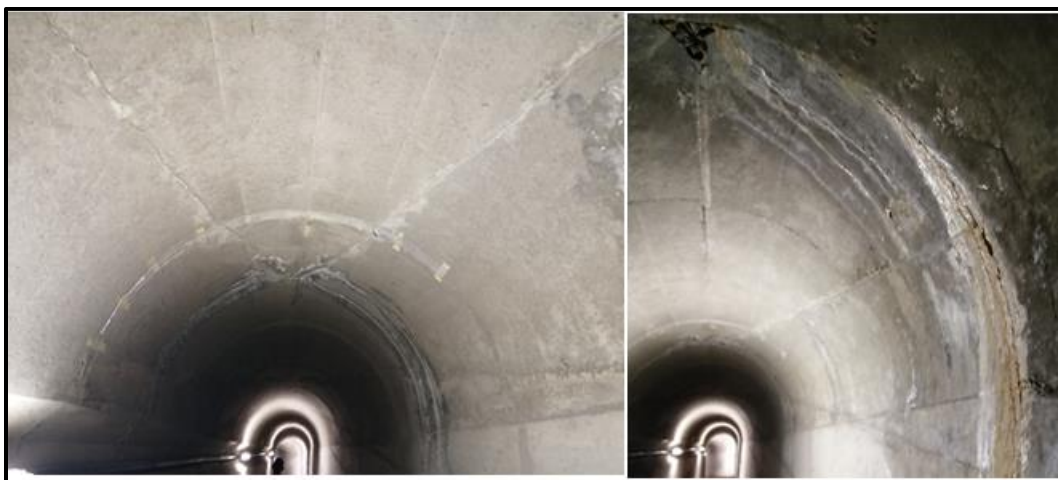
A crack is visible along the centreline of the crest with intersecting transverse cracks at half the distance between the joints. The transverse cracks may be attributed to expansion due to insufficient spacing of joints between the concrete blocks. However, on the other hand, major cracks are also identifiable within the gallery at fairly regular intervals (**Figure 28**). It could not be ascertained if the transverse cracks noticed on the dam crest are the ones protruding all the way through to the gallery or not, as their depth could not be ascertained.

Figure 28: Cracks within the Oanob Dam Gallery

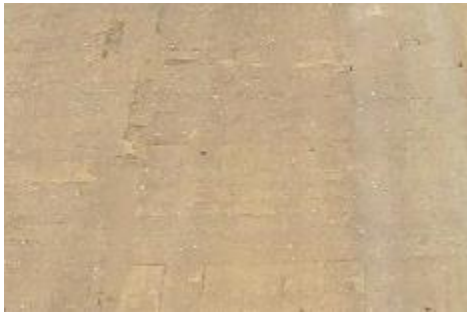
| Dam Item 2: Spillway Section and Apron Slab | | | |
|---|---|---|--|
| Spalling (All loose concrete must be broken away to expose extent of spall) | (0, , - R) | | No visible signs of spalling even though abrasion/weathering of the concrete due to water is visible by the exposed aggregate stones |

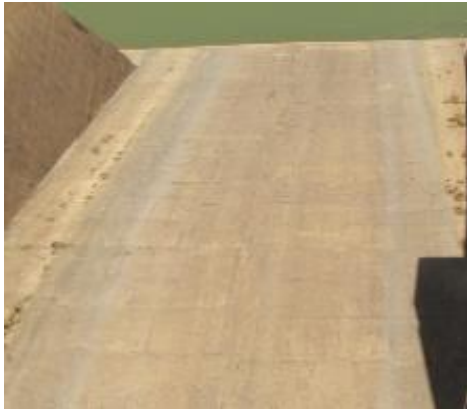
| Dam Item 2: Spillway Section and Apron Slab | | | |
|---|---|---|--|
| Shrinkage and restraint cracks including AAR (Crack should be cleaned. Its width and if possible its depth ascertained) | (0, , - R) | | Due to accessibility restrictions, the item was inspected from a distance and the photos were also taken from a distance. As a result, and as evident from the photograph taken, there was no visible signs of shrinkage or AAR cracks |

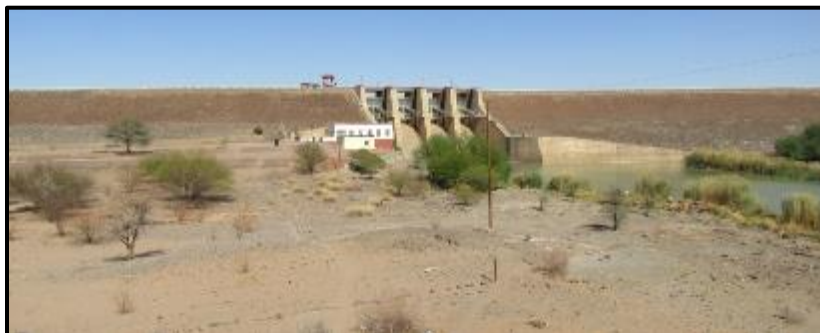
Figure 29: Hardap Dam Spillway and Embankments

The Hardap dam is primarily an embankment dam with the concrete part being only the spillway section (Figure 29). The spillway section has been evaluated under sub-section 5.4.2.3. Additionally, no defects were identified on the upstream side of the concrete spillway (Figure 30).

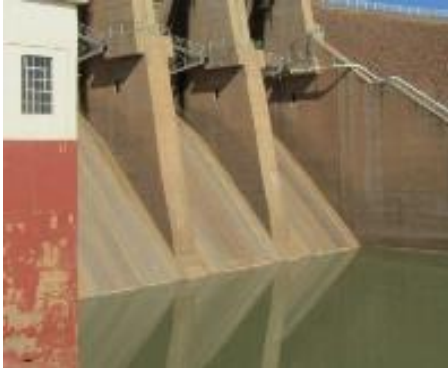
| Dam Item 4: Dam Wall Foundations | | | |
|---|---|--|---|
| Shrinkage and restraint cracks including AAR (Crack should be cleaned. Its width and if possible its depth ascertained) | (U, , - R) | | Unable to inspect as the foundations are r fully submerged in water both on the upstream and downstream |

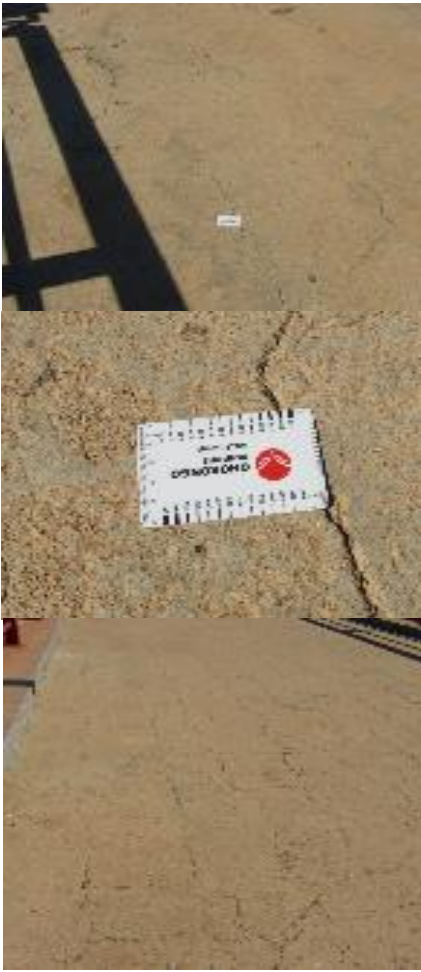
| Dam Item 5: Dam Crest | | | |
|---|---|---|--|
| Shrinkage and restraint cracks including AAR (Crack should be cleaned. Its width and if possible its depth ascertained) | (4, 3, 2 - 0) | | Random cracks of widths greater than 0.6mm across dam slab on dam crest. Primarily attributed to Shrinkage and possibly AAR. |

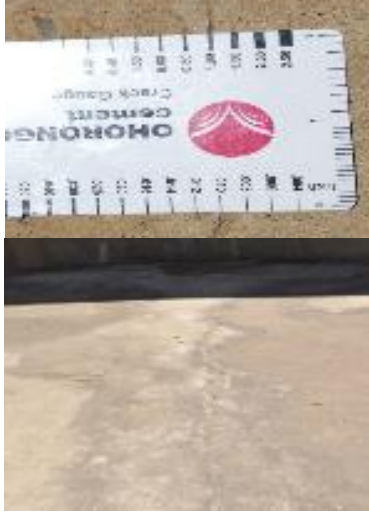
| Dam Item 2: Spillway Section and Apron Slab | | | |
|---|---|---|---|
| Shrinkage and restraint cracks including AAR (Crack should be cleaned. Its width and if possible its depth ascertained) | (4, 4, 1 - R) | | Longitudinal crack at mid-span of each apron slab panel highly attributed to inadequate expansion joint spacing. |

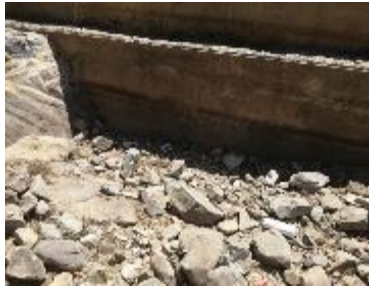
| Dam Item 2: Spillway Section and Apron Slab | | | |
|---|---|---|---|
| Scour of Outlet Structures | (2, 2, 1- 1) | | Unable to inspect due to the fact that the foundations are either fully covered by the stone pitching on the abutment-dam interface or fully submerged in water both on the upstream and downstream |

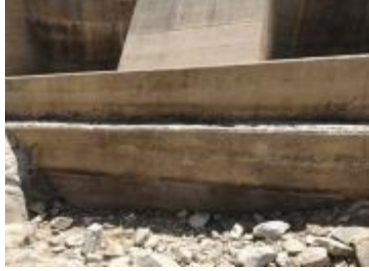
| Dam Item 2: Spillway Section and Apron Slab | | | |
|---|---|---|---|
| Scour or erosion of waterway | (1, 2, 2- 1) | | Unable to inspect due to the fact that the foundations are either fully covered by the stone pitching on the abutment-dam interface or fully submerged in water both on the upstream and downstream |

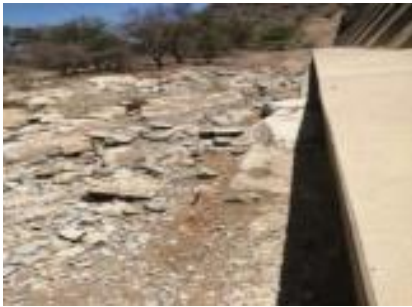
| Dam Item 2: Spillway Section and Apron Slab | | | |
|--|---|--|---|
| Flood debris accumulation | (0, , - 0) | | Other than the loose rocks on the outlet of the apron slab, there is no accumulation of flood debris |

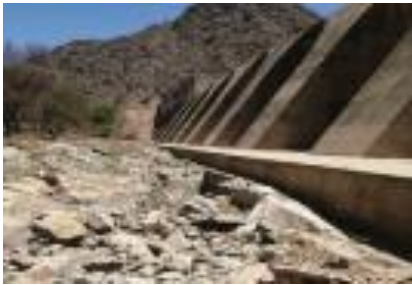
| Dam Item 2: Spillway Section and Apron Slab | | | |
|--|---|--|---|
| Defective scour protection works | (3, 2 , 1- 0) | | Despite the absence of scour protection works, the scour defects are minimal due to the loose rocks and the underlying rock formation |

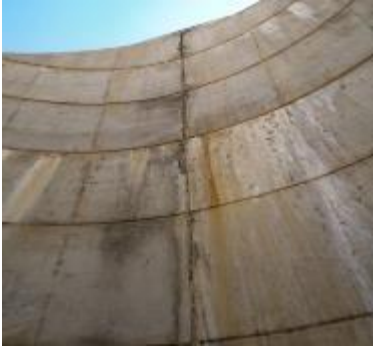
| Dam Item 3: Dam Wall Downstream | | | |
|---|---|--|--|
| Spalling (All loose concrete must be broken away to expose extent of spall) | (1, 1, 1 - 0) | | Minor spalling/delamination identified on the wall particularly at the vertical joints, associated marks reminiscent of leakages or leaching of substances. |

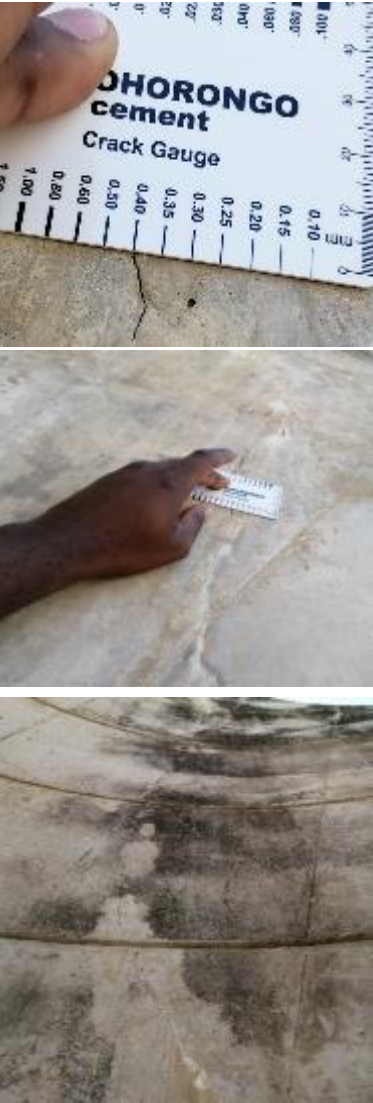
| Dam Item 3: Dam Wall Downstream | | | |
|---|---|--|--|
| Shrinkage and restraint cracks including AAR (Crack should be cleaned. Its width and if possible its depth ascertained) | (2, 4, 1 - 0) | | Vertical cracks of varying widths (range 0.4-0.6mm) on downstream dam wall. May be restraint cracks and potentially AAR. The inadequacy in expansion joints spacing may be a contributing factor. This is exhibited on almost all the buttress sections. |

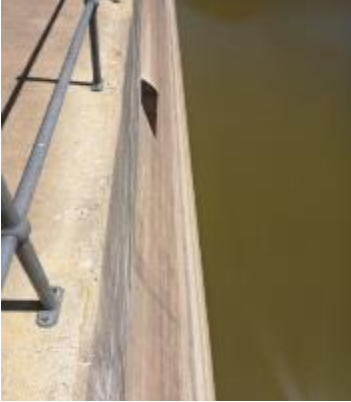
| Dam Item 3: Dam Wall Upstream | | | |
|---|---|---|--|
| Spalling (All loose concrete must be broken away to expose extent of spall) | (U, , - R) | | Unable to do a proper visual inspection due the presence of water on the upstream. However, visible from a distance, there are no clear visible signs of spalling identified on the dam. |

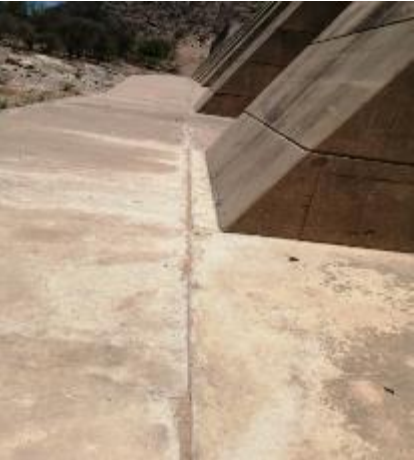
| Dam Item 4: Dam Wall Foundations | | | |
|---|---|--|---|
| Shrinkage and restraint cracks including AAR (Crack should be cleaned. Its width and if possible its depth ascertained) | (U, , - R) | | Unable to inspect as the foundations are covered by the apron slabs downstream and the water upstream |

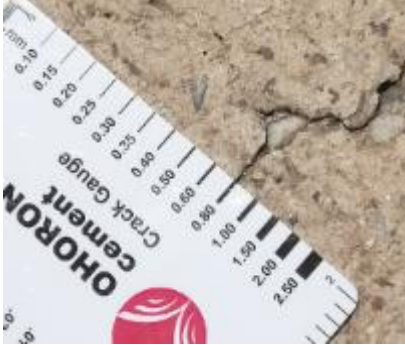
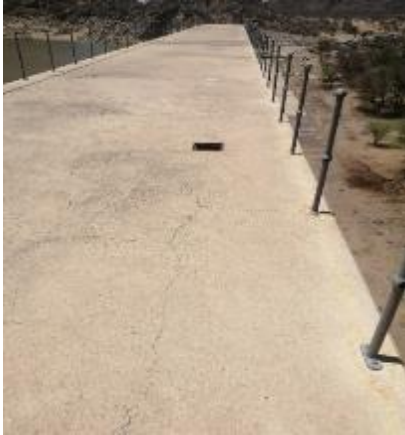
| Dam Item 5: Dam Crest | | | |
|---|---|---|---|
| Shrinkage and restraint cracks including AAR (Crack should be cleaned. Its width and if possible its depth ascertained) | (4, 3, 2 - 0) | | A longitudinal crack is visible along the non-overspill crest. Needs further investigation. |
