**Testing for relationship between diagnostic tests and
DC BDV of in-serviced aged stator bars of a hydro
generator**

**Department of Electrical Engineering
University of Cape Town**

**A Thesis submitted to the Faculty of Engineering and the Built Environment in
fulfilment of the requirements for the degree of Doctor of Philosophy in Engineering**

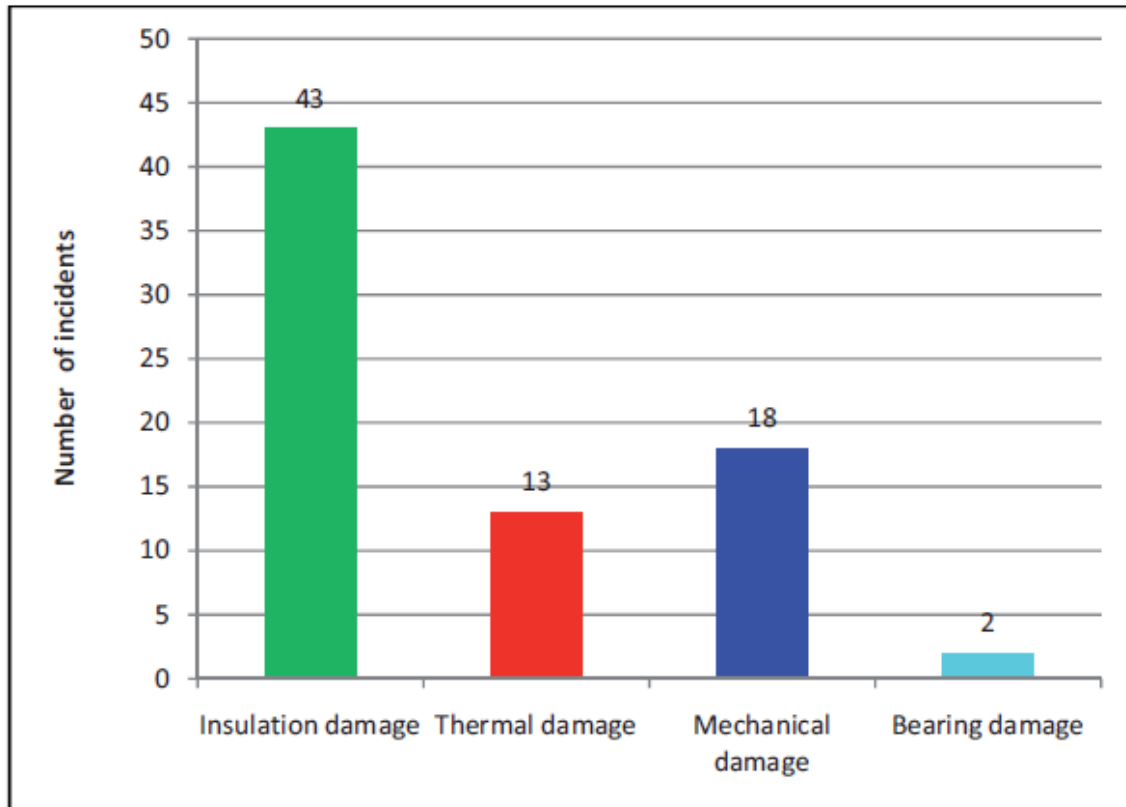
Figure 1-1: Hydro generators failures [5]

Furthermore, a global survey (Cigre TB 392) [5] on hydro generator failures indicates that the most frequent failures (57%) are caused by insulation damage (see figure 1-1). Figure 1-2

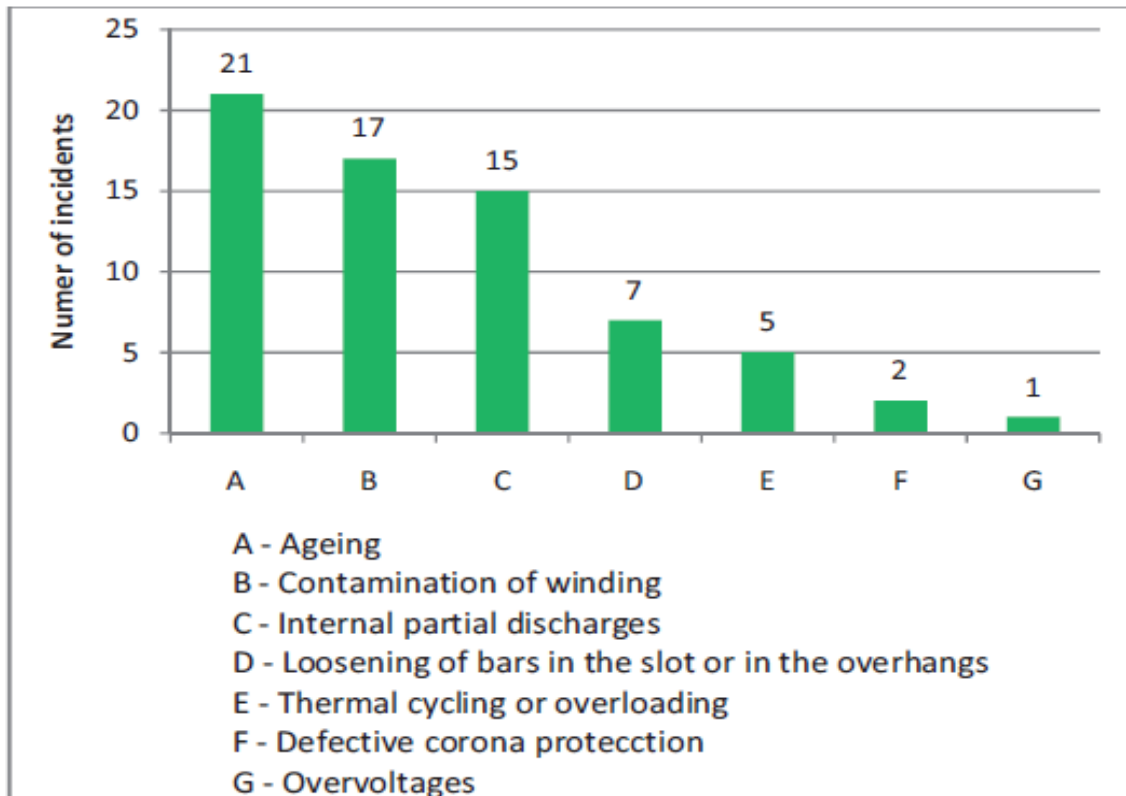
Figure 1-2: Insulation failure root cause analysis [5]

shows the insulation failure root cause analysis which is dominated by ageing and thirdly by internal partial discharges, 31% and 22% respectively.

From figure 1-2 it can be deduced that the dominant root cause failure mechanism is ageing

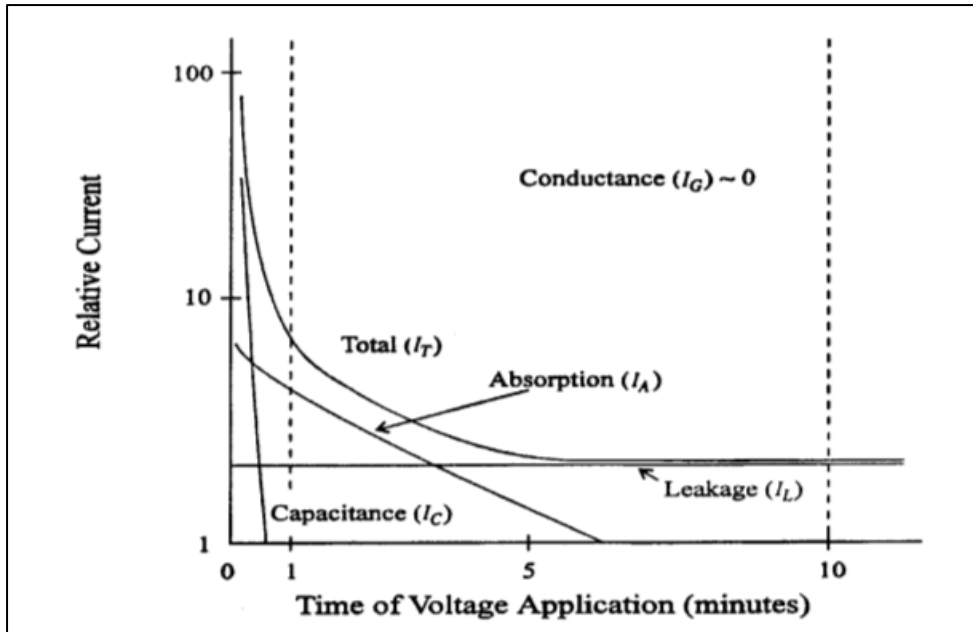
Figure 3-1: Currents present during IR testing [82]

When the DC test voltage is applied the following, test currents are present over time: capacitive, conductive, absorption and surface leakage and decay as per figure 3-1.

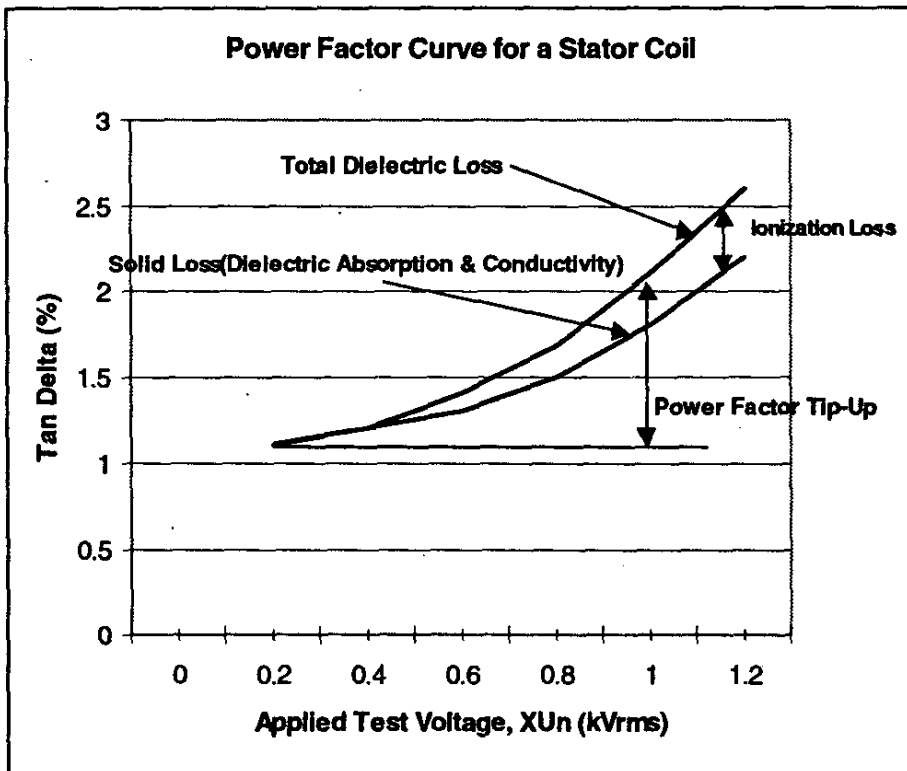
Figure 3-2: Tan delta tip-up as a function of voltage [89]

Dielectric losses consist of the following: solid losses (dielectric absorption and conductivity), and ionisation losses. The sum of these is called the total dielectric losses which is measured during the Tan delta tip-up test. Figure 3-2 shows that these losses can be plotted as a function of applied voltage [89].

The tan delta tip-up value, in percent or per unit, is calculated by subtracting the value of tan delta factor measured at the selected lower test voltage from that measured at the selected higher test voltage.

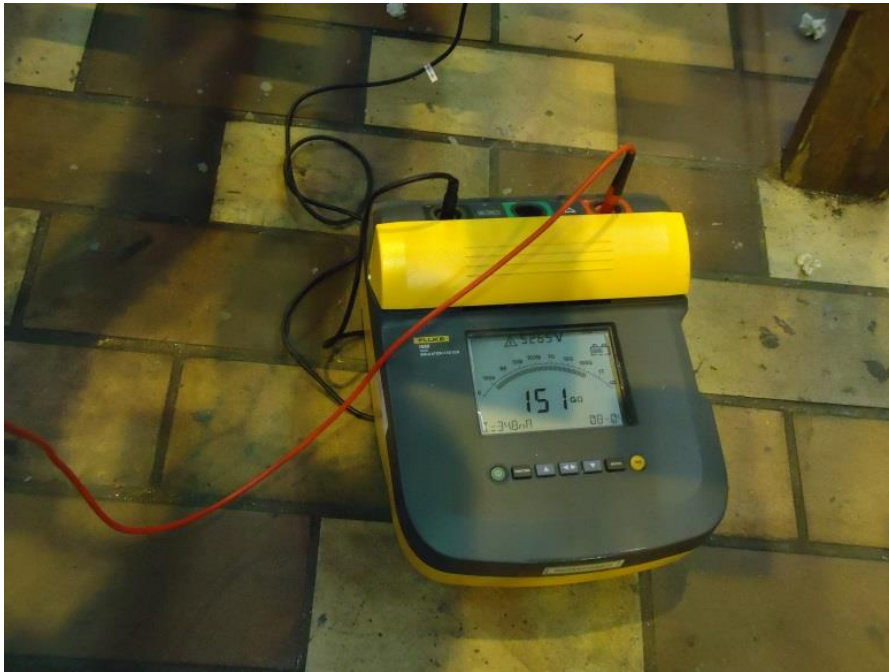
Figure 4-1: Megger, used for measuring IR and PI

These tests were conducted in accordance with [82]. The IR and PI readings were taken after one minute and 10 minutes, respectively, with 5 kV DC being applied to the bars.

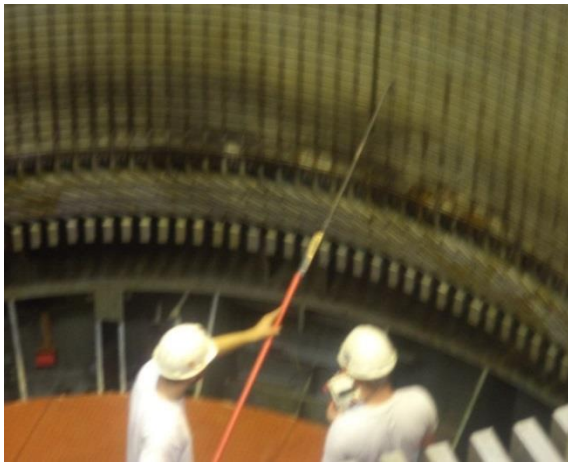
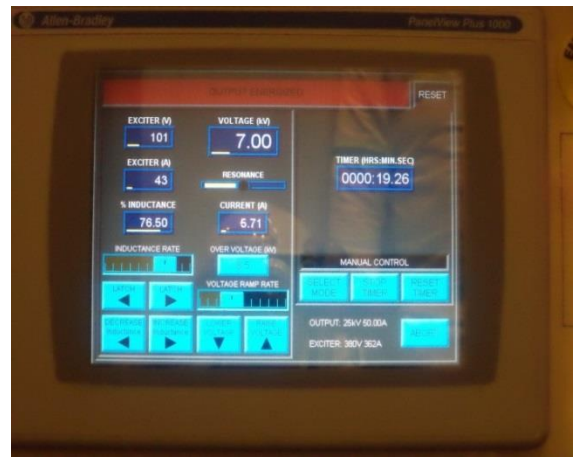
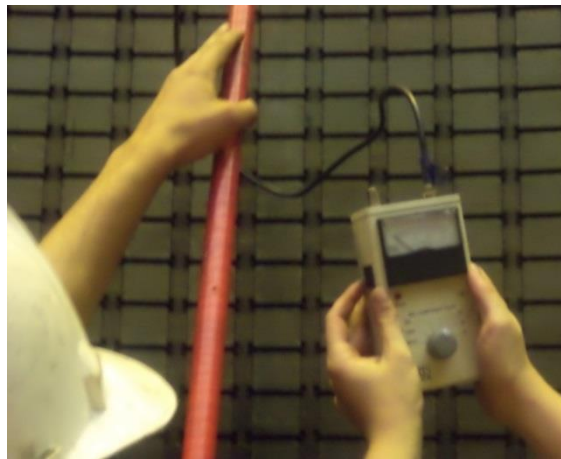
Figure 4-2: Top left and bottom: Taking in-situ TVA readings
Top right: Typical power supply indicators

4.2.1.2. Tennessee valley authority (TVA) test readings inside assembled machine

IEEE 1434-2014 [7] was used to conduct these tests. The test bars were energised to 7.0 kV AC. The probe readings were taken along the slot and the highest value was recorded.

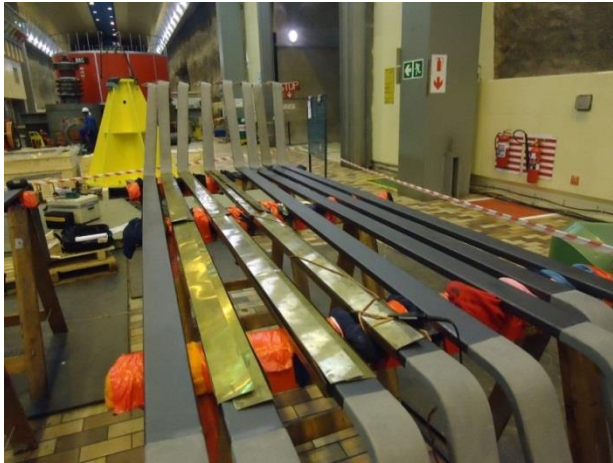
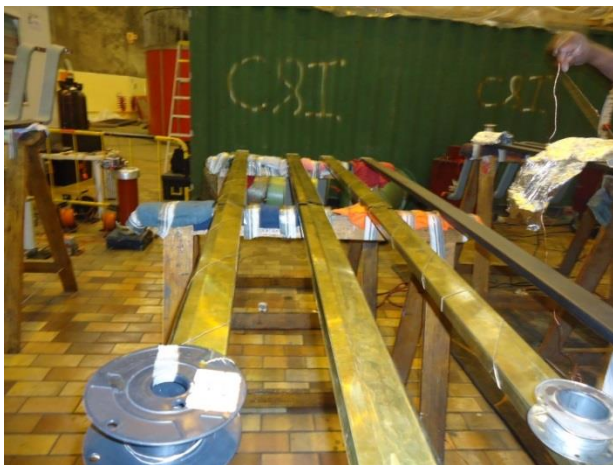
Figure 4-3: Test specimens showing typical connection points for tests.

The bars were clamped in earthed plates to simulate the earthed core. The bars were then suspended on insulated stands and directly connected to the respective test sets for the respective tests, as per the above sequence.

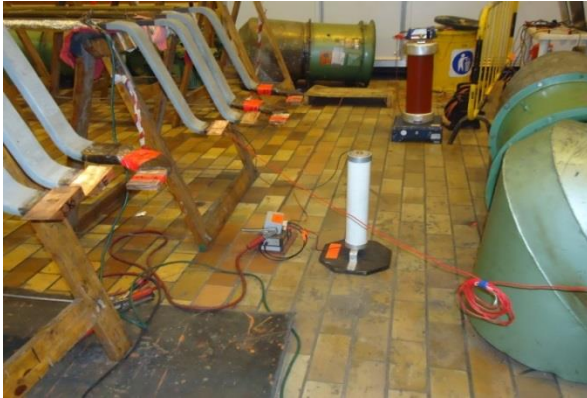
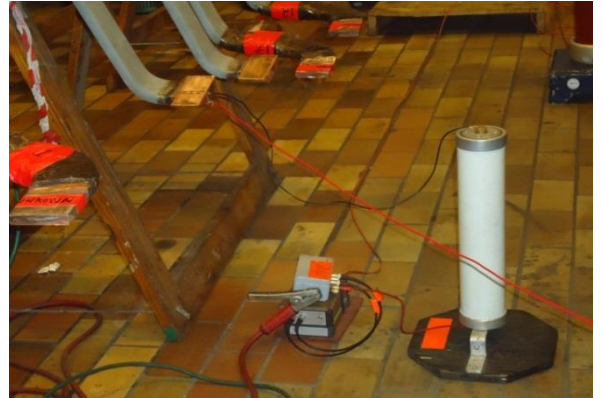
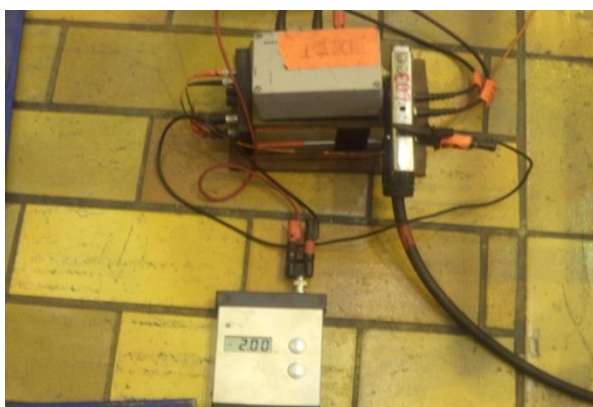
Figure 4-4: PD test configuration showing test equipment and a typical result screen.

The PD testing was conducted in accordance with [7,85,86,87].

The voltage was raised to U phase to ground (6.4 kV), was stabilised for a few minutes and then the PD parameters (Q_{Peak} , Q_{Avg} , DIV) were captured.

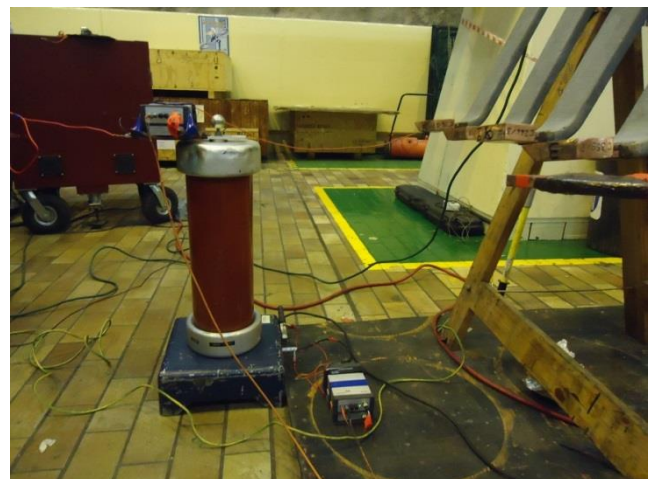
Figure 4-5: TD test configuration showing test equipment

These tests were conducted in accordance with [90,99]. The voltage was gradually increased in steps of 0.2 Un until 6.4 kV AC, and back down to 0 V. Readings of TD, capacitance and current were recorded at the ascending and descending 0.2 Un steps.

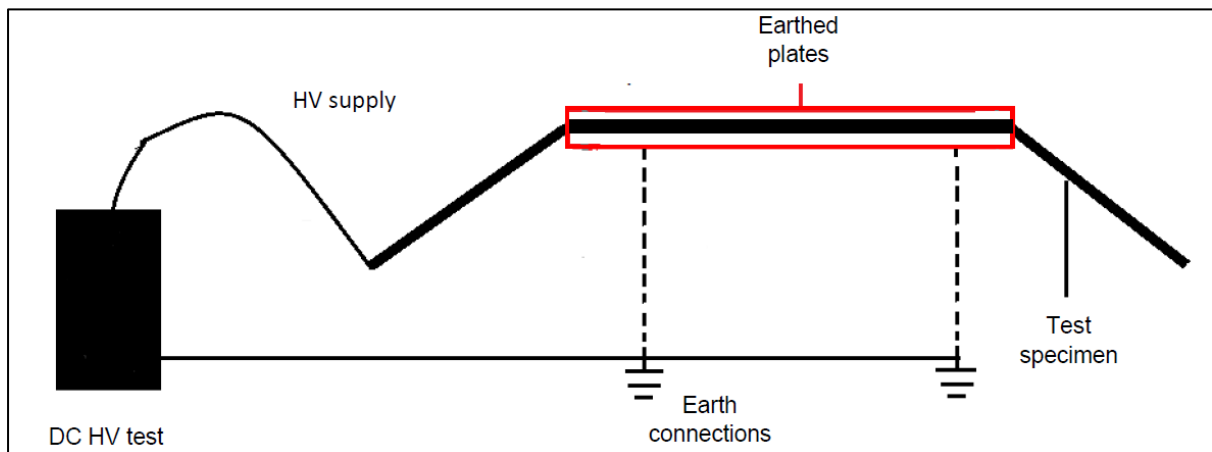
Figure 4-6: HV test circuit [96]

The bars were first tested at 23 kV (VLF) and thereafter at 30 and 50 kV DC respectively.

Figure 4-6 shows the test circuit as per [96 figure1]

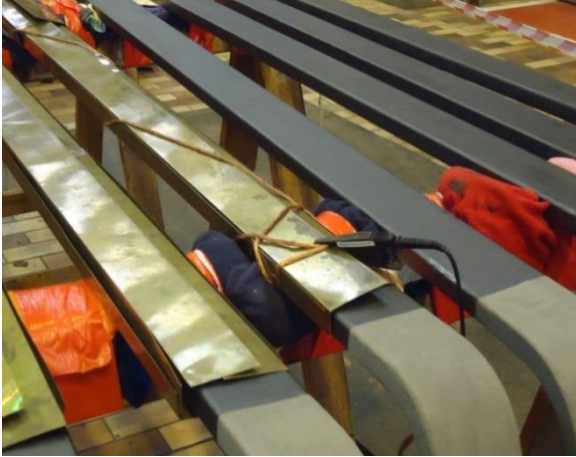
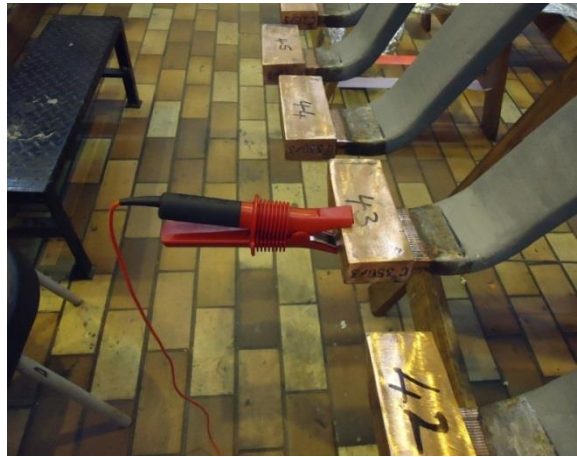
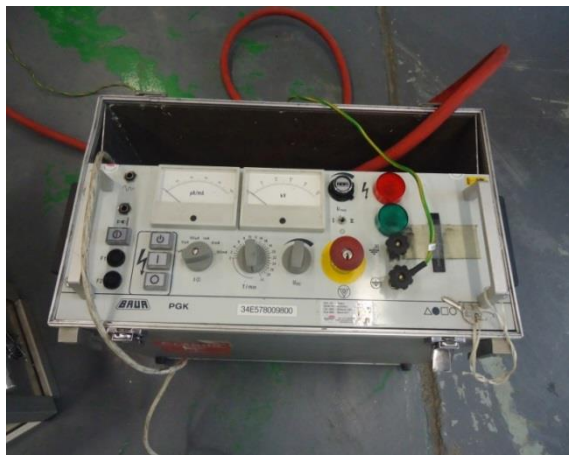
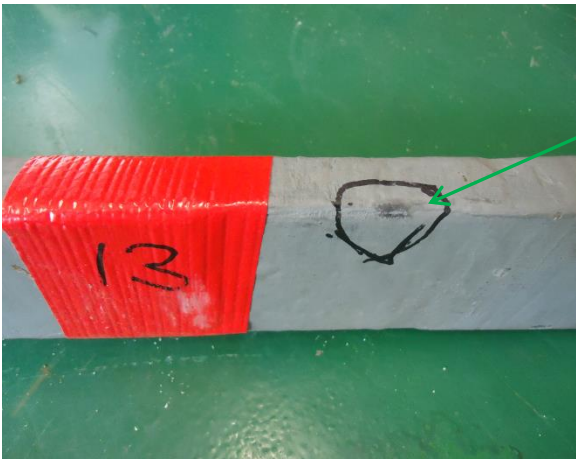
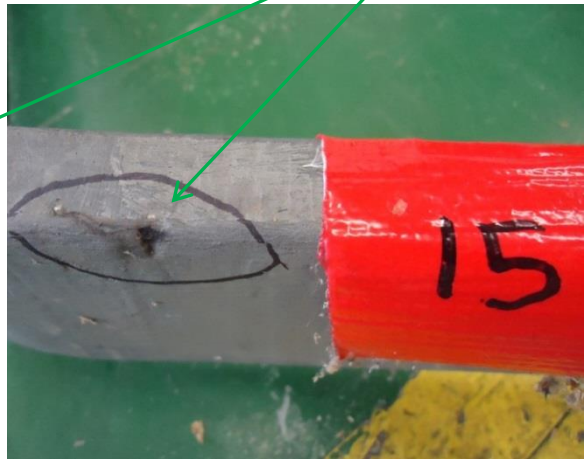
Figure 4-7: HV test configuration with 50 kV test set and fault location of some failed bars

Insulation failure

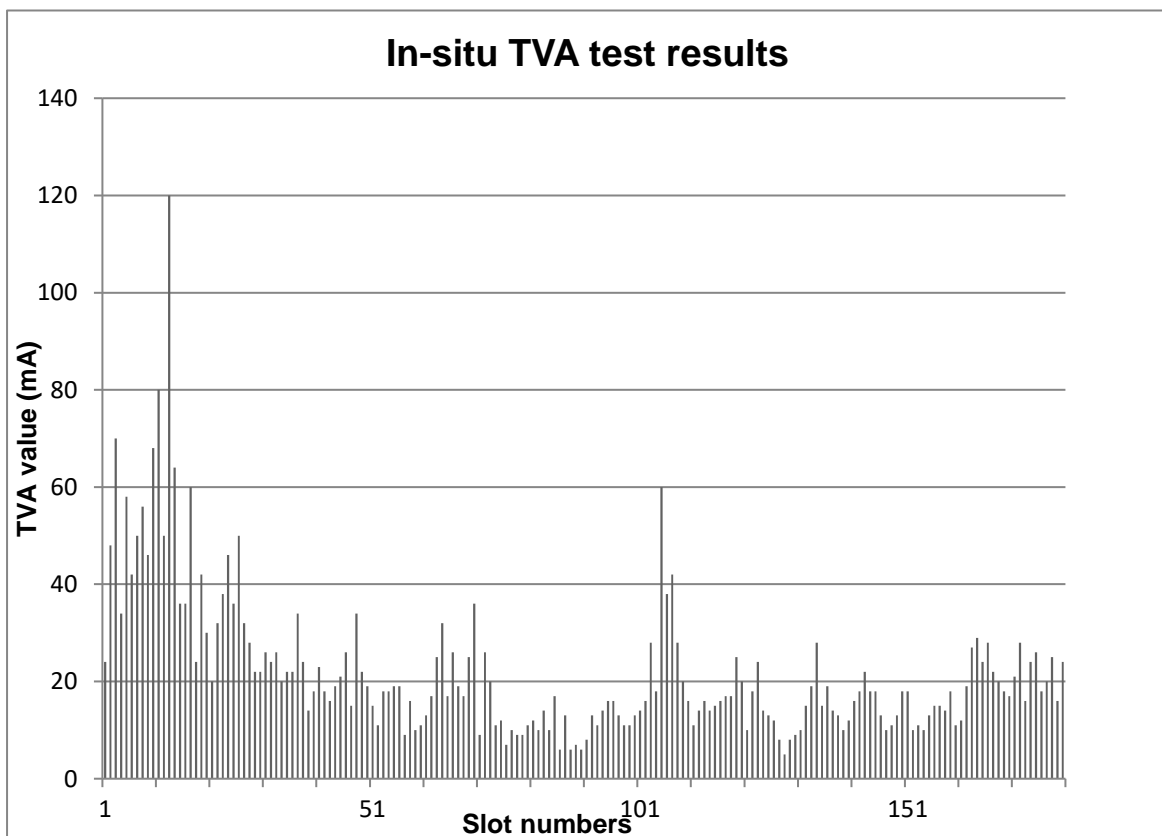
Figure 5-1: In-situ TVA test results

The analyses of the test results are presented in this chapter. The methodology applied was to analyse the in-situ TVA test results (figure 5-1) and select test specimens, with low, medium and high TVA values. It must however be noted that these test values should not be considered as absolutely accurate as the entire generator was energised at 7 kV during this test. Hence, the test values could be influenced from adjacent stator bars. As stated earlier, some test specimens were damaged during removal and the final test specimen selection was made as per table 5-1. These are all top (air gap) bars. These bars were then subjected to the tests as described in section 4.2.2.

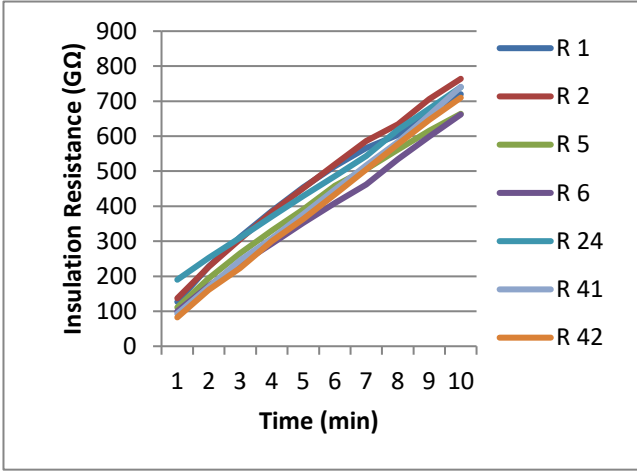
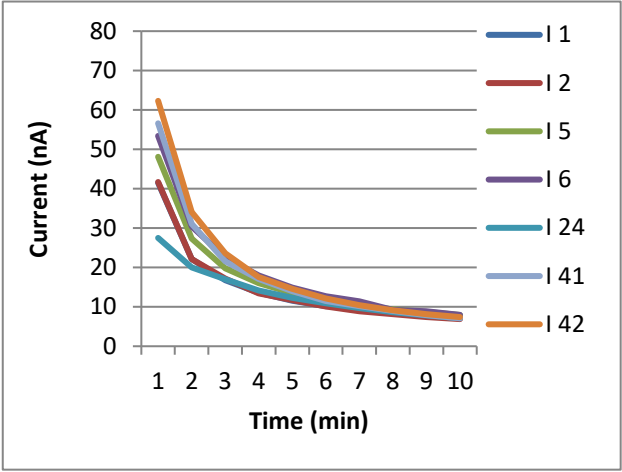
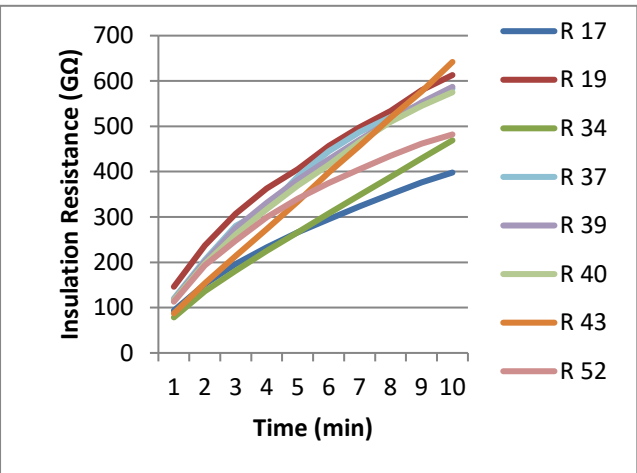
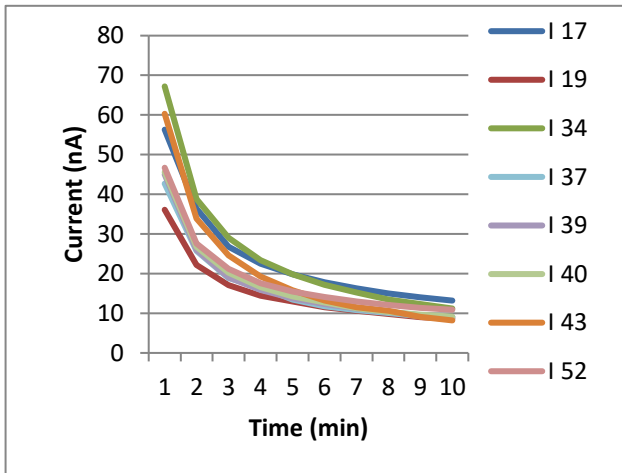
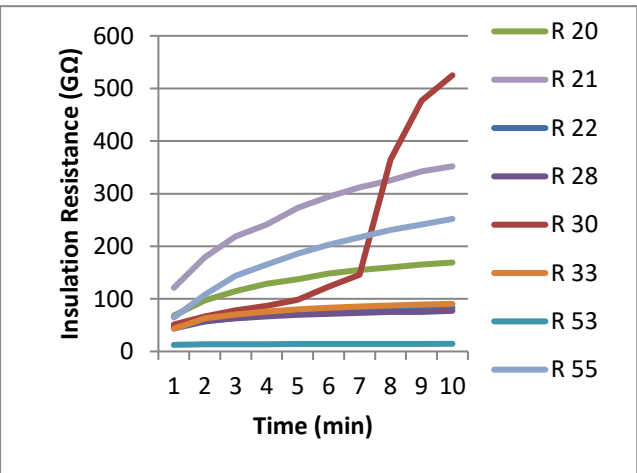
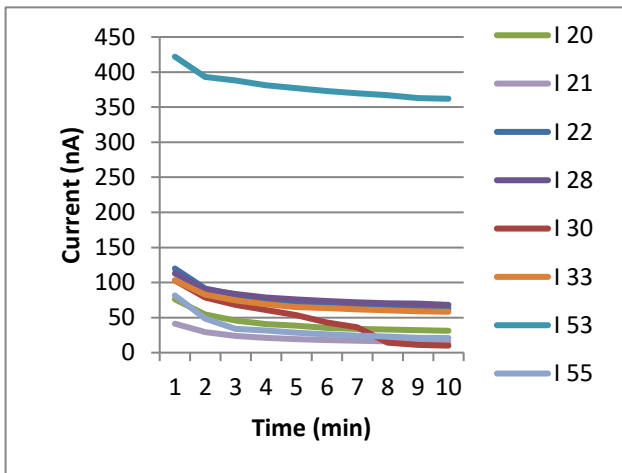
Figure 5-2: Passed bars IR profiles

This demonstrates that the IR value is not a parameter accurately describing insulation deterioration or imminent failure. The test results concur with [32] in stating that high IR values do not indicate no risk of failure during operation.

Figure 5-2 showed that bars 30 and 53 have different profiles to the other bars. This was not immediately evident during testing as the test results were only analysed afterwards. Unfortunately, when this was discovered, it was not possible to return and retest these bars as a possible option would have been to retest with guarded electrodes. Figure 6-1 shows that bar 30 in figure 5-2 could possibly had inconsistent data being recorded as the “before” profile in figure 6-1 shows a normal profile. The “after” profile of bar 30 is however showing an inconsistent curve between minutes 4 and 8 which could again possibly point to inconsistent data being recorded as the HV test cannot have that much of an effect compared to the “before” profile.

Figure 5-2 clearly demonstrates that the IR value is not an indicator of impending insulation failure as there are bars of lower readings, that is, Bars 53 and 28, with values of 14.4 GΩ and 77.3 GΩ respectively, and bars of higher readings, Bars 41 and 2, with values of 741 GΩ and 764 GΩ respectively, all passing the HV tests.

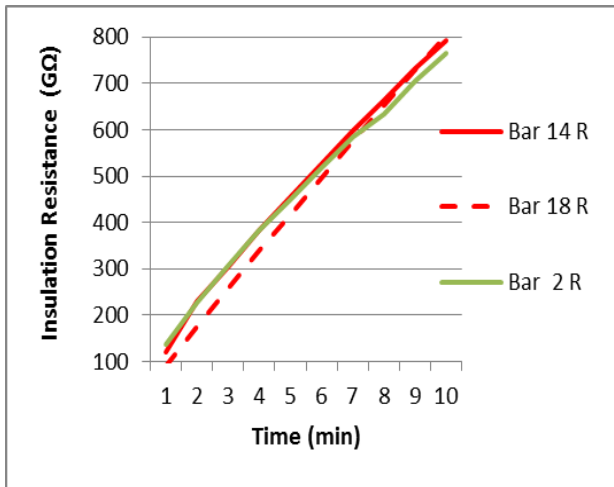
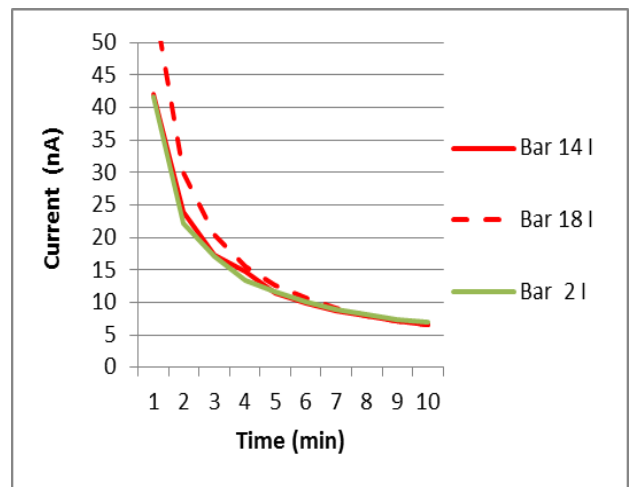
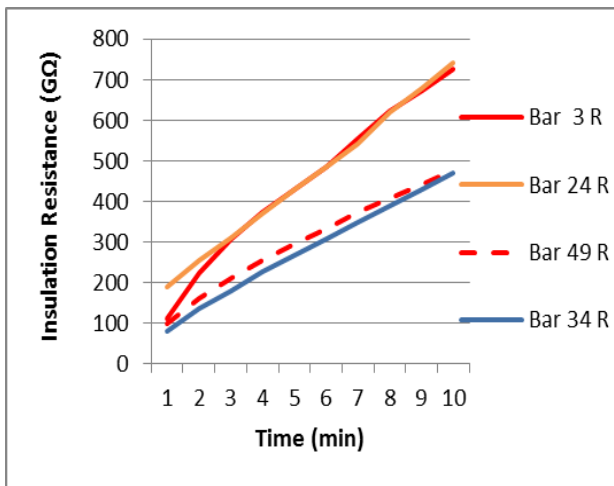
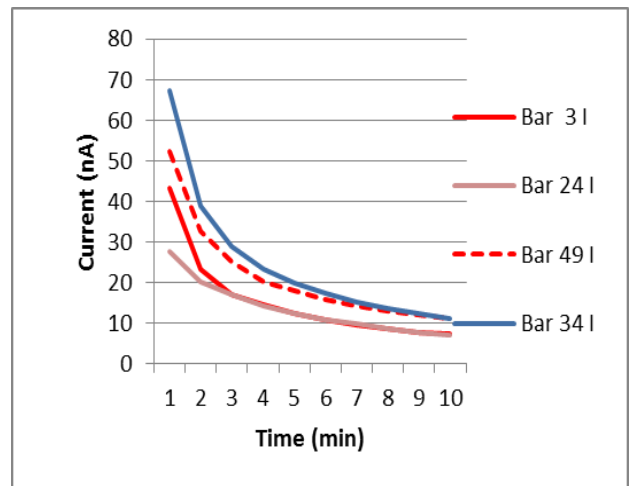
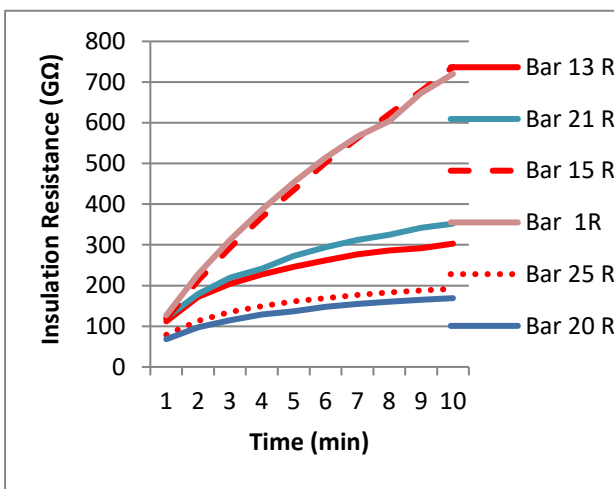
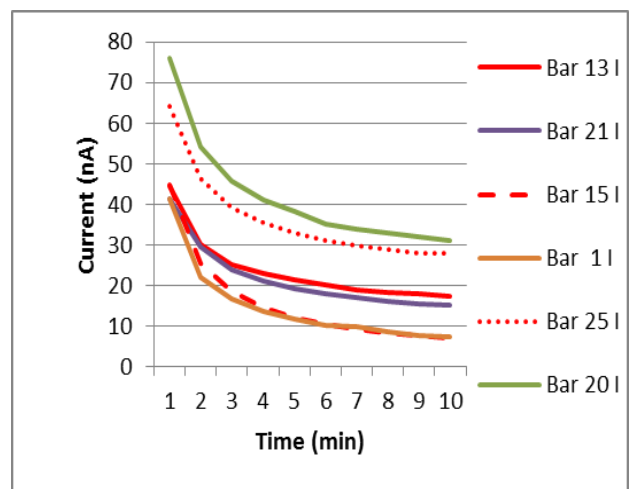
Figure 5-3: Combination of passed and failed bars IR profiles

This is further demonstrated in figure 5-3 when comparing the profiles (red profiles) of the bars that would eventually fail the 50 kV DC test :3, 13, 14, 15, 18, 25 and 49 to that of the passed bars, from figure 5-2, with similar profiles. This is clearly demonstrated with the following profiles: Bars 2 and 14 & 18; 24 and 3; 34 and 49; 1 and 15; 21 and 13; 20 and 25.

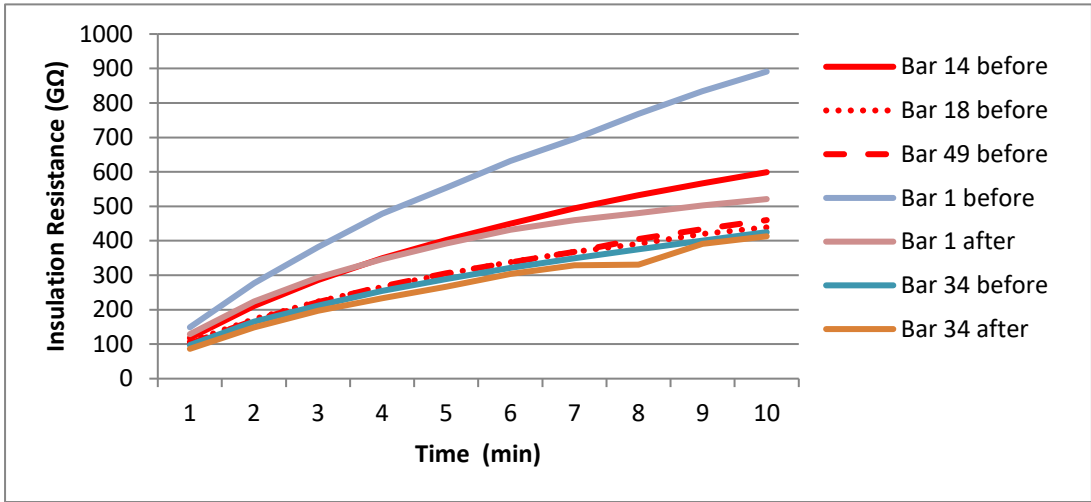
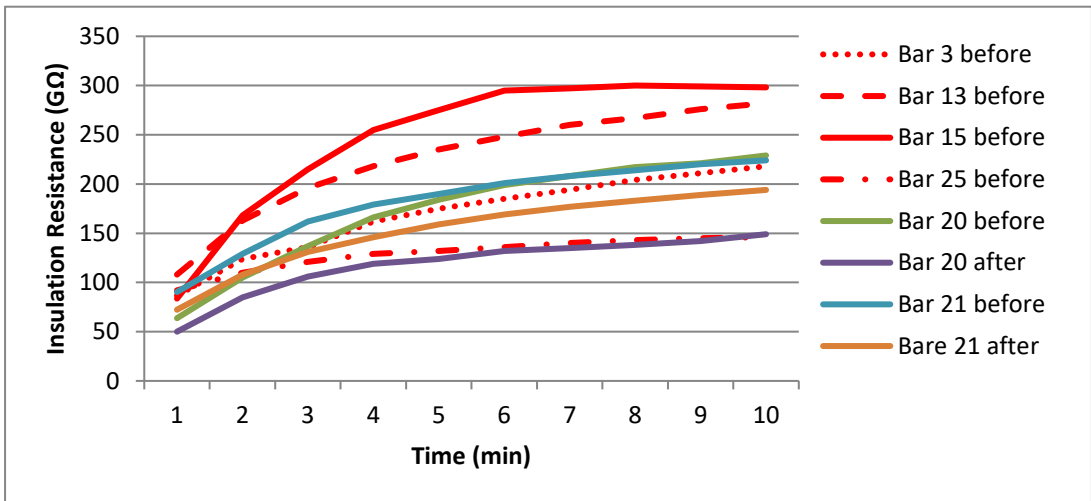
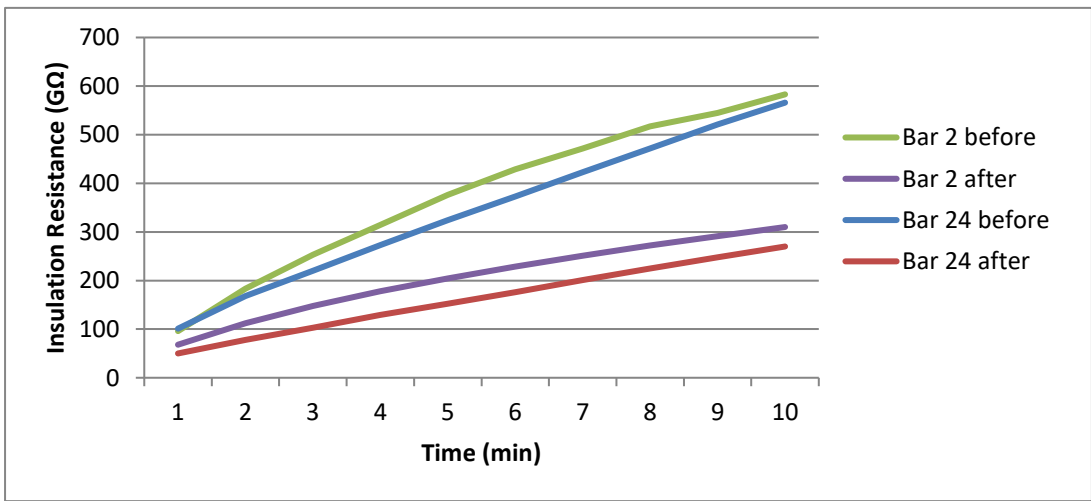
Figure 5-4: Comparing IR profiles "before" and "after" HV tests

There are, naturally no 'after' HV tests profiles to display for the failed bars.

However, even though the failed bars had IR and PI values above the specified [82] values after the diagnostic tests (IR and PI values before HV testing in table C-4), they nevertheless failed the 50 kV DC test.

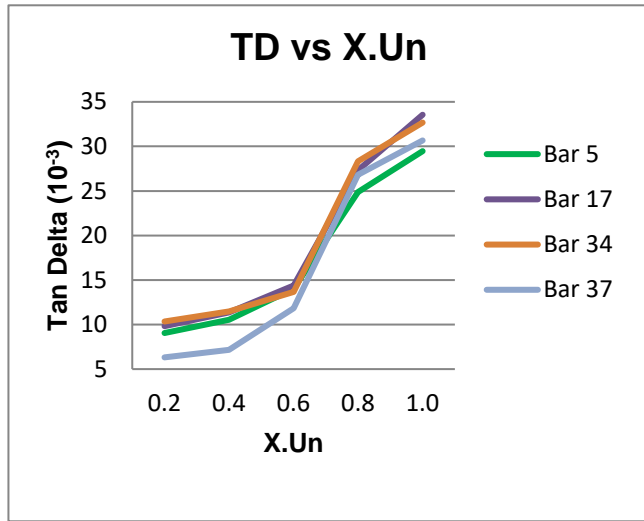
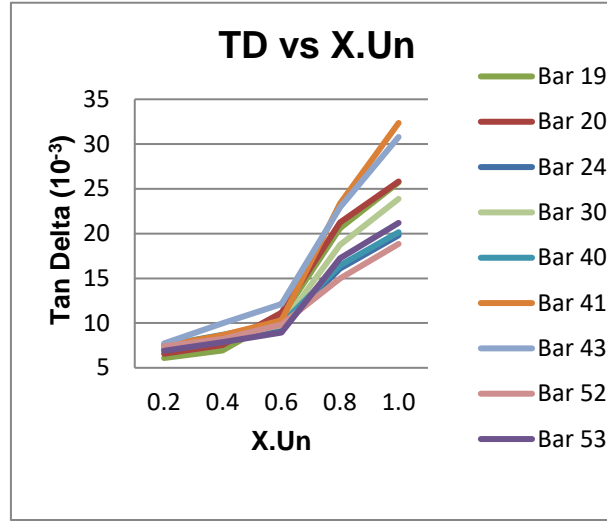
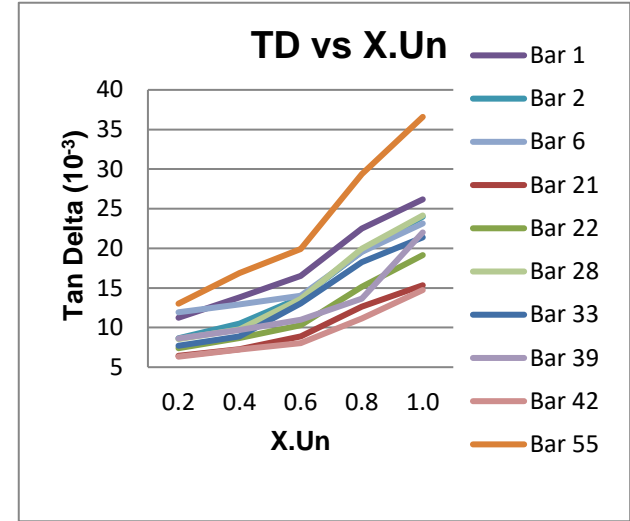
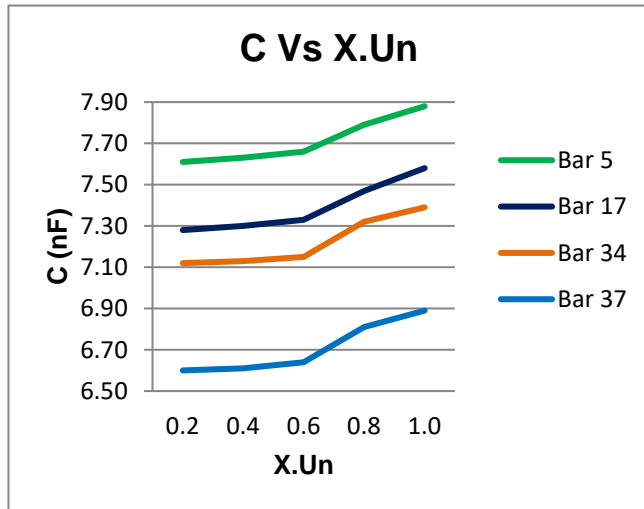
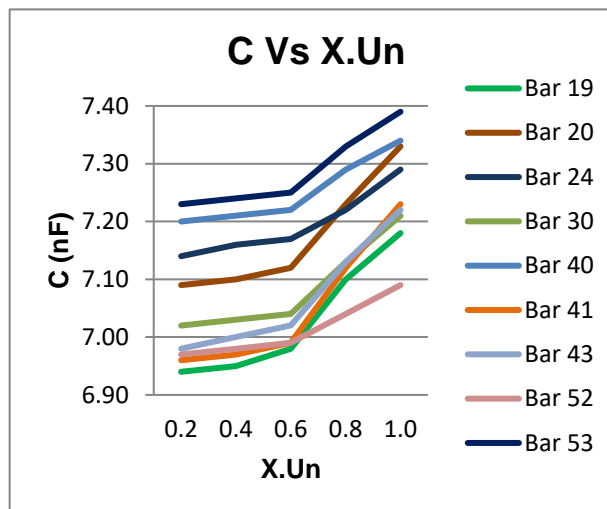
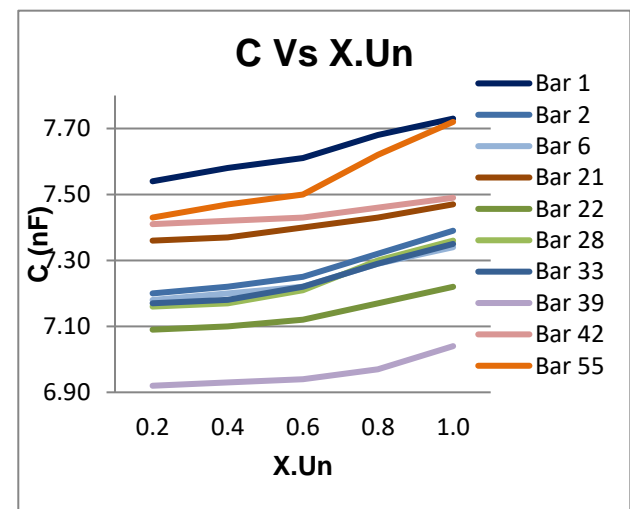
Figure 5-5: Passed bars TD profiles

Figure 5-5 also shows the TD profiles of the passed bars (6.10 -13.02) all below the defined acceptance limit of 20 [90]. Again, the bars that would eventually fail (red profiles) the 50 kV DC test are not shown. Instead, these are shown (red profiles) in figure 5-6, with values of (8.18- 9.20) where they are compared with similar profiles of bars that passed the 50 kV DC test.

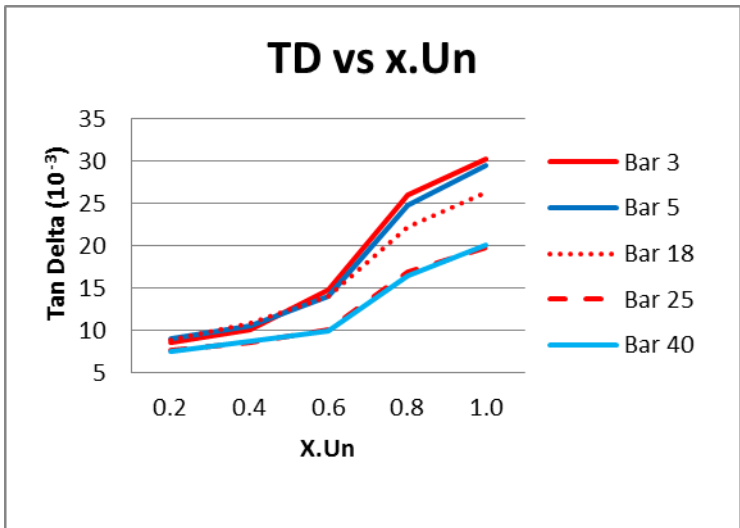
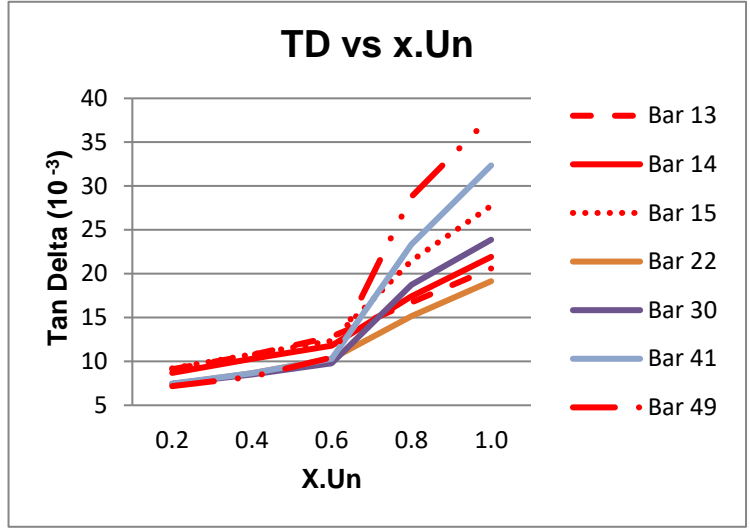
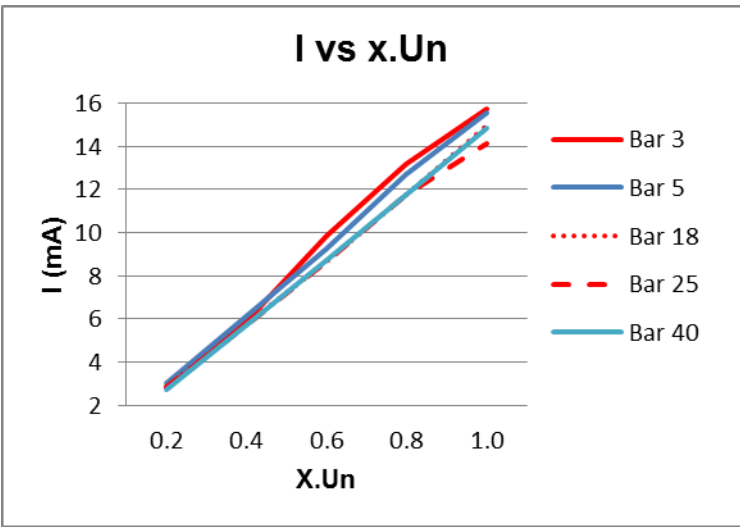
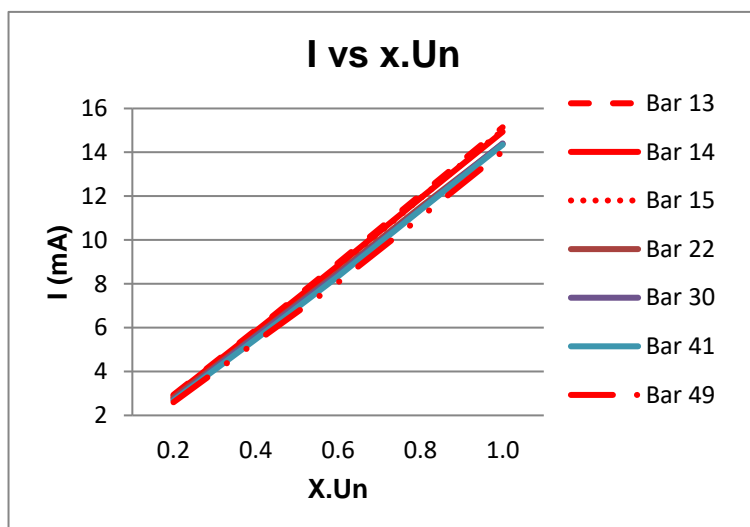
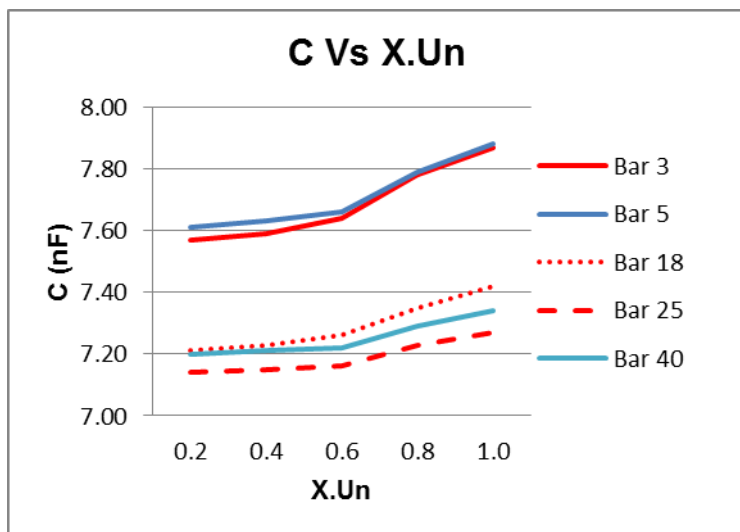
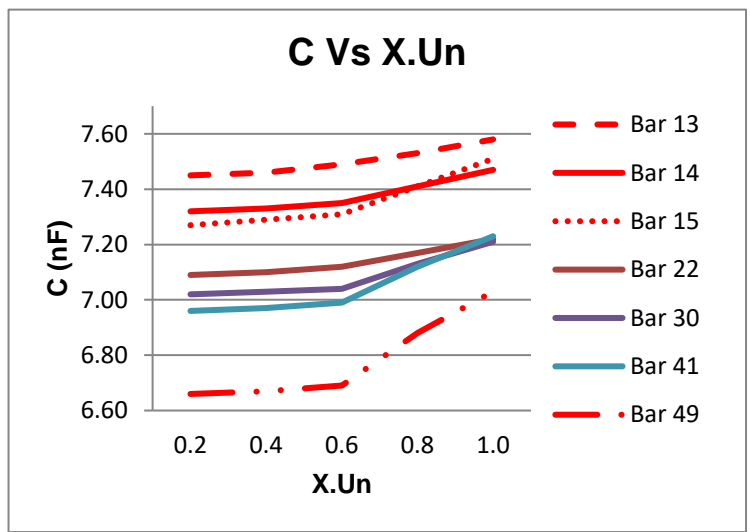
Figure 5-6: Combination of passed and failed bars TD profiles

Figure 5-6 shows very similar profiles for Bars 5 & 3; 40 & 18, 25; 22 & 13; 30 & 15. Once again, this indicates that this test parameter is not a reliable and consistent indicator of imminent insulation failures. It shows that individual data points are inconsistent in predicting bar failure as bars with similar values and profiles both pass and fail the HV test. It points to TD could possibly be more predictive of bar failure if applied as a trending parameter.

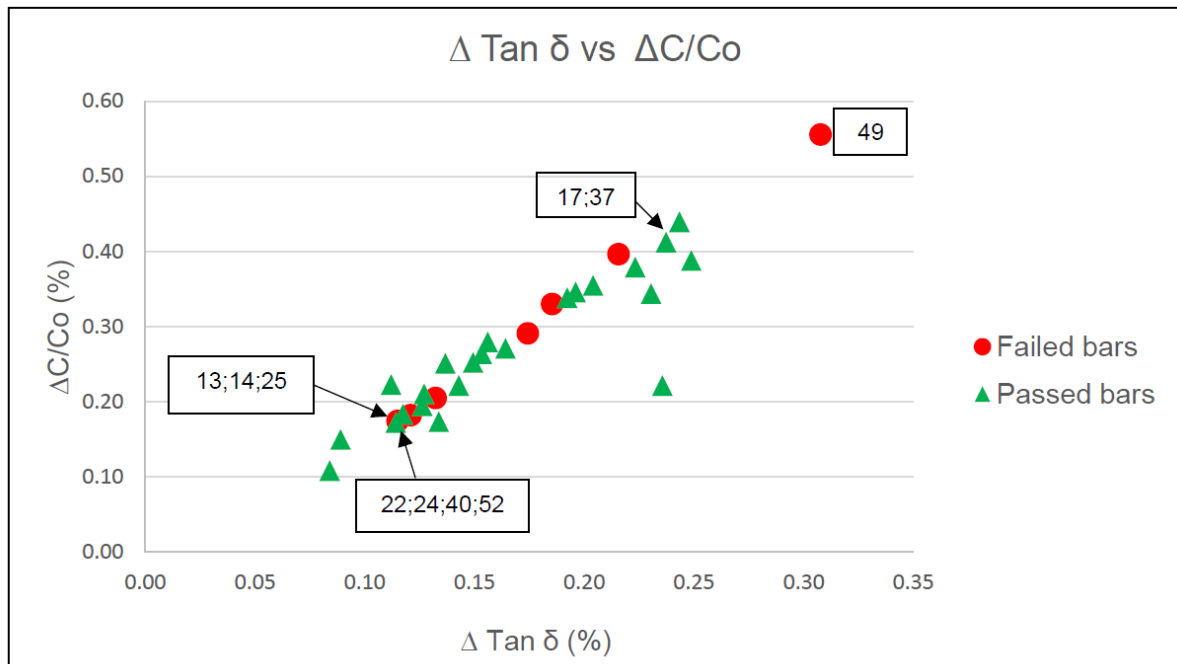
Figure 5-7: $\Delta \text{Tan } \delta$ vs $\Delta \text{C/Co}$

Figure 5-7 and table 5-2 show a high degree of correlation between $\Delta \text{C/Co}$ and $\Delta \text{Tan } \delta$. This is to be expected as both are measuring the content of voids in the insulation. The expectation is that the higher the values, the more deteriorated the insulation and thus more prone to failure [90,16]. This is the case with bar 49 but not with some of the other failed bars 13,14 and 25 as these are of the lower range while bars 17 and 37, with higher values than the failed bars (other than bar 49) passed the HV test. This is contrasting to expectations as other than bar 49, bars 17 and 37 have the highest readings from both $\Delta \text{C/Co}$ and $\Delta \text{Tan } \delta$ perspective. Also, bars 22, 24, 40, and 52 with similar values to bars 13,14 and 25 have also passed the HV test meaning that these parameters are not indicative of bars to be identified for imminent failure.

Figure 5-10 is corresponding with the findings of figure 5-7 in that those bars with very similar diagnostic test values, and in this case an additional parameter of operating voltage, both passed and failed (bars with black border line) at very similar values: 13 and 52; 14 and 24; 6 and 25. It is also showing the contrast that bar 17 with a combination of high $\Delta \text{C/Co}$ and $\Delta \text{Tan } \delta$ does not mean failure at the higher operating voltage contrasting to bar 13 with a combination of almost the lowest test values and operating voltage. Therefor re-affirming that these parameters are not good indicators of imminent insulation failure.

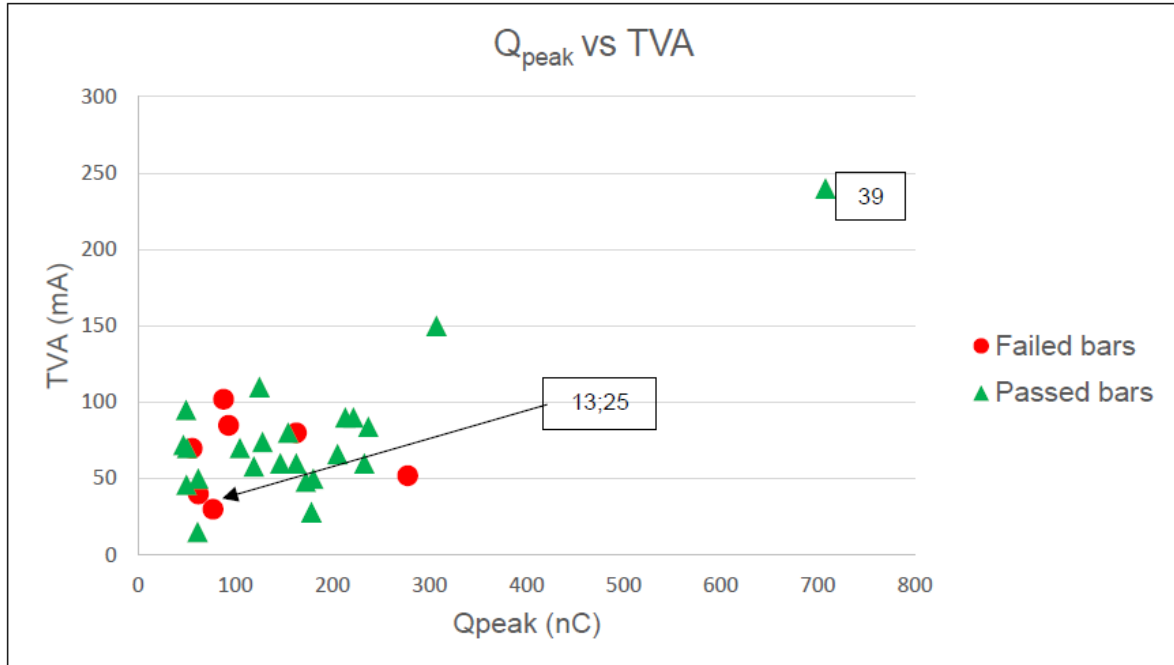
Figure 5-8: Q_{Peak} Vs TVA

Table 5-2 and figure 5-8 also show a degree of correlation between Q_{Peak} and TVA values. Again, this is expected as both values are measuring partial discharges. However, a closer correlation would have been expected. The lack of a higher correlation could possibly be attributed to the instruments taking measurements at different frequencies and that the TVA measurements are not electronically stored measurements but read by the operator. It should also be considered that these readings are read from an analogue meter making the accuracy more operator dependent.

Bar 39 measured the highest values but passed the HV test. Again, against expectations. The fact that Q_{Peak} is the measurement of PD at the most deteriorated part of the bar, and that bar 39 which is almost double in value for both Q_{Peak} and TVA compared to the other bars, did pass is an indication that these parameters are not good indicators of imminent insulation failure [81]. This is contrasting to the failures of bars 13 and 25 which are at the lower spectrum for both Q_{Peak} and TVA. In fact, the figure shows some failed and passed bars showing very similar readings and thereby affirming the previous statement.
