**Testing for relationship between diagnostic tests and
DC BDV of in-serviced aged stator bars of a hydro
generator**

**Department of Electrical Engineering
University of Cape Town**

**A Thesis submitted to the Faculty of Engineering and the Built Environment in
fulfilment of the requirements for the degree of Doctor of Philosophy in Engineering**

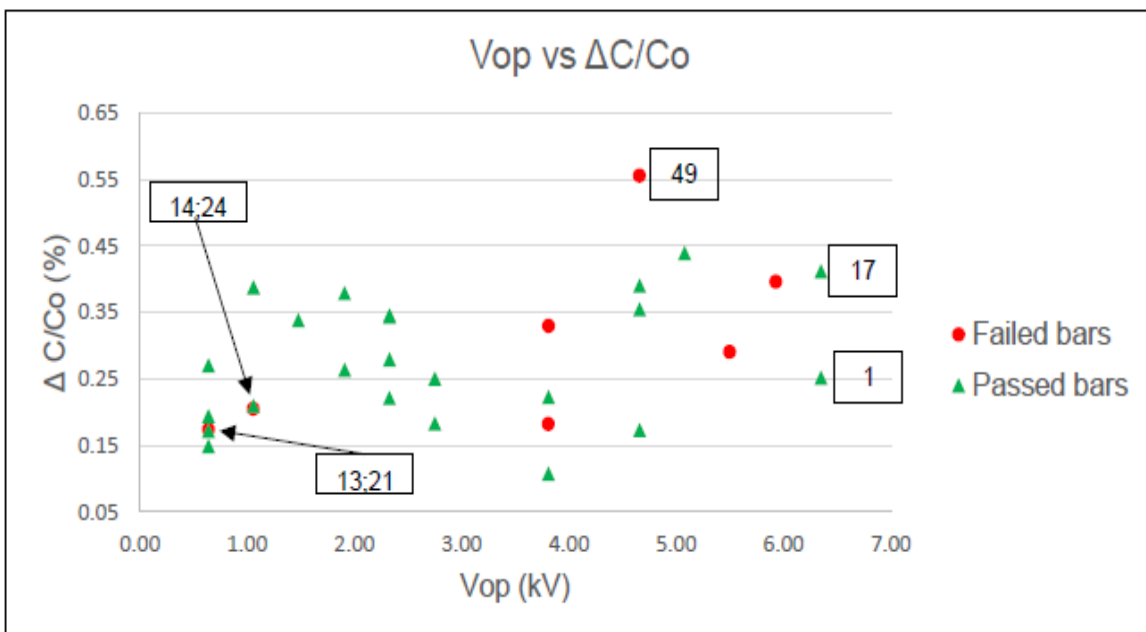
Figure 5-9: Vop vs $\Delta C/Co$

Also, the failure mechanism is not voltage driven as two of the failed bars 13 and 14 failed at the lower voltage spectrum and two passed bars 1 and 17 are at a higher voltage than any of the failed bars.

Also, two of the failed bars 13 and 14 are at the lower spectrum for both voltage and capacitance tip-up and have very similar values to two of the passed bars 21 and 24. Hence, proving that ageing was not driven by electrical stress.

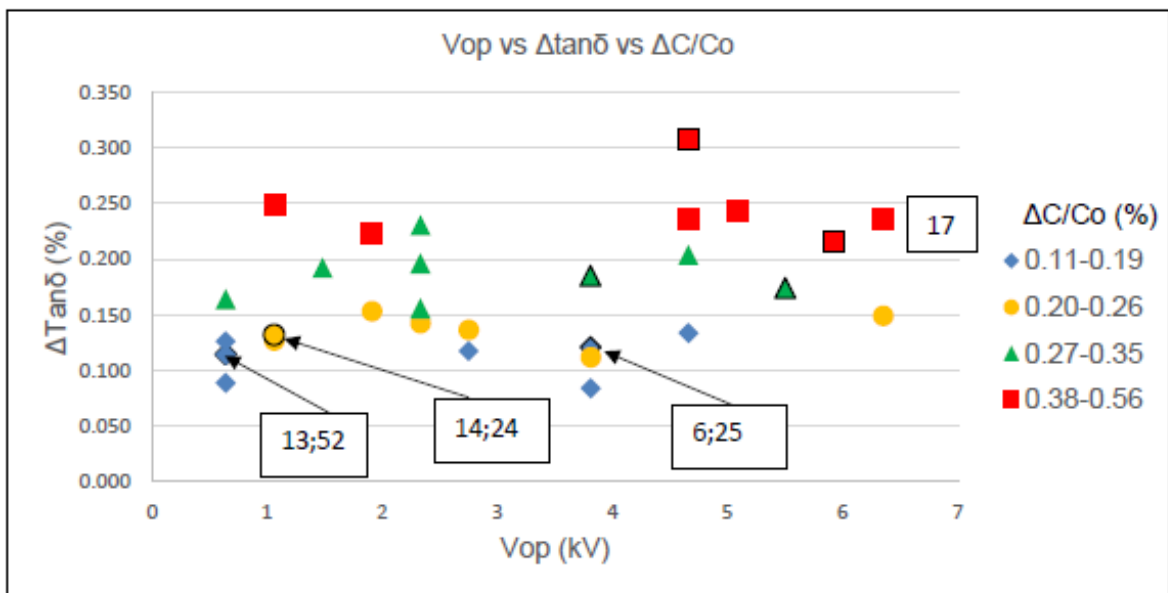
Figure 5-10: Vop vs $\Delta \text{Tan } \delta$ vs $\Delta \text{C/Co}$

Figure 5-10 is corresponding with the findings of figure 5-7 in that those bars with very similar diagnostic test values, and in this case an additional parameter of operating voltage, both passed and failed (bars with black border line) at very similar values: 13 and 52; 14 and 24; 6 and 25. It is also showing the contrast that bar 17 with a combination of high $\Delta \text{C/Co}$ and $\Delta \text{Tan } \delta$ does not mean failure at the higher operating voltage contrasting to bar 13 with a combination of almost the lowest test values and operating voltage. Therefor re-affirming that these parameters are not good indicators of imminent insulation failure.

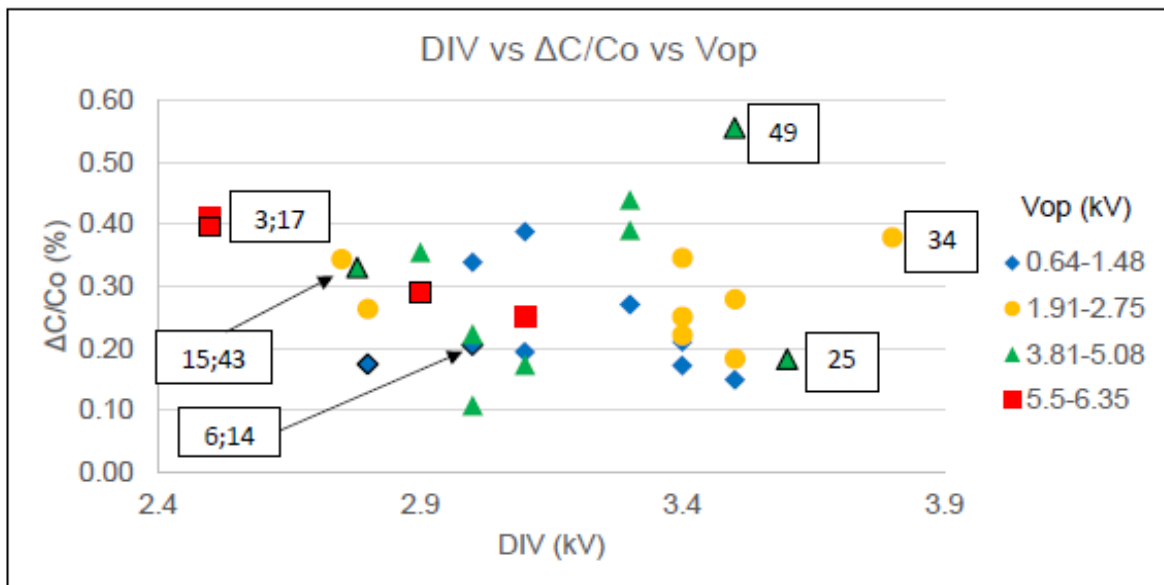
Figure 5-11: DIV vs $\Delta C/Co$ vs Vop

Again, some of the passed and failed bars display similar values for all three parameters: bars 3 and 17. Bars 15 and 43 have similar DIV and $\Delta C/Co$ values and operating voltages of 3.81 kV and 2.33 kV respectively. The same for bars 6 and 14 with operating voltages of 3.81 kV and 1.06 kV respectively. Clearly showing that operating voltage is not the failing mechanism.

Also, although bars 25 and 49 are failed bars with capacitance tip-ups of 0.18% and 0.56% respectively, 78% of the passed bars have tip-up values between these values thereby indicating that the combination of tip-up and DIV value is also not indicative of future insulation failure.

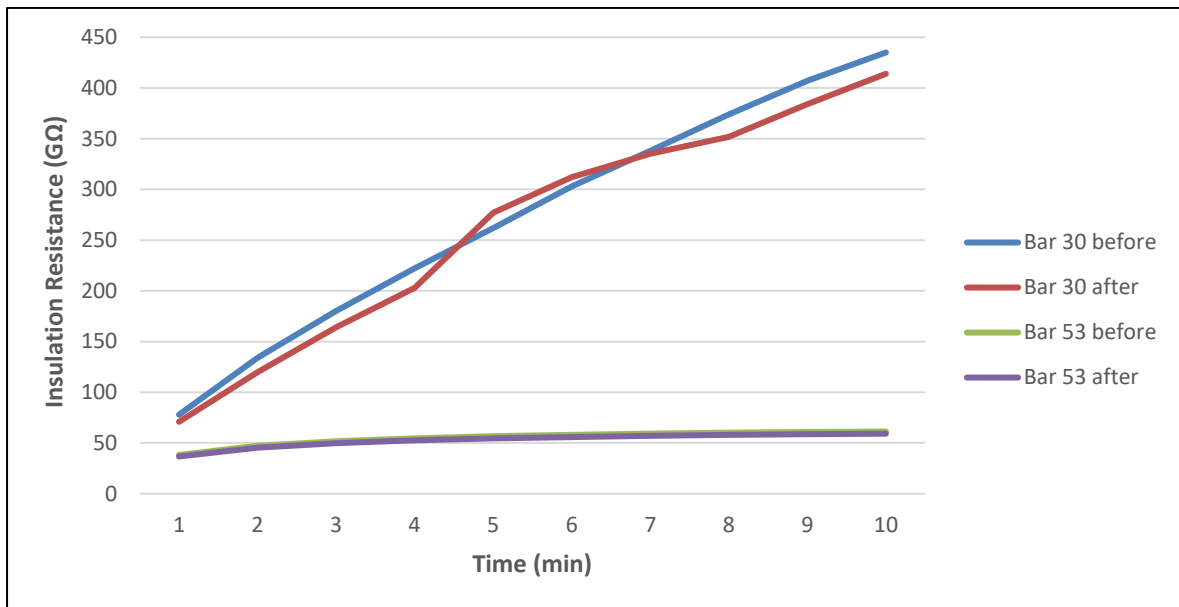
Figure 6-1: Bar 30 and 53 'before' and 'after' HV test profiles

Figure 5-2 showed that bars 30 and 53 have different profiles to the other bars. This was not immediately evident during testing as the test results were only analysed afterwards. Unfortunately, when this was discovered, it was not possible to return and retest these bars as a possible option would have been to retest with guarded electrodes. Figure 6-1 shows that bar 30 in figure 5-2 could possibly had inconsistent data being recorded as the “before” profile in figure 6-1 shows a normal profile. The “after” profile of bar 30 is however showing an inconsistent curve between minutes 4 and 8 which could again possibly point to inconsistent data being recorded as the HV test cannot have that much of an effect compared to the “before” profile.

On the other hand, the profiles of bar 53 show to be reproduceable to those in figure 5-2, albeit at lower IR and PI values of 38.2 GΩ and 1.61 respectively, compared to the average values of 93.92 GΩ and 4.32 of the other tested bars. However, the low IR value of bar 53 is still much higher than the defined acceptance value (100 MΩ) in [82] albeit for a complete winding.
