Department of Civil Engineering

Critical Literature Review on Concrete Crack Repairs

Dissertation presented for the Degree of Master of Engineering in Civil Infrastructure

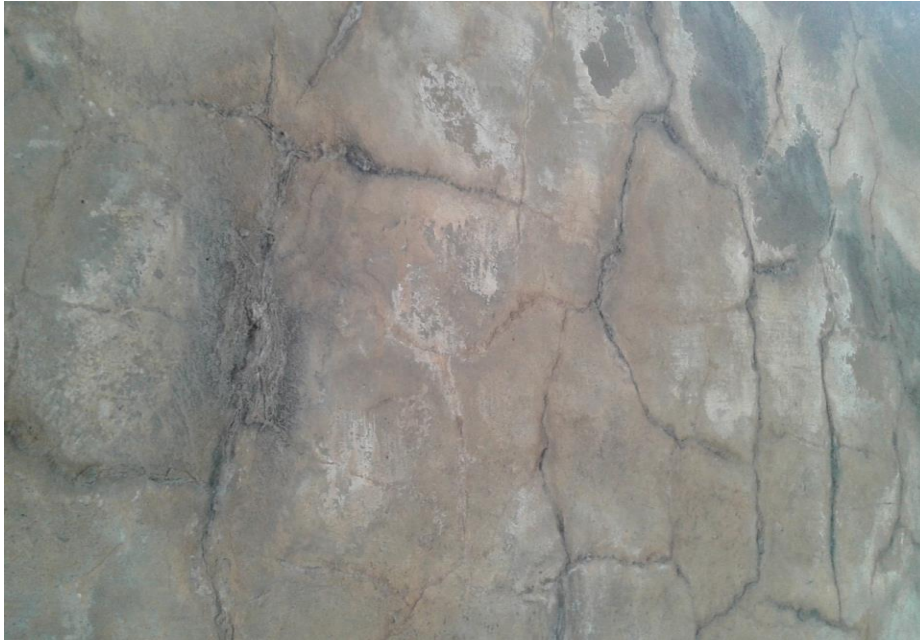
In the Eastern Cape Umtata area, the effects of ASR have been observed in concrete structures such as dams, bridges and electric mast foundations. In Gauteng, there are signs of deterioration due to ASR especially in the Heidelberg region which is located in the eastern side of Gauteng. The type of aggregates used are the Witwatersrand quartzite (Schutte, 1982). Blight and Alexander (2001) have reported the effects of ASR on several structures in South Africa. They have monitored in service a bridge pier affected by ASR. After their investigations, they were of the view that full-scale load testing must be regarded as the ultimate criterion of the serviceability of an ASR-affected structure and state that “If the structure behaves predictably and in accordance with the design requirements and if strains and deformations are of reasonable magnitude and recoverability, there can be little doubt that the structural adequacy has been preserved”. Mitigation of ASR can be achieved through reducing the reactive silica amounts in concrete aggregates, minimising the external alkalis and reducing the alkali content in cement. ASR cracks are usually associated with map pattern cracks as indicated on Figure 1 below.

Figure 1 ASR wider and spreading map pattern cracks (Wood, 2009)

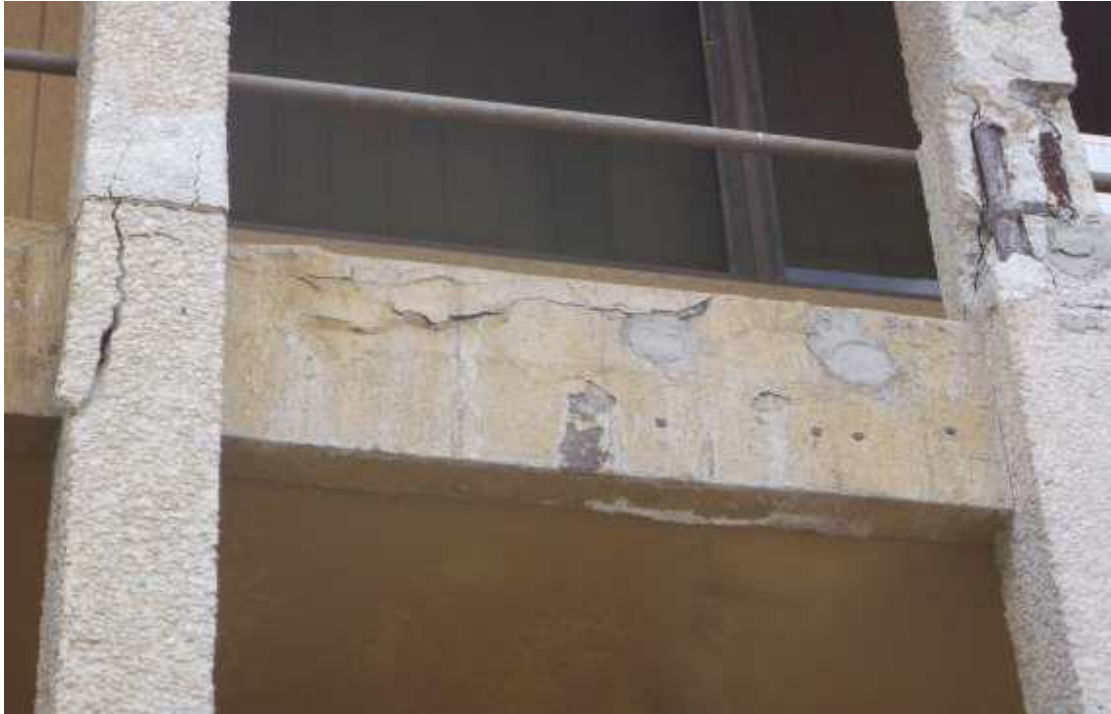
Steel reinforcement corrosion has been experienced in South Africa. Concrete structures located in coastal areas such as Durban, East London, Port Elizabeth and Cape Town are the most affected due to chloride induced corrosion. The corrosion effects are common due to the shallow cover to reinforcement. As a case study carried out by the author, the SABS building in Durban will be utilised as an example. On the structure, significant signs of corrosion were detected in 2014 and the effects were found to compromise the structural integrity of the building (Figure 2) below. Chloride and carbonation tests were carried out and corrosion was detected to be a result of chloride effects and this was mostly likely because the structure is located close to the Indian Ocean. However, corrosion effects are also being experienced on inland structures mainly due to carbonation effects. In Pretoria, the former Public Works Tshwane Building a 14 storey suffered reinforcement steel corrosion and the occupants have been relocated to another structure since the structural integrity has been compromised. A team of professionals has been appointed to conduct condition assessments and develop a detailed maintenance plan to repair the building and restore its structural integrity.

Figure 2: Cracking, spalling and delaminations at the SABS building due to corrosion effects

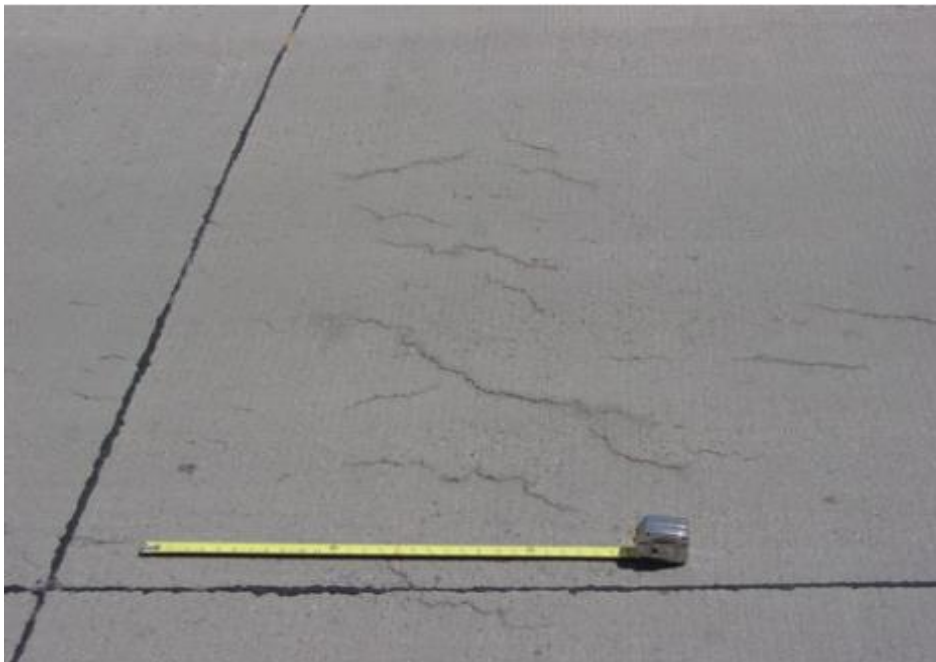
can also be a result of the hydration process which removes free water or a result of drying due to inadequate protection (Witman, 1976). Martin (2008) describes plastic shrinkage cracks in concrete being a result of restraint provided by the concrete below the drying surface, resulting in tensile stresses developing in the weak stiffening plastic concrete. The result is cracks forming in different polygon random patterns of shallow depths parallel to each other as shown on Figure 3 below.

Figure 3: Plastic shrinkage cracks at Unilever Ice Cream Plant in Midrand, Johannesburg

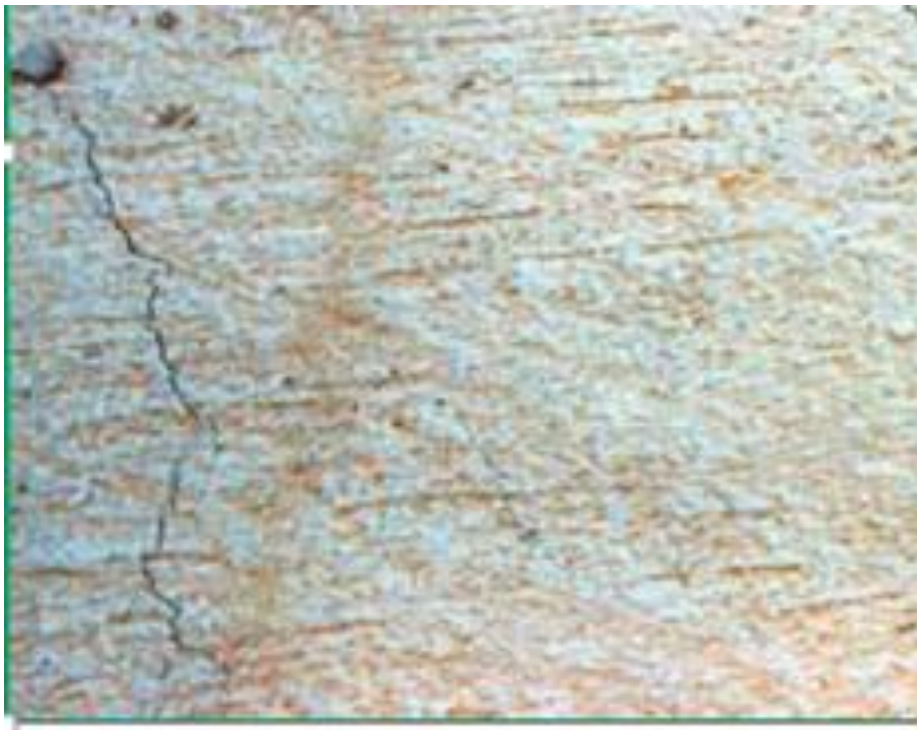
The author has been recently involved in another project in Gauteng. The project was for Peri, the company provides scaffolding for concrete works around South Africa. The company secured a larger area for their operations and they had to build an office block, concrete parking area and a warehouse. The parking area was constructed of reinforced concrete 200 mm thick, 30MPa and concrete joints at 2 m intervals. Concrete cracking due to drying shrinkage was experienced at the Peri scaffolding delivery yard concrete pavement in Centurion, South Africa in March 2017. The author was involved in providing repair solutions to the concrete yard, which was approximately 10 000 m² in size. Figure 4 below shows concrete cracking due to drying shrinkage.

Figure 4: Drying shrinkage cracking on a concrete slab (Peri Scaffolding in Centurion, South Africa)

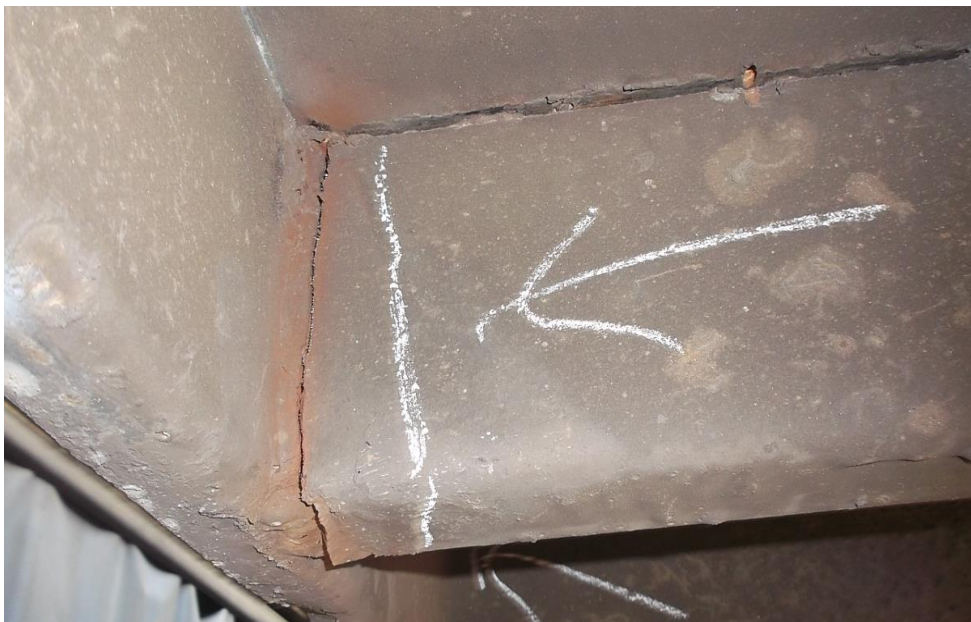
Figure 5: Structural cracks (Edwin, 2017)

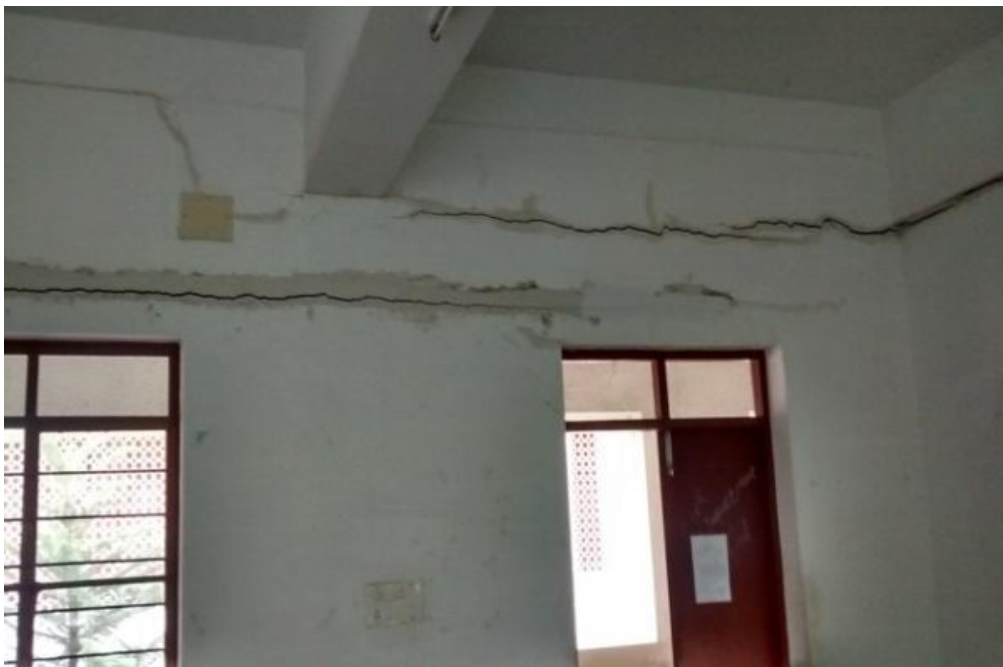
The author's experience on structural cracking was the cracking due to foundation movements at a school built in the Free State, South Africa in 2015. Phephetso Secondary School located in Kroonstad was constructed through the Development Bank of Southern Africa (DBSA), Accelerated Schools Infrastructure Delivery Initiative Programme (ASIDI) in 2015. A year after construction, the classroom blocks started to develop structural cracks in areas above the windows and doors as shown on Figure 6 below. The conclusion was foundation movements due to heaving effects of the clay soil below the foundation during the rainy season.

Figure 6: Structural cracks at Phephetso Secondary School classrooms

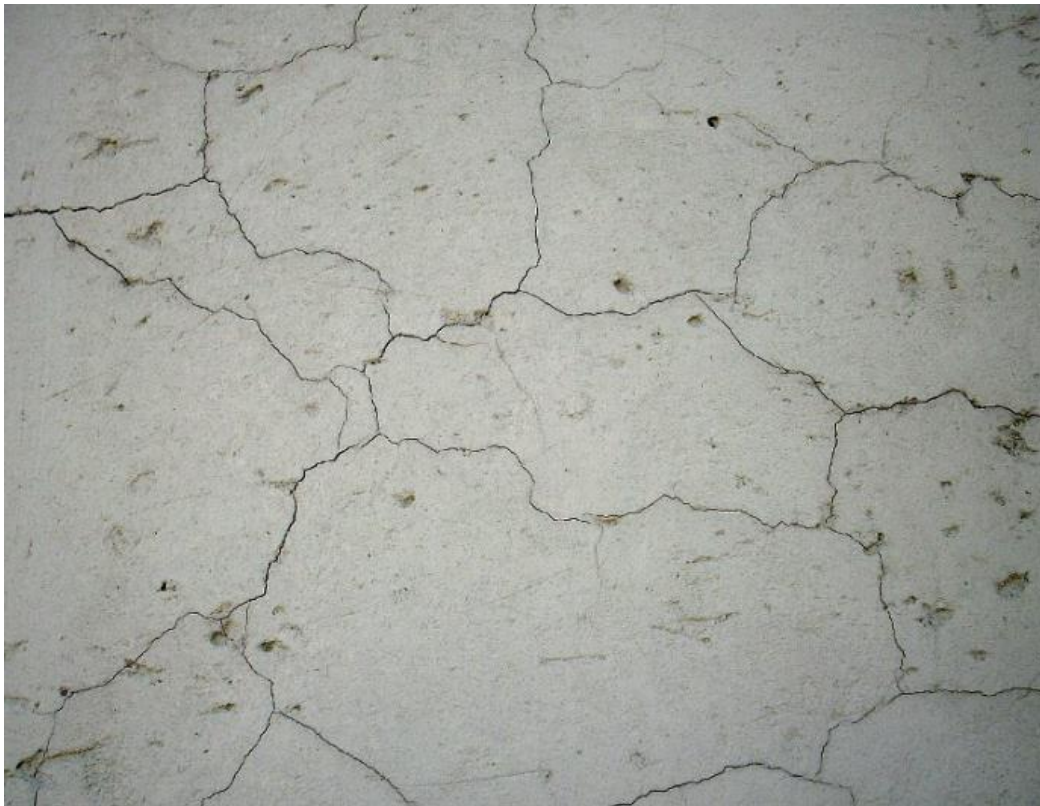
Visual assessments are used to identify effects of cracking in concrete such as map cracking, localised cracking, hairline cracking, offset cracking and diagonal corner cracking. Crack width is one of the features that can be used to determine the cause and effects of cracking. Although there are many sophisticated ways to determine crack width, a plastic crack comparator is a common simple equipment that can be used to determine crack width. Map cracking and hairline cracking usually occur due to non-structural effects and the crack widths are small. Offset and diagonal cracking usually emanate due to structural effects and the crack widths are relatively large. Map cracking or crazing can be identified by a naked eye and they often do not pose any structural issues due to the fact that they are usually shallow and limited to the concrete surface. Crazing cracks or map cracking are often related to plastic shrinkage and commonly regular in appearance (Allam, 2012). Figure 7 below shows an image of map cracking.

Figure 7: Map pattern cracks (CRM1-279, 2012)

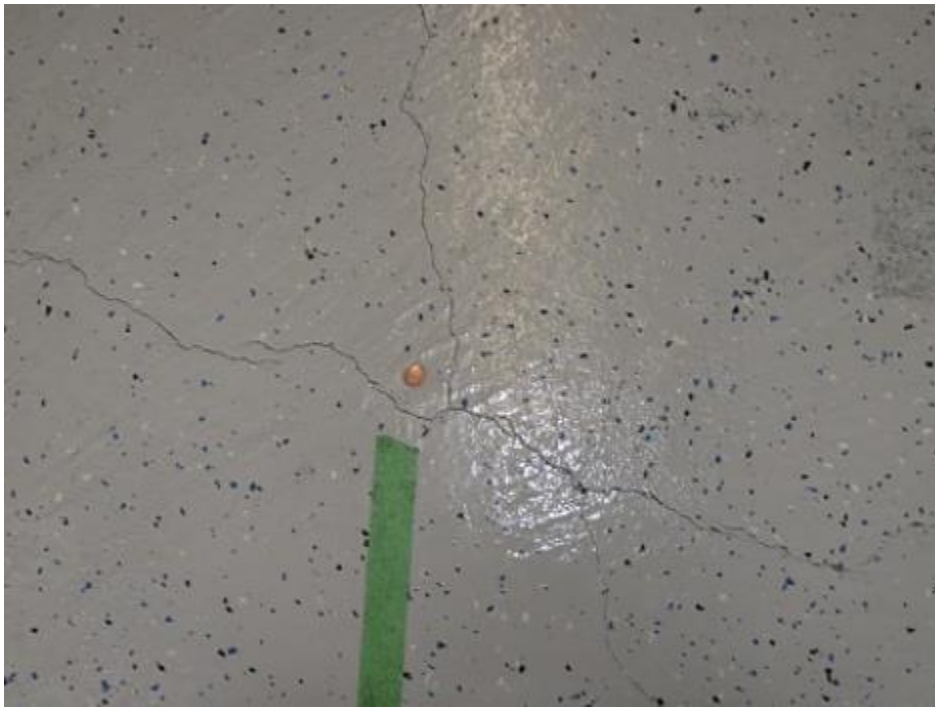
fresh concrete. It is characterised by very thin, shallow features and allow for more serious cracking once the concrete has hardened. An example of hairline cracking is indicated on Figure 8 below and they are usually less than 0.08 mm in width. Hairline cracks originate from various reasons such as concrete settlement after placing and shrinkage effects. However, recent literature does not show any method of determining crack depth based on crack width. Hairline cracks due to thermal variations are observed during the initial stages of cracking and they act as early warning signs to cracking effects. However, if they are not addressed immediately they may widen to values greater than 0.08 mm. Crack widths due to foundation movements can be as wide as 5 mm (Martin, 2008).

Figure 8: Hairline cracks (Allam, 2012)

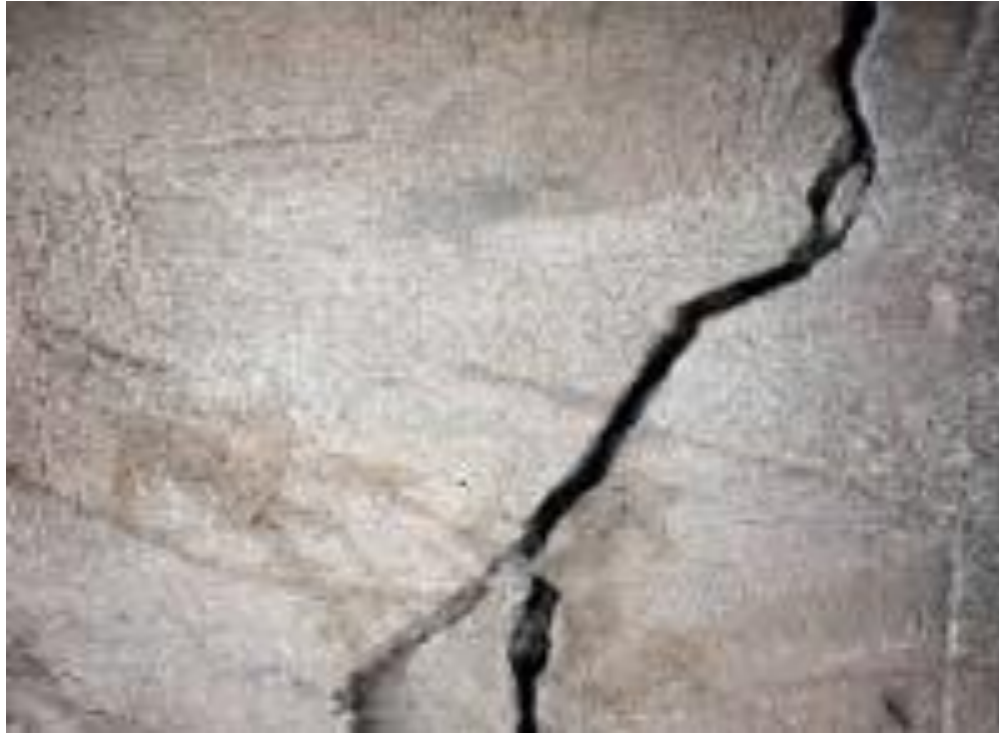
Offset cracks occur due to uneven surfaces below the concrete surface. They are characterised by an elevation differential across the crack. The cause can be due to various reasons such as subgrade settlement, external pressure due to tree root action, poorly consolidated base beneath the concrete and expansive soils. These cracks need to be addressed immediately once they start appearing as they pose safety concerns to the structure. Offset cracks can be as wide as 5 mm if not addressed immediately and Figure 9 below is an example of an offset crack (Addis, 2009).

Figure 9: Offset cracking (CRM1-279, 2012)

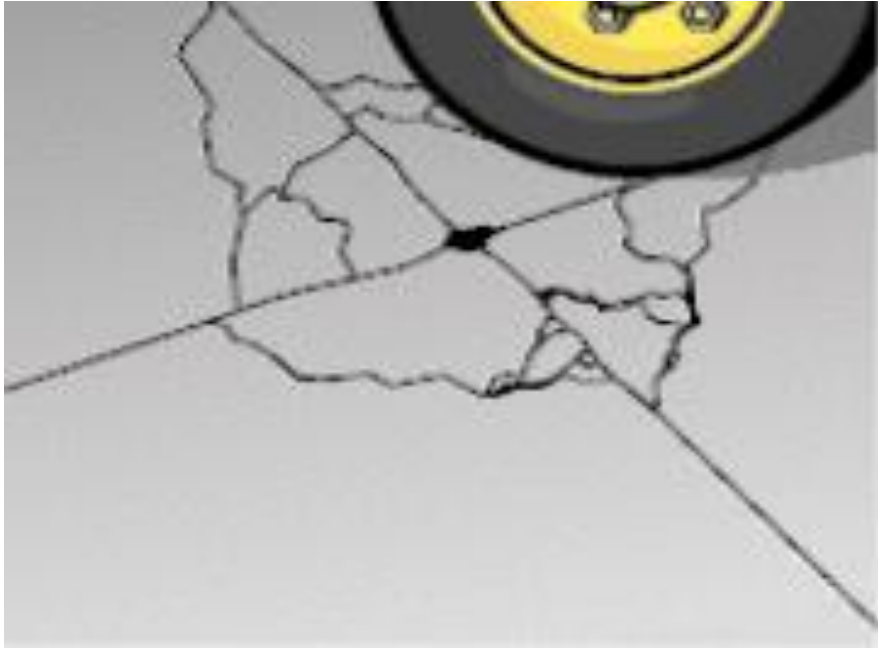
Diagonal corner cracking occurs when a crack runs from one joint to its perpendicular joint at the corner of a concrete slab. Diagonal cracks are observed at the corners of slabs or at a joint intersection caused by warping, curling or by overloading of the slab. The crack widths can be greater than 2 mm in many cases. Warping is caused as a result of moisture differential whereas curling is caused by temperature differences between the bottom of the slab and the surface. An example of overloading is a vehicle driving over the curled corner with no support resulting in the breaking of the concrete as indicated on Figure 10 below (Allam, 2012).

Figure 10: Diagonal cracking (Kumar, 2000)

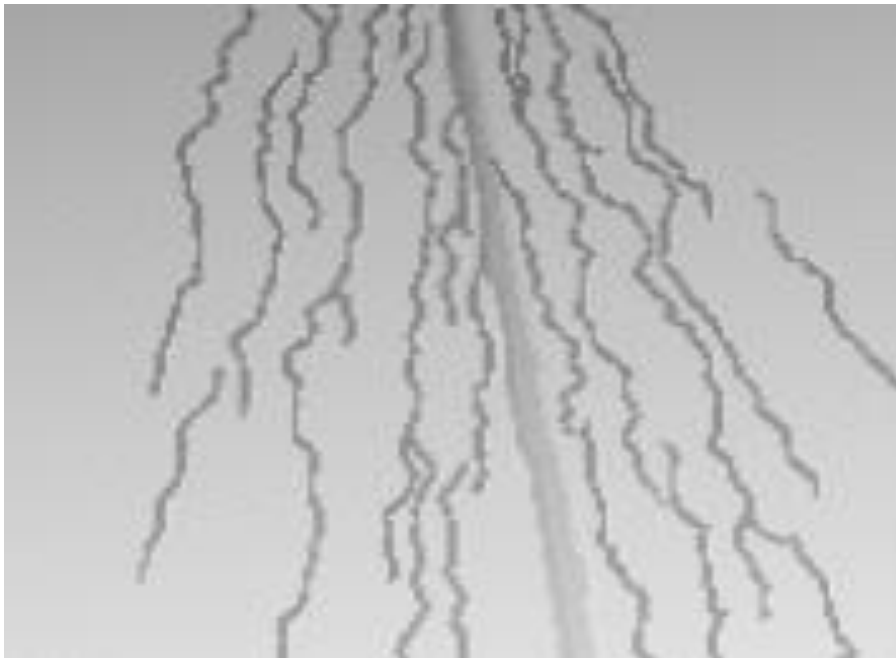
Another type of cracking rarely experienced in concrete structures is the D-crack. This type of cracking is a terminal condition or progressive scenario and does not have a cure. The D-cracks are usually observed as a series of cracks parallel to a joint as indicated on Figure 11 below. Technically, the cracks are a result of moisture infiltration through the joint to the concrete aggregates that will crack under the freezing and thaw conditions. D-cracks can be as wide as 1mm and due to the fact that the concrete near the joint is usually saturated, freezing begins to crack the aggregates and the concrete. These types of cracks are usually experienced in areas where there are high variations of extreme temperatures (Martin, 2008).

Figure 11: D-cracking near a concrete joint (ACI, 116R)

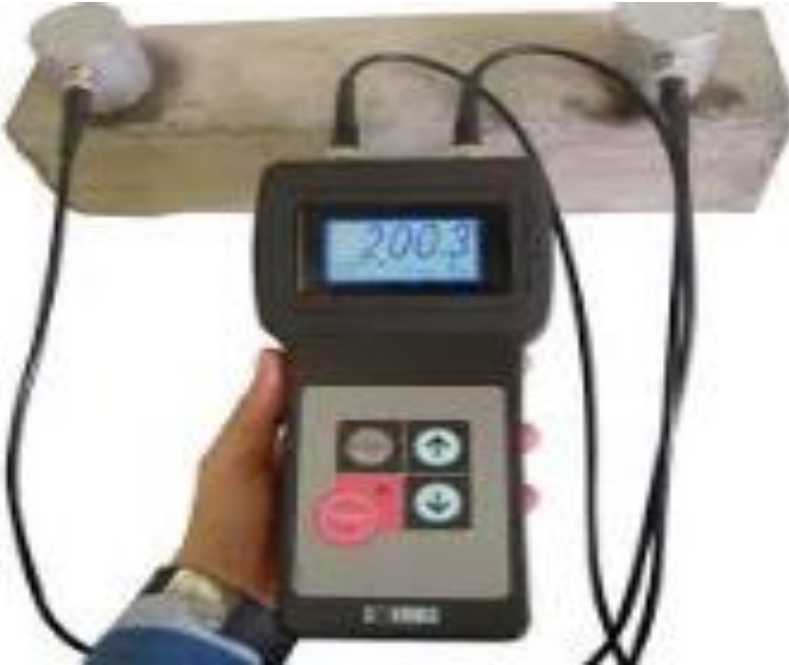
two transducers is measured electronically. The pulse velocity V is obtained by dividing L by T (Komolos, 1995).

Figure 12: Ultrasonic pulse velocity test (HB84, 2006)

The transmission of an ultrasonic pulse is related to the elastic properties and the density of the concrete. The advantages of ultrasonic pulse velocity is that it provides faster and more accurate results without causing destruction or damages to the concrete elements. Some of the challenges for using this method are that it requires manual operations, which require high accuracy and experience (Maierhofer, 2003). Recently, the ultrasonic pulse velocity methods have been used in the UK for dams that were showing significant signs of concrete cracking due to alkali-silica reactions and did provide some guidance on the state of concrete deterioration conditions (Hammersley, 2008).

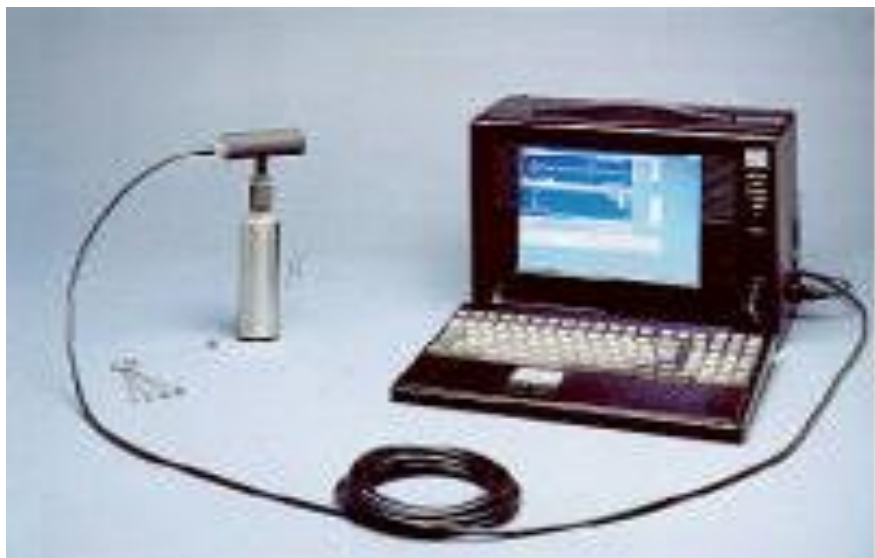
The Impact-echo testing methods is a common non-destructive testing technique of concrete used to determine cracking in concrete. It was invented and diverse applications were developed through research groups such as Cornell University and the US National Bureau of Standards. A setup of the equipment is shown on figure 13 below. This method can be used to detect honeycombing, voids, debonding and delaminations in concrete structures. It functions through propagation of sound waves through concrete which are then reflected by internal flaws and external surfaces

Figure 13: Impact Echo demonstrations (CRM1-279, 2012)

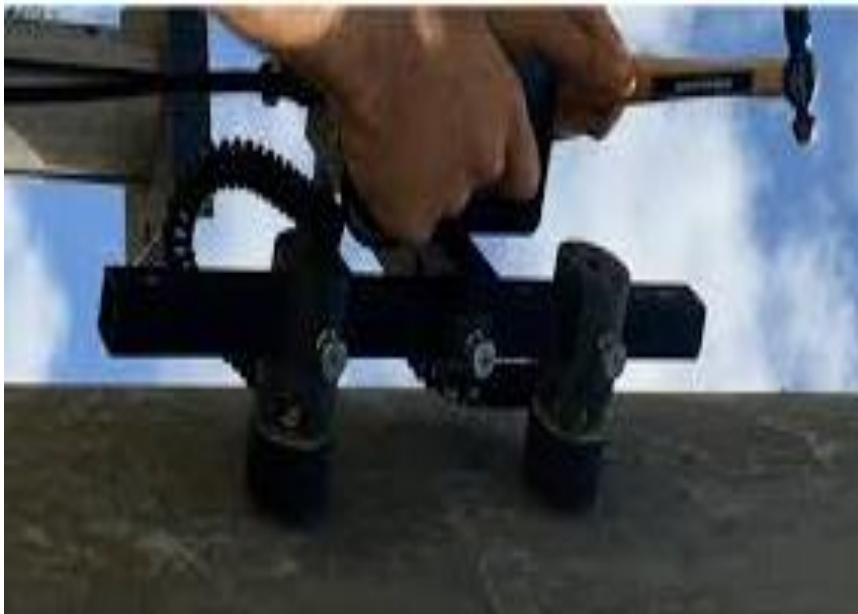
Wave propagation characteristics are influenced by the severity of internal defects such as cracking, delaminations, voids and honeycombing. The properties of mechanical waves such as the amount of wave energy or wave velocity reflected from an interface between two distinct media are a function of the mass density of the solid material or the elastic properties. For instance, the velocity of these waves propagating through a material are controlled by the density of the material and elastic moduli i.e. Shear Modulus, Young's Modulus and the Poisson's ratio (Algernon, 2008).

Figure 14: Spectral Analysis of Surface Waves (CRM1, 2015)

The equipment required to do the test include wave detection sensors, wave source, data acquisition and analysis system. The wave source is typically provided by a local impact event such as the impact of a hammer on the surface of concrete or a steel sphere. The impactor size

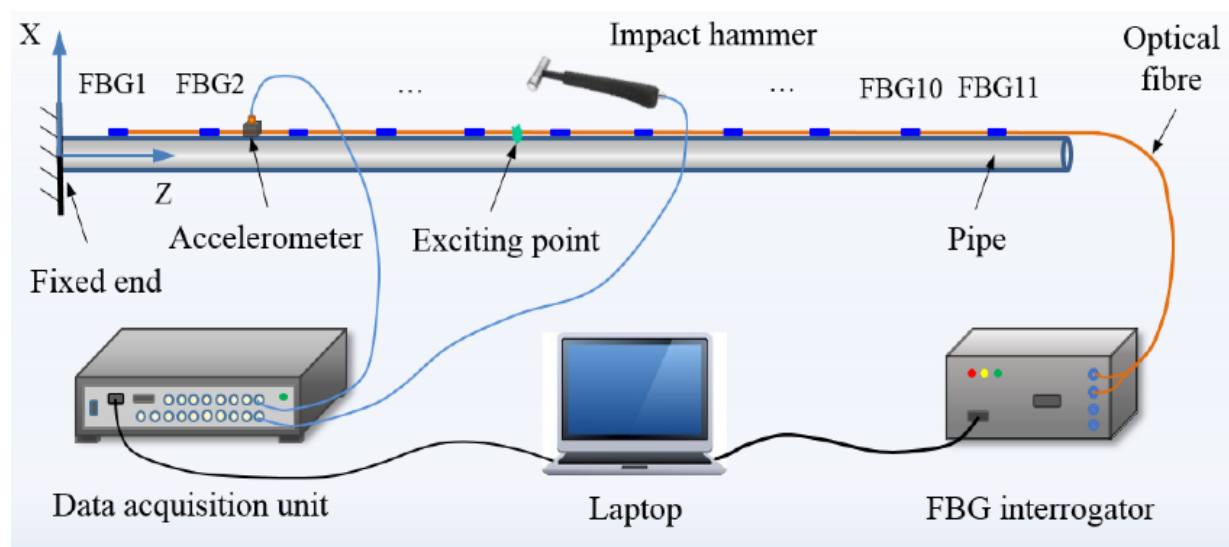
This is another method of determining concrete cracks through forcibly vibrating the whole structure or use of large vibrators under normal loading while monitoring the frequencies of the structure consistently. The natural frequencies of the structures are determined and compared to the natural frequencies of the built-in models. Faults and damages on the structure result in the reduction of frequencies of the structure. The determination of cracks can be through Hilbert-Huang Transform method or through computer models (CRM1, 2015).

Figure 15: Demonstration of Modal Analysis (CRM1, 2015)

Several studies have been done to detect cracks in concrete beams using modal analysis. A crack in a beam element introduces local flexibility of which the dimensions depend upon a number of degrees of freedom considered which would have been expressed by a local flexibility matrix. The flexibility matrix of cracked elements has been concluded using an approach based linear fracture mechanics theory. Numerical studies are performed by considering a simply supported beam with single and multiple cracks at different locations with different crack depths (CRM1, 2015).

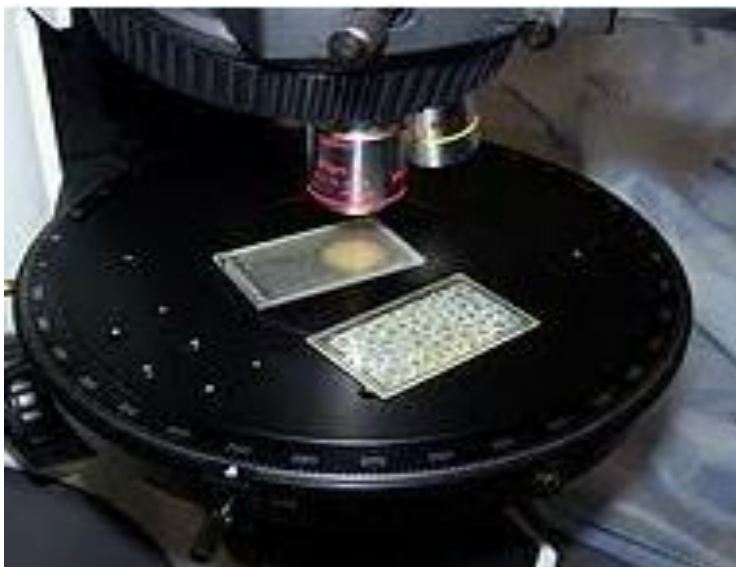
This method can be argued that it is not a crack detection technique but it is used for determining the cause of cracking. However, other sources such as the HB84 (2006) describes petrographic analysis as a method that can be used for detecting the possible causes of damages such as crack locations, concrete homogeneity, air content proportion of aggregates and the concrete ingredients. It can also detect the effects of ASR and it needs an experienced person to do the tests. The test can be used in conjunction with other physical or chemical analysis. Petrography can frequently determine the relative age of cracks and can identify secondary deposits of fractured surfaces which have an influence on repair methods. It can also identify other factors that may be related to cracking such as the relative paste volume, water to cement ratio and distribution of concrete components (HB84, 2006).

Figure 16: Demonstration of petrographic analysis (HB84, 2006)

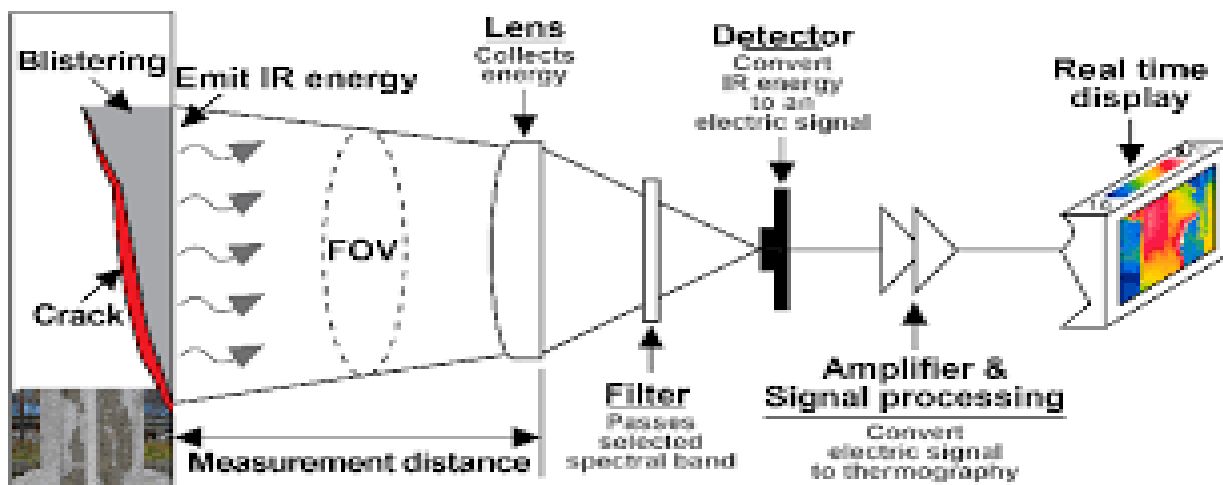
Infrared thermography has emerged as an effective, convenient and economical method to detect the propagation of cracks and determining their width with the substrate structure of the composite system. This method is used to detect crack growth internally within the concrete and is effective in situations where the temperature differential between the surfaces is too high. It has some important qualities such as being repeatable, economical and does not inconvenience the public (Inagaki, 1999).

Figure 17: Demonstration of infrared thermography (Inagaki, 1999)

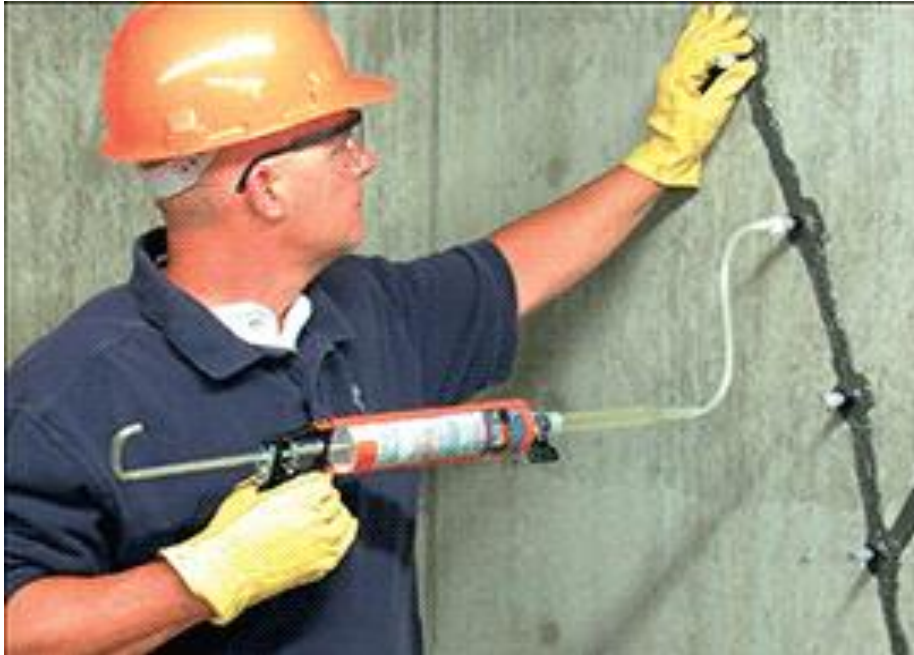
Whiting (1992) describes this method of concrete crack repair as being economical and effective when repairing non-moving cracks in concrete walls, slabs, piers and columns. It is closely related to epoxy injection which is a known concrete crack repairs technique. This method has been in use since the 1940s and is capable of restoring the concrete to its pre-cracking condition without increasing its strength. This is one of the most common method used recently to repair cracking in concrete structures and can repair narrow cracks close to 0.05 mm (Gaul, 1993). The repair materials must constitute certain properties to ensure durability. Some of the properties include low viscosity, good workability, mix stability, aging resistance, compatibility of the substrate material and strength. Figure 18 below presents crack injection using epoxy resins (HB 84, 2006).

Figure 18: Crack injections using epoxy resins (Nomura, 2013)

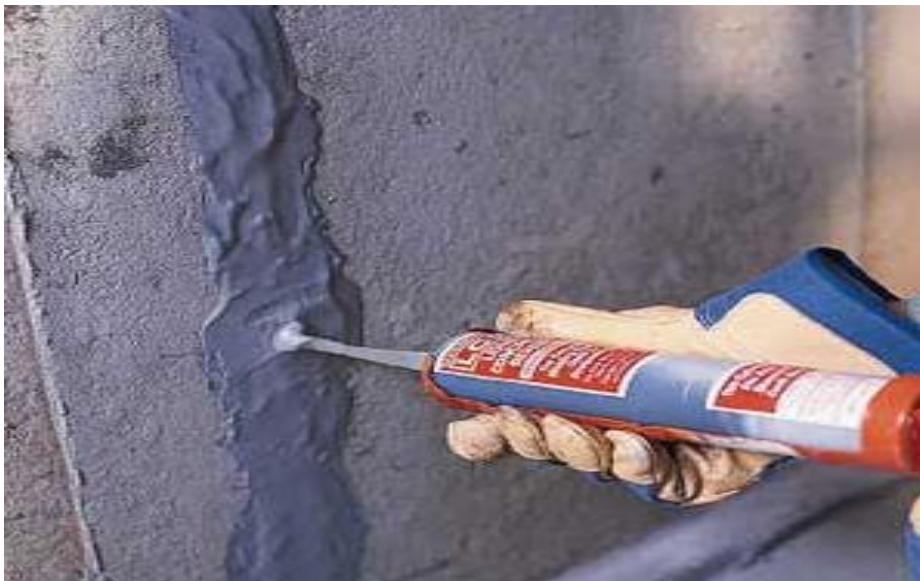
ASTM C 881 Type 4 outlines the repair materials and techniques used for epoxy injections. Figure 19 below shows crack sealing using polyurethane products.

Figure 19: Crack sealing using polyurethane products (Aoyama, 2013)

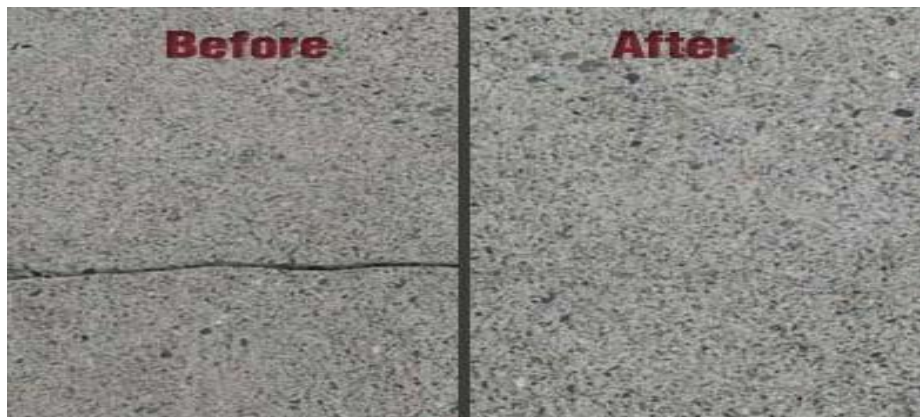
Grouting is used widely to repair concrete cracking ranging from narrow cracks such as 0.05mm to relatively wider cracks less than 2mm. It has been used to repair concrete structures since the 1950s and has been proved to be effective. Warner (2004) describes this method as effective in situations where cracks are in a straight line. It is also effective when repairing thick concrete walls and gravity dams using Portland cement grouting. Figure 20 below shows an example of a concrete crack repair using grouting method. It is recommended to repair concrete cracking showing signs of leakages such as water leaks (ACI 224.1R-07, 2007).

Figure 20: Portland cement grouting (Nojimu, 2007)

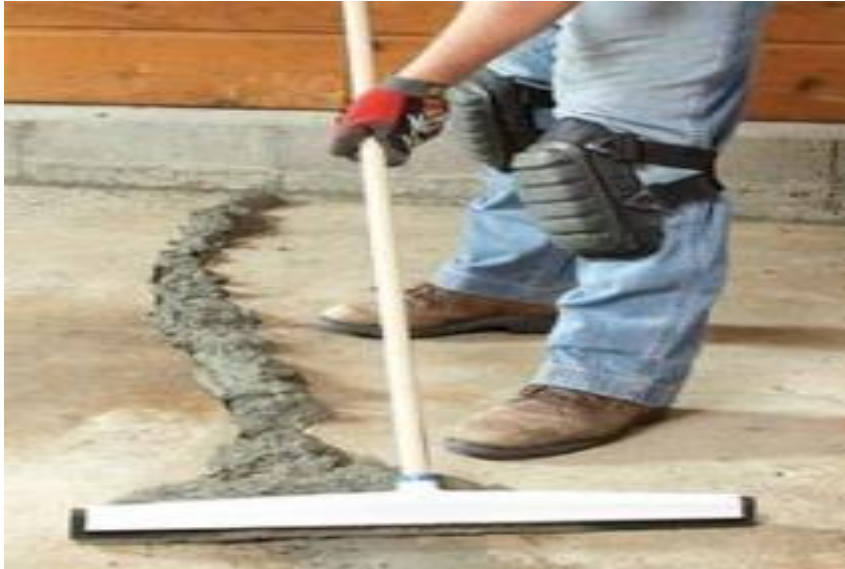
and 25 mm deep. The steps involved in executing the repairs include, cleaning the slot, leaving the slot to dry, application of a bond coating and compaction of the blunt (Addis, 2009).

Figure 21: Repair of concrete cracks through dry packing (Kamamoto, 2007)

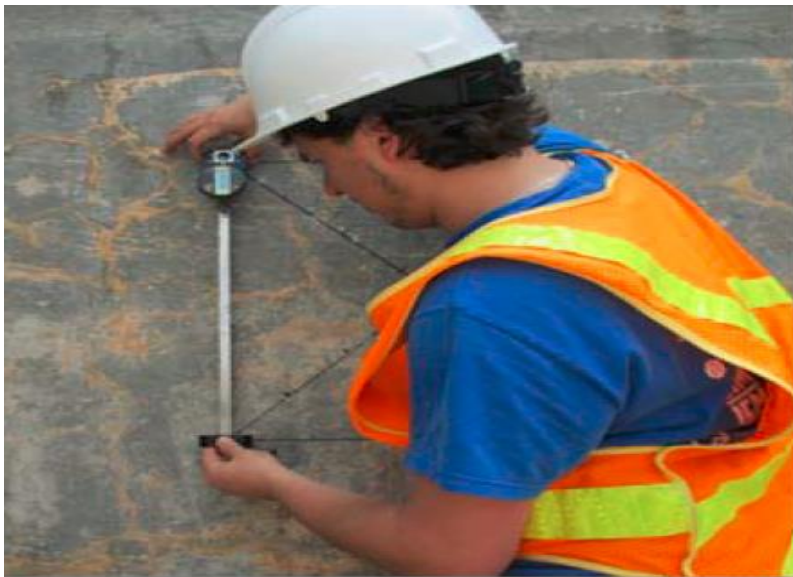
Following the petrographic examinations and the initial condition survey, the structures were selected for various treatments. The selected sections were instrumented to permit measurements such as the cracking index (CI), length change (expansion) and (RH) the relative humidity. After concluding the length, CI and RH parameters, different treatments were applied such as coatings, sealing and lithium treatment. Several periodic visits were conducted to monitor the changes in CI, RH and length. In most cases, visits would be conducted twice a year and in other instances once a year (Michael et.al, 2013). Length measurements were done using a strain gauge called the DEMEC type as shown on Figure 22 below.

Figure 22: DEMEC type strain gauge measuring length changes (Michael et.al, 2013)

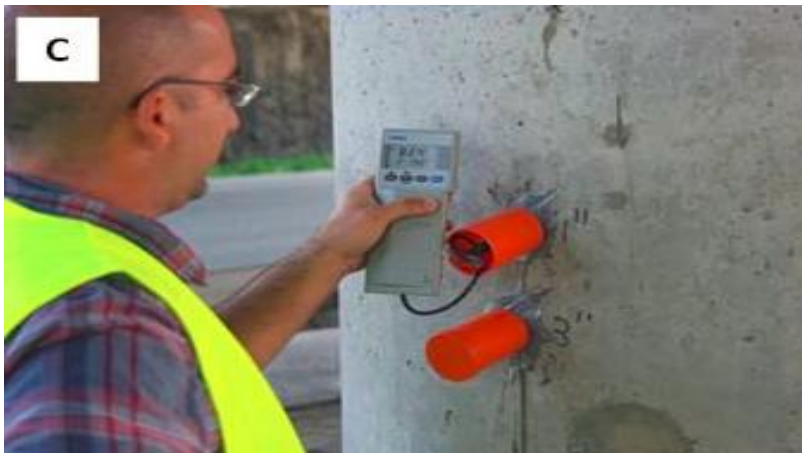
Figure 23: Relative humidity probes inserted into the holes (Michael et.al, 2013)

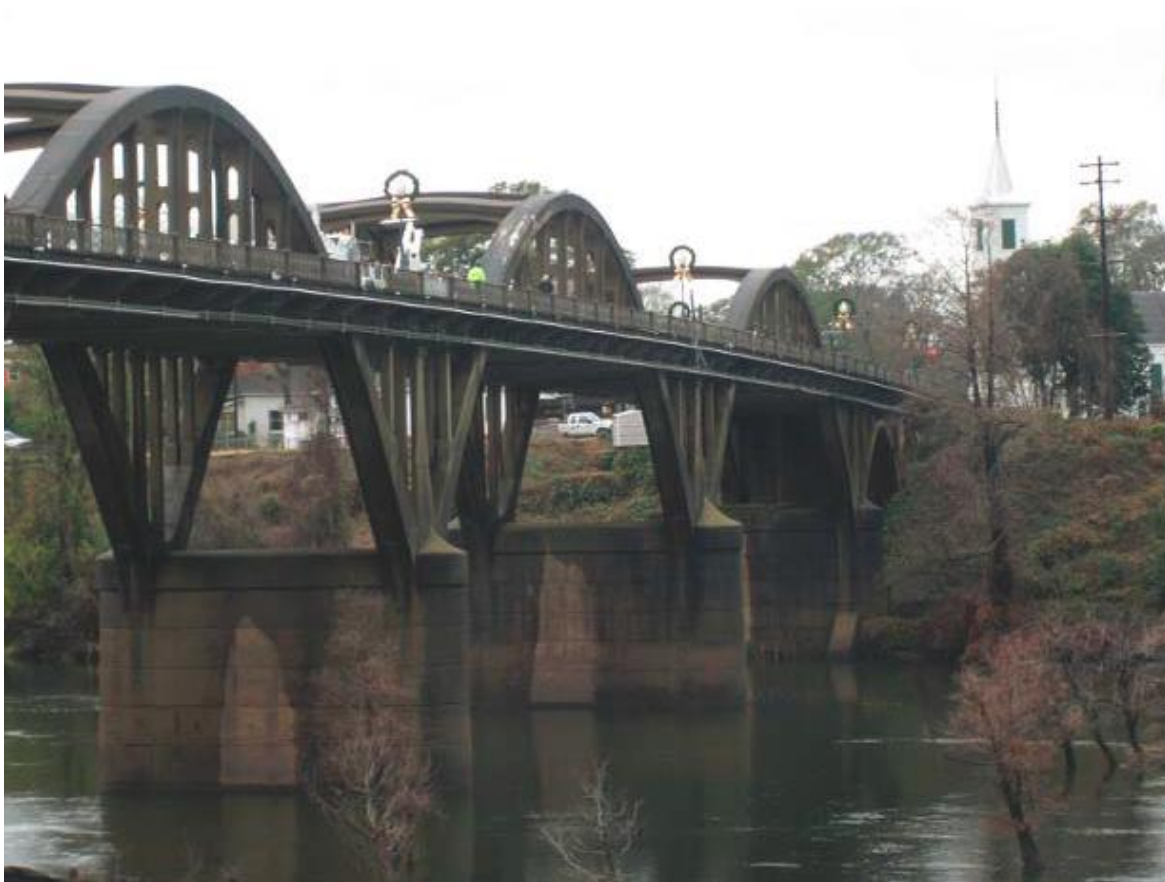
The field sites under investigations included the Alabama site, Delaware site, Massachusetts site, Texas Houston site and Maine Site. The Alabama site showed ASR-affected concrete arches at the Bibb Graves Bridge in Wetumpka as indicated on Figure 24 below. Technologies evaluated included systems such as the hydrophobic sealers i.e. the water based silanes and epoxy coatings. Built in 1931, the Bibb Grave Bridge comprises of seven parabolic arches.

Figure 24: Bibb Grave Bridge north face (Michael et.al, 2013)

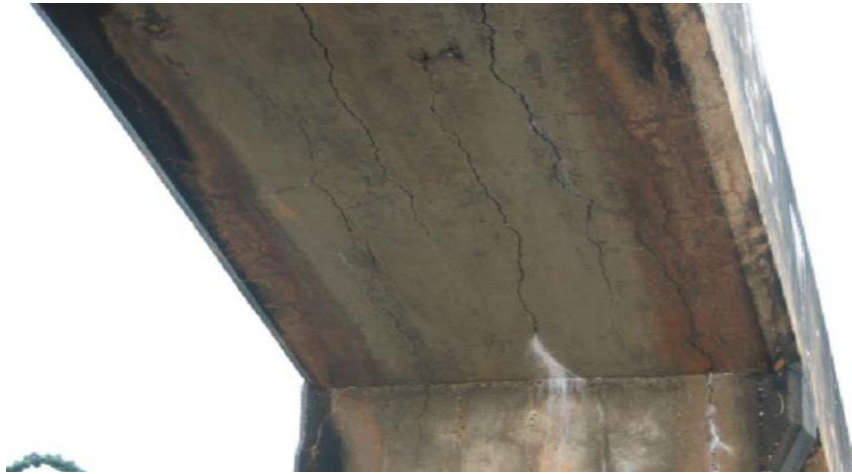
and 1081. Many cracks from the deteriorated arch were found to be filled with large amounts of ettringites (Michael et.al, 2013).

Figure 25: Cracking on top and underside of archway supporting the 5th span (Michael et.al, 2013)

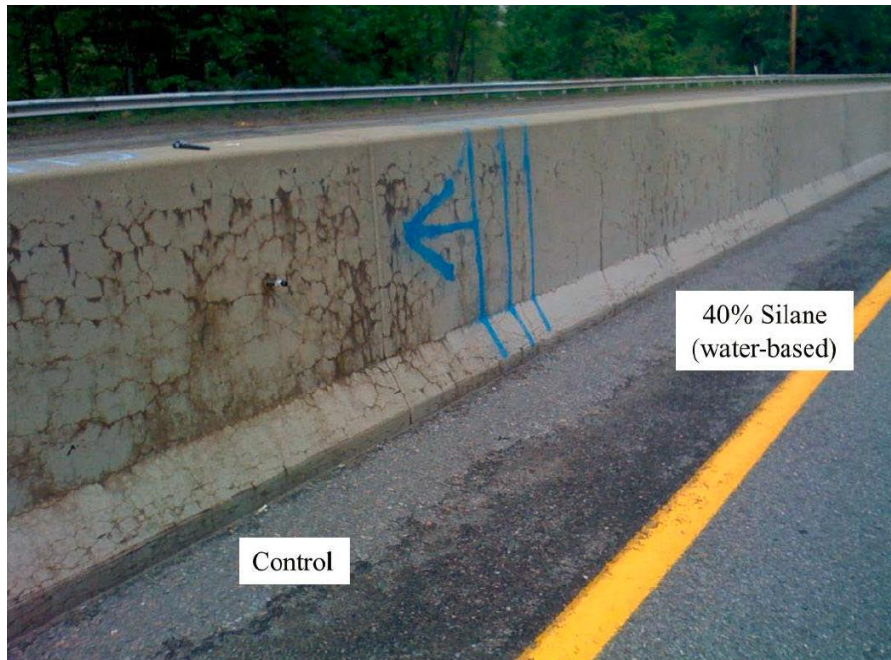
Figure 26: Visual contrast between control section on the left and a section treated with water based saline on the right at Massachusetts site (Michael et.al, 2013)

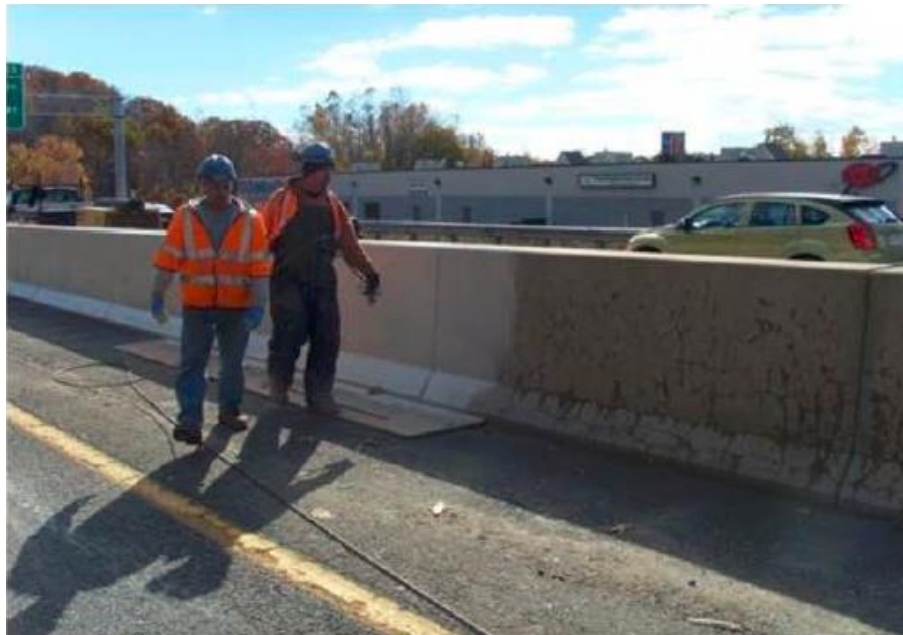
Figure 27: Typical ASR damage on barrier walls treated with elastomeric coating at Massachusetts site (Michael et.al, 2013)

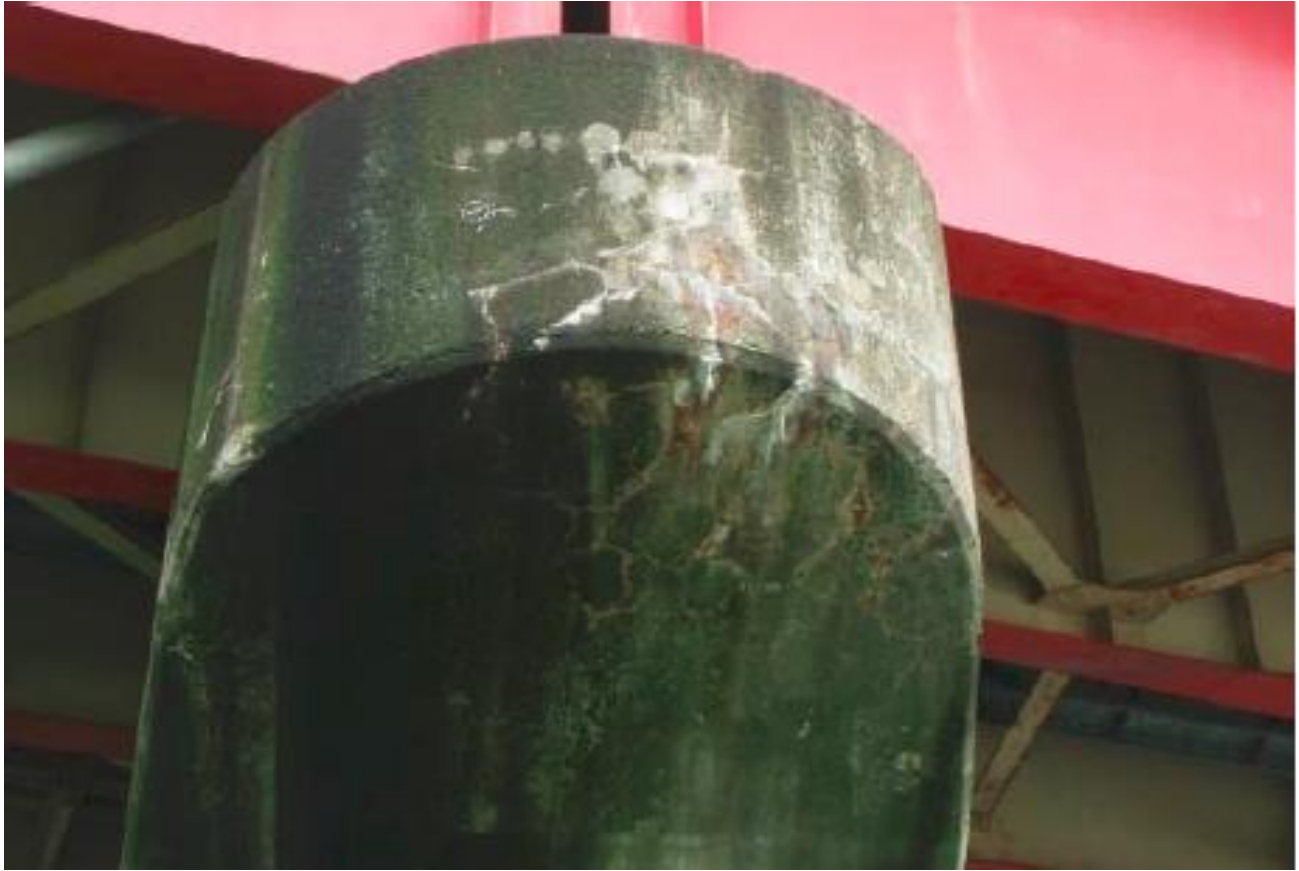
In Toyama, repairs were done using three types of continuous fiber sheet working as surface coatings namely epoxy, acrylic and urethane types as well as the surface treatments with sodium silicate polymer cement for section repairs with concrete jacketing and shotcrete. Urethane type of continuous fiber sheet performed well in cases of high ASR potential whilst the acrylic fiber sheeting coating proved to be effective in cases of low ASR potential.

Figure 28: Deterioration due to ASR (Nomura, M., et.al, 2012)

During 1995, the structure shown on Figure 28 above was repaired through surface treatment using sodium silicate. A few years later, cracks had occurred as indicated on Figure 29 below.
